## LKK Auto Consultants Pte Ltd

### 1. Policy Particulars :- THIRD PARTY CLAIM

## ADJUSTMENT ON REPAIR COST FOR VEHICLE NO. SJN 7560L

PHOTOGRAPHS FOR VEHICLE NO. SJN 7560L

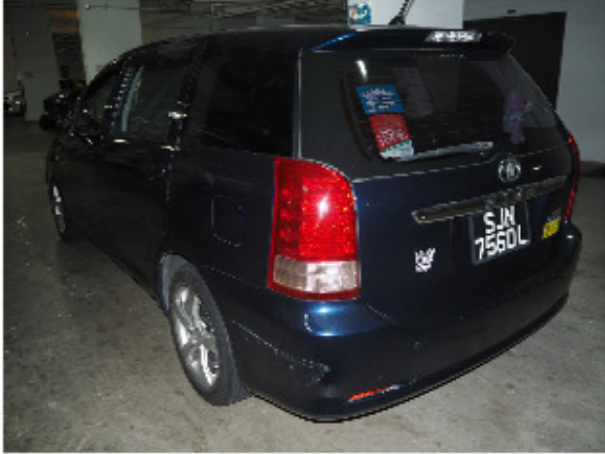
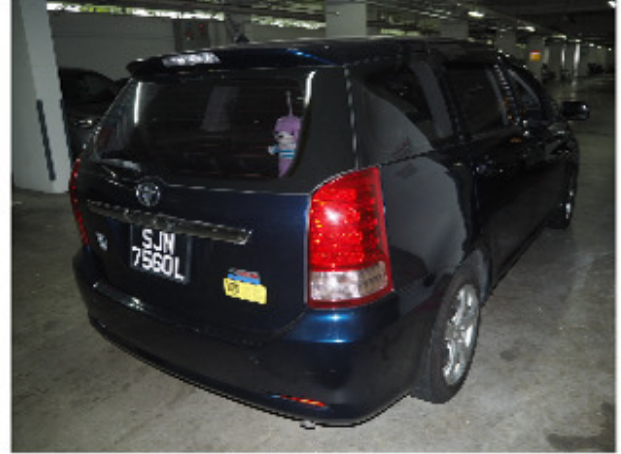
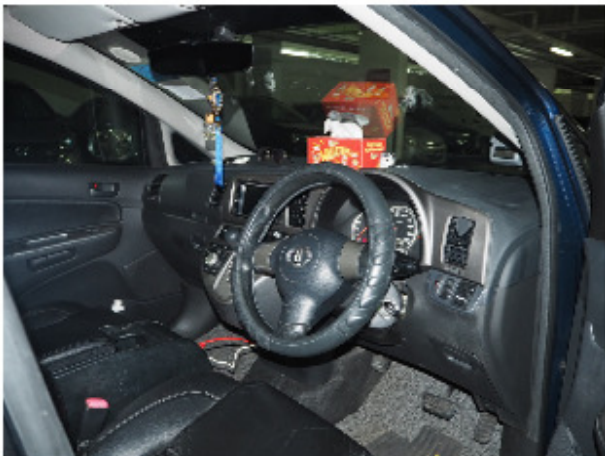
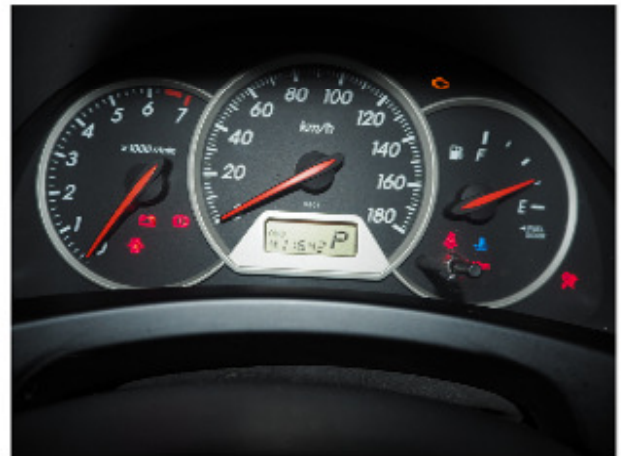
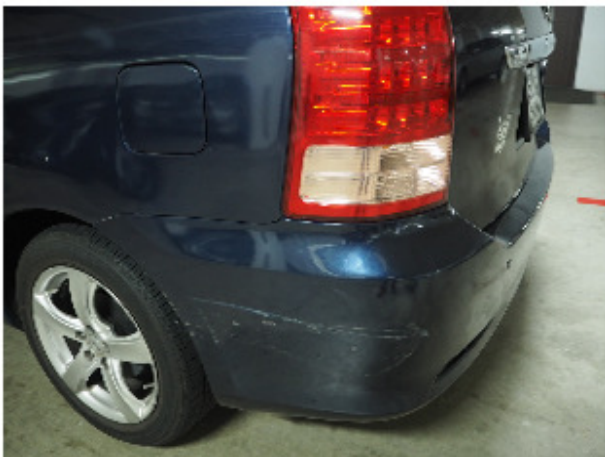
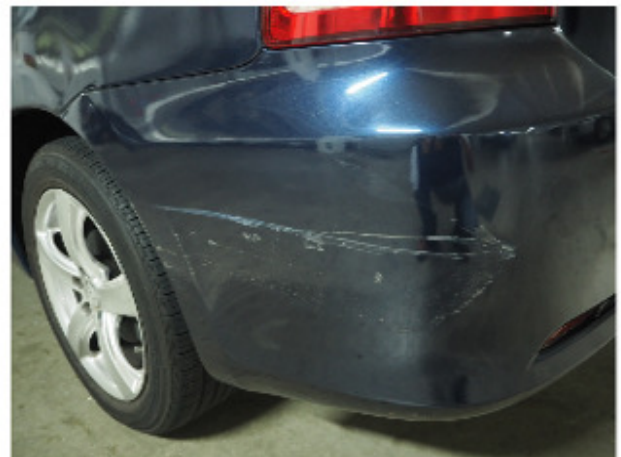
INSPECTION

THE VEHICLE SUSTAINED DAMAGES AT THE REAR N/S PORTION.
