Your Ref : SNM20D201575
Our Ref : CS/CTI20004810/N

18 August 2020

**AUTOMOBILE TECHNICAL INVESTIGATION REPORT OF ACCIDENT
INVOLVING SKT 5832Y AND SJQ 8981H ON 31 MARCH 2020**

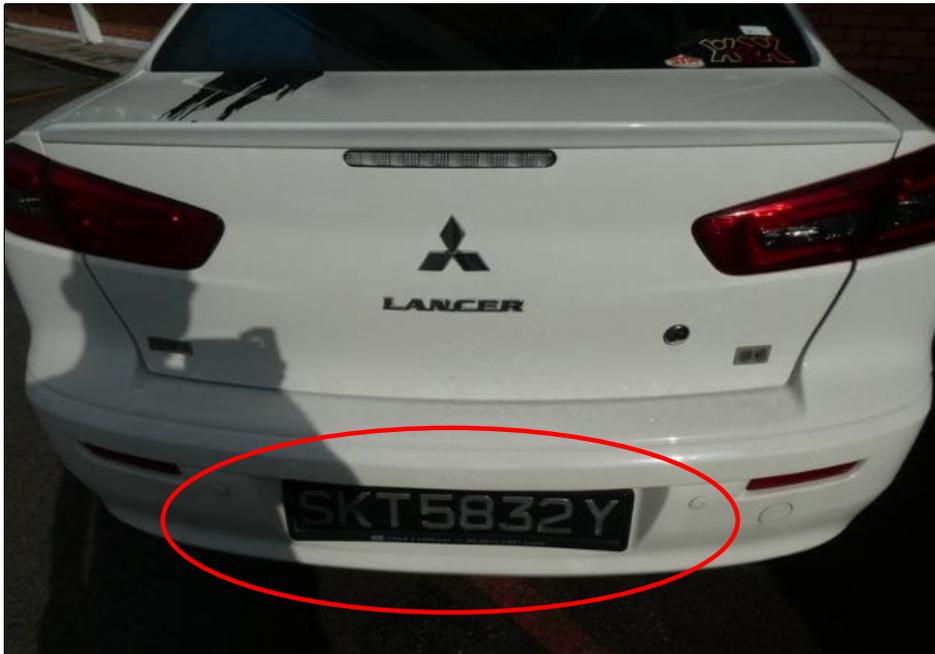
Photo 1 shows the general view of the rear portion of the Mitsubishi at the time of the Pre- Repair Survey conducted by LKK Auto Consultants Pte. Ltd. which was taken about 2 months after the accident. The damage to the Mitsubishi was observed to be confined to the rear bumper and rear number plate (circled).

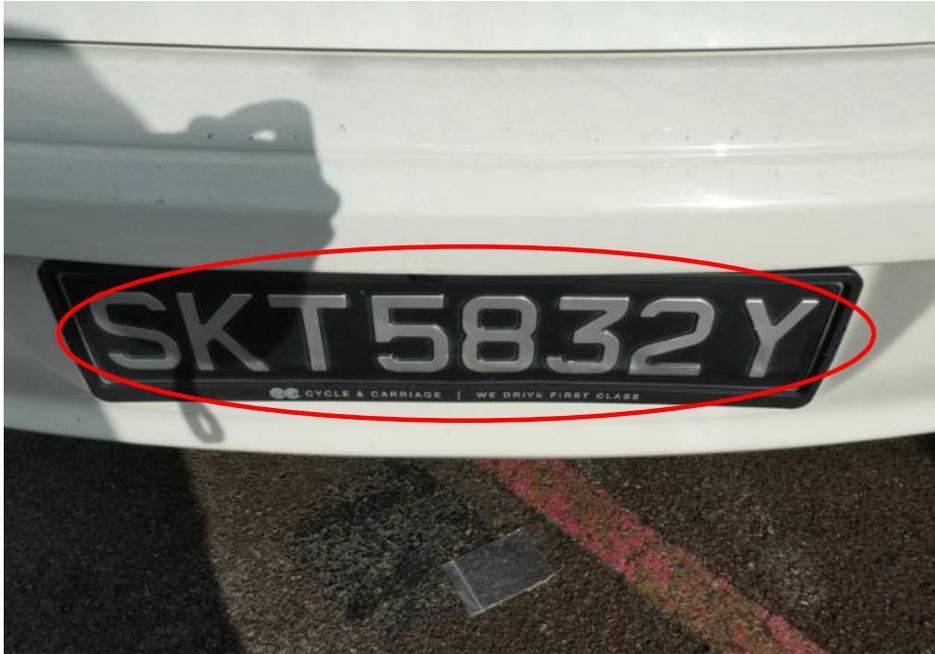
Photo 2 shows a closer view of the damage observed on the rear number plate (circled).

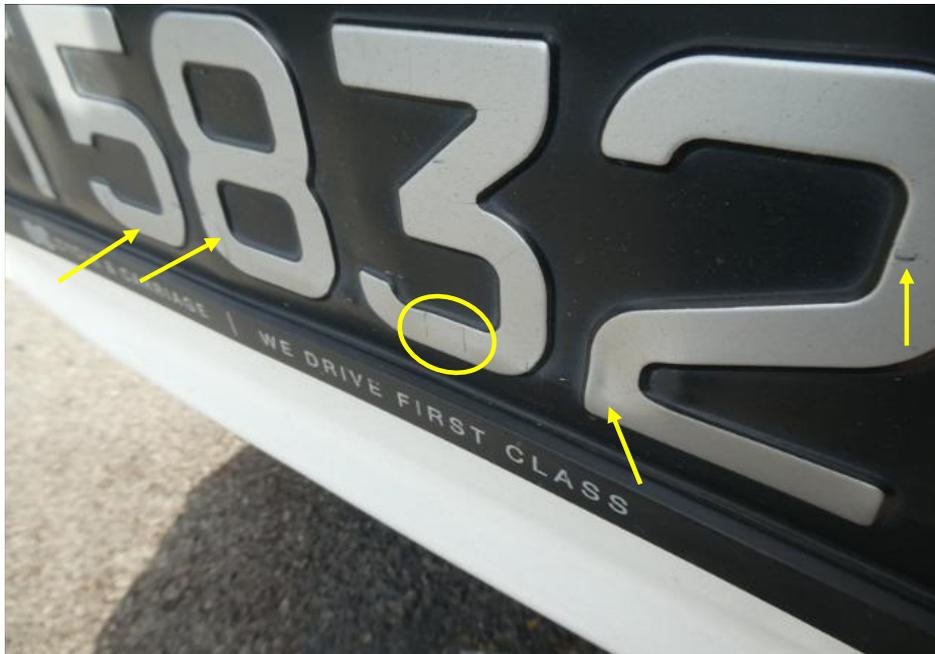
Photo 3 shows a close up view of the dents found some of the alpha-numeric letterings (arrowed) as well as 2 vertical black marks found on one of the alpha-numeric letterings of the rear number plate of the Mitsubishi (circled).

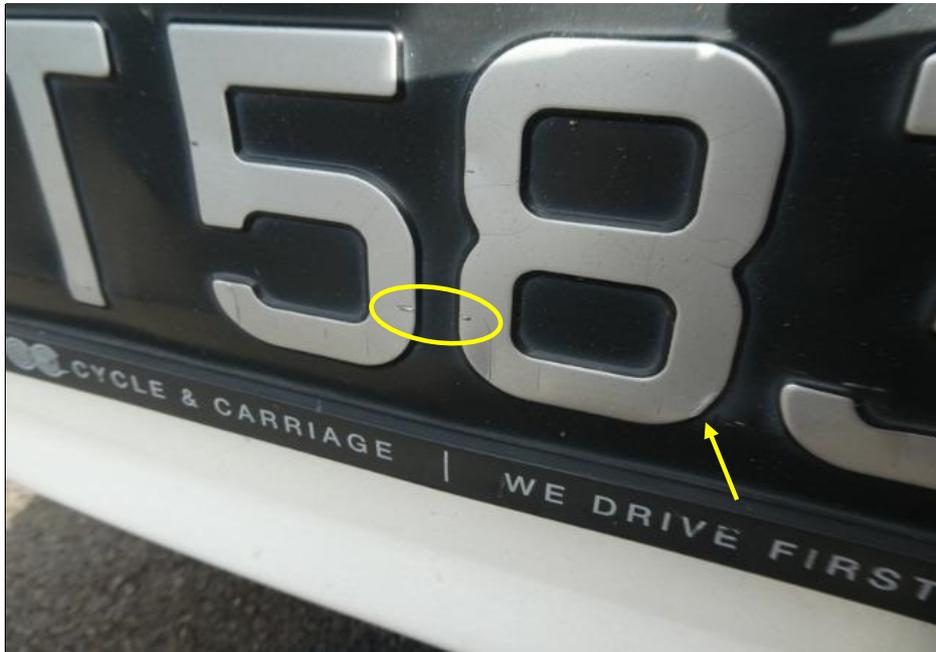
Photo 4 shows a close up view of the dents found some of the alpha- numeric letterings (arrowed) as well as 2 horizontal black lines found on one of the alpha- numeric letterings of the rear number plate of the Mitsubishi (circled).

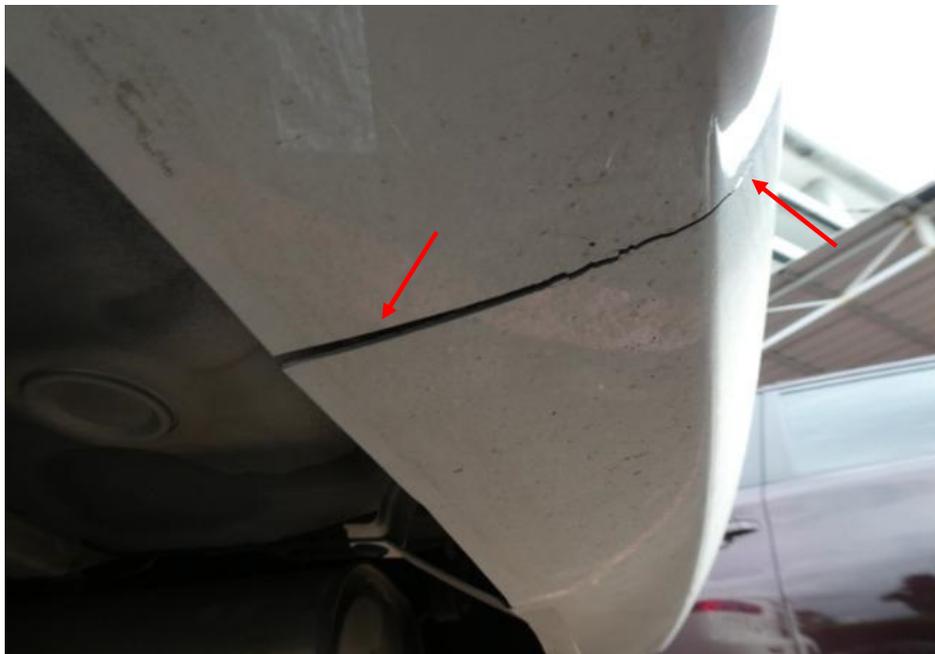
Photo 5 shows a close up view of the crack observed on the underside and lower centre portion of the rear bumper of the Mitsubishi (arrowed).

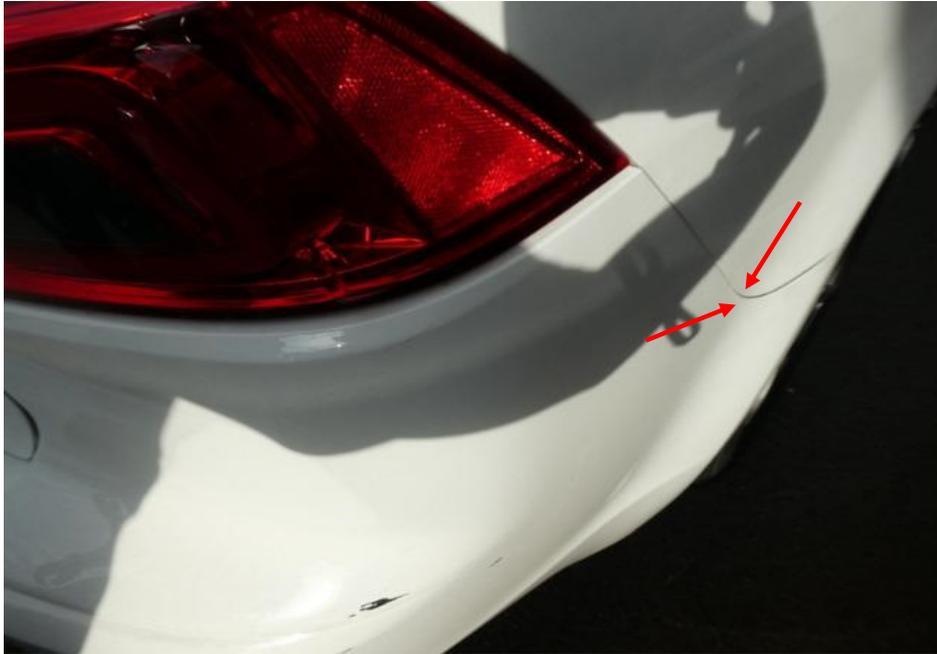
Photo 6 shows a close up view of the right corner edge of the rear bumper of the Mitsubishi. We observed that there was no misalignment at the corner edges (red arrows).

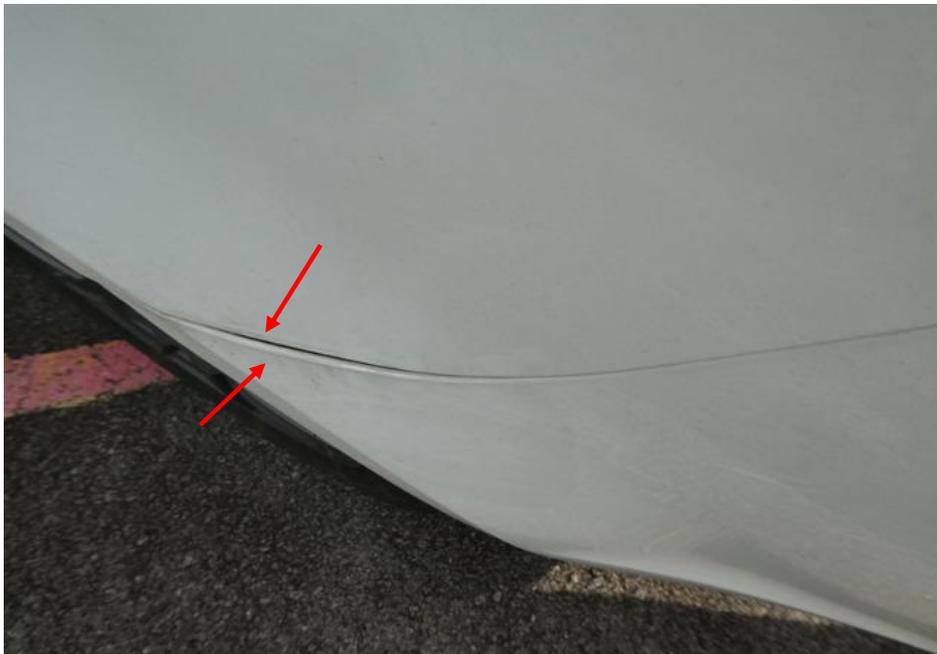
Photo 7 shows a close up view of the left corner edge of the rear bumper of the Mitsubishi. We observed that there was no misalignment at the corner edges (red arrows).

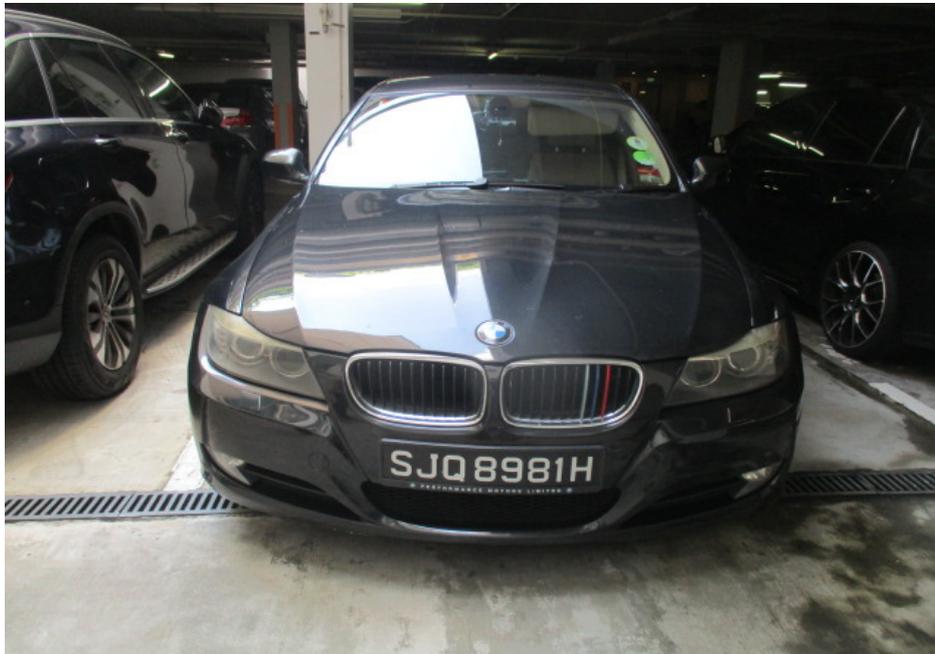
Photo 8 shows the general view of the front portion of the BMW at the time of our inspection. The physical inspection carried out had primarily focused on the front portion of the BMW, in particular its front bumper and front number plate as the accident was reported to be of a head to rear nature where the BMW was behind the Mitsubishi at the material time. The mileage recorded was 120, 932km.

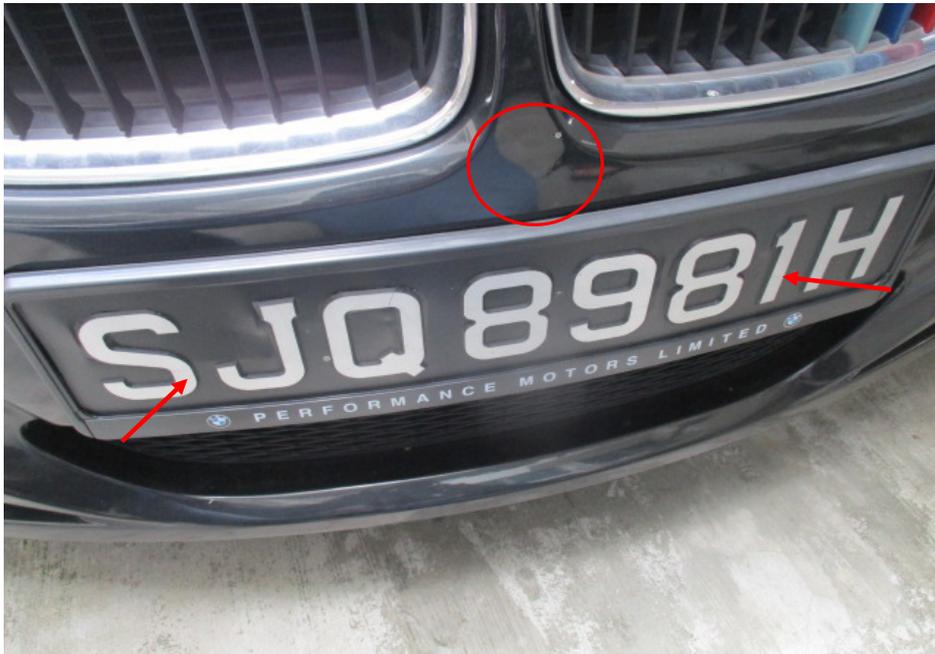
Photo 9 shows a closer visual examination of the BMW's front bumper which revealed a paint chip and cracks (circled). We also observed damages on some of the alpha- numeric letterings on the front number plate of the BMW (arrowed).

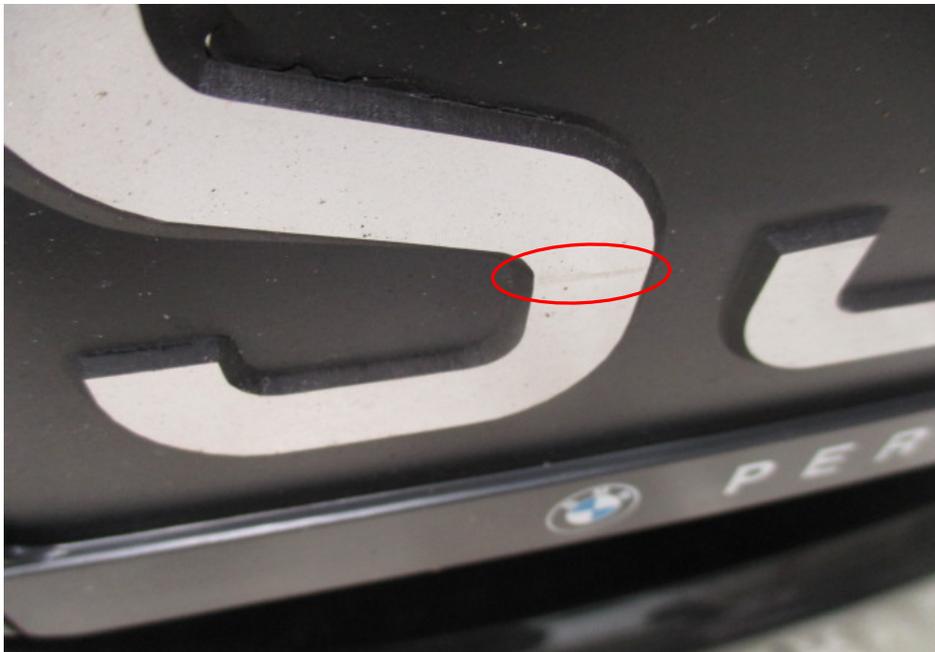
Photo 10 shows a close up view of the horizontal black mark on one of the alpha- numeric letterings of the BMW's front number plate (circled).

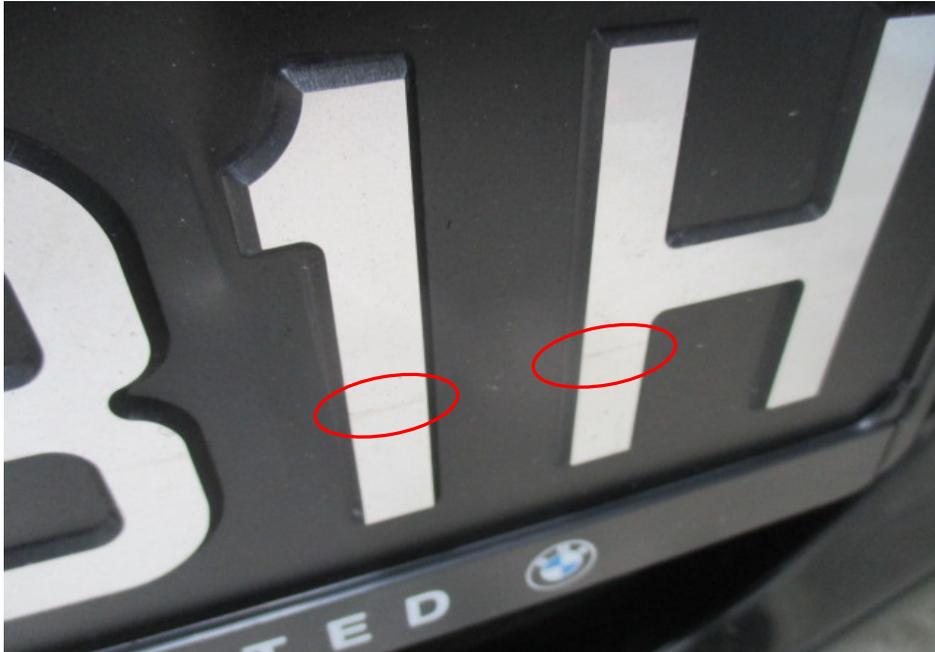
Photo 11 shows a close up view of the horizontal black marks on some of the alpha- numeric letterings of the BMW's front number plate (circled).

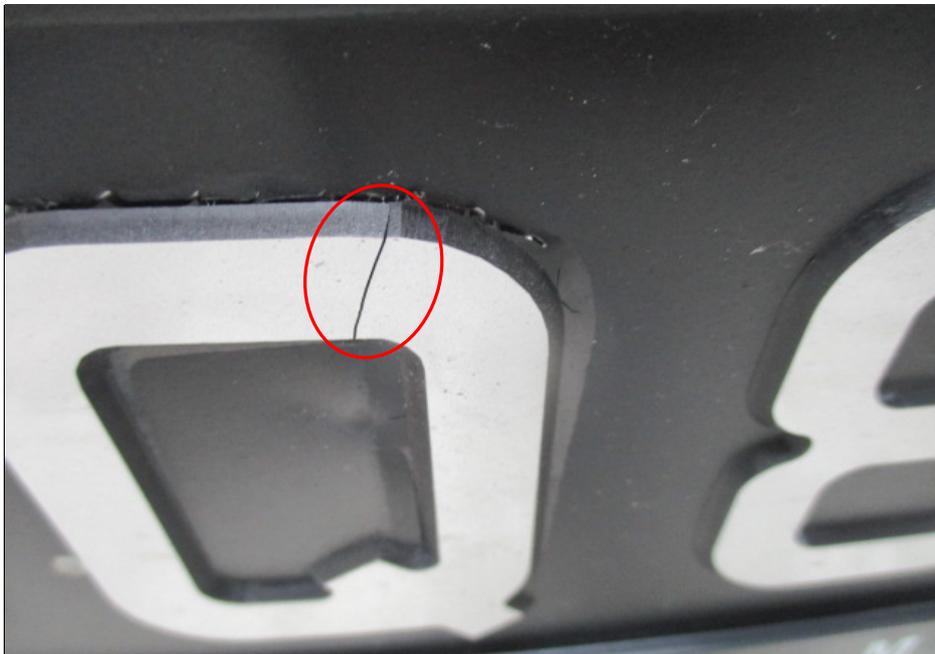
Photo 12 shows a close up view of a crack observed on one of the alpha- numeric letterings of the BMW's front number plate (circled).

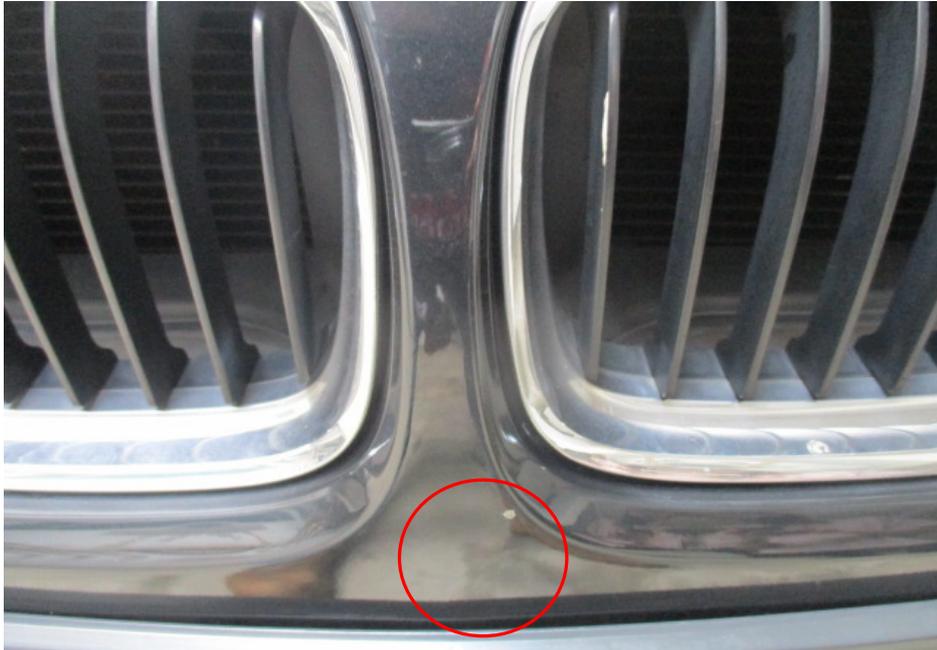
Photo 13 shows a closer view of the paint chip and crack observed on the BMW's front bumper (circled).

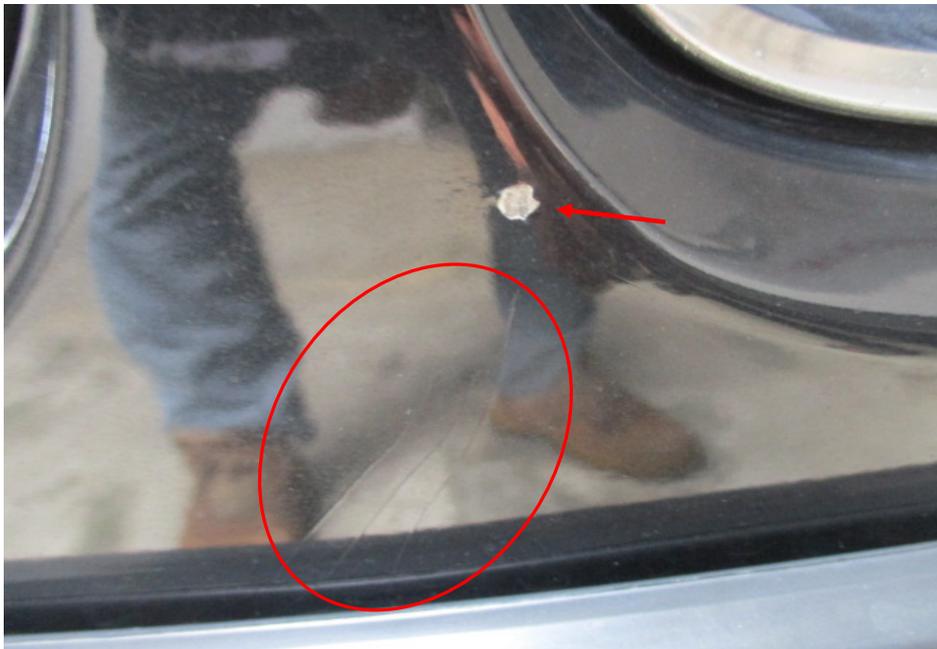
Photo 14 shows a close up view of the paint chip (arrowed) and cracks (circled) observed on the BMW's front bumper.

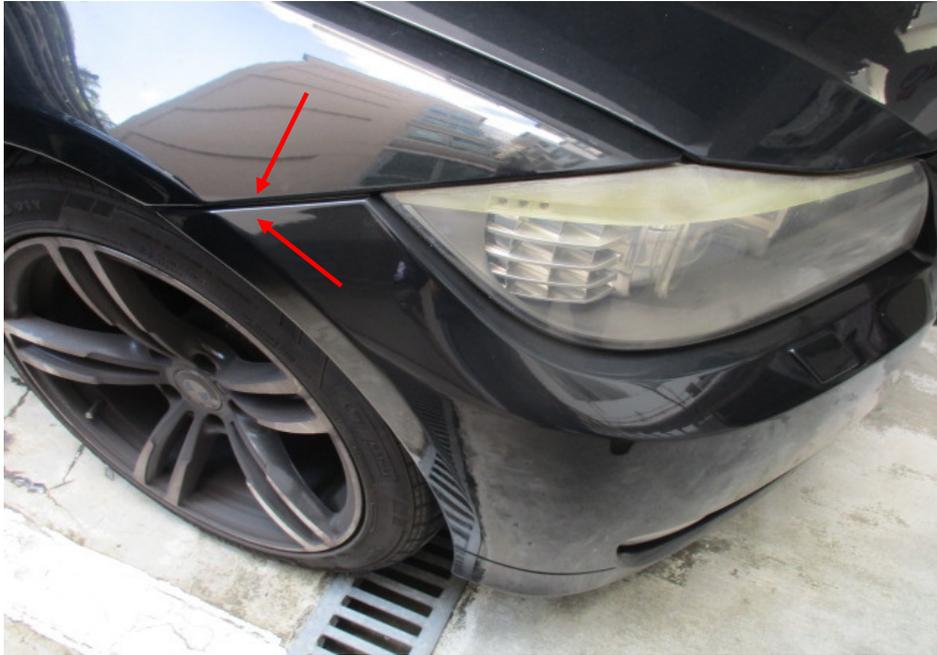
Photo 15 shows a close up view of the right corner edge of the front bumper of the BMW. We observed that there was no misalignment at the corner edges (red arrows).

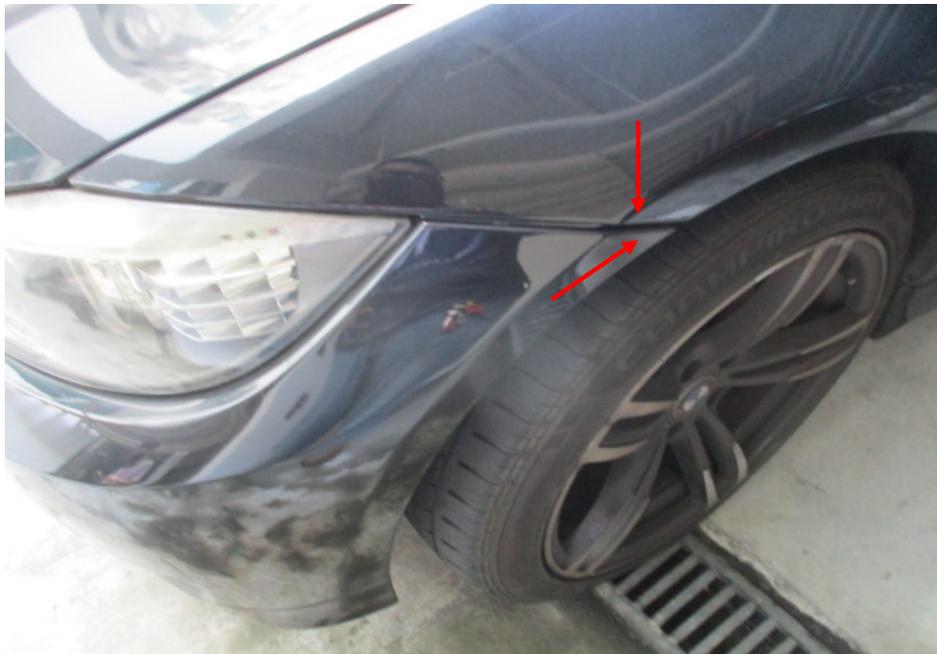
Photo 16 shows a close up view of the left corner edge of the front bumper of the BMW. We observed that there was no misalignment at the corner edges (red arrows).

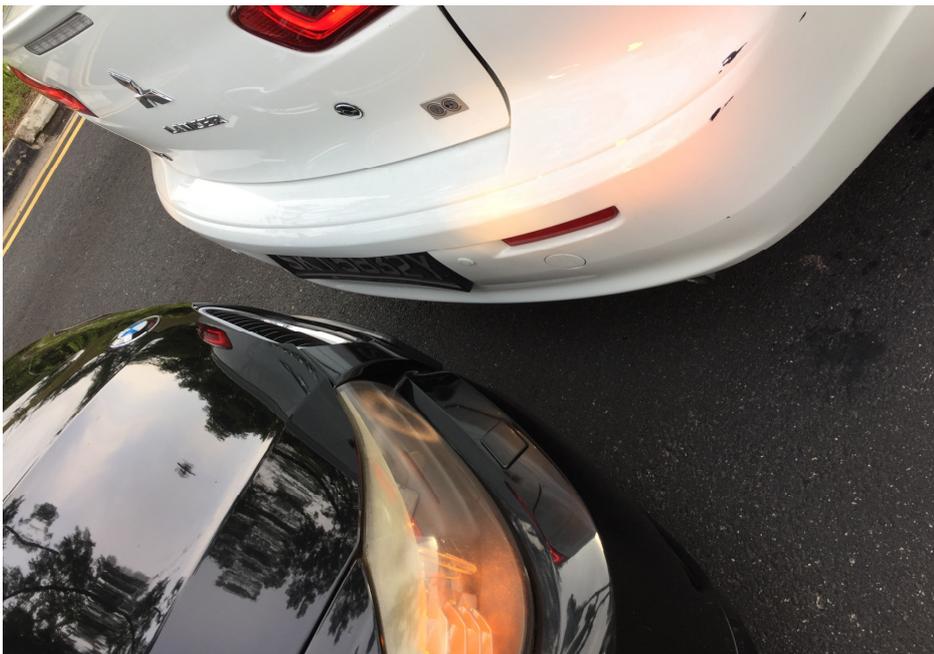
Photo 17 shows the position of the Involved Motor Cars at the accident location. The BMW was observed to be directly behind the rear of the Mitsubishi. In such a position, the front number plate of the BMW would have come into contact with the centre lower portion of the rear bumper of the Mitsubishi as the front number plate was the most protruded body part at the frontal portion of the BMW.

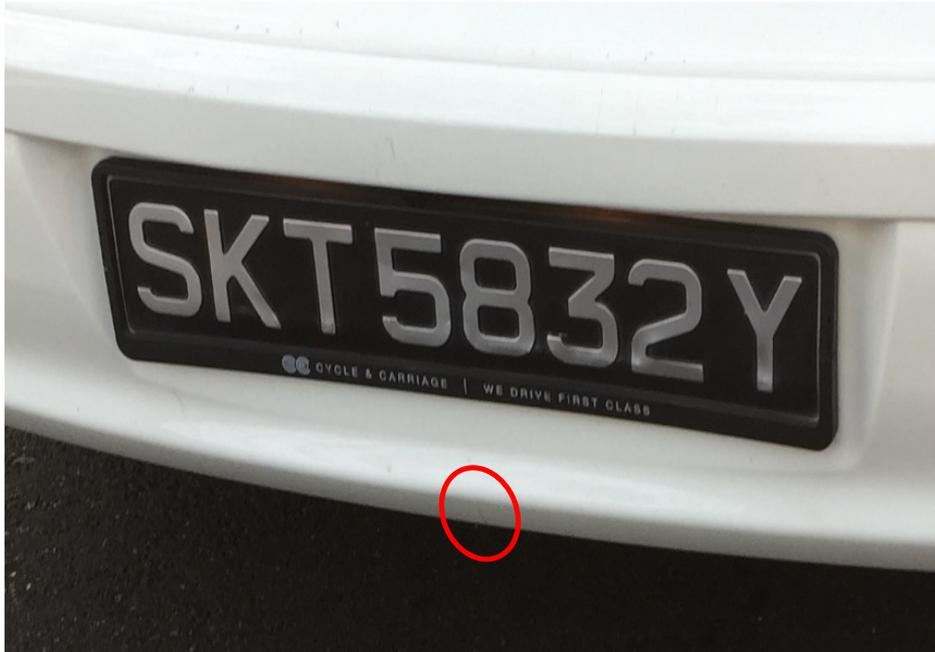
Photo 18 shows a closer view of the rear portion of the Mitsubishi post-accident. Upon closer examination, we observed a crack at the centre bottom portion of the Mitsubishi's rear bumper (circled).

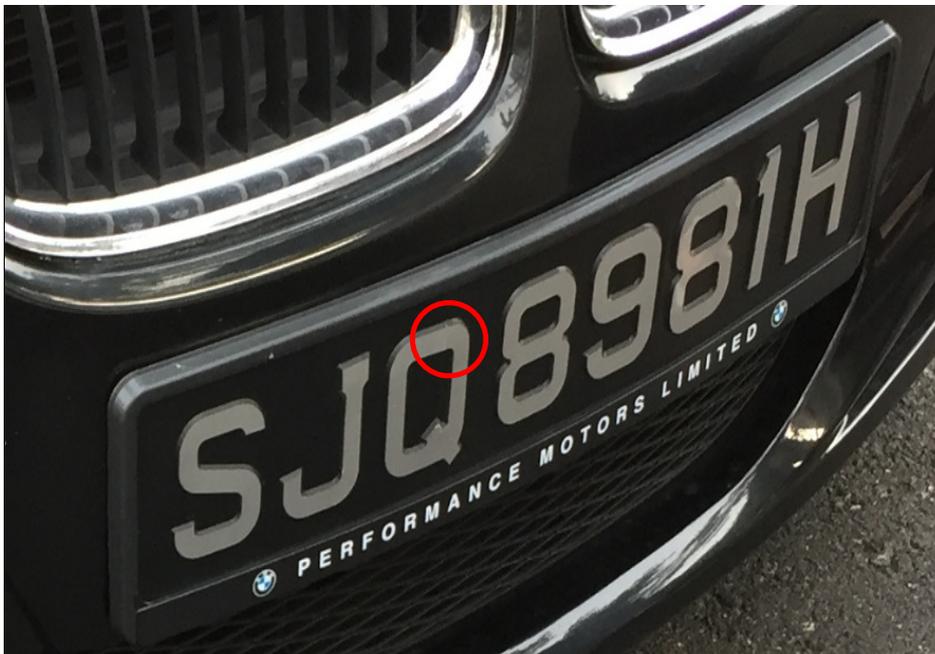
Photo 19 shows a close up view of the front number plate of the BMW post-accident. Upon closer examination, we observed a crack on one of the alphanumeric letterings of the BMW's front number plate (circled).

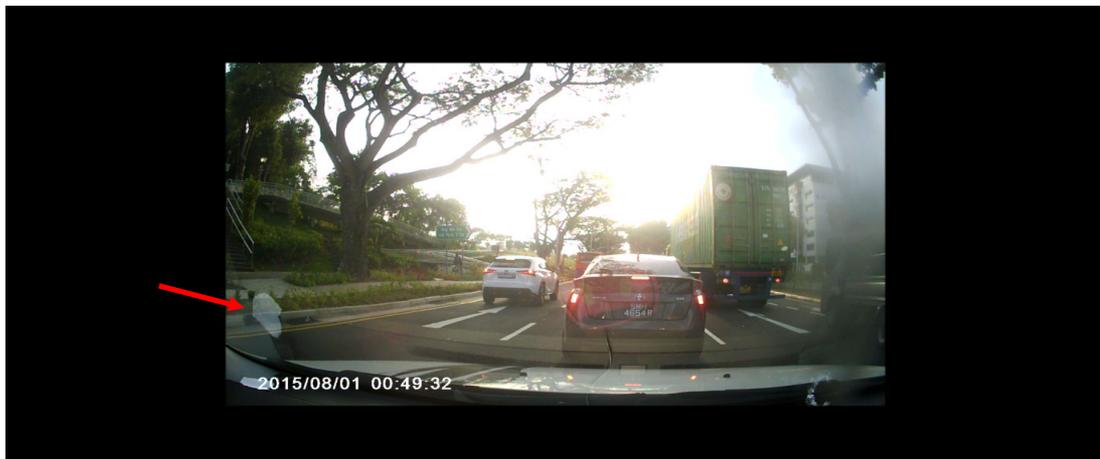
Screenshot 1 shows the 4 second mark of the video recording. The Mitsubishi could be seen coming to a stop at the traffic junction. The white object on the left side of the dashboard is stationary (arrowed)

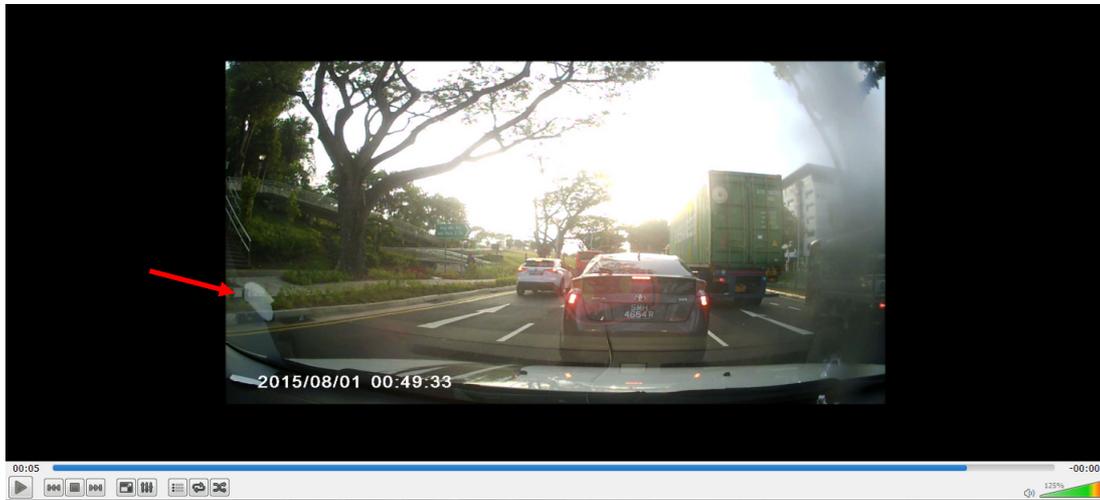
Screenshot 2 shows the 5 second mark of the video recording. Between the 4th and 5th second mark of the video recording, we had noted a slight movement (forward like movement) of a white object on the left side of the dashboard of the Mitsubishi (arrowed).

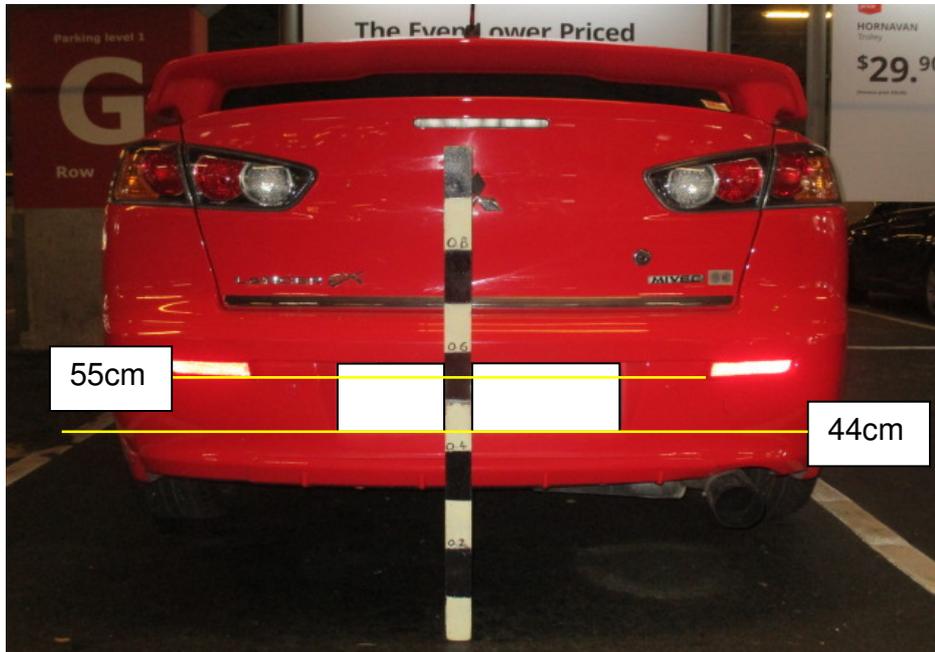
Photo 20 shows the height measurement being conducted on the front portion of the Mitsubishi (using a similar make and model). The height range above ground level of the front number plate of the Mitsubishi, at the area where the damages were found, was measured to be approximately between 44cm to 55cm.

- a) the height range above ground level of the front number plate of the Mitsubishi, at the area where the damages were found, was measured to be approximately between 44cm to 55cm;
- b) the body part at the height range of between 44cm to 55cm above ground level was the front bumper and front number plate of the BMW where the paint chip, cracks and black horizontal marks were observed;
- c) the height measurements appear to support the findings of possible contact between the front portion of the BMW and the rear portion of the Mitsubishi. The damage observed on the front bumper of the BMW was a result of this contact and corresponds to the damage observed on the rear bumper of the Mitsubishi. In other words, the damage observed on the rear portion of the Mitsubishi is consistent to the damage observed on the front portion of the BMW.

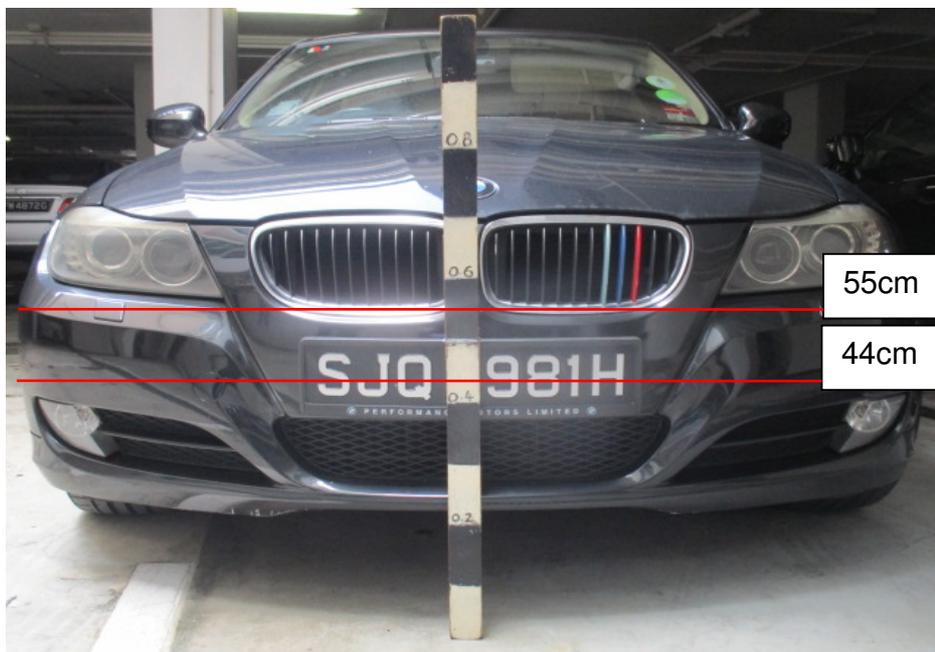
Photo 21 shows the height measurement being conducted on the front portion of the BMW. The body part at the height range of between 44cm to 55cm above ground level was the front bumper and front number plate of the BMW where the paint chip, cracks and black horizontal marks were observed.
