Your Ref: BMW M4  
(chassis number WBS4Y92040AC83553)  
Our Ref : CI/TP20004825/D

03 April 2020

**INSPECTION REPORT OF AN UNREGISTERD BMW M4 MOTOR CAR WITH CHASSIS NUMBER WBS4Y92040AC83553**

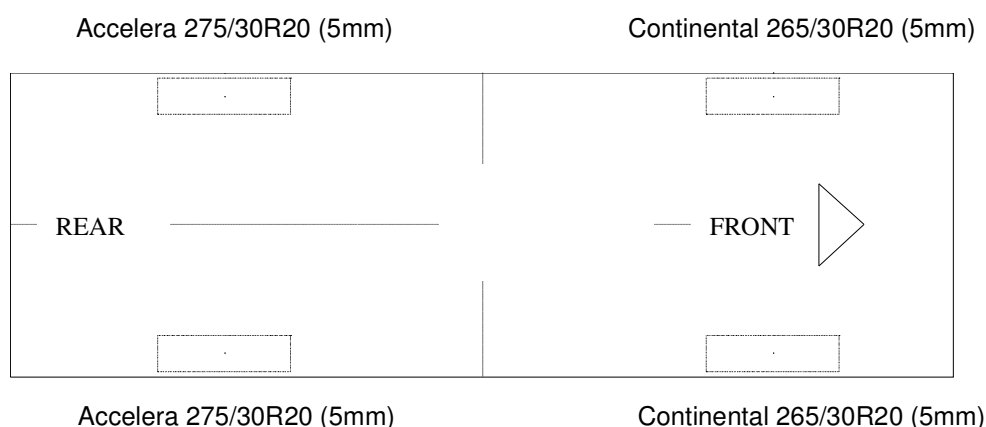
6. It was fitted with 20inch sport wheel rims that were wrapped with tyres that were observed to be of serviceable condition. The tyres were also sufficiently inflated for vehicular operation. The tyre brand, tyre size and approximate remaining tread depth of the 4 tyres of the Motor Car were recorded as follows: -

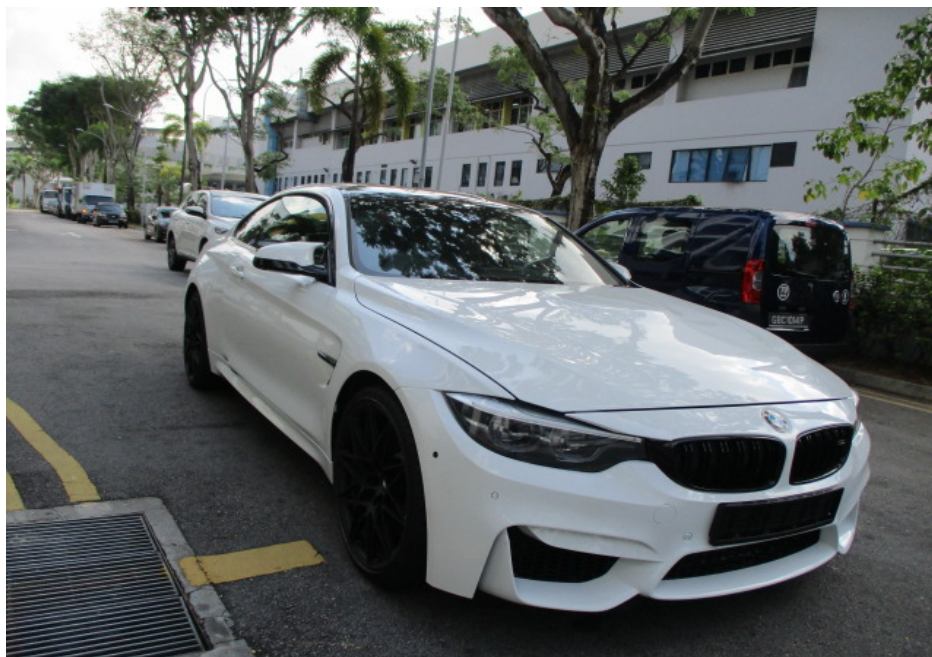
**Photo 1** shows a general view of the front right body of the Motor Car at the time of my inspection. The Motor Car was observed to be in relatively good general condition with no loose exterior fittings observed.

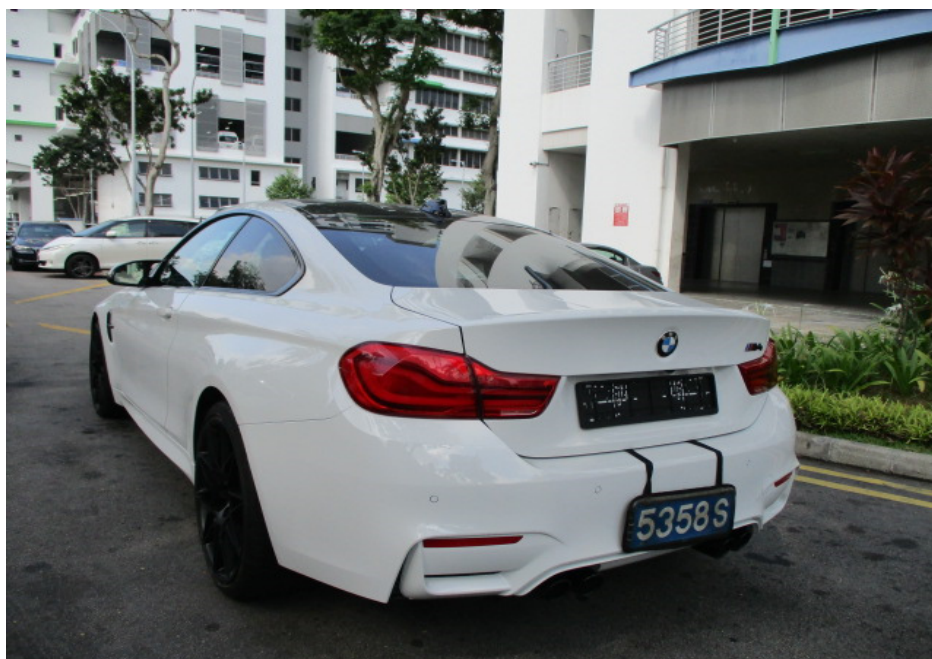
**Photo 2** shows a general view of the rear left body of the Motor Car at the time of my inspection. The Motor Car was observed to be in relatively good general condition with no loose exterior fittings observed.

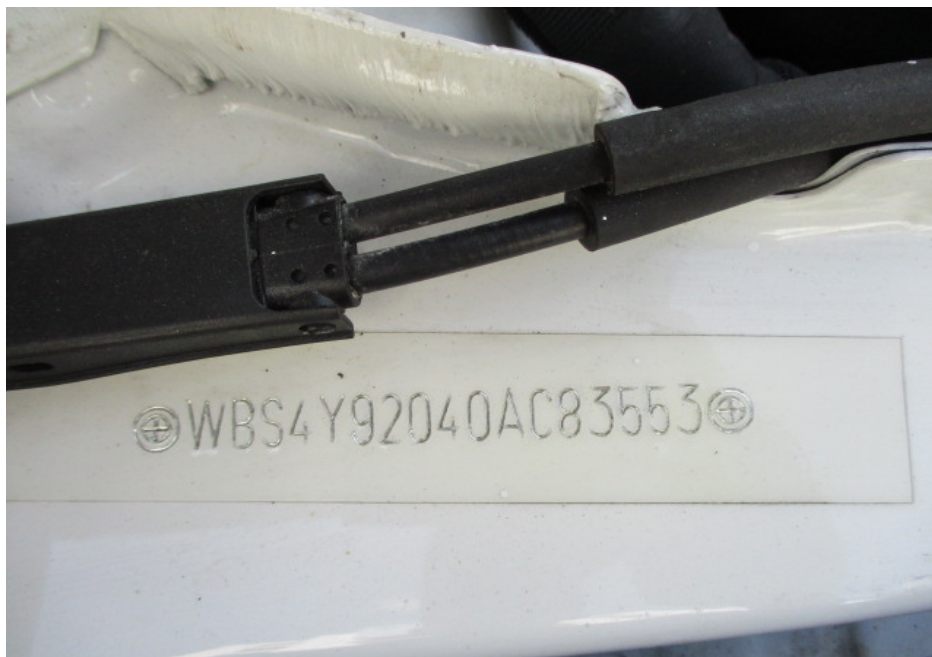
**Photo 3** shows the chassis number of the Motor Car. The chassis number recorded was WBS4Y92040AC83553.

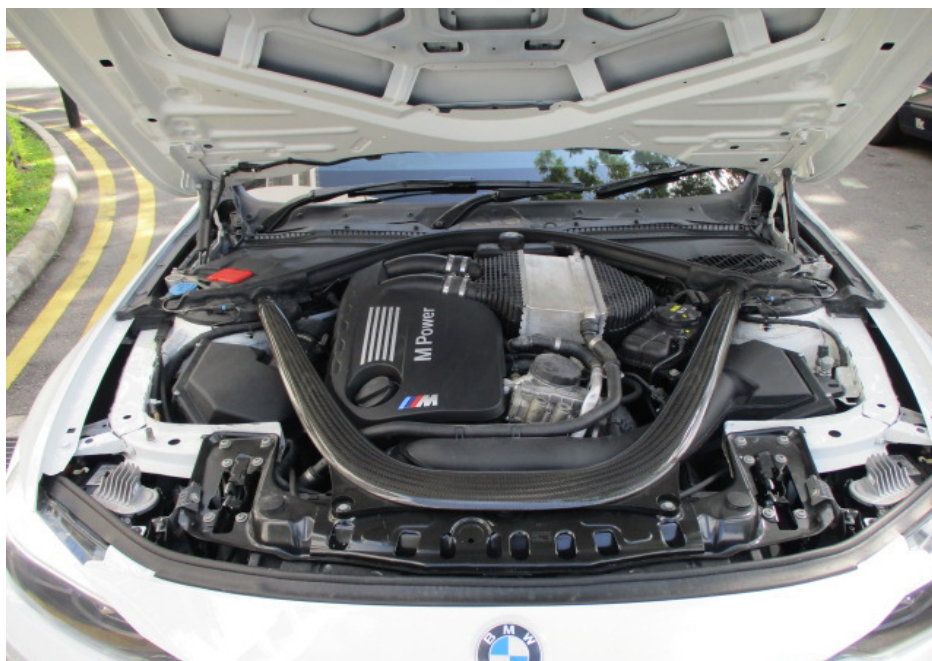
12. My examination of the engine compartment of the Motor Car revealed that the various parts and components inside the engine compartment were all intact and properly fitted. The various operating fluids like the engine oil, brake fluid and engine coolant were all found to be of sufficient level for operating purposes. Visually, there was also no contamination found to these fluids.
13. My checks on the underside of the Motor Car revealed no sign(s) or indication(s) of fluid leakage and/or fluid stain(s). The engine block and automatic transmission assembly were both secured properly. They were not mounted onto the chassis/structural body or any integral body part of the Motor Car. All undercarriage components of the Motor Car were also observed to be intact and secured in an appropriate manner.

**Photo 4** shows a general view of the engine compartment of the Motor Car at the time of my inspection. The various parts and components inside the engine compartment were all observed to be intact and properly fitted. There was also no sign(s) or indication(s) of fluid leak and/or fluid stain found within the engine compartment.

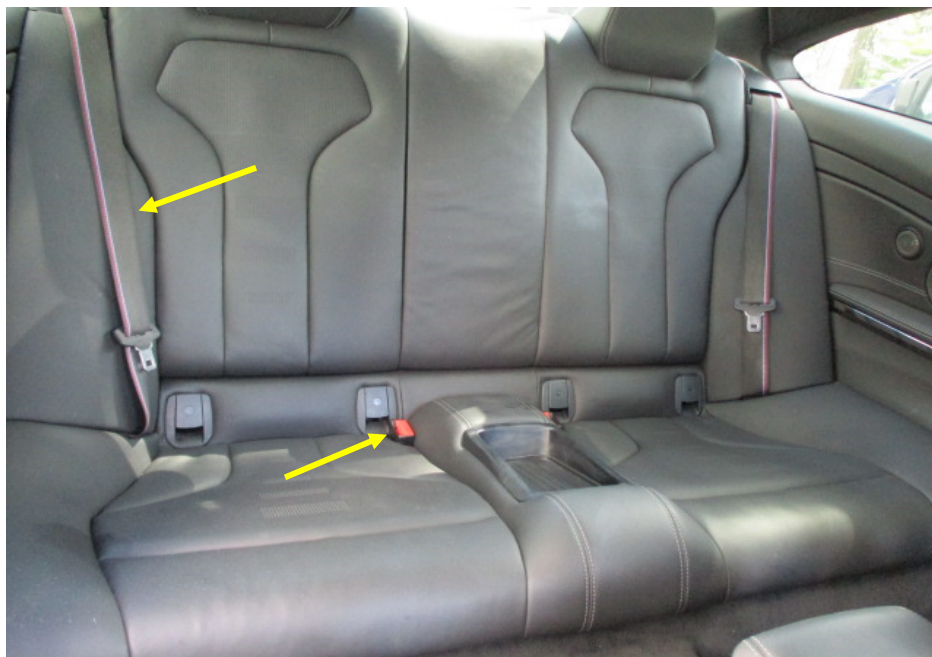
10. The seats of the Motor Car were found to be secured to the floor board of the Motor Car via seat rails bolted onto the floor board. Retractable seat belt reels and pre-tensioners were fitted on all seats of the Motor Car. The seat belt reels were checked and able to be fastened securely to the respective pre-tensioner that was fixed to the side of all the seats.

**Photo 5** shows the rear seats of the Motor Car. All the seats of the Motor Car were secured via seat rails to the floor board. They were also fitted with a retractable seat belt reel and a pre-tensioner (arrowed). The seat belts were checked and able to be fastened securely to the respective pretension that was fitted on the side of each individual seat.

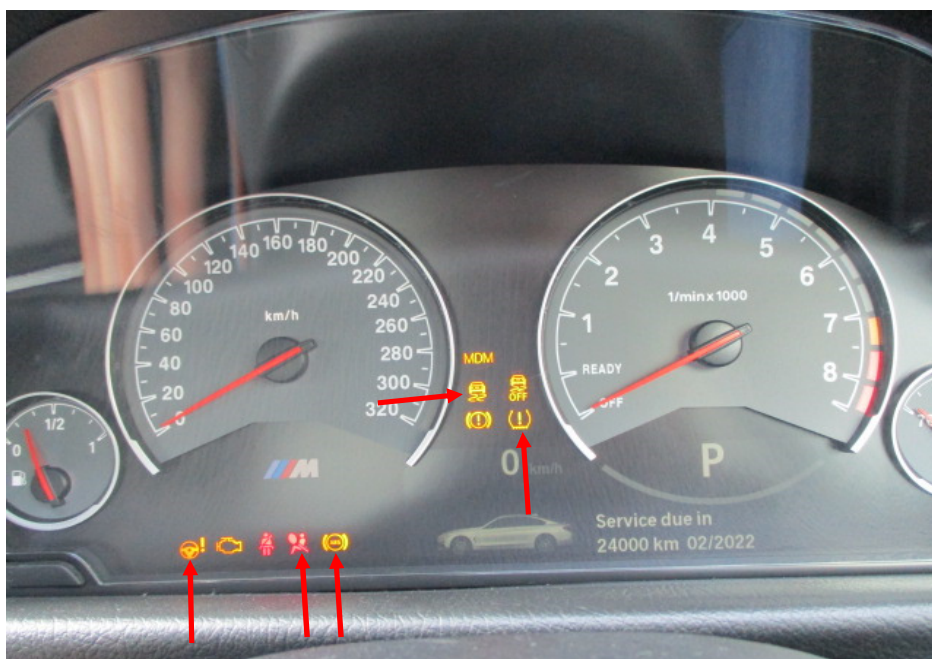
**Photo 6** shows the warning lights for the various electronic safety features appearing on the instrument panel of the Motor Car during its self-test when the engine is cranked, in particular the ABS, SRS, IAS, TPM and DSC lights (arrowed).

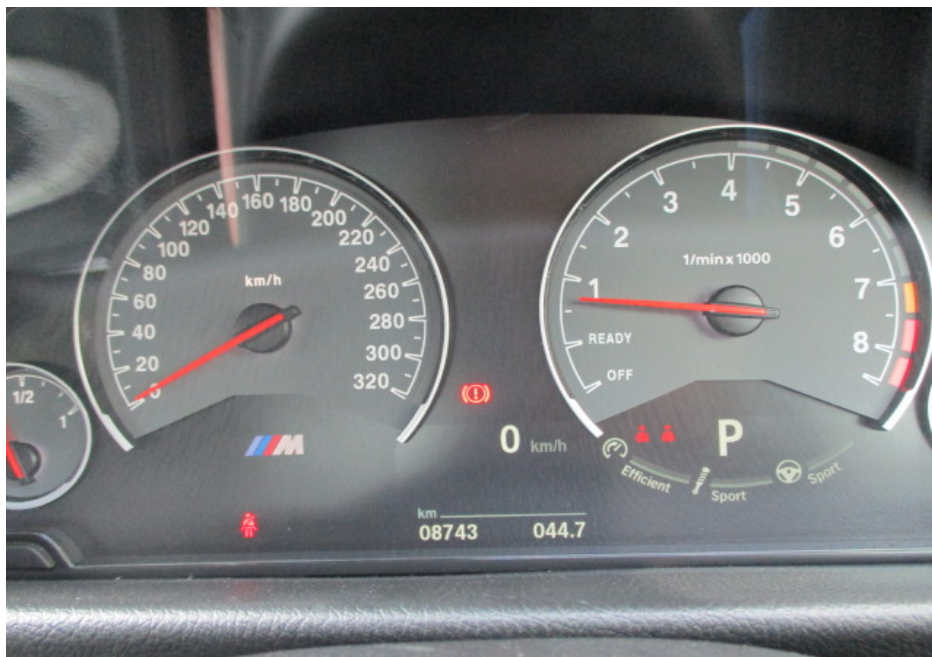
11. The Motor Car's automatic self-test of the functionality of its various electronic safety features like the Anti-Lock Brake System (ABS), Supplemental Restraint System (SRS), Integral Active Steering (IAS), Tyre Pressure Monitor (TPM) and Dynamic Stability Control (DSC) during cranking of the engine had indicated that these electronic systems were in working condition. This was determined from the respective warning lights disappearing from the instrument panel after the self-test.

**Photo 7** shows the respective warning lights no longer illuminated, indicating that there is no fault detected to the ABS, SRS, IAS, TPM and DSC systems of the Motor Car during the self-test. These electronic systems were hence in working condition at the time of my inspection.

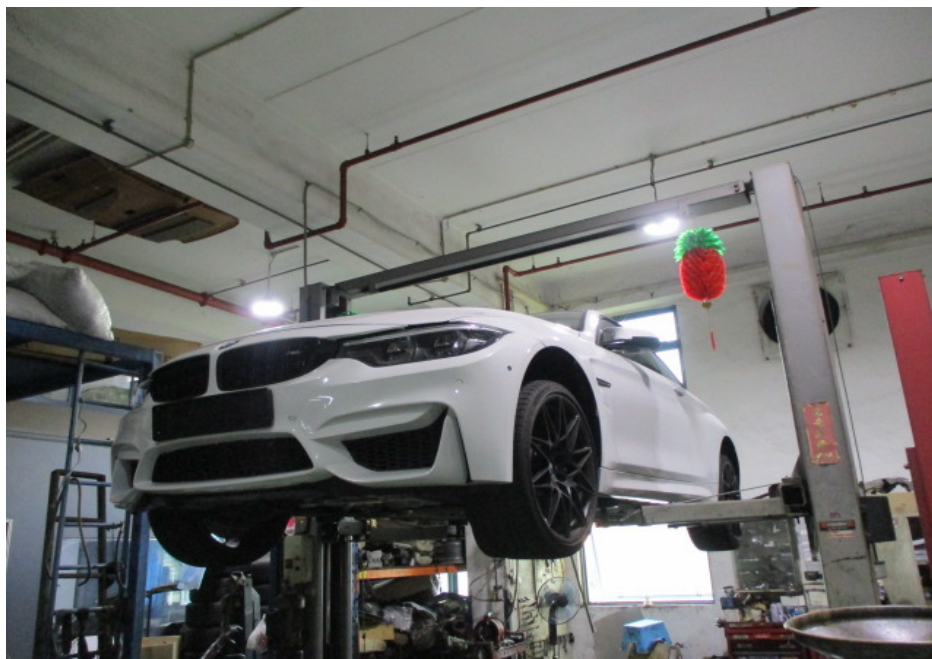
**Photo 8** shows the Motor Car hoisted up for checks on its undercarriage. There was no sign(s) or indication(s) of fluid leakage and/or fluid stain(s). The undercarriage components of the Motor Car were also all observed to be intact and secured in an appropriate manner.

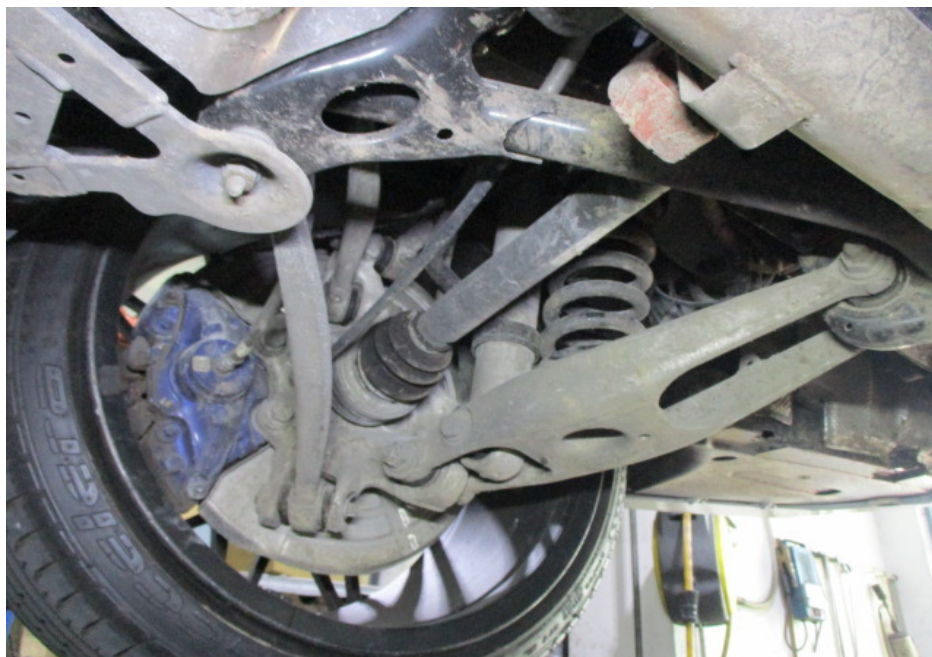
**Photo 9** shows a general view of the control arms and linkages at the rear right wheel of the Motor Car. I did not observe any fluid leak and/or fluid stain on the underside of the Motor Car. All of the Motor Car's undercarriage components were observed to be intact and secured in an appropriate manner.

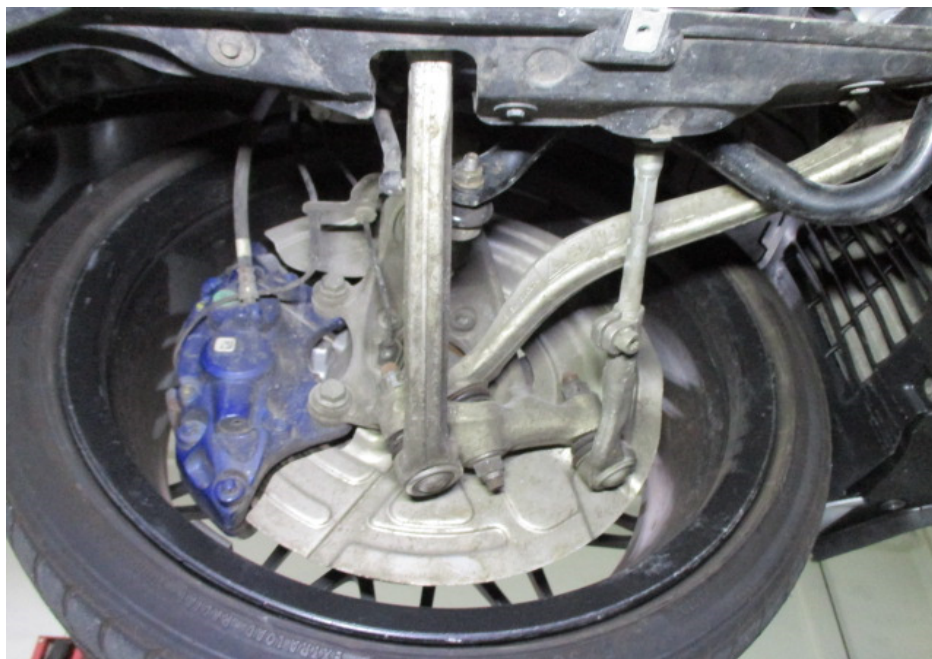
**Photo 10** shows the various undercarriage components at the front left wheel of the Motor Car. The mechanical components, control arms and linkages were all found to be intact and secured in an appropriate manner.

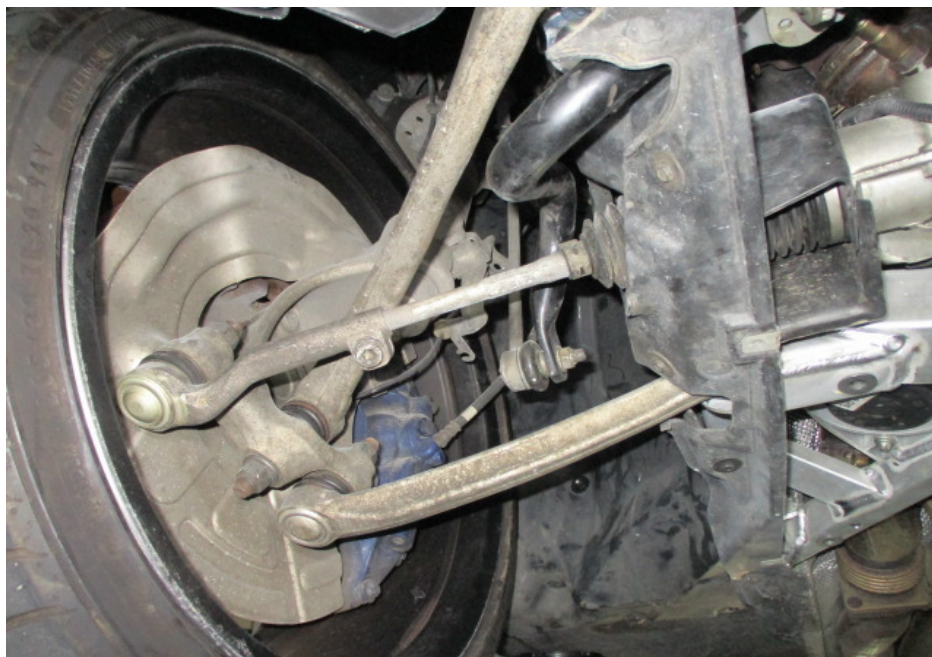
**Photo 11** shows the various undercarriage components at the front right wheel of the Motor Car. The mechanical components, control arms and linkages were all found to be intact and secured in an appropriate manner. All of the Motor Car's undercarriage components were observed to be intact and secured in an appropriate manner.

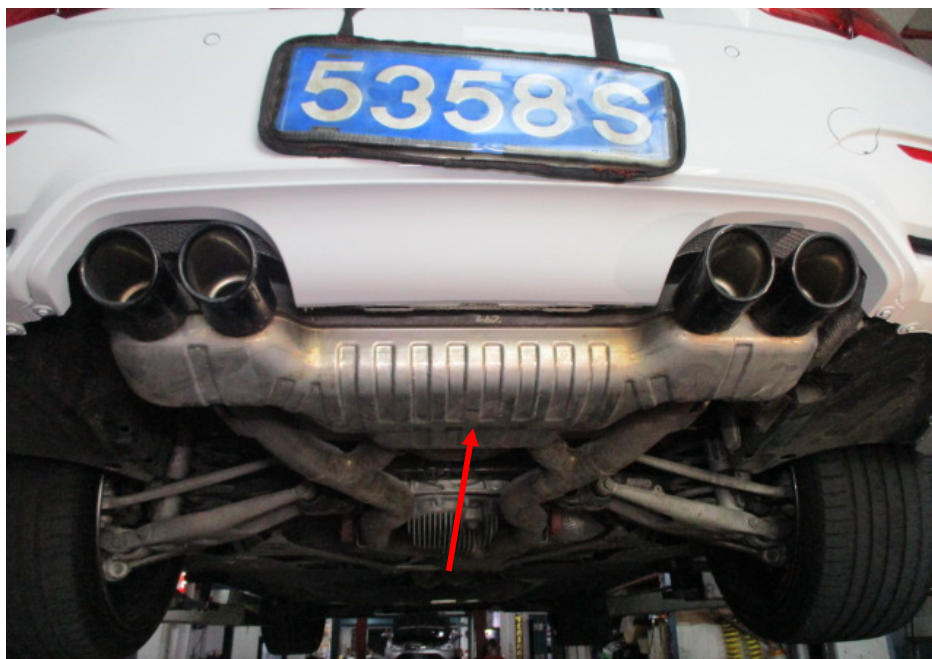
**Photo 12** shows the Motor Car's rear exhaust muffler (arrowed). My examination of the Motor Car's exhaust system revealed no sign(s) or indication(s) of any cut or weld marks along its exhaust pipes and on its rear muffler.

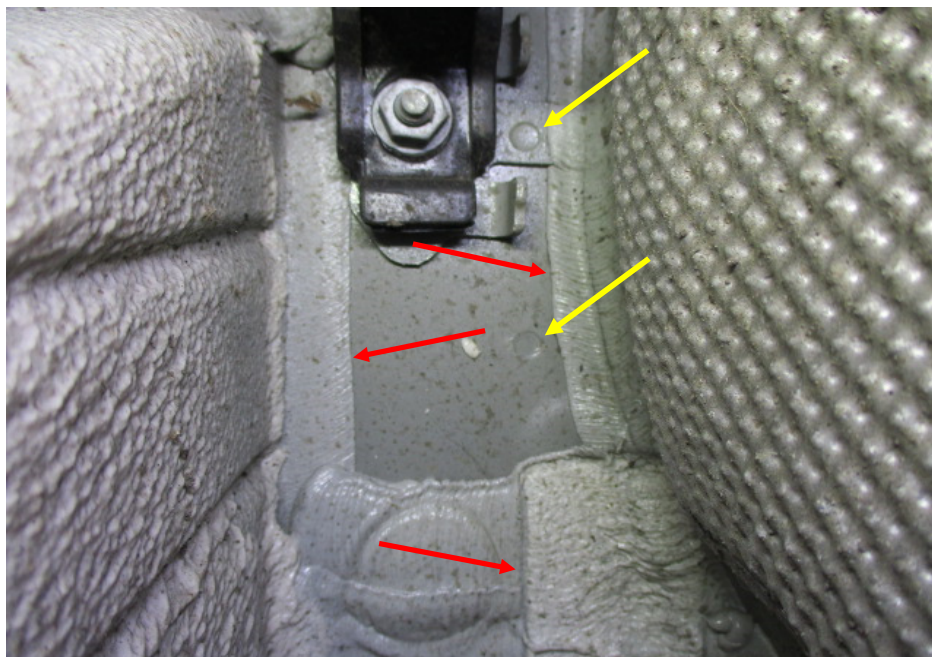
9. Visually, I did not find any weld marks, other than the original spot weld marks, on the chassis/structural body of the Motor Car. The original factory sealant at the joints along the chassis/structural body was also untouched, again indicating that no replacement of the chassis/structural body was carried out; and that the chassis/structural body was originally fitted.

**Photo 13** shows the chassis/structural body at the underside rear right of the Motor Car. Visually, I did not find any weld marks other than original spot weld marks (yellow arrow) on the chassis/structural body of the Motor Car. The original factory sealant (red arrow) at the joints along the chassis/structural body was also untouched, indicating no work was done on the chassis/structural body of the Motor Car and that the chassis/structural body was originally fitted.

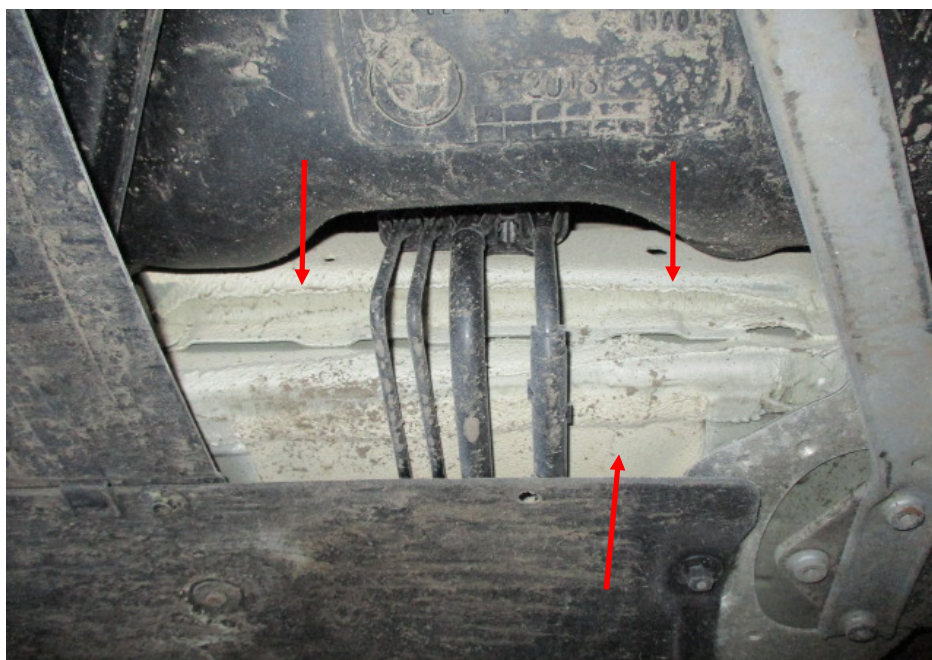
**Photo 14** shows the floor board at the underside centre of the Motor Car. The original factory sealant (arrowed) at the joints of the non-detachable body panels was all untouched indicating no replacement of the non-detachable body panels was carried out.

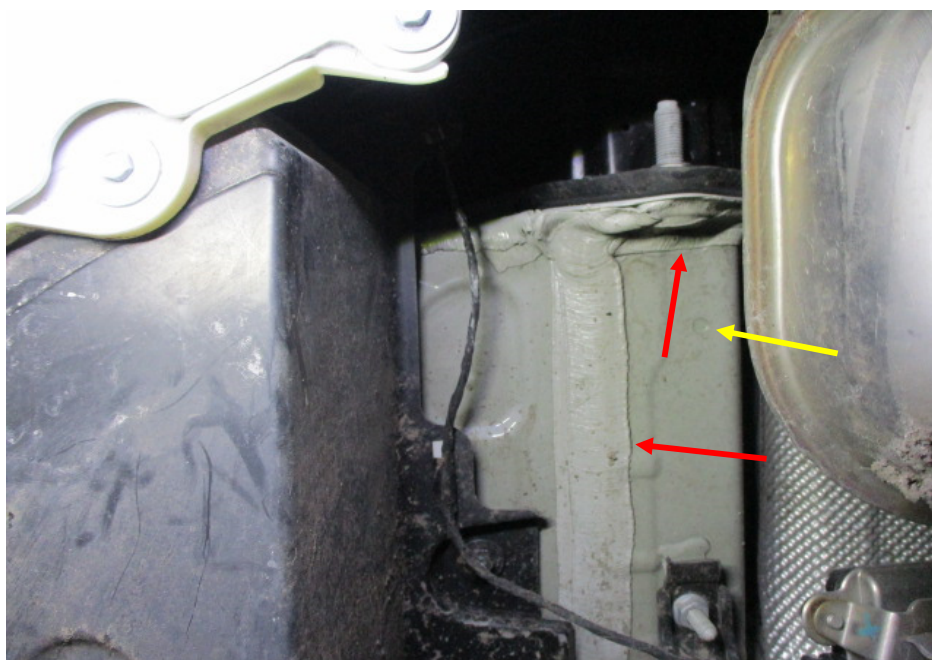
**Photo 15** shows the chassis/structural body at the underside rear left of the Motor Car. Visually, I did not find any weld marks other than original spot weld marks (yellow arrow) on the chassis/structural body of the Motor Car. The original factory sealant (red arrow) at the joints along the chassis/structural body was also untouched, indicating no work was done on the chassis/structural body of the Motor Car and that the chassis/structural body was originally fitted.

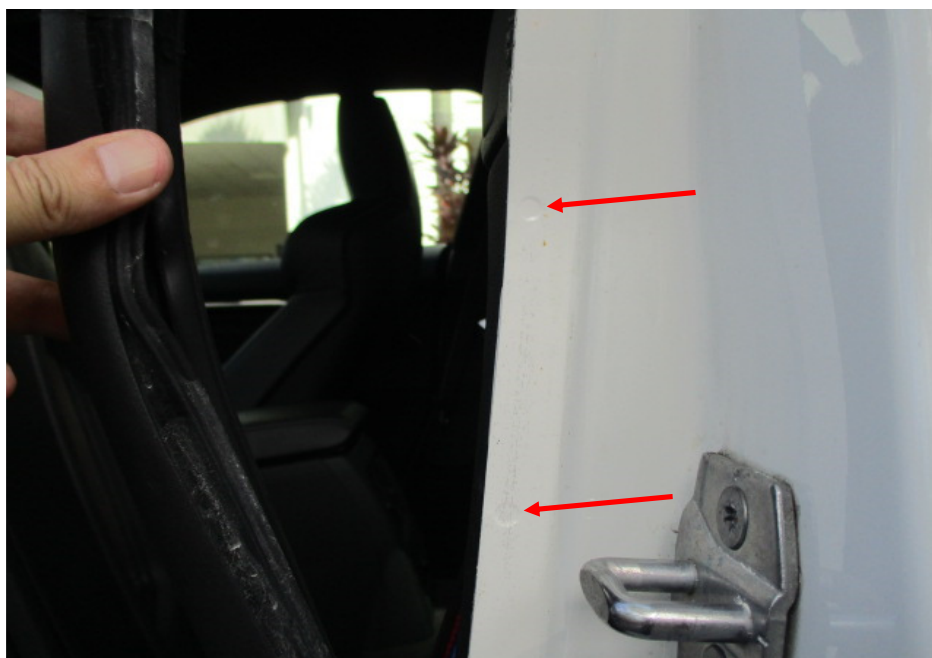
**Photo 16** shows the rear left body panel of the Motor Car. I did not find any weld marks other than original spot weld marks (arrowed) on the non-detachable body panels of the Motor Car, indicating that there was no re-welding works carried out; and that the non-detachable body panels of the Motor Car were originally fitted.

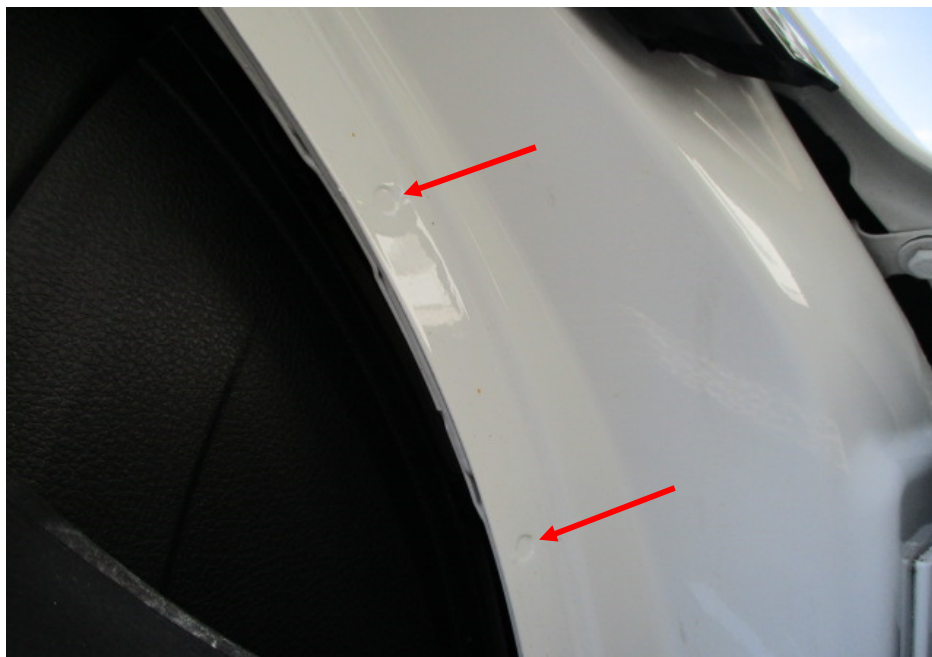
**Photo 17** shows the right “A” pillar of the Motor Car. I did not find any weld marks other than original spot weld marks (arrowed) on the non-detachable body panels of the Motor Car, indicating that there was no re-welding works carried out; and that the non-detachable body panels of the Motor Car were originally fitted.
