Your Ref: TP/IP/04747/2020  
Our Ref : CI/TPD20004851/P

**Fatal Accident Investigation Team**

**MECHANICAL INSPECTION REPORT OF MOTOR TAXI SH 7204R**

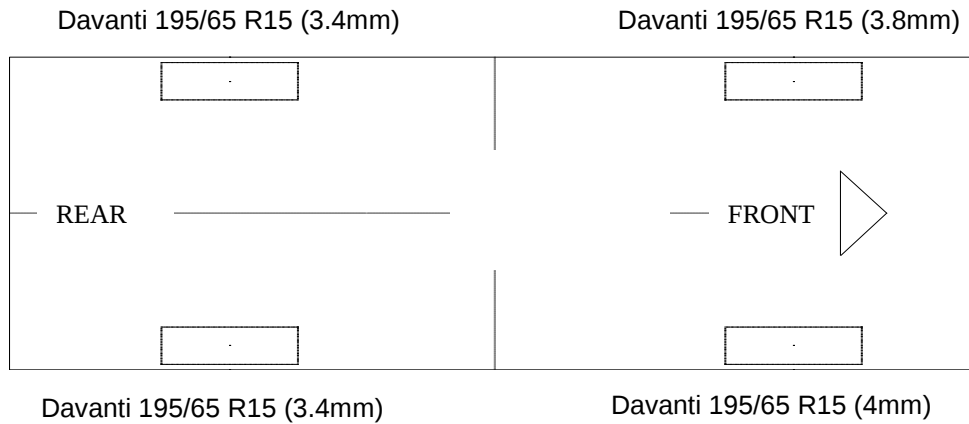
6. The condition of the Motor Taxi's 4 tyres was observed to be in serviceable condition. I did not find any tear, cut or burst mark(s) on the outer and the inner sidewalls as well as across the tread of the 4 tyres. The 4 tyres were also observed to be sufficiently inflated for vehicular operation. The tyre brand, tyre size and remaining tread depth of the 4 tyres were recorded as follows:-

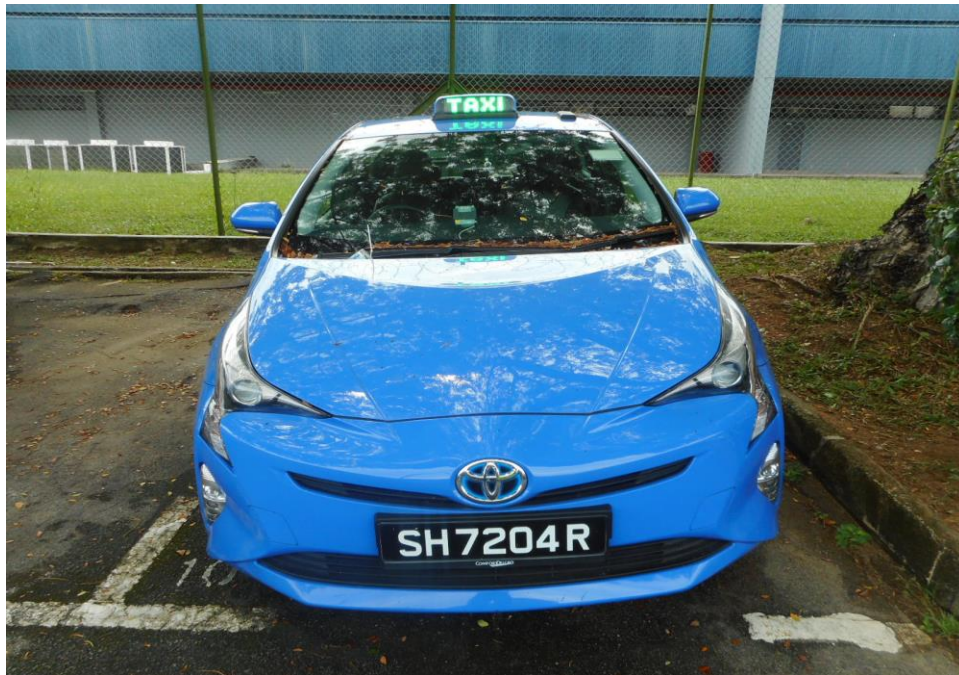
**Photo 1** shows a front general view of the Motor Taxi's at the time of my inspection. The front portion of the Motor Taxi was observed to have been unaffected by the accident. The mileage of the Motor Taxi at the time of my inspection was recorded to be 124,131km.

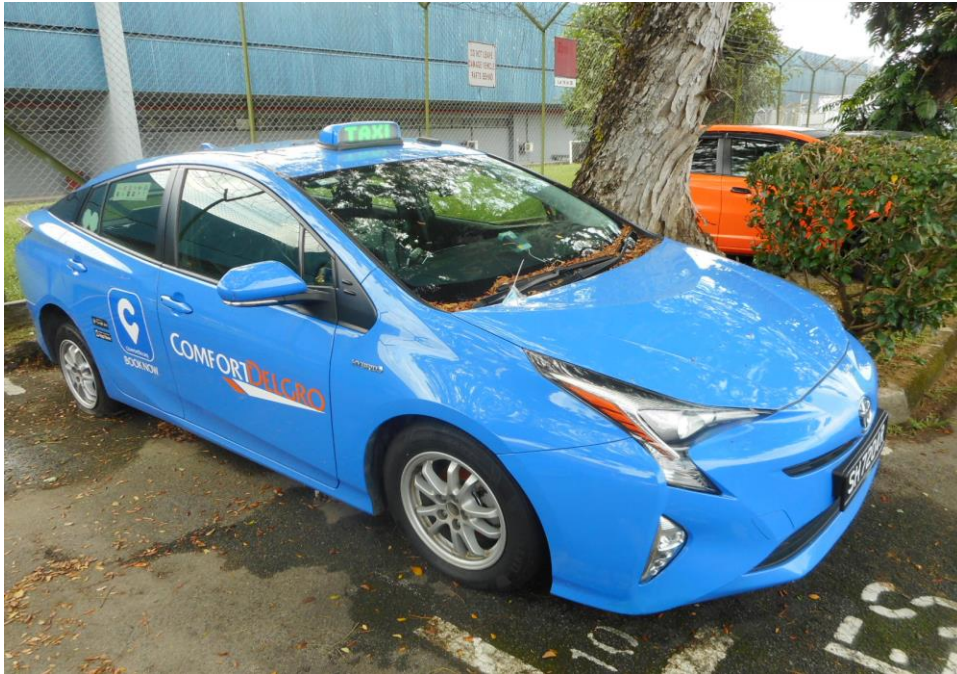
**Photo 2** shows a general view of the Motor Taxi's right body panel at the time of my inspection. The right portion of the Motor Taxi was observed to have been unaffected by the accident.

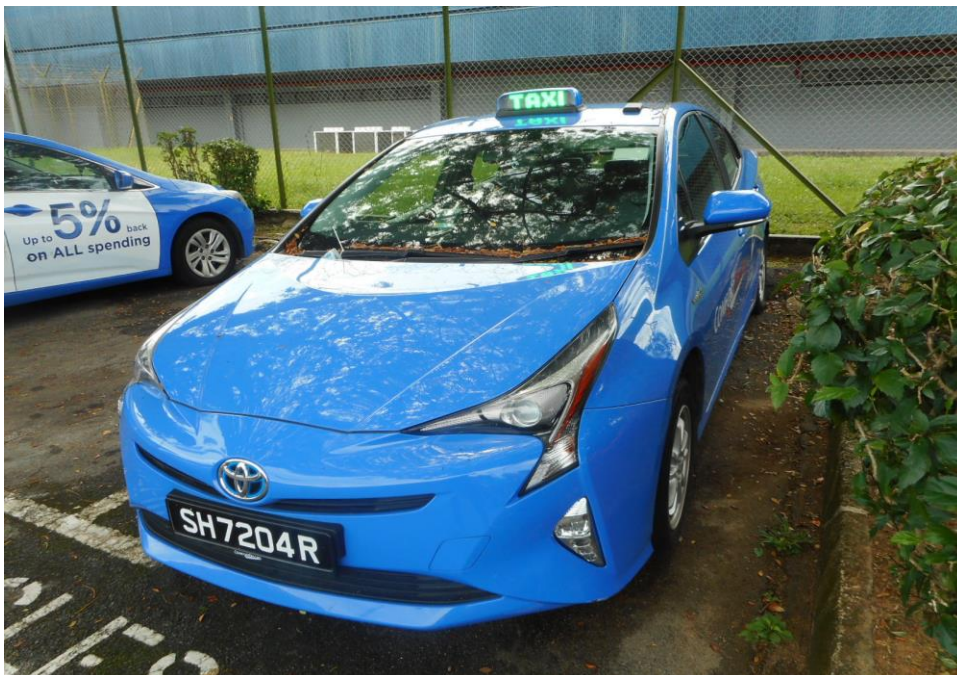
**Photo 3** shows a general view of the Motor Taxi's left body panel at the time of my inspection. The left portion of the Motor Taxi was observed to have been unaffected by the accident.

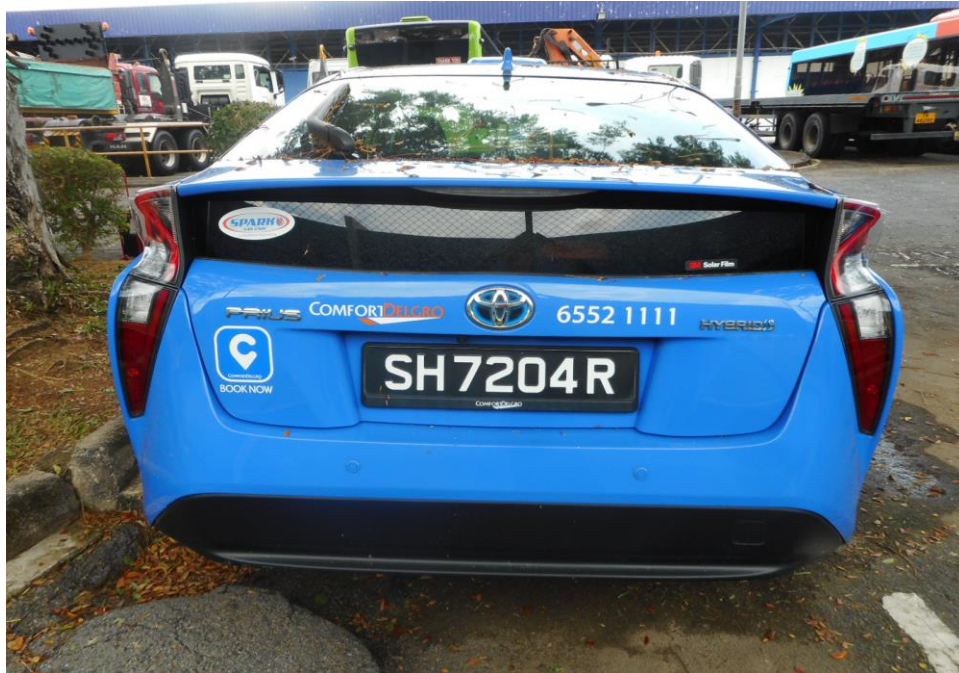
**Photo 4** shows a general view of the Motor Taxi's rear body at the time of my inspection. The rear portion of the Motor Taxi was observed to have been unaffected by the accident.

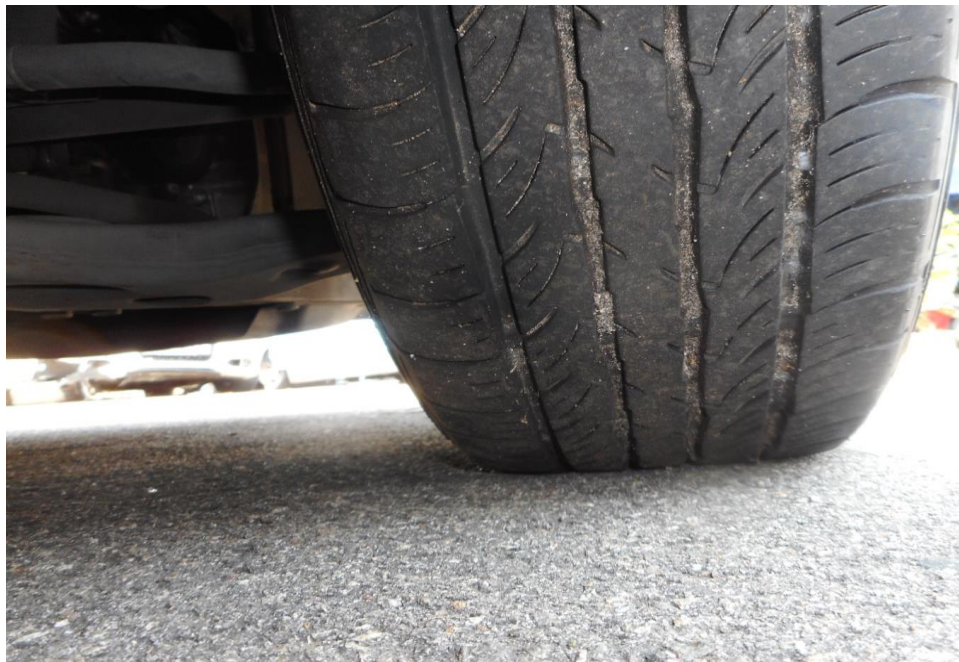
**Photo 5** shows the condition of the front right tyre of the Motor Taxi, which was observed to be in serviceable condition with remaining tread depth of approximately 4mm. The tyre was sufficiently inflated for vehicular operation with no tear, cut or burst mark(s) on the outer and the inner sidewalls as well as across the tread. The 4 tyres of the Motor Taxi were wrapped around standard alloy wheel rims without any damage.

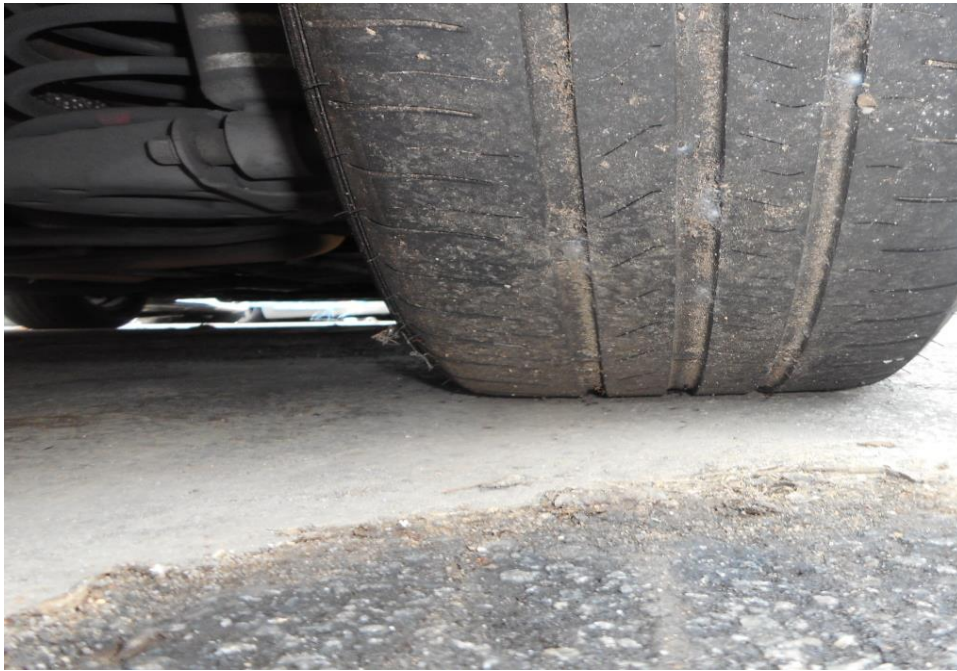
**Photo 6** shows the condition of the rear right tyre of the Motor Taxi, which was observed to be in serviceable condition with remaining tread depth of approximately 3.4mm. The tyre was also observed to be sufficiently inflated for vehicular operation with no tear, cut or burst mark(s).

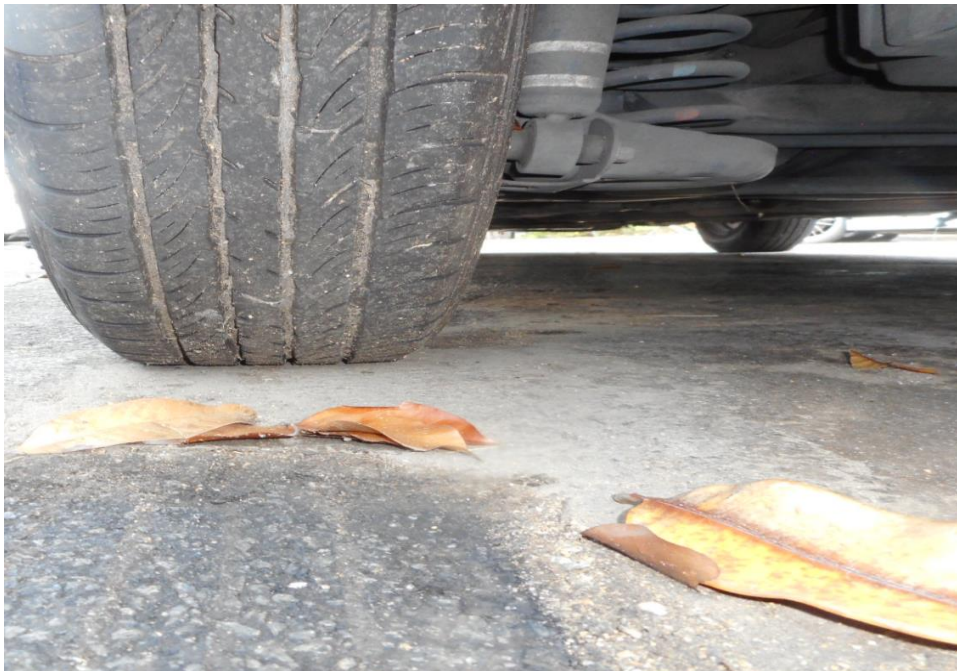
**Photo 7** shows the condition of the rear left tyre of the Motor Taxi, which was observed to be in serviceable condition with remaining tread depth of approximately 3.4mm. The tyre was also observed to be sufficiently inflated for vehicular operation with no tear, cut or burst mark(s).

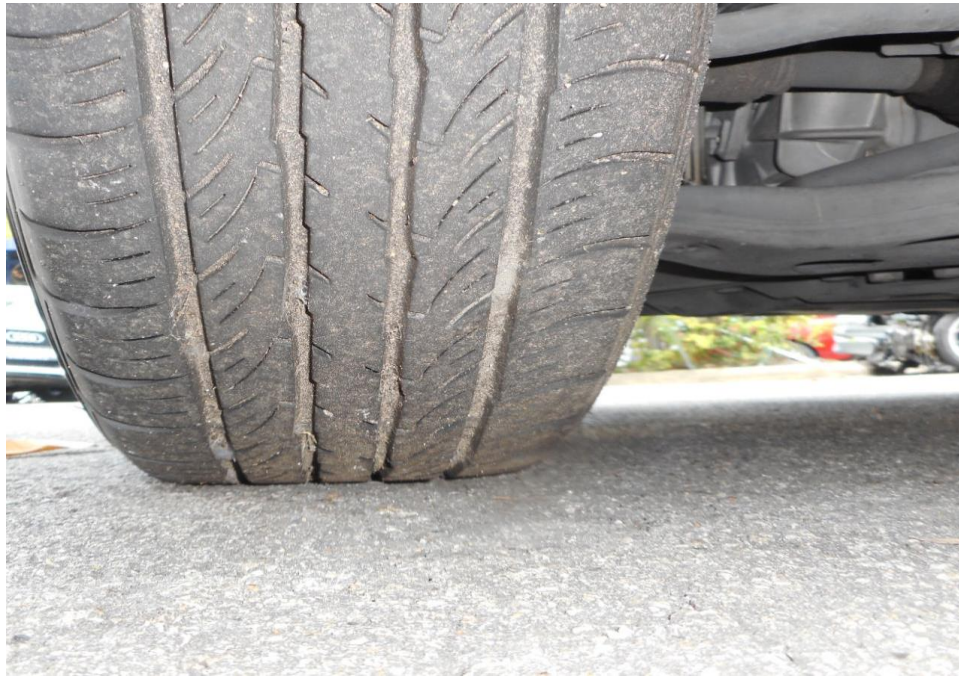
**Photo 8** shows the condition of the front left tyre of the Motor Taxi, which was observed to be in serviceable condition with remaining tread depth of approximately 3.8mm. The tyre was also observed to be sufficiently inflated for vehicular operation with no tear, cut or burst mark(s).

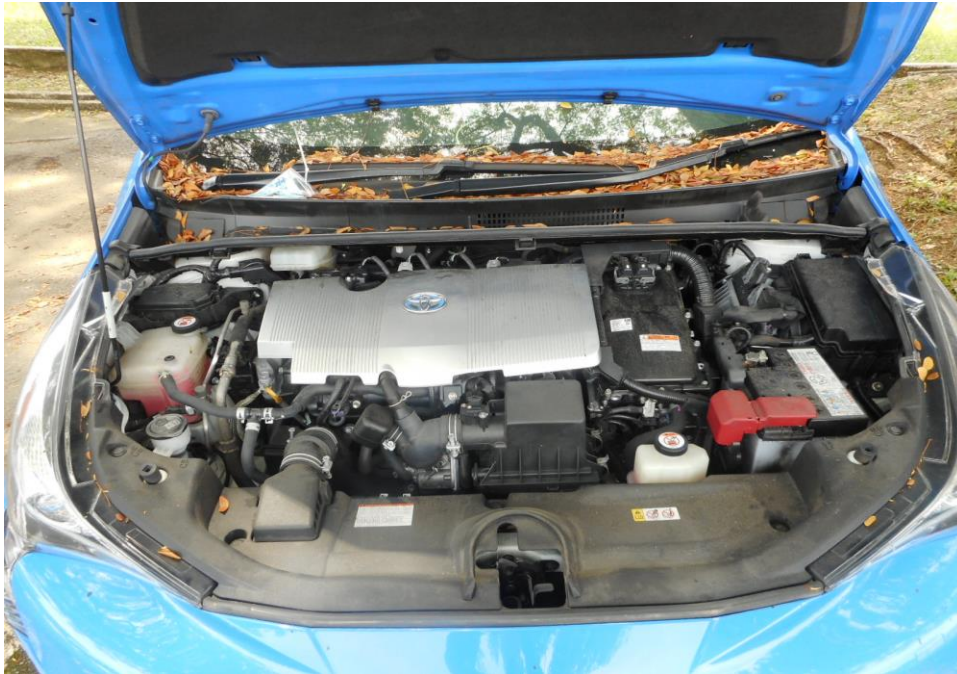
**Photo 11** shows a general view of the Motor Taxi's engine compartment. The various parts and components inside the engine compartment were unaffected by the accident. There was also no sign(s) or indication(s) of fluid leakage and/or fluid stain within the engine compartment.

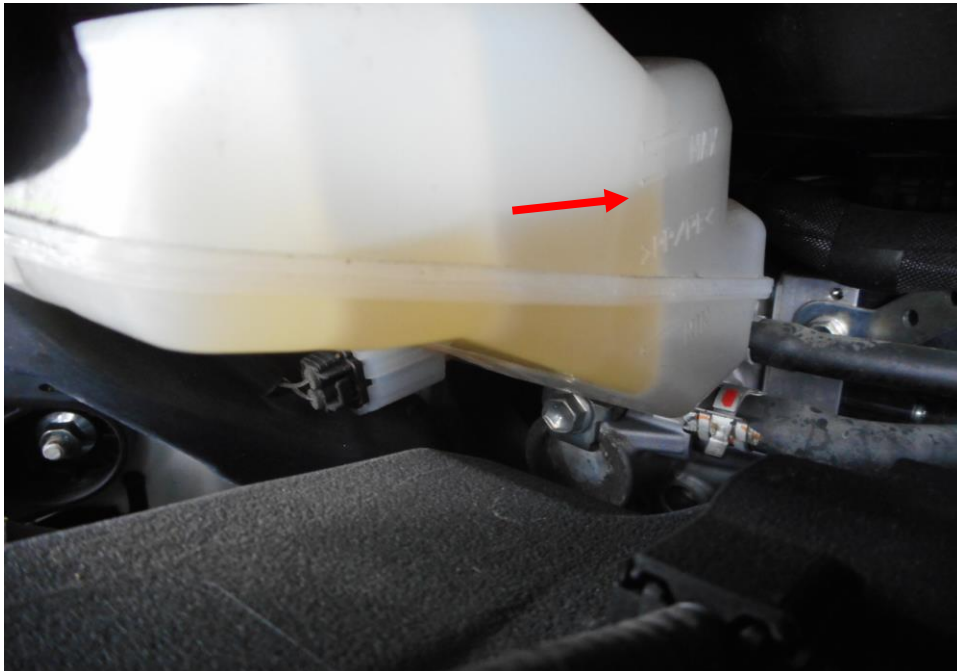
**Photo 12** shows the brake fluid reservoir of the Motor Taxi at the time of my inspection. The brake fluid was observed to be of sufficient level (arrowed) and without any visible contamination.

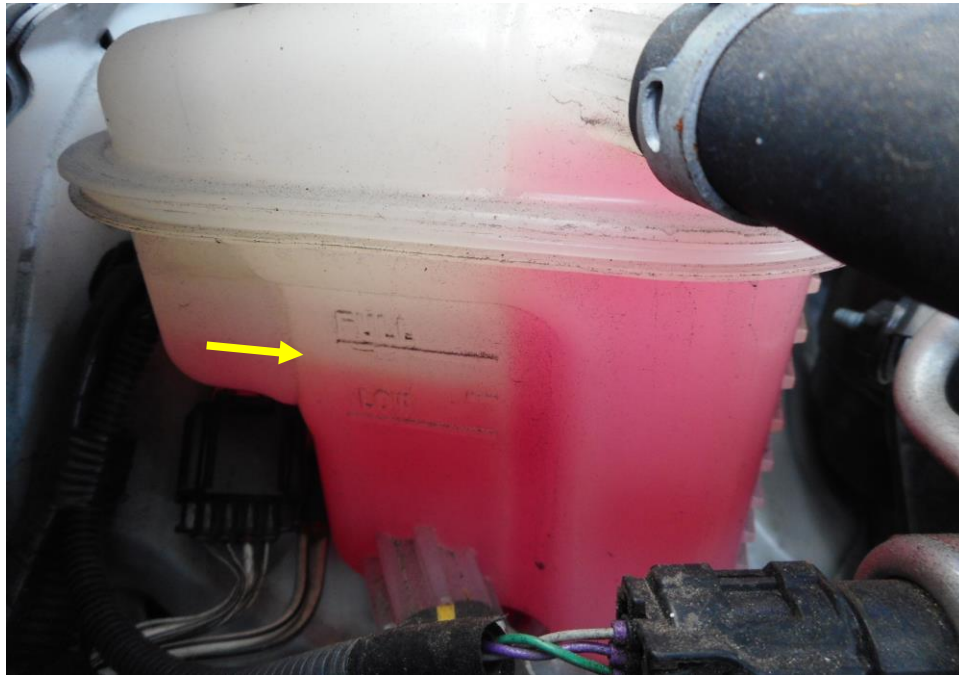
**Photo 13** shows checks being carried out to the engine coolant of the Motor Taxi at the time of my inspection. The engine coolant was observed to be of sufficient level (arrowed) and without any visible contamination.

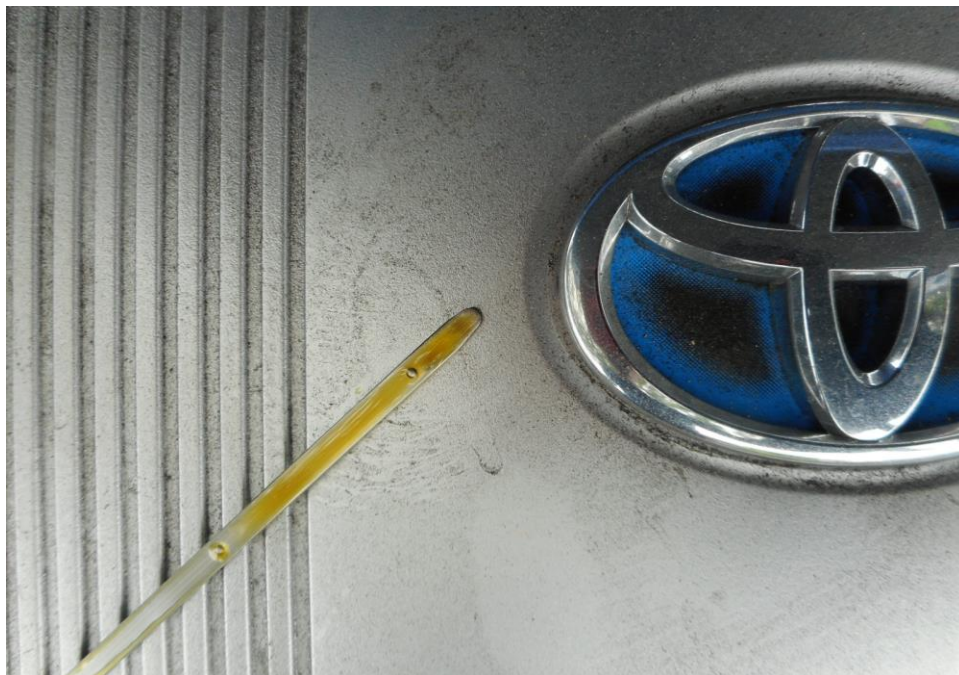
**Photo 14** shows the engine oil dip stick of the Motor Taxi at the time of my inspection. The engine oil was observed to be of sufficient level and without any visible contamination.

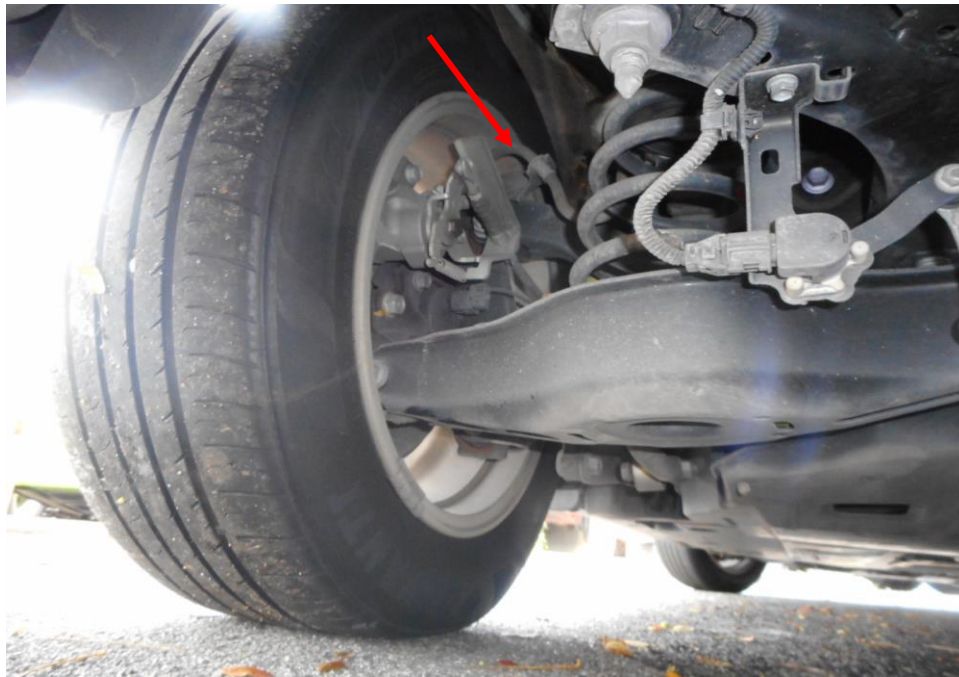
**Photo 15** shows the brake hose/pipe (arrowed) at the rear left wheel of the Motor Taxi. I did not observe any leakage of brake fluid at the time of my inspection of the Motor Taxi. Static tests of the Motor Taxi's braking system had indicated that there was no internal leakage of pressure/vacuum. The undercarriage components of the Motor Taxi were also all found to be intact and without any visible damage.

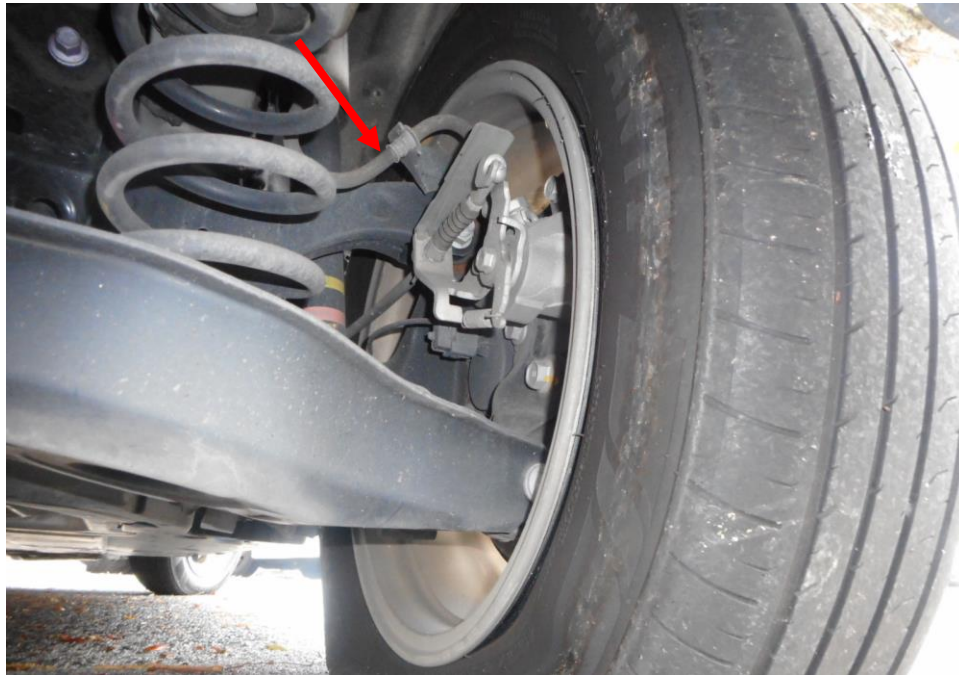
**Photo 16** shows the brake hose/pipe (arrowed) at the rear right wheel of the Motor Taxi. I did not observe any leakage of brake fluid at the time of my inspection of the Motor Taxi. Static tests of the Motor Taxi's braking system had indicated that there was no internal leakage of pressure/vacuum. The undercarriage components of the Motor Taxi were also all found to be intact and without any visible damage.

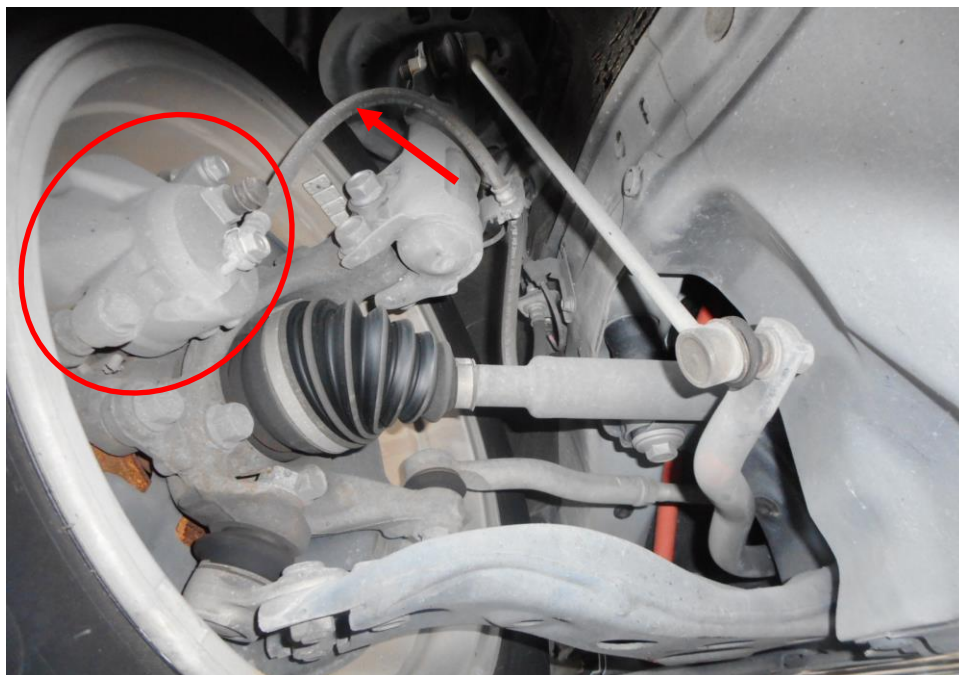
**Photo 17** shows the brake hose/pipe (arrowed) at the front right wheel of the Motor Taxi. No leakage of brake fluid was observed. Visual examination of the various components of the braking system like the brake caliper (circled), brake booster, brake pedal etc had revealed all to be intact and without visible damage.

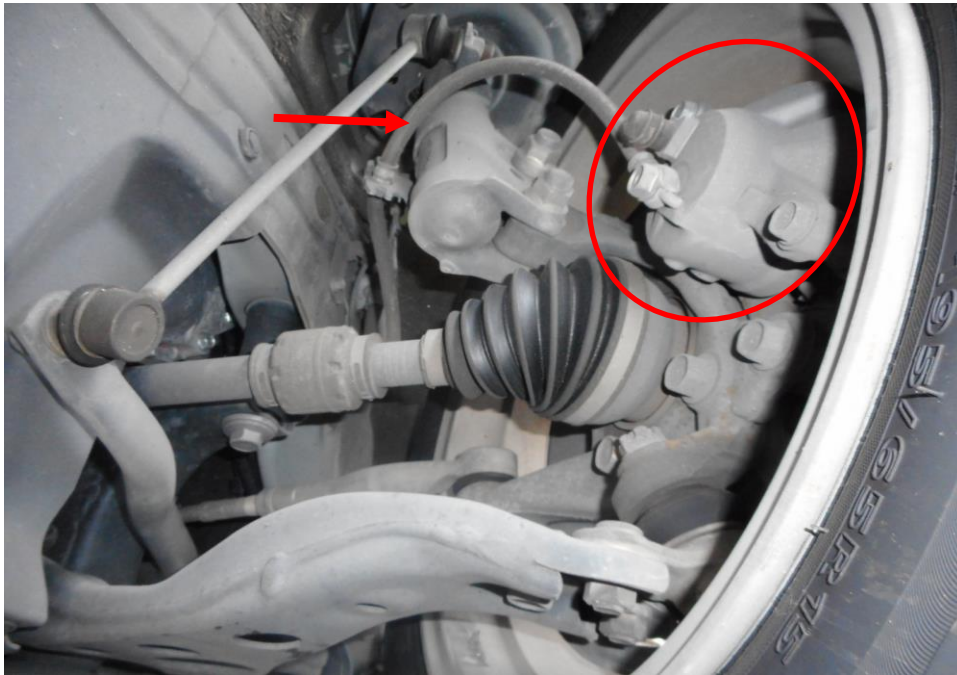
**Photo 18** shows the brake hose/pipe (arrowed) at the front left wheel of the Motor Taxi. No leakage of brake fluid was observed. Visual examination of the various components of the braking system like the brake caliper (circled), brake booster, brake pedal etc had revealed all to be intact and without visible damage.

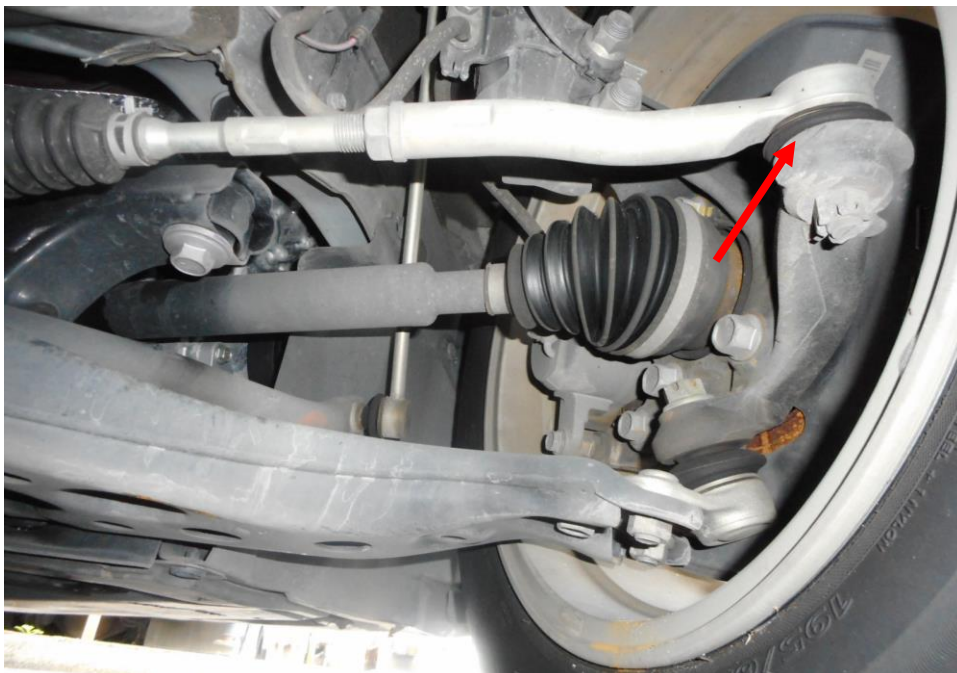
**Photo 19** shows the various undercarriage components at the front right wheel of the Motor Taxi, in particular the steering tie rod (arrowed). The various steering components were all found to be intact, suggesting that the steering system of the Motor Taxi was likely to be in serviceable condition at the material time of accident. There was also no sign of fluid stain observed on the various undercarriage components at the front right wheel of the Motor Taxi.

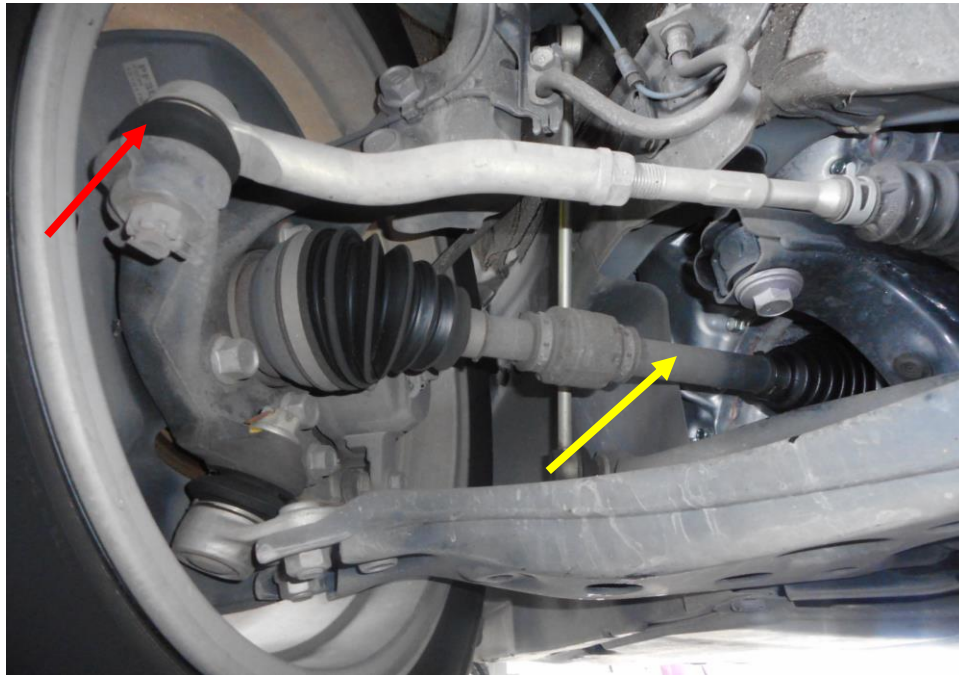
**Photo 20** shows the various undercarriage components at the front left wheel of the Motor Taxi, which had included the steering tie rod (red arrow) and front left drive shaft (yellow arrow). The various undercarriage components of the Motor Taxi were all found to be intact without any visible damage.

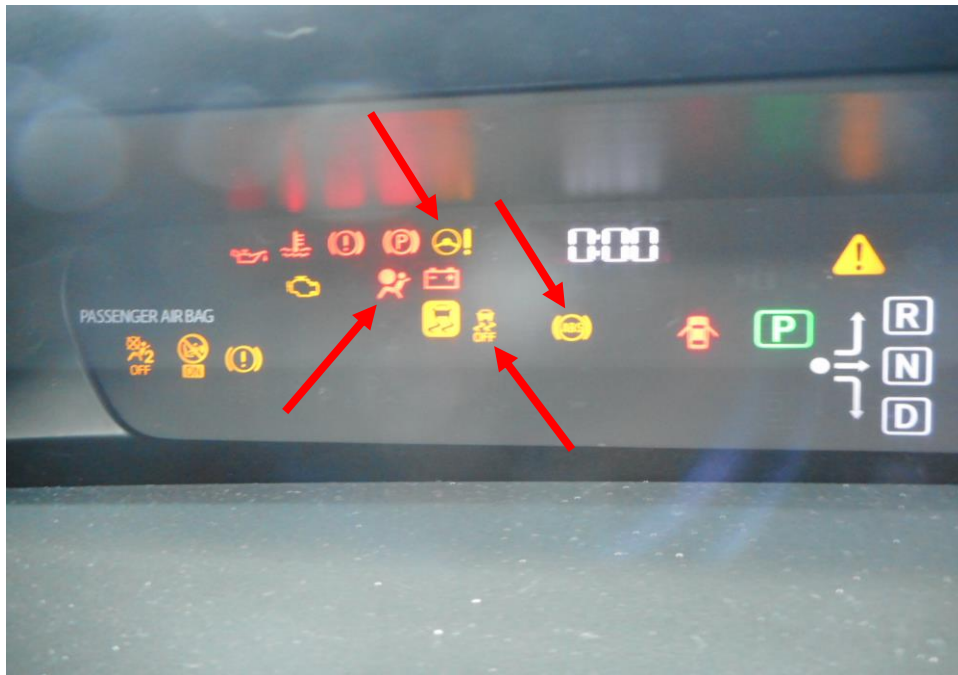
**Photo 20** shows the warning light for Anti-Lock Brake System (ABS), Electric Power Steering System (EPS), Traction Control (TC) and Supplemental Restraint System (SRS) appearing on the instrument panel of the Motor Taxi during the self-test of its various electronic operating systems when its engine was cranked.

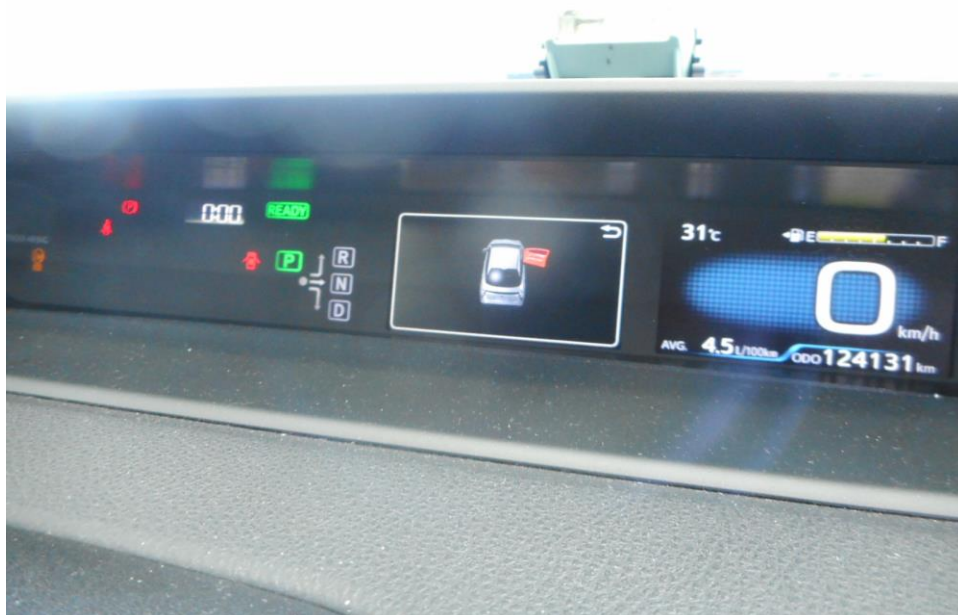
**Photo 21** shows no warning lights illuminated on the instrument panel of the Motor Taxi after the engine was cranked. This would suggest that there was no abnormality to the various electronic operating systems of the Motor Taxi, like the ABS, EPS, TC and SRS etc.
