Your Ref: TP/IP/09133/2020
Our Ref : CI/TPD20004852/P

19th June 2020

Fatal Accident Investigation Team

MECHANICAL INSPECTION REPORT OF MOTOR TAXI SHC 2753L

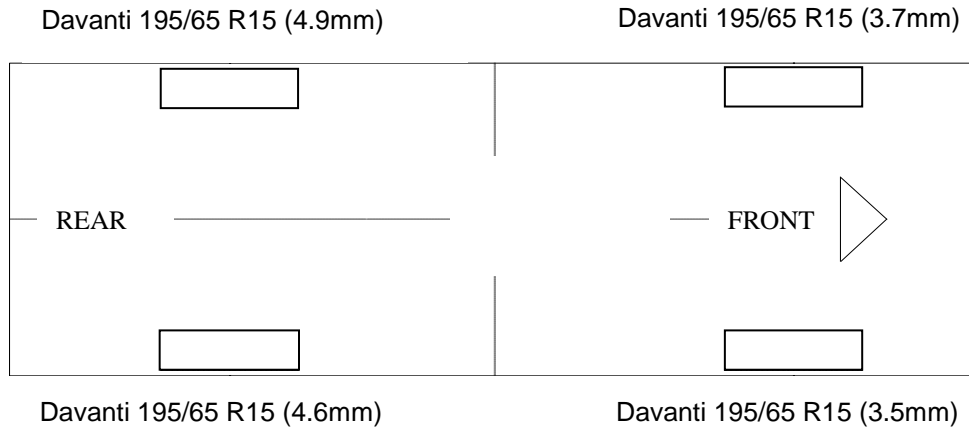
6. The 4 tyres of the Motor Taxi were observed to be in serviceable condition and sufficiently inflated for vehicular operation. I did not find any tear, cut or burst mark(s) on the outer and the inner sidewalls as well as across the tread of the 4 tyres. The tyre brand, tyre size and remaining tread depth of the 4 tyres of the Motor Taxi were recorded as follows:-

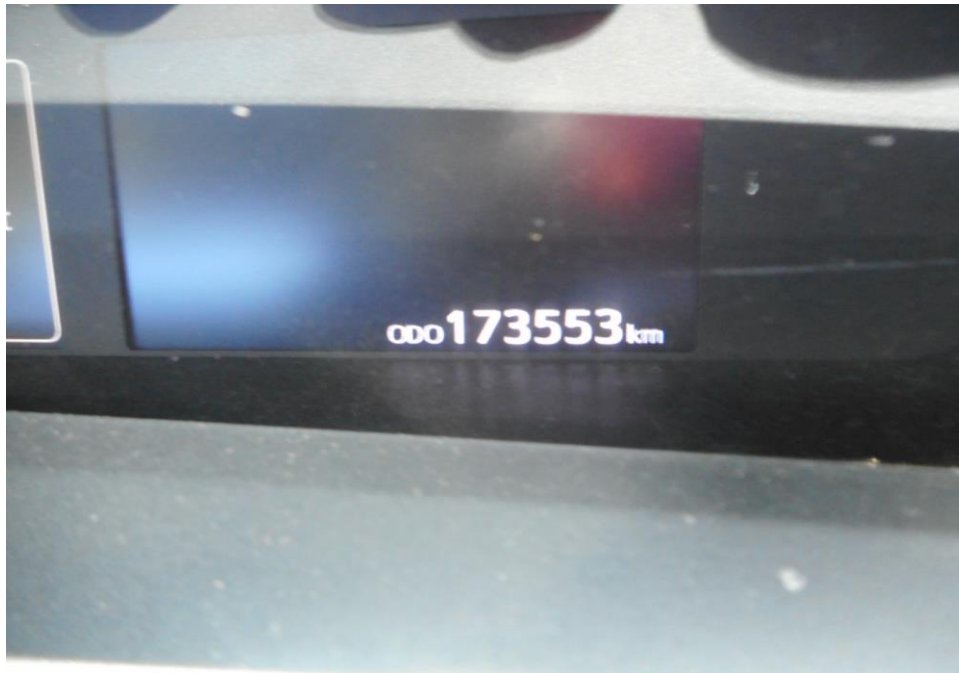
Photo 1 shows a general view of the instrument cluster of the Motor Taxi at the time of my inspection. The mileage of the Motor Taxi was 173,553km

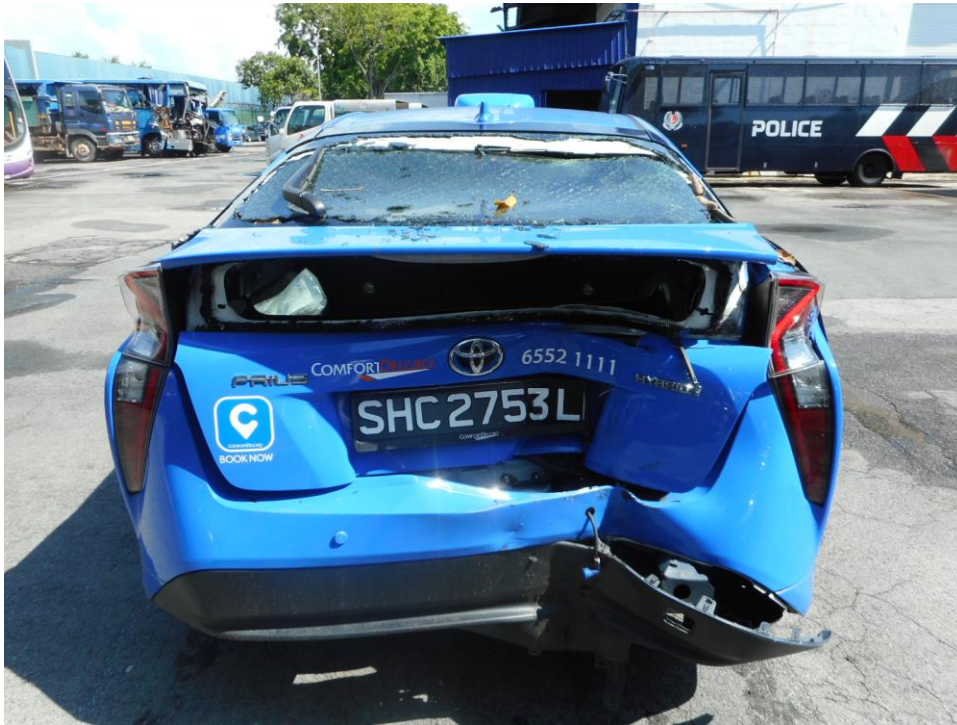
Photo 2 shows a general view of the Motor Taxi front portion at the time of my inspection. The Motor Taxi was observed to visually sustain damage at its rear windscreen, rear bumper and rear boot at the time of inspection.

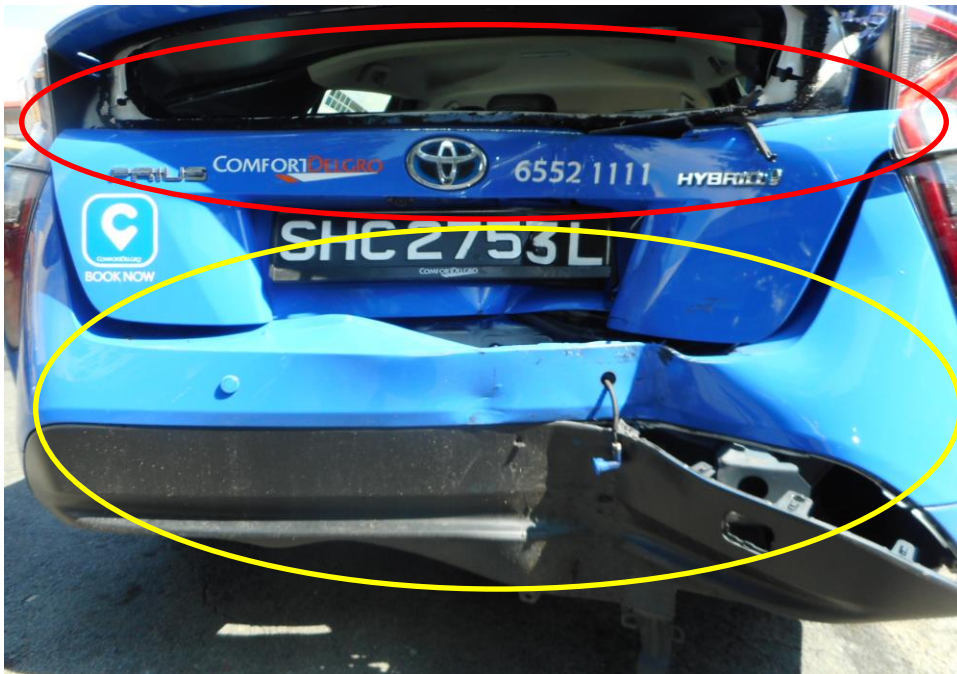
Photo 3 shows a close up view of the front body of the Motor Taxi at the time of my inspection. The Motor Taxi was observed to visually sustain damage at its rear windscreen (red circle), rear bumper and rear boot (yellow circle) at the time of inspection.

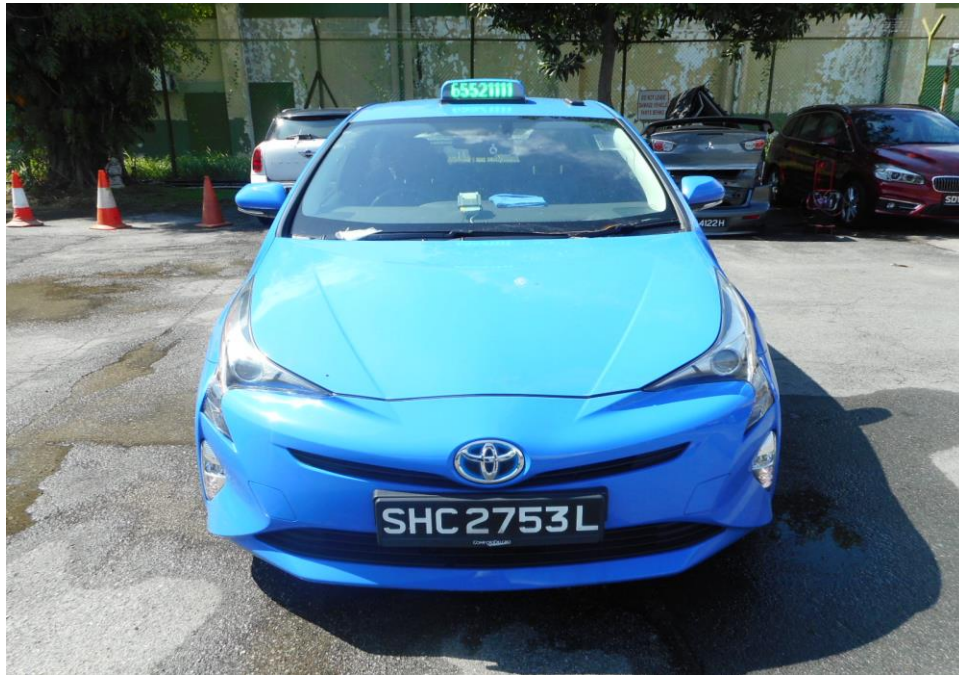
Photo 4 shows a general view of the front body of the Motor Taxi at the time of my inspection. The Motor Taxi was observed to be intact and unaffected by the accident.

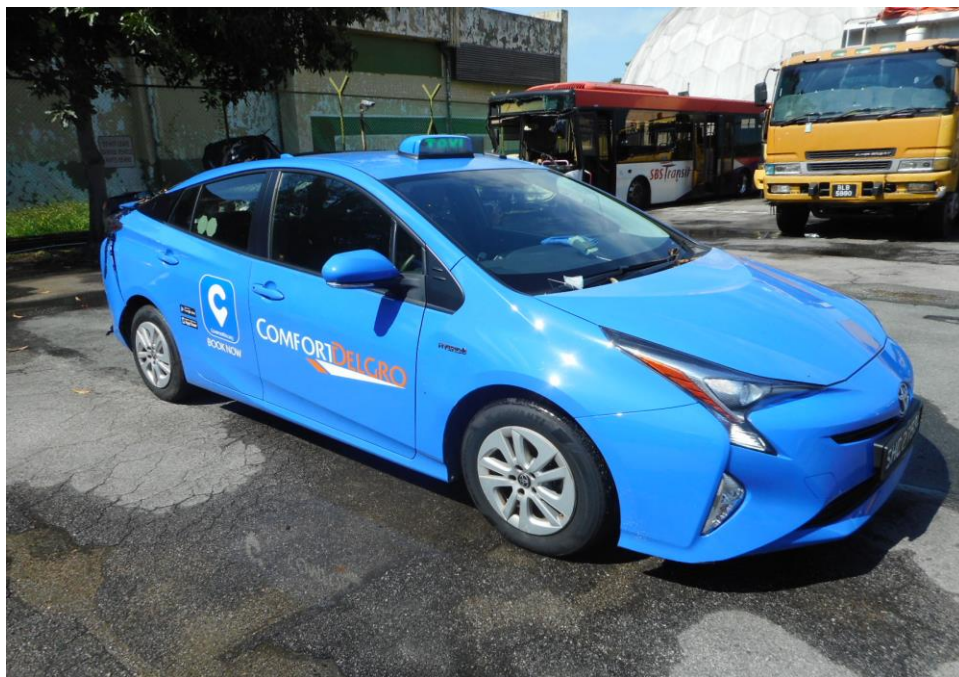
Photo 5 shows a general view of the right body of the Motor Taxi at the time of my inspection. The Motor Taxi was observed to be intact and unaffected by the accident.

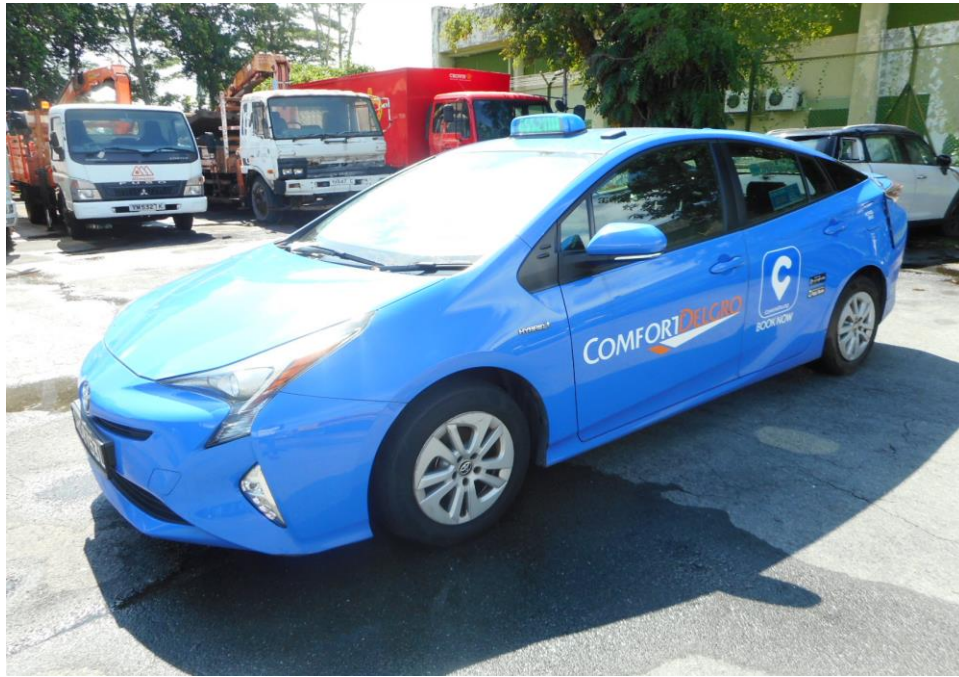
Photo 6 shows a general view of the left body of the Motor Taxi at the time of my inspection. The Motor Taxi was observed to be intact and unaffected by the accident.

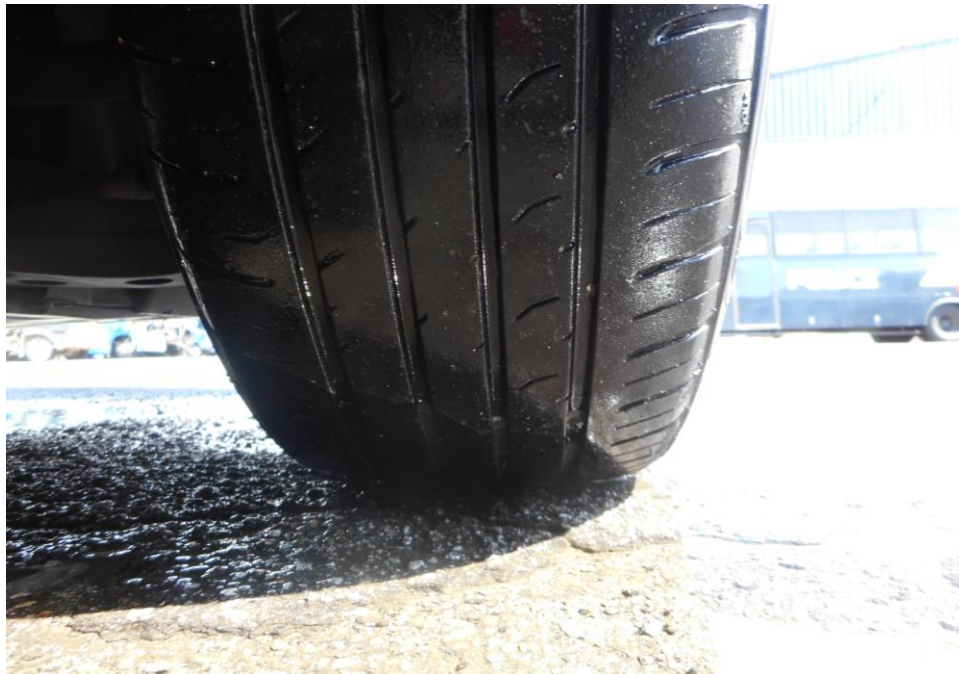
Photo 7 shows the condition of the front right tyre of the Motor Taxi, which was observed to be in serviceable condition with remaining tread depth of approximately 3.5mm. The tyre, which was wrapped around standard alloy wheel rim, was also observed to be sufficiently inflated for vehicular operation. There was no tear, cut or burst mark(s) on the outer and the inner sidewalls as well as across the tread of the 4 tyres that were fitted on the Motor Taxi.

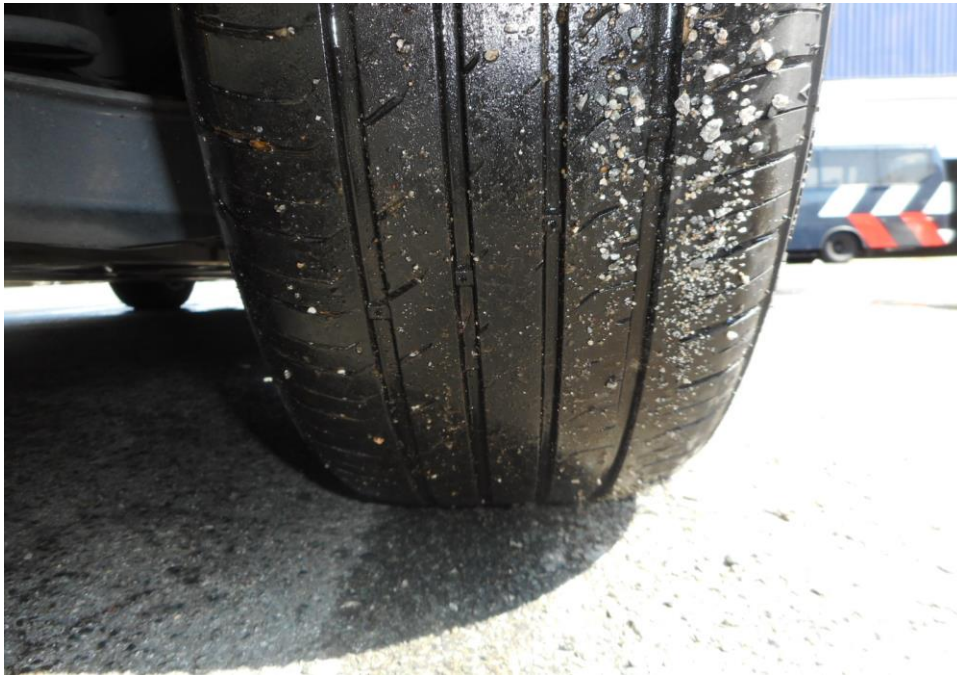
Photo 8 shows the condition of the rear right tyre of the Motor Taxi, which was observed to be in serviceable condition with remaining tread depth of approximately 4.6mm. The tyre, which was wrapped around standard alloy wheel rim, was also observed to be sufficiently inflated for vehicular operation.

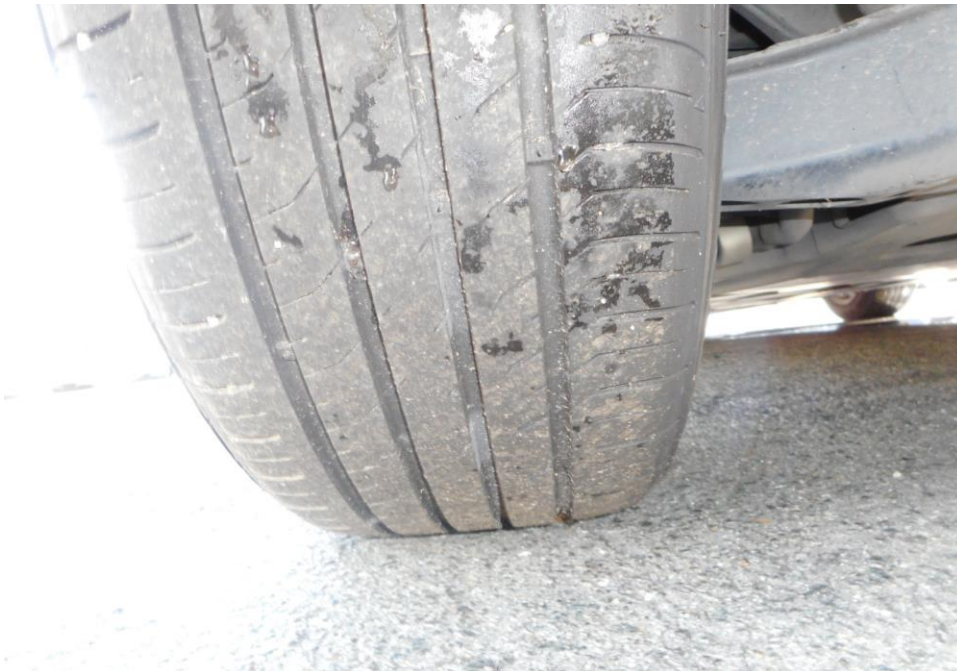
Photo 9 shows the condition of the rear left tyres of the Motor Taxi, which was observed to be in serviceable condition with remaining tread depth of approximately 4.9mm. The tyres, which were wrapped around standard alloy wheel rim, were also observed to be sufficiently inflated for vehicular operation. There was also no damage found on all 4 alloy wheel rims of the Motor Taxi.

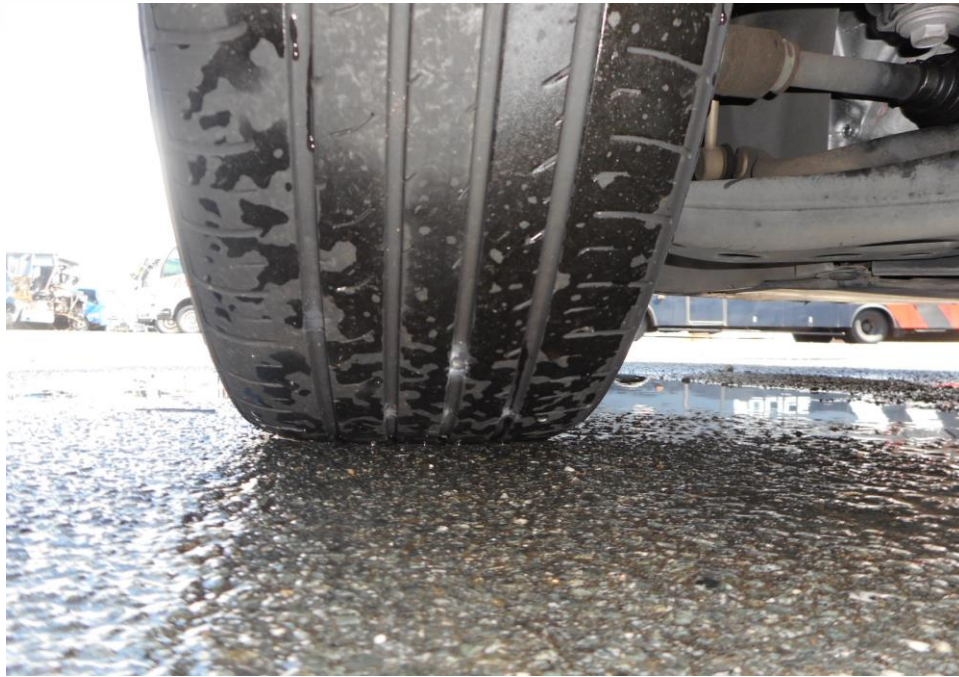
Photo 10 shows the condition of the rear right tyres of the Motor Taxi, which were observed to be in serviceable condition with remaining, tread depth of approximately 3.7mm. There was also no tear, cut or burst mark(s) on the outer and the inner sidewalls as well as across the tread of the 4 tyres that were fitted on the Motor Taxi.

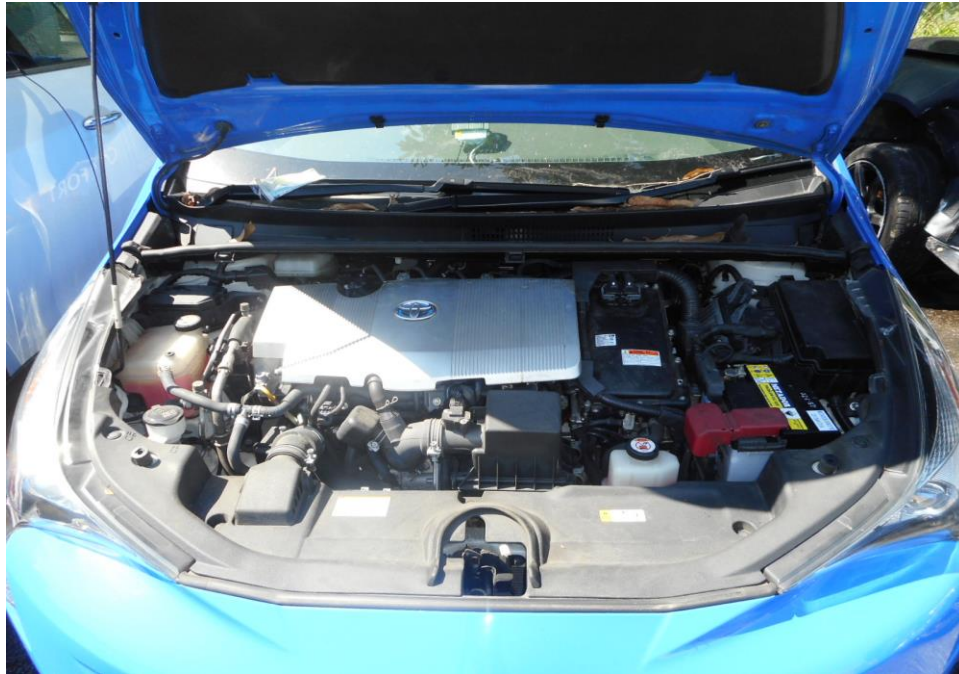
Photo 11 shows a general view of the Motor Taxi's engine compartment, which was accessed by lifting the front cabin of the Motor Taxi. The various parts and components inside the engine compartment were unaffected by the accident. There was also no sign(s) or indication(s) of fresh fluid leakage and/or fluid stain within the engine compartment

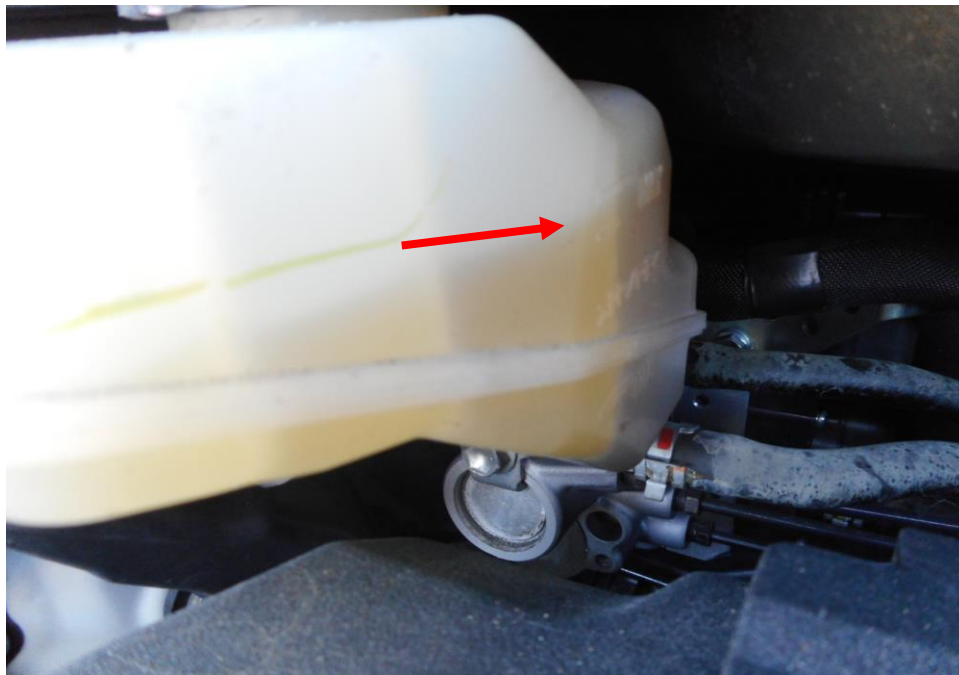
Photo 12 shows the brake fluid reservoir of the Motor Taxi at the time of my inspection. The brake fluid was observed to be of sufficient level (arrowed) and without any visible contamination.

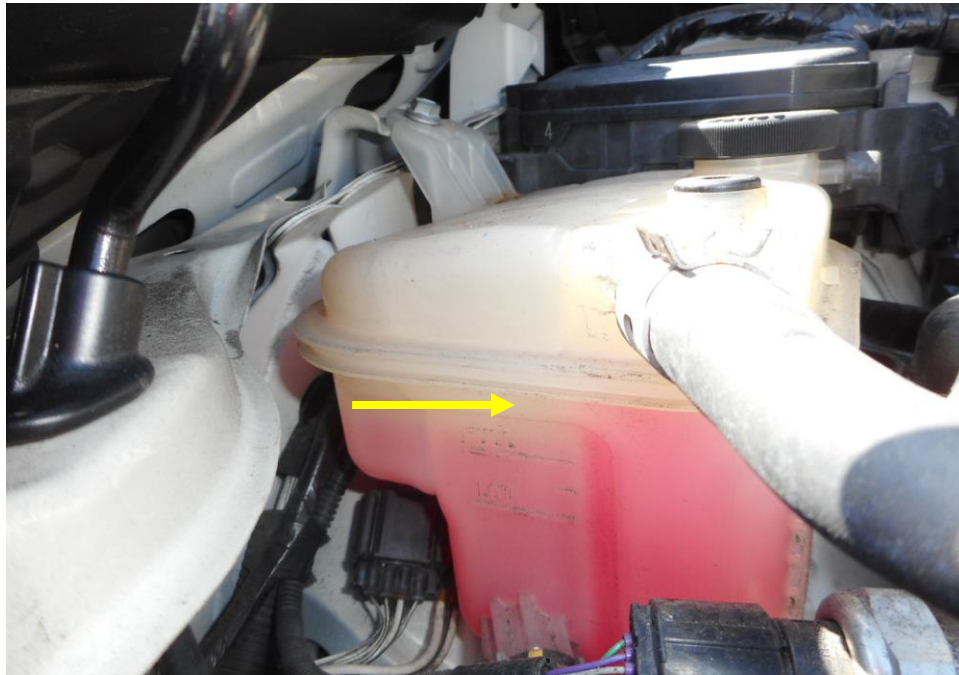
Photo 13 shows the engine coolant reservoir of the Motor Taxi at the time of my inspection. The engine coolant was observed to be of sufficient level (arrowed) and without any visible contamination.

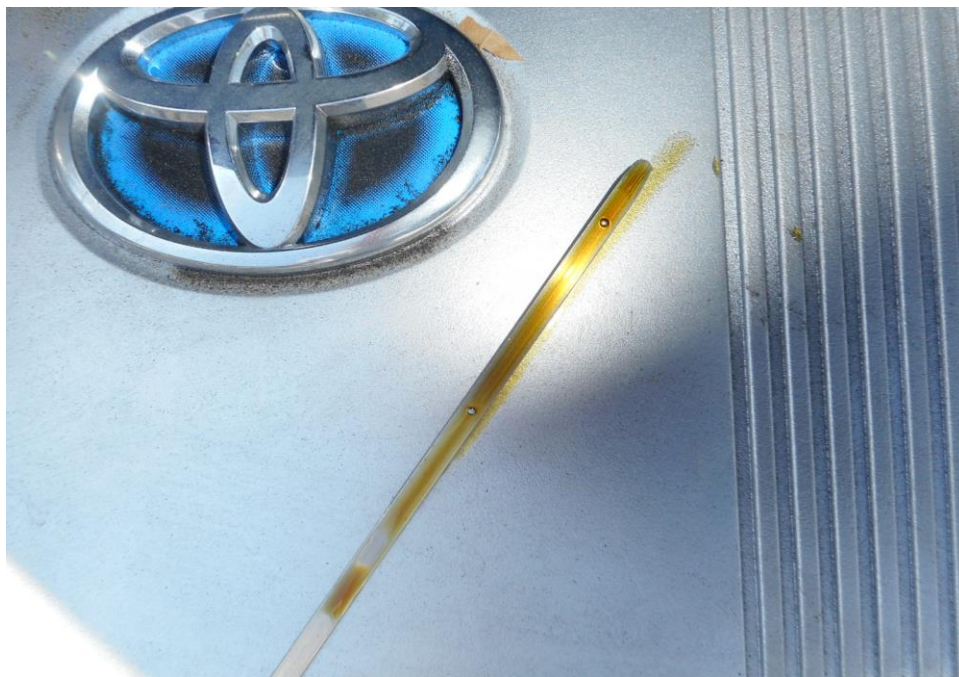
Photo 14 shows the engine oil dip stick of the Motor Taxi at the time of my inspection. The engine oil was observed to be of sufficient level and without any visible contamination.

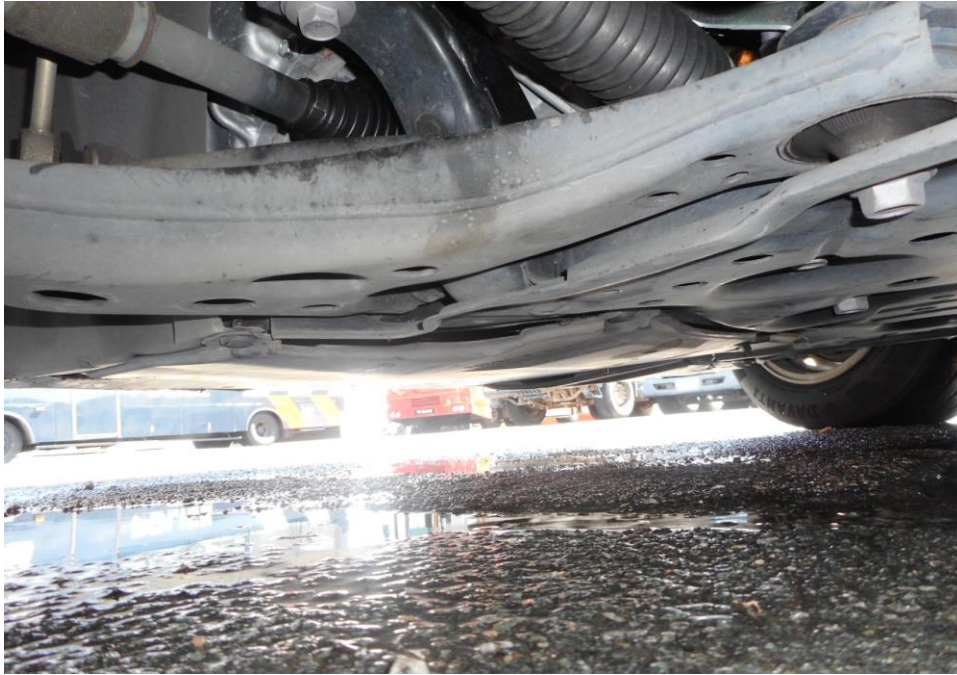
Photo 15 shows the undercarriage of the Motor Taxi, at the area where the engine housing and transmission housing are located. . I did not find any sign(s) or indication(s) of fluid leak and/or fluid stain(s) on the underside of the Motor Taxi.

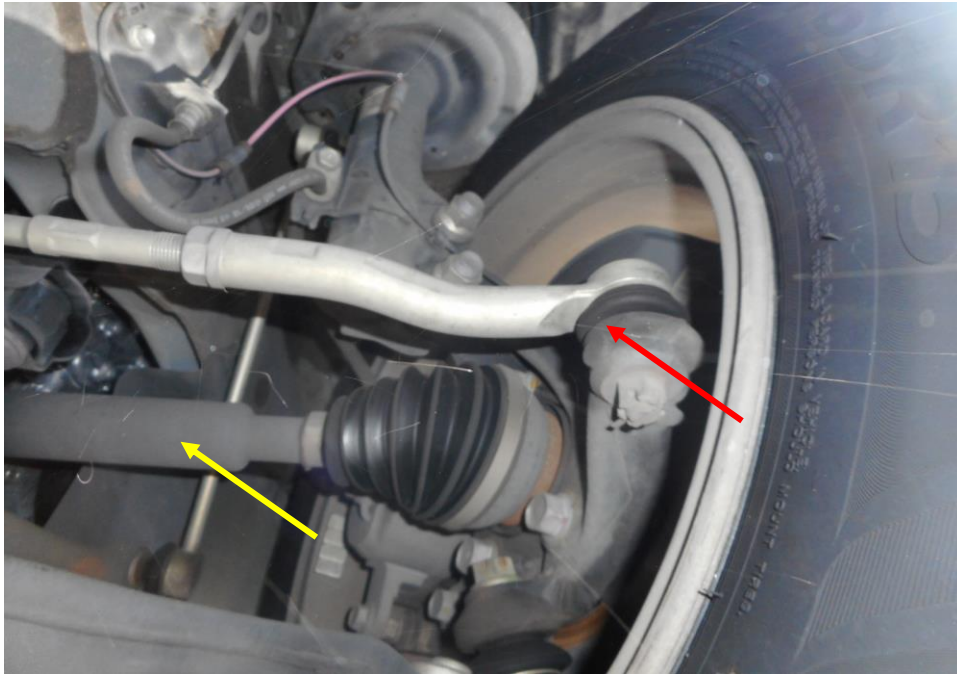
Photo 16 shows the various undercarriage components at the front right wheel of the Motor Taxi, in particular the steering tie rod end (arrowed) and drive shaft (yellow arrow). The various steering components were all found to be intact, suggesting that the steering system of the Motor Taxi was likely to be in serviceable condition at the material time of accident. There was also no sign of fluid stain(s) observed on the various undercarriage components.

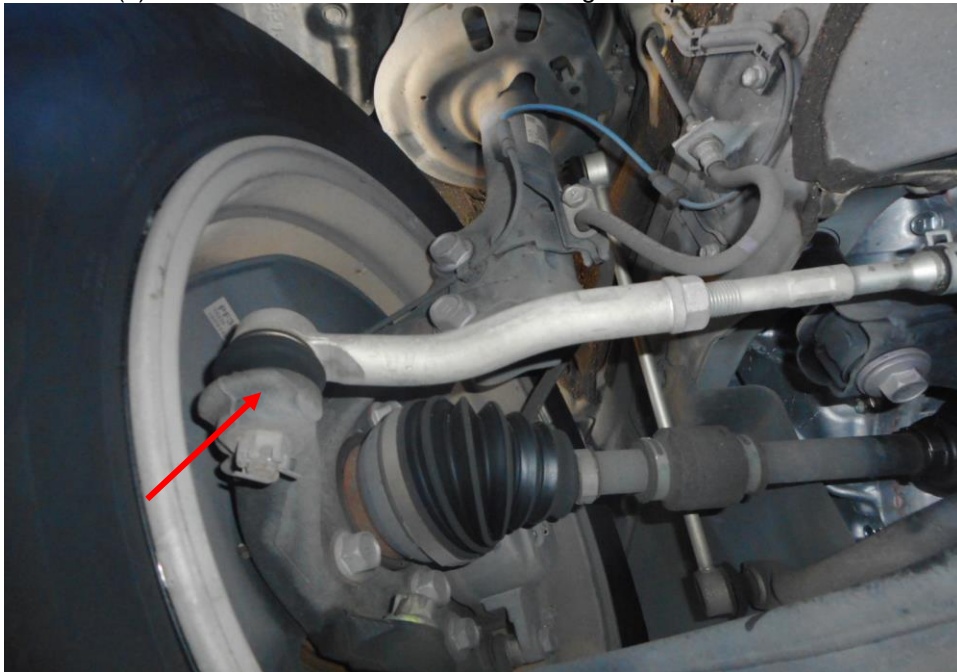
Photo 17 shows the various undercarriage components at the front left wheel of the Motor Taxi, in particular the steering tie rod end (arrowed). The various Undercarriage components of the Motor Taxi were all found to be intact without any visible damage. There was also no sign of fluid stain(s) observed on the various undercarriage components.

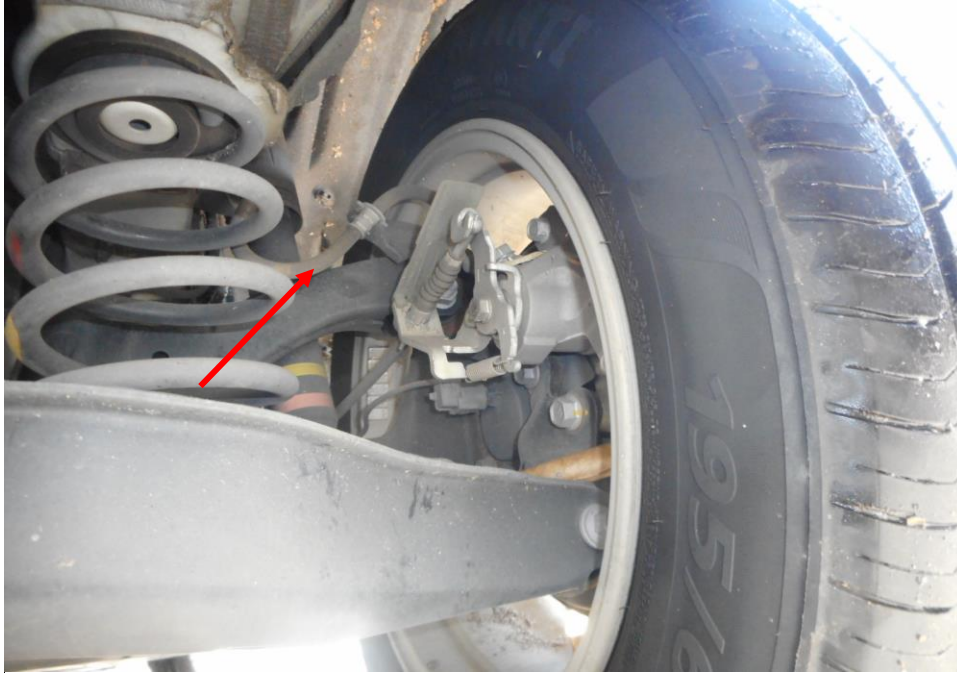
Photo 18 shows the brake pipe (arrowed) at the rear right wheel of the Motor Taxi. I did not observe any leakage of brake fluid at the time of my inspection of the Motor Taxi. My static tests of the Motor Taxi's braking system, along with my visual examination of the various mechanical components in the braking system, had indicated that there was no internal leakage of pressure/vacuum. Hence the braking system of the Motor Taxi was likely to be in serviceable condition at the material time of accident.

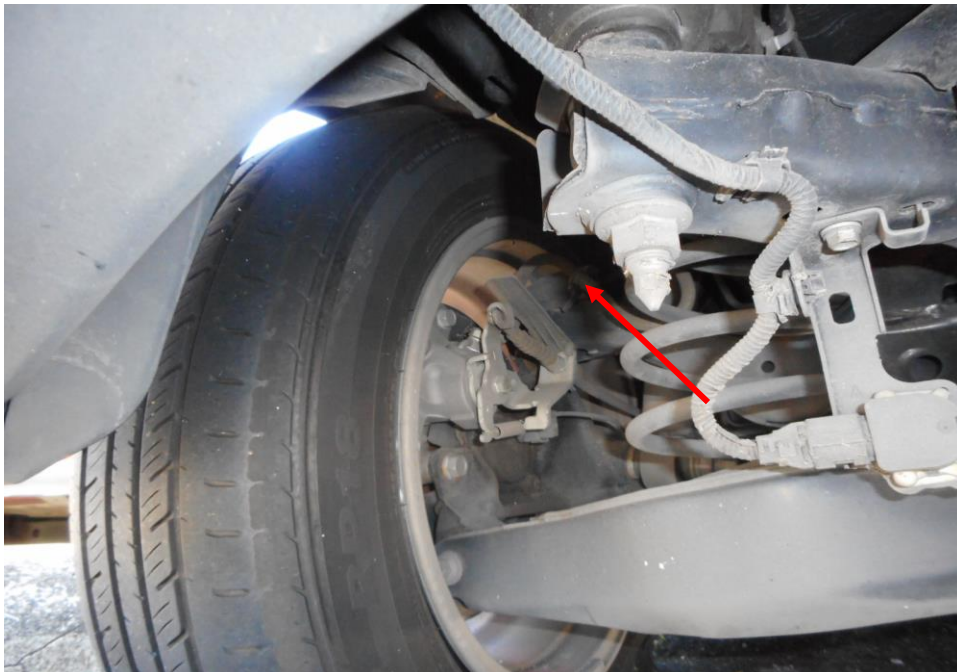
Photo 19 shows the brake pipe (arrowed) at the rear left wheel of the Motor Taxi. I did not observe any leakage of brake fluid at the time of my inspection of the Motor Taxi. My static tests of the Motor Taxi's braking system, along with my visual examination of the various mechanical components in the braking system had indicated that there was no internal leakage of pressure/vacuum. Hence the braking system of the Motor Taxi was likely to be in serviceable condition at the material time of accident.

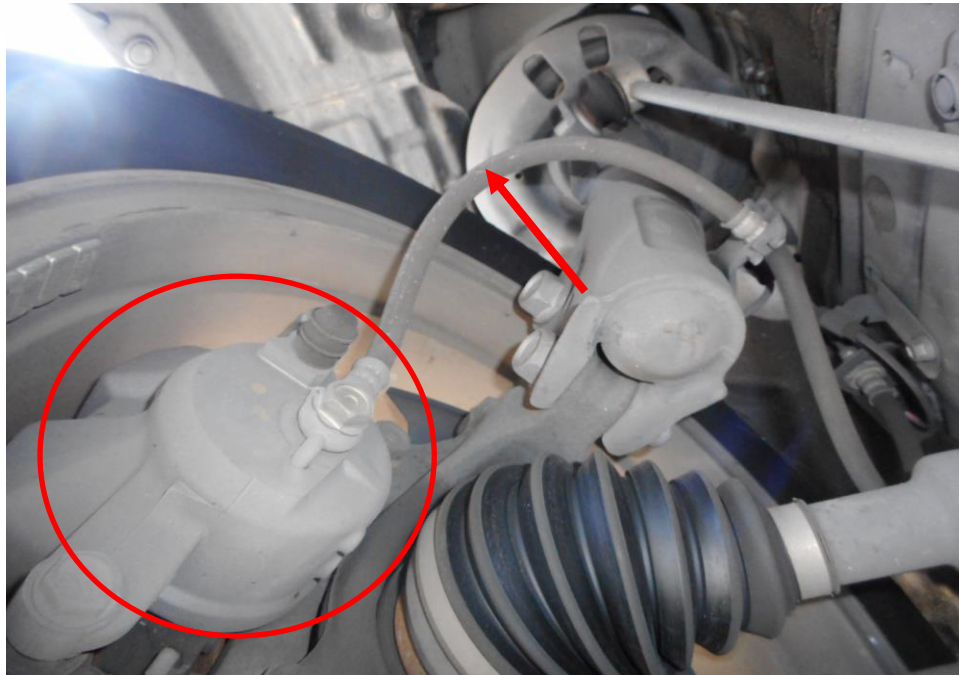
Photo 20 shows the brake hose/pipe (arrowed) at the front right wheel of the Motor Taxi. No leakage of brake fluid was observed. Visual examination of the various components of the braking system like the brake caliper (circled), brake booster, brake pedal etc had revealed all to be intact and without visible damage at the time of accident. There was also no sign of fluid stain(s) observed on the various undercarriage components.

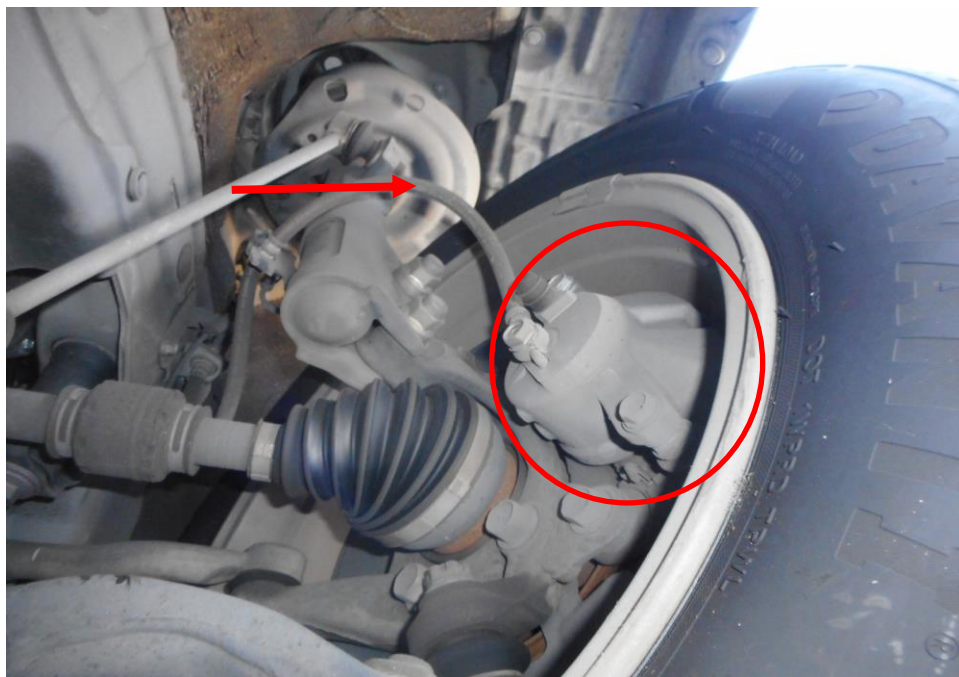
Photo 21 shows the brake hose/pipe (arrowed) at the front left wheel of the Motor Taxi. No leakage of brake fluid was observed. Visual examination of the various components of the braking system like the brake caliper (circled), brake booster, brake pedal etc had revealed all to be intact and without visible damage at the time of accident. There was also no sign of fluid stain(s) observed on the various undercarriage components.

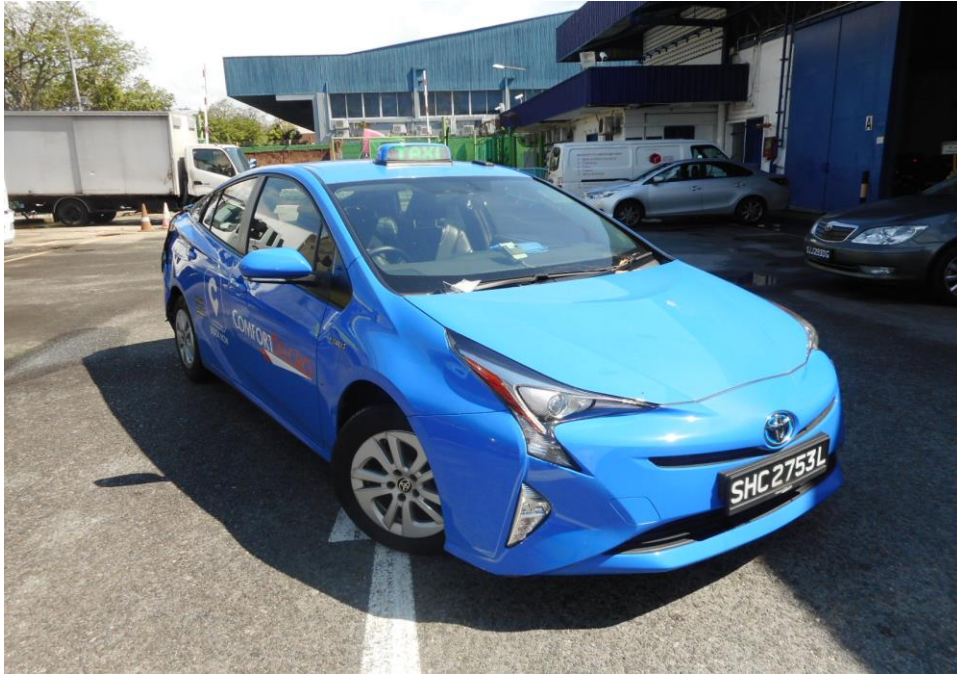
Photo 22 shows the front right wheel of the Motor Taxi turned to its full left. During my steering system test, I did not experience any abnormal free play and/or resistance when I had turned the steering wheel towards full left and full right. This would suggest that the steering system of the Motor Taxi was likely to be in serviceable condition at the material time of accident.

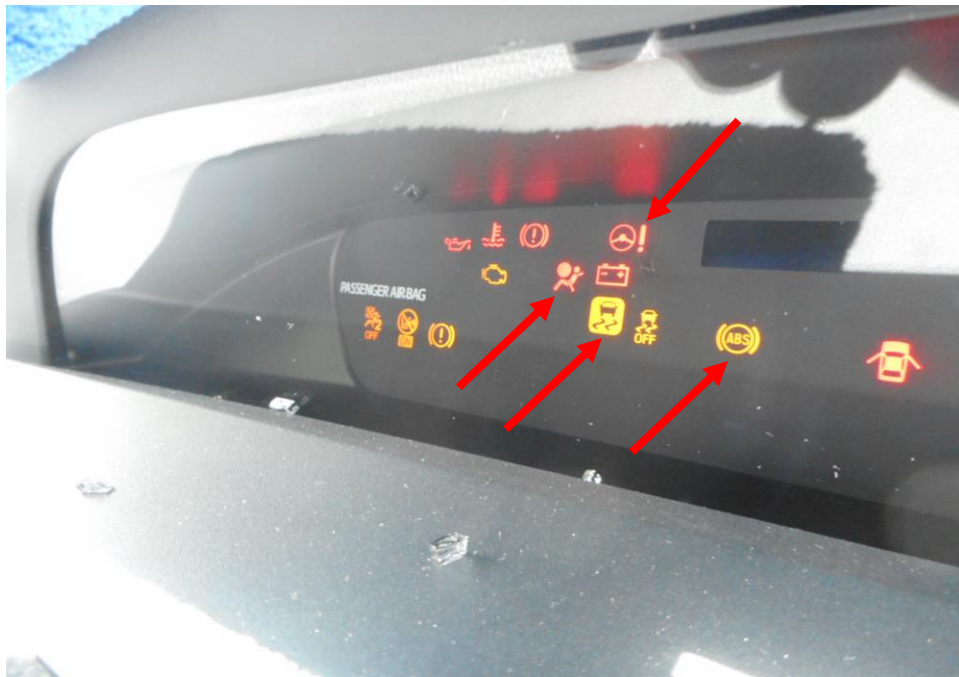
Photo 23 shows the warning light for Anti-Lock Brake System (ABS), Supplemental Restraint System (SRS), Traction Control System (TC) and Electric Power Steering System (EPS) appearing on the instrument panel of the Motor Taxi during the self-test of its various electronic operating systems when its engine was cranked.

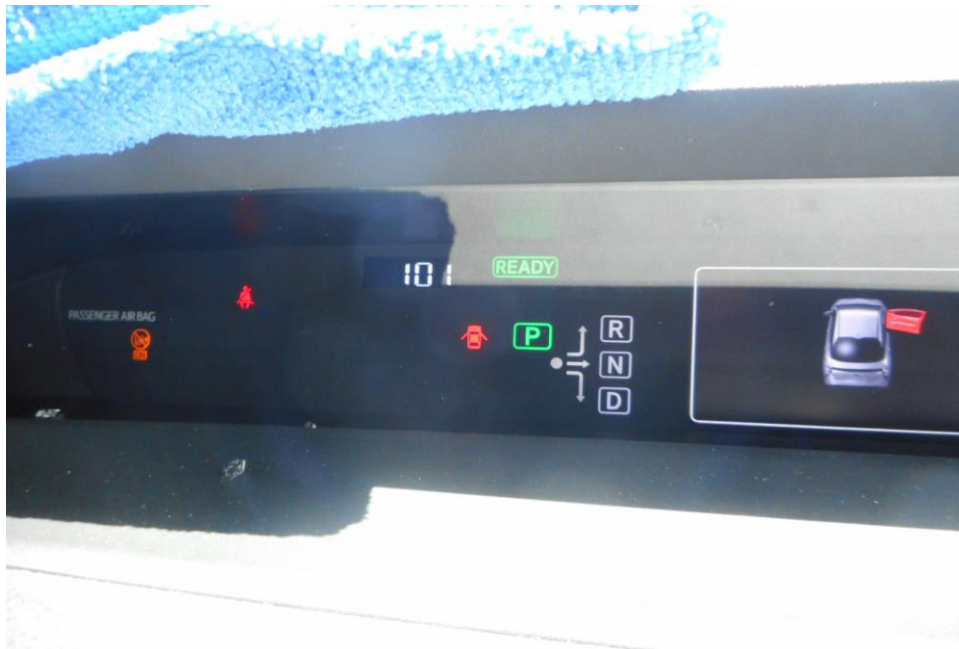
Photo 24 shows no warning lights illuminated on the instrument panel of the Motor Taxi after the engine was cranked. This would suggest that there was no abnormality to the various electronic operating systems of the Motor Taxi, like the ABS, SRS, TC and EPS.
