Your Ref: TP/IP/09681/2020  
Our Ref : CI/TPD20004857/P

**MECHANICAL INSPECTION REPORT OF MOTOR TRAILER BLB 5990**

1. I refer to your request on 2<sup>nd</sup> April 2020 to conduct a physical inspection of a Motor Trailer bearing registration number BLB 5990 (herein referred to as "**Motor Trailer**"), which was involved in a fatal road traffic accident on 19<sup>th</sup> February 2020.
2. The objective of this inspection is to determine if there was any possible mechanical failure to the Motor Trailer that may have contributed to the accident.
3. Following the request, I had carried out a physical inspection of the Motor Trailer on 3<sup>rd</sup> August 2020 at the premises of Traffic Police vehicle pound, 517 Airport Road Singapore 539942. I now set out below my observations and comments with respect to this inspection.

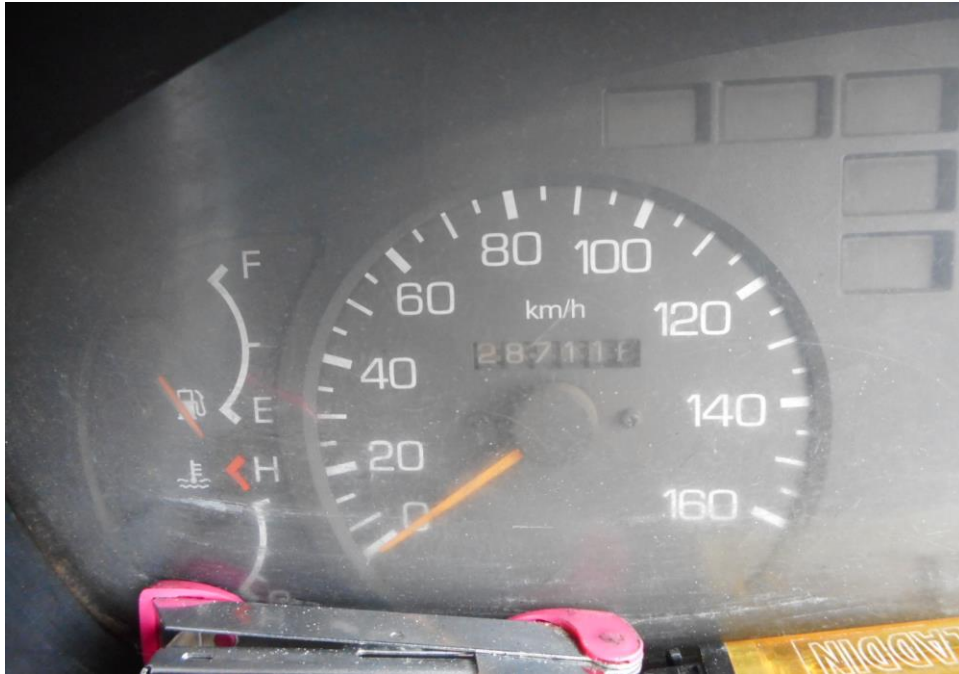
**Photo 1** shows a general view of the instrument cluster of the Motor Trailer at the time of my inspection. The mileage of the Motor Trailer was 287,118km

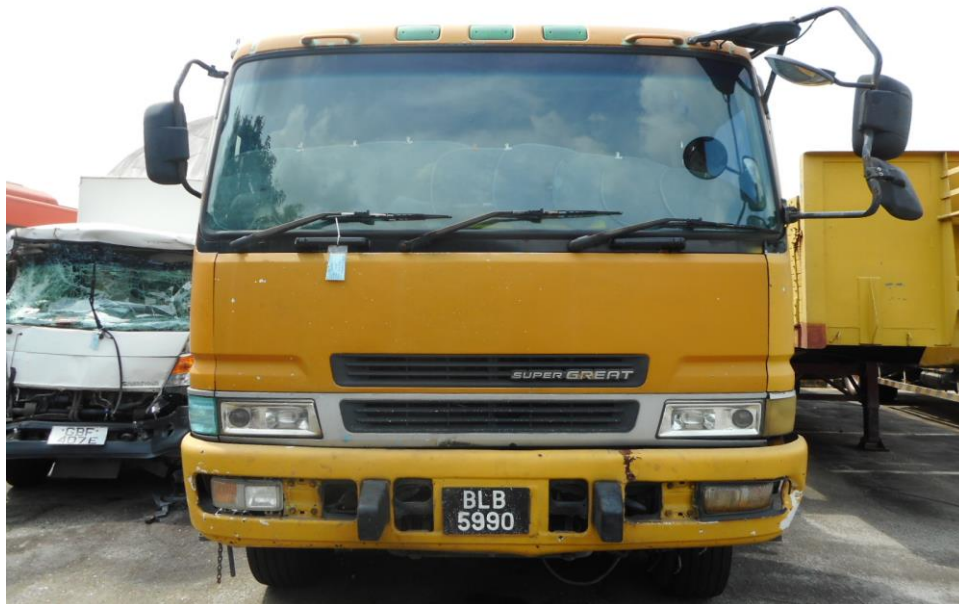
**Photo 2** shows a general view of the front body of the Motor Trailer at the time of my inspection. The Motor Trailer was observed to be intact and unaffected by the accident.

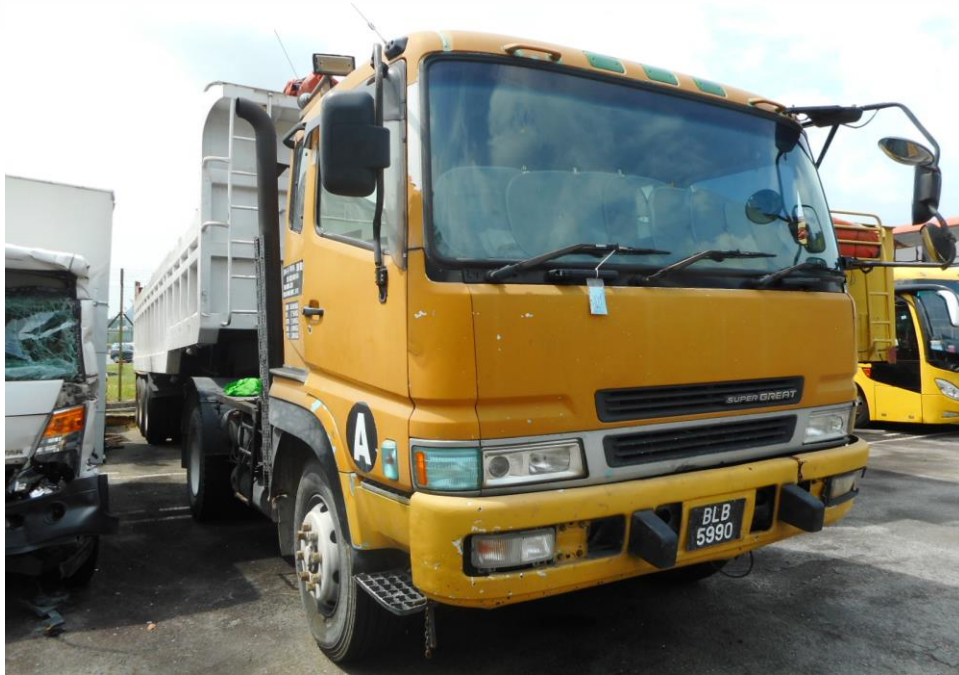
**Photo 3** shows a general view of the front right body of the Motor Trailer at the time of my inspection. The Motor Trailer was observed to be intact and unaffected by the accident.

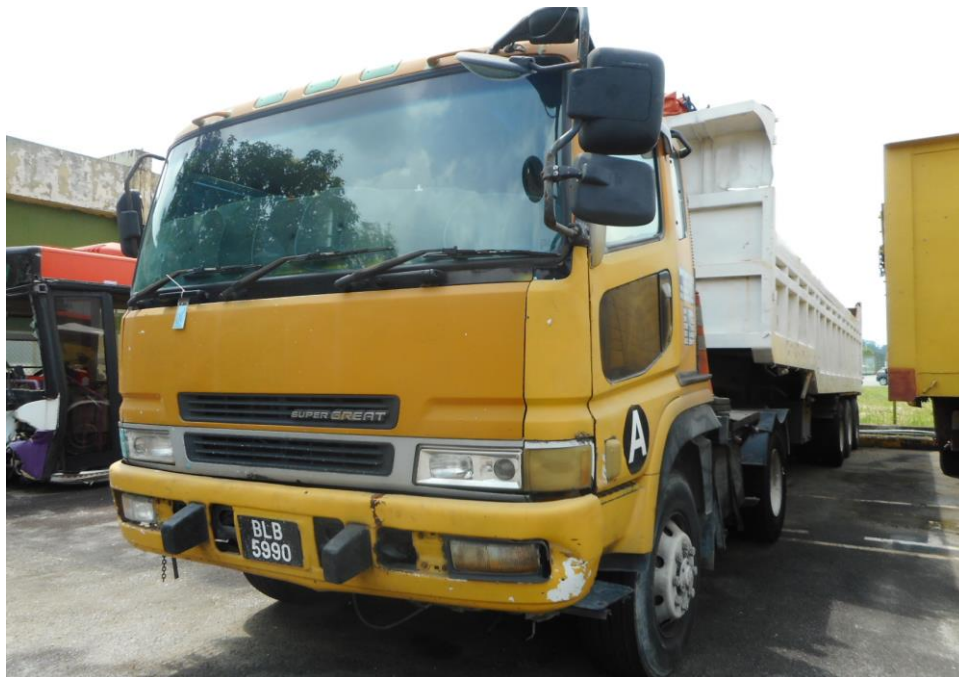
**Photo 4** shows a general view of the front left body of the Motor Trailer at the time of my inspection. The Motor Trailer was observed to be intact and unaffected by the accident.

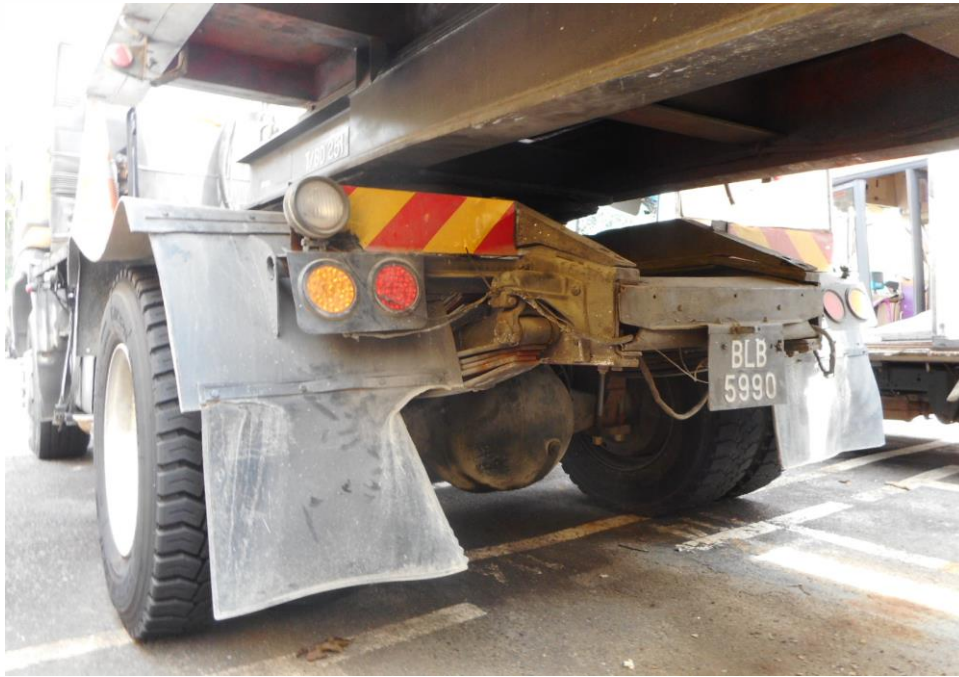
**Photo 5** shows a general view of the Motor Trailer's rear body at the time of my inspection. The Motor Trailer was observed to be intact and unaffected by the accident.

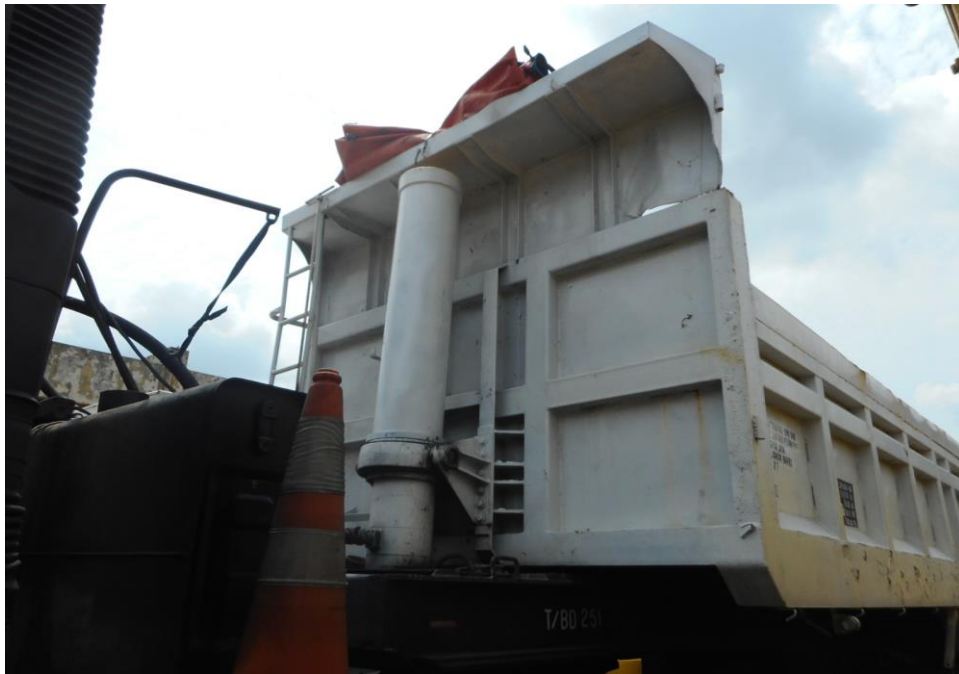
**Photo 6** shows a general view of the front body of the trailer at the time of my inspection. The Motor Trailer was observed to be intact and unaffected by the accident.

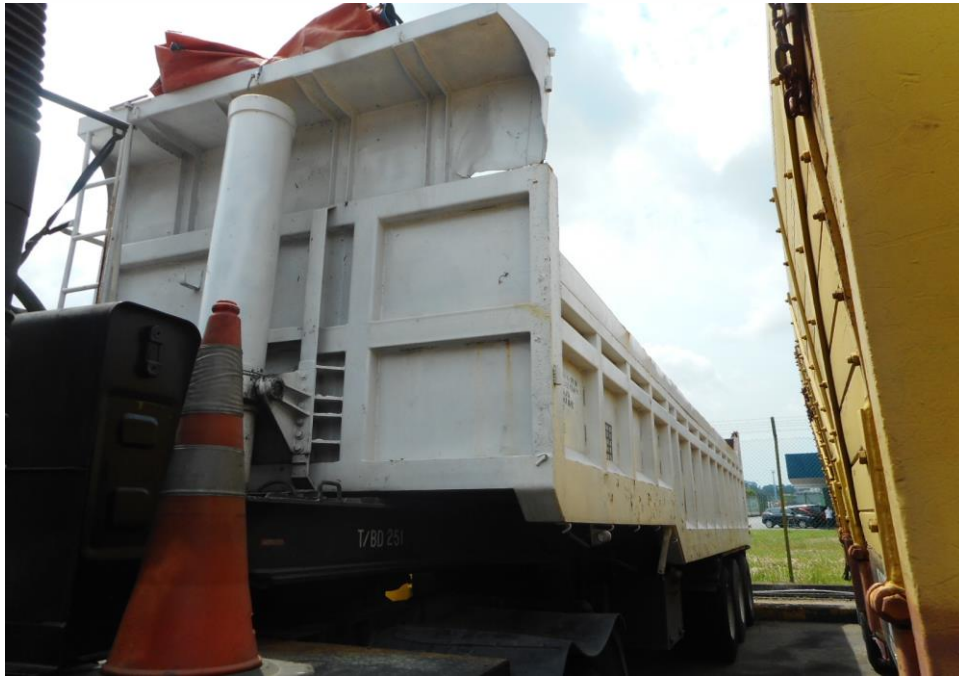
**Photo 7** shows a general view of the trailer's left body at the time of my inspection. The Motor Trailer was observed to be intact and unaffected by the accident.

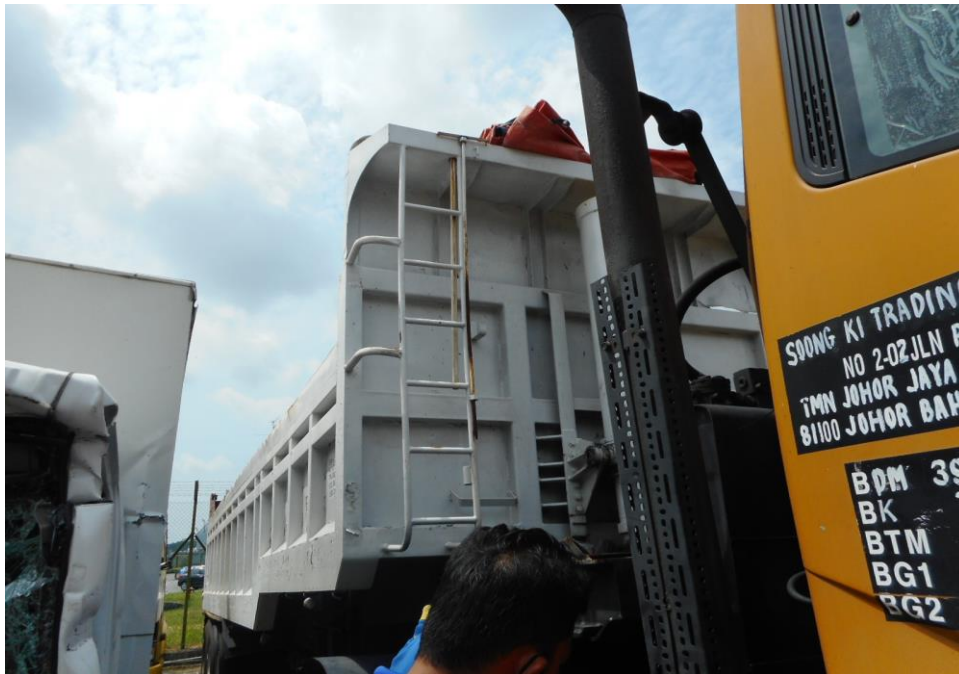
**Photo 8** shows a general view of the trailer's right body at the time of my inspection. The Motor Trailer was observed to be intact and unaffected by the accident.

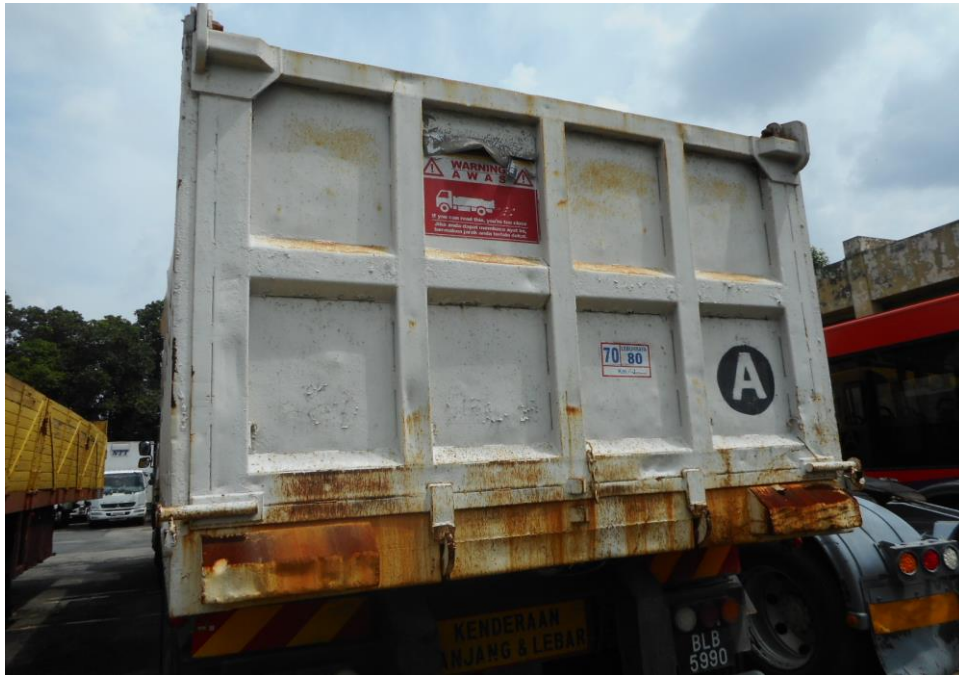
**Photo 9** shows a general view of the trailer's rear body at the time of my inspection. The Motor Trailer was observed to be intact.

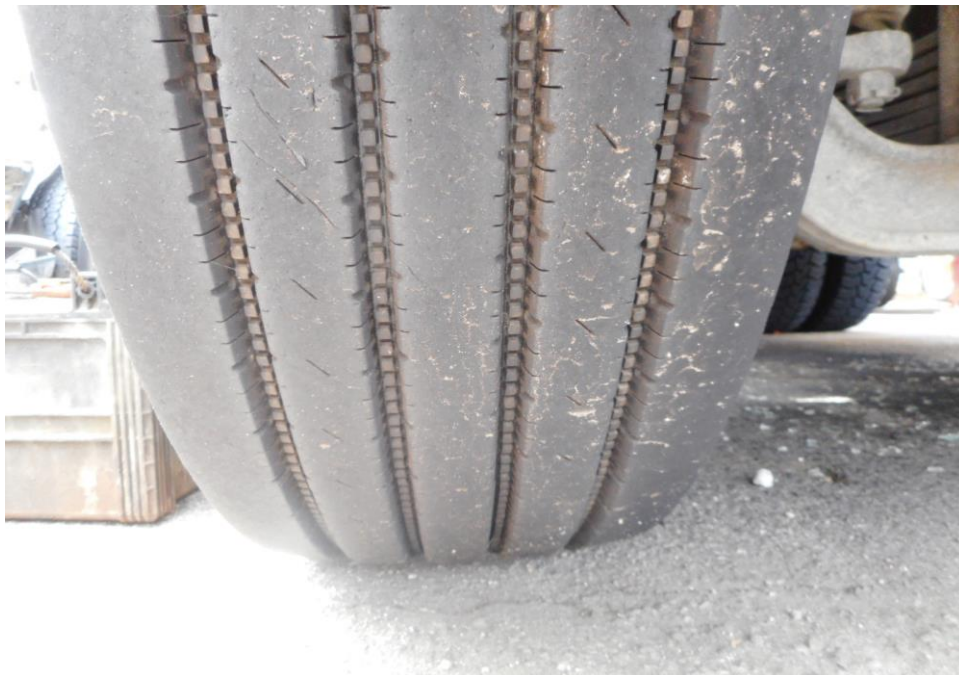
**Photo 10** shows the condition of the front right tyre of the Motor Trailer, which was observed to be in serviceable condition with remaining tread depth of approximately 9.6mm. The tyre, which was wrapped around standard steel wheel rim, was also observed to be sufficiently inflated for vehicular operation. There was no tear, cut or burst mark(s) on the outer and the inner sidewalls as well as across the tread of the 6 tyres that were fitted on the Motor Trailer.

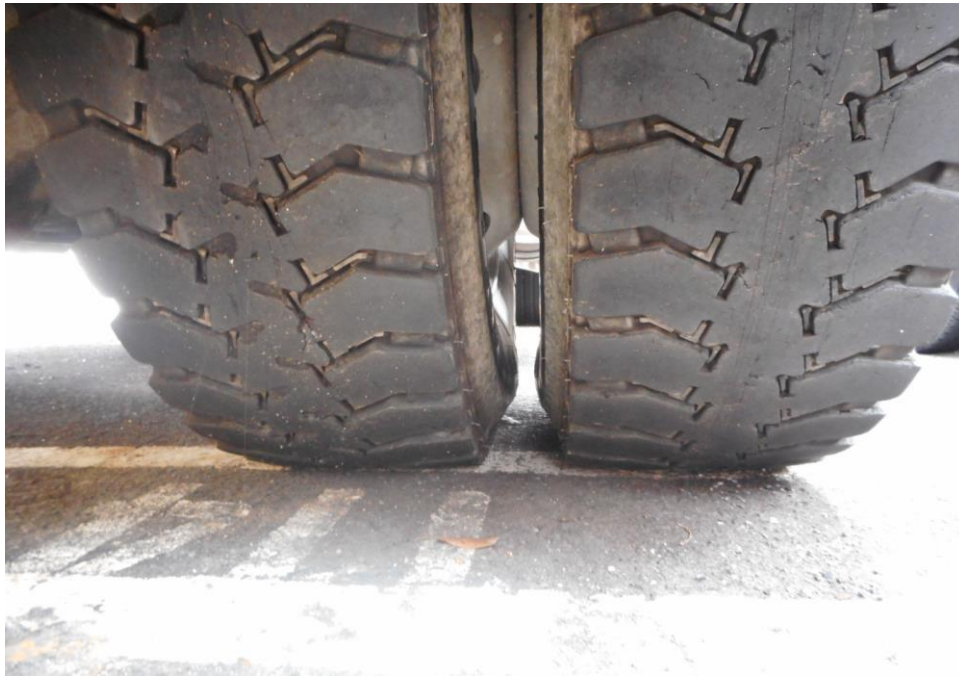
**Photo 11** shows the condition of the rear right tyre of the Motor Trailer, which was observed to be in serviceable condition with remaining tread depth of approximately 8.5mm. The tyre, which was wrapped around standard steel wheel rim, was also observed to be sufficiently inflated for vehicular operation.

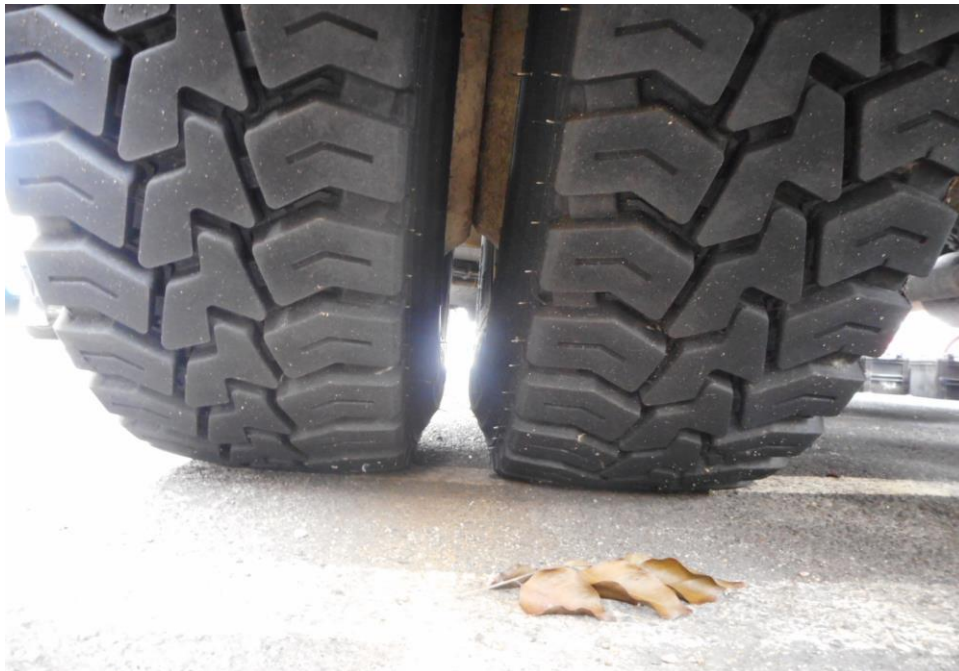
**Photo 12** shows the condition of the rear left tyres of the Motor Trailer, which was observed to be in serviceable condition with remaining tread depth of approximately 14.3mm. The tyres, which were wrapped around standard steel wheel rim, were also observed to be sufficiently inflated for vehicular operation. There was also no damage found on all 6 steel wheel rims of the Motor Trailer.

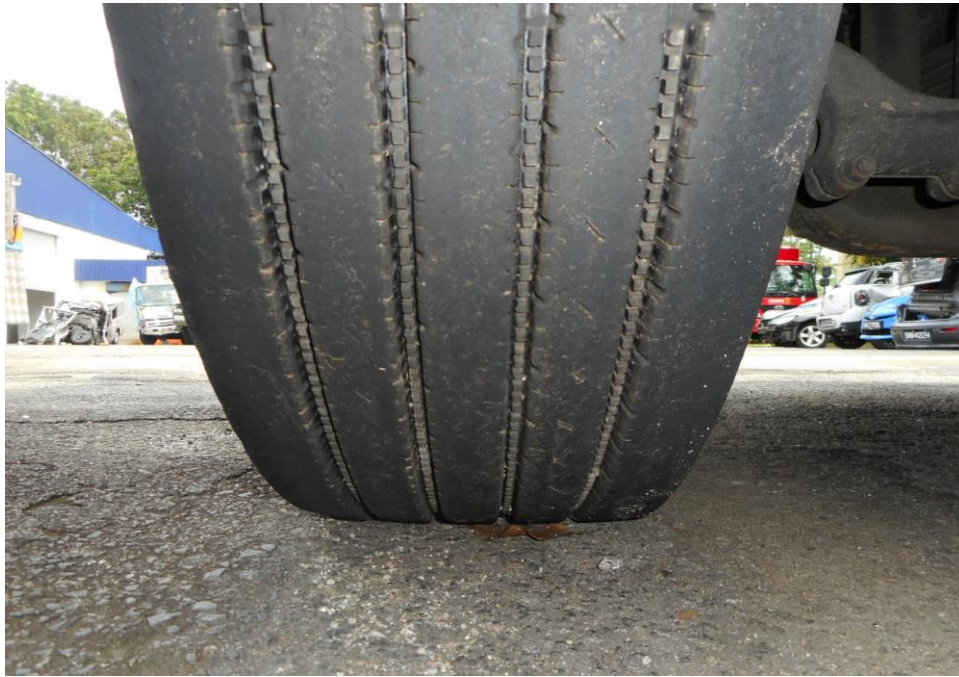
**Photo 13** shows the condition of the front left tyres of the Motor Trailer, which were observed to be in serviceable condition with remaining tread depth of approximately 7.1mm. There was also no tear, cut or burst mark(s) on the outer and the inner sidewalls as well as across the tread of the 6 tyres that were fitted on the Motor Trailer.

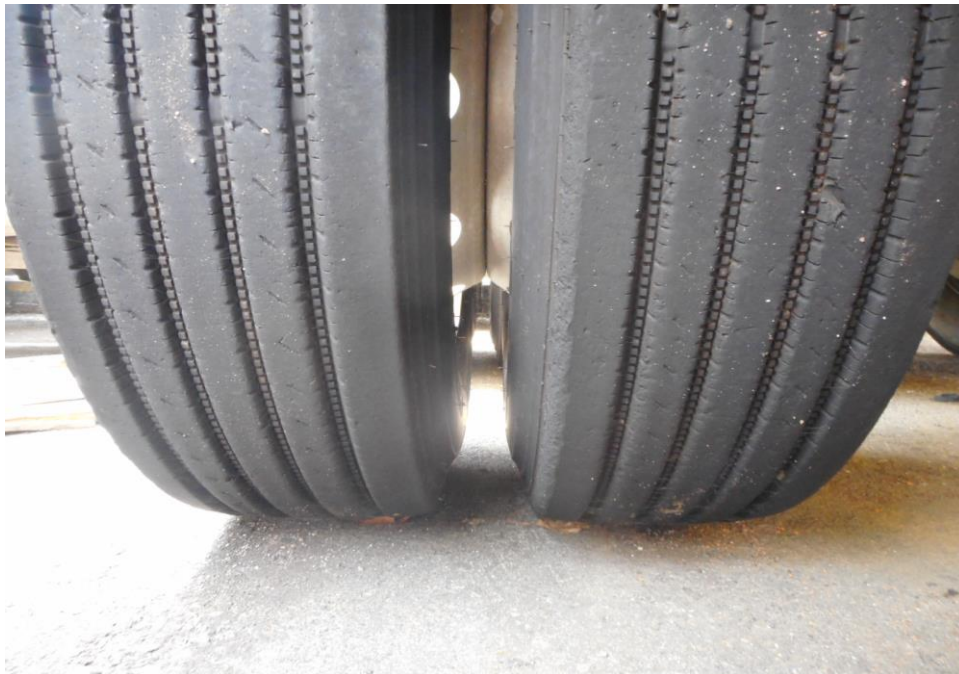
**Photo 14** shows the condition of the right tyres of the trailer, which was observed to be in serviceable condition with remaining, tread depth of approximately 9.5mm. The tyre, which was wrapped around standard steel wheel rim, was also observed to be sufficiently inflated for vehicular operation.

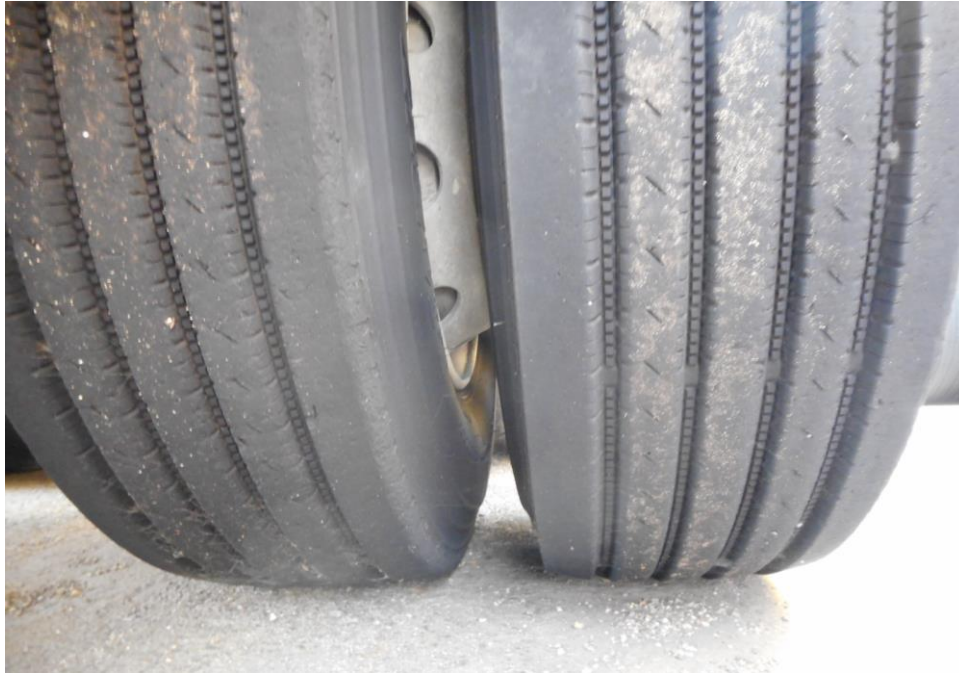
**Photo 15** shows the condition of the left tyres of the trailer, which was observed to be in serviceable condition with remaining tread depth of approximately 9.3mm. The tyres, which were wrapped around standard steel wheel rim, were also observed to be sufficiently inflated for vehicular operation. There was also no damage found on all 6 steel wheel rims of the Motor Trailer.

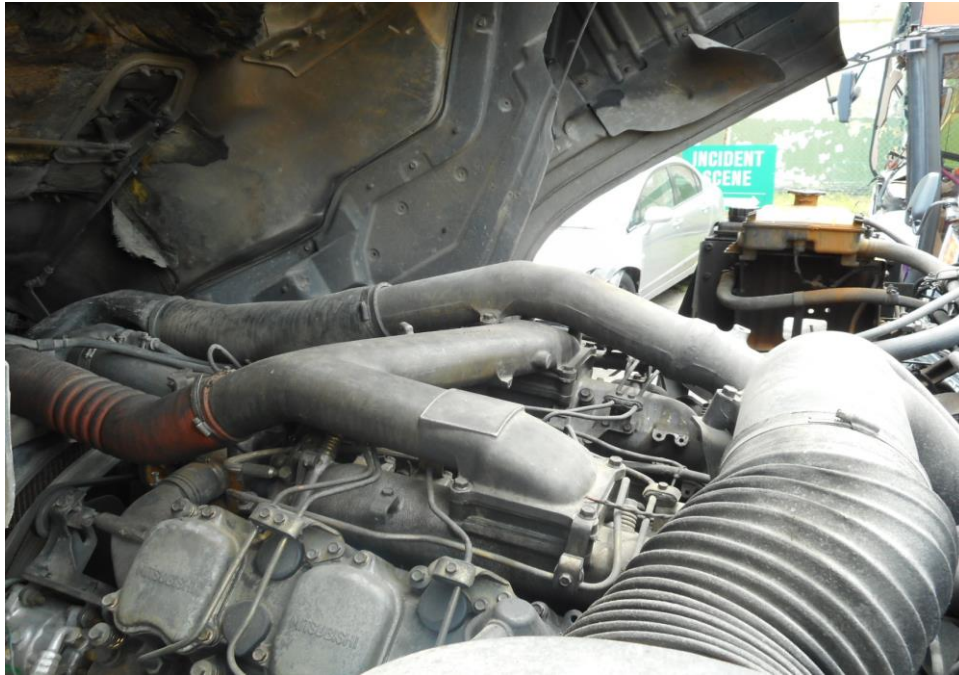
**Photo 16** shows a general view of the Motor Trailer's engine compartment, which was accessed by lifting the front cabin of the Motor Trailer. The various parts and components inside the engine compartment were unaffected by the accident. There was also no sign(s) or indication(s) of fresh fluid leakage and/or fluid stain within the engine compartment

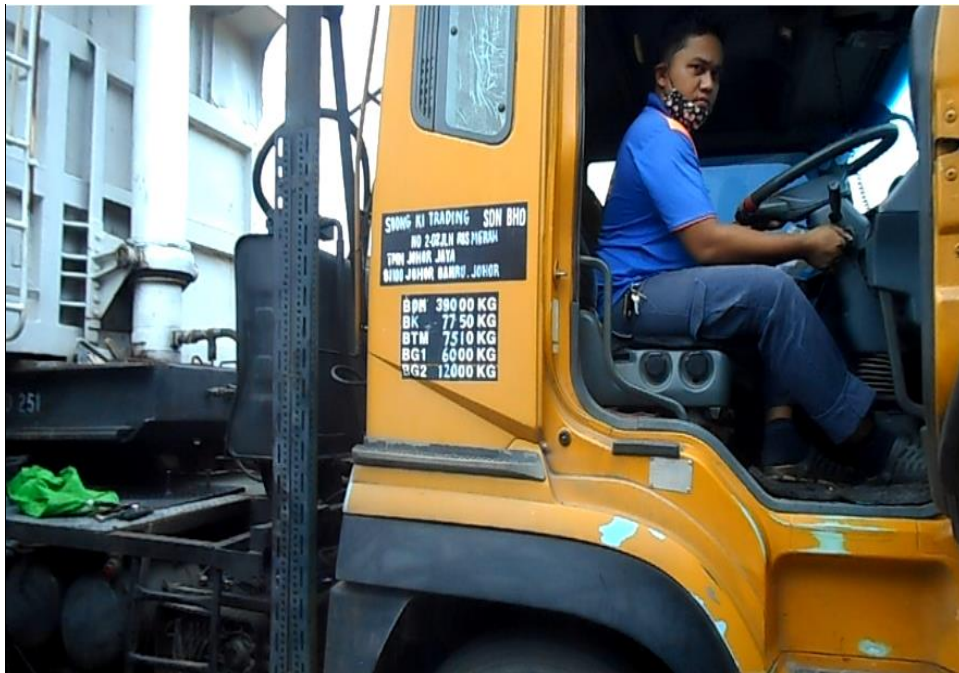
**Photo 17** shows the driver attempting to jumpstart up the Motor Trailer at the time of my inspection, however the engine was not able to be started up despite multiple attempts.

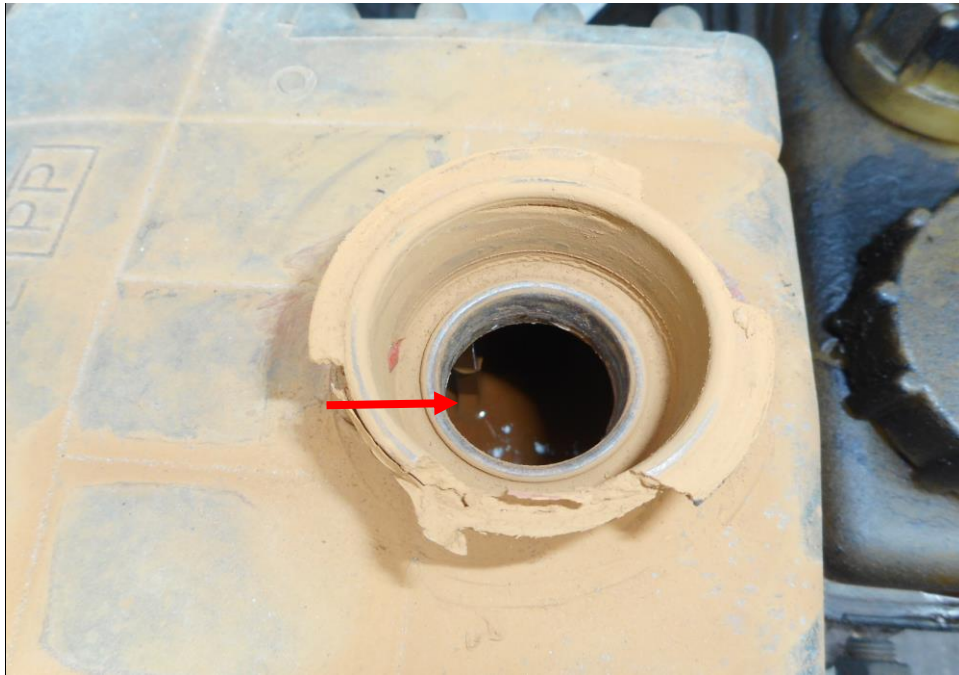
**Photo 18** shows the engine coolant reservoir of the Motor Trailer at the time of my inspection. The engine coolant was observed to be of sufficient level (arrowed) and without any visible contamination.

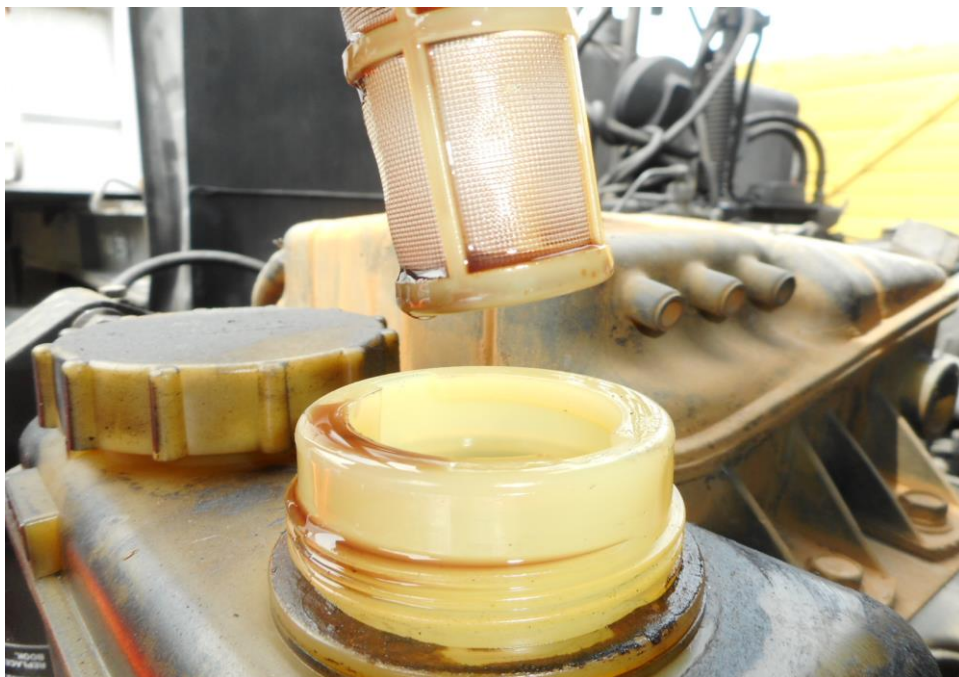
**Photo 19** shows the power steering fluid reservoir of the Motor Trailer at the time of my inspection. The power steering fluid was observed to be of sufficient level and without any visible contamination.

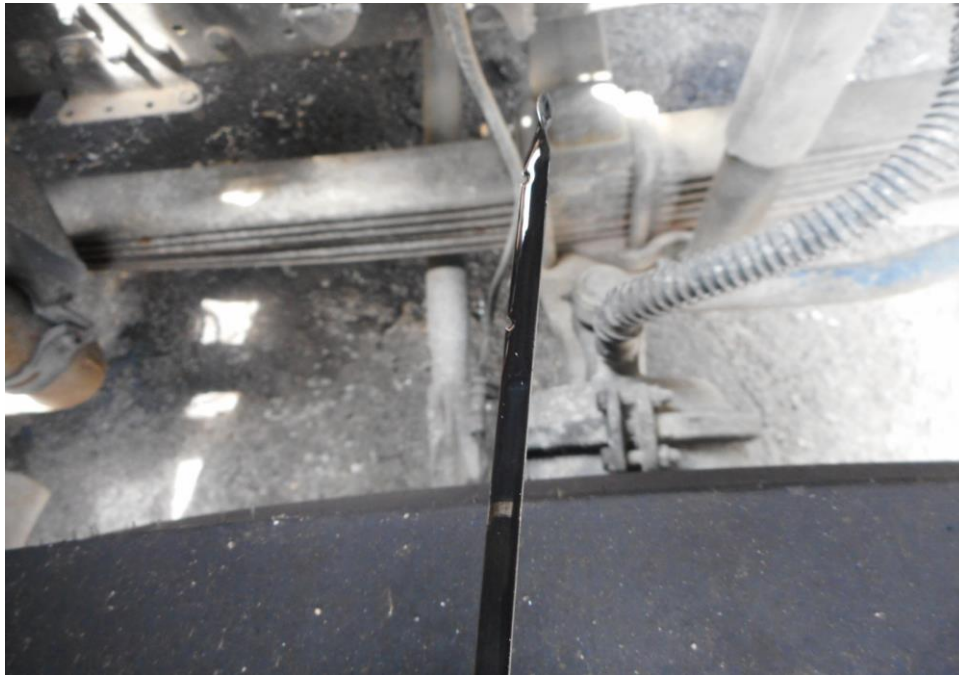
**Photo 20** shows the engine oil dip stick of the Motor Trailer at the time of my inspection. The engine oil was observed to be of sufficient level and without any visible contamination.

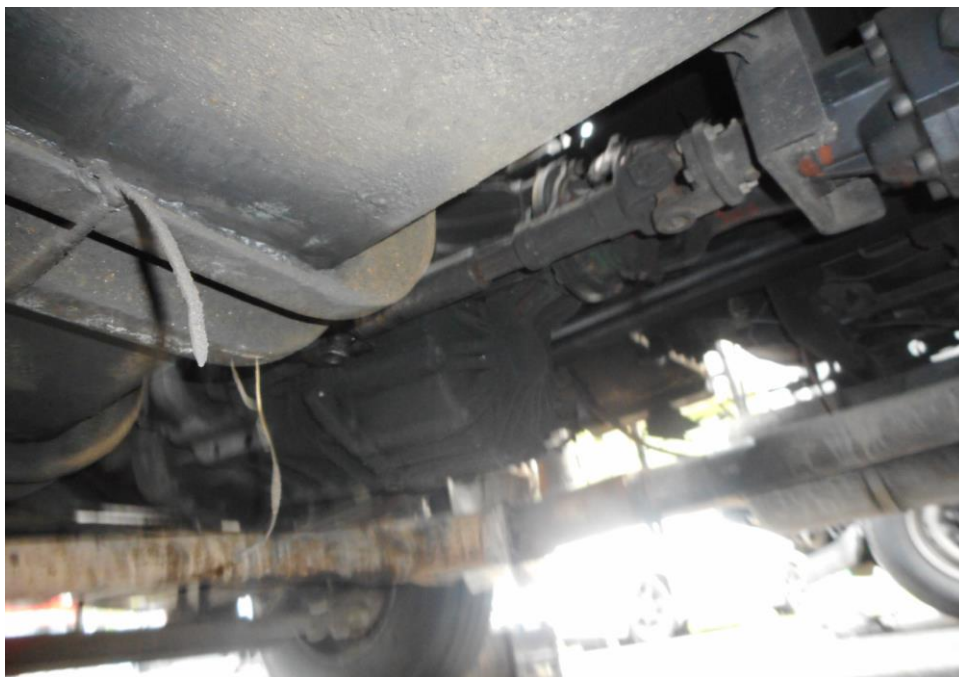
**Photo 21** shows the undercarriage of the Motor Trailer, at the area where the engine housing located. I did not find any sign(s) or indication(s) of fluid leak, however old fluid stain(s) was observed on the underside of the Motor Trailer.

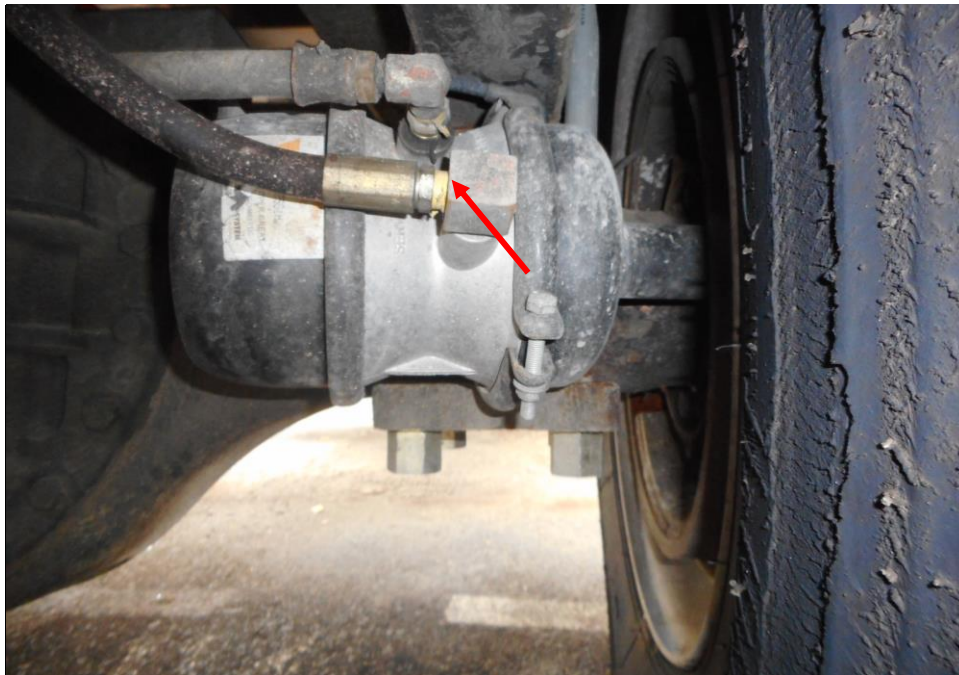
**Photo 22** shows the brake pipe (arrowed) at the rear right wheel of the Motor Trailer. I did not observe any leakage of brake fluid at the time of my inspection of the Motor Trailer. My visual examination of the various mechanical components in the braking system, had indicated that there was no internal leakage of pressure/vacuum and there components were generally in good condition.

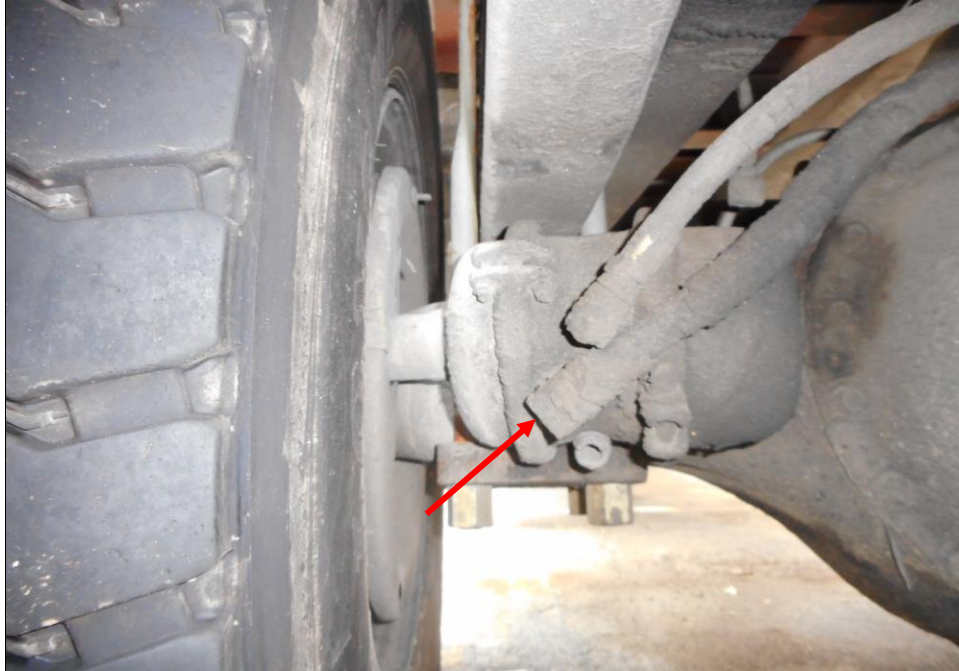
**Photo 23** shows the brake pipe (arrowed) at the rear left wheel of the Motor Trailer. I did not observe any leakage of brake fluid at the time of my inspection of the Motor Trailer. My static tests of the Motor Trailer's braking system, along with my visual examination of the various mechanical components in the braking system, had indicated that there was no internal leakage of pressure/vacuum and there components were generally in good condition.

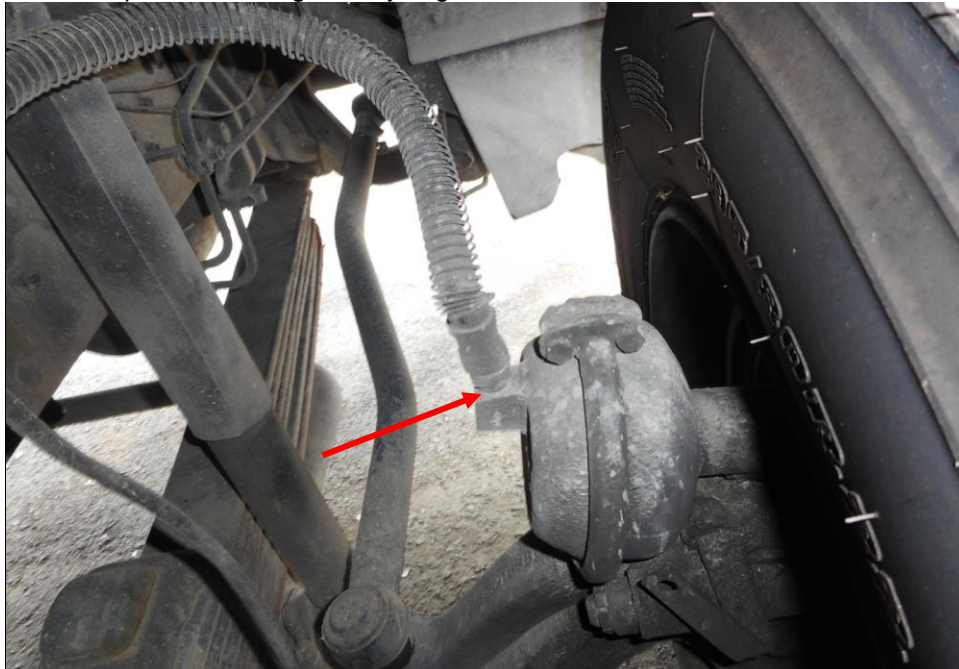
**Photo 24** shows the brake pipe (arrowed) at the front right wheel of the Motor Trailer. I did not observe any leakage of brake fluid at the time of my inspection of the Motor Trailer. My static tests of the Motor Trailer's braking system, along with my visual examination of the various mechanical components in the braking system, had indicated that there was no internal leakage of pressure/vacuum and there components were generally in good condition.

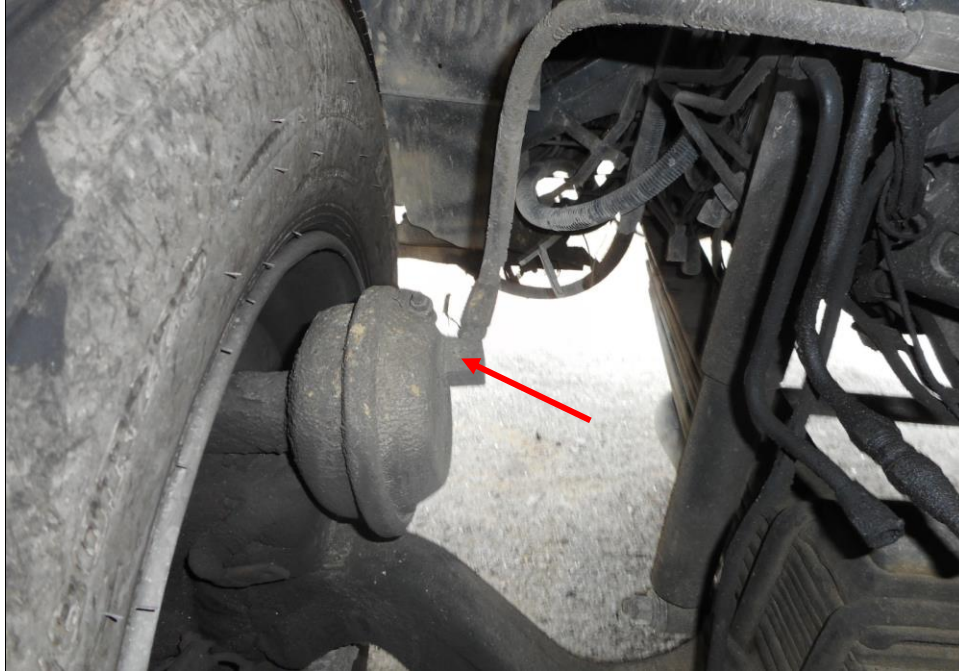
**Photo 25** shows the brake pipe (arrowed) at the front left wheel of the Motor Trailer. I did not observe any leakage of brake fluid at the time of my inspection of the Motor Trailer. My visual examination of the various mechanical components in the braking system had indicated that there was no internal leakage of pressure/vacuum and there components were generally in good condition.

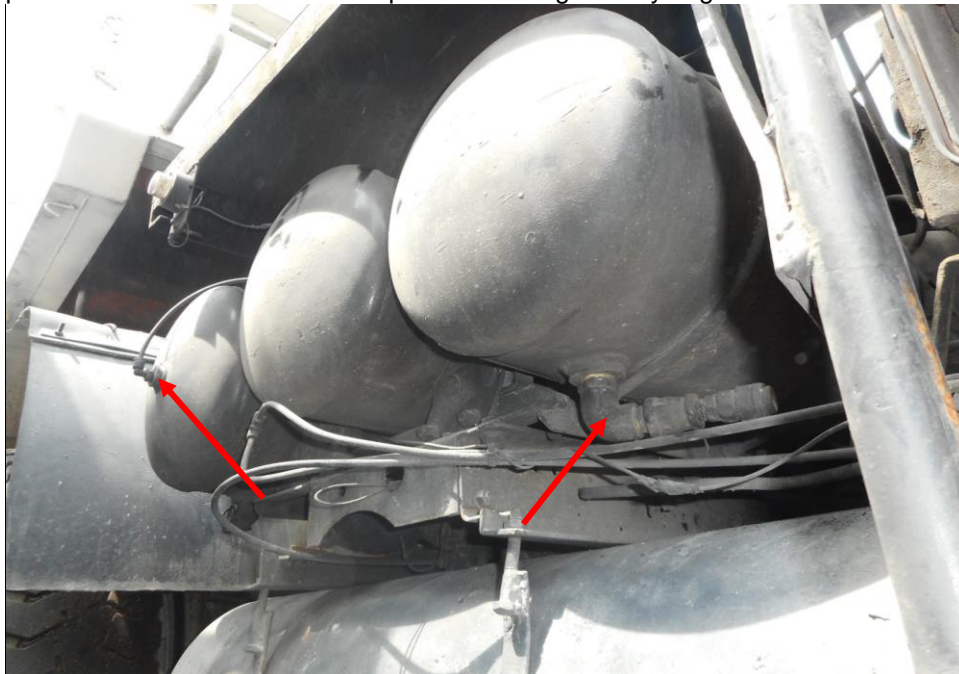
**Photo 26** shows the air brake cylinders (arrowed) at the undercarriage of the Motor Trailer. I did not observe any leakage of air brake fluid at the time of my inspection of the Motor Trailer. My visual examination of the various mechanical components in the braking system had indicated that there was no internal leakage of pressure/vacuum and there components were generally in good condition.

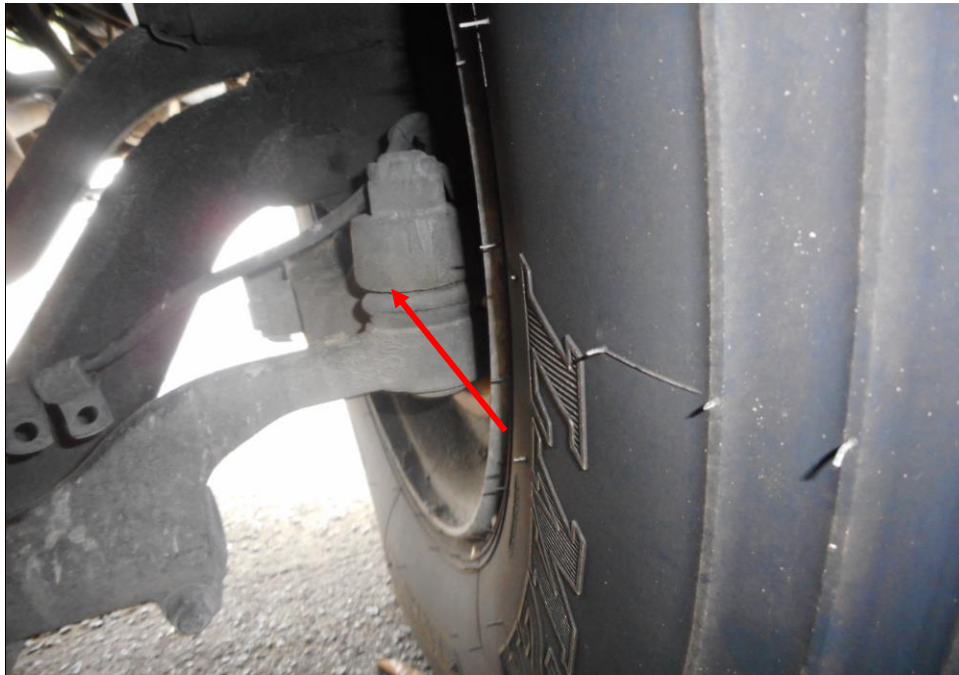
**Photo 27** shows the various undercarriage components at the front right wheel of the Motor Trailer, in particular the steering tie rod end (arrowed). The various steering components were all found to be intact, suggesting that the steering system of the Motor Trailer was likely to be in serviceable condition at the material time of accident. There was also no sign of fluid stain(s) observed on the various undercarriage components.

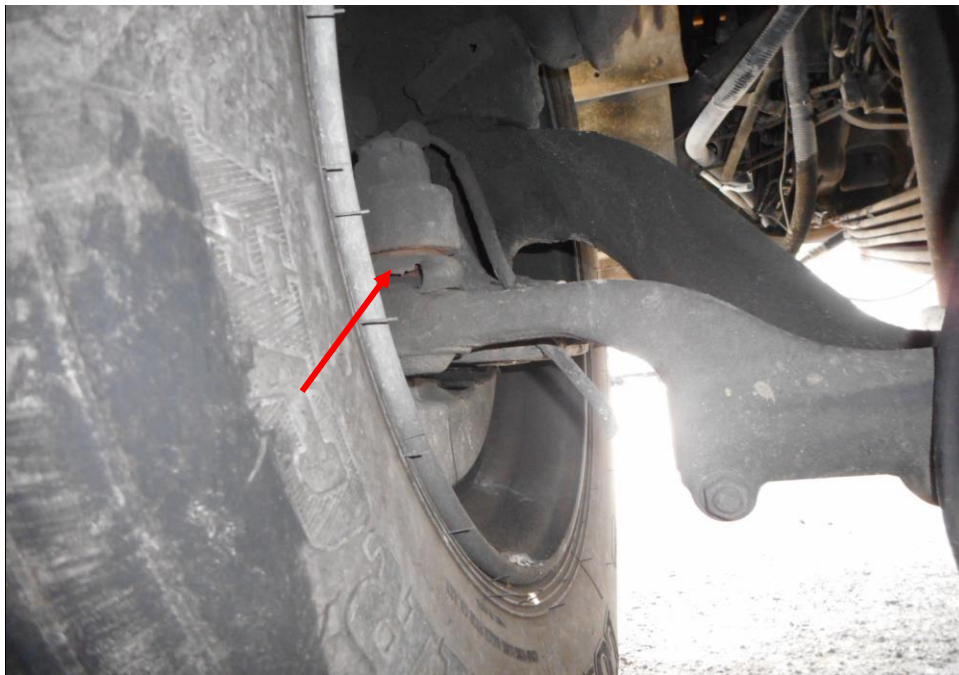
**Photo 28** shows the various undercarriage components at the front left wheel of the Motor Trailer, in particular the steering tie rod end (arrowed). The various undercarriage components of the Motor Trailer were all found to be intact without any visible damage. There was also no sign of fluid stain(s) observed on the various undercarriage components.

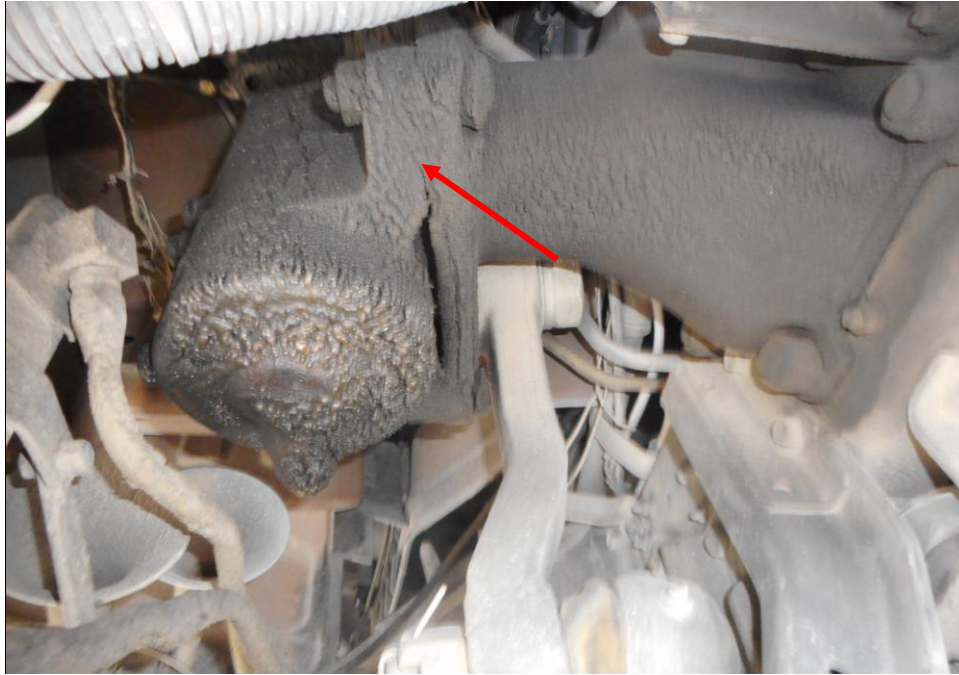
**Photo 29** shows the steering box component (arrowed) at the undercarriage of the Motor Trailer was found to be intact without any visible damage. There was also no sign of fluid stain(s) observed on the various undercarriage components.
