Your Ref: TP/IP/10241/2020  
Our Ref : CI/TPD20004858/P

**Fatal Accident Investigation Team**

**MECHANICAL INSPECTION REPORT OF MOTOR LORRY GX 4845T**

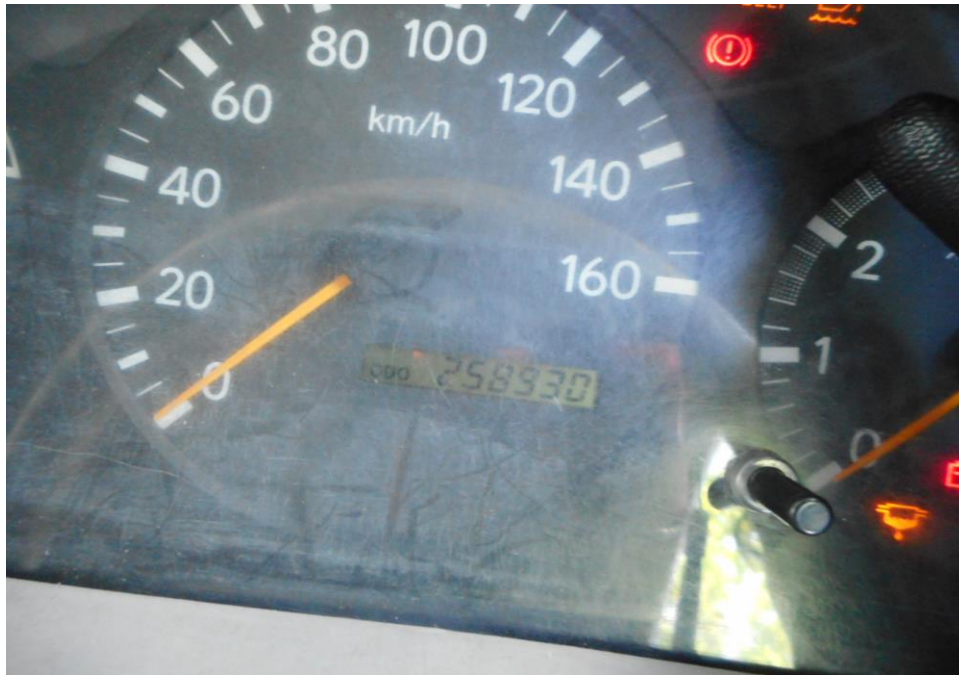
**Photo 1** shows a general view of the instrument cluster of the Motor Lorry at the time of my inspection. The mileage of the Motor Lorry was 258,930km

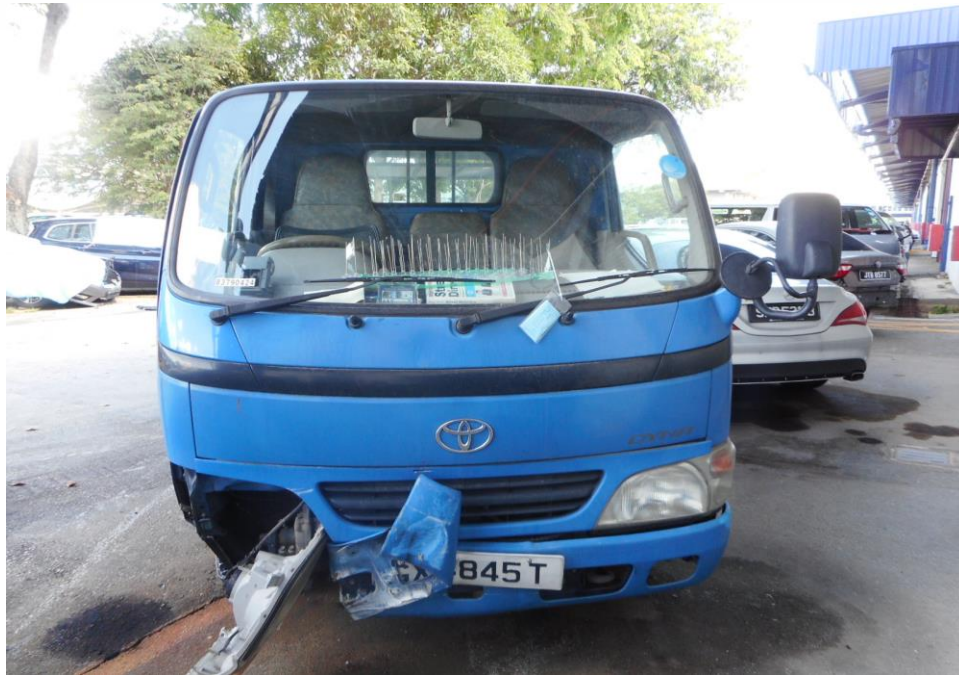
**Photo 2** shows a general view of the Motor Lorry's frontal portion at the time of my inspection. It appeared to have sustained moderate damage at its frontal and right portion. Its front bumper, front right headlamp, right rear view mirror and right door panel were damage at the time of my inspection.

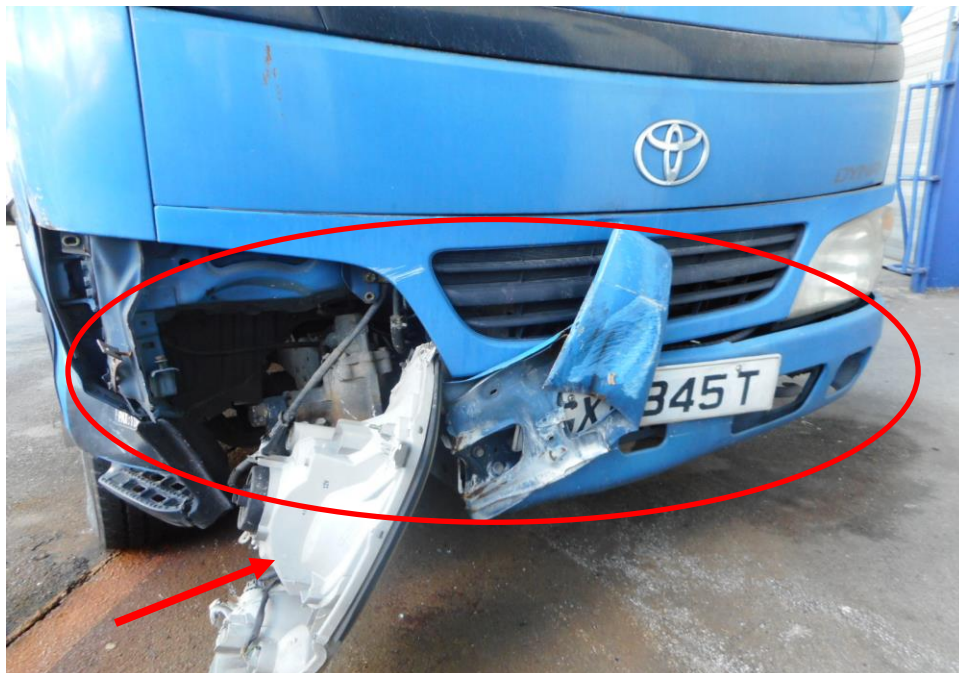
**Photo 3** shows a close up view of the Motor Lorry's frontal portion at the time of my inspection. It appeared to have sustained moderate damage at its frontal portion. Its front bumper (circled) and front right headlamp (arrowed) were damage at the time of my inspection.

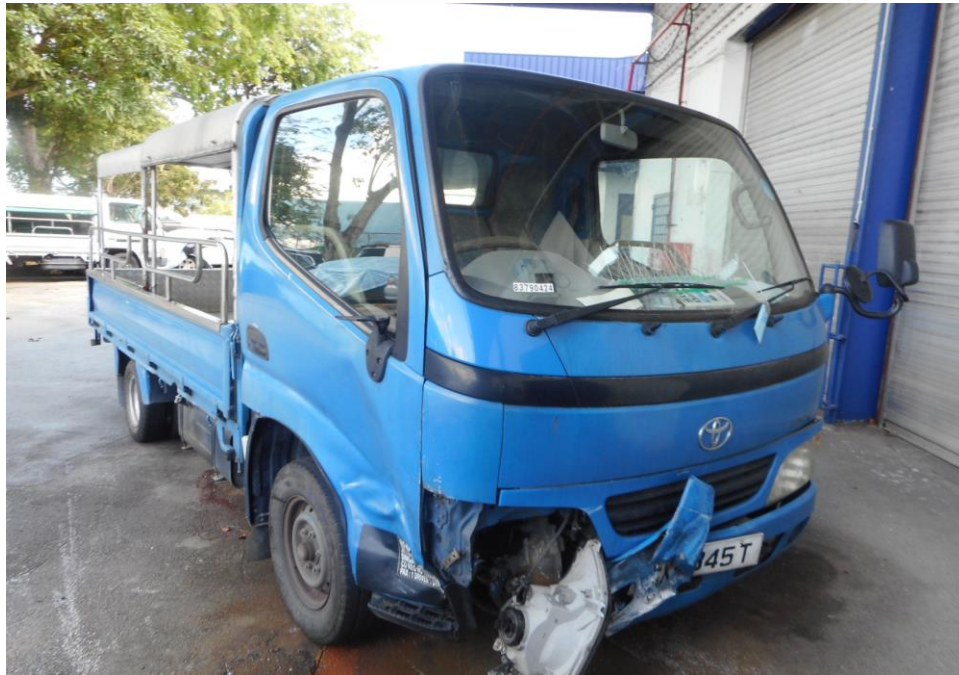
**Photo 4** shows a general view of the Motor Lorry's right portion at the time of my inspection. It appeared to have sustained moderate damage at its right rear view mirror and right door panel were damage at the time of my inspection.

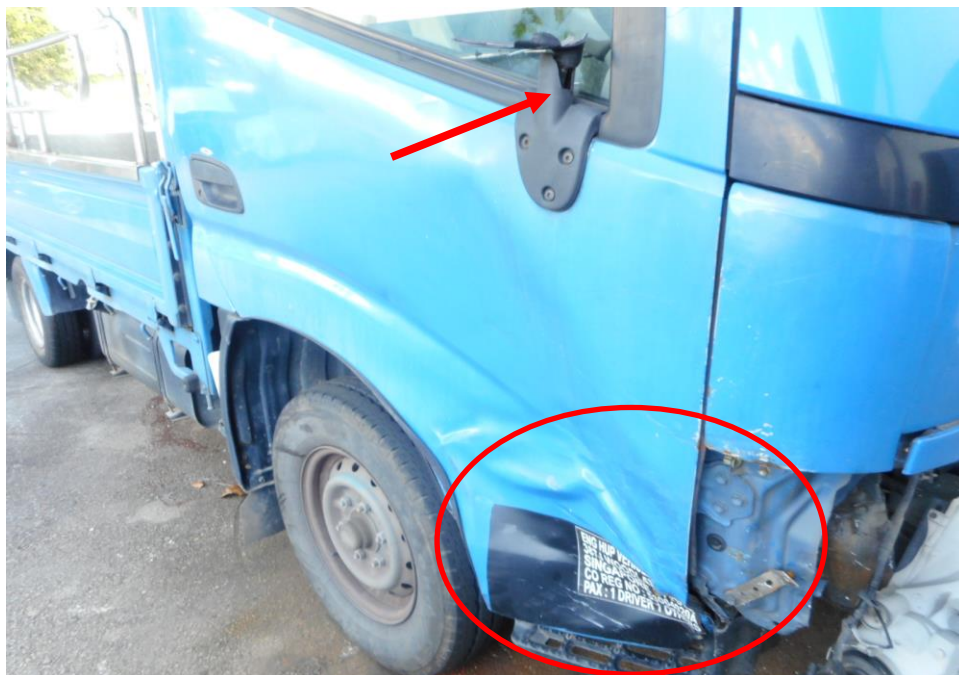
**Photo 5** shows a close up view of the Motor Lorry's right portion at the time of my inspection. It appeared to have sustained moderate damage at its right rear view mirror (arrowed) and right door panel (circled) were damage at the time of my inspection.

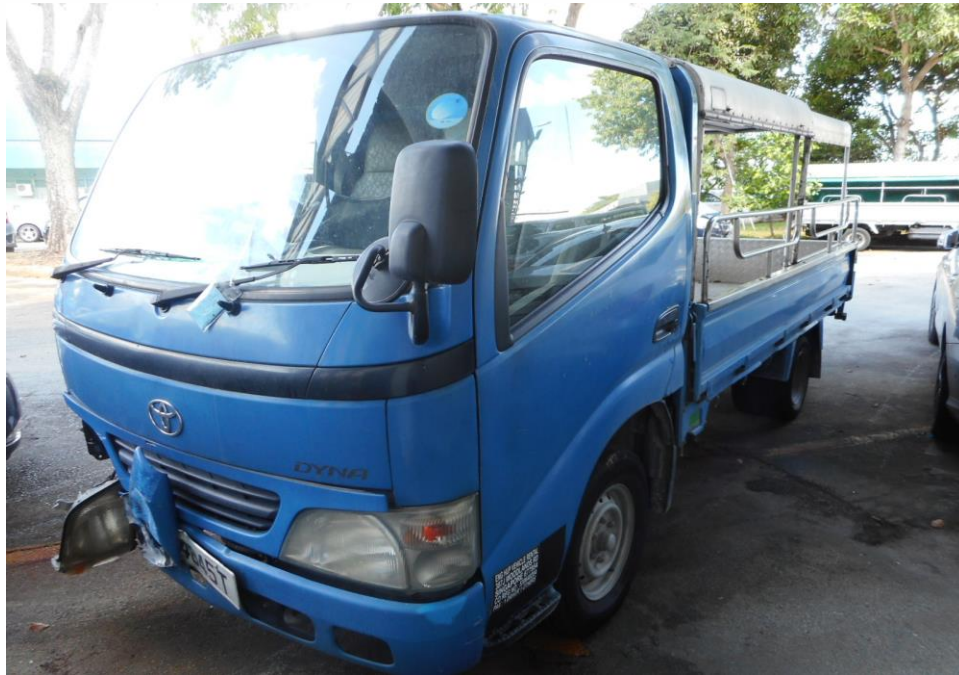
**Photo 6** shows a general view of the front left body of the Motor Lorry at the time of my inspection. The Motor Lorry was observed to be intact and unaffected by the accident.

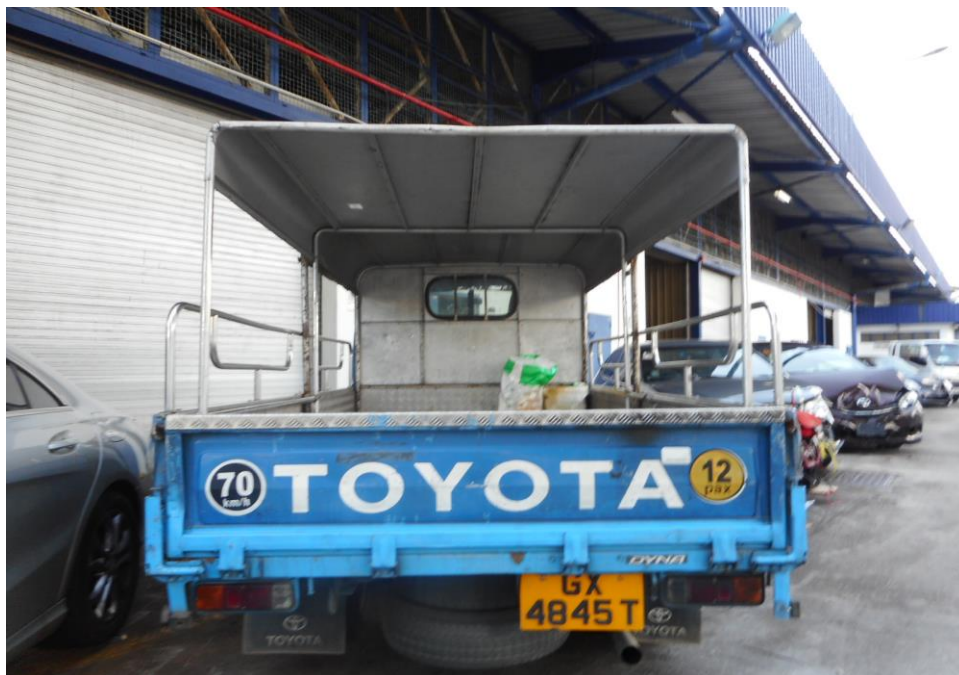
**Photo 7** shows a general view of the rear body of the Motor Lorry at the time of my inspection. The Motor Lorry was observed to be intact and unaffected by the accident.

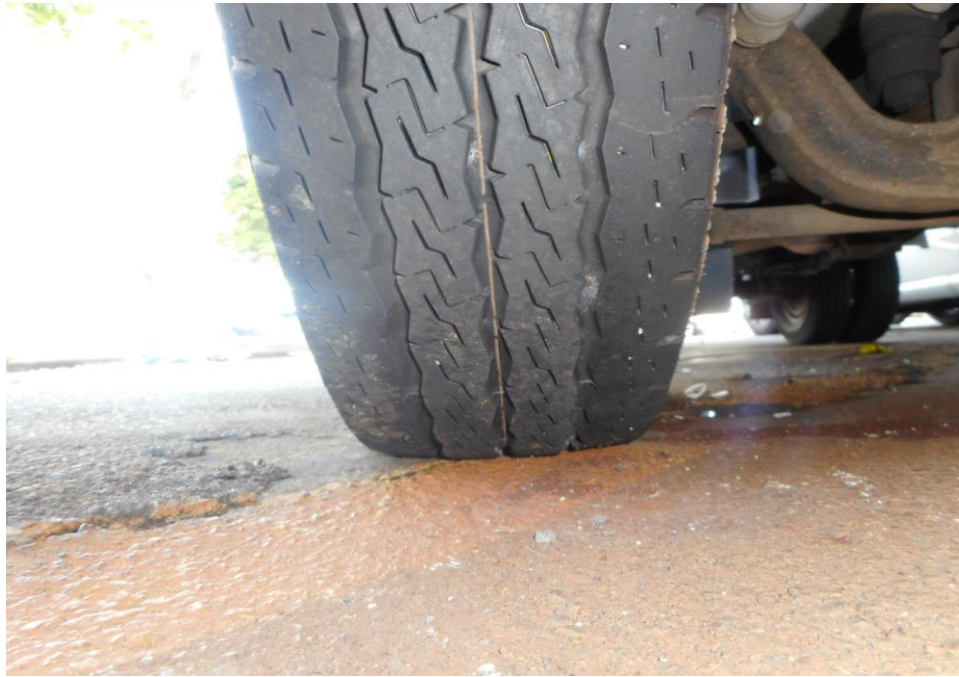
**Photo 8** shows the condition of the front right tyre of the Motor Lorry, which was observed to be in serviceable condition with remaining tread depth of approximately 5.5mm. The tyre, which was wrapped around standard steel wheel rim, was also observed to be sufficiently inflated for vehicular operation. There was no tear, cut or burst mark(s) on the outer and the inner sidewalls as well as across the tread of the 6 tyres that were fitted on the Motor Lorry.

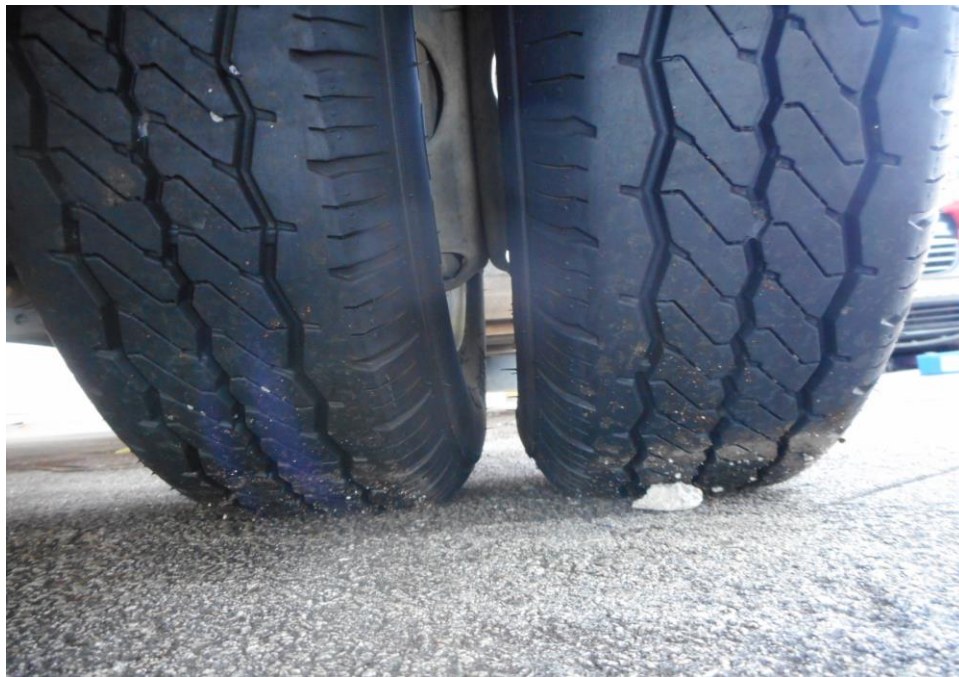
**Photo 9** shows the condition of the rear right tyre of the Motor Lorry, which was observed to be in serviceable condition with remaining tread depth of approximately 5.4mm. The tyre, which was wrapped around standard steel wheel rim, was also observed to be sufficiently inflated for vehicular operation.

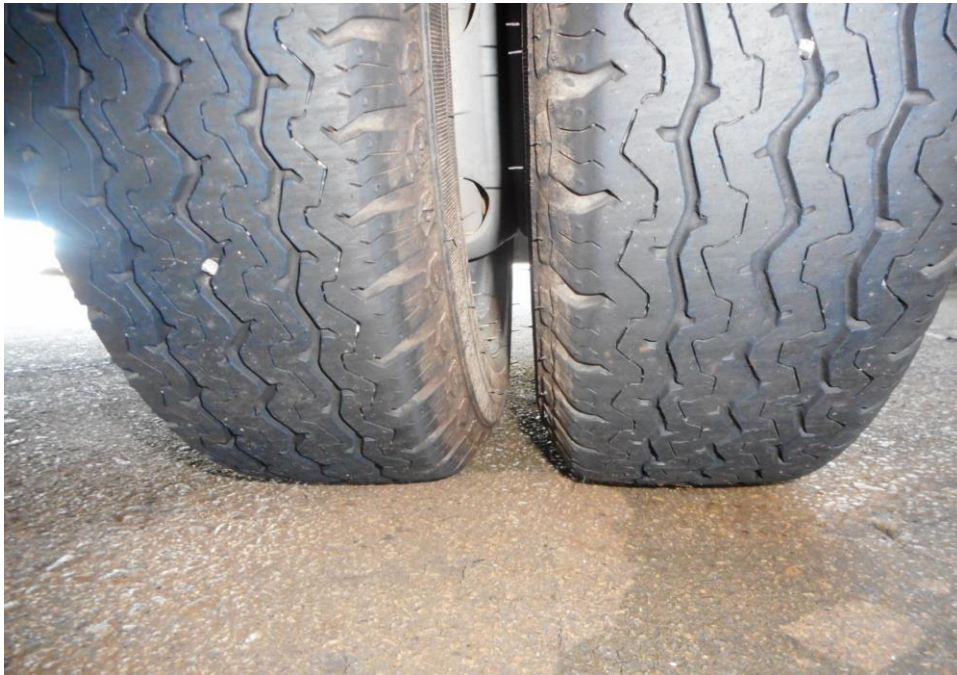
**Photo 10** shows the condition of the rear left tyres of the Motor Lorry, which was observed to be in serviceable condition with remaining tread depth of approximately 4.1mm. The tyres, which were wrapped around standard steel wheel rim, were also observed to be sufficiently inflated for vehicular operation. There was also no damage found on all 6 steel wheel rims of the Motor Lorry.

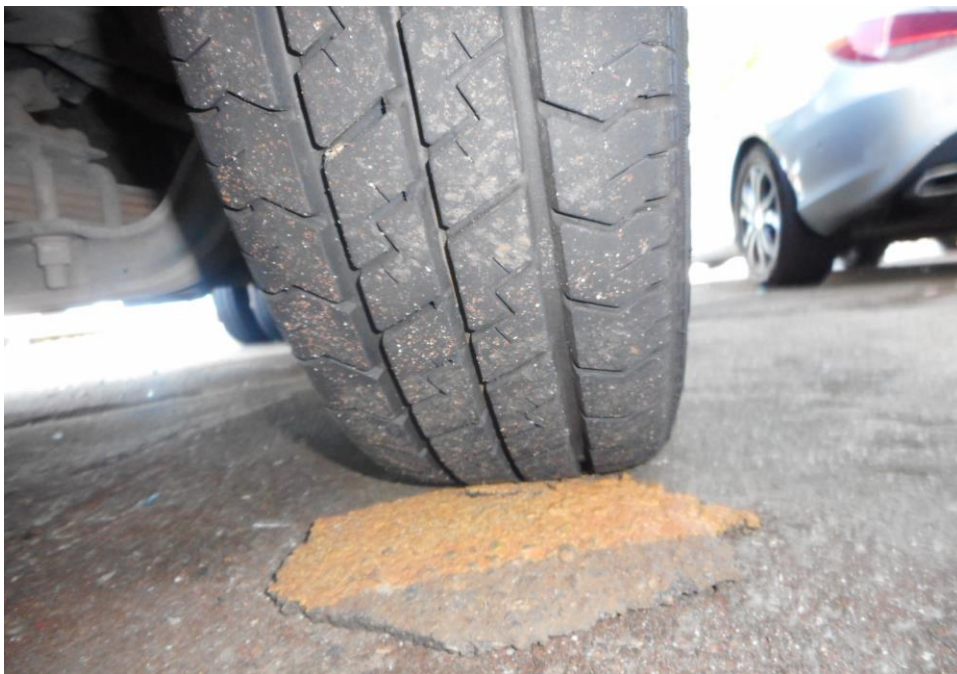
**Photo 11** shows the condition of the rear right tyres of the Motor Lorry, which were observed to be in serviceable condition with remaining, tread depth of approximately 8.2mm. There was also no tear, cut or burst mark(s) on the outer and the inner sidewalls as well as across the tread of the 6 tyres that were fitted on the Motor Lorry.

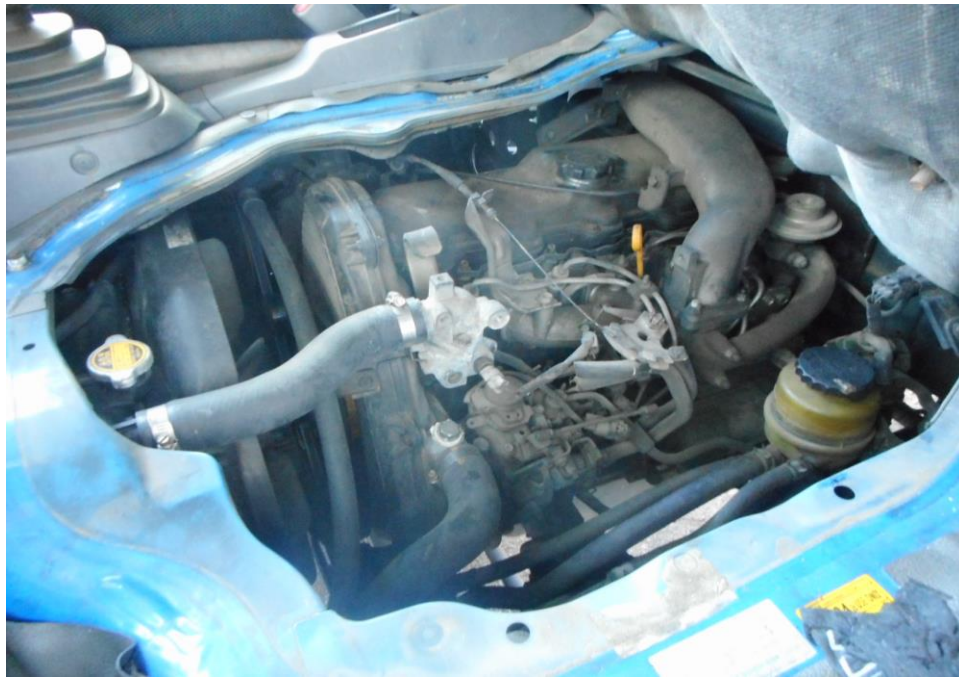
**Photo 12** shows a general view of the Motor Lorry's engine compartment, which was accessed by lifting the front cabin of the Motor Lorry. The various parts and components inside the engine compartment were unaffected by the accident. There was also no sign(s) or indication(s) of fresh fluid leakage and/or fluid stain within the engine compartment (photograph shows the engine compartment as viewed from the right front side of the Motor Lorry).

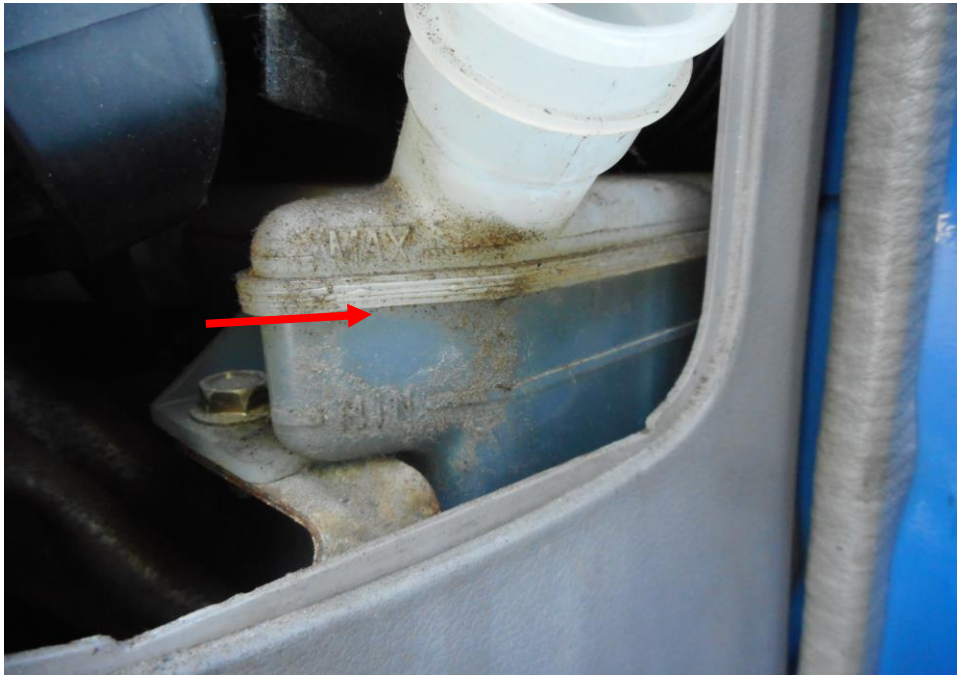
**Photo 13** shows the brake fluid reservoir of the Motor Lorry at the time of my inspection. The brake fluid was observed to be of sufficient level (arrowed) and without any visible contamination.

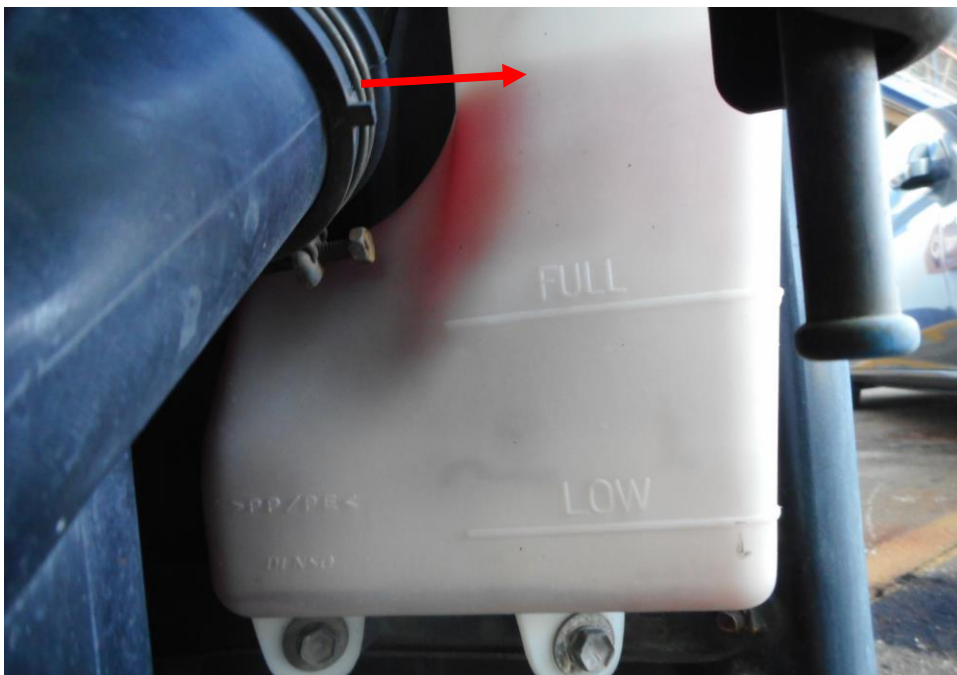
**Photo 14** shows the engine coolant reservoir of the Motor Lorry at the time of my inspection. The engine coolant was observed to be of sufficient level (arrowed) and without any visible contamination.

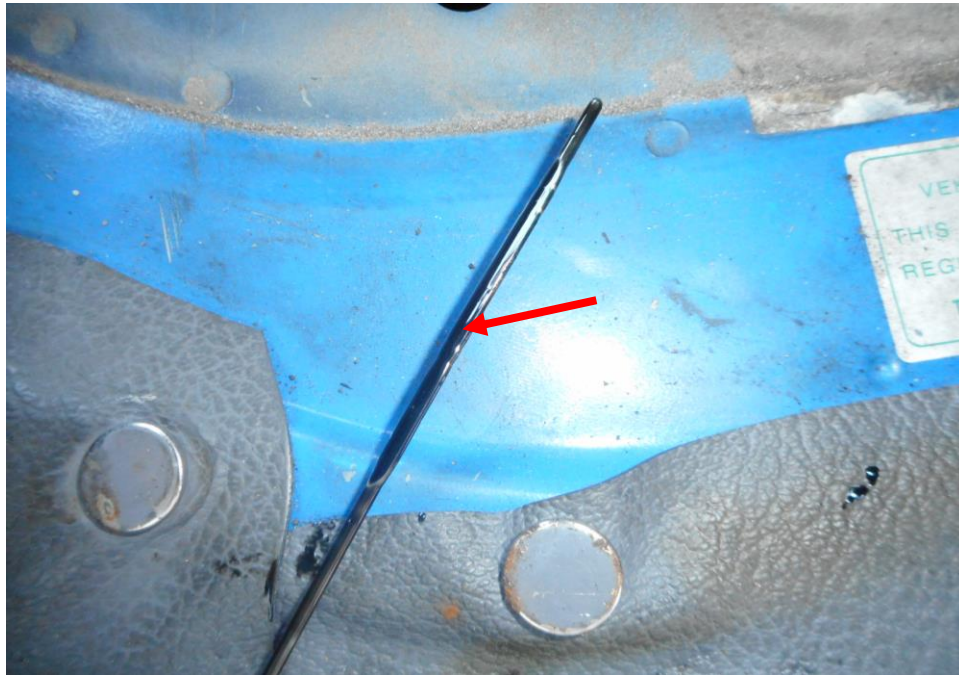
**Photo 15** shows the engine oil dip stick of the Motor Taxi at the time of my inspection. The engine oil was observed to be of sufficient level (arrowed) and without any visible contamination.

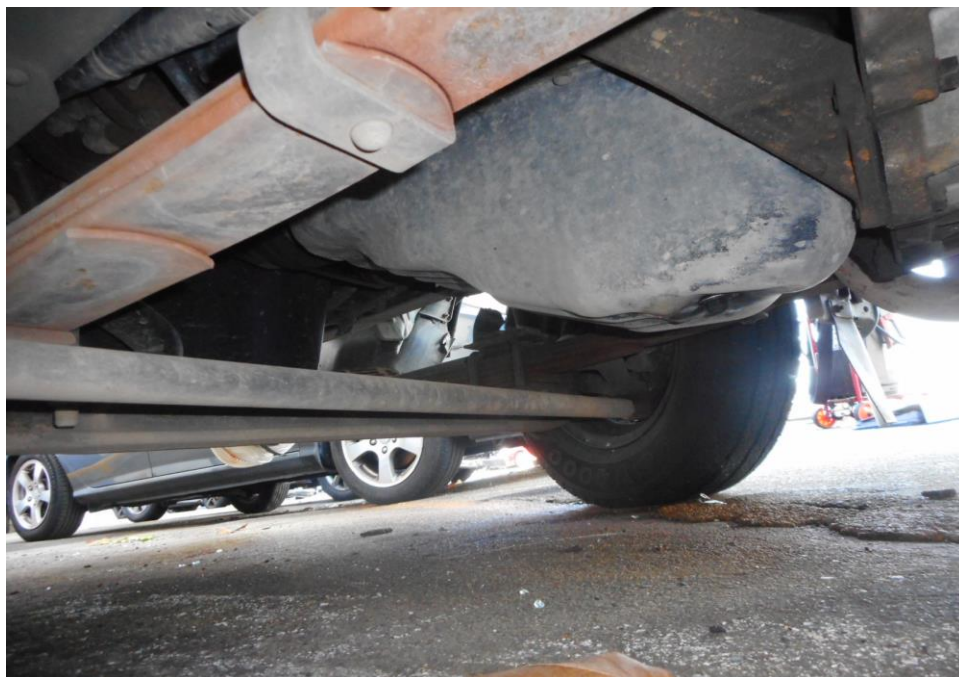
**Photo 16** shows the undercarriage of the Motor Lorry, at the area where the engine housing and transmission housing are located. Observed was minor old engine oil stain on the housing of the engine oil sump

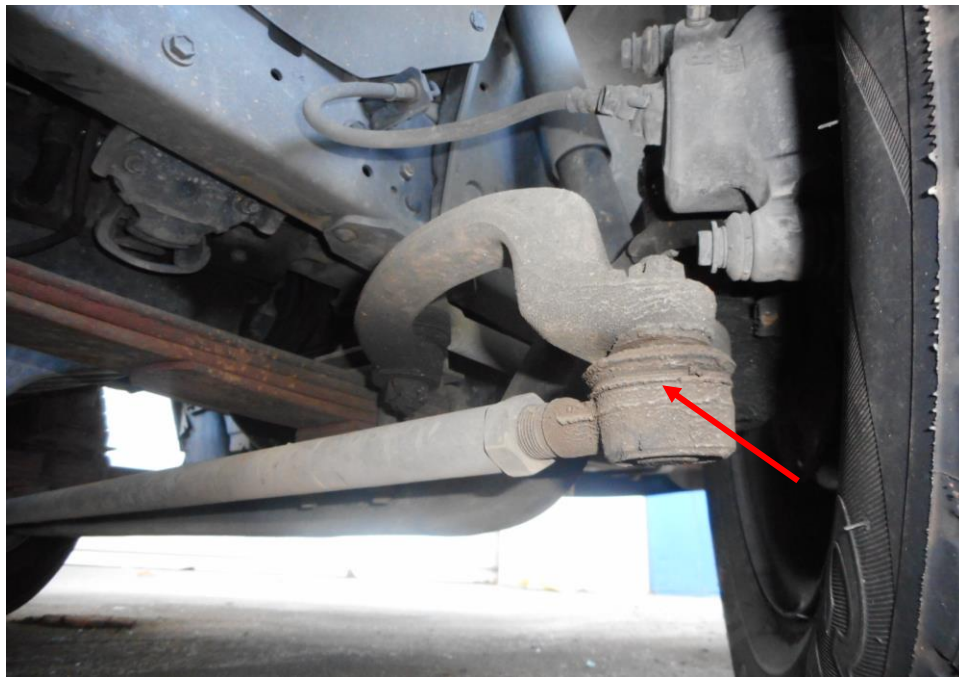
**Photo 17** shows the various undercarriage components at the front right wheel of the Motor Lorry, in particular the steering tie rod end (arrowed). The various steering components were all found to be intact, suggesting that the steering system of the Motor Lorry was likely to be in serviceable condition at the material time of accident. There was also no sign of fluid stain(s) observed on the various undercarriage components.

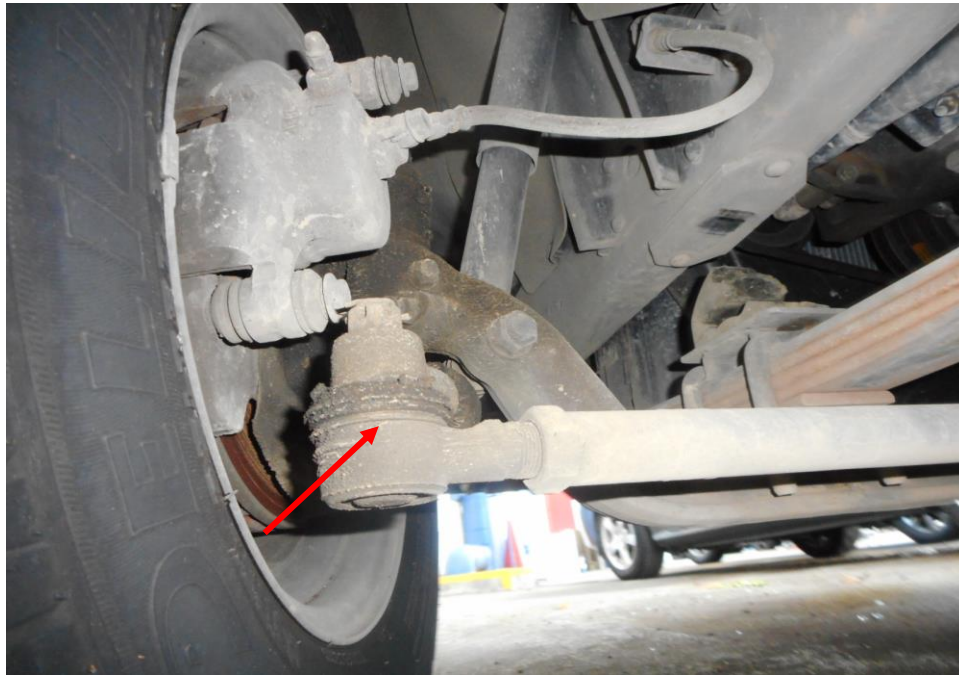
**Photo 18** shows the various undercarriage components at the front left wheel of the Motor Lorry, in particular the steering tie rod end (arrowed). The various Undercarriage components of the Motor Lorry were all found to be intact without any visible damage. There was also no sign of fluid stain(s) observed on the various undercarriage components.

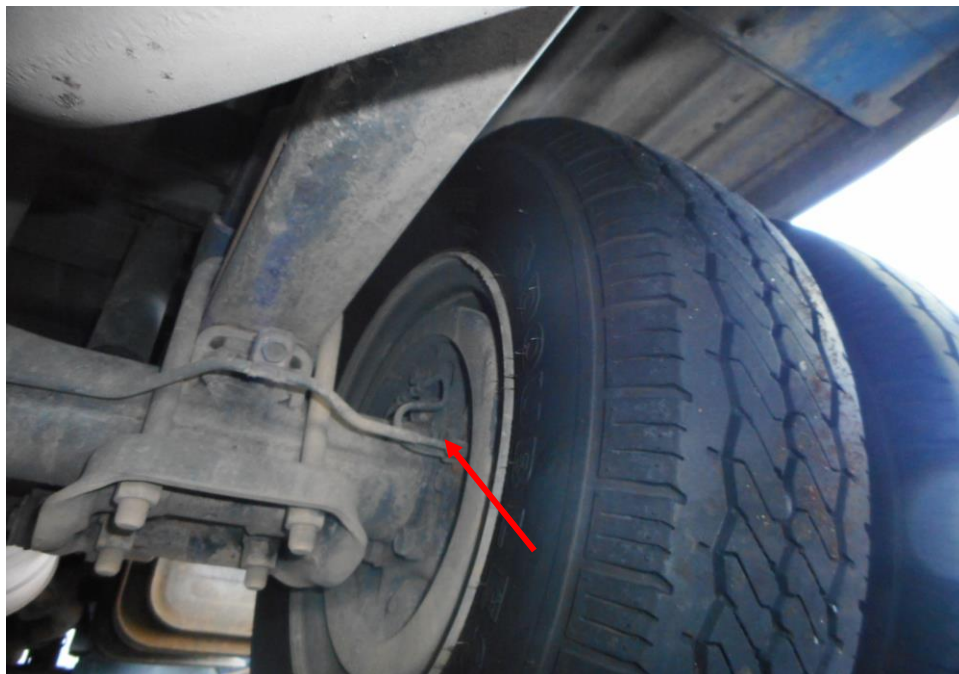
**Photo 19** shows the brake pipe (arrowed) at the rear right wheel of the Motor Lorry. I did not observe any leakage of brake fluid at the time of my inspection of the Motor Lorry. My static tests of the Motor Lorry's braking system, along with my visual examination of the various mechanical components in the braking system, had indicated that there was no internal leakage of pressure/vacuum. Hence the braking system of the Motor Lorry was likely to be in serviceable condition at the material time of accident.

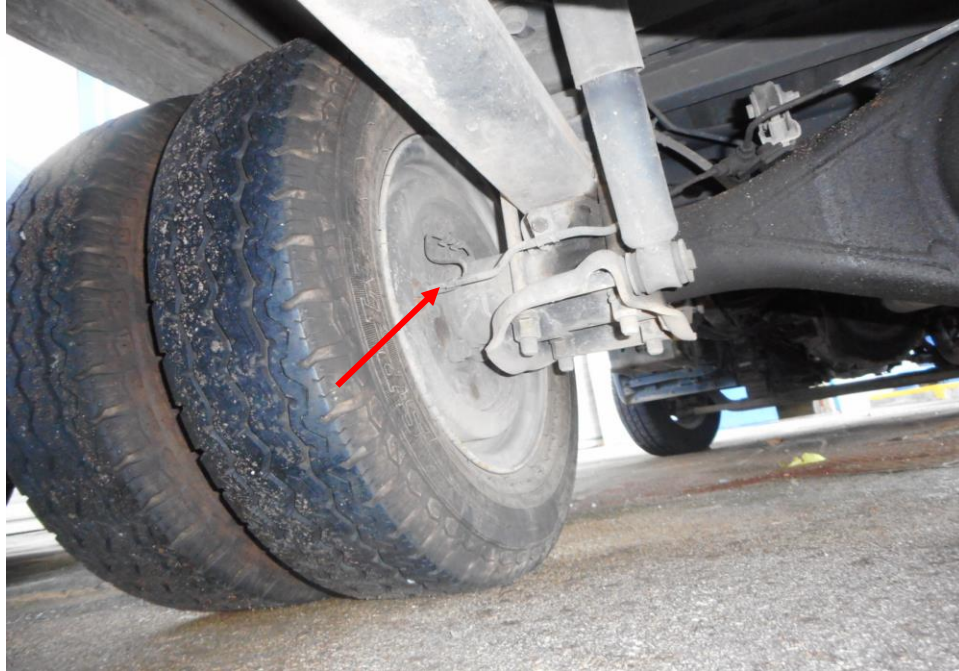
**Photo 20** shows the brake pipe (arrowed) at the rear left wheel of the Motor Lorry. I did not observe any leakage of brake fluid at the time of my inspection of the Motor Lorry. My static tests of the Motor Lorry's braking system, along with my visual examination of the various mechanical components in the braking System had indicated that there was no internal leakage of pressure/vacuum. Hence the braking system of the Motor Lorry was likely to be in serviceable condition at the material time of accident.

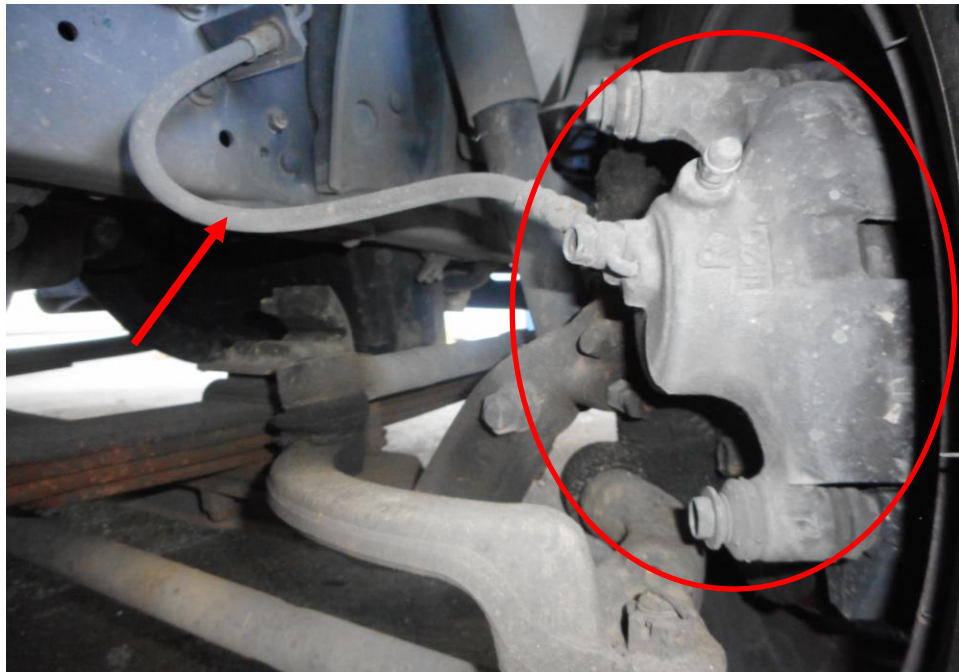
**Photo 21** shows the brake hose/pipe (arrowed) at the front right wheel of the Motor Lorry. No leakage of brake fluid was observed. Visual examination of the various components of the braking system like the brake caliper (circled), brake booster, brake pedal etc had revealed all to be intact and without visible damage at the time of accident. There was also no sign of fluid stain(s) observed on the various undercarriage components.

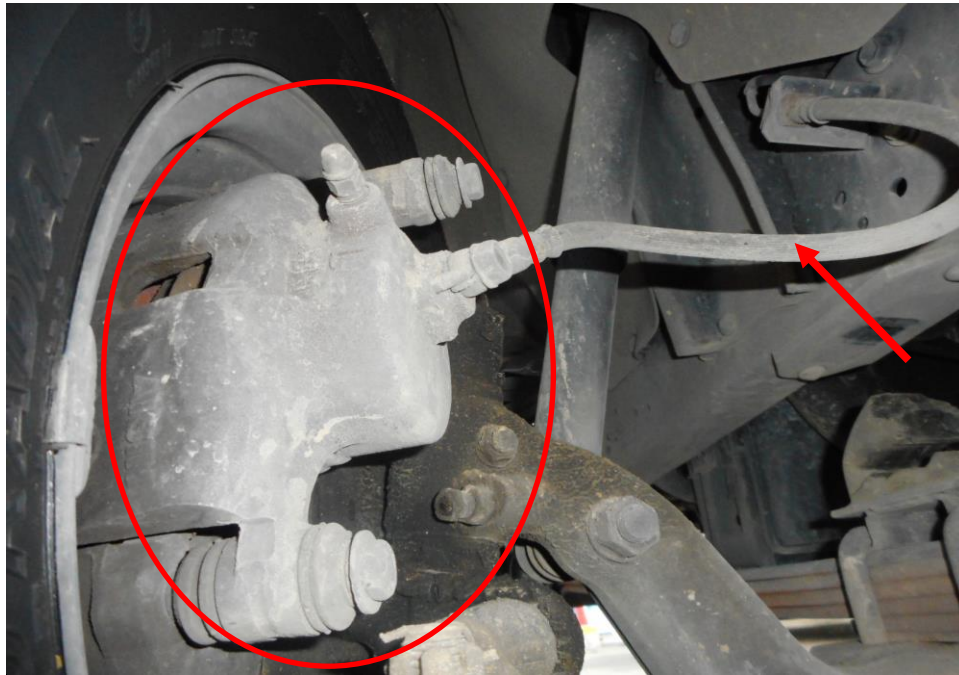
**Photo 22** shows the brake hose/pipe (arrowed) at the front left wheel of the Motor Lorry. No leakage of brake fluid was observed. Visual examination of the various components of the braking system like the brake caliper (circled), brake booster, brake pedal etc had revealed all to be intact and without visible damage at the time of accident. There was also no sign of fluid stain(s) observed on the various undercarriage components.

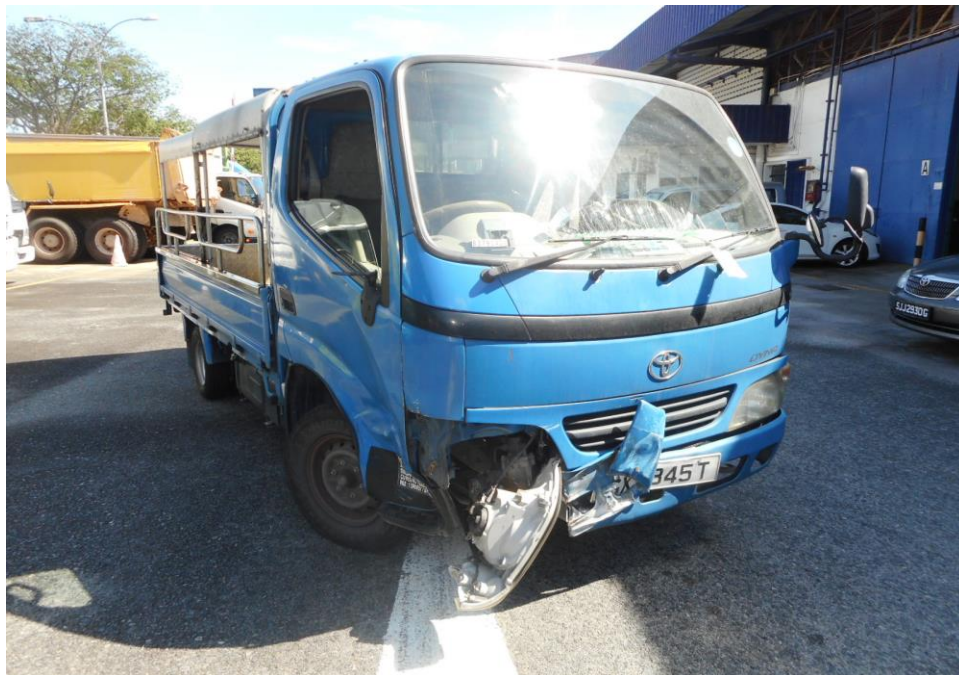
**Photo 23** shows the front left wheel of the Motor Lorry turned to its full right. During my steering system test, I did not experience any abnormal free play and/or resistance when I had turned the steering wheel towards full left and full right. This would suggest that the steering system of the Motor Lorry was likely to be in serviceable condition at the material time of accident.
