Your Ref: TP/IP/10297/2020
Our Ref : CI/TPD20004860/P

Fatal Accident Investigation Team

MECHANICAL INSPECTION REPORT OF MINI BUS PC 4515A

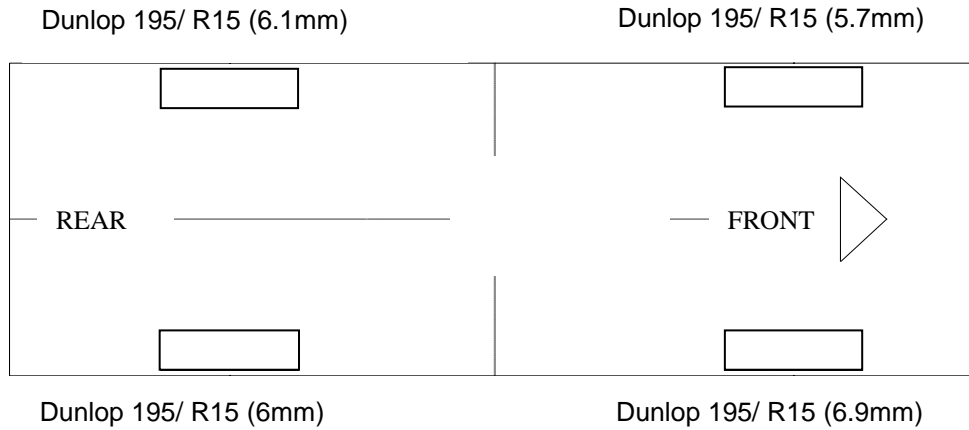
6. The 4 tyres of the Mini Bus were observed to be in serviceable condition and sufficiently inflated for vehicular operation. I did not find any tear, cut or burst mark(s) on the outer and the inner sidewalls as well as across the tread of the 4 tyres. The tyre brand, tyre size and remaining tread depth of the 4 tyres of the Mini Bus were recorded as follows:-

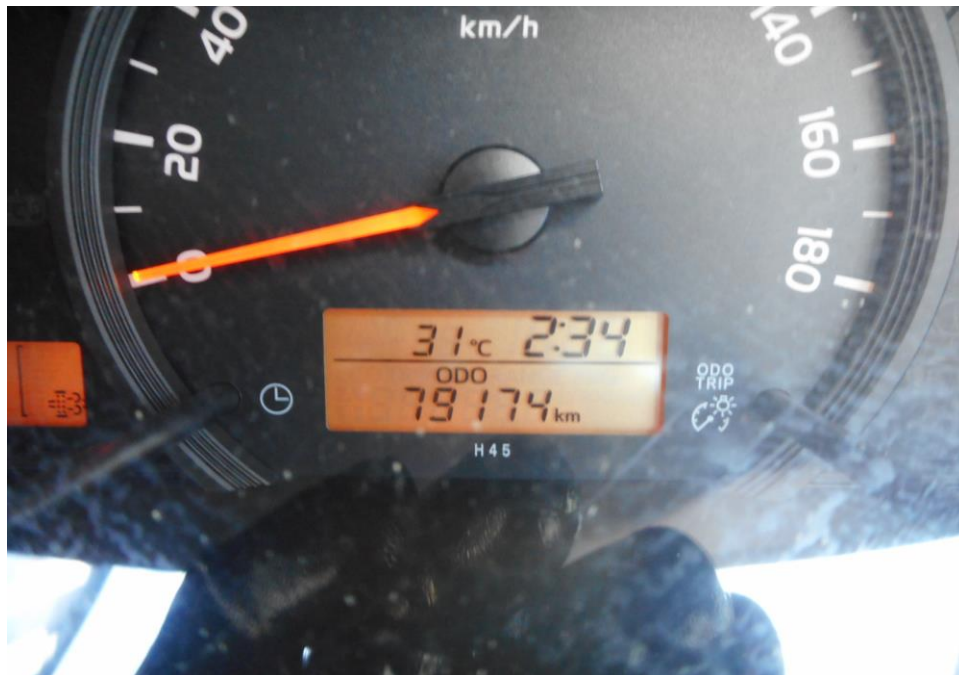
4. The mileage of the Mini Bus at the time of my inspection was 79,174km.
5. The Mini Bus appeared to have sustained damage at its frontal portion. Its front bumper, front bonnet and front right head lamp were damaged at the time of my inspection.

Photo 1 shows a general view of the instrument cluster of the Mini Bus at the time of my inspection. The mileage of the Mini Bus was 79,174km

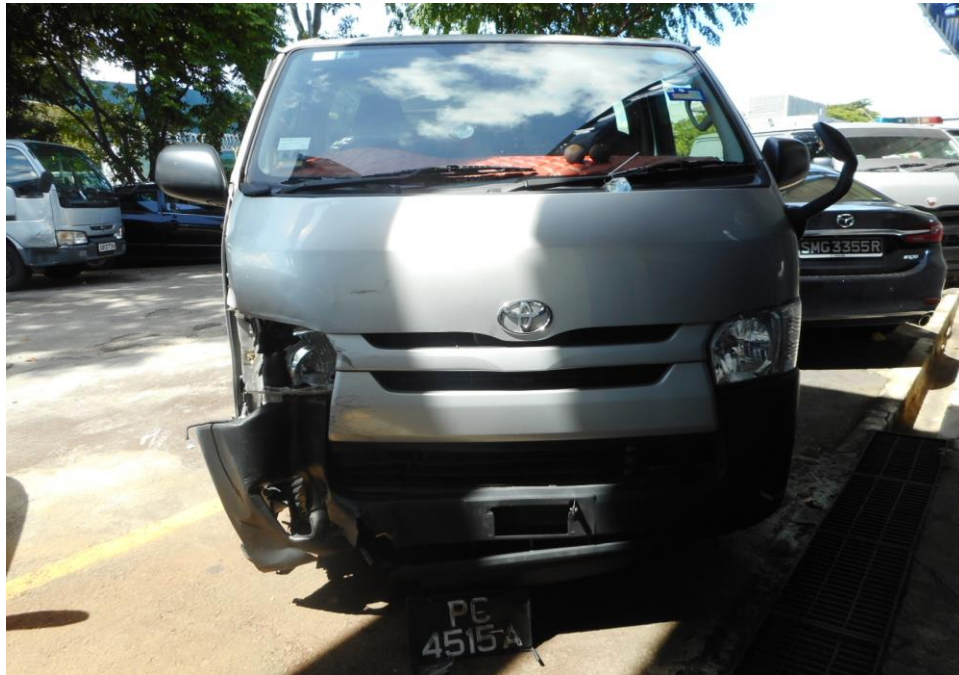
Photo 2 shows a general view of the Mini Bus's frontal portion at the time of my inspection. It appeared to have sustained damage at its frontal portion. Its front bumper, front bonnet and front right head lamp were damage at the time of my inspection.

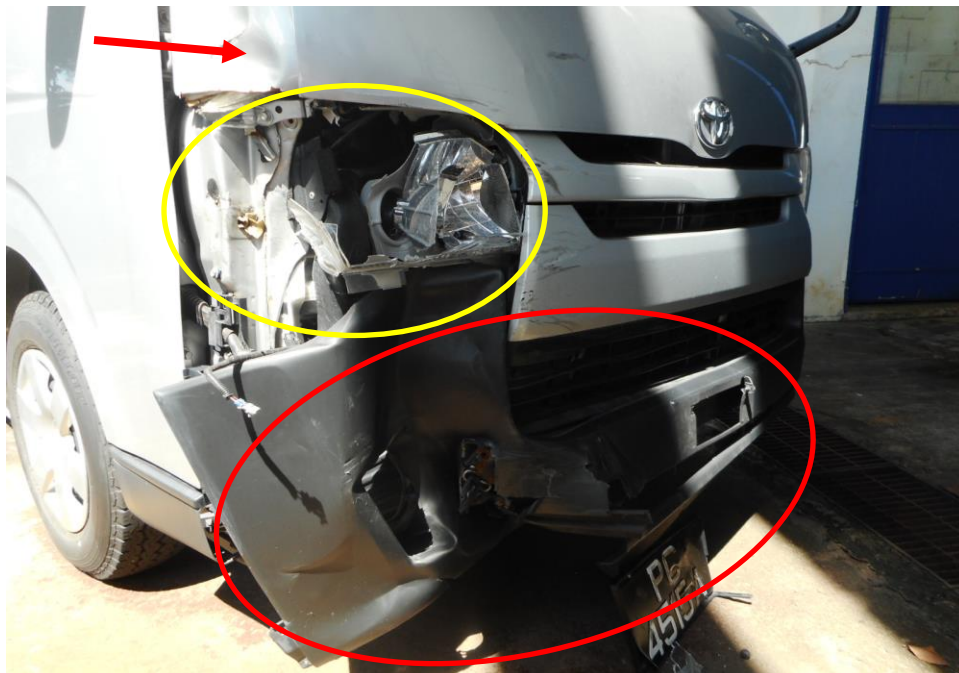
Photo 3 shows a close up view of the Mini Bus's frontal portion at the time of my inspection. It appeared to have sustained damage at its frontal portion. Its front bonnet (arrowed), front bumper (red circle) and front right head lamp (yellow circle) were damage at the time of my inspection.

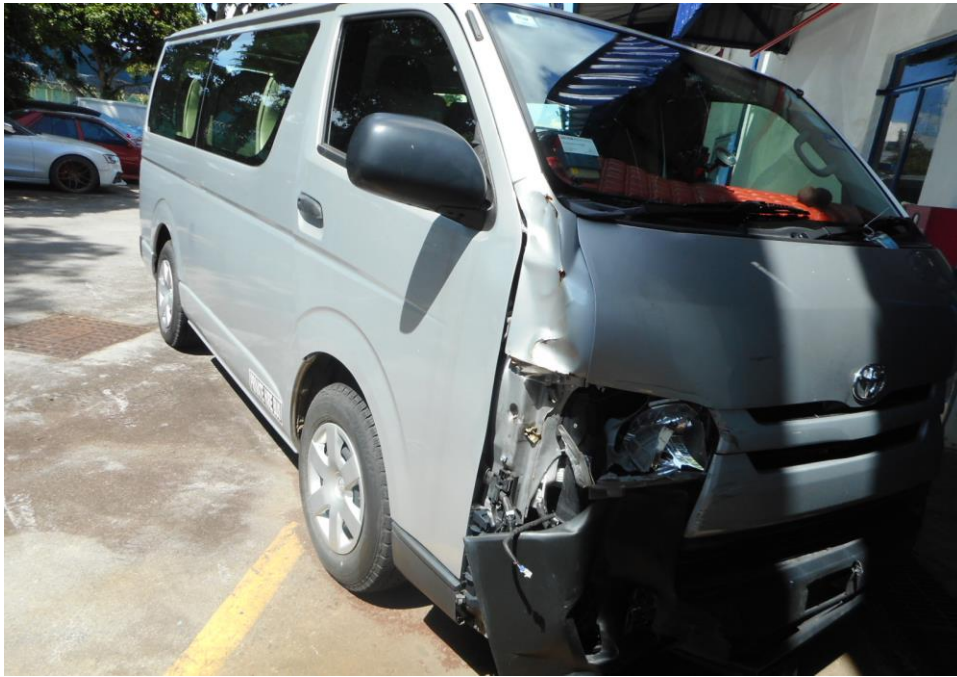
Photo 4 shows a general view of the right body of the Mini Bus at the time of my inspection. The Mini Bus was observed to be intact and unaffected by the accident.

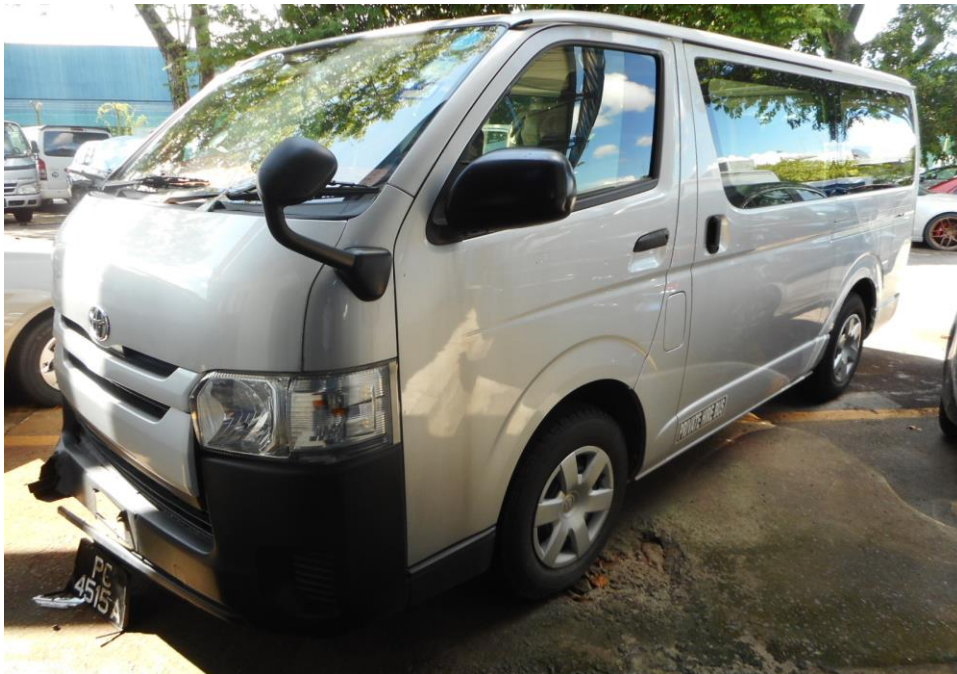
Photo 5 shows a general view of the left body of the Mini Bus at the time of my inspection. The Mini Bus was observed to be intact and unaffected by the accident.

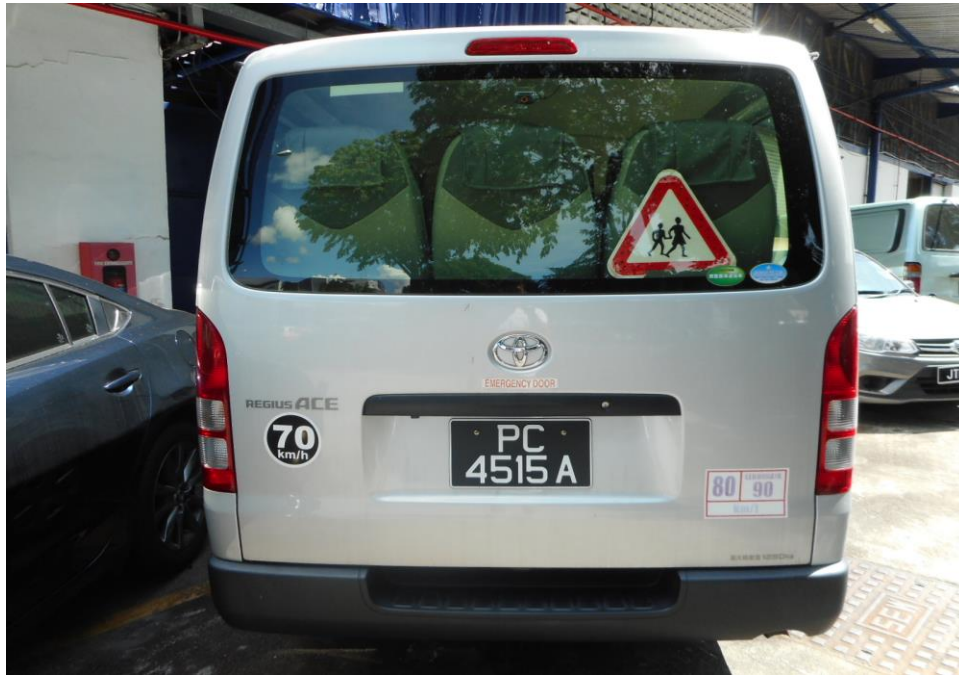
Photo 6 shows a general view of the rear body of the Mini Bus at the time of my inspection. The Mini Bus was observed to be intact and unaffected by the accident.

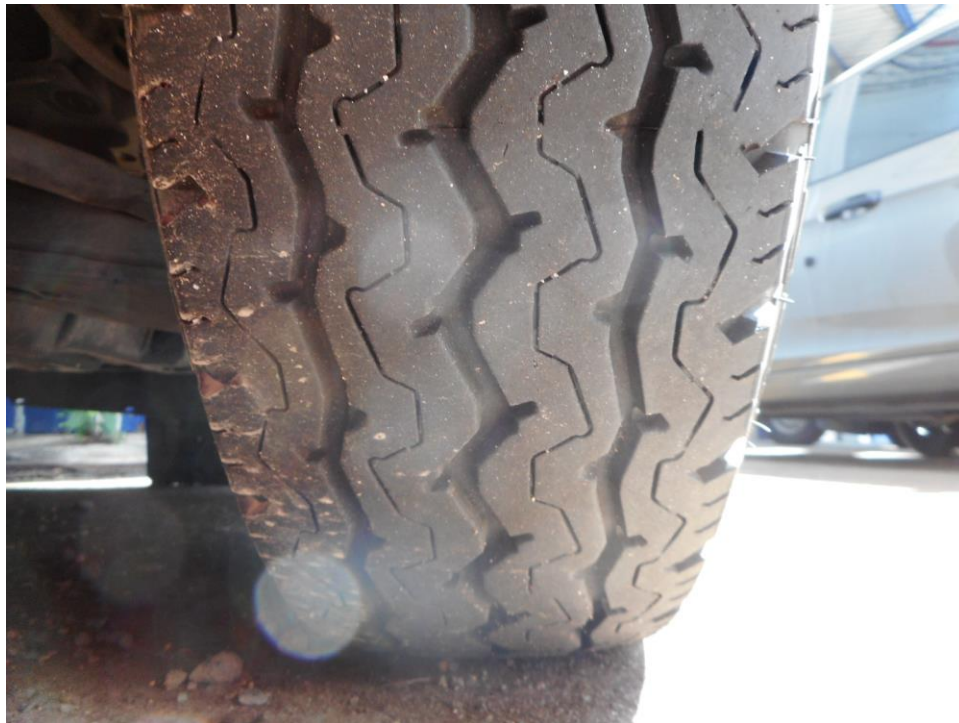
Photo 7 shows the condition of the front right tyre of the Mini Bus, which was observed to be in serviceable condition with remaining tread depth of approximately 6.9mm. The tyre, which was wrapped around standard steel wheel rim, was also observed to be sufficiently inflated for vehicular operation. There was no tear, cut or burst mark(s) on the outer and the inner sidewalls as well as across the tread of the 4 tyres that were fitted on the Mini Bus.

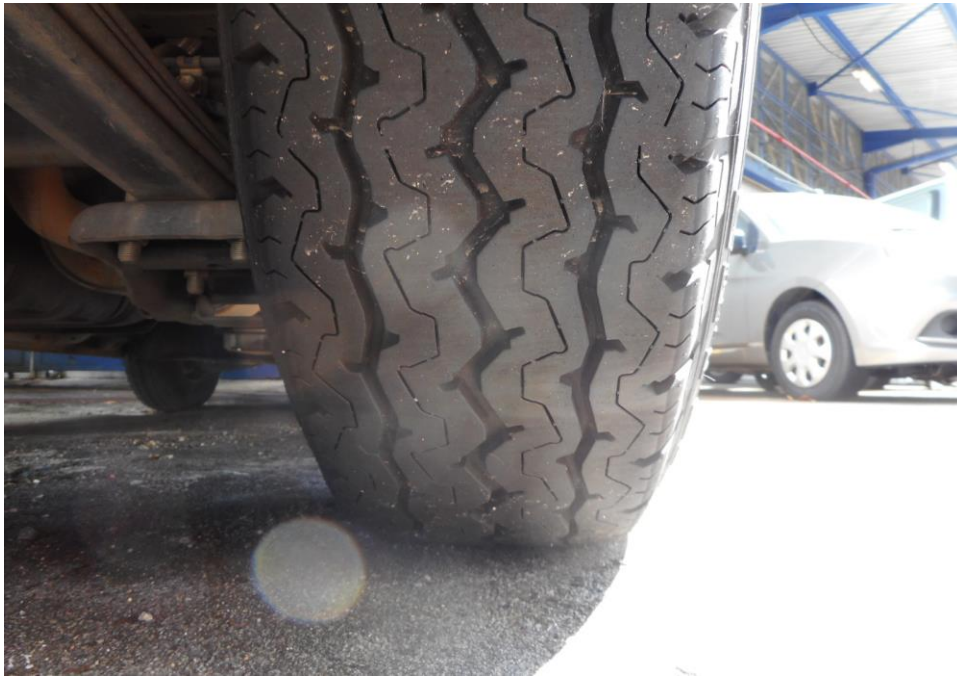
Photo 8 shows the condition of the rear right tyre of the Mini Bus, which was observed to be in serviceable condition with remaining tread depth of approximately 6mm. The tyre, which was wrapped around standard steel wheel rim, it was observed to be sufficiently inflated for vehicular operation.

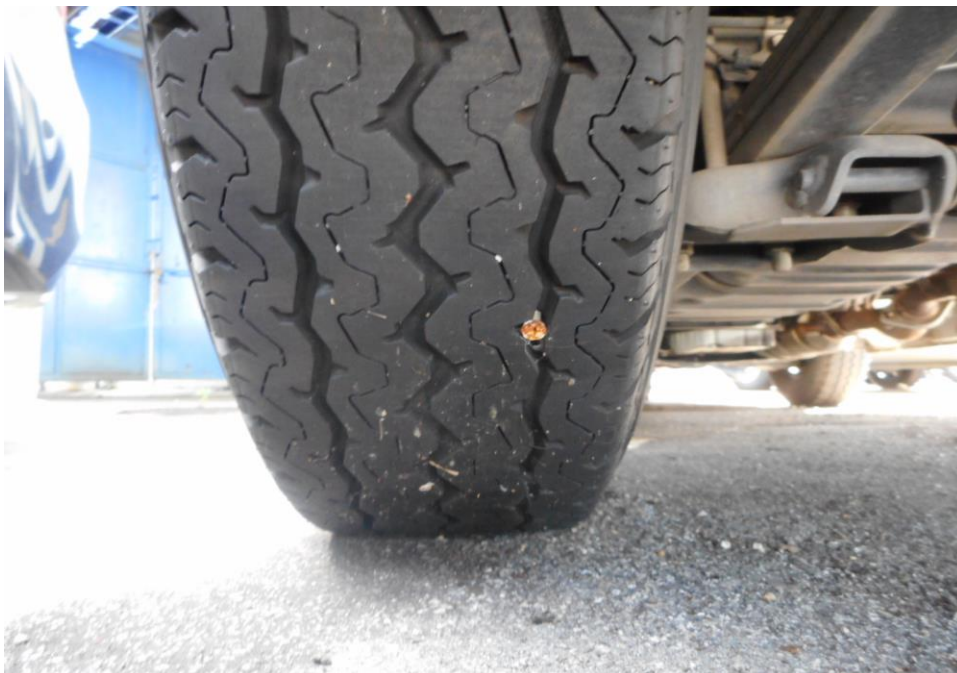
Photo 9 shows the condition of the rear left tyres of the Mini Bus, which was observed to be in serviceable condition with remaining tread depth of approximately 6.1mm. The tyres, which were wrapped around standard steel wheel rim, were also observed to be sufficiently inflated for vehicular operation. There was also no damage found on all 4 steel wheel rims of the Mini Bus.

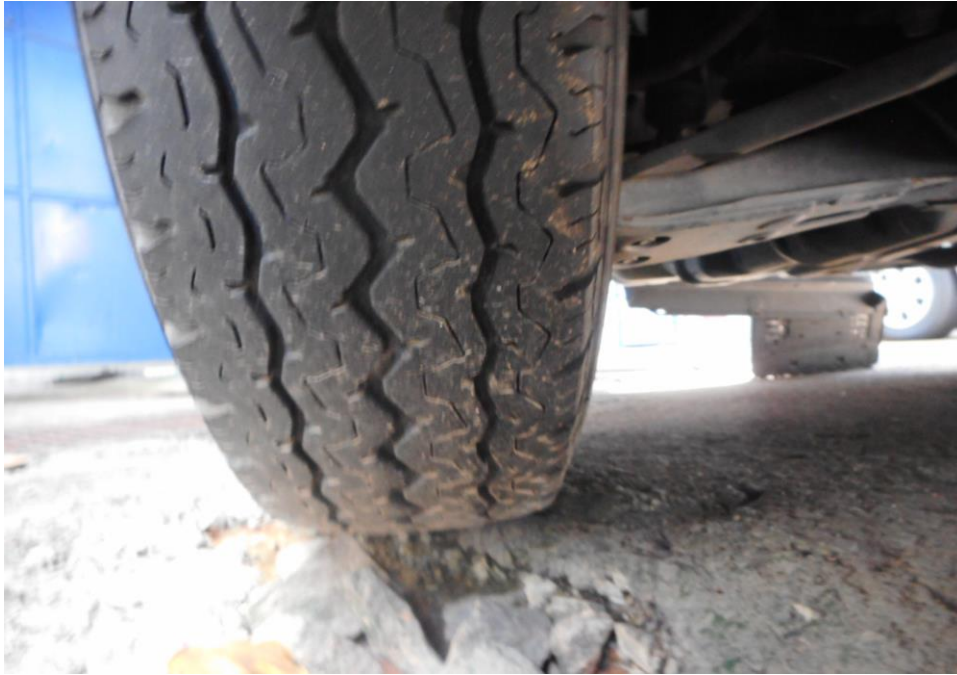
Photo 10 shows the condition of the rear right tyres of the Mini Bus, which were observed to be in serviceable condition with remaining, tread depth of approximately 5.7mm. There was also no tear, cut or burst mark(s) on the outer and the inner sidewalls as well as across the tread of the 4 tyres that were fitted on the Mini Bus.

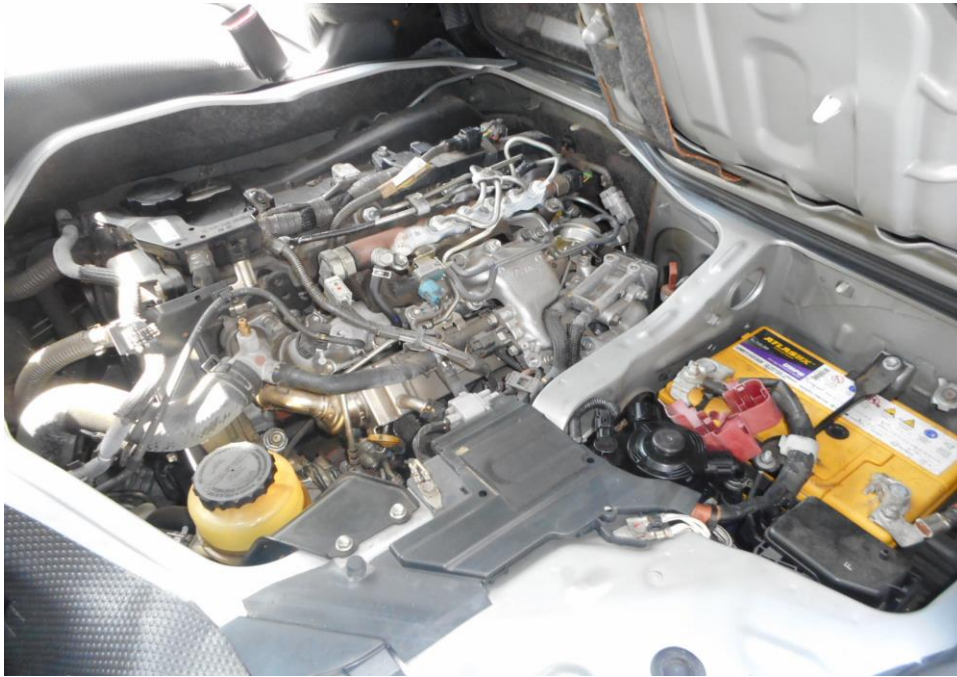
Photo 11 shows a general view of the Mini Bus's engine compartment, which was accessed by lifting the front cabin of the Mini Bus. The various parts and components inside the engine compartment were unaffected by the accident. There was also no sign(s) or indication(s) of fresh fluid leakage and/or fluid stain within the engine compartment

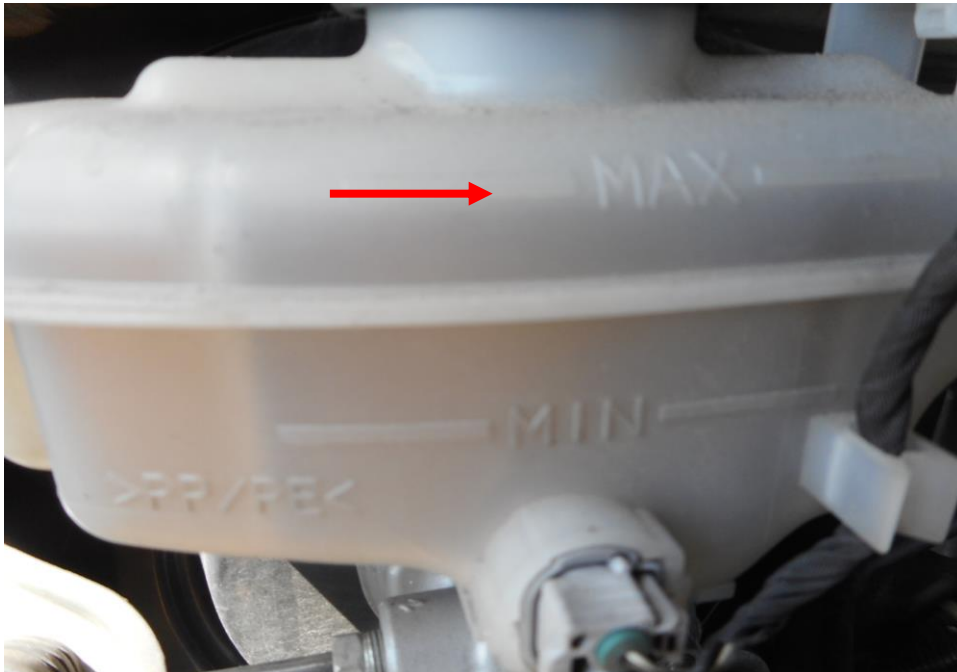
Photo 12 shows the brake fluid reservoir of the Mini Bus at the time of my inspection. The brake fluid was observed to be of sufficient level (arrowed) and without any visible contamination.

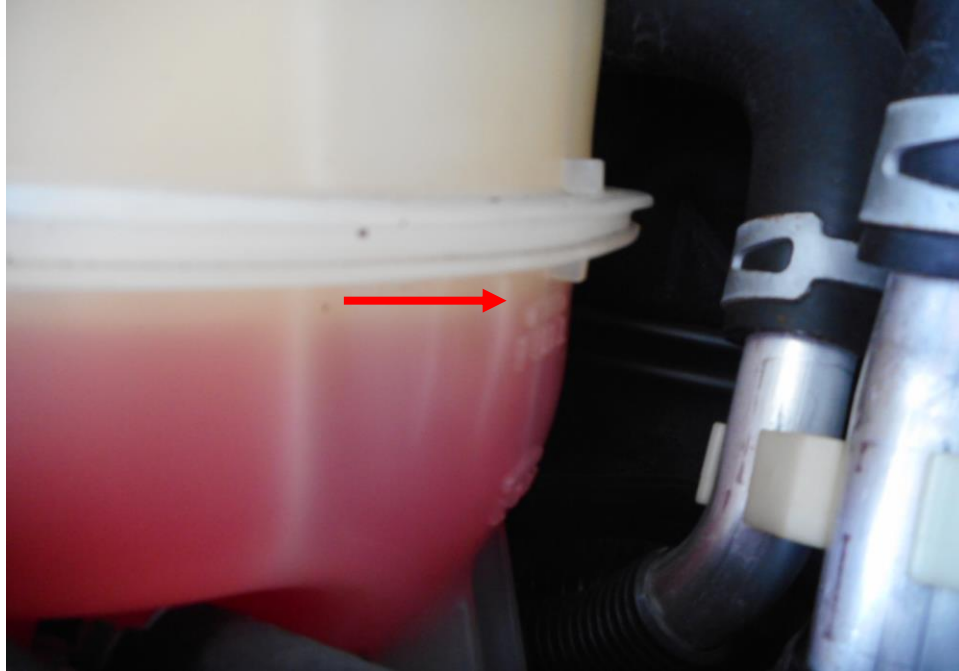
Photo 13 shows the engine coolant reservoir of the Mini Bus at the time of my inspection. The engine coolant was observed to be of sufficient level and without any visible contamination.

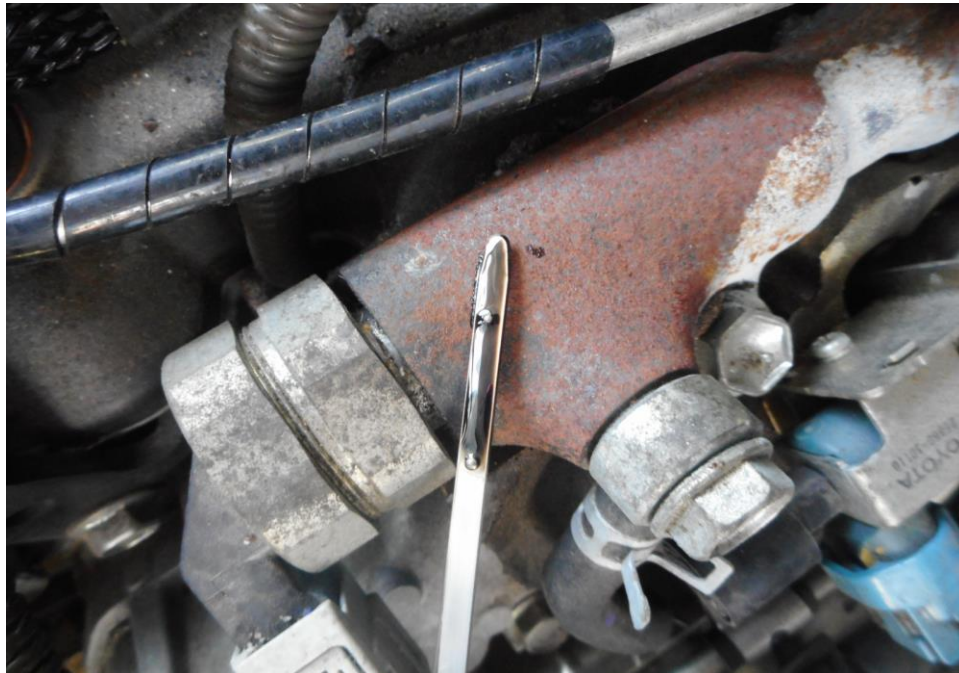
Photo 14 shows the engine oil dip stick of the Mini Bus at the time of my inspection. The engine oil was observed to be of sufficient level and without any visible contamination.

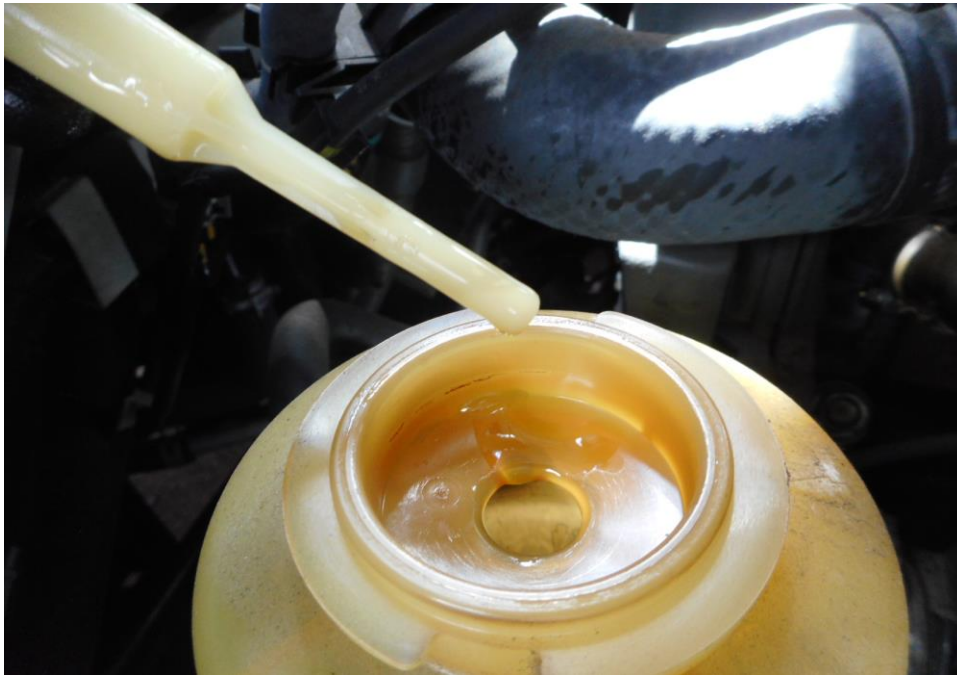
Photo 15 shows the power steering fluid dip stick of the Mini Bus at the time of my inspection. The power steering fluid was observed to be of sufficient level and without any visible contamination.

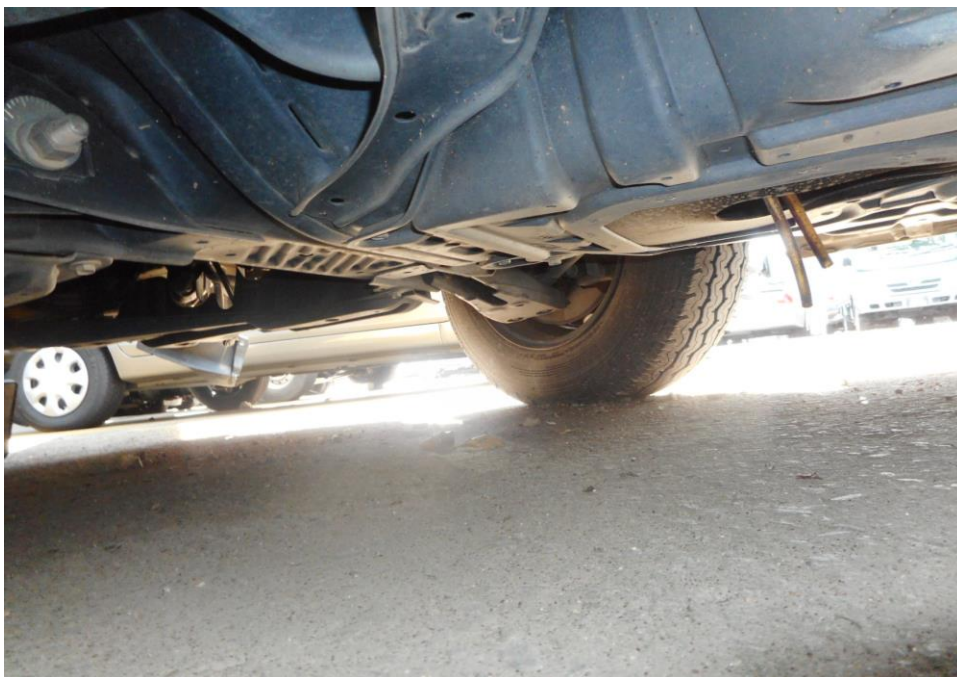
Photo 16 shows the undercarriage of the Mini Bus, at the area where the engine housing and transmission housing are located. . I did not find any sign(s) or indication(s) of fluid leak and/or fluid stain(s) on the underside of the Mini Bus.

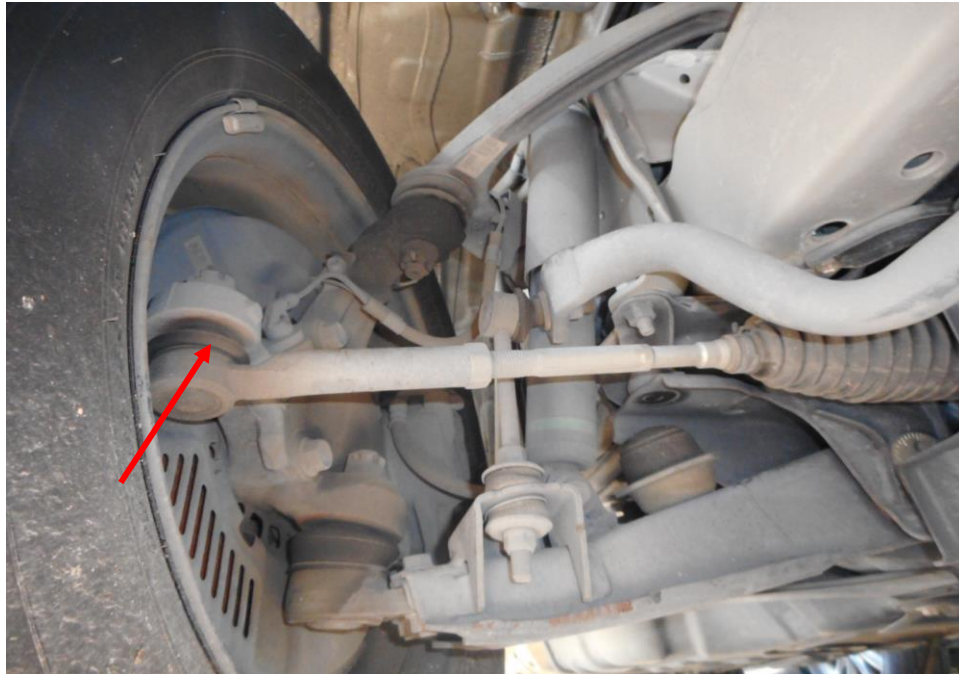
Photo 17 shows the various undercarriage components at the front right wheel of the Mini Bus, in particular the steering tie rod end (arrowed). The various steering components were all found to be intact, suggesting that the steering system of the Mini Bus was likely to be in serviceable condition at the material time of accident. There was also no sign of fluid stain(s) observed on the various undercarriage components.

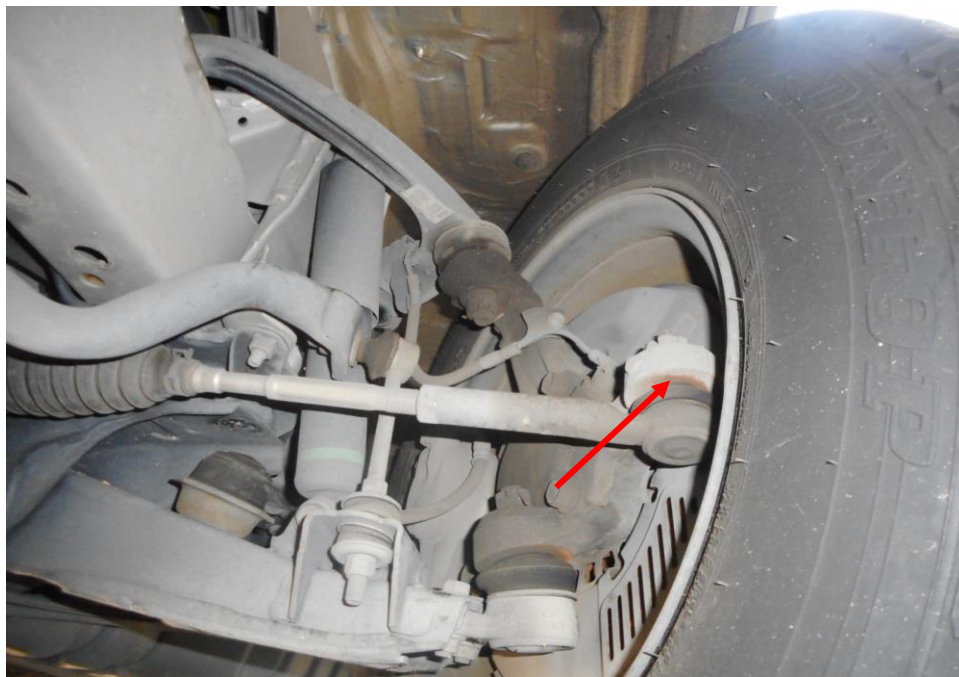
Photo 18 shows the various undercarriage components at the front left wheel of the Mini Bus, in particular the steering tie rod end (arrowed). The various undercarriage components of the Mini Bus were all found to be intact without any visible damage. There was also no sign of fluid stain(s) observed on the various undercarriage components.

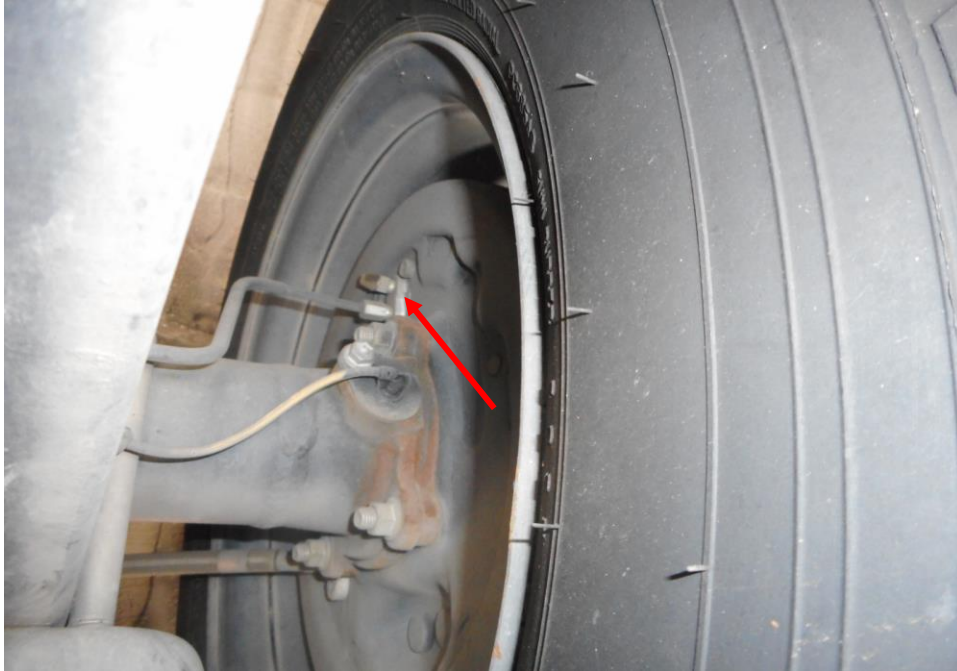
Photo 19 shows the brake pipe (arrowed) at the rear right wheel of the Mini Bus. I did not observe any leakage of brake fluid at the time of my inspection of the Mini Bus. My static tests of the Mini Bus's braking system, along with my visual examination of the various mechanical components in the braking system, had indicated that there was no internal leakage of pressure/vacuum. Hence the braking system of the Mini Bus was likely to be in serviceable condition at the material time of accident.

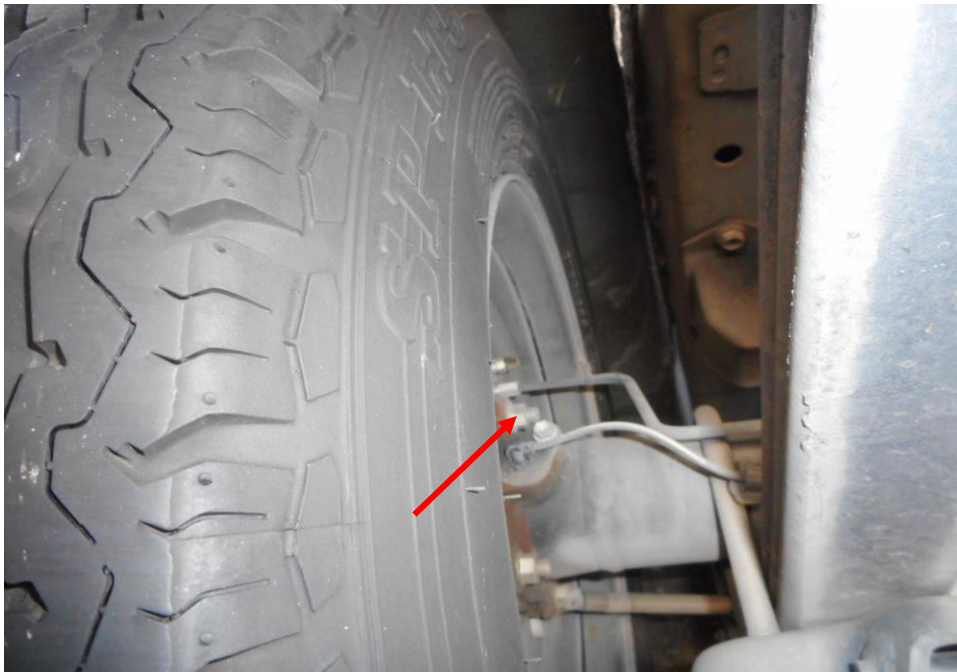
Photo 20 shows the brake pipe (arrowed) at the rear left wheel of the Mini Bus. I did not observe any leakage of brake fluid at the time of my inspection of the Mini Bus. My static tests of the Mini Bus's braking system, along with my visual examination of the various mechanical components in the braking system had indicated that there was no internal leakage of pressure/vacuum. Hence the braking system of the Mini Bus was likely to be in serviceable condition at the material time of accident.

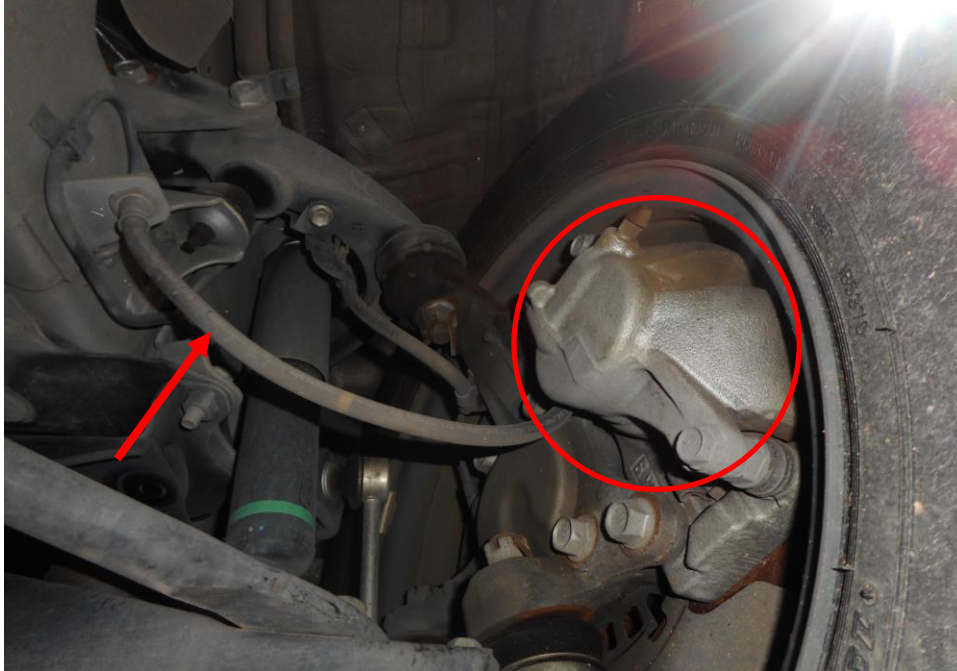
Photo 21 shows the brake hose/pipe (arrowed) at the front right wheel of the Mini Bus. No leakage of brake fluid was observed. Visual examination of the various components of the braking system like the brake caliper (circled), brake booster, brake pedal etc had revealed all to be intact and without visible damage at the time of accident. There was also no sign of fluid stain(s) observed on the various undercarriage components.

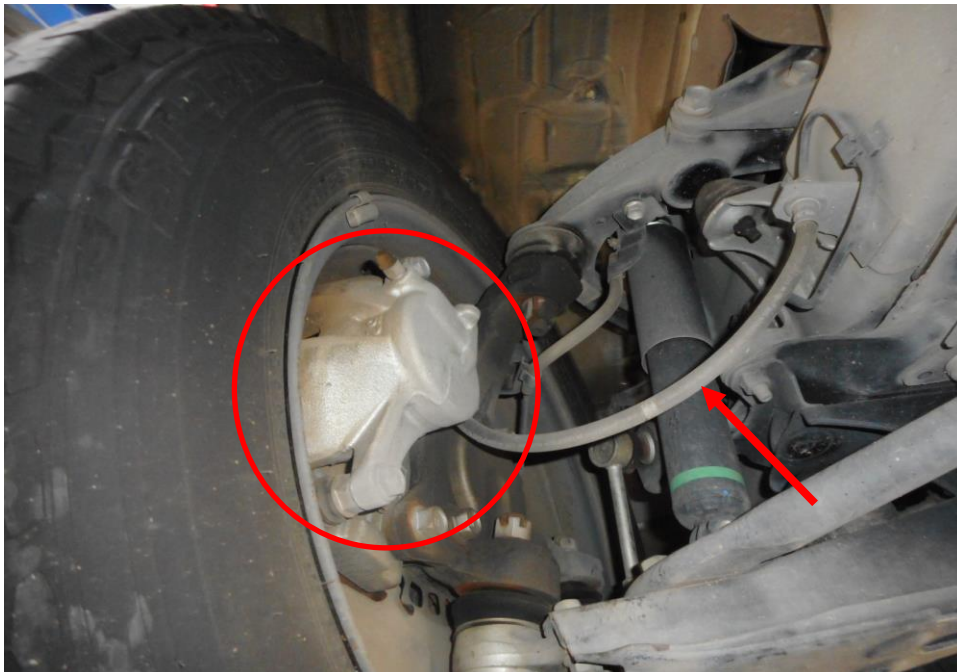
Photo 22 shows the brake hose/pipe (arrowed) at the front left wheel of the Mini Bus. No leakage of brake fluid was observed. Visual examination of the various components of the braking system like the brake caliper (circled), brake booster, brake pedal etc had revealed all to be intact and without visible damage at the time of accident. There was also no sign of fluid stain(s) observed on the various undercarriage components.

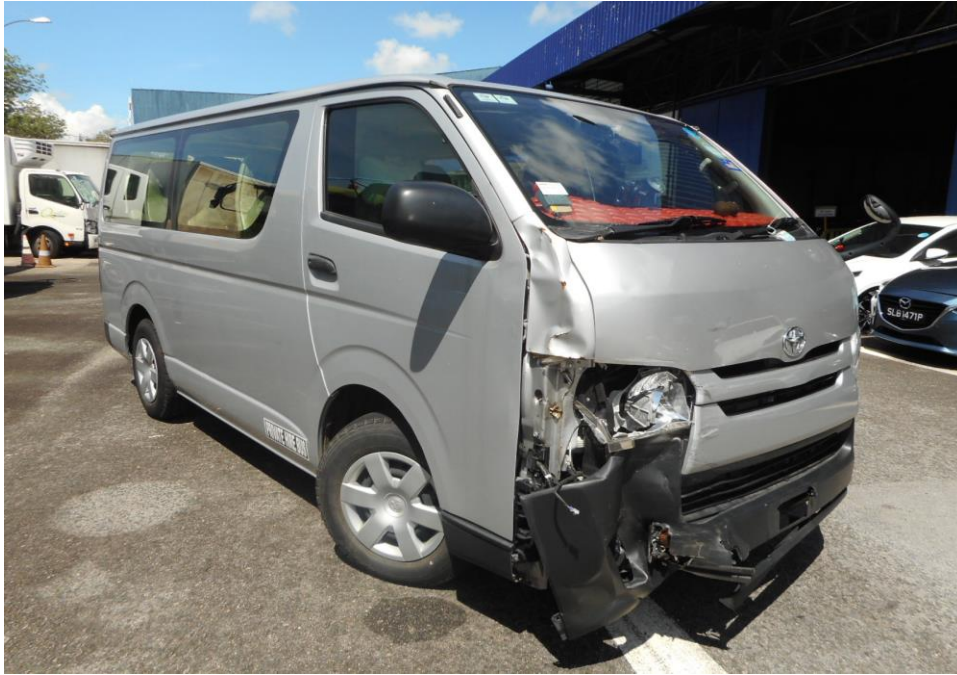
Photo 23 shows the front right wheel of the Mini Bus turned to its full left. During my steering system test, I did not experience any abnormal free play and/or resistance when I had turned the steering wheel towards full left and full right. This would suggest that the steering system of the Mini Bus was likely to be in serviceable condition at the material time of accident.

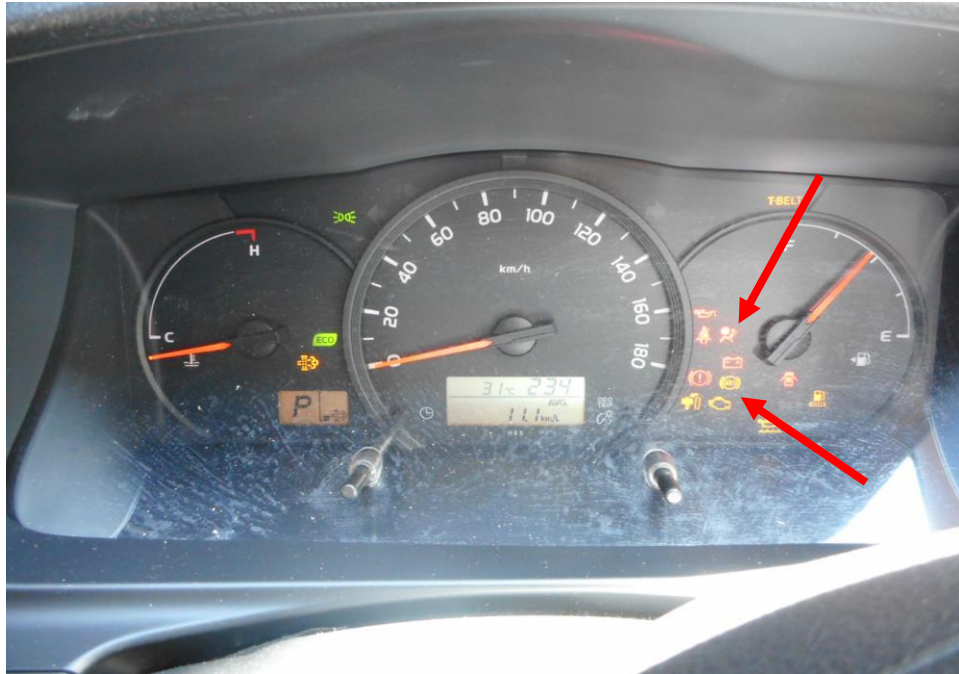
Photo 24 shows the warning light for Anti-Lock Brake System (ABS) and Supplemental Restraint System (SRS) (arrowed) appearing on the instrument panel of the Mini Bus during the self-test of its various electronic operating systems when its engine was cranked.

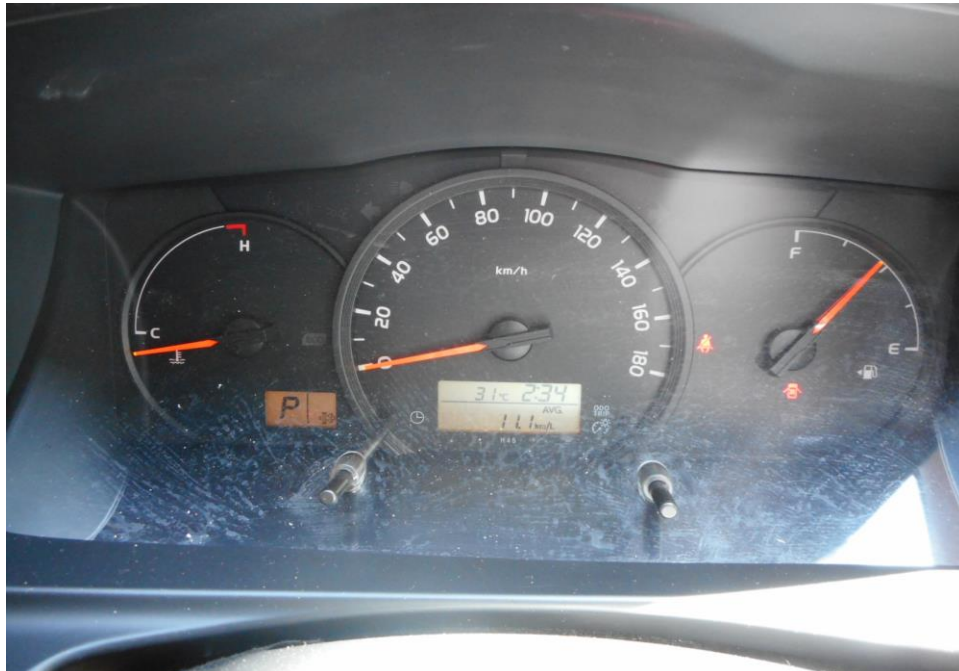
Photo 25 shows no warning lights illuminated on the instrument panel of the Mini Bus after the engine was cranked. This would suggest that there was no abnormality to the electronic operating system of the Mini Bus, like the ABS and SRS etc.
