Your Ref: TP/IP/11887/2020
Our Ref : CI/TPD20004861/P

Fatal Accident Investigation Team

MECHANICAL INSPECTION REPORT OF MINI BUS PC 8744D

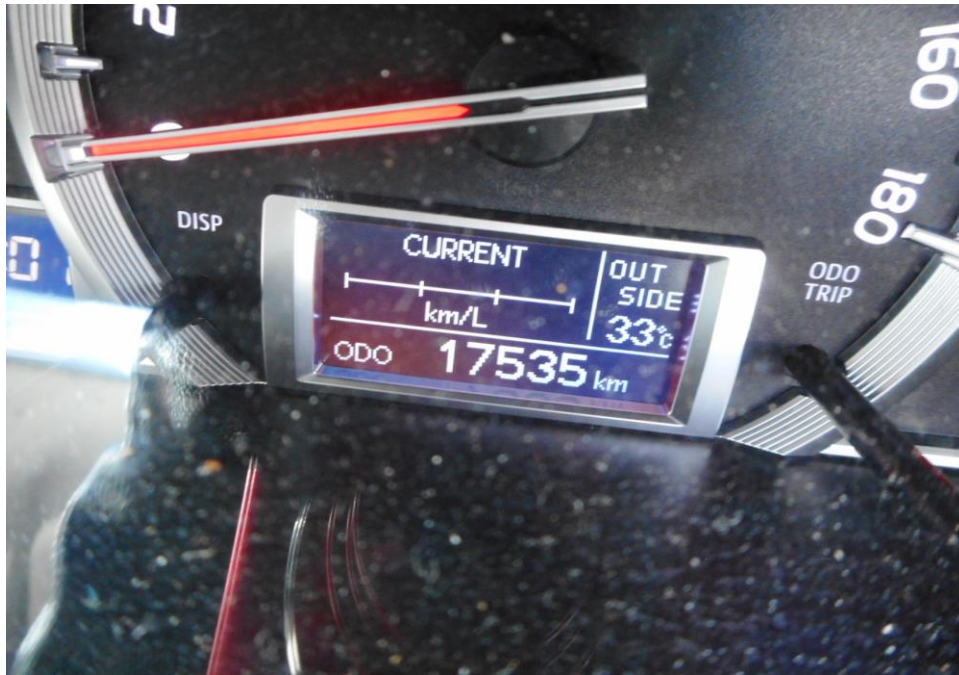
Photo 1 shows a general view of the instrument cluster of the Mini Bus at the time of my inspection. The mileage of the Mini Bus was 17,535km

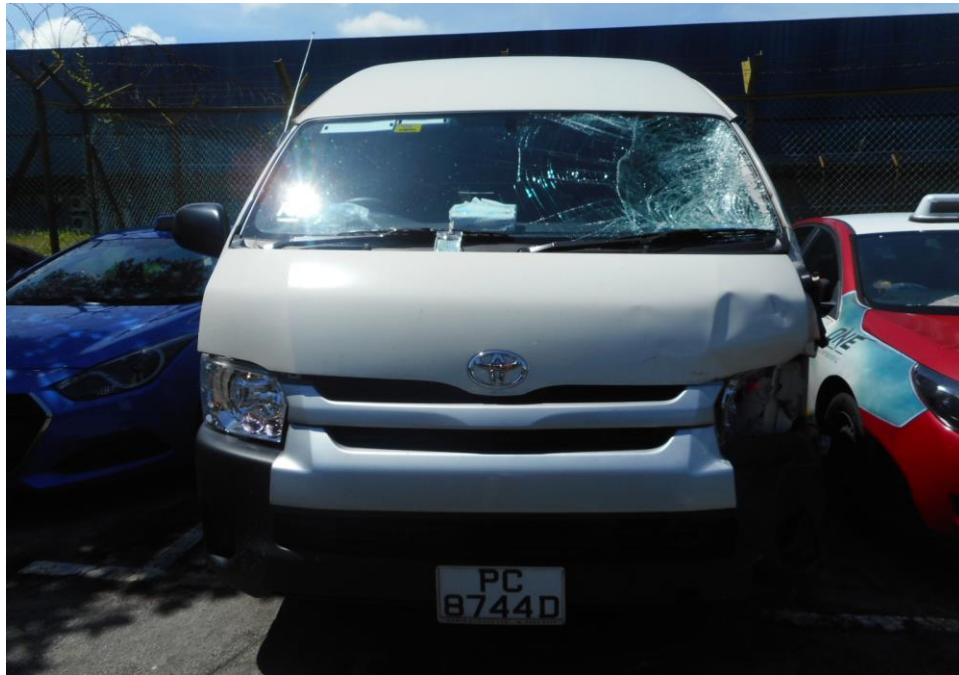
4. The mileage of the Mini Bus at the time of my inspection was 17,535km.
5. The Mini Bus appeared to have sustained damage at its frontal portion. Its front windscreen, front bumper, front bonnet, left rear view mirror and front left head lamp were damaged at the time of my inspection.

Photo 2 shows a general view of the Mini Bus's frontal portion at the time of my inspection. It appeared to have sustained damage at its frontal portion. Its front windscreen, front bumper, front bonnet, left rear view mirror and front left head lamp were damage at the time of my inspection.

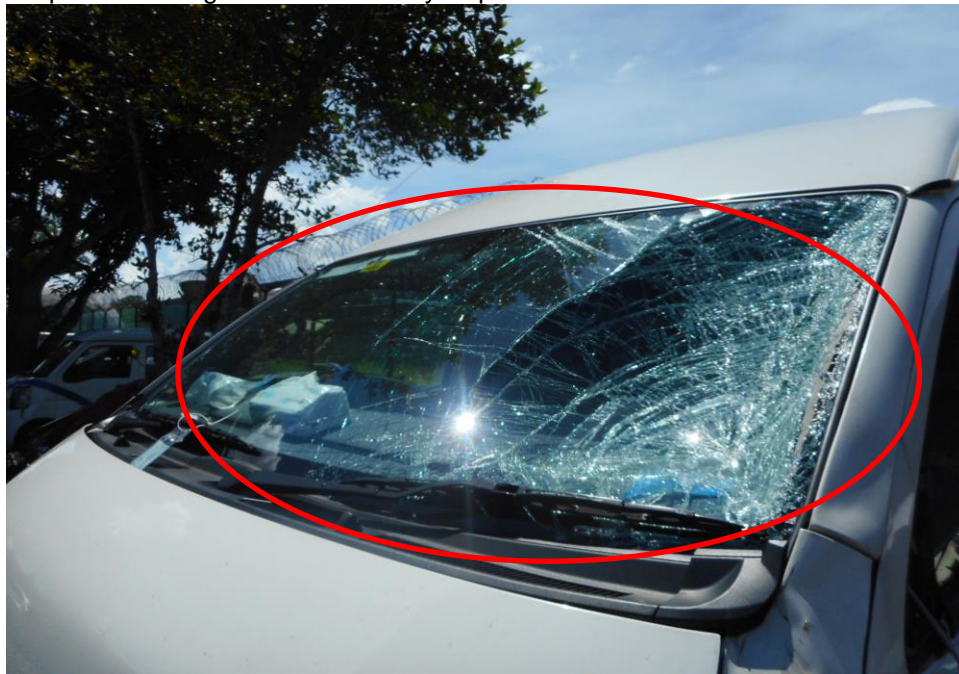
Photo 3 shows a close up view of the Mini Bus's frontal portion at the time of my inspection. It appeared to have sustained damage at its frontal portion. Its front windscreen (circled) were damage at the time of my inspection.

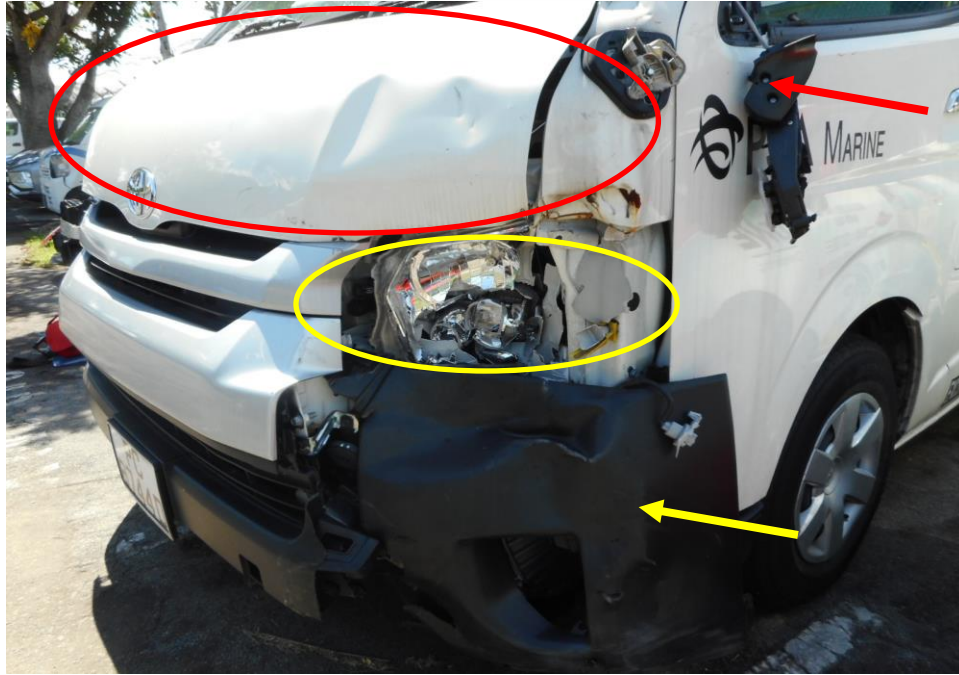
Photo 4 shows a close up view of the Mini Bus's frontal portion at the time of my inspection. It appeared to have sustained damage at its frontal portion. Its front bonnet (red circle), front bumper (yellow arrow), left rear view mirror (red arrow) and front left head lamp (yellow circle) were damage at the time of my inspection.

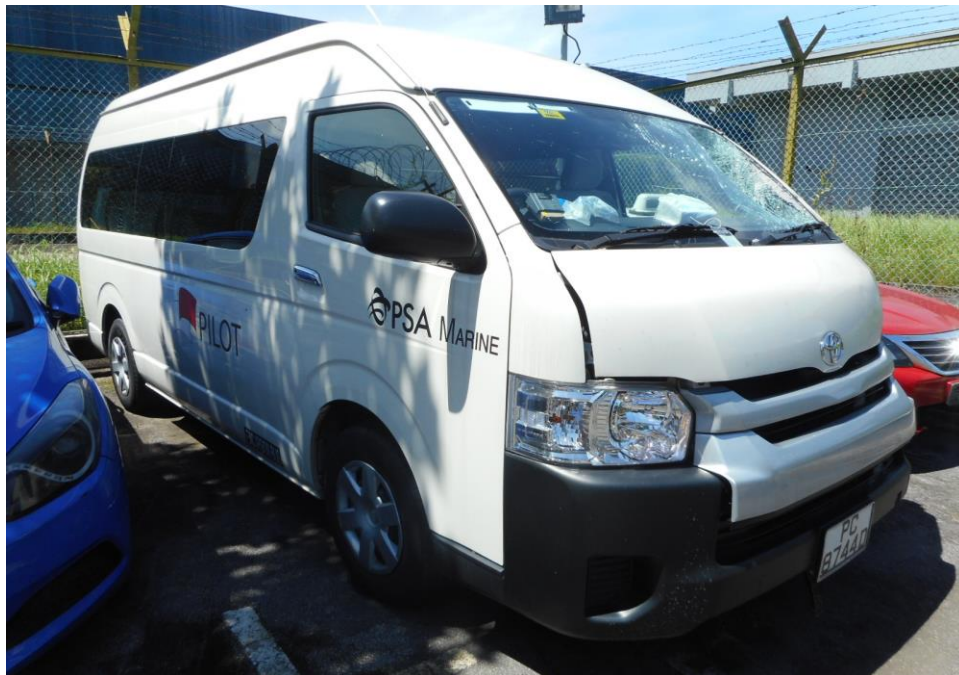
Photo 5 shows a general view of the right body of the Mini Bus at the time of my inspection. The Mini Bus was observed to be intact and unaffected by the accident.

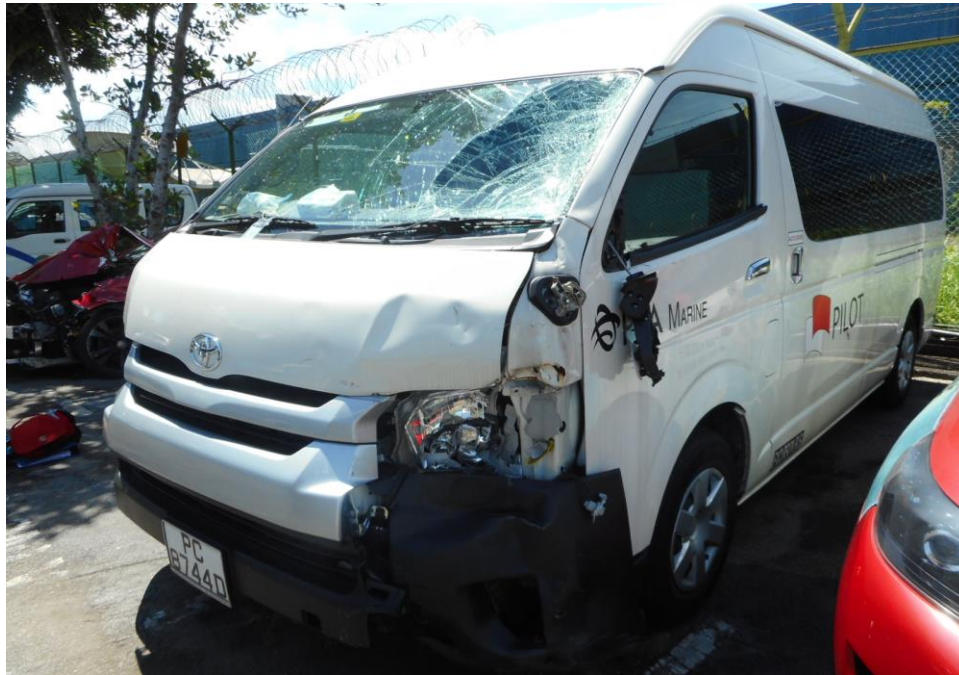
Photo 6 shows a general view of the left side body of the Mini Bus at the time of my inspection. The Mini Bus was observed to be intact and unaffected by the accident.

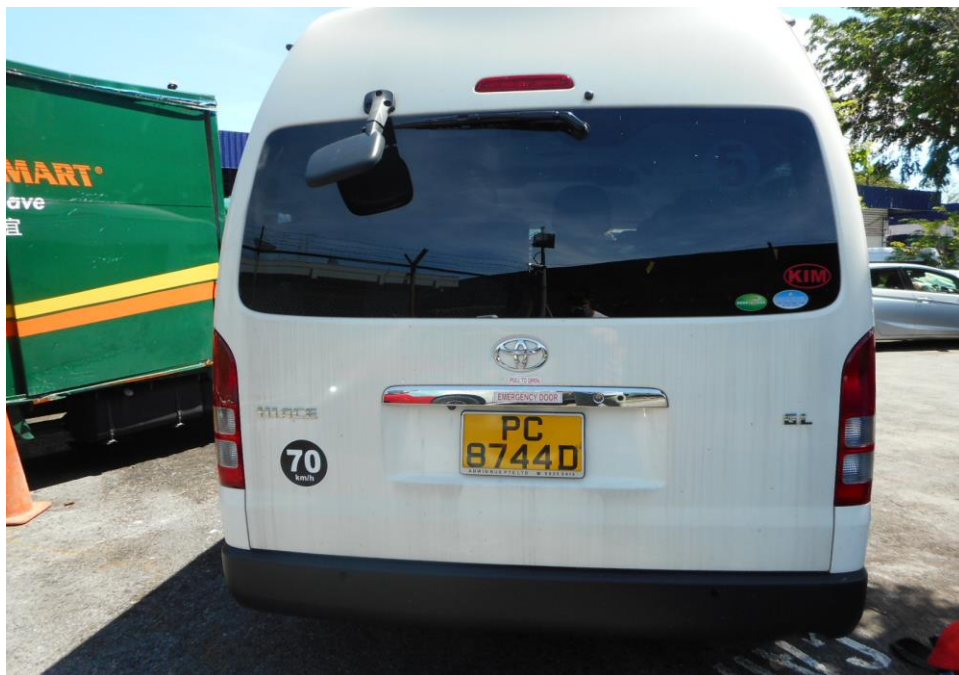
Photo 7 shows a general view of the rear body of the Mini Bus at the time of my inspection. The Mini Bus was observed to be intact and unaffected by the accident.

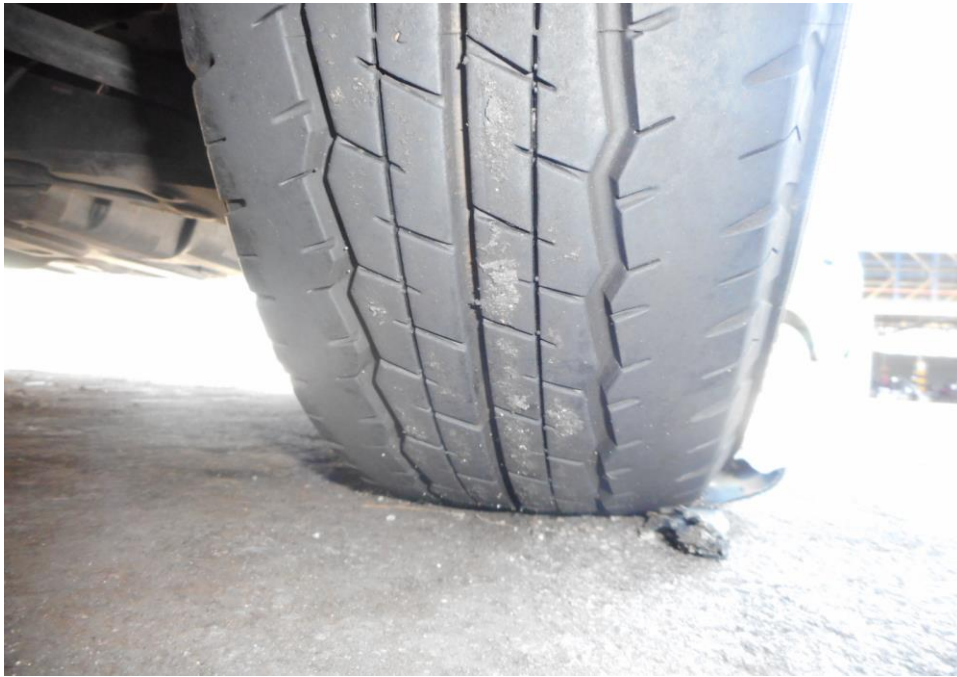
Photo 8 shows the condition of the front right tyre of the Mini Bus, which was observed to be in serviceable condition with remaining tread depth of approximately 7.9mm. The tyre, which was wrapped around standard steel wheel rim, was also observed to be sufficiently inflated for vehicular operation. There was no tear, cut or burst mark(s) on the outer and the inner sidewalls as well as across the tread of the 4 tyres that were fitted on the Mini Bus.

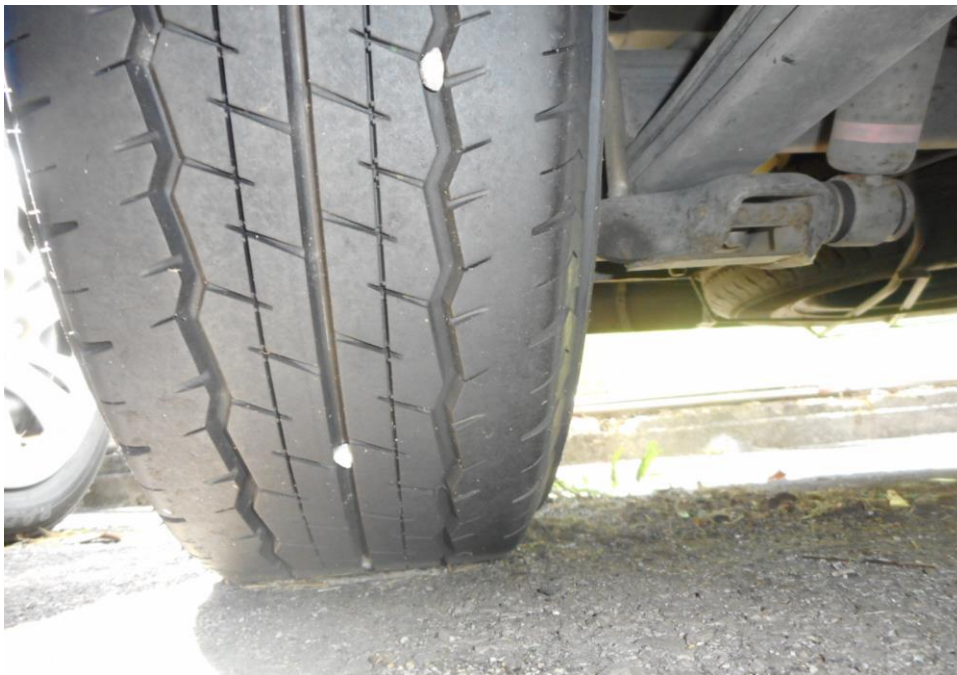
Photo 9 shows the condition of the rear right tyre of the Mini Bus, which was observed to be in serviceable condition with remaining tread depth of approximately 7.2mm. The tyre, which was wrapped around standard steel wheel rim, it was observed to be sufficiently inflated for vehicular operation.

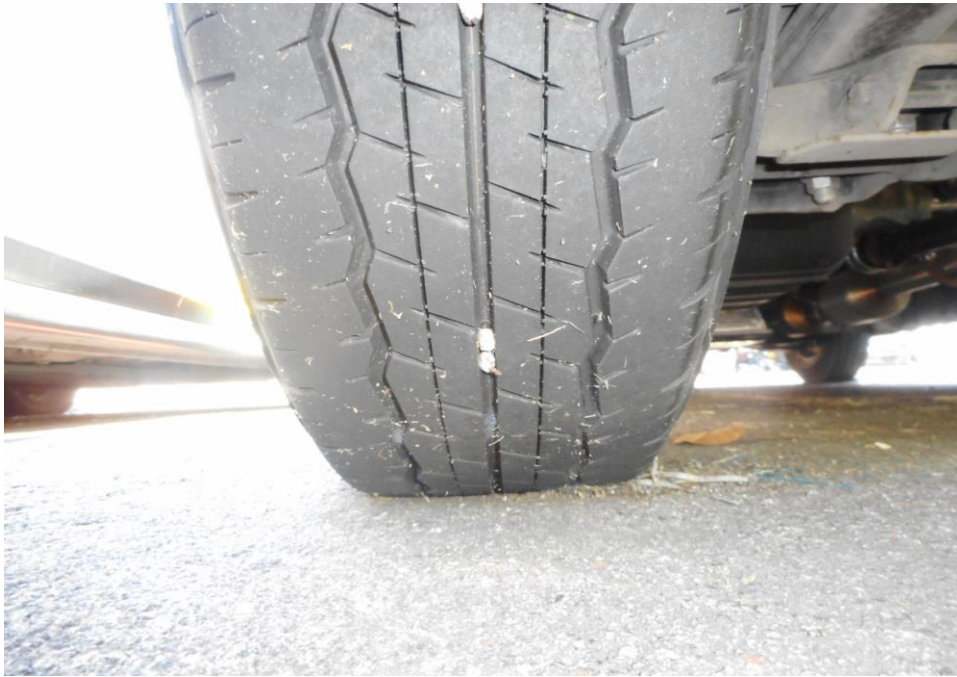
Photo 10 shows the condition of the rear left tyres of the Mini Bus, which was observed to be in serviceable condition with remaining tread depth of approximately 7mm. The tyres, which were wrapped around standard steel wheel rim, were also observed to be sufficiently inflated for vehicular operation. There was also no damage found on all 4 steel wheel rims of the Mini Bus.

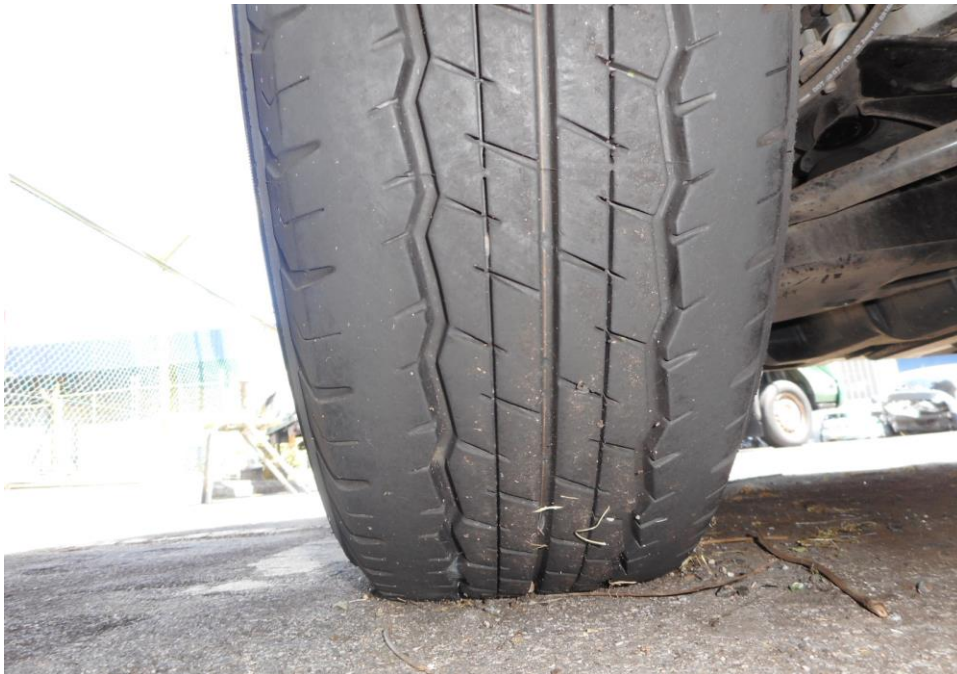
Photo 11 shows the condition of the rear right tyres of the Mini Bus, which were observed to be in serviceable condition with remaining, tread depth of approximately 7.6mm. There was also no tear, cut or burst mark(s) on the outer and the inner sidewalls as well as across the tread of the 4 tyres that were fitted on the Mini Bus.

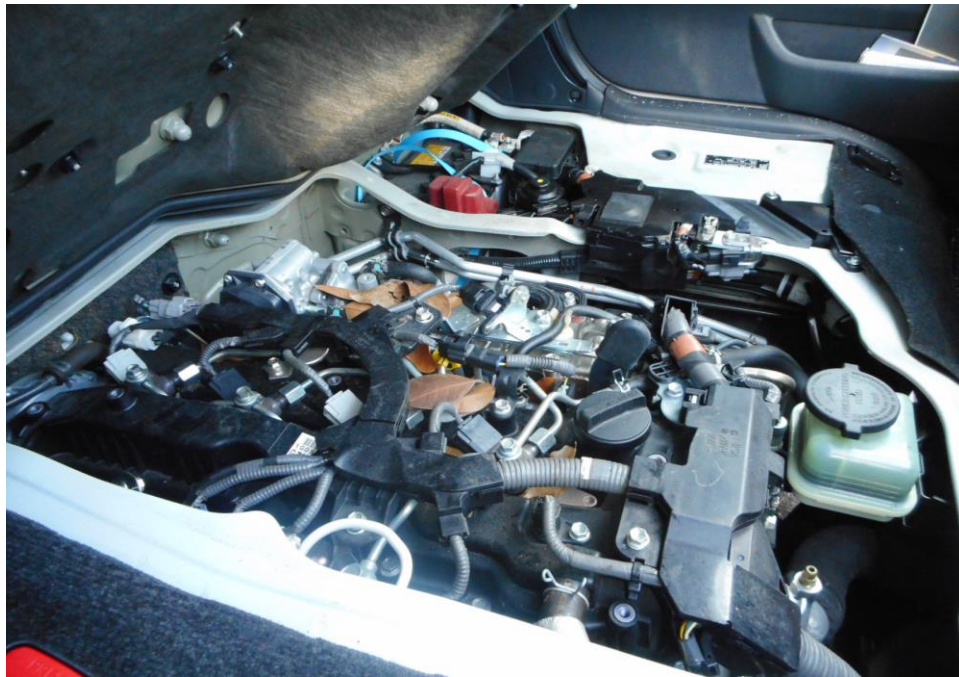
Photo 12 shows a general view of the Mini Bus's engine compartment, which was accessed by lifting the front cabin of the Mini Bus. The various parts and components inside the engine compartment were unaffected by the accident. There was also no sign(s) or indication(s) of fresh fluid leakage and/or fluid stain within the engine compartment

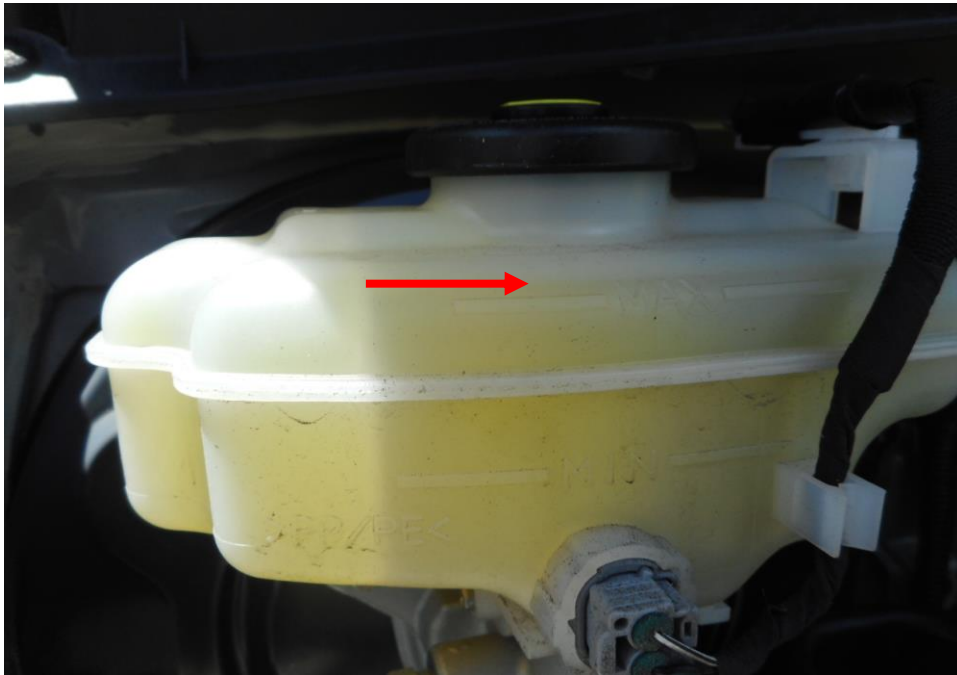
Photo 13 shows the brake fluid reservoir of the Mini Bus at the time of my inspection. The brake fluid was observed to be of sufficient level (arrowed) and without any visible contamination.

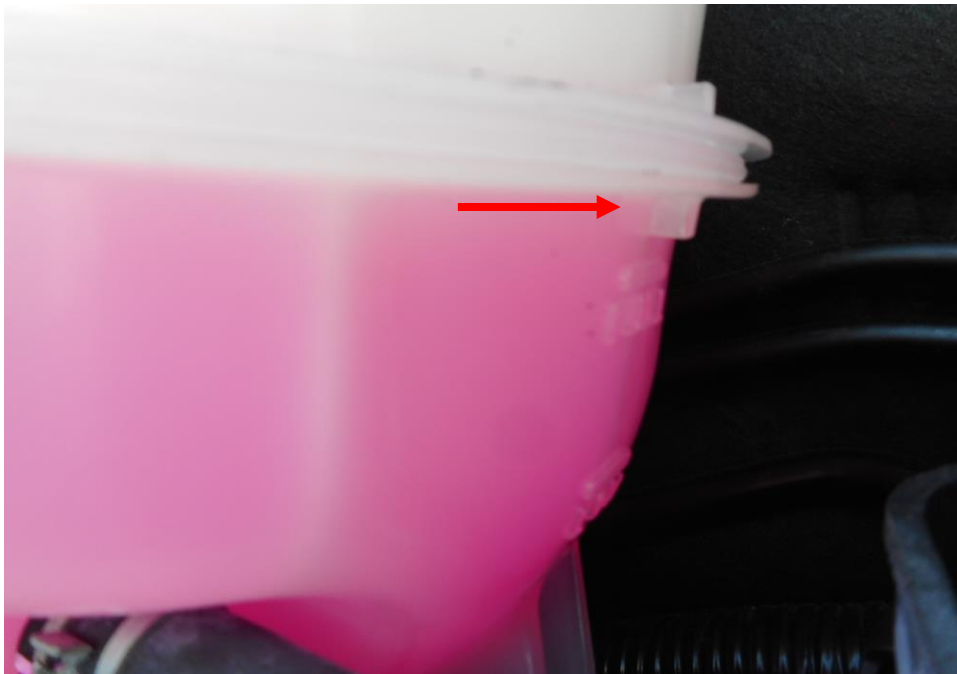
Photo 14 shows the engine coolant reservoir of the Mini Bus at the time of my inspection. The engine coolant was observed to be of sufficient level and without any visible contamination.

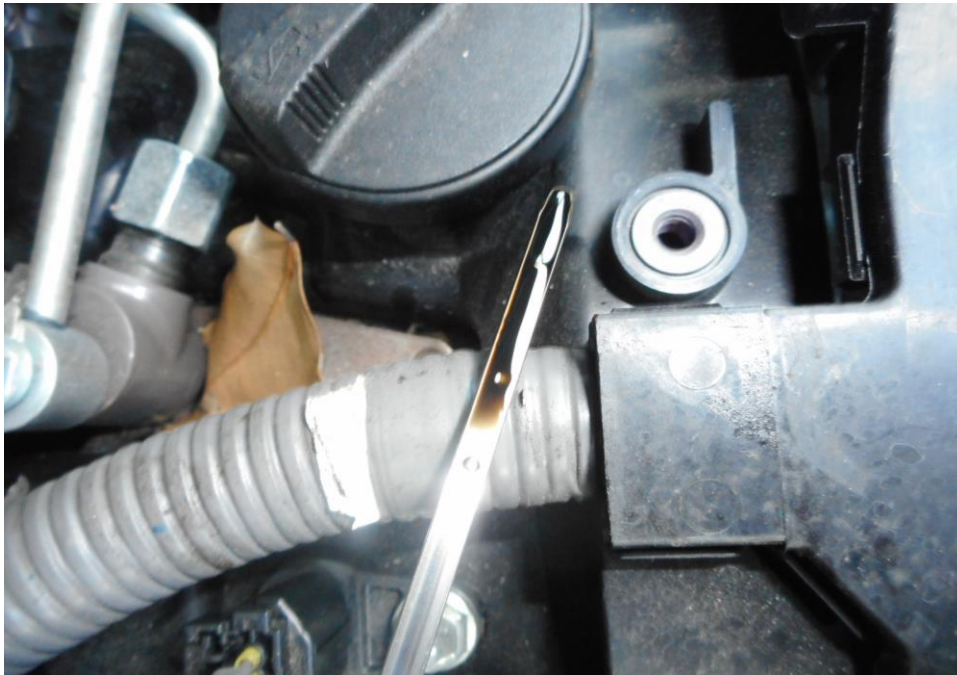
Photo 15 shows the engine oil dip stick of the Mini Bus at the time of my inspection. The engine oil was observed to be of sufficient level and without any visible contamination.

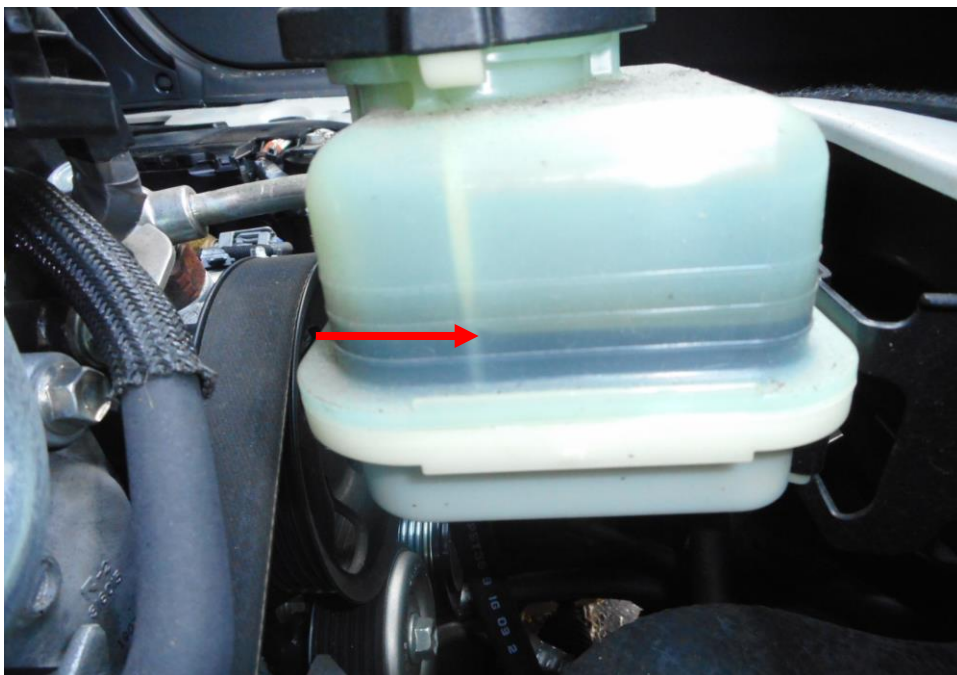
Photo 16 shows the power steering fluid of the Mini Bus at the time of my inspection. The power steering fluid was observed to be of sufficient level (arrowed) and without any visible contamination.

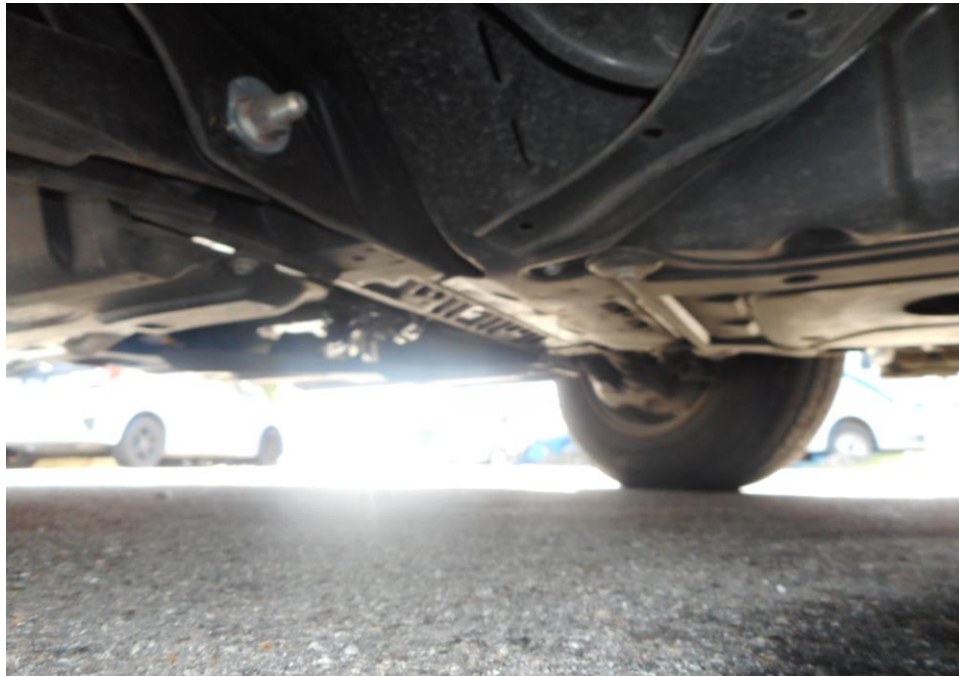
Photo 17 shows the undercarriage of the Mini Bus, at the area where the engine housing and transmission housing are located. . I did not find any sign(s) or indication(s) of fluid leak and/or fluid stain(s) on the underside of the Mini Bus.

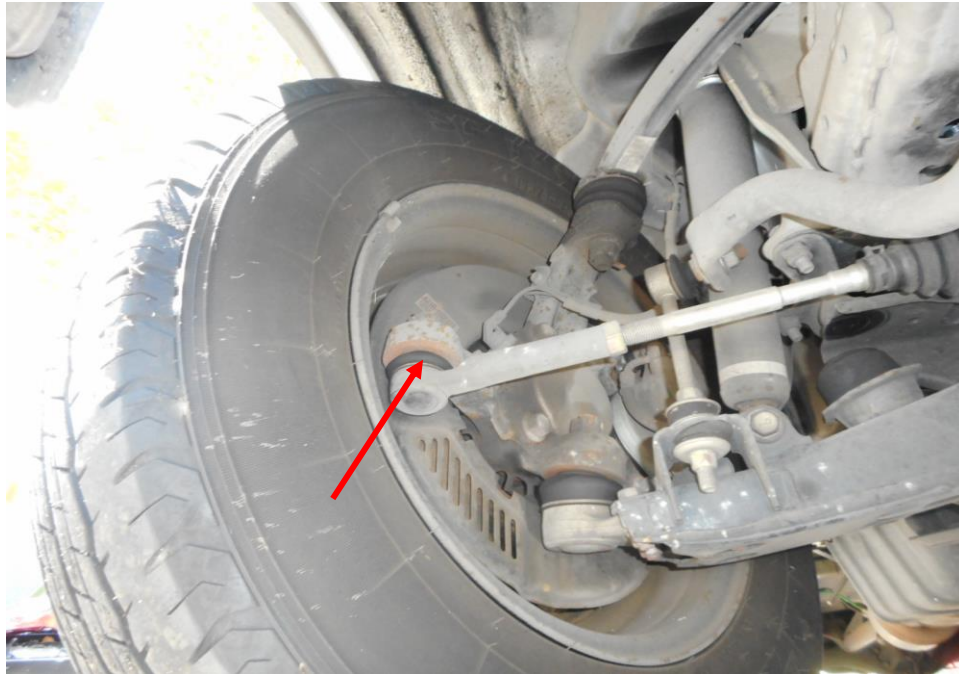
Photo 18 shows the various undercarriage components at the front right wheel of the Mini Bus, in particular the steering tie rod end (arrowed). The various steering components were all found to be intact, suggesting that the steering system of the Mini Bus was likely to be in serviceable condition at the material time of accident. There was also no sign of fluid stain(s) observed on the various undercarriage components.

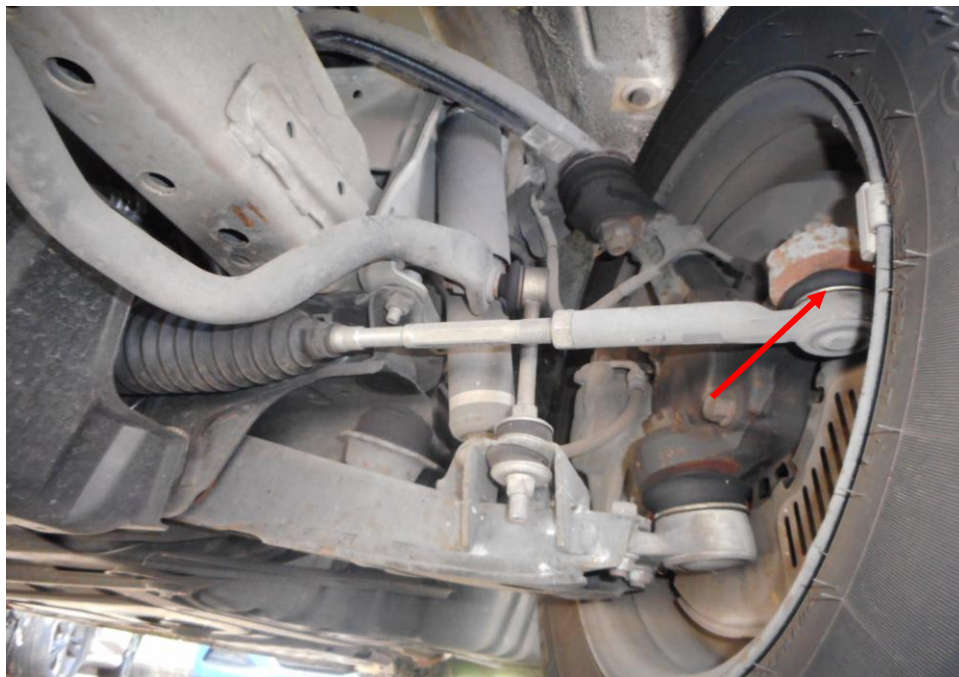
Photo 19 shows the various undercarriage components at the front left wheel of the Mini Bus, in particular the steering tie rod end (arrowed). The various undercarriage components of the Mini Bus were all found to be intact without any visible damage. There was also no sign of fluid stain(s) observed on the various undercarriage components.

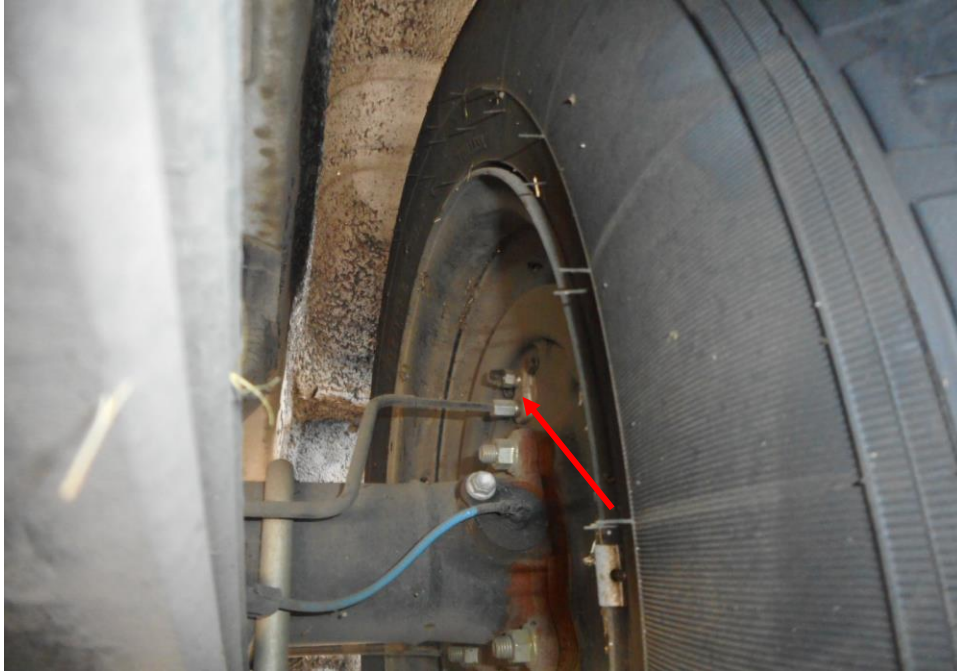
Photo 20 shows the brake pipe (arrowed) at the rear right wheel of the Mini Bus. I did not observe any leakage of brake fluid at the time of my inspection of the Mini Bus. My static tests of the Mini Bus's braking system, along with my visual examination of the various mechanical components in the braking system, had indicated that there was no internal leakage of pressure/vacuum. Hence the braking system of the Mini Bus was likely to be in serviceable condition at the material time of accident.

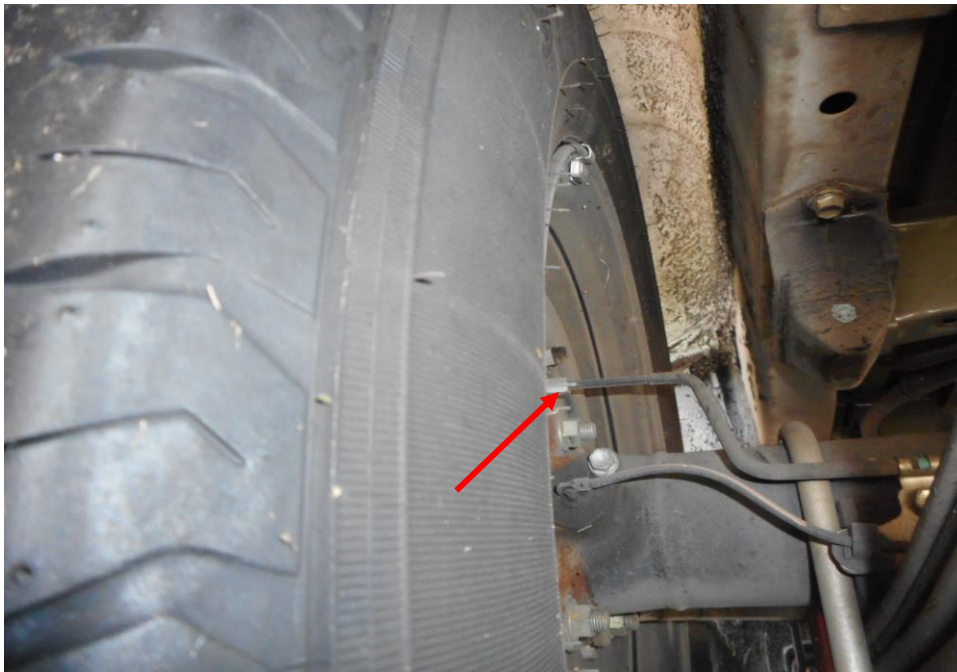
Photo 21 shows the brake pipe (arrowed) at the rear left wheel of the Mini Bus. I did not observe any leakage of brake fluid at the time of my inspection of the Mini Bus. My static tests of the Mini Bus's braking system, along with my visual examination of the various mechanical components in the braking system had indicated that there was no internal leakage of pressure/vacuum. Hence the braking system of the Mini Bus was likely to be in serviceable condition at the material time of accident.

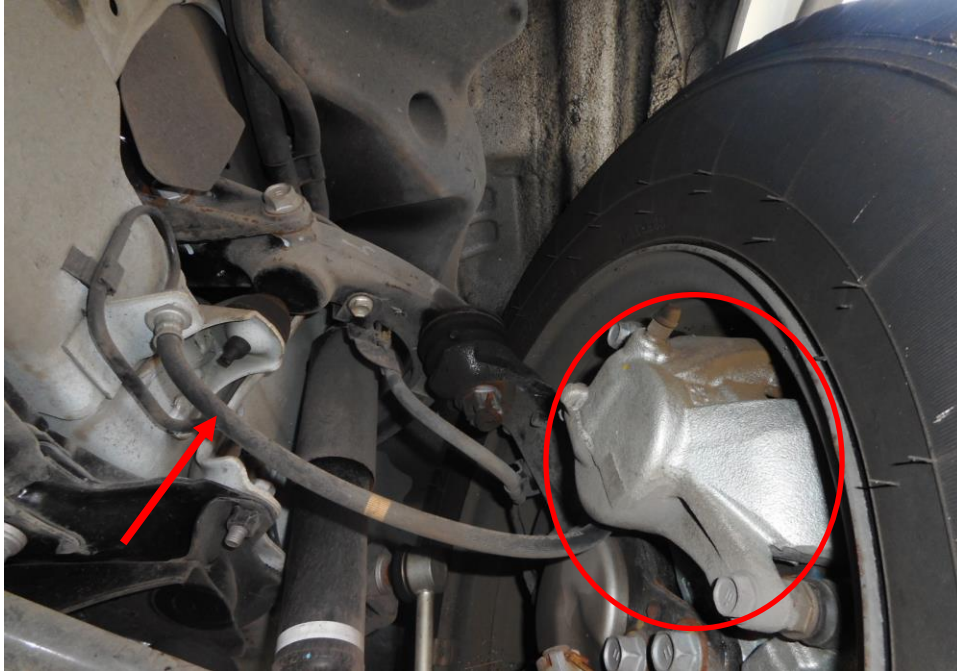
Photo 22 shows the brake hose/pipe (arrowed) at the front right wheel of the Mini Bus. No leakage of brake fluid was observed. Visual examination of the various components of the braking system like the brake caliper (circled), brake booster, brake pedal etc had revealed all to be intact and without visible damage at the time of accident. There was also no sign of fluid stain(s) observed on the various undercarriage components.

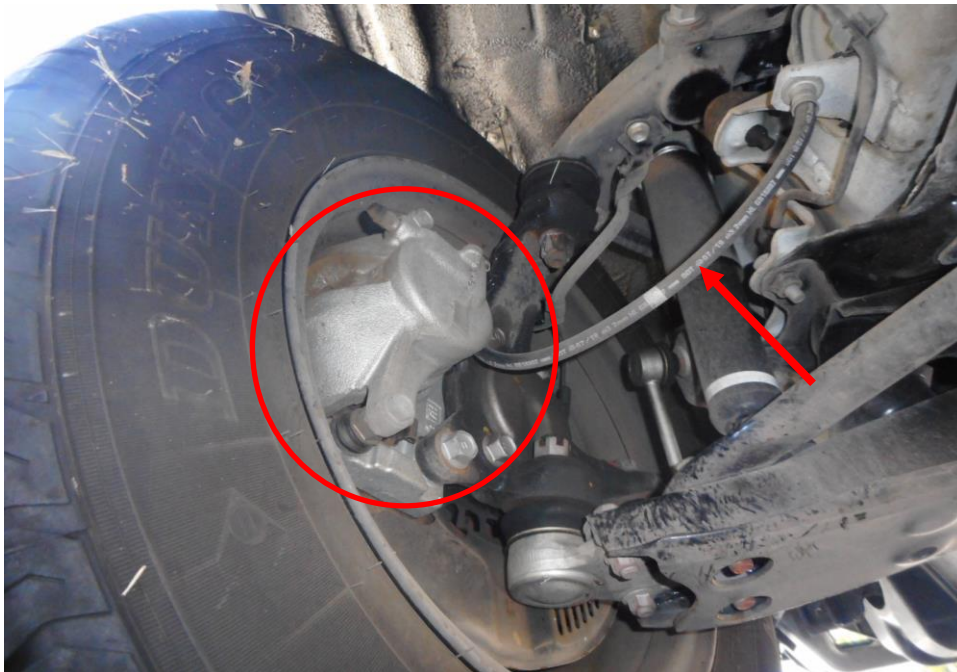
Photo 23 shows the brake hose/pipe (arrowed) at the front left wheel of the Mini Bus. No leakage of brake fluid was observed. Visual examination of the various components of the braking system like the brake caliper (circled), brake booster, brake pedal etc had revealed all to be intact and without visible damage at the time of accident. There was also no sign of fluid stain(s) observed on the various undercarriage components.

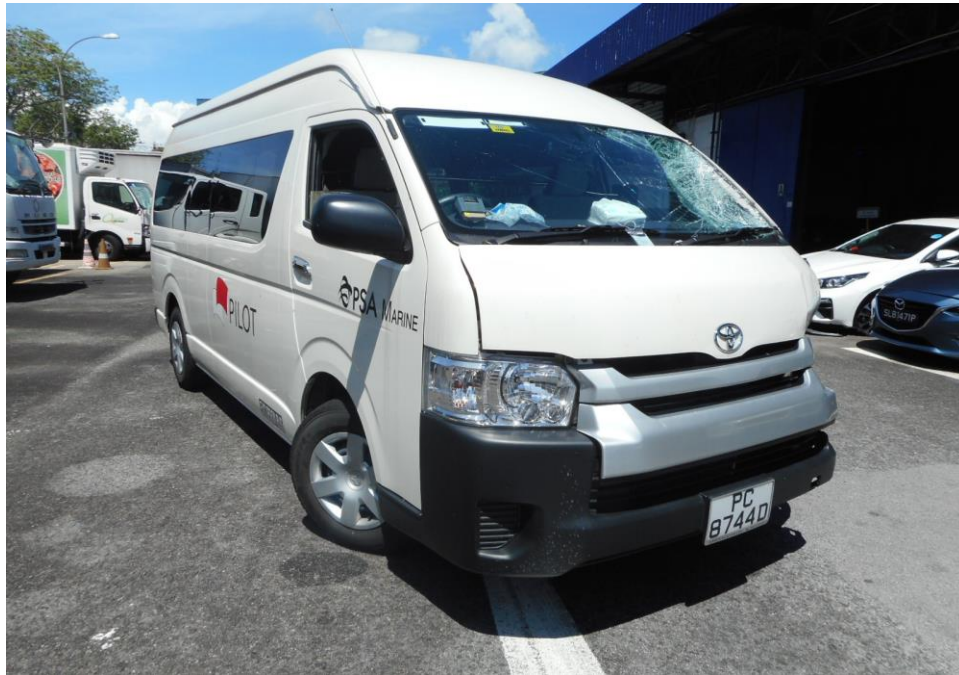
Photo 24 shows the front right wheel of the Mini Bus turned to its full left. During my steering system test, I did not experience any abnormal free play and/or resistance when I had turned the steering wheel towards full left and full right. This would suggest that the steering system of the Mini Bus was likely to be in serviceable condition at the material time of accident.

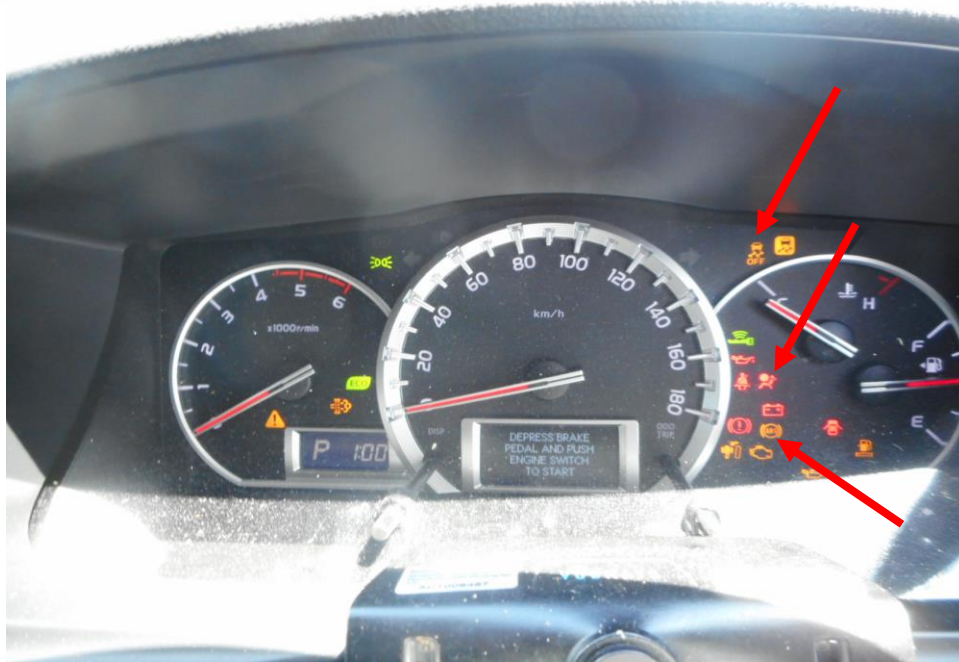
Photo 24 shows the warning light for Anti-Lock Brake System (ABS) and Supplemental Restraint System (SRS) and Traction Control System (TC) (arrowed) appearing on the instrument panel of the Mini Bus during the self-test of its various electronic operating systems when its engine was cranked.

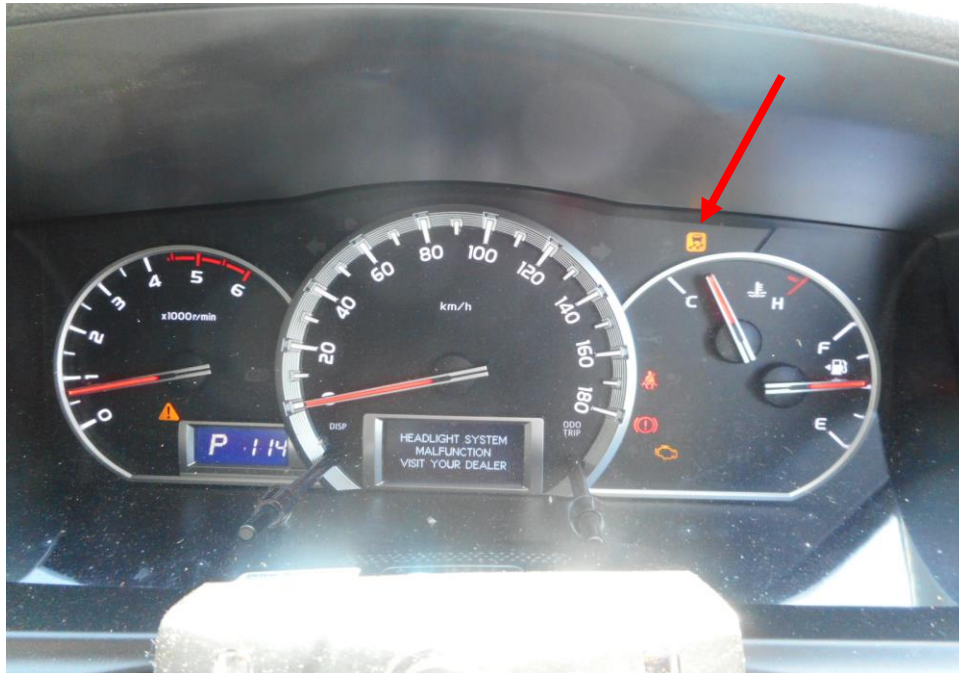
13. Mini Bus's automatic self-test of the functionality of its electronic operating systems like the Anti-Lock Brake System (ABS) and Supplemental Restraint System (SRS) during cranking of the engine had indicated that the system were in working condition and without abnormality. This can be established from the warning lights disappearing from the instrument panel after the self-test. However the Traction Control (TC) light remained illuminated on, likely caused by the result of the accident. System See photo 25 & 26 below.

Photo 25 shows no warning lights illuminated on the instrument panel of the Mini Bus after the engine was cranked. This would suggest that there was no abnormality to the electronic operating system of the Mini Bus, like the ABS and SRS etc. However the Traction Control System (TC) light remained illuminated on likely caused by the result of the accident.
