Your Ref: TP/IP/12977/2020
Our Ref : CI/TPD20004862/P

30th May 2020

Fatal Accident Investigation Team

MECHANICAL INSPECTION REPORT OF MOTOR TAXI SHD 1096B

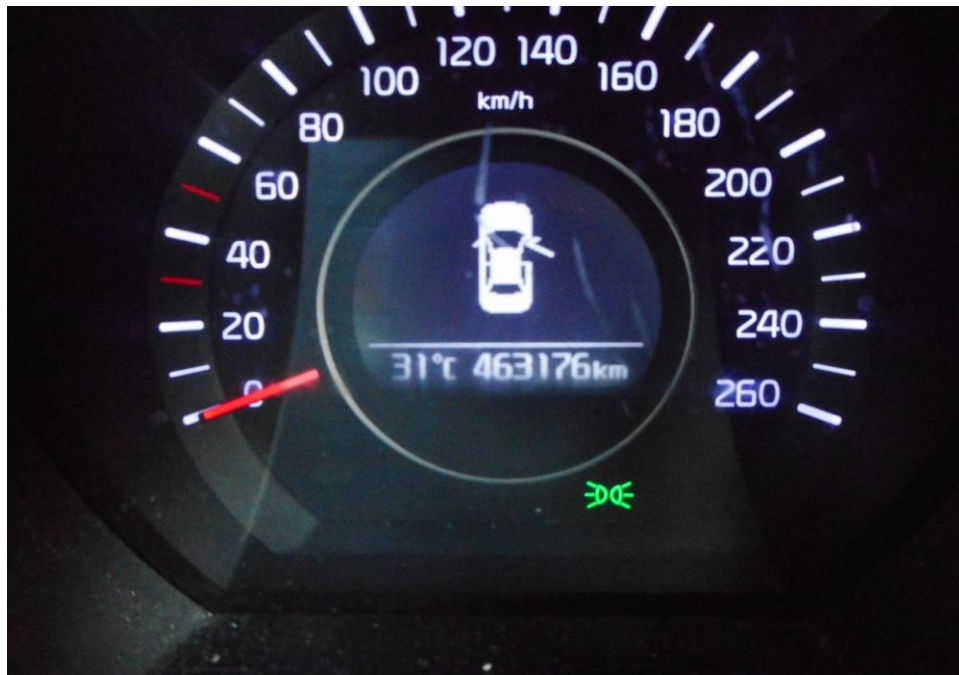
Photo 1 shows the mileage of the Motor Taxi at the time of my inspection. The mileage observed was 463,176km.

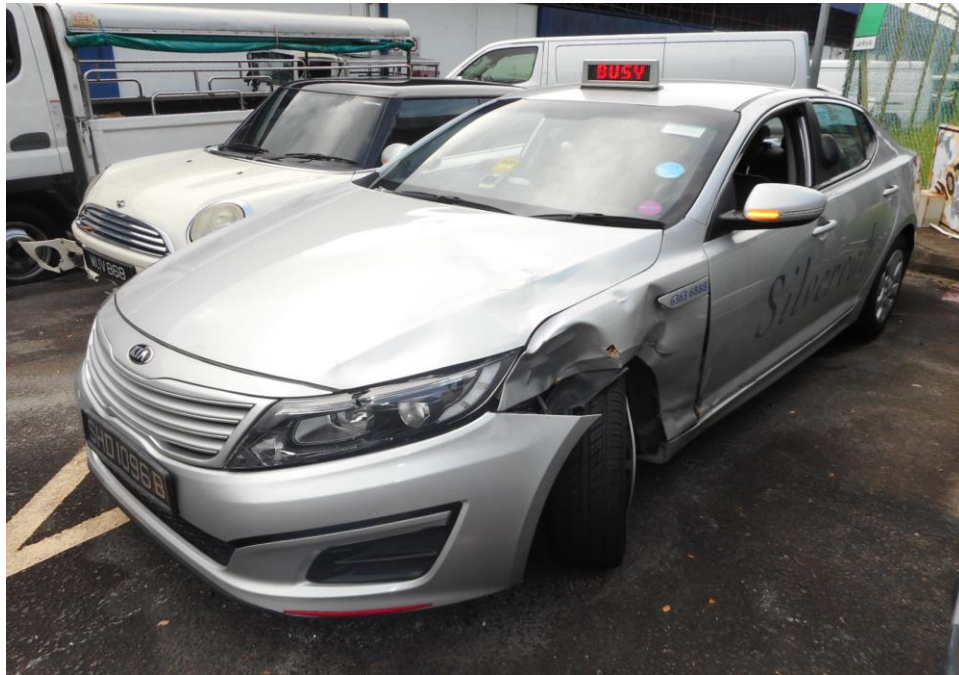
4. The mileage of the Motor Taxi at the time of my inspection was 463,176km.
5. The Motor Taxi was observed to have sustained damage at its front portion. Its front bonnet, front bumper, front left headlamp and front left fender were amongst the body parts that were damaged as a result of the accident.

Photo 2 shows a general view of the Motor Taxi's front body at the time of my inspection. The Motor Taxi was observed to have sustained damage at its frontal portion. Its front bonnet, front bumper, front left headlamp and front left fender were amongst the body parts that were damaged as a result of the accident.

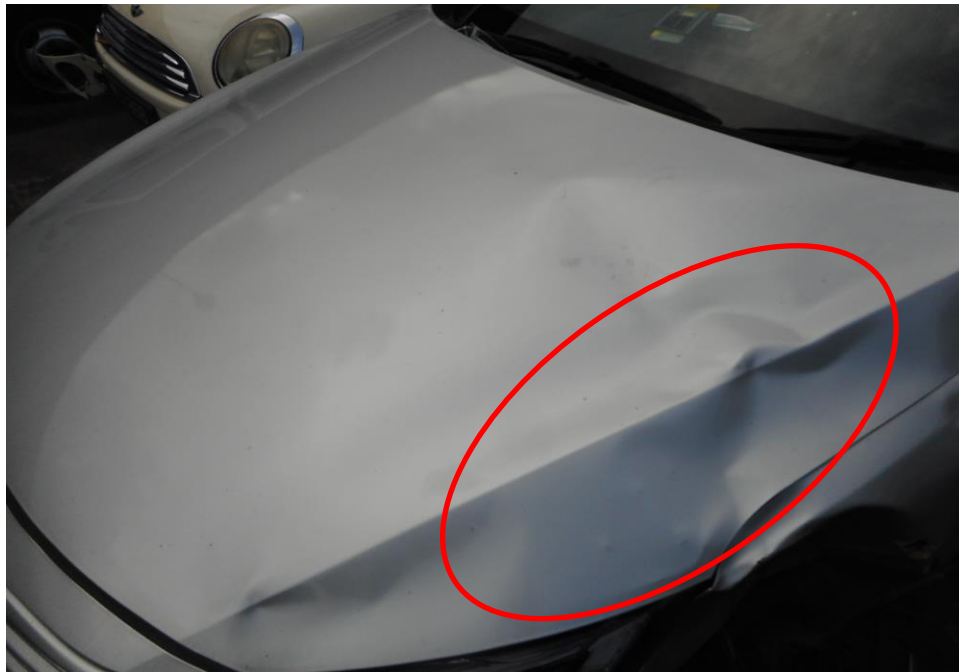
Photo 3 shows the close up view of the Motor Taxi's front portion at the time of my inspection. The Motor Taxi was observed to have sustained damage at its front bonnet (circled) as a result of the accident.

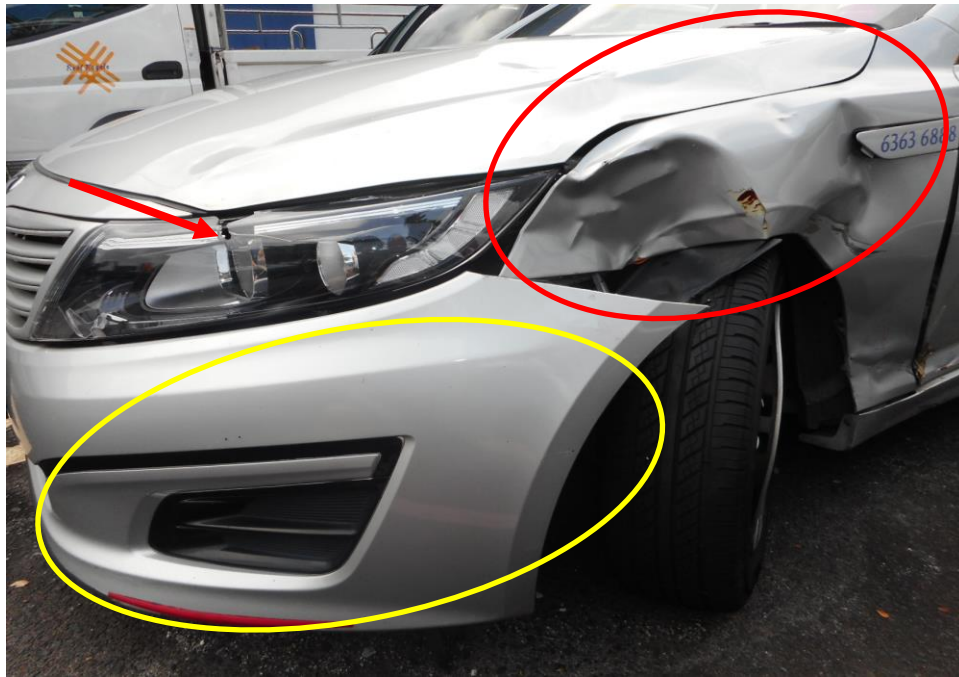
Photo 4 shows the close up view of the Motor Taxi's front left body at the time of my inspection. The Motor Taxi was observed to have sustained damage at its front left headlamp (arrowed) front left fender (red circle) and front bumper (yellow circle) as a result of the accident.

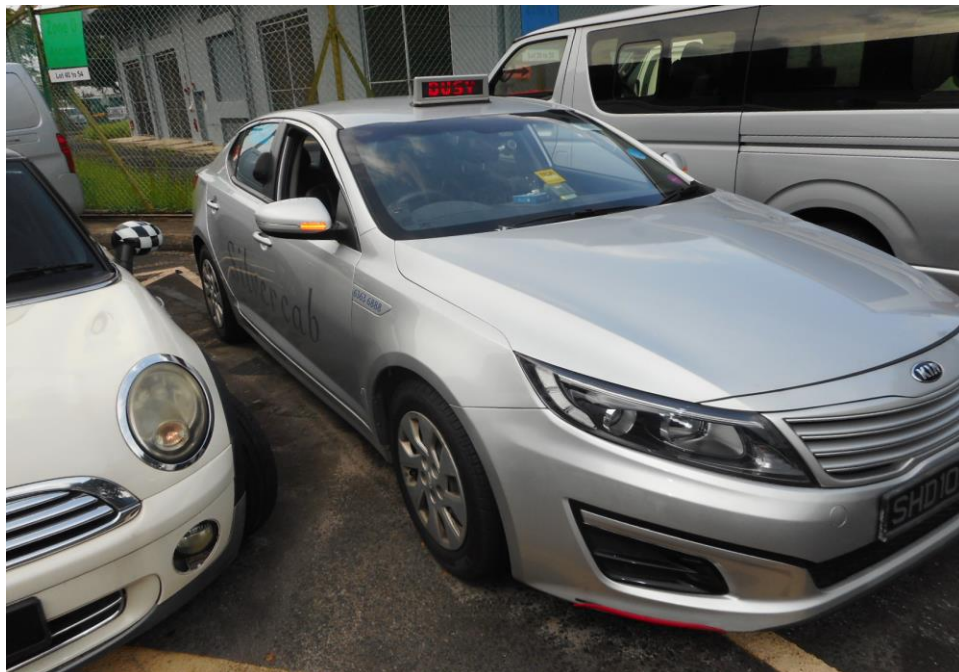
Photo 5 shows a general view of the Motor Taxi's right body at the time of my inspection. The right portion of the Motor Taxi was observed to have been unaffected by the accident.

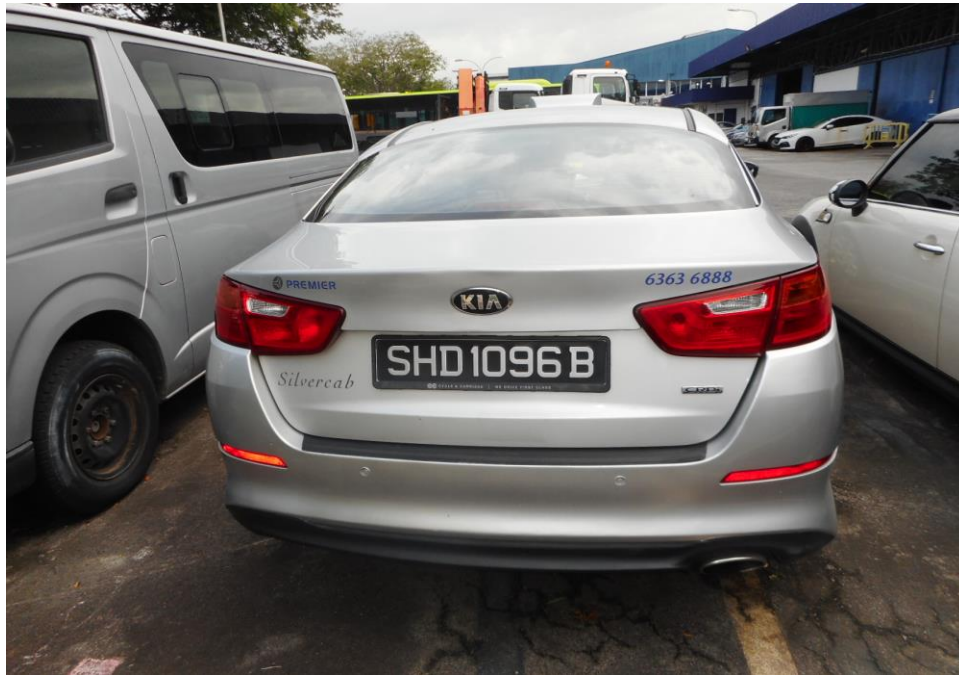
Photo 6 shows the general view of the Motor Taxi's rear body at the time of my inspection. The Motor Taxi rear was observed to be unaffected by the accident.

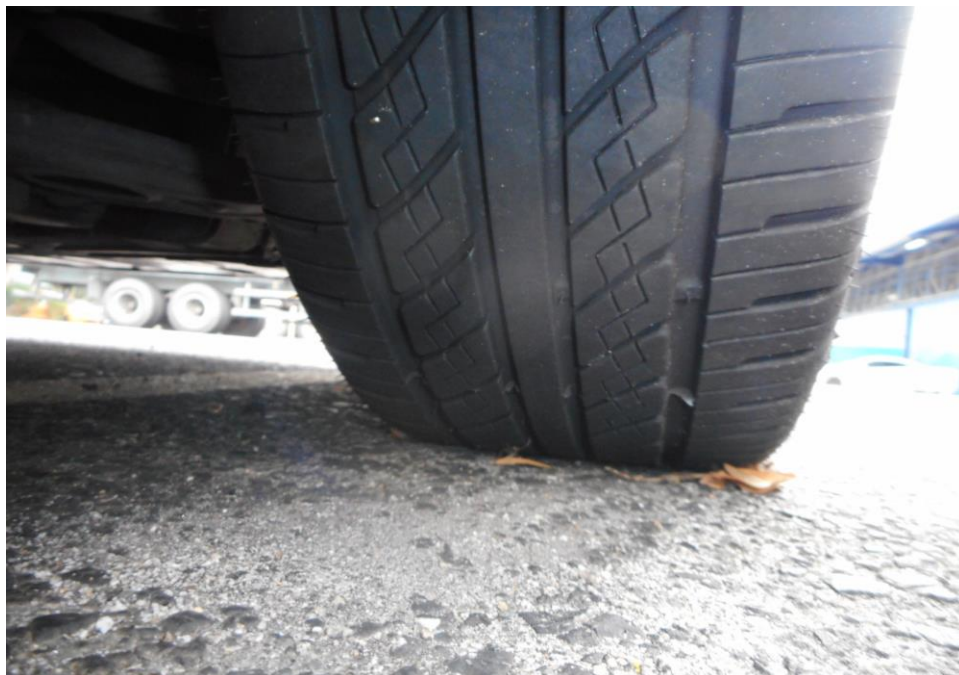
Photo 7 shows the condition of the front right tyre of the Motor Taxi, which was observed to be in serviceable condition with remaining tread depth of approximately 5.4mm. The tyre was sufficiently inflated for vehicular operation with no tear, cut or burst mark(s) on the outer and the inner sidewalls as well as across the tread. The 4 tyres of the Motor Taxi were wrapped around standard steel wheel rims without any damage.

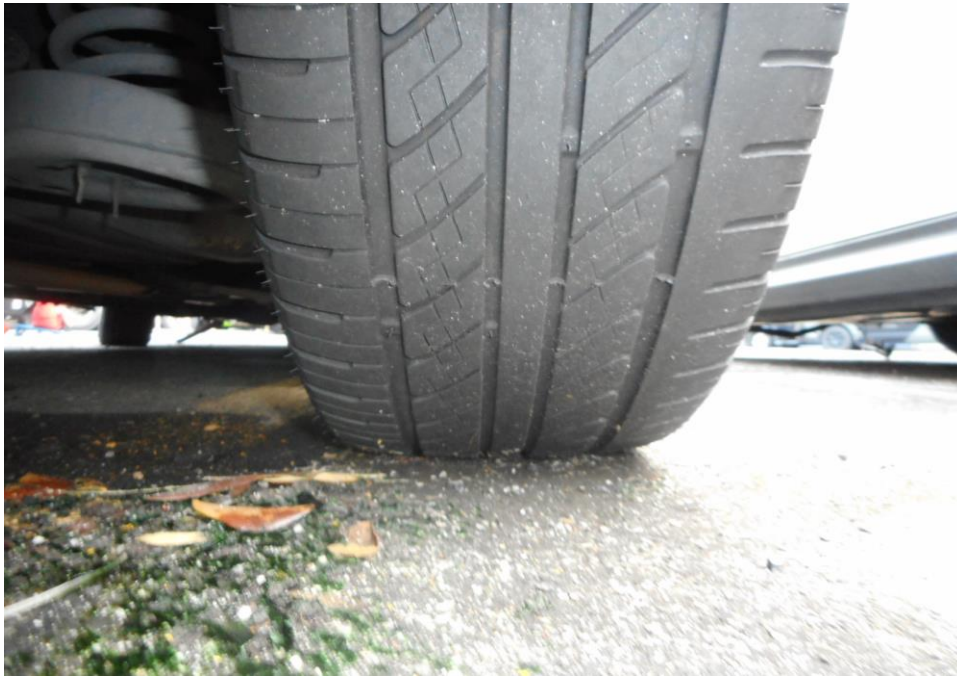
Photo 8 shows the condition of the rear right tyre of the Motor Taxi, which was observed to be in serviceable condition with remaining tread depth of approximately 3.4mm. The tyre was also observed to be sufficiently inflated for vehicular operation with no tear, cut or burst mark(s).

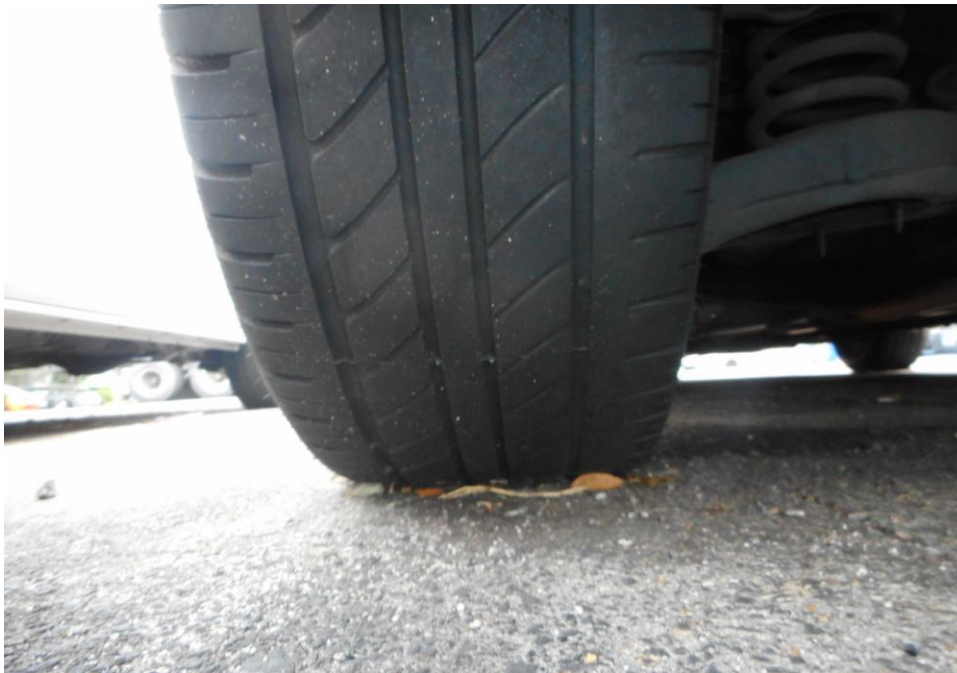
Photo 9 shows the condition of the rear left tyre of the Motor Taxi, which was observed to be in serviceable condition with remaining tread depth of approximately 4.1mm. The tyre, which was wrapped around steel wheel rim, was also observed to be sufficiently inflated for vehicular operation. The 4 tyres of the Motor Taxi were wrapped around standard steel wheel rims.

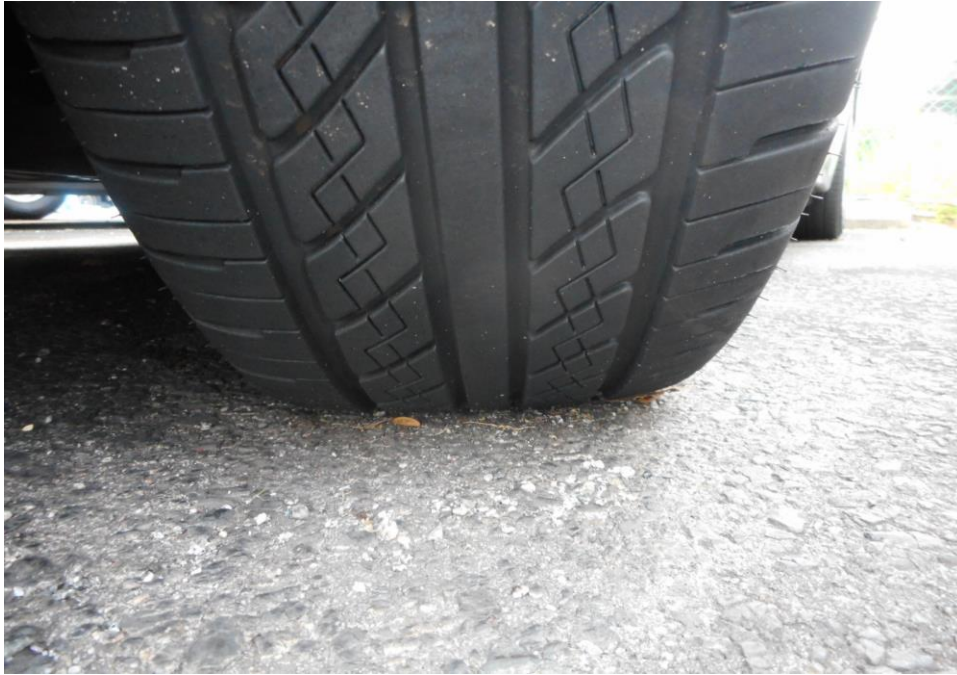
Photo 10 shows the condition of the front left tyre of the Motor Taxi, which was observed to be in serviceable condition with remaining tread depth of approximately 5mm. There was also no tear, cut or burst mark(s) on the outer and the inner sidewalls as well as across the tread of the Motor Taxi's 4 tyres.

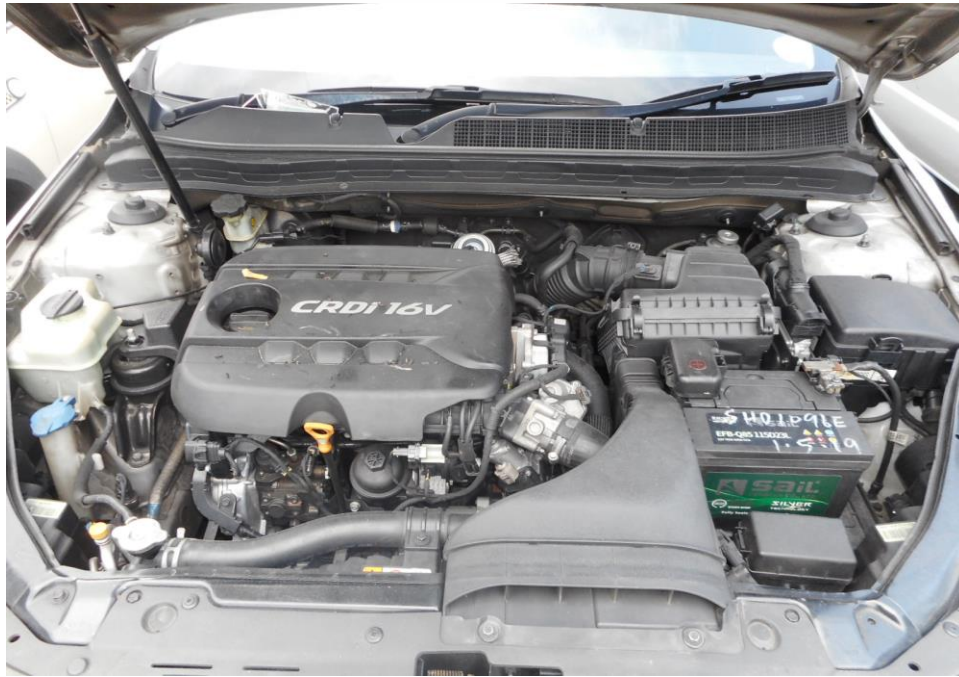
Photo 11 shows a general view of the Motor Taxi's engine compartment. The various parts and components inside the engine compartment were unaffected by the accident. There was also no sign(s) or indication(s) of fluid leakage and/or fluid stain within the engine compartment.

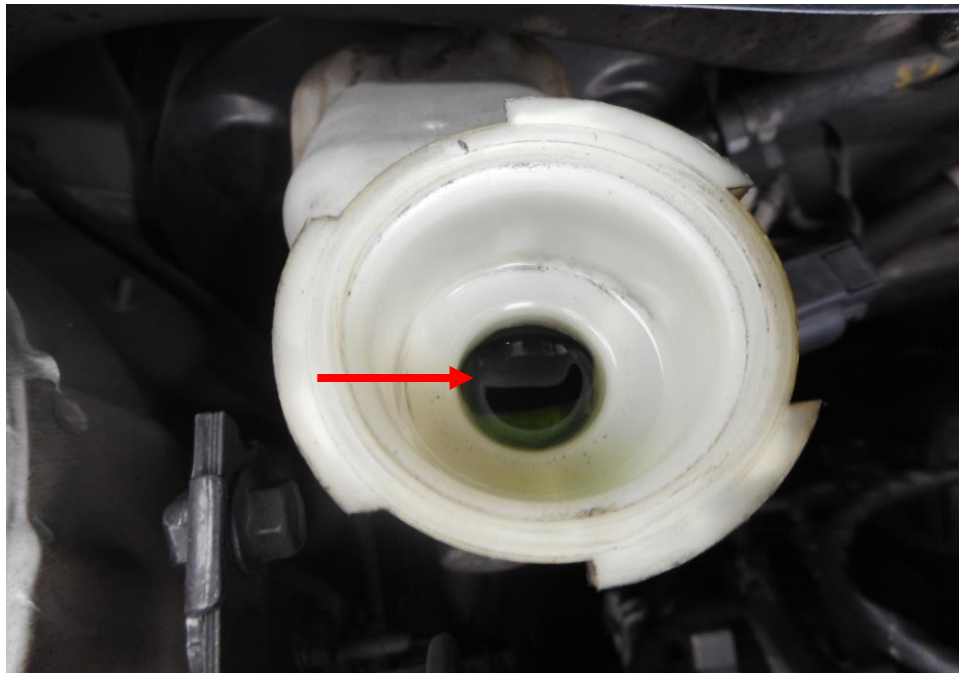
Photo 12 shows the brake fluid reservoir of the Motor Taxi at the time of my inspection. The brake fluid was observed to be of sufficient level (arrowed) and without any visible contamination.

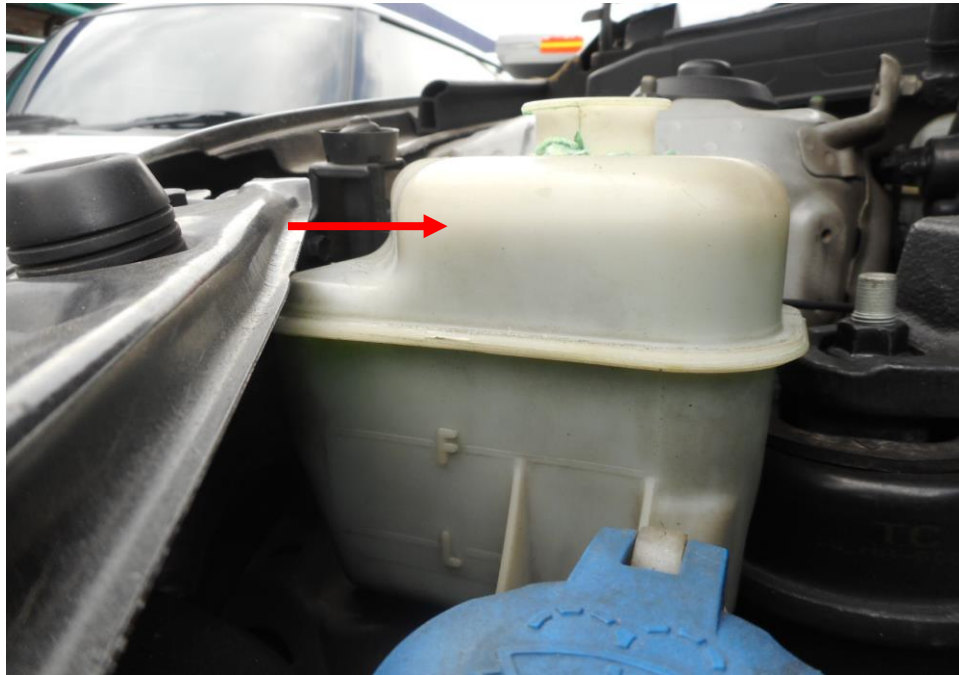
Photo 13 shows checks being carried out to the engine coolant of the Motor Taxi at the time of my inspection. The engine coolant was observed to be of sufficient level (arrowed) and without any visible contamination.

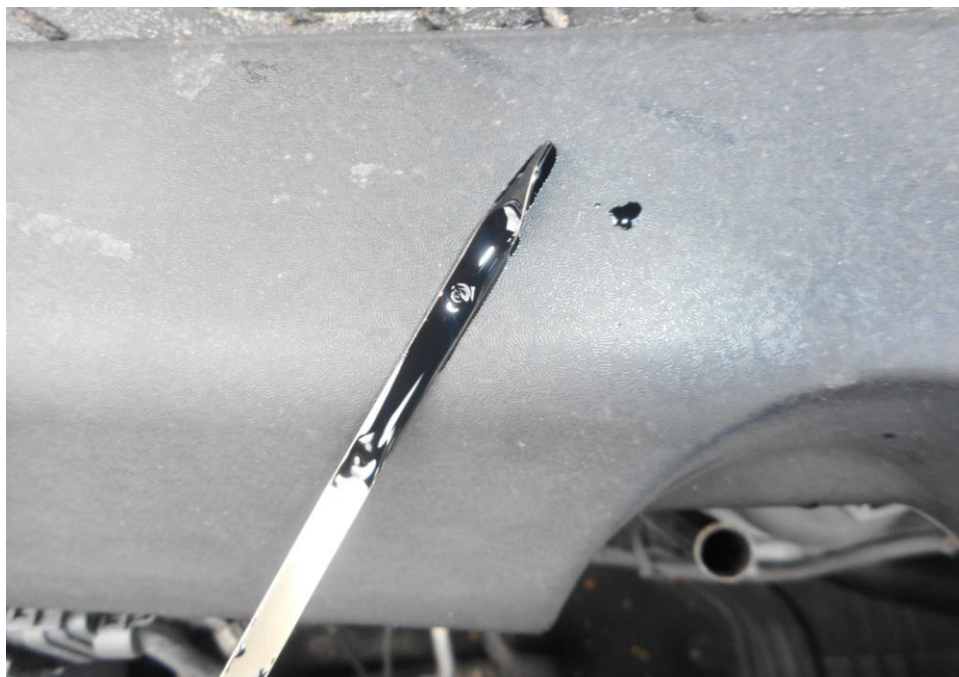
Photo 14 shows the engine oil dip stick of the Motor Taxi at the time of my inspection. The engine oil was observed to be of sufficient level and without any visible contamination.

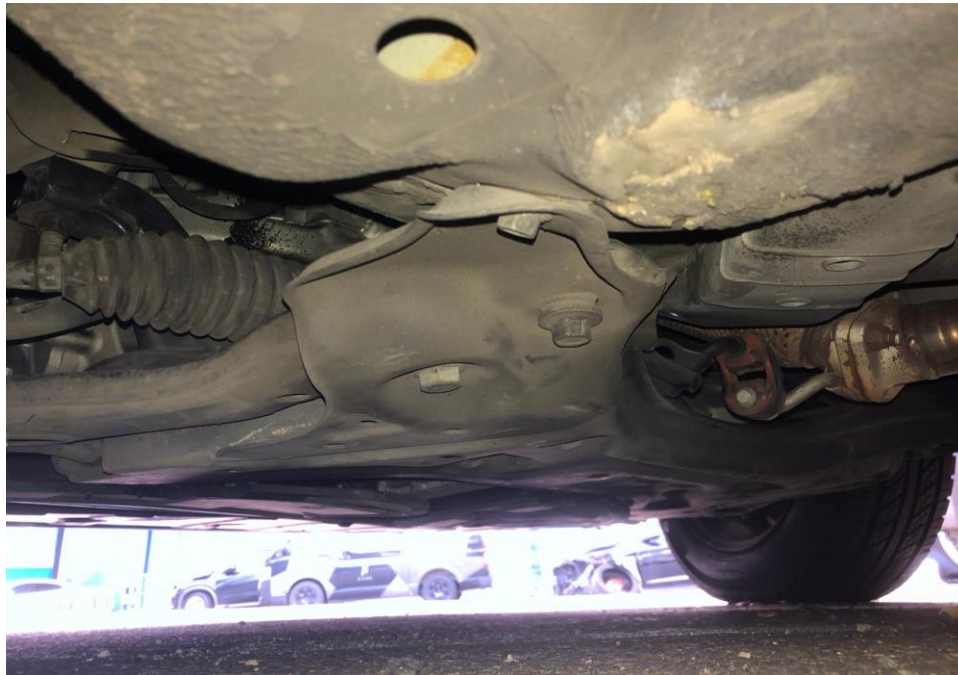
Photo 15 shows the undercarriage of the Motor Taxi, at the area where the engine housing and transmission housing are located. I did not find any sign(s) or indication(s) of fluid leak and/or fluid stain(s) on the underside of the Motor Taxi.

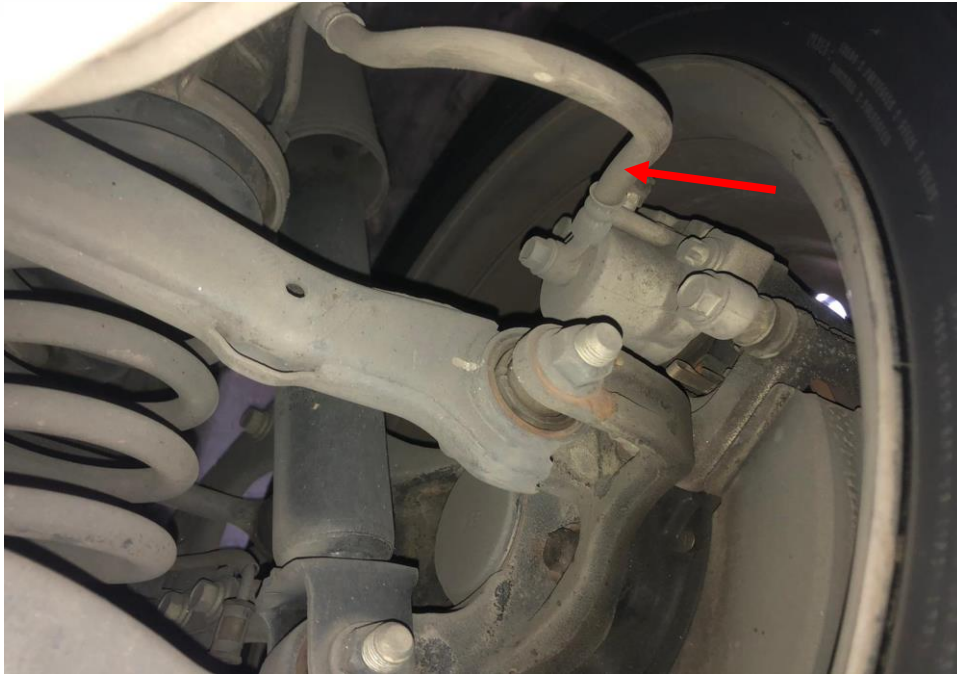
Photo 16 shows the brake hose/pipe (arrowed) at the rear right wheel of the Motor Taxi. No leakage of brake fluid was observed. Visual examination of the various components of the braking system like the drum brake, brake booster, brake pedal etc. had revealed all to be intact and without visible damage.

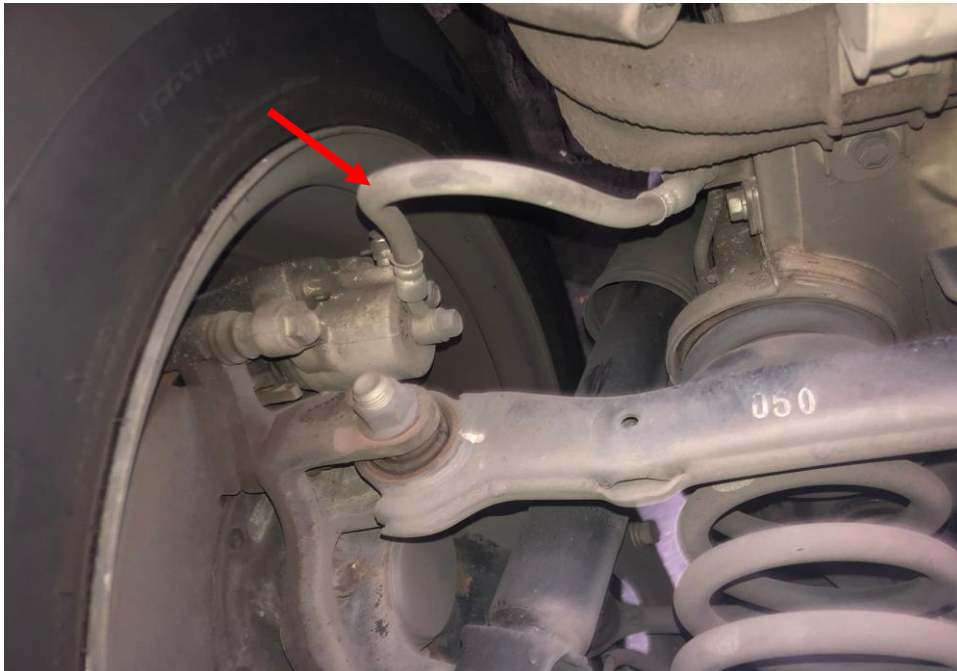
Photo 17 shows the brake hose/pipe (arrowed) at the rear left wheel of the Motor Taxi. I did not observe any leakage of brake fluid at the time of my inspection of the Motor Taxi. Static tests of the Motor Taxi's braking system had indicated that there was no internal leakage of pressure/vacuum. The undercarriage components of the Motor Taxi were also all found to be intact and without any visible damage.

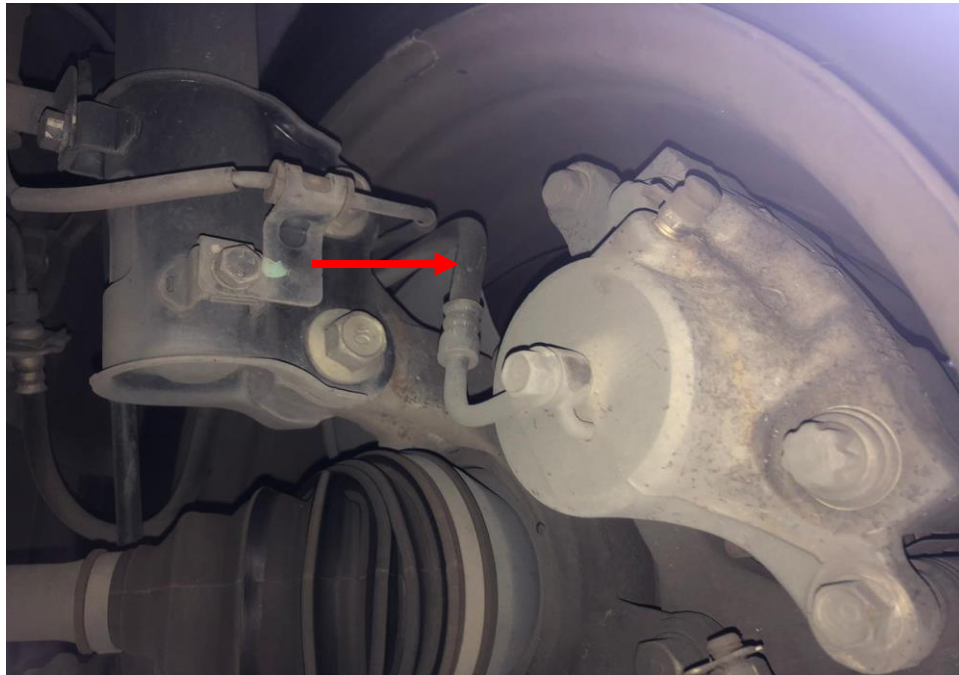
Photo 18 shows the brake hose/pipe (arrowed) at the front right wheel of the Motor Taxi. I did not observe any leakage of brake fluid at the time of my inspection of the Motor Taxi. Static tests of the Motor Taxi's braking system had indicated that there was no internal leakage of pressure/vacuum. The undercarriage components of the Motor Taxi were also all found to be intact and without any visible damage.

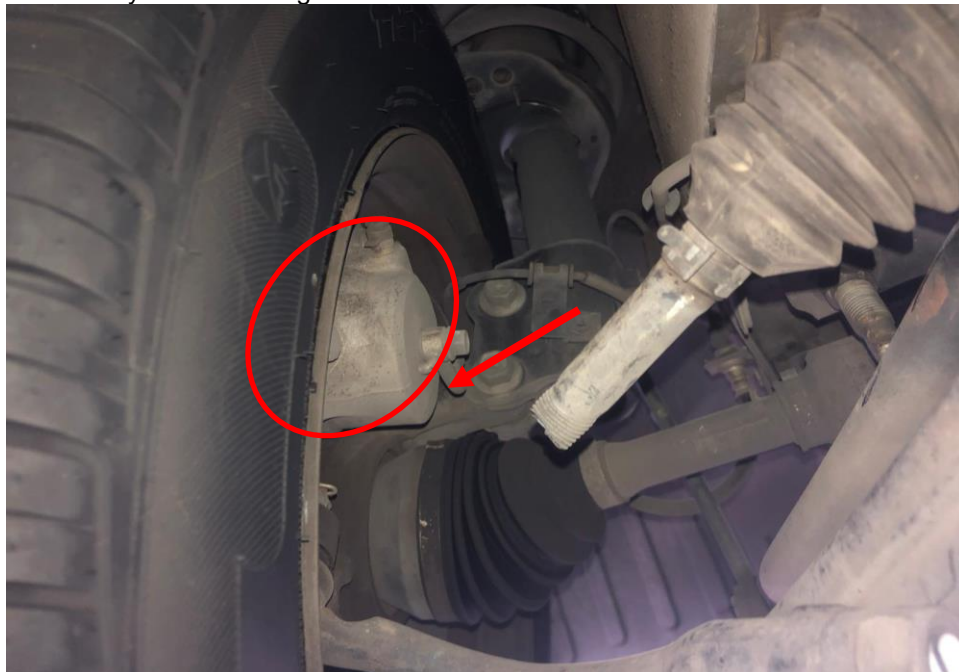
Photo 19 shows the brake hose/pipe (arrowed) at the front left wheel of the Motor Taxi. No leakage of brake fluid was observed. Visual examination of the various components of the braking system like the brake caliper (circled), brake booster, brake pedal etc had revealed all to be intact and without visible damage.

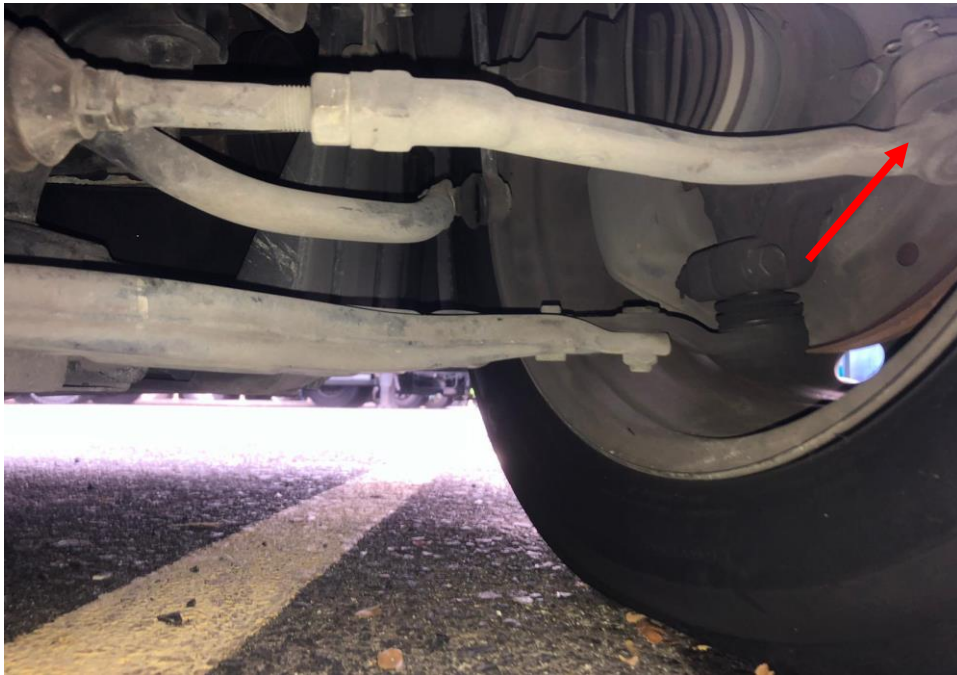
Photo 20 shows the various undercarriage components at the front right wheel of the Motor Taxi, in particular the steering tie rod (red arrow) and drive shaft (yellow arrow). The various steering components were all found to be intact, suggesting that the steering system of the Motor Taxi was likely to be in serviceable condition at the material time of accident. There was also no sign of fluid stain observed on the various undercarriage components at the front right wheel of the Motor Taxi.

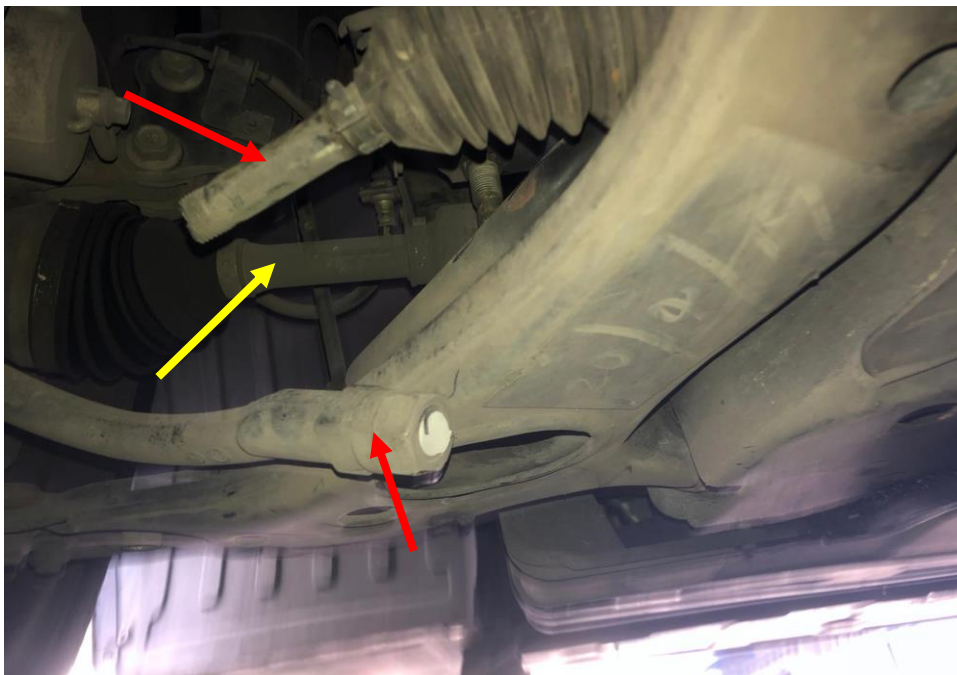
12. Static test on the steering system of the Motor Taxi also revealed abnormality to the steering system. I experience abnormal free play and/or other resistance when turning the steering wheel left and right to full lock positions. My visual examination of the various steering components which had included the steering rack and pinion, tie rod ends and ball joints revealed that these components were all generally in good condition. However, the tie rod at the front left wheel was observed to be damaged as a result of the accident. See photo 16 - 21 below.

Photo 21 shows the various undercarriage components at the front left wheel of the Motor Taxi, the steering tie rod (red arrow) was observed to be damaged as a result of the accident and the drive shaft (yellow arrow) was observed to be intact and unaffected.

- 14.A Operational test by driving the Motor Taxi to primarily determine whether there was any abnormality to the engine system, transmission system and braking system of the Motor Car could not be conducted given the extent of damage that it had sustained (Steering system of the Motor Car damage as a result of the accident.).

- 15.For this particular case, from my physical inspection of the Motor Taxi, the steering system was likely damaged as a result of the accident and the extent of damage that it had sustained had prevented me from carrying out any operational test, however it appears that its engine system, transmission system and braking system were all in found to be in serviceable condition at the material time. I did not find any evidence(s) to suggest that there was possible mechanical failure and/or abnormal behaviour to the Motor Taxi that may have caused and/or contributed to the accident.

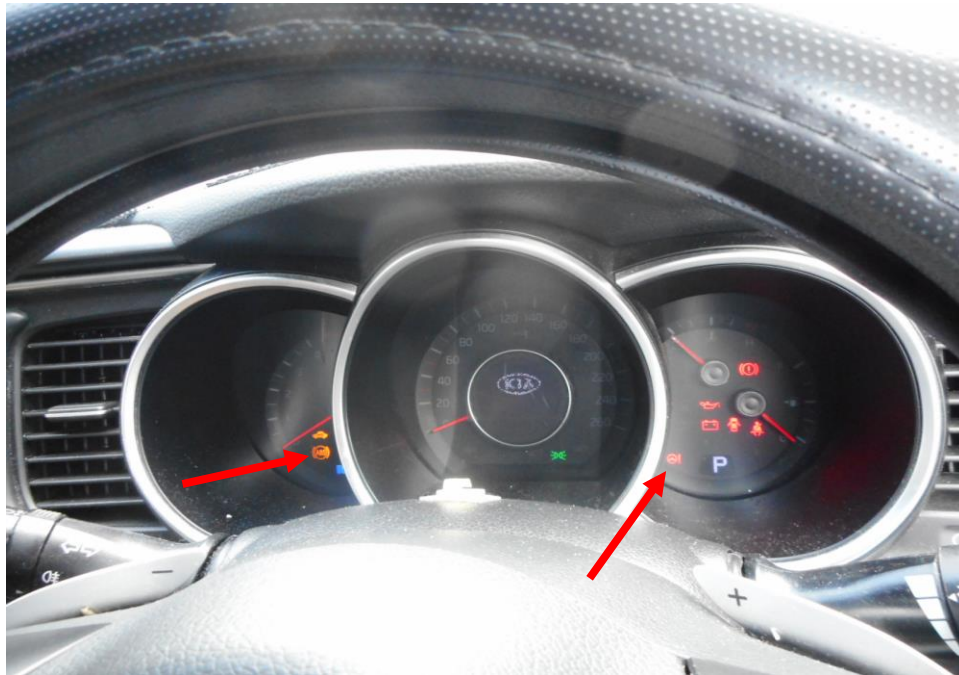
Photo 22 shows the warning light for Anti-Lock Brake System (ABS) and Power Steering System (EPS) (arrowed) appearing on the instrument panel of the Motor Taxi during the self-test of its various electronic operating systems when its engine was cranked.

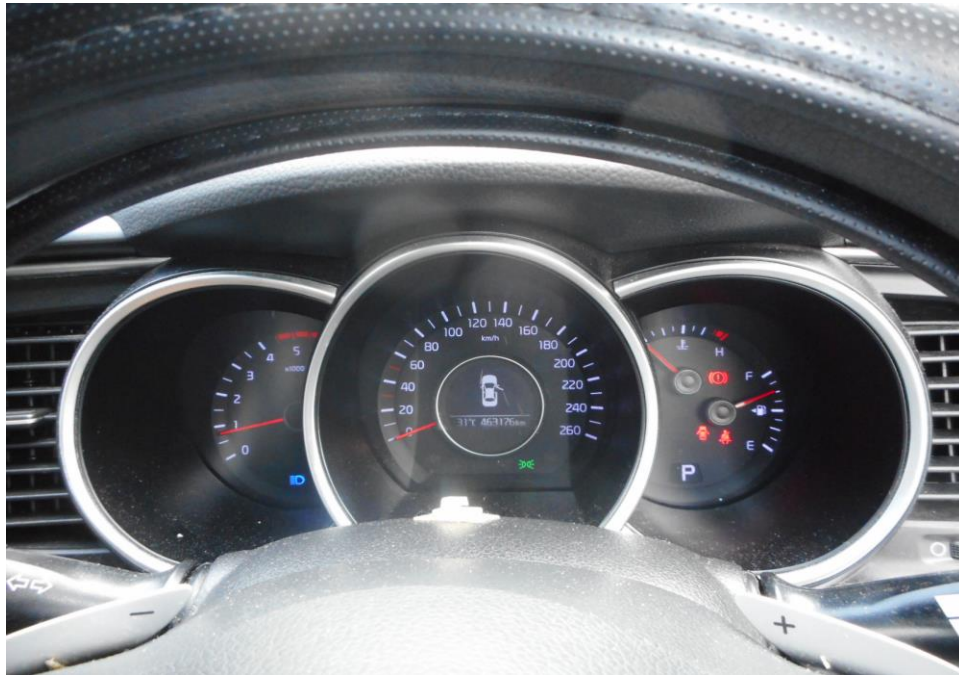
Photo 23 shows no warning lights illuminated on the instrument panel of the Motor Taxi after the engine was cranked. This would suggest that there was no abnormality to the electronic operating system of the Motor Taxi, like the ABS and EPS etc.
