Your Ref: TP/IP/13499/2020
Our Ref : CI/TPD20004864/P

18th May 2020

Fatal Accident Investigation Team

MECHANICAL INSPECTION REPORT OF MOTOR CAR SCV 6655U

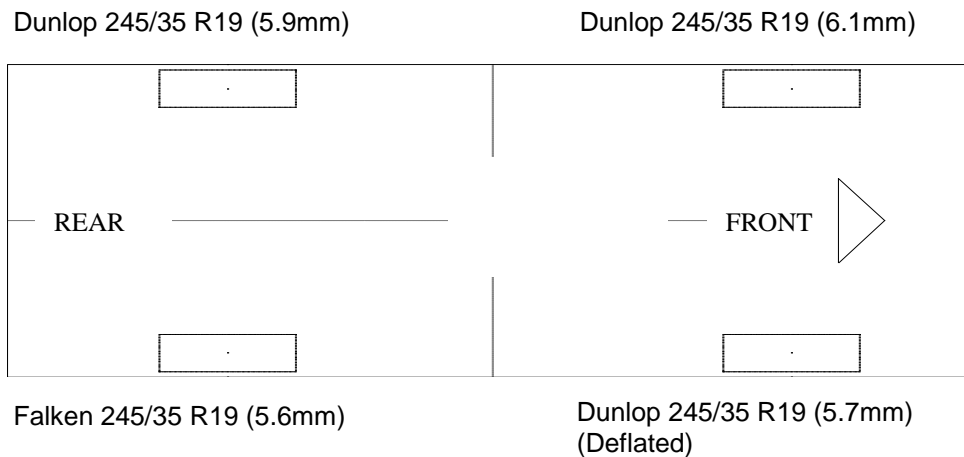
6. The front tyre of the Motor Car was observed to be deflated due to the damaged rim, however the condition of the Motor Car's other 3 tyres was observed to be in serviceable condition. I did not find any tear, cut or burst mark(s) on the outer and the inner sidewalls as well as across the tread of the 3 tyres. The 3 tyres were also observed to be sufficiently inflated for vehicular operation. The tyre brand, tyre size and remaining tread depth of the 4 tyres were recorded as follows:-

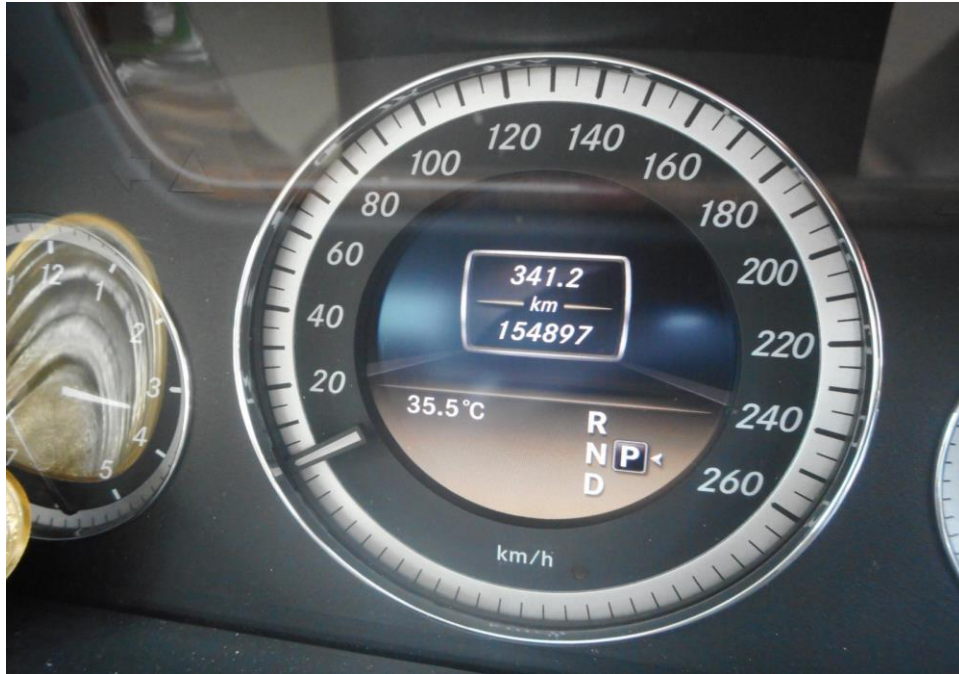
Photo 1 shows a general view of the instrument cluster of the Motor Car at the time of my inspection. The mileage of the Motor Car was 154,897km

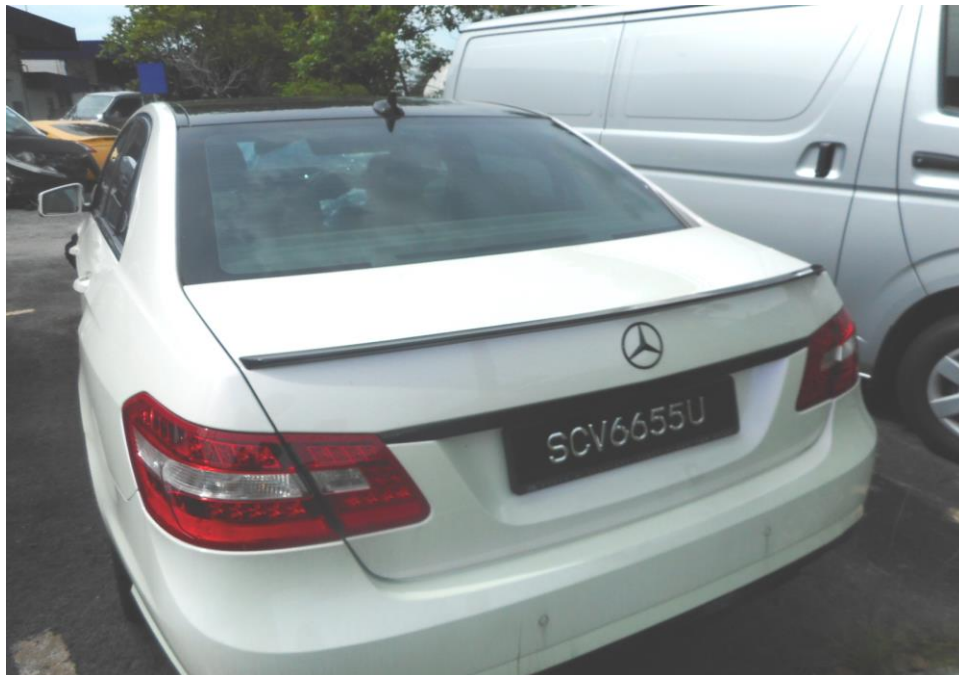
Photo 2 shows a general view of the Motor Car's rear body at the time of my inspection. The rear portion of the Motor Car was observed to have been undamaged by the accident.

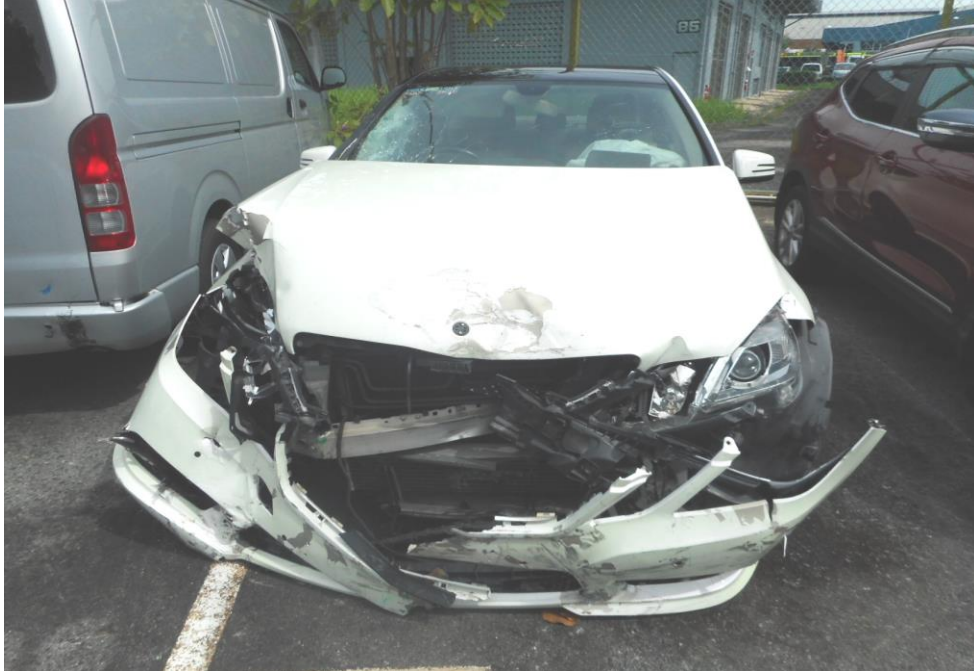
4. The mileage of the Motor car at the time of my inspection was 154,897km
5. The Motor car was observed to have sustained damage at its front, left & right portion. Its front windscreen, front bonnet, front bumper, front left and right fender, front left and right headlamp was amongst the body parts and various components in the engine compartments were also damaged as a result of the accident. The Supplemental Restraint System (SRS) was activated as a result of the accident.

Photo 3 shows a general view of the Motor Car's front body at the time of my inspection. The Motor car was observed to have sustained damage at its front, left and right portion. Its front windscreen, front bonnet, front bumper, front left and right fender, front left and right headlamp was amongst the body parts and various components in the engine compartments were also damaged as a result of the accident. The Supplemental Restraint System (SRS) was activated as a result of the accident.

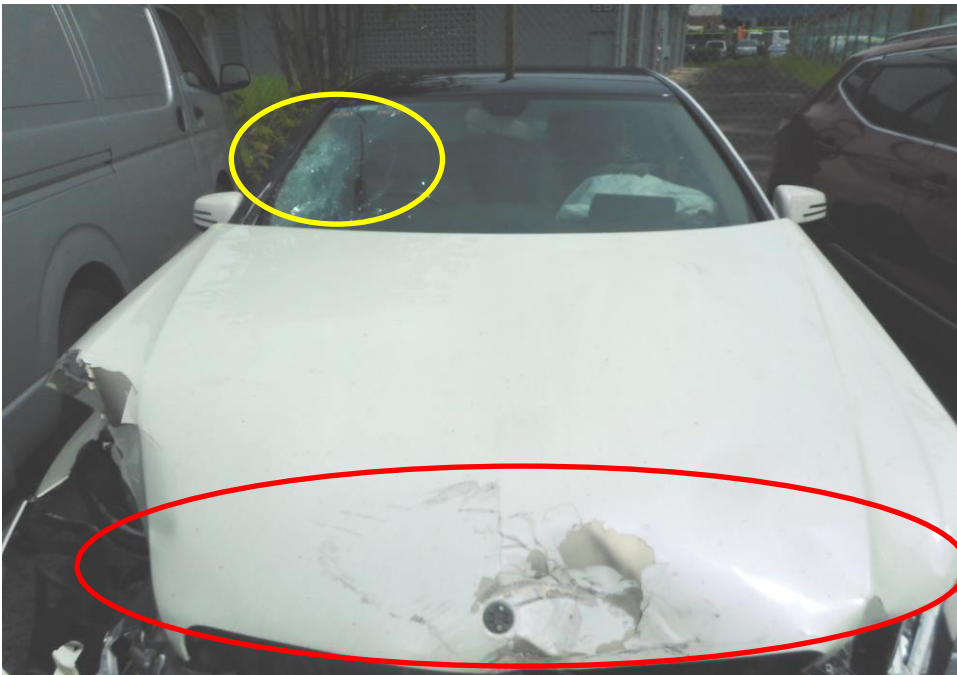
Photo 4 shows the close up view of the Motor Car's front body at the time of my inspection. The Motor car was observed to have sustained damage at its front portion. Its front windscreen (yellow circle) and front bonnet (red circle) was amongst the body parts and various components in the engine compartments were also damaged as a result of the accident.

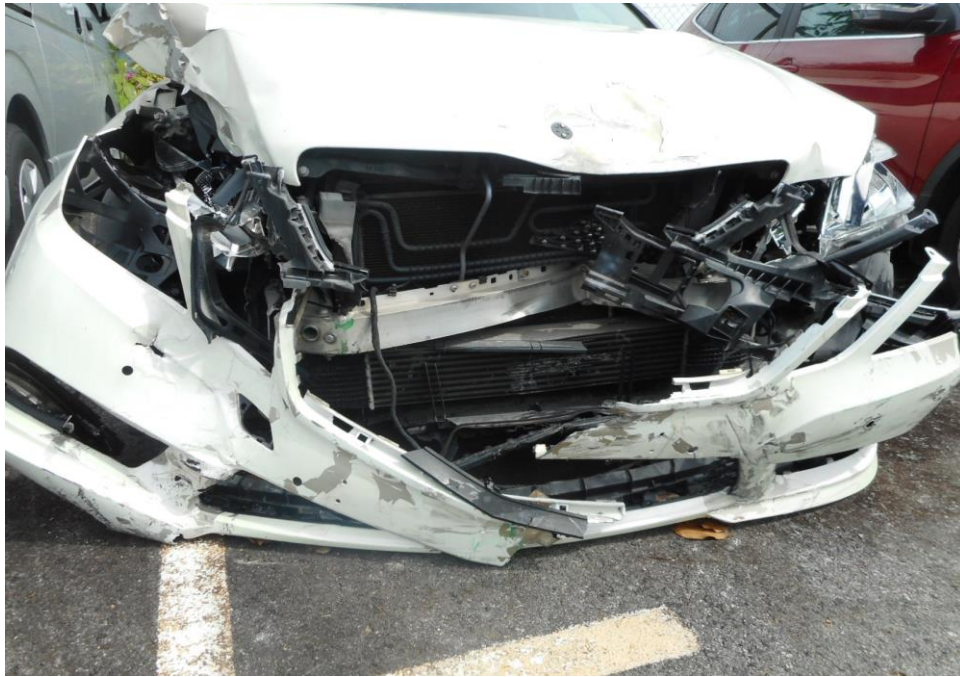
Photo 5 shows the close up view of the Motor Car's front body at the time of my inspection. The Motor car was observed to have sustained damage at its front portion. Its front bumper, front left and right fender, front left and right headlamp was amongst the body parts and various components in the engine compartments were also damaged as a result of the accident.

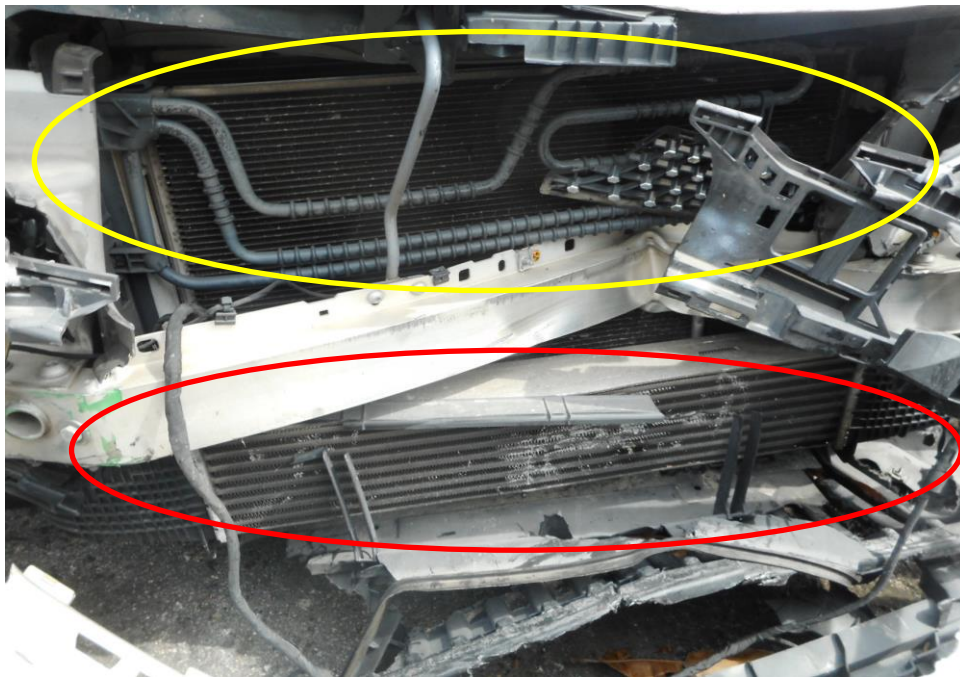
Photo 6 shows the close up view of the Motor Car's front body at the time of my inspection. The Motor car was observed to have sustained damage at its front portion. Its engine radiator (yellow circle), front bumper and various components in the engine compartments (red circle) were also damaged as a result of the accident.

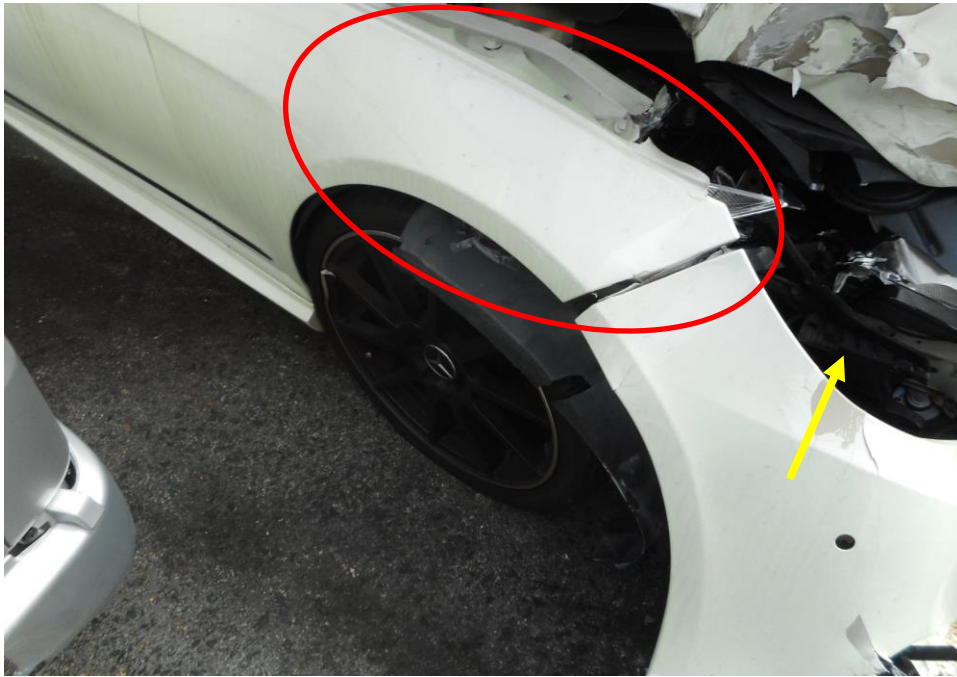
Photo 7 shows a close up view of the Motor Car's engine compartment at the time of my inspection. The Motor car was observed to have sustained damage at its right portion. Its front right fender (red circle) and front right headlamp (yellow arrow) was damaged as a result of the accident.

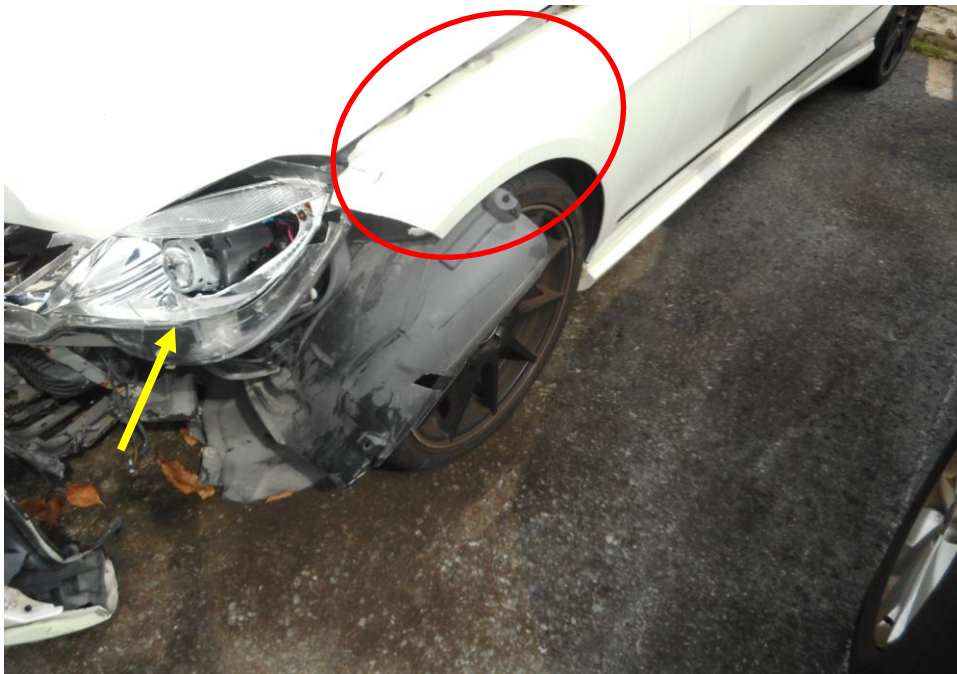
Photo 8 shows a close up view of the Motor Car's engine compartment at the time of my inspection. The Motor car was observed to have sustained damage at its left portion. Its front left fender (red circle) and front left headlamp (yellow arrow) was damaged as a result of the accident.

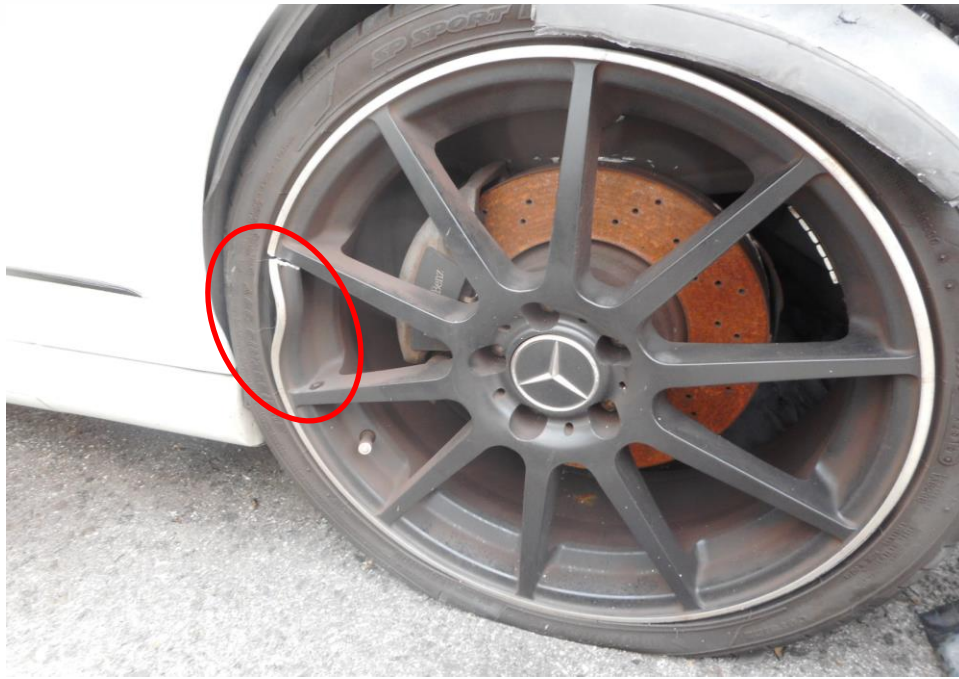
7. The 4 tyres were observed to be wrapped around standard alloy wheel rims. The front right rim was observed to be damaged as a result of the accident. See photo 1 – 13 below.

Photo 9 shows the condition of the front right tyre of the Motor Car, which was observed to be in unserviceable condition with deflated tyre which was a result of the damaged rim (circled) as a result of the accident. The remaining tread depth was approximately 5.7mm.

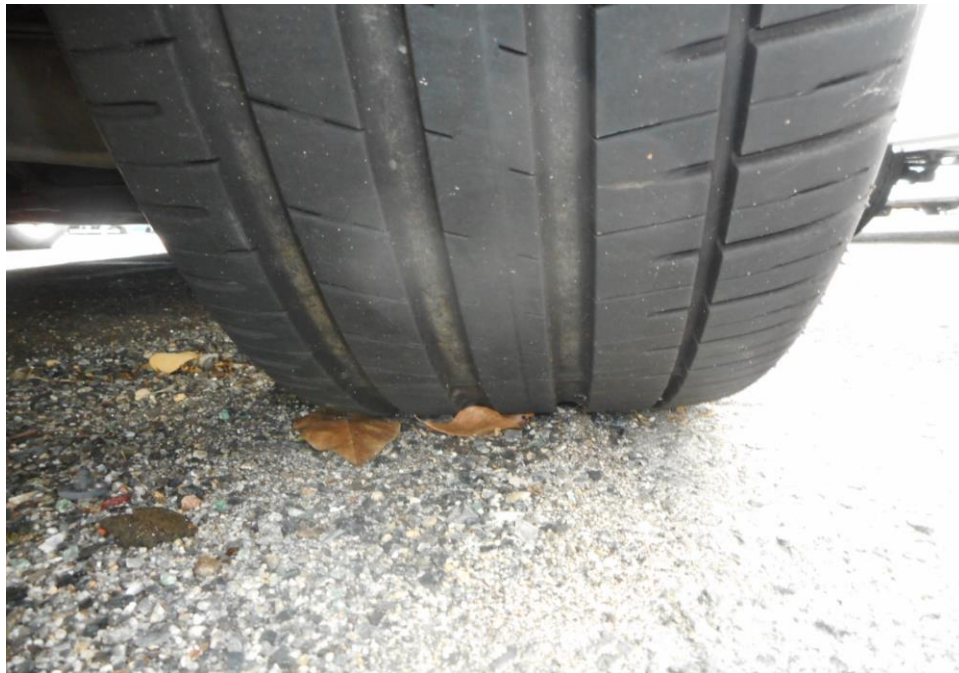
Photo 10 shows the condition of the rear right tyre of the Motor Car, which was observed to be in serviceable condition with remaining tread depth of approximately 5.6mm. The tyre was also observed to be sufficiently inflated for vehicular operation with no tear, cut or burst mark(s).

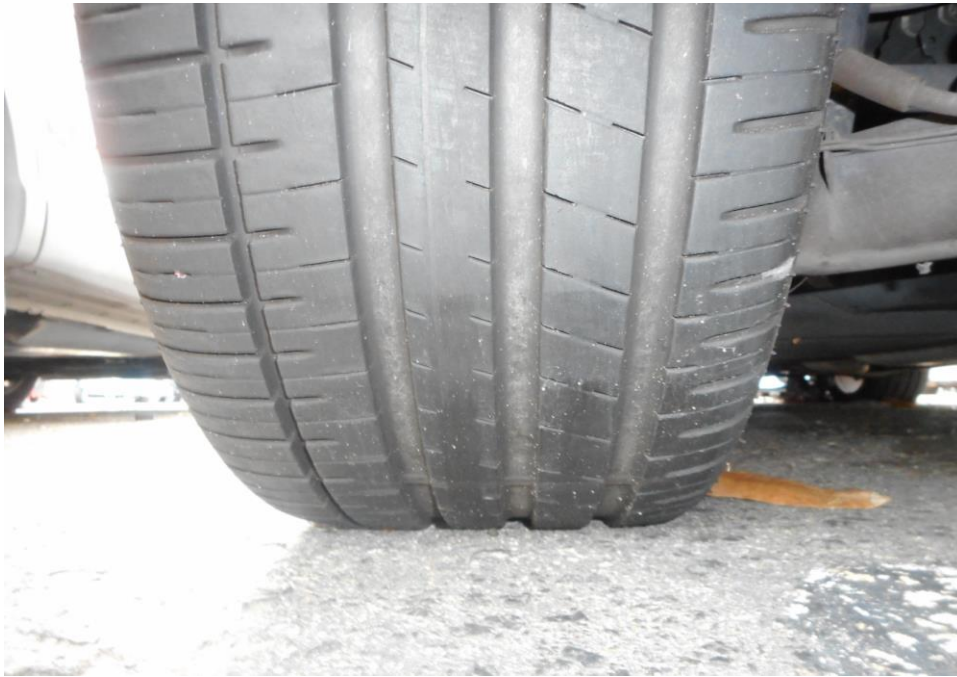
Photo 11 shows the condition of the rear left tyre of the Motor Car, which was observed to be in serviceable condition with remaining tread depth of approximately 5.9mm. The tyre was also observed to be sufficiently inflated for vehicular operation with no tear, cut or burst mark(s).

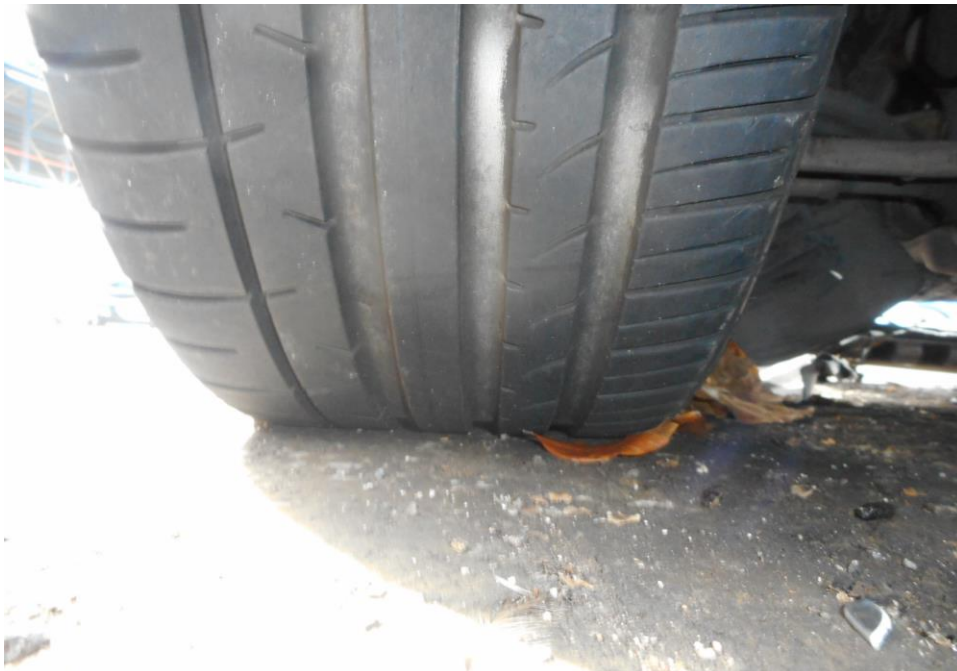
Photo 12 shows the condition of the front left tyre of the Motor Car, which was observed to be in serviceable condition with remaining tread depth of approximately 6.1mm. The tyre was also observed to be sufficiently inflated for vehicular operation with no tear, cut or burst mark(s).

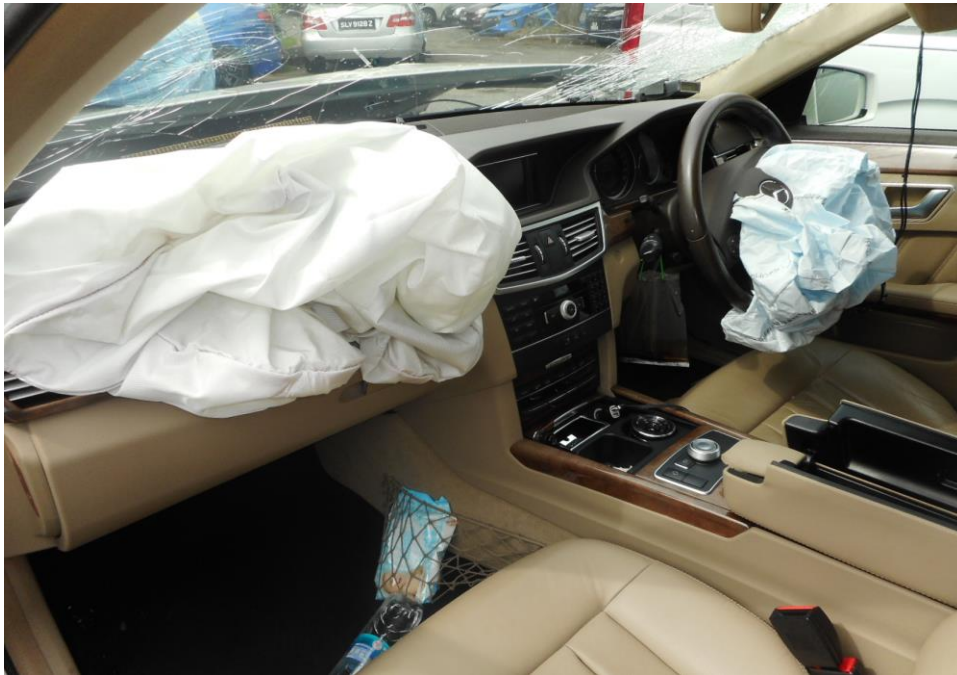
Photo 13 shows the deployment of the Supplemental Restraint System (SRS) airbag (arrowed) in the Motor Car as a result of the accident.

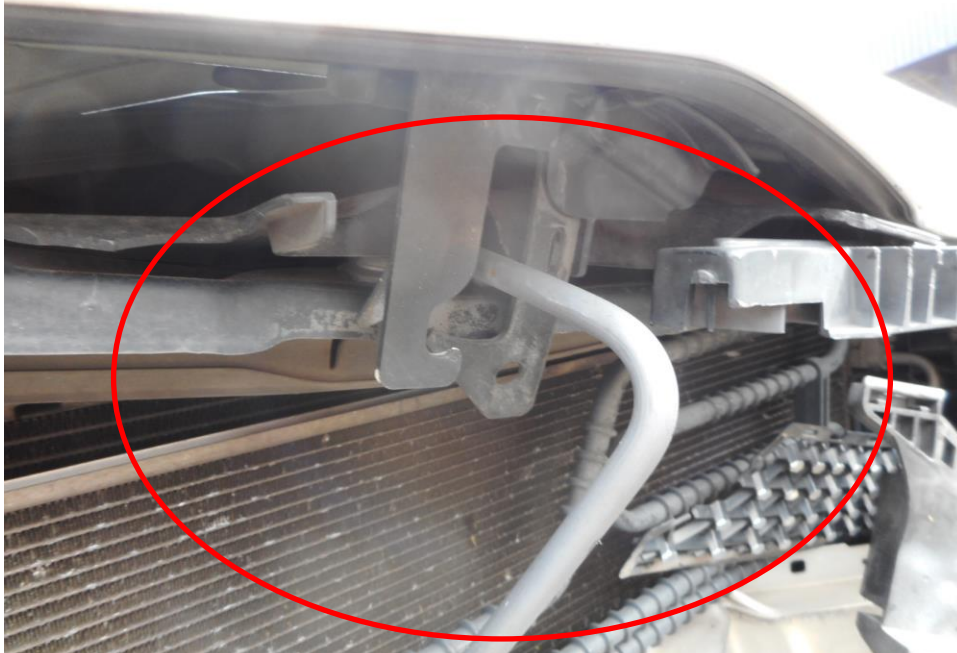
8. We were unable to raise the front bonnet of the Motor car to conduct the examination of the Motor Car's engine compartment because the damage caused by the accident had resulted in the damages to the lock mechanism of the bonnet and the structure of the engine compartment. (unable to open) However we were able to view & inspect the only brake fluid reservoir from an opening at the damaged bonnet See photo 14 & 15below

Photo 14 shows a close up view of the damaged front bonnet lock mechanism and the structure of the engine compartment of the Motor Car at the time of my inspection resulting it unable to open a result of the accident. (circled) (Unable to open)

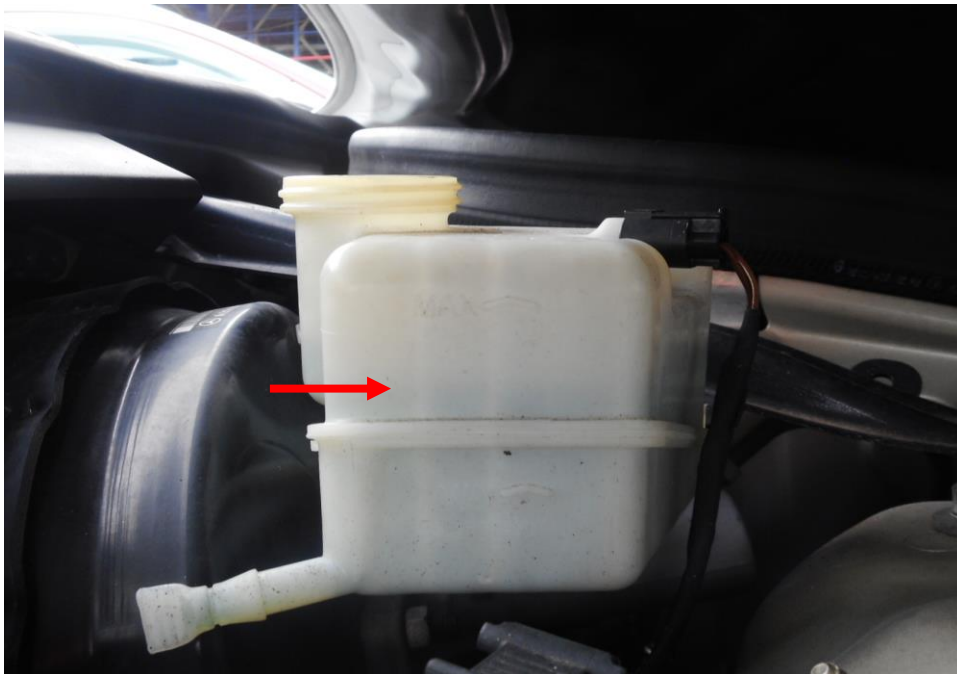
Photo 15 shows the brake fluid reservoir of the Motor Car at the time of my inspection. The brake fluid was observed to be of sufficient level (arrowed) and without any visible contamination.

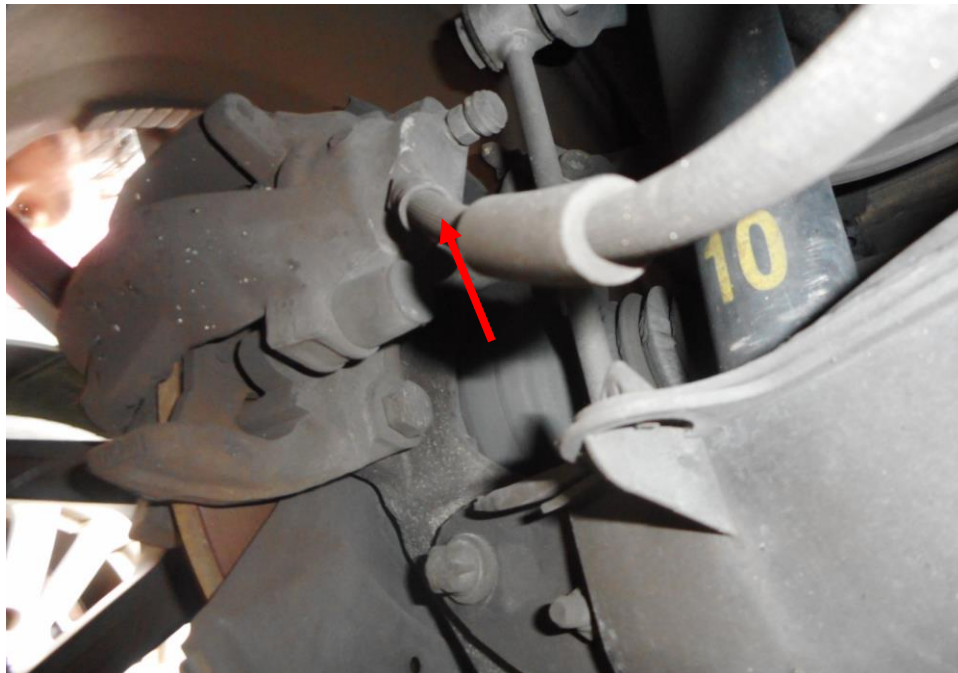
Photo 16 shows the brake hose/pipe (arrowed) at the rear left wheel of the Motor Car. No leakage of brake fluid was observed. Visual examination of the various components of the braking system like the drum brake, brake booster, brake pedal etc. had revealed all to be intact and without visible damage.

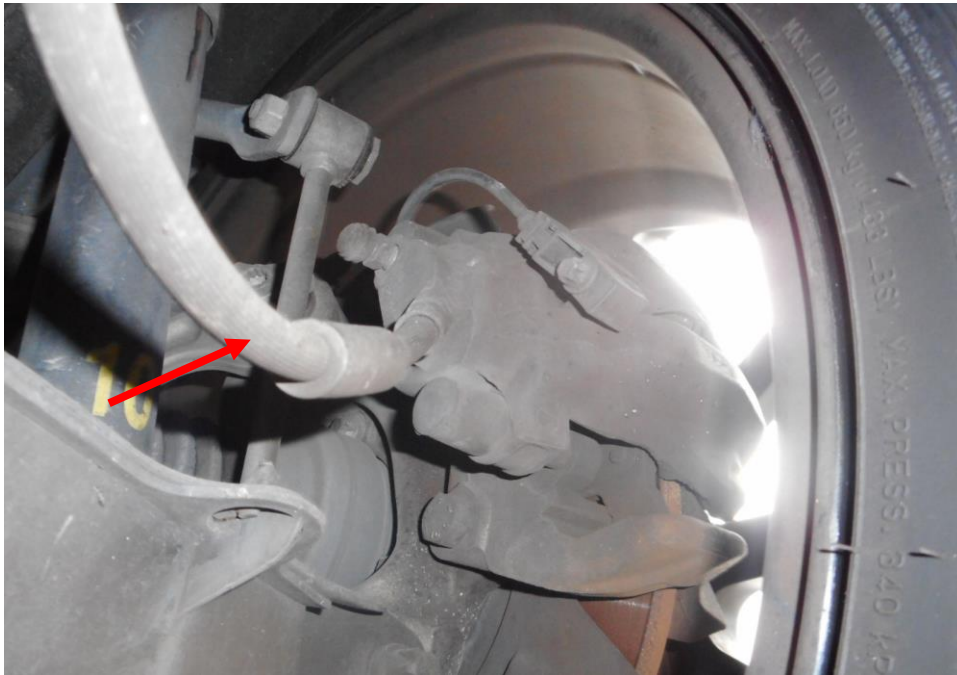
Photo 17 shows the brake hose/pipe (arrowed) at the rear right wheel of the Motor Car. No leakage of brake fluid was observed. Visual examination of the various components of the braking system like the drum brake, brake booster, brake pedal etc. had revealed all to be intact and without visible damage.

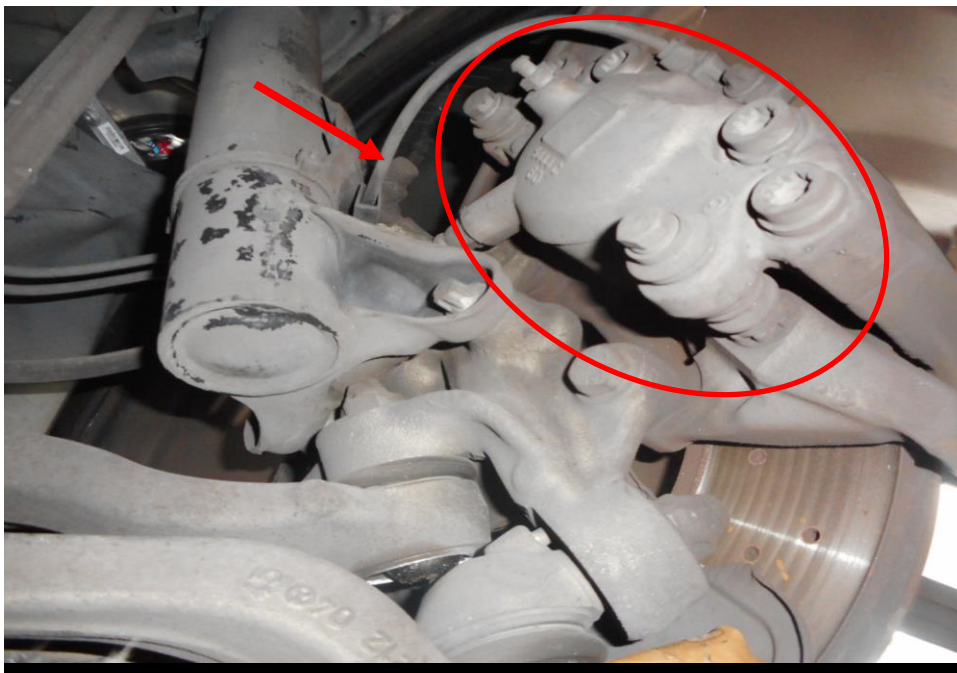
Photo 18 shows the brake hose/pipe (arrowed) at the front right wheel of the Motor Car. No leakage of brake fluid was observed. Visual examination of the various components of the braking system like the brake caliper (circled), brake booster, brake pedal etc. had revealed all to be intact and without visible damage at the time of accident. There was also no sign of fluid stain(s) observed on the various undercarriage components.

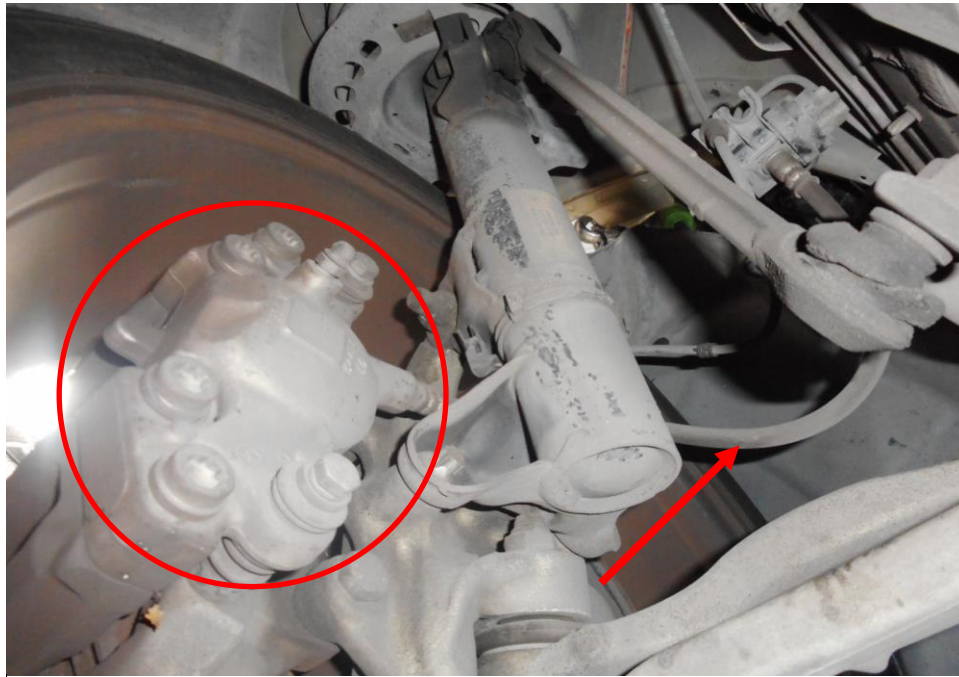
Photo 19 shows the brake hose/pipe (arrowed) at the front left wheel of the Motor Car. No leakage of brake fluid was observed. Visual examination of the various components of the braking system like the brake caliper (circled), brake booster, brake pedal etc had revealed all to be intact and without visible damage at the time of accident. There was also no sign of fluid stain(s) observed on the various undercarriage components.

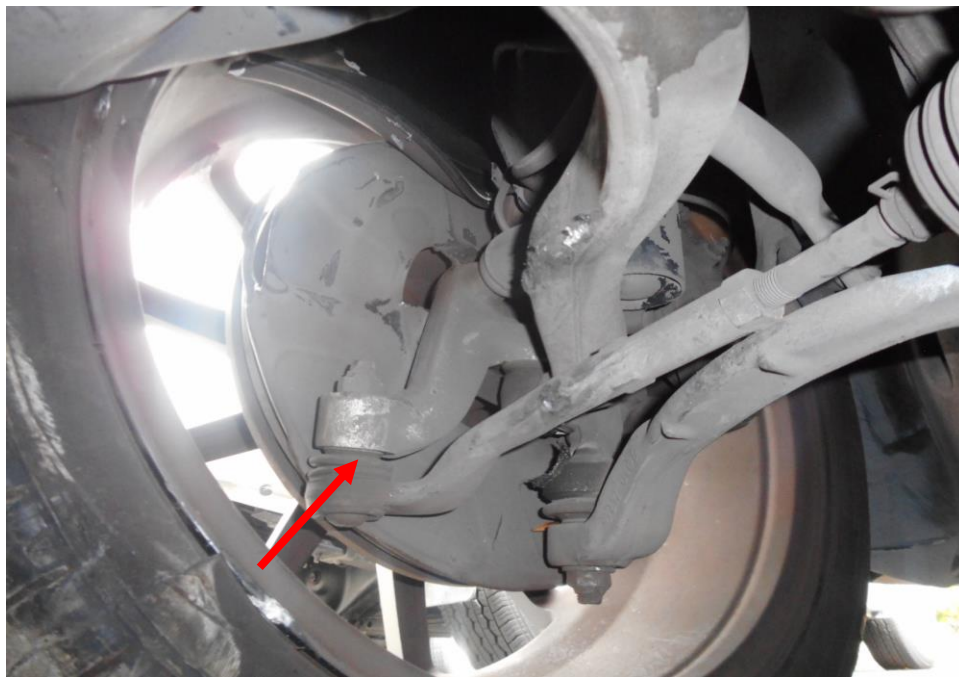
Photo 20 shows the various undercarriage components at the front right wheel of the Motor Car, in particular the steering tie rod end (arrowed). The various steering components were all found to be intact, suggesting that the steering system of the Motor Car was likely to be in serviceable condition at the material time of accident. There was also no sign of fluid stain(s) observed on the various undercarriage components.

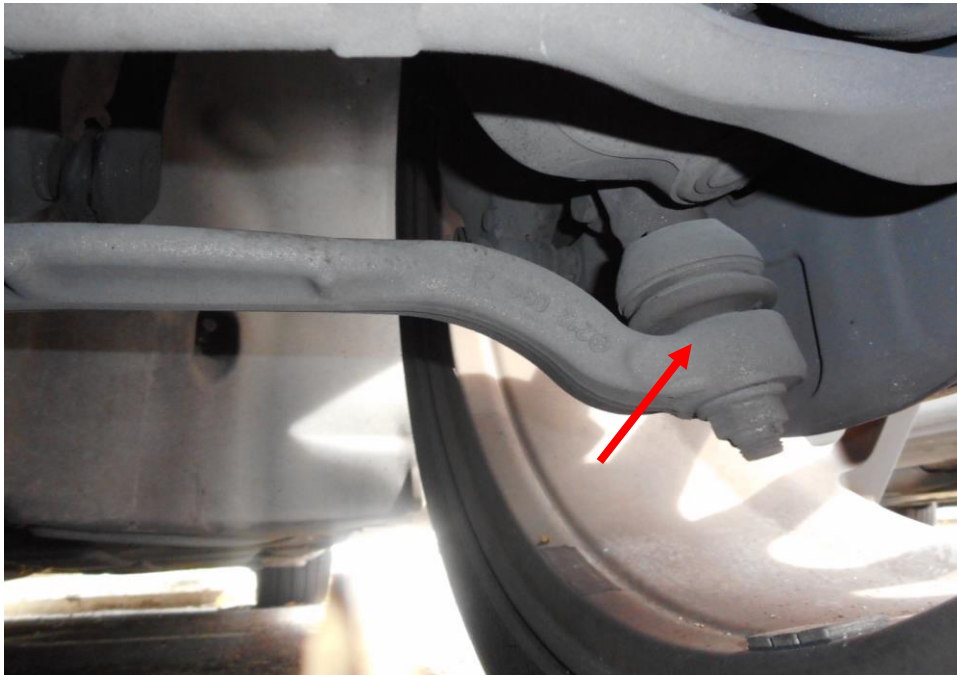
Photo 21 shows the various undercarriage components at the front left wheel of the Motor Car, in particular the steering tie rod end (arrowed). The various Undercarriage components of the Motor Car were all found to be intact without any visible damage. There was also no sign of fluid stain(s) observed on the various undercarriage components.

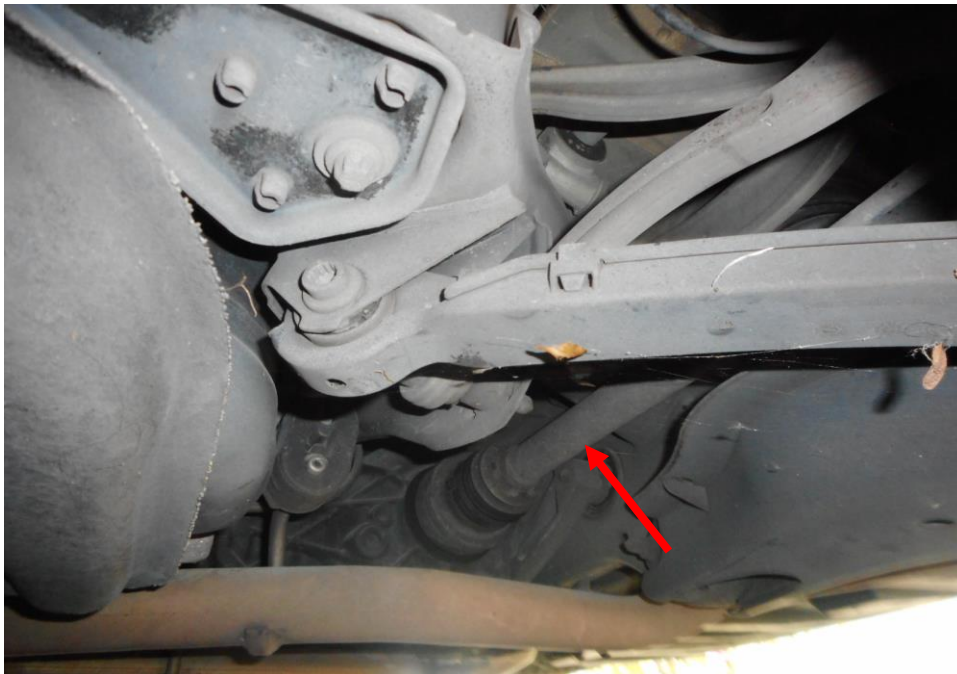
Photo 22 shows the various undercarriage components at the rear left wheel of the Motor Car, in particular the drive shaft (arrowed) were found to be intact, there was also no sign of fluid stain(s) observed on the various undercarriage components.

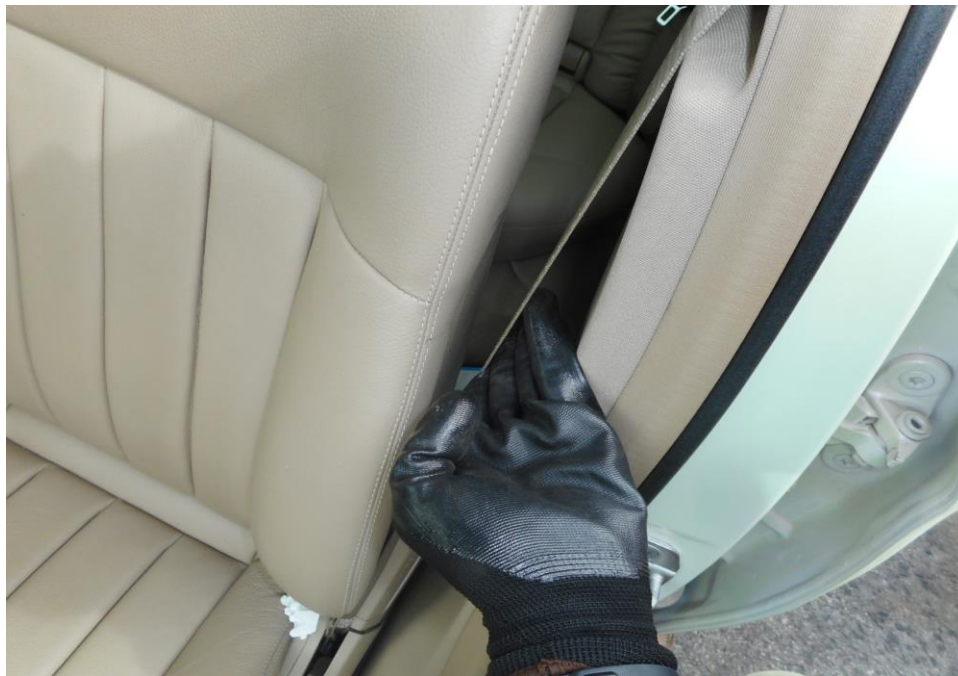
14. The both left and right seat belt of the "Motor Car" were unworn at the material time of accident as the respective pre-tensioners that were fitted at the sides of each seat was activated upon the material time and locked both belts in retracted position. See photo 23 & 24 below.

Photo 23 shows that the seat belt on the left seat was unworn at the material time of accident as the safety pre-tensioners was activated at the moment of impact and caused the seat belts to be locked into the last position.

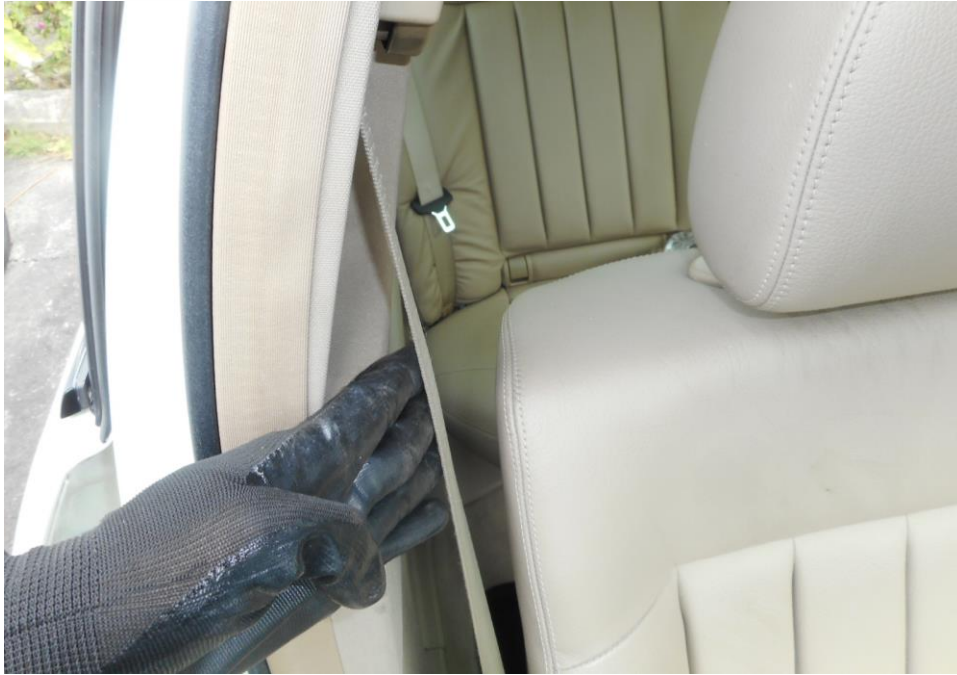
Photo 24 shows that the seat belt on the right seat was unworn at the material time of accident as the safety pre-tensioners was activated at the moment of impact and caused the seat belts to be locked into the last position.
