Your Ref: TP/IP/13045/2020
Our Ref : CI/TPD20004865/P

Fatal Accident Investigation Team

MECHANICAL INSPECTION REPORT OF MOTOR LORRY YM 9961C

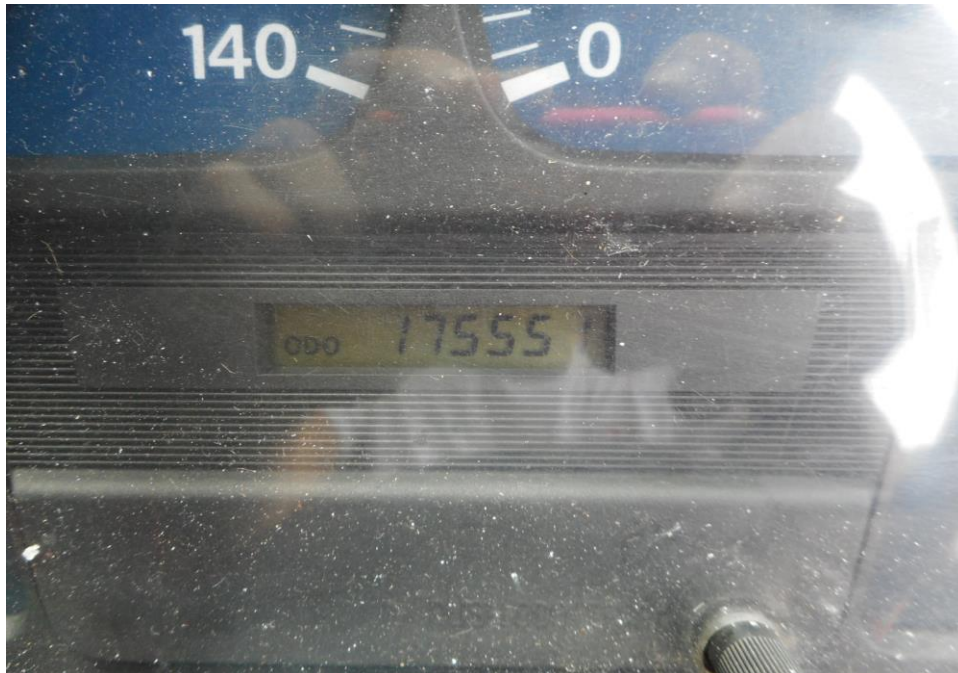
Photo 1 shows a general view of the instrument cluster of the Motor Lorry at the time of my inspection. The mileage of the Motor Lorry was 175,551m

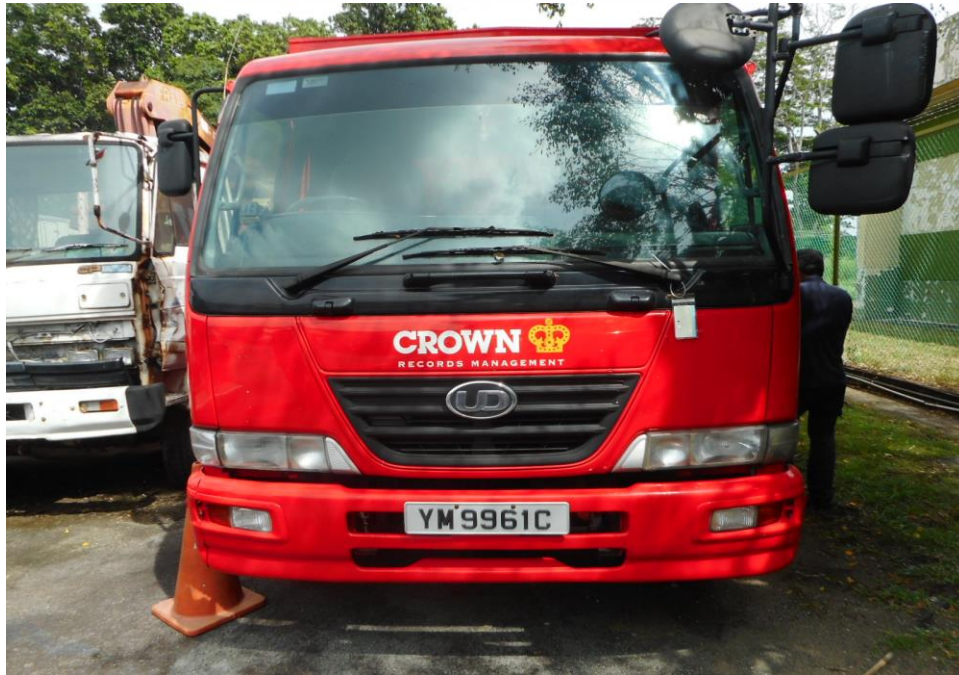
Photo 2 shows a general view of the Motor Lorry's frontal portion at the time of my inspection. The Motor Lorry was observed to be intact and unaffected by the accident.

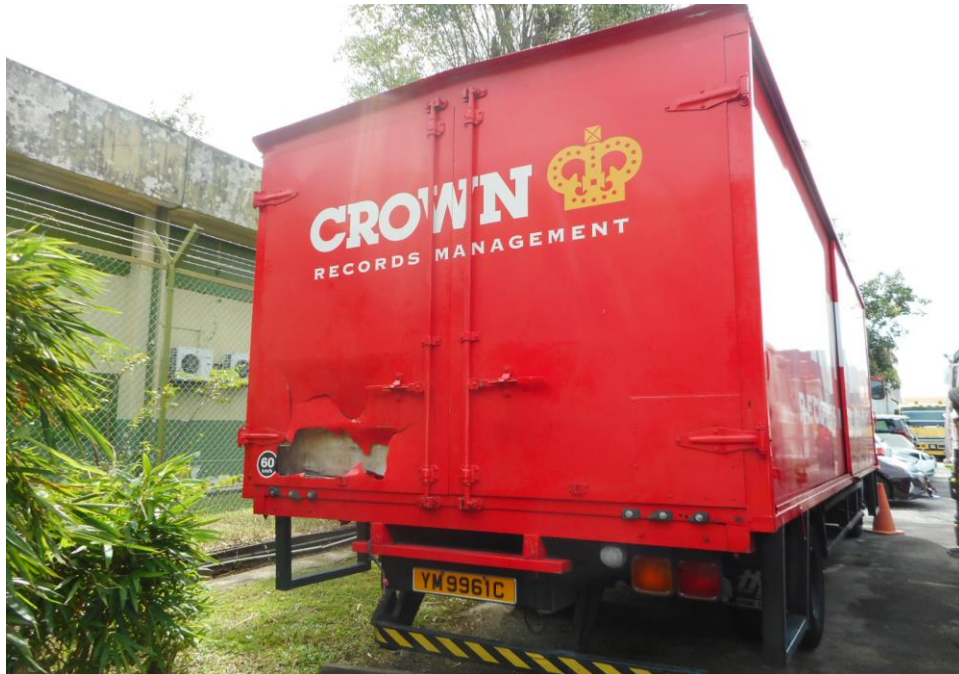
Photo 3 shows a general view of the rear body of the Motor Lorry at the time of my inspection. The Motor Lorry was observed to have sustained damage at its rear portion. Its rear left door panel, rear guard rail and rear left brake lamp was damaged as a result of the accident.

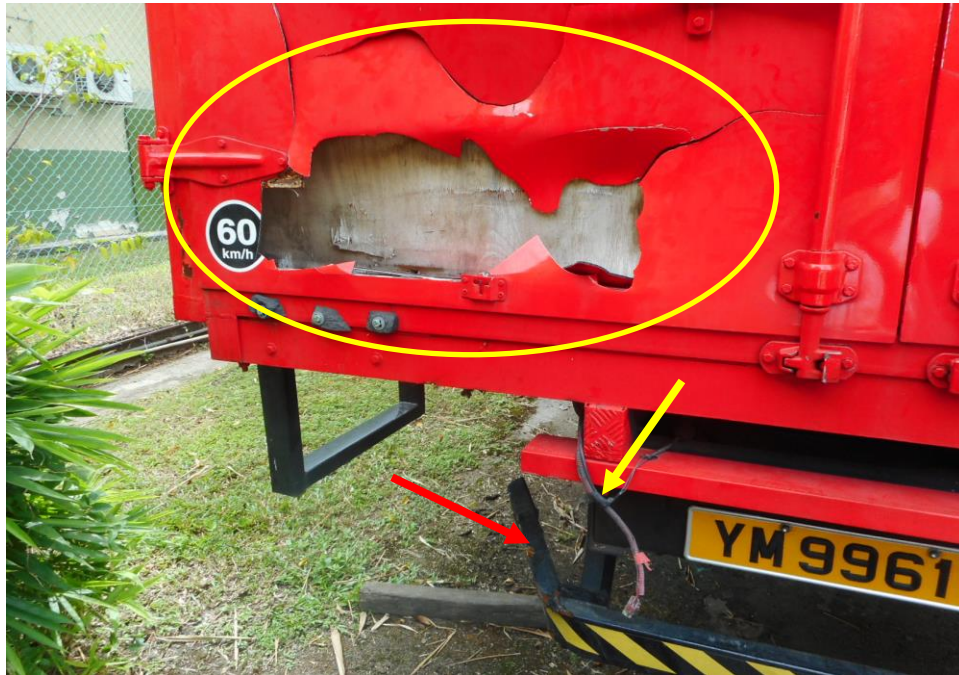
Photo 4 shows a close up view of the left body of the Motor Lorry at the time of my inspection. The Motor Lorry was observed to have sustained damage at its rear portion. Its rear left door panel (circled), rear guard rail (red arrow) and rear left brake lamp (yellow arrowed) was damaged as a result of the accident.

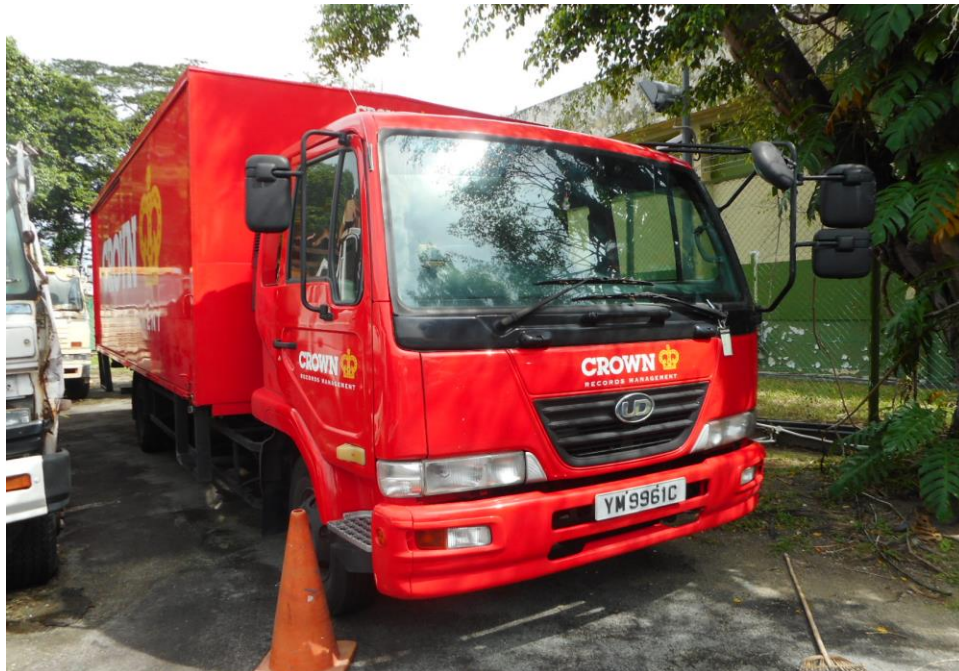
Photo 5 shows a general view of the right body of the Motor Lorry at the time of my inspection. The Motor Lorry was observed to be intact and unaffected by the accident.

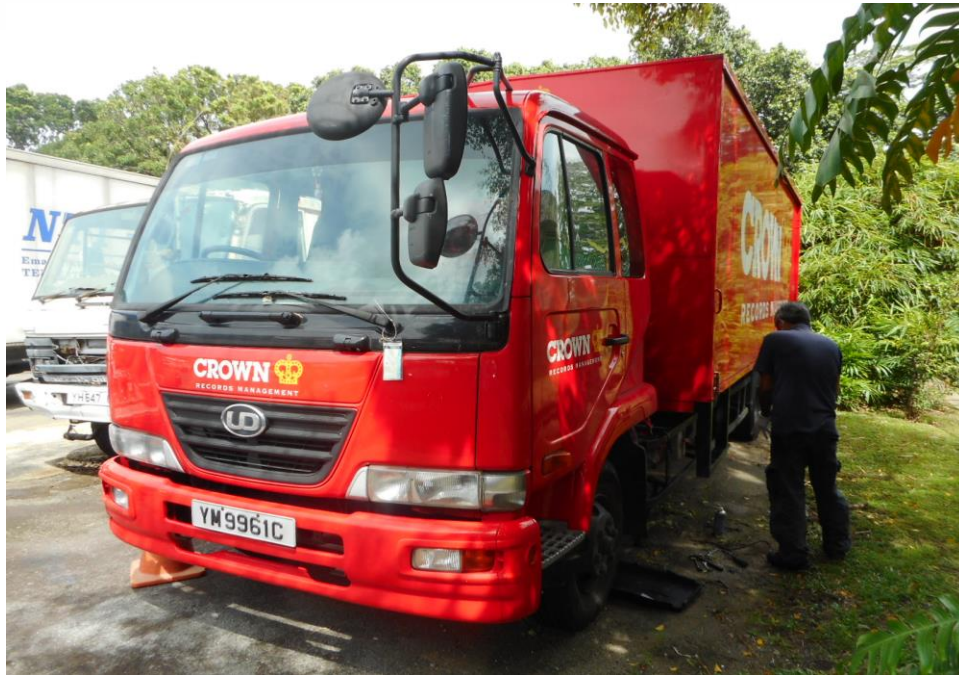
Photo 6 shows a general view of the left body of the Motor Lorry at the time of my inspection. The Motor Lorry was observed to be intact and unaffected by the accident.

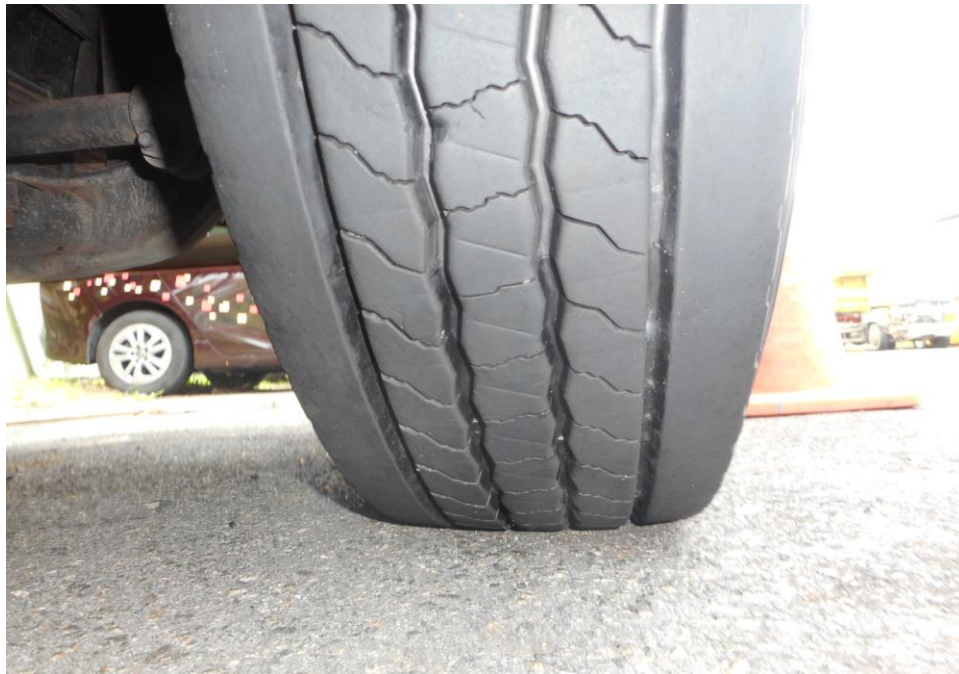
Photo 7 shows the condition of the front right tyre of the Motor Lorry, which was observed to be in serviceable condition with remaining tread depth of approximately 11.8mm. The tyre, which was wrapped around standard steel wheel rim, was also observed to be sufficiently inflated for vehicular operation. There was no tear, cut or burst mark(s) on the outer and the inner sidewalls as well as across the tread of the 6 tyres that were fitted on the Motor Lorry.

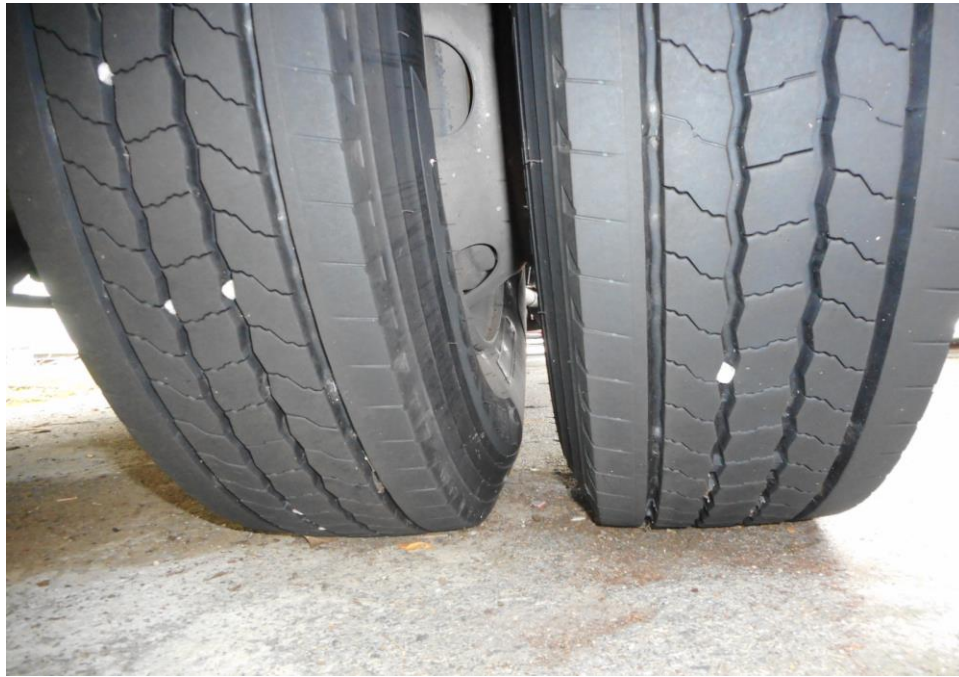
Photo 8 shows the condition of the rear right tyres of the Motor Lorry, which was observed to be in serviceable condition with remaining, tread depth of approximately 10.8mm. The tyres, which were wrapped around standard steel wheel rim, were also observed to be sufficiently inflated for vehicular operation. There was also no damage found on all 6 steel wheel rims of the Motor Lorry.

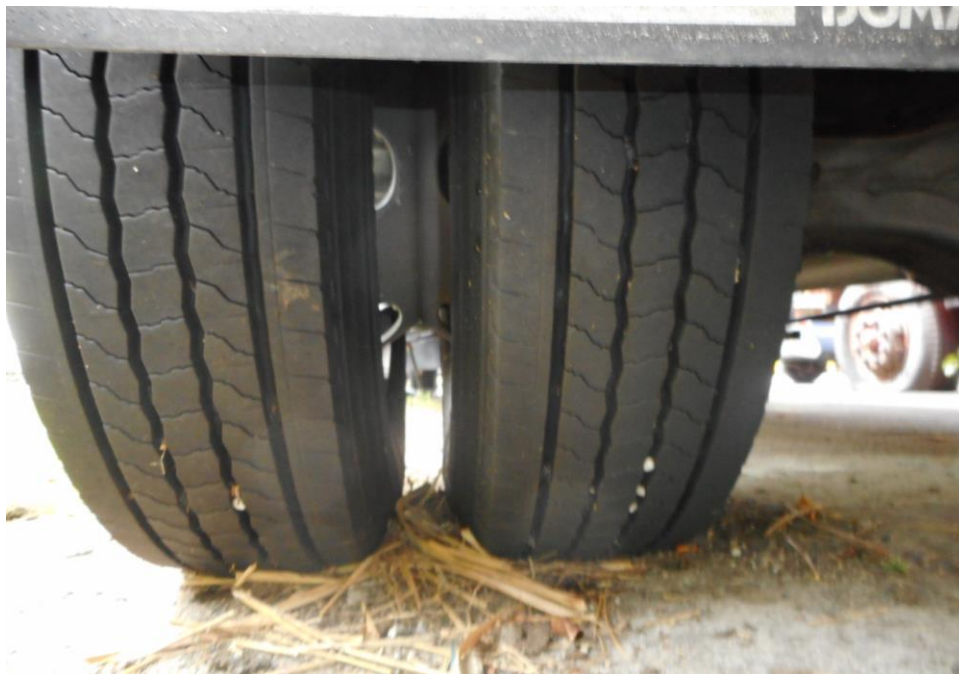
Photo 9 the condition of the rear left tyres of the Motor Lorry, which was observed to be in serviceable condition with remaining, tread depth of approximately 10.9mm. The tyres, which were wrapped around standard steel wheel rim, were also observed to be sufficiently inflated for vehicular operation. There was also no damage found on all 6 steel wheel rims of the Motor Lorry.

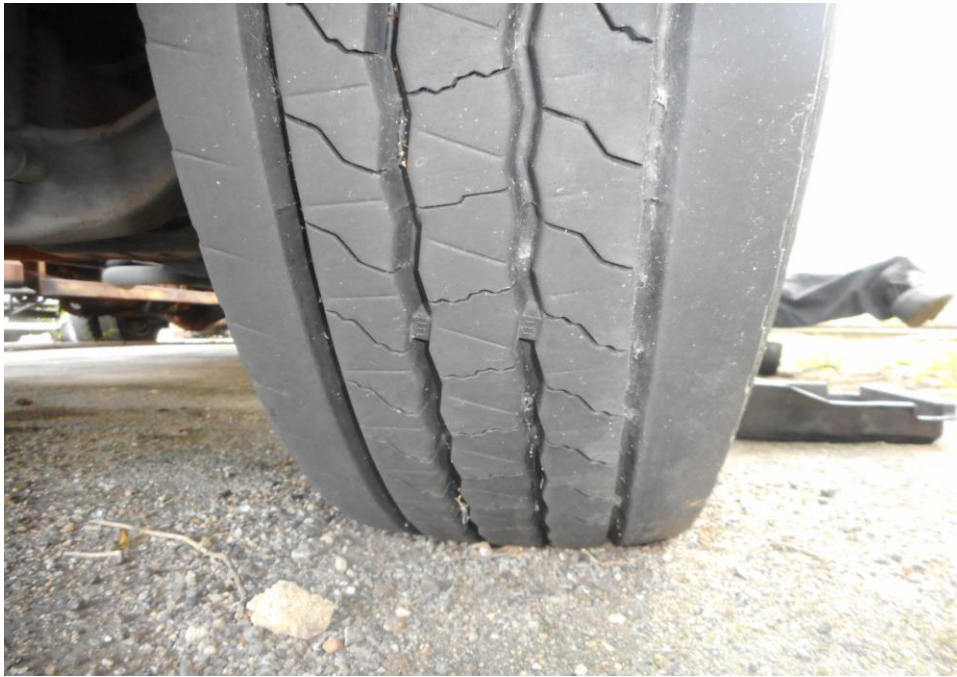
Photo 10 shows the condition of the front left tyre of the Motor Lorry, which were observed to be in serviceable condition with remaining, tread depth of approximately 11.8mm. There was also no tear, cut or burst mark(s) on the outer and the inner sidewalls as well as across the tread of the 6 tyres that were fitted on the Motor Lorry.

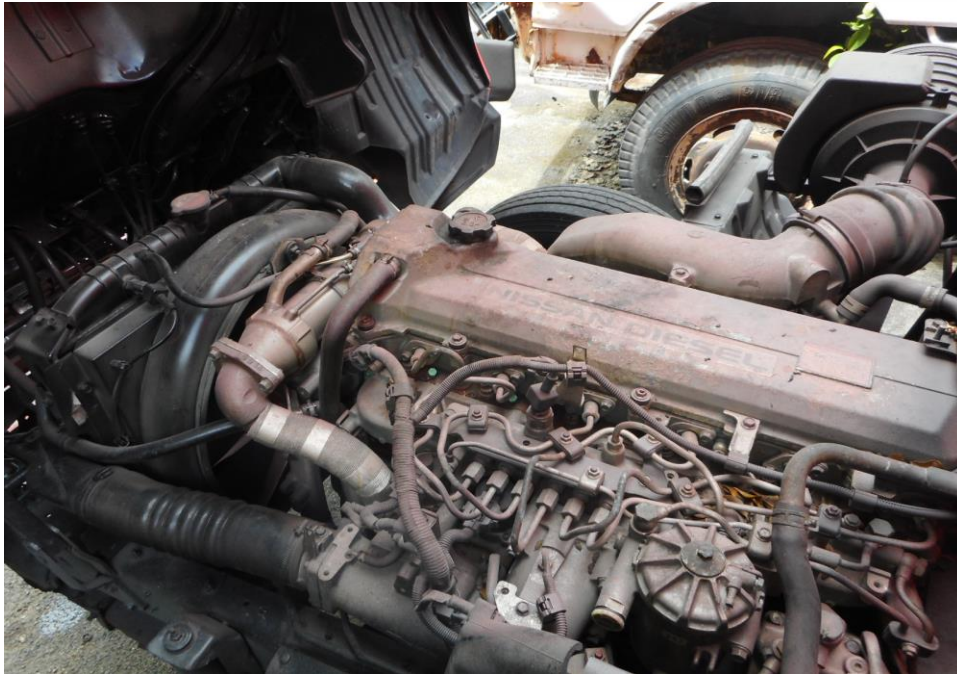
Photo 11 shows a general view of the Motor Lorry's engine compartment, which was accessed by lifting the front cabin of the Motor Lorry. The various parts and components inside the engine compartment were unaffected by the accident. There was also no sign(s) or indication(s) of fresh fluid leakage and/or fluid stain within the engine compartment

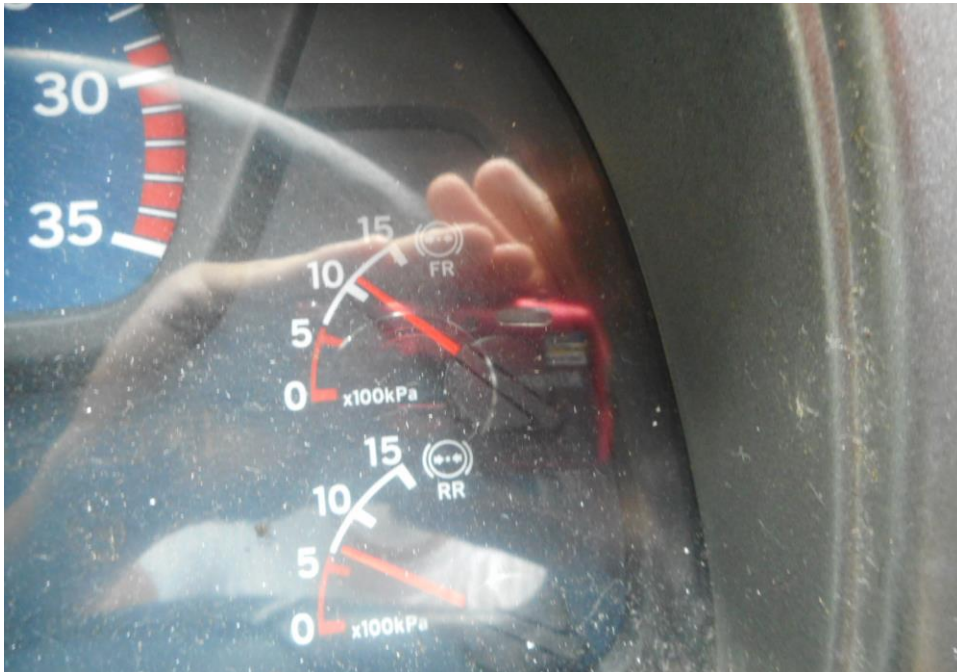
Photo 13 shows the air in the air brake cylinders of the Motor Lorry at the time of my inspection. The air in the cylinder was observed to be of sufficient level & serviceable at the time of the accident.

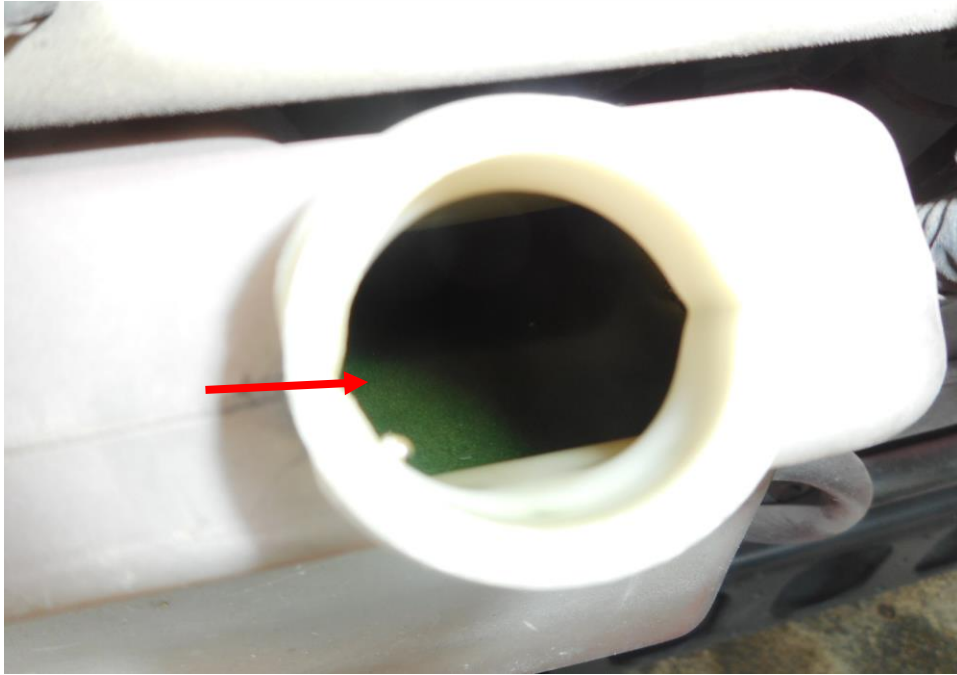
Photo 13 shows the engine coolant reservoir of the Motor Lorry at the time of my inspection. The engine coolant was observed to be of sufficient level (arrowed) and without any visible contamination.

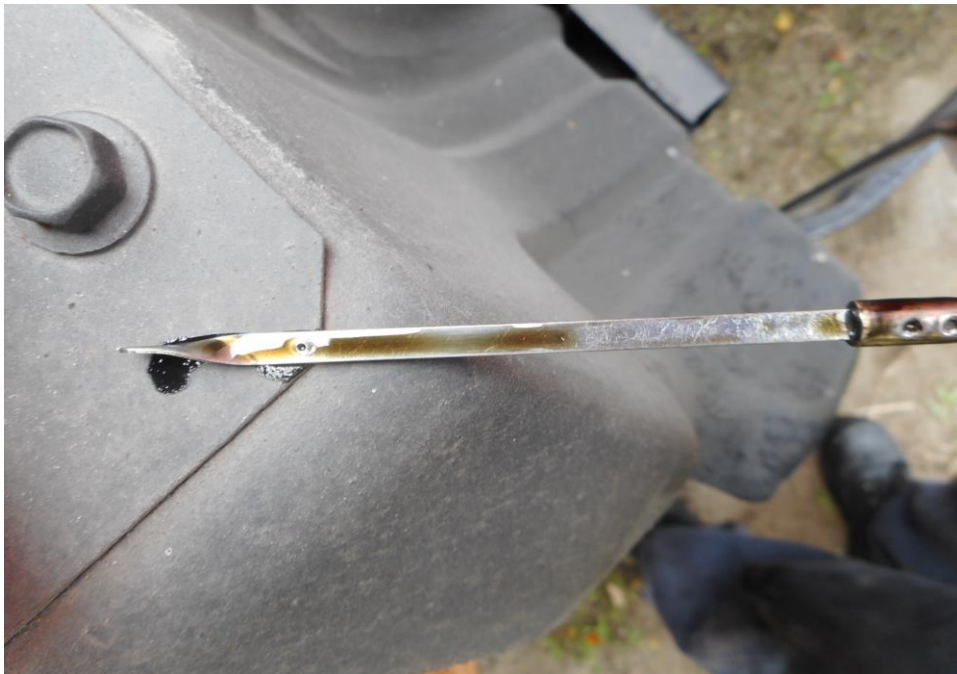
Photo 14 shows the engine oil dip stick of the Motor Lorry at the time of my inspection. The engine oil was observed to be of sufficient level and without any visible contamination.

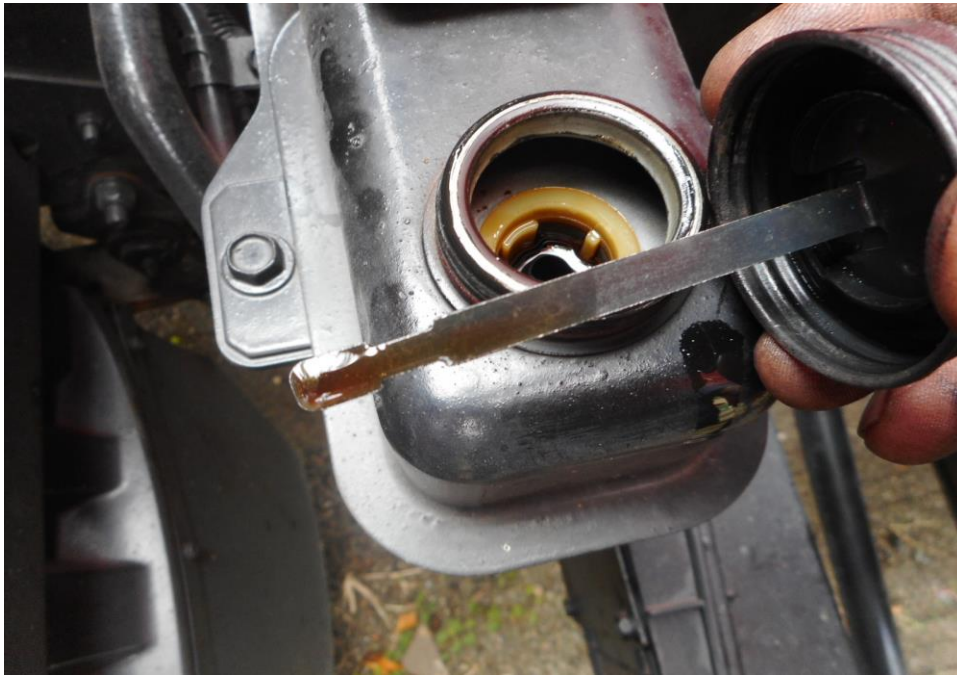
Photo 15 shows the power steering fluid reservoir of the Motor Lorry at the time of my inspection. The power steering fluid was observed to be of sufficient level and without any visible contamination.

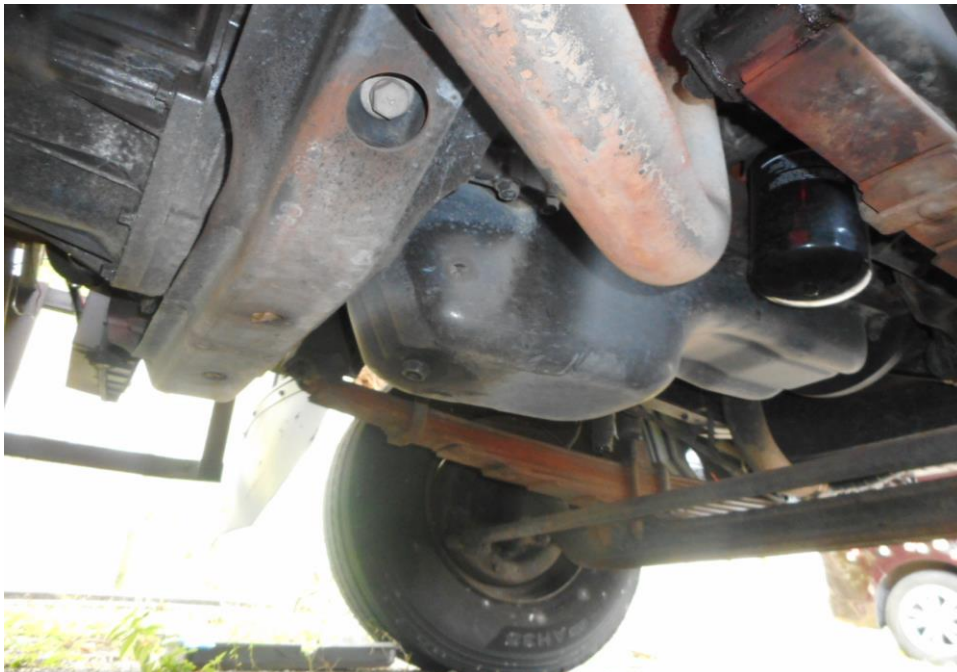
Photo 16 shows the undercarriage of the Motor Lorry, at the area where the engine housing and transmission housing are located. I did not observe any leakage or fluid stain on the underside of the Motor Lorry.

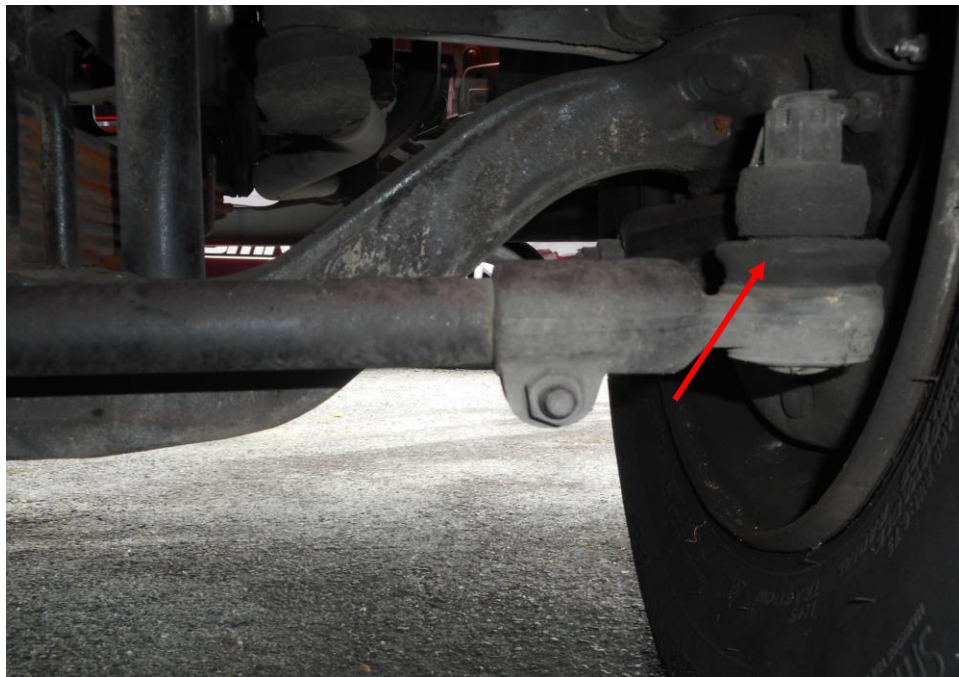
Photo 17 shows the various undercarriage components at the front right wheel of the Motor Lorry, in particular the steering tie rod end (arrowed). The various steering components were all found to be intact, suggesting that the steering system of the Motor Lorry was likely to be in serviceable condition at the material time of accident. There was also no sign of fluid stain(s) observed on the various undercarriage components.

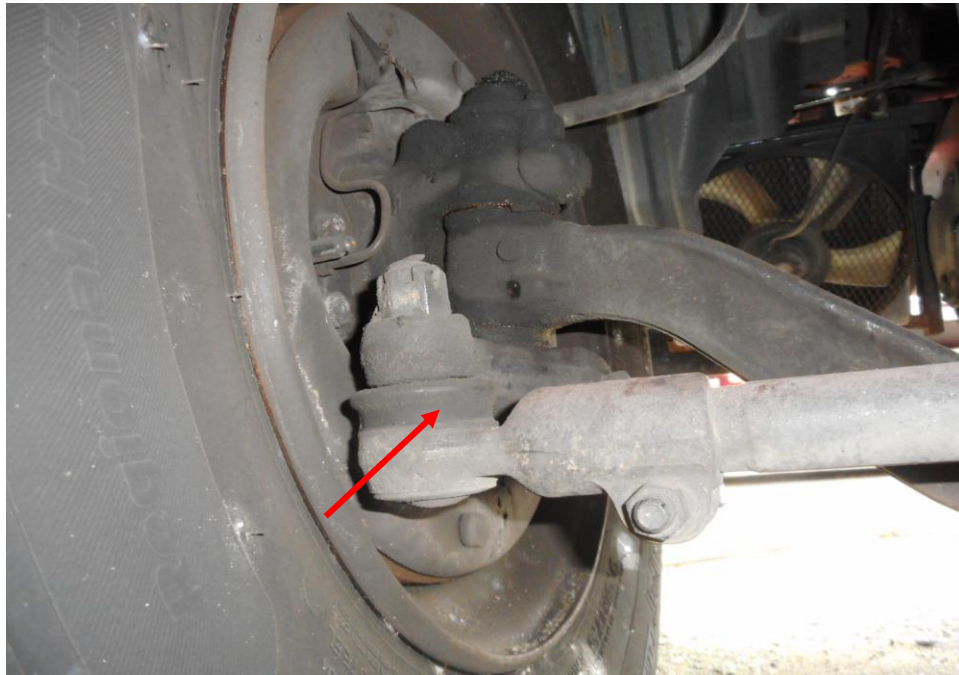
Photo 18 shows the various undercarriage components at the front left wheel of the Motor Lorry, in particular the steering tie rod end (arrowed). The various Undercarriage components of the Motor Lorry were all found to be intact without any visible damage. There was also no sign of fluid stain(s) observed on the various undercarriage components.

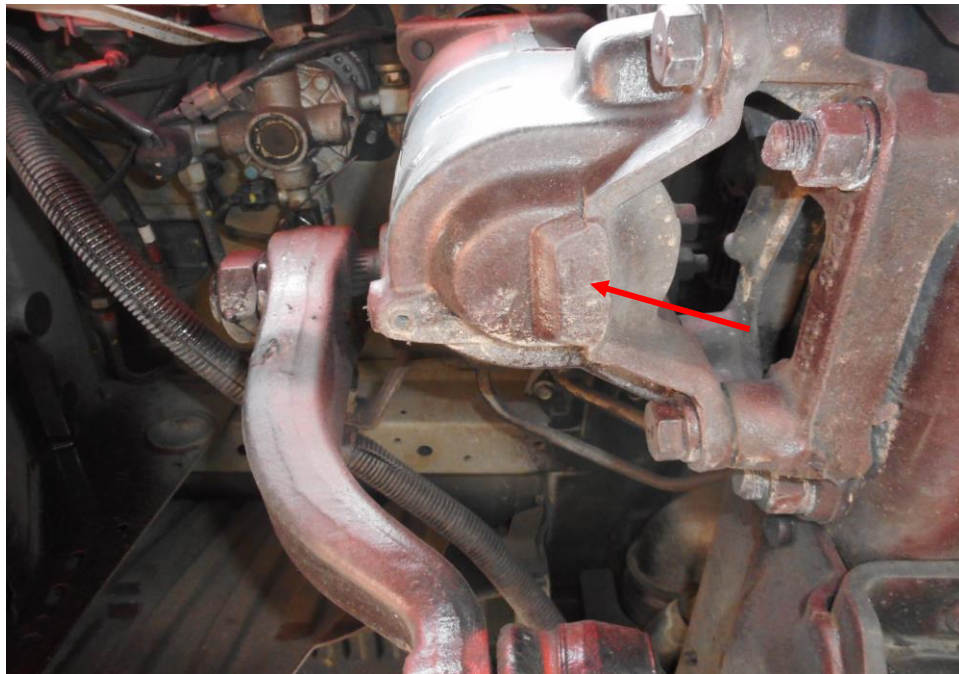
Photo 19 shows the steering box component (arrowed) at the undercarriage of the Motor Lorry was found to be intact without any visible damage. There was also no sign of fluid stain(s) observed on the various undercarriage components.

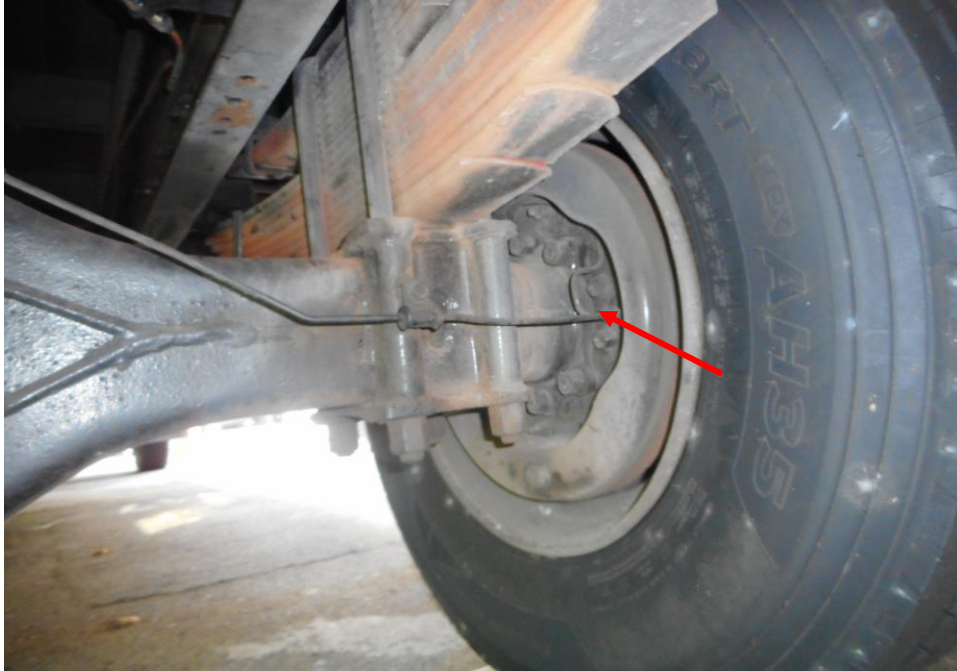
Photo 20 shows the brake pipe (arrowed) at the rear right wheel of the Motor Lorry. I did not observe any leakage of brake fluid at the time of my inspection of the Motor Lorry. My static tests of the Motor Lorry's braking system, along with my visual examination of the various mechanical components in the braking system, had indicated that there was no internal leakage of pressure/vacuum. Hence the braking system of the Motor Lorry was likely to be in serviceable condition at the material time of accident.

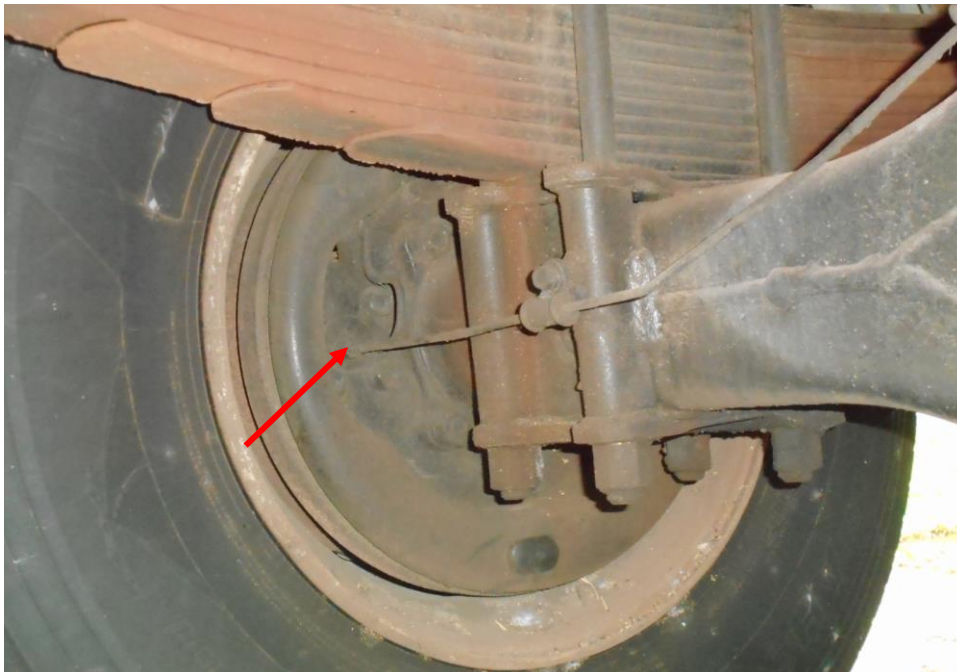
Photo 21 shows the brake pipe (arrowed) at the rear left wheel of the Motor Lorry. I did not observe any leakage of brake fluid at the time of my inspection of the Motor Lorry. My static tests of the Motor Lorry's braking system, along with my visual examination of the various mechanical components in the braking system had indicated that there was no internal leakage of pressure/vacuum. Hence the braking system of the Motor Lorry was likely to be in serviceable condition at the material time of accident.

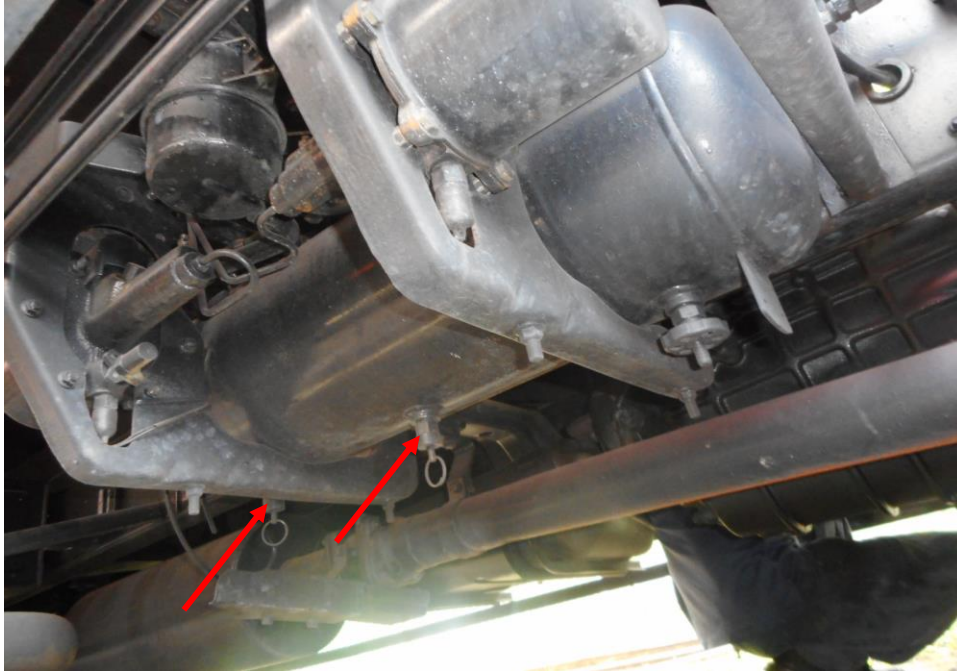
Photo 22 shows the air brake cylinders (arrowed) at the undercarriage of the Motor Lorry. I did not observe any leakage of air brake fluid at the time of my inspection of the Motor Lorry. My static tests of the Motor Lorry's braking system, along with my visual examination of the various mechanical components in the braking system had indicated that there was no internal leakage of pressure/vacuum. Hence the braking system of the Motor Lorry was likely to be in serviceable condition at the material time of accident.

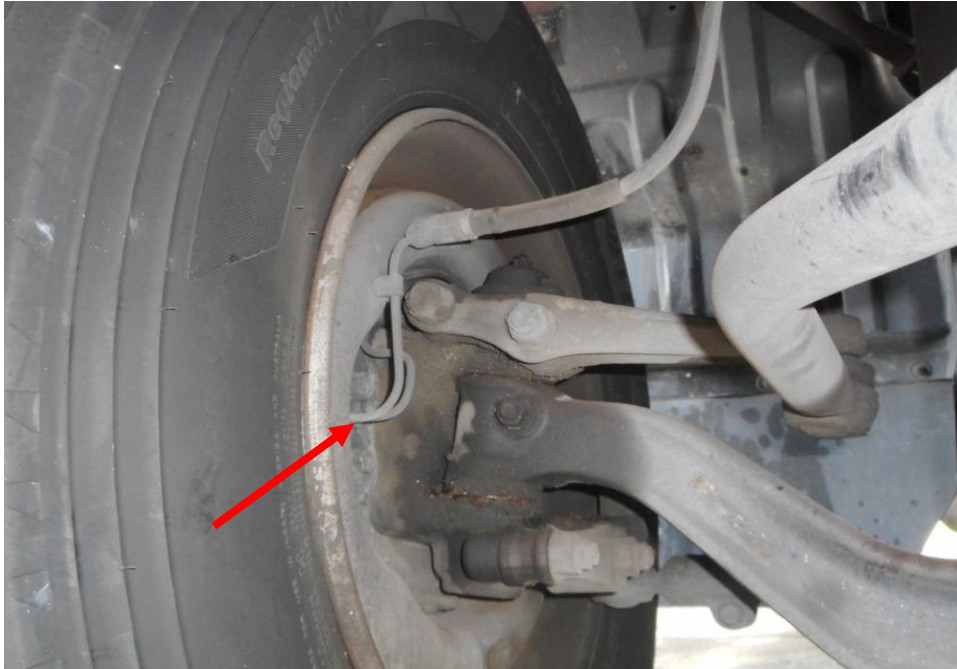
Photo 23 shows the brake hose/pipe (arrowed) at the front right wheel of the Motor Lorry. I did not observe any leakage of brake fluid at the time of my inspection of the Motor Lorry. My static tests of the Motor Lorry's braking system, along with my visual examination of the various mechanical components in the braking system had indicated that there was no internal leakage of pressure/vacuum. Hence the braking system of the Motor Lorry was likely to be in serviceable condition at the material time of accident.

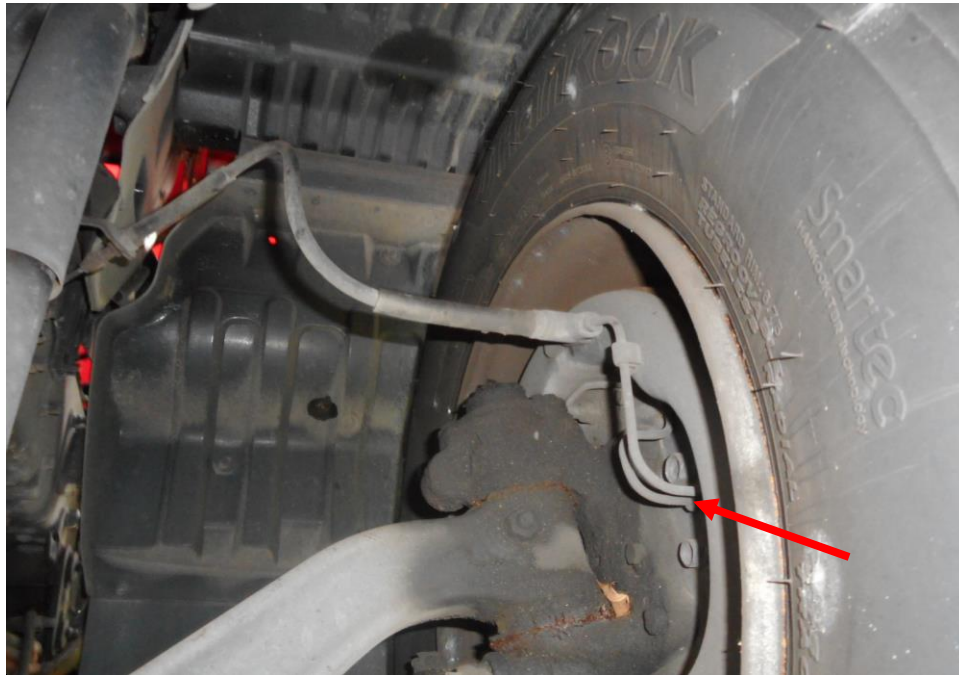
Photo 24 shows the brake hose/pipe (arrowed) at the front left wheel of the Motor Lorry. I did not observe any leakage of brake fluid at the time of my inspection of the Motor Lorry. My static tests of the Motor Lorry's braking system, along with my visual examination of the various mechanical components in the braking system had indicated that there was no internal leakage of pressure/vacuum. Hence the braking system of the Motor Lorry was likely to be in serviceable condition at the material time of accident.

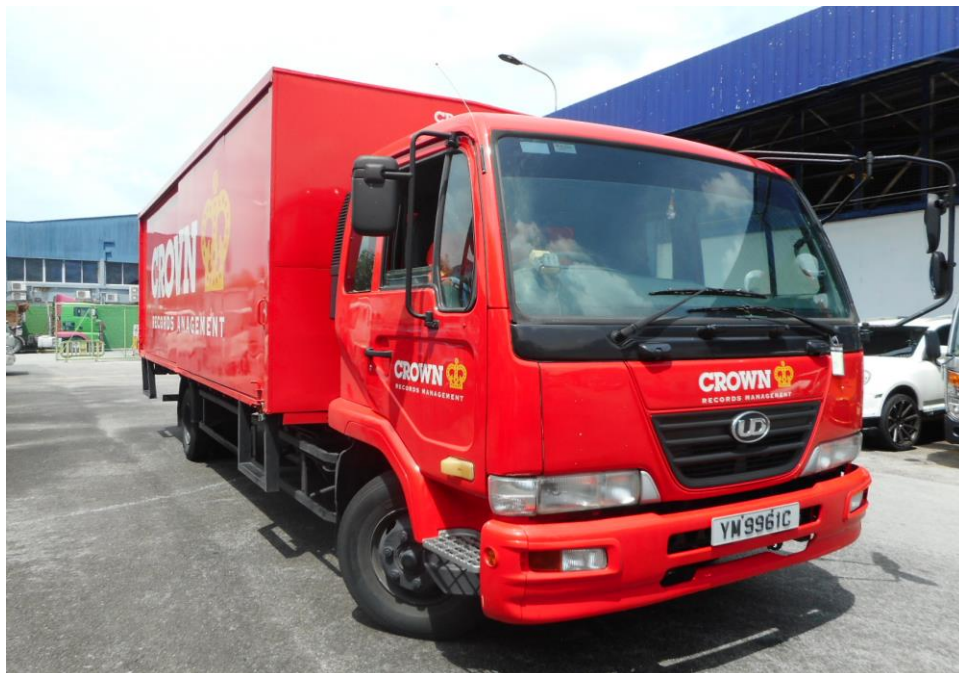
Photo 25 shows the front right wheel of the Motor Lorry turned to its full left. During my steering system test, I did not experience any abnormal free play and/or resistance when I had turned the steering wheel towards full left and full right. This would suggest that the steering system of the Motor Lorry was likely to be in serviceable condition at the material time of accident.
