Your Ref: TP/IP/05017/2020  
Our Ref : CI/TPD20004867/P

**Fatal Accident Investigation Team**

**MECHANICAL INSPECTION REPORT OF MOTOR CAR SDV 9938Y**

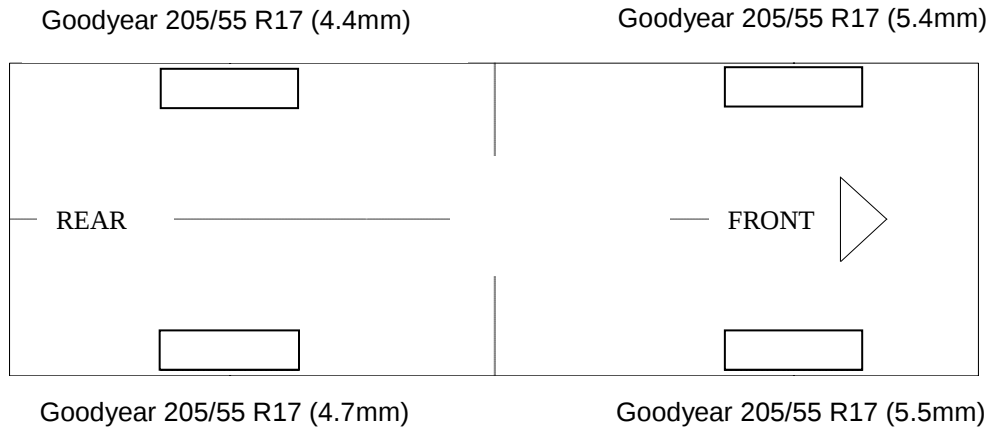
6. The 4 tyres of the Motor Car were observed to be in serviceable condition and sufficiently inflated for vehicular operation. I did not find any tear, cut or burst mark(s) on the outer and the inner sidewalls as well as across the tread of the 4 tyres. The tyre brand, tyre size and remaining tread depth of the 4 tyres of the Motor Car were recorded as follows:-

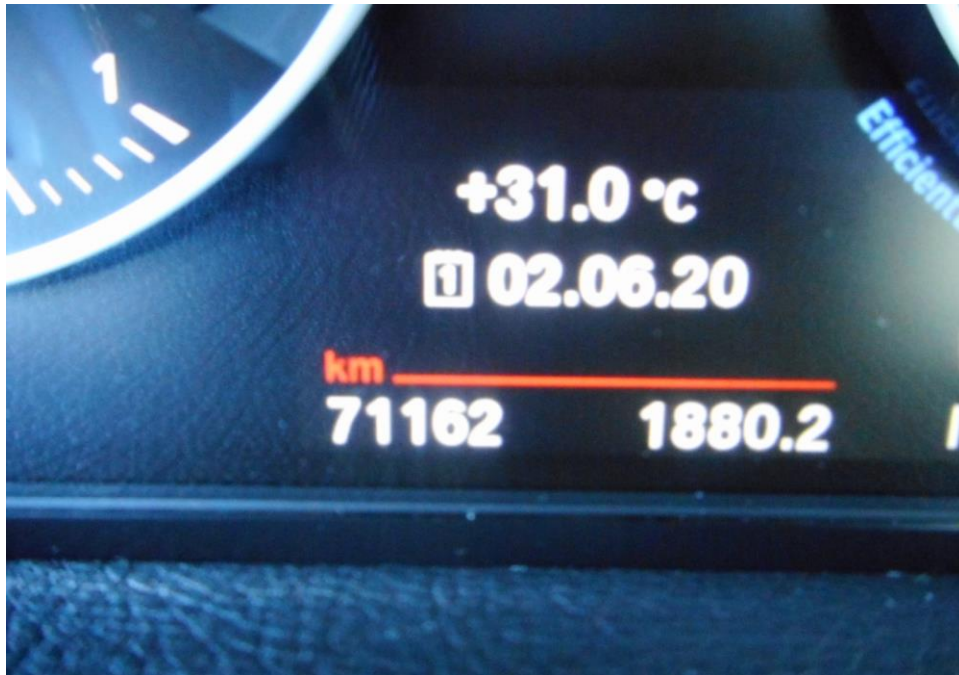
4. The mileage of the Motor Car at the time of my inspection was 71,162km.
5. There was no visible damage observed on Motor Car at the time of my inspection.

**Photo 1** shows a general view of the instrument cluster of the Motor Car at the time of my inspection. The mileage of the Motor Car was 71,162km

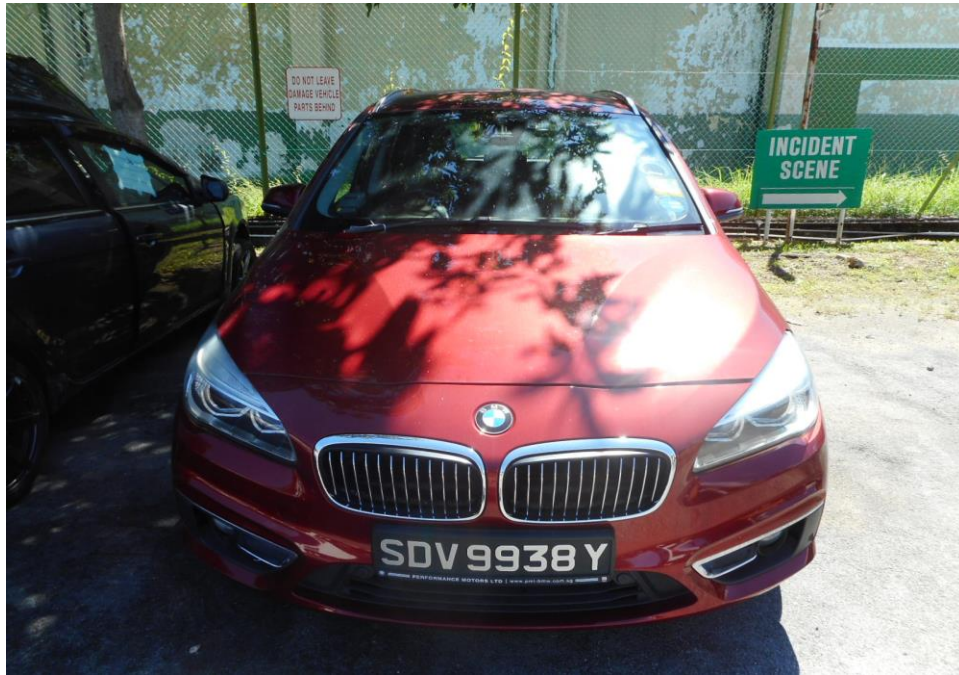
**Photo 2** shows a general view of the Motor Car at the time of my inspection. The Motor Car was observed to be intact and unaffected by the accident.

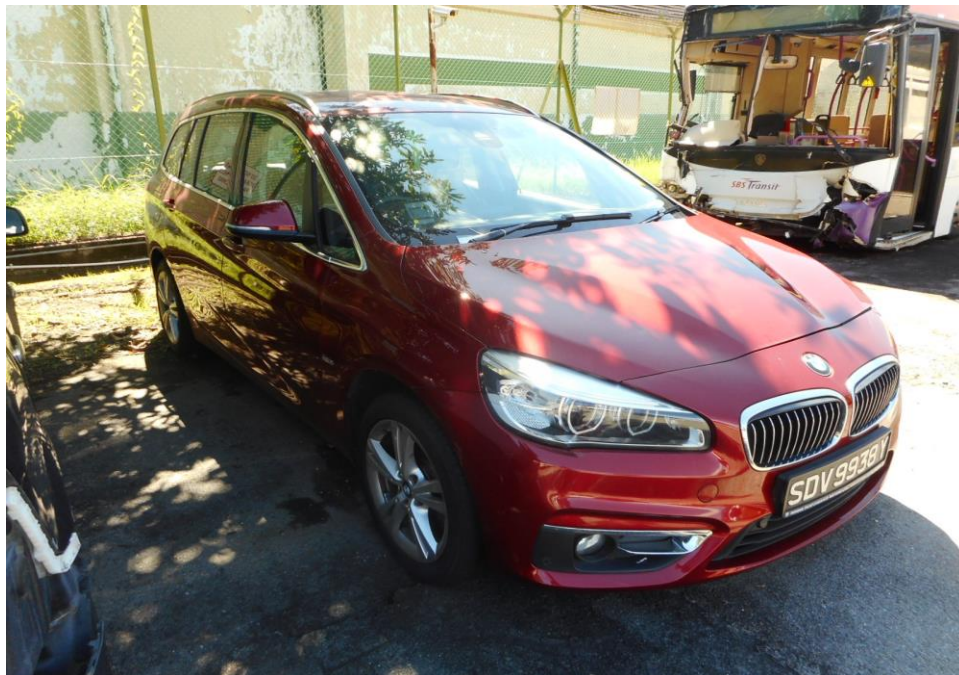
**Photo 3** shows a general view of the right body of the Motor Car at the time of my inspection. The Motor Car was observed to be intact and unaffected by the accident.

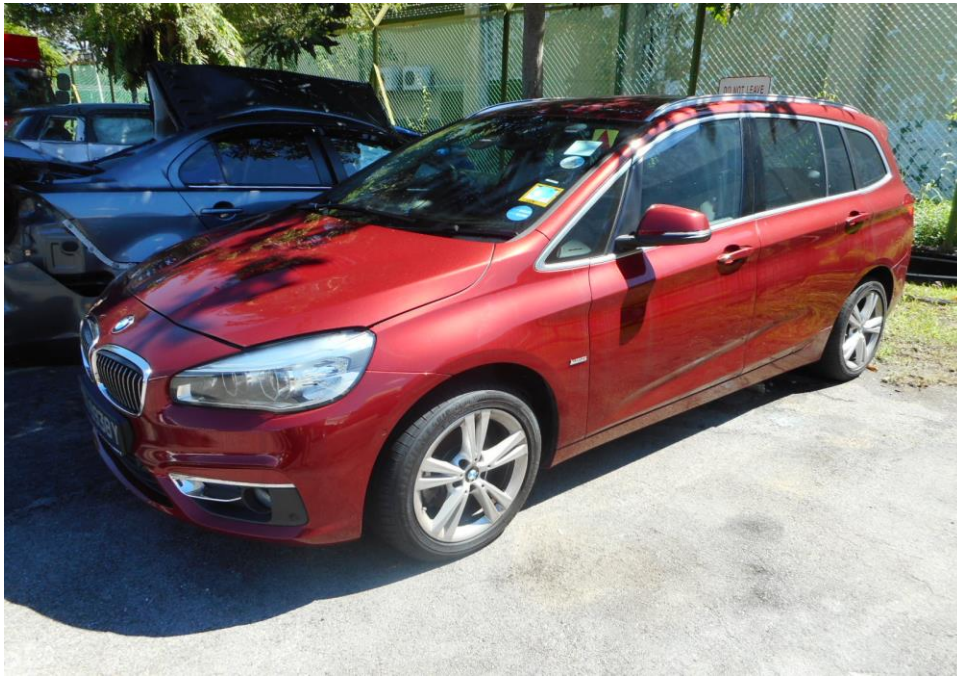
**Photo 4** shows a general view of the left body of the Motor Car at the time of my inspection. The Motor Car was observed to be intact and unaffected by the accident.

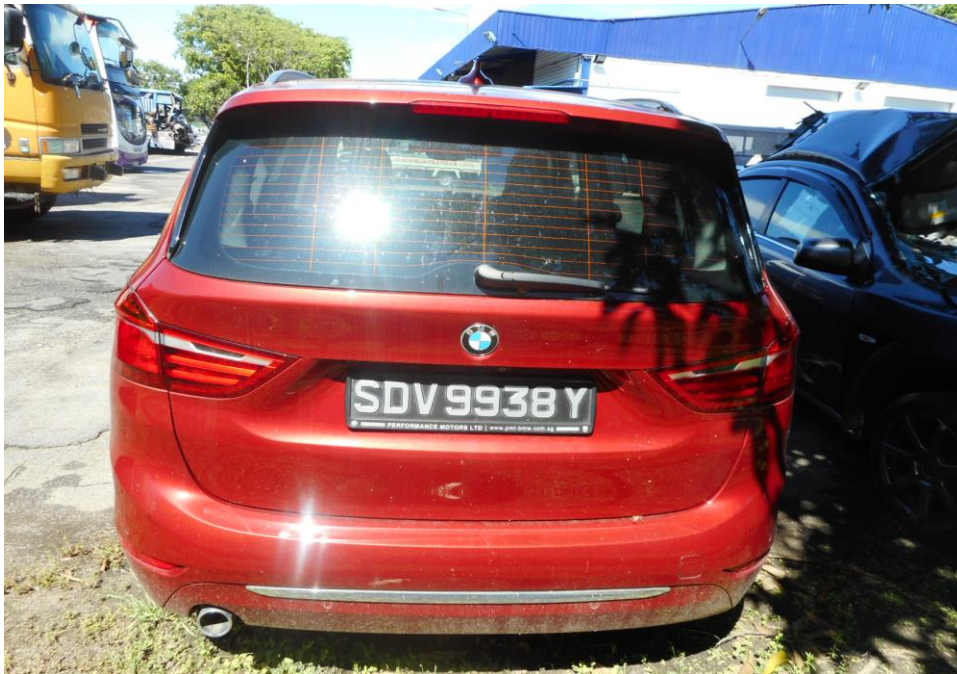
**Photo 5** shows a general view of the rear body of the Motor Car at the time of my inspection. The Motor Car was observed to be intact and unaffected by the accident.

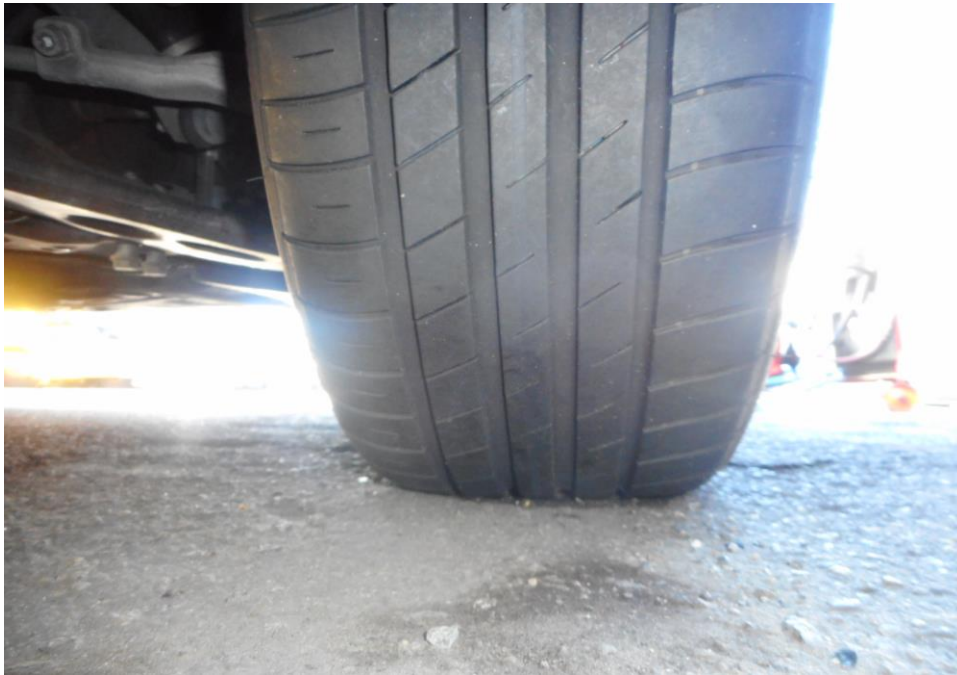
**Photo 6** shows the condition of the front right tyre of the Motor Car, which was observed to be in serviceable condition with remaining tread depth of approximately 5.5mm. The tyre, which was wrapped around standard alloy wheel rim, was also observed to be sufficiently inflated for vehicular operation. There was no tear, cut or burst mark(s) on the outer and the inner sidewalls as well as across the tread of the 4 tyres that were fitted on the Motor Car.

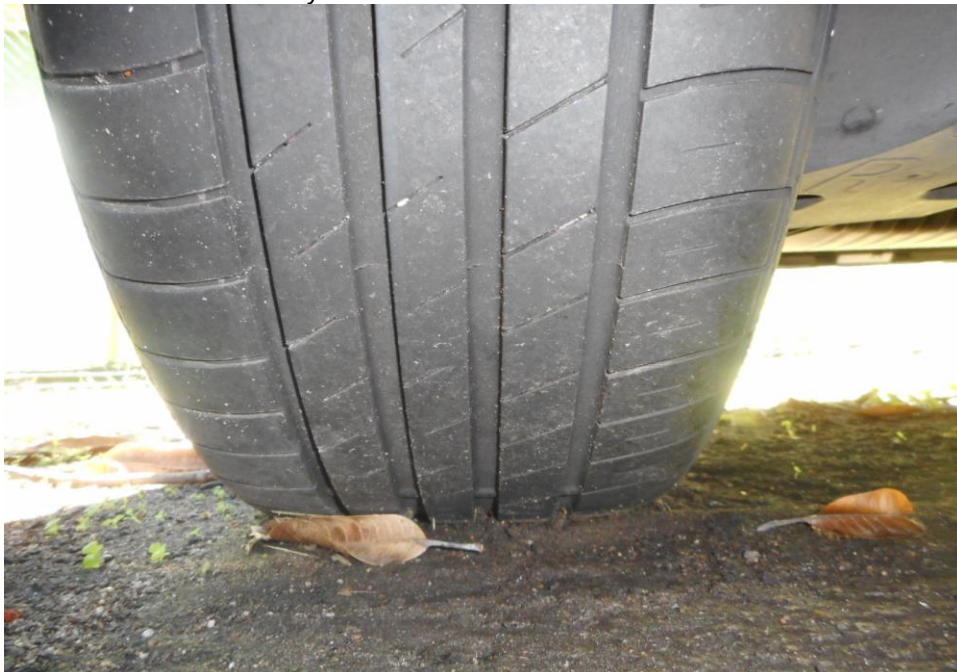
**Photo 7** shows the condition of the rear right tyre of the Motor Car, which was observed to be in serviceable condition with remaining tread depth of approximately 4.7mm. The tyre, which was wrapped around standard alloy wheel rim, was also observed to be sufficiently inflated for vehicular operation.

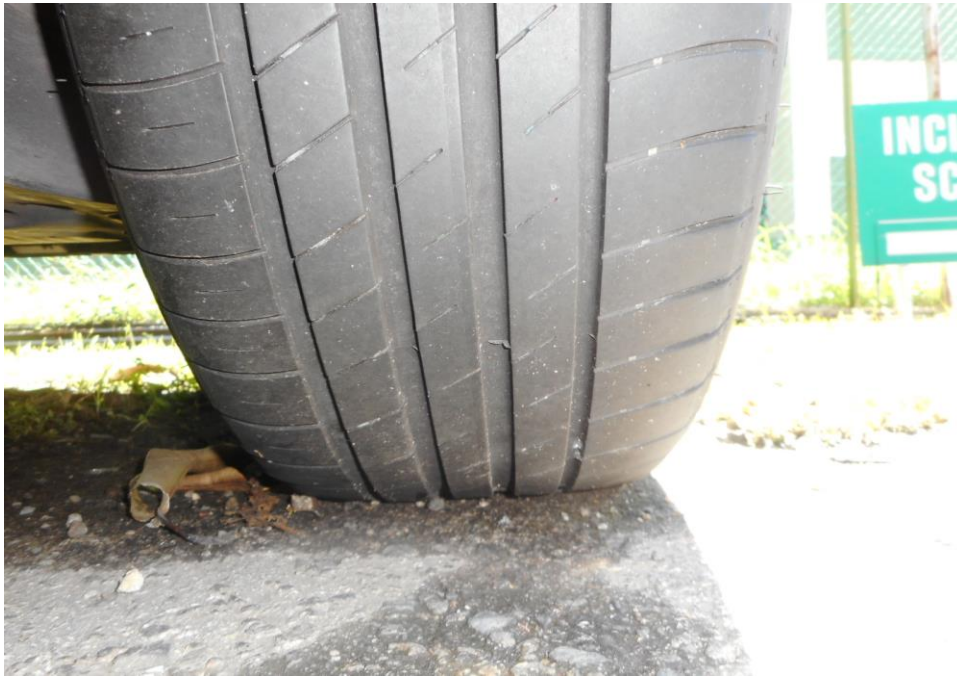
**Photo 8** shows the condition of the rear left tyres of the Motor Car, which was observed to be in serviceable condition with remaining tread depth of approximately 4.4mm. The tyres, which were wrapped around standard alloy wheel rim, were also observed to be sufficiently inflated for vehicular operation. There was also no damage found on all 4 alloy wheel rims of the Motor Car.

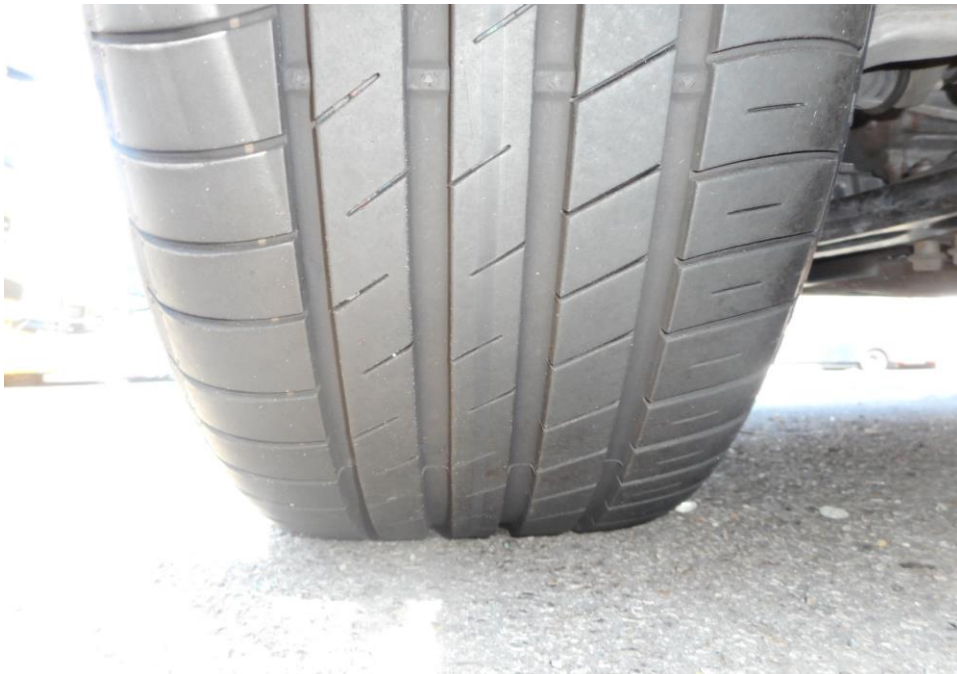
**Photo 9** shows the condition of the rear right tyres of the Motor Car, which were observed to be in serviceable condition with remaining, tread depth of approximately 5.4mm. There was also no tear, cut or burst mark(s) on the outer and the inner sidewalls as well as across the tread of the 4 tyres that were fitted on the Motor Car.

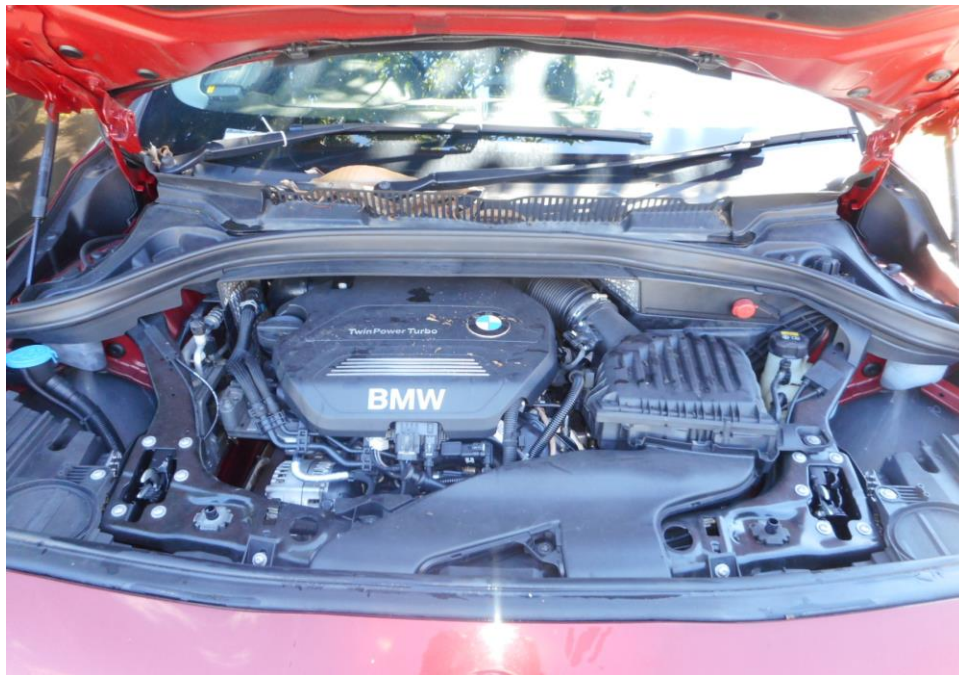
**Photo 10** shows a general view of the Motor Car's engine compartment, which was accessed by lifting the front cabin of the Motor Car. The various parts and components inside the engine compartment were unaffected by the accident. There was also no sign(s) or indication(s) of fresh fluid leakage and/or fluid stain within the engine compartment

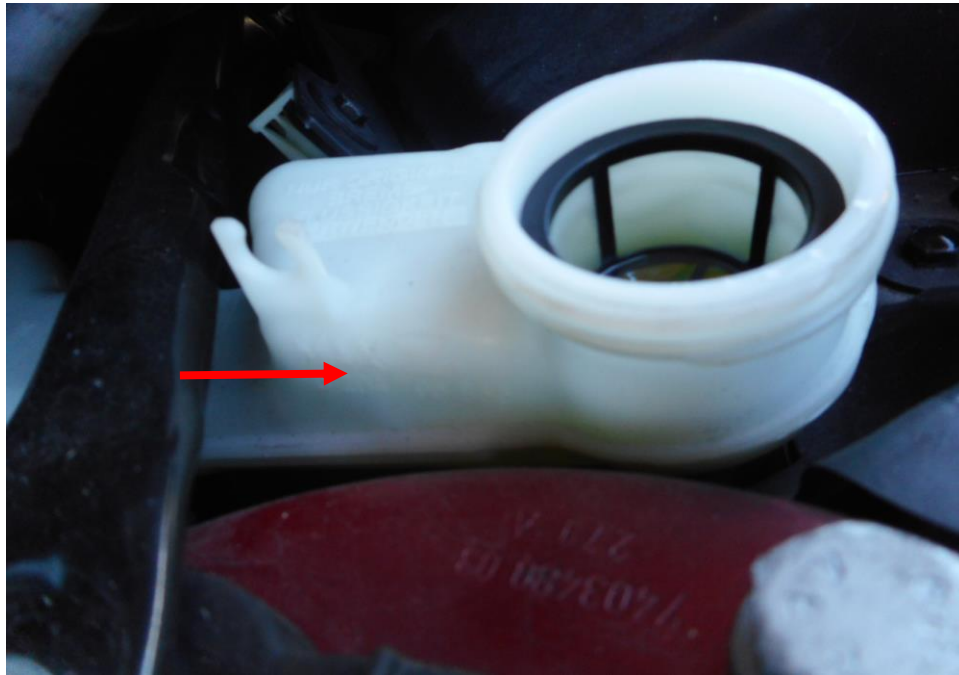
**Photo 11** shows the brake fluid reservoir of the Motor Car at the time of my inspection. The brake fluid was observed to be of sufficient level (arrowed) and without any visible contamination.

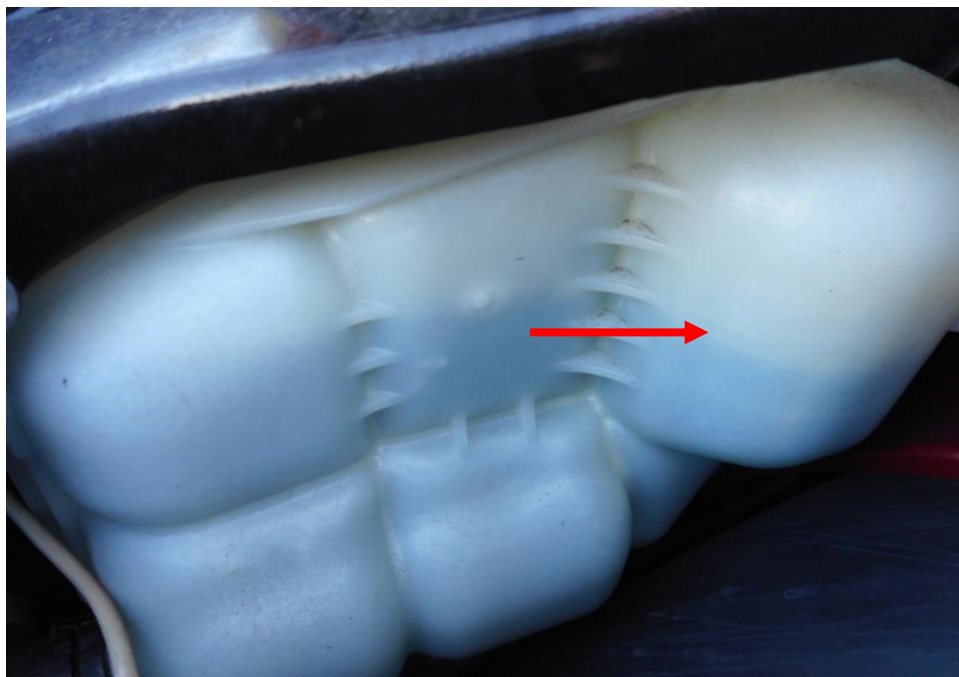
**Photo 12** shows the engine coolant reservoir of the Motor Car at the time of my inspection. The engine coolant was observed to be of sufficient level (arrowed) and without any visible contamination.

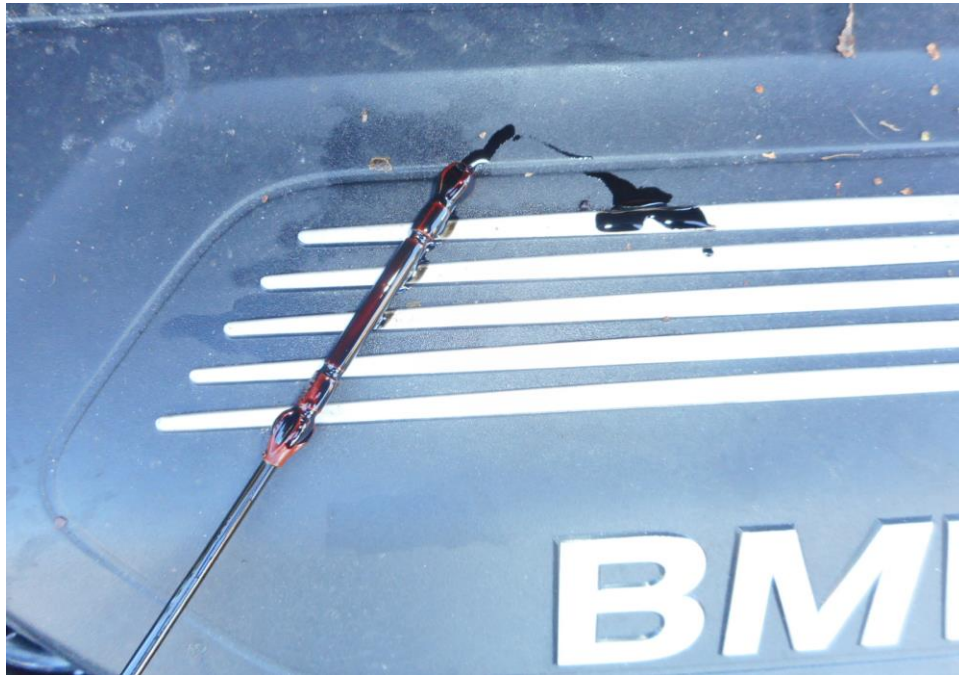
**Photo 13** shows the engine oil dip stick of the Motor Car at the time of my inspection. The engine oil was observed to be of sufficient level and without any visible contamination.

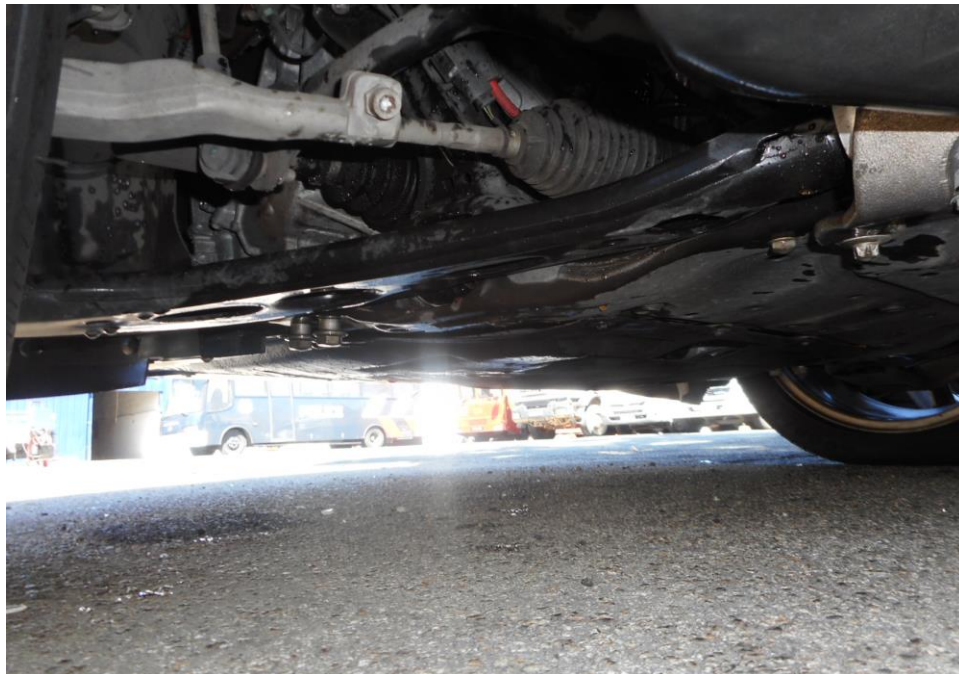
**Photo 14** shows the undercarriage of the Motor Car, at the area where the engine housing and transmission housing are located. . I did not find any sign(s) or indication(s) of fluid leak and/or fluid stain(s) on the underside of the Motor Car.

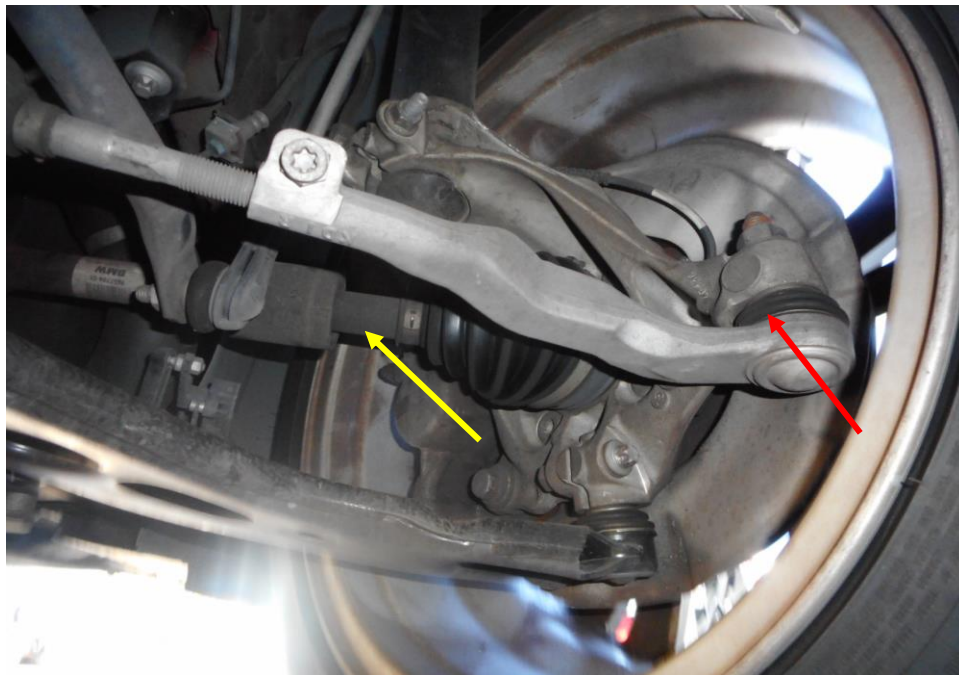
**Photo 15** shows the various undercarriage components at the front right wheel of the Motor Car, in particular the steering tie rod end (red arrowed) and drive shaft (yellow arrow). The various steering components were all found to be intact, suggesting that the steering system of the Motor Car was likely to be in serviceable condition at the material time of accident. There was also no sign of fluid stain(s) observed on the various undercarriage components.

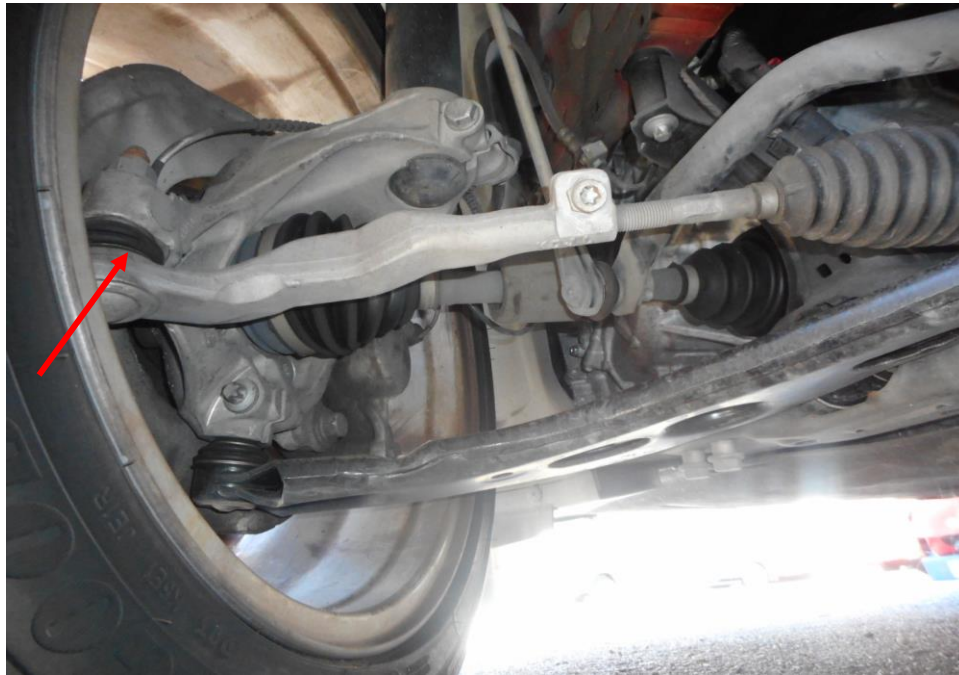
**Photo 16** shows the various undercarriage components at the front left wheel of the Motor Car, in particular the steering tie rod end (arrowed). The various Undercarriage components of the Motor Car were all found to be intact without any visible damage. There was also no sign of fluid stain(s) observed on the various undercarriage components.

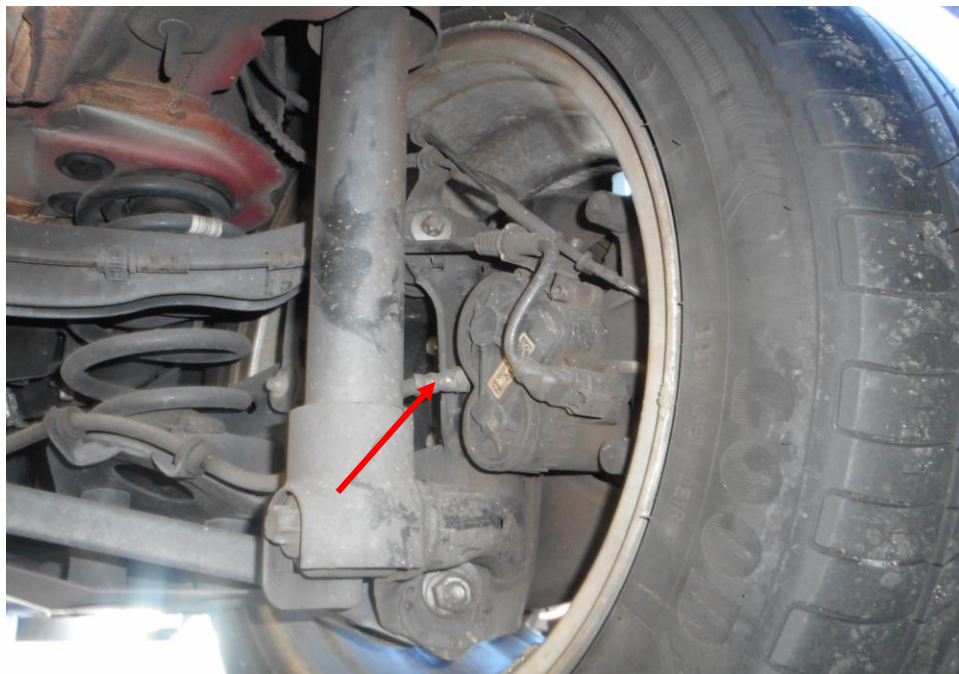
**Photo 17** shows the brake pipe (arrowed) at the rear right wheel of the Motor Car. I did not observe any leakage of brake fluid at the time of my inspection of the Motor Car. My static tests of the Motor Car's braking system, along with my visual examination of the various mechanical components in the braking system, had indicated that there was no internal leakage of pressure/vacuum. Hence the braking system of the Motor Car was likely to be in serviceable condition at the material time of accident.

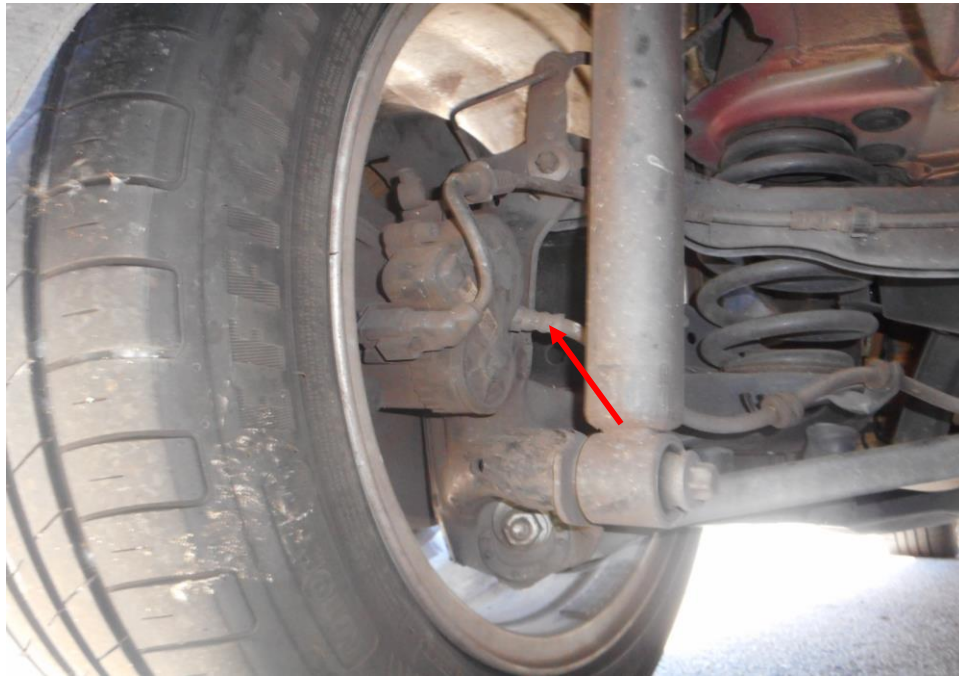
**Photo 18** shows the brake pipe (arrowed) at the rear left wheel of the Motor Car. I did not observe any leakage of brake fluid at the time of my inspection of the Motor Car. My static tests of the Motor Car's braking system, along with my visual examination of the various mechanical components in the braking system had indicated that there was no internal leakage of pressure/vacuum. Hence the braking system of the Motor Car was likely to be in serviceable condition at the material time of accident.

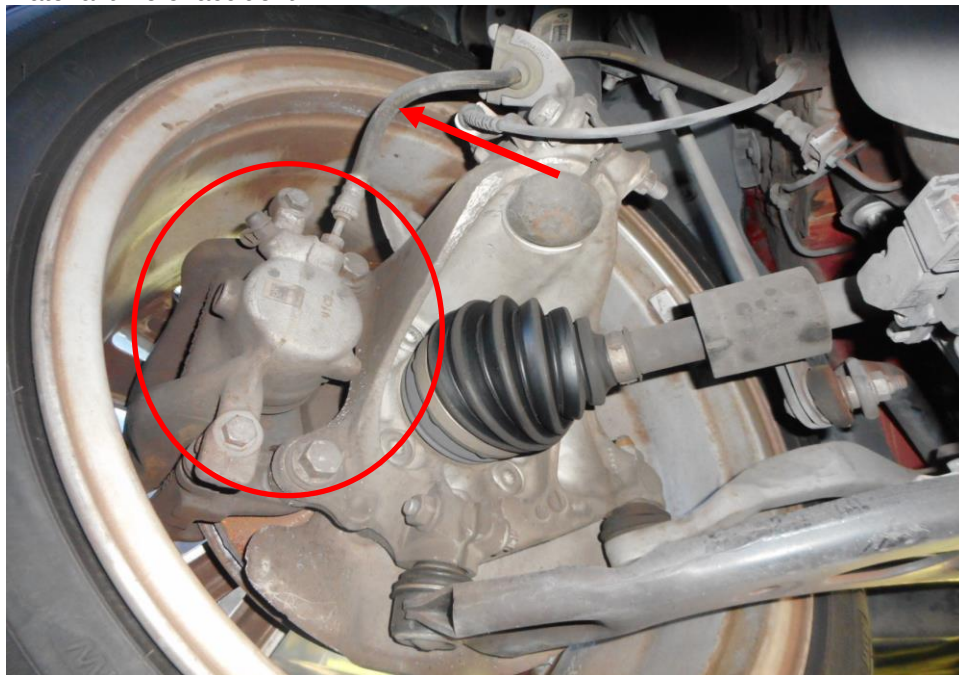
**Photo 19** shows the brake hose/pipe (arrowed) at the front right wheel of the Motor Car. No leakage of brake fluid was observed. Visual examination of the various components of the braking system like the brake caliper (circled), brake booster, brake pedal etc had revealed all to be intact and without visible damage at the time of accident. There was also no sign of fluid stain(s) observed on the various undercarriage components.

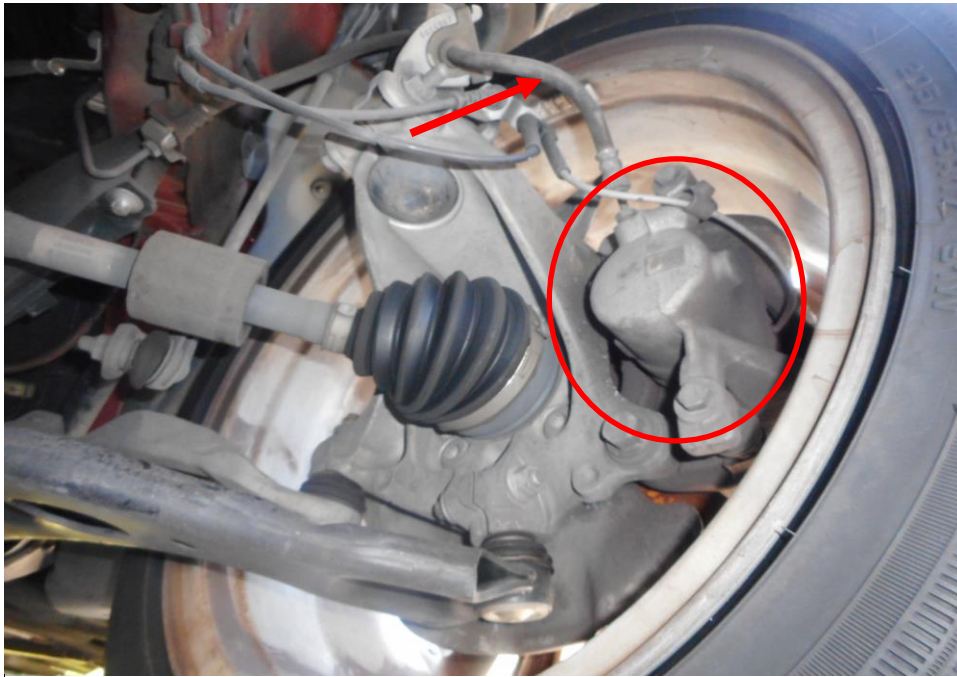
**Photo 20** shows the brake hose/pipe (arrowed) at the front left wheel of the Motor Car. No leakage of brake fluid was observed. Visual examination of the various components of the braking system like the brake caliper (circled), brake booster, brake pedal etc had revealed all to be intact and without visible damage at the time of accident. There was also no sign of fluid stain(s) observed on the various undercarriage components.

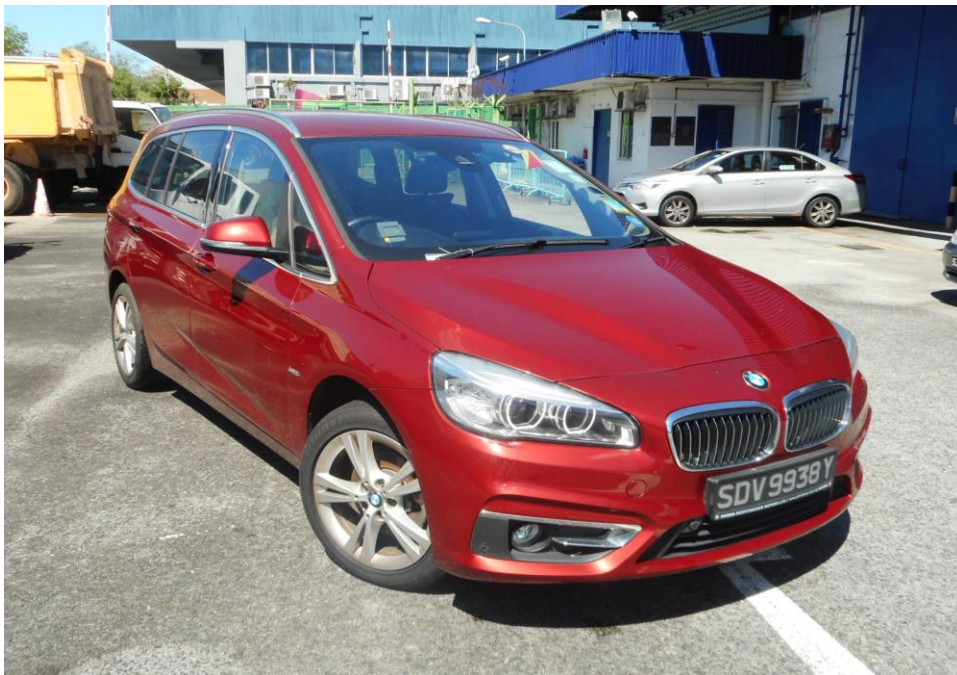
**Photo 21** shows the front right wheel of the Motor Car turned to its full left. During my steering system test, I did not experience any abnormal free play and/or resistance when I had turned the steering wheel towards full left and full right. This would suggest that the steering system of the Motor Car was likely to be in serviceable condition at the material time of accident.

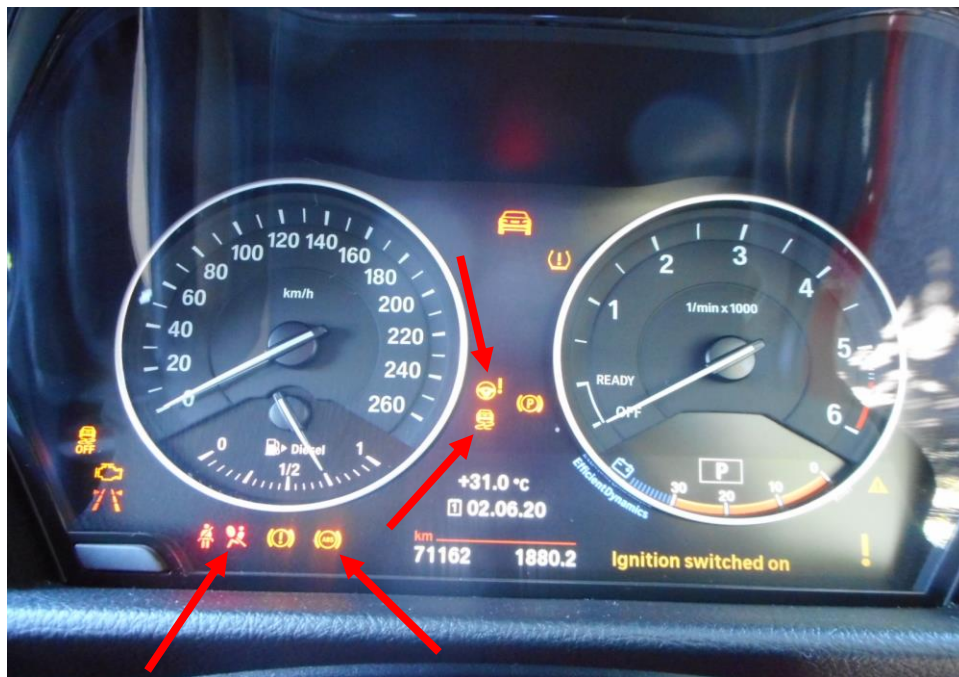
**Photo 22** shows the warning light for Anti-Lock Brake System (ABS), Traction Control (TC), Supplemental Restraint System (SRS) and Electric Power Steering System (EPS) appearing on the instrument panel of the Motor Car during the self-test of its various electronic operating systems when its engine was cranked.

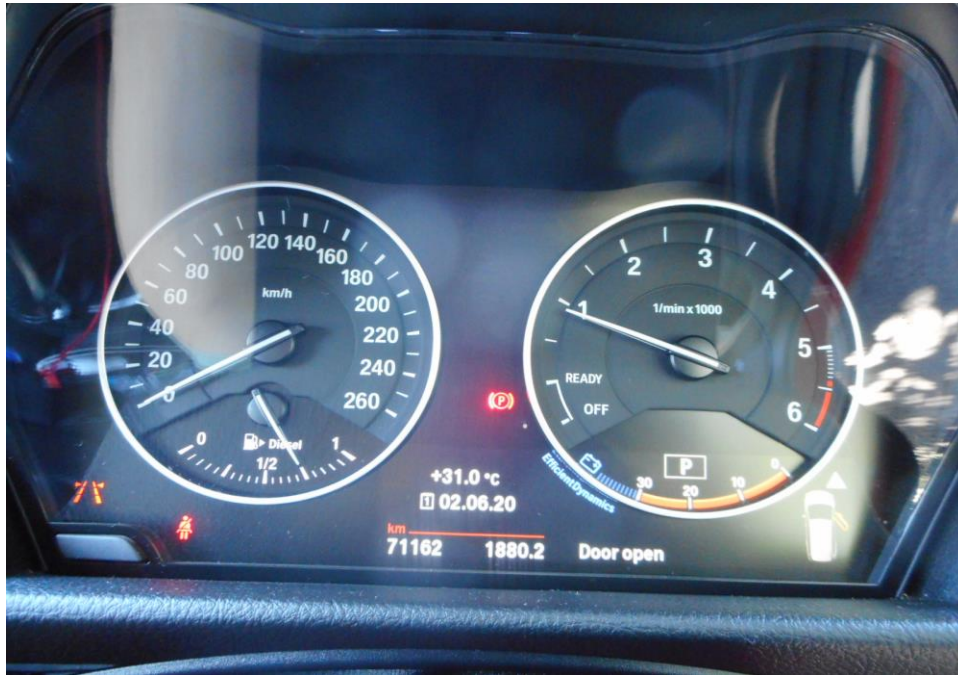
**Photo 23** shows no warning lights illuminated on the instrument panel of the Motor Car after the engine was cranked. This would suggest that there was no abnormality to the various electronic operating systems of the Motor Car, like the ABS, TC, SRS and EPS.
