Your Ref: TP/IP/11513/2019  
Our Ref : CI/TPD20004868/P

### **Fatal Accident Investigation Team**

### **MECHANICAL INSPECTION REPORT OF MOTOR LORRY YP 4978Y**

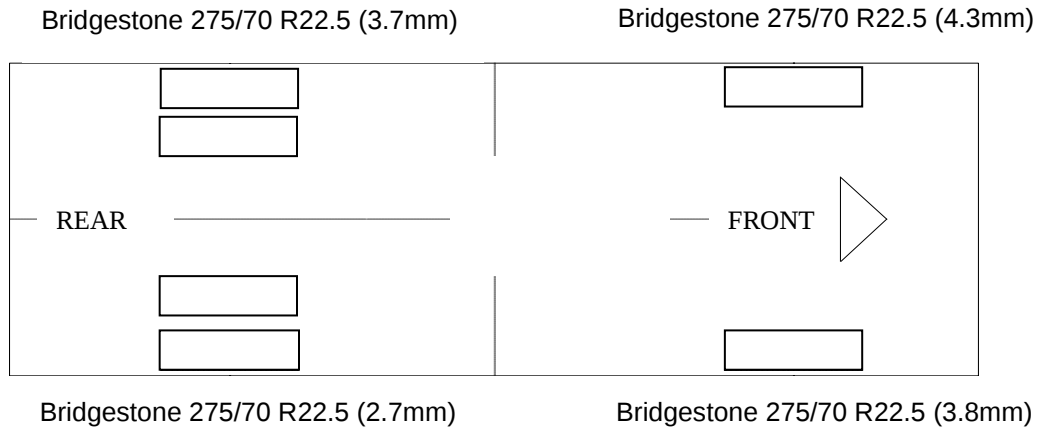
6. The 6 tyres of the Motor Lorry was observed to be in serviceable condition; sufficiently inflated for vehicular operation. I did not find any tear, cut or burst mark(s) on the outer and the inner sidewalls as well as across the tread of the 6 tyres. The tyre brand, tyre size and remaining tread depth of the 6 tyres of the Motor Lorry were recorded as follows:-

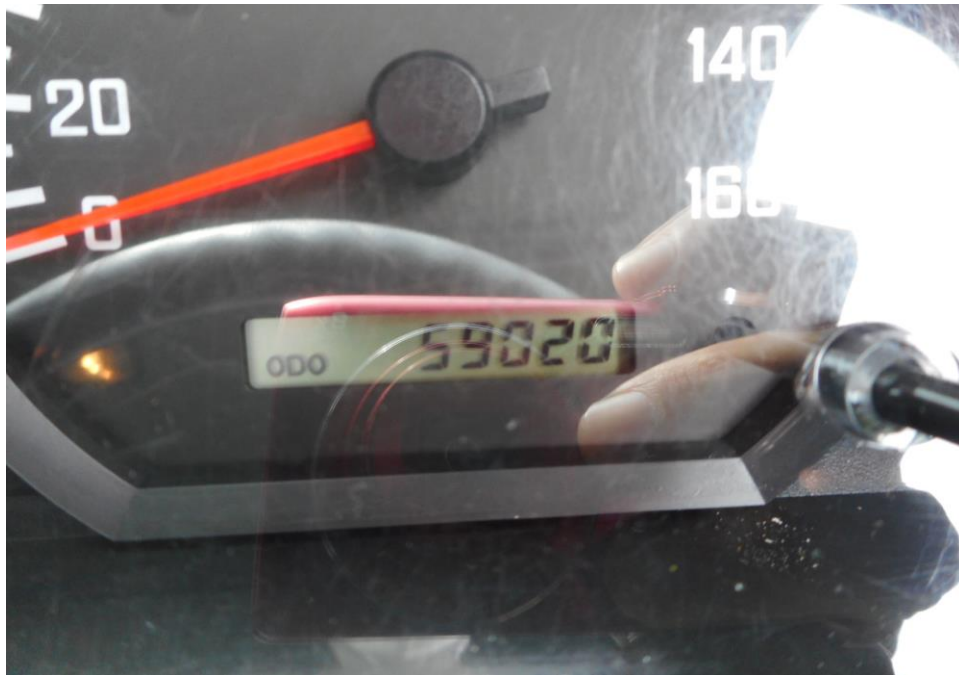
**Photo 1** shows a general view of the instrument cluster of the Motor Lorry at the time of my inspection. The mileage of the Motor Lorry was 59,020m

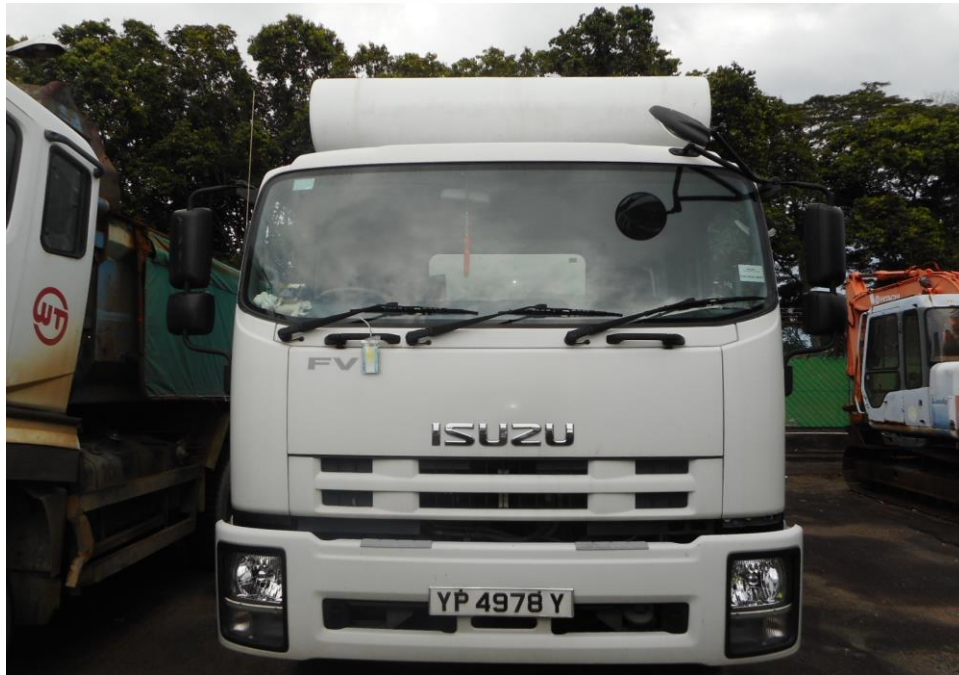
**Photo 2** shows a general view of the Motor Lorry's frontal portion at the time of my inspection. The Motor Lorry was observed to be intact and unaffected by the accident.

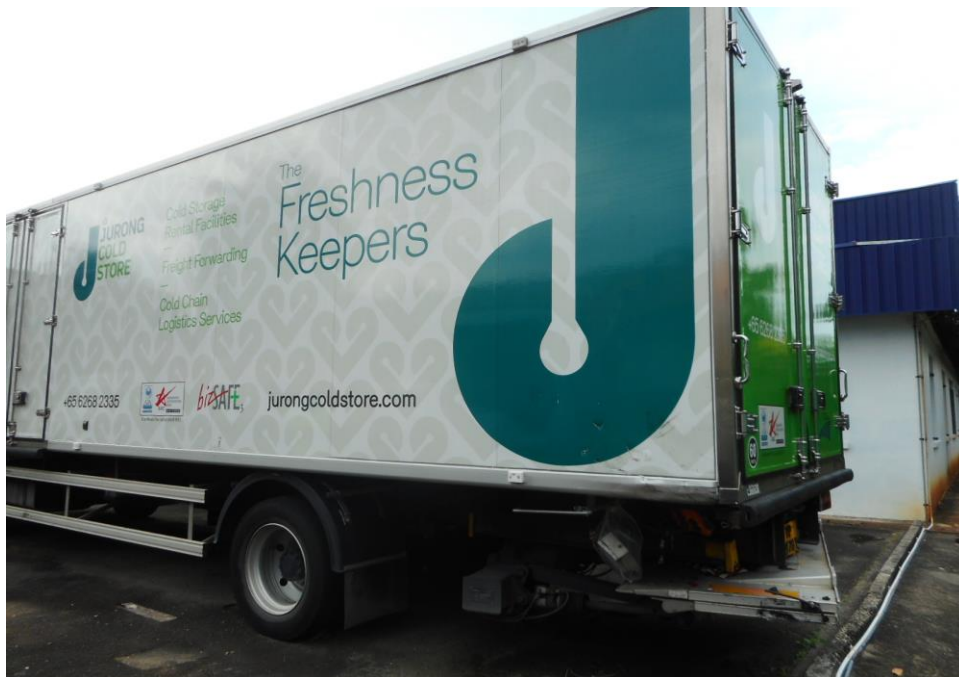
4. The mileage of the Motor Lorry at the time of my inspection was 59,020km.
5. The Motor Lorry was observed to have sustained damage at its left rear portion. Its left side body panel and rear tailgate was damaged as a result of the accident.

**Photo 3** shows a general view of the left body of the Motor Lorry at the time of my inspection. The Motor Lorry was observed to have sustained damage at its left side body panel and rear tailgate as a result of the accident.

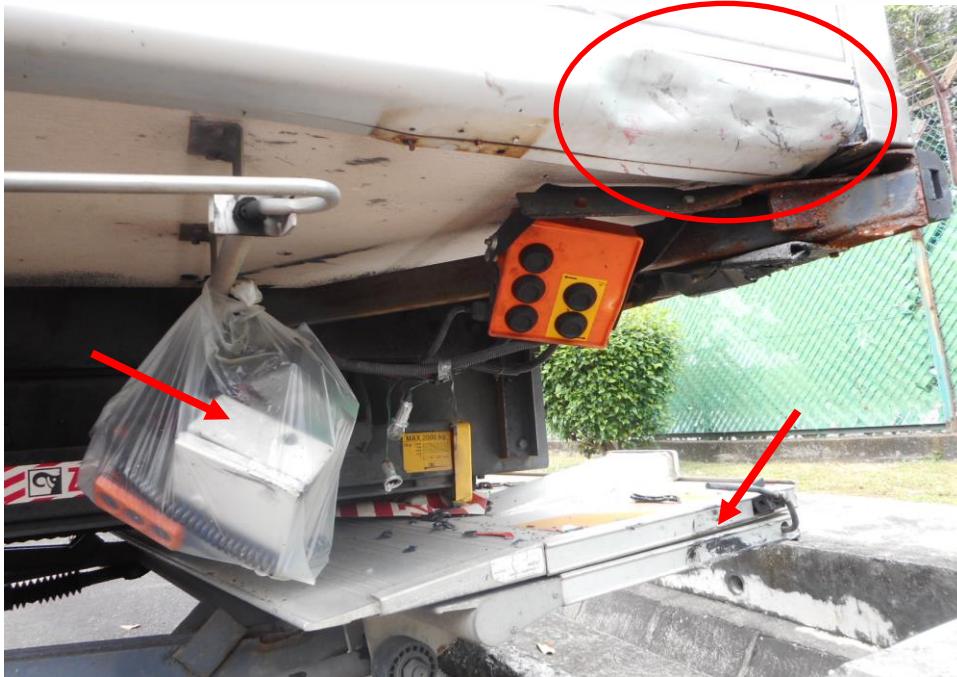
**Photo 4** shows a close up view of the left body of the Motor Lorry at the time of my inspection. The Motor Lorry was observed to have sustained damage at its left side body panel (circled) and rear tailgate (arrowed) as a result of the accident.

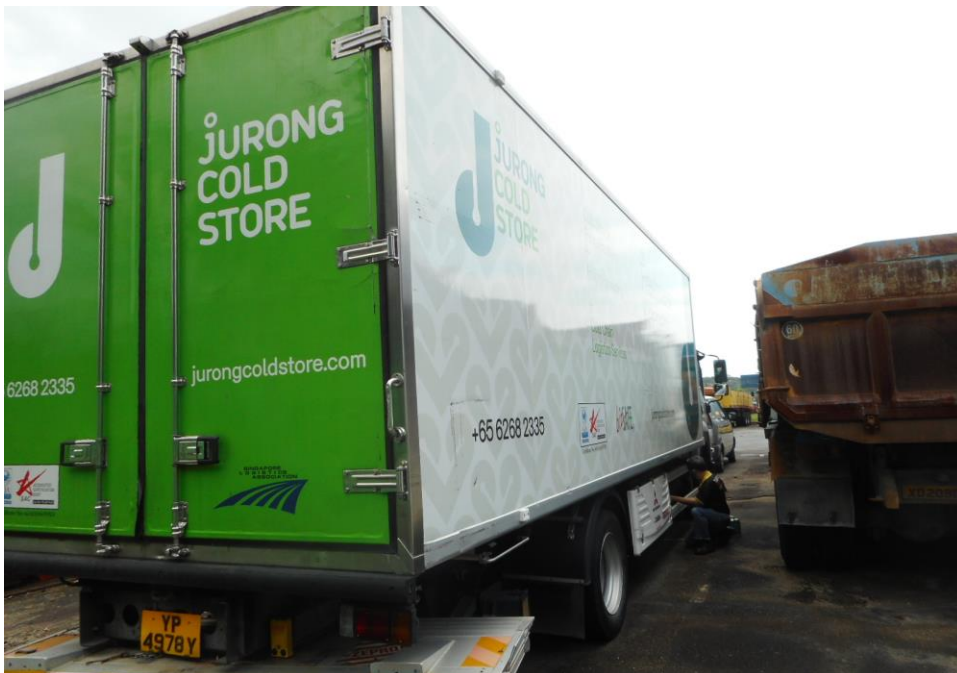
**Photo 5** shows a general view of the right body of the Motor Lorry at the time of my inspection. The Motor Lorry was observed to be intact and unaffected by the accident.

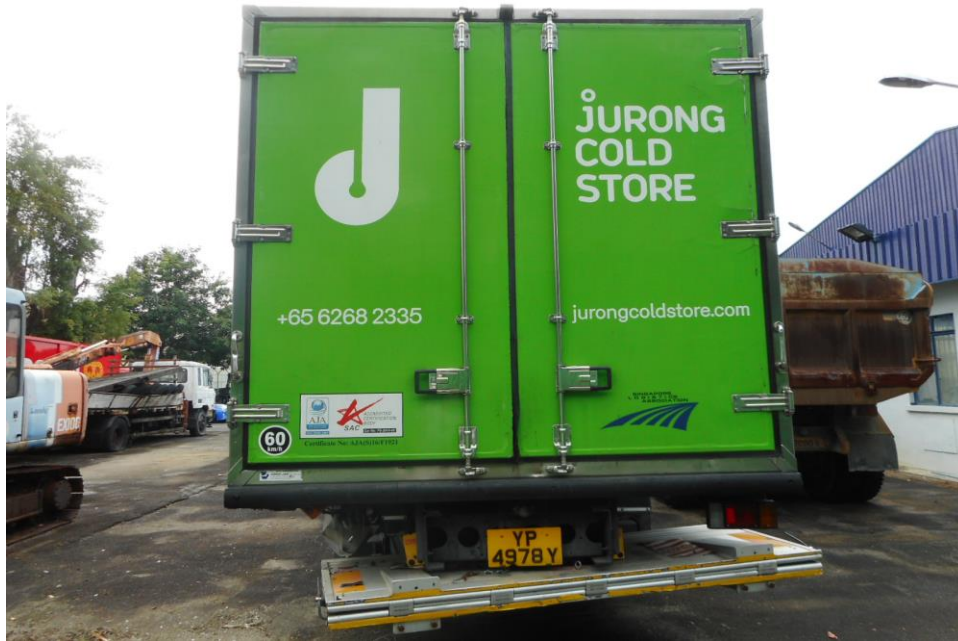
**Photo 6** shows a general view of the rear body of the Motor Lorry at the time of my inspection. The Motor Lorry was observed to be intact and unaffected by the accident.

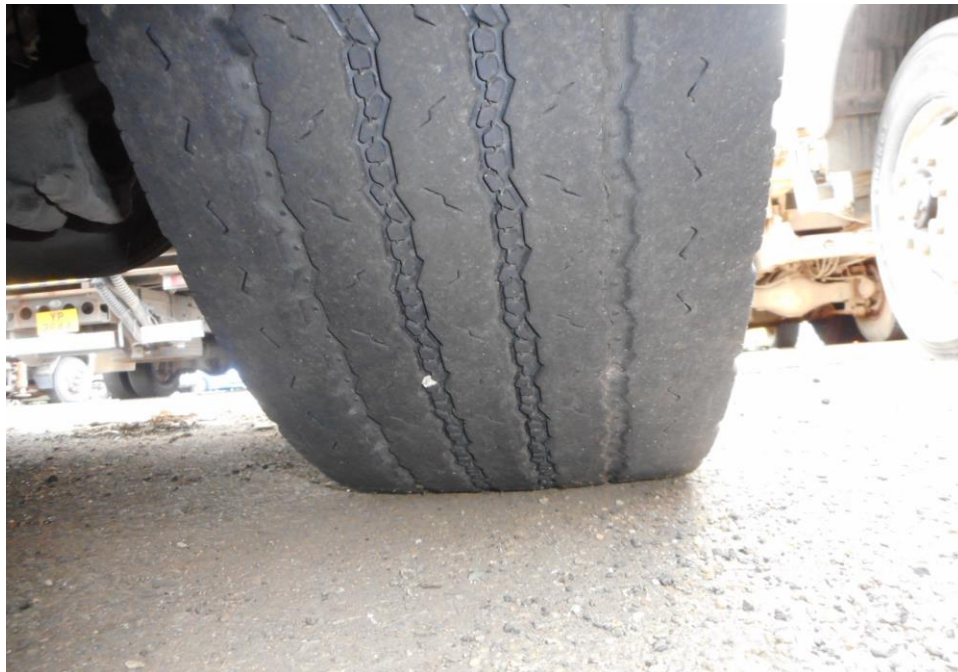
**Photo 7** shows the condition of the front right tyre of the Motor Lorry, which was observed to be in serviceable condition with remaining tread depth of approximately 3.8mm. The tyre, which was wrapped around standard steel wheel rim, was also observed to be sufficiently inflated for vehicular operation. There was no tear, cut or burst mark(s) on the outer and the inner sidewalls as well as across the tread of the 6 tyres that were fitted on the Motor Lorry.

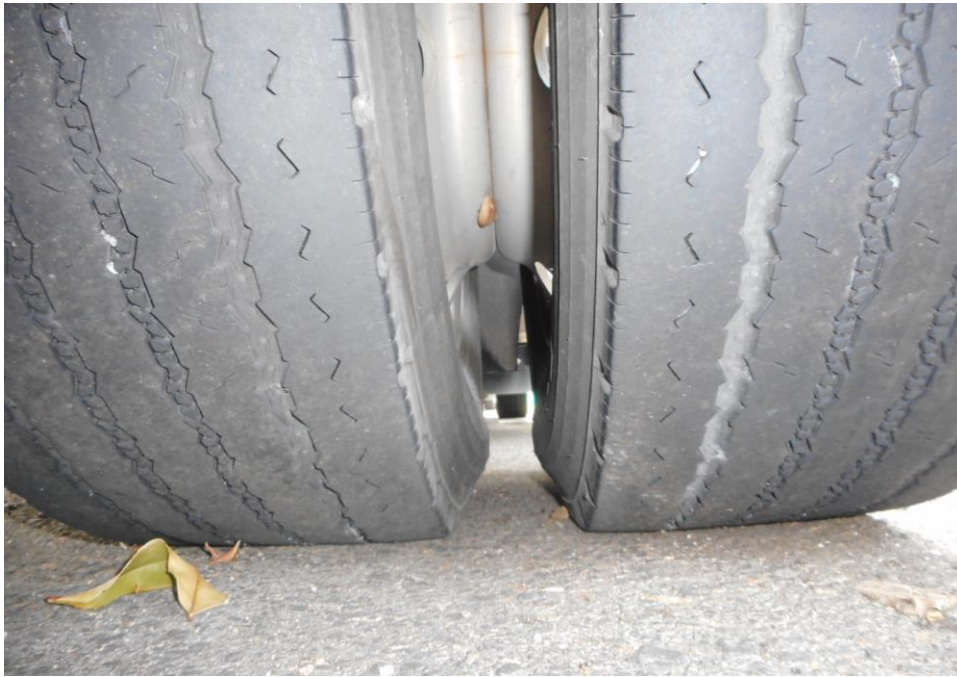
**Photo 8** shows the condition of the rear right tyres of the Motor Lorry, which was observed to be in serviceable condition with remaining, tread depth of approximately 2.7mm. The tyres, which were wrapped around standard steel wheel rim, were also observed to be sufficiently inflated for vehicular operation. There was also no damage found on all 6 steel wheel rims of the Motor Lorry.

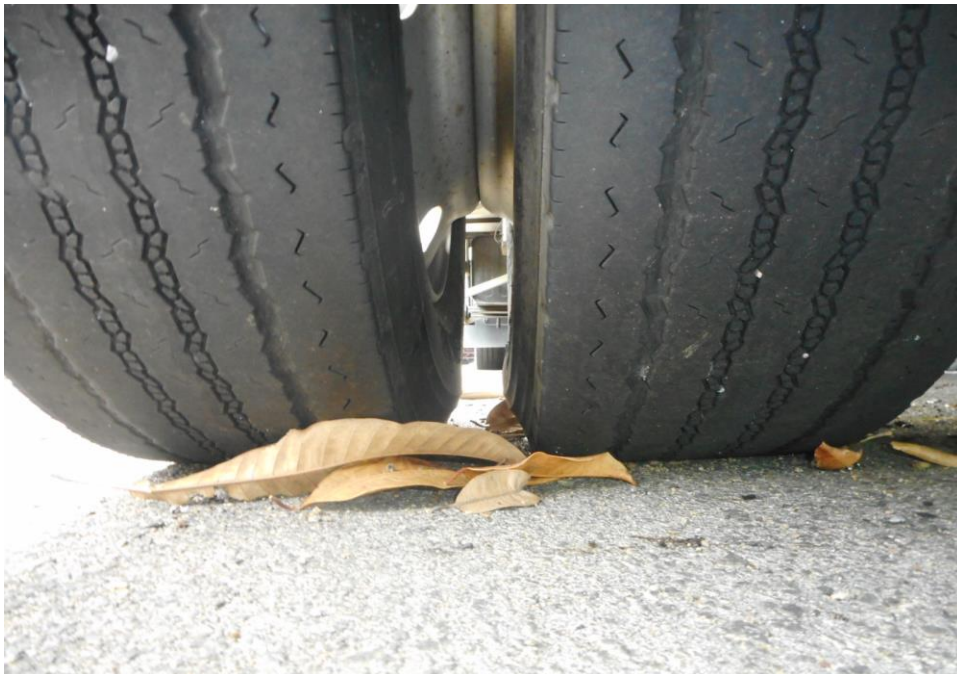
**Photo 9** the condition of the rear left tyres of the Motor Lorry, which was observed to be in serviceable condition with remaining, tread depth of approximately 3.7mm. The tyres, which were wrapped around standard steel wheel rim, were also observed to be sufficiently inflated for vehicular operation. There was also no damage found on all 6 steel wheel rims of the Motor Lorry.

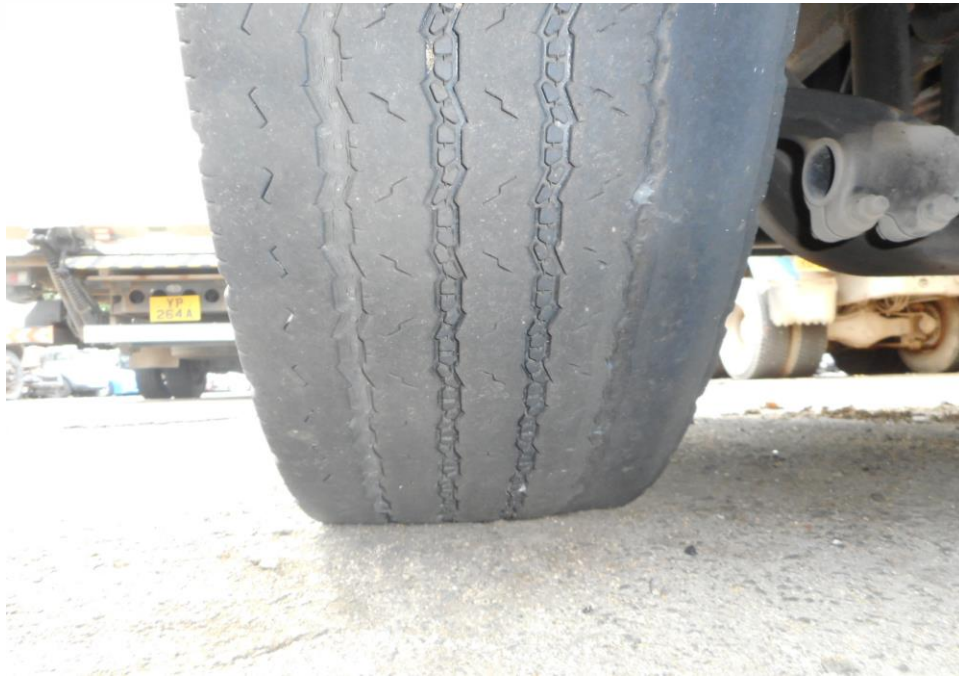
**Photo 10** shows the condition of the front left tyre of the Motor Lorry, which were observed to be in serviceable condition with remaining, tread depth of approximately 4.3mm. There was also no tear, cut or burst mark(s) on the outer and the inner sidewalls as well as across the tread of the 6 tyres that were fitted on the Motor Lorry.

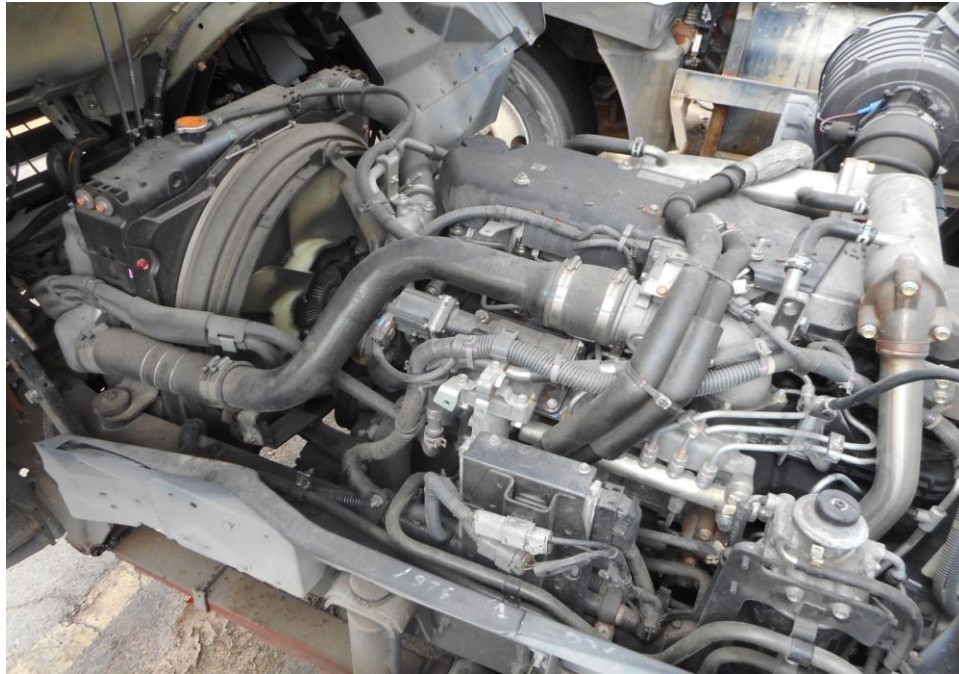
**Photo 11** shows a general view of the Motor Lorry's engine compartment, which was accessed by lifting the front cabin of the Motor Lorry. The various parts and components inside the engine compartment were unaffected by the accident. There was also no sign(s) or indication(s) of fresh fluid leakage and/or fluid stain within the engine compartment

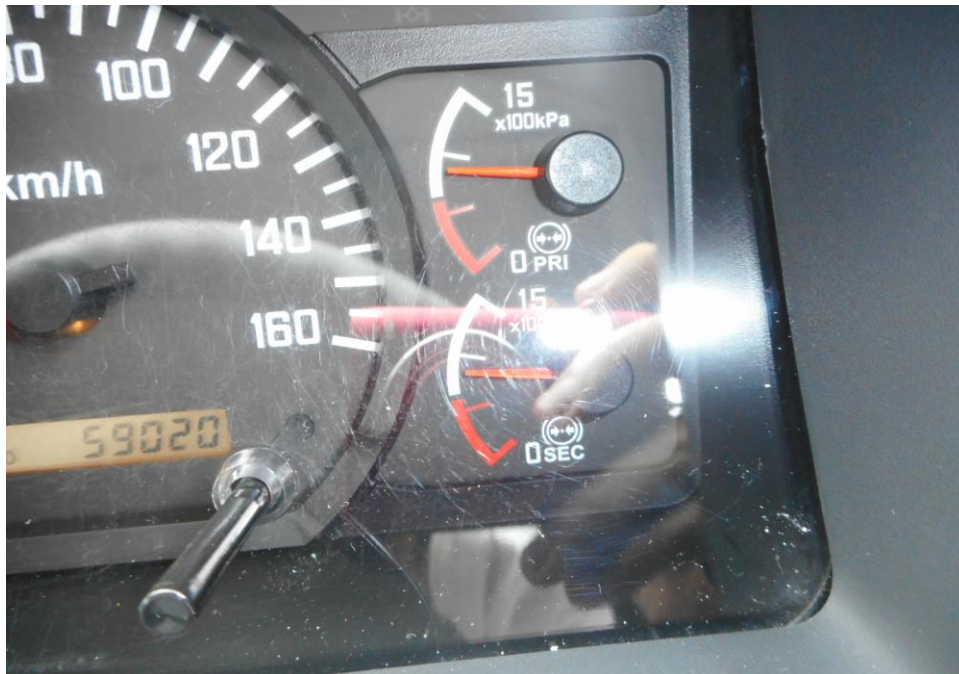
**Photo 13** shows the air in the air brake cylinders of the Motor Lorry at the time of my inspection. The air in the cylinder was observed to be of sufficient level & serviceable at the time of the accident.

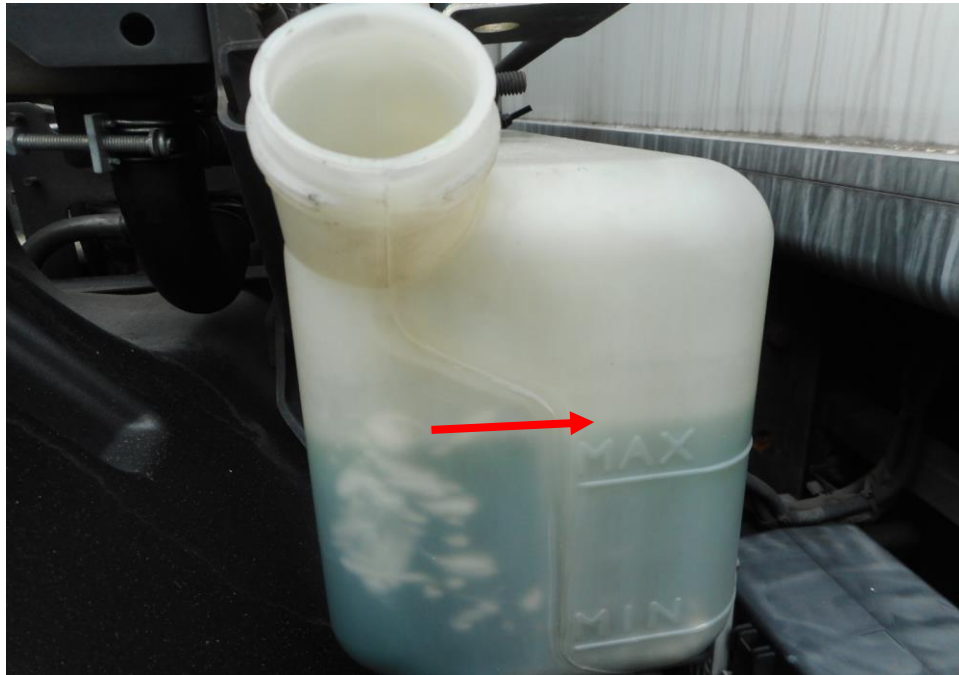
**Photo 13** shows the engine coolant reservoir of the Motor Lorry at the time of my inspection. The engine coolant was observed to be of sufficient level (arrowed) and without any visible contamination.

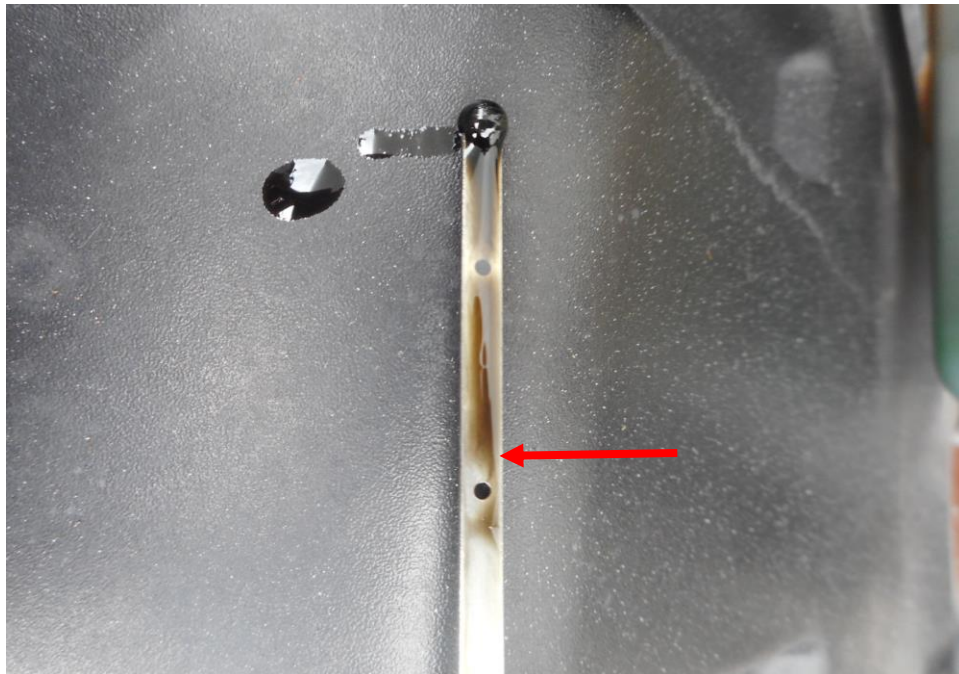
**Photo 14** shows the engine oil dip stick of the Motor Lorry at the time of my inspection. The engine oil was observed to be of sufficient level (arrowed) and without any visible contamination.

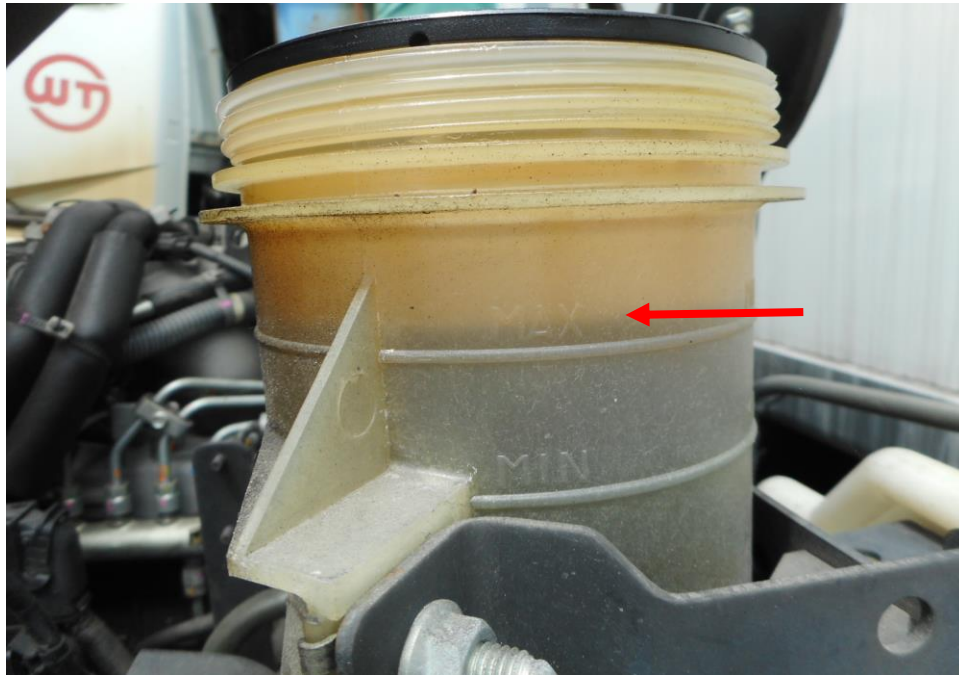
**Photo 15** shows the power steering fluid reservoir of the Motor Lorry at the time of my inspection. The power steering fluid (arrowed) was observed to be of sufficient level and without any visible contamination.

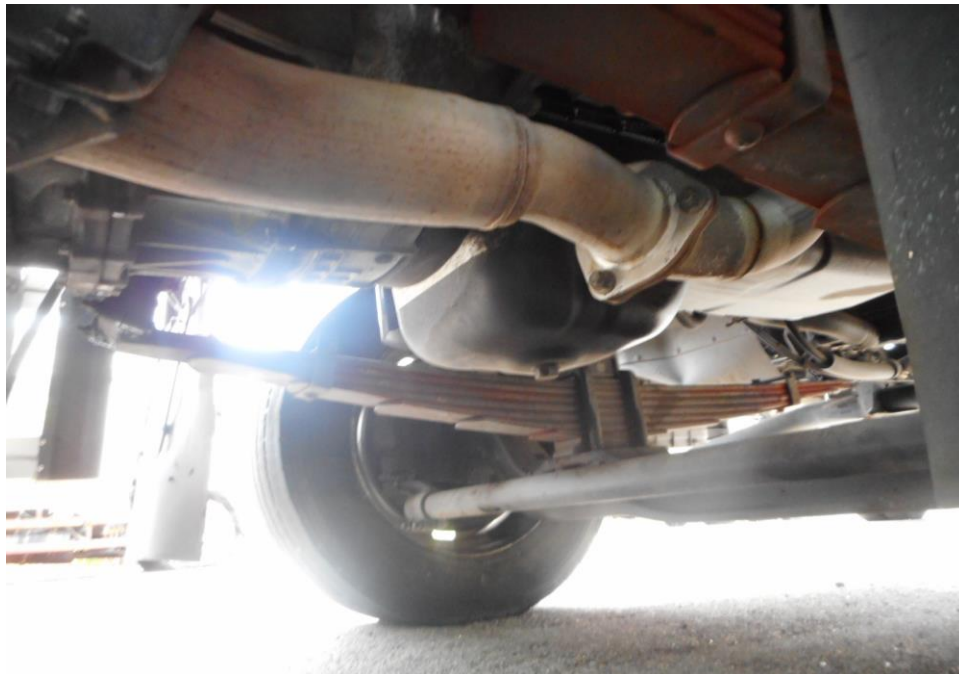
**Photo 16** shows the undercarriage of the Motor Lorry, at the area where the engine housing and transmission housing are located. I did not observe any leakage or fluid stain on the underside of the Motor Lorry.

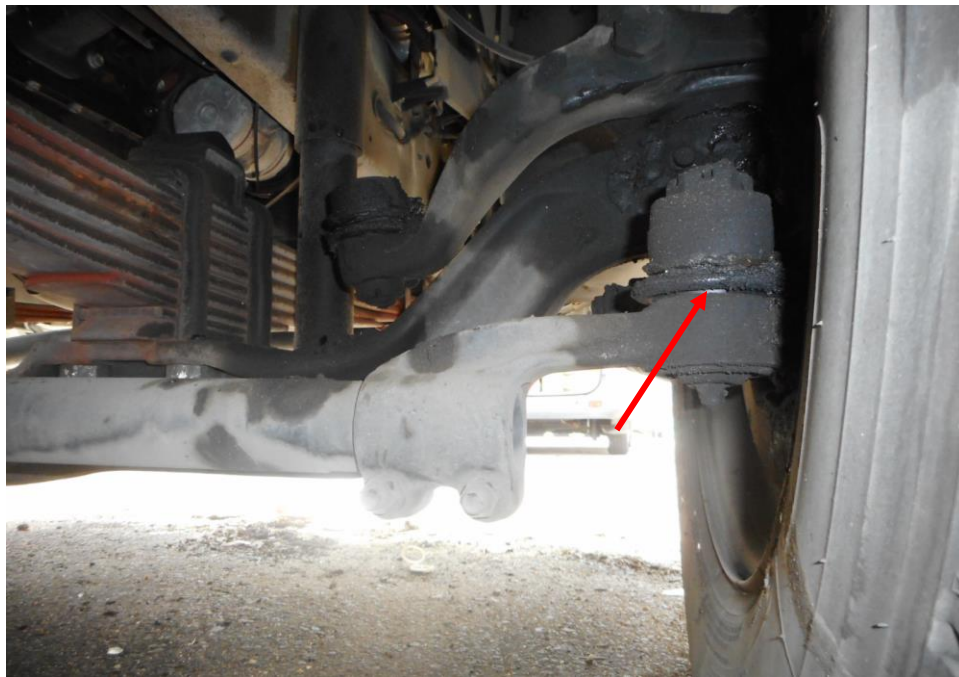
**Photo 17** shows the various undercarriage components at the front right wheel of the Motor Lorry, in particular the steering tie rod end (arrowed). The various steering components were all found to be intact, suggesting that the steering system of the Motor Lorry was likely to be in serviceable condition at the material time of accident. There was also no sign of fluid stain(s) observed on the various undercarriage components.

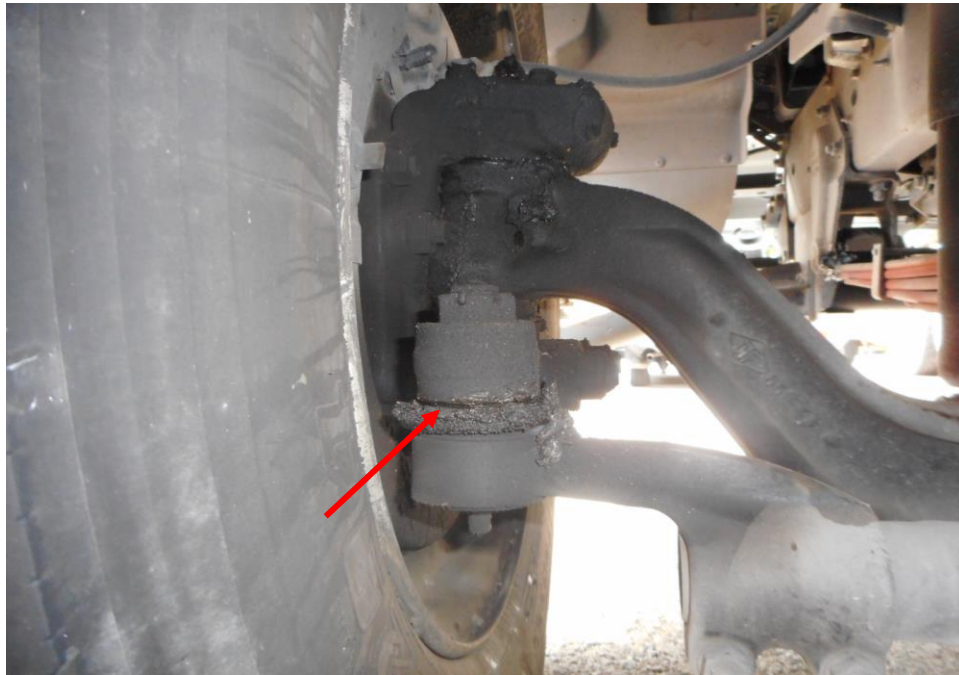
**Photo 18** shows the various undercarriage components at the front left wheel of the Motor Lorry, in particular the steering tie rod end (arrowed). The various Undercarriage components of the Motor Lorry were all found to be intact without any visible damage. There was also no sign of fluid stain(s) observed on the various undercarriage components.

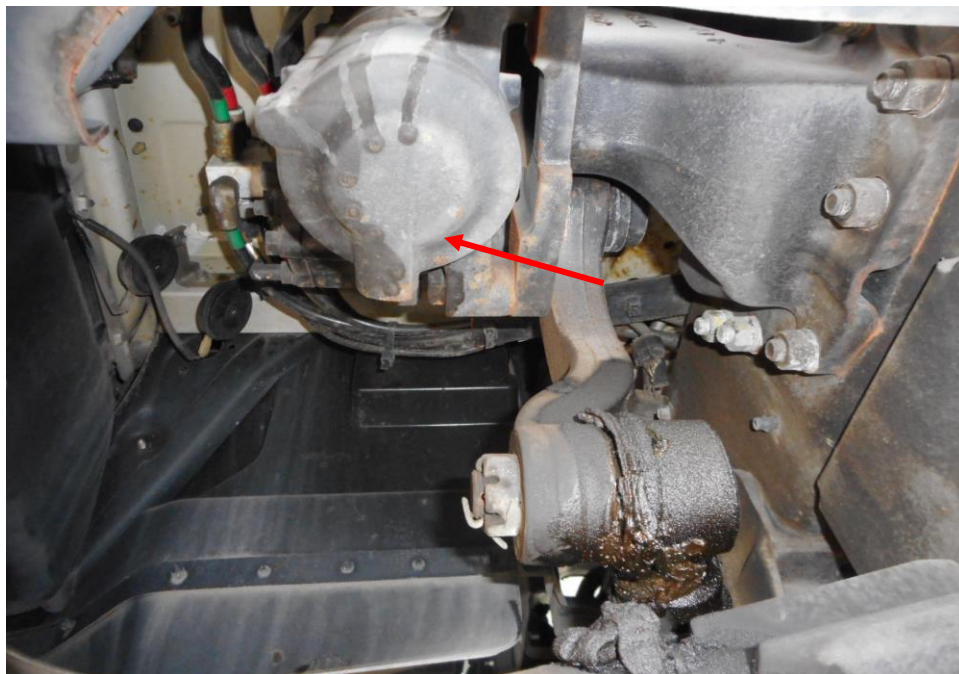
**Photo 19** shows the steering box component (arrowed) at the undercarriage of the Motor Lorry was found to be intact without any visible damage. There was also no sign of fluid stain(s) observed on the various undercarriage components.

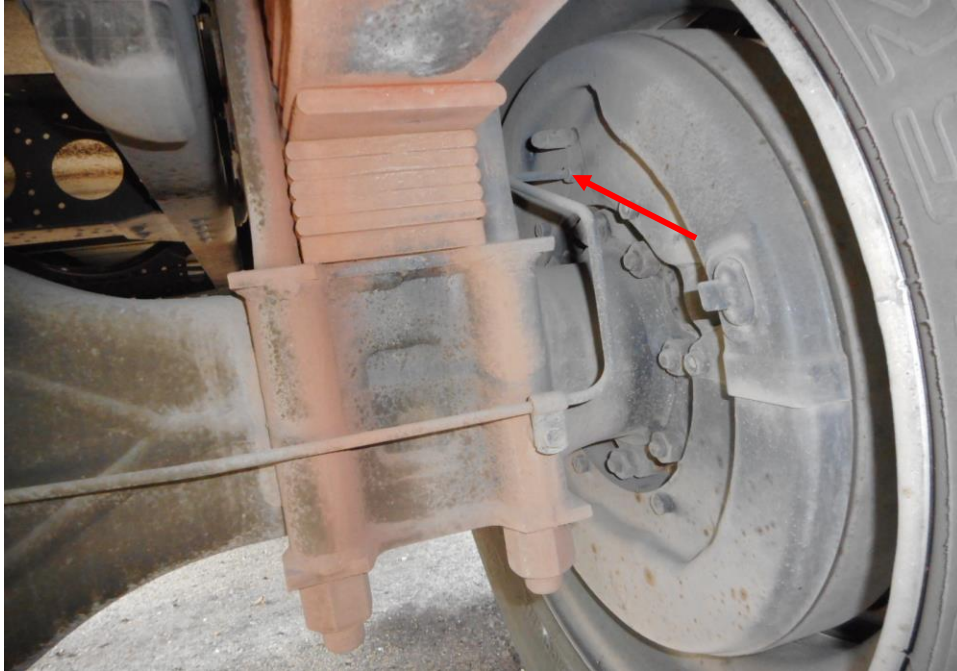
**Photo 20** shows the brake pipe (arrowed) at the rear right wheel of the Motor Lorry. I did not observe any leakage of brake fluid at the time of my inspection of the Motor Lorry. My static tests of the Motor Lorry's braking system, along with my visual examination of the various mechanical components in the braking system, had indicated that there was no internal leakage of pressure/vacuum. Hence the braking system of the Motor Lorry was likely to be in serviceable condition at the material time of accident.

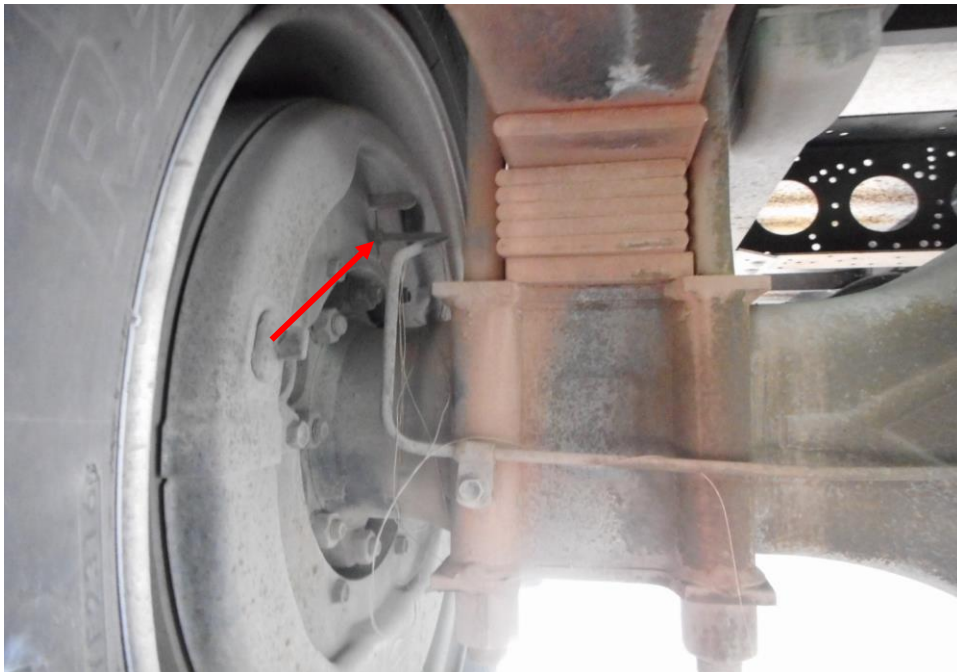
**Photo 21** shows the brake pipe (arrowed) at the rear left wheel of the Motor Lorry. I did not observe any leakage of brake fluid at the time of my inspection of the Motor Lorry. My static tests of the Motor Lorry's braking system, along with my visual examination of the various mechanical components in the braking system had indicated that there was no internal leakage of pressure/vacuum. Hence the braking system of the Motor Lorry was likely to be in serviceable condition at the material time of accident.

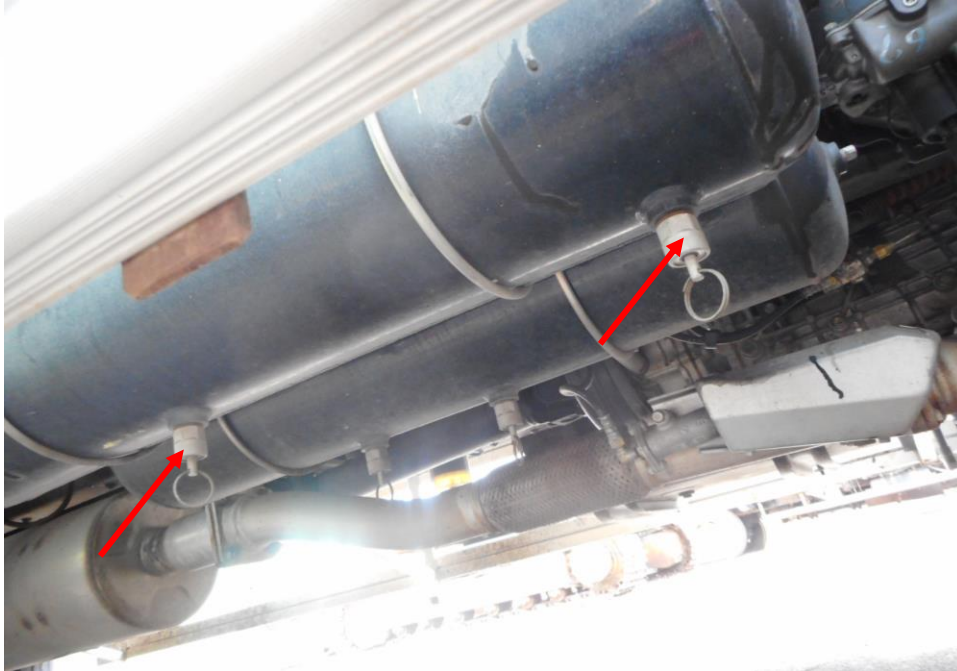
**Photo 22** shows the air brake cylinders (arrowed) at the undercarriage of the Motor Lorry. I did not observe any leakage of air brake fluid at the time of my inspection of the Motor Lorry. My static tests of the Motor Lorry's braking system, along with my visual examination of the various mechanical components in the braking system had indicated that there was no internal leakage of pressure/vacuum. Hence the braking system of the Motor Lorry was likely to be in serviceable condition at the material time of accident.

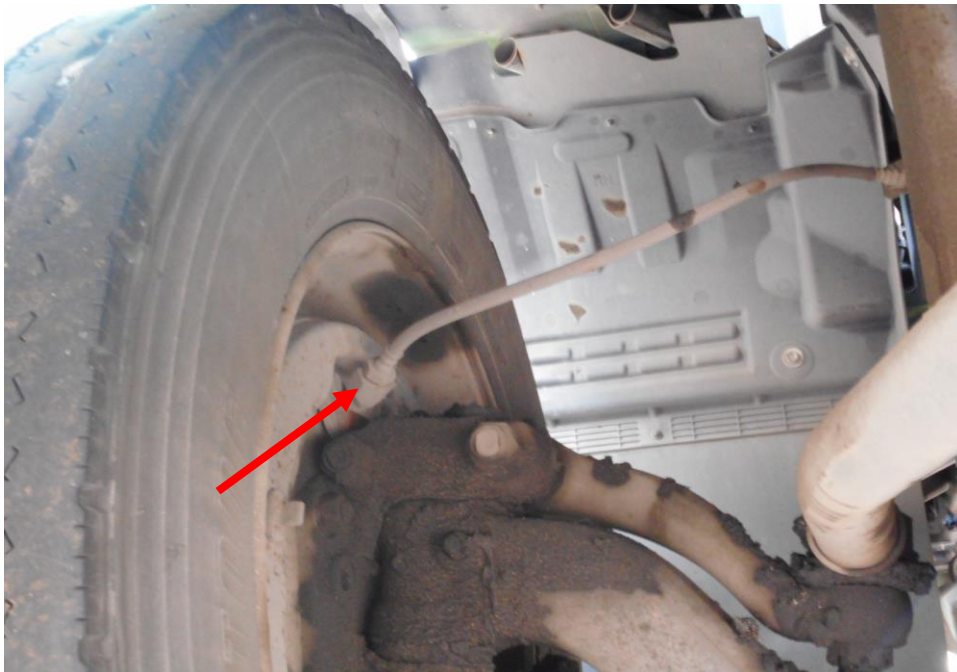
**Photo 23** shows the brake hose/pipe (arrowed) at the front right wheel of the Motor Lorry. I did not observe any leakage of brake fluid at the time of my inspection of the Motor Lorry. My static tests of the Motor Lorry's braking system, along with my visual examination of the various mechanical components in the braking system had indicated that there was no internal leakage of pressure/vacuum. Hence the braking system of the Motor Lorry was likely to be in serviceable condition at the material time of accident.

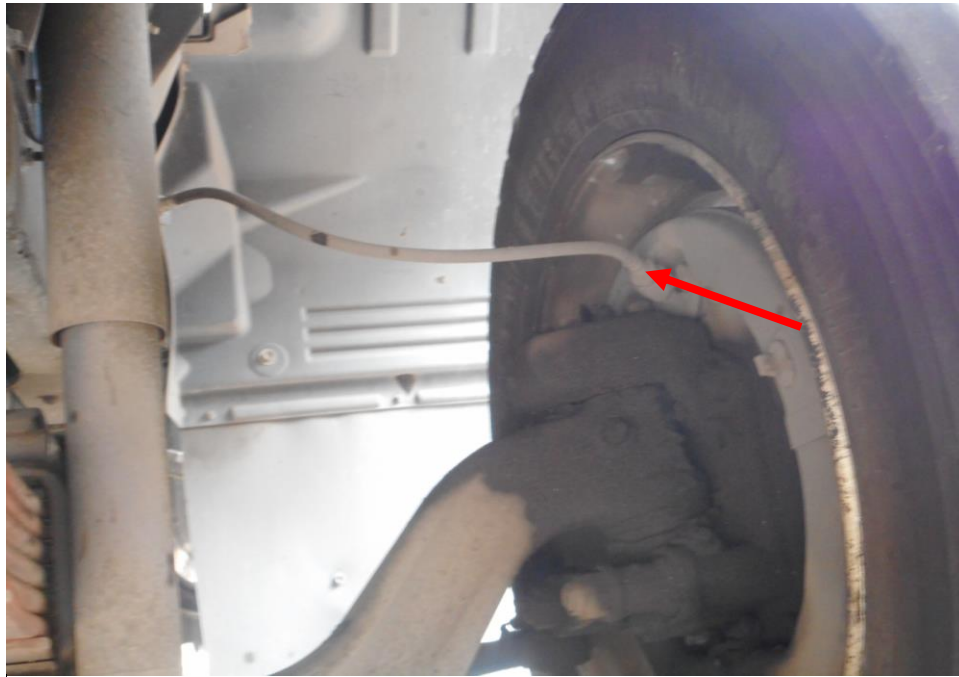
**Photo 24** shows the brake hose/pipe (arrowed) at the front left wheel of the Motor Lorry. I did not observe any leakage of brake fluid at the time of my inspection of the Motor Lorry. My static tests of the Motor Lorry's braking system, along with my visual examination of the various mechanical components in the braking system had indicated that there was no internal leakage of pressure/vacuum. Hence the braking system of the Motor Lorry was likely to be in serviceable condition at the material time of accident.

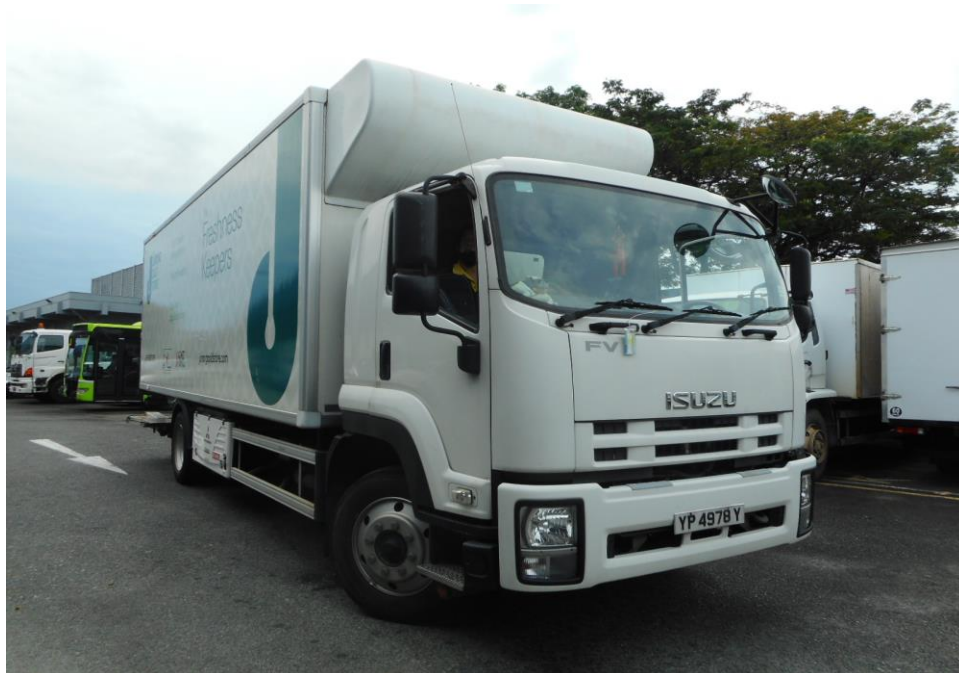
**Photo 25** shows the front right wheel of the Motor Lorry turned to its full left. During my steering system test, I did not experience any abnormal free play and/or resistance when I had turned the steering wheel towards full left and full right. This would suggest that the steering system of the Motor Lorry was likely to be in serviceable condition at the material time of accident.
