Your Ref: TP/IP/08817/2020  
Our Ref : CI/TPD20004873/P

**Fatal Accident Investigation Team**

**MECHANICAL INSPECTION REPORT OF MOTOR TAXI SHF 74K**

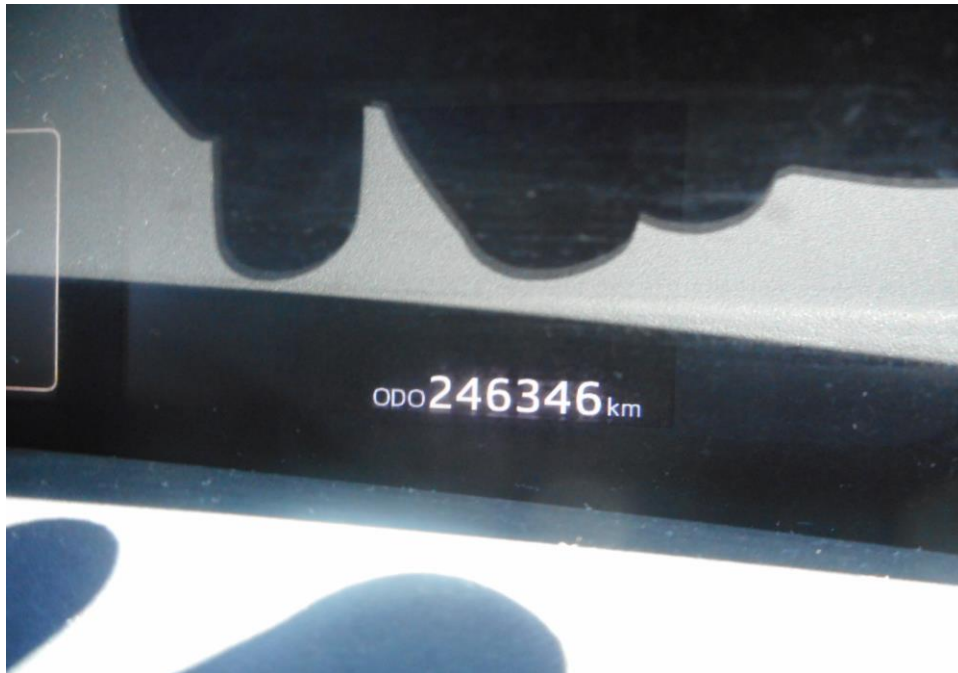
4. The mileage of the Motor Taxi at the time of my inspection was 246,346km.
5. There was visible damage observed on Motor Taxi's front bumper and front left headlamp at the time of my inspection.

**Photo 1** shows a general view of the instrument cluster of the Motor Taxi at the time of my inspection. The mileage of the Motor Taxi was 246,346km

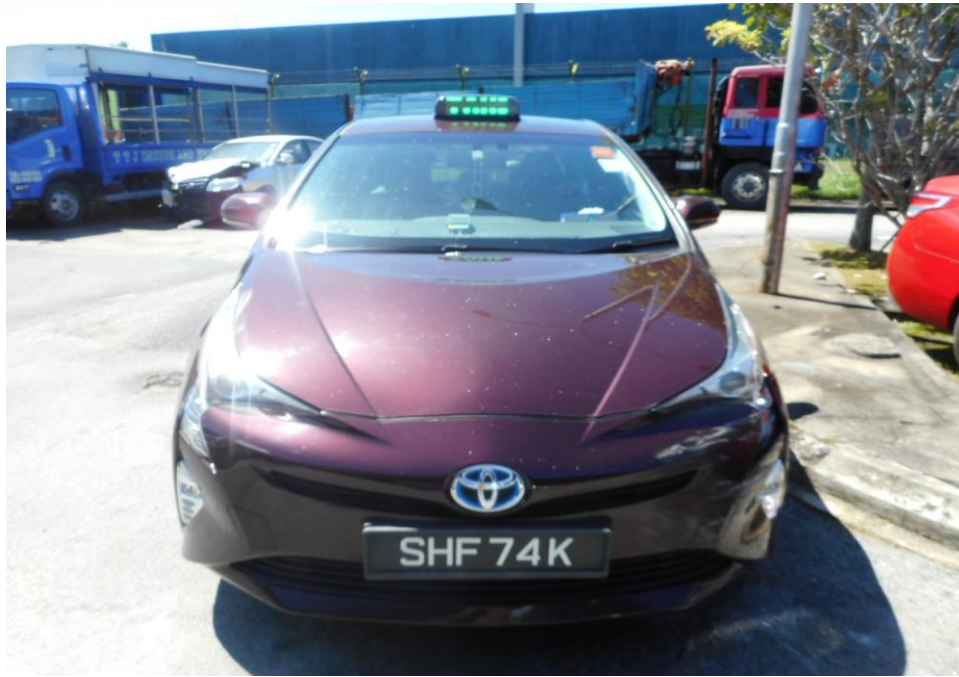
**Photo 2** shows a general view of the Motor Taxi front portion at the time of my inspection. The Motor Taxi was observed to visually sustain damage at its front bumper and front left headlamp at the time of inspection.

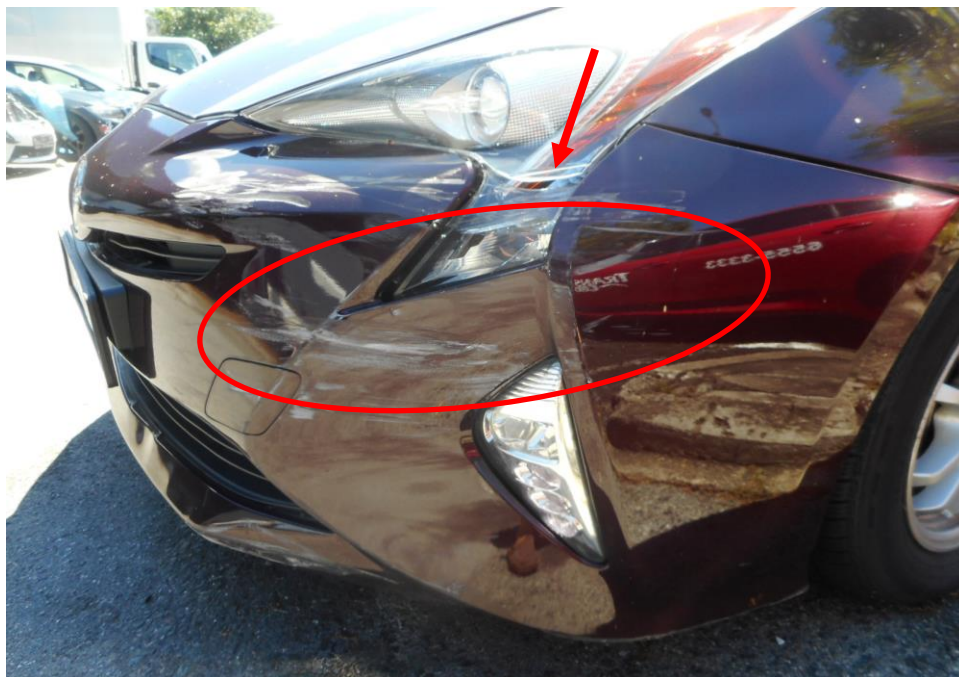
**Photo 3** shows a close up view of the front body of the Motor Taxi at the time of my inspection. The Motor Taxi was observed to visually sustain damage at its front bumper (circled) and front left headlamp (arrowed) at the time of inspection.

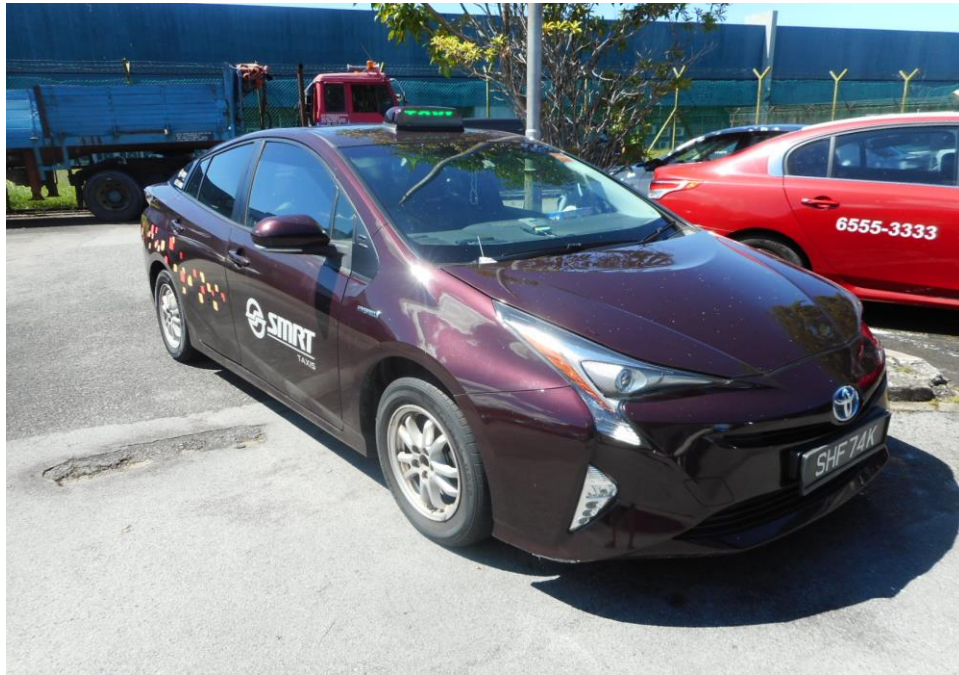
**Photo 4** shows a general view of the right body of the Motor Taxi at the time of my inspection. The Motor Taxi was observed to be intact and unaffected by the accident.

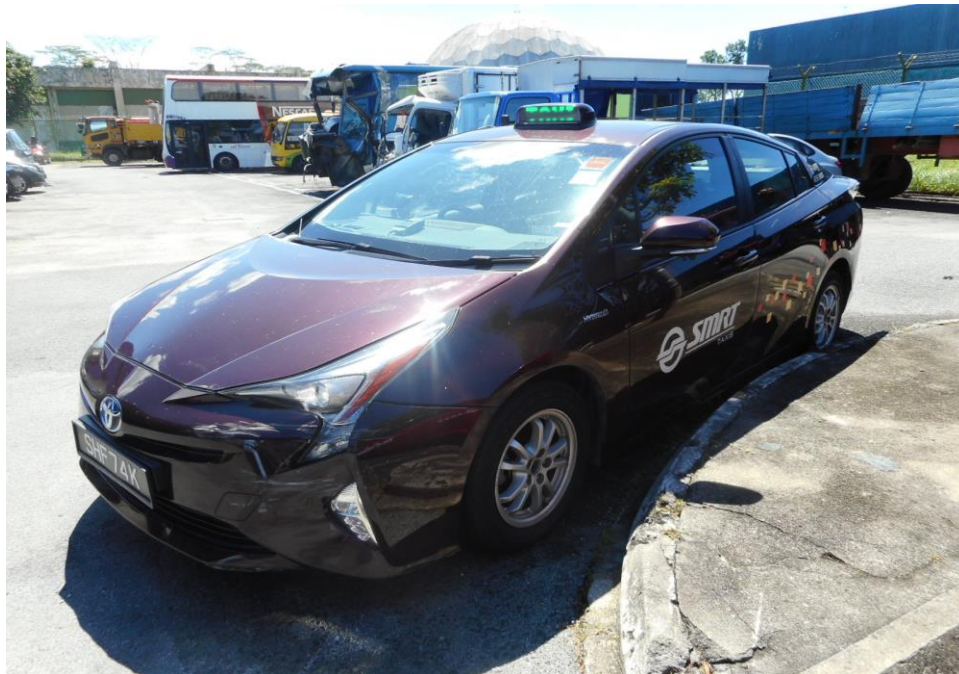
**Photo 5** shows a general view of the left body of the Motor Taxi at the time of my inspection. The Motor Taxi was observed to be intact and unaffected by the accident.

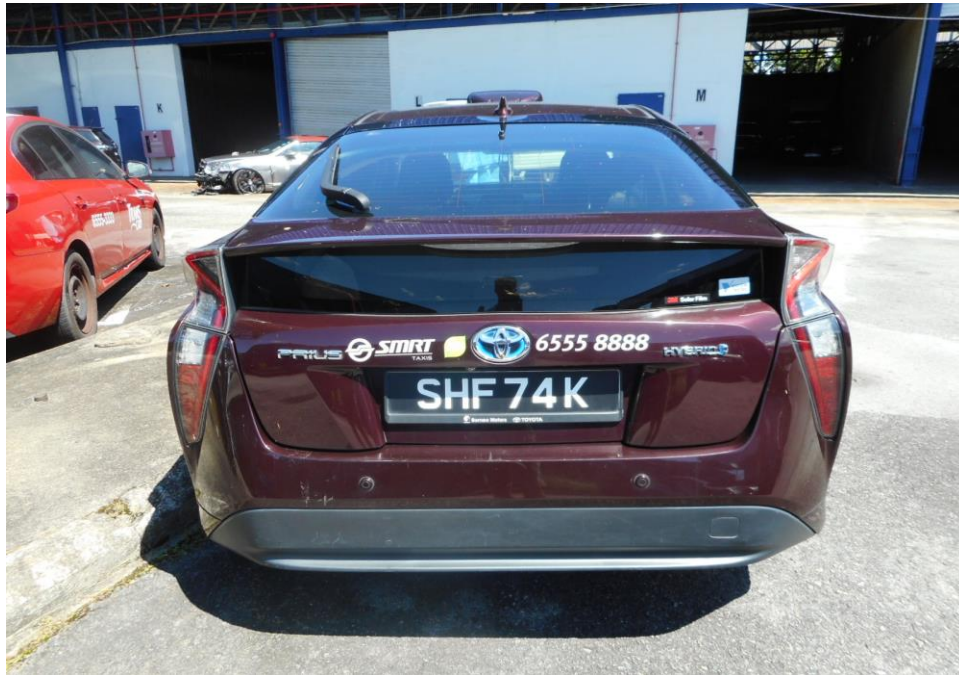
**Photo 6** shows a general view of the rear body of the Motor Taxi at the time of my inspection. The Motor Taxi was observed to be intact and unaffected by the accident.

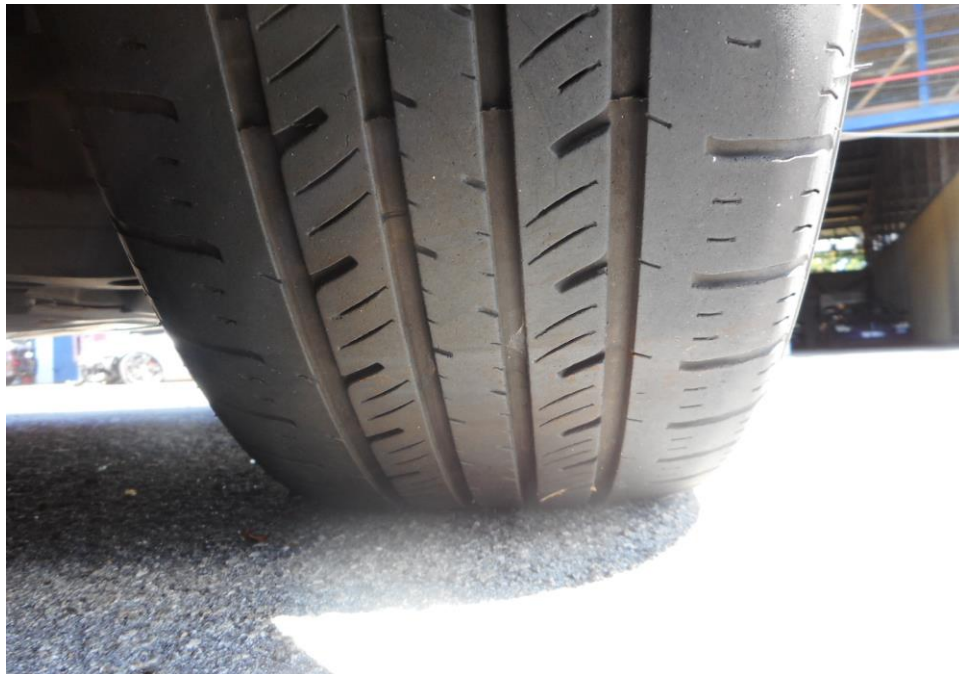
**Photo 7** shows the condition of the front right tyre of the Motor Taxi, which was observed to be in serviceable condition with remaining tread depth of approximately 4.8mm. The tyre, which was wrapped around standard alloy wheel rim, was also observed to be sufficiently inflated for vehicular operation. There was no tear, cut or burst mark(s) on the outer and the inner sidewalls as well as across the tread of the 4 tyres that were fitted on the Motor Taxi.

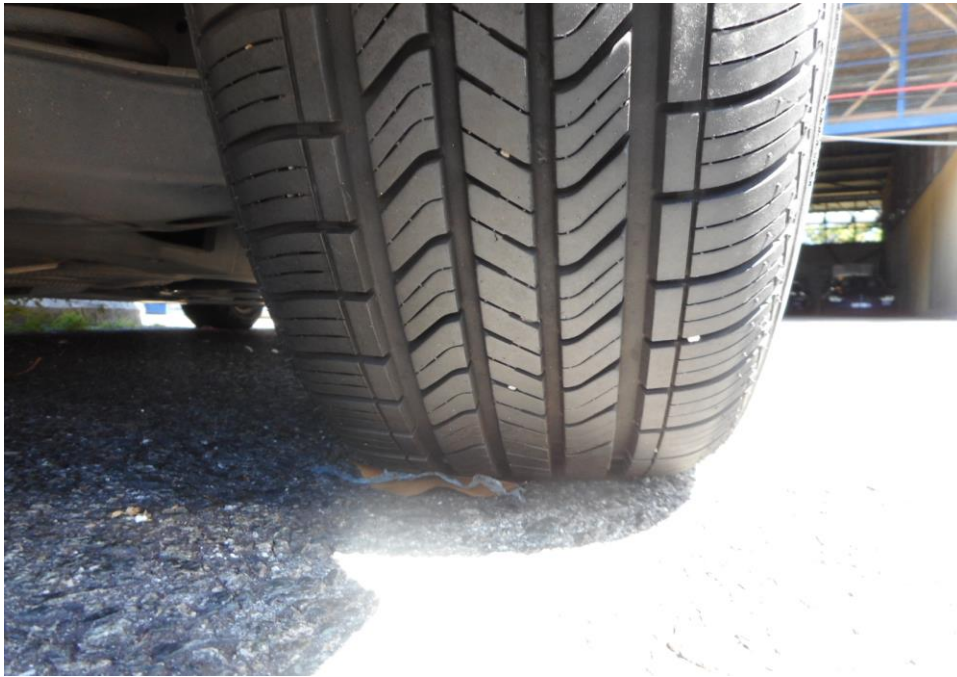
**Photo 8** shows the condition of the rear right tyre of the Motor Taxi, which was observed to be in serviceable condition with remaining tread depth of approximately 6.9mm. The tyre, which was wrapped around standard alloy wheel rim, was also observed to be sufficiently inflated for vehicular operation.

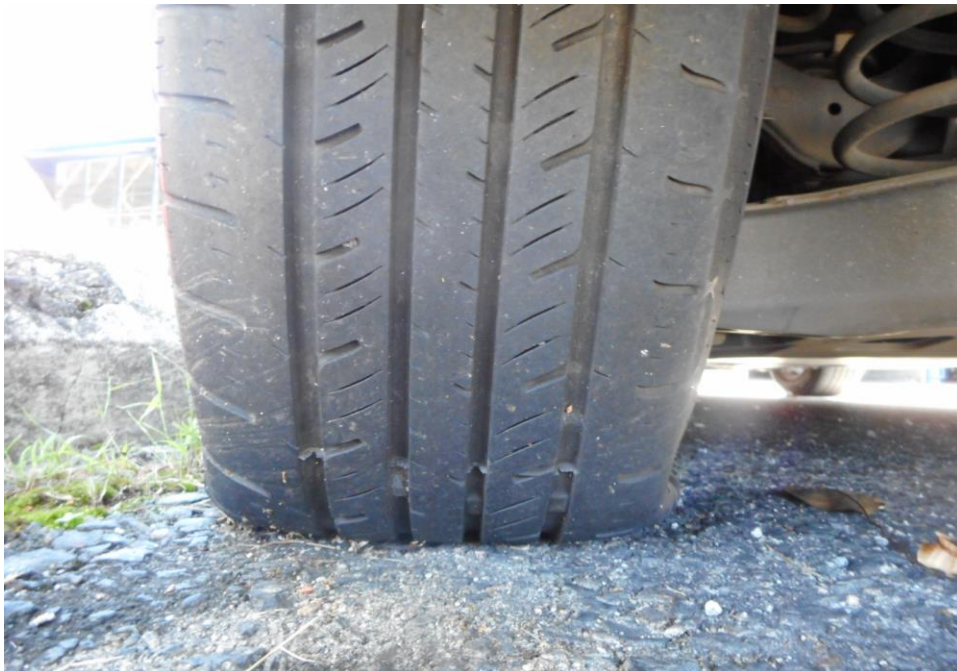
**Photo 9** shows the condition of the rear left tyres of the Motor Taxi, which was observed to be in serviceable condition with remaining tread depth of approximately 4.6mm. The tyres, which were wrapped around standard alloy wheel rim, were also observed to be sufficiently inflated for vehicular operation. There was also no damage found on all 4 alloy wheel rims of the Motor Taxi.

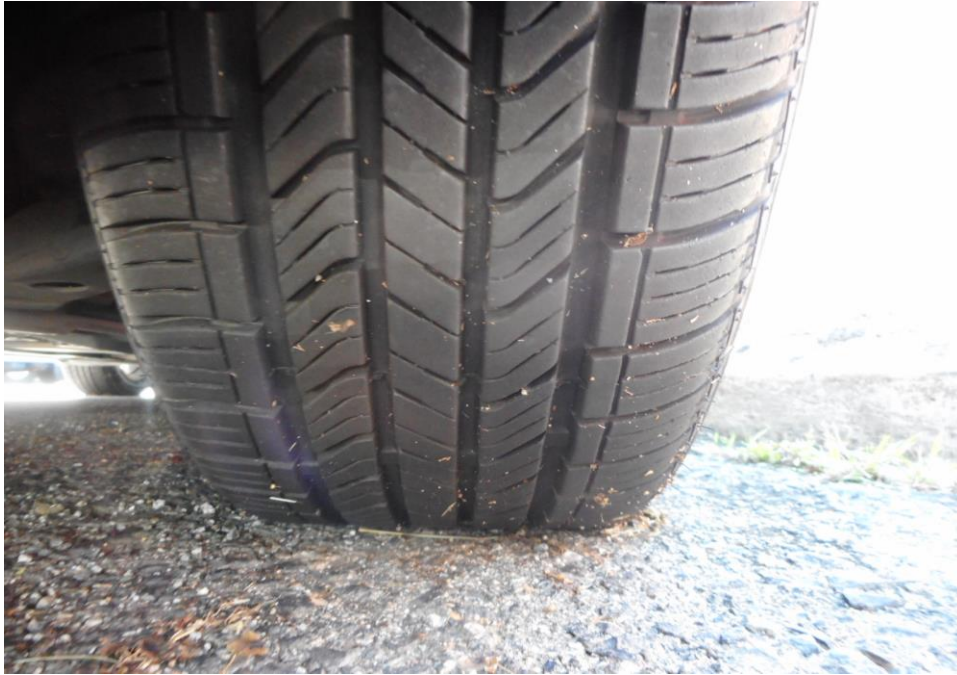
**Photo 10** shows the condition of the rear right tyres of the Motor Taxi, which were observed to be in serviceable condition with remaining, tread depth of approximately 6.4mm. There was also no tear, cut or burst mark(s) on the outer and the inner sidewalls as well as across the tread of the 4 tyres that were fitted on the Motor Taxi.

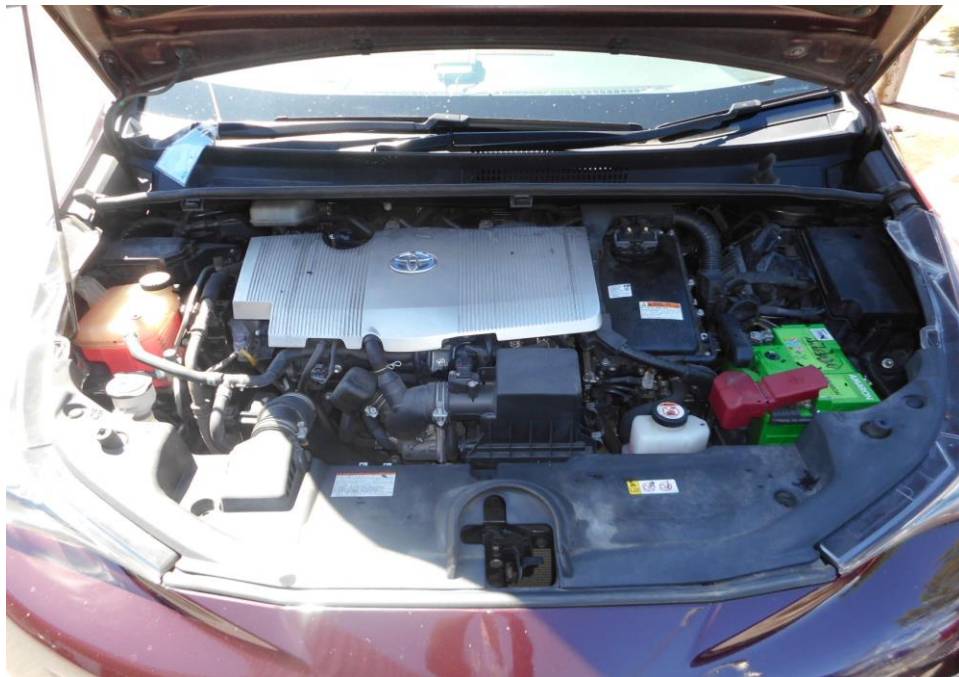
**Photo 11** shows a general view of the Motor Taxi's engine compartment, which was accessed by lifting the front cabin of the Motor Taxi. The various parts and components inside the engine compartment were unaffected by the accident. There was also no sign(s) or indication(s) of fresh fluid leakage and/or fluid stain within the engine compartment

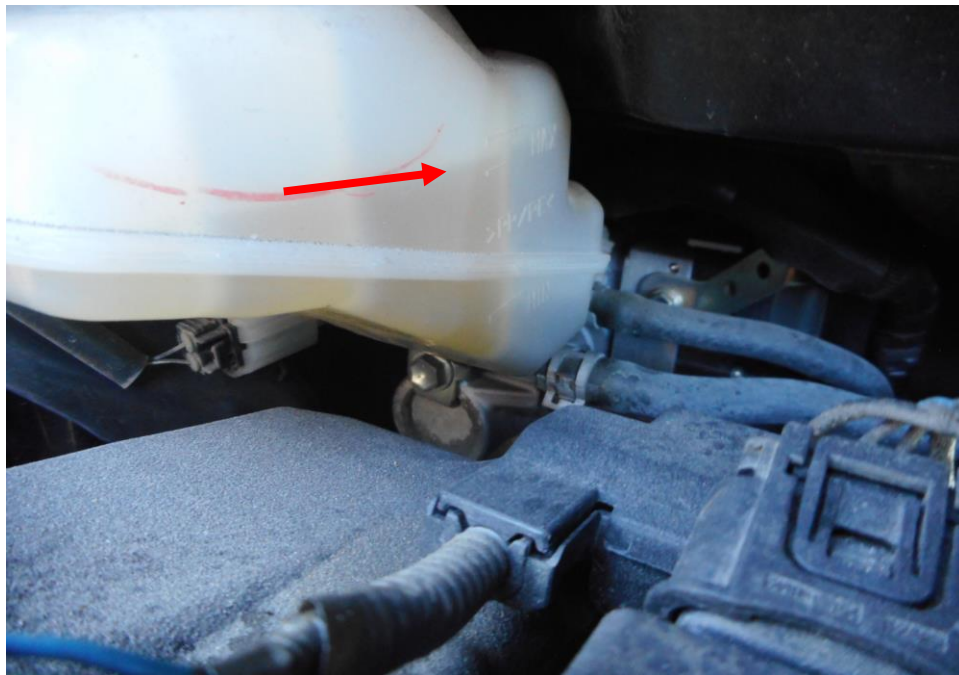
**Photo 12** shows the brake fluid reservoir of the Motor Taxi at the time of my inspection. The brake fluid was observed to be of sufficient level (arrowed) and without any visible contamination.

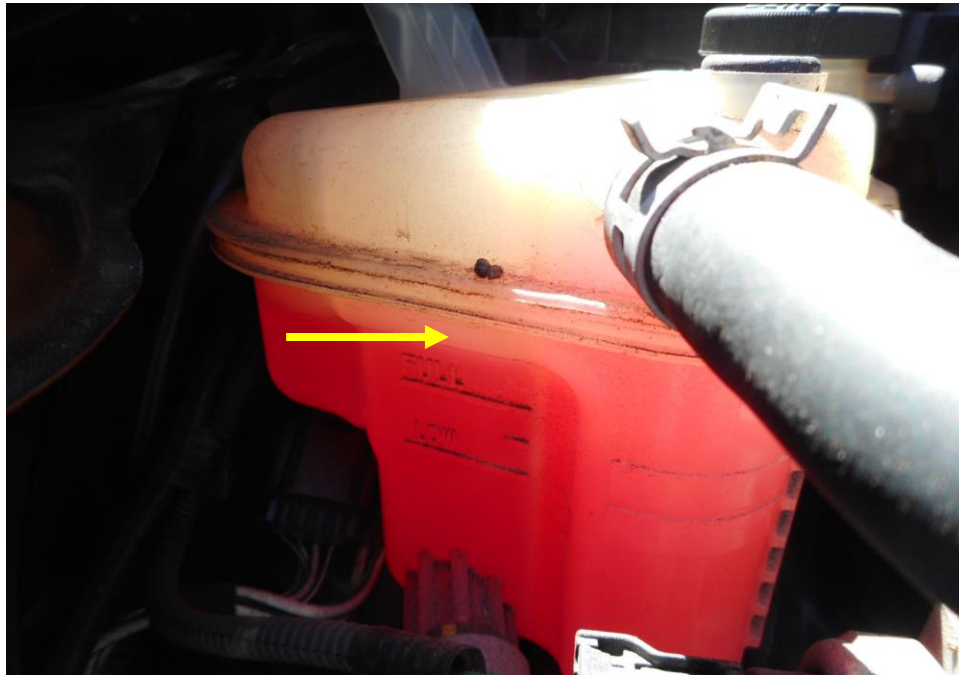
**Photo 13** shows the engine coolant reservoir of the Motor Taxi at the time of my inspection. The engine coolant was observed to be of sufficient level (arrowed) and without any visible contamination.

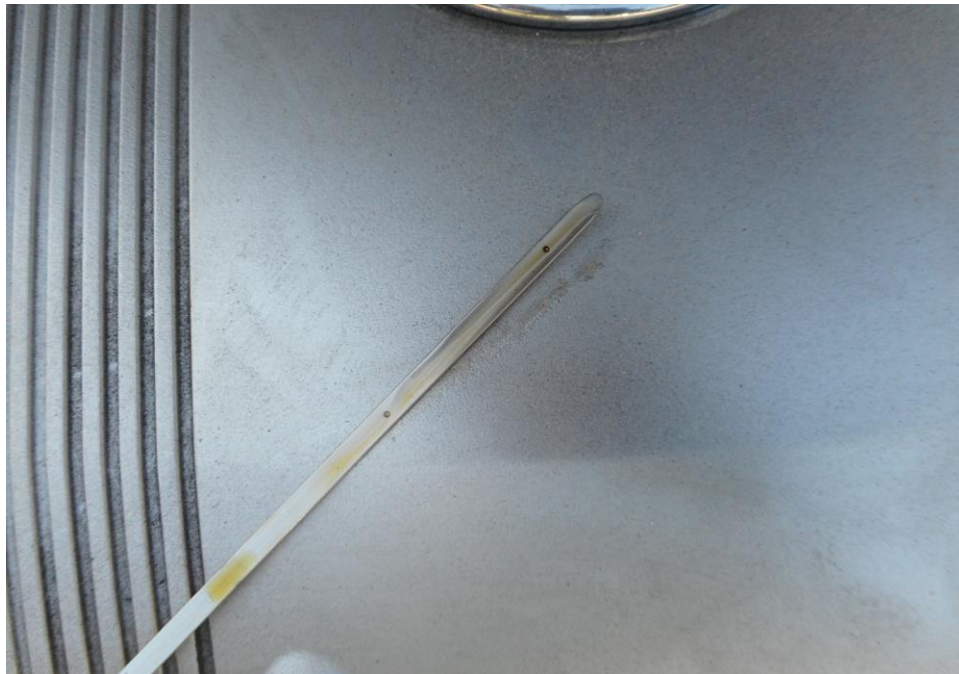
**Photo 14** shows the engine oil dip stick of the Motor Taxi at the time of my inspection. The engine oil was observed to be of sufficient level and without any visible contamination.

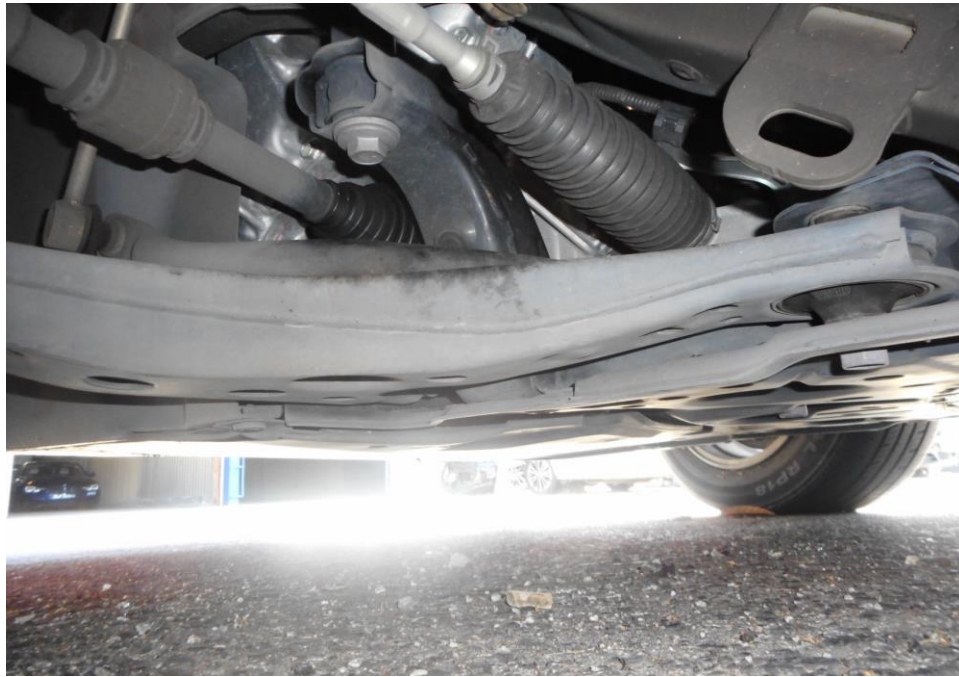
**Photo 15** shows the undercarriage of the Motor Taxi, at the area where the engine housing and transmission housing are located. . I did not find any sign(s) or indication(s) of fluid leak and/or fluid stain(s) on the underside of the Motor Taxi.

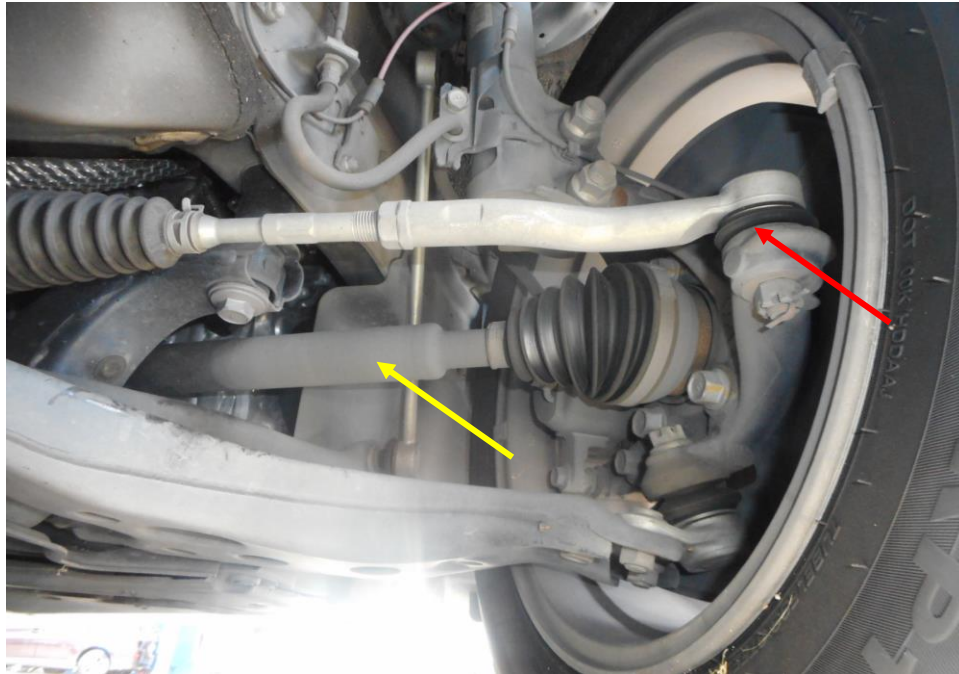
**Photo 16** shows the various undercarriage components at the front right wheel of the Motor Taxi, in particular the steering tie rod end (arrowed) and drive shaft (yellow arrow). The various steering components were all found to be intact, suggesting that the steering system of the Motor Taxi was likely to be in serviceable condition at the material time of accident. There was also no sign of fluid stain(s) observed on the various undercarriage components.

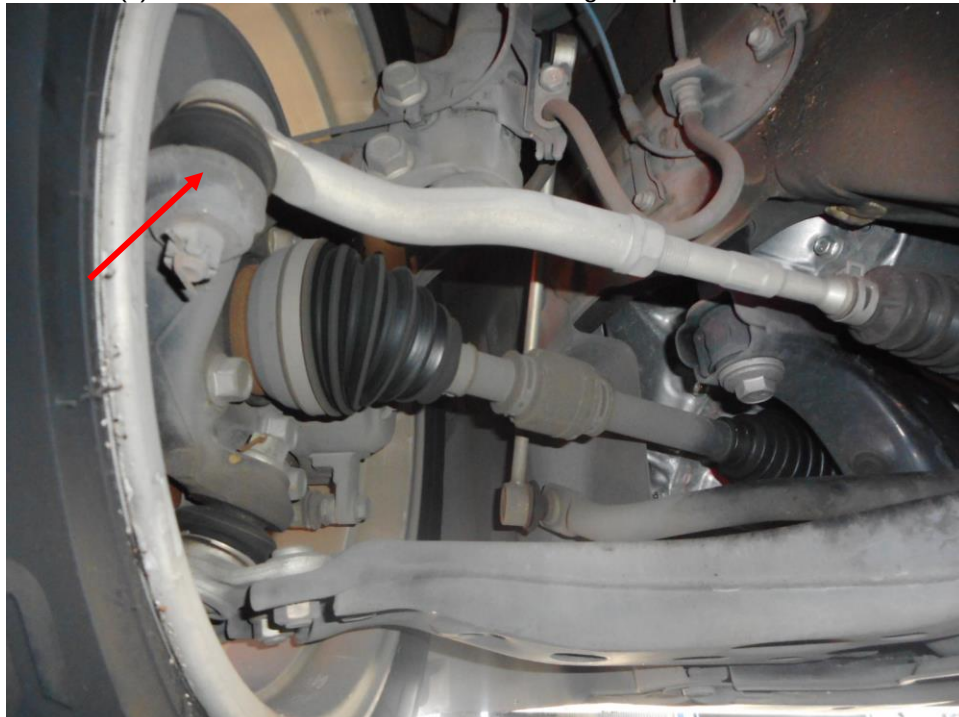
**Photo 17** shows the various undercarriage components at the front left wheel of the Motor Taxi, in particular the steering tie rod end (arrowed). The various Undercarriage components of the Motor Taxi were all found to be intact without any visible damage. There was also no sign of fluid stain(s) observed on the various undercarriage components.

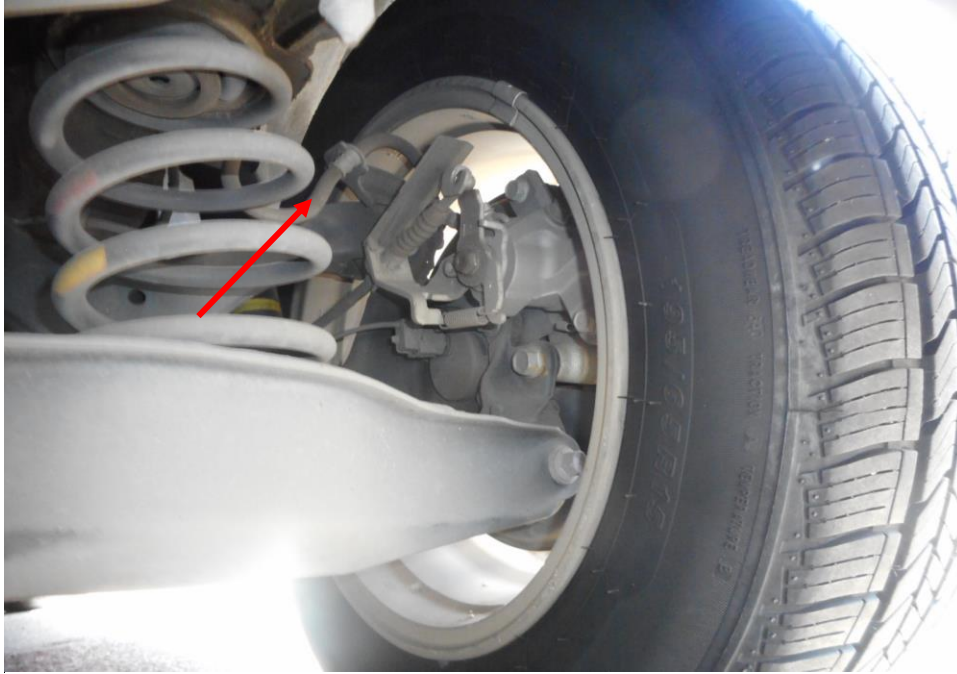
**Photo 18** shows the brake pipe (arrowed) at the rear right wheel of the Motor Taxi. I did not observe any leakage of brake fluid at the time of my inspection of the Motor Taxi. My static tests of the Motor Taxi's braking system, along with my visual examination of the various mechanical components in the braking system, had indicated that there was no internal leakage of pressure/vacuum. Hence the braking system of the Motor Taxi was likely to be in serviceable condition at the material time of accident.

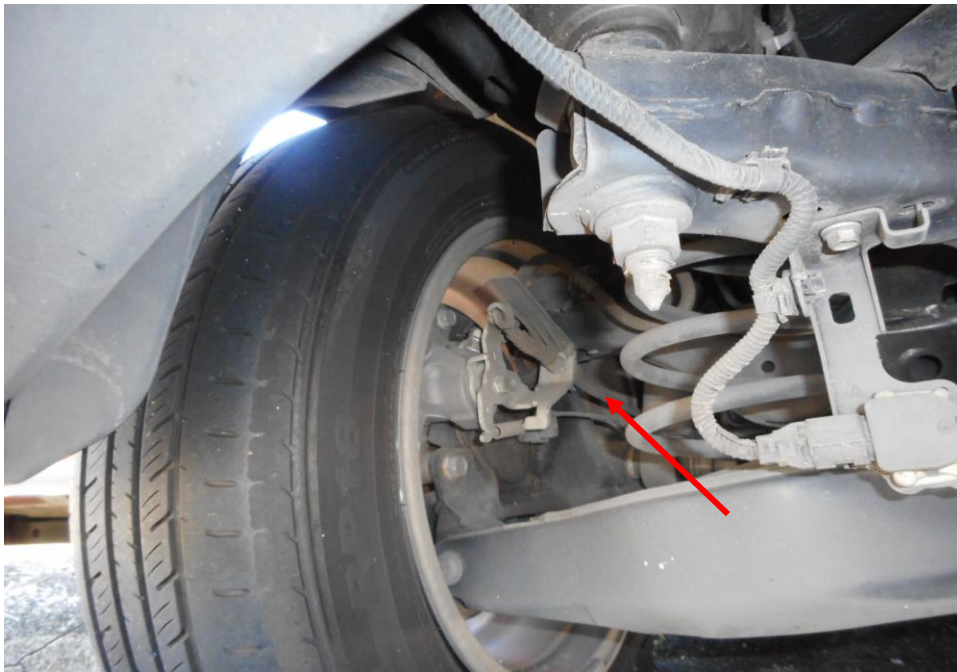
**Photo 19** shows the brake pipe (arrowed) at the rear left wheel of the Motor Taxi. I did not observe any leakage of brake fluid at the time of my inspection of the Motor Taxi. My static tests of the Motor Taxi's braking system, along with my visual examination of the various mechanical components in the braking system had indicated that there was no internal leakage of pressure/vacuum. Hence the braking system of the Motor Taxi was likely to be in serviceable condition at the material time of accident.

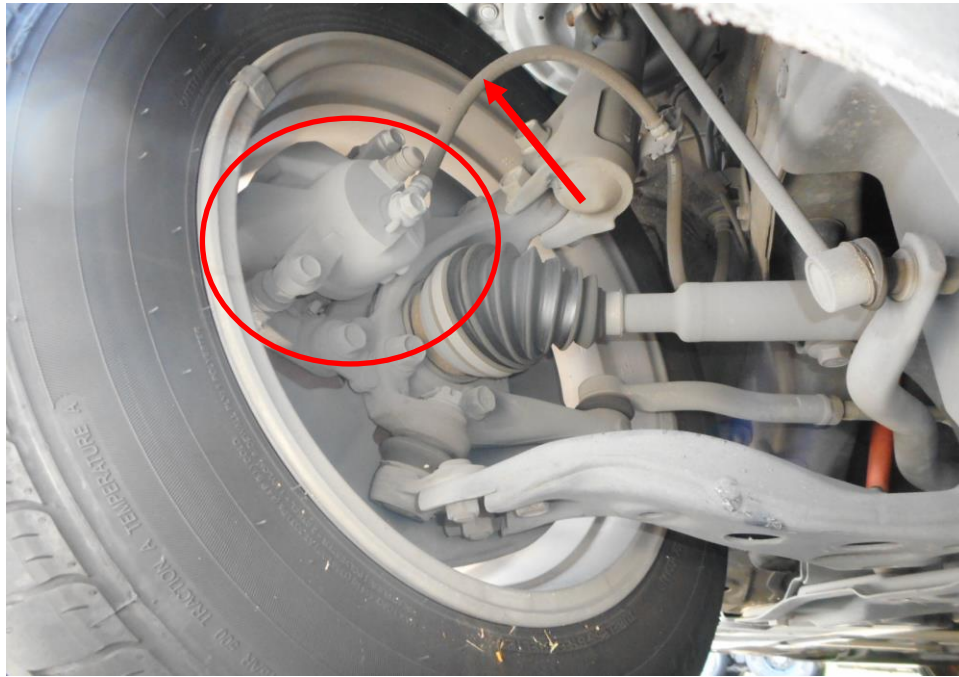
**Photo 20** shows the brake hose/pipe (arrowed) at the front right wheel of the Motor Taxi. No leakage of brake fluid was observed. Visual examination of the various components of the braking system like the brake caliper (circled), brake booster, brake pedal etc had revealed all to be intact and without visible damage at the time of accident. There was also no sign of fluid stain(s) observed on the various undercarriage components.

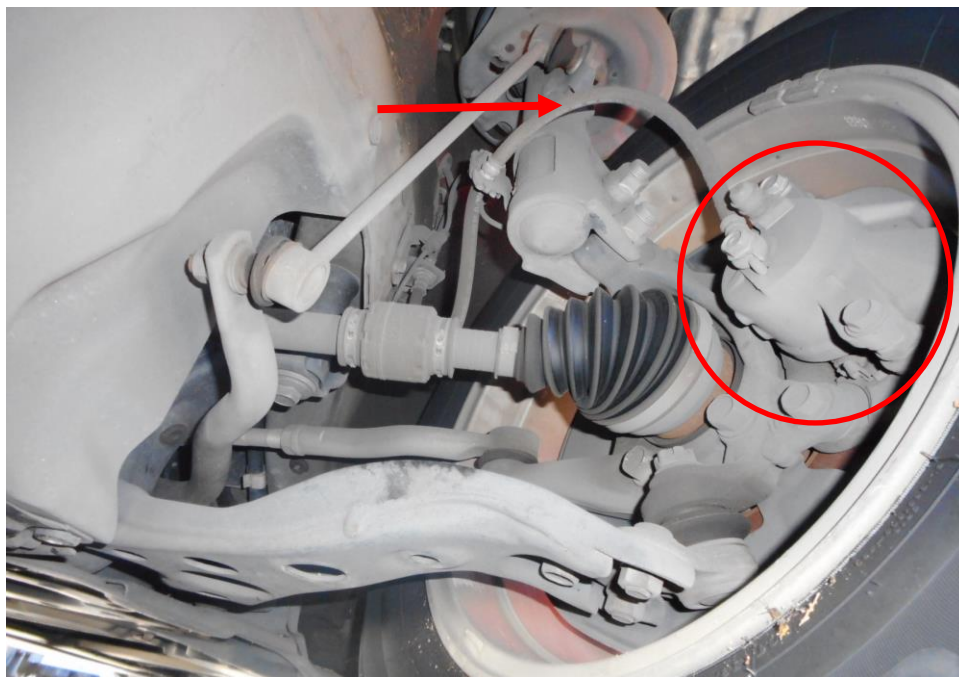
**Photo 21** shows the brake hose/pipe (arrowed) at the front left wheel of the Motor Taxi. No leakage of brake fluid was observed. Visual examination of the various components of the braking system like the brake caliper (circled), brake booster, brake pedal etc had revealed all to be intact and without visible damage at the time of accident. There was also no sign of fluid stain(s) observed on the various undercarriage components.

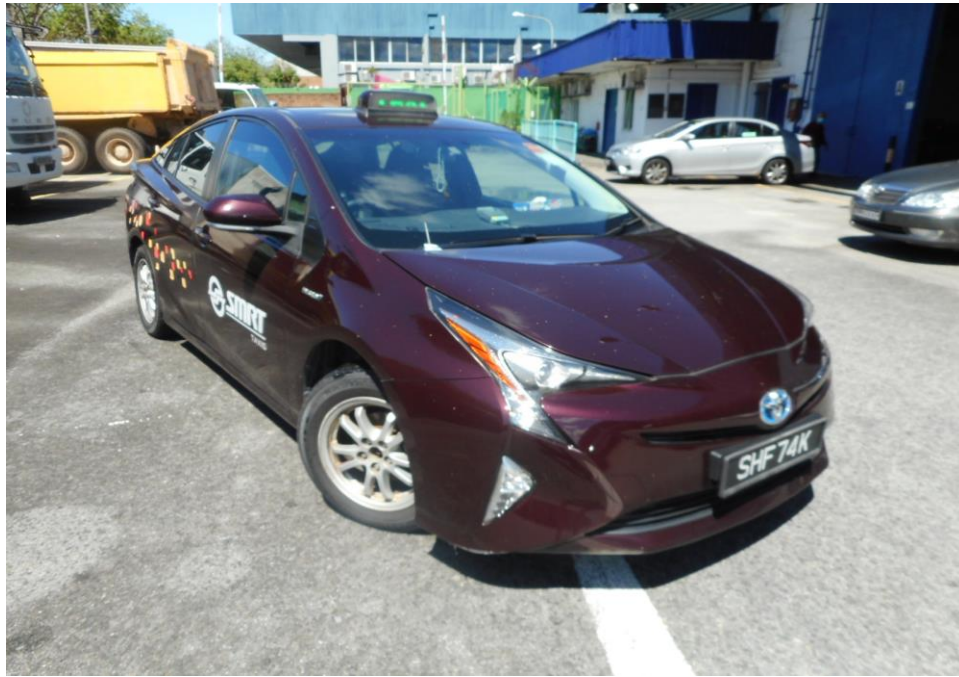
**Photo 22** shows the front right wheel of the Motor Taxi turned to its full left. During my steering system test, I did not experience any abnormal free play and/or resistance when I had turned the steering wheel towards full left and full right. This would suggest that the steering system of the Motor Taxi was likely to be in serviceable condition at the material time of accident.

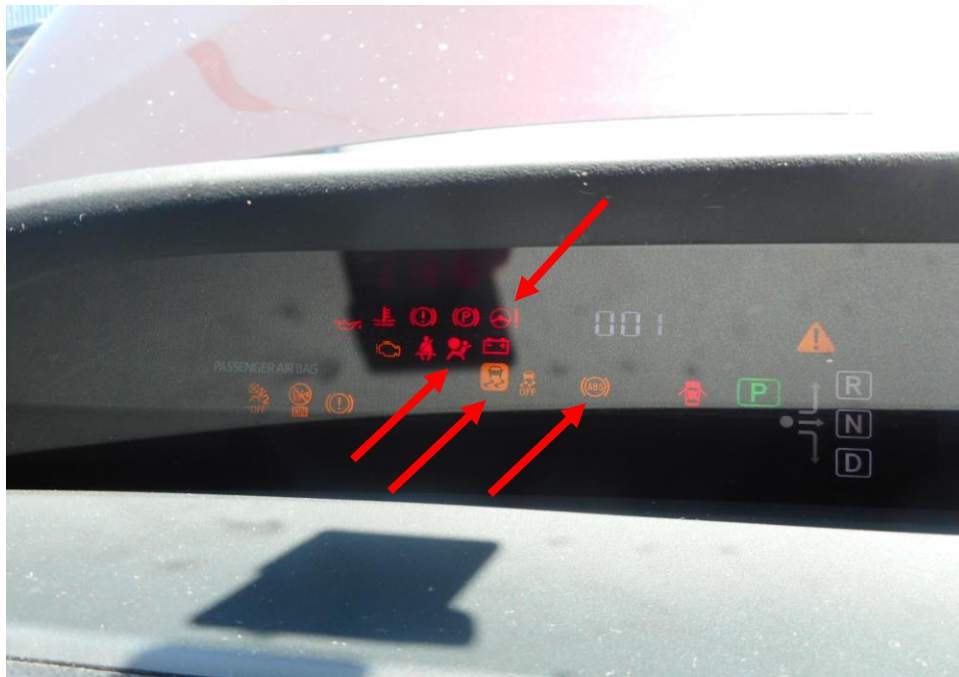
**Photo 23** shows the warning light for Anti-Lock Brake System (ABS), Supplemental Restraint System (SRS), Traction Control System (TC) and Electric Power Steering System (EPS) appearing on the instrument panel of the Motor Taxi during the self-test of its various electronic operating systems when its engine was cranked.

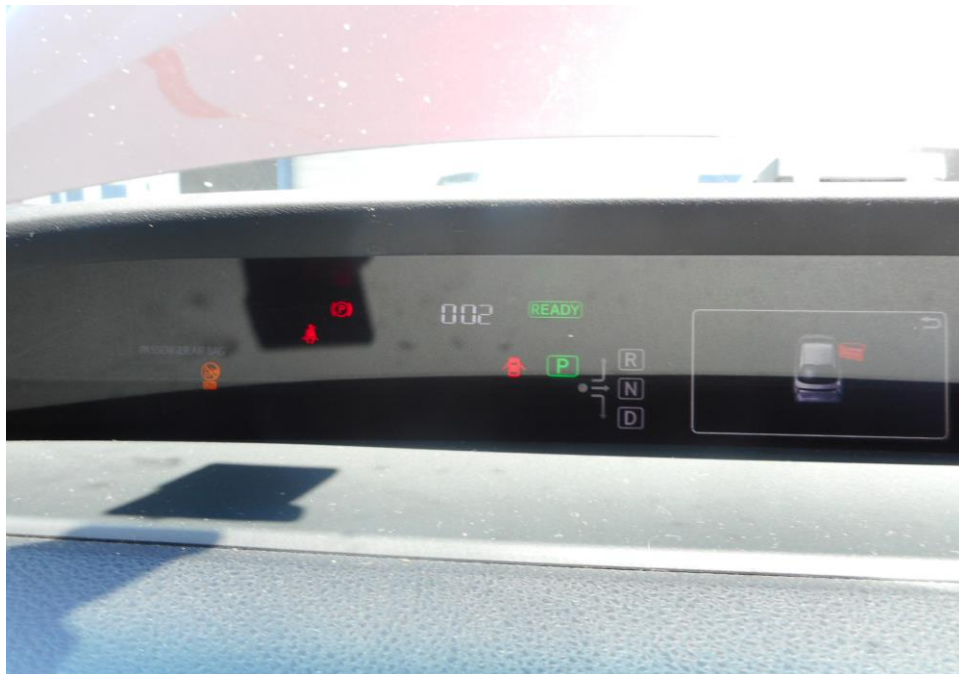
**Photo 24** shows no warning lights illuminated on the instrument panel of the Motor Taxi after the engine was cranked. This would suggest that there was no abnormality to the various electronic operating systems of the Motor Taxi, like the ABS, SRS, TC and EPS.
