Your Ref: TP/IP/15449/2020
Our Ref : CI/TPD20004876/P

3rd June 2020

Fatal Accident Investigation Team

MECHANICAL INSPECTION REPORT OF MOTOR CAR SMM 4122H

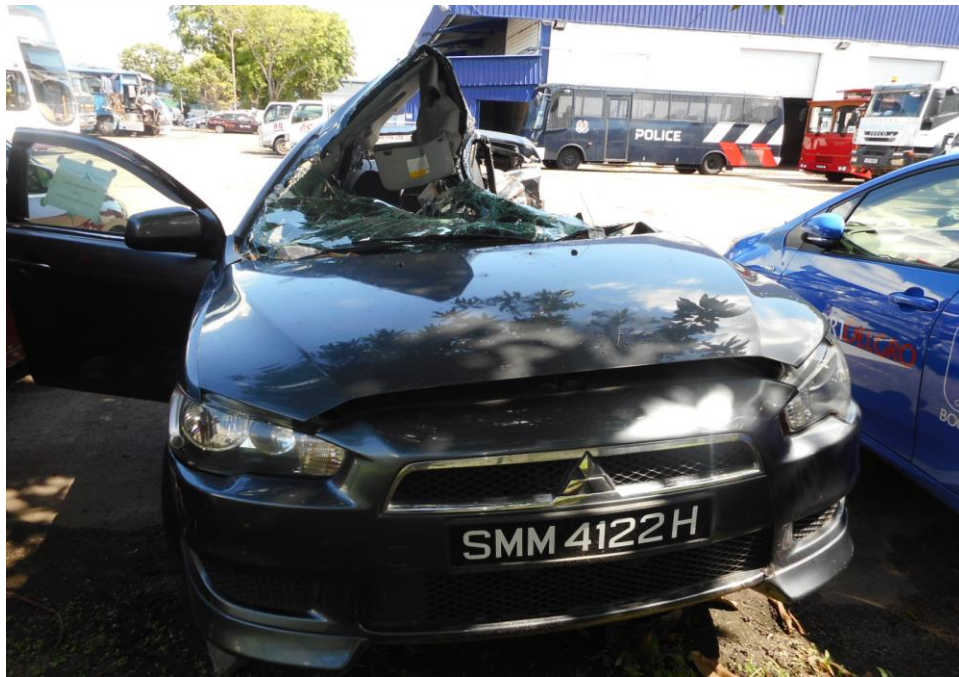
4. The mileage of the Motor Car at the time of my inspection was not recorded as its ignition system was affected by the collision.
5. The Motor Car had sustained extensive major impact damage at its left portion, body parts around the whole Motor Car had sustained damage as well. The front bonnet and rear boot and roof were also observed to have been damaged as a result of the accident.
6. Parts towards the front of the engine compartment were also damaged. This had included, its front bonnet, intake pipe and its ignition system, as a result of the accident. See photo 1 – 8 below.

Photo 1 shows a general view of the front portion of the Motor Car at the time of my inspection. The Motor Car was also observed to have sustained extensive major impact damage at its left portion, body parts around the whole Motor Car had sustained damage as well. The front bonnet and rear boot and roof were also observed to have been damaged as a result of the accident.

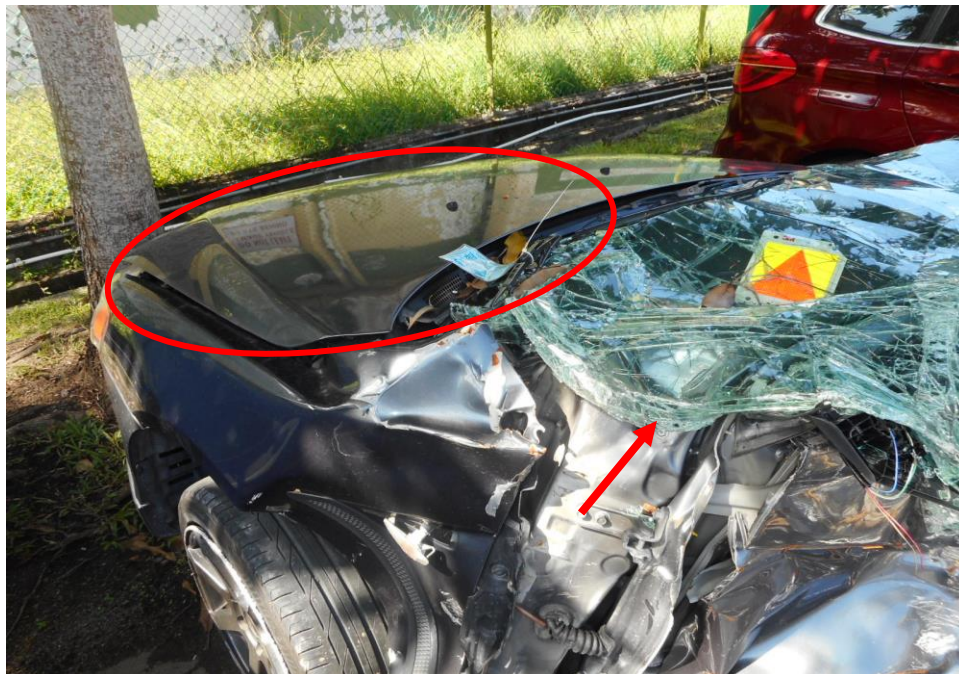
Photo 2 shows a close up view of the front portion of the Motor Car at the time of my inspection. The front bonnet (circled) and front windscreen (arrowed) was observed to have been damaged as a result of the accident.

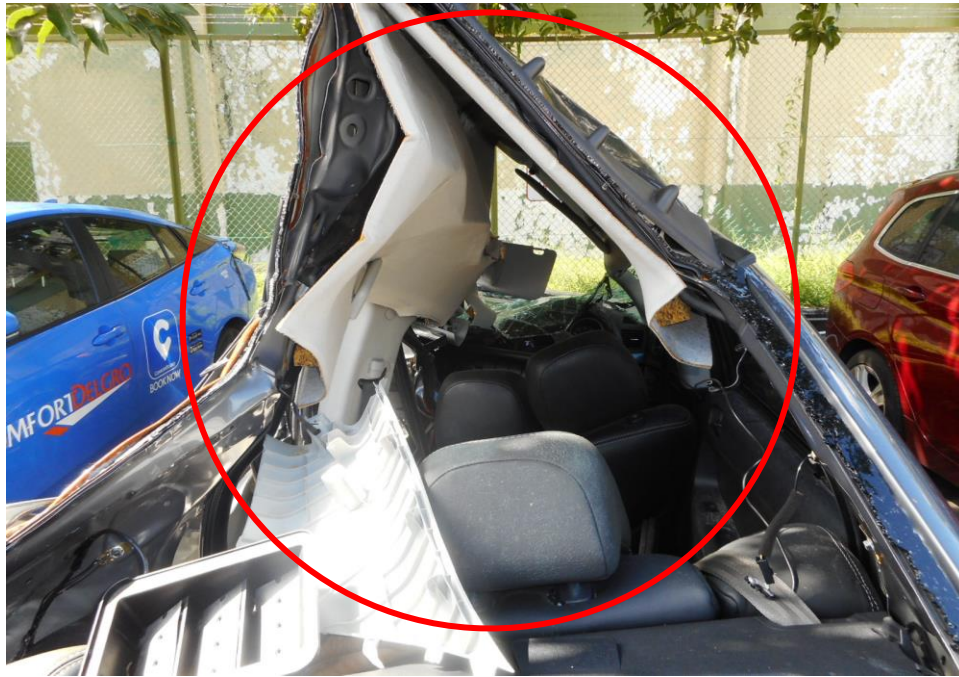
Photo 3 shows a close up view of the roof portion of the Motor Car at the time of my inspection. The roof of the Motor Car was observed to have been damaged as a result of the induced impact from the accident (circled)

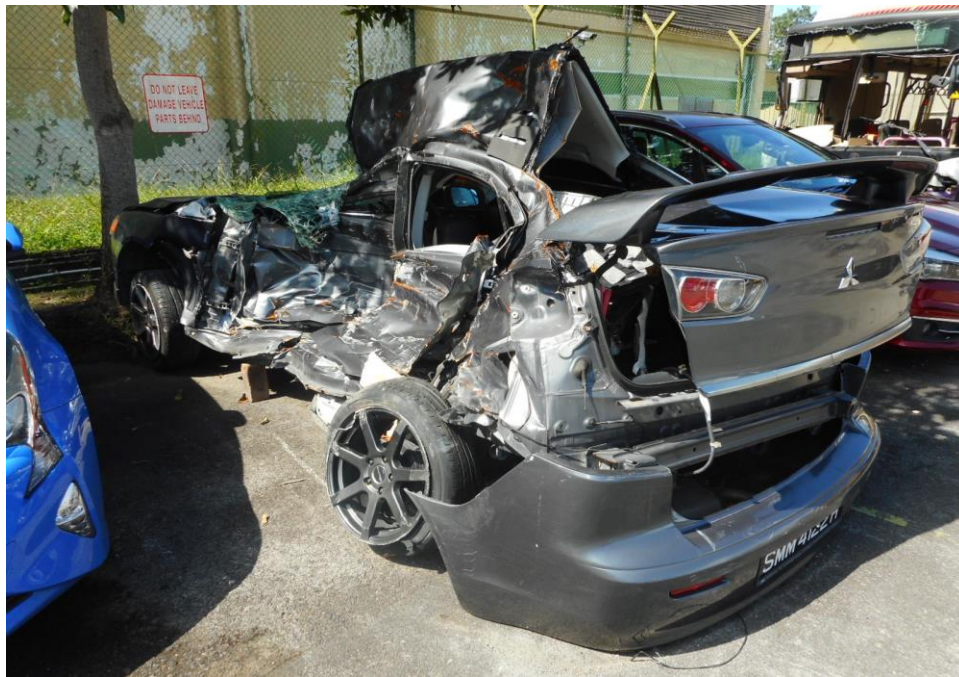
Photo 4 shows a general view of the left portion of the Motor Car at the time of my inspection. The left side of the Motor Car had sustained extensive impact, its doors and the whole body panel structure was observed to have been damaged as a result of the accident.

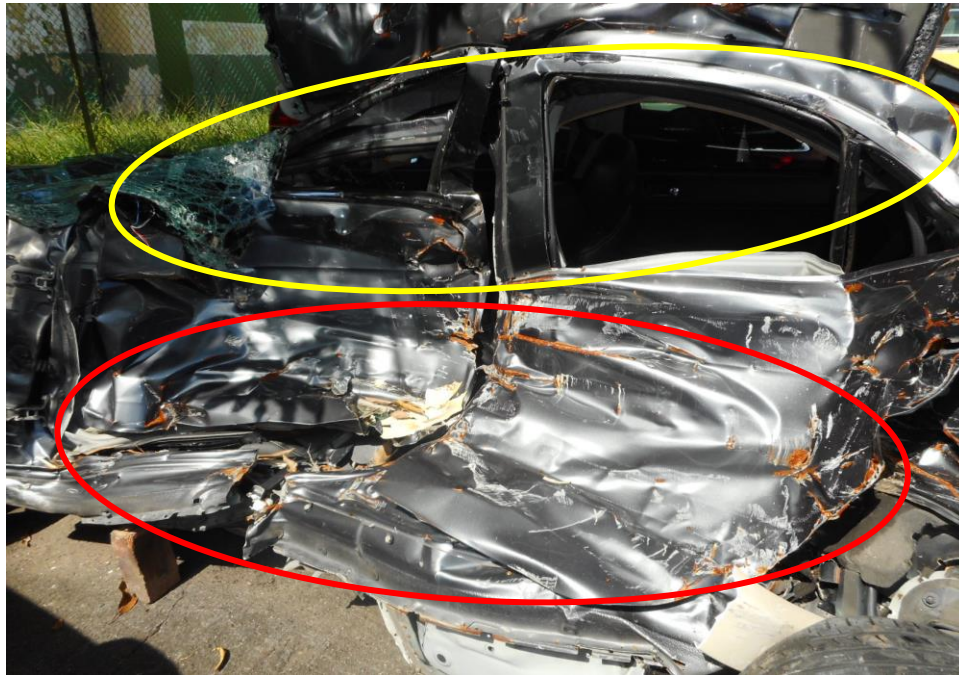
Photo 5 shows a close up view of the left portion of the Motor Car at the time of my inspection. The left side of the Motor Car had sustained extensive impact, it's both left doors (red circle), whole body panel structure and both left windscreens (yellow circle) was observed to have been damaged as a result of the accident.

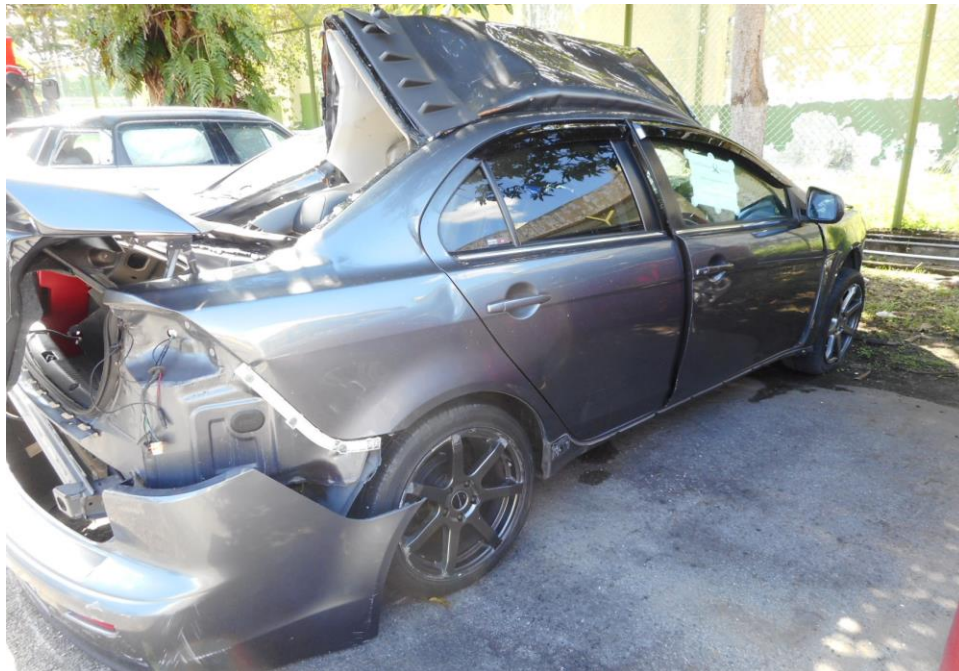
Photo 6 shows a general view of the right portion of the Motor Car at the time of my inspection. The right body panel of the Motor Car was relatively intact with minor dents on the panels as a result of the accident.

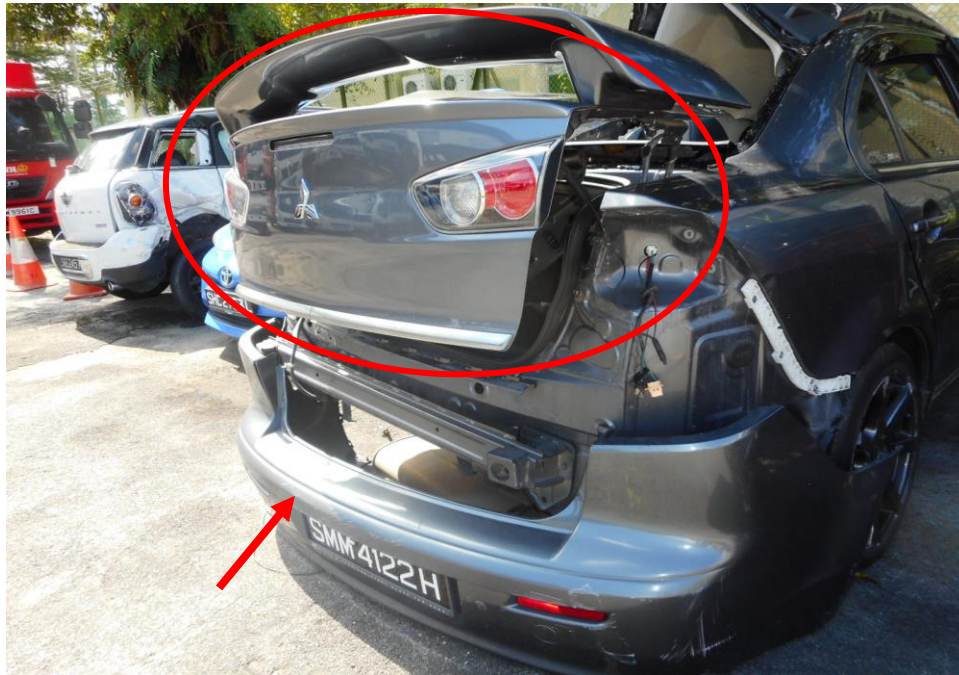
Photo 7 shows a general view of the rear portion of the Motor Car at the time of my inspection. The rear portion boot (circled) and bumper (arrowed) of the Motor Car was observed to have been damaged as well from the induced impact by the accident.

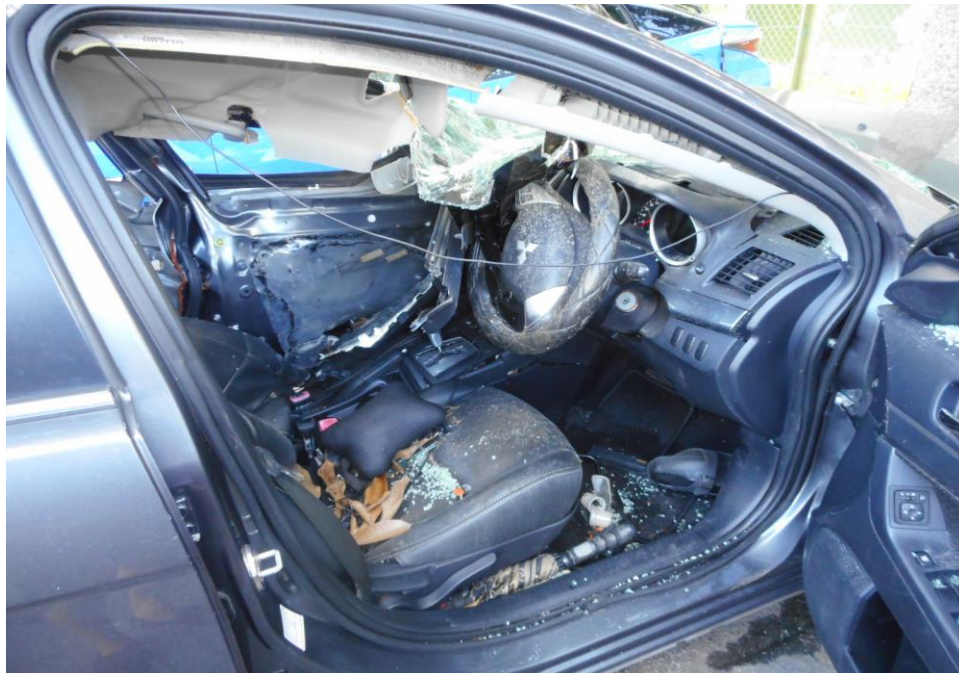
Photo 8 shows a general view of the Motor Car's interior compartment from the driver's seat. The driver's cabin had sustained damaged as a result of the accident.

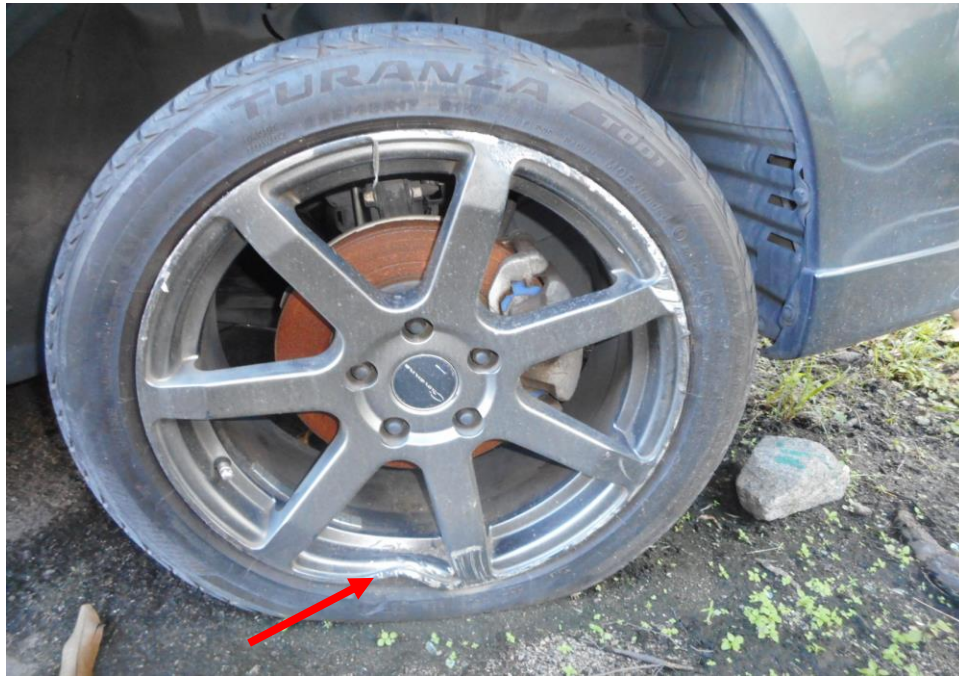
7. The front right and rear left wheel was inspected to be deflated due to the damage to the rims caused by the accident however; condition of the Motor car's 4 tyres was observed to be in serviceable condition. I did not find any tear, cut or burst mark(s) on the outer and the inner sidewalls as well as across the tread of the 4 tyres. The tyre brand, tyre size and remaining tread depth of the 4 tyres were recorded as follows:-
8. All 4 tyres of the Motor Car were wrapped around alloy wheel rims. The front right and rear left wheel rim found to be dented due to the accident however; the front left and rear right wheel rim were observed to be in good condition. See photo 9 – 12 below.

Photo 9 shows the condition of the front right tyre of the Motor Car, which was observed to be in serviceable condition with remaining tread depth of approximately 5.3mm. There was also no tear, cut or burst mark(s) on the outer and the inner sidewalls as well as across the tread of the Motor Car's 4 tyres, however observed to be deflated due to damage to the rims (arrowed).

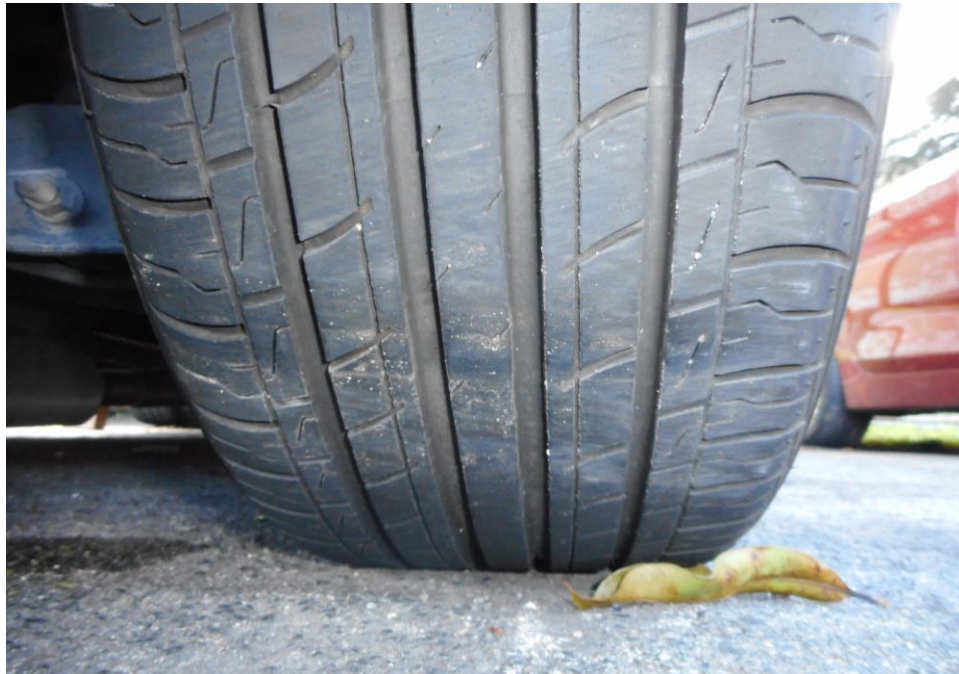
Photo 10 shows the condition of the rear right tyre of the Motor Car, which was observed to be in serviceable condition with remaining tread depth of approximately 5.6mm. The tyre was also observed to be sufficiently inflated for vehicular operation with no tear, cut or burst mark(s).

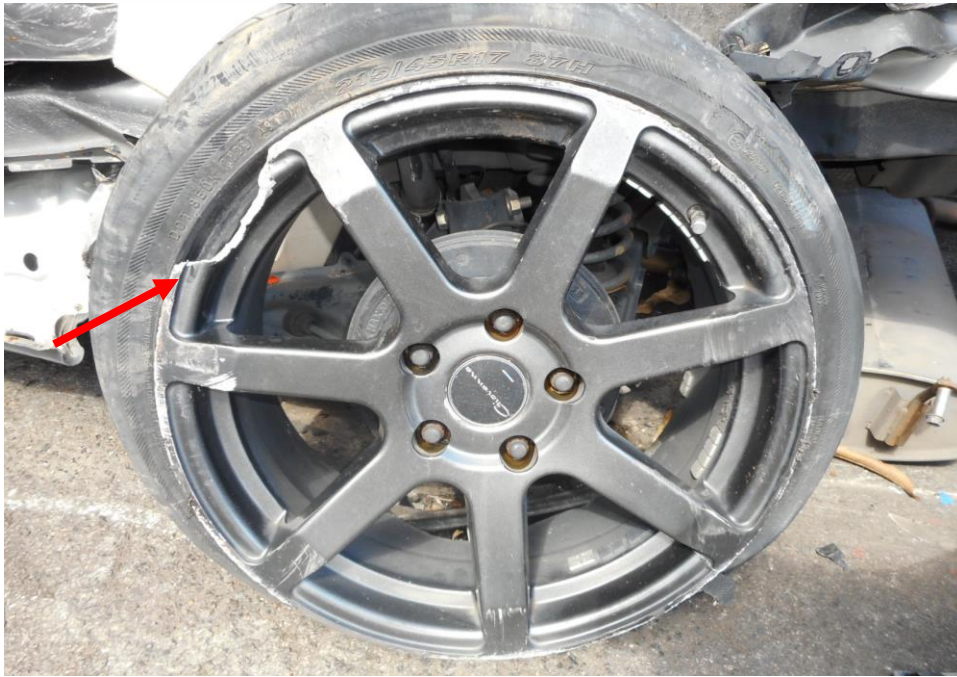
Photo 11 shows the condition of the rear left tyre of the Motor Car, which was observed to be in serviceable condition with remaining tread depth of approximately 5.5mm. The tyre was also observed to be sufficiently inflated for vehicular operation with no tear, cut or burst mark(s), however observed to be deflated due to damage to the rims (arrowed).

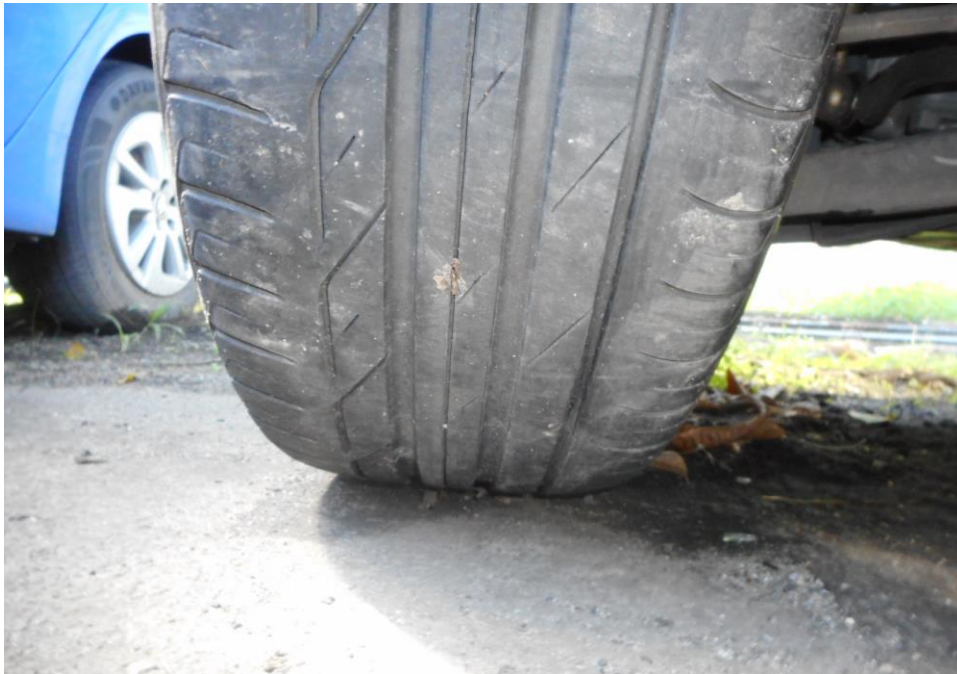
Photo 12 shows the condition of the front left tyre of the Motor Car, which was observed to be in serviceable condition with remaining tread depth of approximately 5.5mm. The tyre was also observed to be sufficiently inflated for vehicular operation with no tear, cut or burst mark(s).

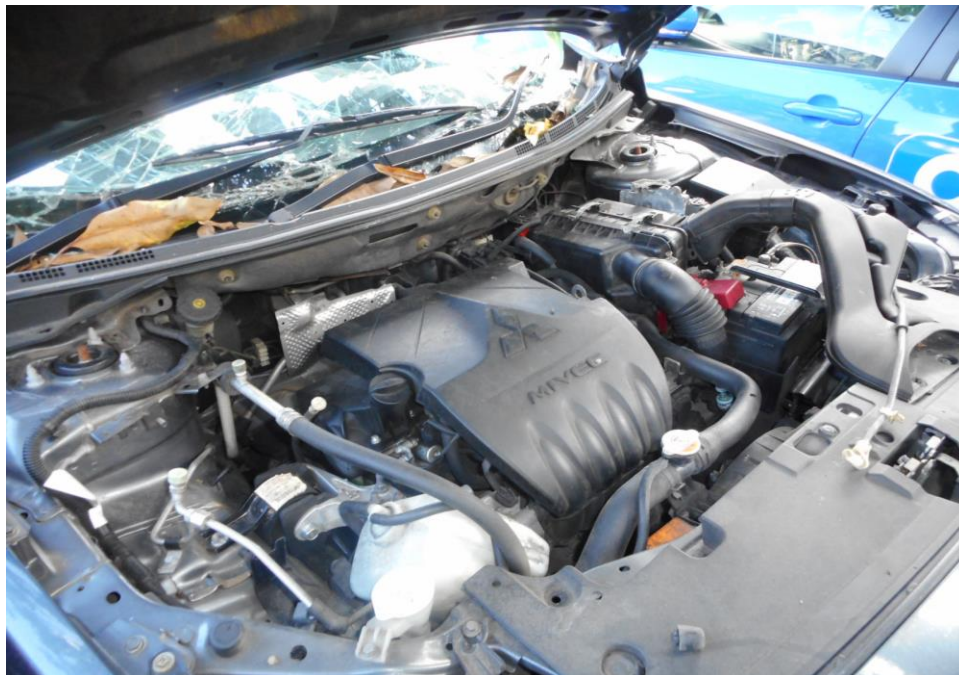
9. Upon examination of the Motor Car's engine compartment, I had observed the intake pipe and ignition system to be damaged due to the induced impact from the accident. However all the other parts and components inside the engine compartment were observed to be intact. The brake fluid, engine oil and engine coolant were all found to be of sufficient level for operating purposes. Visually, there was also no contamination found to these fluids.
10. Further examination of the engine compartment revealed, there was no sign(s) or indication(s) of fresh fluid leakage and/or fluid stain within the engine compartment of the Motor Car.
11. My subsequent checks on the underside of the Motor Car also revealed no fluid stain. Visually, the various undercarriage components of the Motor Car were all observed to be intact and without any visible damage. See photo 13 – 18 below.

Photo 13 shows a general view of the Motor Car's engine compartment, which was accessed by lifting the front cabin of the Motor Car. The various parts and components inside the engine compartment were unaffected by the accident. However, the intake pipe and ignition system was observed to be damaged due to the induced impact from the accident. There was also no sign(s) or indication(s) of fresh fluid leakage and/or fluid stain within the engine compartment

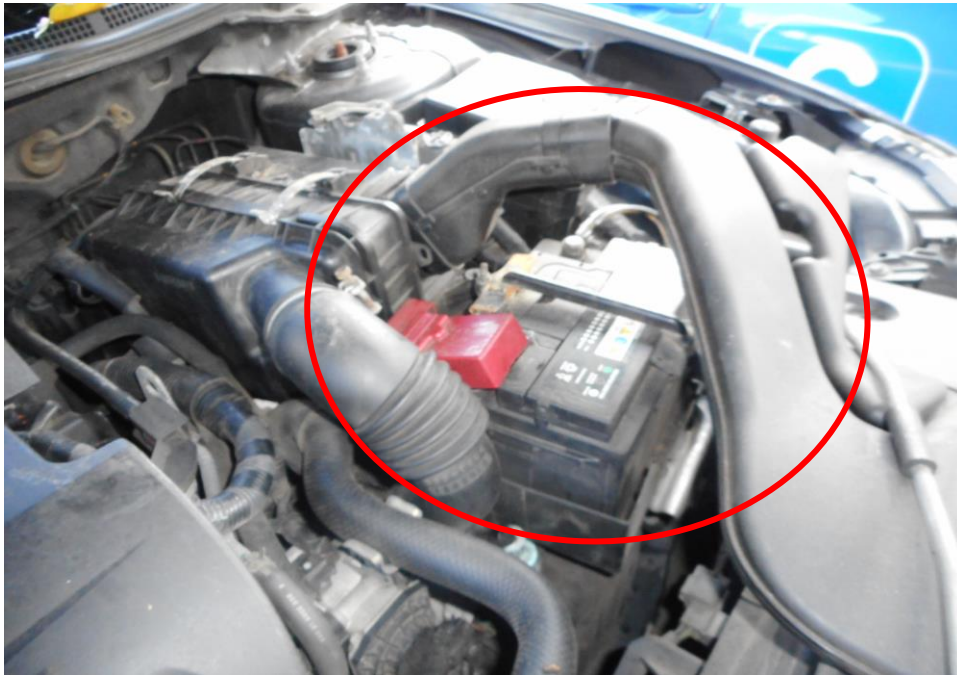
Photo 14 shows a close up view of the Motor Car's engine compartment, which was accessed by lifting the front cabin of the Motor Car. The intake pipe and ignition system (circled) was observed to be damaged due to the induced impact from the accident.

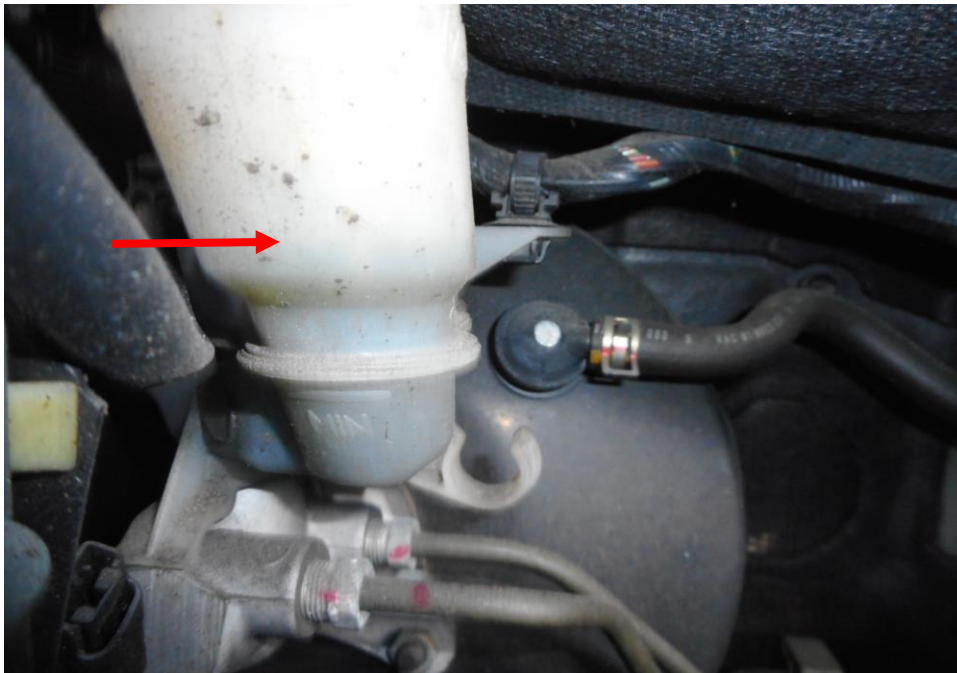
Photo 15 shows the brake fluid reservoir of the Motor Car at the time of my inspection. The brake fluid was observed to be of sufficient level (arrowed) and without any visible contamination.

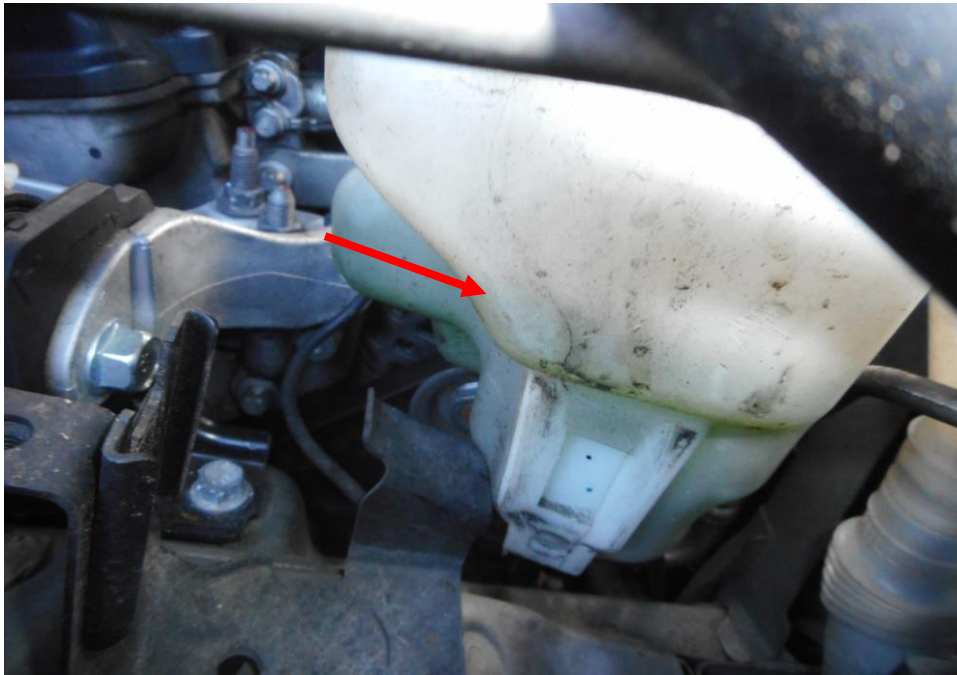
Photo 16 shows the engine coolant reservoir of the Motor Car at the time of my inspection. The engine coolant was observed to be of sufficient level (arrowed) and without any visible contamination.

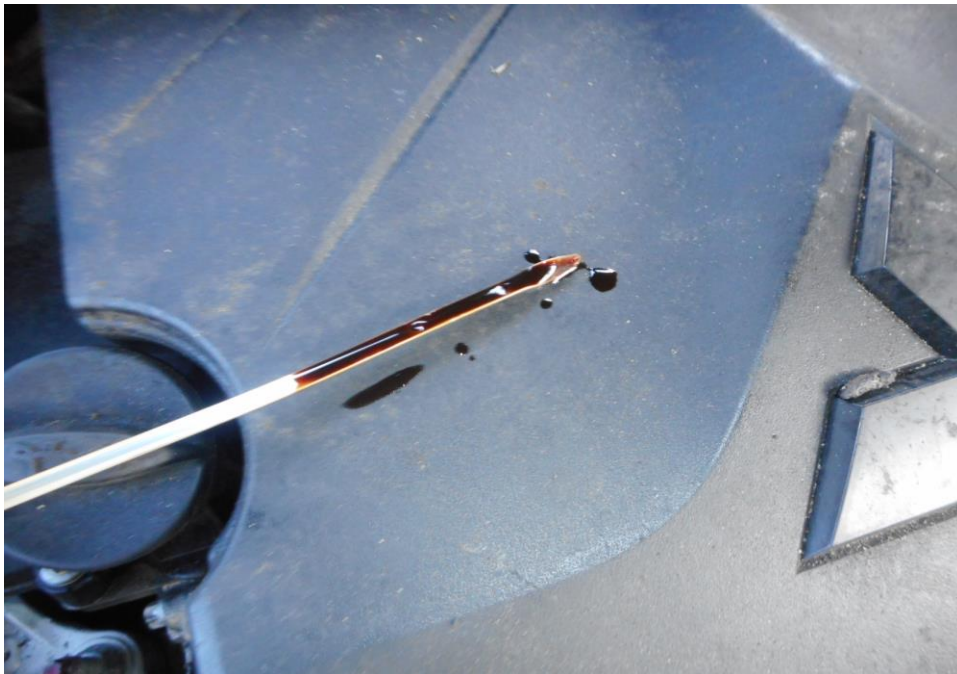
Photo 17 shows the engine oil dip stick of the Motor Car at the time of my inspection. The engine oil was observed to be of sufficient level and without any visible contamination.

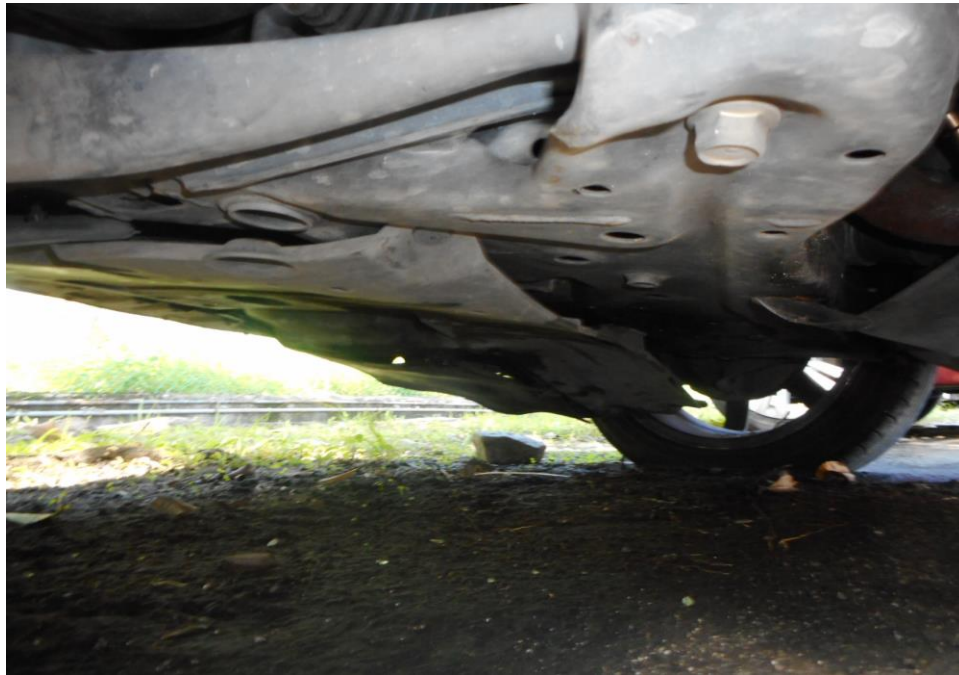
Photo 18 shows the undercarriage of the Motor Car, at the area where the engine housing and transmission housing are located. . I did not find any sign(s) or indication(s) of fluid leak and/or fluid stain(s) on the underside of the Motor Car.

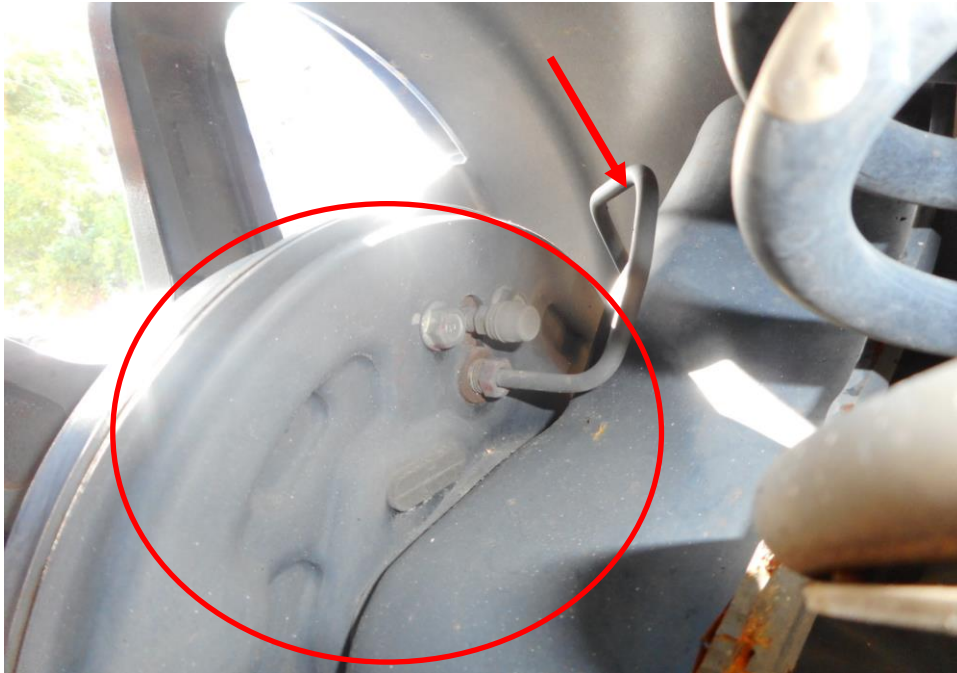
Photo 19 shows the brake drum (circled) and brake hose/pipe (arrowed) at the rear left wheel of the Motor Car and it was observed to be intact

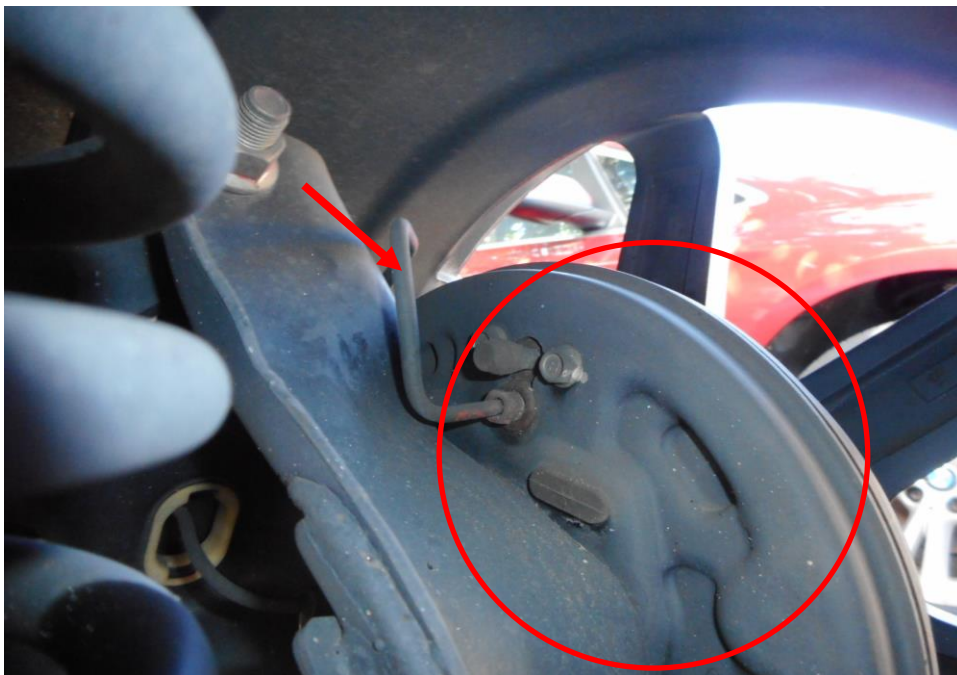
Photo 20 shows the brake drum (circled) brake hose/pipe (arrowed) at the rear right wheel of the Motor Car and it was observed to be intact

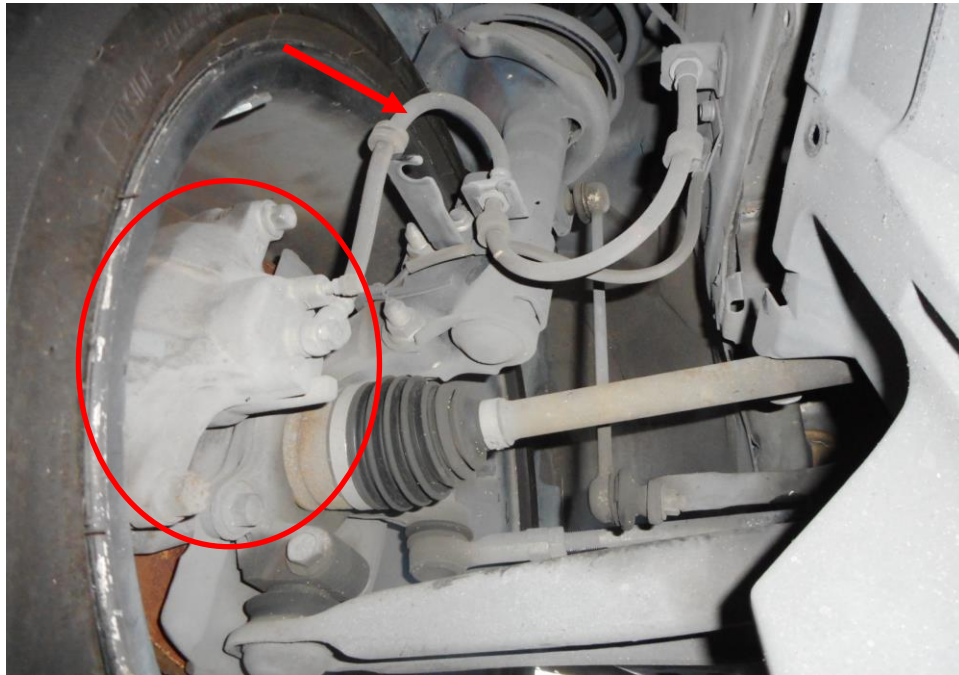
Photo 21 shows the brake hose/pipe (arrowed) at the front right wheel of the Motor Car. No leakage of brake fluid was observed. Visual examination of the various components of the braking system like the brake caliper (circled), brake booster, brake pedal etc had revealed all to be intact and without visible damage at the time of accident. There was also no sign of fluid stain(s) observed on the various undercarriage components.

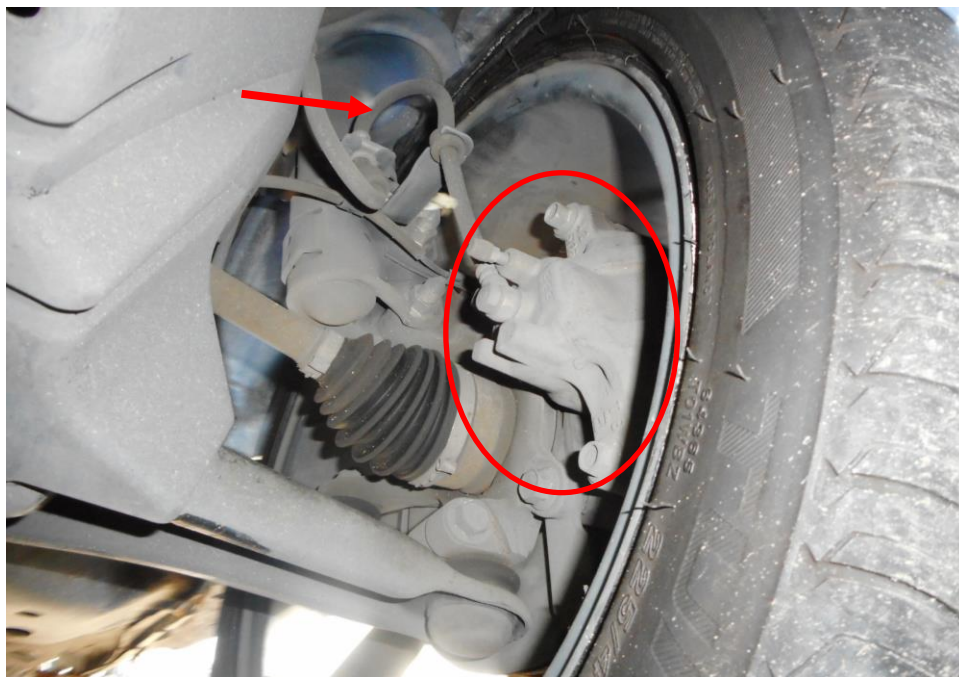
Photo 22 shows the brake hose/pipe (arrowed) at the front left wheel of the Motor Car. No leakage of brake fluid was observed. Visual examination of the various components of the braking system like the brake caliper (circled), brake booster, brake pedal etc had revealed all to be intact and without visible damage at the time of accident. There was also no sign of fluid stain(s) observed on the various undercarriage components.

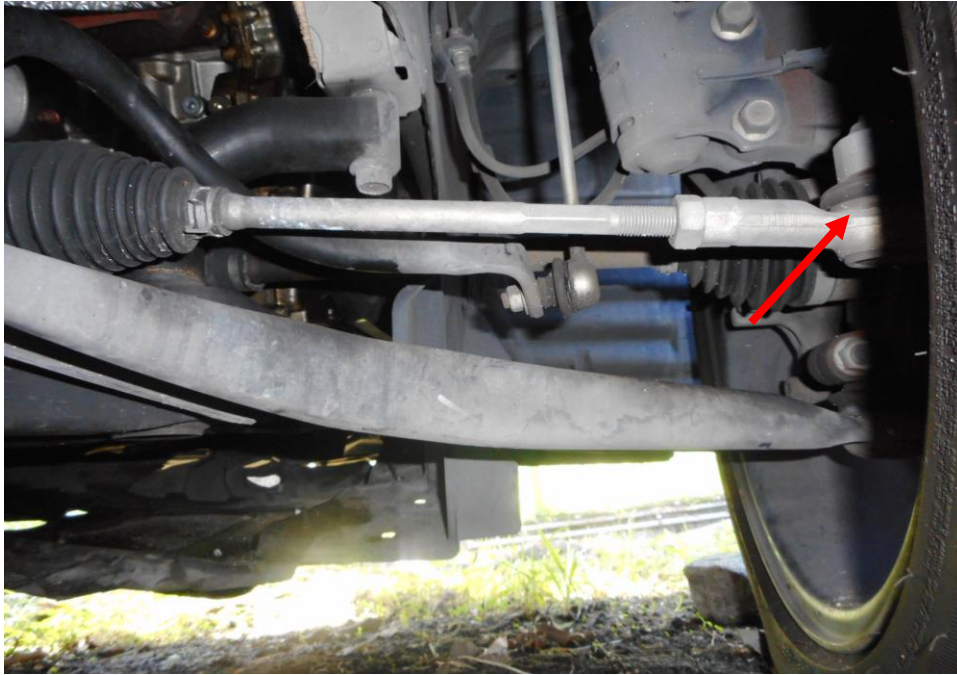
Photo 23 shows the various undercarriage components at the front right wheel of the Motor Car, in particular the steering tie rod end (arrowed). The various steering components were all found to be intact, suggesting that the steering system of the Motor Car was likely to be in serviceable condition at the material time of accident. There was also no sign of fluid stain(s) observed on the various undercarriage components.

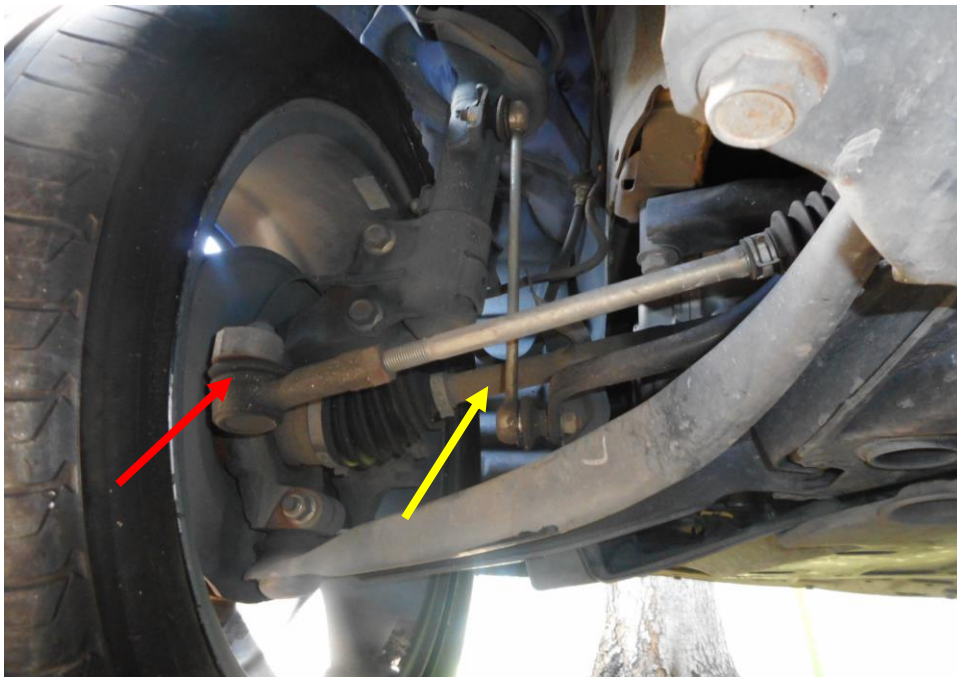
Photo 24 shows the various undercarriage components at the front left wheel of the Motor Car, in particular the steering tie rod end (arrowed) and drive shaft (yellow arrow). The various undercarriage components of the Motor Car were all found to be intact without any visible damage. There was also no sign of fluid stain(s) observed on the various undercarriage components.
