Your Ref: TP/IP/15449/2020  
Our Ref : CI/TPD20004877/P

7<sup>th</sup> July 2020

**Fatal Accident Investigation Team**

**MECHANICAL INSPECTION REPORT OF OIL TANKER YN 2909X**

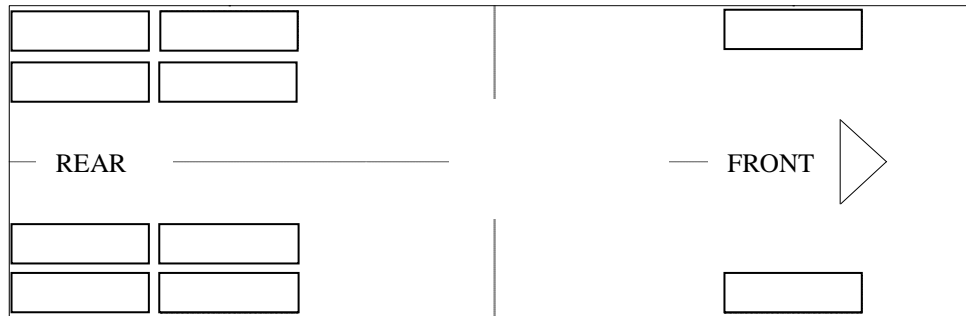
Linglong 295/80 R22.5 (15mm)

Kapsen 295/80 R22.5 (6.9mm)

Hilo 295/80 R22.5 (9mm)

Kapsen 295/80 R22.5 (4.6mm)

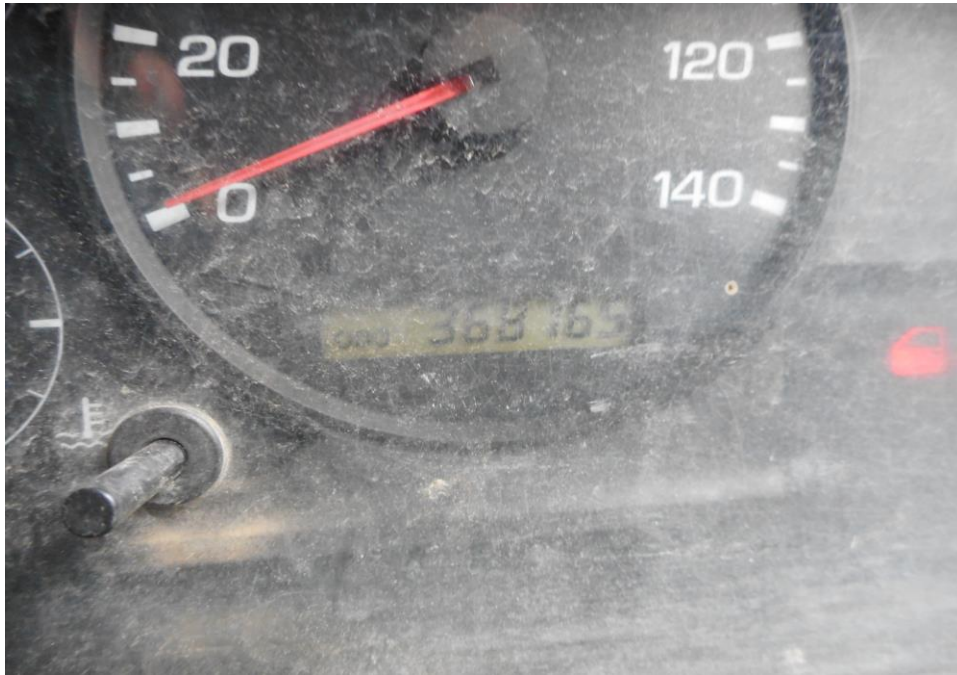
**Photo 1** shows a general view of the instrument cluster of the Oil Tanker at the time of my inspection. The mileage of the Oil Tanker was 368,165km

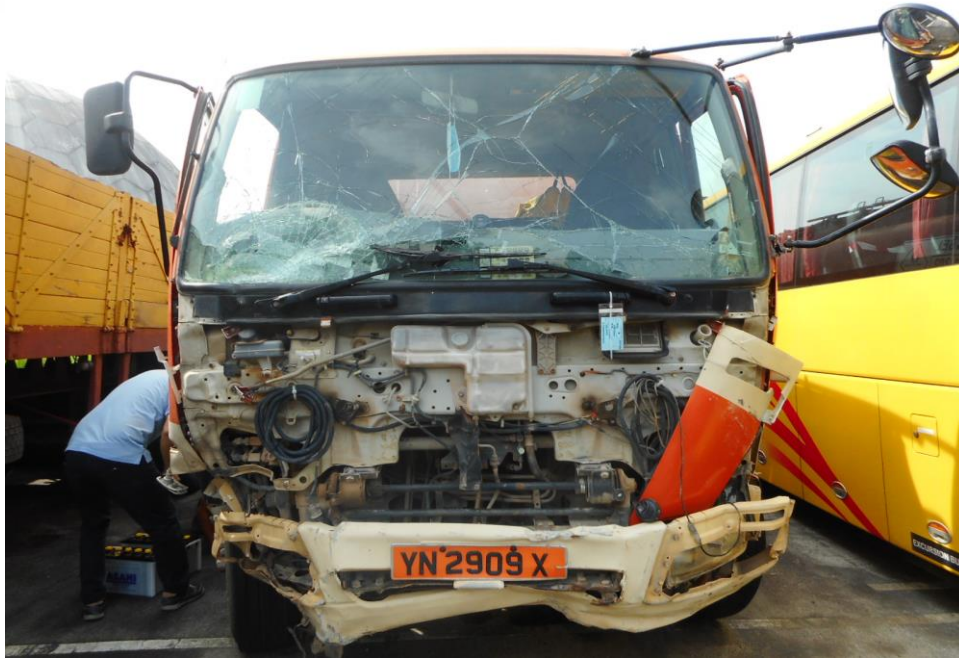
4. The mileage of the Oil Tanker at the time of my inspection was 368,165km.
5. The Oil Tanker was observed to have sustained damage at its front portion. Its front windscreen and front body panel were amongst the body parts that were damaged as a result of the accident.

**Photo 2** shows a general view of the front body of the Oil Tanker at the time of my inspection. The Oil Tanker was observed to have sustained damage at its frontal portion. Its front windscreen and front body panel were amongst the body parts that were damaged as a result of the accident.

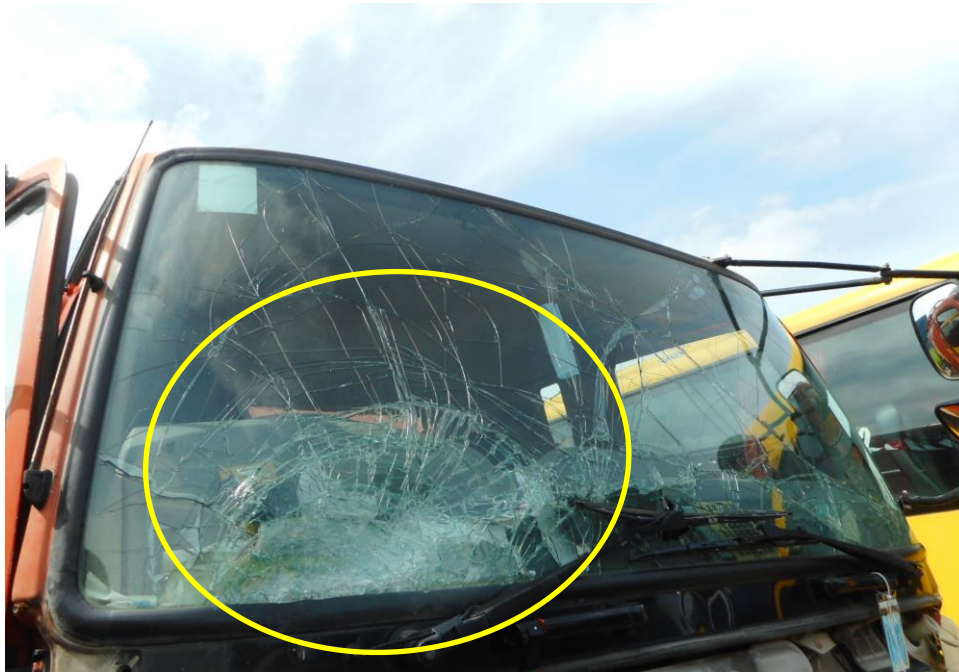
**Photo 3** shows the close up view of the Oil Tanker front body at the time of my inspection. The Oil Tanker was observed to have sustained damage at its front windscreen (circled), as a result of the accident.

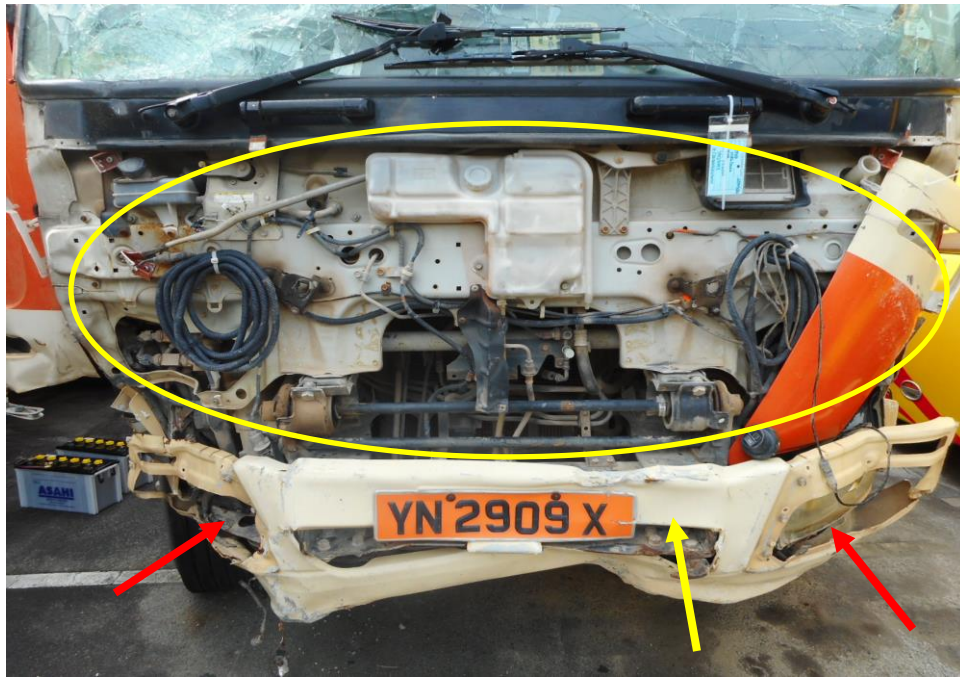
**Photo 4** shows the close up view of the Oil Tanker front body at the time of my inspection. The Oil Tanker was observed to have sustained damage at its front body panel (circled), it's both front headlamps (red arrow) and front bumper (yellow arrow) was also damaged as a result of the accident.

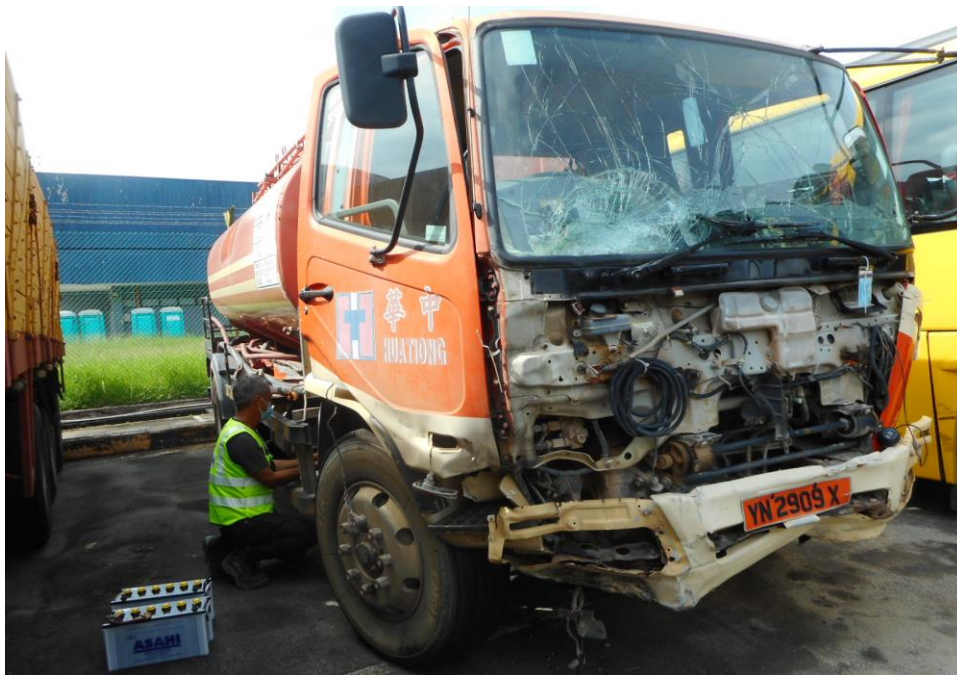
**Photo 5** shows a general view of the front right body of the Oil Tanker at the time of my inspection, observed to have been unaffected by the accident.

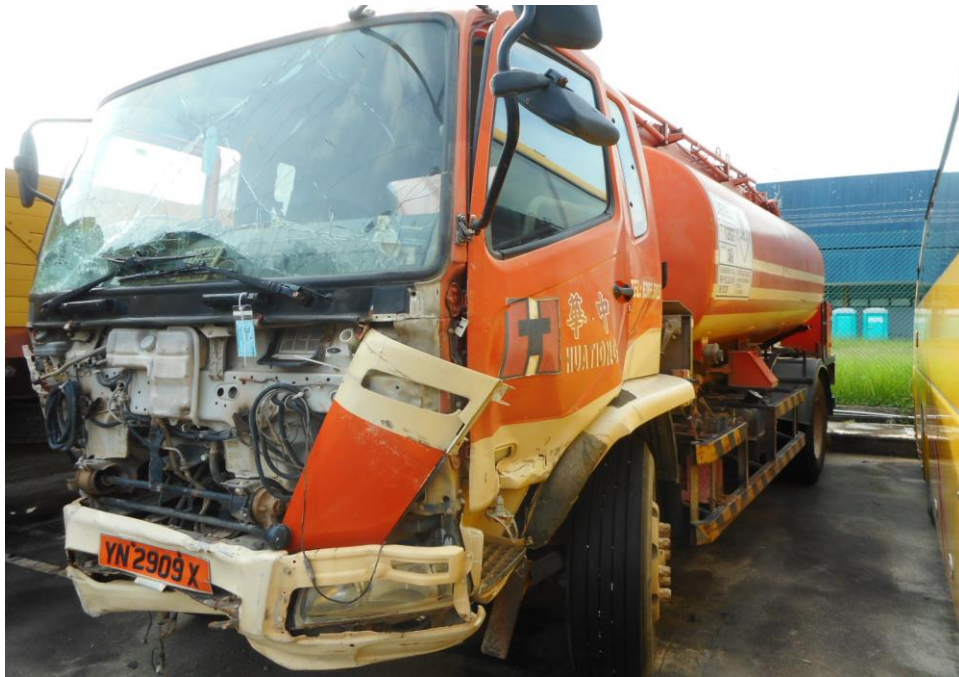
**Photo 6** shows a general view of the front right body of the Oil Tanker at the time of my inspection, observed to have been unaffected by the accident.

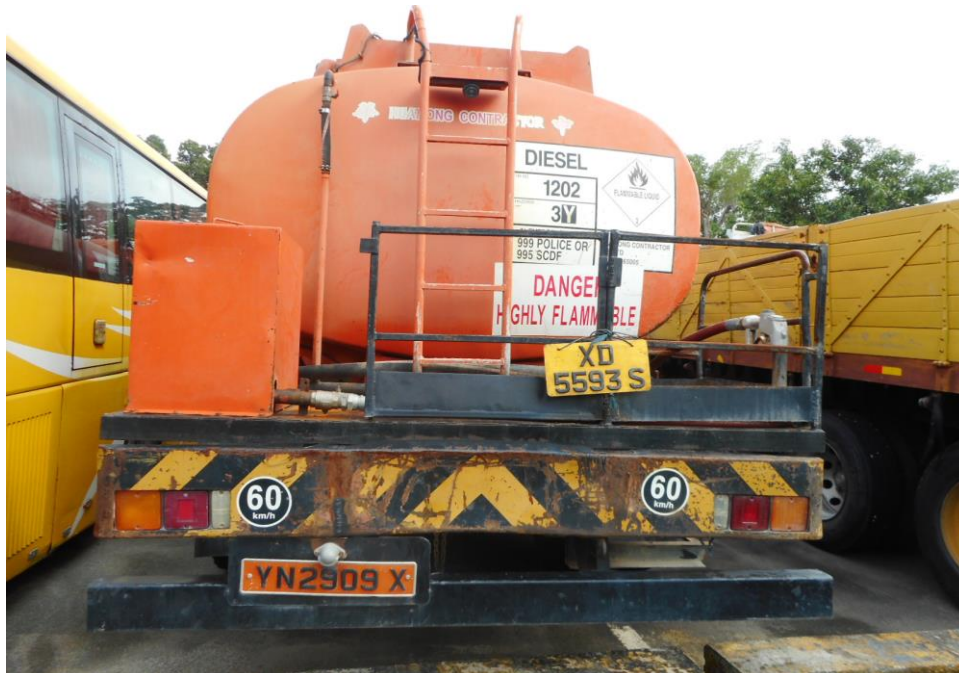
**Photo 7** shows a general view of the Oil Tanker's rear body at the time of my inspection. There was no damage found to the rear portion of the Oil Tanker.

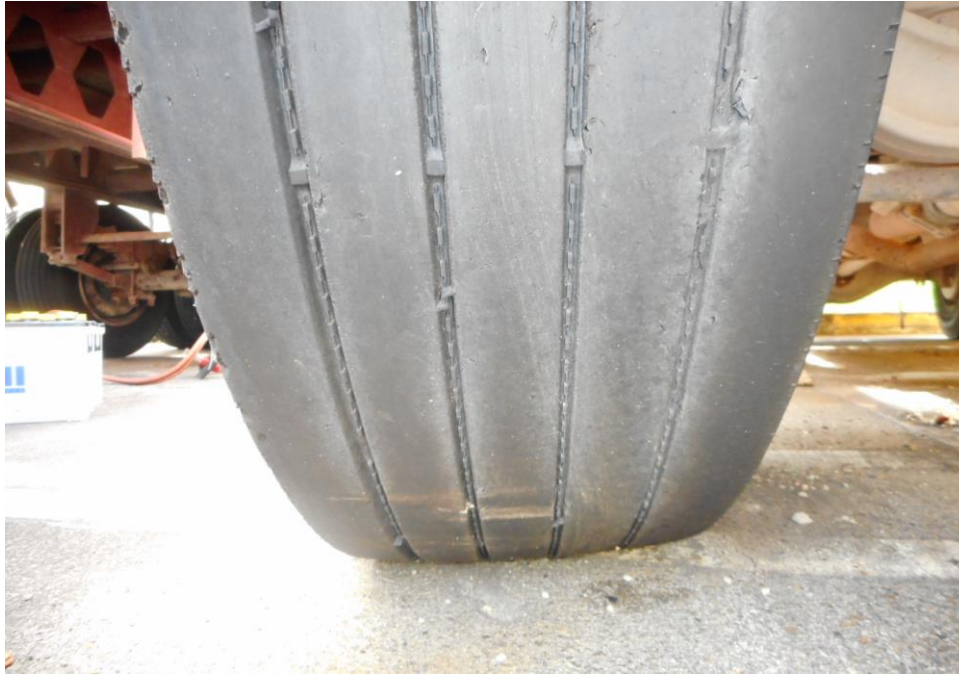
**Photo 8** shows the condition of the front right tyre of the Oil Tanker, which was observed to be in serviceable condition with remaining tread depth of approximately 4.6 mm. The tyre, which was wrapped around standard steel wheel rim, was also observed to be sufficiently inflated for vehicular operation. There was no tear, cut or burst mark(s) on the outer and the inner sidewalls as well as across the tread of the 10 tyres that were fitted on the Oil Tanker.

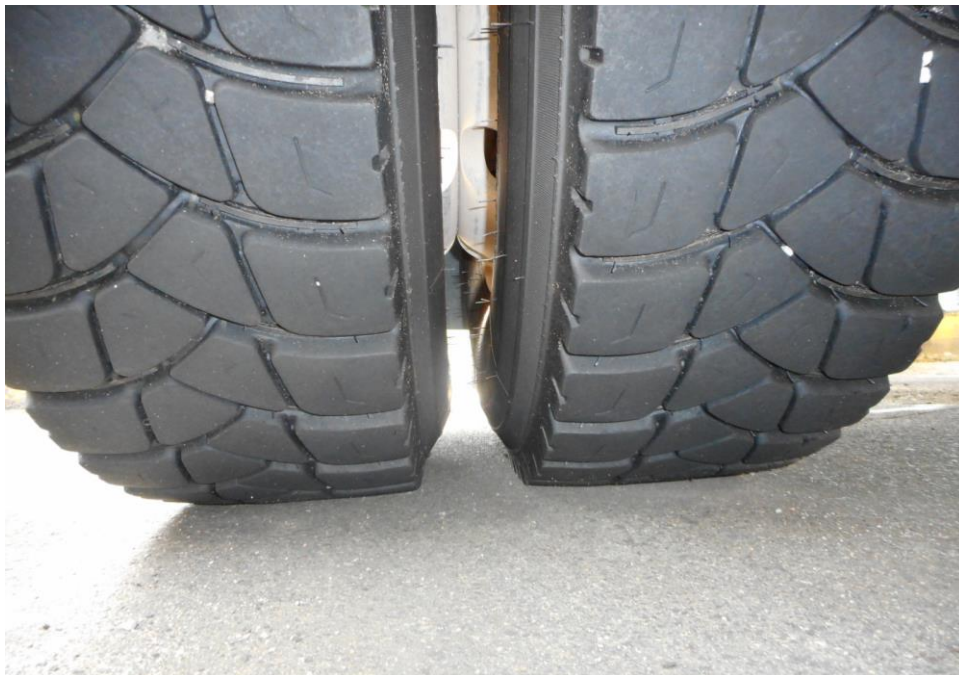
**Photo 9** shows the condition of the rear right tyre of the Oil Tanker, which was observed to be in serviceable condition with remaining tread depth of approximately 9mm. The tyre, which was wrapped around standard steel wheel rim, was also observed to be sufficiently inflated for vehicular operation.

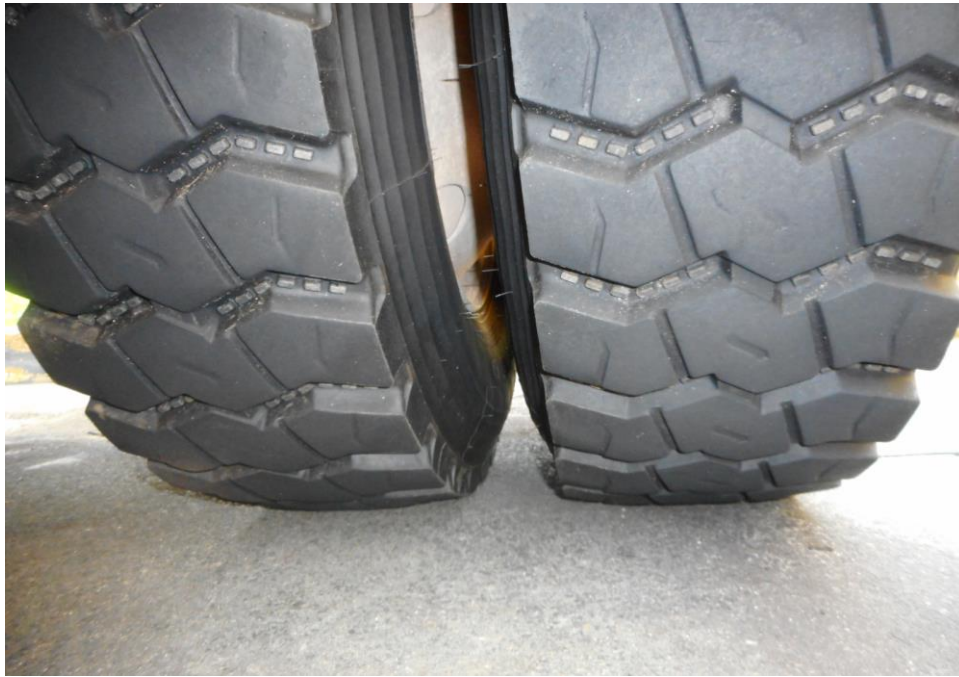
**Photo 10** shows the condition of the rear left tyres of the Oil Tanker, which was observed to be in serviceable condition with remaining tread depth of approximately 15mm. The tyres, which were wrapped around standard steel wheel rim, were also observed to be sufficiently inflated for vehicular operation. There was also no damage found on all 10 steel wheel rims of the Oil Tanker.

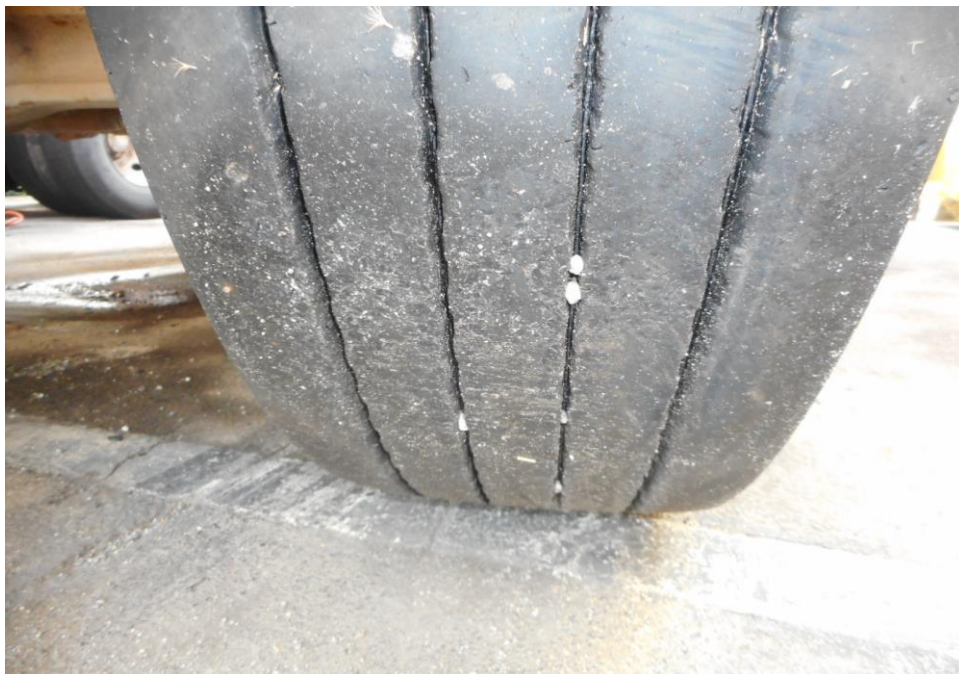
**Photo 11** shows the condition of the front left tyres of the Oil Tanker, which were observed to be in serviceable condition with remaining tread depth of approximately 6.9mm. There was also no tear, cut or burst mark(s) on the outer and the inner sidewalls as well as across the tread of the 10 tyres that were fitted on the Oil Tanker.

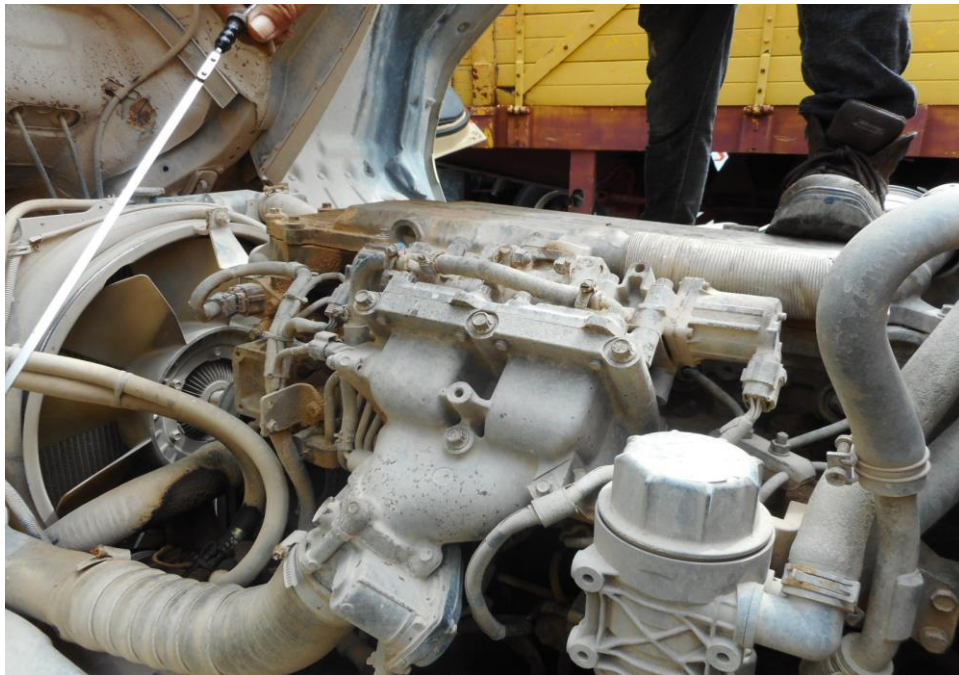
**Photo 12** shows a general view of the Oil Tanker's engine compartment, which was accessed by lifting the front cabin of the Oil Tanker. The various parts and components inside the engine compartment were unaffected by the accident. There was also no sign(s) or indication(s) of fresh fluid leakage and/or fluid stain within the engine compartment

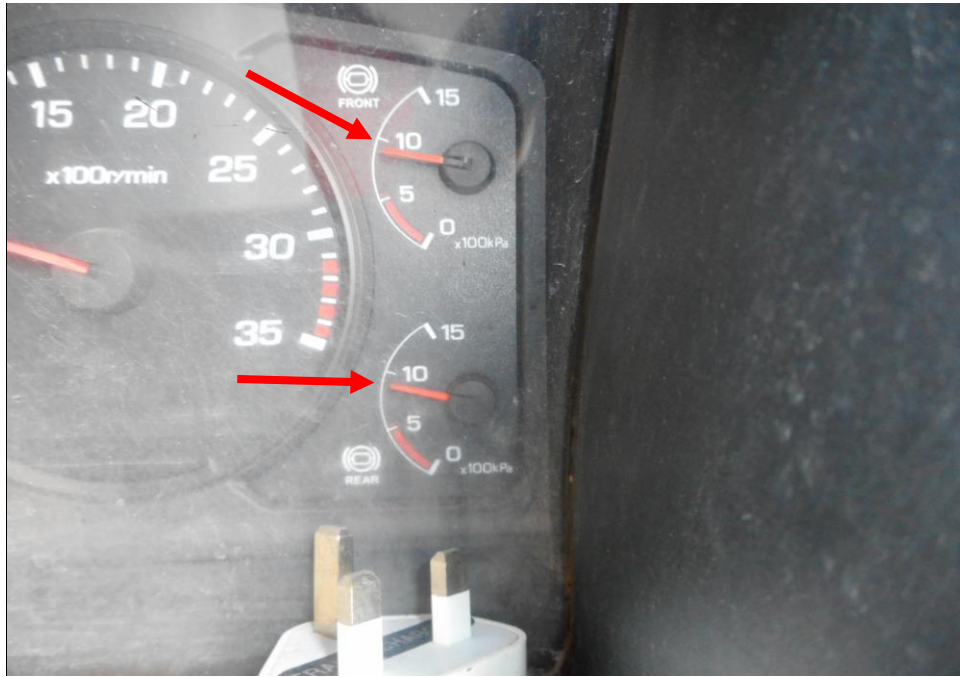
**Photo 13** shows the air in the air brake cylinders of the Oil Tanker at the time of my inspection. The air in the cylinder was observed to be of sufficient level & serviceable at the time of the accident.

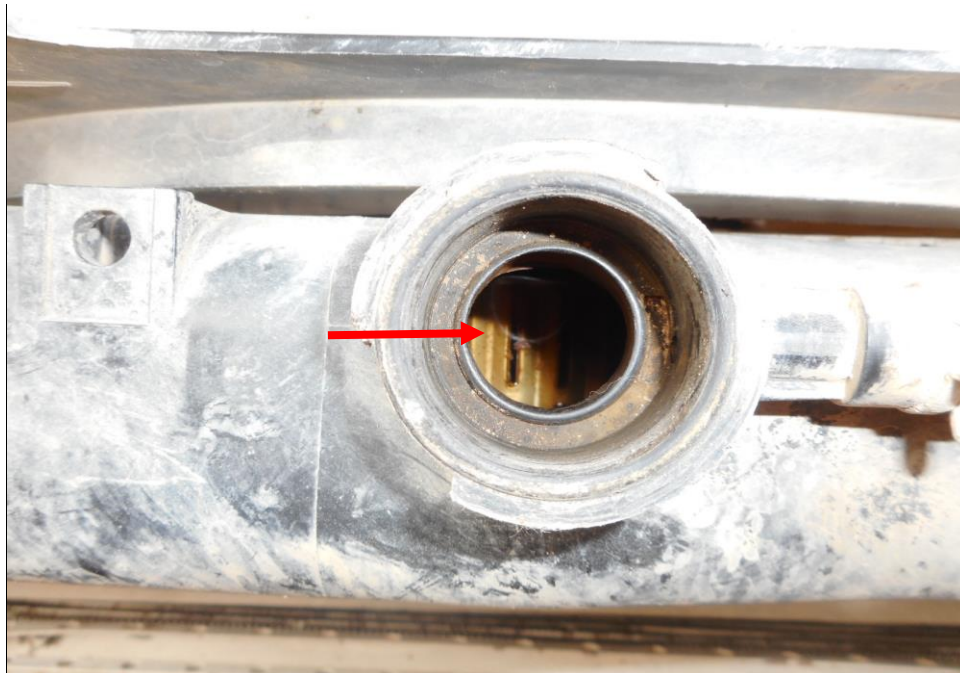
**Photo 14** shows the engine coolant reservoir of the Oil Tanker at the time of my inspection. The engine coolant was observed to be of sufficient level (arrowed) and without any visible contamination.

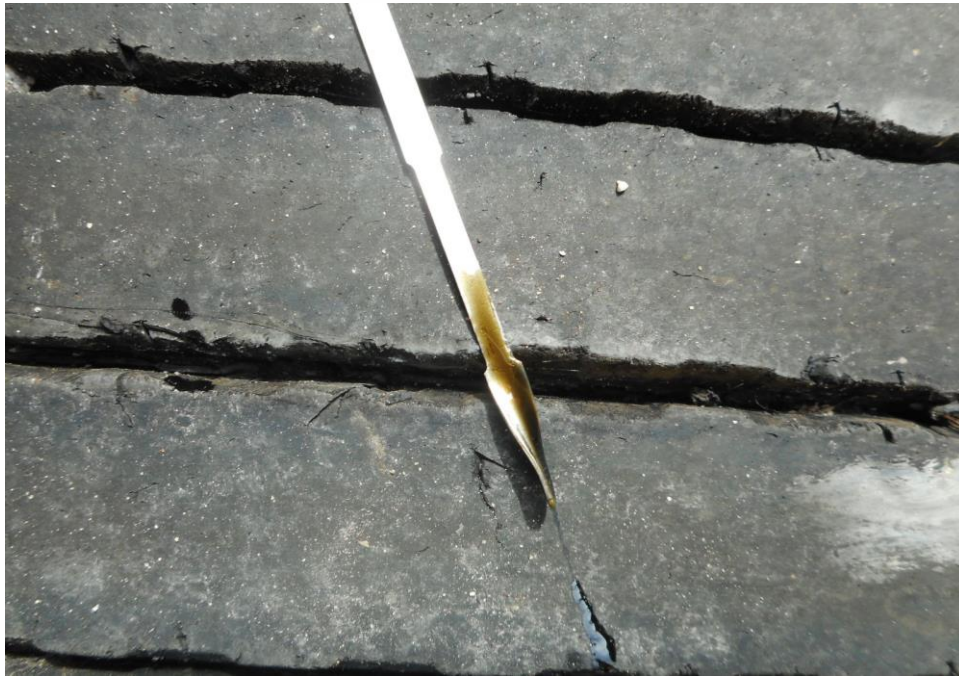
**Photo 15** shows the engine oil dipstick of the Oil Tanker at the time of my inspection. The engine oil was observed to be of sufficient level and without any visible contamination.

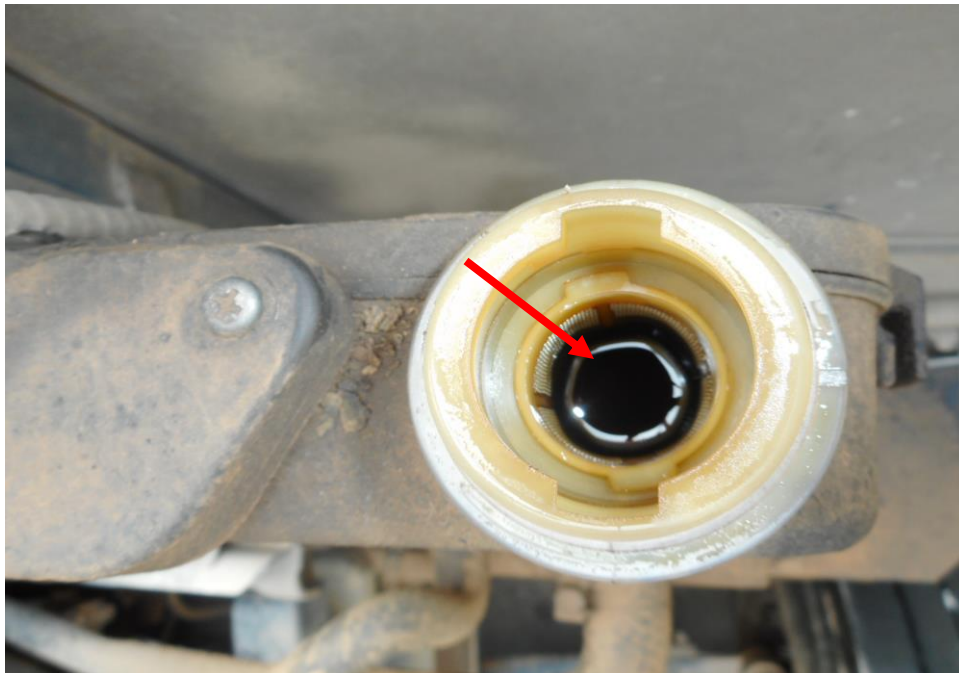
**Photo 16** shows the power steering reservoir of the Oil Tanker at the time of my inspection. The steering fluid was observed to be of sufficient level (arrowed) and without any visible contamination.

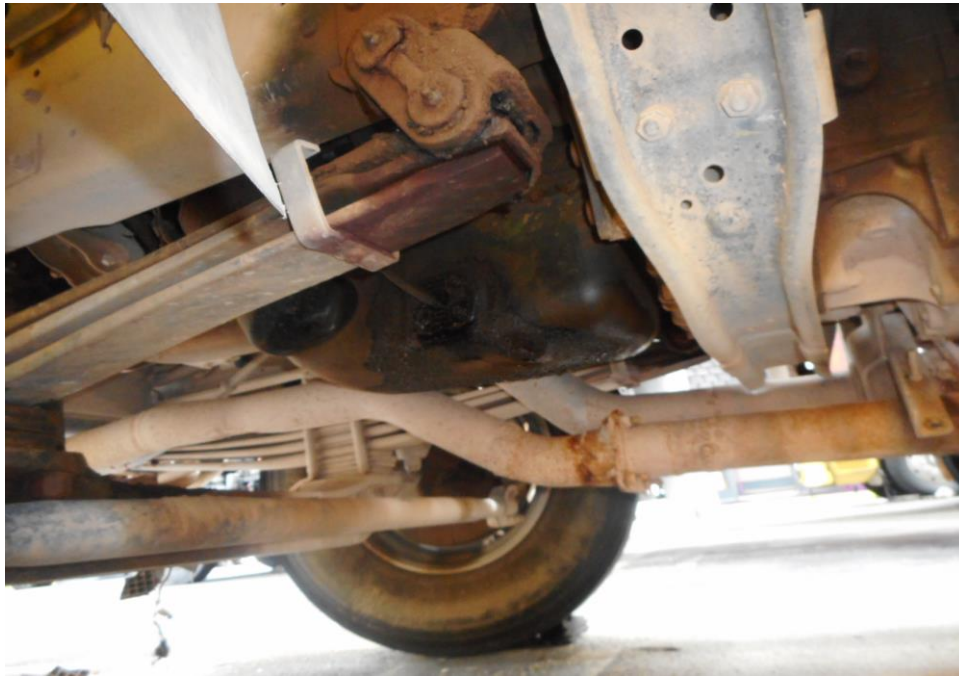
**Photo 17** shows the undercarriage of the Oil Tanker, at the area where the engine housing located. I did not find any sign(s) or indication(s) of fluid leak and/or fluid stain(s) on the underside of the Oil Tanker.

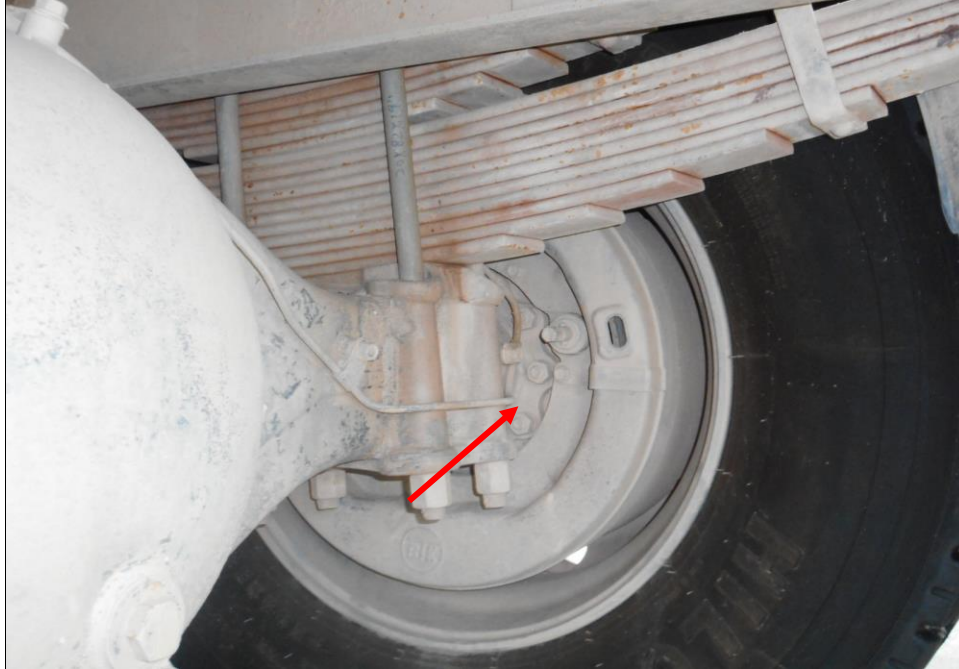
**Photo 18** shows the brake pipe (arrowed) at the rear right wheel of the Oil Tanker. I did not observe any leakage of brake fluid at the time of my inspection of the Oil Tanker. My static tests of the Oil Tanker's braking system, along with my visual examination of the various mechanical components in the braking system, had indicated that there was no internal leakage of pressure/vacuum. Hence the braking system of the Oil Tanker was likely to be in serviceable condition at the material time of accident.

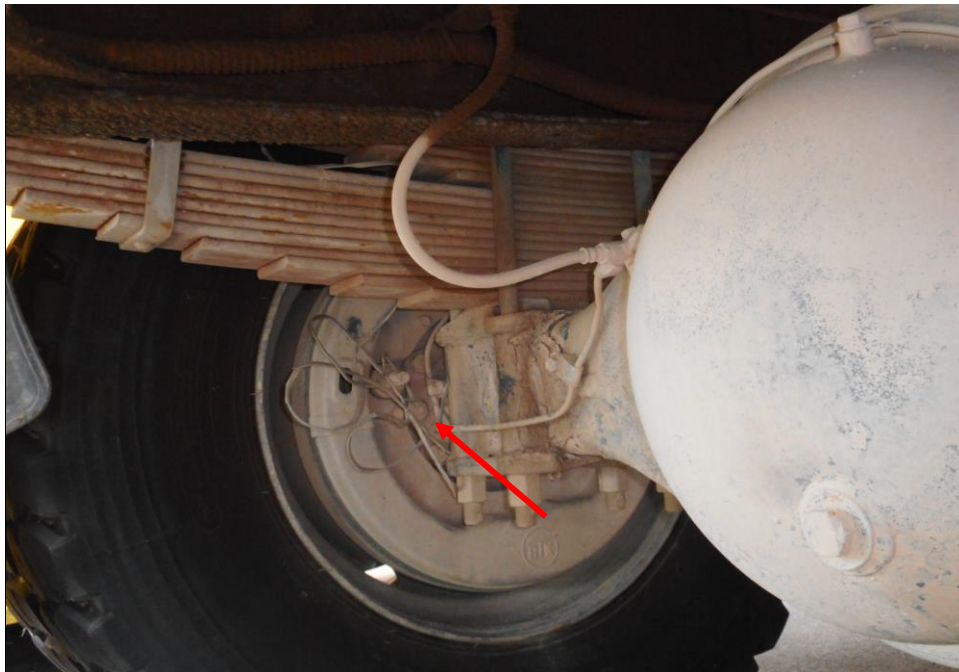
**Photo 19** shows the brake pipe (arrowed) at the rear left wheel of the Oil Tanker. I did not observe any leakage of brake fluid at the time of my inspection of the Oil Tanker. My static tests of the Oil Tanker's braking system, along with my visual examination of the various mechanical components in the braking system, had indicated that there was no internal leakage of pressure/vacuum. Hence the braking system of the Oil Tanker was likely to be in serviceable condition at the material time of accident.

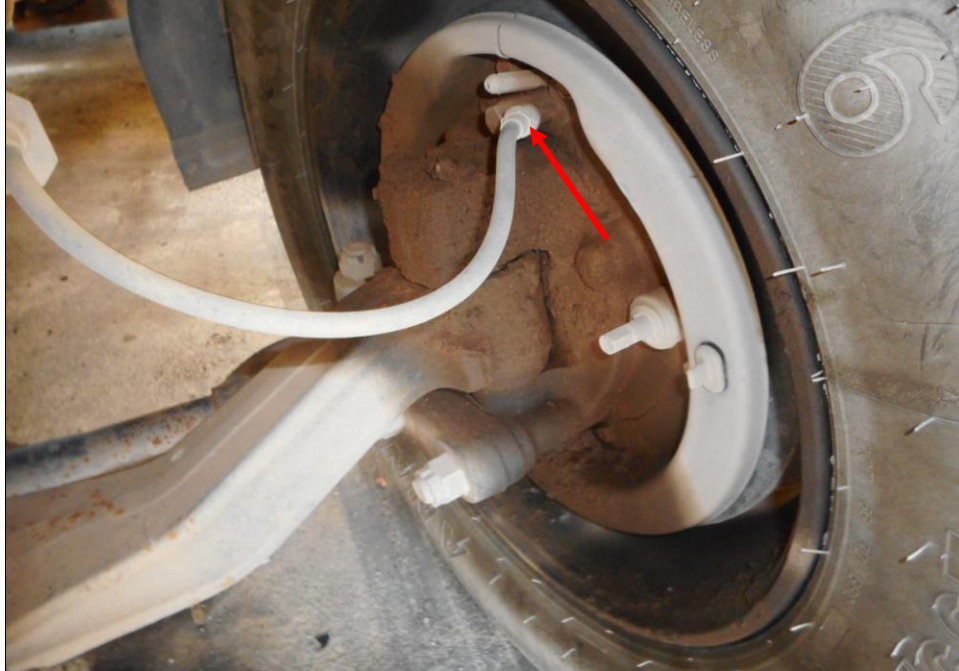
**Photo 20** shows the brake pipe (arrowed) at the front left wheel of the Oil Tanker. I did not observe any leakage of brake fluid at the time of my inspection of the Oil Tanker. My static tests of the Oil Tanker's braking system, along with my visual examination of the various mechanical components in the braking system, had indicated that there was no internal leakage of pressure/vacuum. Hence the braking system of the Oil Tanker was likely to be in serviceable condition at the material time of accident.

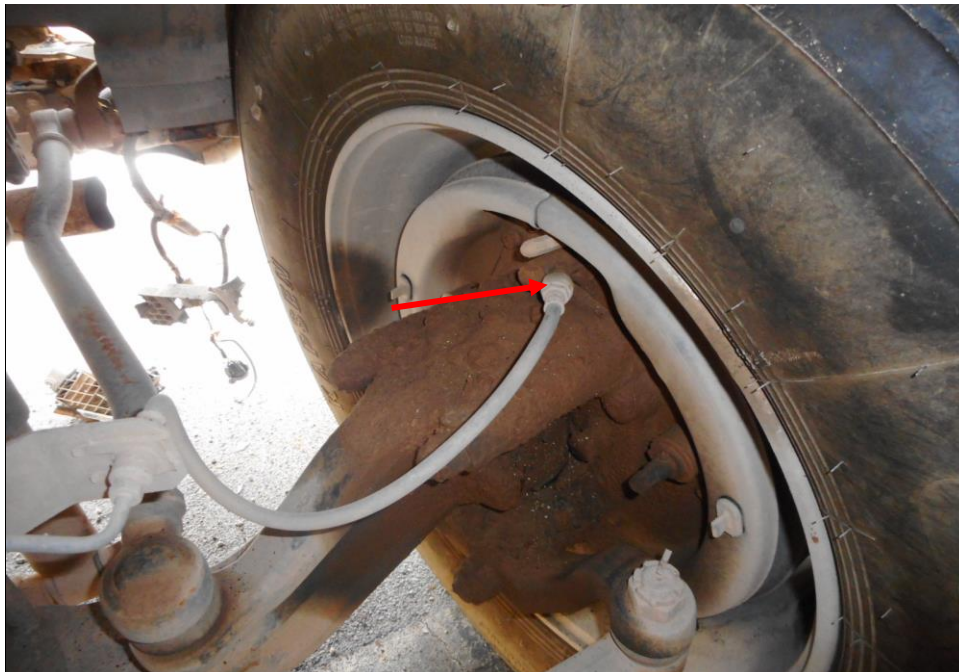
**Photo 21** shows the brake pipe (arrowed) at the front right wheel of the Oil Tanker. I did not observe any leakage of brake fluid at the time of my inspection of the Oil Tanker. My static tests of the Oil Tanker's braking system, along with my visual examination of the various mechanical components in the braking system had indicated that there was no internal leakage of pressure/vacuum. Hence the braking system of the Oil Tanker was likely to be in serviceable condition at the material time of accident.

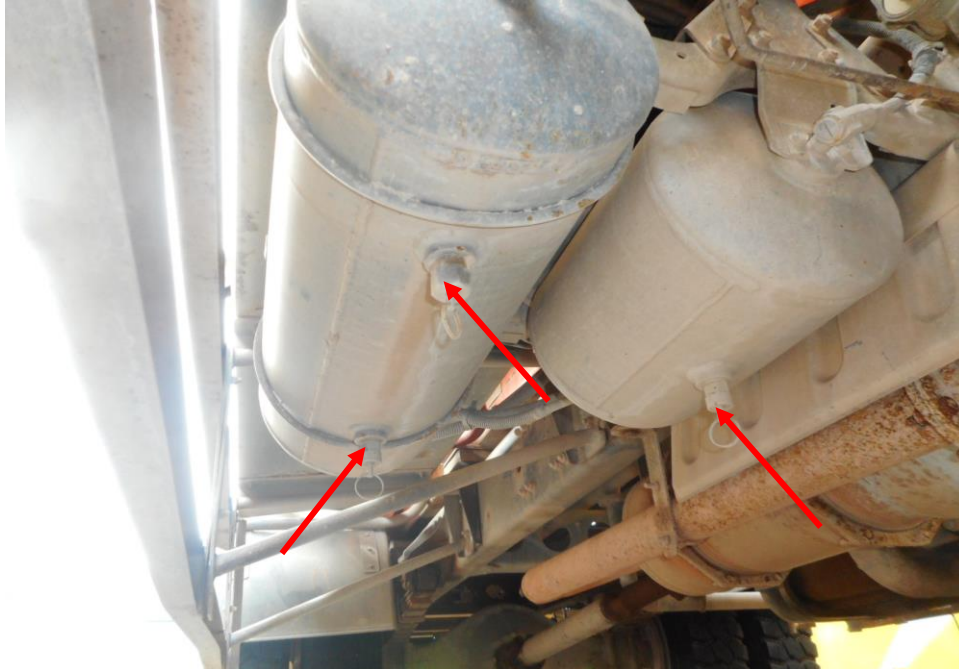
**Photo 22** shows the air brake cylinders (arrowed) at the undercarriage of the Oil Tanker. I did not observe any leakage of air brake fluid at the time of my inspection of the Oil Tanker. My static tests of the Oil Tanker's braking system, along with my visual examination of the various mechanical components in the braking system had indicated that there was no internal leakage of pressure/vacuum. Hence the braking system of the Oil Tanker was likely to be in serviceable condition at the material time of accident.

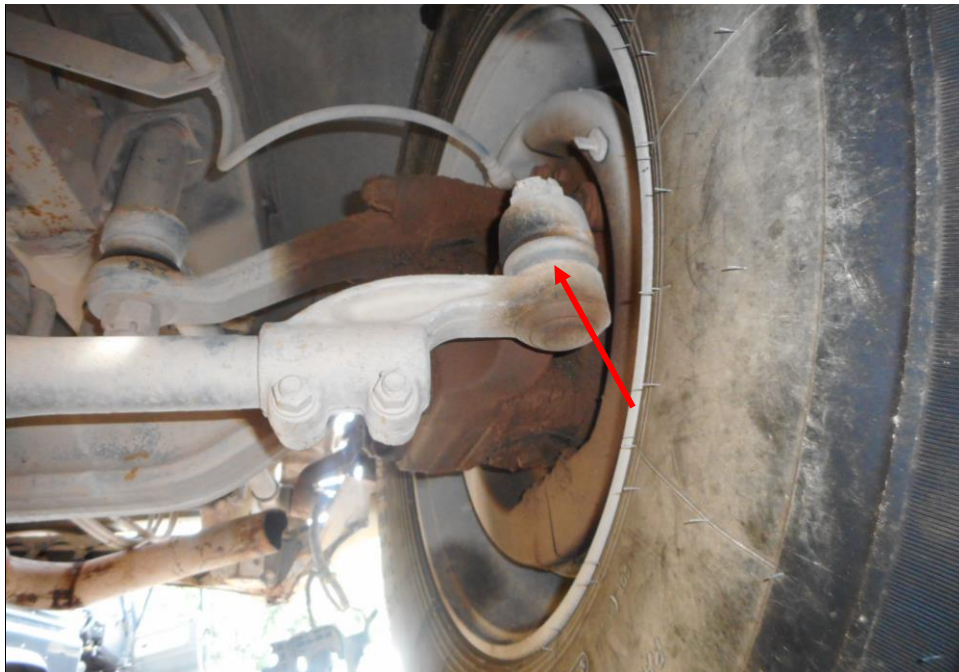
**Photo 23** shows the various undercarriage components at the front right wheel of the Oil Tanker, in particular the steering tie rod end (arrowed). The various steering components were all found to be intact, suggesting that the steering system of the Oil Tanker was likely to be in serviceable condition at the material time of accident. There was also no sign of fluid stain(s) observed on the various undercarriage components.

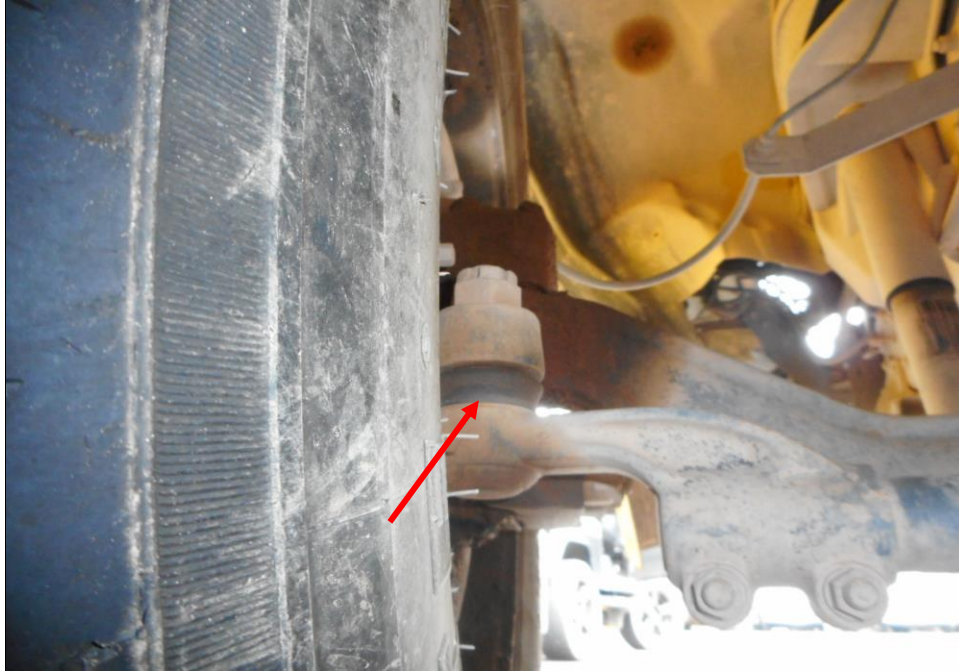
**Photo 24** shows the various undercarriage components at the front left wheel of the Oil Tanker, in particular the steering tie rod end (arrowed). The various undercarriage components of the Oil Tanker were all found to be intact without any visible damage. There was also no sign of fluid stain(s) observed on the various undercarriage components.

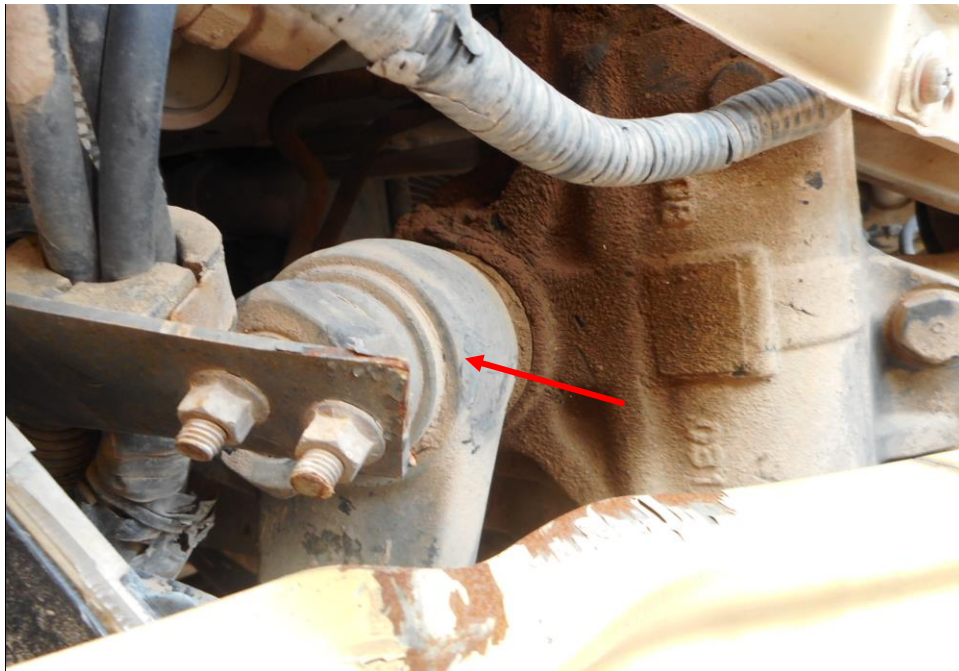
**Photo 25** shows the steering box component (arrowed) at the undercarriage of the Oil Tanker was found to be intact without any visible damage. There was also no sign of fluid stain(s) observed on the various undercarriage components.

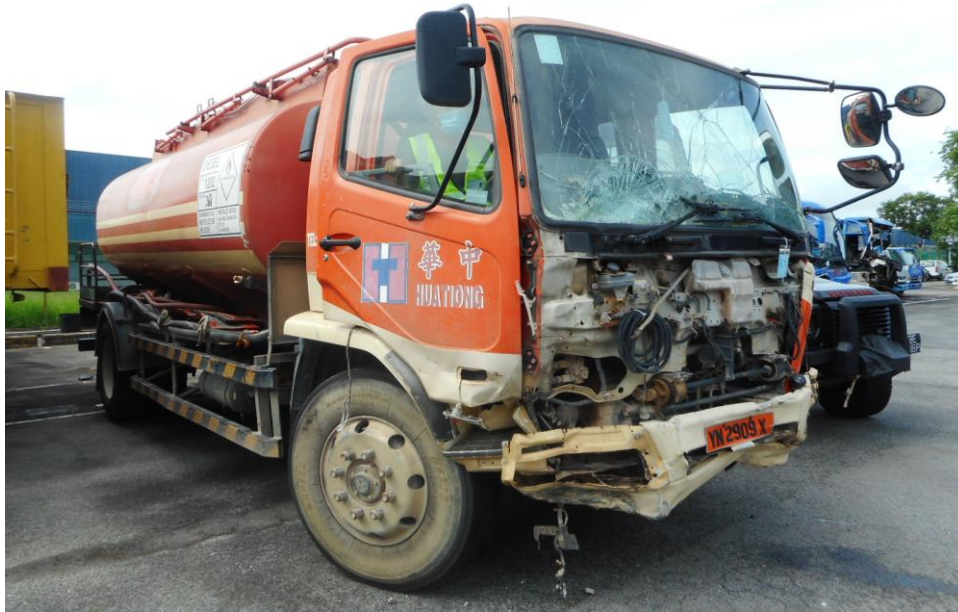
**Photo 26** shows the front right wheel of the Oil Tanker turned to its full left. During my steering system test, I did not experience any abnormal free play and/or resistance when I had turned the steering wheel towards full left and full right. This would suggest that the steering system of the Oil Tanker was likely to be in serviceable condition at the material time of accident.
