Your Ref: TP/IP/12635/2020  
Our Ref : CI/TPD20004879/P

**MECHANICAL INSPECTION REPORT OF MOTOR CAR SKA 7832J**

1. I refer to your request on 2<sup>nd</sup> April 2020 to conduct a physical inspection of a Motor Car bearing registration number SKA 7832J (herein referred to as "**Motor Car**"), which was involved in a road traffic accident on 11<sup>th</sup> March 2020.
2. The objective of the inspection is to determine if there was any possible mechanical failure to the Motor Car that may have contributed to the accident.
3. Following the request, I had carried out a physical inspection of the Motor Car on 7<sup>th</sup> April 2020 at the premises of Traffic Police vehicle pound, 517 Airport Road Singapore 539942. I now set out below my observations and comments with respect to this inspection.

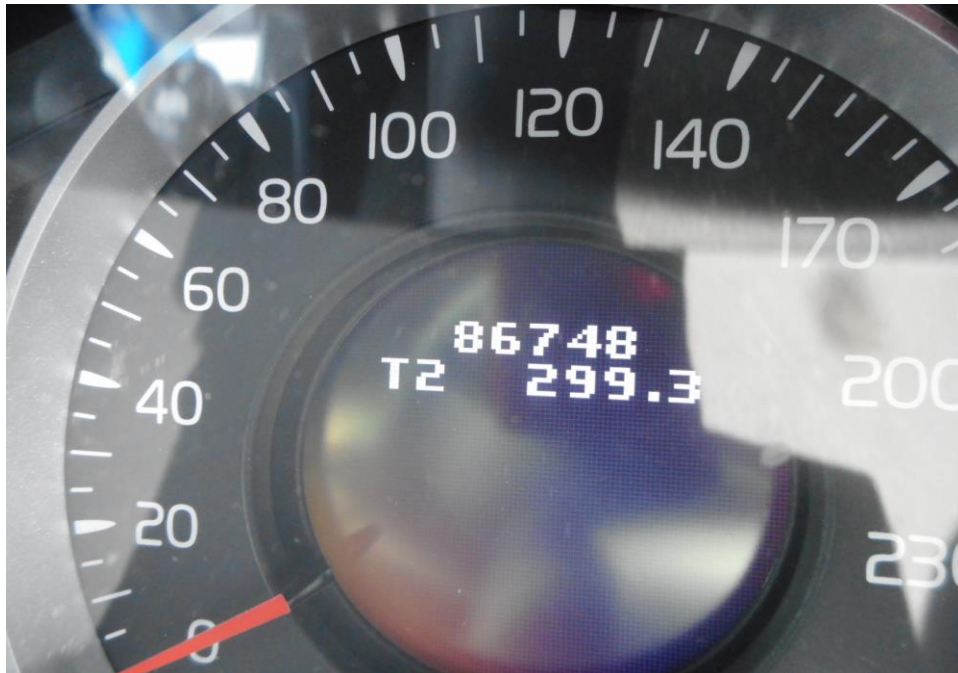
**Photo 1** shows the mileage of the Motor Car at the time of my inspection. The mileage observed was 86,748km.

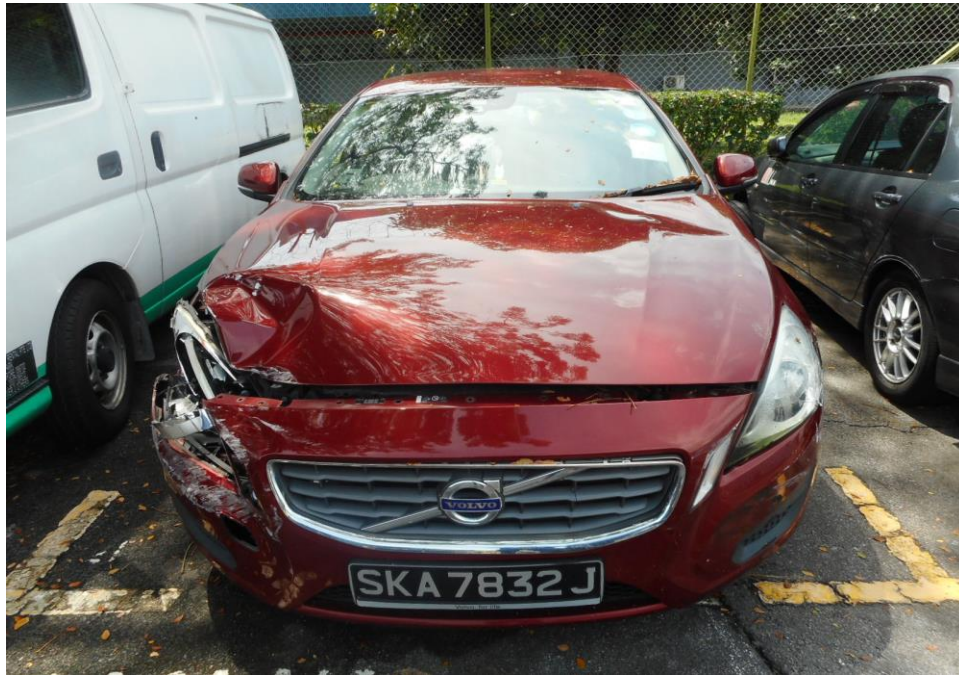
4. The mileage of the Motor Car at the time of my inspection was 86,748km.
5. The Motor Car was observed to have sustained damage at its front and rear portion. Its front bonnet, rear boot, front bumper and rear bumper, it's both front headlamps were amongst the body parts that were damaged as a result of the accident.

**Photo 2** shows a general view of the Motor Car's front body at the time of my inspection. The Motor Car was observed to have sustained damage at its front and rear portion. Its front bonnet, rear boot, front bumper and rear bumper, its both front headlamps were amongst the body parts that were damaged as a result of the accident.

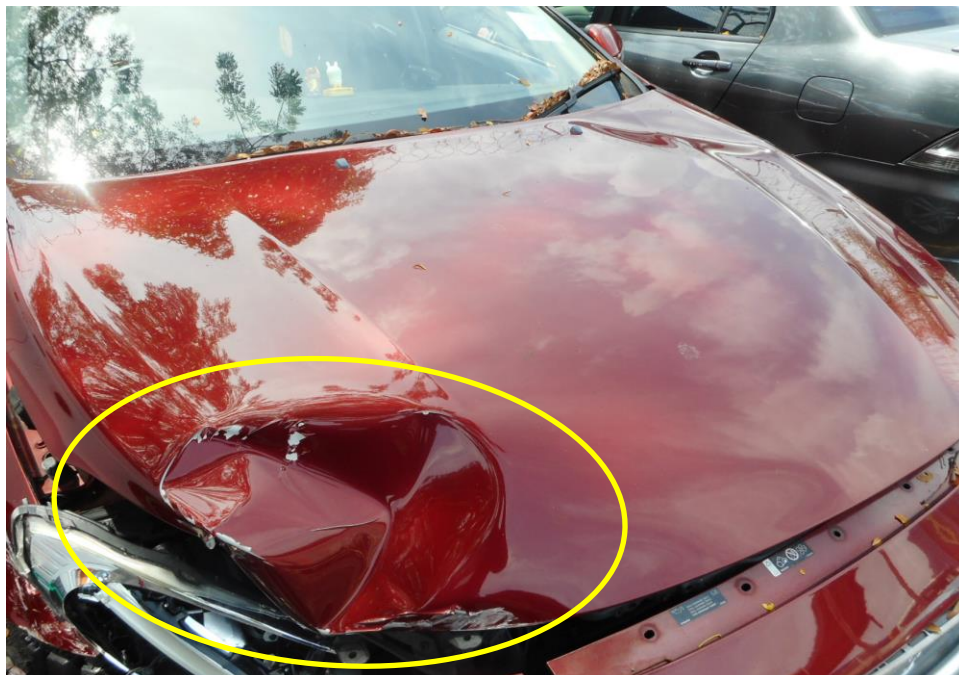
**Photo 3** shows the close up view of the Motor Car's front body at the time of my inspection. The Motor Car was observed to have sustained damage at its front bonnet (circled), as a result of the accident.

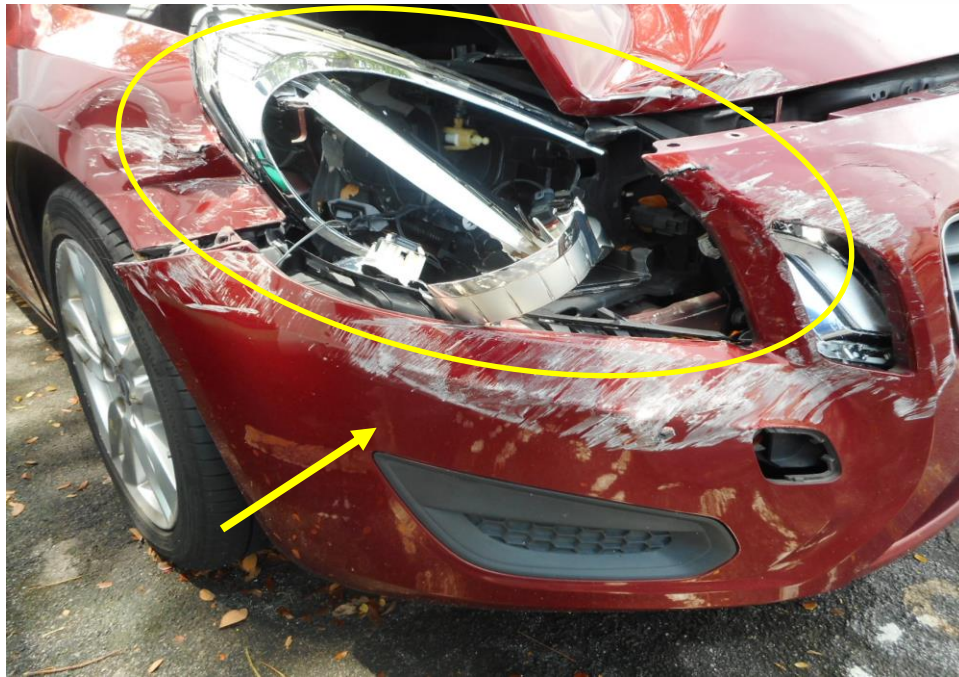
**Photo 4** shows the close up view of the Motor Car's front body at the time of my inspection. The Motor Car was observed to have sustained damage at its front bumper (arrowed) and front right headlamps (circled) as a result of the accident.

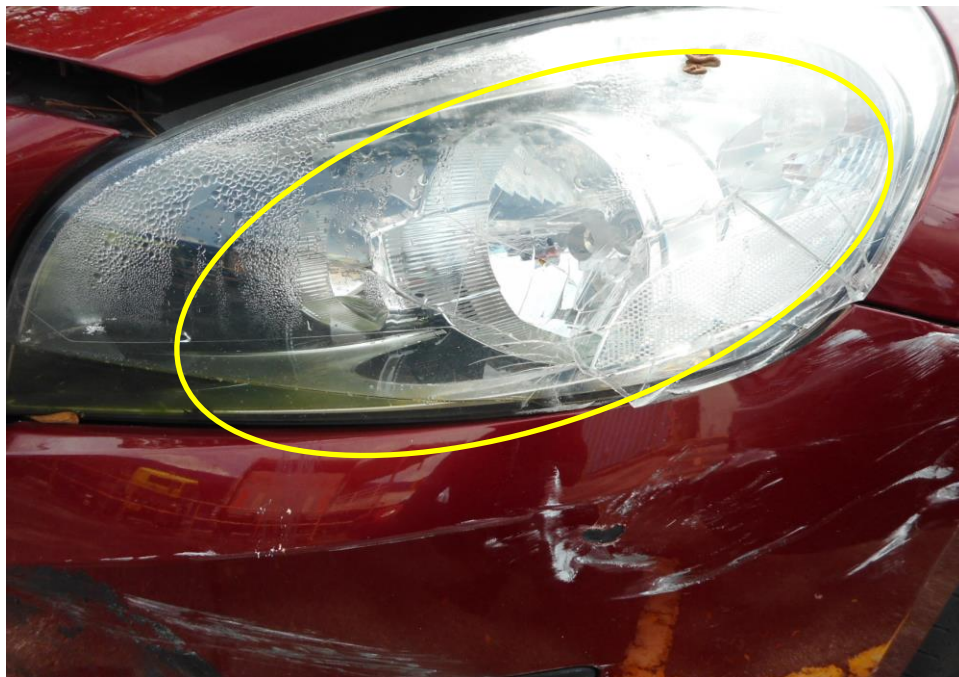
**Photo 5** shows the close up view of the Motor Car's front body at the time of my inspection. The Motor Car was observed to have sustained damage at its front left headlamps (circled) as a result of the accident.

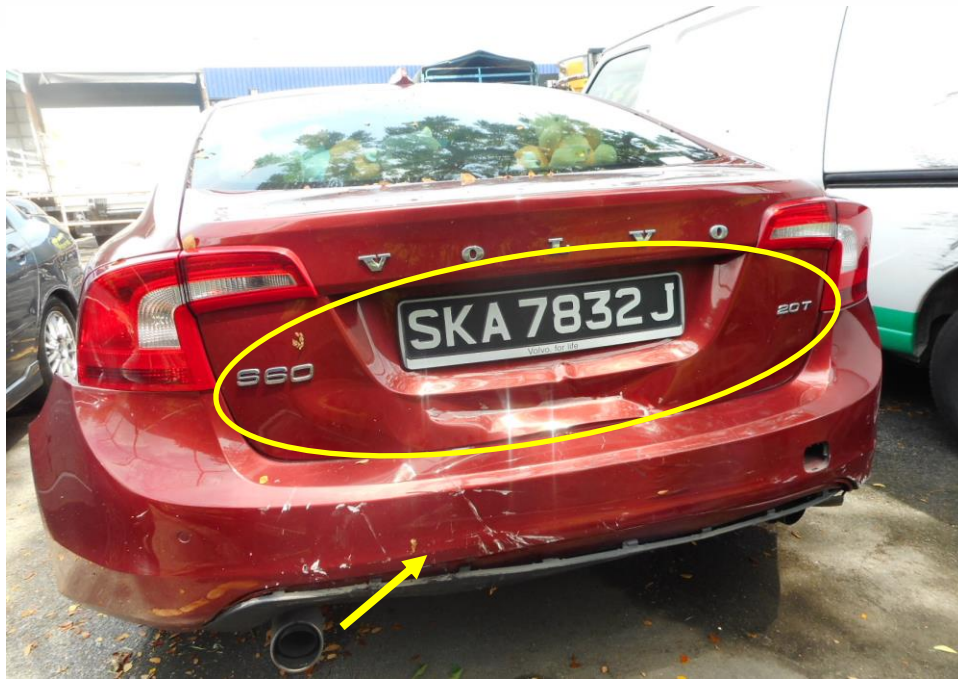
**Photo 6** shows the general view of the Motor Car's rear body at the time of my inspection. The Motor Car rear was observed to have sustained damage at its rear boot (circled) and rear bumper (arrowed) as a result of the accident.

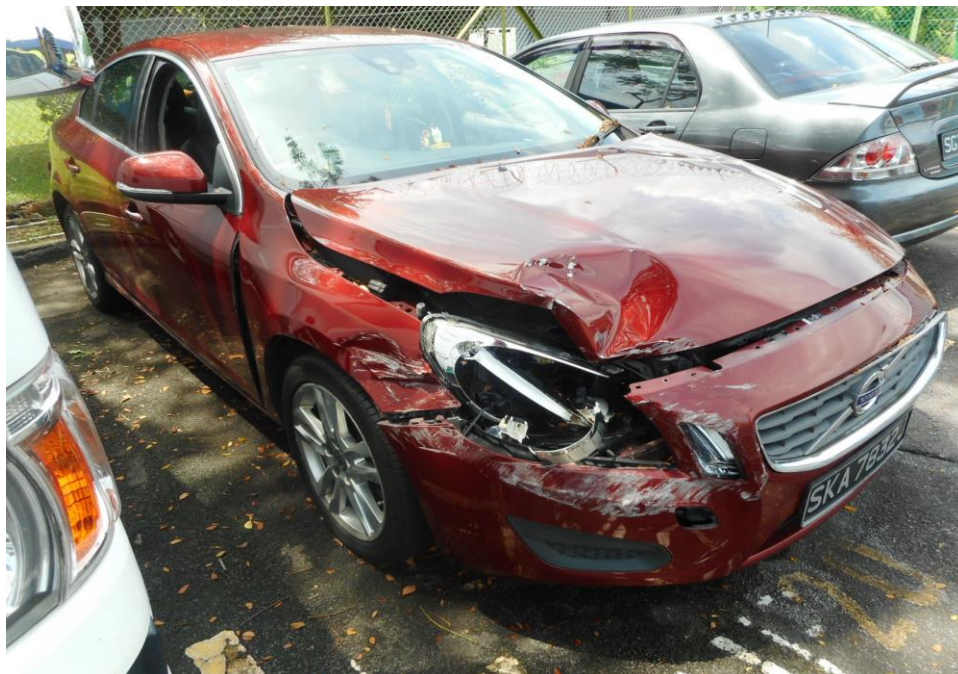
**Photo 7** shows a general view of the Motor Car's right body at the time of my inspection. The right portion of the Motor Car was observed to have been unaffected by the accident.

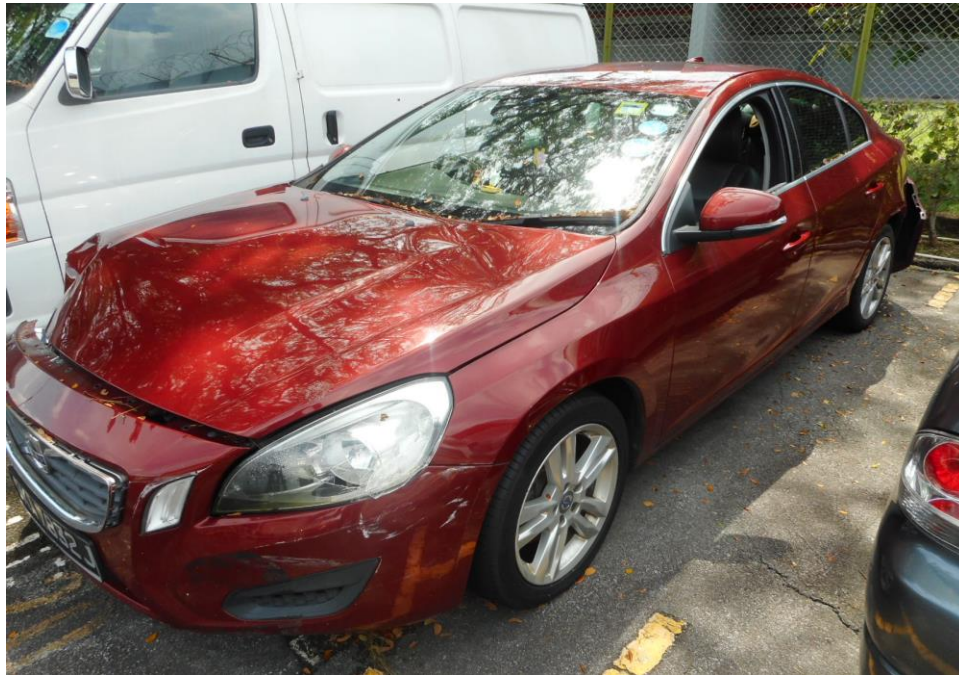
**Photo 8** shows a general view of the Motor Car's left body at the time of my inspection. The left portion of the Motor Car was observed to have been unaffected by the accident.

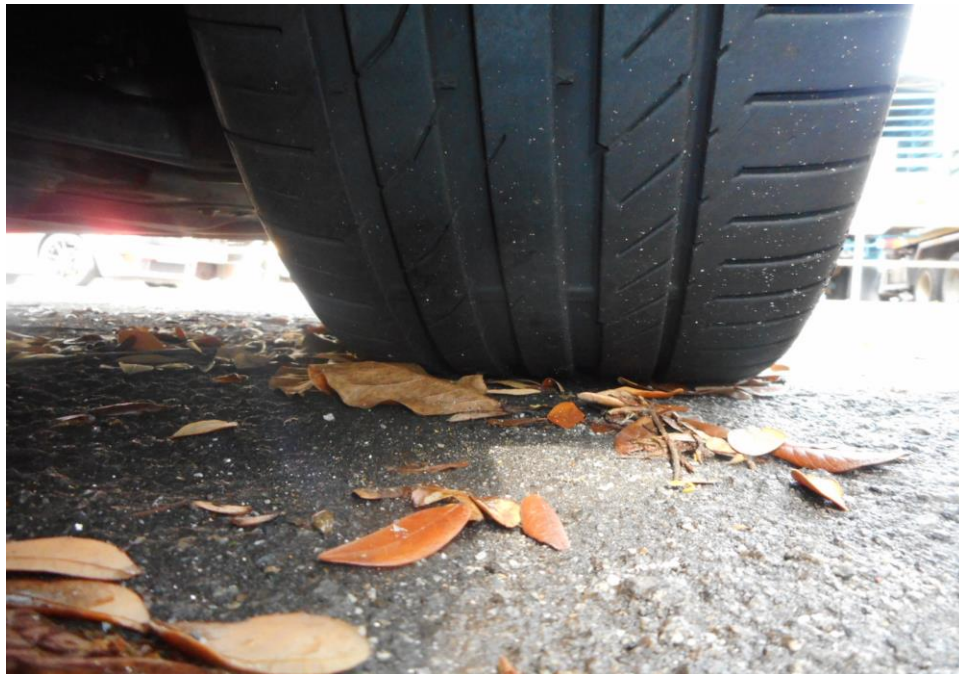
**Photo 9** shows the condition of the front right tyre of the Motor Car, which was observed to be in serviceable condition with remaining tread depth of approximately 4.9mm. The tyre was sufficiently inflated for vehicular operation with no tear, cut or burst mark(s) on the outer and the inner sidewalls as well as across the tread. The 4 tyres of the Motor Car were wrapped around standard steel wheel rims without any damage.

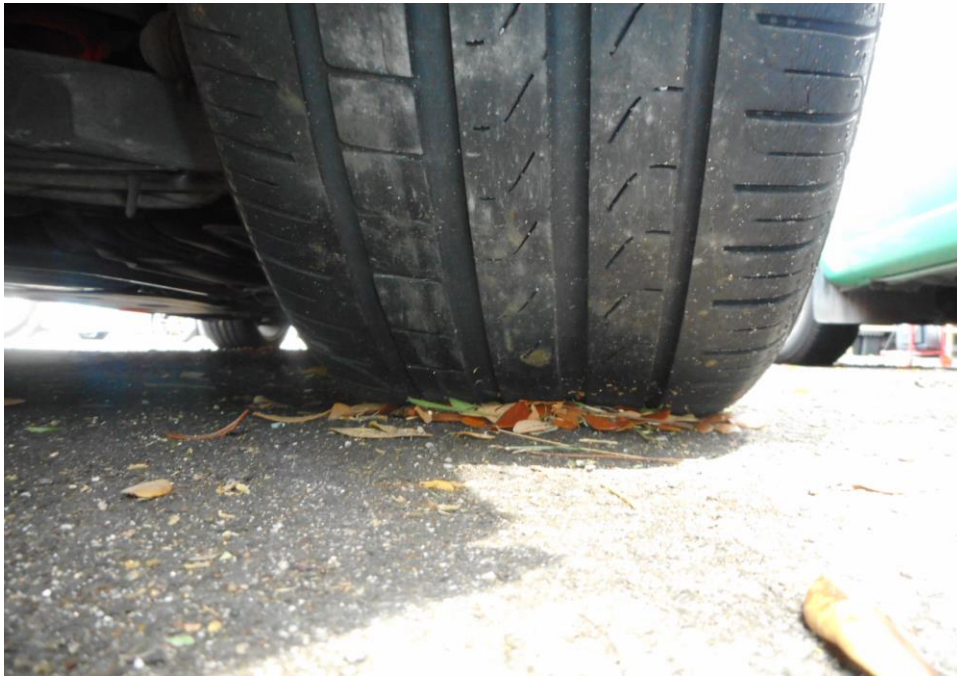
**Photo 10** shows the condition of the rear right tyre of the Motor Car, which was observed to be in serviceable condition with remaining tread depth of approximately 3.8mm. The tyre was also observed to be sufficiently inflated for vehicular operation with no tear, cut or burst mark(s).

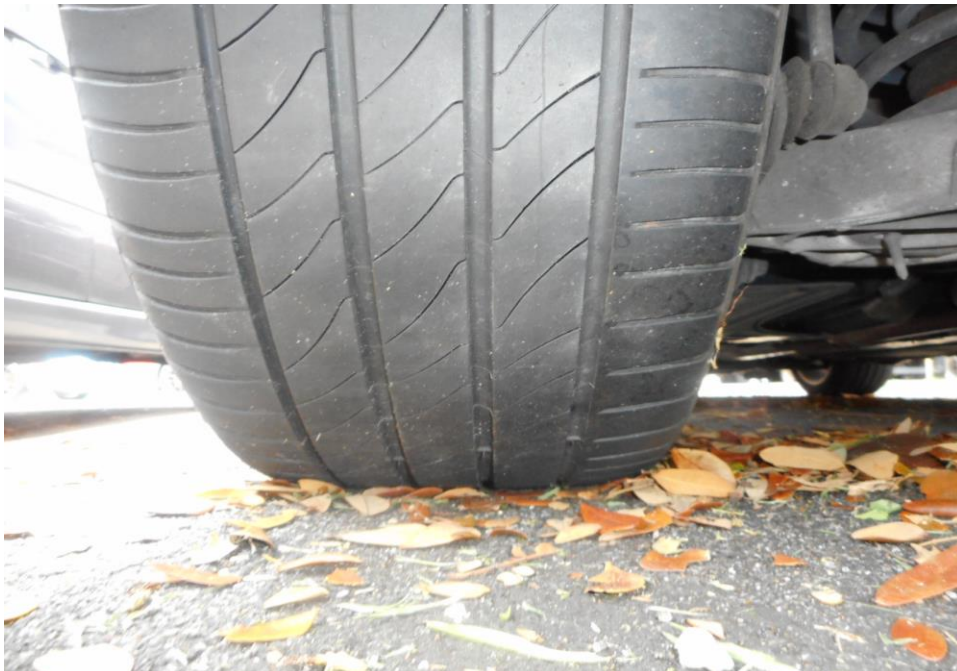
**Photo 11** shows the condition of the rear left tyre of the Motor Car, which was observed to be in serviceable condition with remaining tread depth of approximately 4.1mm. The tyre, which was wrapped around steel wheel rim, was also observed to be sufficiently inflated for vehicular operation. The 4 tyres of the Motor Car were wrapped around standard steel wheel rims.

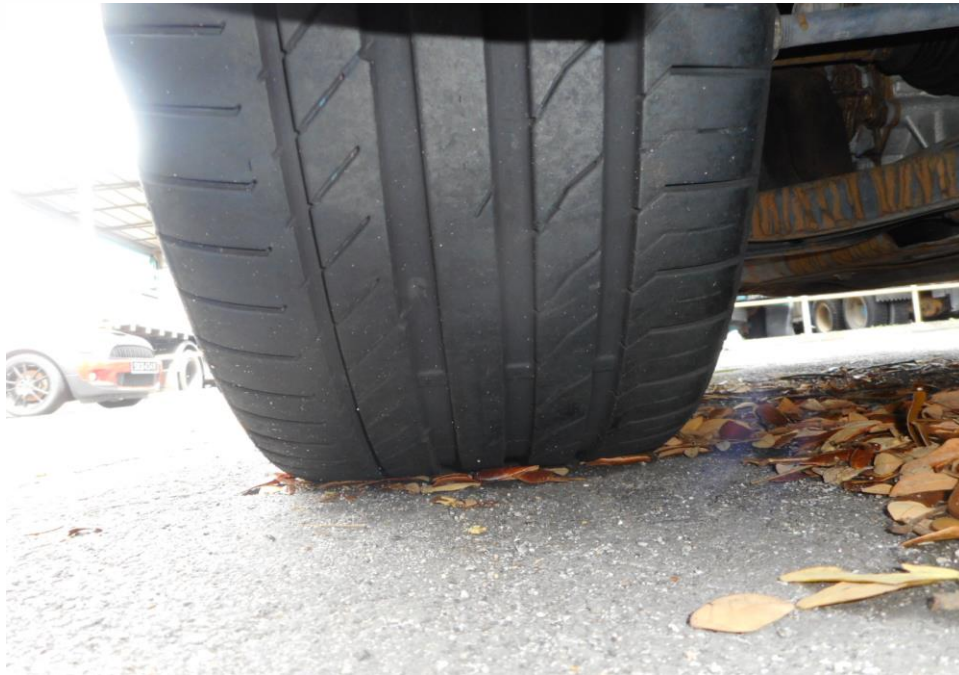
**Photo 12** shows the condition of the front left tyre of the Motor Car, which was observed to be in serviceable condition with remaining tread depth of approximately 5mm. There was also no tear, cut or burst mark(s) on the outer and the inner sidewalls as well as across the tread of the Motor Car's 4 tyres.

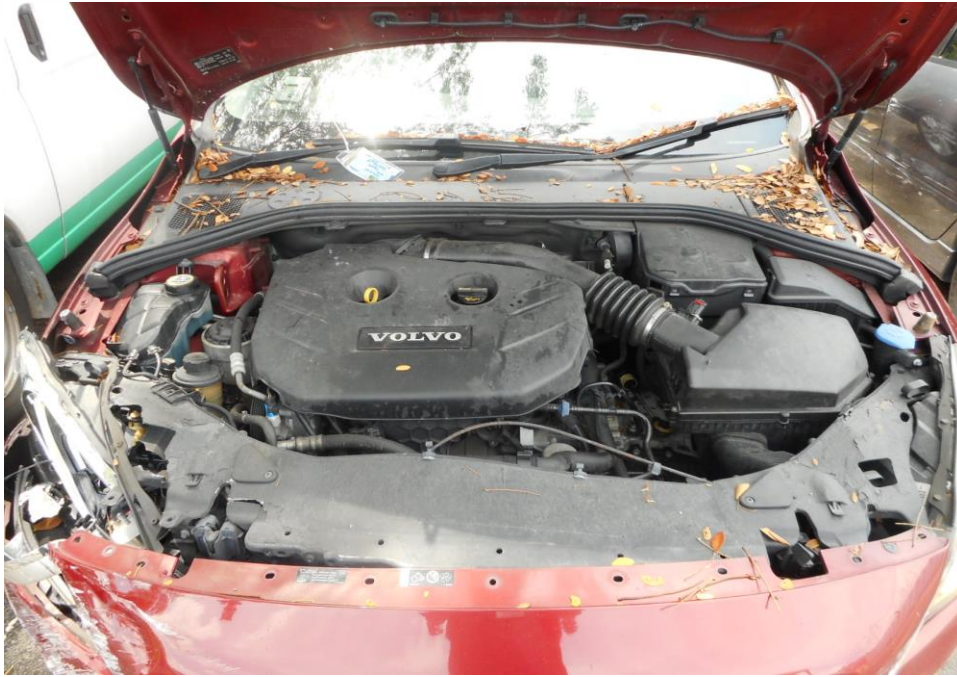
**Photo 13** shows a general view of the Motor Car's engine compartment. The various parts and components inside the engine compartment were unaffected by the accident. There was also no sign(s) or indication(s) of fluid leakage and/or fluid stain within the engine compartment.

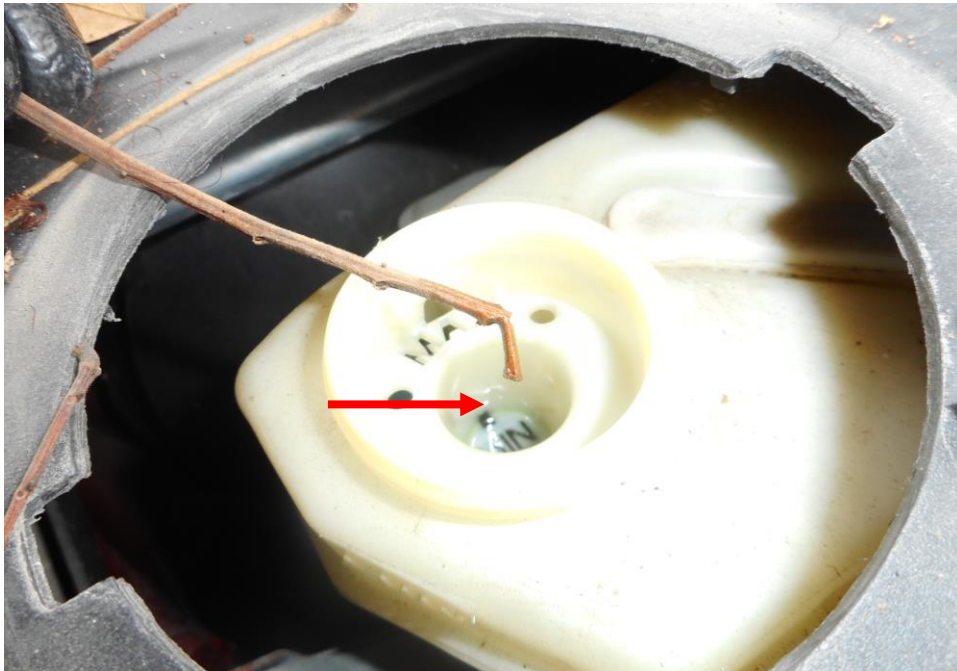
**Photo 14** shows the brake fluid reservoir of the Motor Car at the time of my inspection. The brake fluid was observed to be of sufficient level (arrowed) and without any visible contamination.

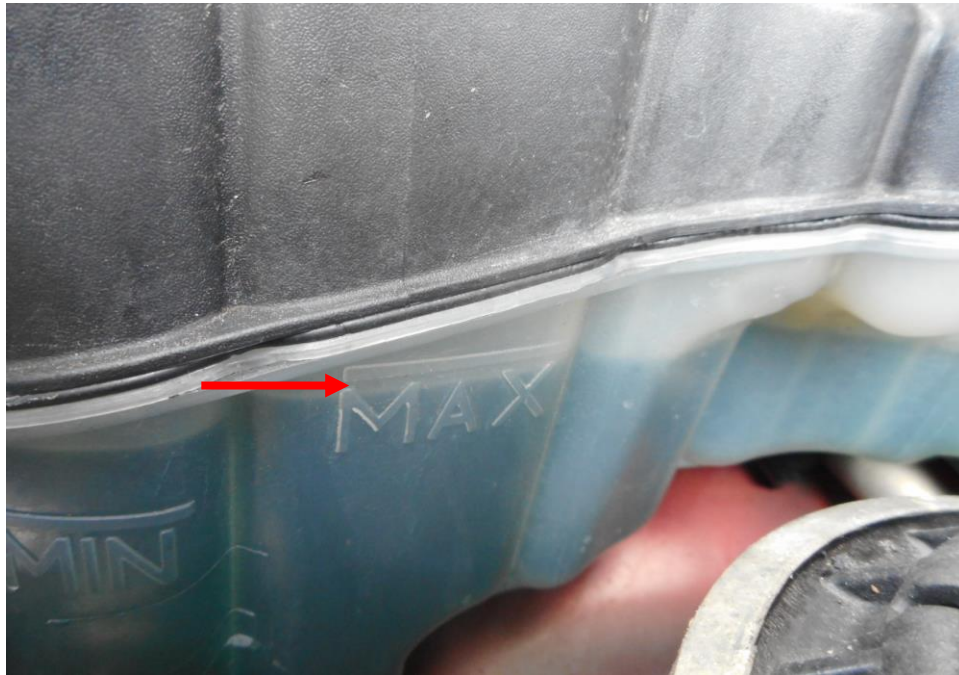
**Photo 15** shows checks being carried out to the engine coolant of the Motor Car at the time of my inspection. The engine coolant was observed to be of sufficient level (arrowed) and without any visible contamination.

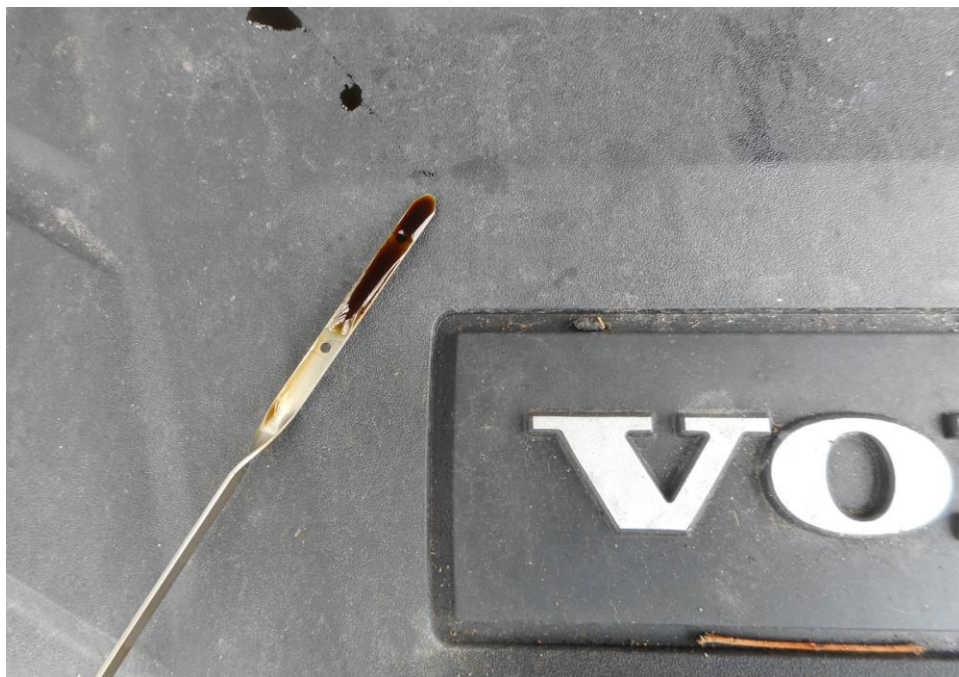
**Photo 16** shows the engine oil dip stick of the Motor Car at the time of my inspection. The engine oil was observed to be of sufficient level and without any visible contamination.

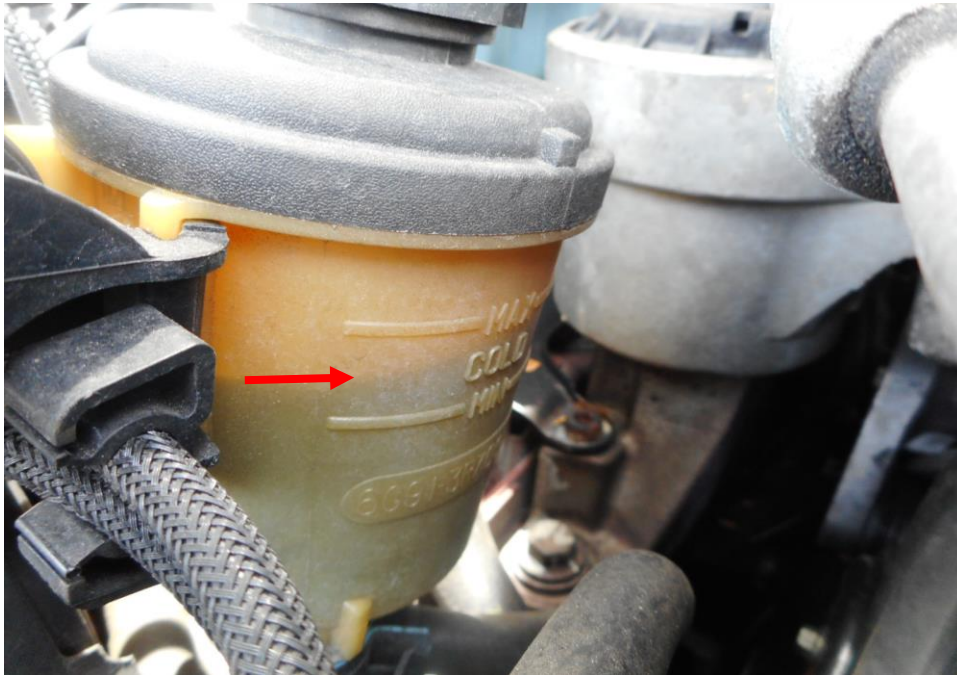
**Photo 17** shows the power steering fluid reservoir of the Motor Car at the time of my inspection. The power steering fluid was observed to be of sufficient level (arrowed) and without any visible contamination.

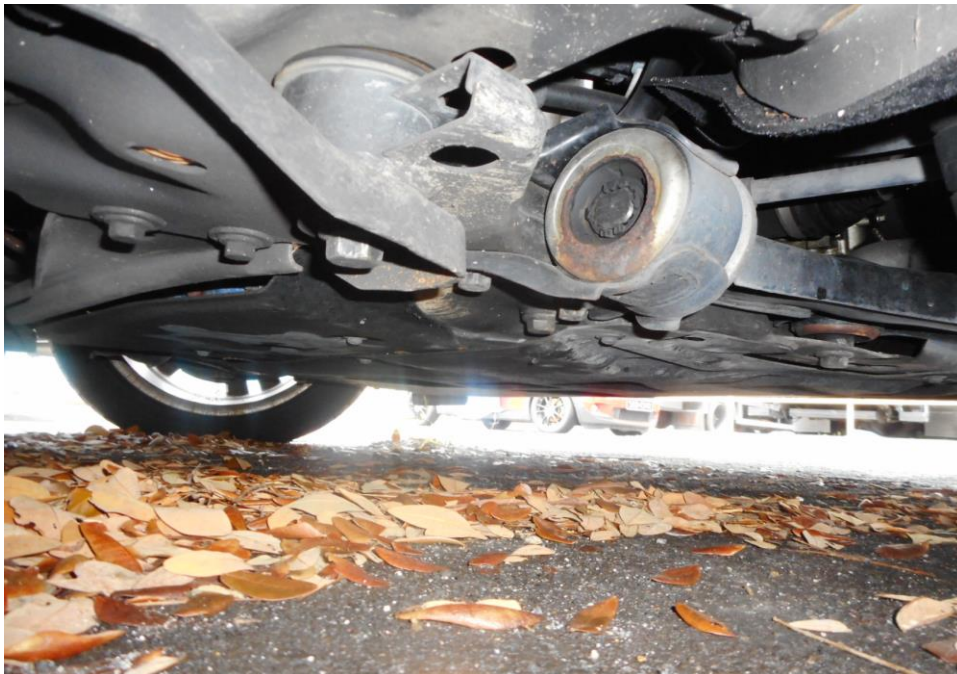
**Photo 18** shows the undercarriage of the Motor Car, at the area where the engine housing and transmission housing are located. I did not find any sign(s) or indication(s) of fluid leak and/or fluid stain(s) on the underside of the Motor Car.

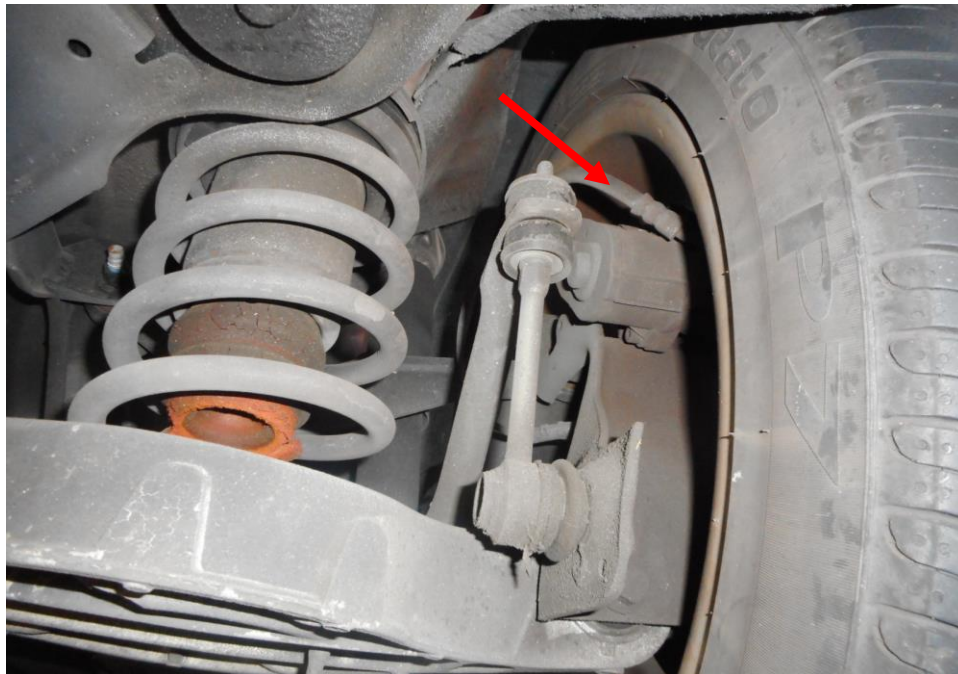
**Photo 19** shows the brake hose/pipe (arrowed) at the rear right wheel of the Motor Car. No leakage of brake fluid was observed. Visual examination of the various components of the braking system like the drum brake, brake booster, brake pedal etc. had revealed all to be intact and without visible damage.

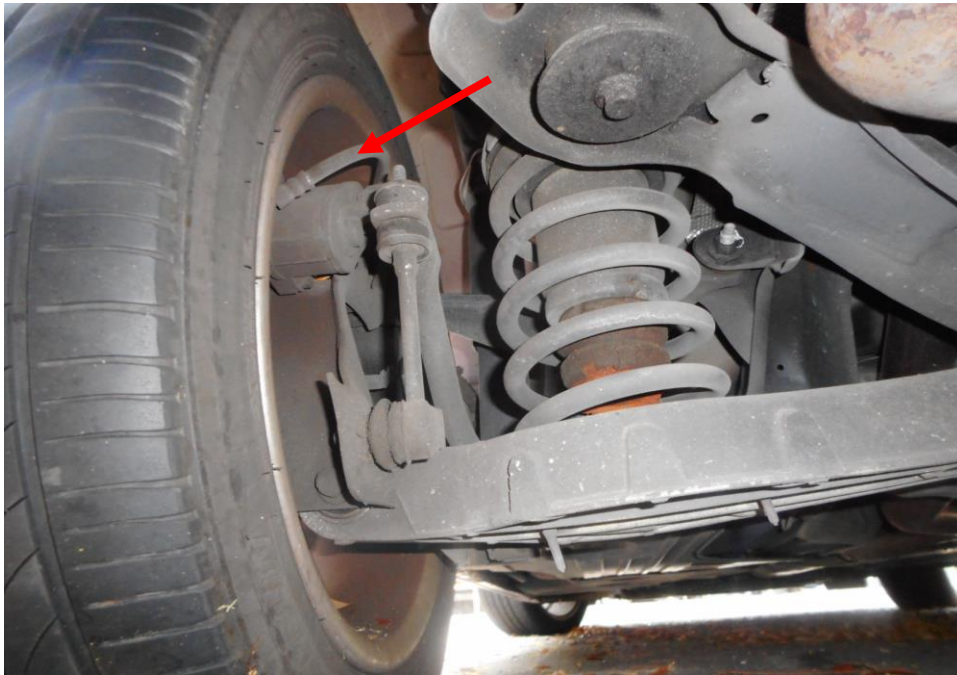
**Photo 20** shows the brake hose/pipe (arrowed) at the rear left wheel of the Motor Car. I did not observe any leakage of brake fluid at the time of my inspection of the Motor Car. Static tests of the Motor Car's braking system had indicated that there was no internal leakage of pressure/vacuum. The undercarriage components of the Motor Car were also all found to be intact and without any visible damage.

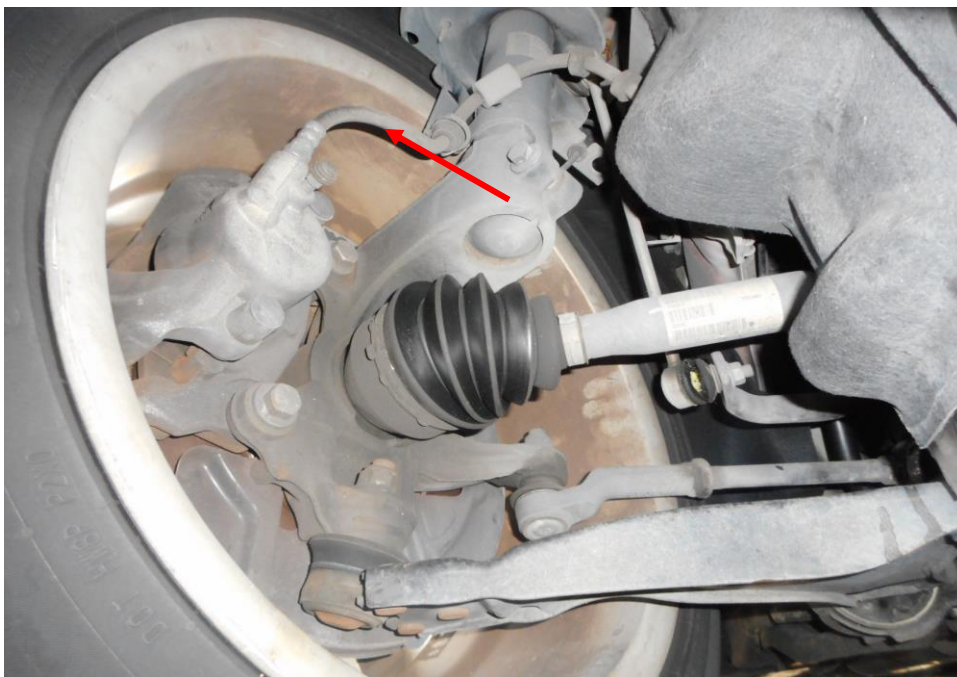
**Photo 21** shows the brake hose/pipe (arrowed) at the front right wheel of the Motor Car. I did not observe any leakage of brake fluid at the time of my inspection of the Motor Car. Static tests of the Motor Car's braking system had indicated that there was no internal leakage of pressure/vacuum. The undercarriage components of the Motor Car were also all found to be intact and without any visible damage.

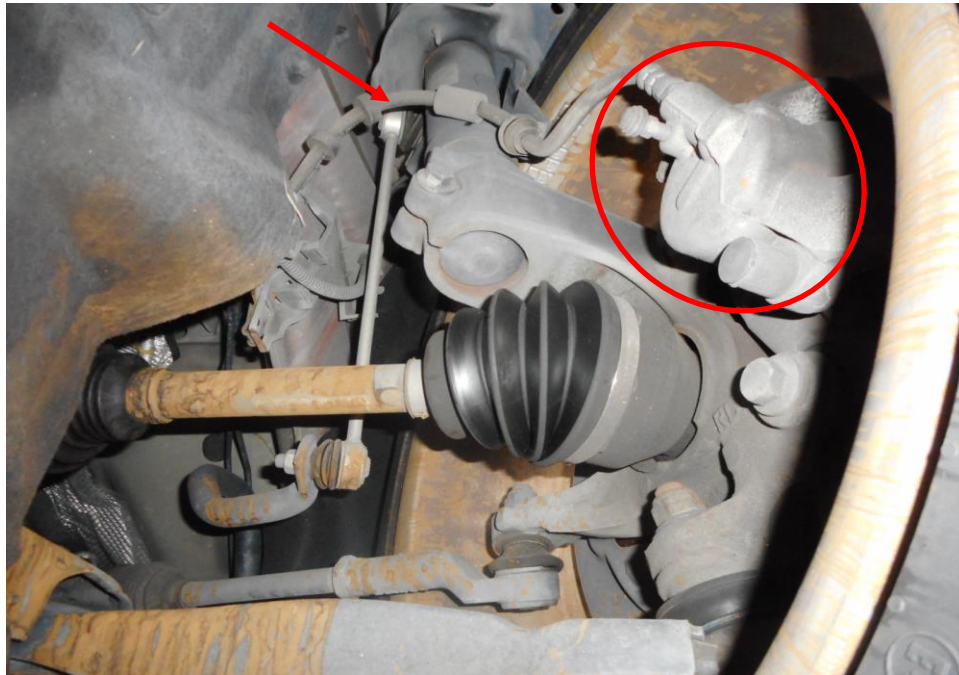
**Photo 22** shows the brake hose/pipe (arrowed) at the front left wheel of the Motor Car. No leakage of brake fluid was observed. Visual examination of the various components of the braking system like the brake caliper (circled), brake booster, brake pedal etc had revealed all to be intact and without visible damage.

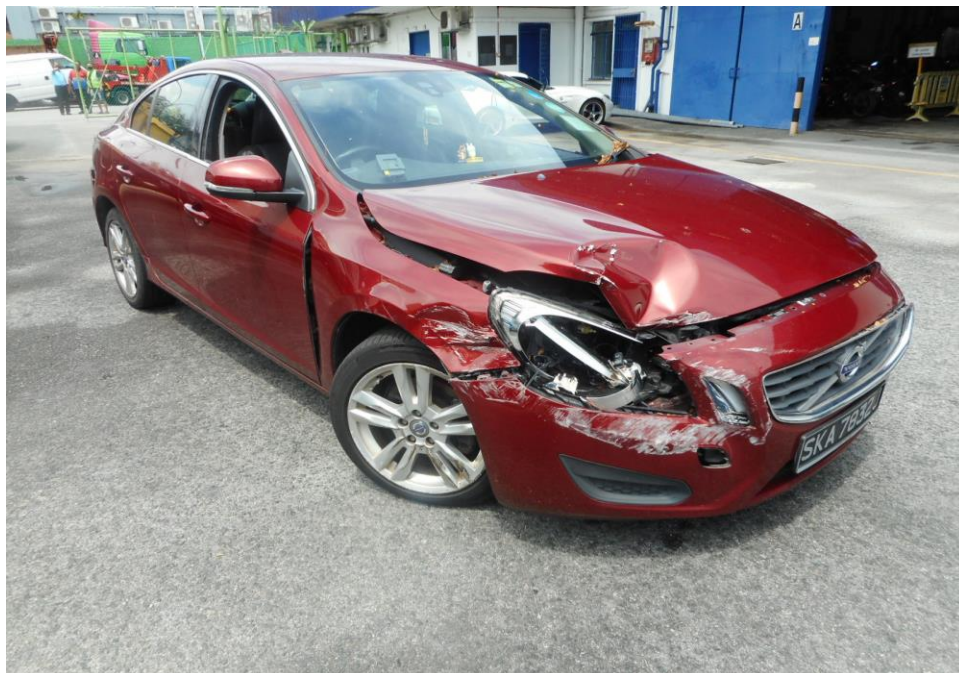
**Photo 23** shows the front right wheel of the Motor Car turned to its full left. During my steering system test, I did not experience any abnormal free play and/or resistance when I had turned the steering wheel towards the left and right. This would suggest that the steering system of the Motor Car was likely to be in serviceable condition at the material time of accident.

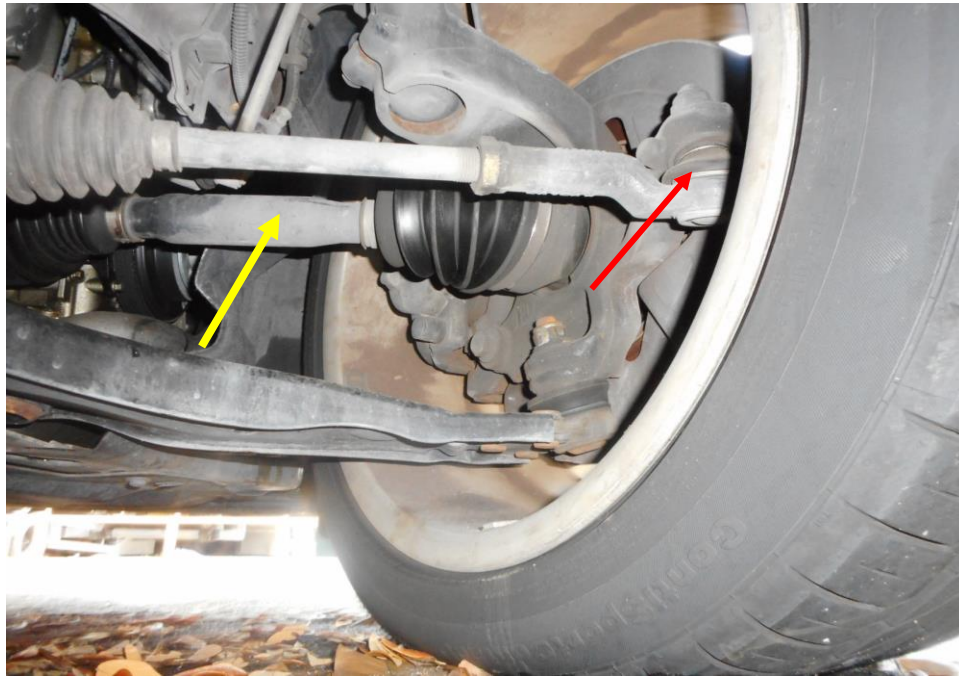
**Photo 24** shows the various undercarriage components at the front right wheel of the Motor Car, in particular the steering tie rod (red arrow) and drive shaft (yellow arrow). The various steering components were all found to be intact, suggesting that the steering system of the Motor Car was likely to be in serviceable condition at the material time of accident. There was also no sign of fluid stain observed on the various undercarriage components at the front right wheel of the Motor Car.

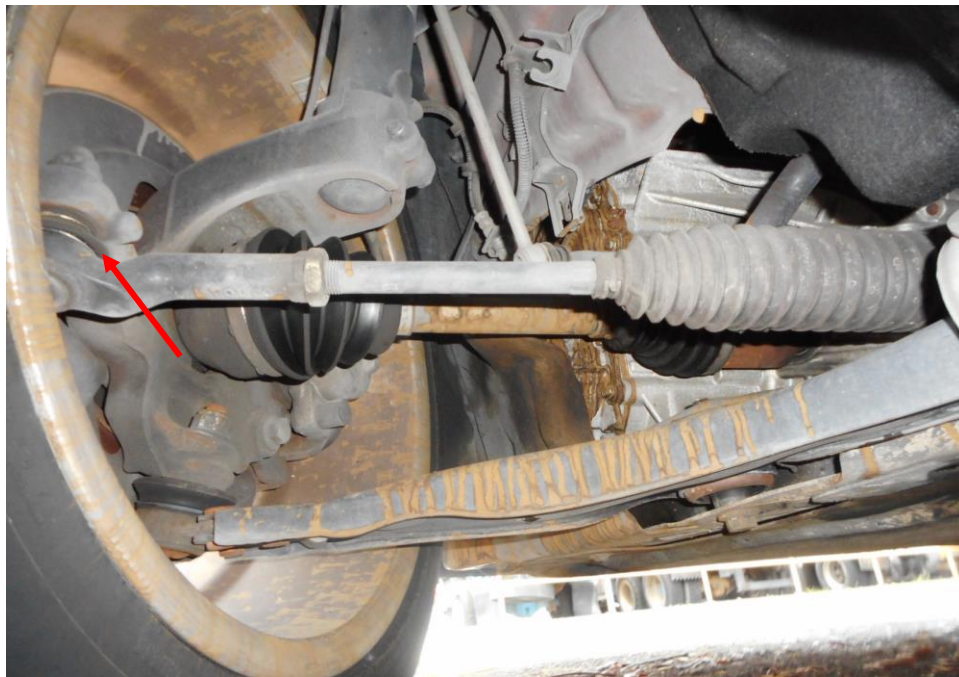
**Photo 25** shows the various undercarriage components at the front left wheel of the Motor Car, which had included the steering tie rod (red arrow). The various undercarriage components of the Motor Car were all found to be intact without any visible damage.

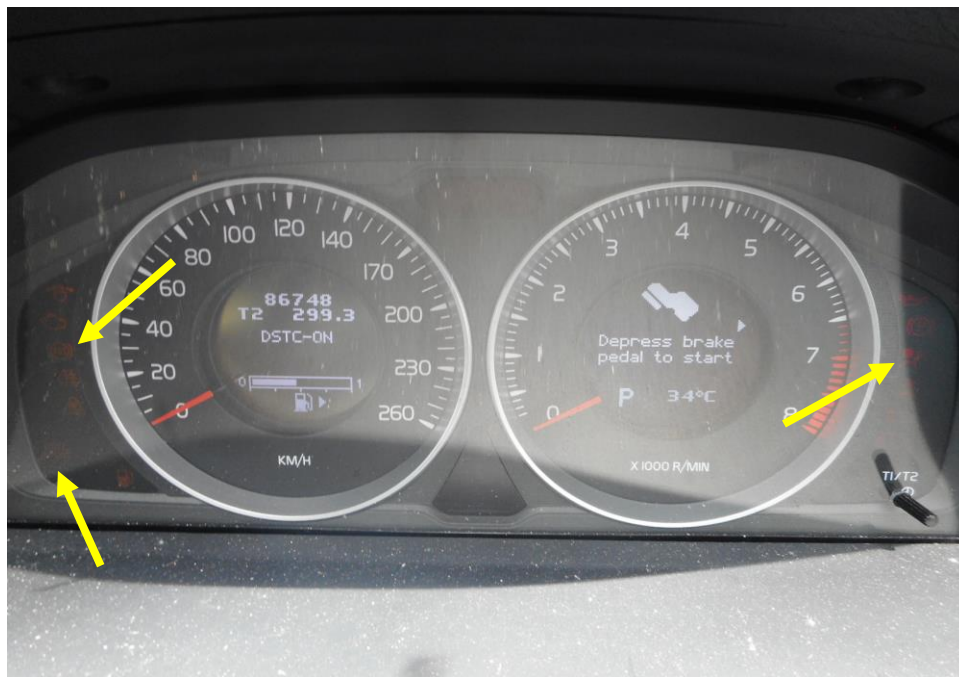
**Photo 26** shows the warning light for Anti-Lock Brake System (ABS), Traction Control System (TC) and Supplemental Restraint System (SRS) (arrowed) appearing on the instrument panel of the Motor Car during the self-test of its various electronic operating systems when its engine was cranked.

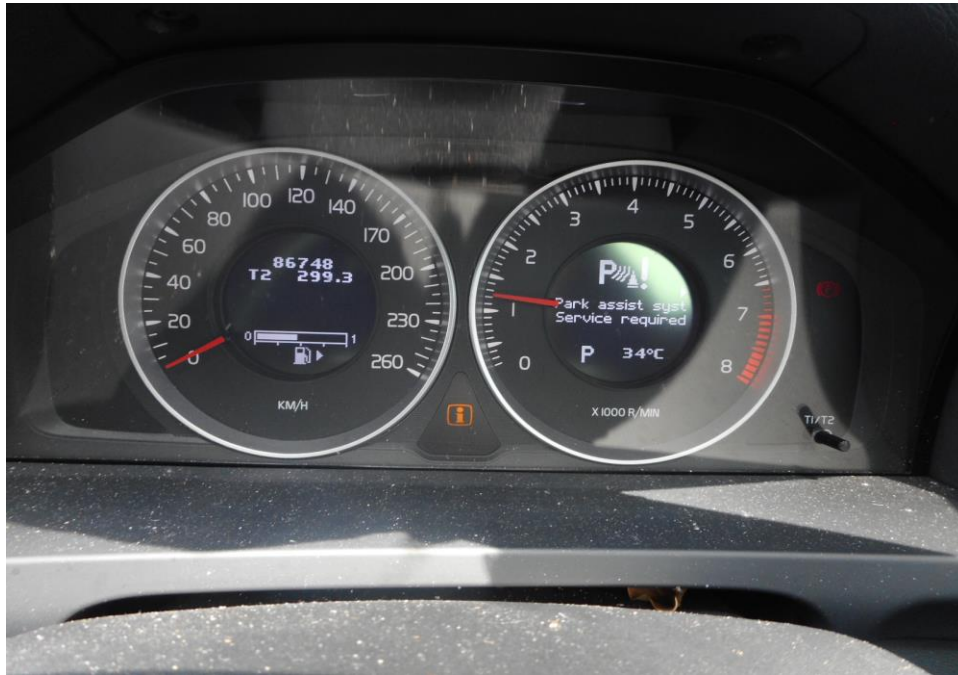
**Photo 27** shows no warning lights illuminated on the instrument panel of the Motor Car after the engine was cranked. This would suggest that there was no abnormality to the electronic operating system of the Motor Car, like the ABS, TC and SRS etc.
