Your Ref: TP/IP/13635/2020  
Our Ref : CI/TPD20004880/P

18<sup>th</sup> June 2020

**MECHANICAL INSPECTION REPORT OF MOTOR CAR SKB 3503E**

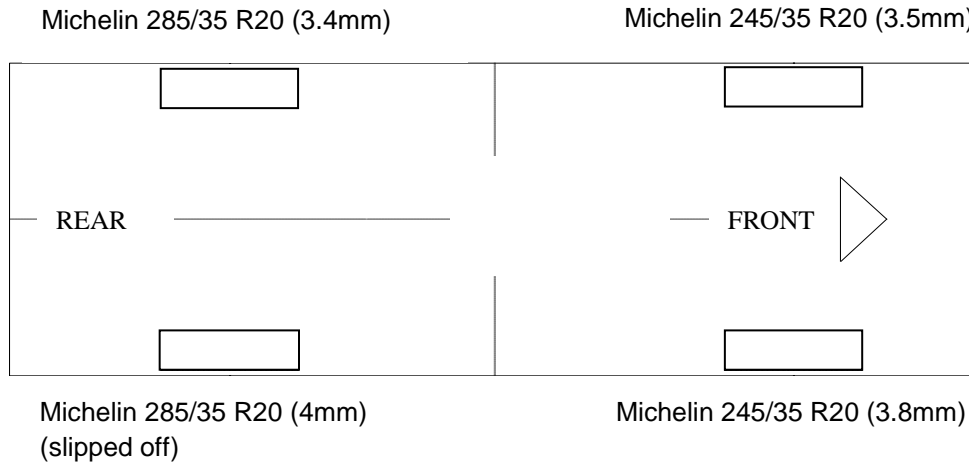
6. The rear right tyre of the Motor Car were observed to be slipped off the rims due to the damaged the Motor car's rim that it had sustained from the accident, however the other 3 tyres are observed to be in serviceable condition and sufficiently inflated for vehicular operation. I did not find any tear, cut or burst mark(s) on the outer and the inner sidewalls as well as across the tread of the 4 tyres. The tyre brand, tyre size and remaining tread depth of the 4 tyres of the Motor Car were recorded as follows:-

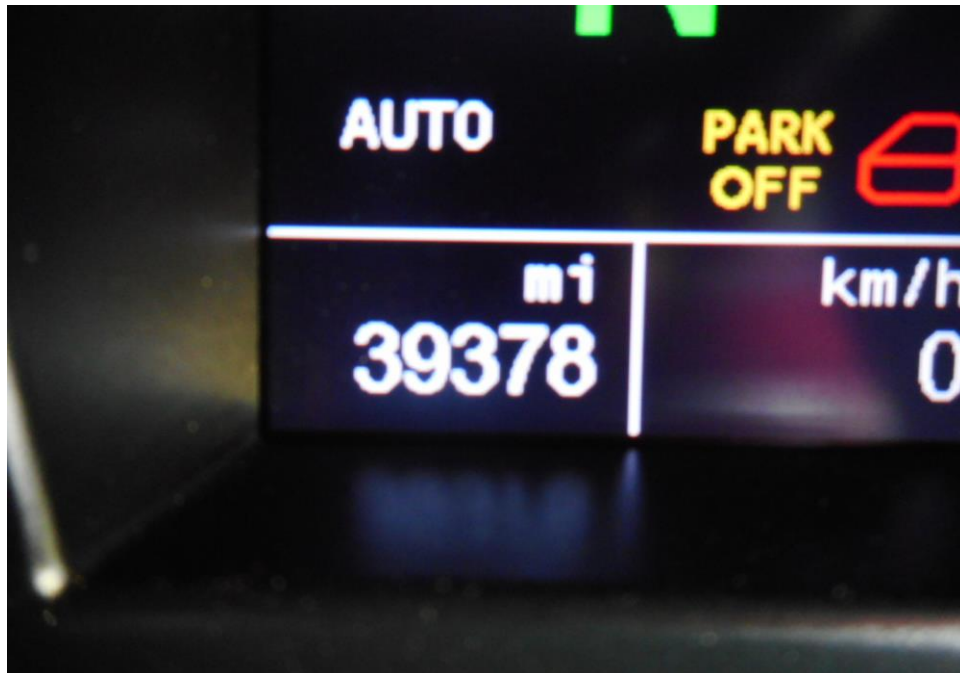
**Photo 1** shows a general view of the instrument cluster of the Motor Car at the time of my inspection. The mileage of the Motor Car was 39,378mi = 63,372km

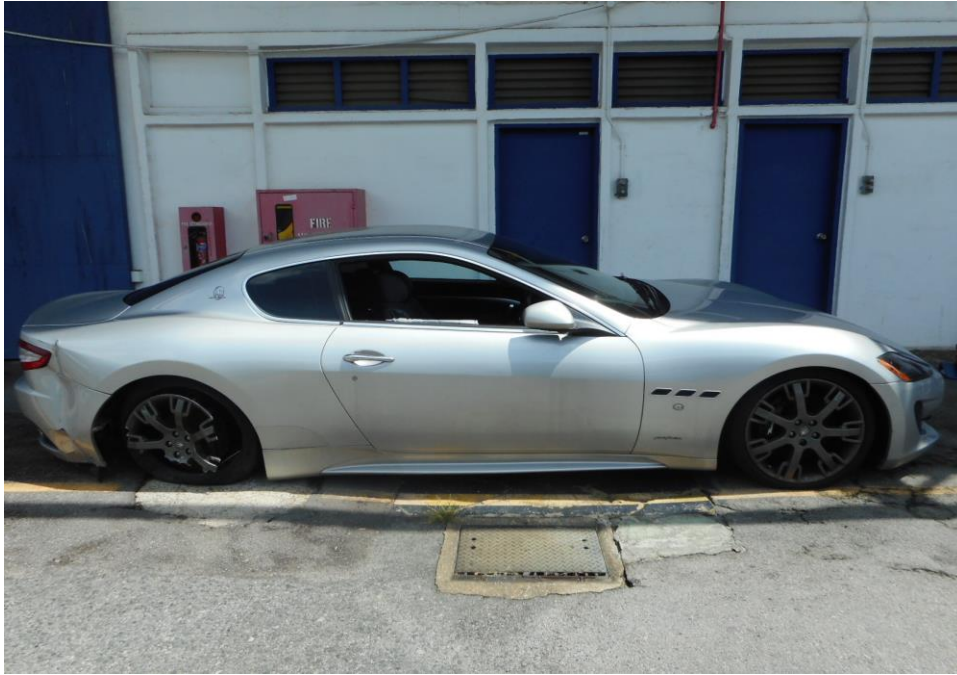
4. The mileage of the Motor Car at the time of my inspection was 39,378 mi = 63,372km.
5. The Motor Car appeared to have sustained damage at its rear right portion. Its rear bumper, rear right fender and rear right rims were damage at the time of my inspection. The Supplemental Restraint System (SRS) was activated as a result of the accident.

**Photo 2** shows a general view of the Motor Car's right portion at the time of my inspection. It appeared to have sustained moderate damage at its right portion. Its rear bumper, rear right fender, rear right rim were damage at the time of my inspection.

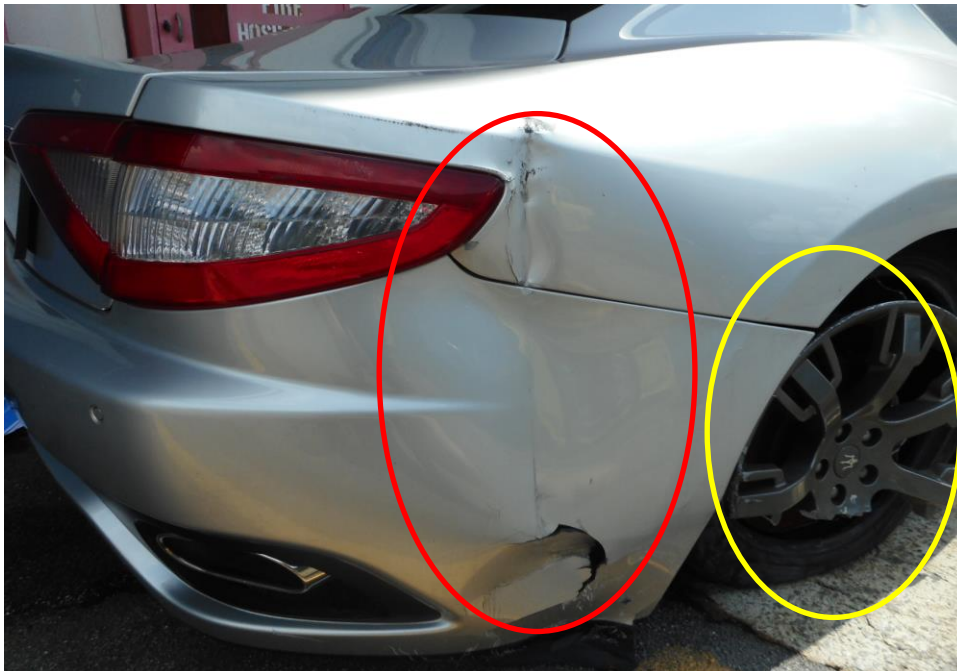
**Photo 3** shows a close up view of the Motor Car's rear right portion at the time of my inspection. Its rear bumper and rear right fender (red circle), rear right rim (yellow circle) were damage at the time of my inspection.

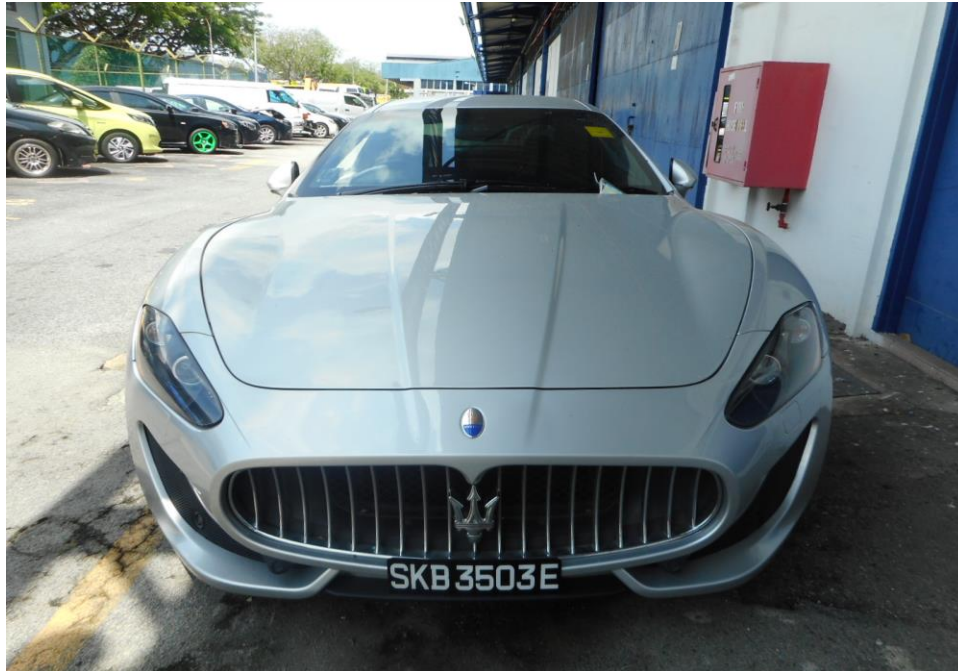
**Photo 4** shows a general view of the Motor Car's frontal portion at the time of my inspection. The Motor Car was observed to be intact and unaffected by the accident.

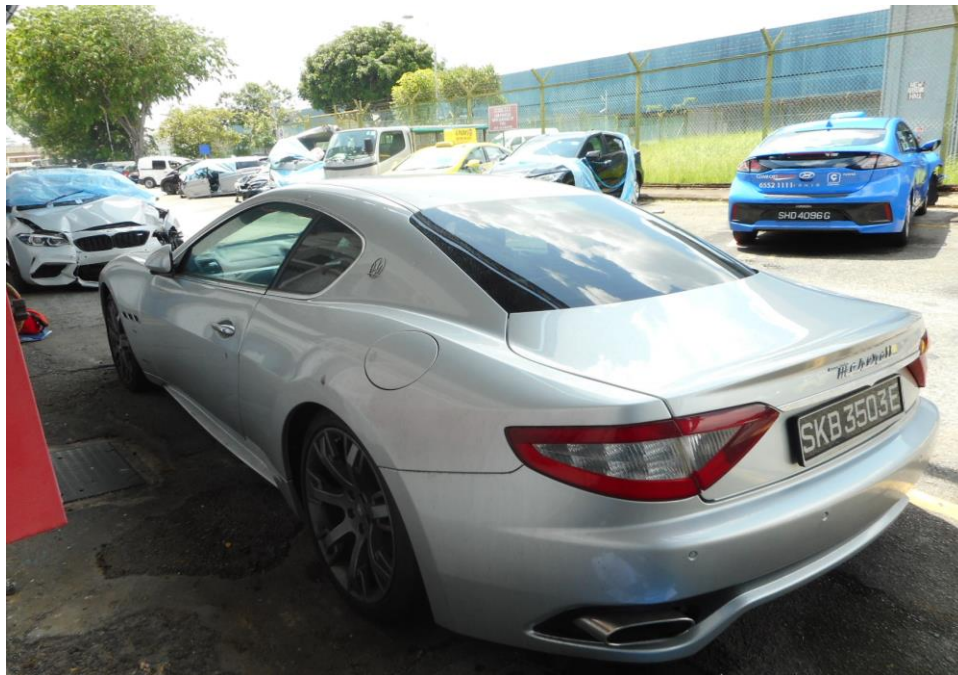
**Photo 5** shows a general view of the left body of the Motor Car at the time of my inspection. The Motor Car was observed to be intact and unaffected by the accident.

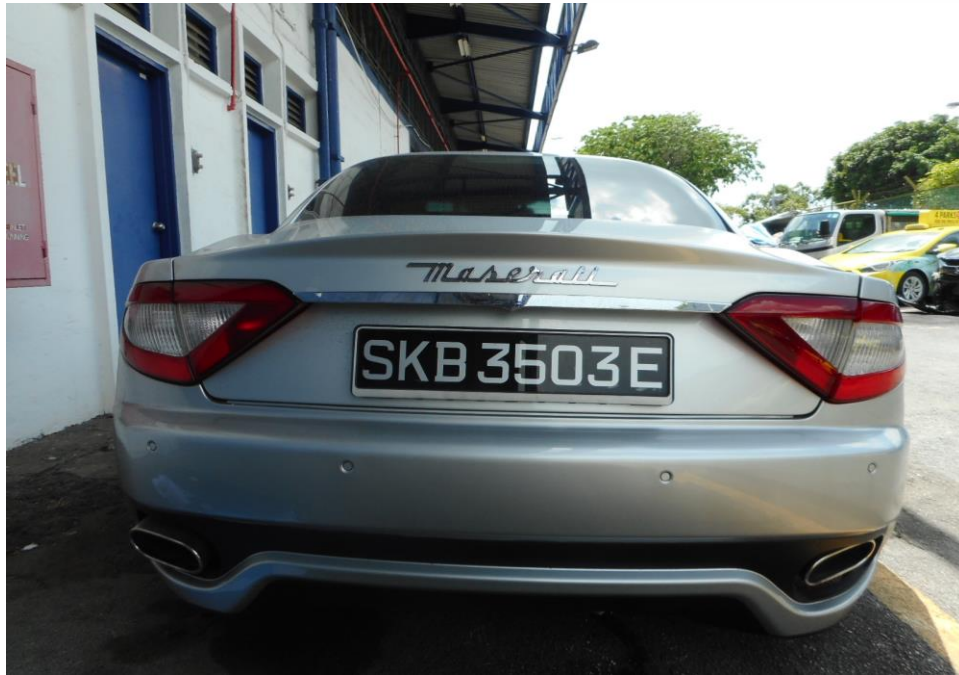
**Photo 6** shows a general view of the rear body of the Motor Car at the time of my inspection. The Motor Car was observed to be intact and unaffected by the accident.

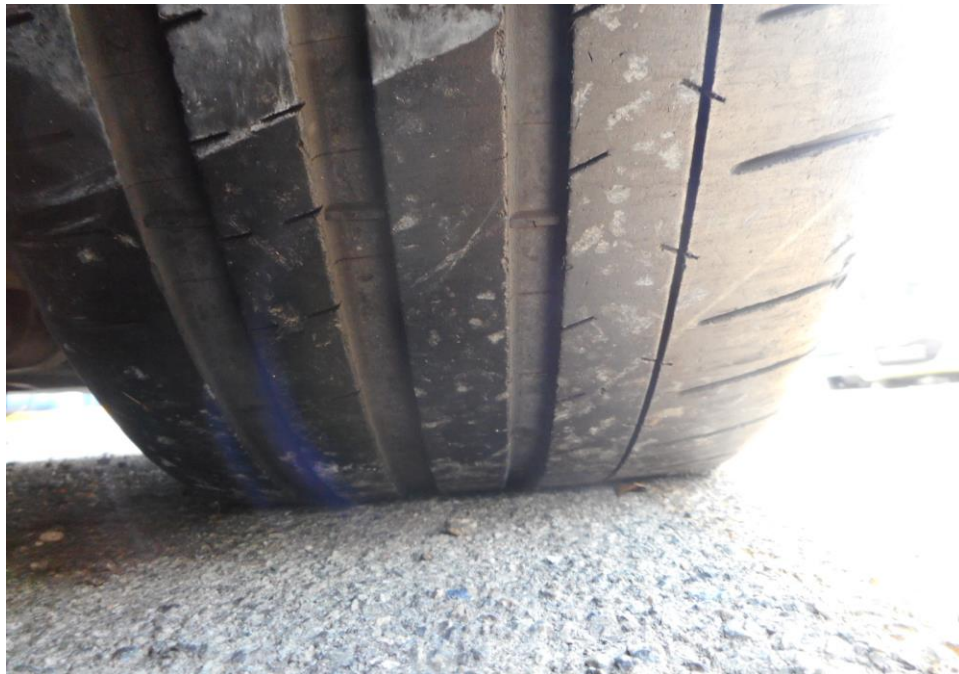
**Photo 7** shows the condition of the front right tyre of the Motor Car, which was observed to be in serviceable condition with remaining tread depth of approximately 3.8mm. The tyre, which was wrapped around standard alloy wheel rim, was also observed to be sufficiently inflated for vehicular operation. There was no tear, cut or burst mark(s) on the outer and the inner sidewalls as well as across the tread of the 4 tyres that were fitted on the Motor Car.

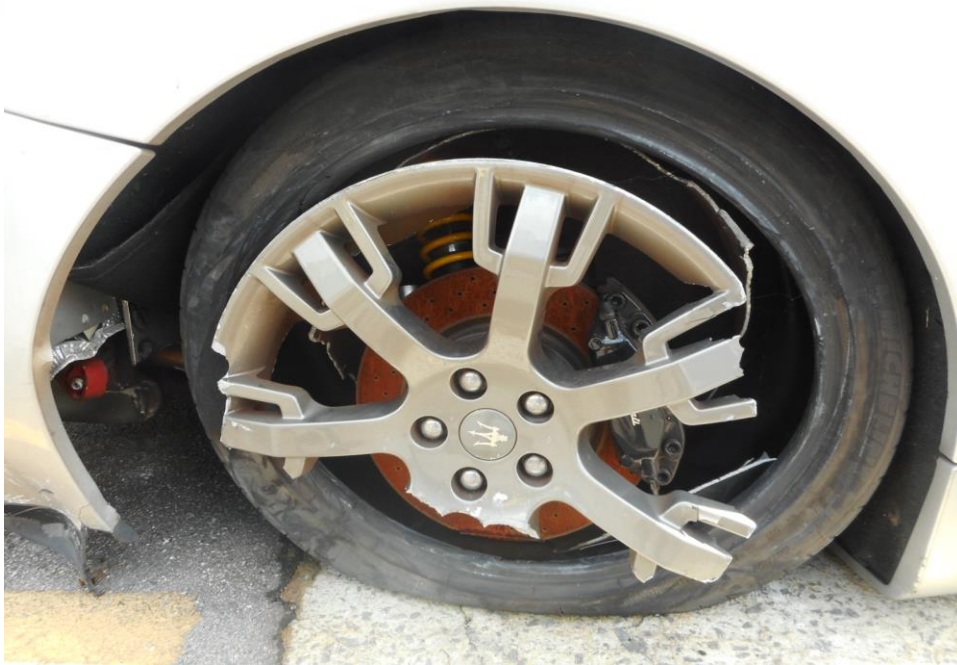
7. The rear right tyres were observed to slip off as the rim was damage as a result of the accident. However the other 3 tyres were observed to be wrapped around standard alloy wheel rims that were found to be without any damage. See photo 1 – 11 below.

**Photo 8** shows the condition of the rear right tyre of the Motor Car, which was observed to be in unserviceable condition. The tyre, which was wrapped around standard alloy wheel rim was slipped out due to the damaged to the rim as a result of the accident. There was no tear, cut or burst mark(s) on the outer and the inner sidewalls as well as across the tread of the tyre with remaining tread depth of approximately 4mm.

18. The rear right tyre of the Motor Car were observed to be in unserviceable condition as the tyre had slipped off the rim due to the damaged the rim had sustained. However, the other 3 tyres fitted on the Motor Car were found to be in serviceable condition. I did not find any tear, cut or burst mark(s) on the outer and the inner sidewalls as well as across the tread of the 4 tyres. The 3 tyres were also observed to be sufficiently inflated for vehicular operation with remaining tread depth of approximately 3.4mm – 3.8mm and the rear right tyre with remaining tread depth of approximately 4mm.

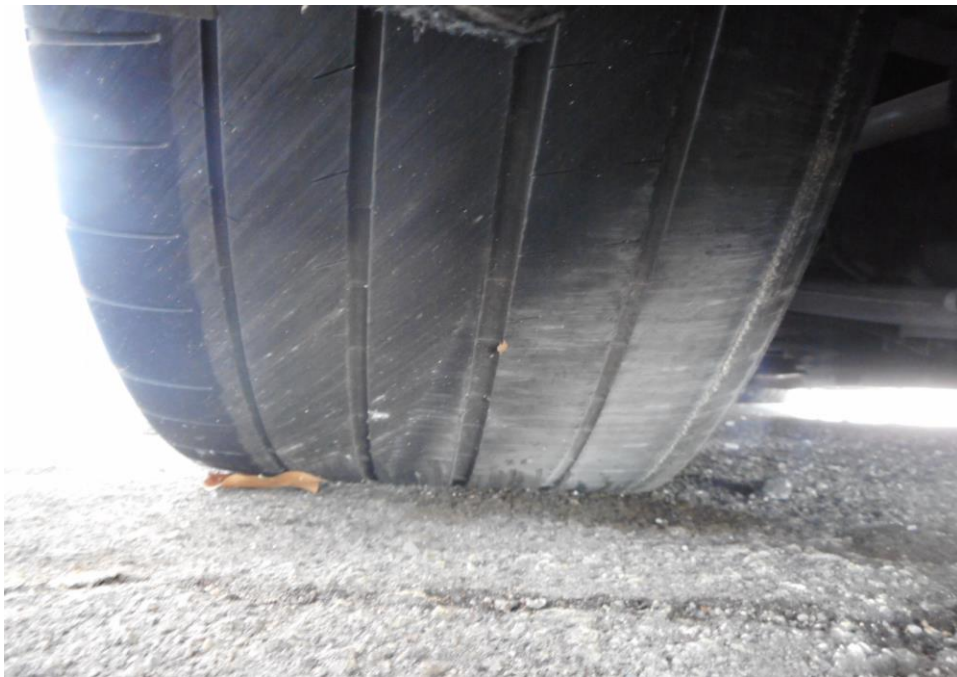
**Photo 9** shows the condition of the rear left tyres of the Motor Car, which were observed to be in serviceable condition with remaining, tread depth of approximately 3.4mm. There was also no tear, cut or burst mark(s) on the outer and the inner sidewalls as well as across the tread of the 4 tyres that were fitted on the Motor Car.

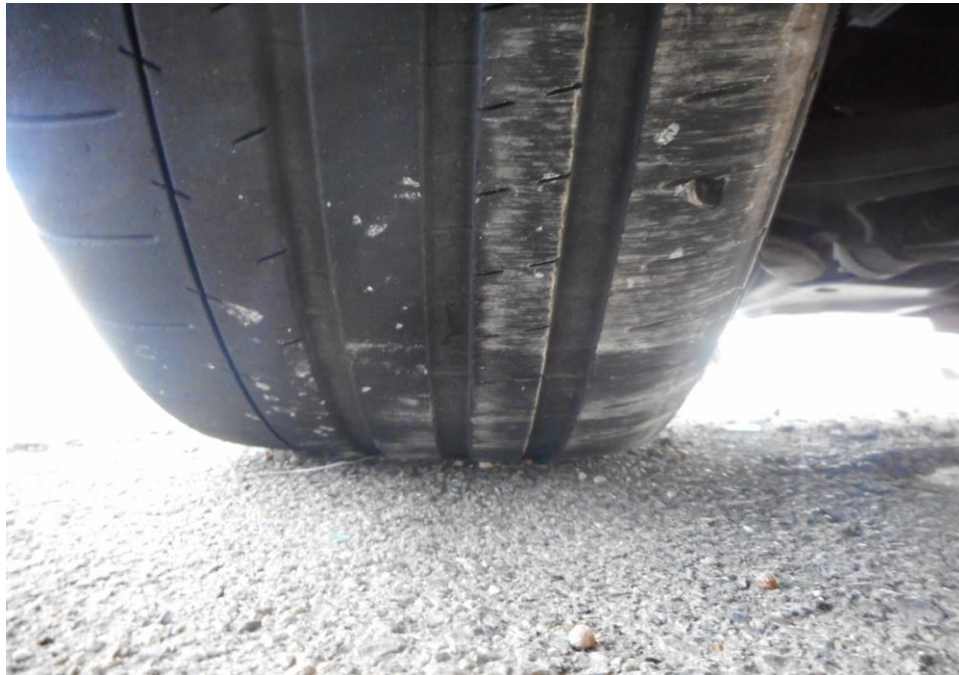
**Photo 10** shows the condition of the front left tyres of the Motor Car, which were observed to be in serviceable condition with remaining, tread depth of approximately 3.5mm. There was also no tear, cut or burst mark(s) on the outer and the inner sidewalls as well as across the tread of the 4 tyres that were fitted on the Motor Car.

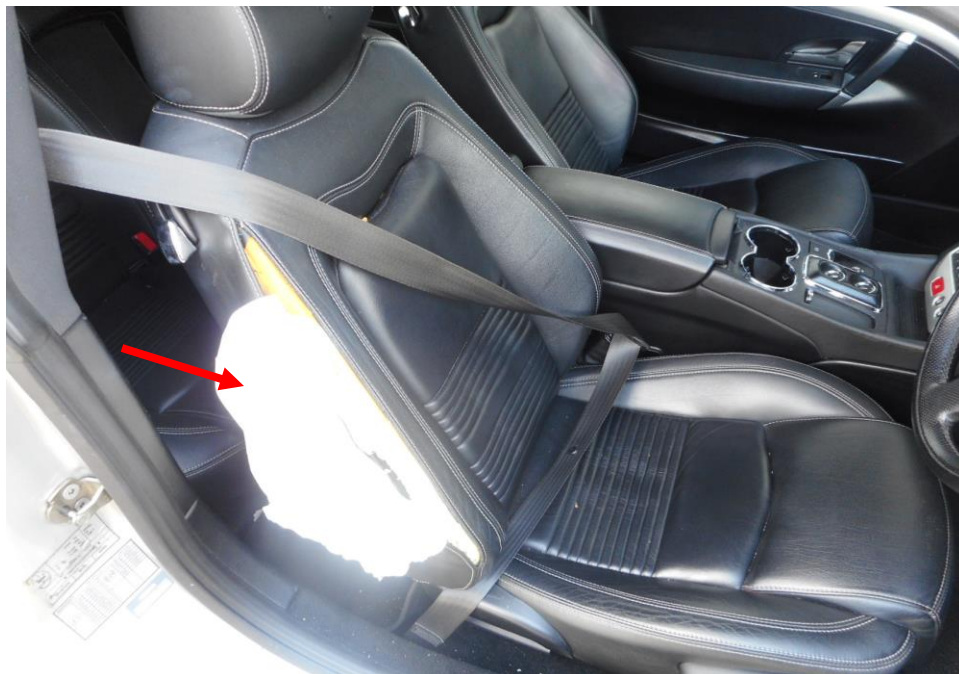
**Photo 11** shows the deployment of the Supplemental Restraint System (SRS) airbag (arrowed) in the Motor Car as a result of the accident.

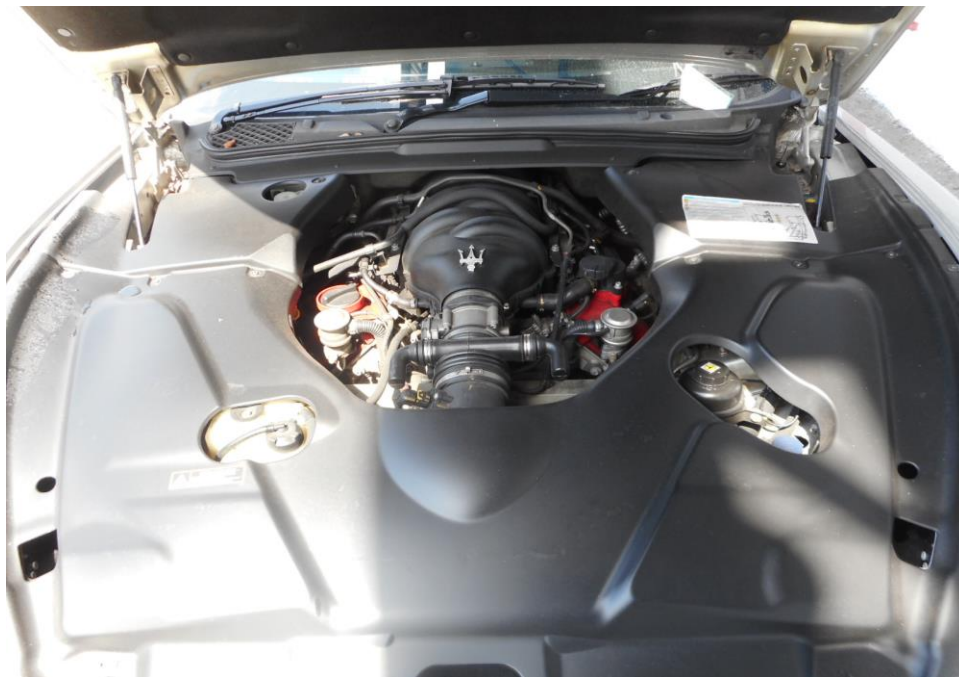
**Photo 12** shows a general view of the Motor Car's engine compartment, which was accessed by lifting the front cabin of the Motor Car. The various parts and components inside the engine compartment were unaffected by the accident. There was also no sign(s) or indication(s) of fresh fluid leakage and/or fluid stain within the engine compartment

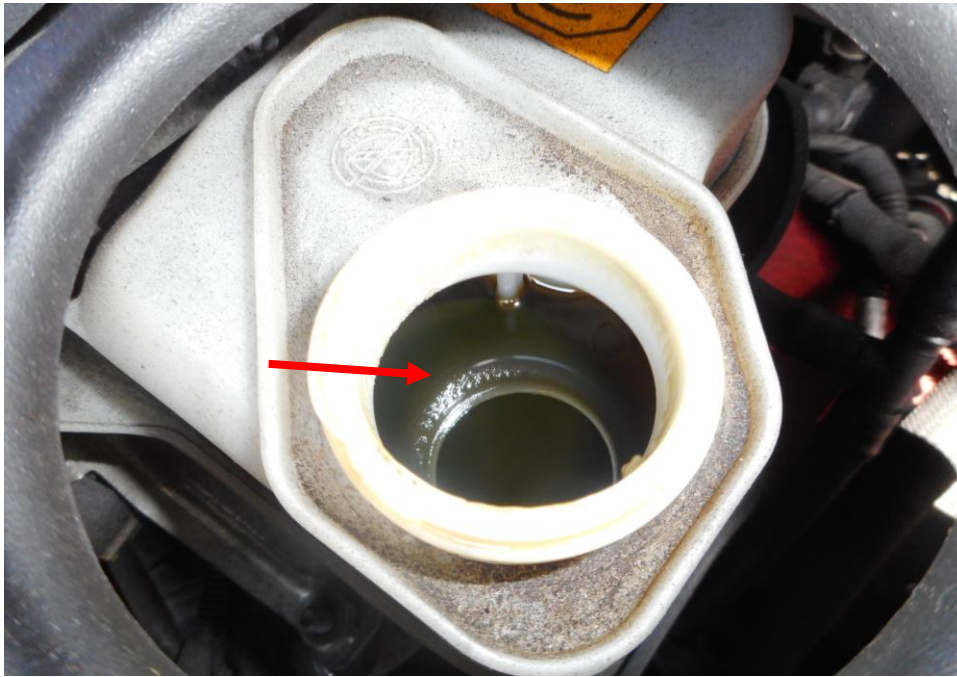
**Photo 13** shows the brake fluid reservoir of the Motor Car at the time of my inspection. The brake fluid was observed to be of sufficient level (arrowed) and without any visible contamination.

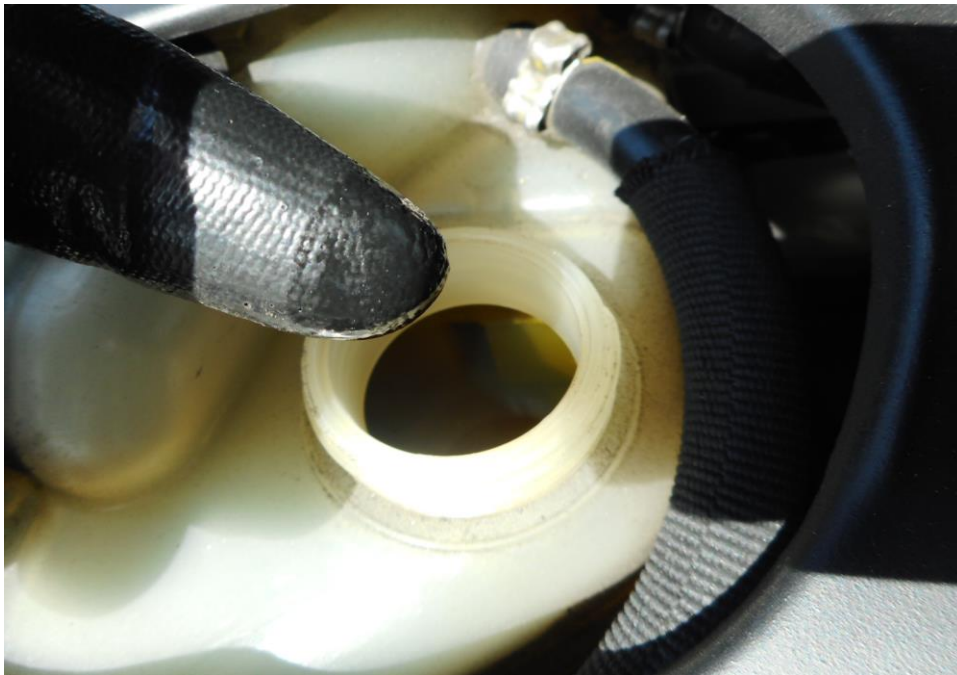
**Photo 14** shows the engine coolant reservoir of the Motor Car at the time of my inspection. The engine coolant was observed to be of sufficient level and without any visible contamination.

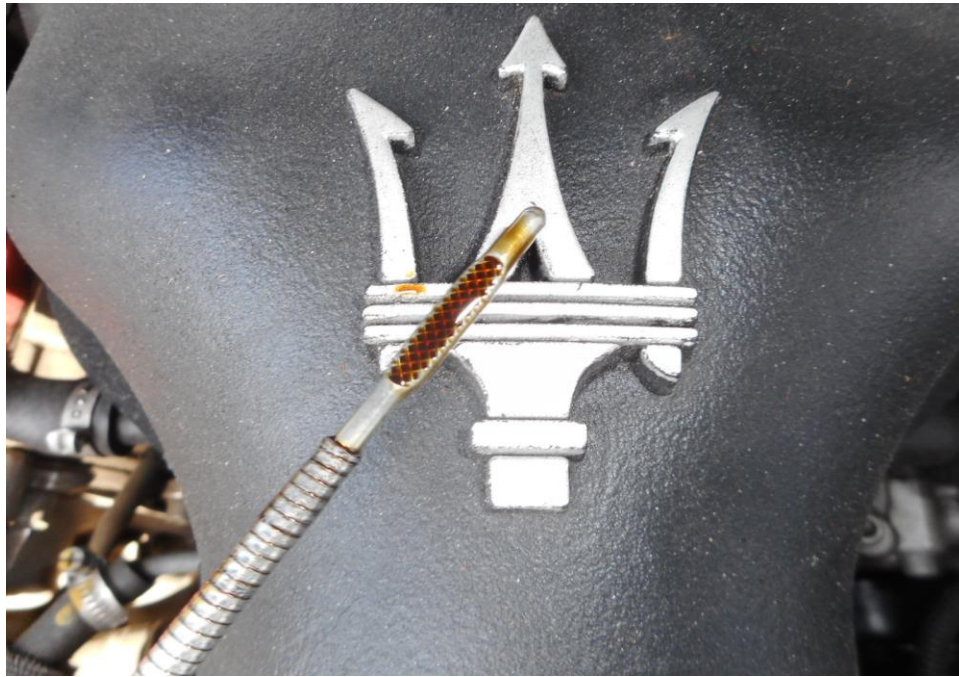
**Photo 15** shows the engine oil dip stick of the Motor Car at the time of my inspection. The engine oil was observed to be of sufficient level and without any visible contamination.

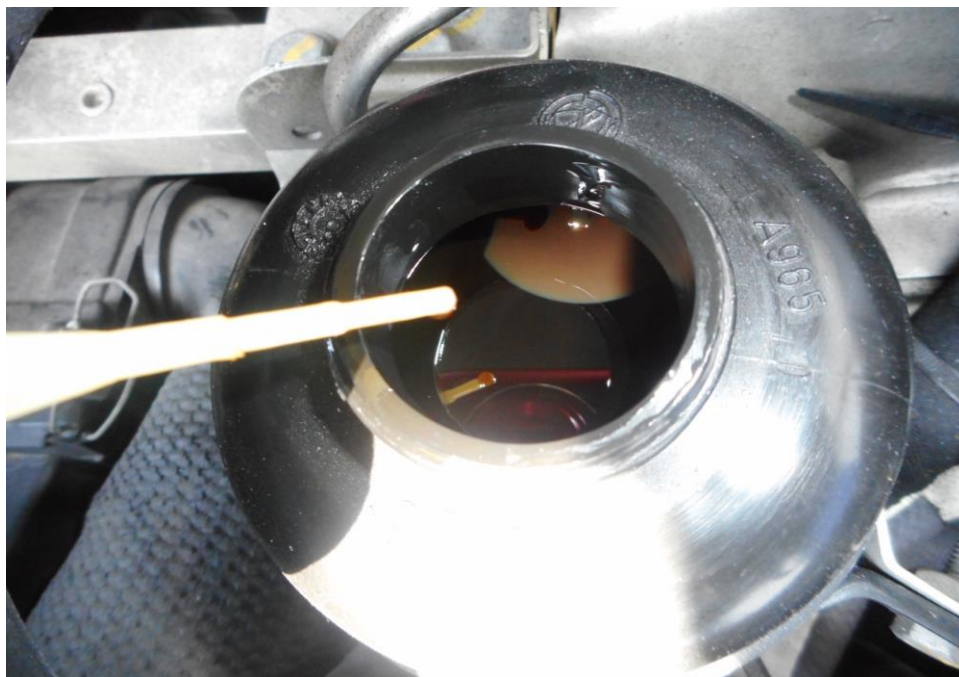
**Photo 16** shows the power steering dip stick of the Motor Car at the time of my inspection. The power steering fluid was observed to be of sufficient level and without any visible contamination.

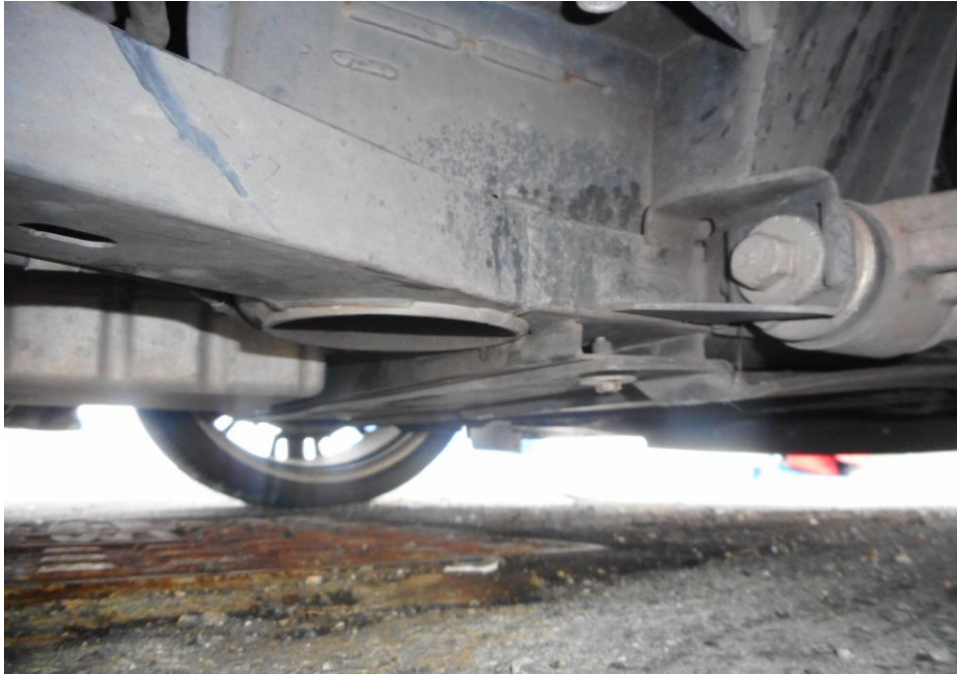
**Photo 17** shows the undercarriage of the Motor Car, at the area where the engine housing and transmission housing are located. . I did not find any sign(s) or indication(s) of fluid leak and/or fluid stain(s) on the underside of the Motor Car.

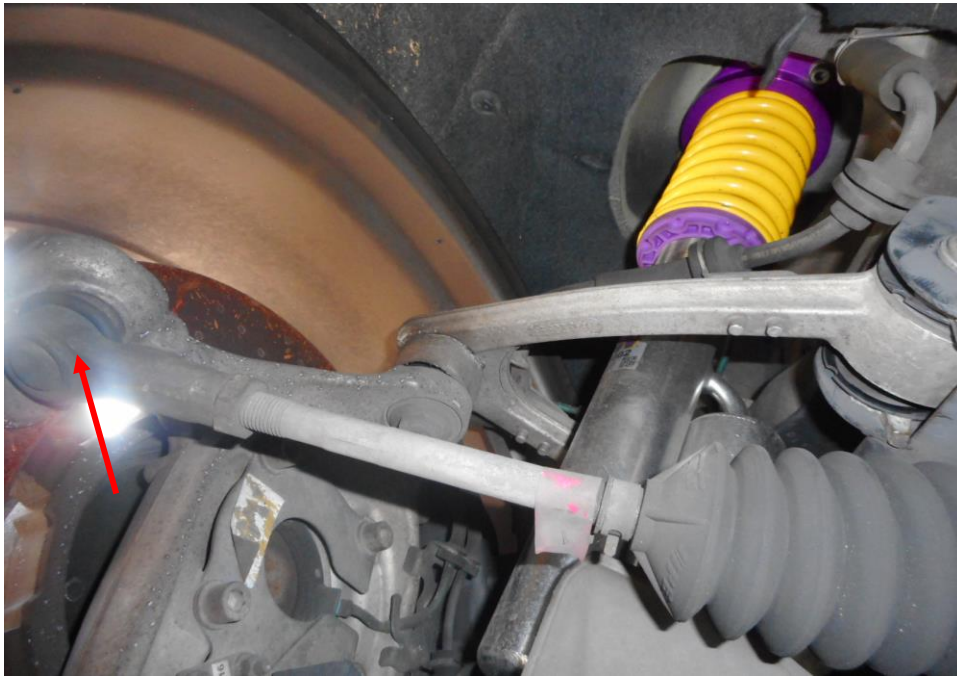
**Photo 18** shows the various undercarriage components at the front right wheel of the Motor Car, in particular the steering tie rod end (arrowed). The various steering components were all found to be intact, suggesting that the steering system of the Motor Car was likely to be in serviceable condition at the material time of accident. There was also no sign of fluid stain(s) observed on the various undercarriage components.

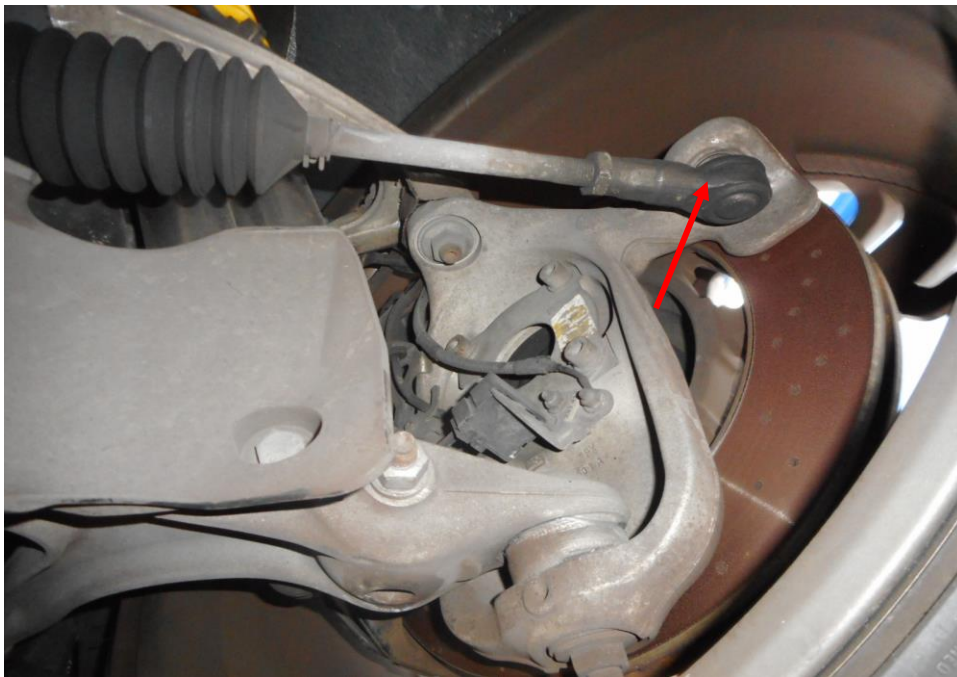
**Photo 19** shows the various undercarriage components at the front left wheel of the Motor Car, in particular the steering tie rod end (arrowed). The various Undercarriage components of the Motor Car were all found to be intact without any visible damage. There was also no sign of fluid stain(s) observed on the various undercarriage components.

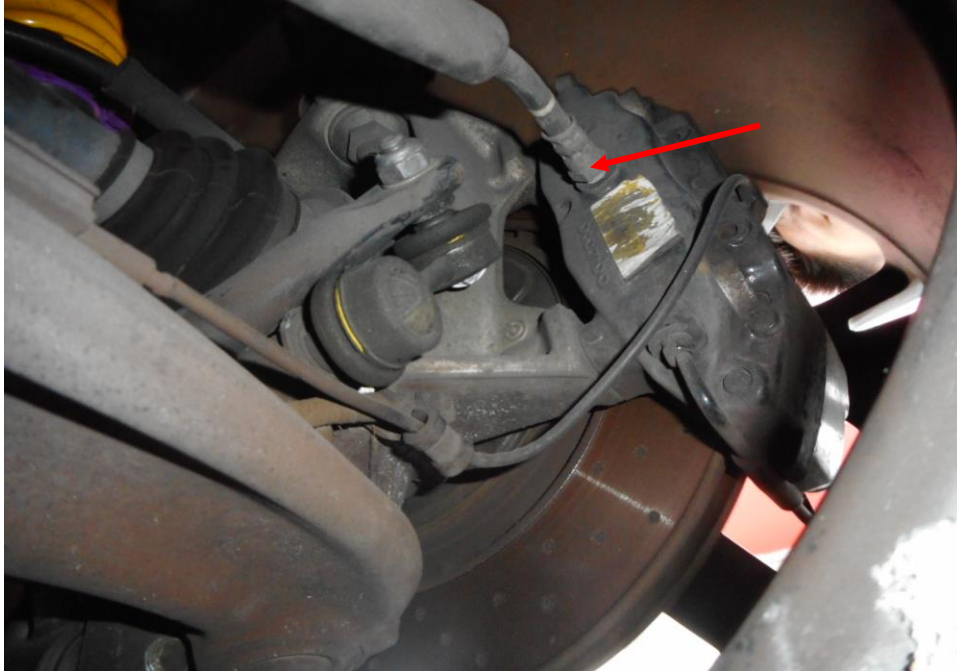
**Photo 20** shows the brake pipe (arrowed) at the rear right wheel of the Motor Car. I did not observe any leakage of brake fluid at the time of my inspection of the Motor Car. My static tests of the Motor Car's braking system, along with my visual examination of the various mechanical components in the braking system, had indicated that there was no internal leakage of pressure/vacuum. Hence the braking system of the Motor Car was likely to be in serviceable condition at the material time of accident.

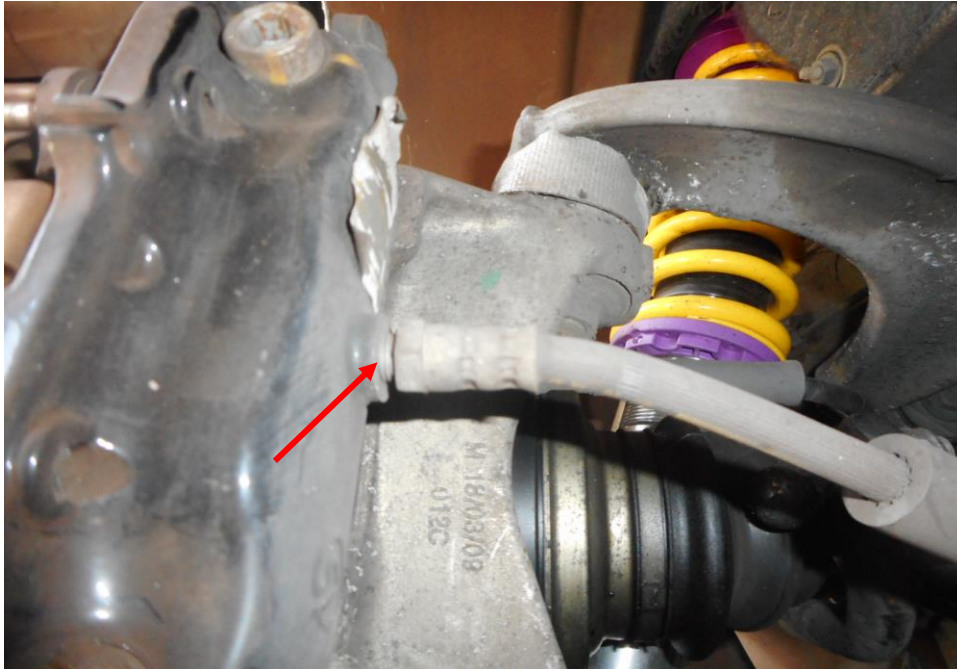
**Photo 21** shows the brake pipe (arrowed) at the rear left wheel of the Motor Car. I did not observe any leakage of brake fluid at the time of my inspection of the Motor Car. My static tests of the Motor Car's braking system, along with my visual examination of the various mechanical components in the braking system had indicated that there was no internal leakage of pressure/vacuum. Hence the braking system of the Motor Car was likely to be in serviceable condition at the material time of accident.

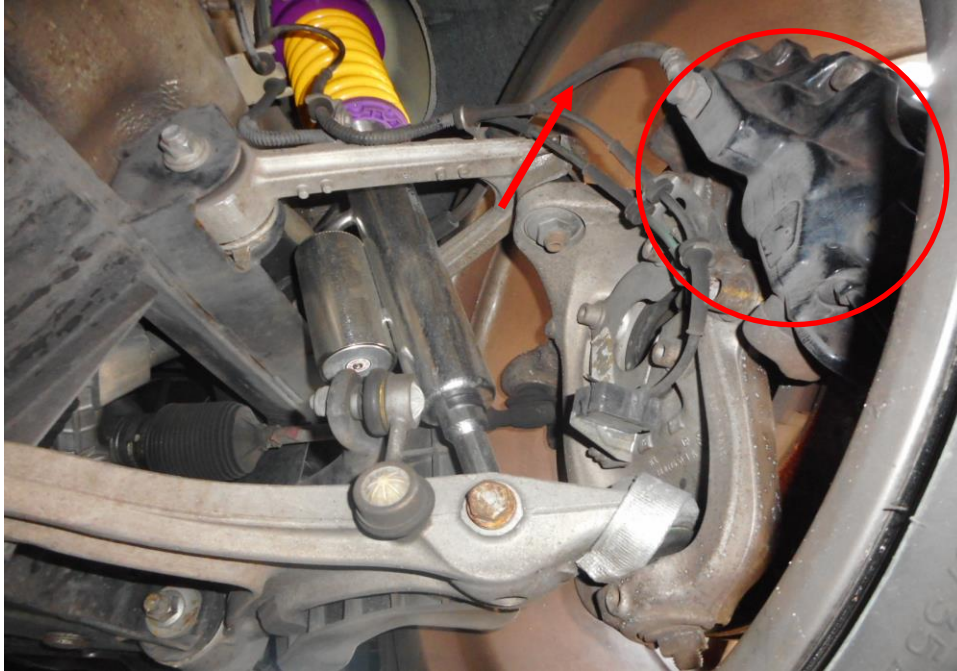
**Photo 22** shows the brake hose/pipe (arrowed) at the front right wheel of the Motor Car. No leakage of brake fluid was observed. Visual examination of the various components of the braking system like the brake caliper (circled), brake booster, brake pedal etc had revealed all to be intact and without visible damage at the time of accident. There was also no sign of fluid stain(s) observed on the various undercarriage components.

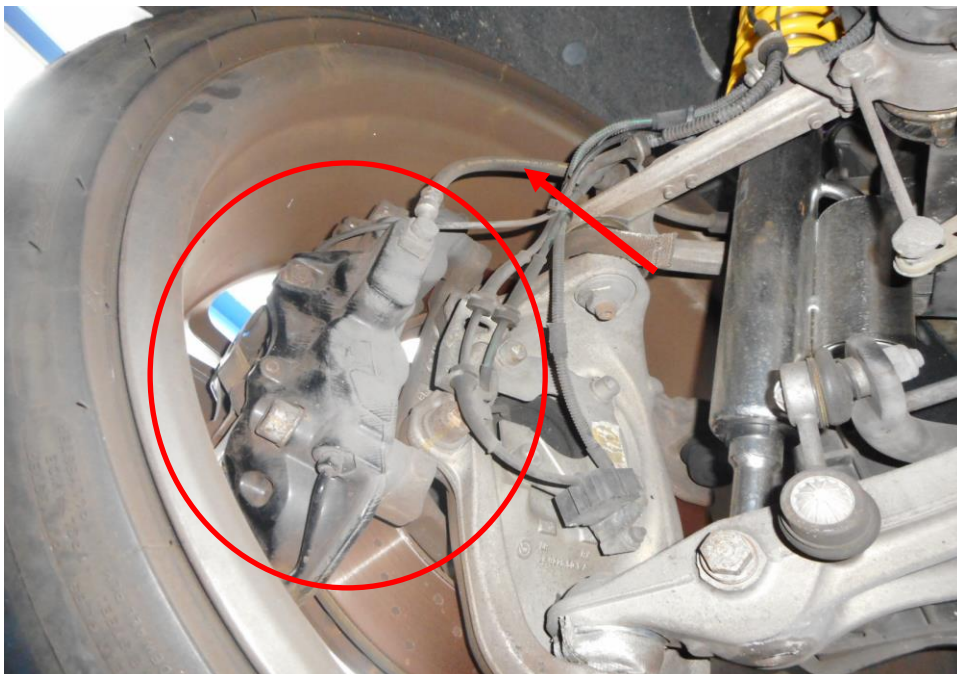
**Photo 23** shows the brake hose/pipe (arrowed) at the front left wheel of the Motor Car. No leakage of brake fluid was observed. Visual examination of the various components of the braking system like the brake caliper (circled), brake booster, brake pedal etc had revealed all to be intact and without visible damage at the time of accident. There was also no sign of fluid stain(s) observed on the various undercarriage components.

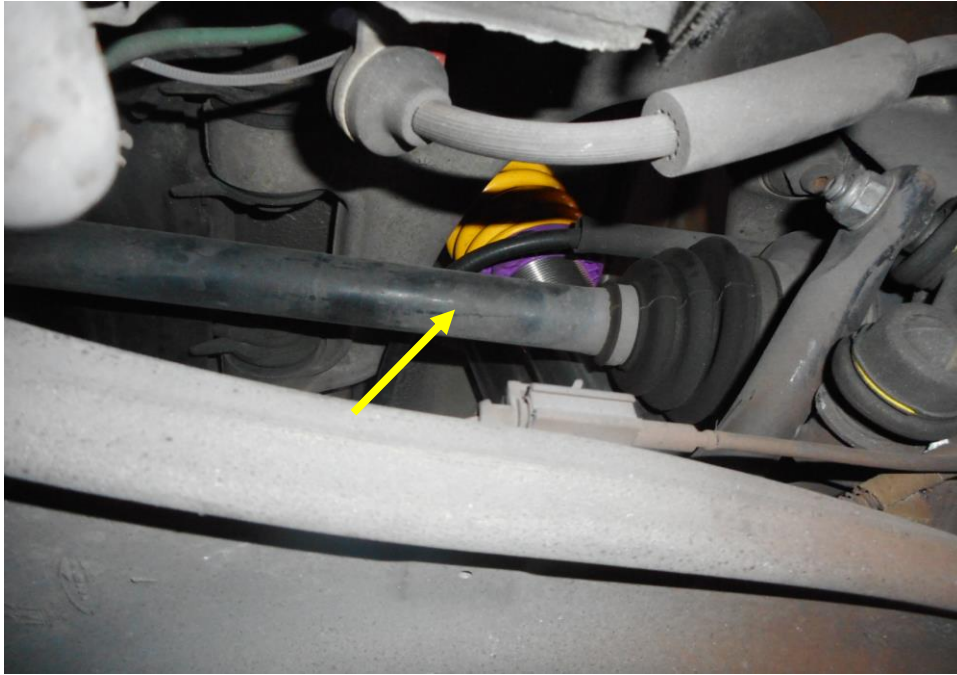
**Photo 24** shows the various undercarriage components at the rear left wheel of the Motor Car, The drive shaft (yellow arrow) was found to be intact and there was no sign of fluid stain(s) observed on the various undercarriage components.

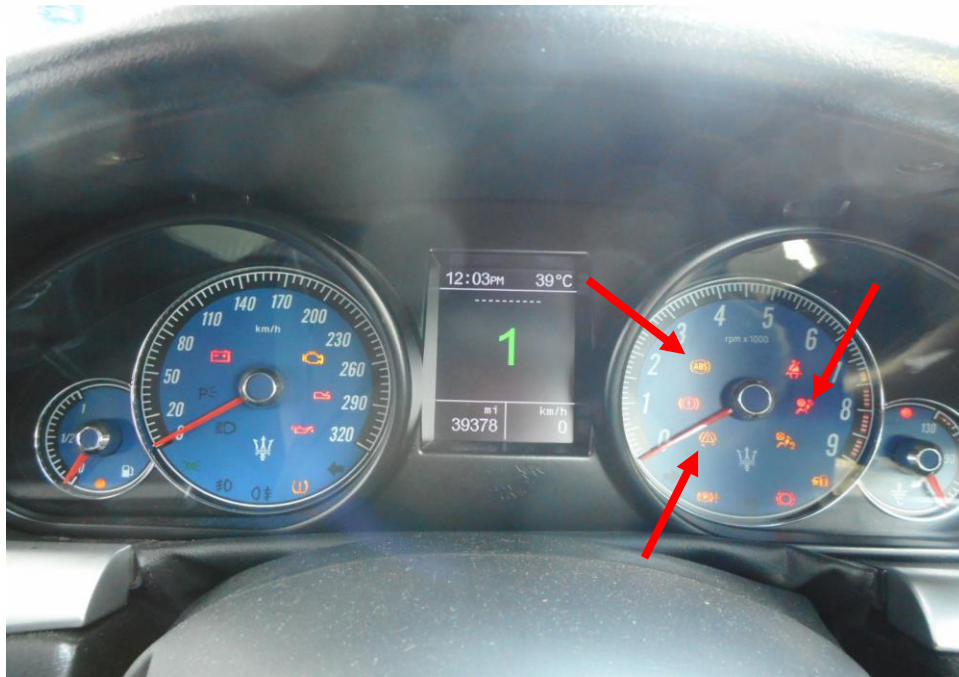
**Photo 25** shows the warning light for Anti-Lock Brake System (ABS) and Supplemental Restraint System (SRS) and Traction Control System (TC) appearing on the instrument panel of the Motor Car during the self-test of its various electronic operating systems when its engine was cranked.

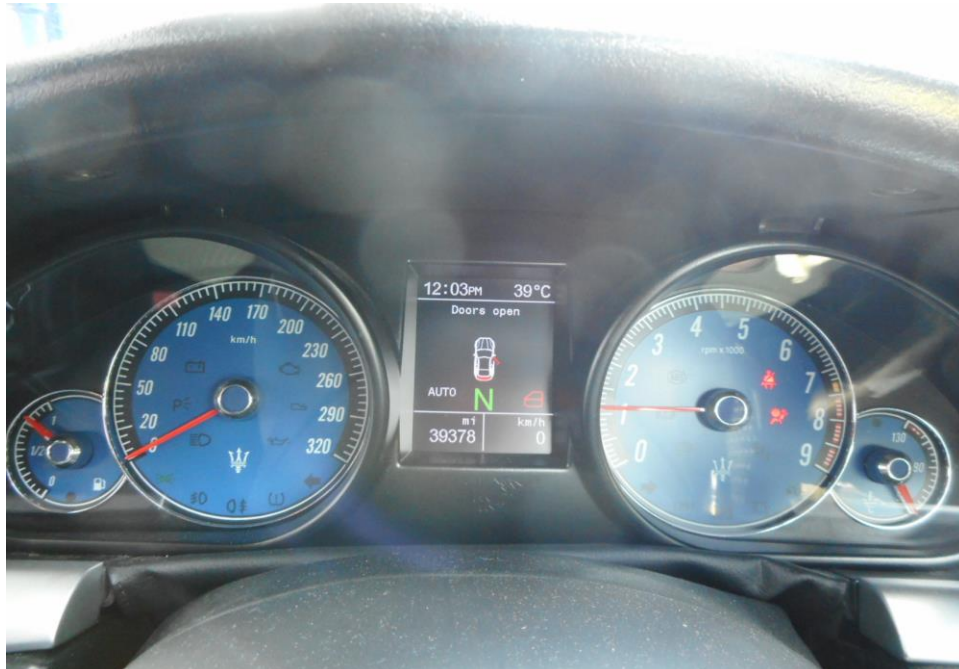
**Photo 26** shows no warning lights illuminated on the instrument panel of the Motor Car after the engine was cranked. This would suggest that there was no abnormality to the various electronic operating systems of the Motor Car, like the ABS, SRS and TC.
