LKK Auto Consultants Pte Ltd

Vehicle No. SLN 4026J
Insured Veh. GBB 8123S
Claim No. DM20HO00708/SG
Policy No. DMCPHQ19-002857
Accident Date 30/03/2020
Inspection Date 06/04/2020

ADJUSTMENT ON REPAIR COST FOR VEHICLE NO. SLN 4026J

PHOTOGRAPHS FOR VEHICLE NO. SLN 4026J

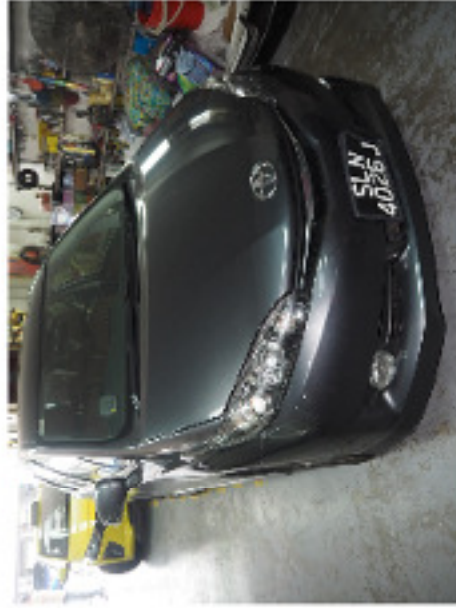
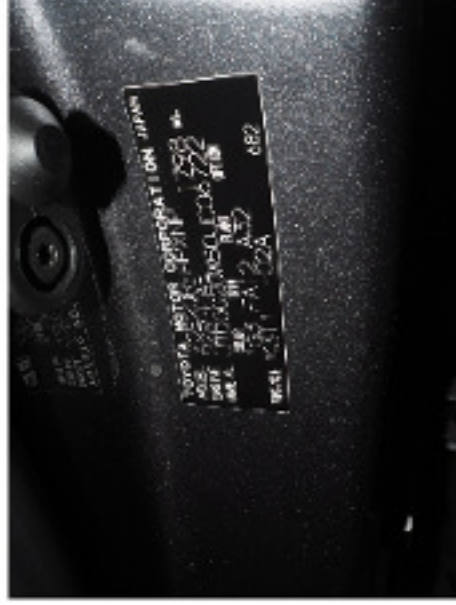
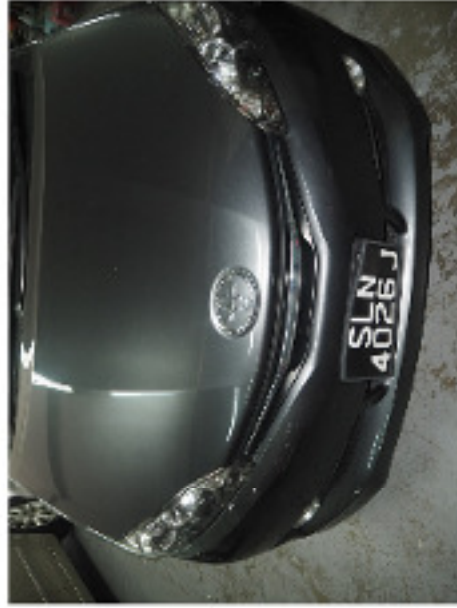
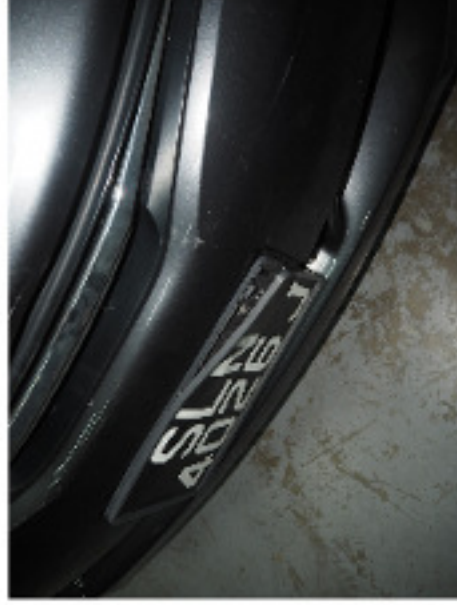
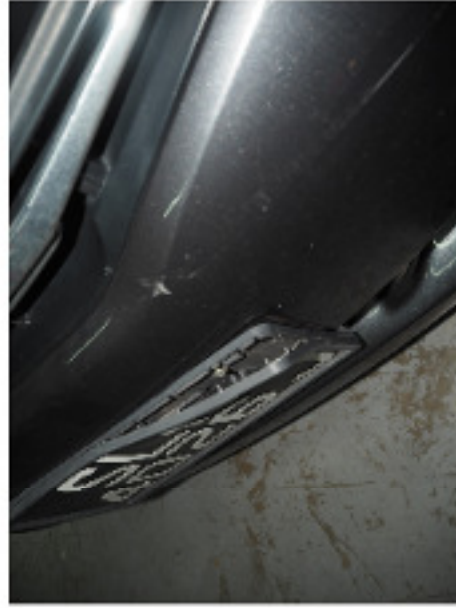
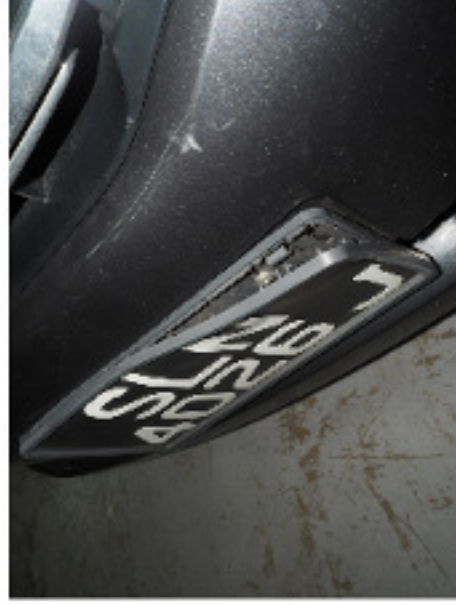
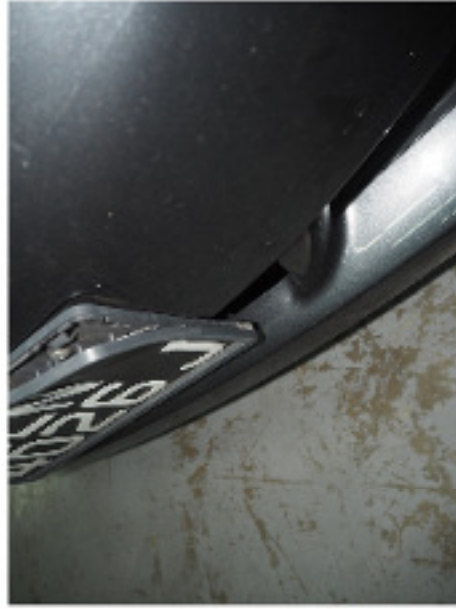
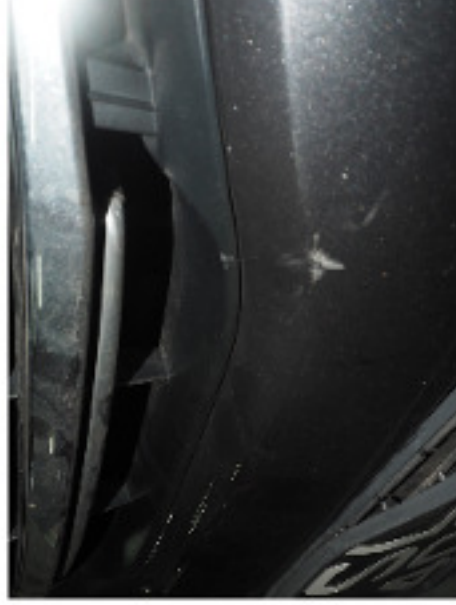
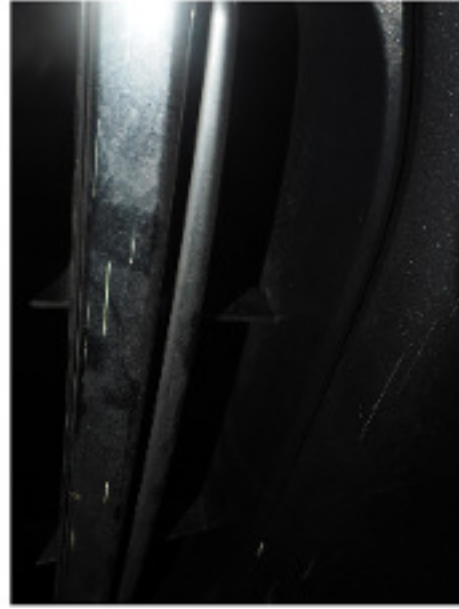
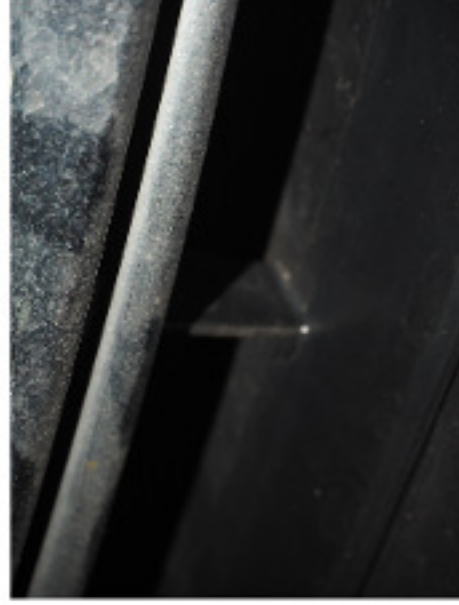
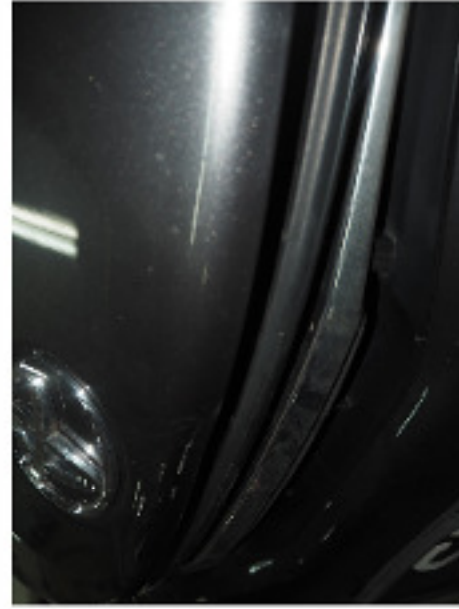
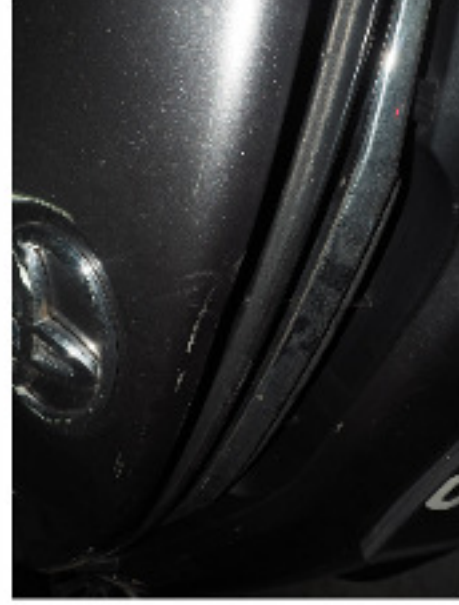
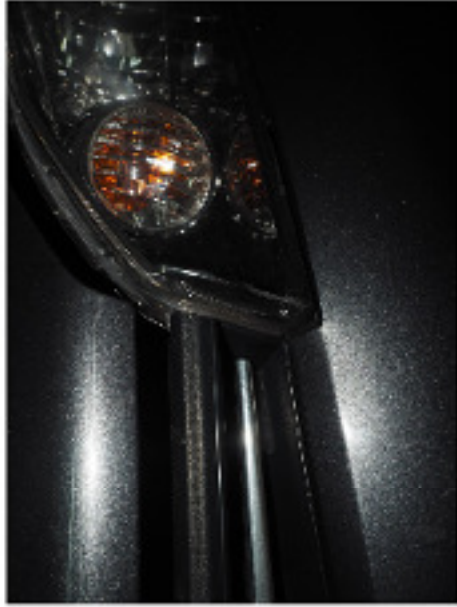
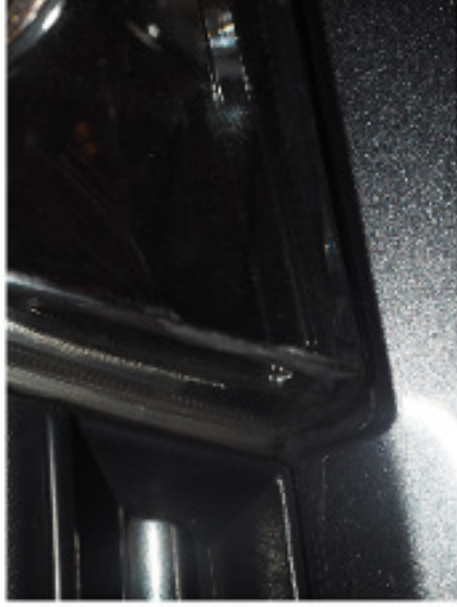
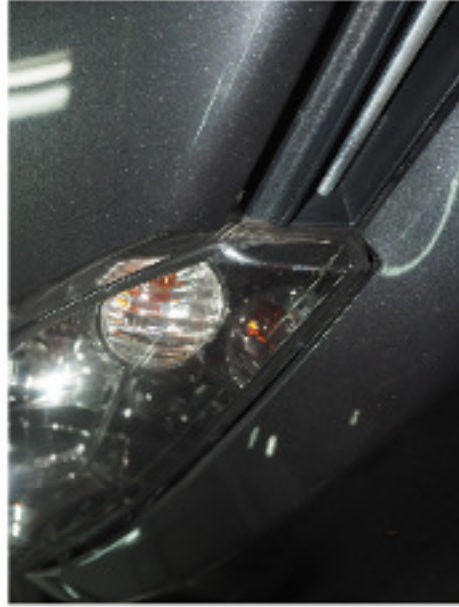
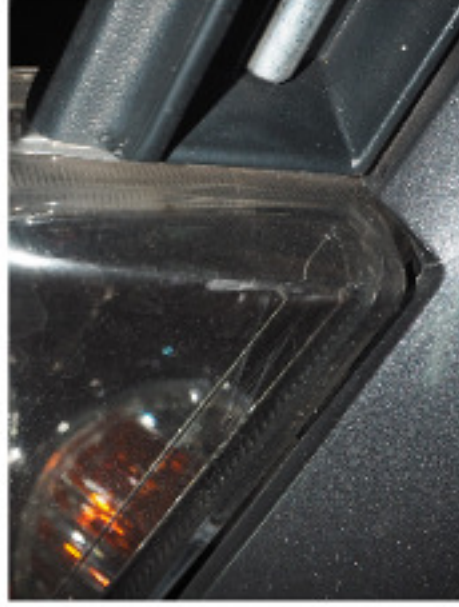
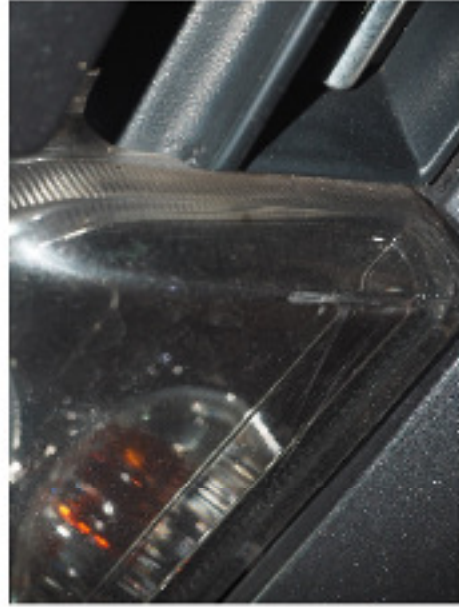
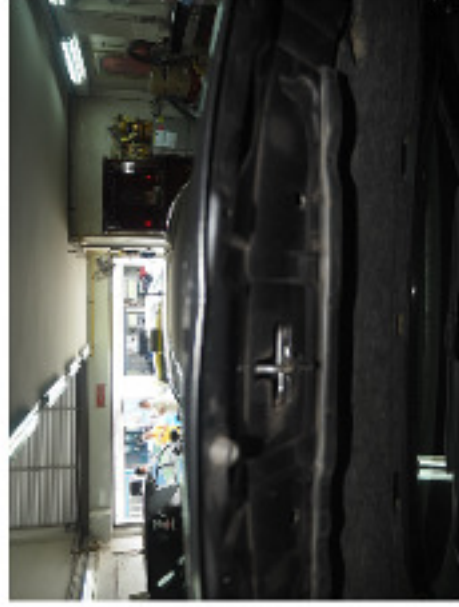
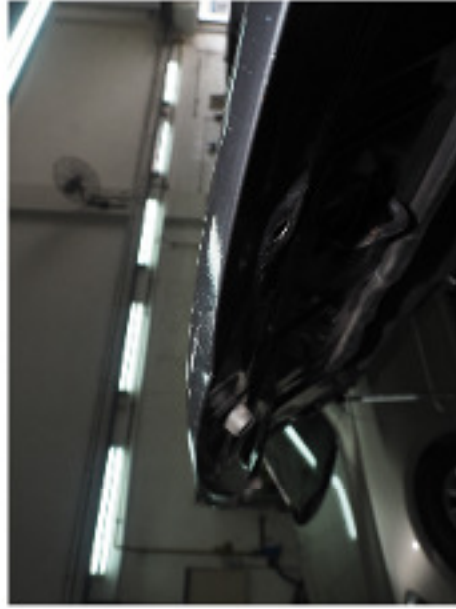
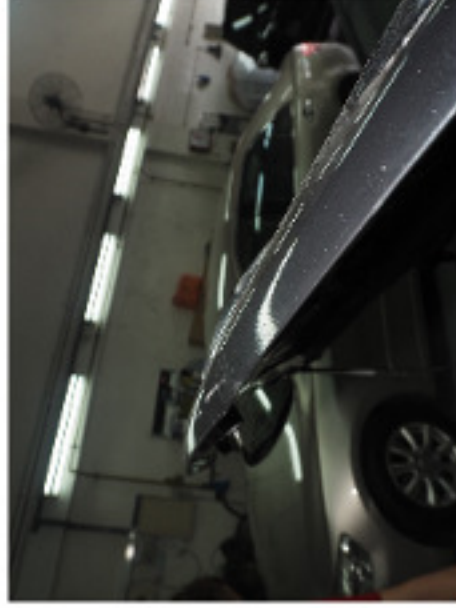
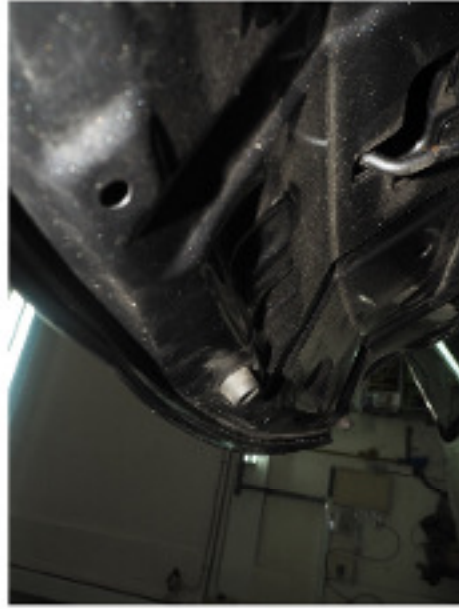
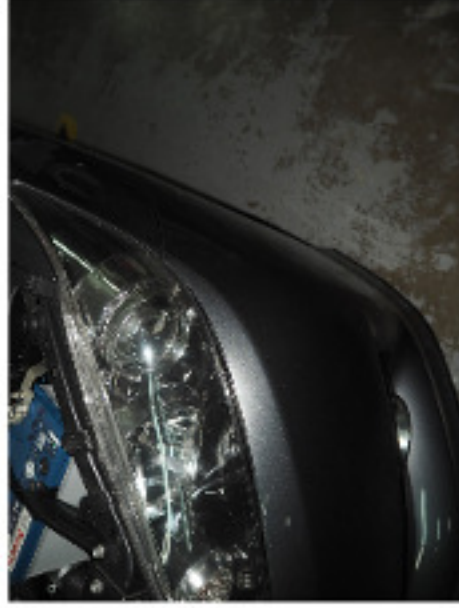
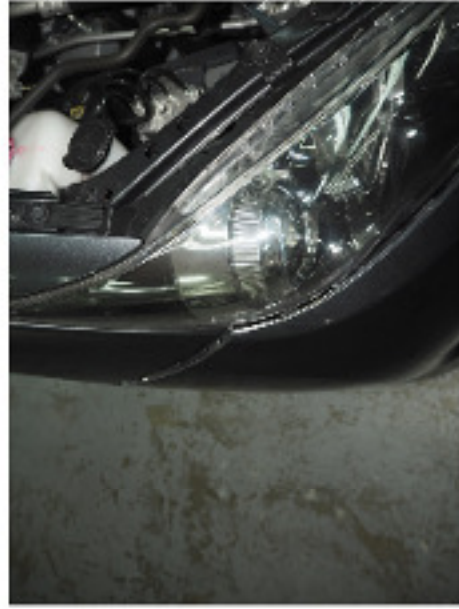
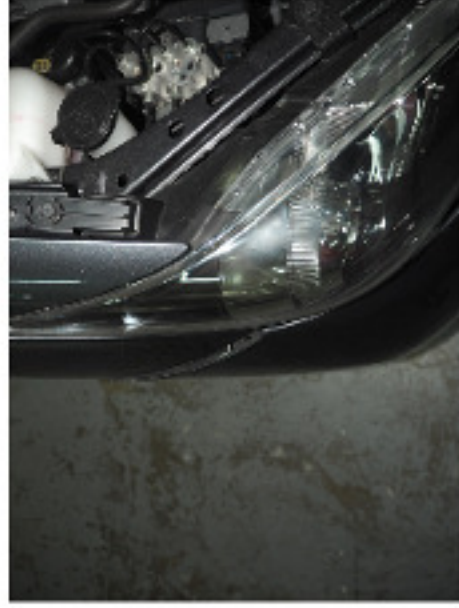
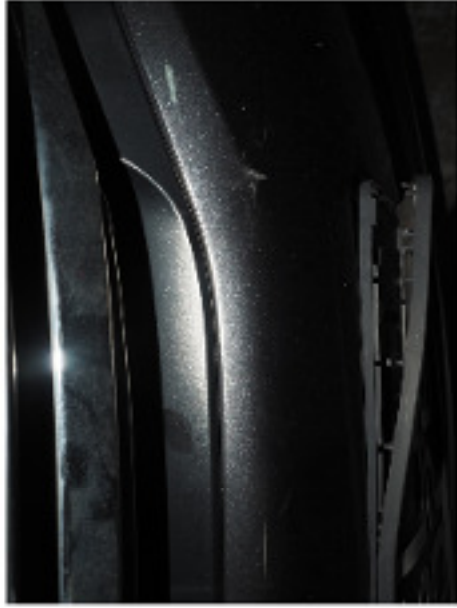
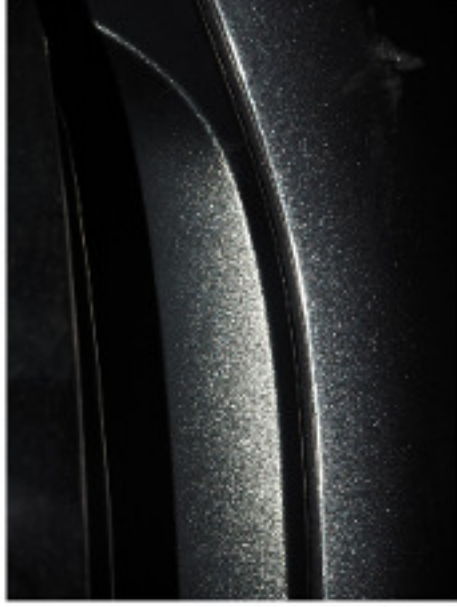
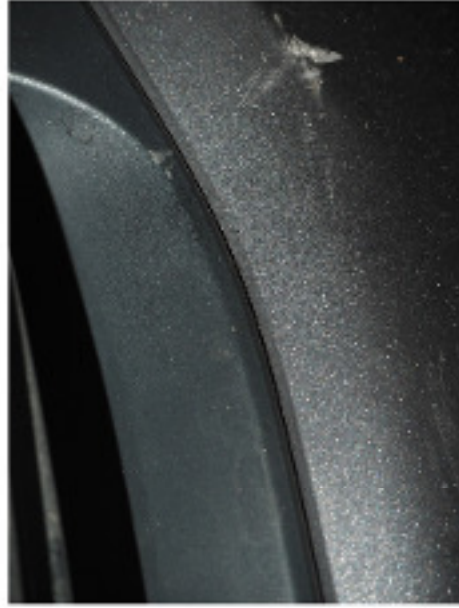
4. Description of Damages				
	THE VEHICLE SUSTAINED DAMAGES AT THE FRONT PORTION. DAMAGES SEE DETAILS.			
5. General Information				
	Accident Date	30/03/2020	Inspection Date	06/04/2020
	Survey held at	HUA MENG SPRAY PAINTING WORKSHOP 1 KAKI BUKIT AVE 6 #01-61 AUTOBAY SINGAPORE 417883		
5a. Remarks				
	A)THE INSPECTION WAS CONDUCTED ON A"WITHOUT PREJUDICE" BASIS. B)IN ACCORDANCE TO YOUR INSTRUCTIONS, WE HAVE NOT AUTHORISED REPAIRS.			
5b. Estimate Days of Repair				
	ESTIMATED NORMAL PERIOD FOR REPAIR:		4 Working Days
