LKK Auto Consultants Pte Ltd

Ref : CS/AGI20005122/Atf3n2

2. Vehicle Particulars & Condition

4. Description of Damages

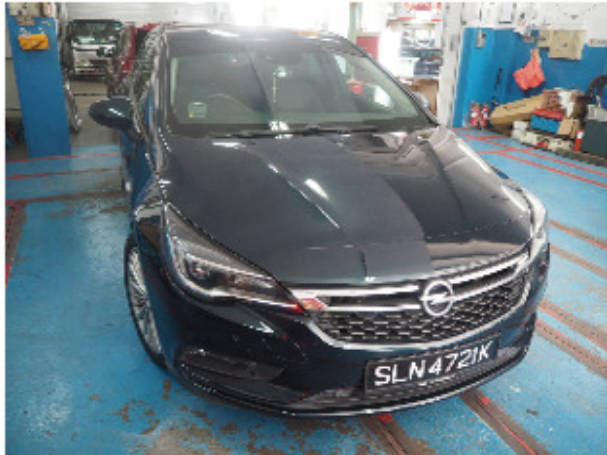
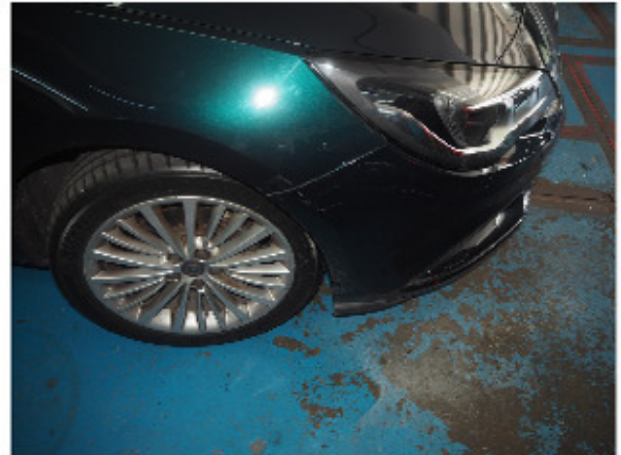
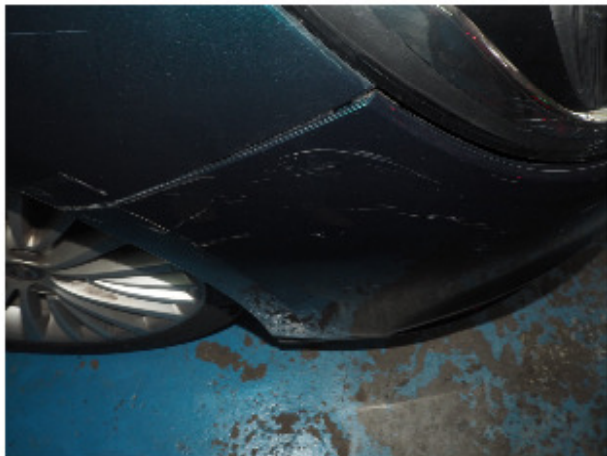
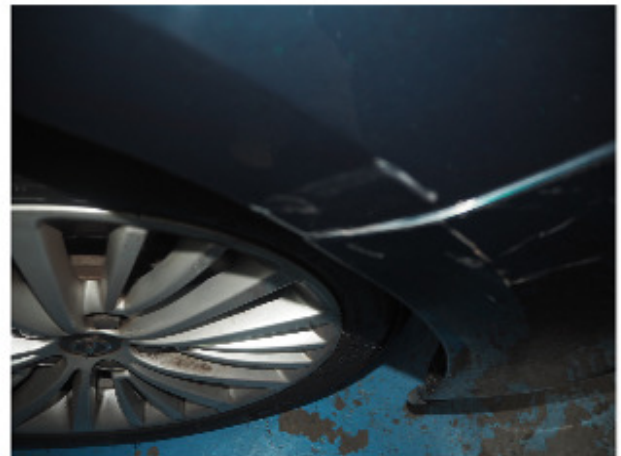
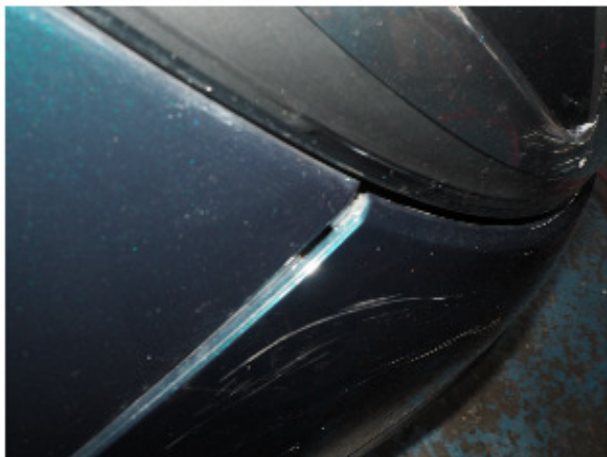
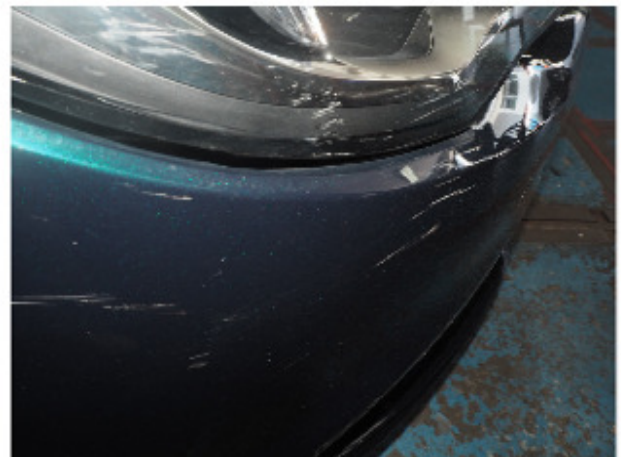
INSPECTION

THE VEHICLE SUSTAINED DAMAGES AT THE FRONT O/S PORTION. DAMAGES SEE DETAILS.
