VEHICLE DAMAGE INSPECTION REPORT

Our Ref: 340/TP/2018

Reg No:	SJQ7989T	Make &	Toyota
Reg date:	27/5/2009	Model	Corolla Altis 1.6 Auto
Colour:	Silver	Engine No:	3ZZ4884644
Type:	Motor Car	Chassis No:	MR053ZEE106144330
Type of Claims:	Third Party	Odometer No:	76001km
		Engine Cap:	1598cc

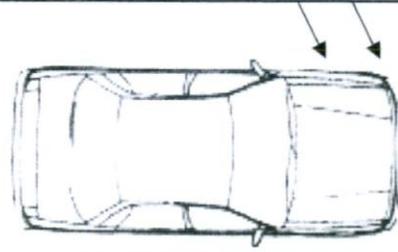
POINT OF IMPACT

Damaged at the left hand front portion

Our visual inspection of the vehicle revealed that the damages noted are at the left hand front portion.
