Your Ref: S0M02IV5  
Our Ref : CS4/ASM20005190/P

**TECHNICAL INVESTIGATION REPORT OF FIRE INCIDENT INVOLVING THE INSURED VEHICLE XD 3348Y ON 9th March 2020**

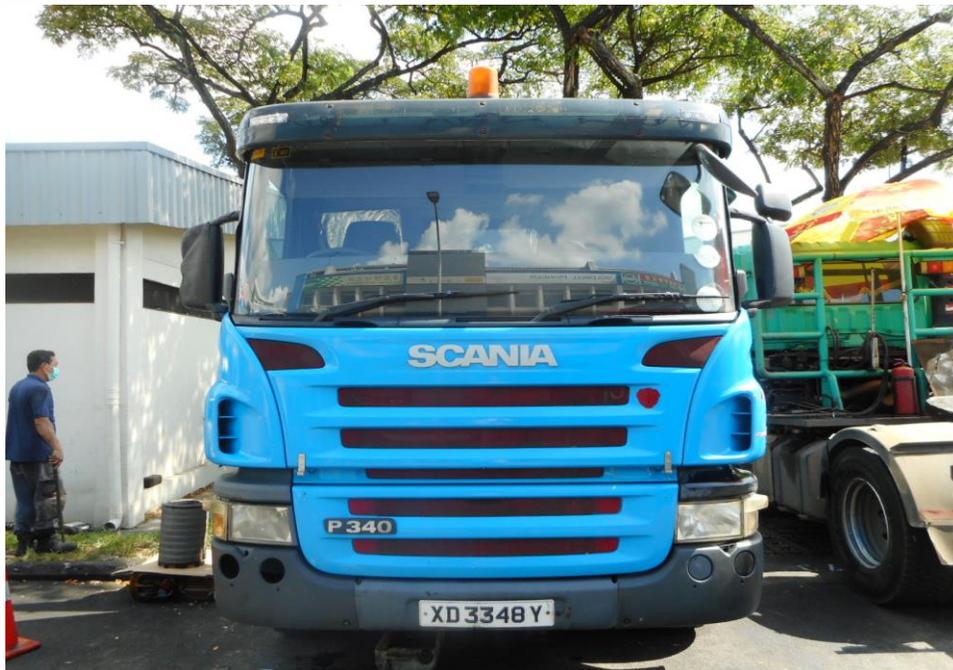
**Photo 1** shows the front view of the Insured Vehicle at the time of our inspection. The heat damage to the Insured Vehicle was confined to its right cabin portion. The rear portion of the Insured Vehicle was relatively unaffected by the fire.

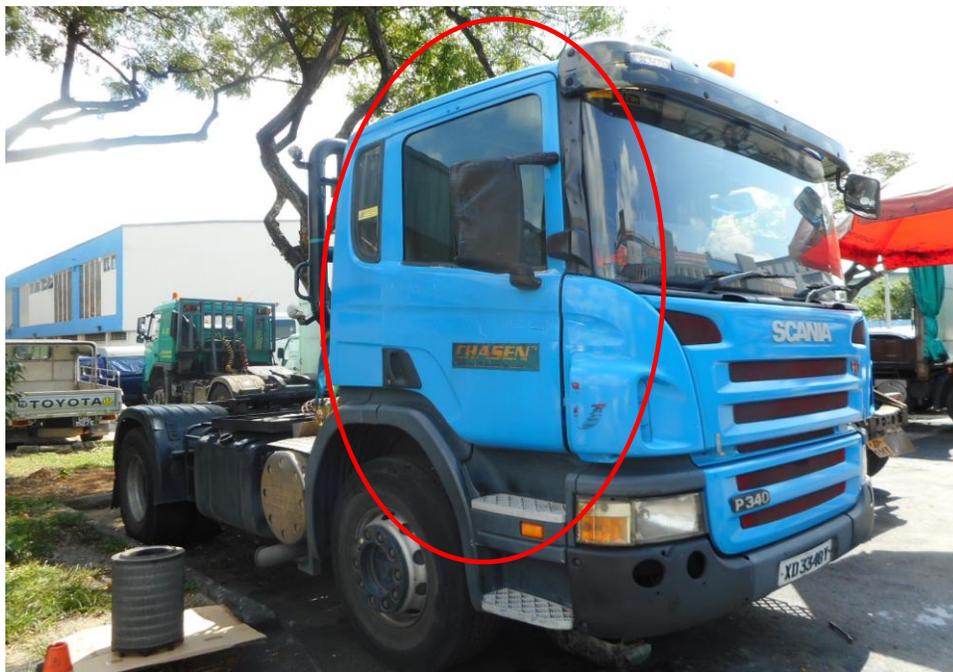
**Photo 2** shows the general right side view of the Insured Vehicle at the time of our inspection. The exterior body of the Insured Vehicle was affected by the heat. The door panels, right door panel, rubber strips and plastic fittings had sustained heat damage as a result of the fire (circled).

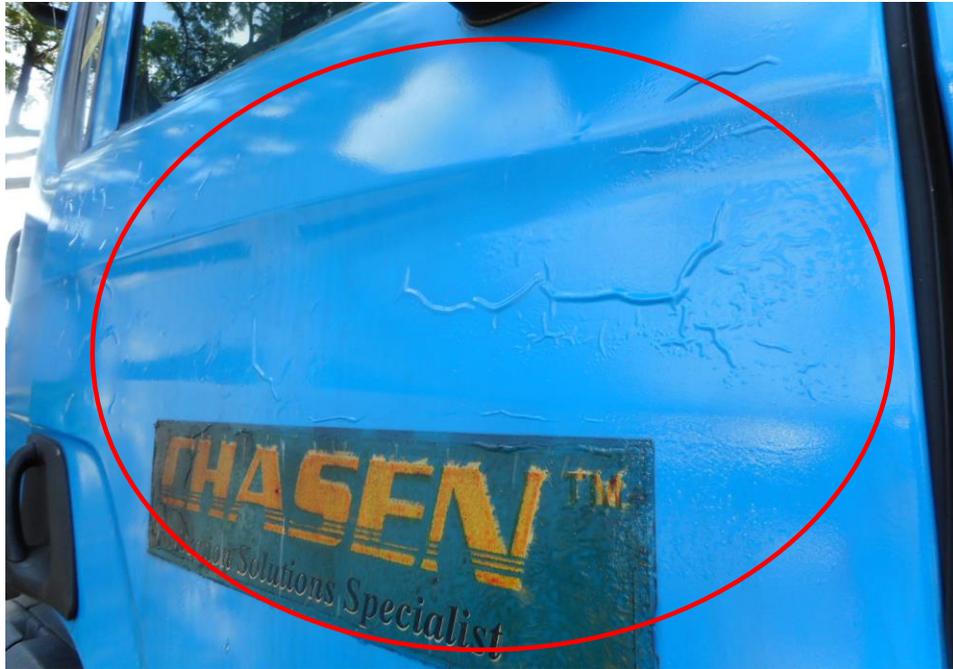
**Photo 3** shows the close up view of the right side of the Insured Vehicle at the time of our inspection. The painted on the body panel had sustained heat damage and melted as a result of the fire (circled).

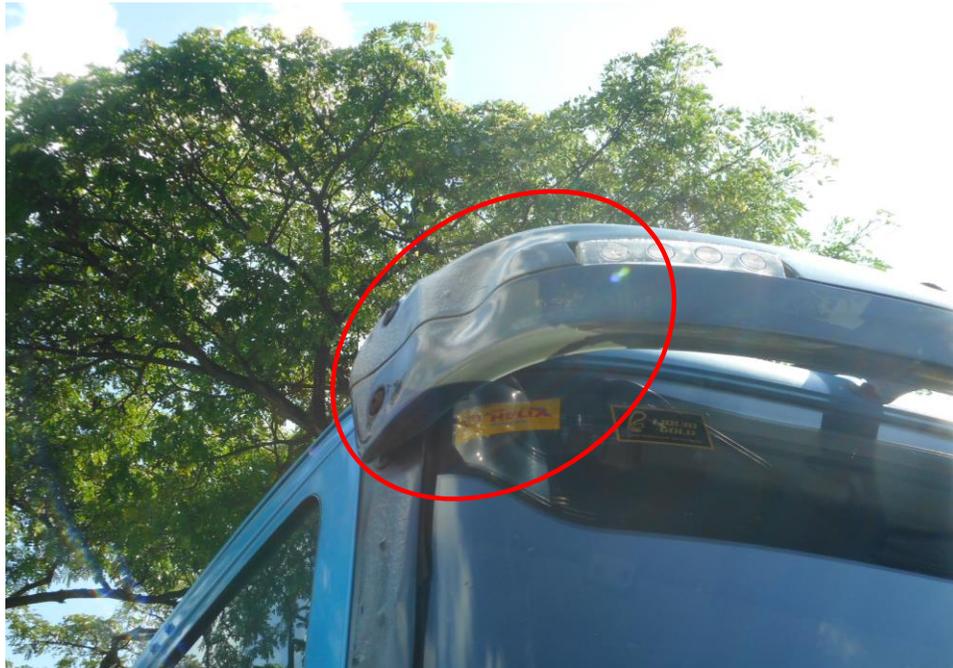
**Photo 4** shows the close up view of the right side of the Insured Vehicle at the time of our inspection. The plastic fittings had sustained heat damage and melted as a result of the fire (circled).

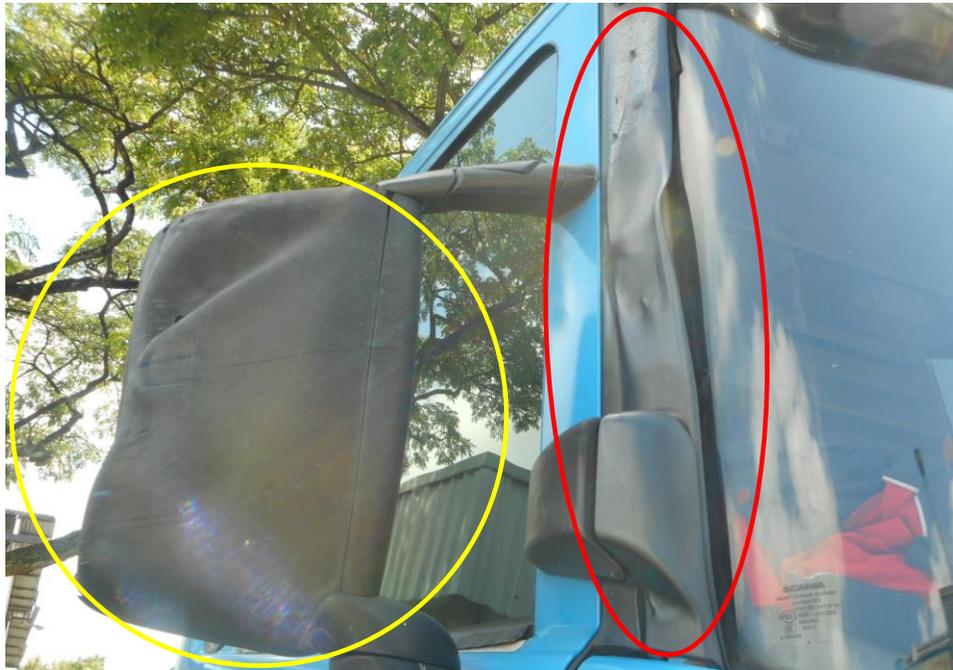
**Photo 5** shows the close up view of the right side of the Insured Vehicle at the time of our inspection. The right rear view mirror (yellow circle) and rubber strips (red circle) had sustained heat damage and melted as a result of the fire.

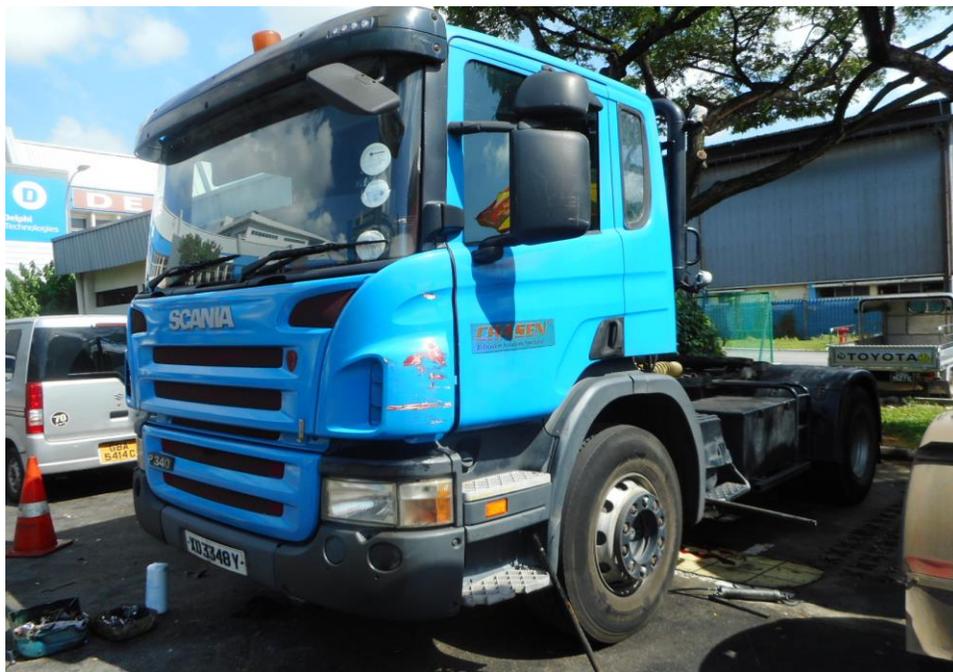
**Photo 6** shows the left portion of the Insured at the time of our inspection. The left portion of the Insured Vehicle was unaffected by the fire

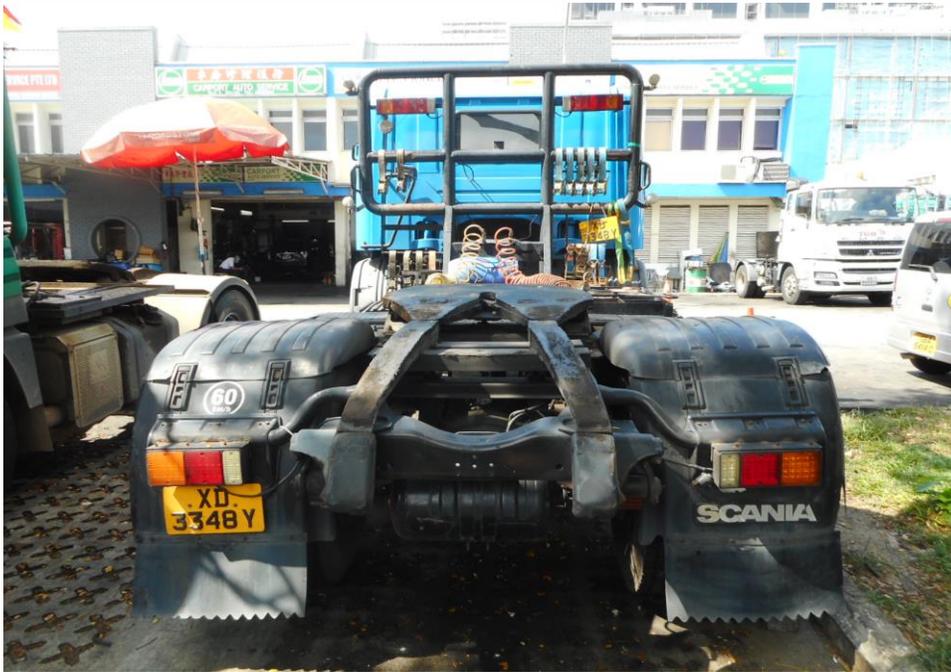
**Photo 7** shows the rear portion of the Insured at the time of our inspection. The rear portion of the Insured Vehicle was unaffected by the fire

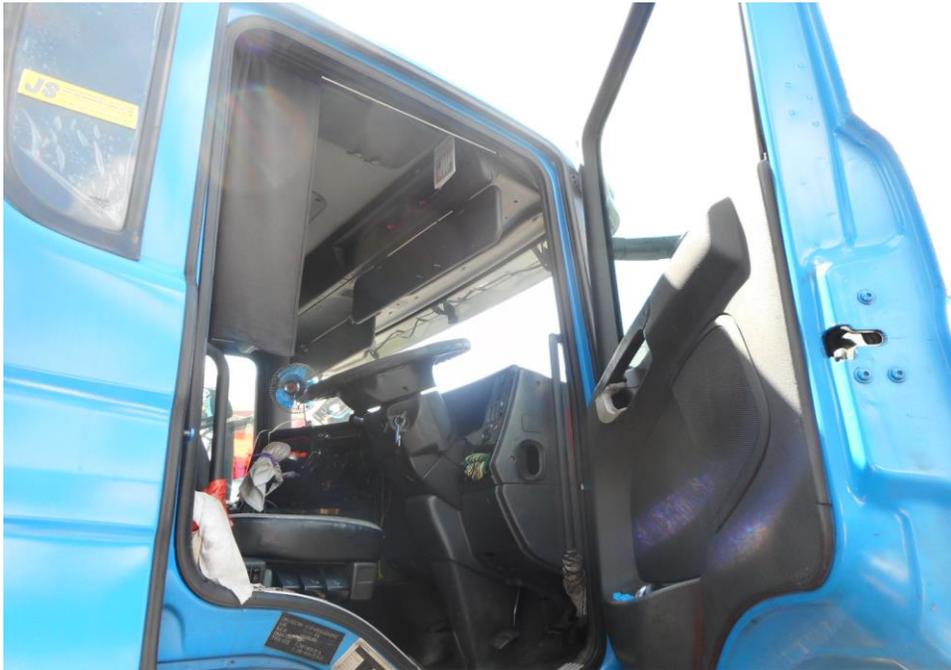
**Photo 8** shows the cabin portion of the Insured at the time of our inspection. The interior portion of the Insured Vehicle was unaffected by the fire

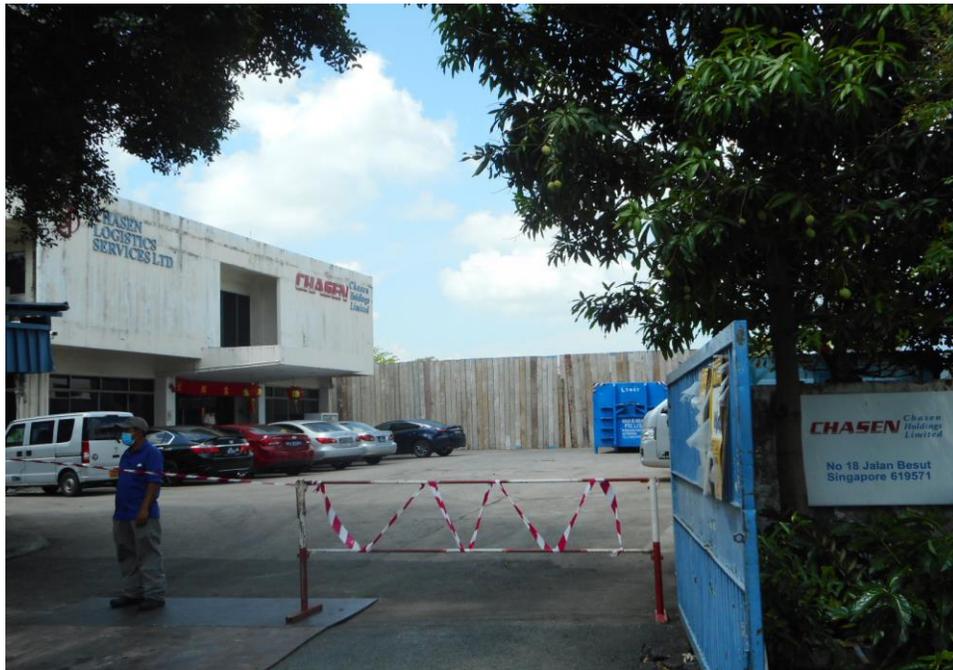
**Photo 9** shows the general view of the location where the fire incident had occurred. The Insured Vehicle was positioned beside the warehouse which was located inside the cordon off area.

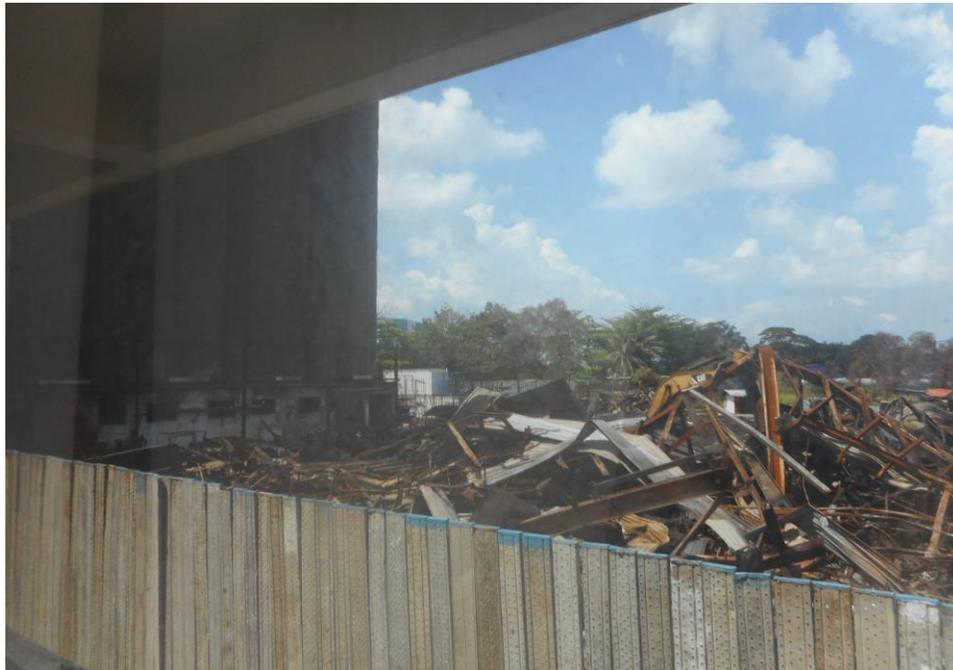
**Photo 10** shows the general view of the of the warehouse compound area which was burned down by the fire. From our observations, the metal building structures roof and surroundings materials were affected by the fire.

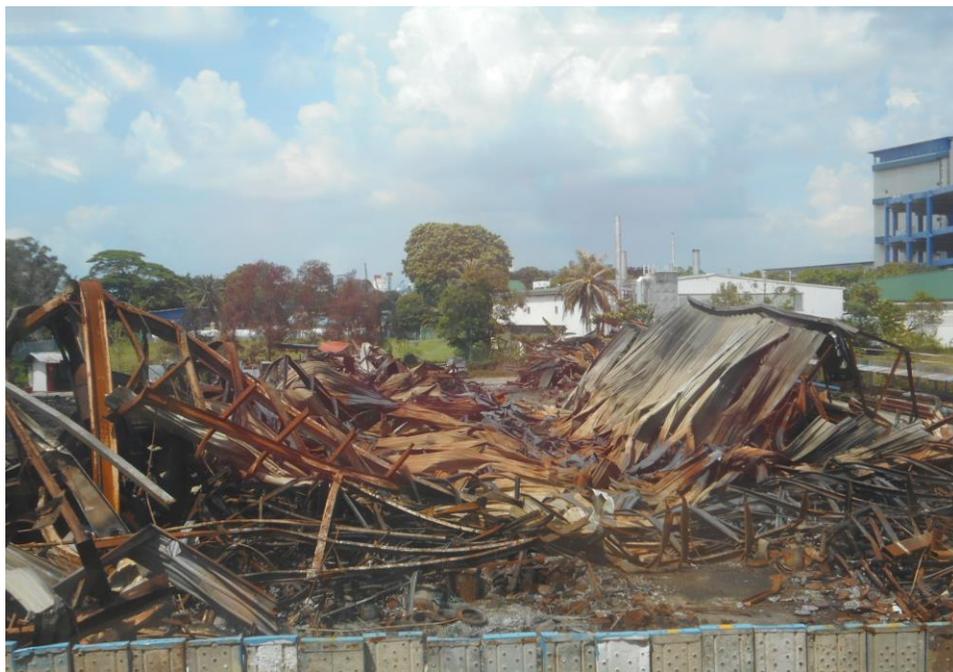
**Photo 11** shows the close up view of the inside of the warehouse area which was burned down by the fire. From our observations, the metal building structures roof and surroundings materials were affected by the fire.

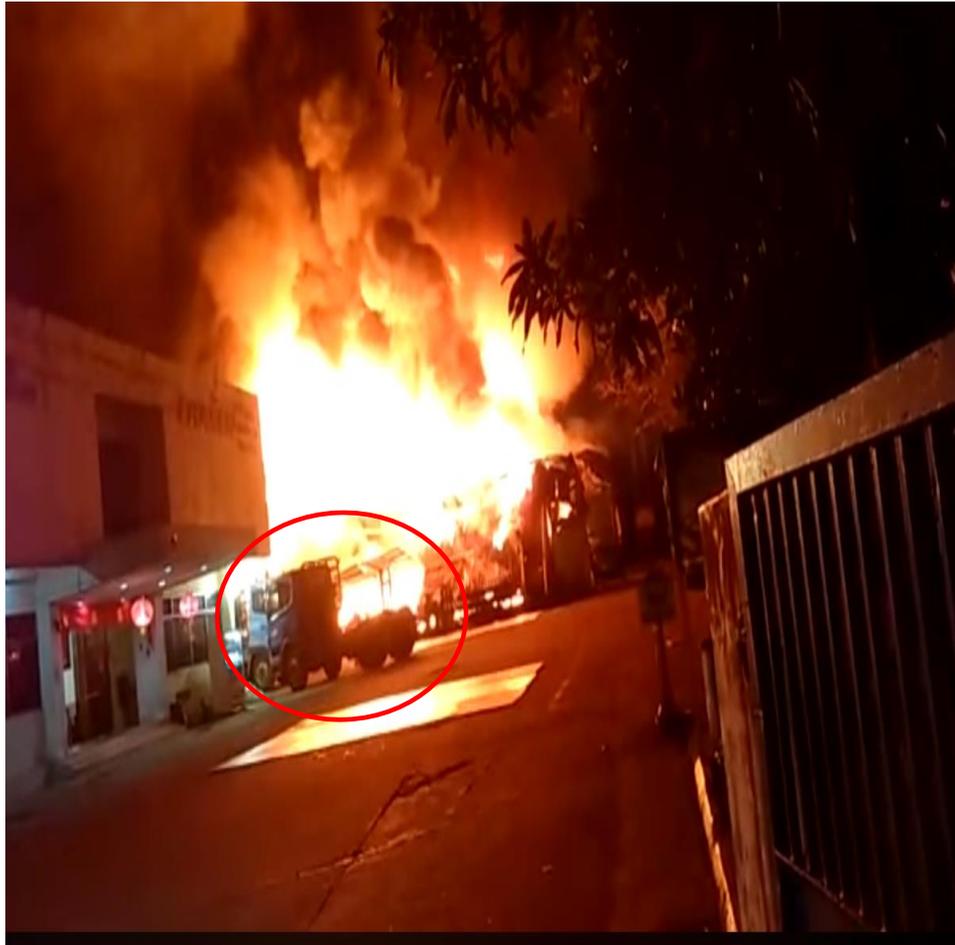
15. We have also conducted our research and found information regarding the fire incident. The SCDF was alerted to the fire on 9 April 2020 at 1810 hours. And they had arrived to find the warehouse located in compound was fully engulfed in flames. And we have establish the exact location of where the Insured Vehicle was parked during the fire incident. The Insured Vehicle was parked head in with the front right side facing the fire and that would have caused the damage which corresponds to the damage on the Insured Vehicle during our time of inspection. See Photo 2 and 12

**Photo 12** shows the exact location of where the Insured Vehicle had been parked at the material time of the fire incident (circled) this findings had corresponds to the damage on the Insured Vehicle at our time of inspection.
