Your Ref: S0M02LR8
Our Ref: CS4/ASM20005192/P

23rd April 2020

**TECHNICAL INVESTIGATION REPORT OF FIRE INCIDENT INVOLVING THE
INSURED VEHICLE GBC 7891J ON 9th April 2020**

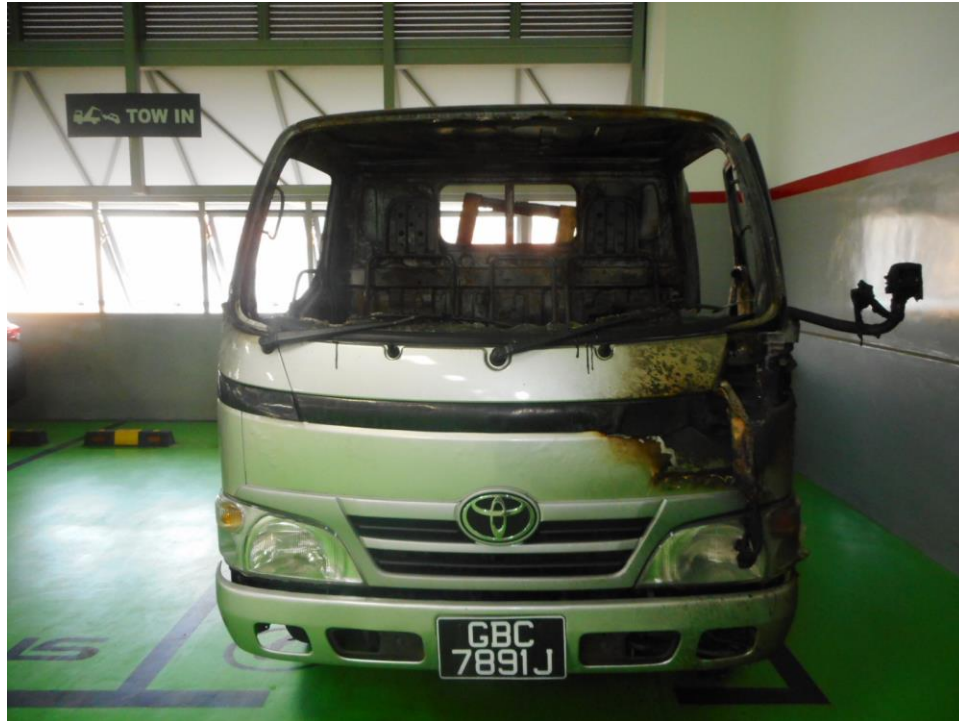
Photo 1 shows the front view of the Insured Vehicle at the time of our inspection. The fire damage to the Insured Vehicle was confined to its front cabin, interior compartment and rear portion.

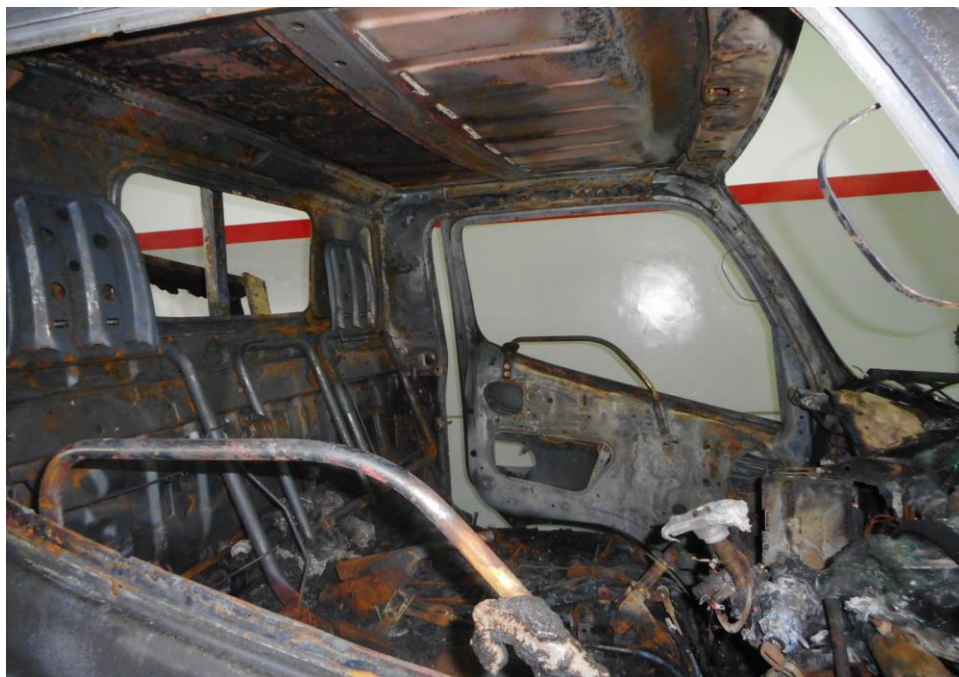
Photo 2 shows the general view of the interior compartment of the Insured Vehicle. The entire windscreen and the interior compartment have been badly burnt by the fire.

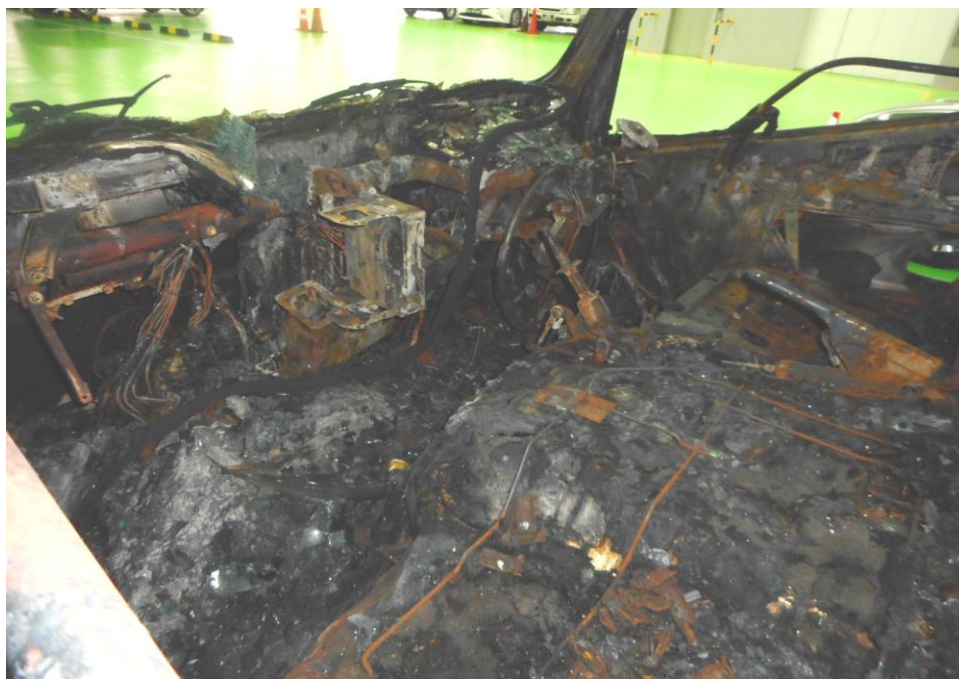
Photo 3 shows the close up view of the interior compartment of the Insured Vehicle. The interior compartment have been badly burnt by the fire.

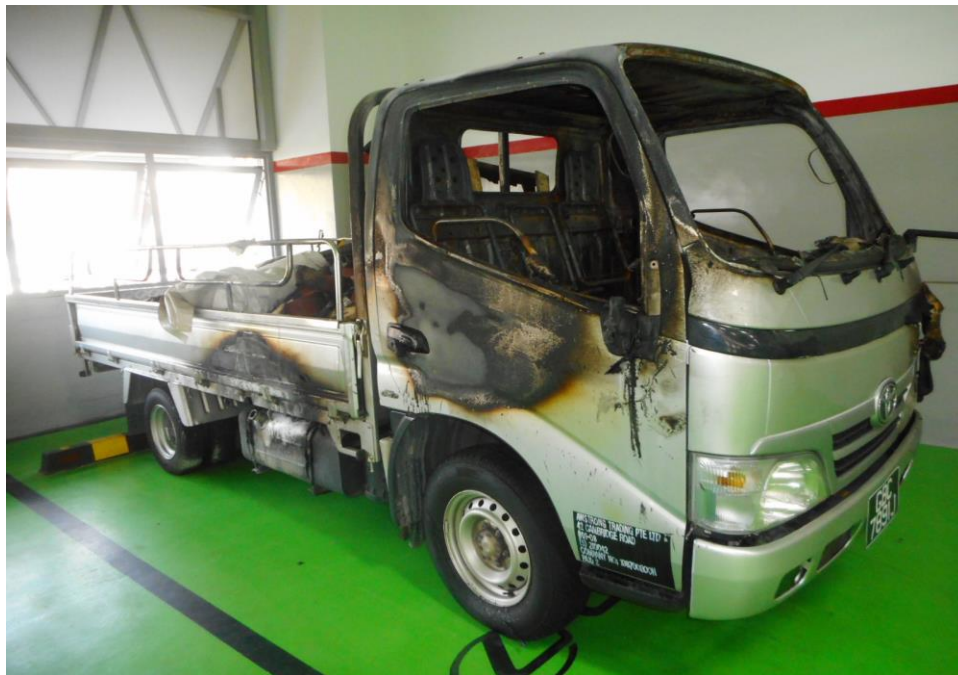
Photo 4 shows the right side of the Insured Vehicle at the time of our inspection. The fire damage to the Insured Vehicle was confined to its rear portion and interior compartment. The right rear cabin panel, handle railings and rear portion of the driver side door were amongst the parts that were observed to have been affected by the fire.

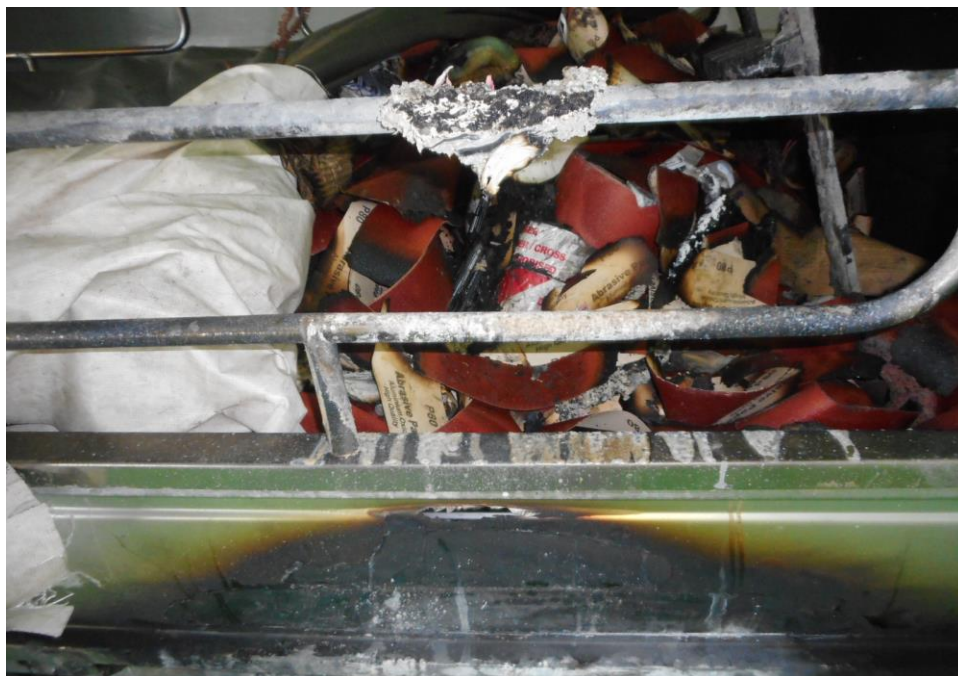
Photo 5 shows the close up view of the right side of the Insured Vehicle at the time of our inspection. The fire damage to the Insured Vehicle was confined to its rear portion and interior compartment. The right rear cabin panel and handle railings were amongst the parts that were observed to have been affected by the fire.

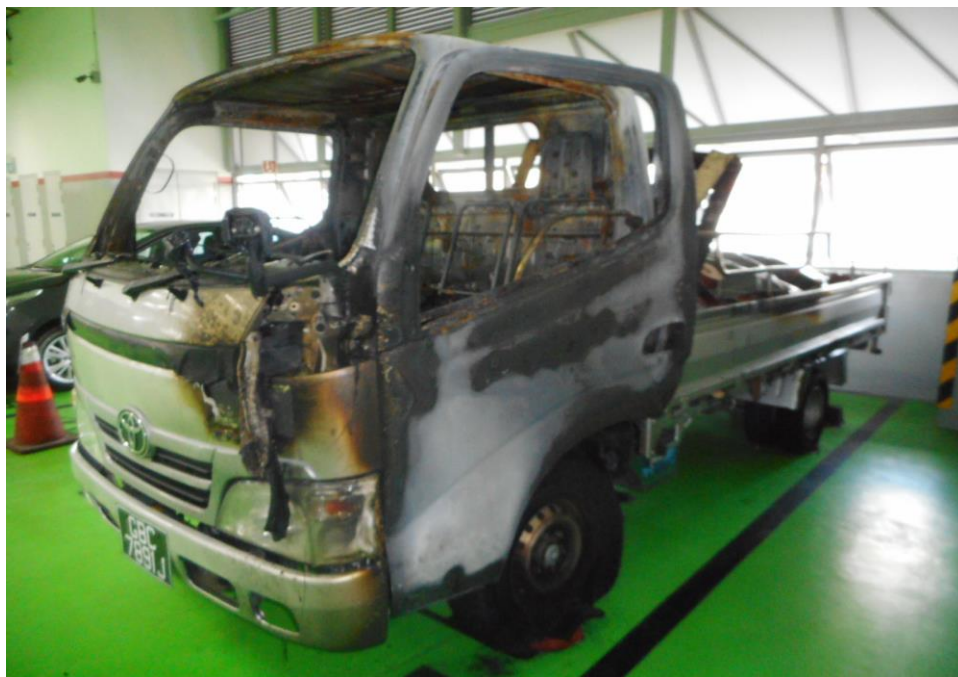
Photo 6 shows the left side of the Insured Vehicle at the time of our inspection. The fire damage to the Insured Vehicle was confined to its rear portion and interior compartment. The right rear cabin panel, handle railings and rear portion of the driver side door were amongst the parts that were observed to have been affected by the fire.

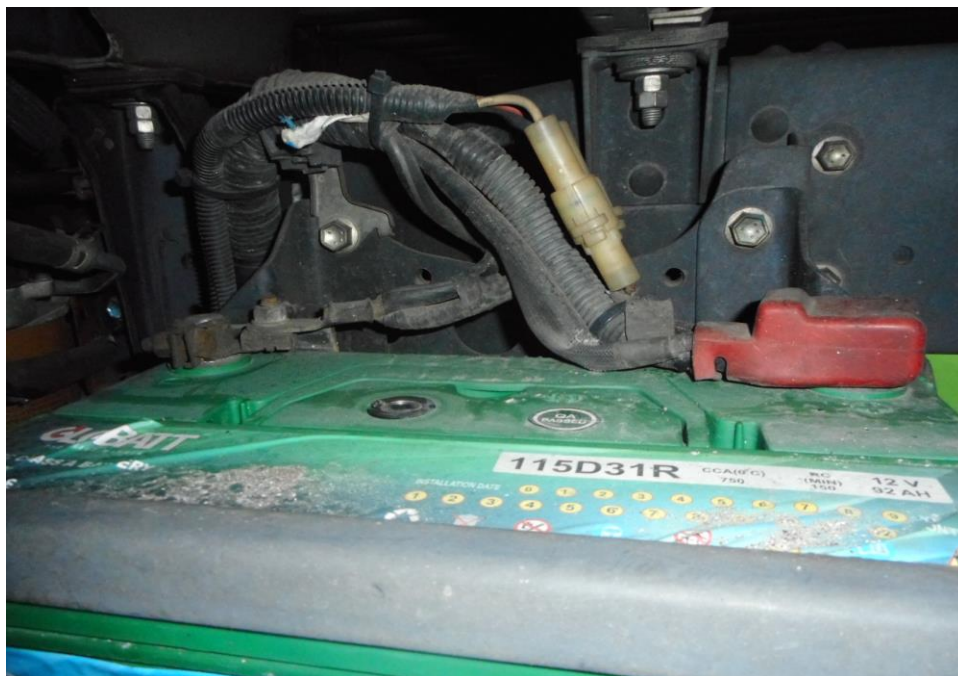
Photo 7 shows the battery unit of the Insured Vehicle at the time of our inspection. The battery unit and the battery terminal was unaffected by the fire damage to the Insured Vehicle.

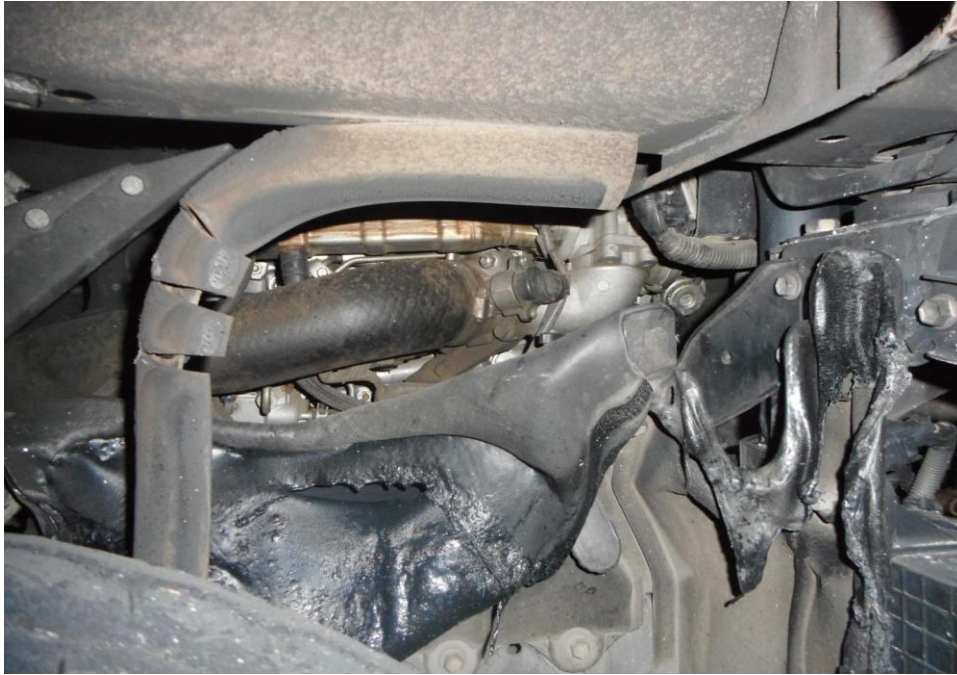
Photo 8 shows the engine compartment of the Insured Vehicle at the time of our inspection. The front cabin of the Insured Vehicle was not able to be lifted due to the damage it sustained from the fire, however visually the engine unit looks to be intact and was unaffected by the fire.

9. The fire originating from the exterior of the Insured Vehicle is further supported by the lack of visible fire damage to the interior of the engine compartment, which had contained more combustible materials (flammable fluids amongst others). See photos 11 & 12 below.

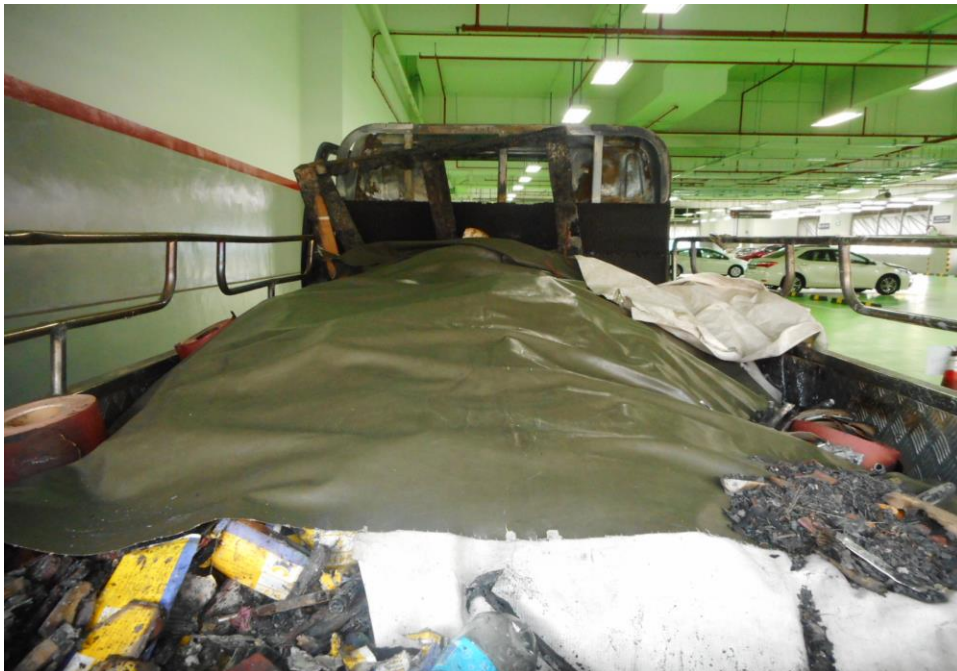
Photo 9 shows a closer view of the rear portion of the Insured Vehicle at the time of our inspection. The entire rear goods compartment, rear cabin panel, and sustained severe visible fire damage.

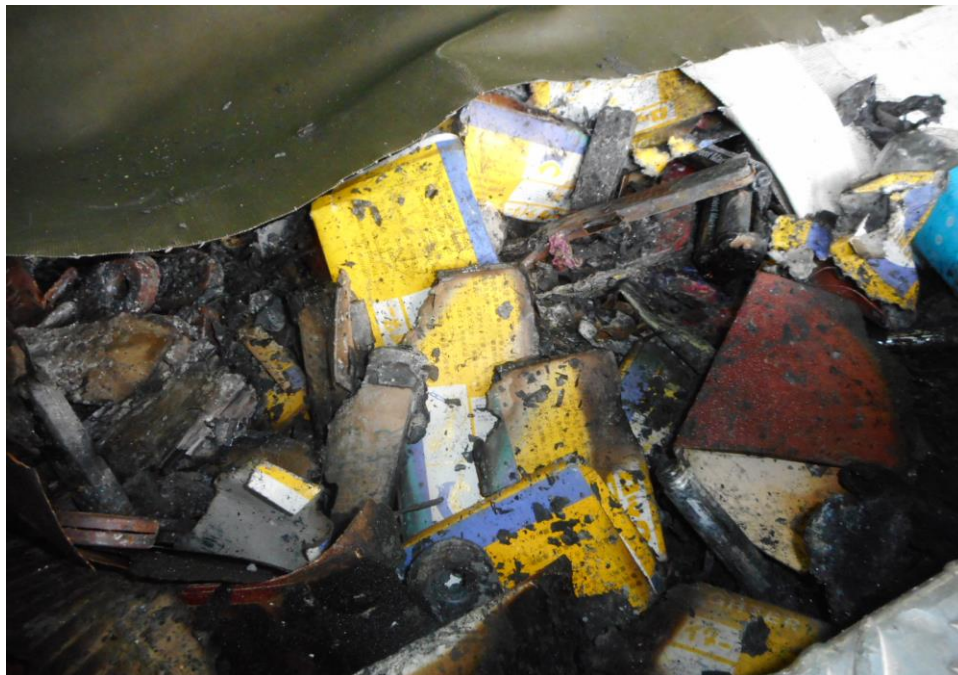
Photo 10 shows a closer view of the rear goods compartment of the Insured Vehicle at the time of our inspection. The rear cabin was significantly burnt and/or melted as a result of the fire. We also found remnants of burned sand paper, cardboard and various other items in the rear goods compartment.

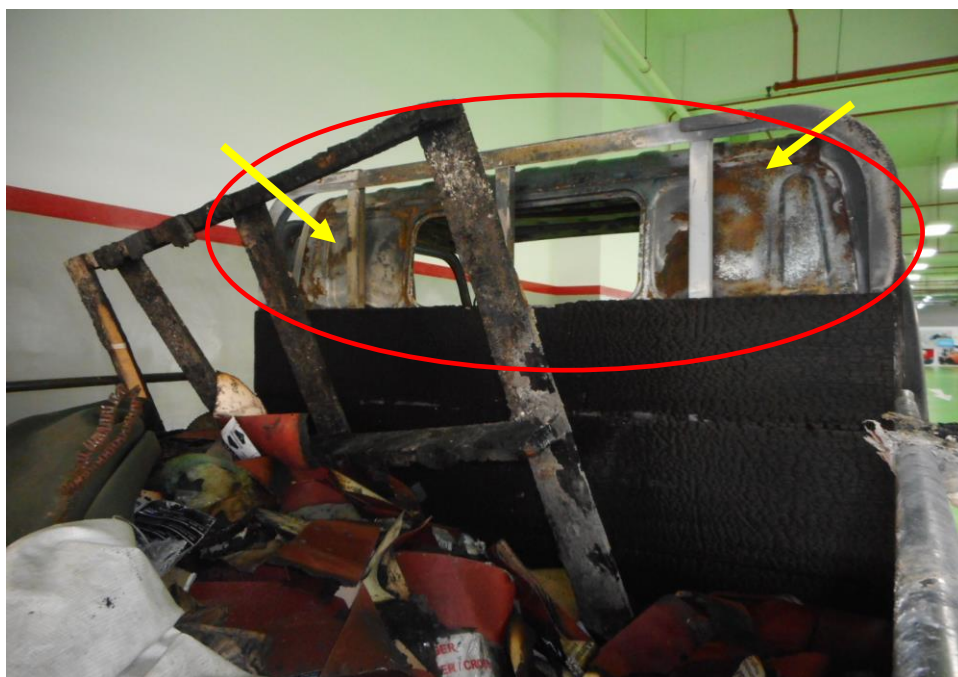
8. For this particular case, the fire appears to have originated from the exterior of the Insured Vehicle, at the rear portion. This was determined basing on the area where the extent of fire damage was most severe which was at the rear goods compartment portion of the Insured Vehicle which metal plates and also the high heat intensity burn marks (whitish burn marks) that were found on the exterior surface of the back portion of the front cabin. These whitish burn marks are a result of exposure to prolonged heat intensity. Rust would normally start to develop around these areas soon after a fire as the prolonged exposure to high heat intensity usually causes the bare steel/metal material of the body parts to be exposed to natural environmental condition. The rust that had developed on the exterior surface of the back portion of the front cabin, at the immediate vicinity where these whitish burn marks were found, would also support our findings of where the fire to the Insured Vehicle had originated.

Photo 11 shows the fire damage at the rear portion of the Insured Vehicle. The high heat intensity burn marks (whitish burn marks) found on the exterior surface of the back portion of the front cabin (circled) and rust that had developed on the sides (red arrows) indicates that the fire to the Insured Vehicle had originated from the exterior of the Insured Vehicle. Indicating that the fire may have started from the rear goods compartment portion of the Insured Vehicle. This is also taking into consideration that there was no extensive fire damage at the interior of its engine compartment. Refer to photo 8 above.

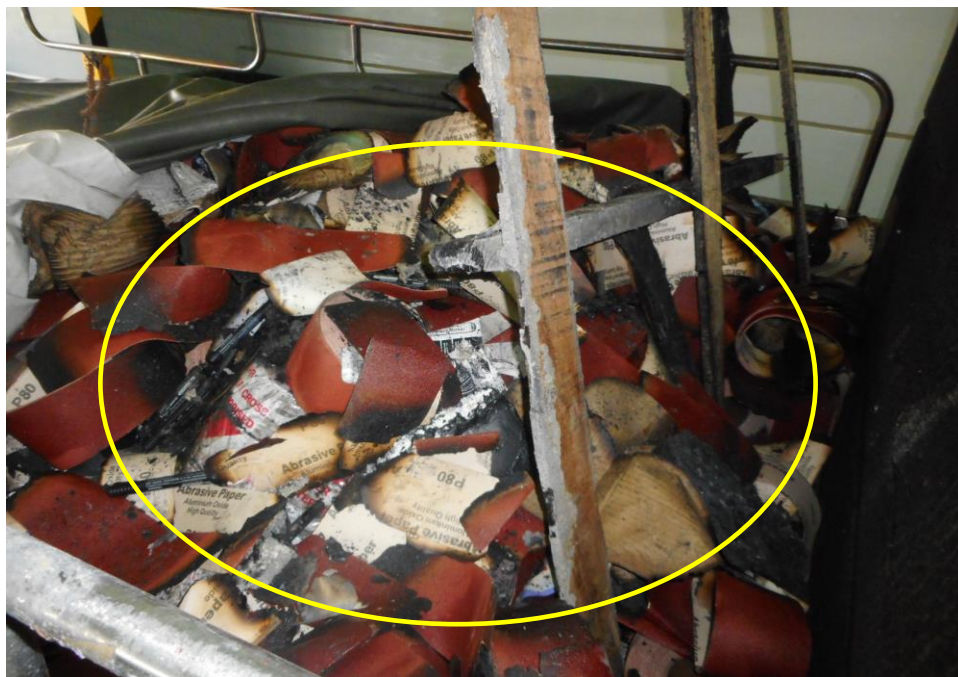
Photo 12 shows the fire damage at the rear portion of the Insured Vehicle. We observed burned and damaged goods at the rear goods compartment of the Insured Vehicle which was (circled).

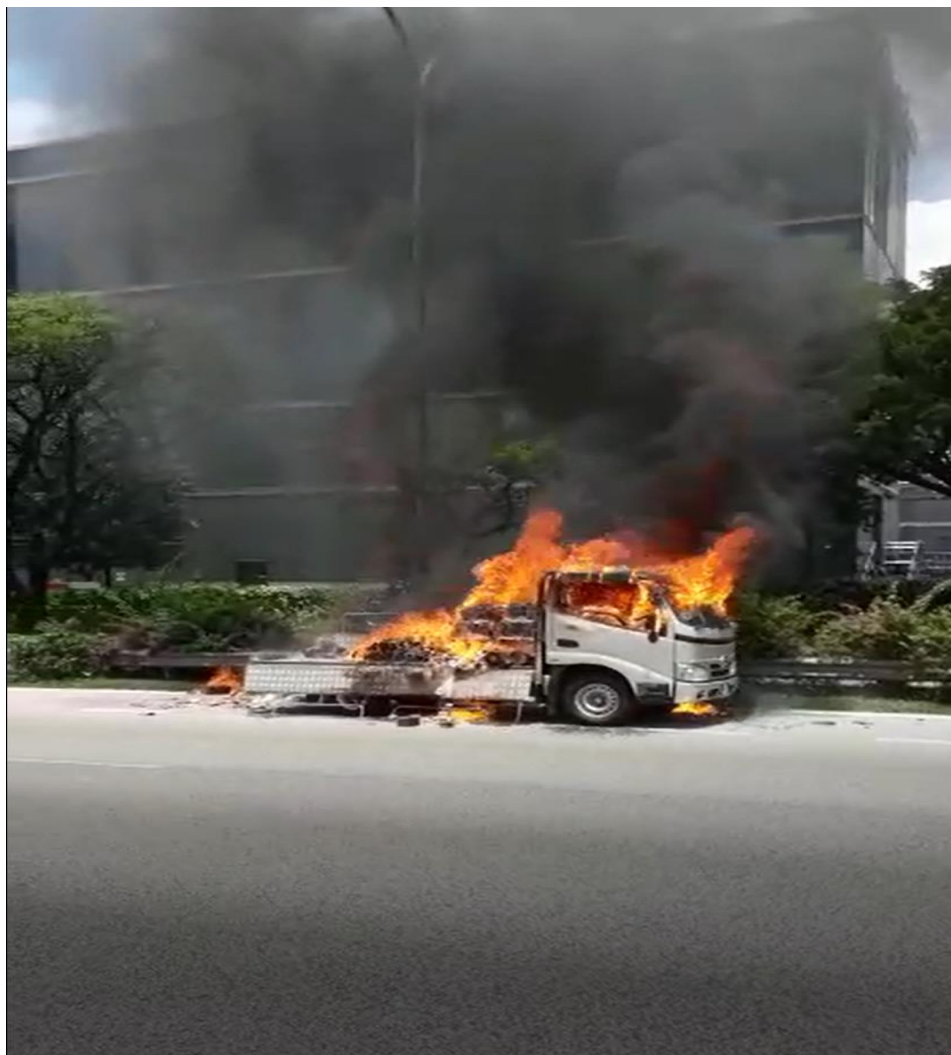
23. In general, the information that could be gathered from the photograph had corresponded to the events that were related to us by Mr Chua. Our close examination of these photograph also showed no unusual foreign material(s) and/or object(s) found on the ground in the immediate area of the road where the Insured Vehicle was positioned. See photo 13 below.

Photo 13 shows general view of the Insured Vehicle on fire. In general, the information that could be gathered from this photograph had corresponded to the events that were related to us by Mr Chua, where the fire had started on the Insured Vehicle.
