Our Reference : KAAS/TA/5924/0709/TP/11.19
Date : 20 March 2020

VEHICLE APPRAISAL REPORT

Registration No.	: GBG 709D	Chassis Frame No.	: JN1SC2F24Z0859677
Make / Model	: Nissan Cabstar 3.0 5MT 2Dr 2WD Euro5	Engine No. (Logcard)	: ZD30022549N
Year of Manufacture/Reg	: 2017	Odometer Reading	: 69,952 KM
Colour	: Blue		
Class / Type	: Truck

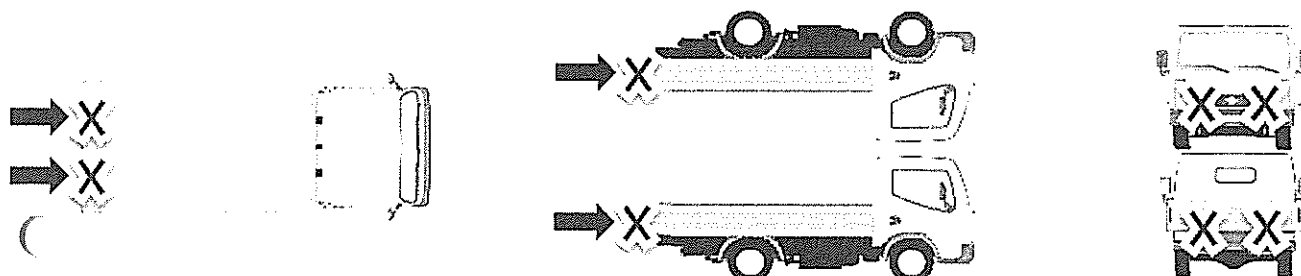
Damages sustained were consistent with the subject vehicle being involved in a collision with another vehicle and the impact was delivered

Squarely to the Rear

portion of the vehicle.

The general area of damages is at the

Front and Rear portion
