FINAL REPAIRS BILL TO NISSAN WITH VEHICLE NOS: GBG 709D  
CABSTAR

Our Reference : KAAS/TA/5924/0709/TP/11.19  
Date : 20 March 2020

## VEHICLE APPRAISAL REPORT

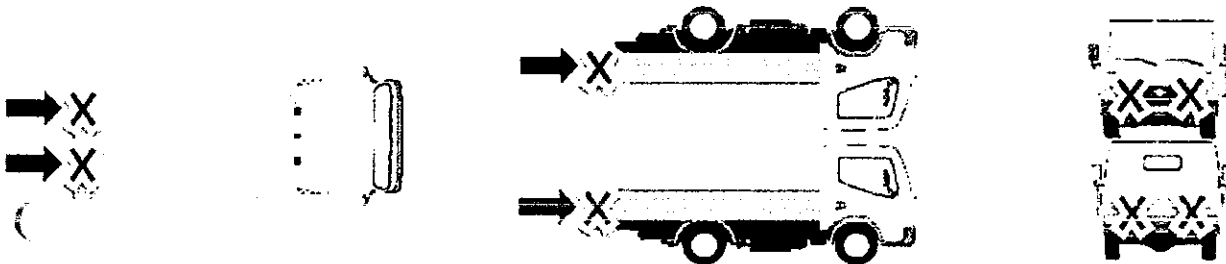
Damages sustained were consistent with the subject vehicle being involved in a collision with another vehicle and the impact was delivered **Squarely to the Rear** portion of the vehicle.

The general area of damages is at the **Front and Rear portion**  
( Please refer to the parts list and photographs as attached for more information )

The estimated repair costs submitted by Messrs **Auto Best Motor Services** is \$ 11,373.70 .  
We have adjusted the cost to \$ 9,200.21 and the repairer has agreed to undertake the repairs at a  
Contract Lump Sum of \$ 7,350.00 to a acceptable quality and standards.  
However, we have not given authorization and instruction to the repairer to proceed with the repairs.
