# PRECISION APPRAISAL SERVICES

## AUTOMOBILE INSPECTION REPORT

Assigned By : As above  
Accident Date : 25 FEBRUARY 2020  
Assignment Date : 25 FEBRUARY 2020  
Inspection Date : 25 FEBRUARY 2020  
Our Reference No. : PAS/PF/200309/TP

Registration No.	: SBY 885 H	Mileage	: 59122	Km/h
Make/Model	: TOYOTA COROLLA ALTIS 1.6 CVT	Radio/Cassette	: Fitted	
Yr of Manuf/Regn	: 2016 / 2017	CD Disc Player	: Fitted	
Carrying Capacity	: 4 Seater	Air Conditioner	: Fitted	
Chassis No.	: MR053REH104560328	Clock	: Fitted	
Engine No.	: 1ZRY339916	Seat Belt	: Fitted	
Colour	: Metallic White	Wing Mirror Other	: Fitted	
Class	: Passenger ( Private )	Accessories	: Fitted

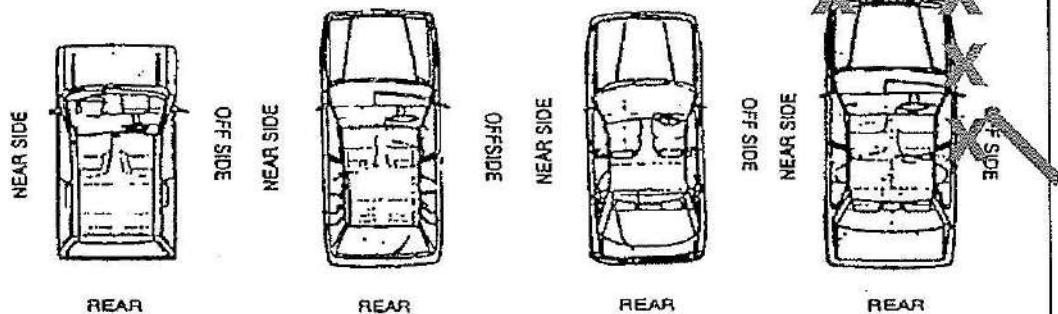
## POINT OF IMPACT

(Diagram A) (Diagram B) (Diagram C) (Diagram D)  
Direction of impact/damage marked (→) (X) FRONT FRONT FRONT FRONT

**The vehicle sustained impact on its O/s Front Portion. It was also affected on its Front Portion (see Diagram D)**
