## LKK Auto Consultants Pte Ltd

### 1. Policy Particulars :- THIRD PARTY CLAIM

### ADJUSTMENT ON REPAIR COST FOR VEHICLE NO. SHD 5158E

PHOTOGRAPHS FOR VEHICLE NO. SHD 5158E

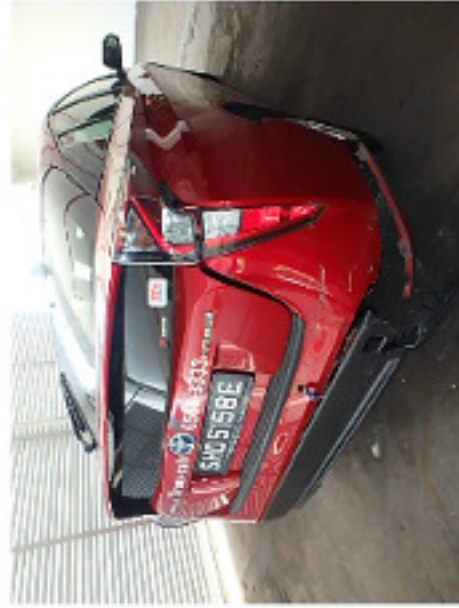
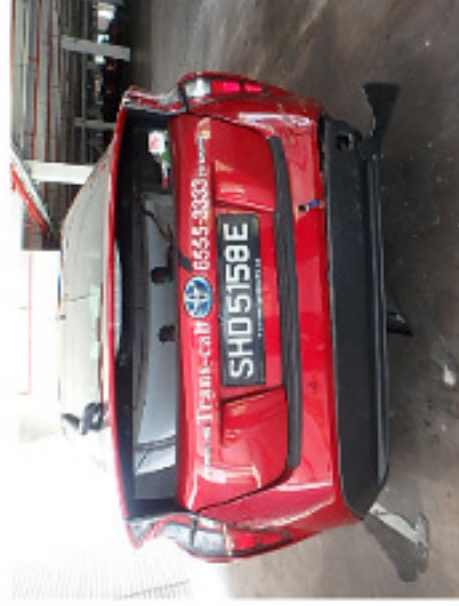
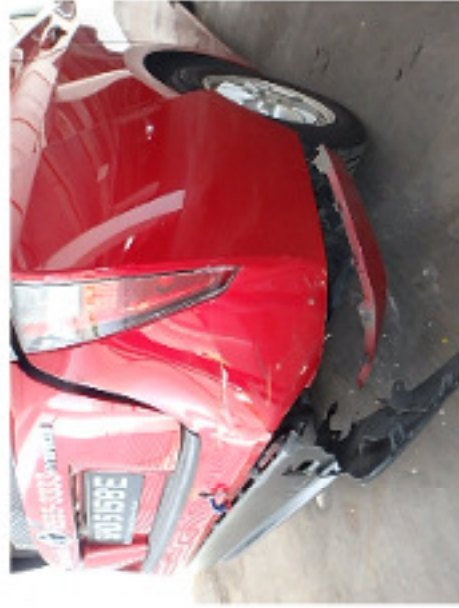
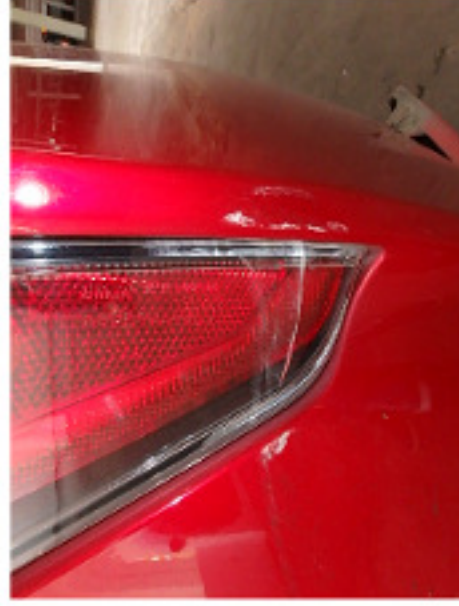
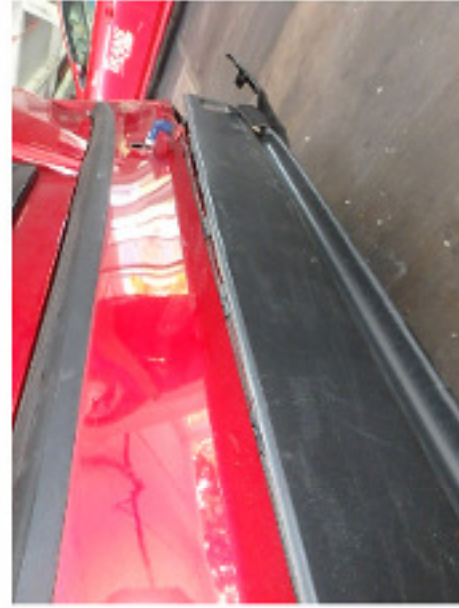
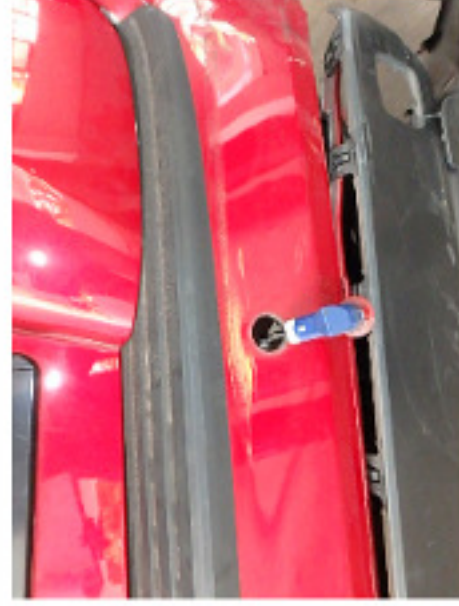
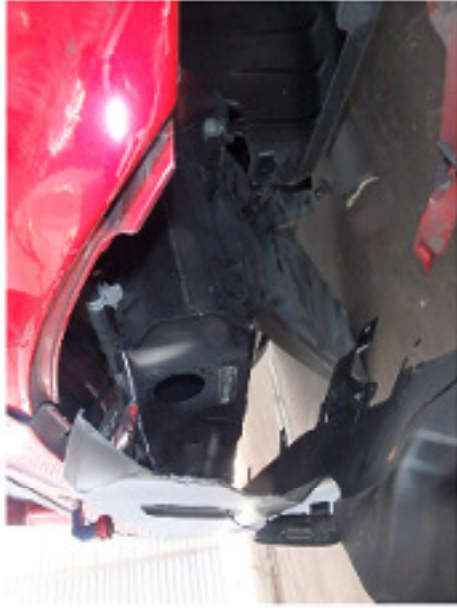
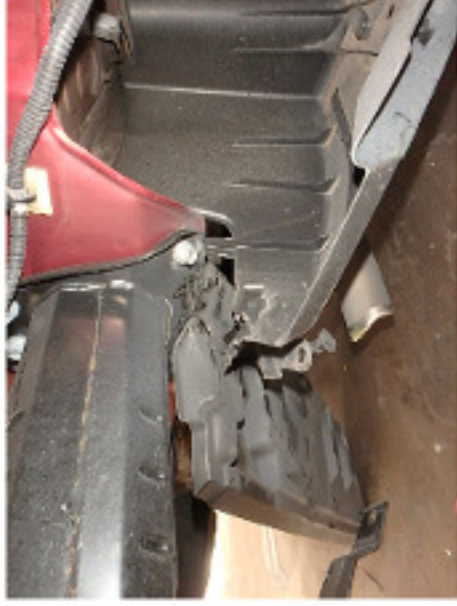
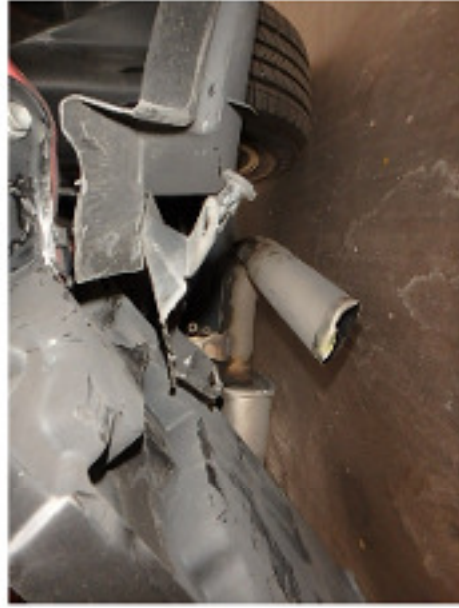
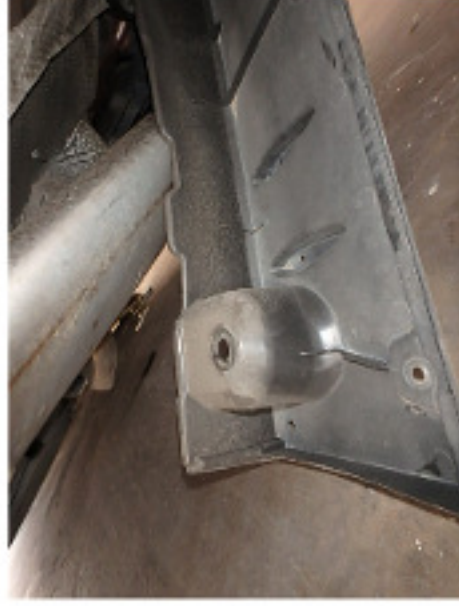
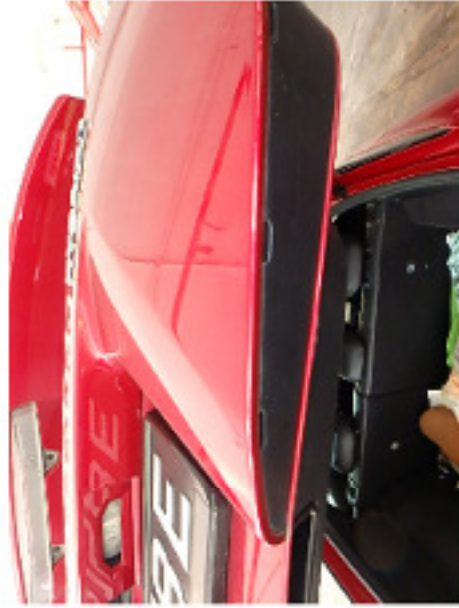
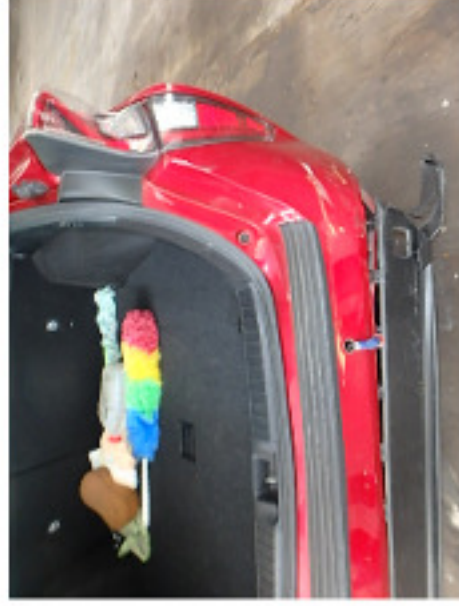
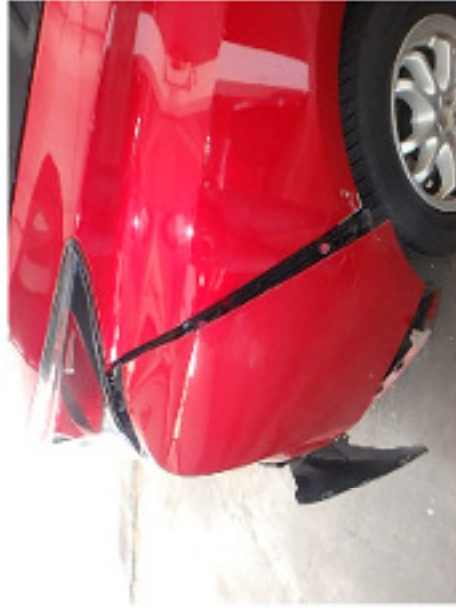
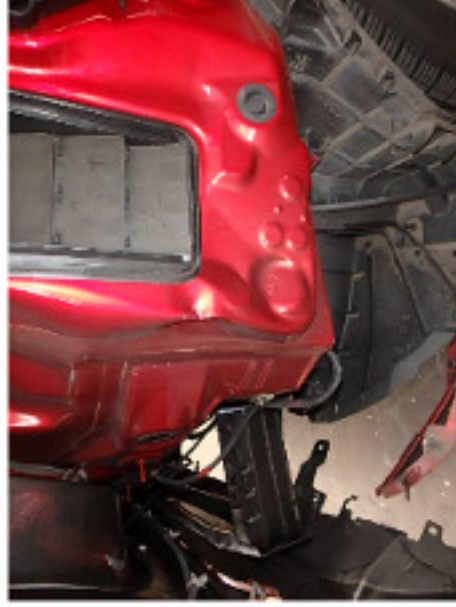
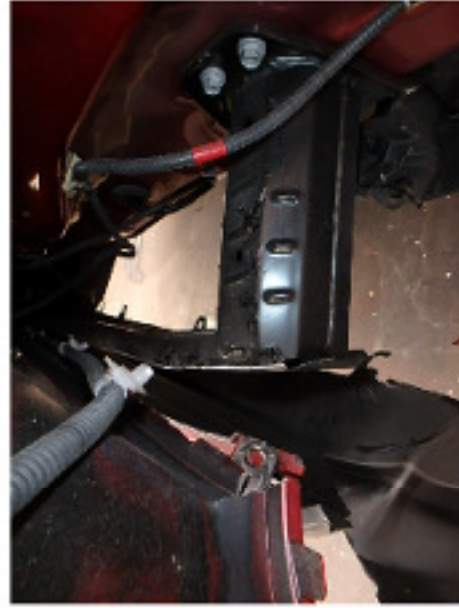
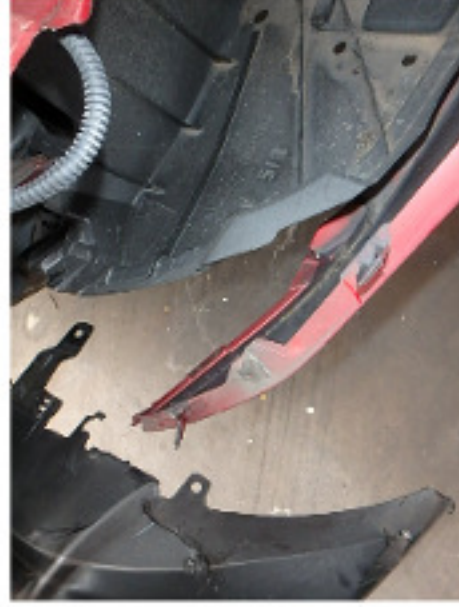
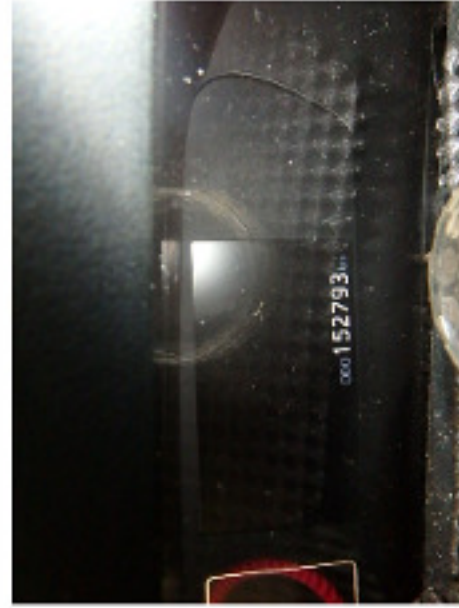
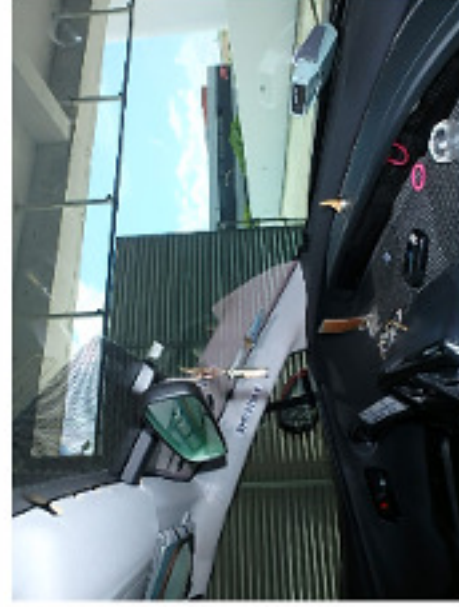
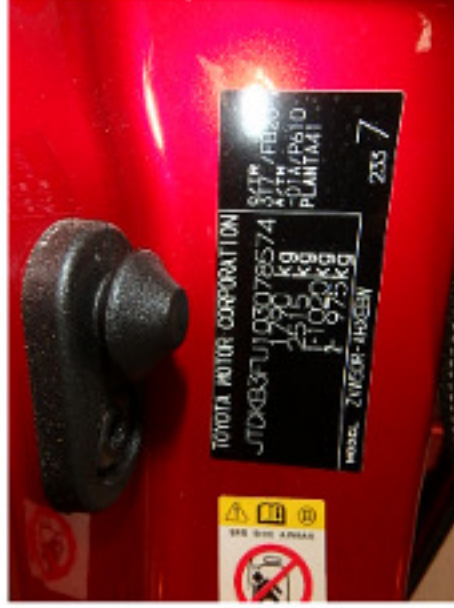
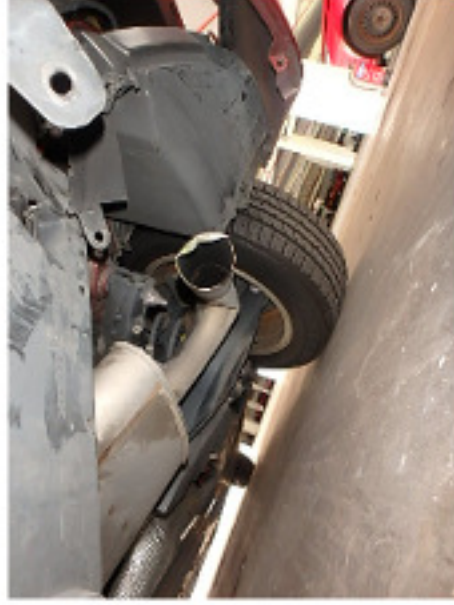
INSPECTION

THE VEHICLE SUSTAINED DAMAGES AT THE REAR O/S PORTION. DAMAGES SEE DETAILS.
--
