LKK Auto Consultants Pte Ltd

Ref : CS/SCD20005264/Qsf3e2

1. Policy Particulars :- OWN DAMAGE

PHOTOGRAPHS FOR VEHICLE NO. YN 3693K

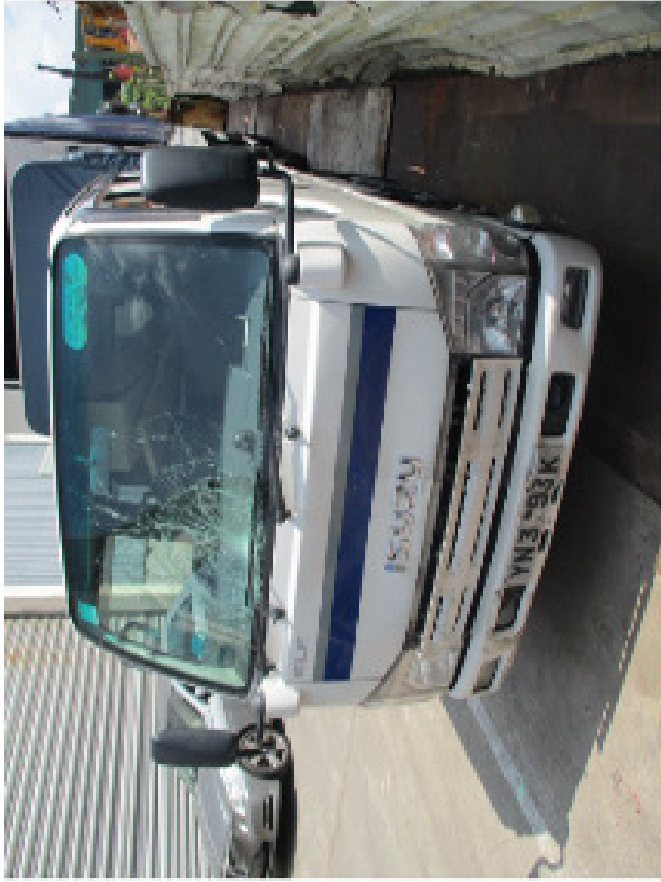
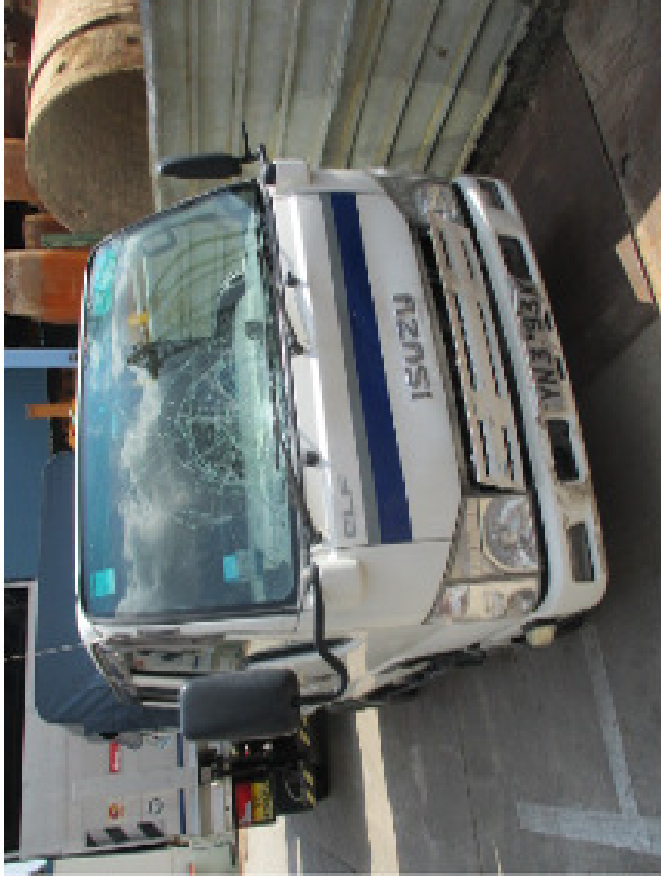
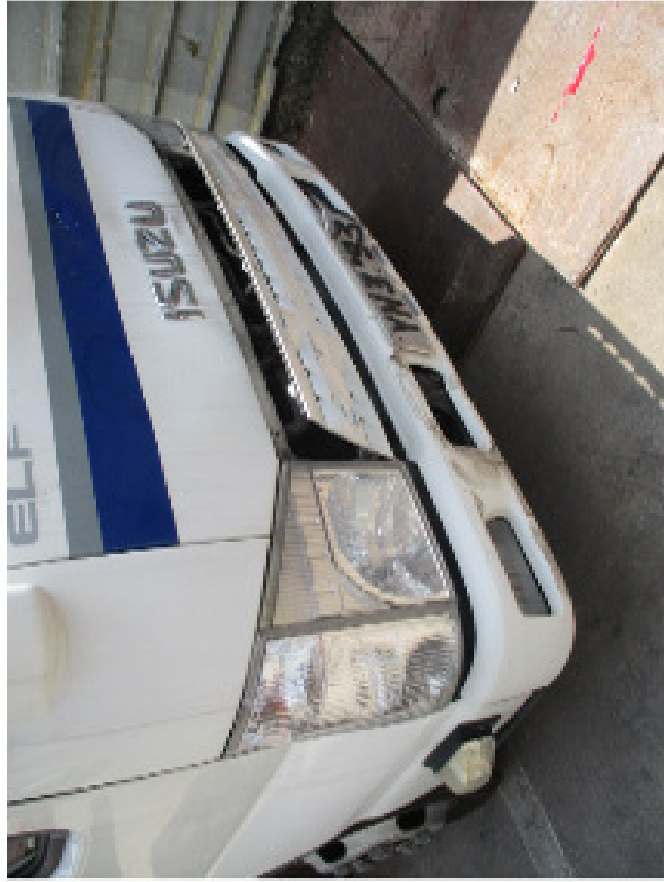
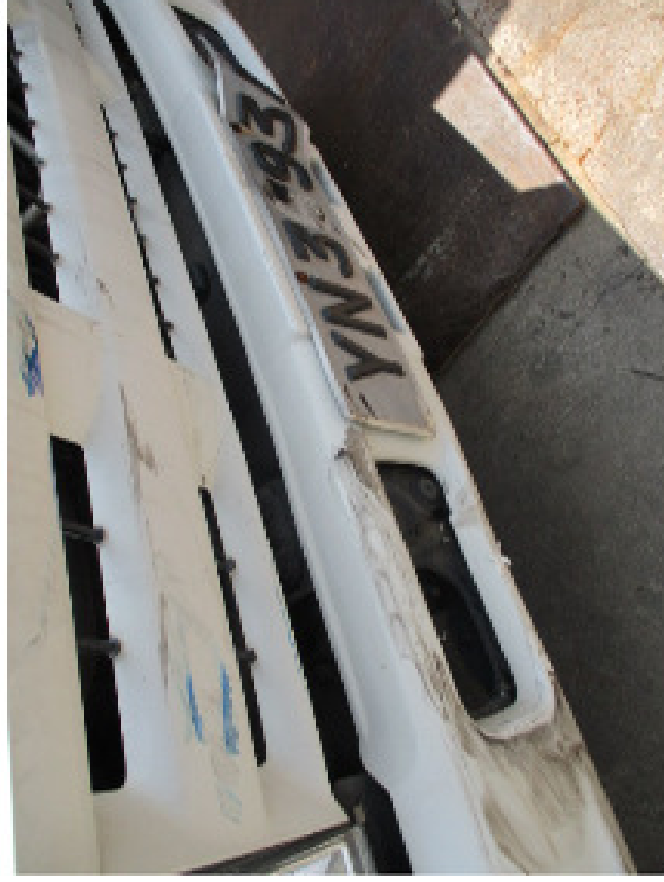
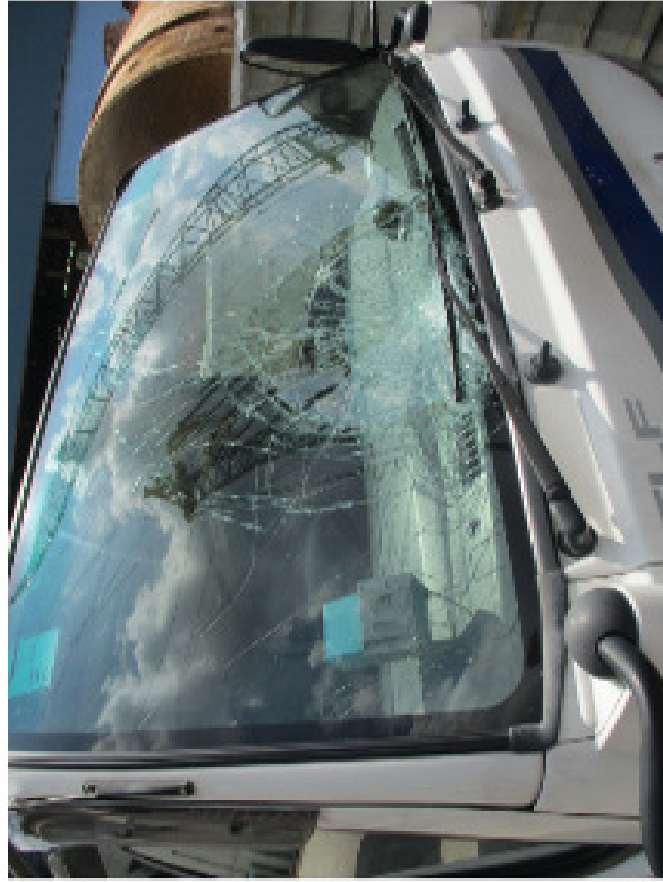
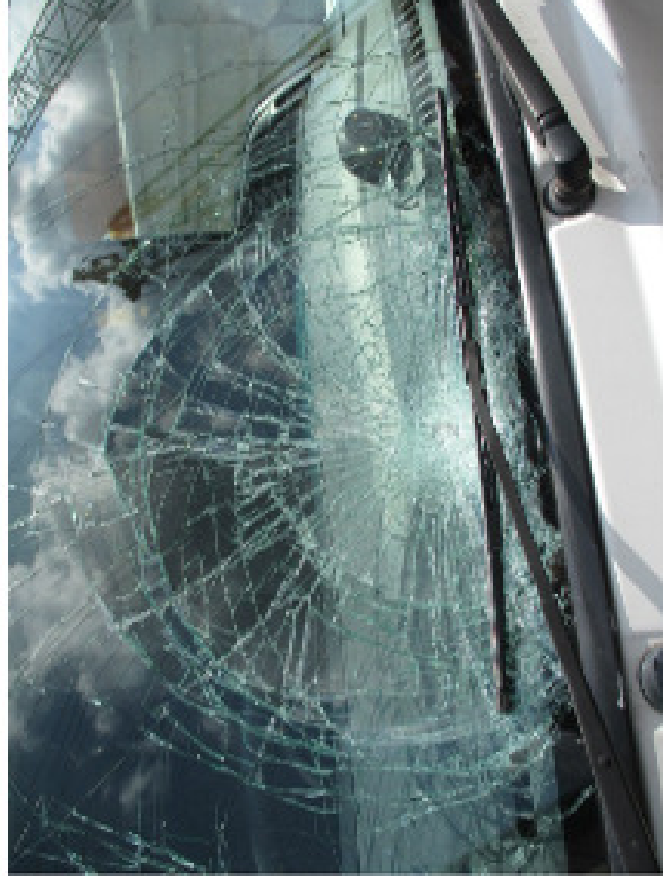
INSPECTION

THE VEHICLE SUSTAINED DAMAGES AT THE FRONT PORTION. DAMAGES SEE DETAILS.
