## LKK Auto Consultants Pte Ltd

Ref : CS/SCD20005265/Qsf3e2

| Insured Veh. | | Veh. Inspected | YN 3945J |

PHOTOGRAPHS FOR VEHICLE NO. YN 3945J

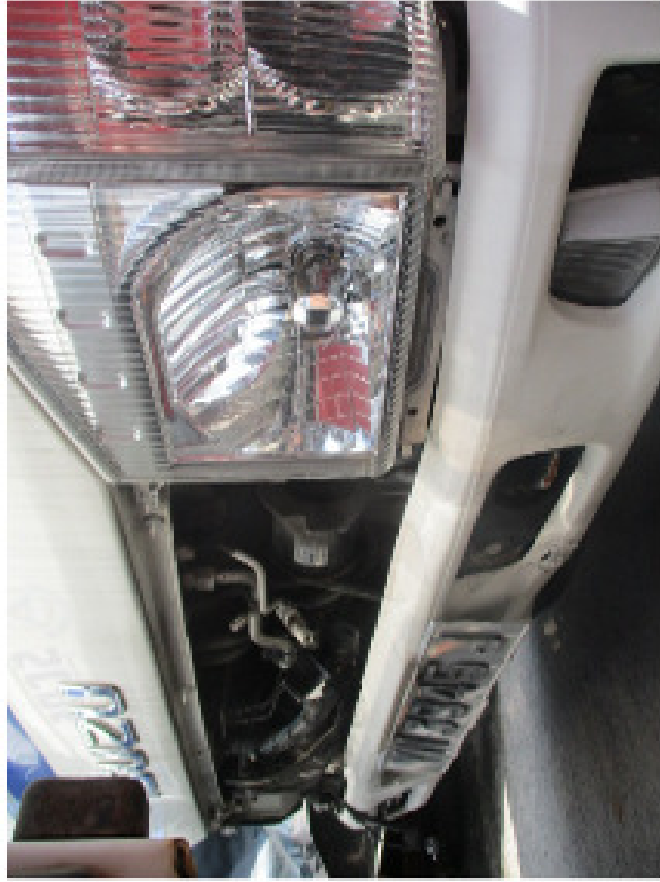
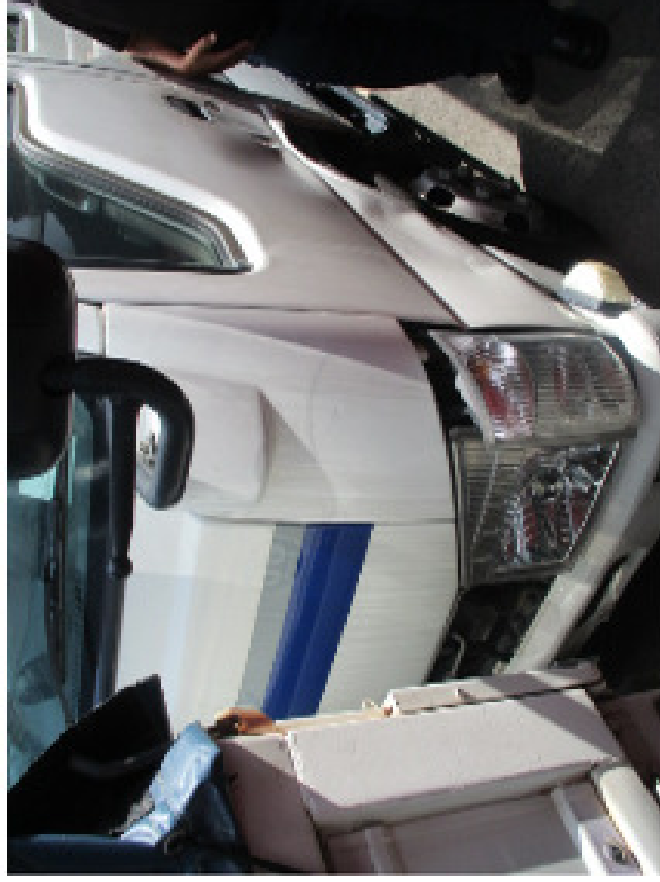
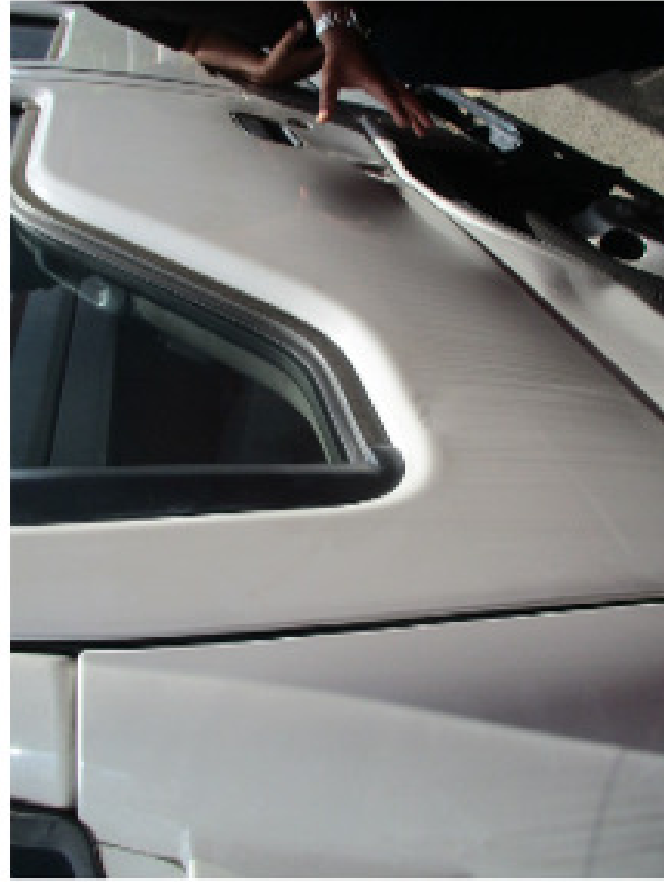
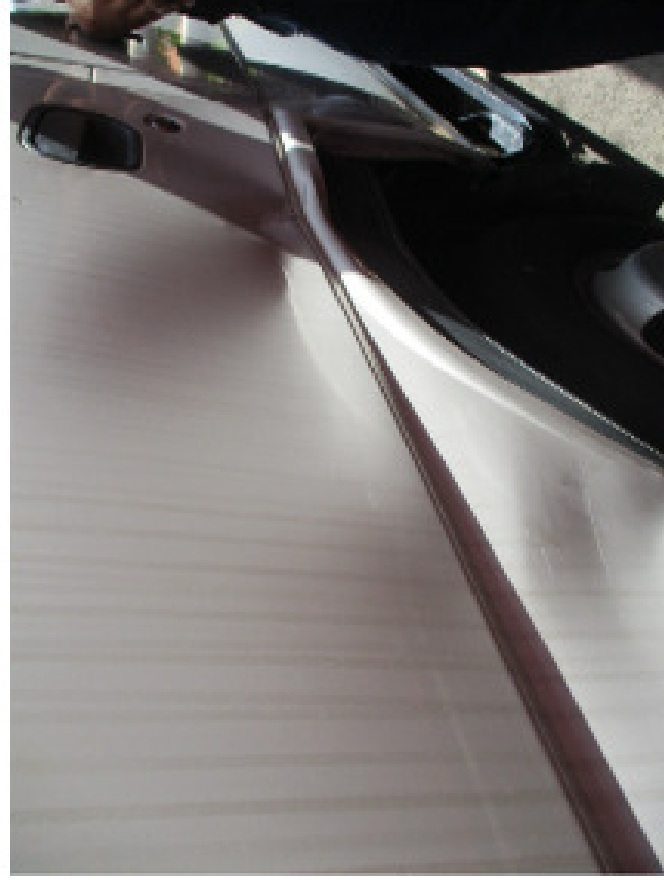
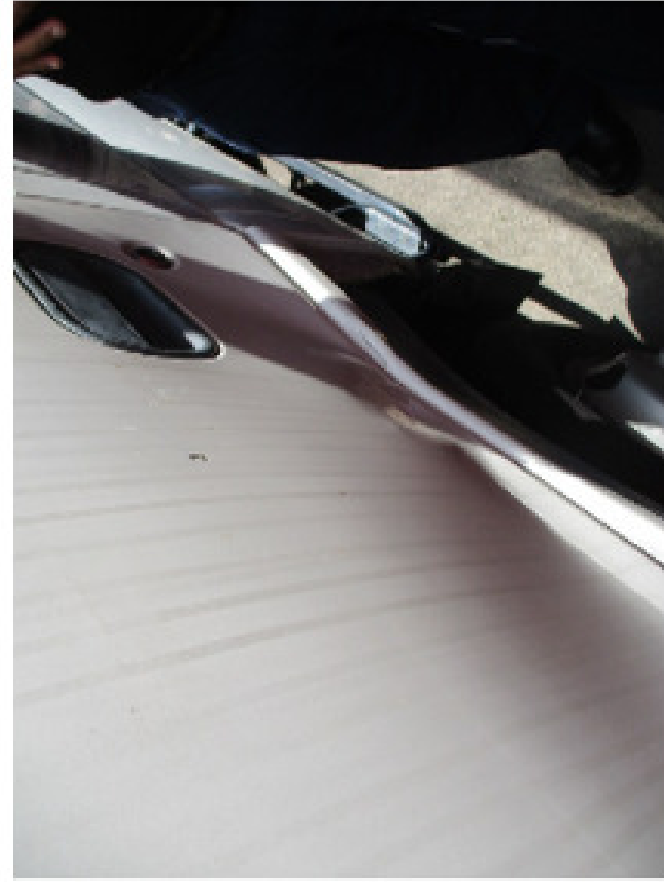
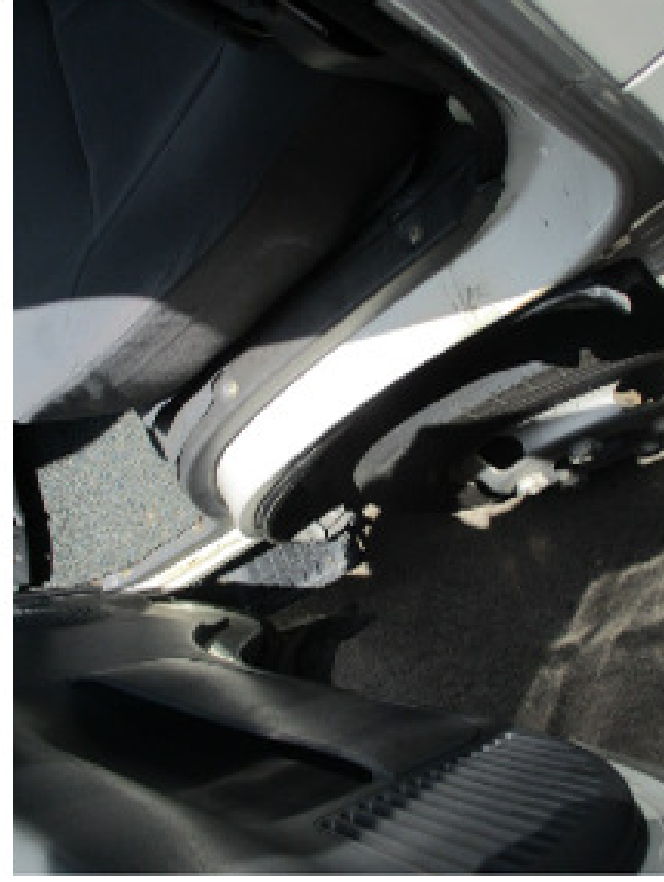
| THE VEHICLE SUSTAINED DAMAGES AT THE FRONT PORTION.<br>DAMAGES SEE DETAILS. |
