Your Ref: Honda Odyssey
(chassis number RC1-1207652)
Our Ref : CI/TP20005341/D

23 April 2020

INSPECTION REPORT OF AN UNREGISTERD HONDA ODYSSEY MOTOR CAR WITH CHASSIS NUMBER RC1-1207652

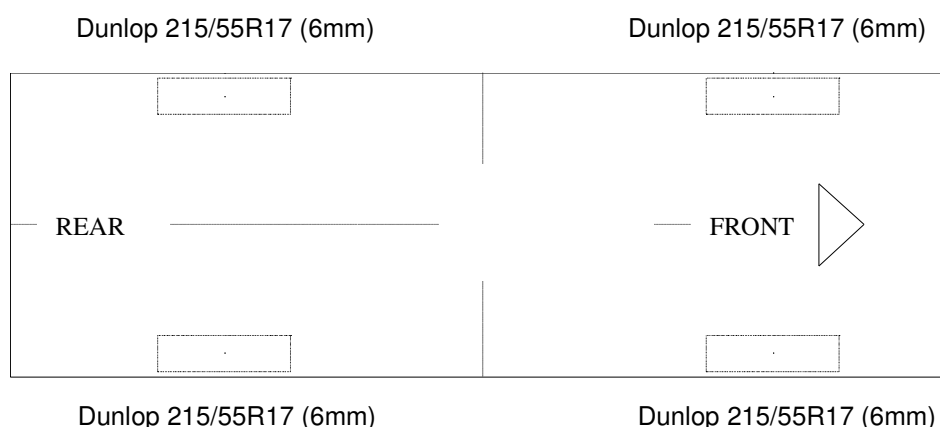
6. It was fitted with 17inch sport wheel rims that were wrapped with tyres that were observed to be of serviceable condition. The tyres were also sufficiently inflated for vehicular operation. The tyre brand, tyre size and approximate remaining tread depth of the 4 tyres of the Motor Car were recorded as follows: -

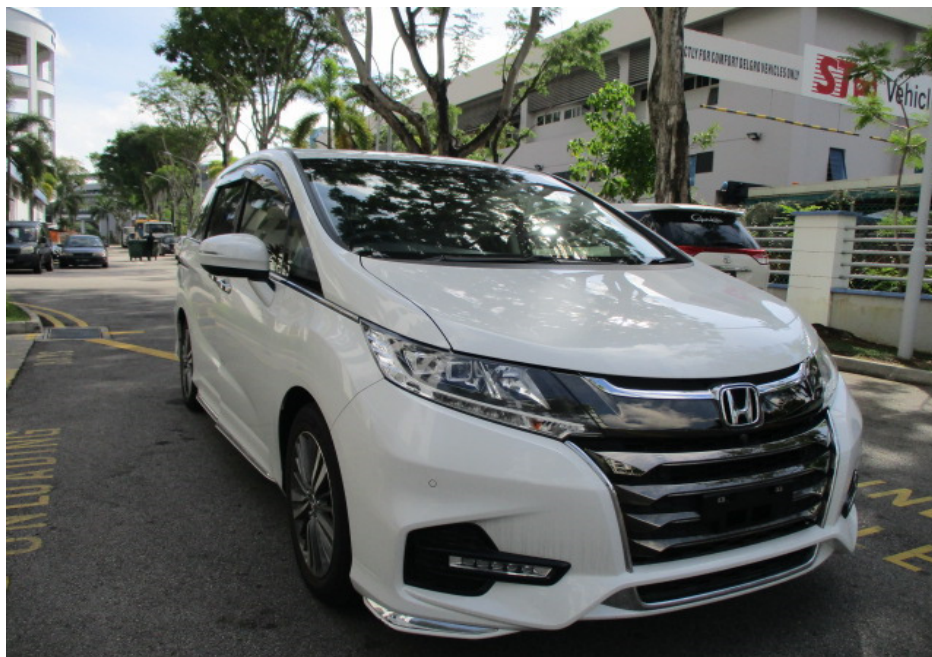
5. The Motor Car was observed to be in a relatively good general condition with no loose exterior fittings observed.

Photo 1 shows a general view of the front right body of the Motor Car at the time of my inspection. The Motor Car was observed to be in relatively good general condition with no loose exterior fittings observed.

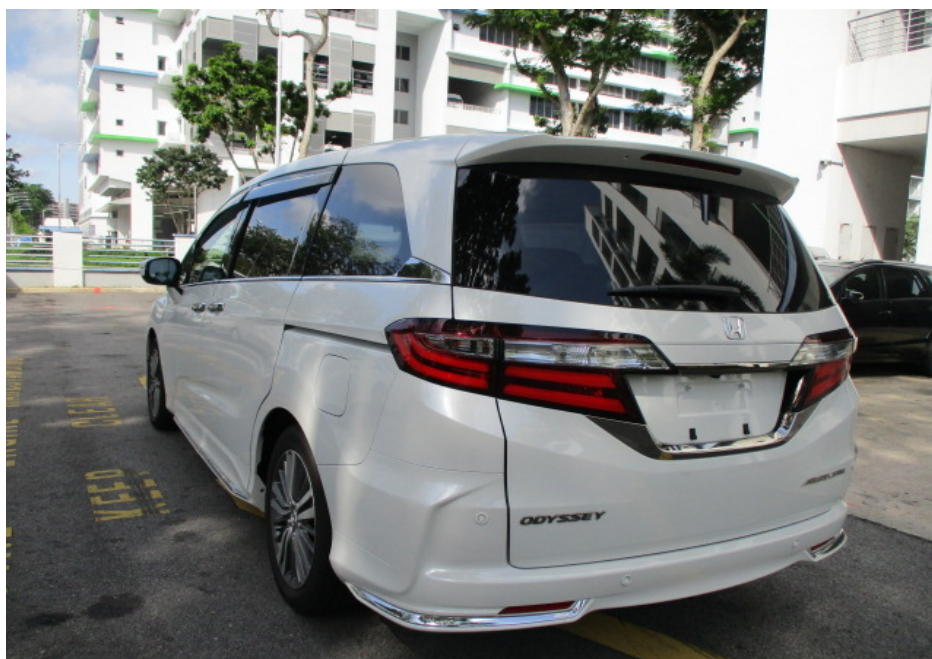
Photo 2 shows a general view of the rear left body of the Motor Car at the time of my inspection. The Motor Car was observed to be in relatively good general condition with no loose exterior fittings observed.

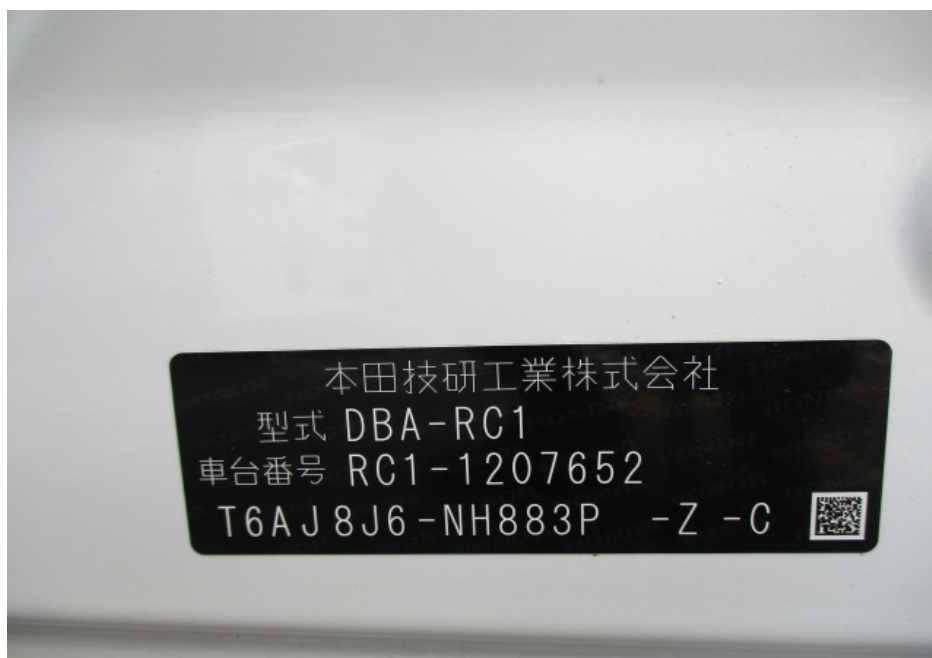
Photo 3 shows the chassis number of the Motor Car. The chassis number recorded was RC1-1207652.

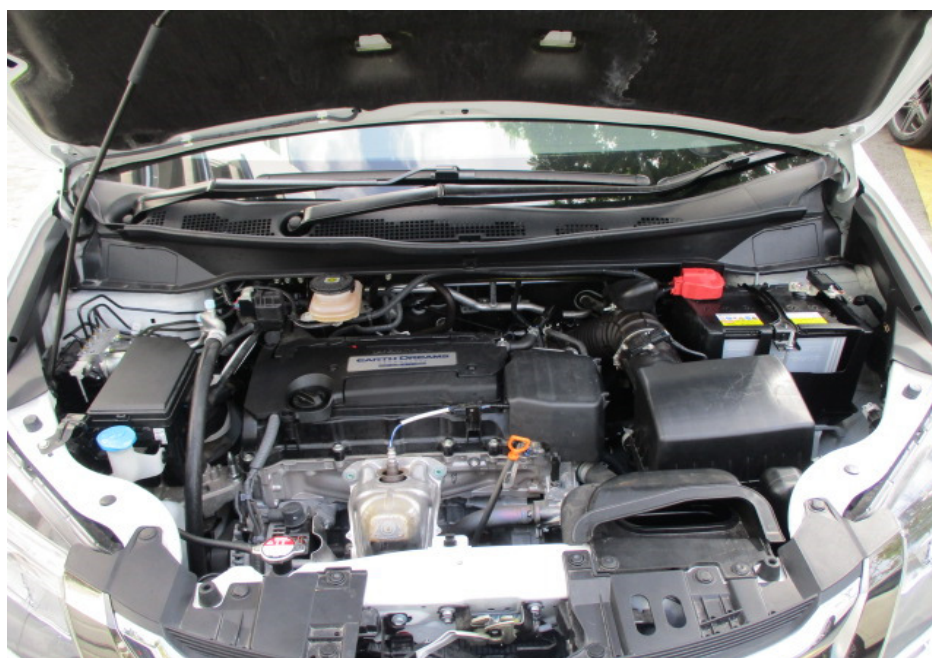
12. My examination of the engine compartment of the Motor Car revealed that the various parts and components inside the engine compartment were all intact and properly fitted. The various operating fluids like the engine oil, brake fluid and engine coolant were all found to be of sufficient level for operating purposes. Visually, there was also no contamination found to these fluids.
13. My checks on the underside of the Motor Car revealed no sign(s) or indication(s) of fluid leakage and/or fluid stain(s). The engine block and automatic transmission assembly were both secured properly. They were not mounted onto the chassis/structural body or any integral body part of the Motor Car. All undercarriage components of the Motor Car were also observed to be intact and secured in an appropriate manner.

Photo 4 shows a general view of the engine compartment of the Motor Car at the time of my inspection. The various parts and components inside the engine compartment were all observed to be intact and properly fitted. There was also no sign(s) or indication(s) of fluid leak and/or fluid stain found within the engine compartment.

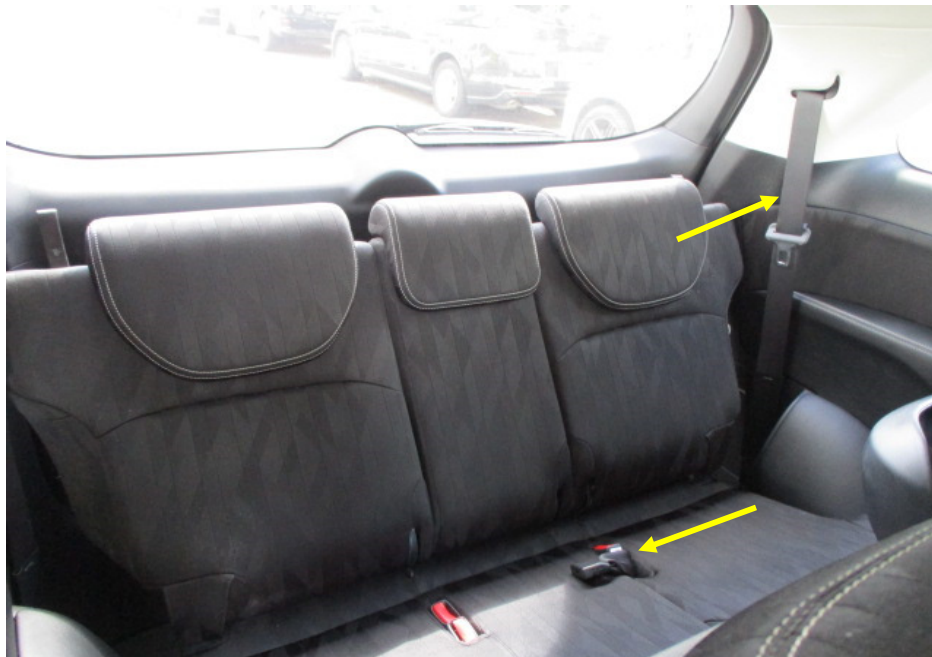
10. The seats of the Motor Car were found to be secured to the floor board of the Motor Car via seat rails bolted onto the floor board. Retractable seat belt reels and pre-tensioners were fitted on all seats of the Motor Car. The seat belt reels were checked and able to be fastened securely to the respective pre-tensioner that was fixed to the side of all the seats.

Photo 5 shows the rear seats (2nd row) of the Motor Car. All the seats of the Motor Car were secured via seat rails to the floor board. They were also fitted with a retractable seat belt reel and a pre-tensioner (arrowed). The seat belts were all checked and able to be fastened securely to the respective pretension that was fitted on the side of each individual seat.

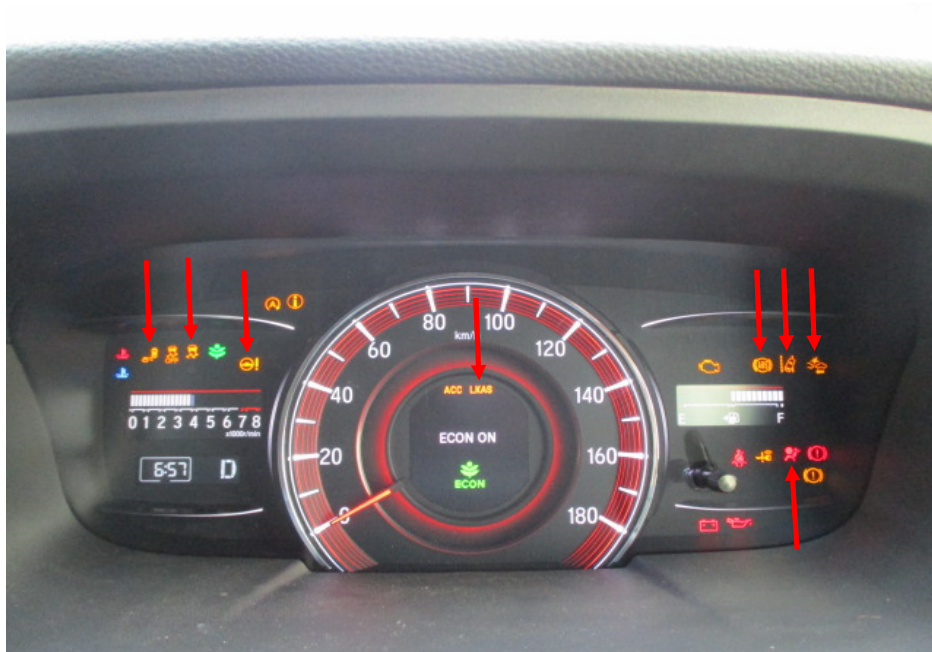
Photo 6 shows the warning lights for the various electronic safety features appearing on the instrument panel of the Motor Car during its self-test when the engine is cranked, in particular the ABS, SRS, EPS, VSA, BSI, LKAS, RDM, CMBS lights (arrowed).

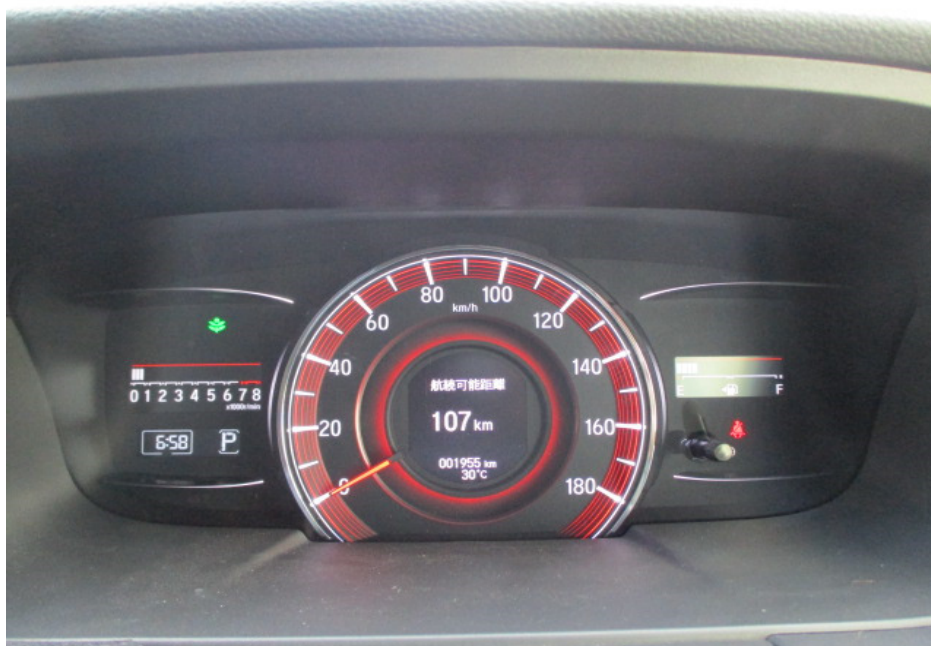
11. The Motor Car's automatic self-test of the functionality of its electronic safety features like the Anti-Lock Brake System (ABS), Supplemental Restraint System (SRS), Electric Power Steering (EPS), Vehicle Stability Assist (VSA), Blind Spot Information (BSI), Lane Keeping Assist System (LKAS), Road Departure Mitigation (RDM) and Collision Mitigation Braking System (CMBS), during cranking of the engine had indicated that these electronic systems were in working condition. This was determined from the respective warning lights disappearing from the instrument panel after the self-test.

Photo 7 shows the respective warning lights no longer illuminated, indicating that there is no fault detected to the ABS, SRS, IAS, TPM and DSC systems of the Motor Car during the self-test. These electronic systems were hence in working condition at the time of my inspection.

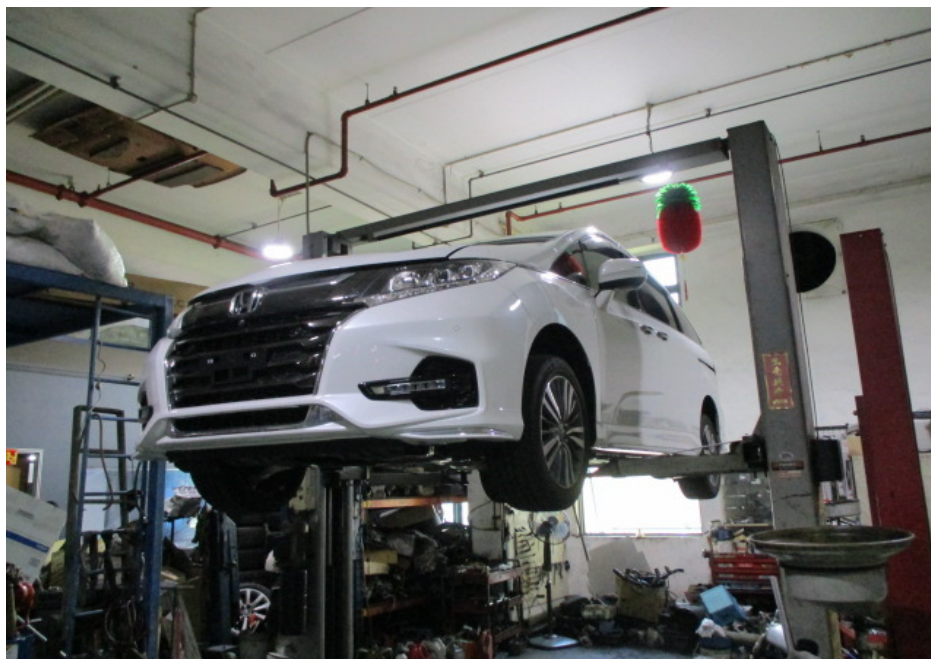
Photo 8 shows the Motor Car hoisted up for checks on its undercarriage. There was no sign(s) or indication(s) of fluid leakage and/or fluid stain(s). The undercarriage components of the Motor Car were also all observed to be intact and secured in an appropriate manner.

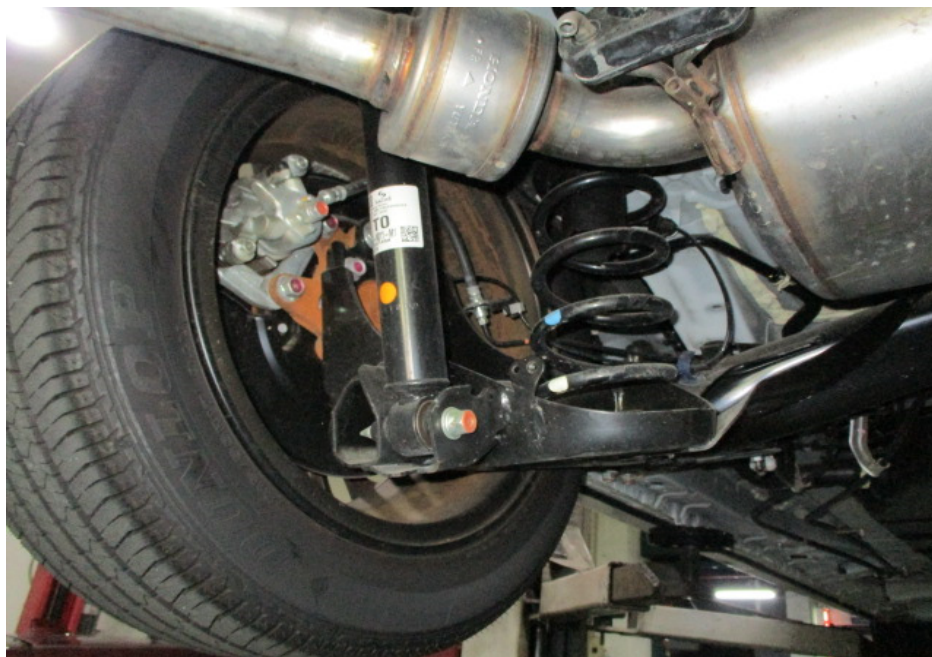
Photo 9 shows a general view of the control arms and linkages at the rear left wheel of the Motor Car. I did not observe any fluid leak and/or fluid stain on the underside of the Motor Car. All of the Motor Car's undercarriage components were observed to be intact and secured in an appropriate manner.

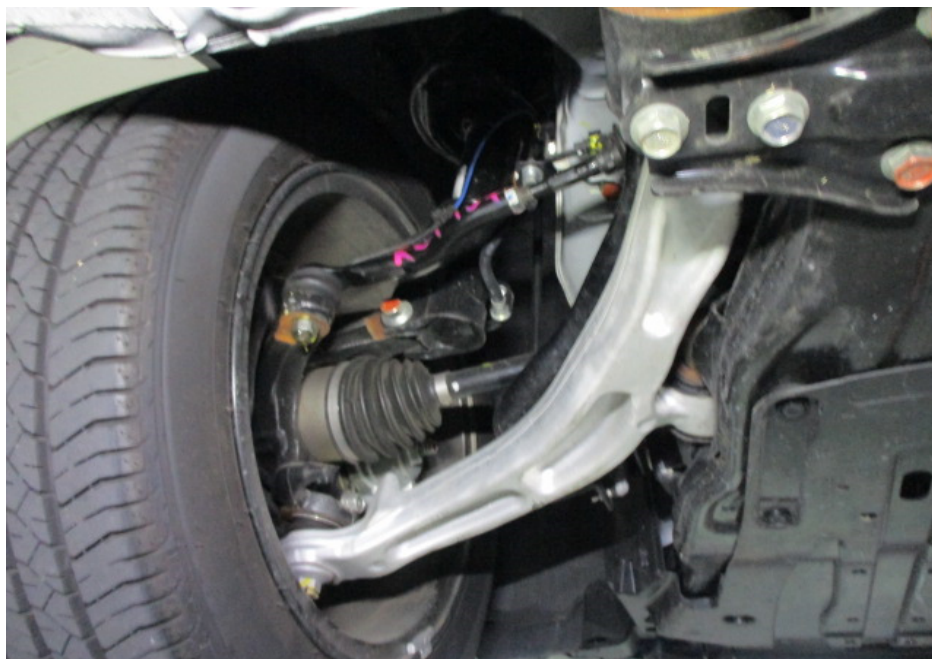
Photo 10 shows the various undercarriage components at the front left wheel of the Motor Car. The mechanical components, control arms and linkages were all found to be intact and secured in an appropriate manner.

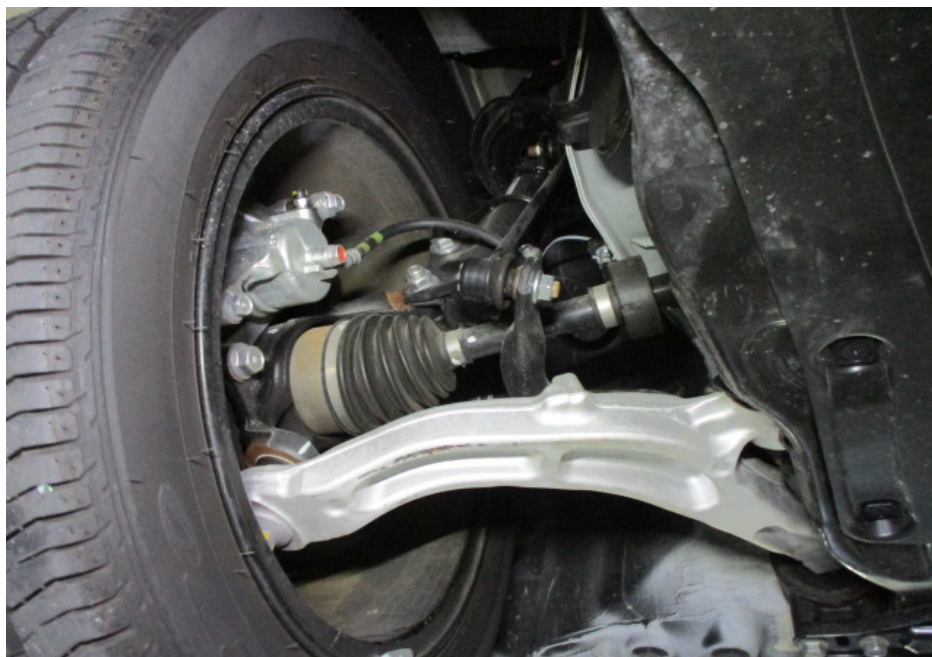
Photo 11 shows the various undercarriage components at the front right wheel of the Motor Car. The mechanical components, control arms and linkages were all found to be intact and secured in an appropriate manner. All of the Motor Car's undercarriage components were observed to be intact and secured in an appropriate manner.

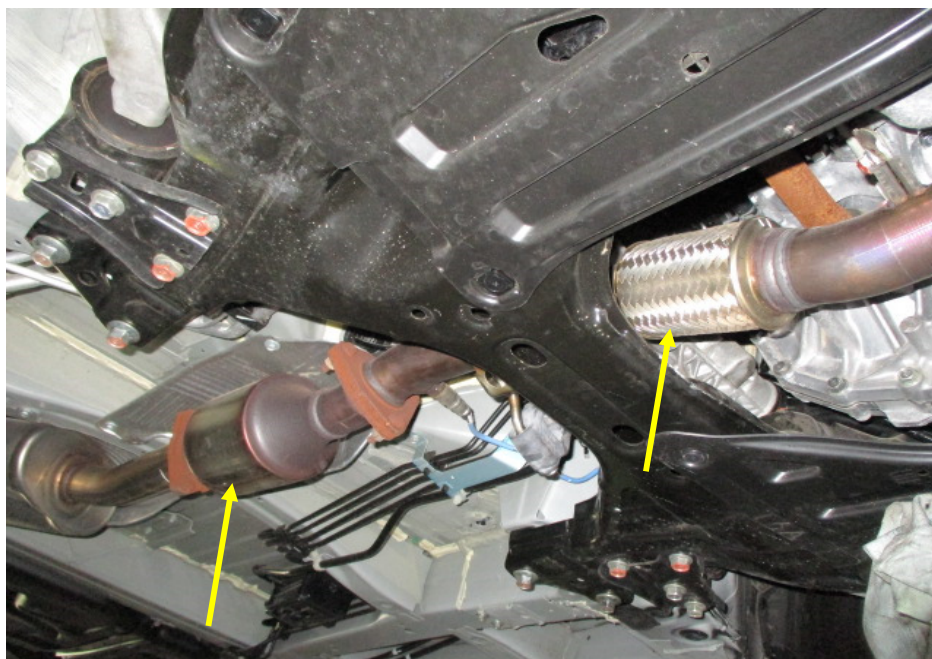
Photo 12 shows the Motor Car's catalytic converters (arrowed). My examination of the Motor Car's exhaust system revealed no sign(s) or indication(s) of any cut or weld marks along its exhaust pipes and on its rear muffler.

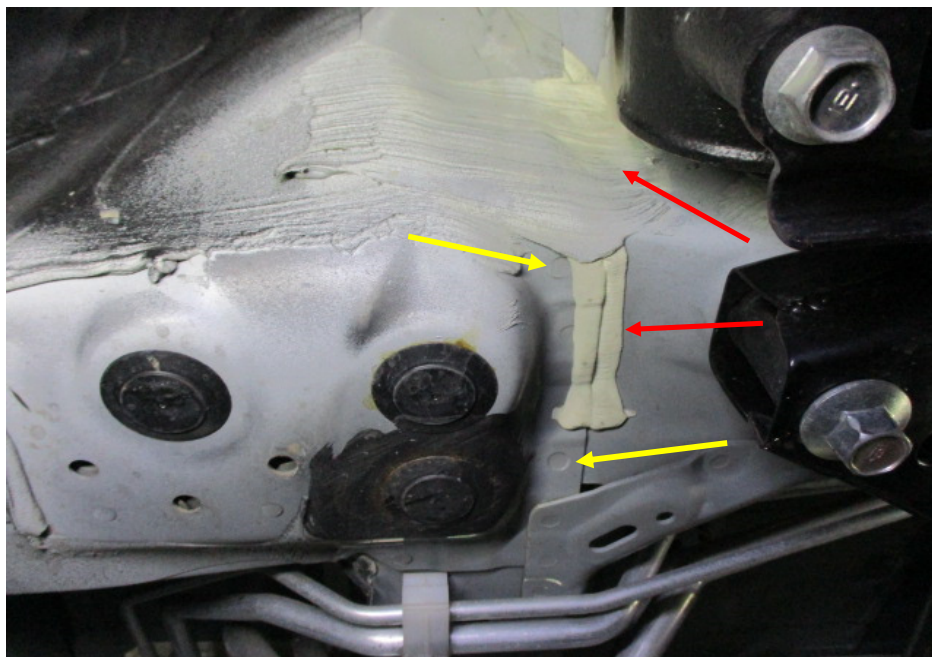
9. Visually, I did not find any weld marks, other than the original spot weld marks, on the chassis/structural body of the Motor Car. The original factory sealant at the joints along the chassis/structural body was also untouched, again indicating that no replacement of the chassis/structural body was carried out; and that the chassis/structural body was originally fitted.

Photo 13 shows the chassis/structural body at the underside front right of the Motor Car. Visually, I did not find any weld marks other than original spot weld marks (yellow arrow) on the chassis/structural body of the Motor Car. The original factory sealant (red arrow) at the joints along the chassis/structural body was also untouched, indicating no work was done on the chassis/structural body of the Motor Car and that the chassis/structural body was originally fitted.

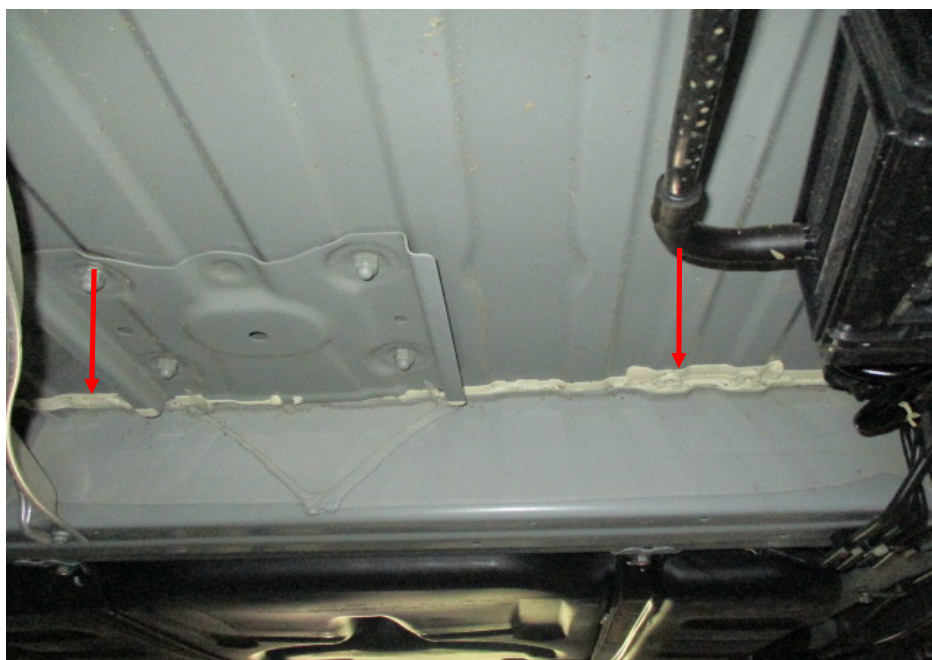
Photo 14 shows the floor board at the underside centre of the Motor Car. The original factory sealant (arrowed) at the joints of the non-detachable body panels was all untouched indicating no replacement of the non-detachable body panels was carried out.

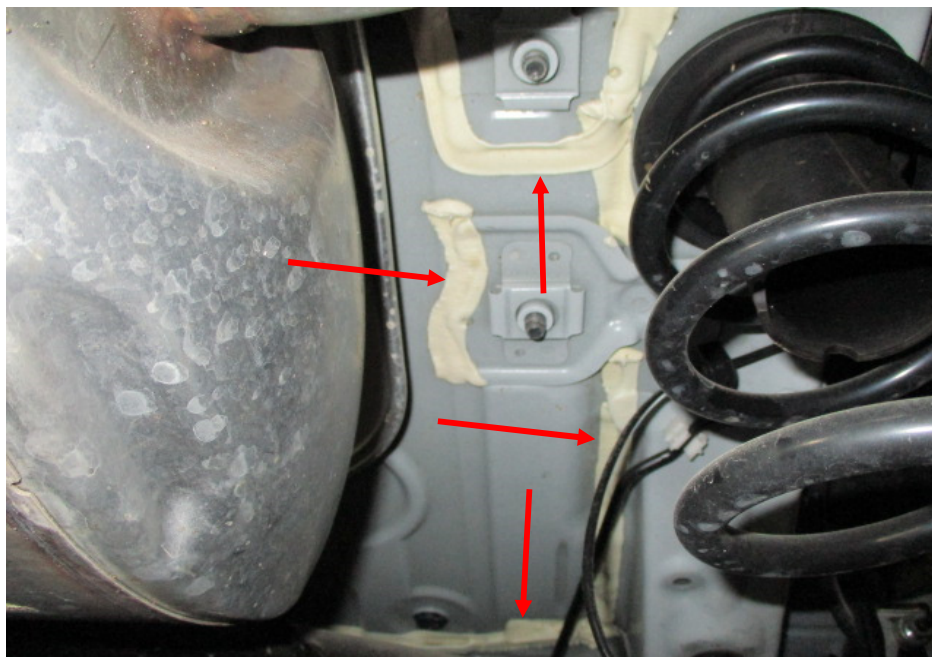
Photo 15 shows the floor board at the underside rear right of the Motor Car. The original factory sealant (arrowed) at the joints of the non-detachable body panels was all untouched indicating no replacement of the non-detachable body panels was carried out.

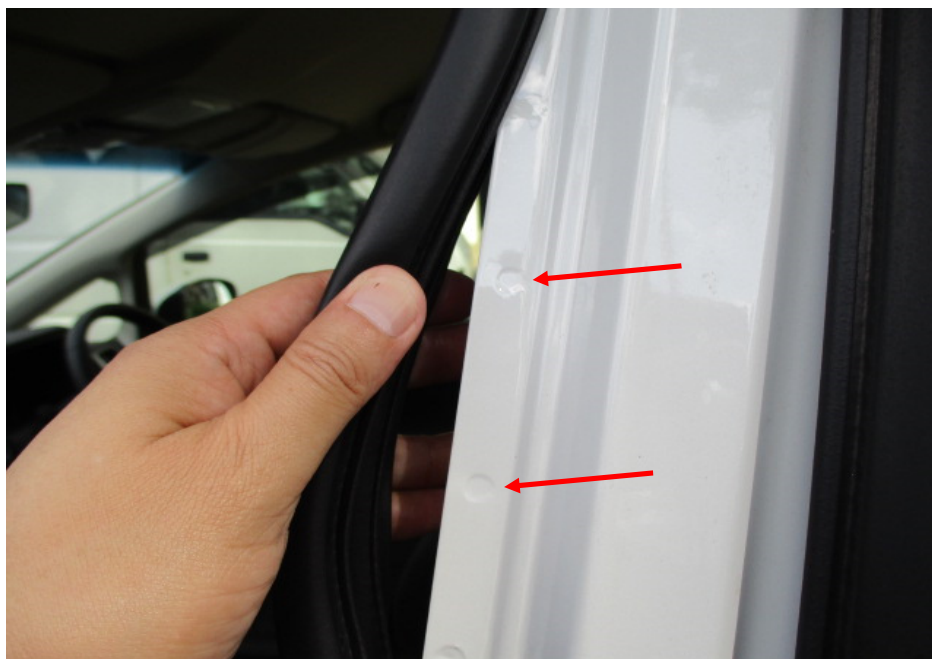
Photo 16 shows the left "B" Pillar of the Motor Car. I did not find any weld marks other than original spot weld marks (arrowed) on the non-detachable body panels of the Motor Car, indicating that there was no re-welding works carried out; and that the non-detachable body panels of the Motor Car were originally fitted.

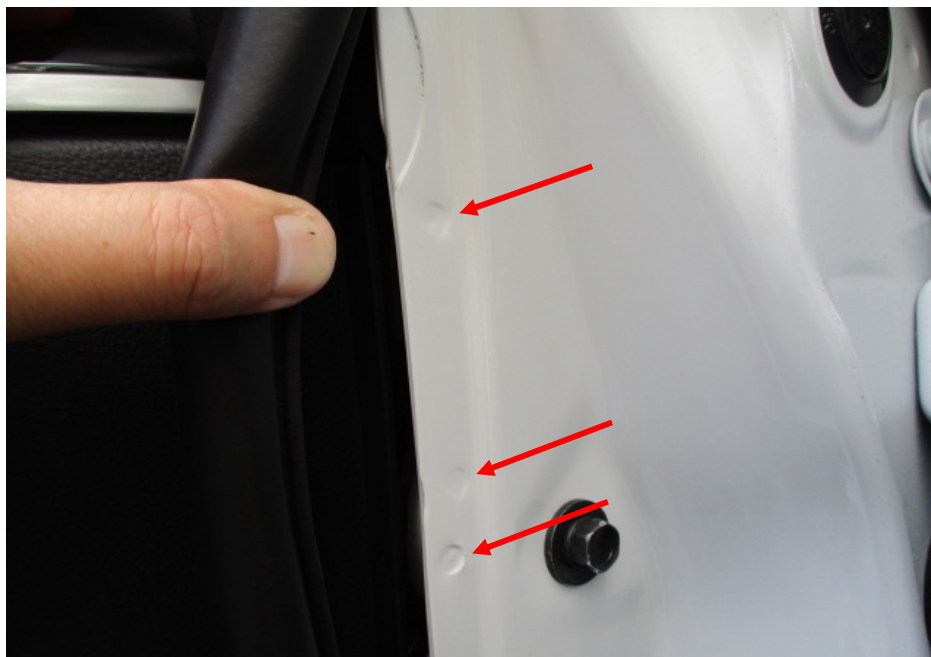
Photo 17 shows the right “A” pillar of the Motor Car. I did not find any weld marks other than original spot weld marks (arrowed) on the non-detachable body panels of the Motor Car, indicating that there was no re-welding works carried out; and that the non-detachable body panels of the Motor Car were originally fitted.
