Your Ref: BMW 530i  
(chassis number WBAJA52090WC70644)  
Our Ref : CI/TP20005342/D

23 April 2020

**INSPECTION REPORT OF AN UNREGISTERD BMW 530i MOTOR CAR WITH CHASSIS NUMBER WBAJA52090WC70644**

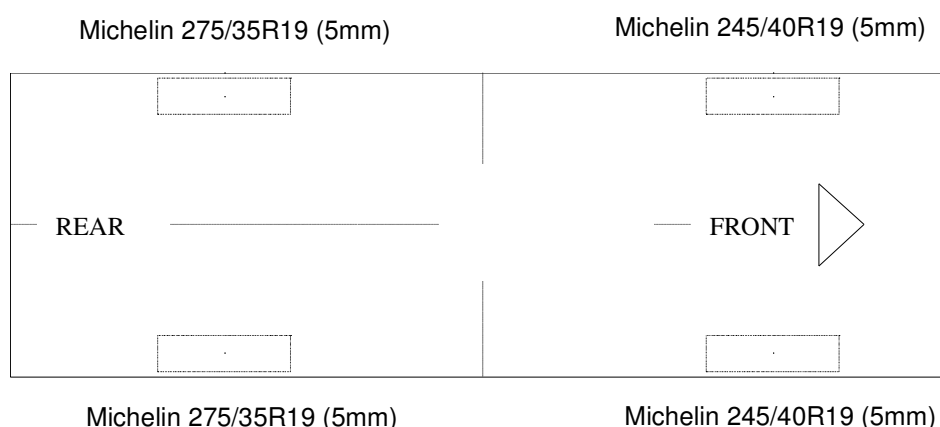
6. It was fitted with 19inch sport wheel rims that were wrapped with tyres that were observed to be of serviceable condition. The tyres were also sufficiently inflated for vehicular operation. The tyre brand, tyre size and approximate remaining tread depth of the 4 tyres of the Motor Car were recorded as follows: -

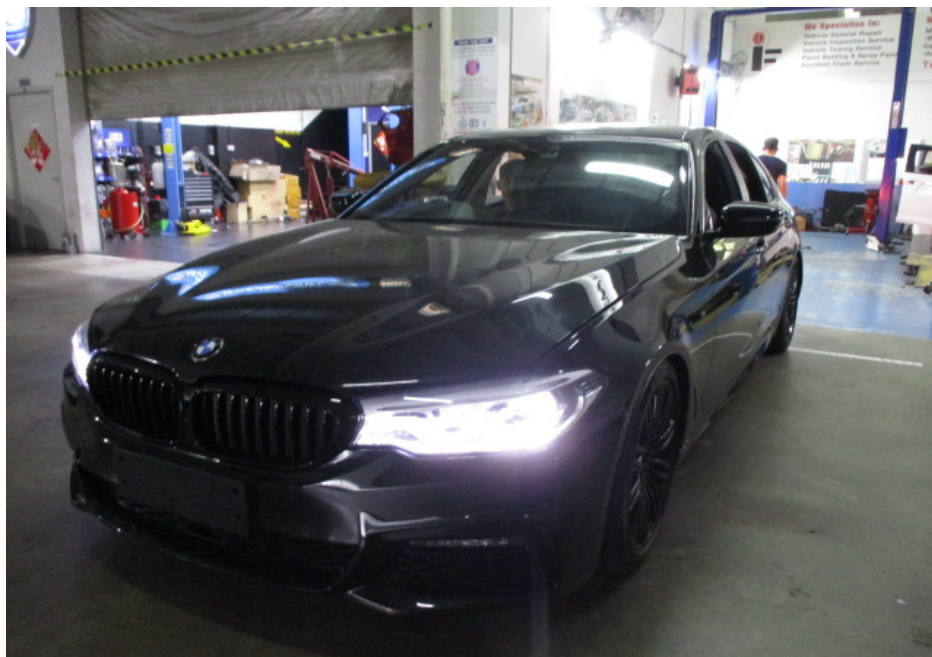
**Photo 1** shows a general view of the front left body of the Motor Car at the time of my inspection. The Motor Car was observed to be in relatively good general condition with no loose exterior fittings observed.

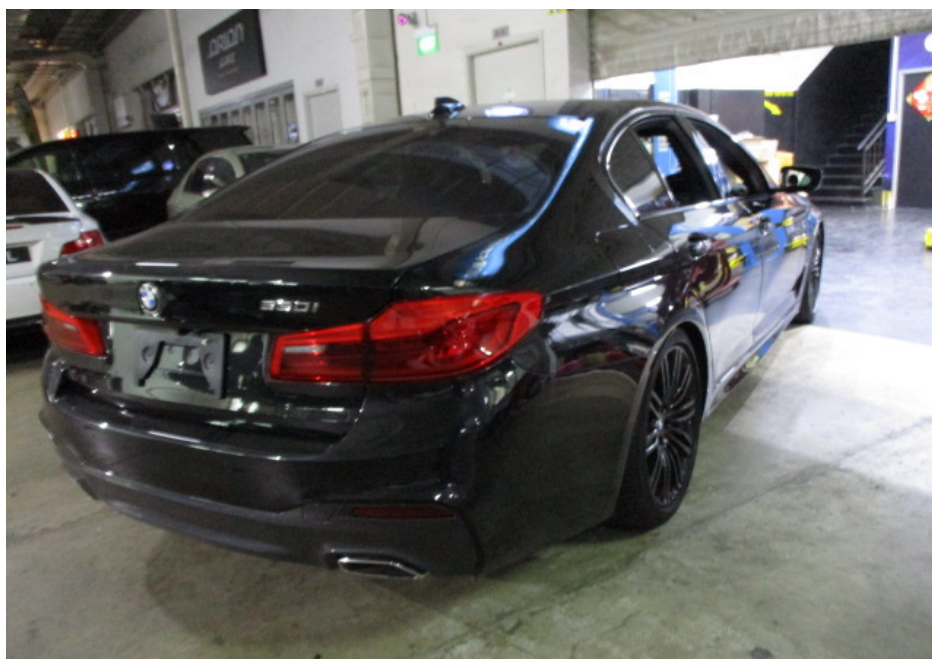
**Photo 2** shows a general view of the rear right body of the Motor Car at the time of my inspection. The Motor Car was observed to be in relatively good general condition with no loose exterior fittings observed.

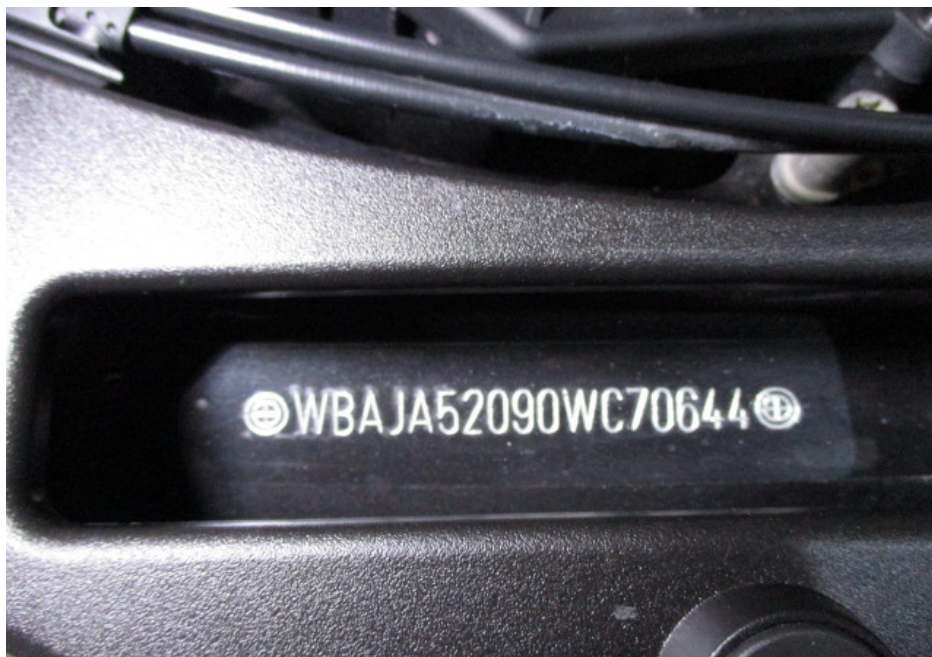
**Photo 3** shows the chassis number of the Motor Car. The chassis number recorded was WBAJA52090WC70644.

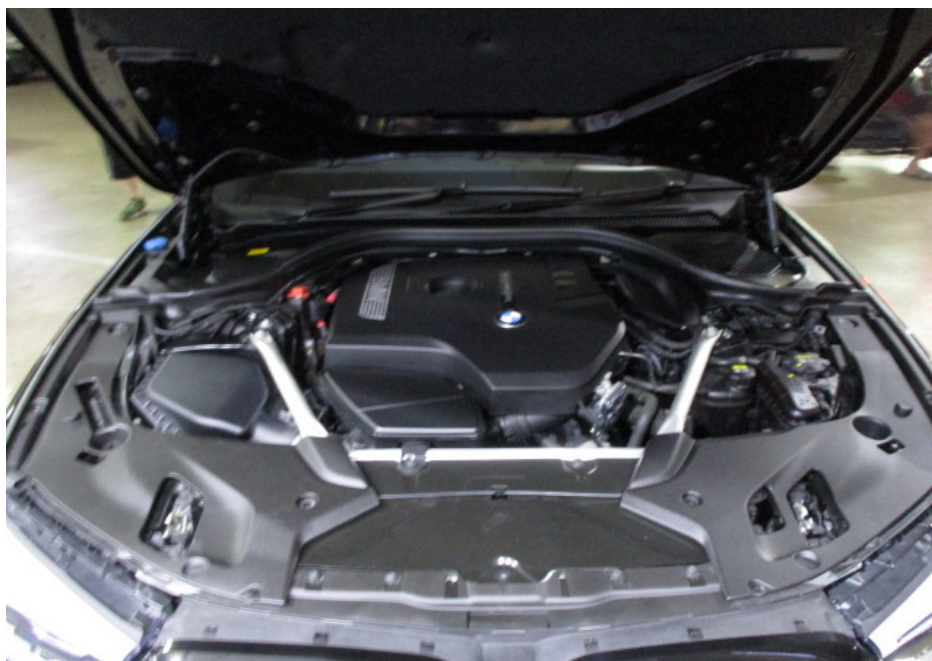
12. My examination of the engine compartment of the Motor Car revealed that the various parts and components inside the engine compartment were all intact and properly fitted. The engine oil, brake fluid and engine coolant were all found to be of sufficient level for operating purposes. Visually, there was also no contamination found to these fluids.
13. My checks on the underside of the Motor Car revealed no sign(s) or indication(s) of fluid leakage and/or fluid stain(s). The engine block and automatic transmission assembly were both secured properly. They were not mounted onto the chassis/structure body or any integral body part of the Motor Car. All undercarriage components of the Motor Car were also observed to be intact and secured in an appropriate manner.

**Photo 4** shows a general view of the engine compartment of the Motor Car at the time of my inspection. The various parts and components inside the engine compartment were all observed to be intact and properly fitted. There was also no sign(s) or indication(s) of fluid leak and/or fluid stain found inside the engine compartment.

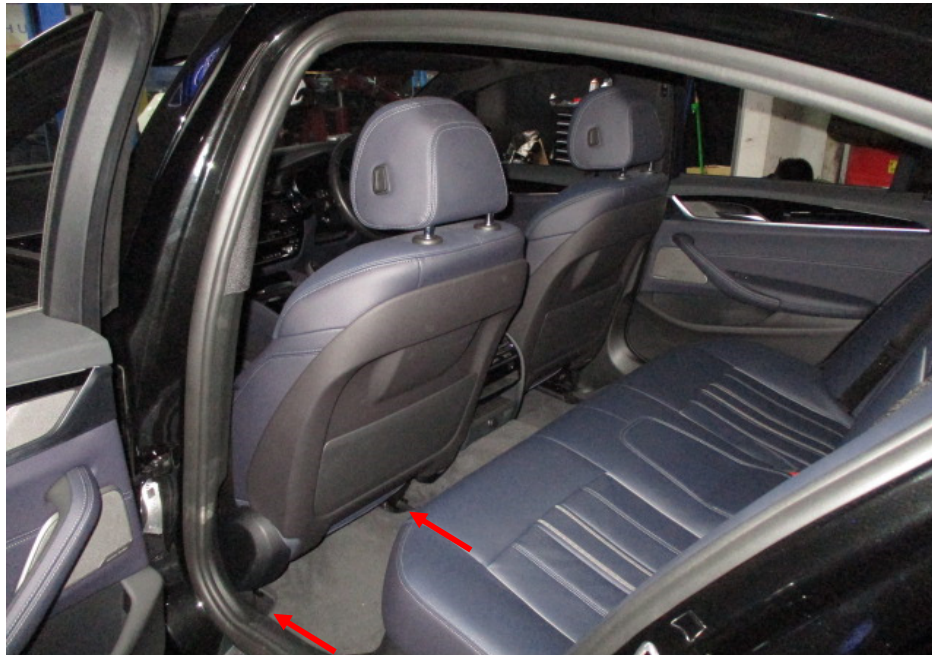
10. The seats of the Motor Car were found to be secured to the floor board of the Motor Car via seat rails bolted onto the floor board. Retractable seat belt reels and pre-tensioners were fitted on all seats of the Motor Car. The seat belt reels were able to be fastened securely into the respective pre-tensioners that were fixed to the side of all the seats.

**Photo 5** shows the seats of the Motor Car, which were secured via seat rails (arrowed) to the floor board. All the seats of the Motor Car were fitted with a retractable seat belt reel and pre-tensioner. The seat belts were also able to be fastened into the respective pre-tensions that were fitted on the side of each individual seat.

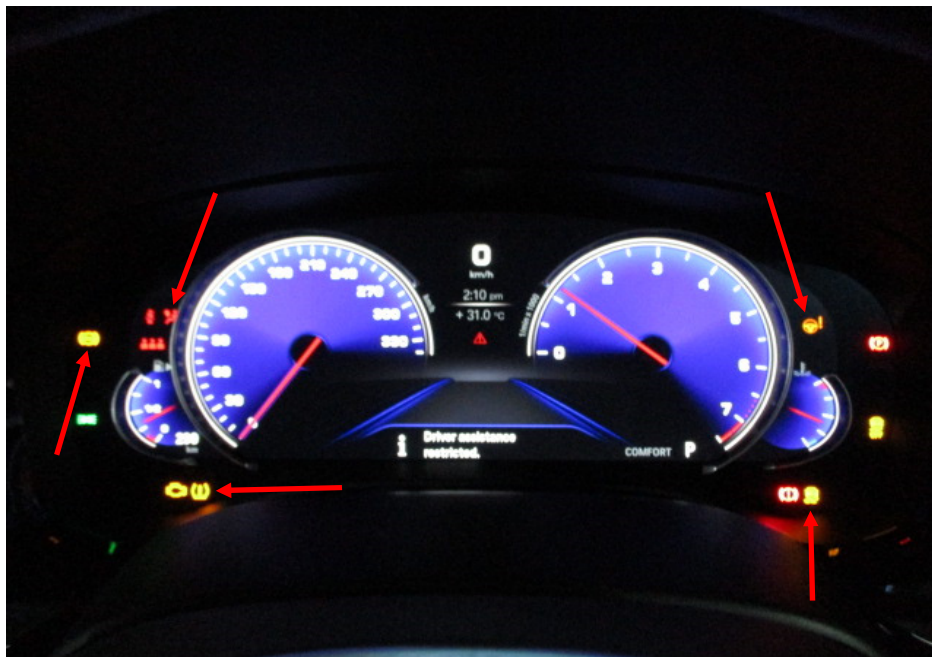
**Photo 6** shows the warning lights for the various electronic safety features appearing on the instrument panel of the Motor Car during its self-test when the engine is cranked, in particular the ABS, SRS, IAS, TPM and DSC lights (arrowed).

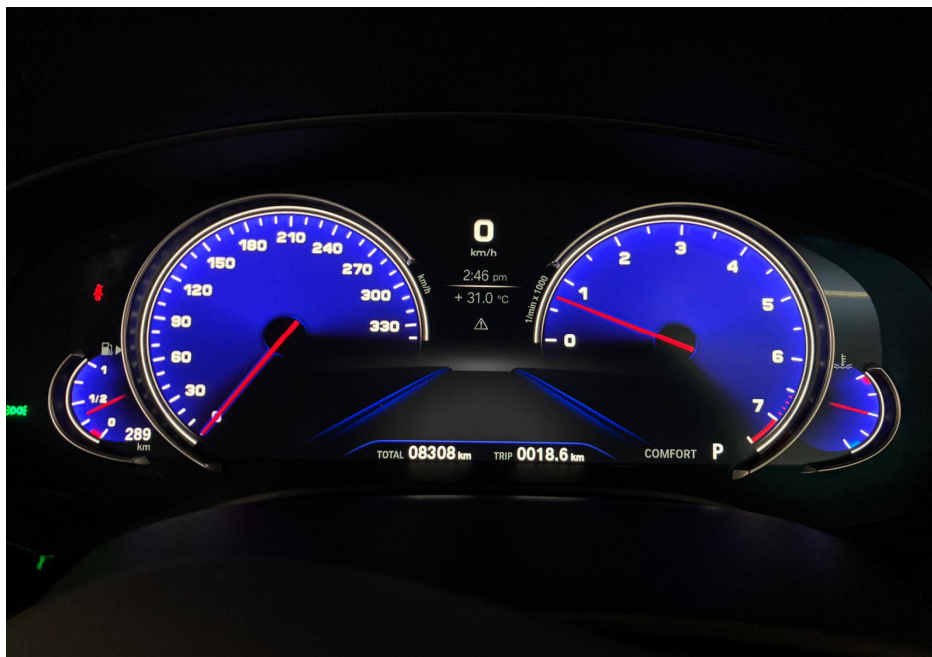
11. The Motor Car's automatic self-test of the functionality of its various electronic safety features like the Anti-Lock Brake System (ABS), Supplemental Restraint System (SRS), Integral Active Steering (IAS), Tyre Pressure Monitor (TPM) and Dynamic Stability Control (DSC) during cranking of the engine had indicated that these electronic systems were in working condition. This was determined from the respective warning lights disappearing from the instrument panel after the self-test.

**Photo 7** shows the respective warning lights no longer illuminated after the engine was started, indicating that there was no fault detected to the ABS, SRS, IAS, TPM and DSC systems of the Motor Car during the self-test. These electronic systems were hence in working condition at the time of my inspection.

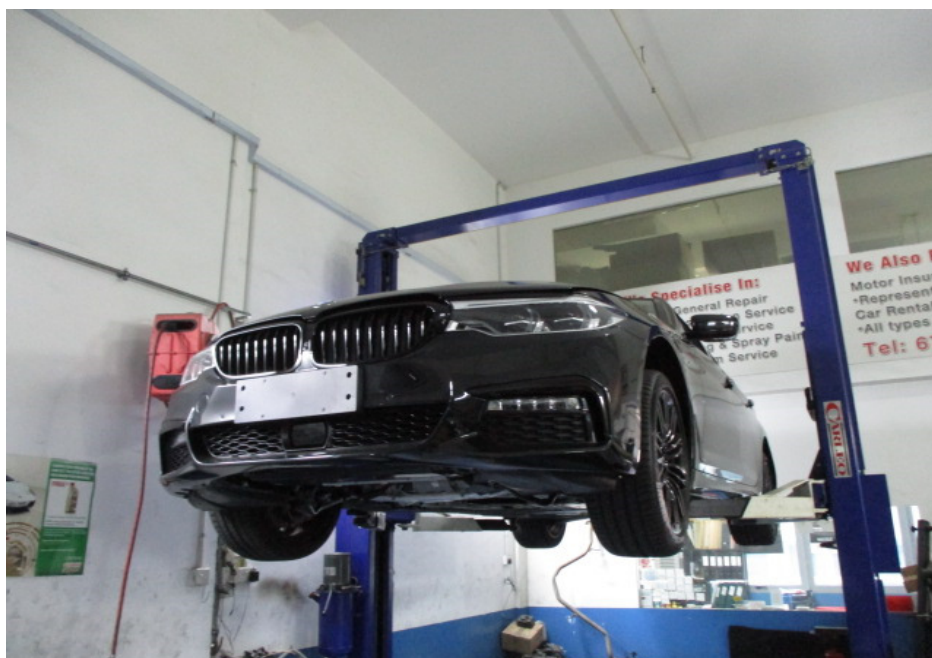
**Photo 8** shows the Motor Car hoisted up for checks on its undercarriage. There was no sign(s) or indication(s) of fluid leakage and/or fluid stain(s) on the underside of the Motor Car. The undercarriage components of the Motor Car were also all observed to be intact and secured in an appropriate manner.

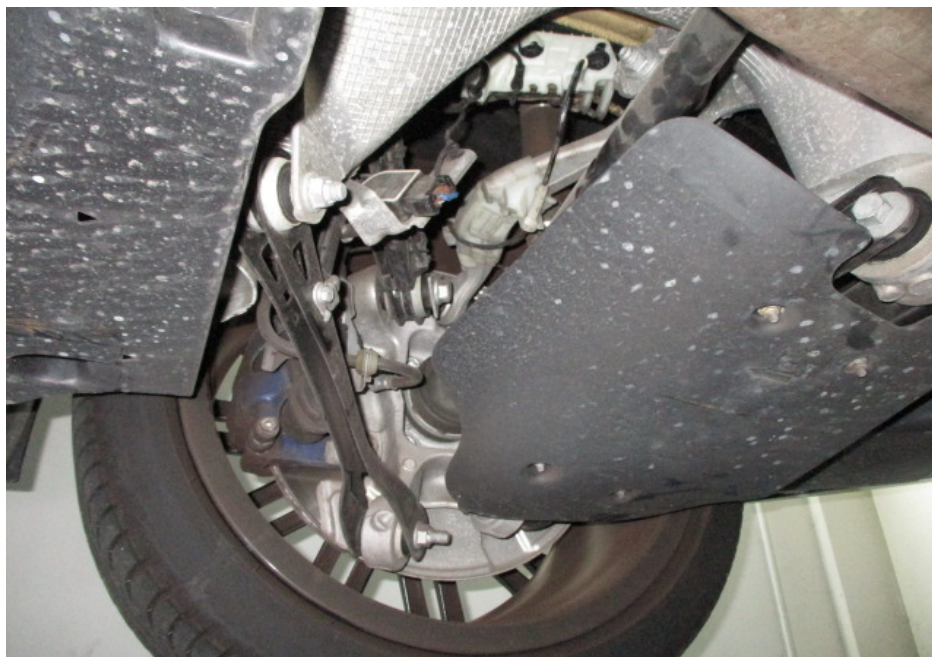
**Photo 9** shows a general view of the control arms and linkages at the rear right wheel of the Motor Car. I did not observe any fluid leak and/or fluid stain on the underside of the Motor Car. All of the Motor Car's undercarriage components were observed to be intact and secured in an appropriate manner.

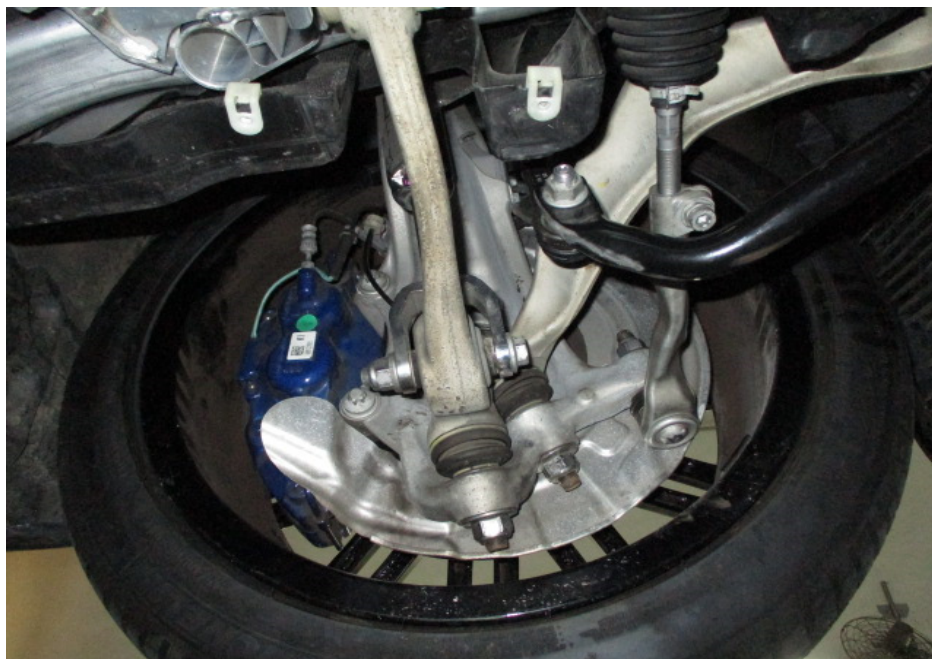
**Photo 10** shows the various undercarriage components at the front left wheel of the Motor Car. The mechanical components, control arms and linkages were all found to be intact and secured in an appropriate manner.

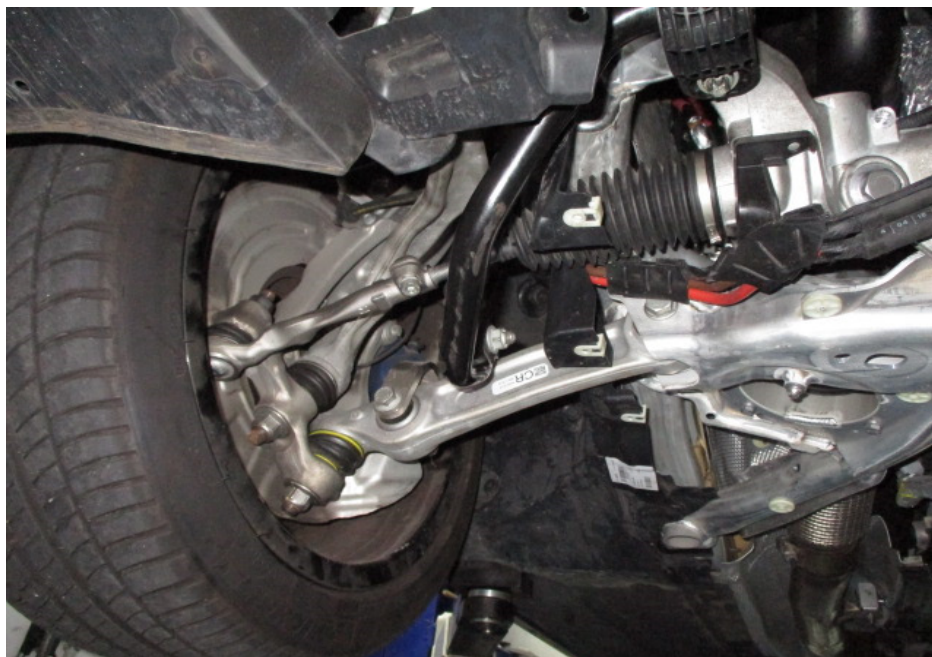
**Photo 11** shows the various undercarriage components at the front right wheel of the Motor Car. The mechanical components, control arms and linkages were all found to be intact and secured in an appropriate manner.

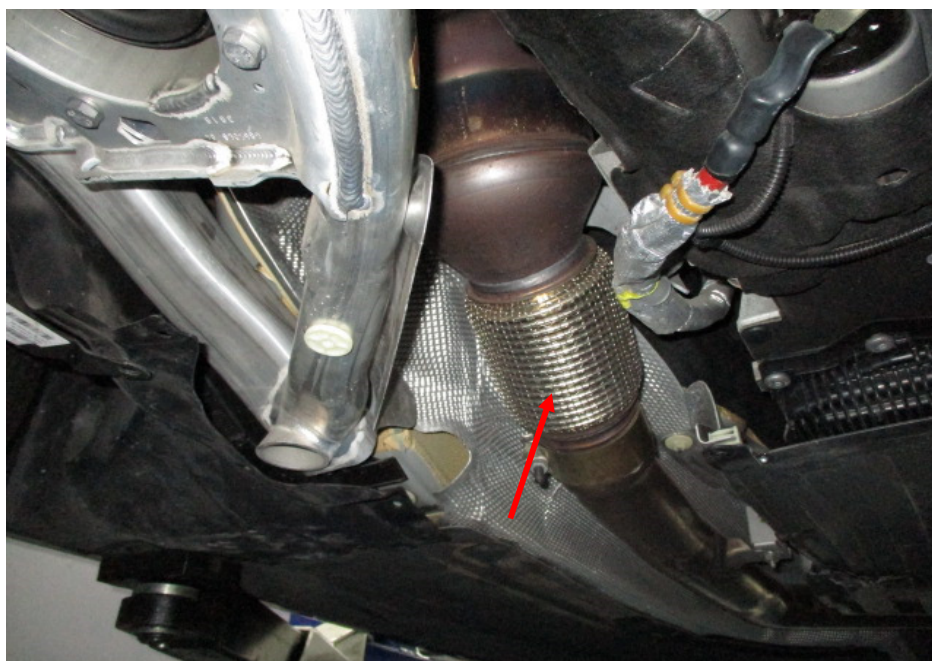
**Photo 12** shows the Motor Car's catalytic converter (arrowed). My examination of the Motor Car's exhaust system revealed no sign(s) or indication(s) of any cut or weld marks along its exhaust pipes and on its rear muffler.

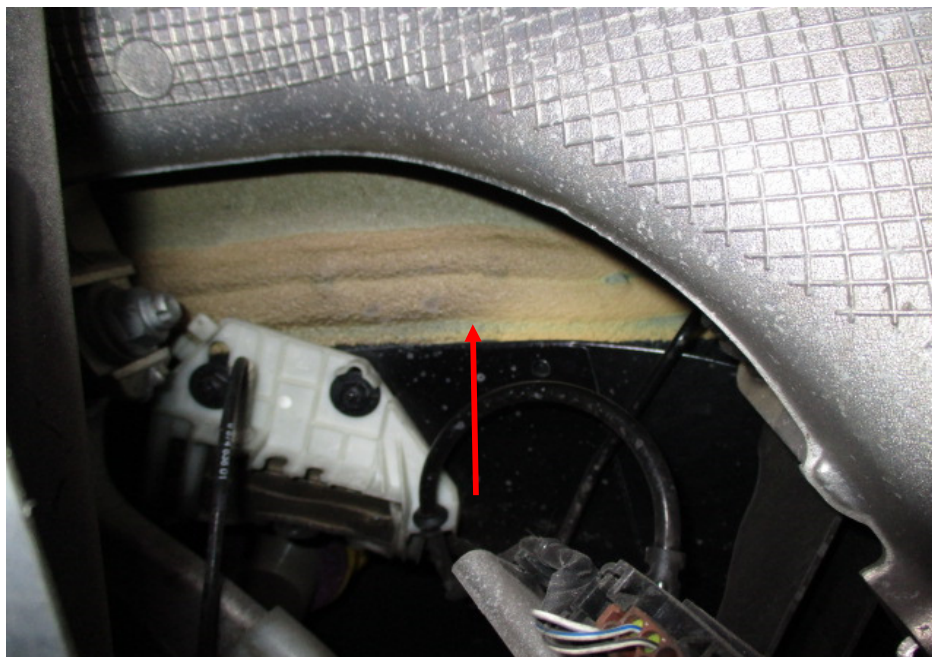
9. Visually, I did not find any weld marks, other than the original spot weld marks, on the chassis/structure body of the Motor Car. The original factory sealant at the joints along the chassis/structure body was also untouched, again indicating that no replacement of the chassis/structure body was carried out; and that the chassis/structure body was originally fitted.

**Photo 13** shows the chassis/structure body at the underside rear right of the Motor Car. I did not find any weld marks other than original spot weld marks on the chassis/structure body of the Motor Car. The original factory sealant (arrowed) at the joints along the chassis/structure body was also untouched, indicating no work was done on the chassis/structure body of the Motor Car and that the chassis/structure body was originally fitted.

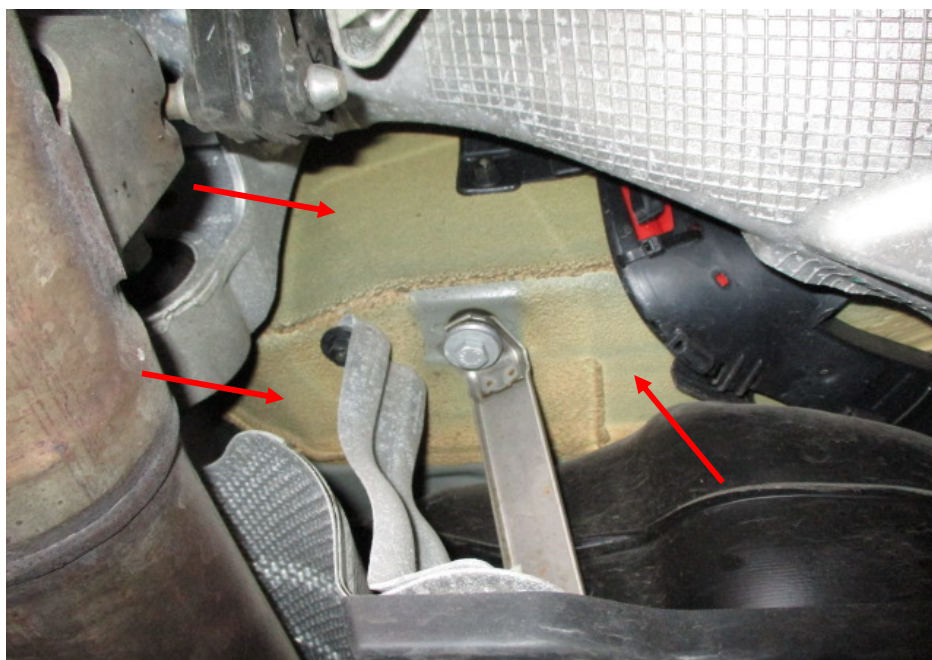
**Photo 14** shows the floor board at the underside centre of the Motor Car. The original factory sealant (arrowed) at the joints along the non-detachable body panels were untouched, indicating no work was done on the non-detachable body panels of the Motor Car; and that these body panels were originally fitted.

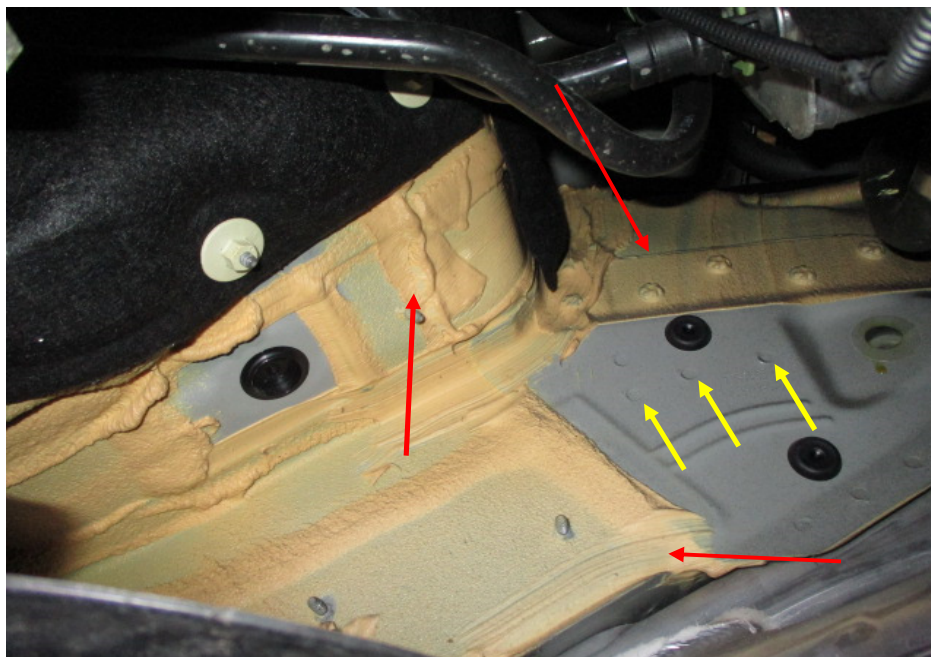
**Photo 15** shows the chassis/structure body at the underside front left of the Motor Car. Visually, I did not find any weld marks other than original spot weld marks (yellow arrow) on the chassis/structure body of the Motor Car. The original factory sealant (red arrow) at the joints along the chassis/structure body was also untouched, indicating no work was done on the chassis/structure body of the Motor Car and that the chassis/structure body was originally fitted.
