Your Ref: Honda Civic Type R  
(chassis number FK81201026)  
Our Ref : CI/TP20005343/D

23 June 2020

**INSPECTION REPORT OF AN UNREGISTERD HONDA CIVIC TYPE R  
MOTOR CAR WITH CHASSIS NUMBER FK81201026**

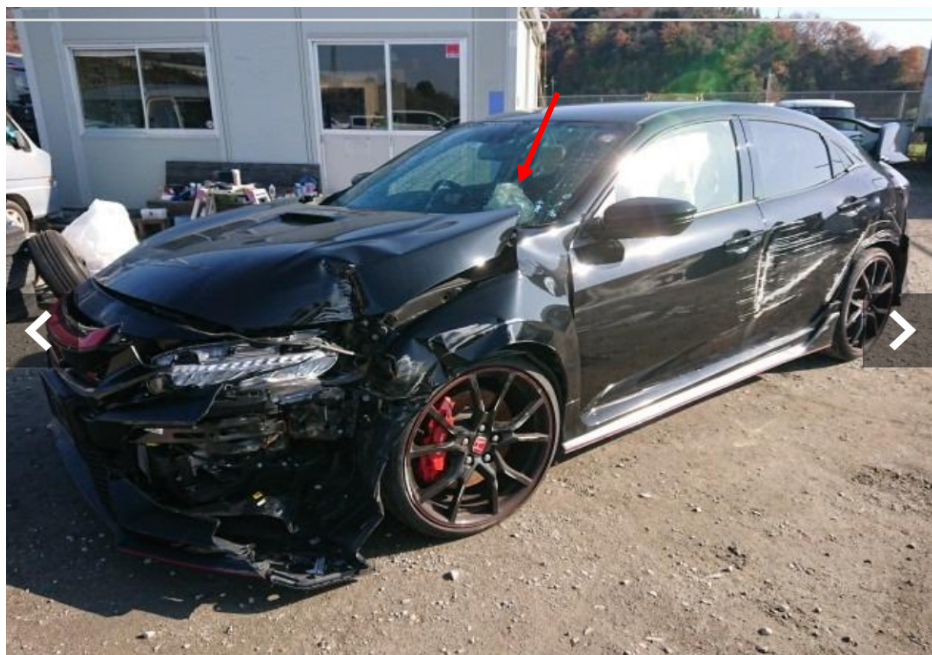
3. From the photographs provided to me, it was observed that the Motor Car had sustained damages along its left side. Body parts observed to have been damaged include its front bumper, front left fender, front bonnet, front left headlamp, front left door, rear left door and rear left fender amongst others. The front left passenger airbag and left side roof airbag of the Motor Car were also deployed.
4. Photograph showing the engine compartment of the Motor Car had indicated damage to the front support panel, front grille, front left headlamp top panel and front left fender inner panel amongst others. See photo 1 – 3 below.

**Photo 1** shows the front left body of the Motor Car prior to any repairs being carried out (photograph provided to me). The Motor Car was observed to have sustained damages along its left side. The body parts observed to be damaged had included its front bumper, front left headlamp, front left fender, front bonnet and front left door amongst others. The front left passenger airbag was also observed to be deployed (arrowed).

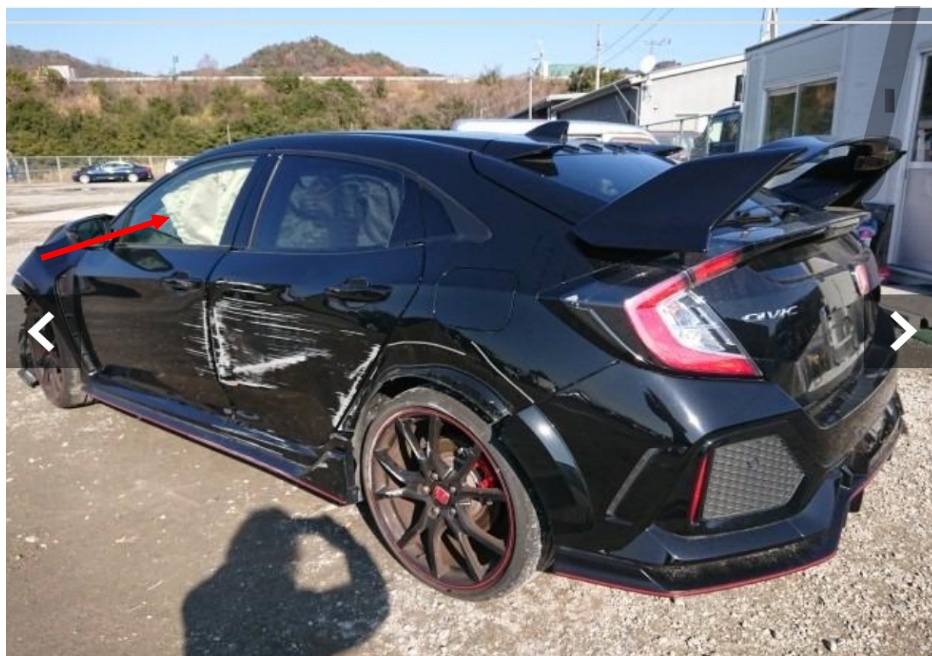
**Photo 2** shows the rear left body of the Motor Car prior to any repairs being carried out (photograph provided to me). The Motor Car was observed to have sustained damages along its left side. The rear left door and rear left fender were amongst the body parts that were observed to be damaged. The left side roof airbag was also observed to be deployed (arrowed).

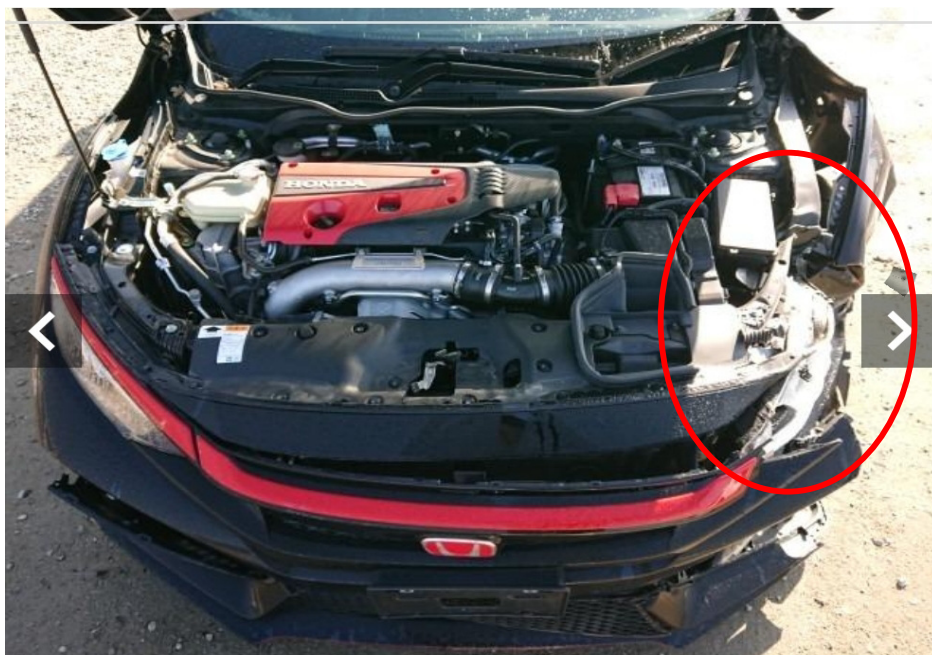
**Photo 3** shows the engine compartment of the Motor Car prior to any repairs being carried out (photograph provided to me). The front support panel, front grille, front left headlamp top panel and front left fender inner panel were amongst the body parts that were observed to be damaged. The damage was confined to the left side of the engine compartment (circled). From my review of the photograph, the engine of the Motor Car was not affected.

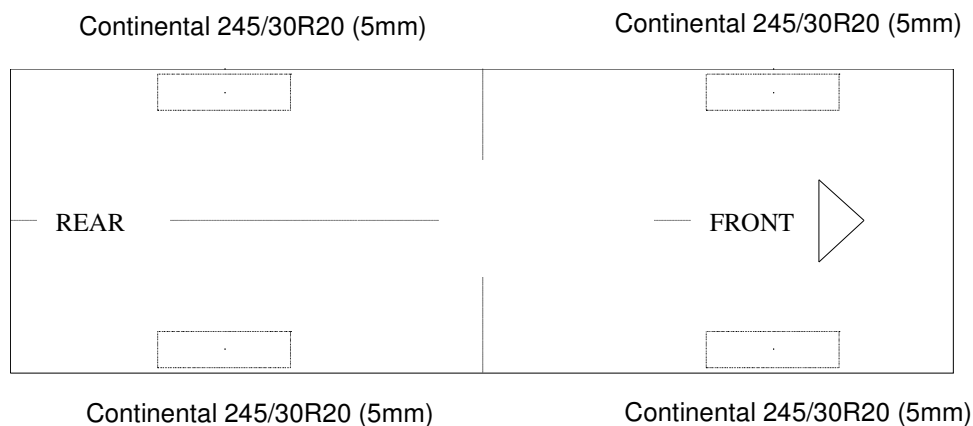
8. It was fitted with 20inch sport wheel rims that were wrapped with tyres that were observed to be of serviceable condition. The tyres were also sufficiently inflated for vehicular operation. The tyre brand, tyre size and approximate remaining tread depth of the 4 tyres of the Motor Car were recorded as follows: -

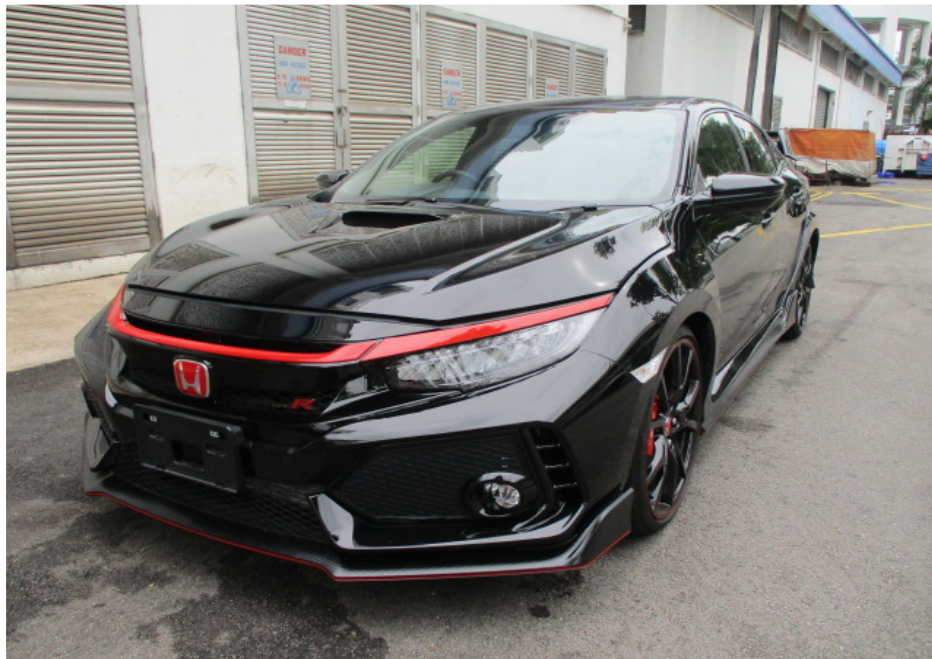
**Photo 4** shows a general view of the front left body of the Motor Car at the time of my inspection. The Motor Car was observed to be in relatively good general condition with no loose exterior fittings observed. The body parts along the left side of the Motor Car were visually examined and it was observed that the repair/restoration works carried out to the damaged area of the Motor Car (refer photograph 1 to 3 above) were reasonably adequate and in order.

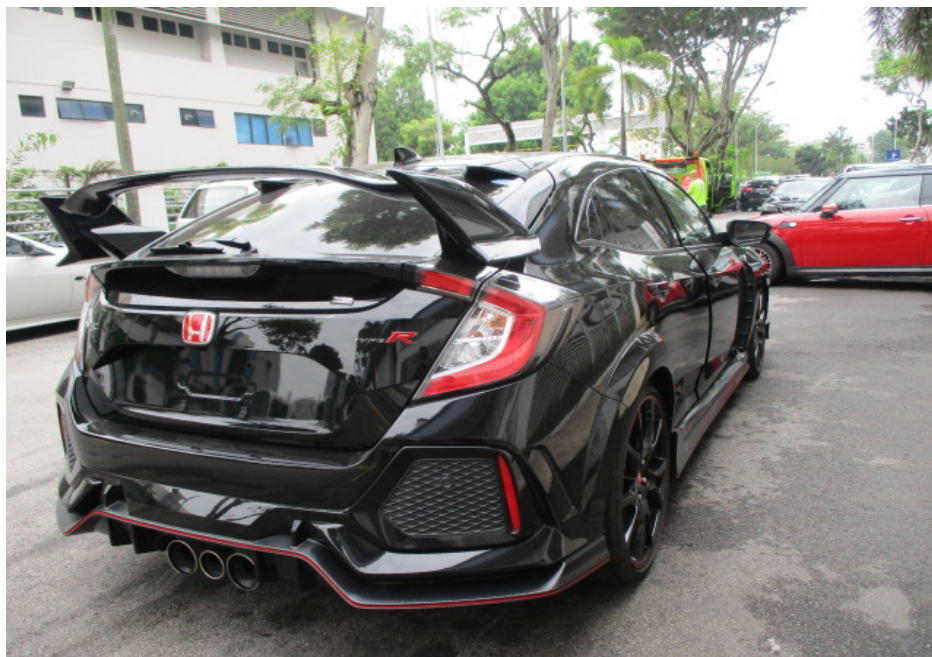
**Photo 5** shows a general view of the rear right body of the Motor Car at the time of my inspection. The Motor Car was observed to be in relatively good general condition with no loose exterior fittings observed.

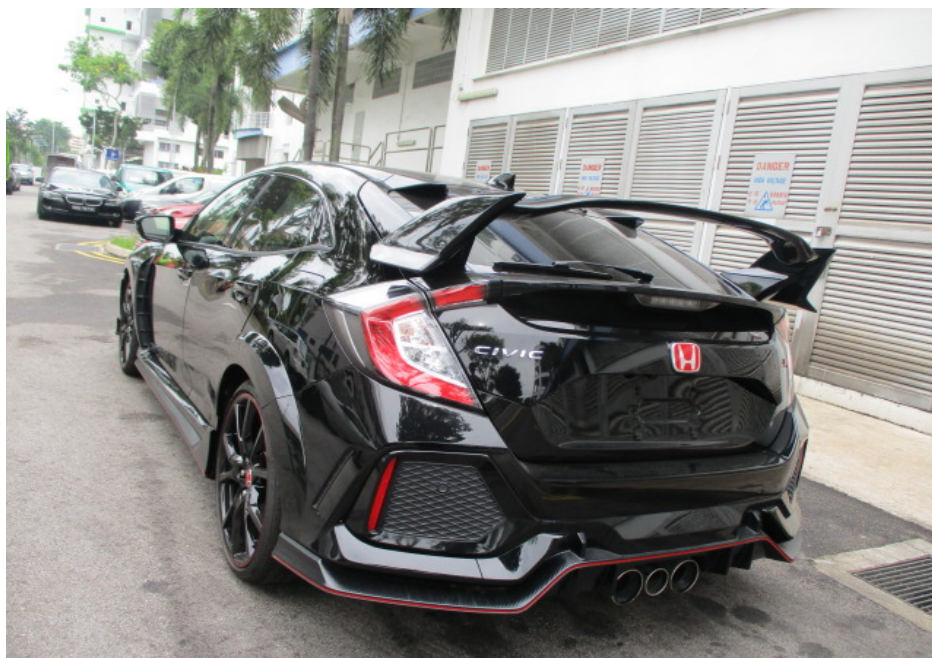
**Photo 6** shows a general view of the rear left body of the Motor Car at the time of my inspection. The Motor Car was observed to be in relatively good general condition with no loose exterior fittings observed. The body parts along the left side of the Motor Car were visually examined and it was observed that the repair/restoration works carried out to the damaged area of the Motor Car (refer photograph 1 to 3 above) were reasonably adequate and in order.

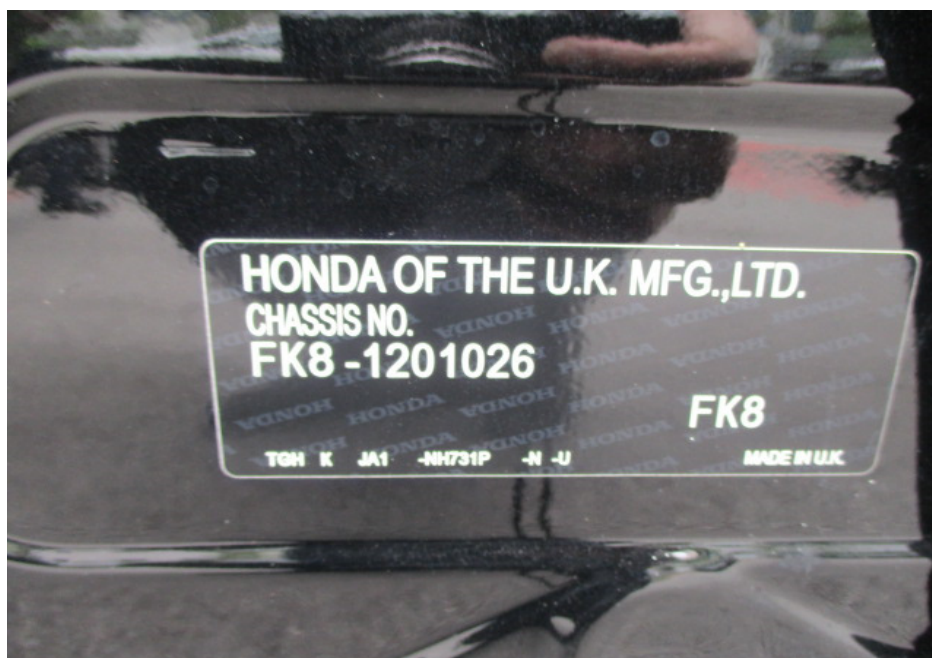
**Photo 7** shows the chassis number of the Motor Car. The chassis number recorded was FK81201026.

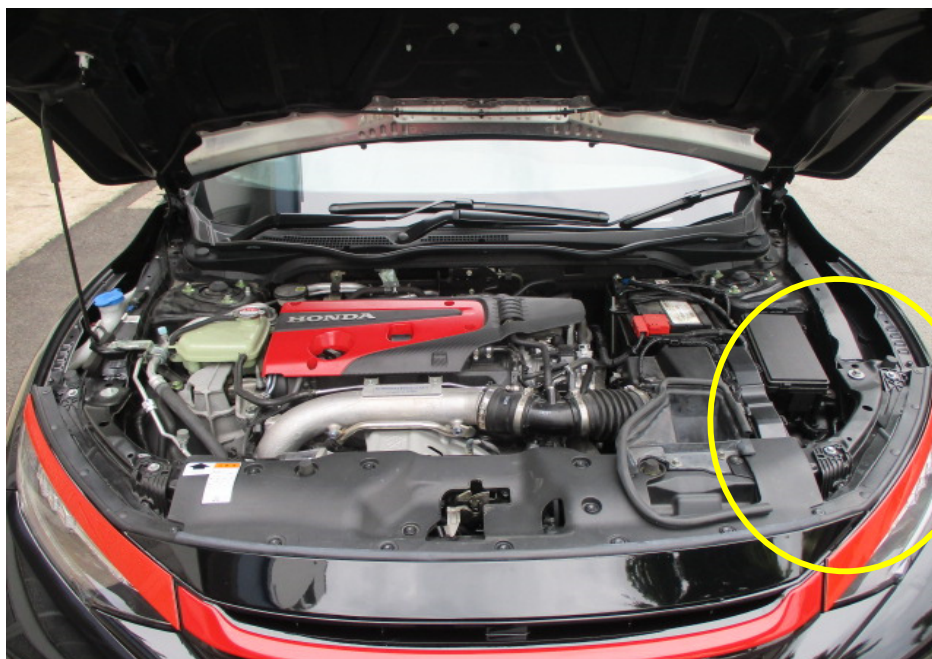
**Photo 8** shows a general view of the engine compartment of the Motor Car at the time of my inspection. The various parts and components inside the engine compartment were all observed to be intact and properly fitted. There was also no sign(s) or indication(s) of fluid leak and/or fluid stain found inside the engine compartment. The damage area at the left side of the engine compartment (circled) was found to be adequately restored in a satisfactory manner.

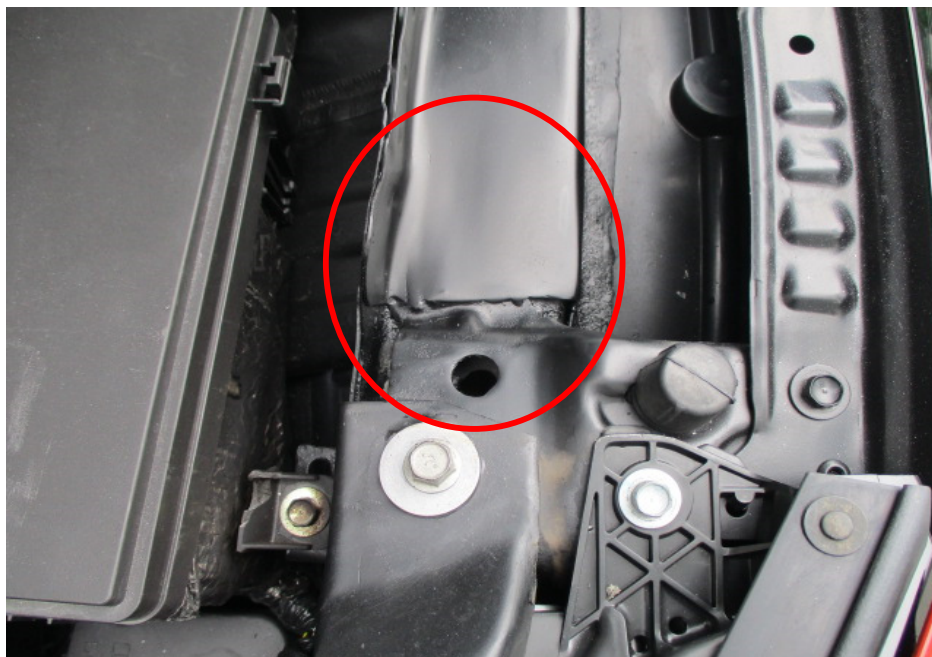
**Photo 9** shows the front left fender inner panel of the Motor Car. Signs of repair was observed (circled). Generally, the repair/restoration works carried out to the damaged area of the Motor Car (refer photograph 1 to 3 above) were reasonably adequate and in order.

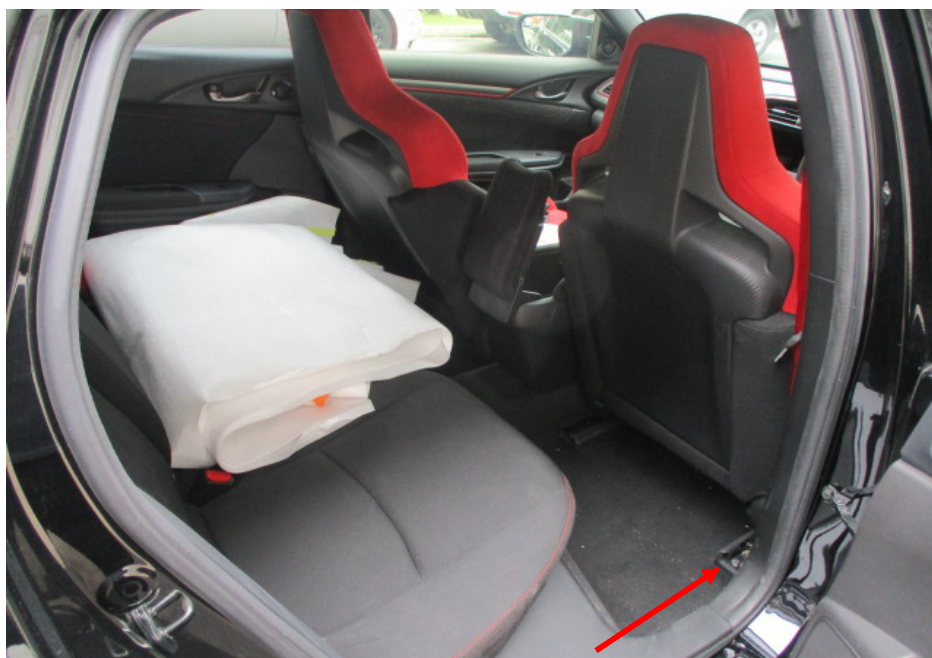
**Photo 10** shows the seats of the Motor Car, which were secured via seat rails (arrowed) to the floor board. All the seats of the Motor Car were fitted with a retractable seat belt reel and pre-tensioner. The seat belts were tested and able to be fastened into the respective pre-tensions that were fitted on the side of each individual seat.

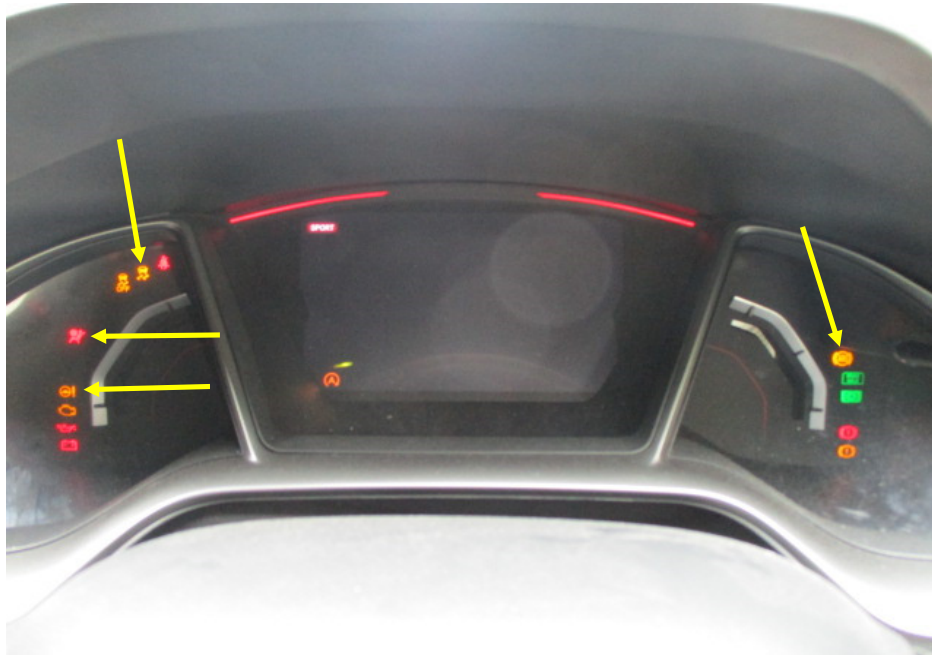
**Photo 11** shows the warning lights for the various electronic safety features appearing on the instrument panel of the Motor Car during its self-test when the engine is cranked, in particular the ABS, SRS, VSA and EPS lights (arrowed).

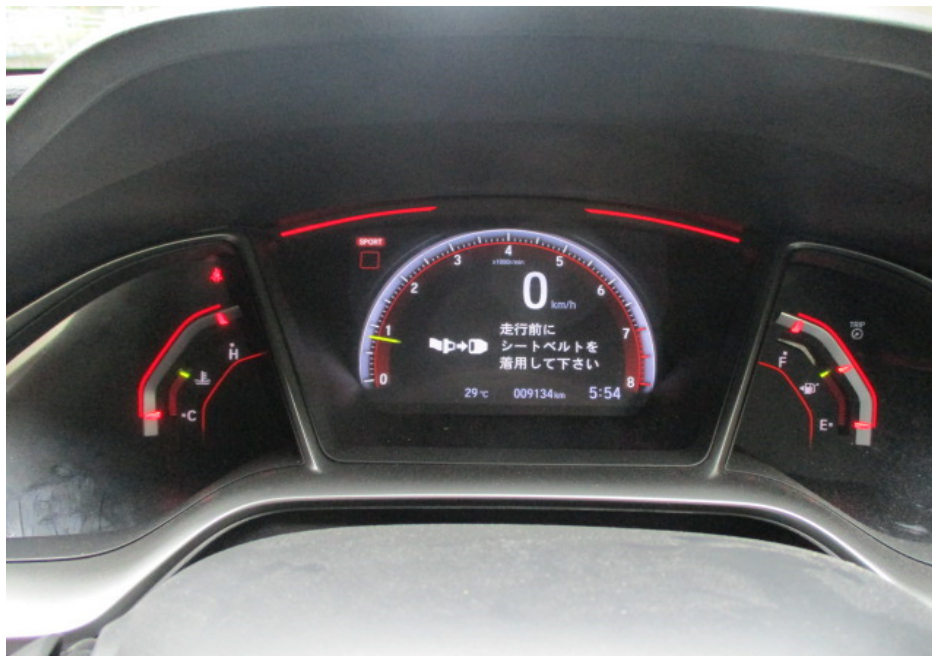
**Photo 12** shows the respective warning lights no longer illuminated after the engine was started, indicating that there was no fault detected to the ABS, SRS, VSA and EPS systems of the Motor Car during the self-test. These electronic systems were hence in working condition at the time of my inspection.

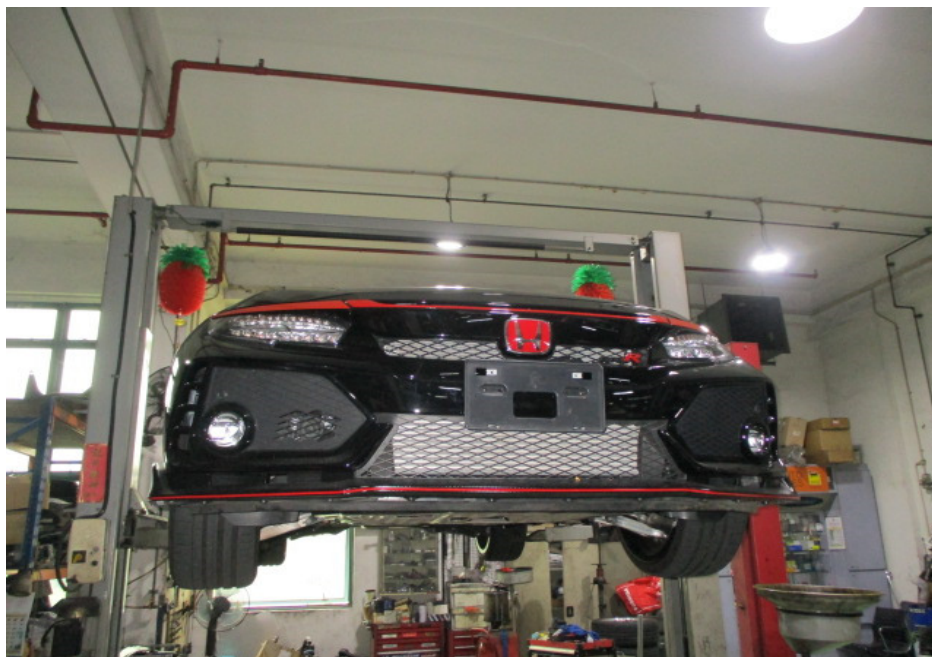
**Photo 13** shows the Motor Car hoisted up for checks on its undercarriage. There was no sign(s) or indication(s) of fluid leakage and/or fluid stain(s) on the underside of the Motor Car. The undercarriage components of the Motor Car were also all observed to be intact and secured in an appropriate manner.

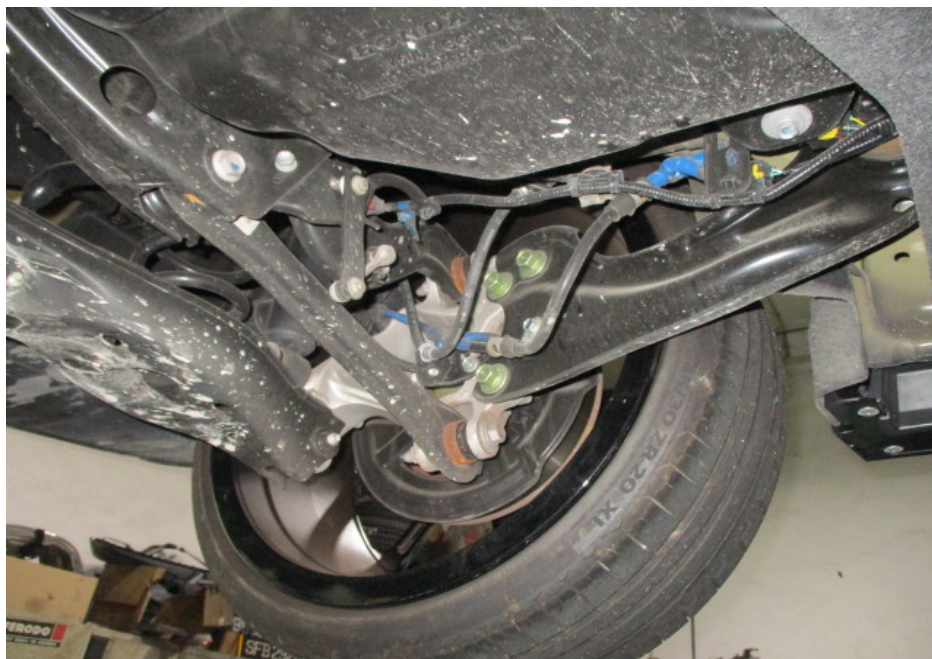
**Photo 14** shows a general view of the control arms and linkages at the rear left wheel of the Motor Car. I did not observe any fluid leak and/or fluid stain on the underside of the Motor Car. All of the Motor Car's undercarriage components were observed to be intact and secured in an appropriate manner.

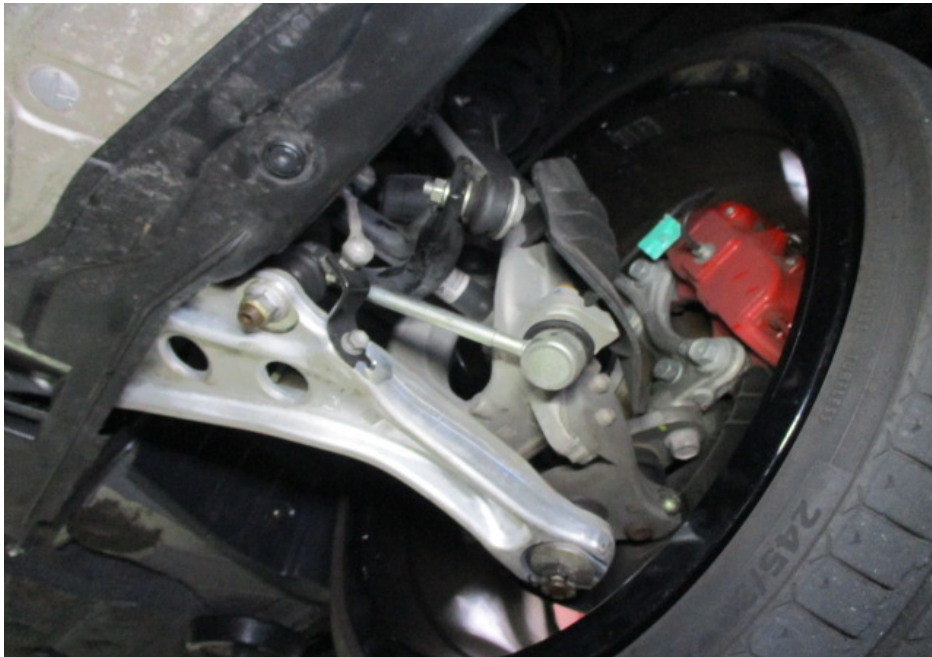
**Photo 15** shows the various undercarriage components at the front left wheel of the Motor Car. The mechanical components, control arms and linkages were all found to be intact and secured in an appropriate manner.

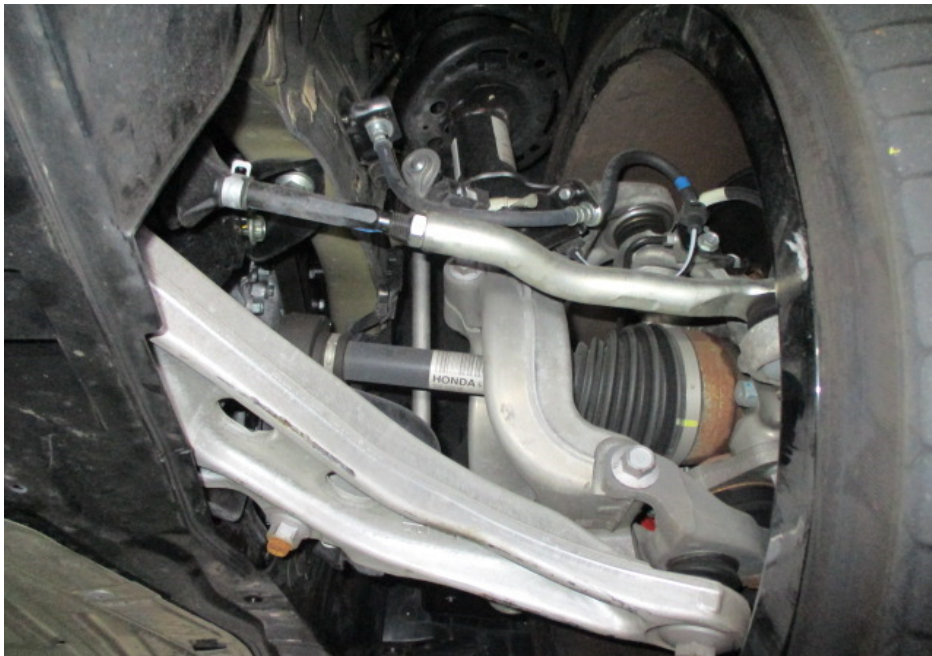
**Photo 16** shows the various undercarriage components at the front right wheel of the Motor Car. The mechanical components, control arms and linkages were all found to be intact and secured in an appropriate manner. I also did not observe any fluid leak and/or fluid stain on the underside of the Motor Car.

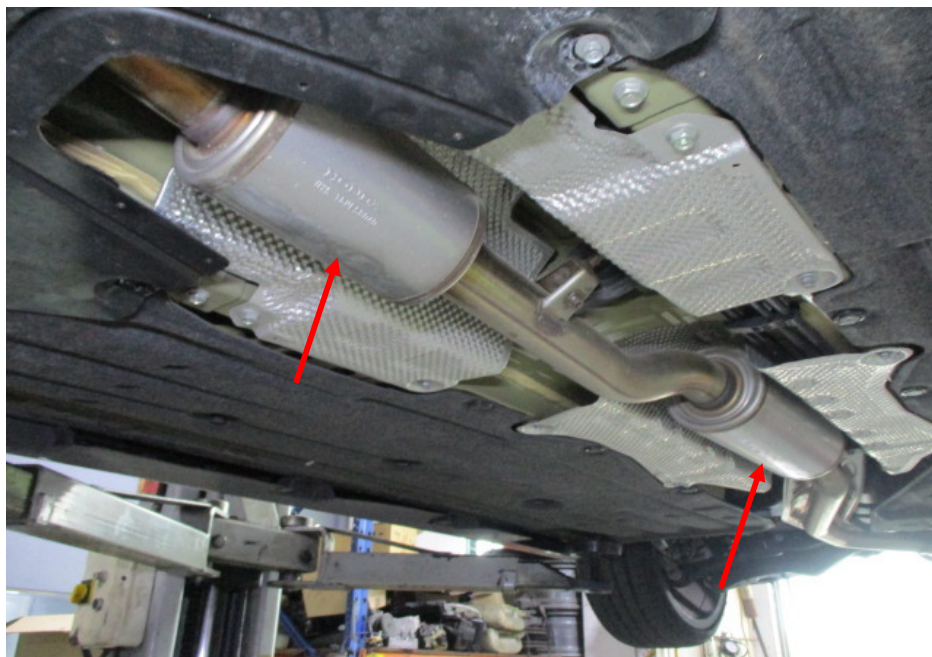
**Photo 17** shows the Motor Car's centre pipe (arrowed). My examination of the Motor Car's exhaust system revealed no sign(s) or indication(s) of any cut or weld marks along its exhaust pipes and on its rear mufflers.

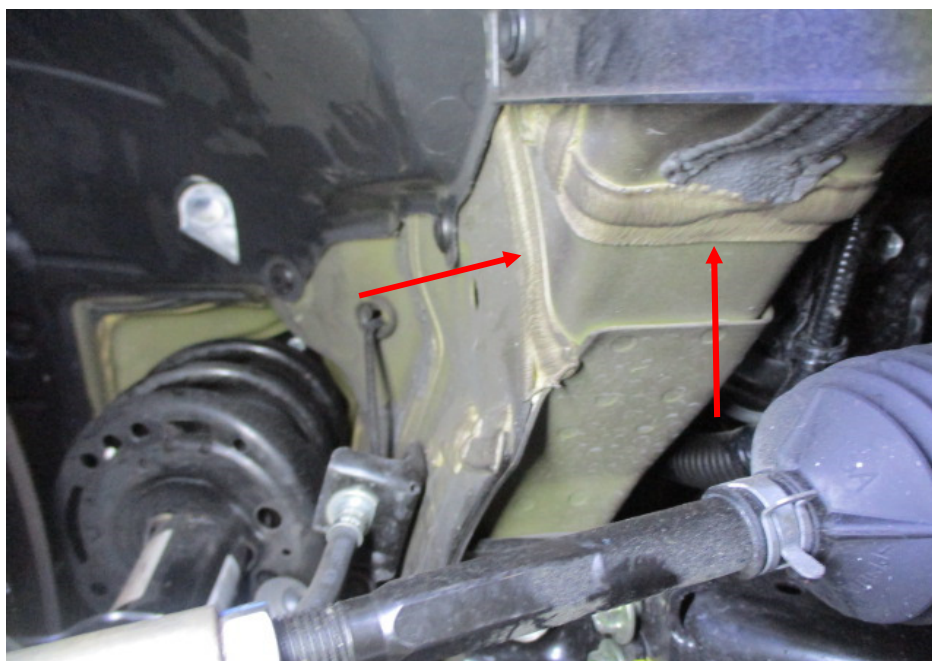
**Photo 18** shows the chassis/structure body at the underside front left of the Motor Car. The original factory sealant (arrowed) at the joints along the chassis/structural body was also untouched, indicating no work was done on the chassis/structural body of the Motor Car and that the chassis/structural body was originally fitted.

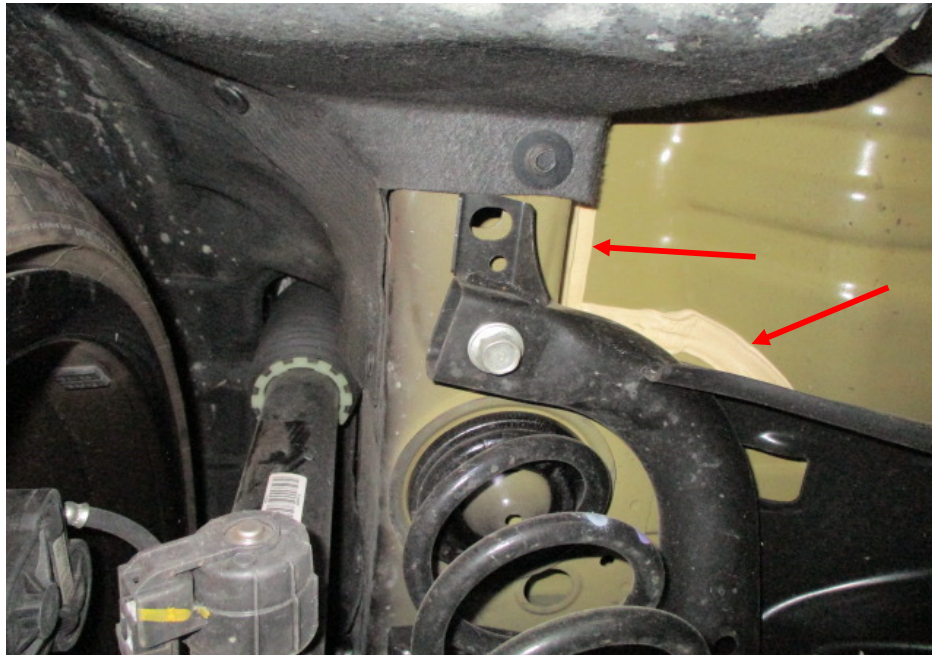
**Photo 19** shows the chassis/structure body at the underside rear left of the Motor Car. The original factory sealant (arrowed) at the joints along the chassis/structural body was untouched, indicating no work was done on the chassis/structural body of the Motor Car and that the chassis/structural body was originally fitted.

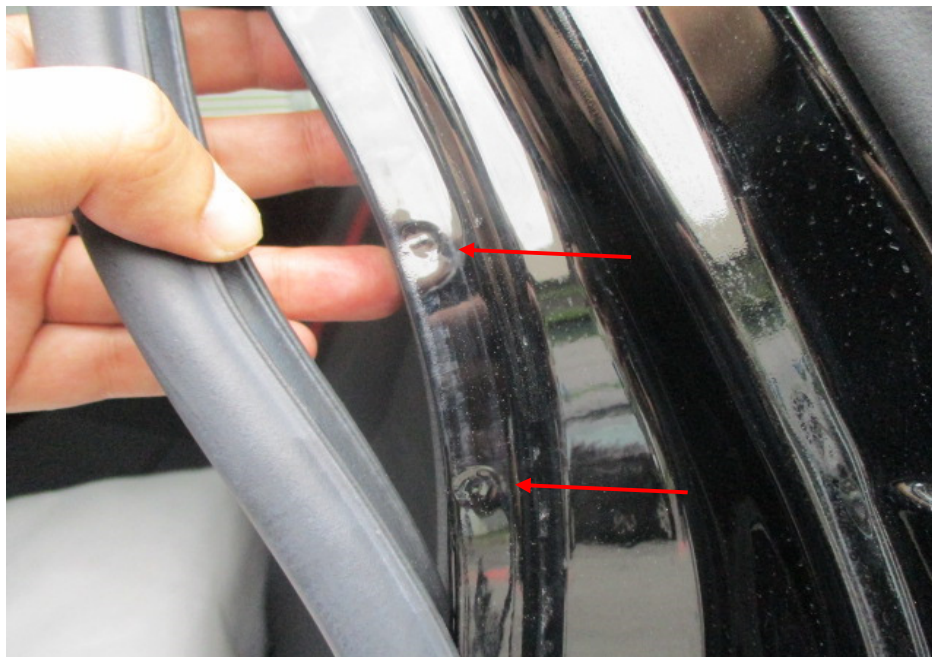
**Photo 20** shows the left "C" pillar of the Motor Car. I did not find any weld marks other than original spot weld marks (arrowed) on the non-detachable body panels of the Motor Car, indicating that there was no re-welding works carried out; and that the non-detachable body panels of the Motor Car were originally fitted.

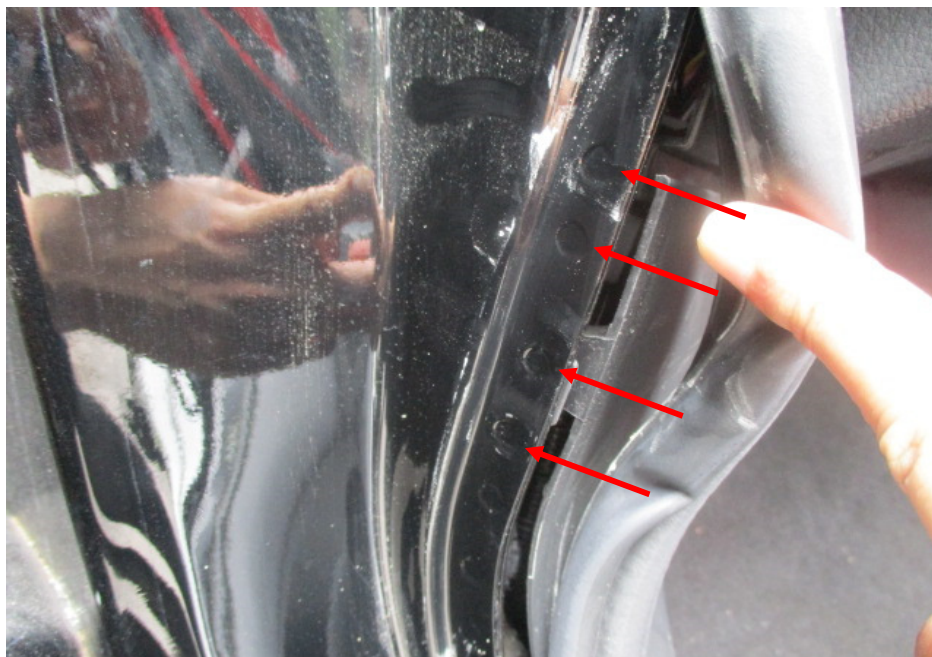
**Photo 21** shows the left "A" pillar of the Motor Car. I did not find any weld marks other than original spot weld marks (arrowed) on the non-detachable body panels of the Motor Car, indicating that there was no re-welding works carried out; and that the non-detachable body panels of the Motor Car were originally fitted.
