Your Ref: TP/IP/13255/2020
Our Ref : CI/TPD20005416/N

Fatal Accident Investigation Team

**INSPECTION REPORT OF BICYCLE (DARK GREEN) - TRAFFIC POLICE
POUND REPORT NO. 0928/2020**

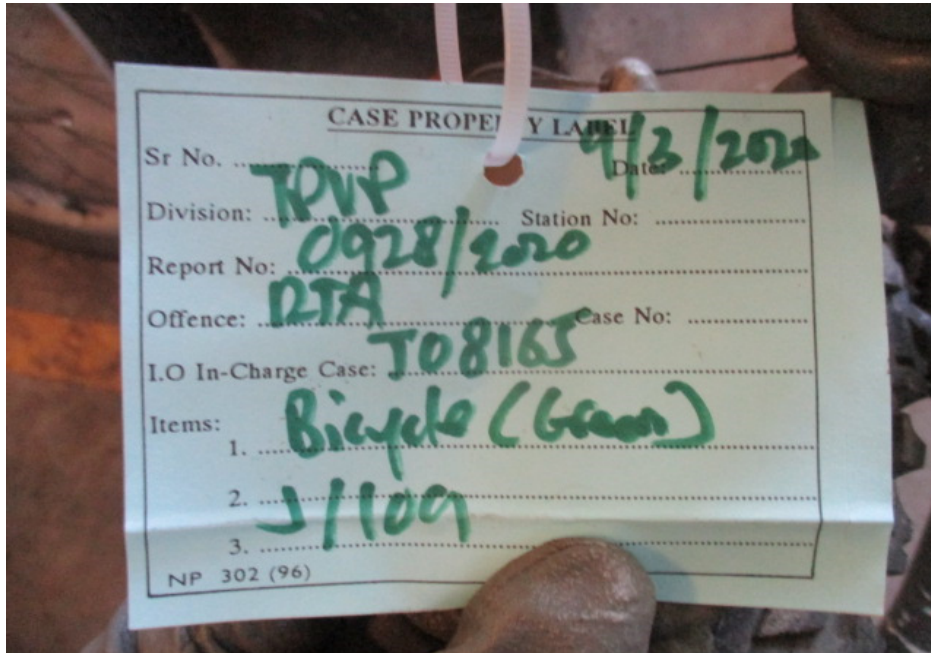
Photo 1 shows the identification of the Bicycle with reference to Traffic Police Pound Report No. 0928/2020.

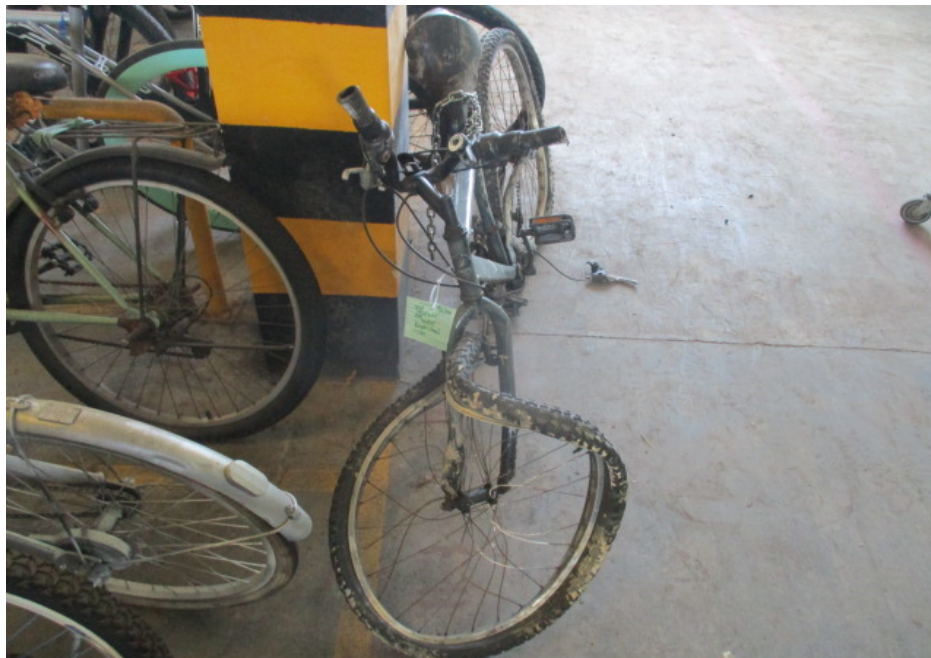
Photo 2 shows the frontal portion of the Bicycle at the time of our inspection. The Bicycle had sustained damages all around.

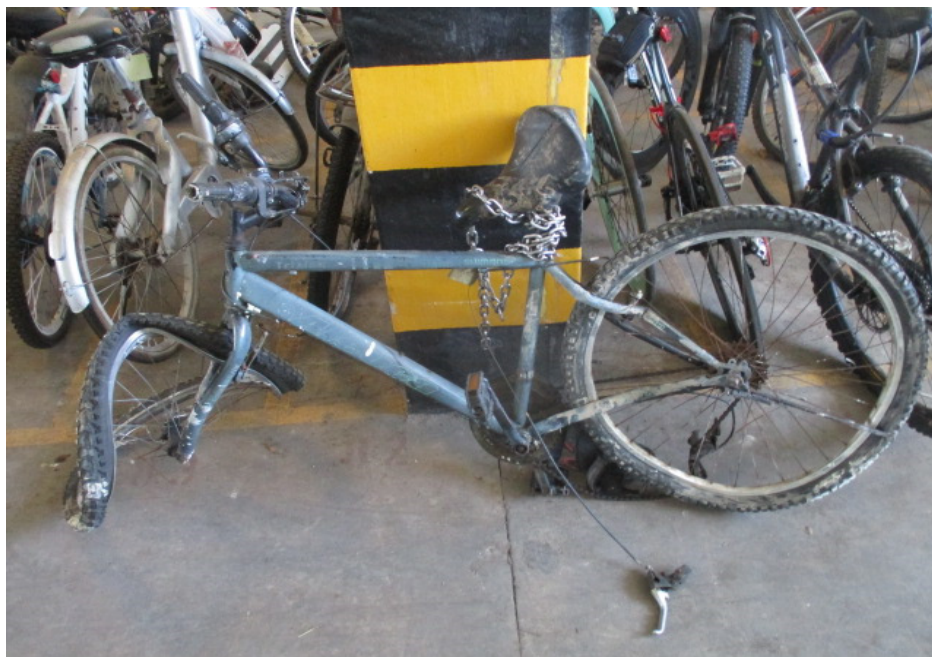
Photo 3 shows the left portion of the Bicycle at time of our inspection. The Bicycle had sustained damages all around. The Bicycle had sustained damages all around. The body parts that were found to have been damaged include its front forks, handlebar, frame and braking components, amongst others as a result of the accident.

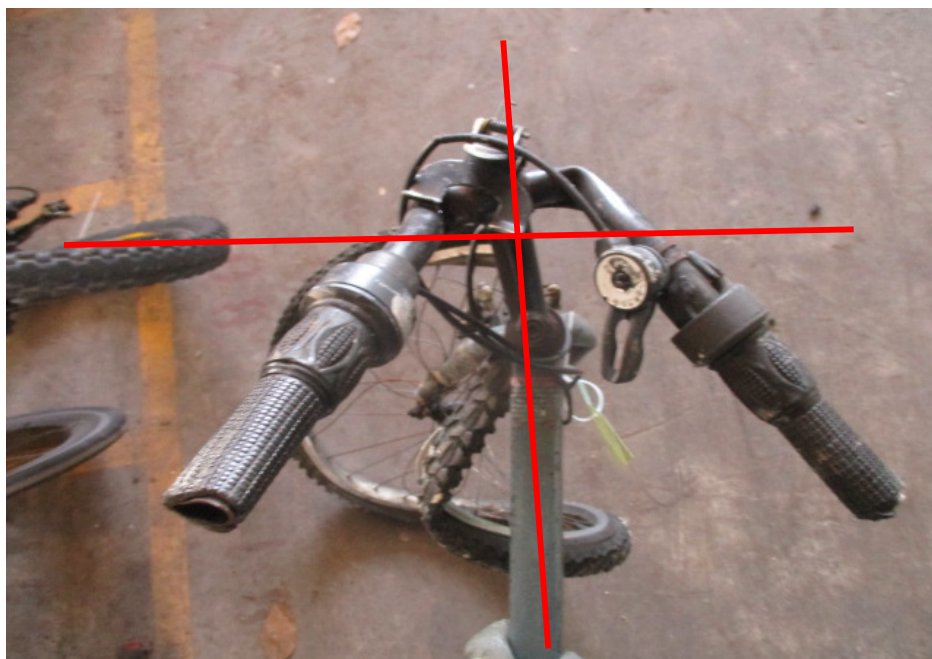
Photo 4 shows the frontal portion of the Bicycle (top view) at the time of our inspection. A misalignment of the handle bar & front tyre was observed.

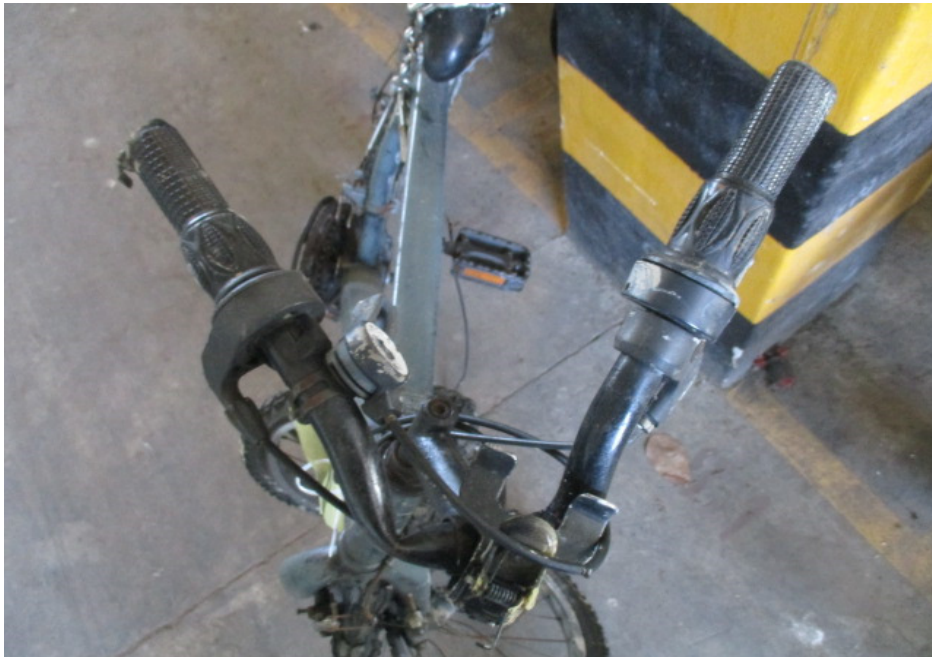
Photo 5 shows the deformed handlebar of the Bicycle at the time of our inspection.

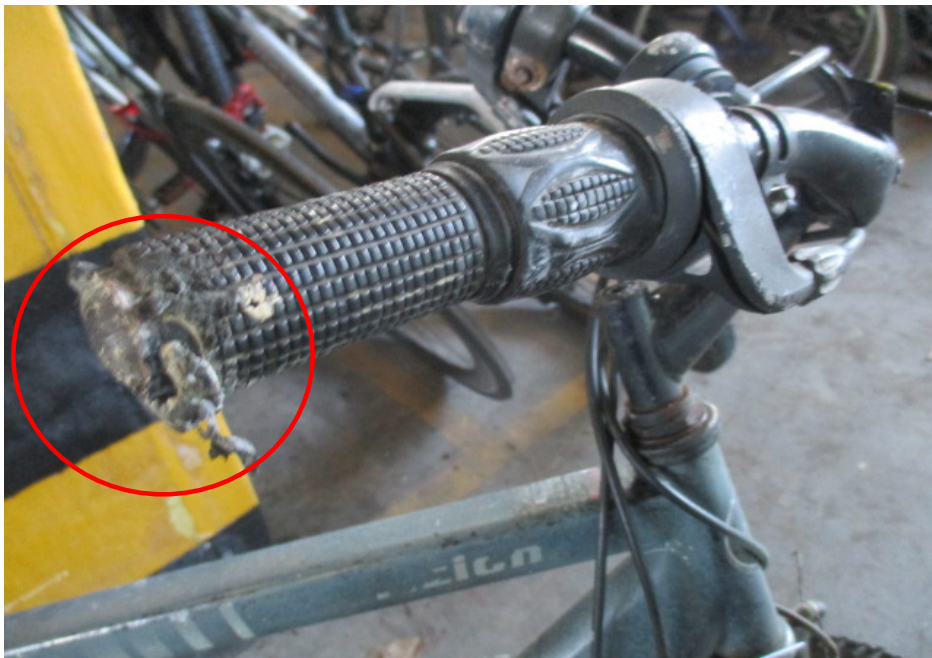
Photo 6 shows the damaged right handlebar end of the Bicycle at the time of our inspection (circled).

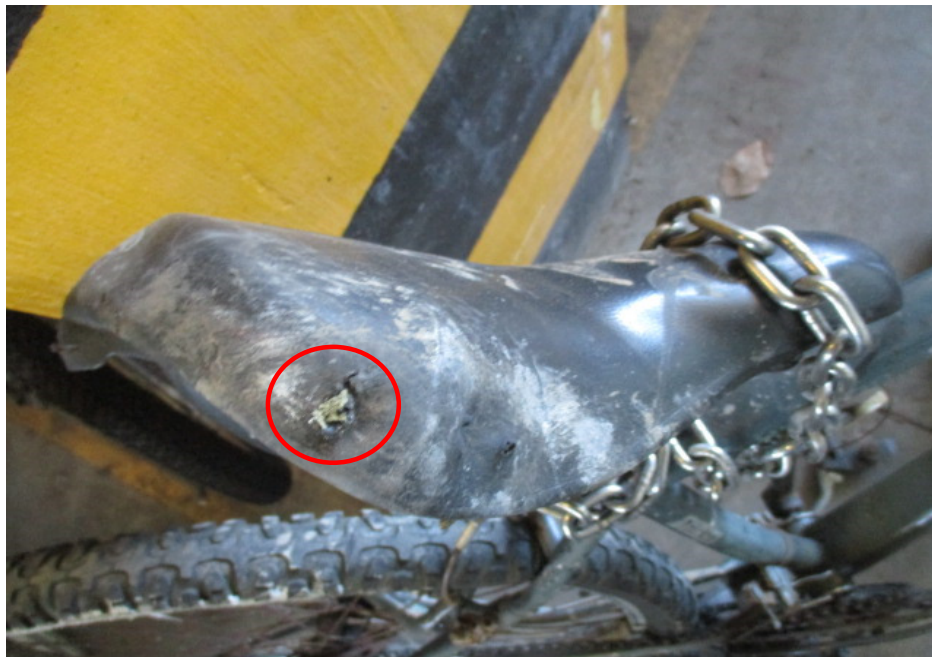
Photo 7 shows a close-up view of the torn seat of the Bicycle due to the accident.

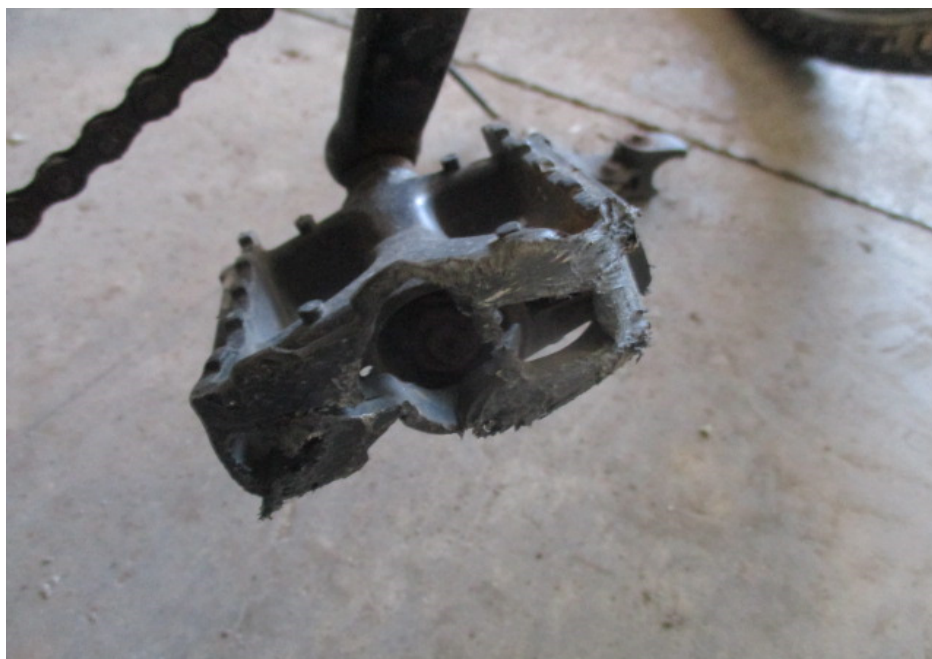
Photo 8 shows the right pedal of the Bicycle which sustained damage as a result of the accident.

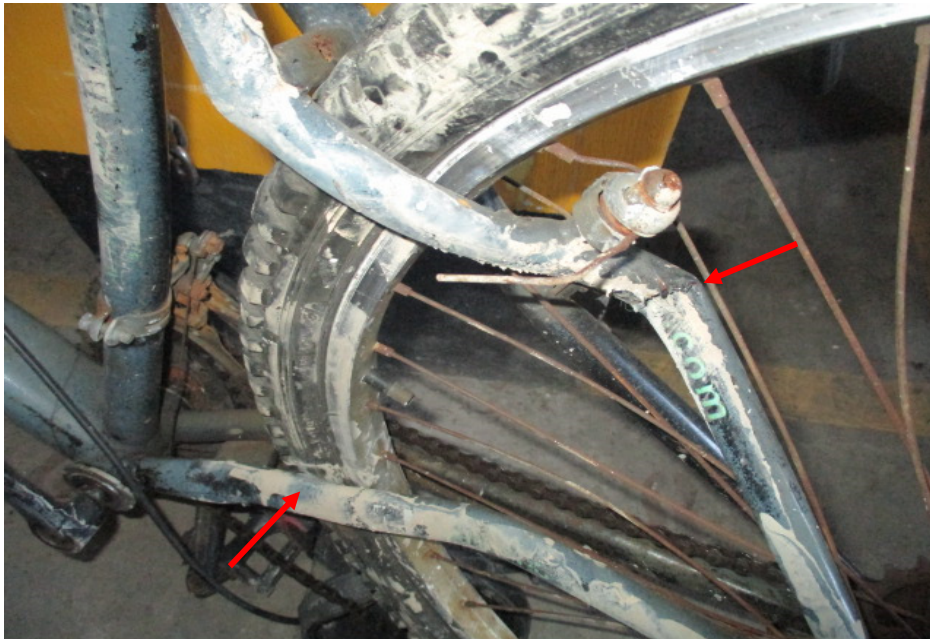
Photo 9 shows a close-up view of the bent rear frame which was observed to be pushed against the rear tyre of the Bicycle as a result of the accident (arrowed).

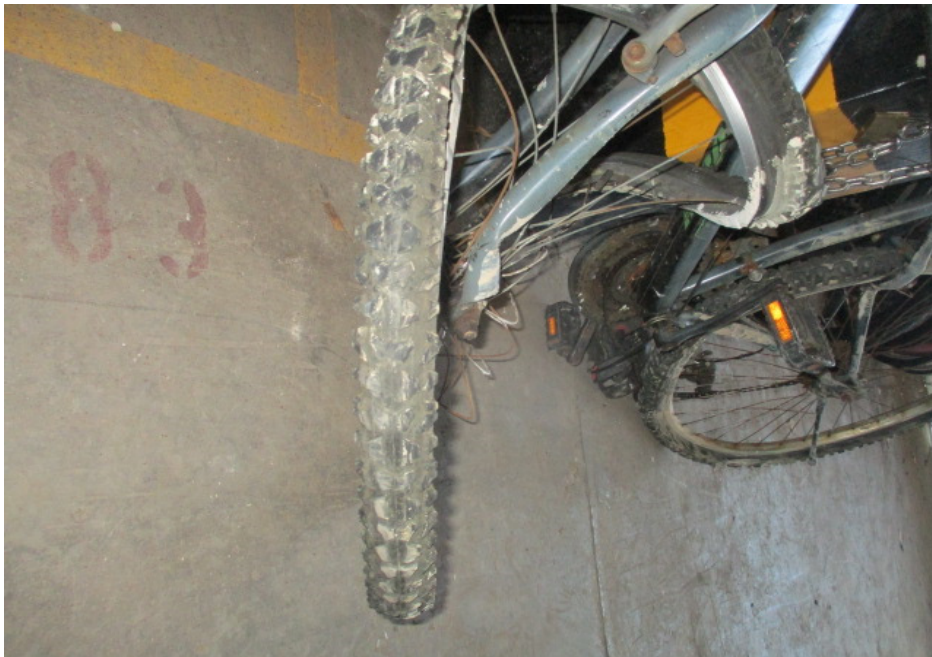
Photo 10 shows the deflated front tyre of the Bicycle most likely as a result of the accident. The pattern of the tread was clearly visible. There was no tear, burst mark(s) and/or punctured hole(s) on the sidewalls as well as across the tread of the front tyre.

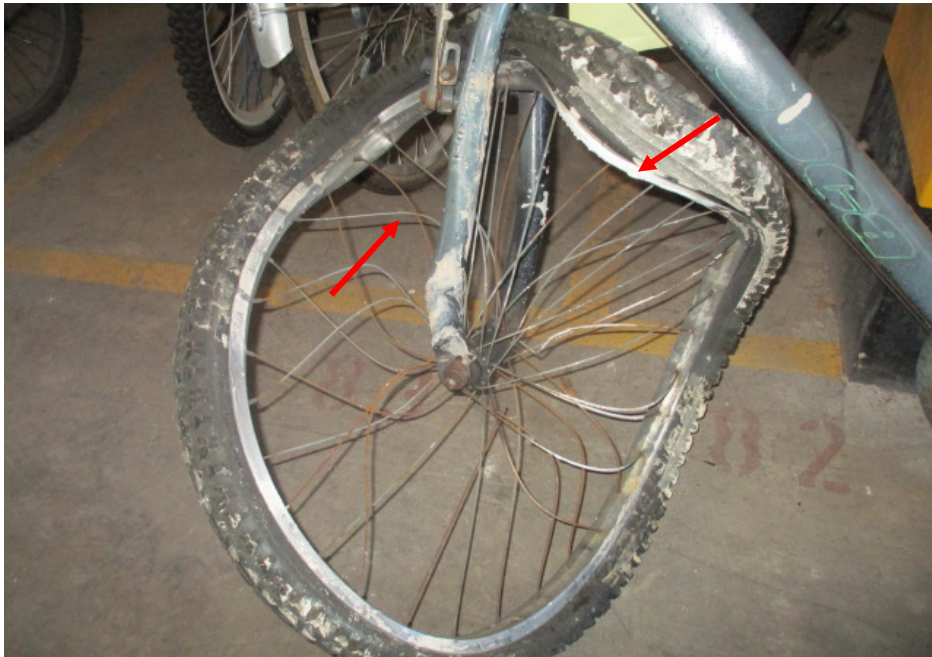
6. Both tyres were wrapped around alloy spoke wheel rims. At the time of our inspection, we did not observe any visible damage on the rear wheel rim of the Bicycle. However we did observe that the front wheel rim was bent and the spokes on the front wheel rim were bent as a result of the accident. See photos 10 - 12 below.

Photo 11 shows the bent spokes and front wheel rim of the Bicycle at the time of our inspection (arrowed).

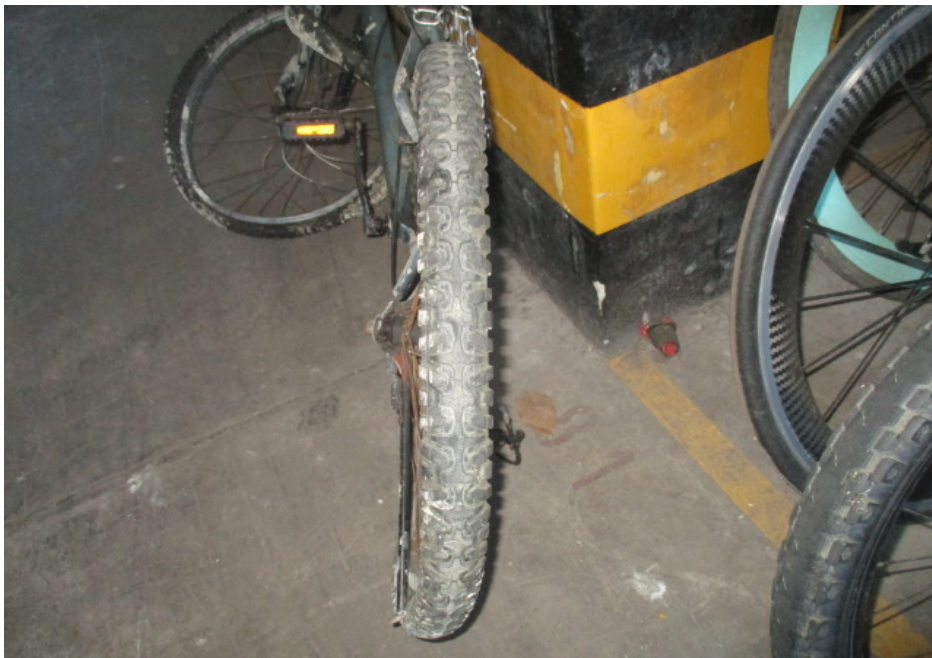
Photo 12 shows the rear tyre of the Motorcycle. The pattern of the tread was clearly visible. There was no tear, burst mark(s) and/or punctured hole(s) on the sidewalls as well as across the tread of the rear tyre.

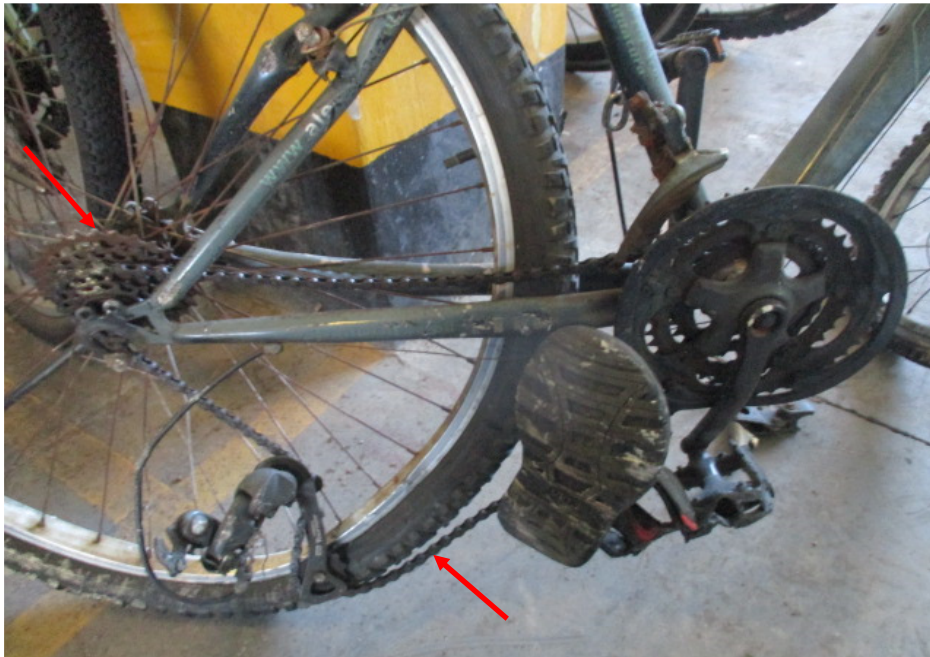
7. The gear train of the Bicycle was found to be severely damaged as a result of the accident. No free play tension test can be conducted due to the extensive damages. See photos 13 & 14 below.

Photo 13 shows the general view of the gear train of the Bicycle, which was observed to have sustained severe damages as a result of the accident (arrowed).

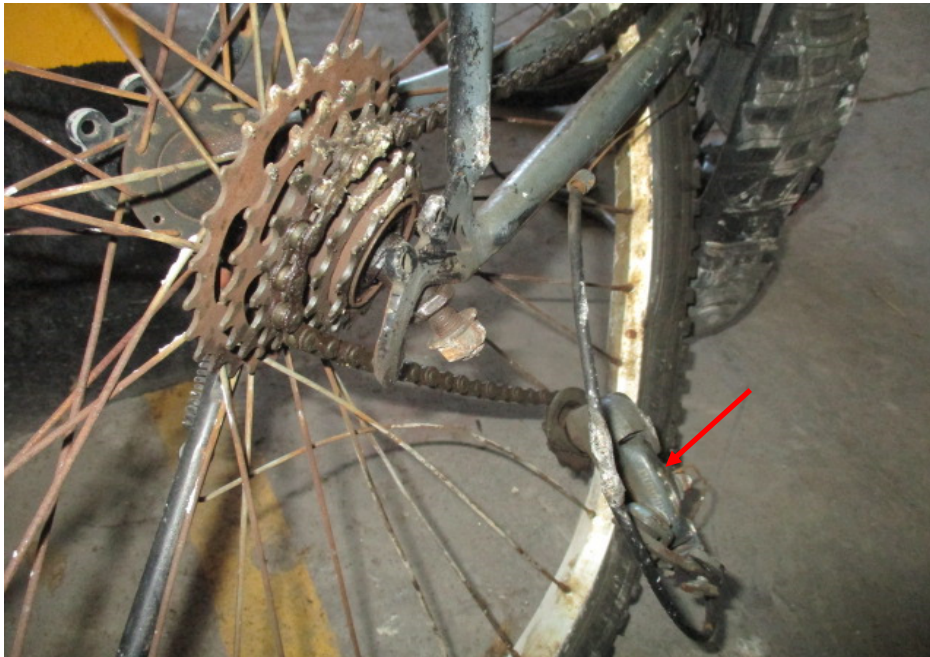
Photo 14 shows a close up view of the gear train of the Bicycle, which was observed to have sustained severe damages as a result of the accident (arrowed). No free play tension test can be conducted due to the extensive damages.

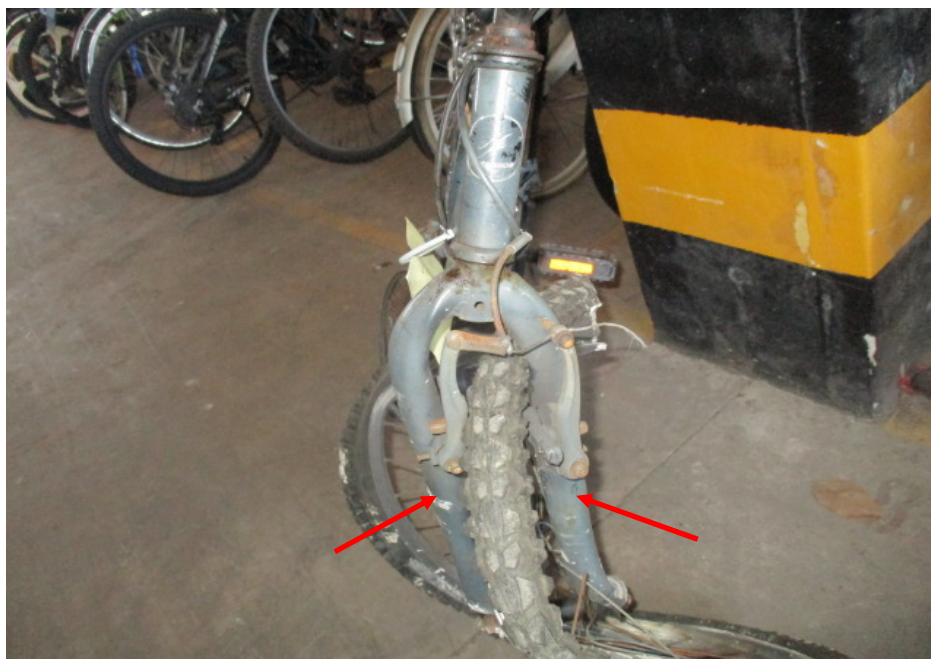
8. For this case, we were not able to conduct any test(s) on the steering system of the Bicycle due to the damages on its front fork. The front fork was found to be bent as a result of the accident, hence causing the whole steering system to be out of alignment and rendering the Bicycle immobile for any static or operational tests.

Photo 15 shows the front fork (arrowed) of the Bicycle. The front fork and fork bracket of the Bicycle were both found to be bent as a result of the accident, hence causing the whole steering system to be out of alignment and rendering the Bicycle immobile for any static or operational tests.

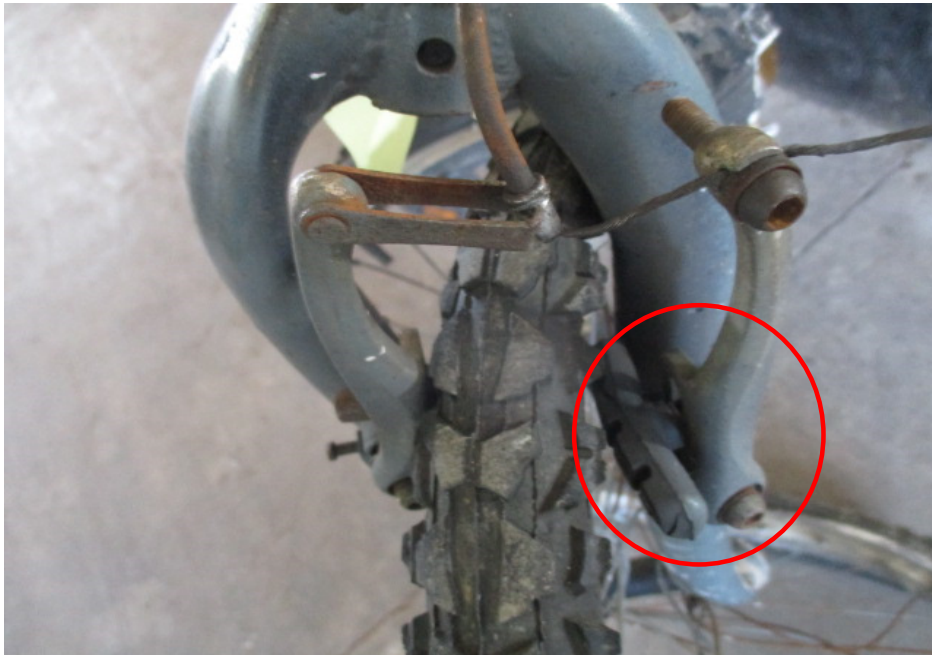
10. A static brake test could not be conducted on the front brake of the Bicycle due to the jammed front hand brake lever. We also noted that the front brake clamp assembly of the Bicycle was intact however it was observed to be slightly misaligned.
11. A static brake test could not be conducted on the rear brake of the Bicycle due to the broken rear hand brake lever as well as the disconnected rear brake connecting cable.

Photo 16 shows the front brake clamp assembly of the Bicycle which was intact however it was observed to be misaligned (circled).

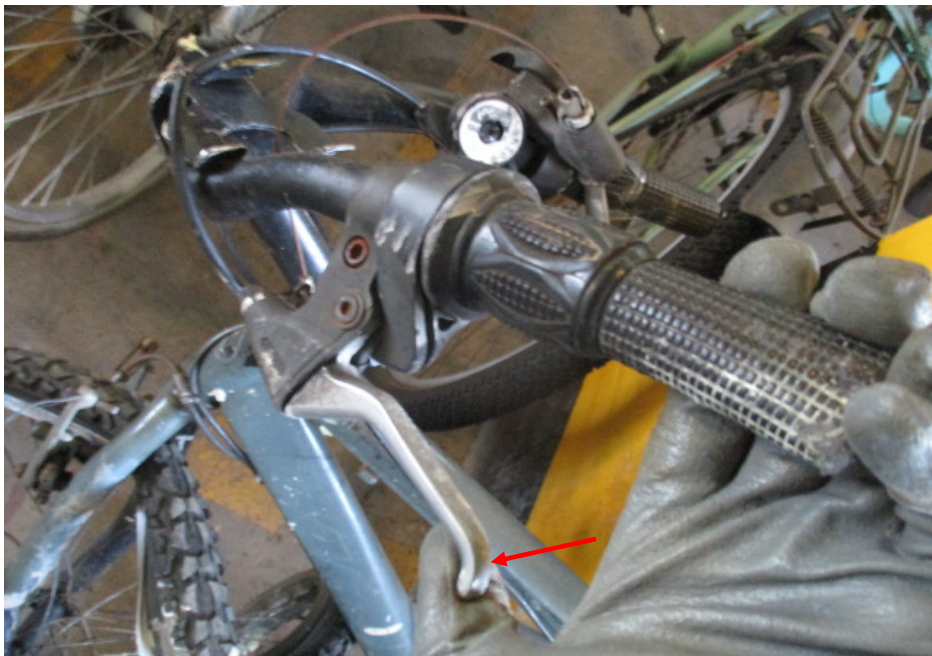
Photo 17 shows the jammed front brake lever as a result of the accident (arrowed). Hence a static brake test could not be conducted on the Bicycle's front braking system.

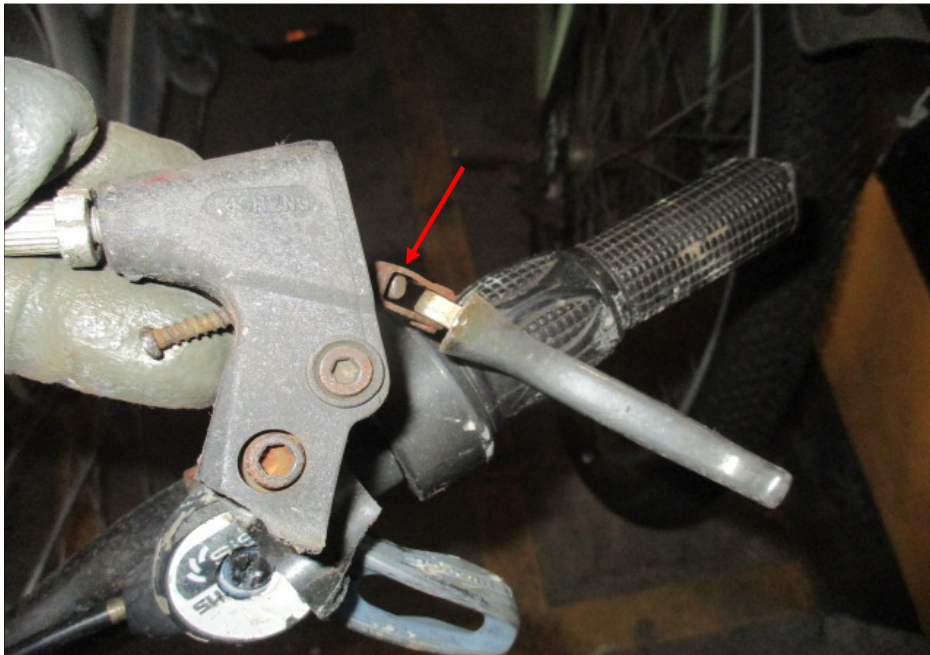
Photo 18 shows the broken rear brake lever as a result of the accident (arrowed). Hence a static brake test could not be conducted on the Bicycle's rear braking system.

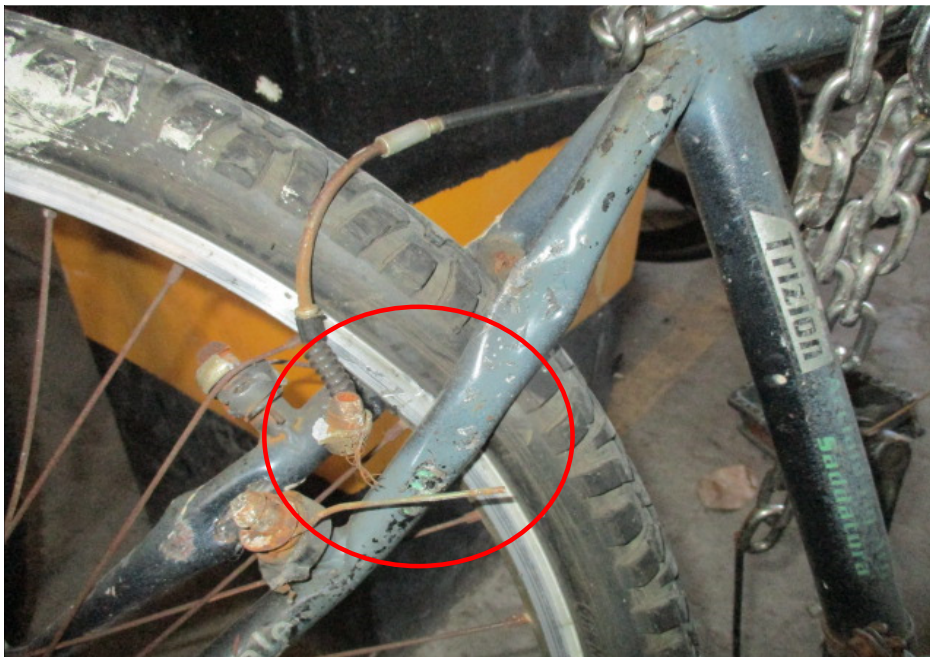
9. The brake system of the Bicycle was controlled by mechanical means (cables and springs). Our visual examination of the various components in the brake system, like the hand brake levers (left & right), brake clamps (front & rear), revealed some of the components sustained damages. The front hand brake lever was jammed as a result of the accident. The rear hand brake lever was broken as a result of the accident. We did not observe any visible tear or cut on the front connecting cable. However the rear connecting cable had been disconnected from the rear hand brake lever as a result of the accident.

Photo 19 shows the rear connecting cable which had been disconnected from the rear hand brake lever as a result of the accident (circled).
