Your Ref: TP/IP/15675/2020
Our Ref : CI/TPD20005417/N

Fatal Accident Investigation Team

INSPECTION REPORT OF MOTORCYCLE WXG 7348

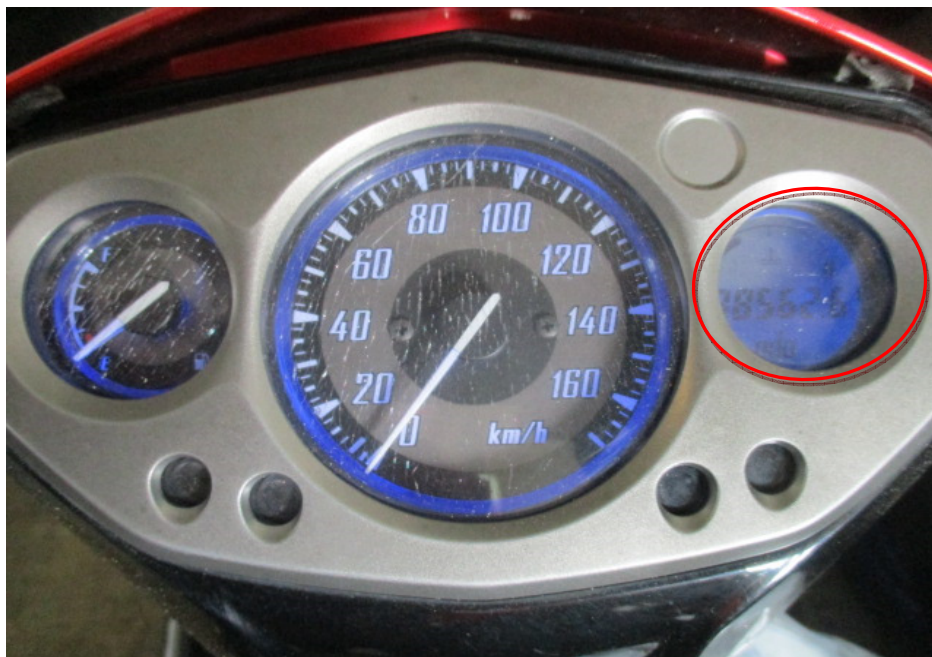
Photo 1 shows the speedometer gauge of the Motorcycle where the mileage recorded at time of our inspection was 38, 562km.

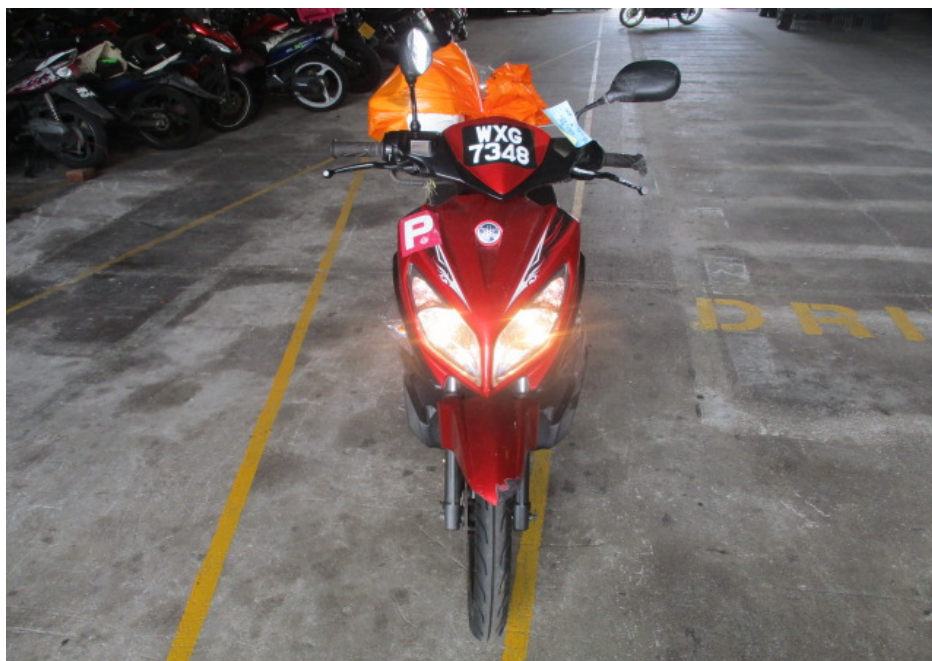
Photo 2 shows a general view of the frontal portion of the Motorcycle at the time of our inspection. The Motorcycle was observed to have sustained minor damages at the frontal portion and left body.

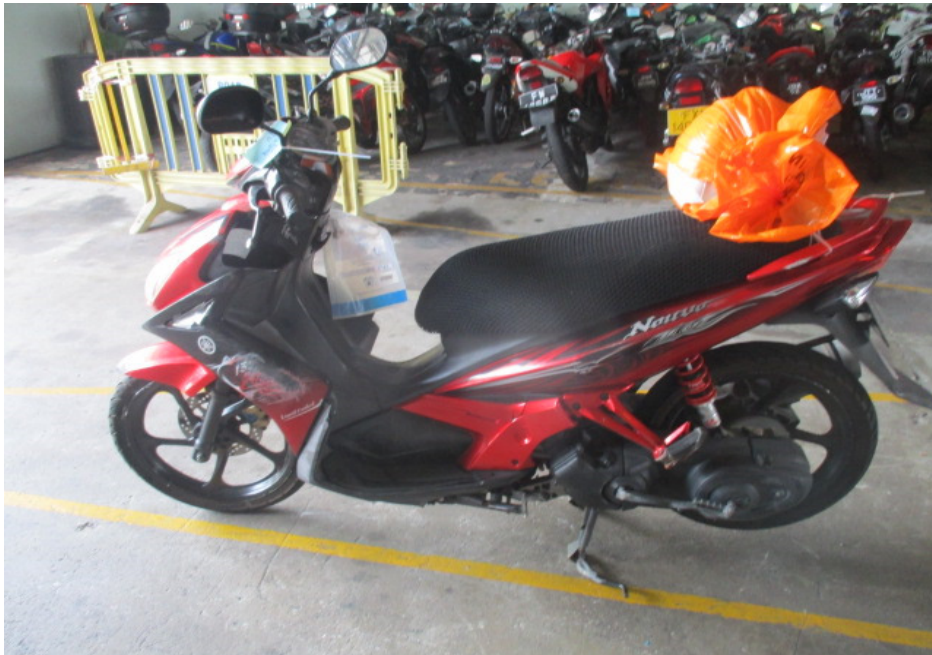
Photo 3 shows a general view of the left body of the Motorcycle at the time of our inspection. The body parts that were found to have been damaged include its front cowling, front mudguard, rear brake lever, left side mirror, left handlebar grip, left side cowling, left side cover, left rear side cover, left pillion footpeg and left rear signal lamp, amongst others as a result of the accident.

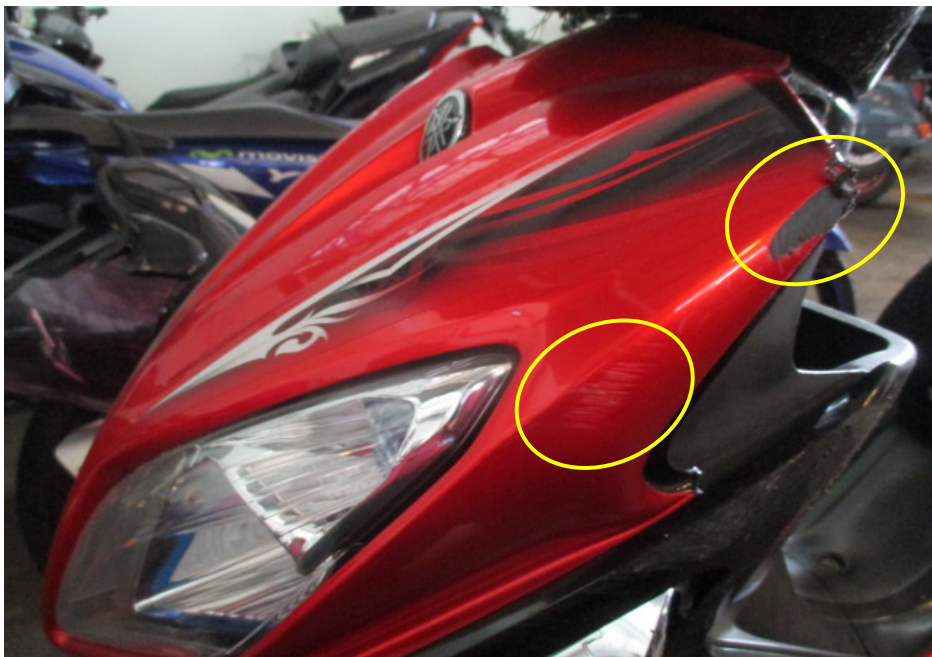
Photo 4 shows a closer view of the damaged front cowling of the Motorcycle at the time of our inspection (circled).

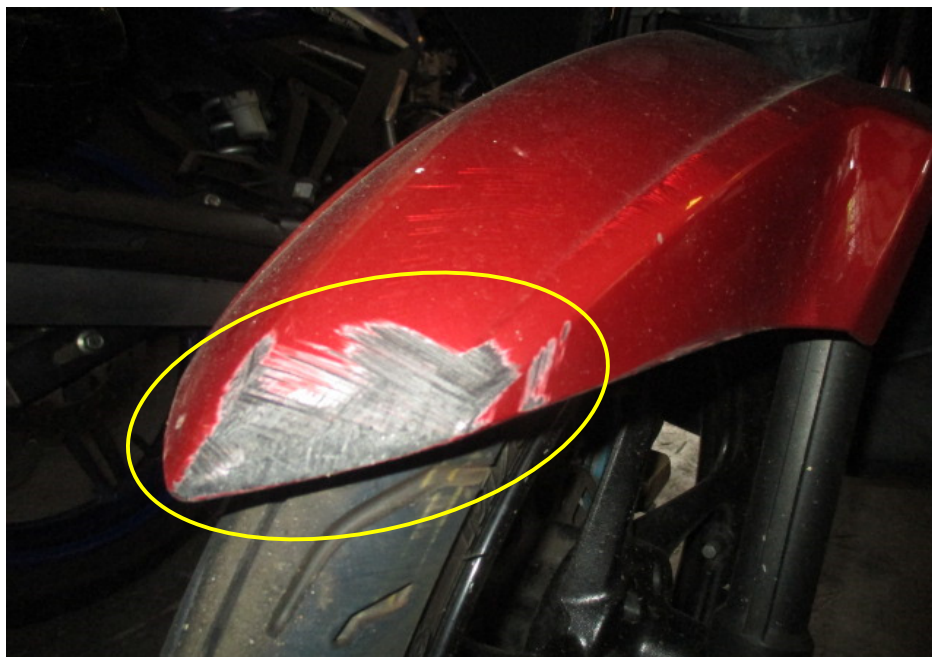
Photo 5 shows a closer view of the front mudguard which was amongst the body parts at the front body of the Motorcycle that had sustained damage as a result of the accident (circled.)

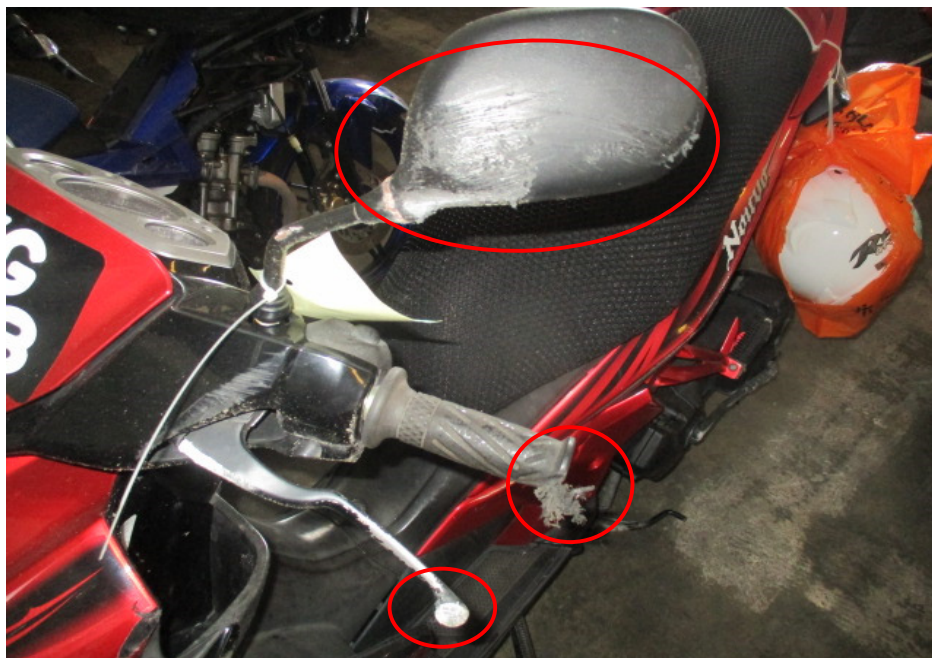
Photo 6 shows a closer view of the left side mirror, left handlebar grip and rear brake lever of the Motorcycle which were observed to be damaged due to the accident (circled).

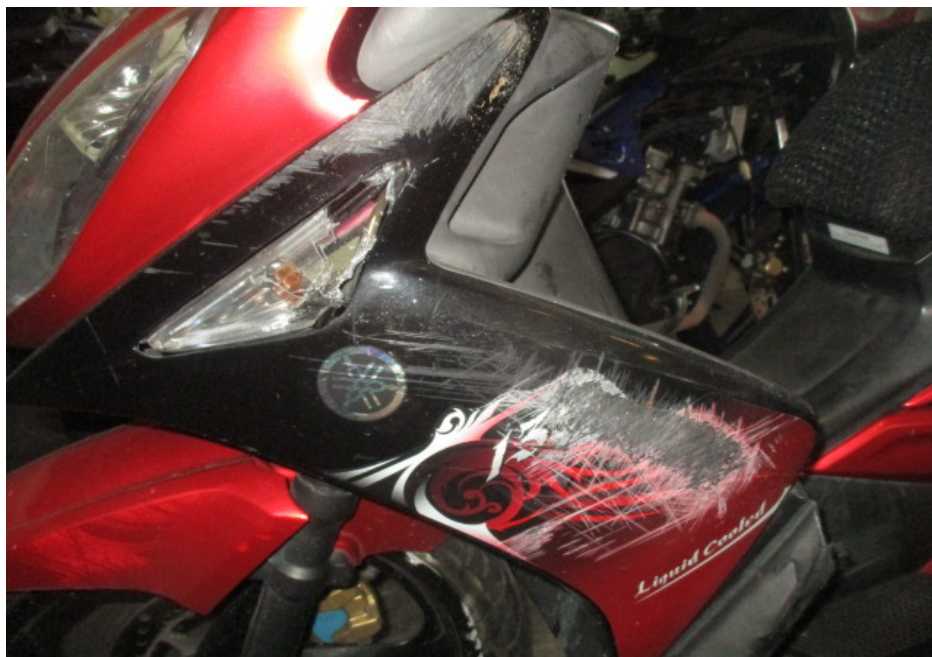
Photo 7 shows the damaged left side cowling of the Motorcycle. The damage sustained was mainly of grazing nature.

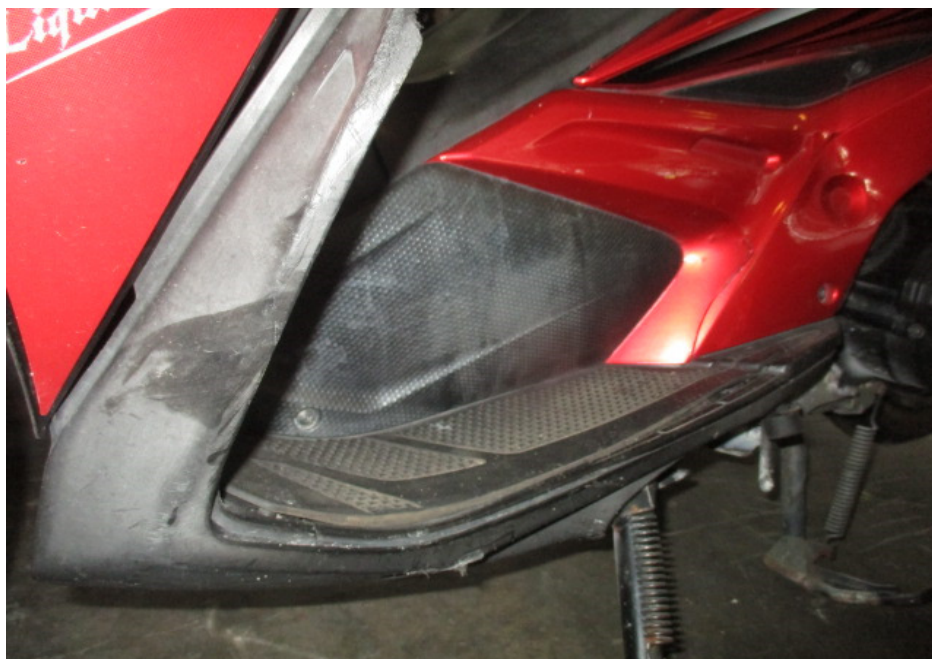
Photo 8 shows a close-up view of the left lower side cowling of the Motorcycle at the time of our inspection. The damage sustained was mainly of grazing nature.

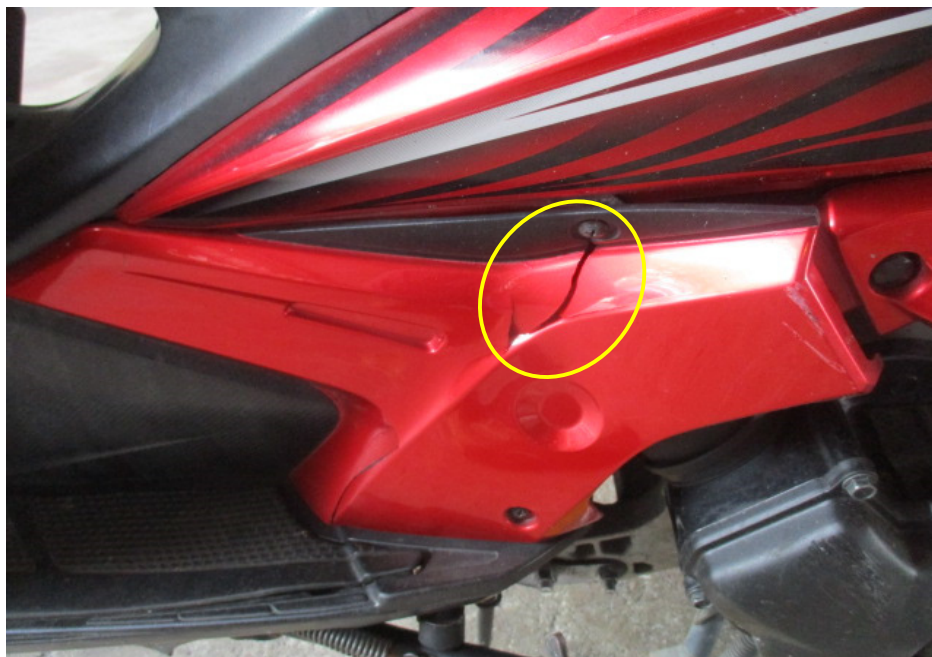
Photo 9 shows a close-up view of the cracked left side cover of the Motorcycle at the time of our inspection (circled).

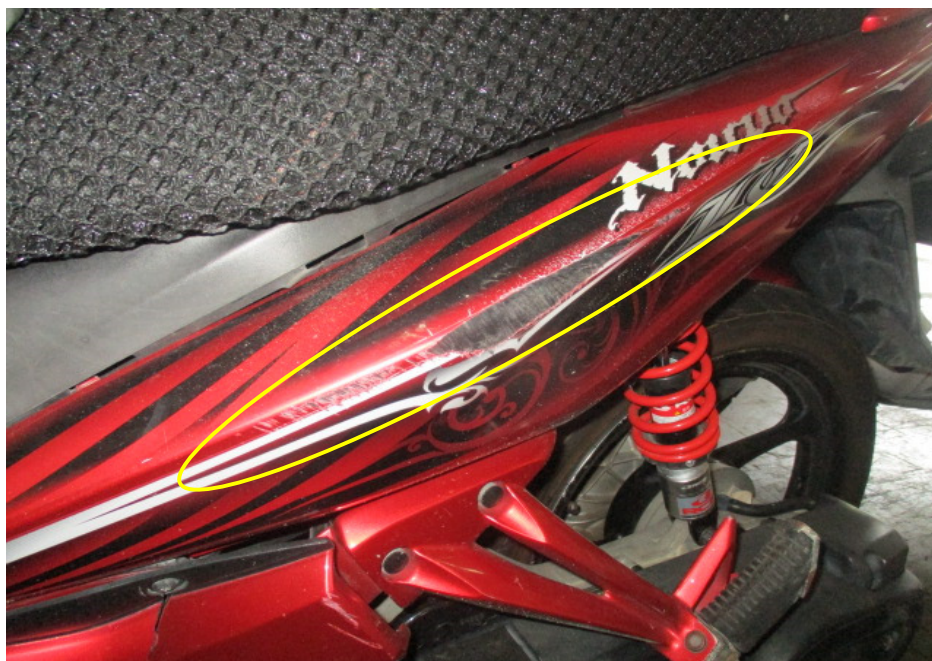
Photo 10 shows a closer view of the damaged left rear side cover of the Motorcycle which was observed to have sustained scratches due to the accident (circled).

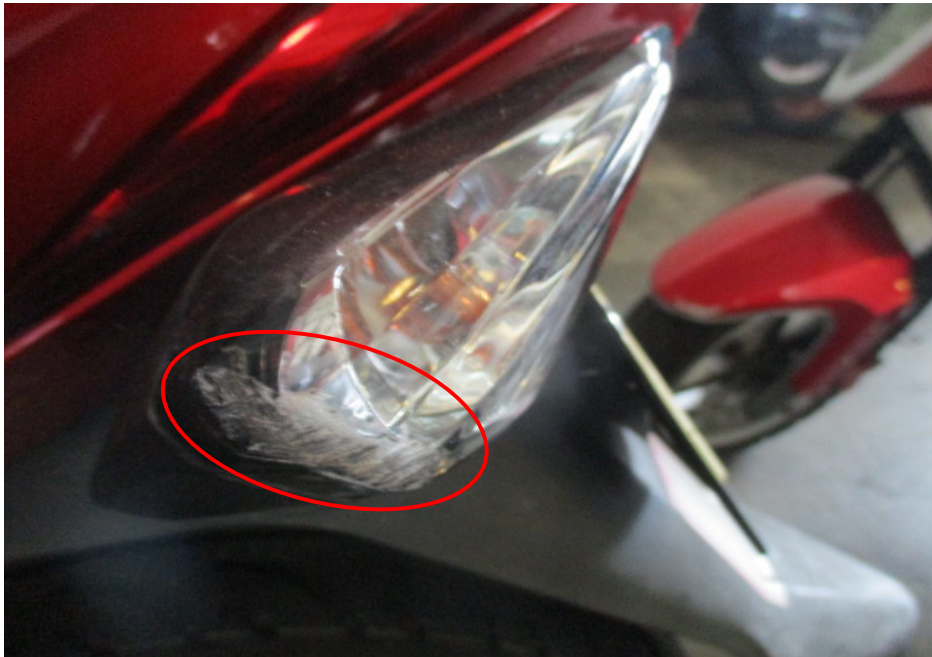
Photo 11 shows a closer view of the grazed left rear signal lamp of the Motorcycle at the time of our inspection (circled).

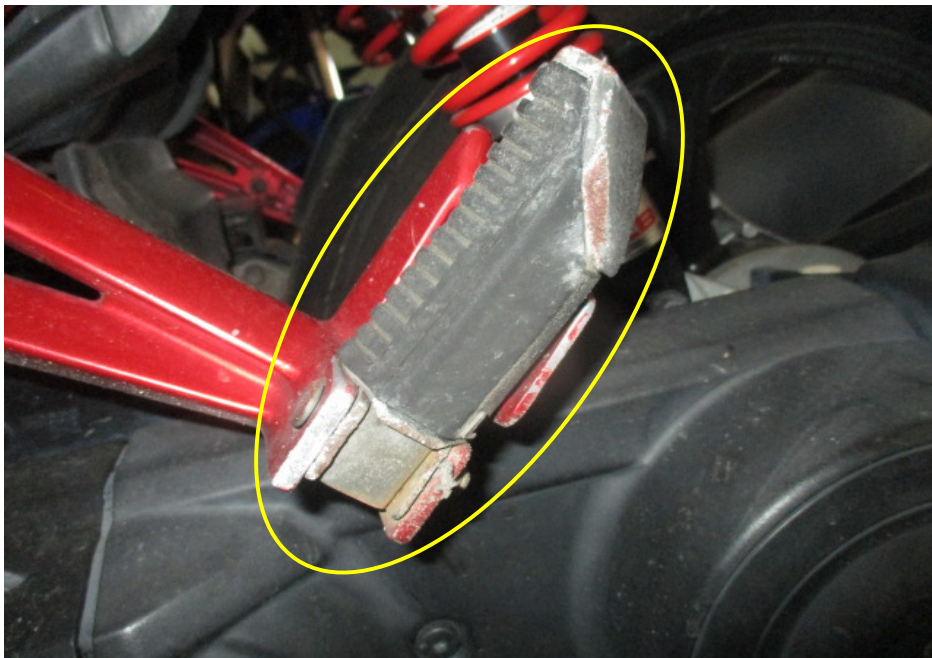
Photo 12 shows a closer view of the damaged left pillion footpeg of the Motorcycle at the time of our inspection (circled).

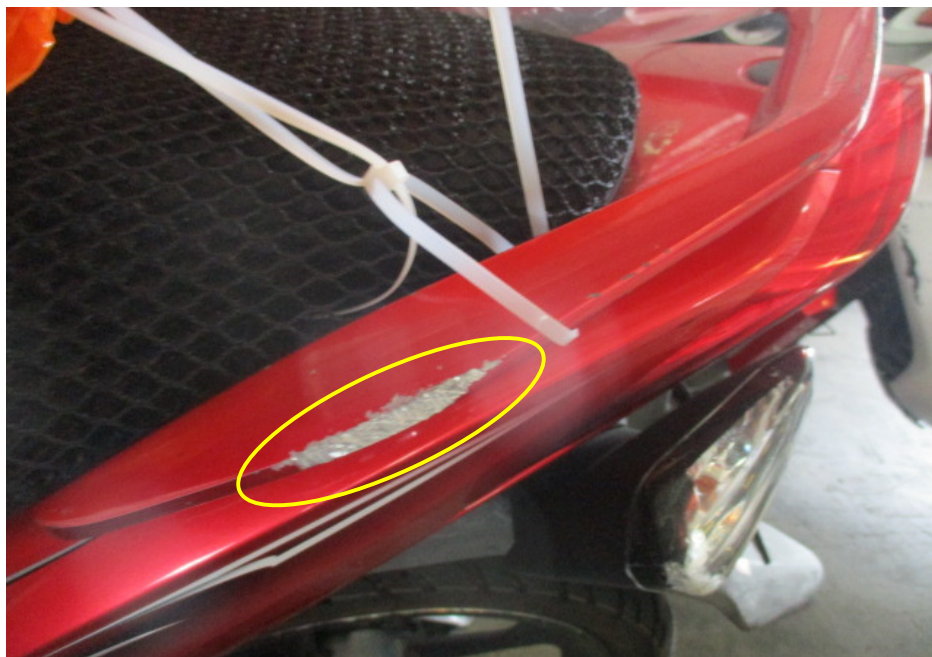
Photo 13 shows a closer view of the left grab bar of the Motorcycle which had sustained damage due to the accident (circled).

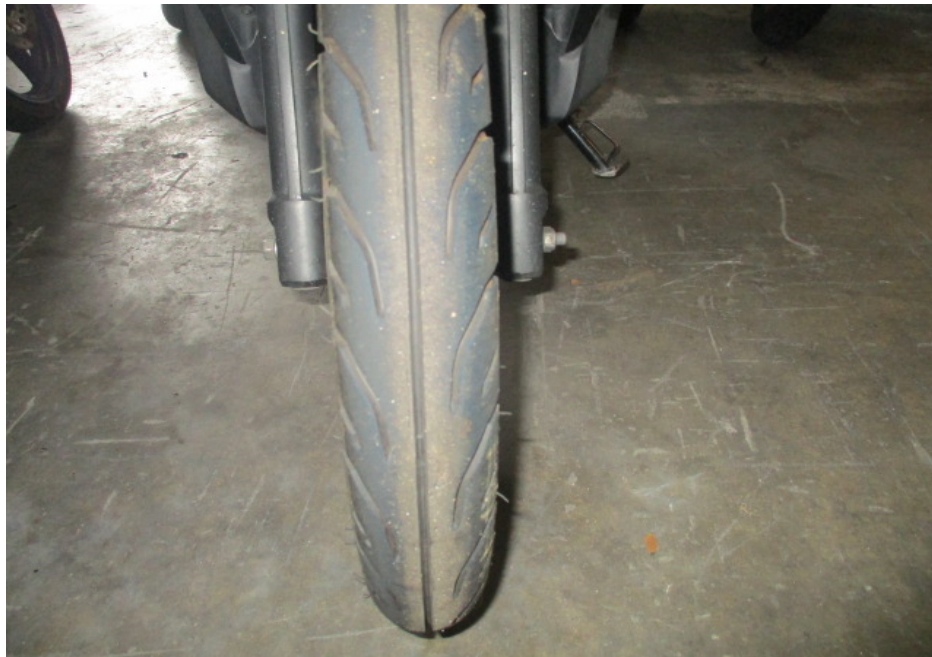
Photo 14 shows the condition of the Motorcycle's front tyre. The front tyre was observed to be in serviceable condition with remaining tread depth of approximately 3mm. There was no tear, burst mark(s) and/or punctured hole(s) on the sidewalls as well as across the tread of the front tyre.

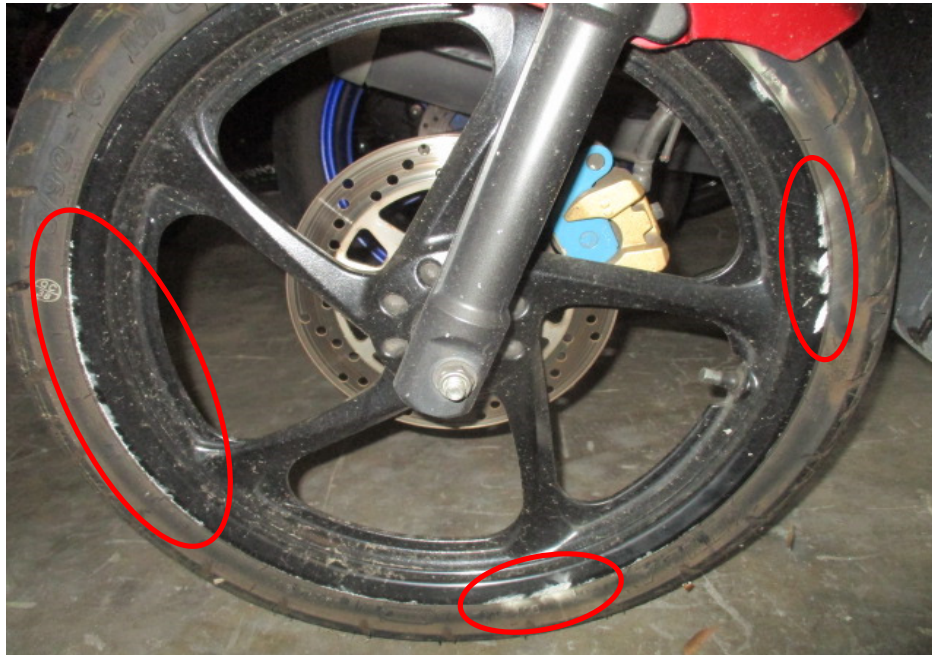
7. The 2 tyres were wrapped around alloy wheel rims. At the time of our inspection, we did not observe any visible damage on the rear wheel rim of the Motorcycle. We had however found some relatively minor marks of grazing nature on the edges of the front wheel rim, at the left side of the Motorcycle. See photos 14 - 16 below.

Photo 15 shows the left front wheel rim and tyre of the Motorcycle at the time of our inspection. The front tyre was observed to be in serviceable condition and sufficiently inflated for vehicular operation. Some relatively minor marks of grazing nature were observed on the edges of the front wheel rim (circled), at the left side of the Motorcycle.

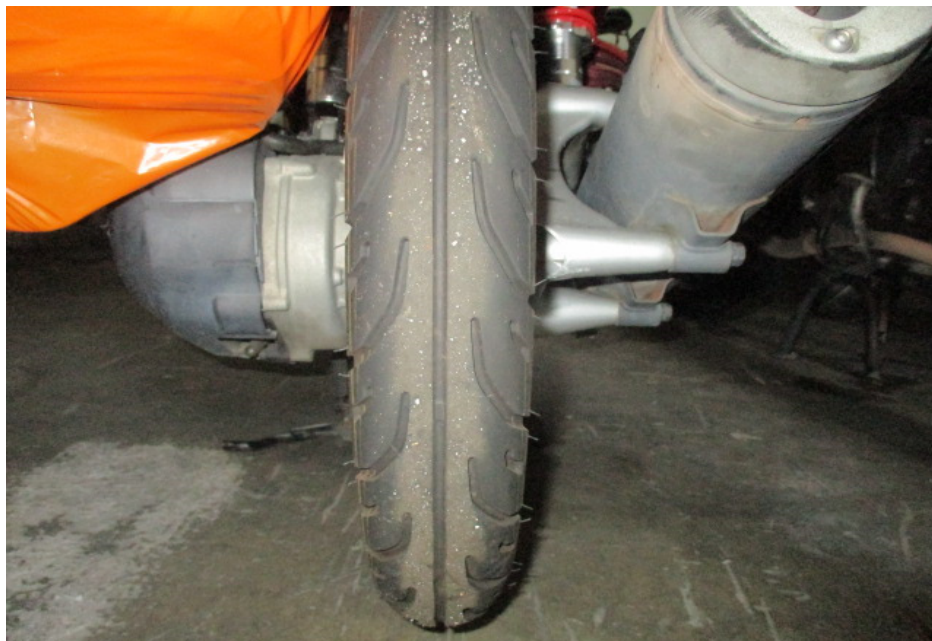
Photo 16 shows the condition of the Motorcycle's rear tyre. The rear tyre was observed to be in serviceable condition with remaining tread depth of approximately 3mm. The tyre was also observed to be sufficiently inflated for vehicular operation. We did not observe any tear, burst mark(s) and/or punctured hole(s) on the sidewalls as well as across the tread of the rear tyre.

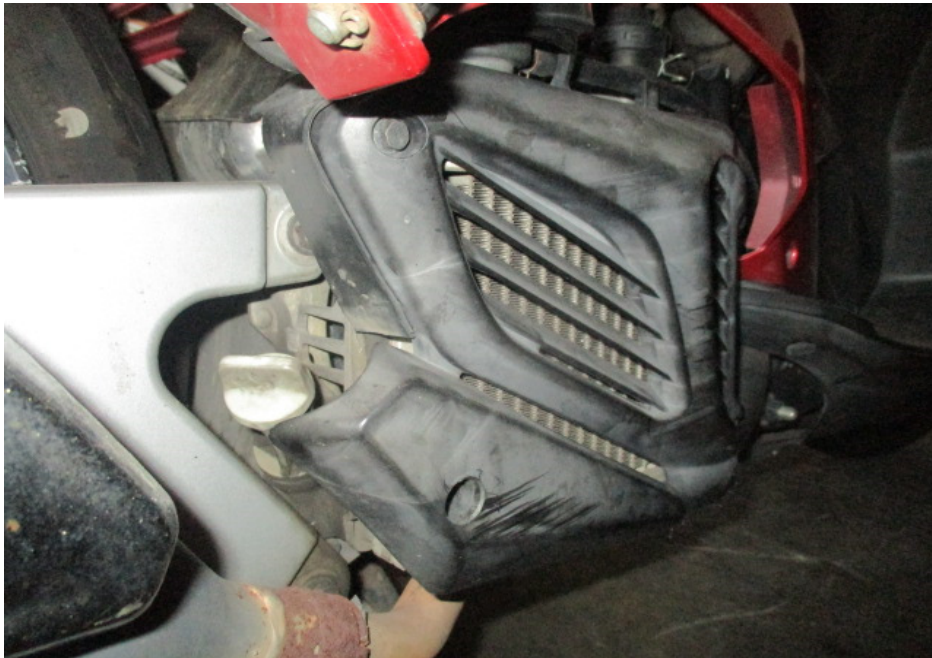
Photo 17 shows the radiator of the Motorcycle at the time of our inspection. The radiator was found to be intact with no visible damage. There was also no sign(s) or indication(s) of fluid leak observed around the radiator of the Motorcycle.

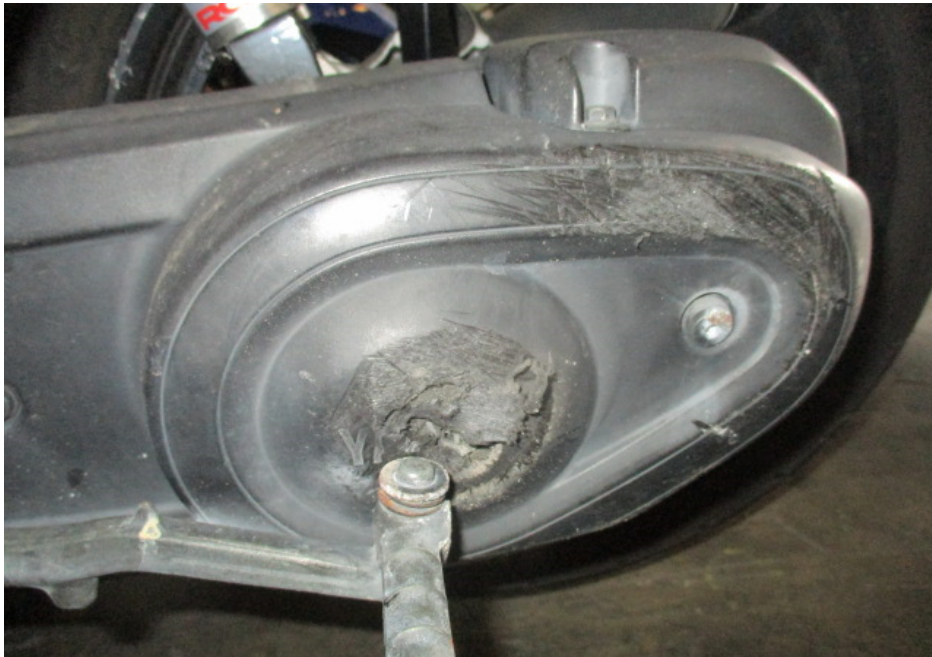
Photo 18 shows the drive train of the Motorcycle which was found to be intact without any misalignment. However the drive train cover had sustained damages of grazing nature as a result of the accident.

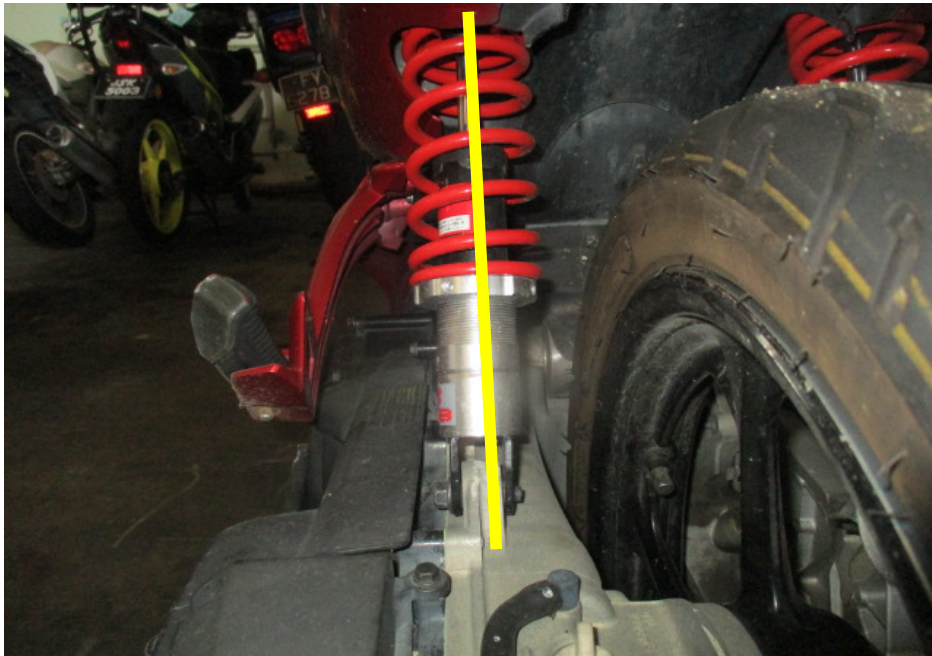
Photo 19 shows the left shock absorber of the Motorcycle which was found to be intact without any misalignment.

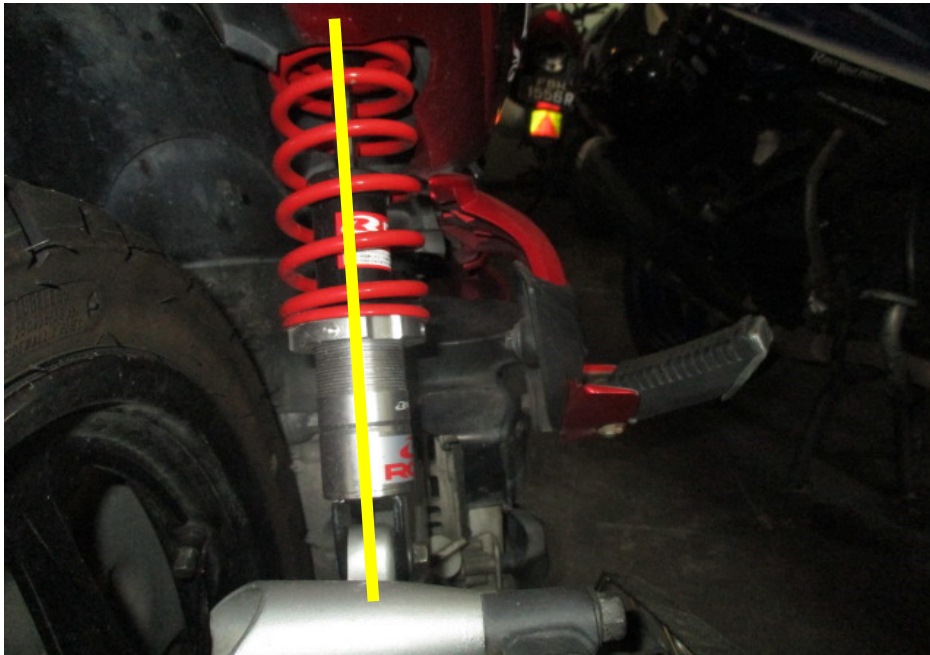
Photo 20 shows the right shock absorber of the Motorcycle which was found to be intact without any misalignment.

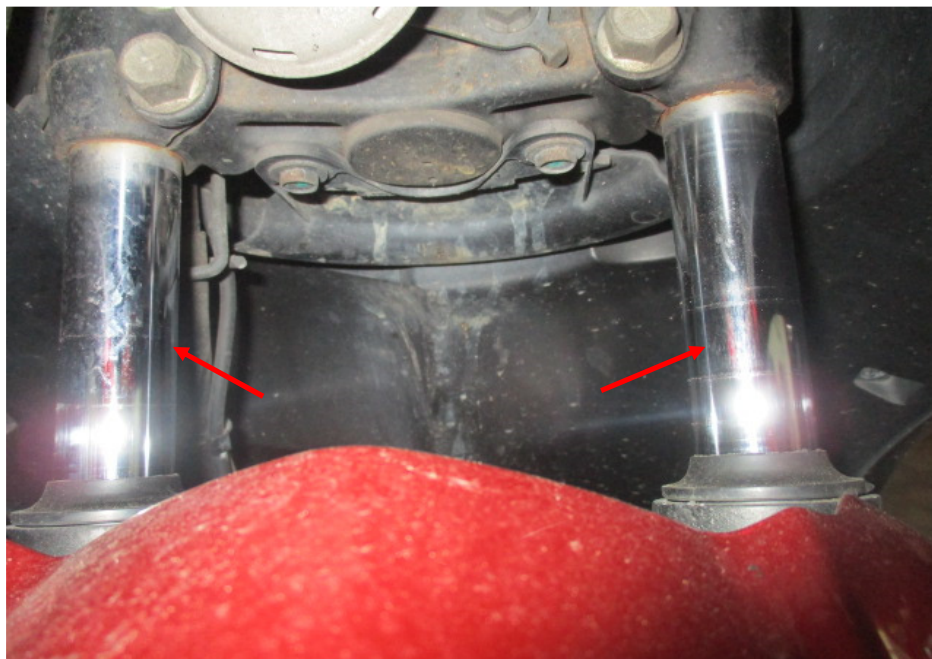
Photo 21 shows the front forks (arrowed) of the Motorcycle. The front forks and fork brackets of the Motorcycle were both found to be intact and undamaged. Turning the Motorcycle's handle bar towards the left and right did not produce any abnormal free play and/or resistance. The steering system of the Motorcycle was in serviceable condition at the time of our inspection.

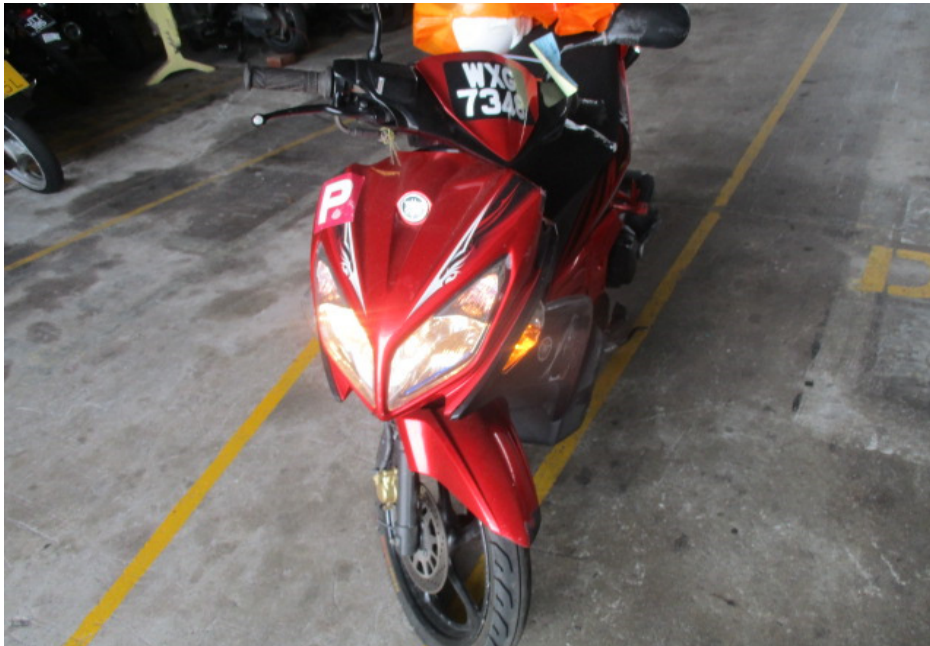
Photo 22 shows the front wheel of the Motorcycle turned towards its full left. Turning the Motorcycle's handle bar towards the left and right did not produce any abnormal free play and/or resistance. This would indicate that the steering system of the Motorcycle was in serviceable condition at the time of our inspection.

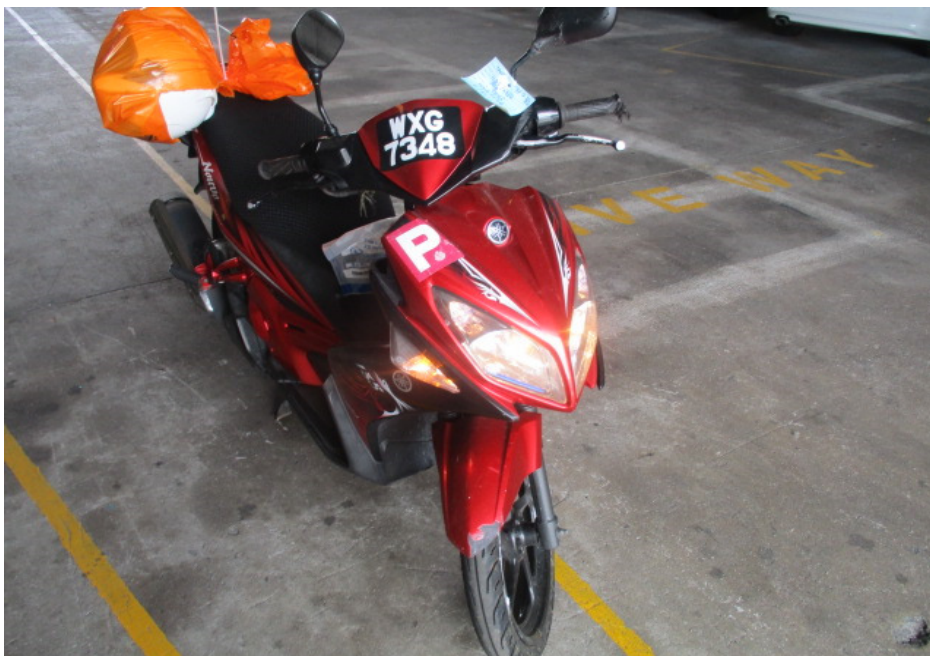
Photo 23 shows the front wheel of the Motorcycle turned towards its full right. Turning the Motorcycle's handle bar towards the left and right did not produce any abnormal free play and/or resistance. This would indicate that the steering system of the Motorcycle was in serviceable condition at the time of our inspection.

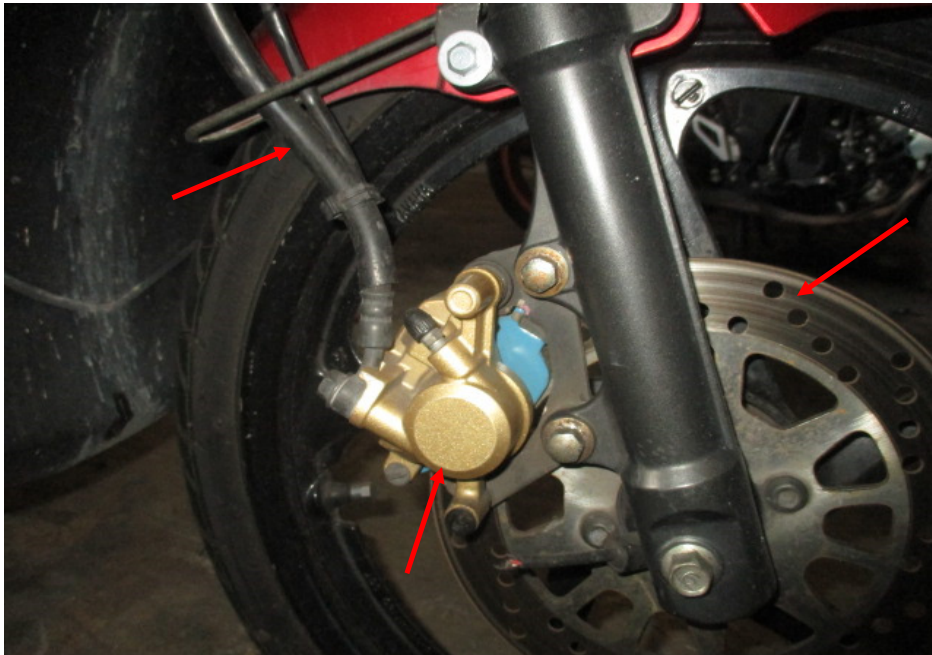
Photo 24 shows a close up view of the front brake caliper, front brake disc and front brake hose (arrowed) of the Motorcycle, which are all part of the components in the hydraulic front brake system of the Motorcycle. Our visual checks of these various components had revealed all to be intact with no visible damage. No leakage of brake fluid was also observed.

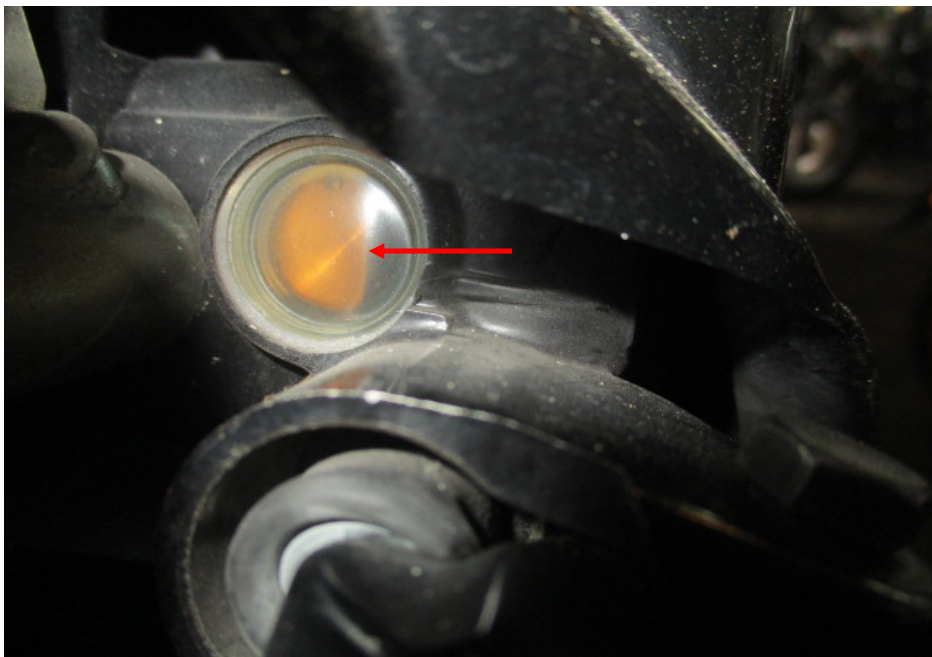
Photo 25 shows the brake fluid reservoir for the front brake of the Motorcycle. The brake fluid was observed to be of sufficient level and without contamination for operational purposes (arrowed).

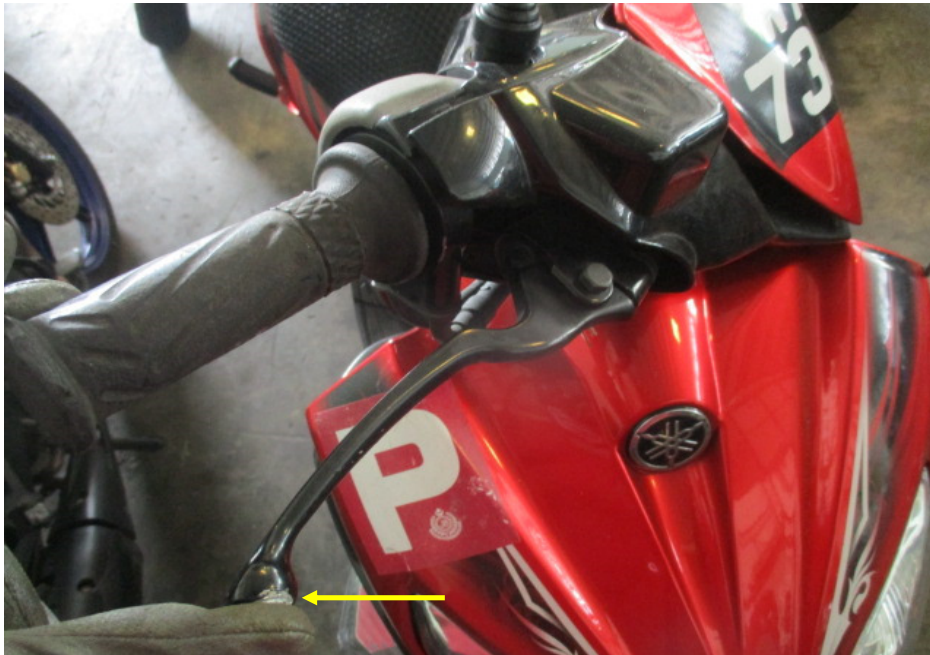
12. Static brake tests conducted on the Motorcycle had appeared to indicate that the brake system of the Motorcycle was in serviceable condition. There was some resistance felt (spongy like feel) upon pressing the front brake lever. This would indicate that there's no leakage of pressure/vacuum in the brake system. Our checks on the brake fluid had also indicated that the brake fluid was of sufficient level for operational purposes, and without contamination.

Photo 26 shows the front brake lever being depressed. There was some resistance felt (spongy like feel) upon pressing the front brake lever (arrowed). This would indicate that there is no leakage of pressure/vacuum in the brake system.

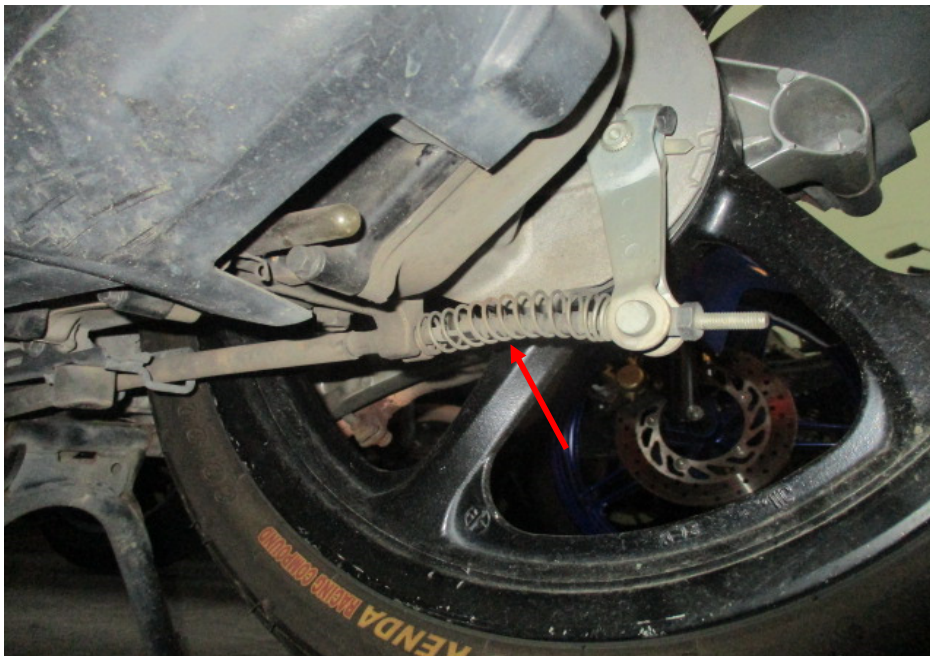
Photo 27 shows the rear wheel of the Motorcycle. The type of brake system for the rear wheel was of a mechanical type, controlled by the brake foot pedal of the Motorcycle. Our checks of the cable (arrowed), spring and drum which are all part of the components in the rear brake system of the Motorcycle reveal all to be intact and without damage.
