Your Ref: TP/IP/09681/2020
Our Ref : CI/TPD20005418/N

12 May 2020

MECHANICAL INSPECTION REPORT OF MOTORCYCLE VM 5736

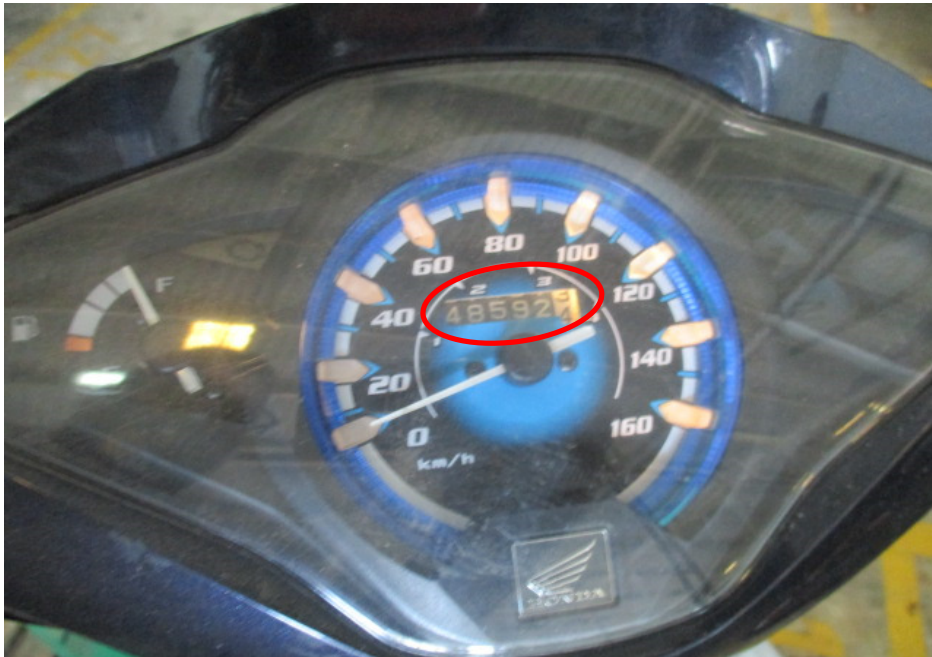
Photo 1 shows the speedometer gauge of the Motorcycle where the mileage recorded at the time of our inspection was 48, 592km (circled).

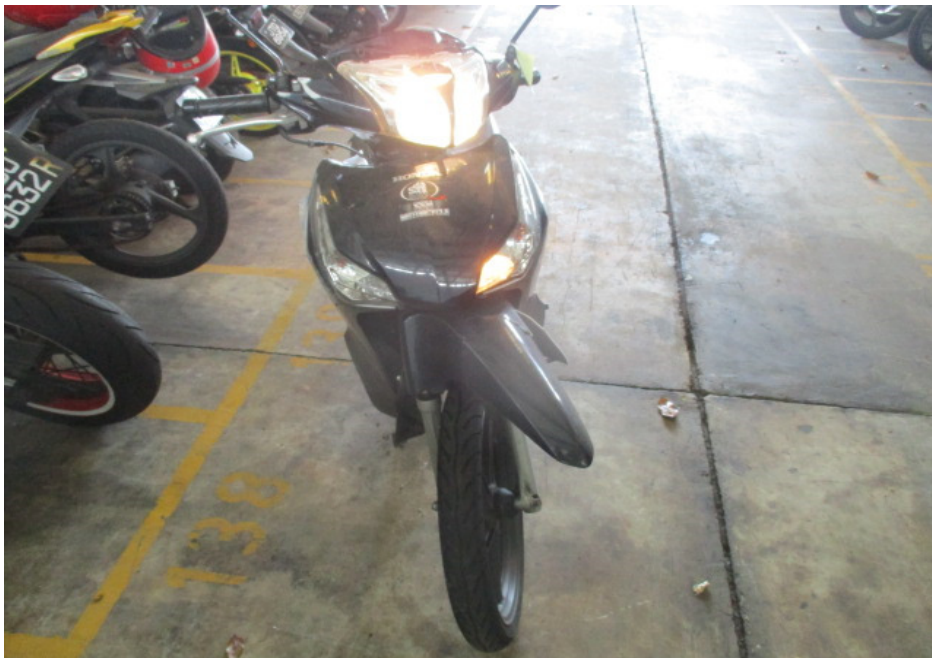
Photo 2 shows a general view of the frontal portion of the Motorcycle at the time of our inspection. The Motorcycle had sustained damages all around.

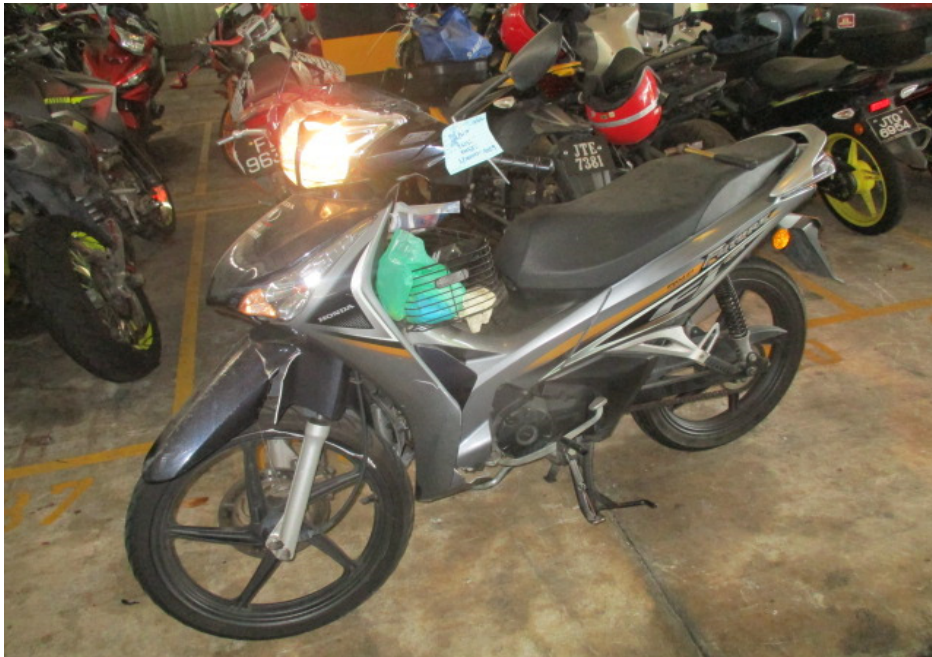
Photo 3 shows a general view of the left body of the Motorcycle at the time of our inspection. The Motorcycle had sustained damages all around. Body parts that were found to have been damaged include its headlight assembly, front cowlings, front fork assembly, front mudguard, side cowlings, right side mirror, front brake lever, right handlebar end, brake foot pedal, right front footrest, tail light assembly and rear number plate, amongst others.

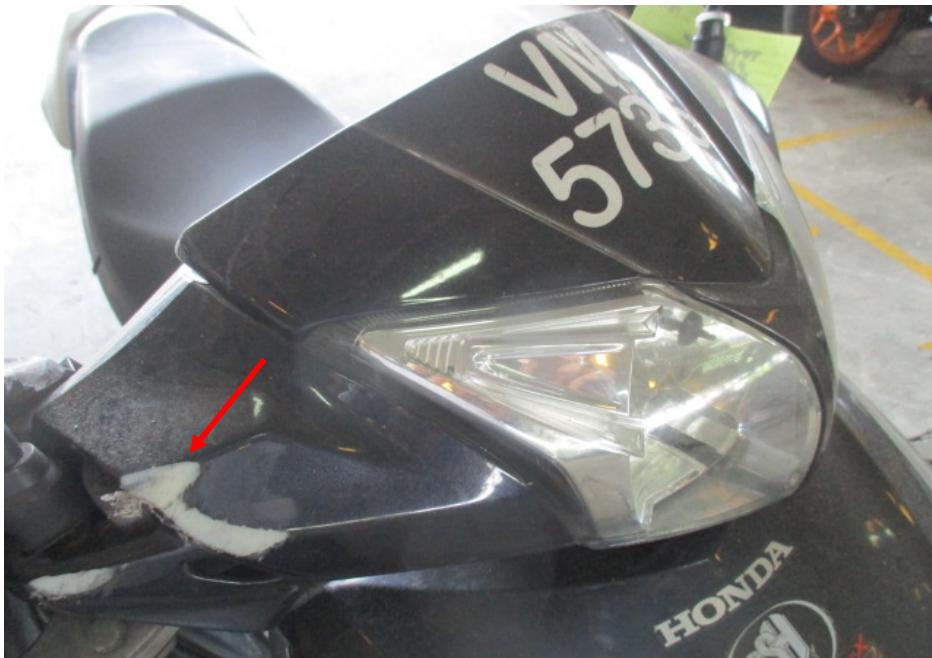
Photo 4 shows a closer view of the headlight assembly which was amongst the body parts at the front body of the Motorcycle that had sustained damages as a result of the accident (arrowed).

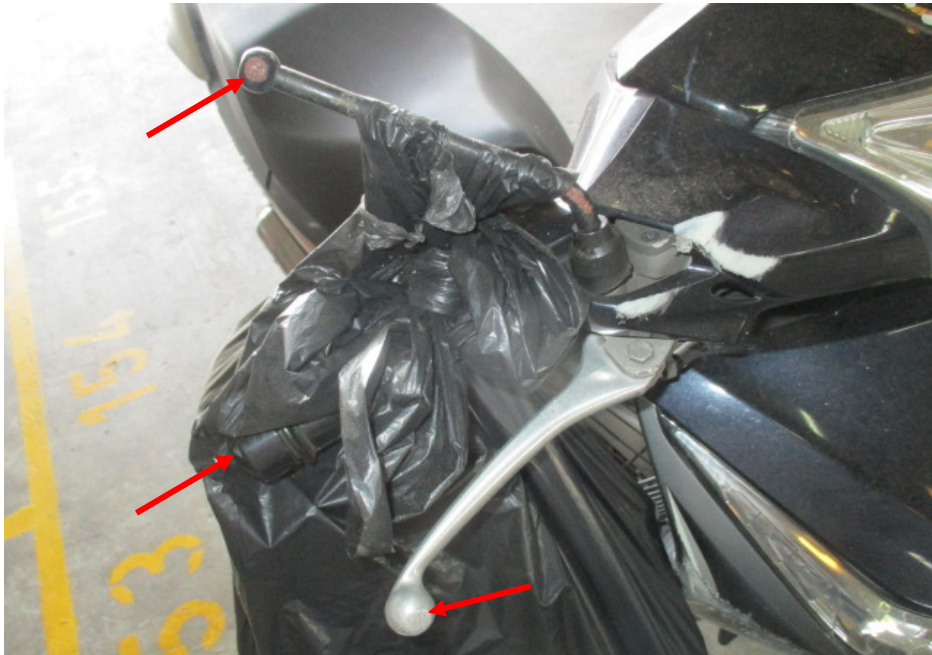
Photo 5 shows a closer view of the front brake lever, right side mirror and right handlebar end (arrowed) of the Motorcycle. These parts were amongst the body parts of the Motorcycle which were damaged as a result of the accident.

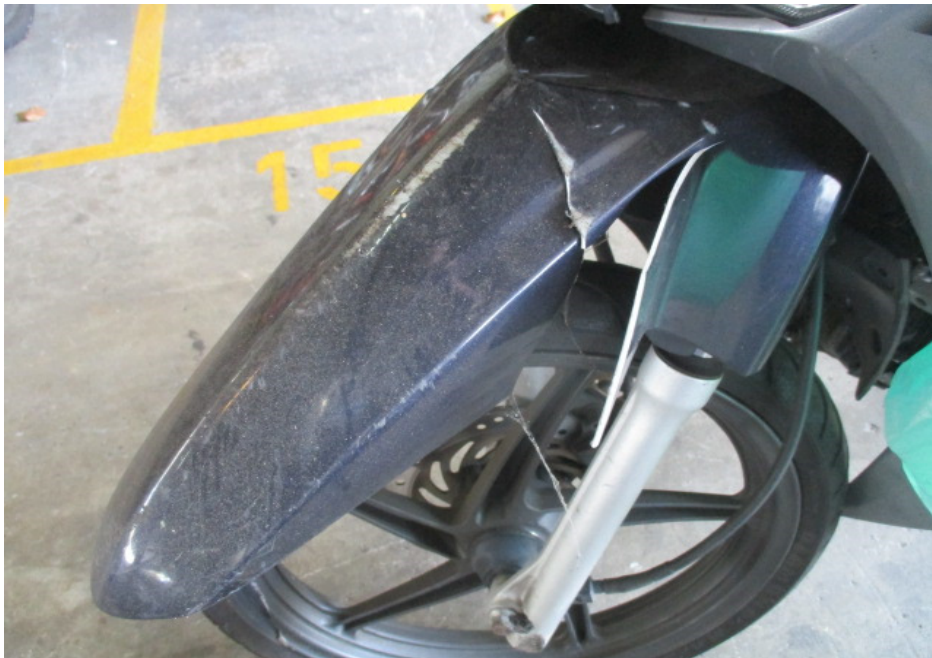
Photo 6 shows a closer view of the front mudguard, which was amongst the body parts of the Motorcycle that had sustained damage as a result of the accident.

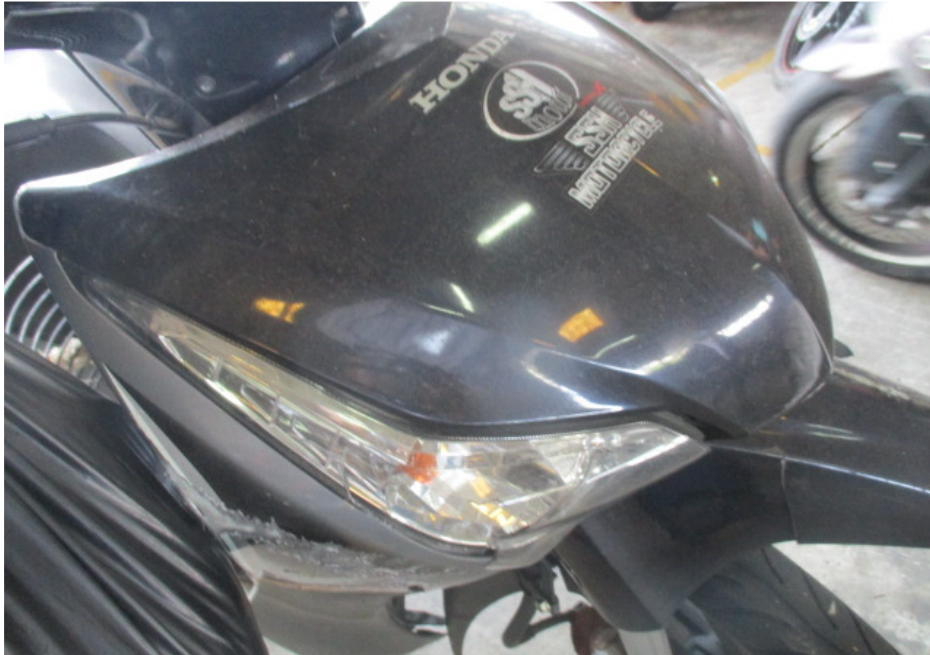
Photo 7 shows a closer view of the front cowling which was amongst the body parts at the front body of the Motorcycle that had sustained damages as a result of the accident.

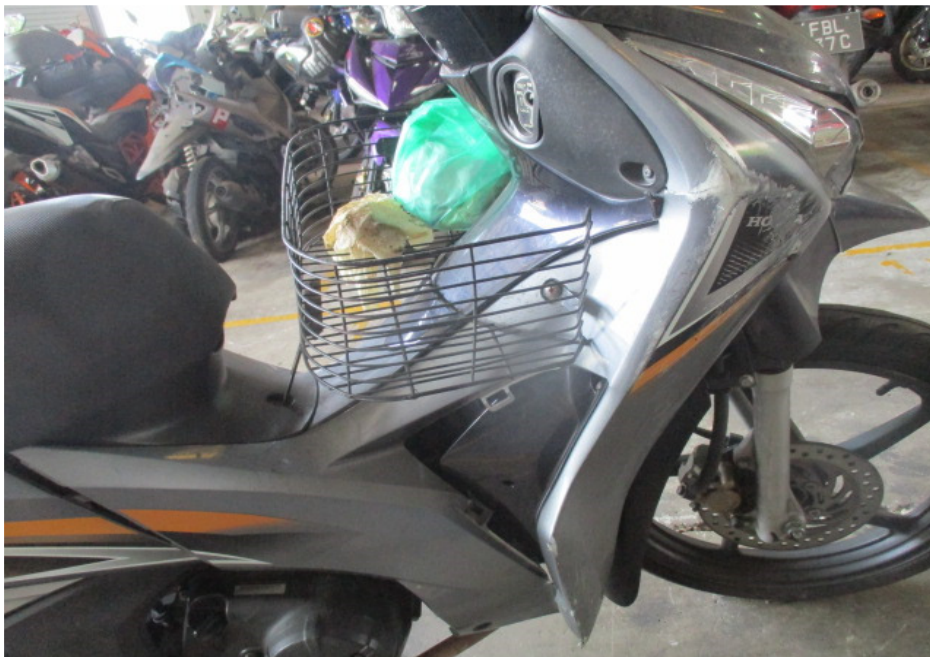
Photo 8 shows a closer view of the right cowling which was amongst the body parts of the Motorcycle that had sustained damages as a result of the accident.

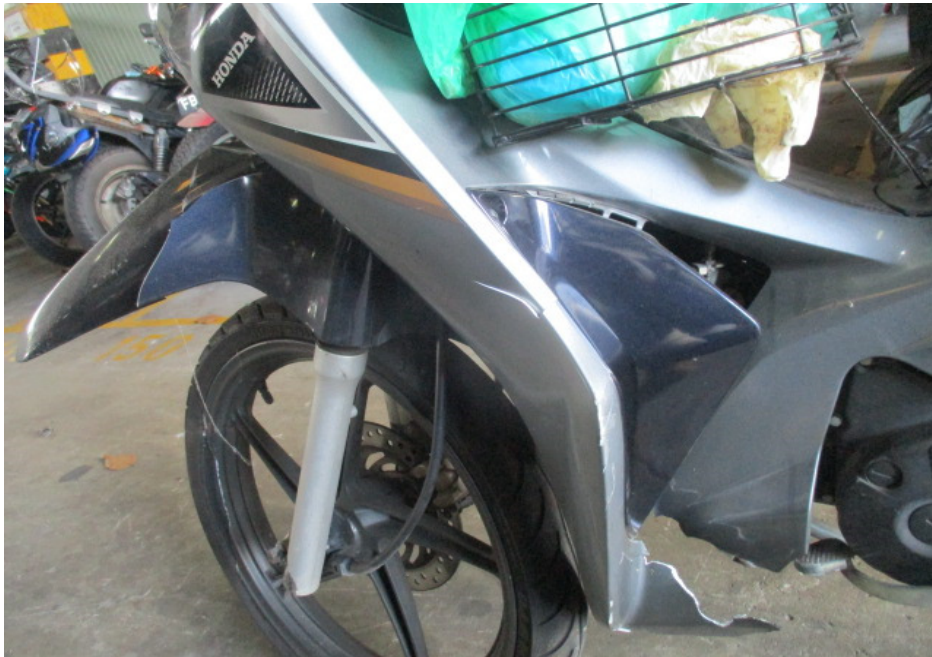
Photo 9 shows a closer view of the left cowling which was amongst the body parts of the Motorcycle that had sustained damages as a result of the accident.

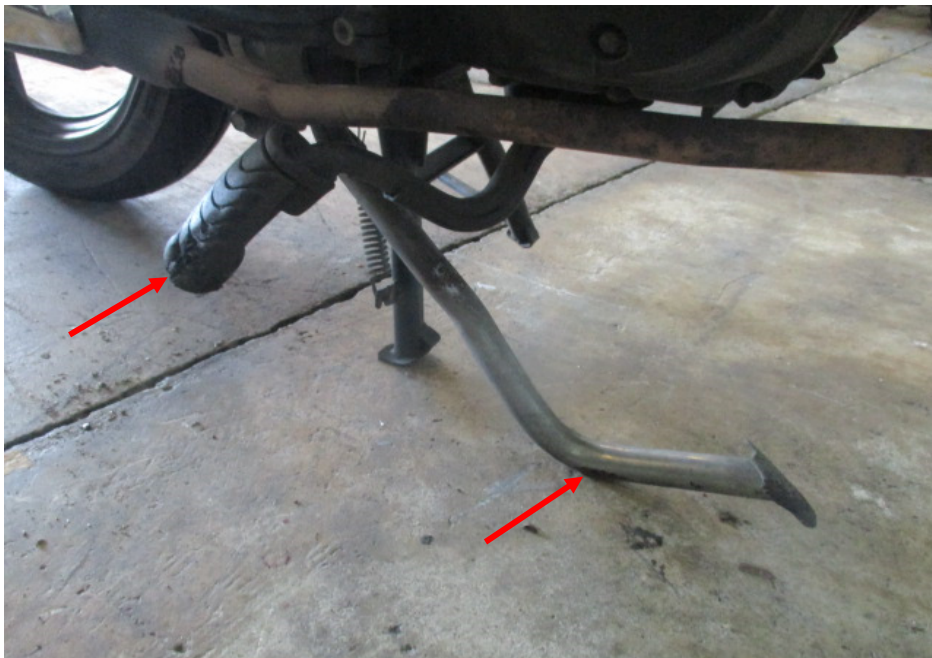
Photo 10 shows the bent brake foot pedal and right front footrest (arrowed), which were amongst the body parts of the Motorcycle that had sustained damage as a result of the accident.

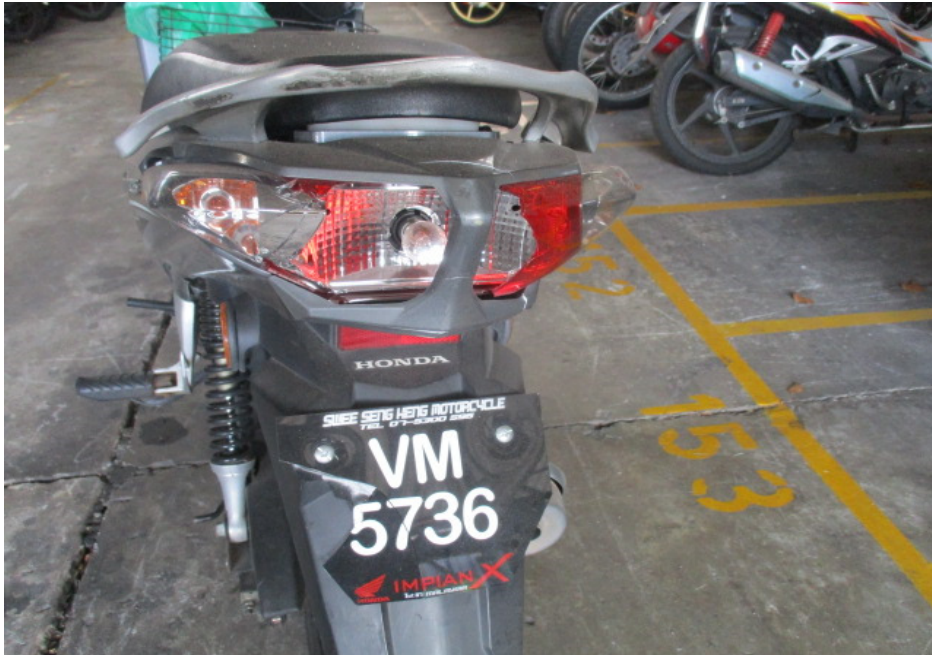
Photo 11 shows the broken tail light assembly and cracked rear number plate of the Motorcycle as a result of the accident.

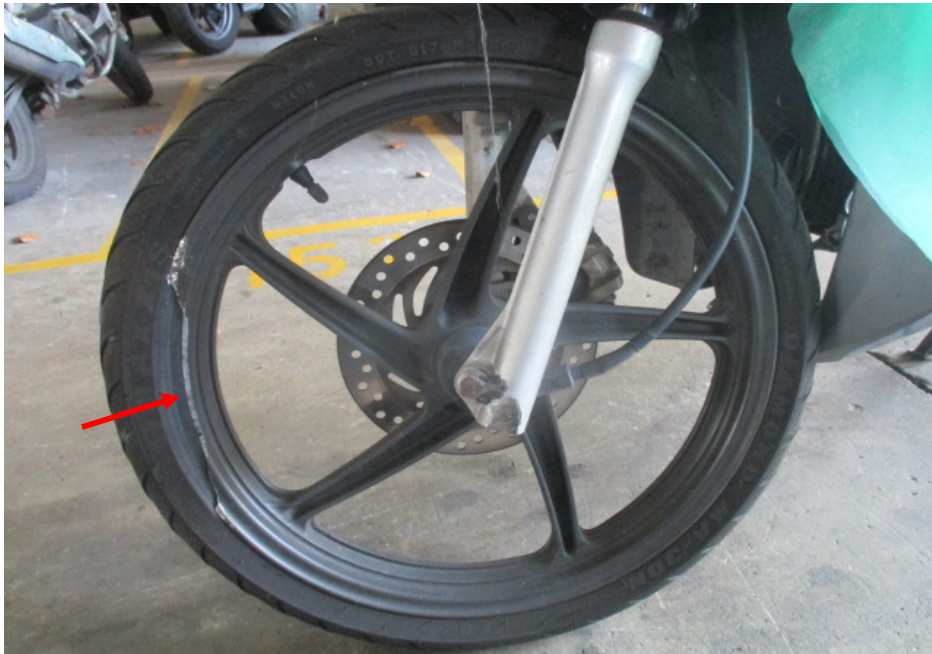
8. The 2 tyres were wrapped around alloy wheel rims. At the time of our inspection, we did not observe any visible damage on the rear wheel rim of the Motorcycle. However we did observe that the front wheel rim was broken. See photos 1 – 14 below.

Photo 12 shows the broken front wheel rim (arrowed) of the Motorcycle as a result of the accident at the time of our inspection.

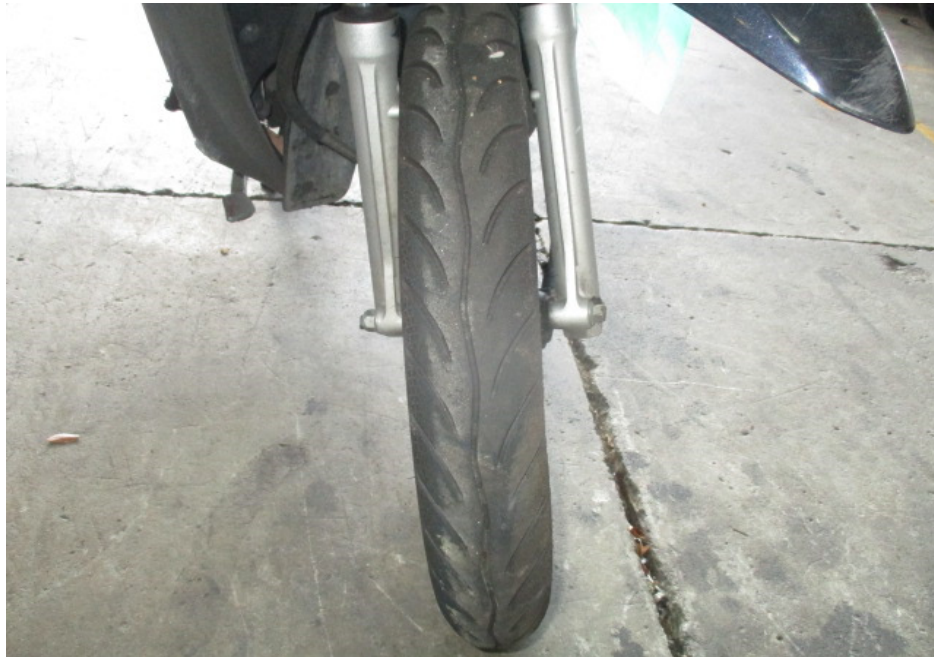
Photo 13 shows the front tyre of the Motorcycle at the time of our inspection. The front tyre was observed to be in serviceable condition with remaining tread depth of approximately 3mm. The pattern of the tread was also clearly visible. There was no tear, burst mark(s) and/or punctured hole(s) on the sidewalls as well as across the tread of the front tyre.

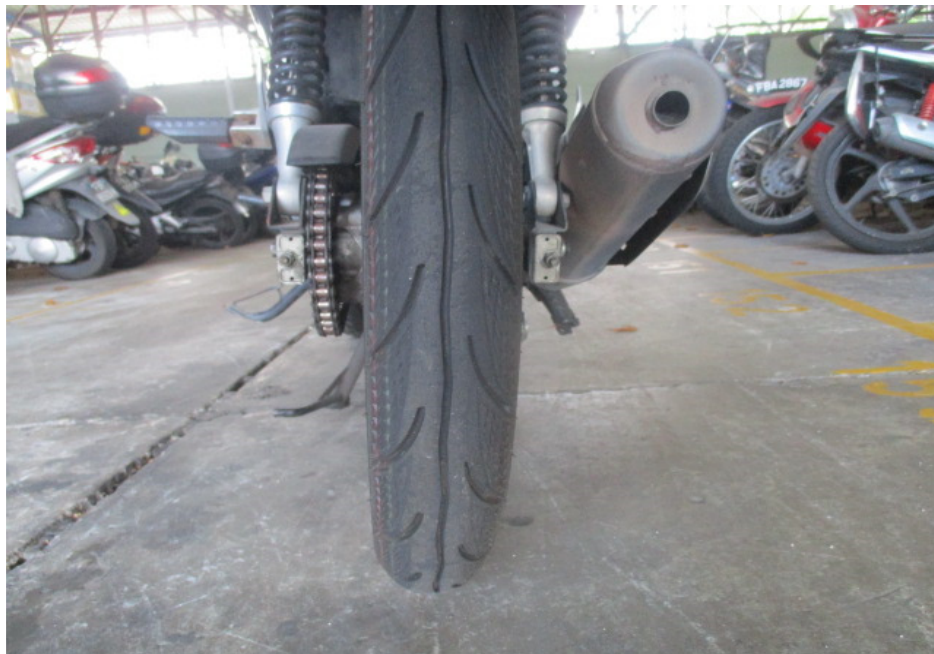
Photo 14 shows the condition of the Motorcycle's rear tyre. The rear tyre was observed to be in serviceable condition with remaining tread depth of approximately 3mm. The tyre was also observed to be sufficiently inflated for vehicular operation. We did not observe any tear, burst mark(s) and/or punctured hole(s) on the sidewalls as well as across the tread of the rear tyre.

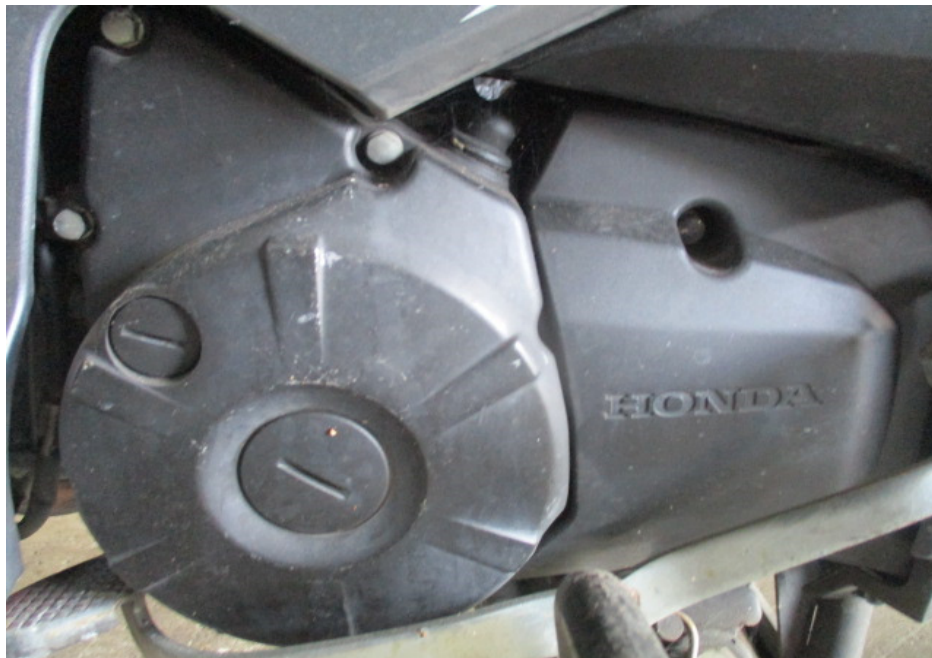
Photo 15 shows the left side of the engine of the Motorcycle at the time of our inspection. The various engine related parts and components were found to be intact with no visible damage. There was also no sign(s) or indication(s) of fluid leak observed around the left engine area of the Motorcycle.

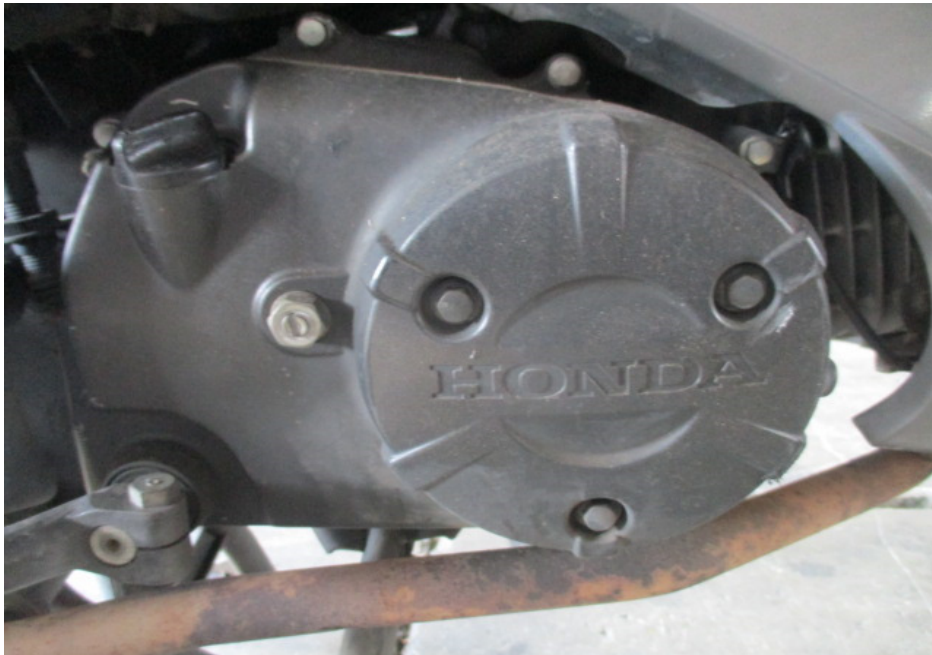
Photo 16 shows the right side of the engine of the Motorcycle at the time of our inspection. The various engine related parts and components were found to be intact with no visible damage. There was also no sign(s) or indication(s) of fluid leak observed around the right engine area of the Motorcycle.

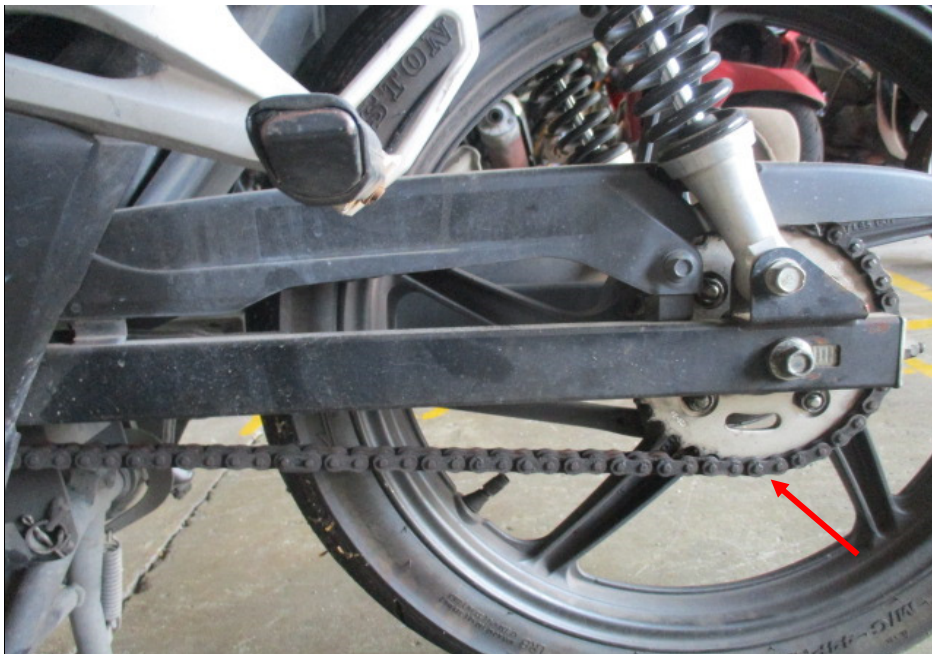
Photo 17 shows the gear chain (arrowed) of the Motorcycle, which was observed to be intact with no misalignment. It was also adequately lubricated for operating purposes. The gear chain rotates the rear wheel of the Motorcycle.

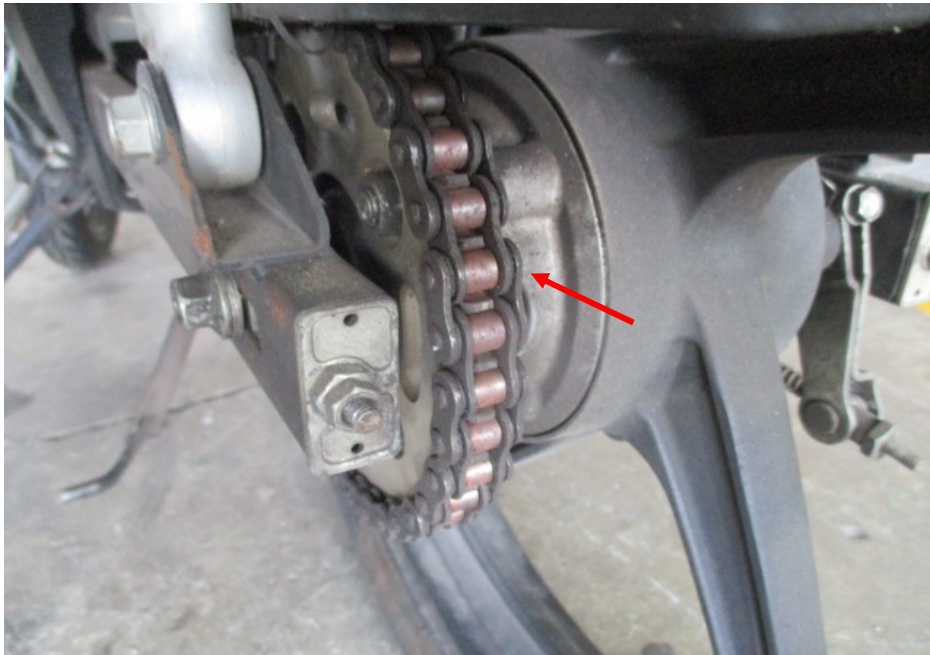
Photo 18 shows the closer view of the gear chain (arrowed) of the Motorcycle, which was observed to be intact with no misalignment. It was also adequately lubricated for operating purposes.

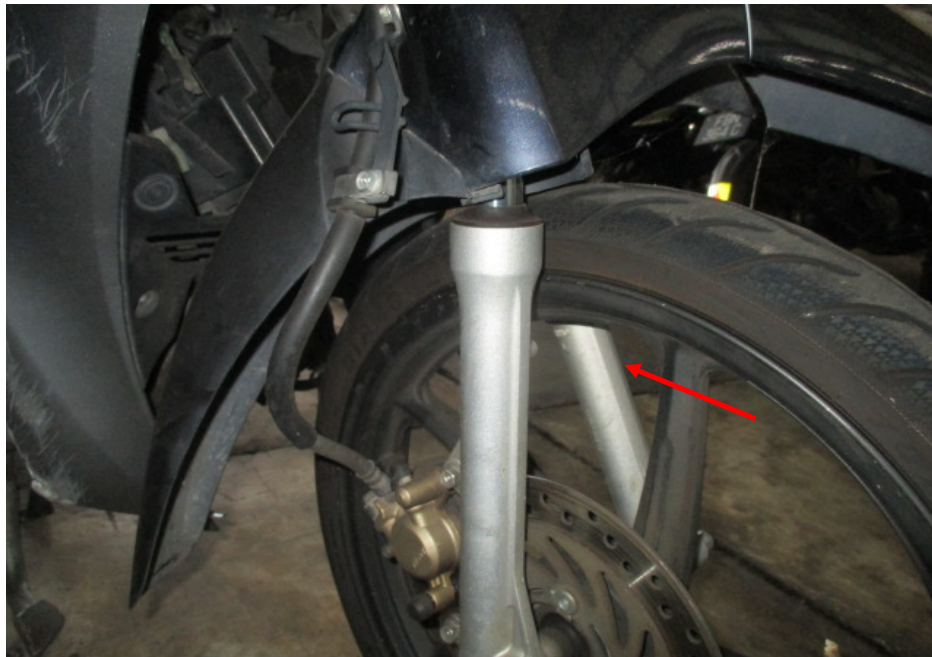
11. For this case, we were not able to conduct any test(s) on the steering system of the Motorcycle due to the damage of its front forks. The left front fork was found to be bent as a result of the accident.

Photo 19 shows the front forks of the Motorcycle. The front left fork (arrowed) was observed to be bent as a result of the accident. We were hence not able to conduct any tests on the steering system of the Motorcycle.

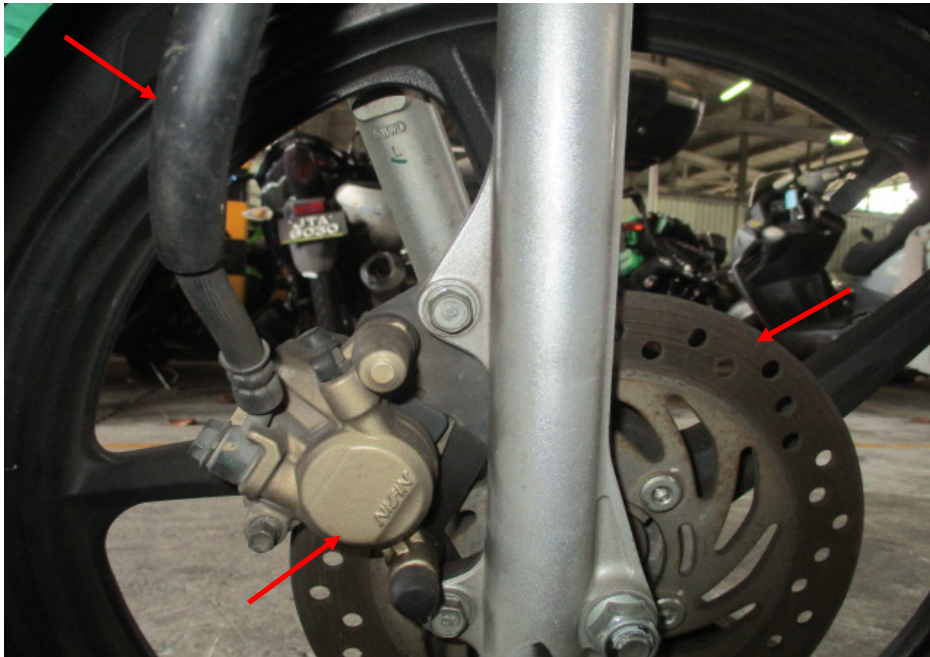
Photo 20 shows a close up view of the front brake caliper, front brake disc and front brake hose (arrowed) of the Motorcycle, which are all part of the components in the hydraulic front brake system of the Motorcycle. Our visual checks of these various components had revealed all to be intact with no visible damage. No leakage of brake fluid was also observed.

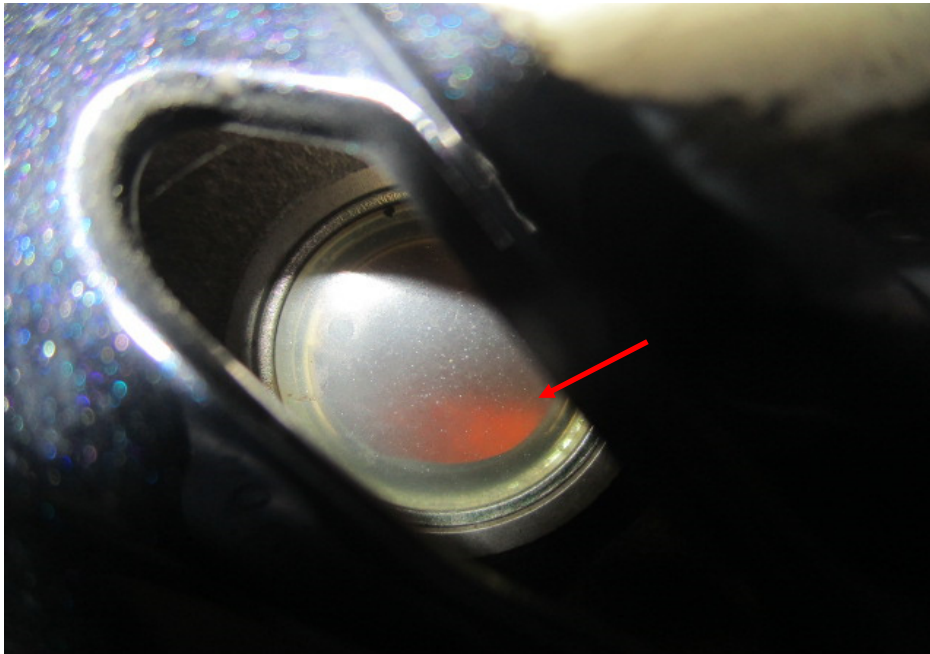
Photo 21 shows the brake fluid reservoir for the front brake of the Motorcycle. The brake fluid was found to be of sufficient level for operating purposes. However the brake fluid was found to be slightly contaminated (arrowed).

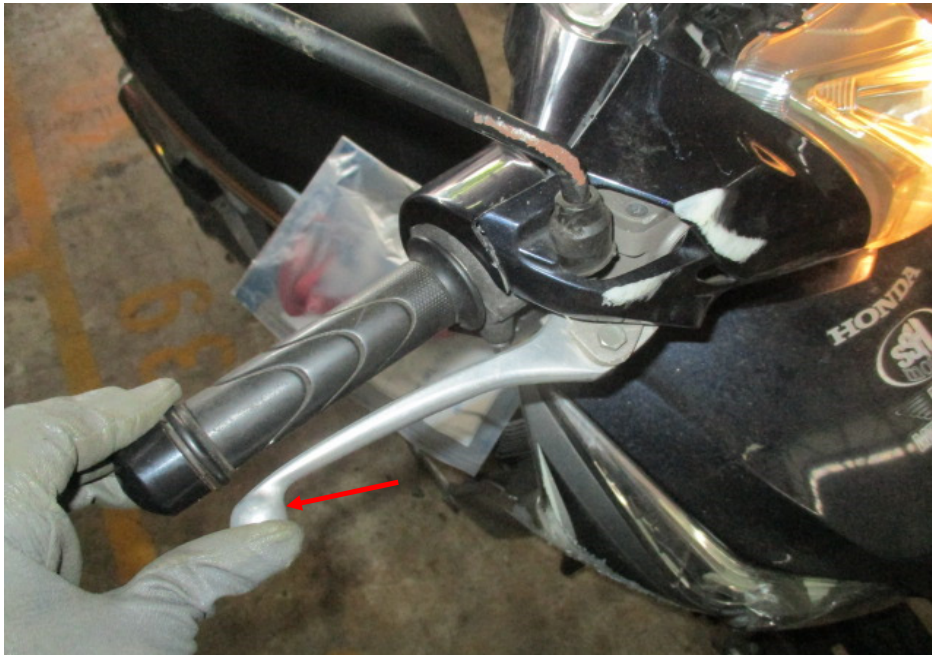
Photo 22 shows the front brake lever being depressed. There was some resistance felt (spongy like feel) upon pressing the front brake lever (arrowed). This would indicate that there is no leakage of pressure/vacuum in the brake system.

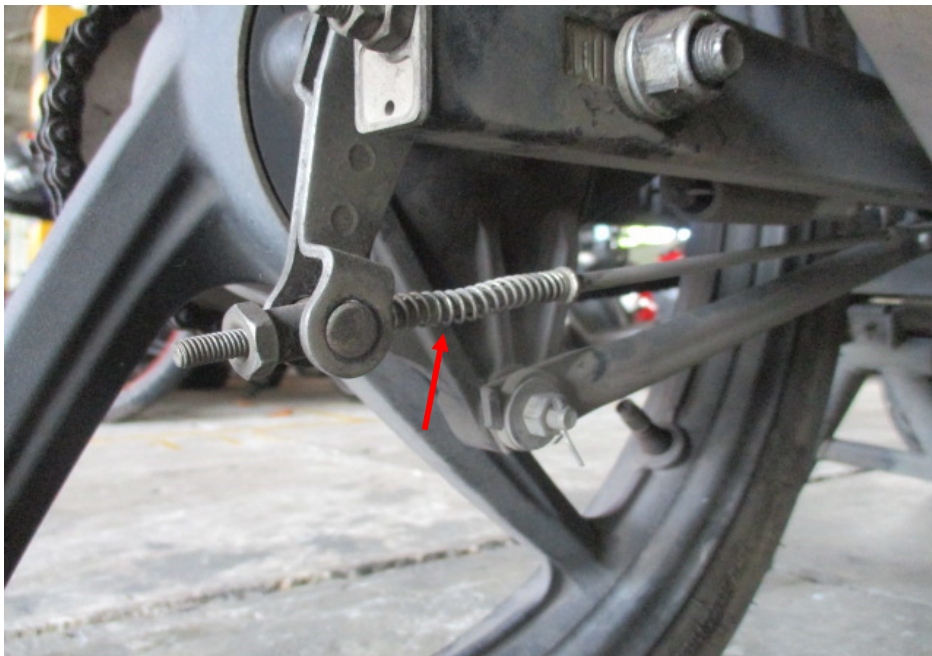
Photo 23 shows the rear wheel of the Motorcycle. The type of brake system for the rear wheel was of a mechanical type, controlled by the brake foot pedal of the Motorcycle. Our checks of the cable (arrowed), spring and drum which are all part of the components in the rear brake system of the Motorcycle reveal all to be intact and without damage.
