Your Ref: TP/IP/10241/2020  
Our Ref : CI/TPD20005420/N

**Fatal Accident Investigation Team**

**INSPECTION REPORT OF MOTORCYCLE FY 6278Z**

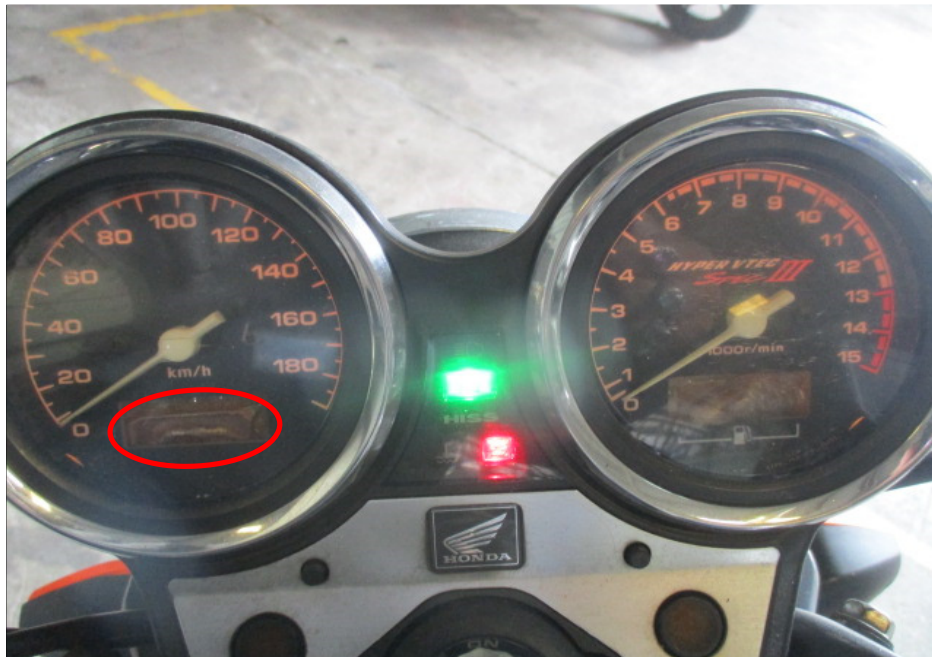
4. The mileage of the Motorcycle could not be recorded at the time of our inspection due to the damage sustained to the speedometer gauge.
5. The Motorcycle was observed to have sustained no damages.

**Photo 1** shows the mileage of the Motorcycle which could not be recorded at the time of our inspection due to the damage sustained to the speedometer gauge (circled).

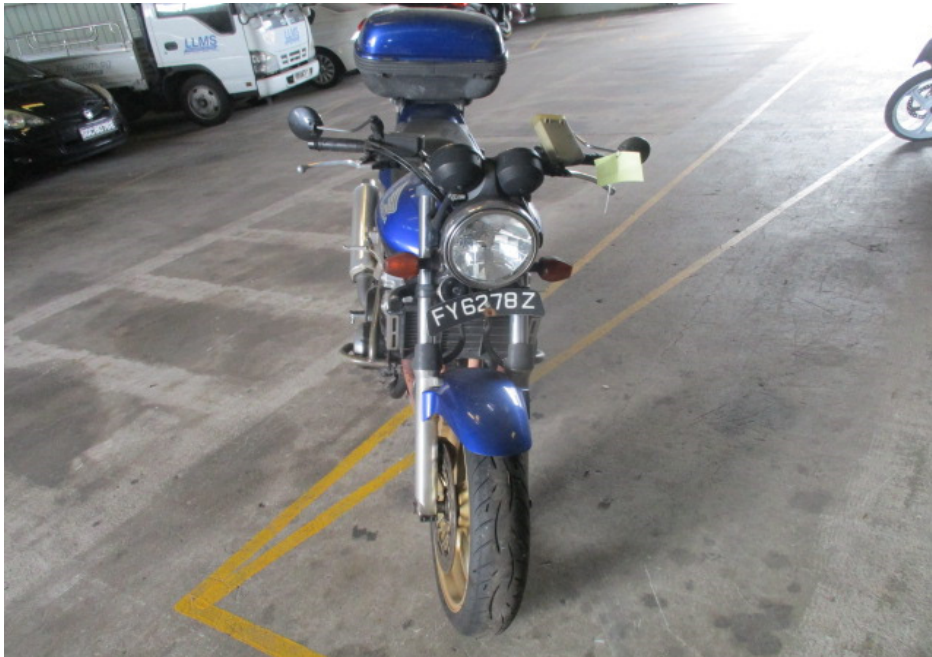
**Photo 2** shows a general view of the frontal portion of the Motorcycle at the time of our inspection. The Motorcycle was observed to have sustained no damages.

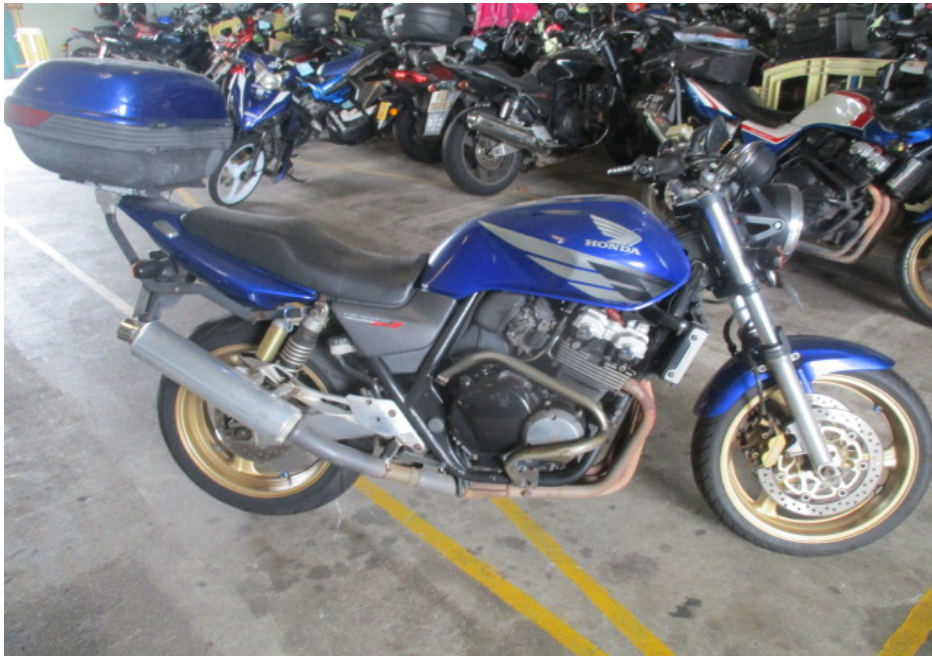
**Photo 3** shows a general view of the right body of the Motorcycle at the time of our inspection. The Motorcycle was observed to have sustained no damages.

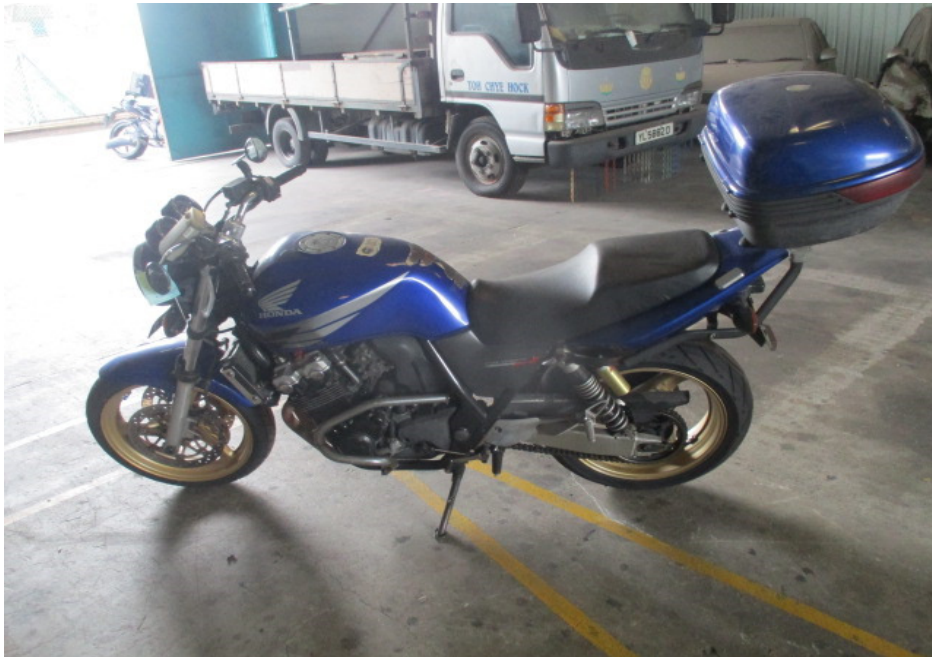
**Photo 4** shows a general view of the left body of the Motorcycle at the time of our inspection. The Motorcycle was observed to have sustained no damages.

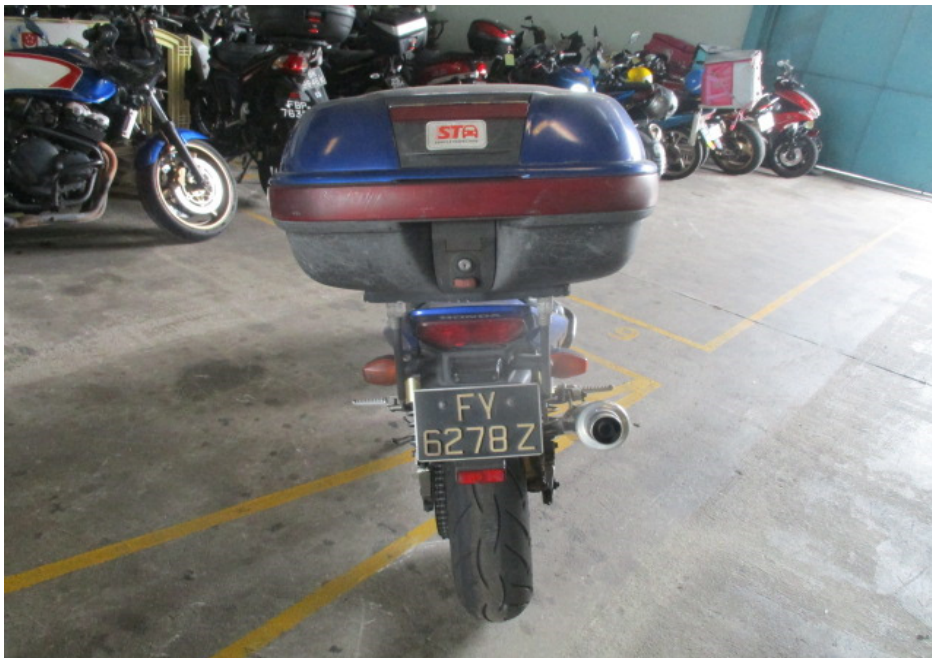
**Photo 5** shows a general view of the rear portion of the Motorcycle at the time of our inspection. The Motorcycle was observed to have sustained no damages.

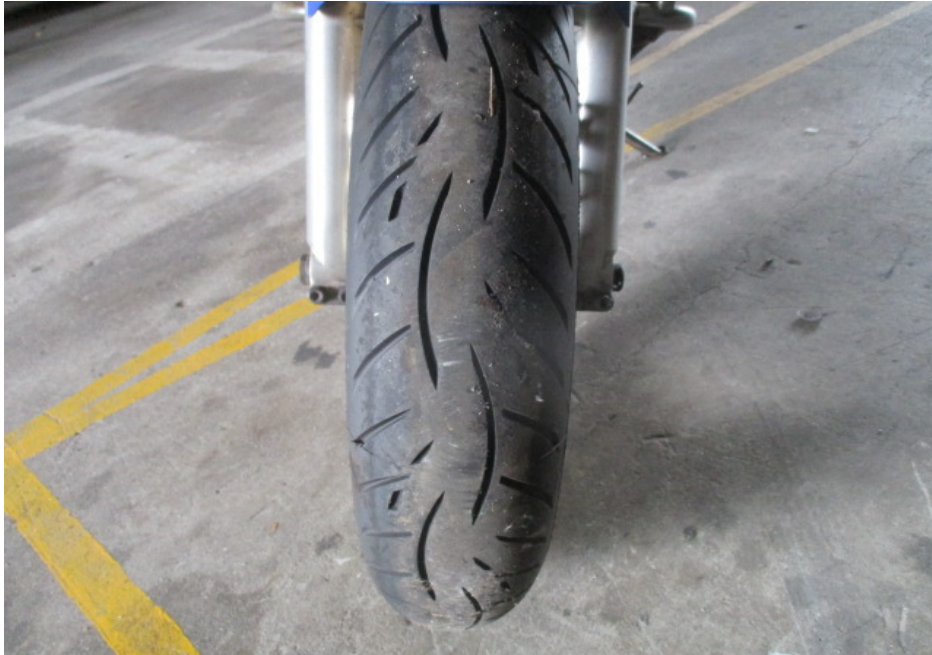
**Photo 6** shows the condition of the Motorcycle's front tyre. The front tyre was observed to be in serviceable condition with remaining tread depth of approximately 4mm. There was no tear, burst mark(s) and/or punctured hole(s) on the sidewalls as well as across the tread of the front tyre.

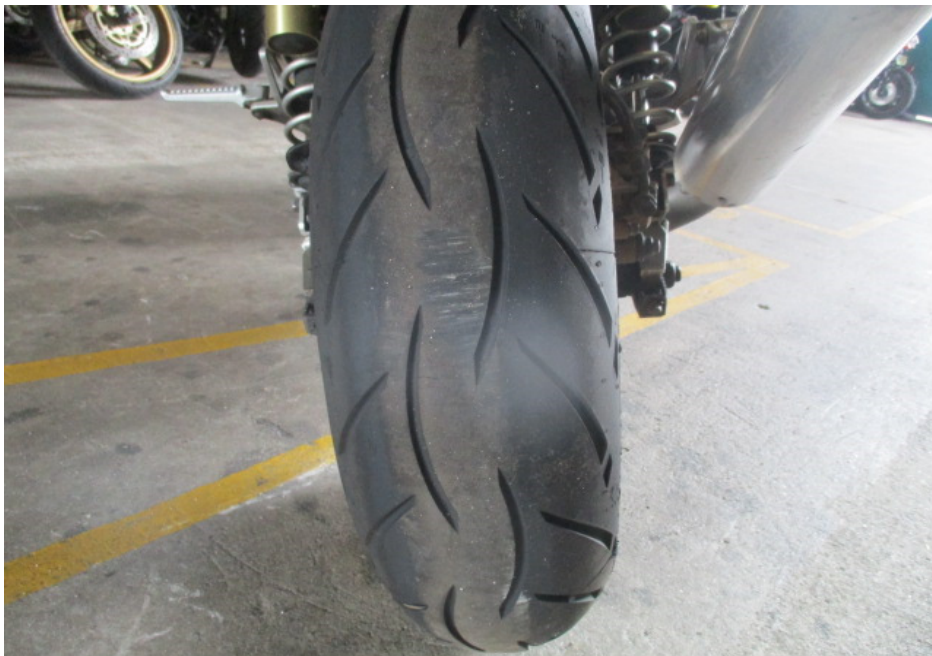
**Photo 7** shows the condition of the Motorcycle's rear tyre. The rear tyre was observed to be in serviceable condition with remaining tread depth of approximately 4mm. The tyre was also observed to be sufficiently inflated for vehicular operation. We did not observe any tear, burst mark(s) and/or punctured hole(s) on the sidewalls as well as across the tread of the rear tyre.

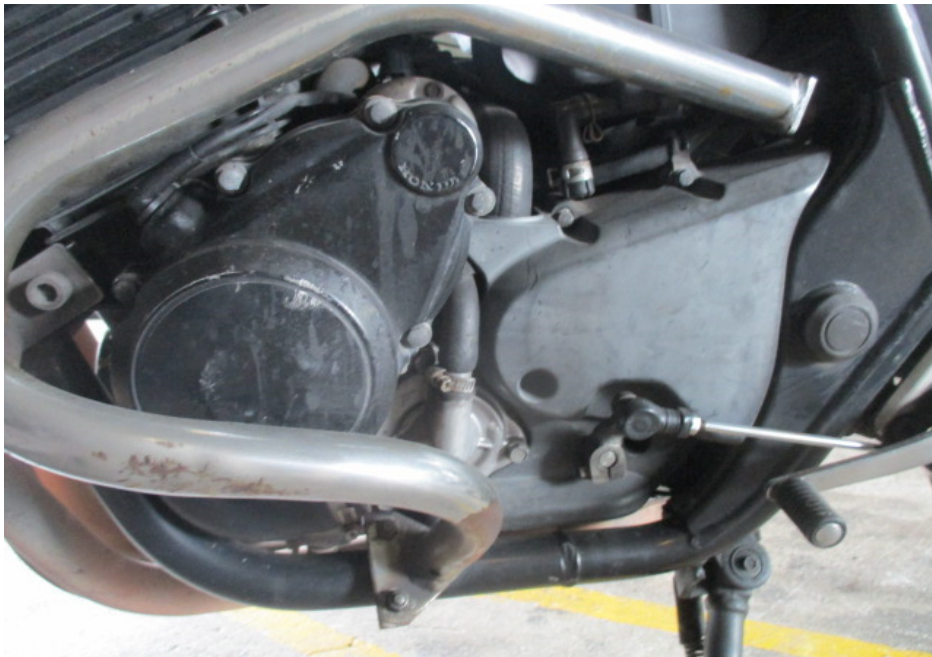
**Photo 8** shows the left side of the engine of the Motorcycle at the time of our inspection. The various engine related parts and components were found to be intact with no visible damage. There was also no sign(s) or indication(s) of fluid leak observed around the left engine area of the Motorcycle.

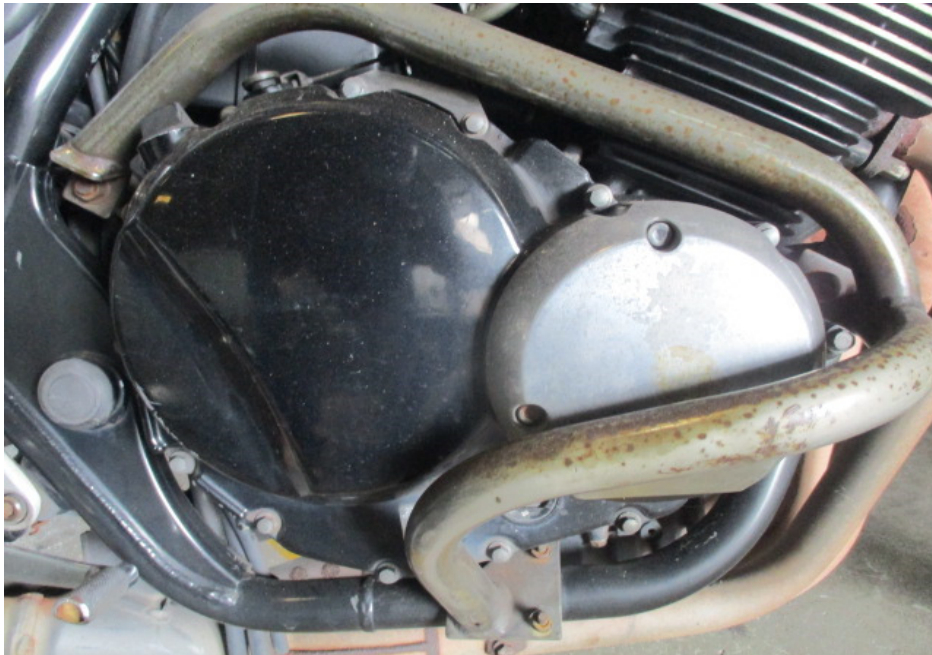
**Photo 9** shows the right side of the engine of the Motorcycle at the time of our inspection. The various engine related parts and components were found to be intact with no visible damage. There was also no sign(s) or indication(s) of fluid leak observed around the right engine area of the Motorcycle.

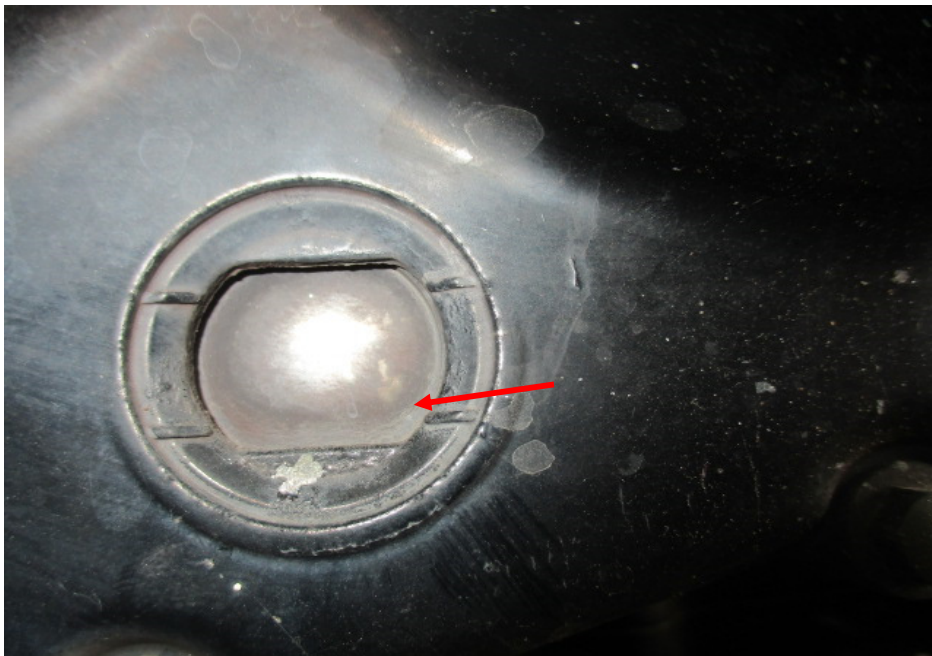
**Photo 10** shows the engine oil of the Motorcycle at the time of our inspection (as viewed from the gauge level window). The engine oil was observed to be of sufficient level (arrowed) and without contamination for operational purposes.

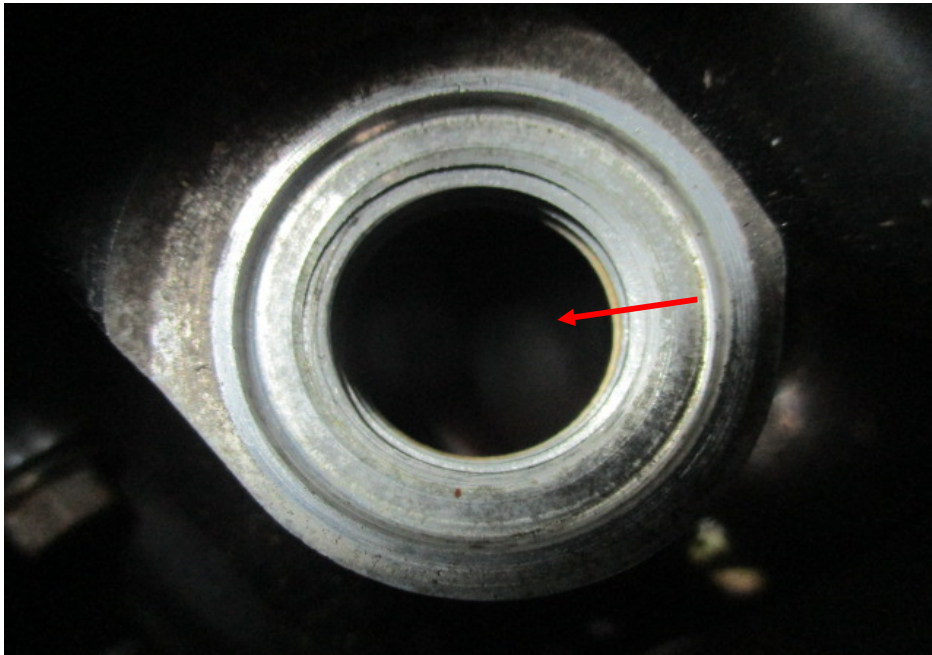
**Photo 11** shows checks being carried out to the engine coolant of the Motorcycle at the time of our inspection. The engine coolant was observed to be of insufficient level (arrowed).

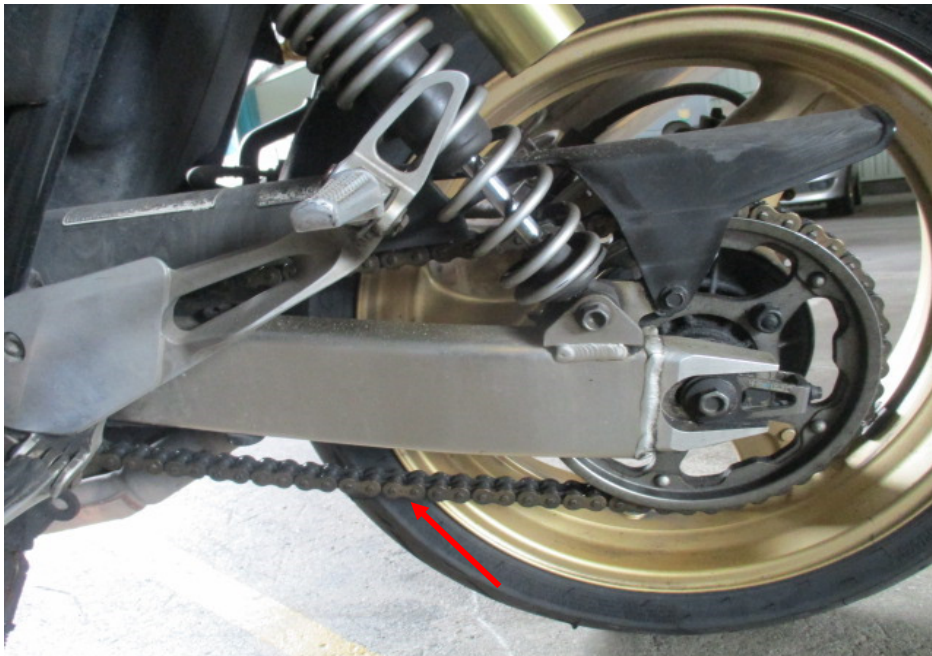
**Photo 12** shows the general view of the gear train (arrowed) of the Motorcycle, which was observed to be intact with no misalignment. It was also adequately lubricated for operating purposes.

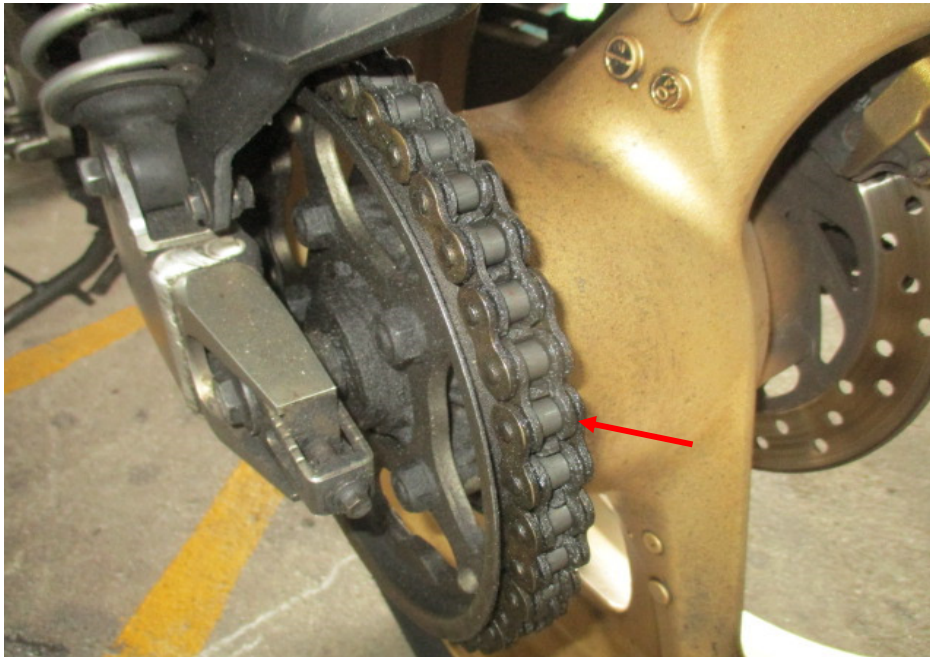
**Photo 13** shows a closer view of the gear train (arrowed) of the Motorcycle, which was observed to be intact with no misalignment. It was also adequately lubricated for operating purposes.

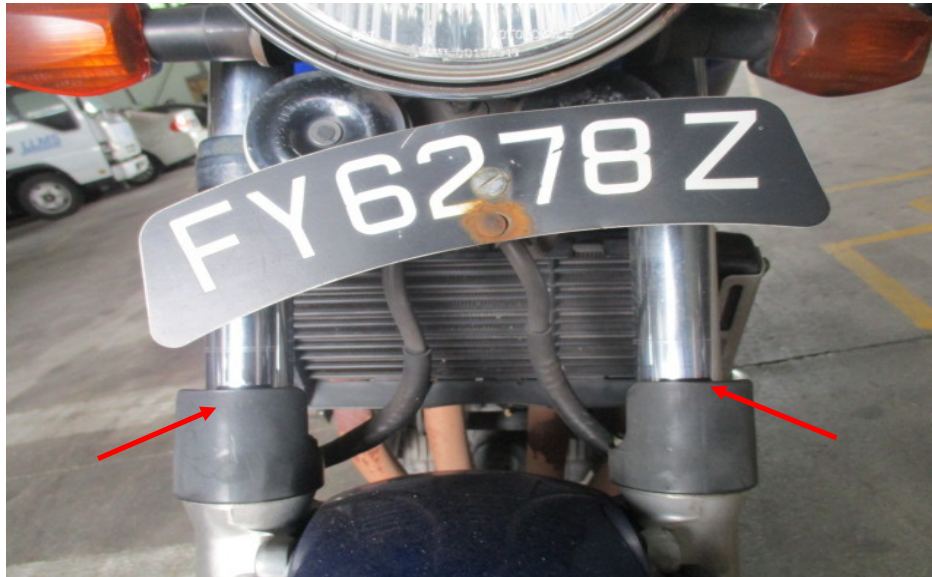
**Photo 14** shows the front fork (arrowed) of the Motorcycle. The front fork and fork bracket of the Motorcycle were both found to be intact and undamaged. Turning the Motorcycle's handle bar towards the left and right did not produce any abnormal free play and/or resistance. The steering system of the Motorcycle was in serviceable condition at the time of our inspection.

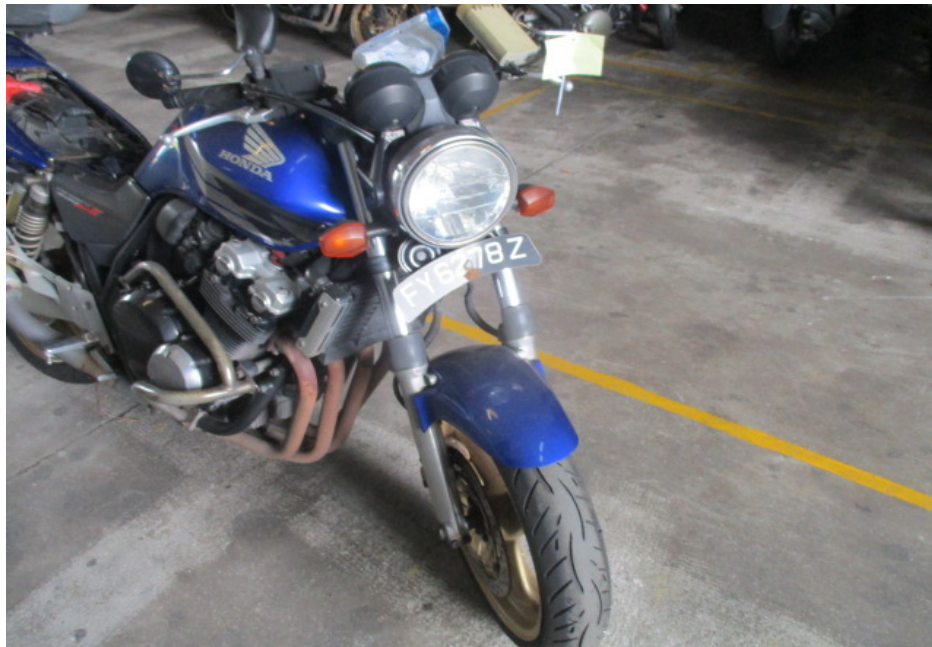
**Photo 15** shows the front wheel of the Motorcycle turned towards its full right. Turning the Motorcycle's handle bar towards the left and right did not produce any abnormal free play and/or resistance. This would indicate that the steering system of the Motorcycle was in serviceable condition at the time of our inspection.

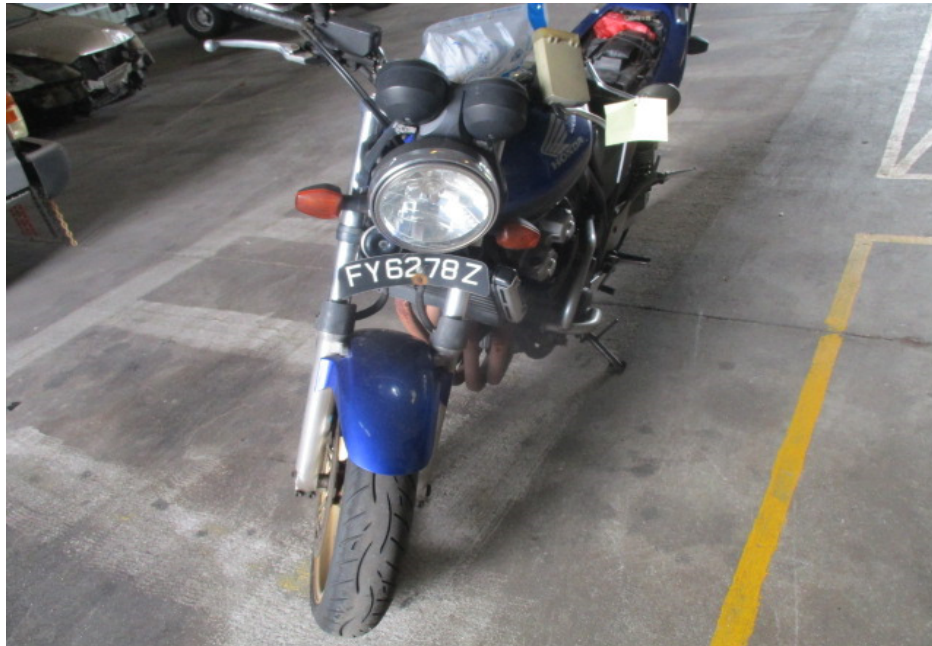
**Photo 16** shows the front wheel of the Motorcycle turned towards its full left. Turning the Motorcycle's handle bar towards the left and right did not produce any abnormal free play and/or resistance. This would indicate that the steering system of the Motorcycle was in serviceable condition at the time of our inspection.

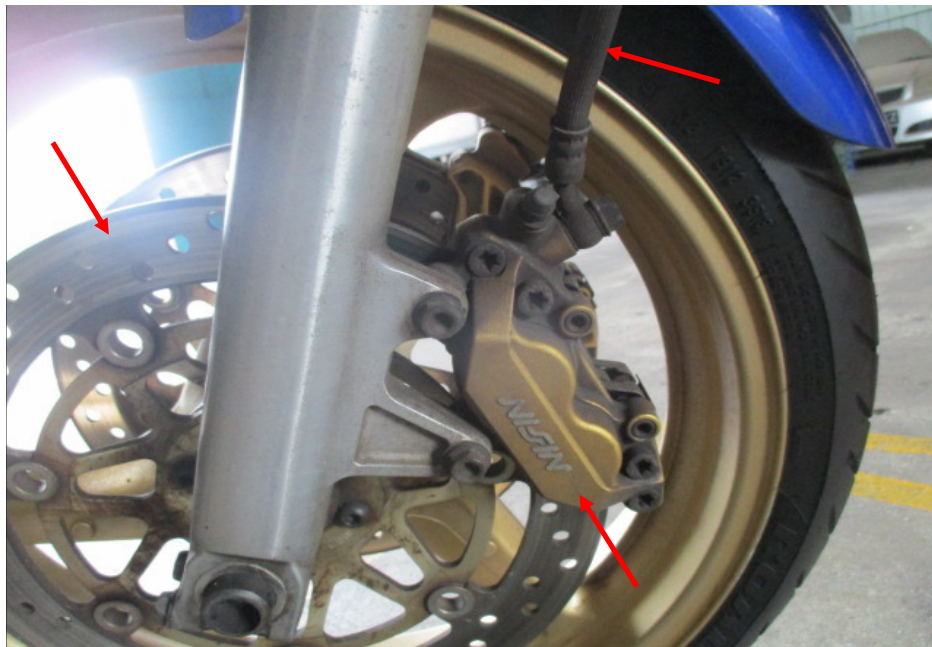
**Photo 17** shows a close up view of the front brake caliper, front brake disc and front brake hose (arrowed) at the right side of the Motorcycle's front wheel, which are all part of the components in the hydraulic front brake system of the Motorcycle. Our visual checks of these various components had revealed all to be intact with no visible damage. No leakage of brake fluid was also observed.

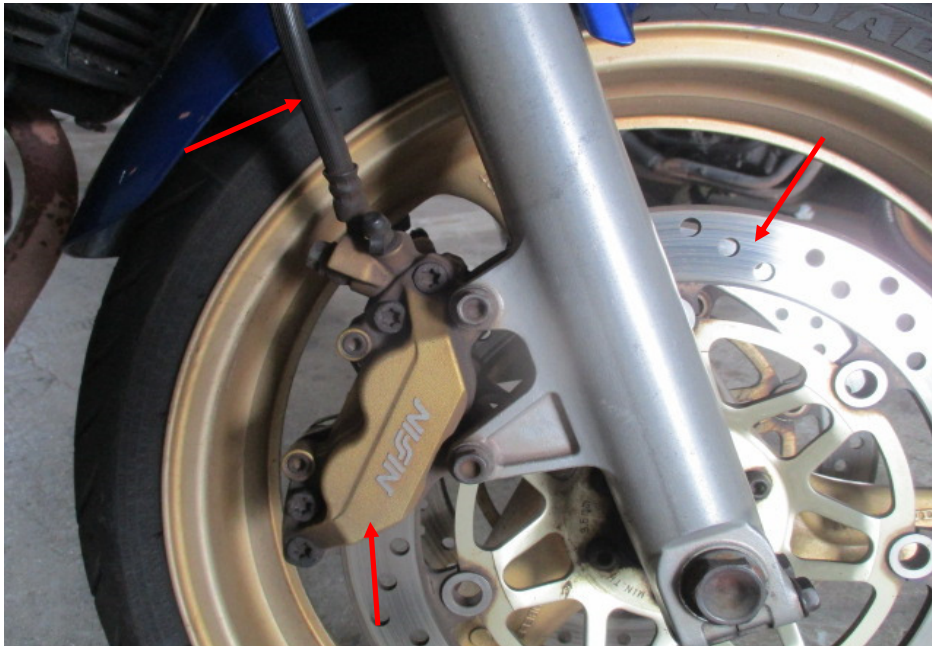
**Photo 18** shows a close up view of the front brake caliper, front brake disc and front brake hose (arrowed) at the left side of the Motorcycle's front wheel, which are all part of the components in the hydraulic front brake system of the Motorcycle. Our visual checks of these various components had revealed all to be intact with no visible damage. No leakage of brake fluid was also observed.

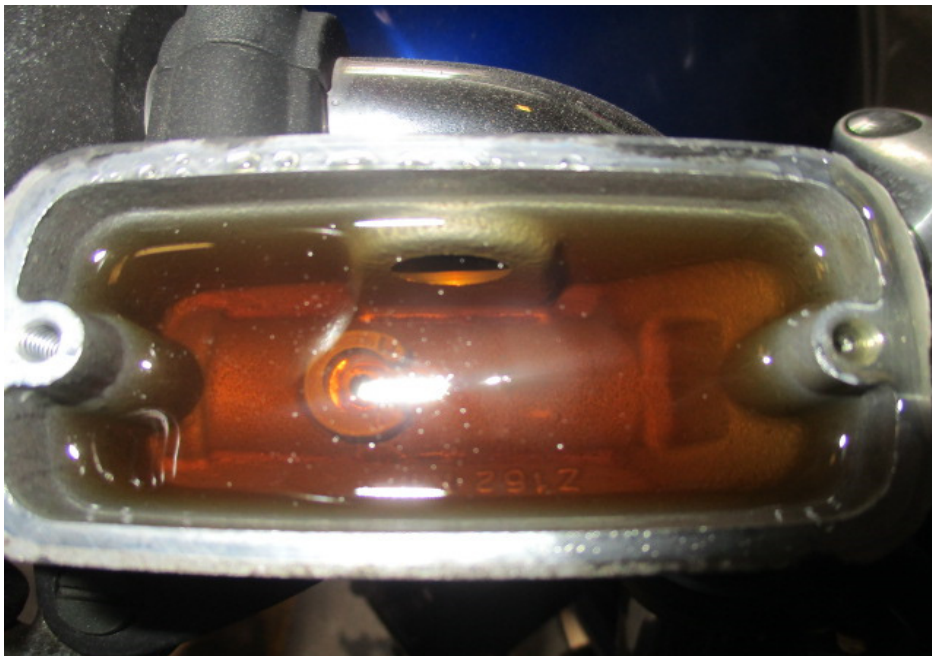
**Photo 19** shows the brake fluid reservoir for the front brake of the Motorcycle. The brake fluid was observed to be of sufficient level and without contamination for operational purposes.

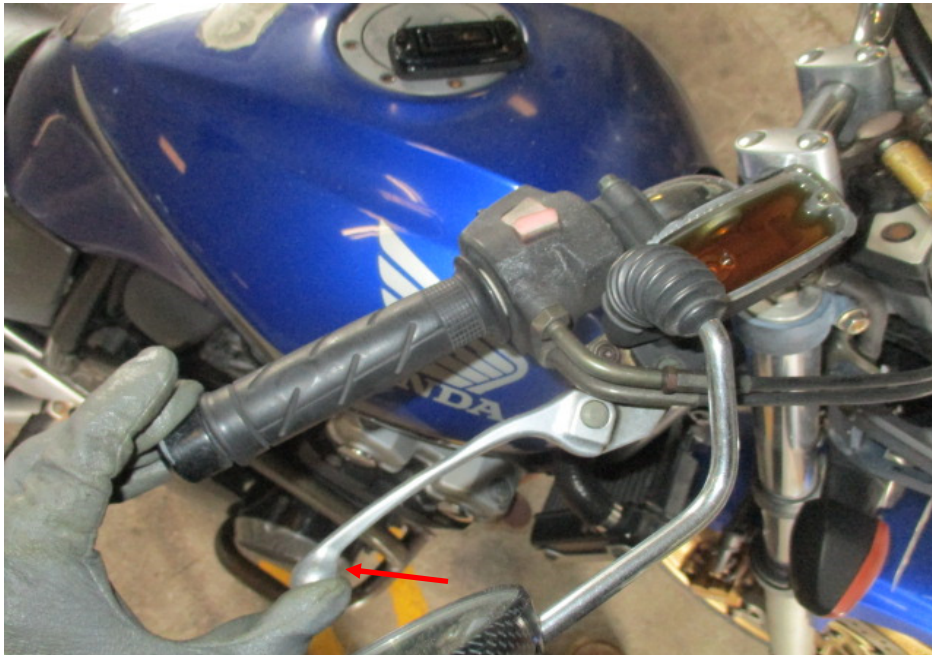
**Photo 20** shows the front brake lever being depressed. There was some resistance felt (spongy like feel) upon pressing the front brake lever (arrowed). This would indicate that there is no leakage of pressure/vacuum in the brake system.

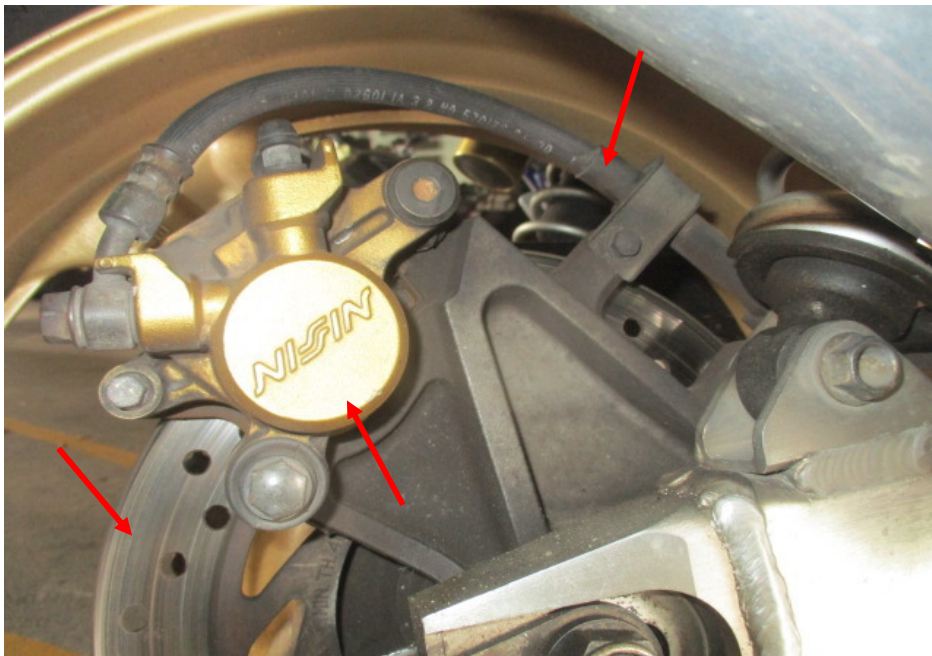
**Photo 21** shows a close up view of the rear brake caliper, rear brake disc and rear brake hose (arrowed) of the Motorcycle, which are all part of the components in the hydraulic rear brake system of the Motorcycle. Our visual checks of these various components had revealed all to be intact with no visible damage. No leakage of brake fluid was also observed.

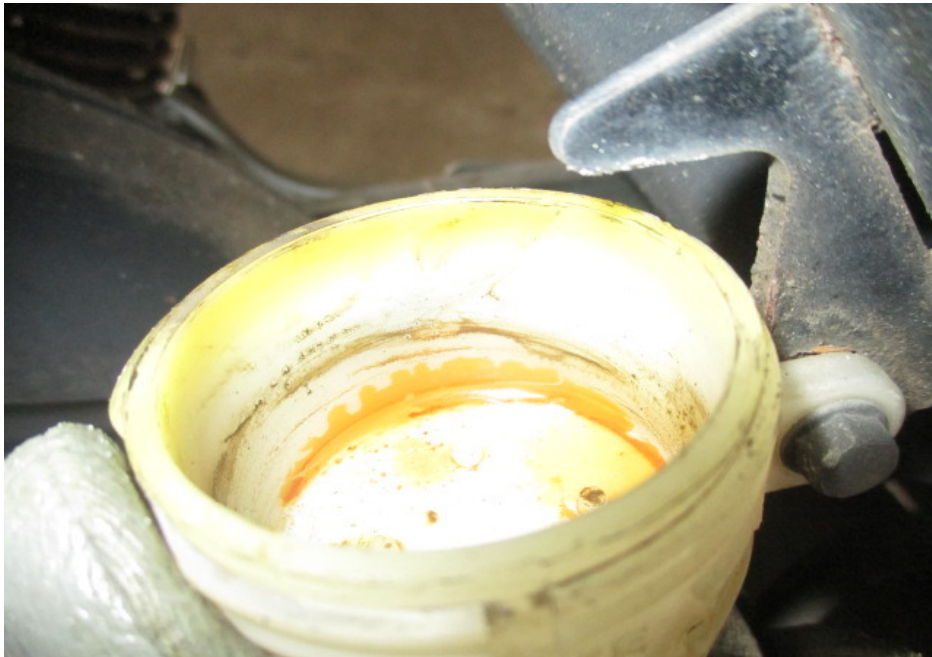
14. However the brake fluid for the rear brake was found to be of insufficient level for operational purposes.
15. Static brake tests conducted on the Motorcycle had appear to indicate that the front braking system of the Motorcycle was in serviceable condition. There was some resistance felt (spongy like feel) upon pressing the brake lever. This would indicate that there was no leakage of pressure/vacuum in the front brake system. As for the rear braking system, there was some resistance felt (spongy like feel) upon stepping on the rear brake pedal. This could be due to remaining brake fluid in the rear brake caliper. However, due to the insufficient level of brake fluid in the rear brake reservoir, the rear braking system was found not to be in serviceable condition.

**Photo 22** shows the brake fluid reservoir for the rear brake of the Motorcycle. The brake fluid was observed to be of insufficient level for operational purposes.
