Your Ref: TP/IP/11887/2020
Our Ref : CI/TPD20005422/N

15 July 2020

MECHANICAL INSPECTION REPORT OF MOTORCYCLE FBA 620G

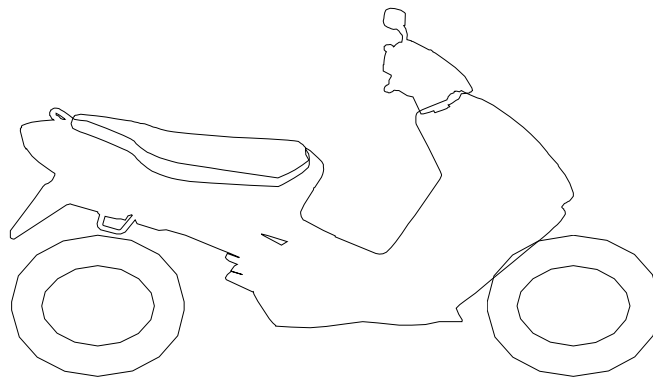
6. The condition of the 2 tyres of the Motorcycle was observed to be in serviceable condition. We did not observe any tear, burst mark(s) and/or punctured hole(s) on the sidewalls as well as across the tread of the 2 tyres. Both the tyres were observed to be sufficiently inflated for vehicular operation.
7. The tyre brand, tyre size and remaining tread depth of the 2 tyres were recorded as follows:-

Pirelli 130/70 - 17 (3mm)

Pirelli 110/70 - 17 (3mm)

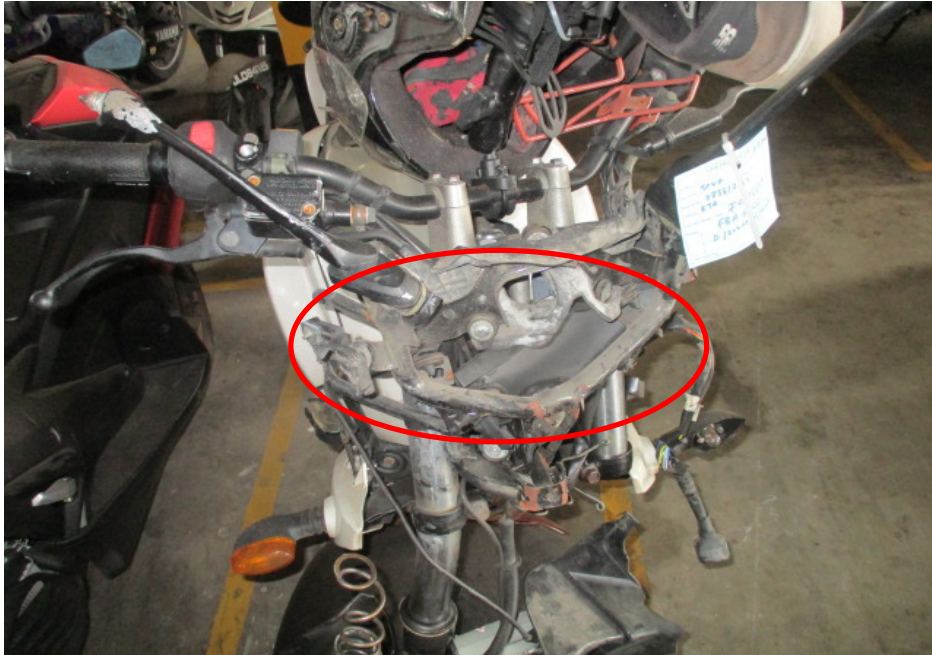
4. The mileage of the Motorcycle could not be recorded at the time of our inspection due to a missing speedometer gauge.
5. The Motorcycle had sustained damages all around. Body parts that were found to have been damaged include its headlight assembly, front fork assembly, front mudguard, petrol tank, side mirrors, front brake lever, clutch lever, handlebar ends, gear shift pedal, exhaust header and right rear signal lamp, amongst others.

Photo 1 shows the mileage of the Motorcycle which could not be recorded at the time of our inspection due to a missing speedometer gauge (circled).

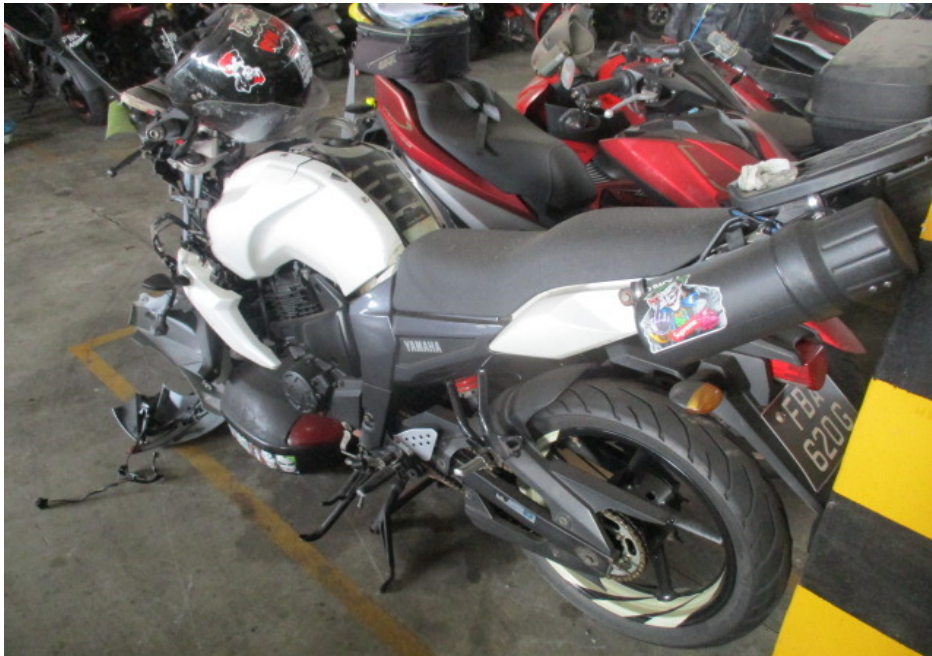
Photo 2 shows a general view of the left body of the Motorcycle at the time of our inspection. The Motorcycle had sustained damages all around.

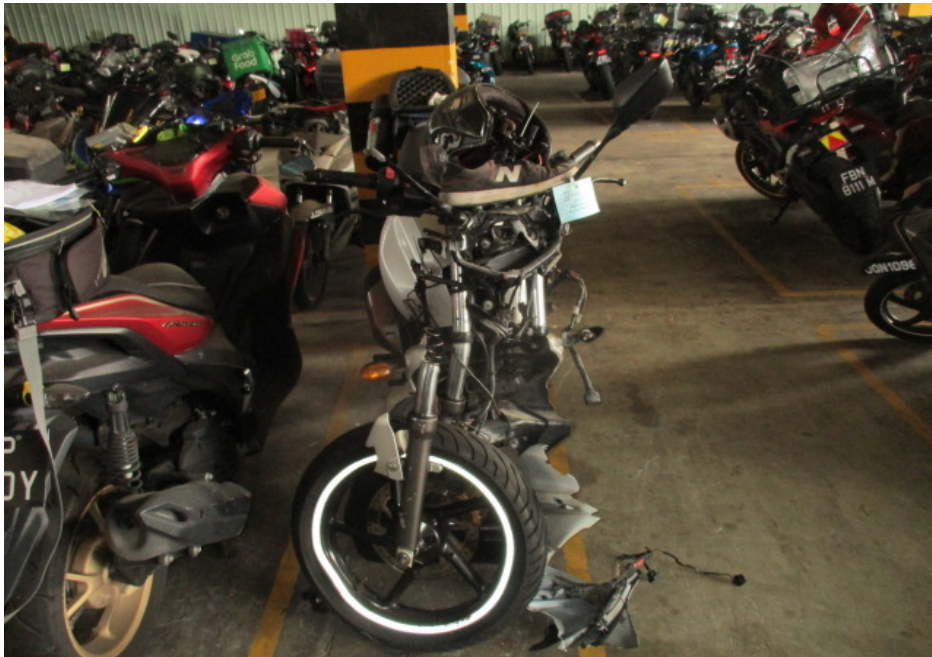
Photo 3 shows a general view of the frontal portion of the Motorcycle at the time of our inspection. The Motorcycle had sustained damages all around. Body parts that were found to have been damaged include its headlight assembly, front fork assembly, front mudguard, petrol tank, side mirrors, front brake lever, clutch lever, handlebar ends, gear shift pedal, exhaust header and right rear signal lamp, amongst others.

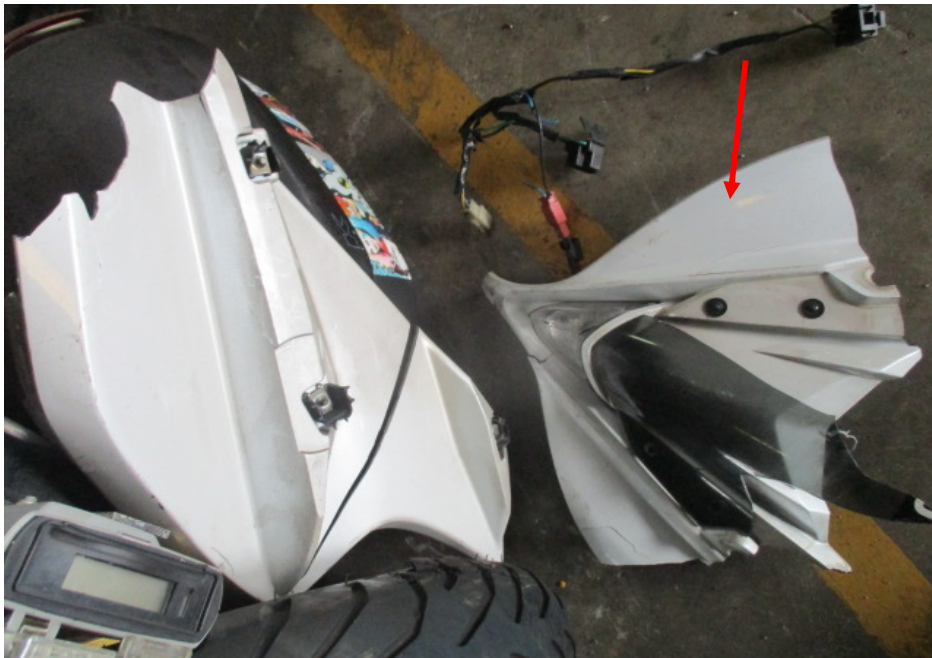
Photo 4 shows a closer view of the cracked headlight assembly of the Motorcycle as a result of the accident (arrowed).

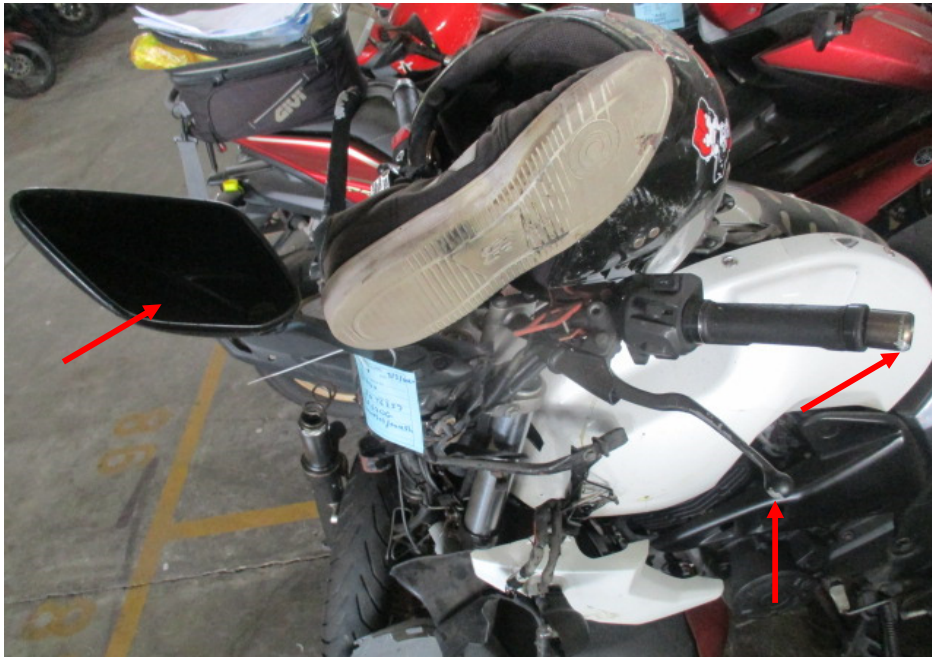
Photo 5 shows a closer view of the clutch lever, left side mirror and left handlebar end (arrowed) of the Motorcycle. These parts were amongst the body parts of the Motorcycle which were damaged as a result of the accident.

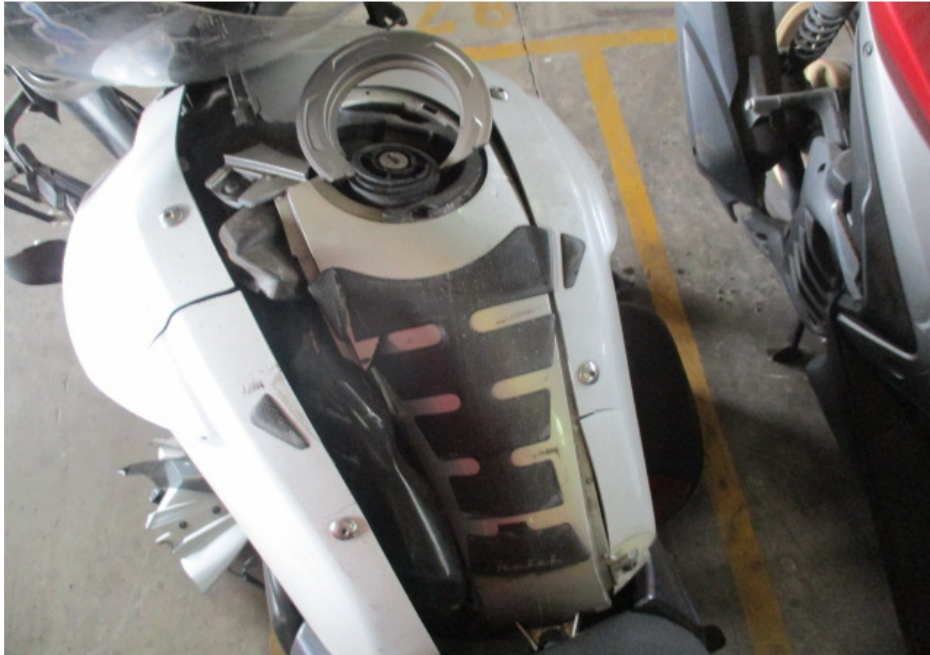
Photo 7 shows a closer view of the deformed petrol tank which was amongst the body parts of the Motorcycle that had sustained damages as a result of the accident.

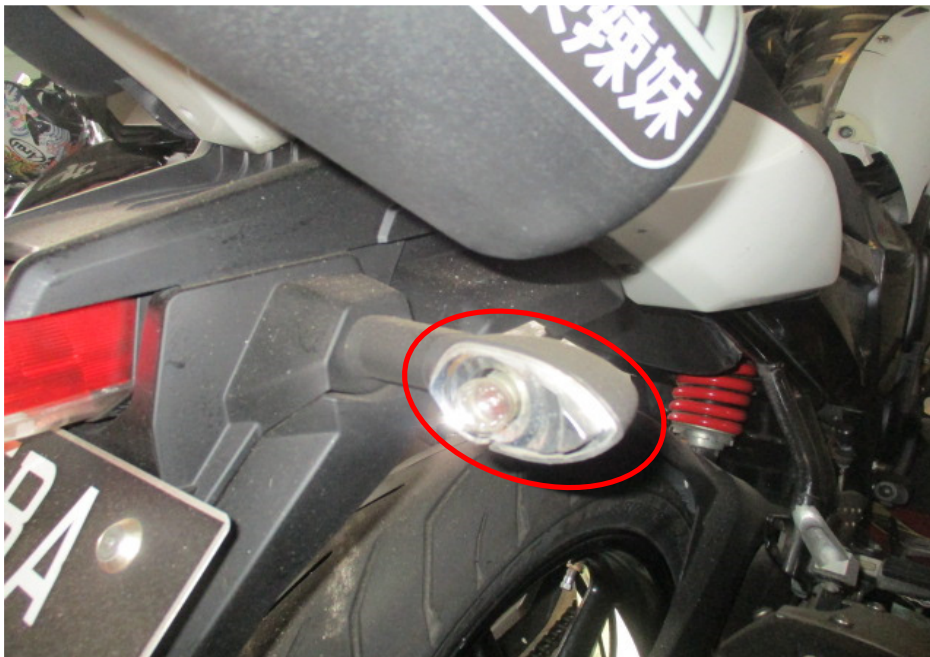
Photo 8 shows a closer view of the cracked right rear signal lamp which was amongst the body parts at the rear body of the Motorcycle that had sustained damages as a result of the accident (circled).

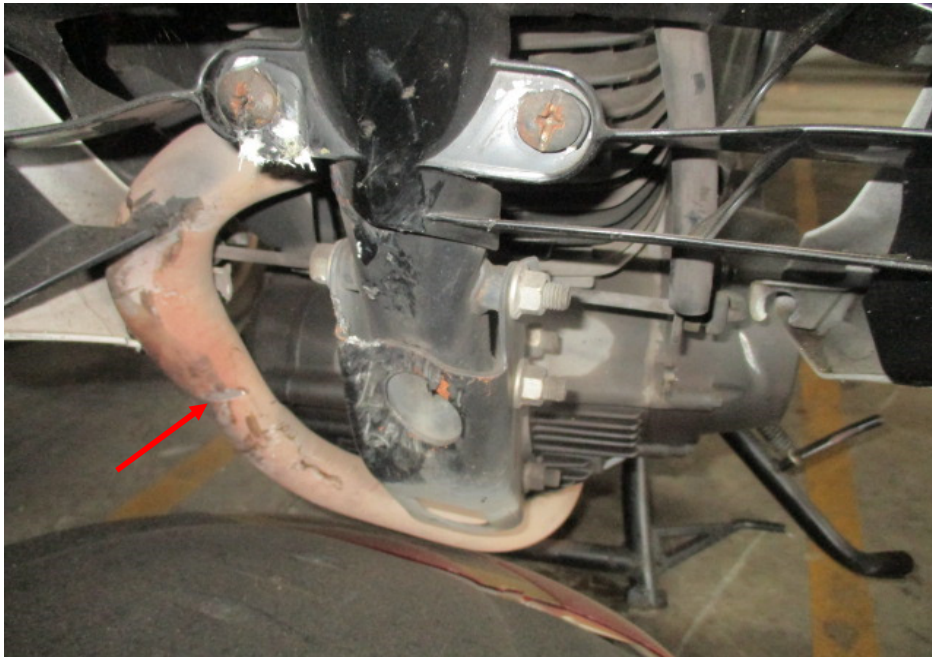
Photo 9 shows a closer view of the deformed exhaust header which was amongst the body parts at the front body of the Motorcycle that had sustained damages as a result of the accident (arrowed).

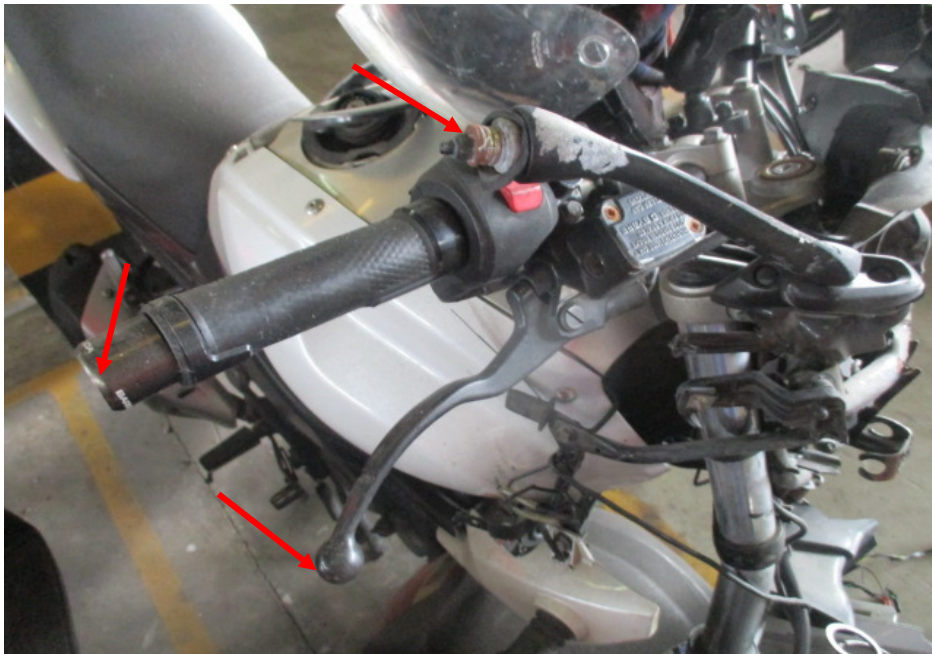
Photo 10 shows a closer view of the right side mirror and right handlebar end and front brake lever (arrowed), which were amongst the body parts of the Motorcycle that had sustained damage as a result of the accident.

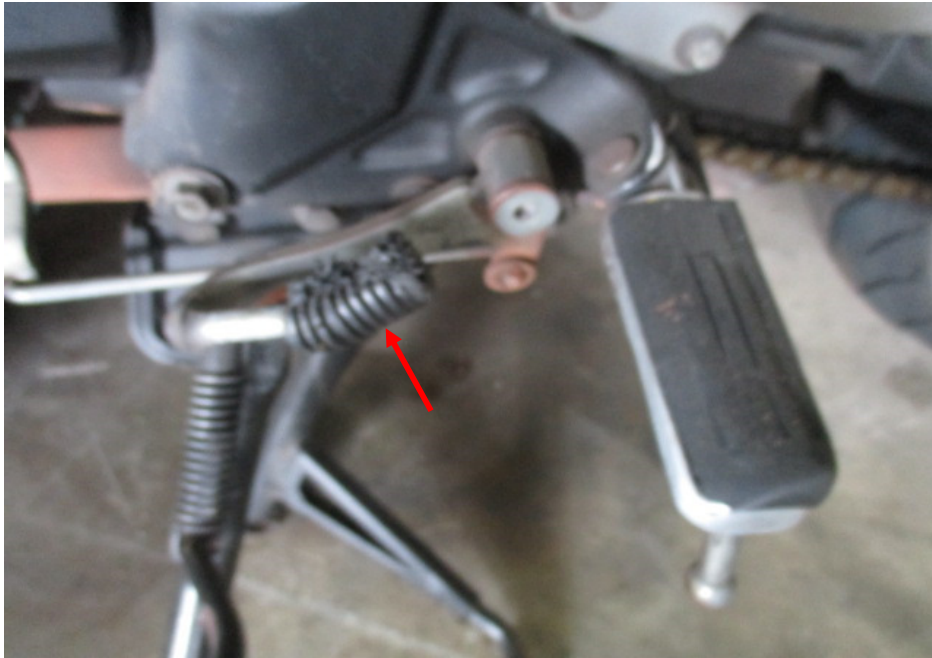
Photo 11 shows the bent gear shift pedal of the Motorcycle as a result of the accident (arrowed).

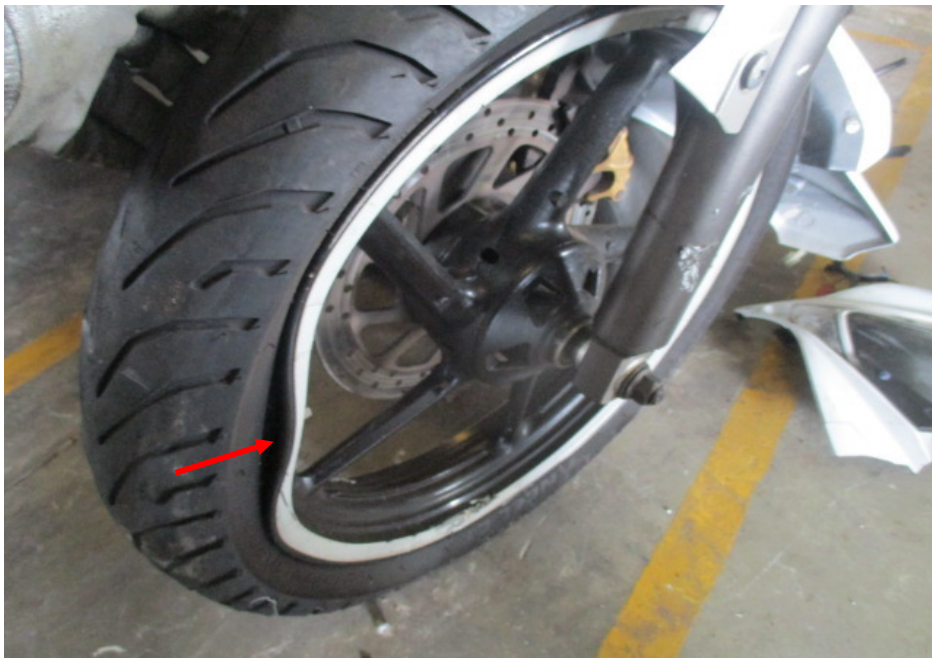
8. The 2 tyres were wrapped around alloy wheel rims. At the time of our inspection, we did not observe any visible damage on the rear wheel rim of the Motorcycle. However we did observe that the front wheel rim was bent. See photos 1 – 14 below.

Photo 12 shows the bent front wheel rim of the Motorcycle as a result of the accident at the time of our inspection (arrowed).

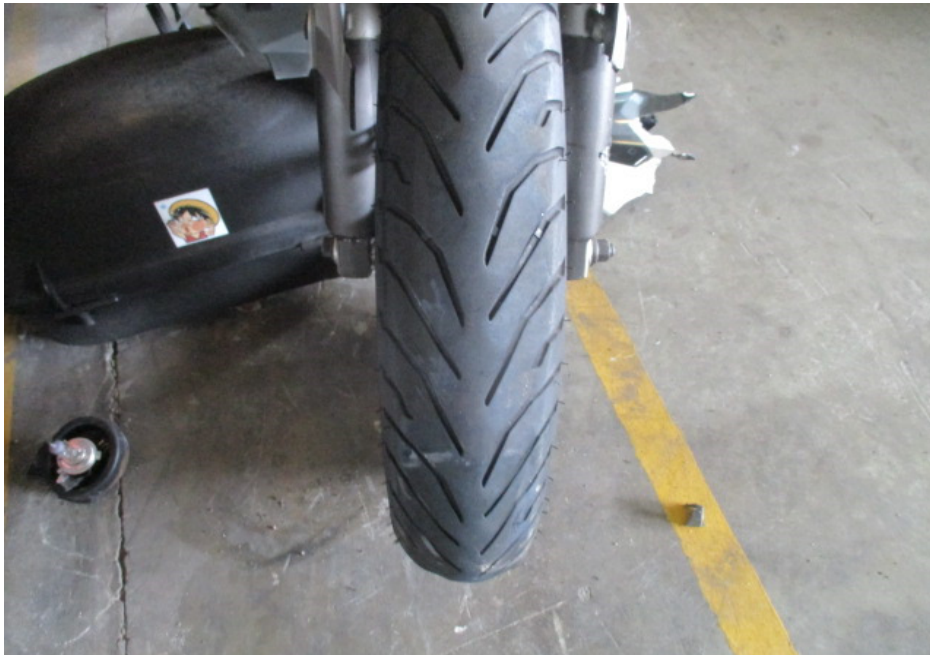
Photo 13 shows the front tyre of the Motorcycle at the time of our inspection. The front tyre was observed to be in serviceable condition with remaining tread depth of approximately 3mm. The pattern of the tread was also clearly visible. There was no tear, burst mark(s) and/or punctured hole(s) on the sidewalls as well as across the tread of the front tyre.

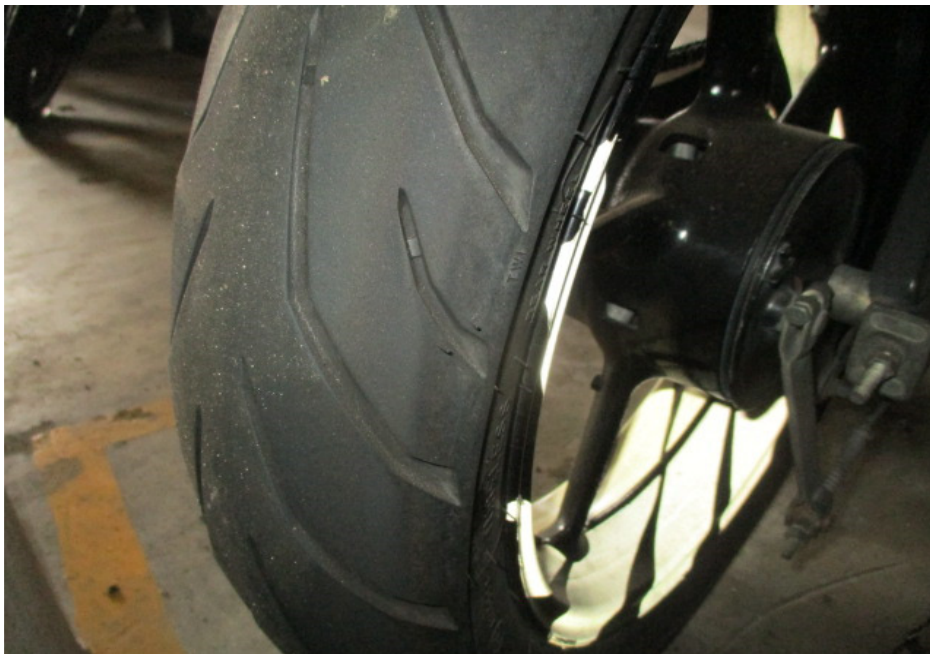
Photo 14 shows the condition of the Motorcycle's rear tyre. The rear tyre was observed to be in serviceable condition with remaining tread depth of approximately 3mm. The tyre was also observed to be sufficiently inflated for vehicular operation. We did not observe any tear, burst mark(s) and/or punctured hole(s) on the sidewalls as well as across the tread of the rear tyre.

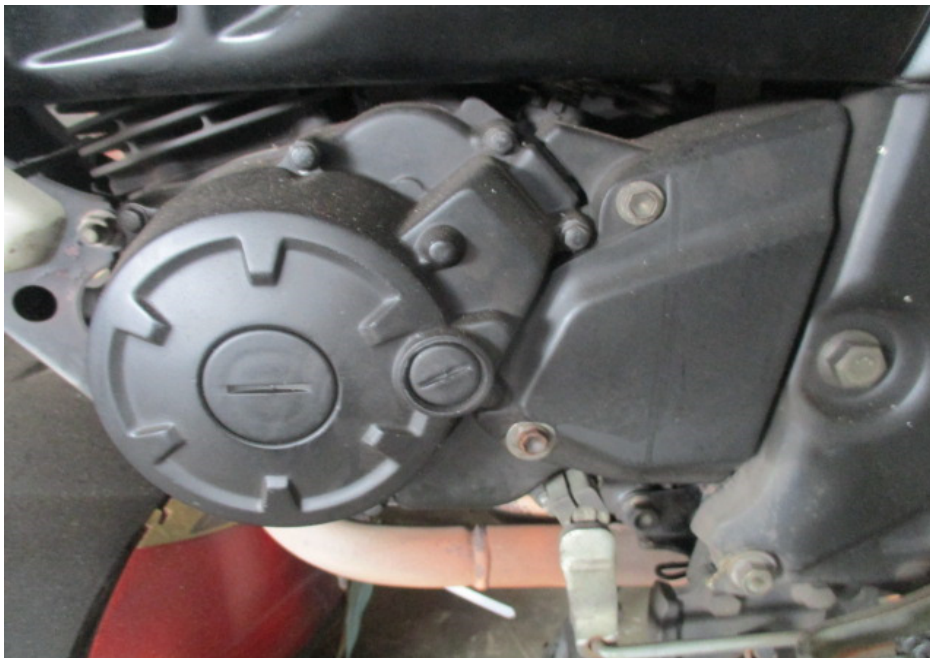
Photo 15 shows the left side of the engine of the Motorcycle at the time of our inspection. The various engine related parts and components were found to be intact with no visible damage. There was also no sign(s) or indication(s) of fluid leak observed around the left engine area of the Motorcycle.

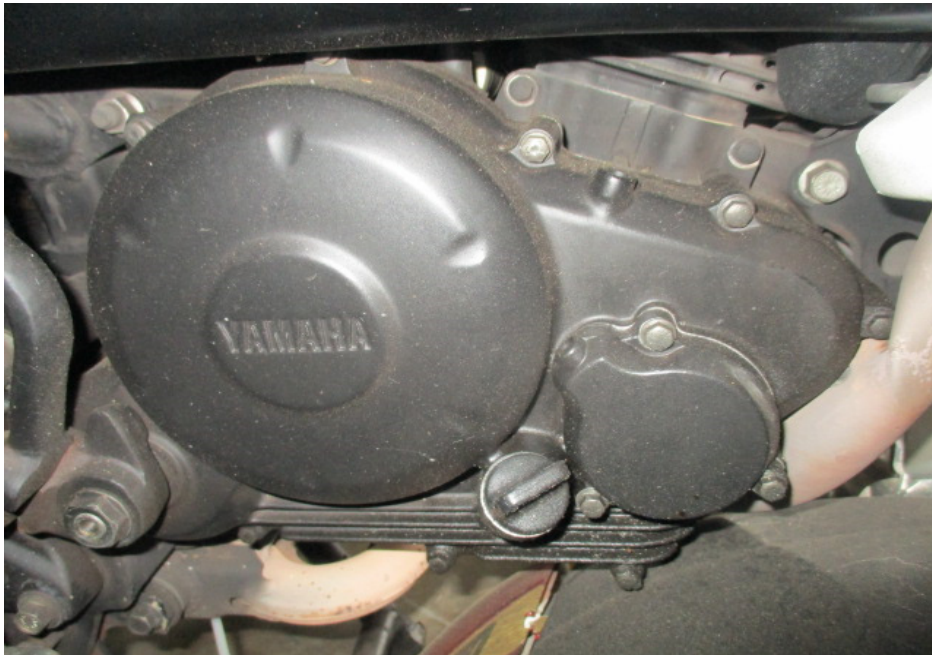
Photo 16 shows the right side of the engine of the Motorcycle at the time of our inspection. The various engine related parts and components were found to be intact with no visible damage. There was also no sign(s) or indication(s) of fluid leak observed around the right engine area of the Motorcycle.

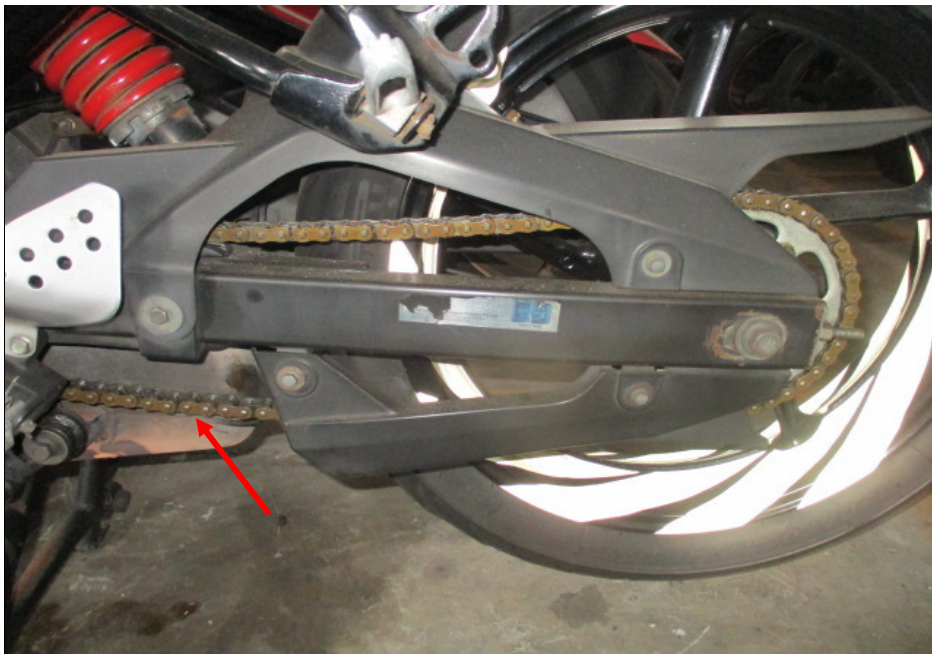
Photo 17 shows the gear chain (arrowed) of the Motorcycle, which was observed to be intact with no misalignment. It was also adequately lubricated for operating purposes. The gear chain rotates the rear wheel of the Motorcycle.

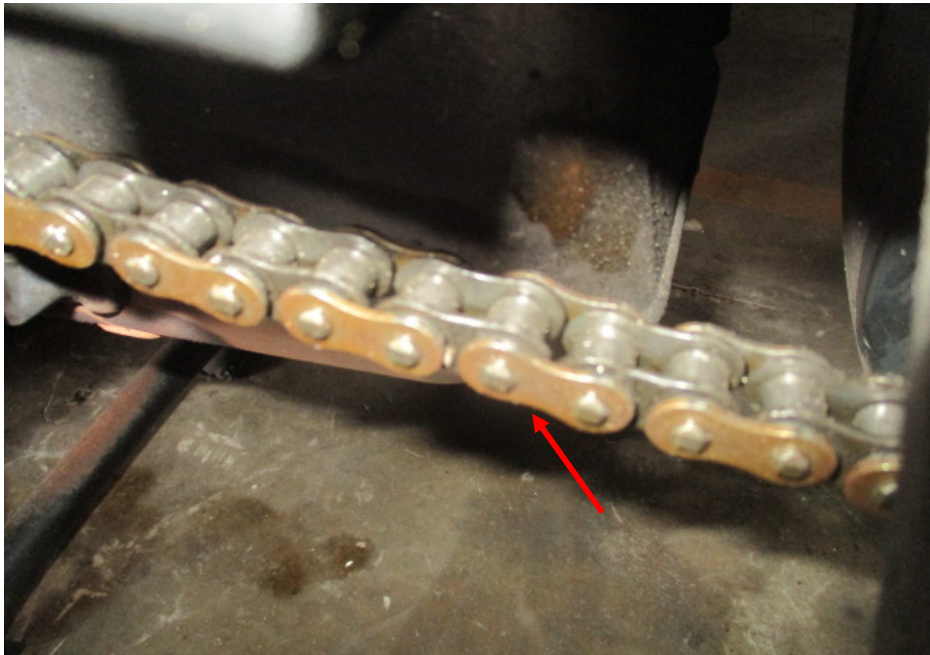
Photo 18 shows the closer view of the gear chain (arrowed) of the Motorcycle, which was observed to be intact with no misalignment. It was also adequately lubricated for operating purposes.

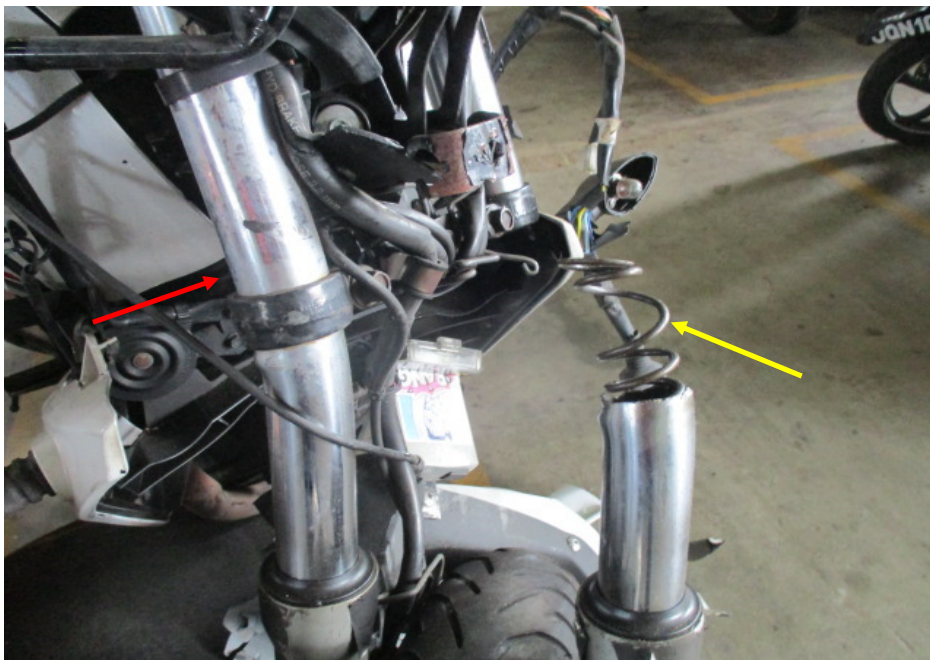
11. For this case, we were not able to conduct any test(s) on the steering system of the Motorcycle due to the damage of its front forks and steering stem. The right front fork was found to be bent inwards and the left front fork was observed to be dislodged as a result of the accident.

Photo 19 shows the front forks of the Motorcycle. The front right fork was observed to be bent inwards (red arrow) and the left front fork was observed to be dislodged (yellow arrow) as a result of the accident. We were hence not able to conduct any tests on the steering system of the Motorcycle.

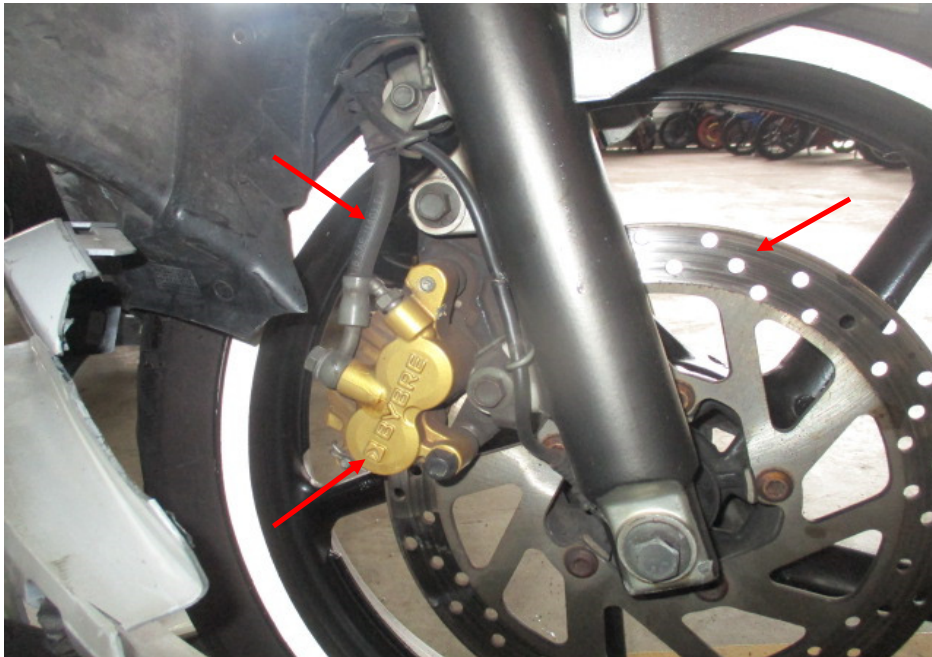
Photo 20 shows a close up view of the front brake caliper, front brake disc and front brake hose (arrowed) of the Motorcycle, which are all part of the components in the hydraulic front brake system of the Motorcycle. Our visual checks of these various components had revealed all to be intact with no visible damage. No leakage of brake fluid was also observed.

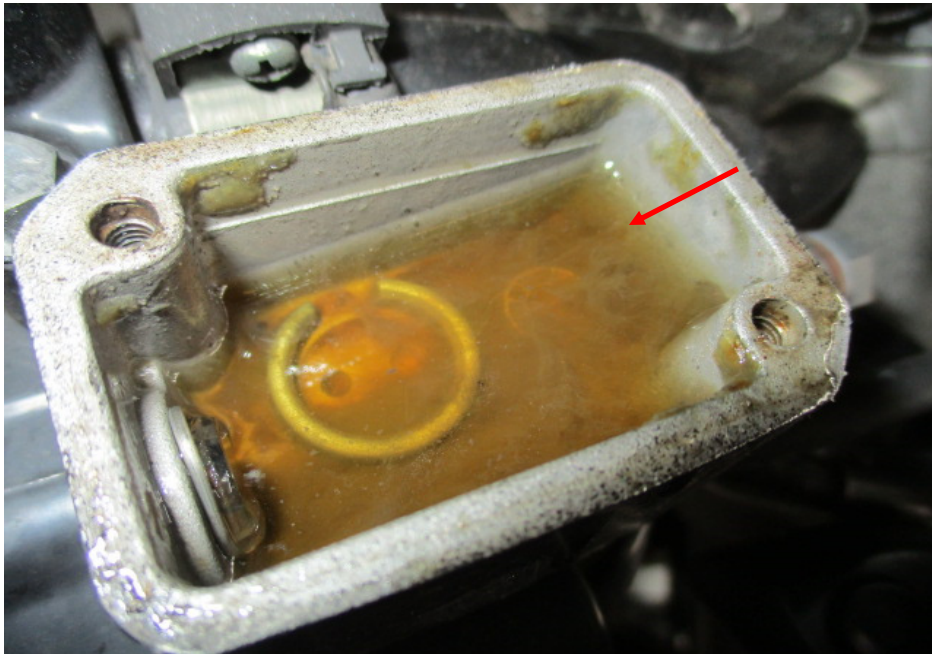
Photo 21 shows the brake fluid reservoir for the front brake of the Motorcycle. The brake fluid was found to be of sufficient level for operating purposes. However the brake fluid was found to be slightly contaminated (arrowed).

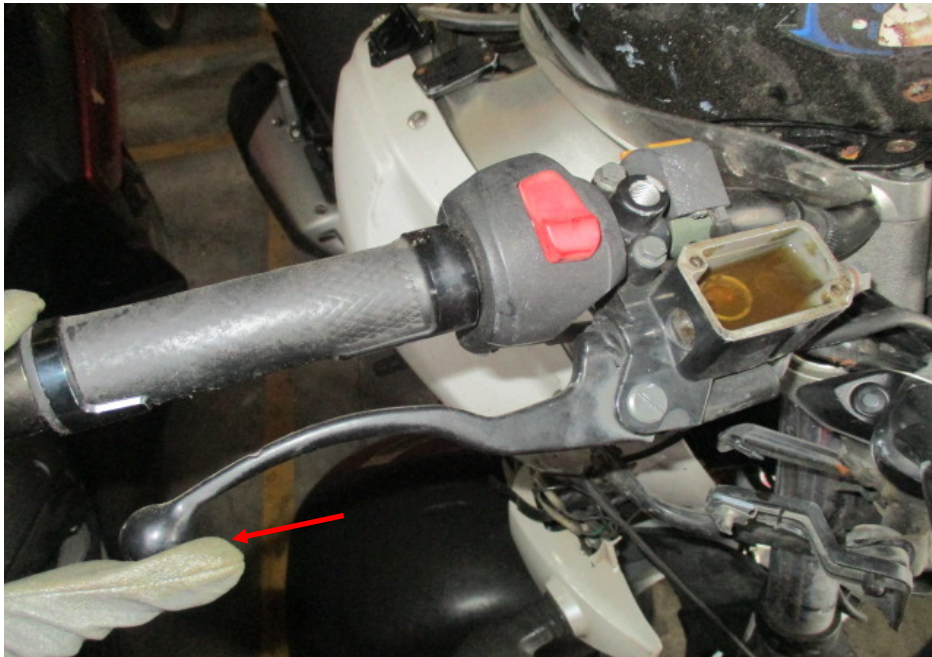
13. Static brake tests conducted on the Motorcycle had appeared to indicate that the brake system of the Motorcycle was in serviceable condition. There was some resistance felt (spongy like feel) upon pressing the front brake lever. This would indicate that there's no leakage of pressure/vacuum in the front brake system.
14. For this case, we were not able to carry out any operational tests to the steering system and front braking system of the Motorcycle due to the damage of its front forks, which had rendered the Motorcycle immobile for the operational tests. We were not able to push the Motorcycle manually forward and backward, simulating movement of the Motorcycle, for the operational tests. See photos 19 – 23 below.

Photo 22 shows the front brake lever being depressed. There was some resistance felt (spongy like feel) upon pressing the front brake lever (arrowed). This would indicate that there is no leakage of pressure/vacuum in the brake system.

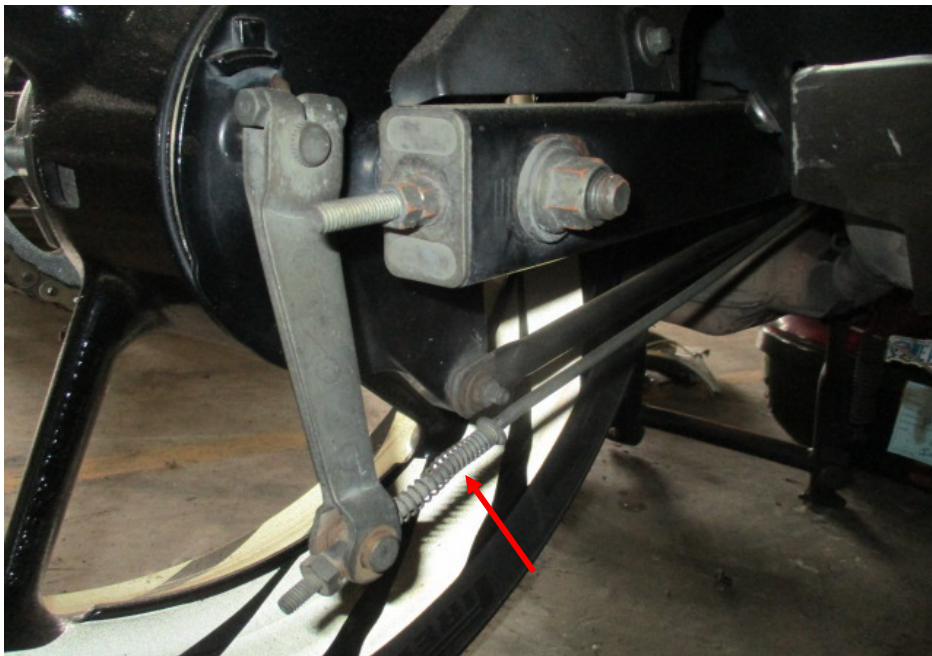
Photo 23 shows the rear wheel of the Motorcycle. The type of brake system for the rear wheel was of a mechanical type, controlled by the brake foot pedal of the Motorcycle. Our checks of the cable (arrowed), spring and drum which are all part of the components in the rear brake system of the Motorcycle reveal all to be intact and without damage.
