Your Ref: TP/IP/13045/2020
Our Ref : CI/TPD20005426/N

4 August 2020

INSPECTION REPORT OF MOTORCYCLE JQG 5206

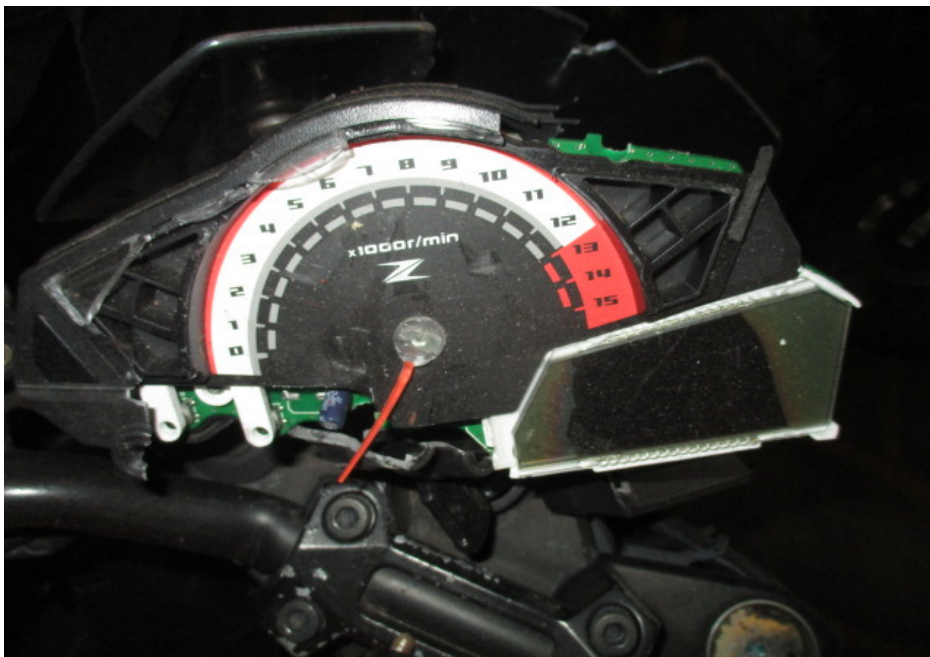
4. The mileage of the Motorcycle could not be recorded at the time of our inspection due to the damaged speedometer gauge.
5. The Motorcycle was observed to have sustained damages all around. The body parts that were found to have been damaged include its headlight assembly, head cowl, front mudguard, right cowl, front brake lever, clutch lever, right footrest bracket and left rear side cover, amongst others.

Photo 1 shows the damaged speedometer gauge of the Motorcycle as a result of the accident. As a result, the mileage of the Motorcycle could not be recorded at the time of our inspection.

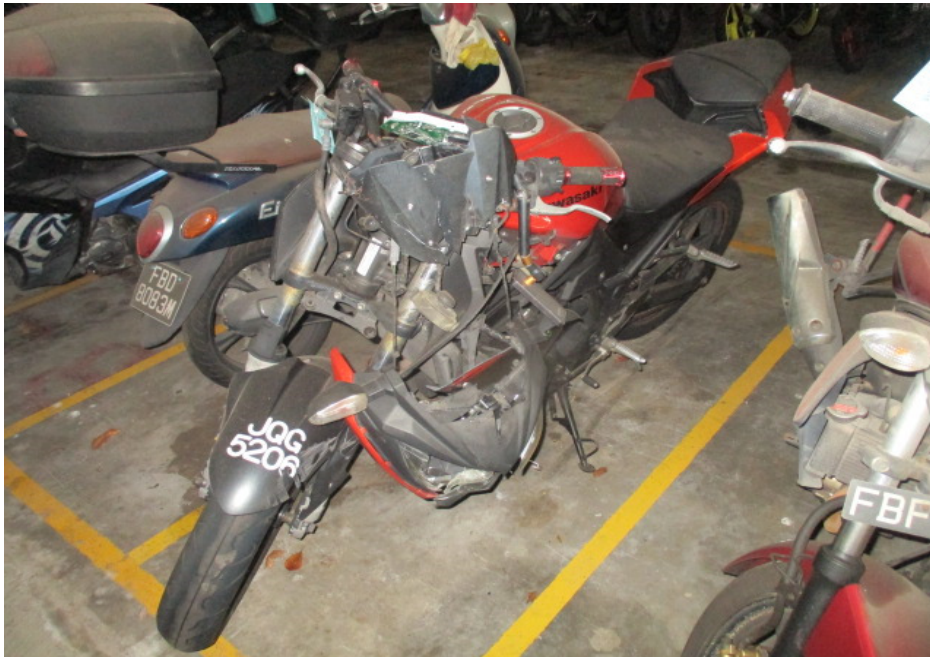
Photo 2 shows a general view of the left front body of the Motorcycle at the time of our inspection. The Motorcycle was observed to have sustained damages all around.

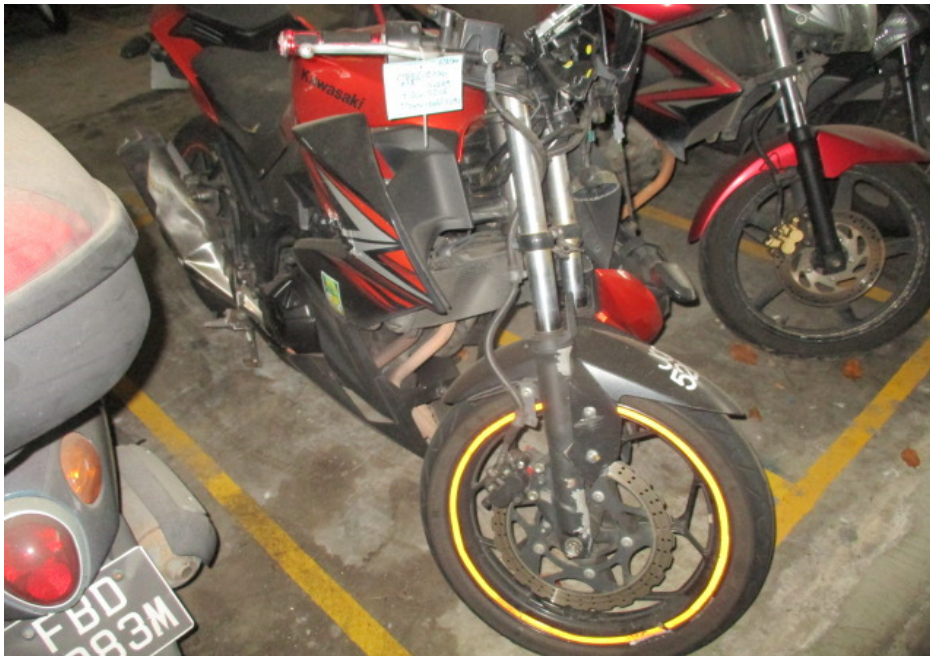
Photo 3 shows a general view of the right front body of the Motorcycle at the time of our inspection. The Motorcycle was observed to have sustained damages all around body. Amongst the body parts that were found to have been damaged include its headlight assembly, head cowl, front mudguard, right cowl, front brake lever, clutch lever, right footrest bracket and left rear side cover, amongst others.

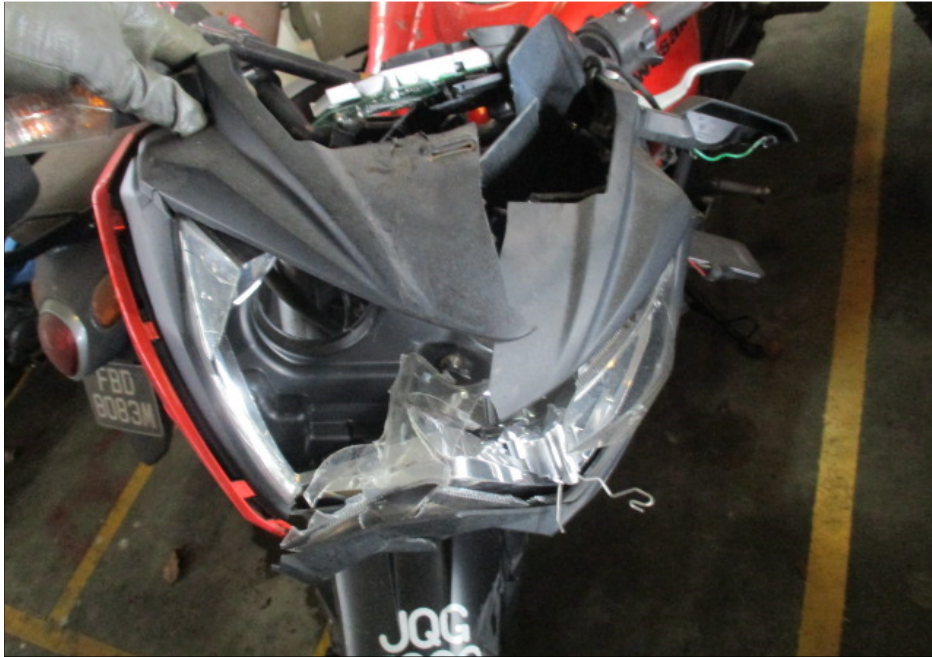
Photo 4 shows a close up view of the head cowl and headlight assembly which were amongst the body parts at the front of the Motorcycle that had sustained damage as a result of the accident.

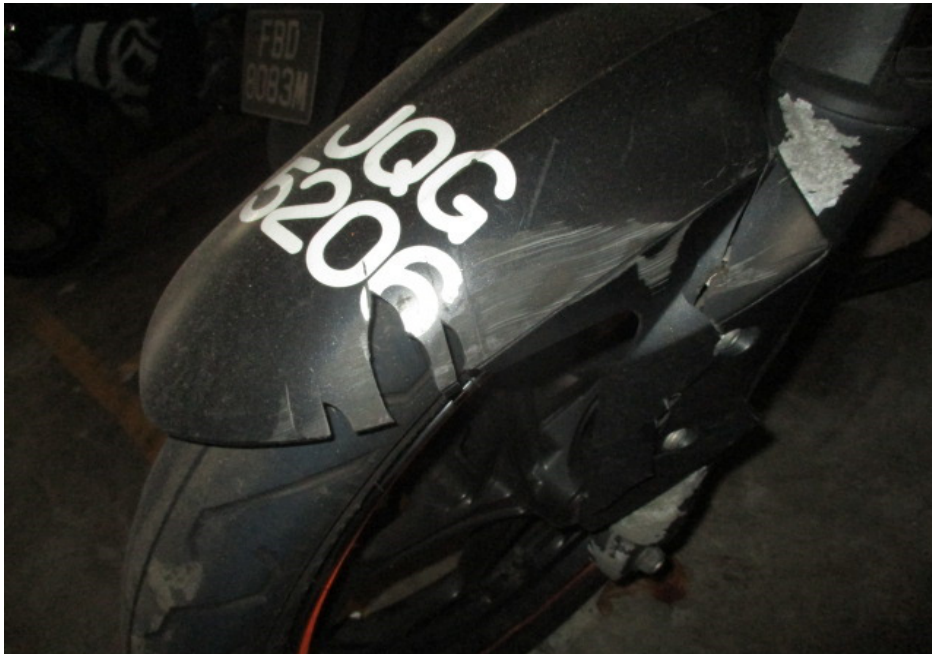
Photo 5 shows a closer view of the cracked front mudguard which was amongst the body parts of the Motorcycle that had sustained damage as a result of the accident.

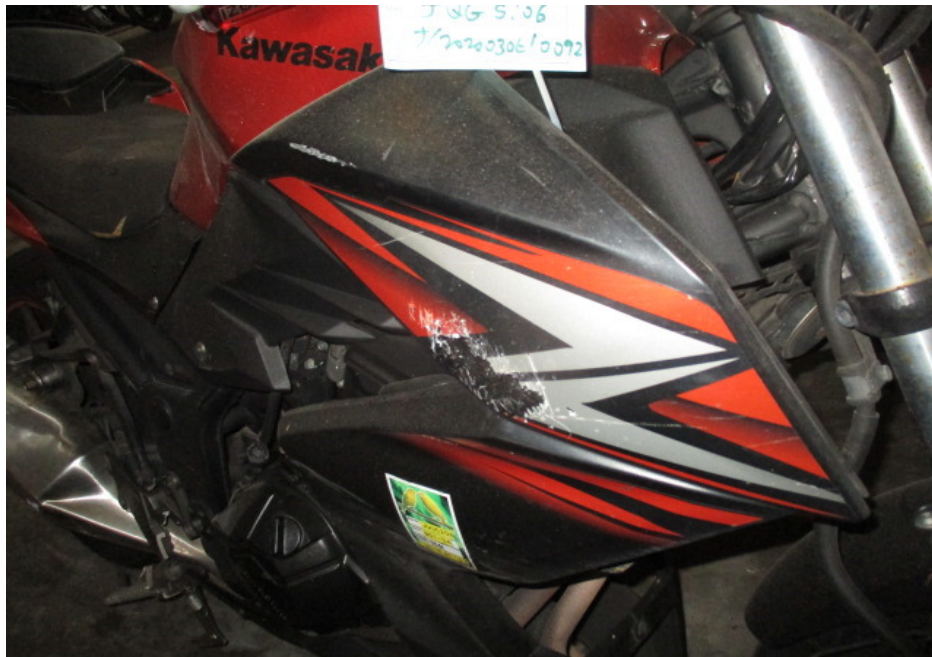
Photo 6 shows a closer view of the right cowling of the Motorcycle which had sustained damages of grazing nature as a result of the accident.

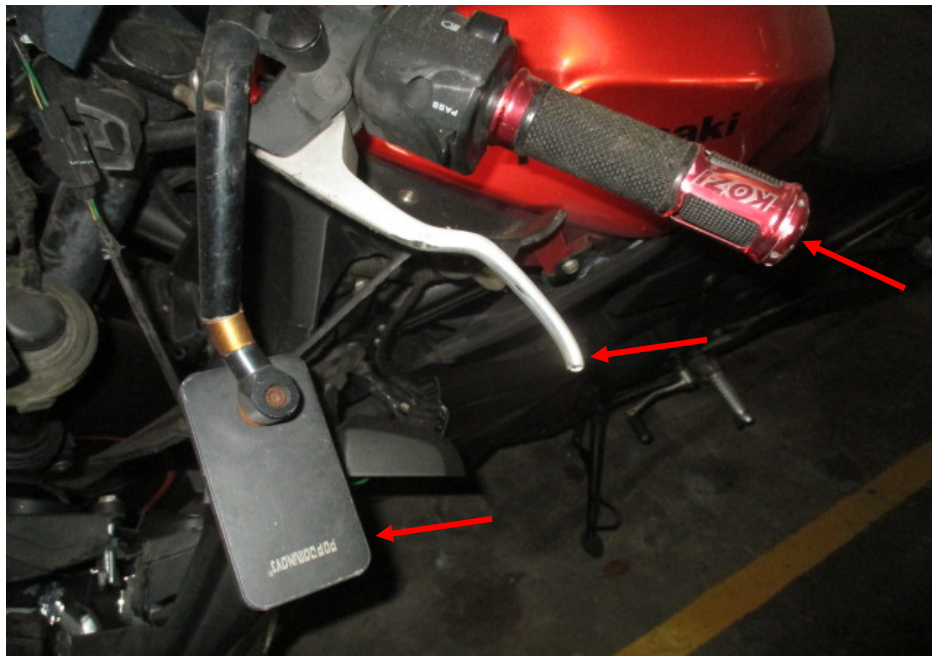
Photo 7 shows the left handlebar end, clutch lever and left side mirror (arrowed), which were amongst the body parts of the Motorcycle that had sustained damage as a result of the accident.

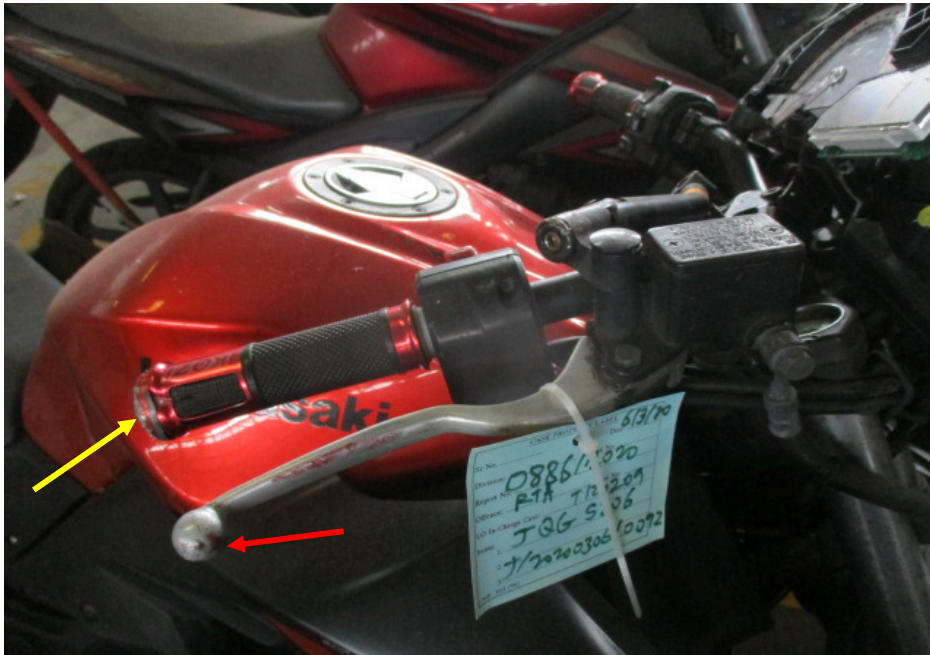
Photo 8 shows the right handlebar end and front brake lever (arrowed), which were amongst the body parts of the Motorcycle that had sustained damage as a result of the accident.

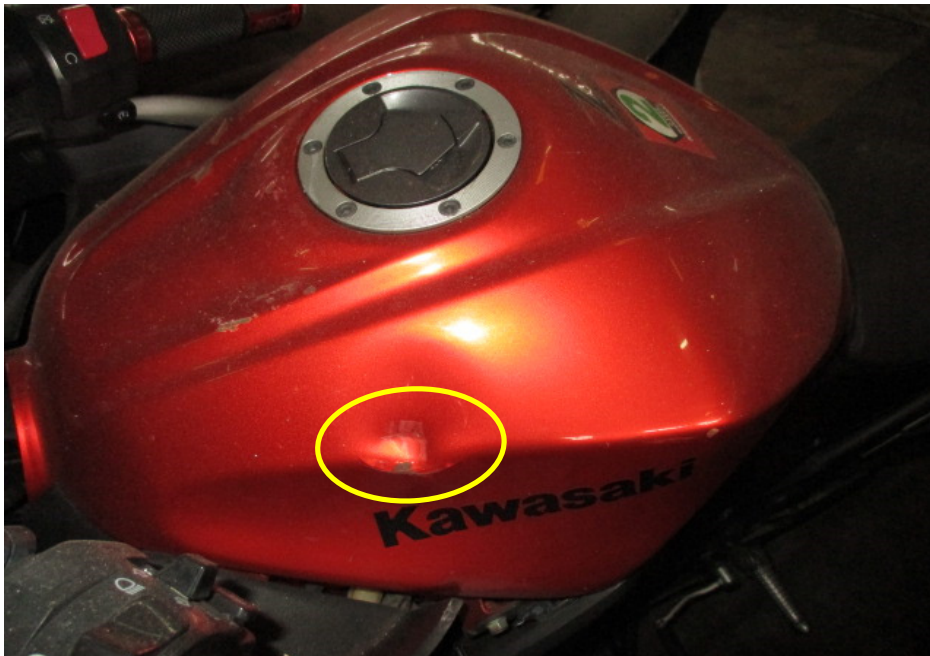
Photo 9 shows a closer view of the dented petrol tank (circled) which was amongst the body parts of the Motorcycle that had sustained damage as a result of the accident.

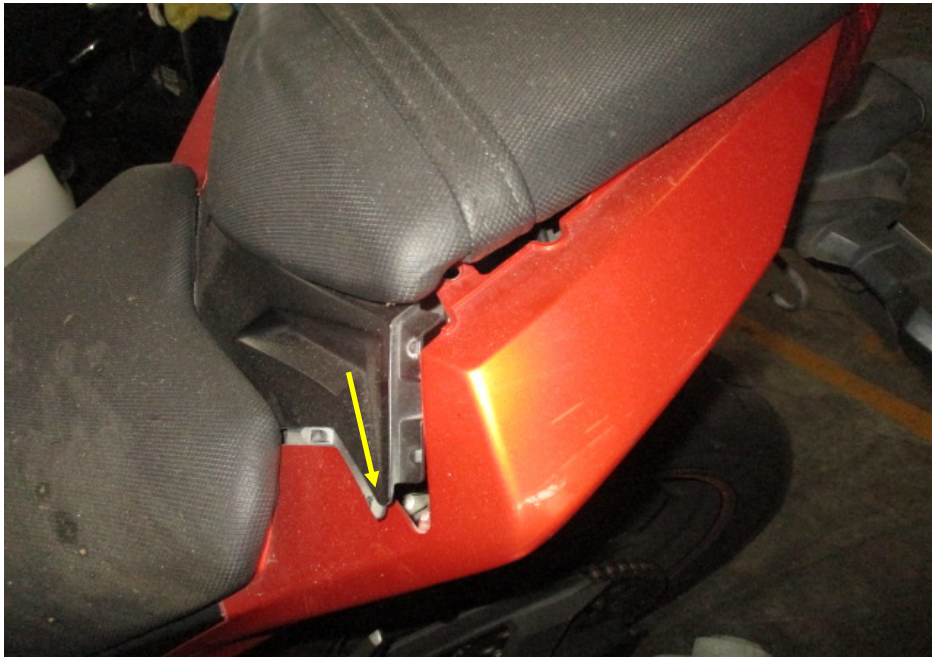
Photo 10 shows a closer view of the cracked left rear side cover of the Motorcycle as a result of the accident (arrowed).

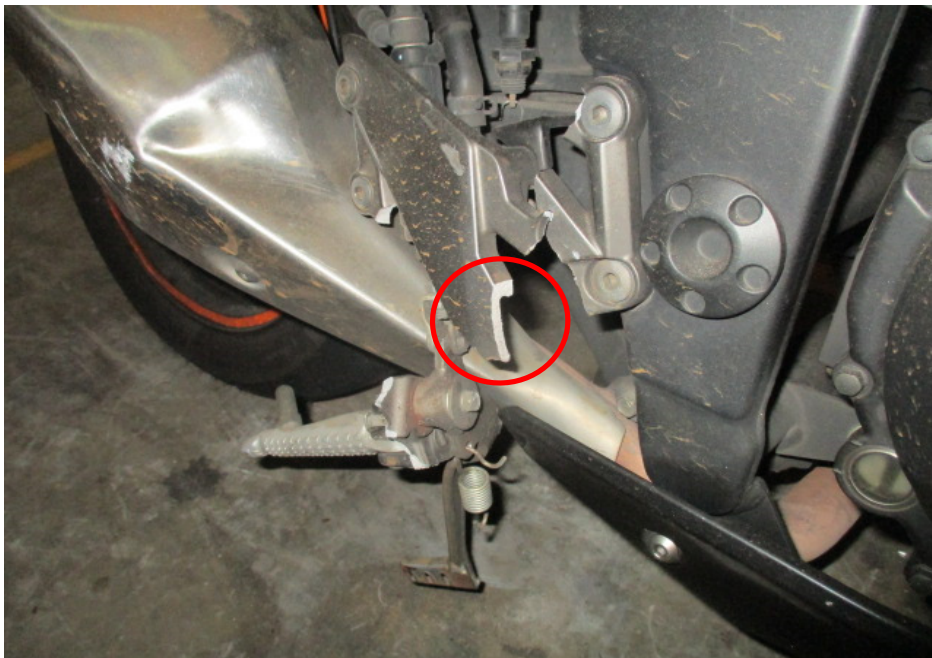
Photo 11 shows a closer view of the broken right front footrest bracket of the Motorcycle as a result of the accident (circled).

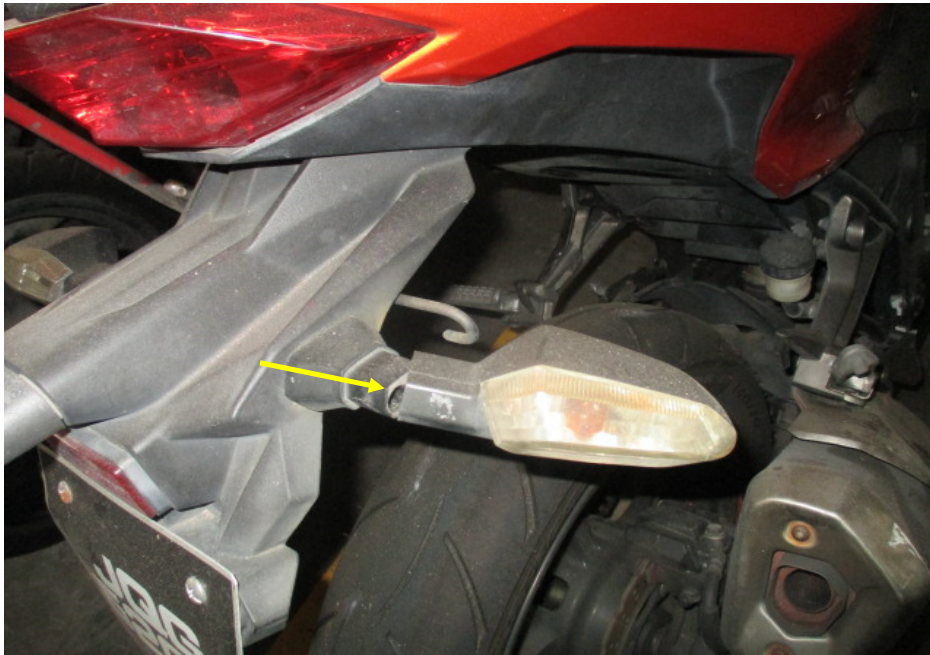
Photo 12 shows the right rear signal lamp of the Motorcycle that had sustained damage as a result of the accident (arrowed).

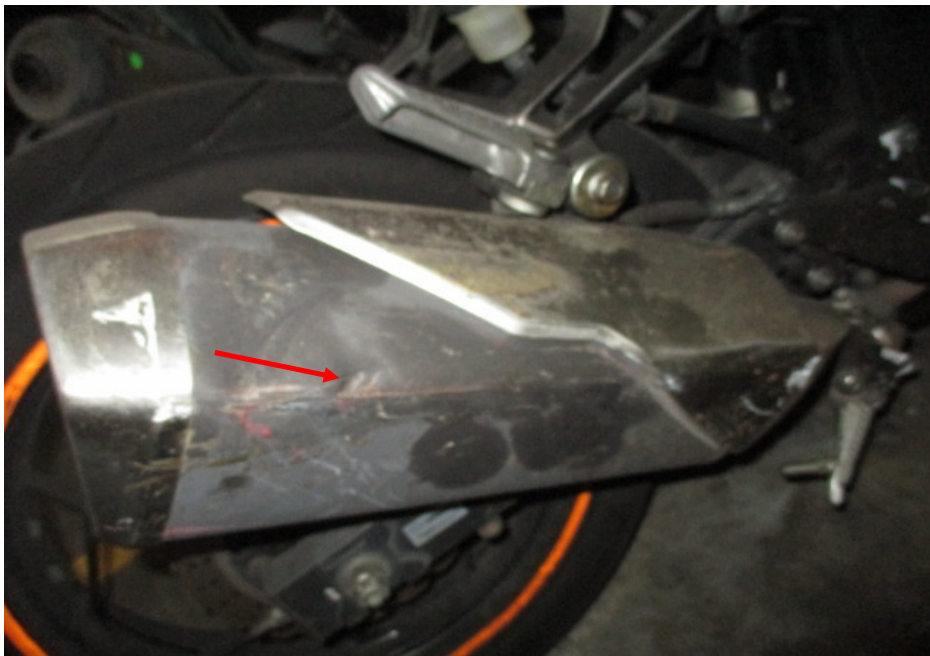
Photo 13 shows the dented exhaust muffler of the Motorcycle as a result of the accident (arrowed).

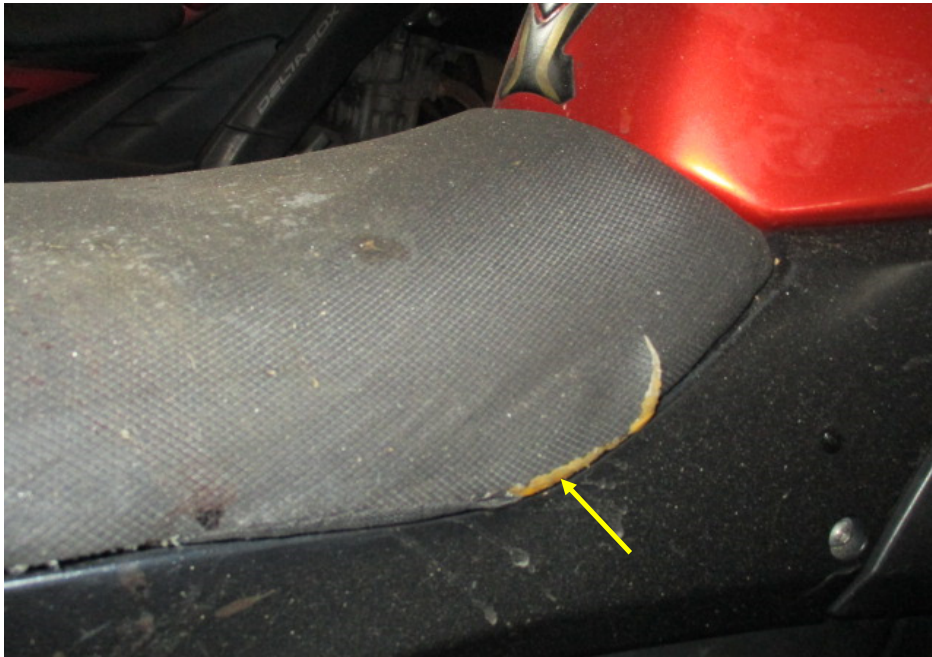
Photo 14 shows the torn seat of the Motorcycle as a result of the accident (arrowed).

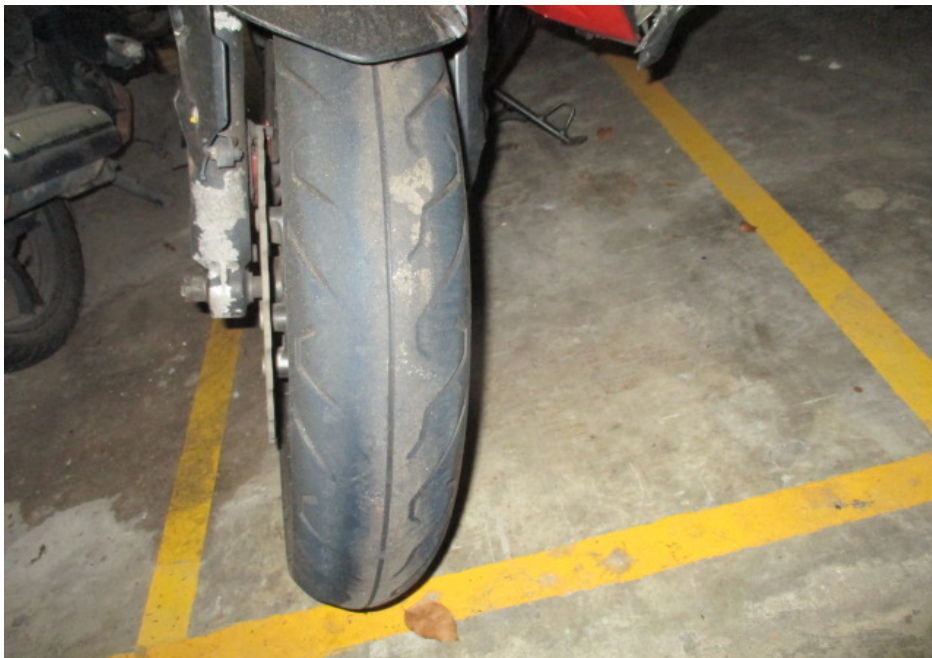
Photo 15 shows the front tyre of the Motorcycle at the time of our inspection. The front tyre was observed to be in serviceable condition with remaining tread depth of approximately 3mm. The pattern of the tread was also clearly visible. There was no tear, burst mark(s) and/or punctured hole(s) on the sidewalls as well as across the tread of the front tyre.

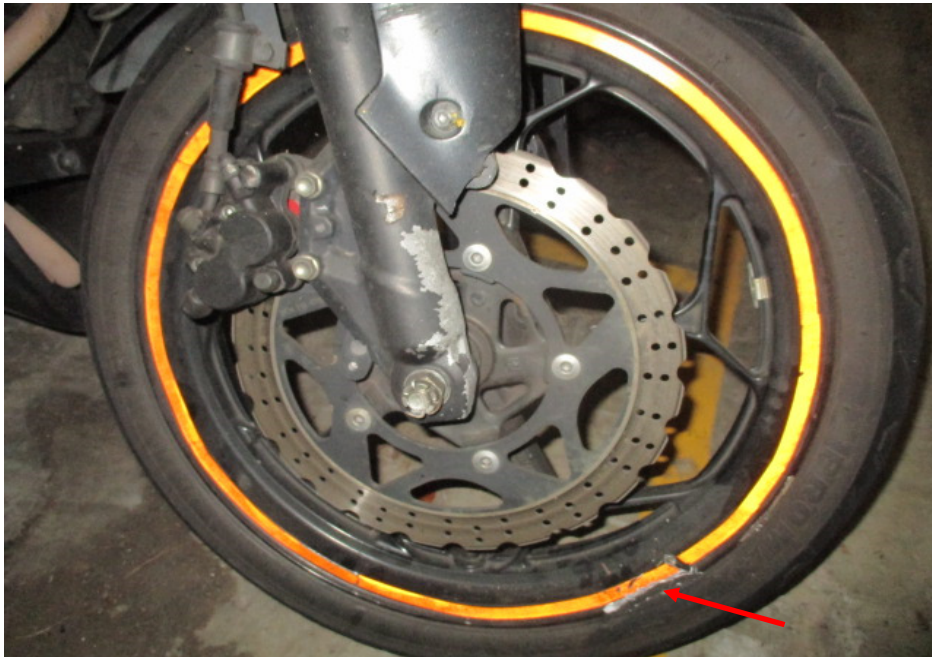
8. The 2 tyres were wrapped around alloy wheel rims. At the time of our inspection, we did not observe any visible damage on the rear wheel rim of the Motorcycle. However, the front wheel rim of the Motorcycle was observed to be chipped as a result of the accident. See photos 1 – 17 below.

Photo 16 shows the front wheel rim of the Motorcycle which was observed to be chipped as a result of the accident (arrowed).

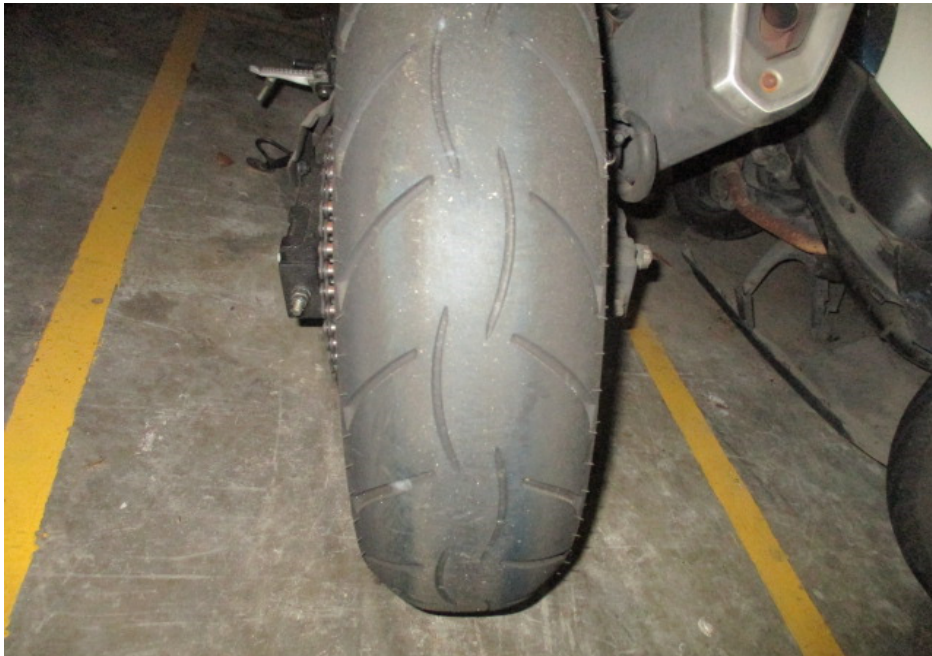
Photo 17 shows the condition of the Motorcycle's rear tyre. The rear tyre was observed to be in serviceable condition with remaining tread depth of approximately 3mm. The tyre was also observed to be sufficiently inflated for vehicular operation. We did not observe any tear, burst mark(s) and/or punctured hole(s) on the sidewalls as well as across the tread of the rear tyre.

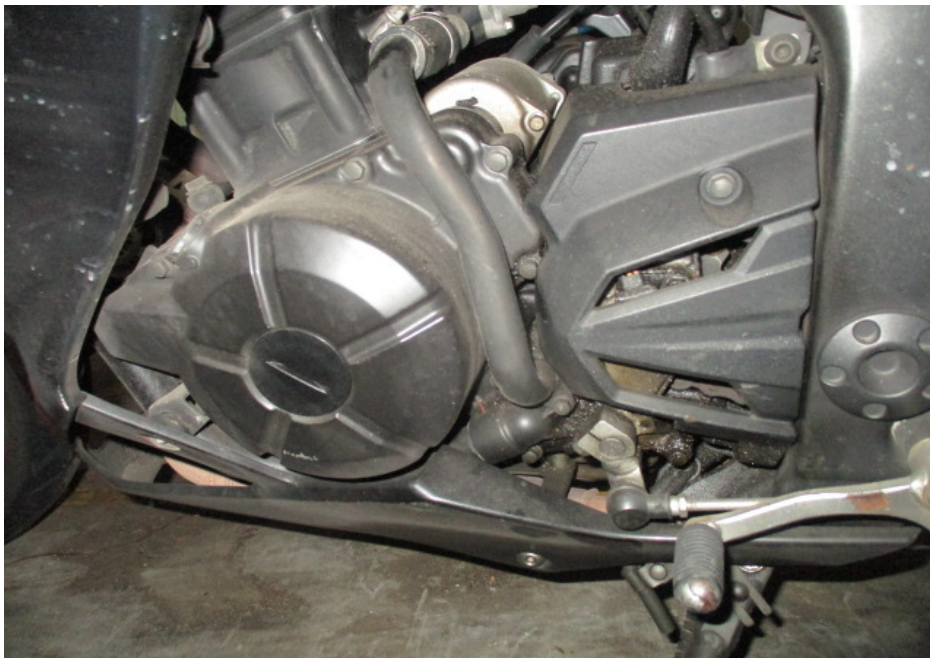
Photo 18 shows the left side of the engine of the Motorcycle at the time of our inspection. The various engine related parts and components were found to be intact with no visible damage. There was also no sign(s) or indication(s) of fluid leak observed around the left engine area of the Motorcycle.

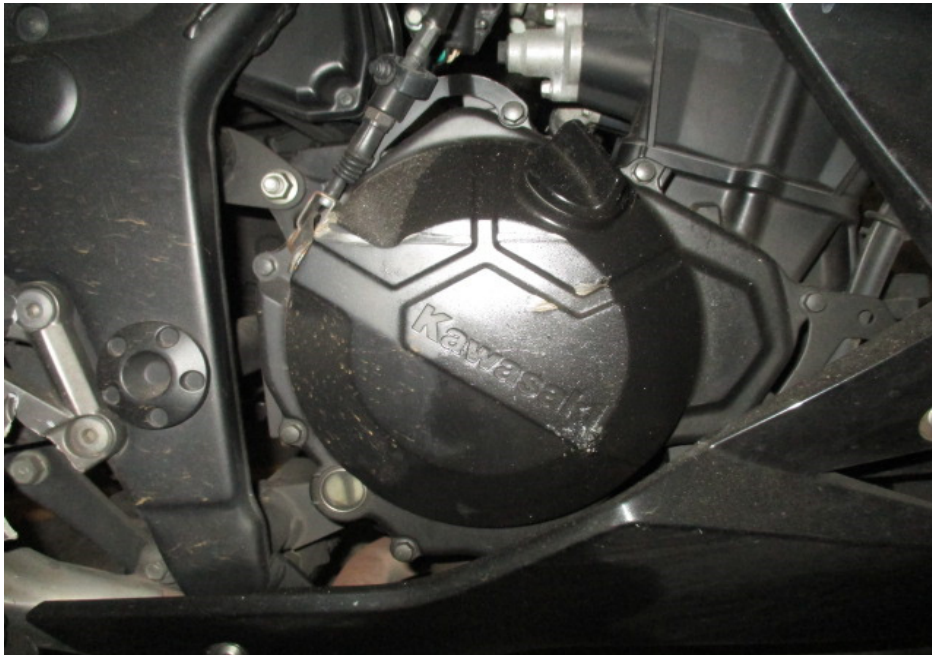
Photo 19 shows the right side of the engine of the Motorcycle at the time of our inspection. The various engine related parts and components were found to be intact with no visible damage. There was also no sign(s) or indication(s) of fluid leak observed around the right engine area of the Motorcycle.

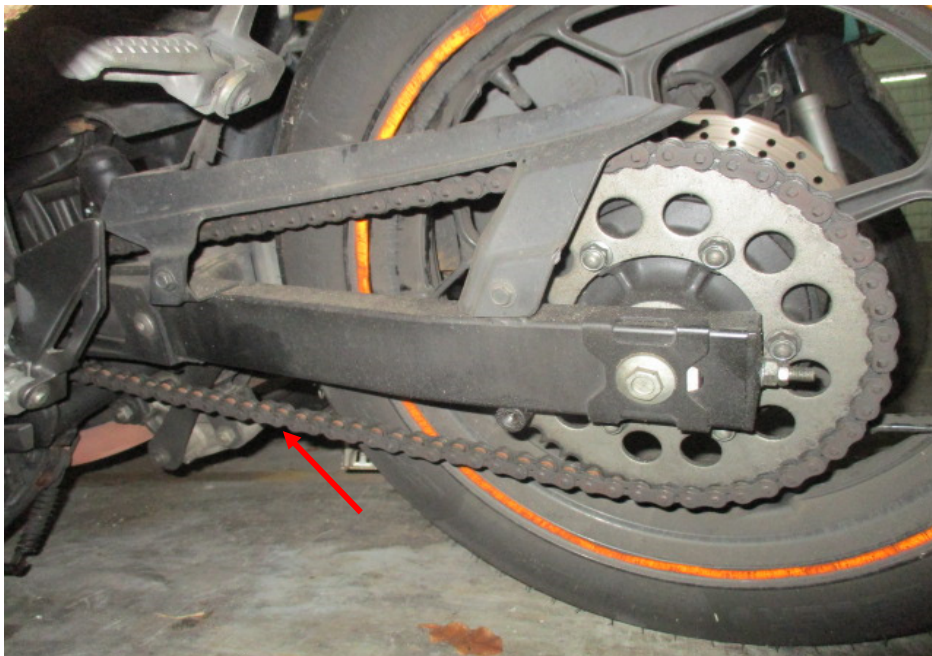
Photo 20 shows the general view of the gear train (arrowed) of the Motorcycle, which was observed to be intact with no misalignment. It was also adequately lubricated for operating purposes.

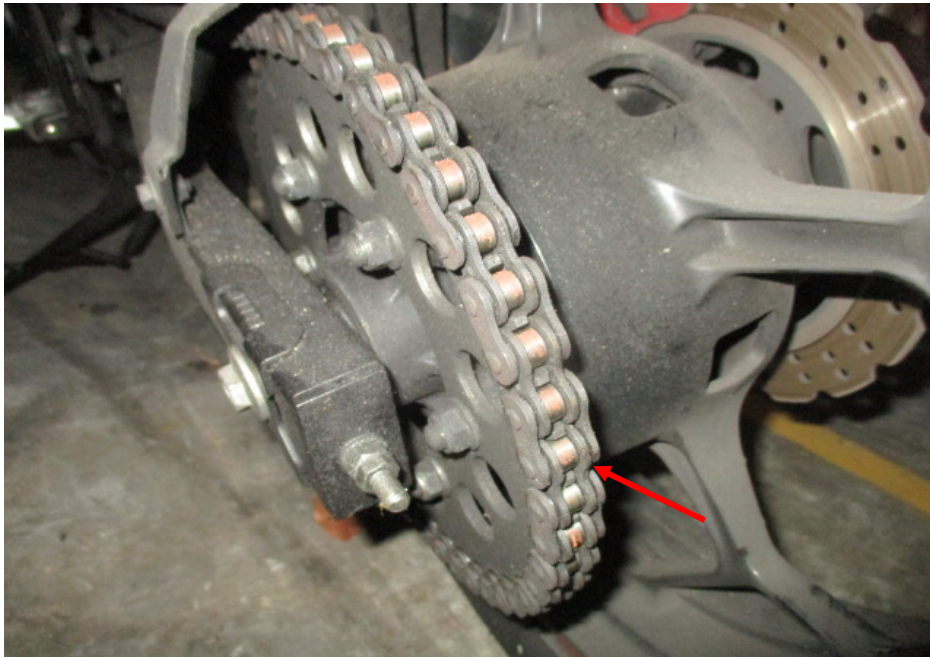
Photo 21 shows a closer view of the gear train (arrowed) of the Motorcycle, which was observed to be intact with no misalignment. It was also adequately lubricated for operating purposes.

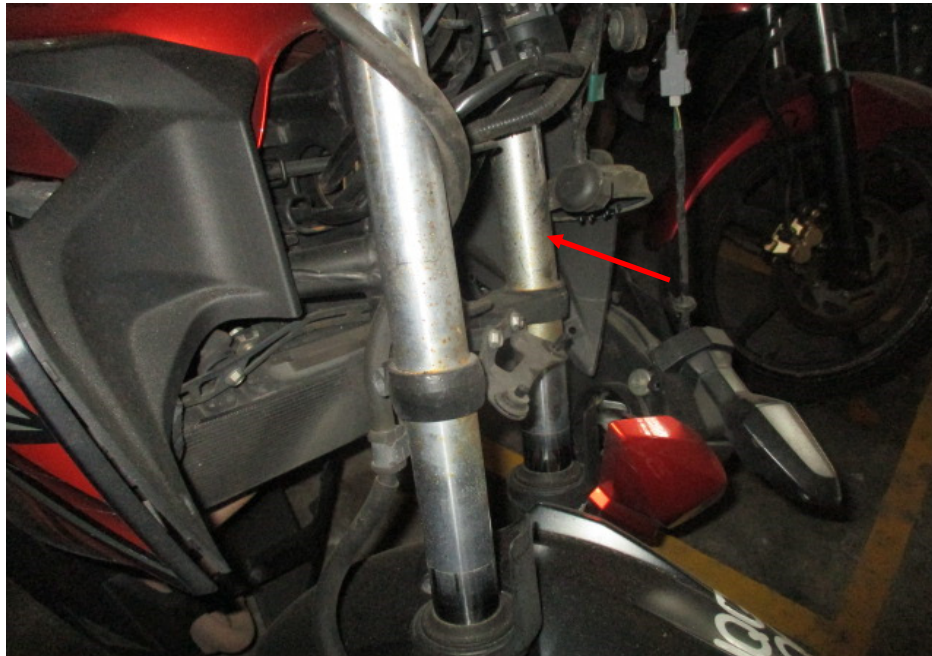
11. For this case, we were not able to conduct any test(s) on the steering system of the Motorcycle due to the damage of its front forks and handlebar. The left front fork was found to be bent inwards as a result of the accident. The handlebar was also found to be bent inwards as a result of the accident. Hence we were unable to turn the handle bar fully towards the left and right.

Photo 22 shows the front forks of the Motorcycle. The left front fork was found to be bent inwards as a result of the accident (arrowed). We were hence not able to conduct any tests on the steering system of the Motorcycle.

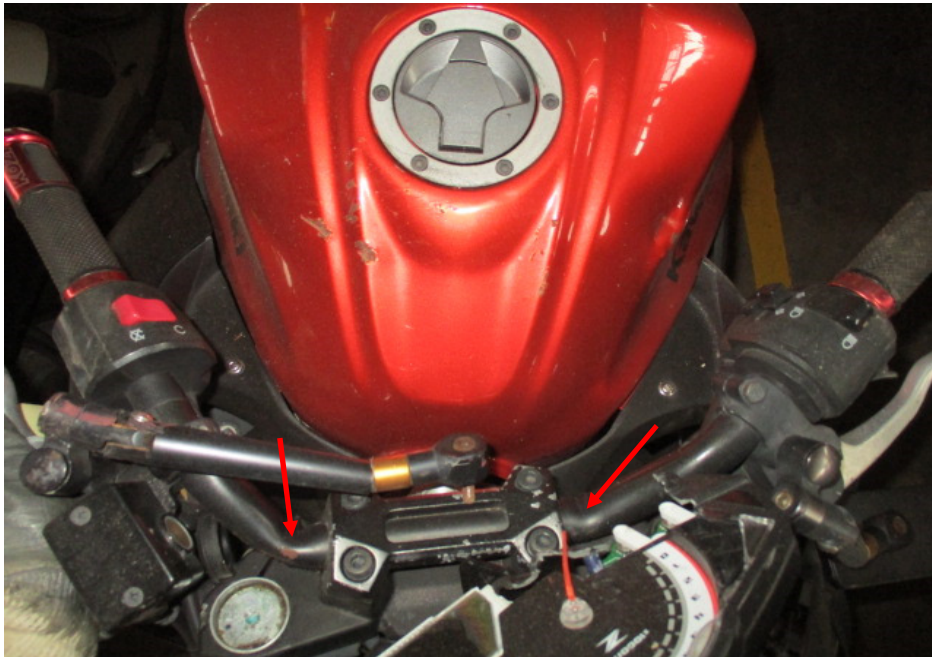
Photo 23 shows the handlebar of the Motorcycle. The handlebar was found to be bent inwards as a result of the accident (arrowed). We were hence unable to turn the handle bar fully towards the left and right.

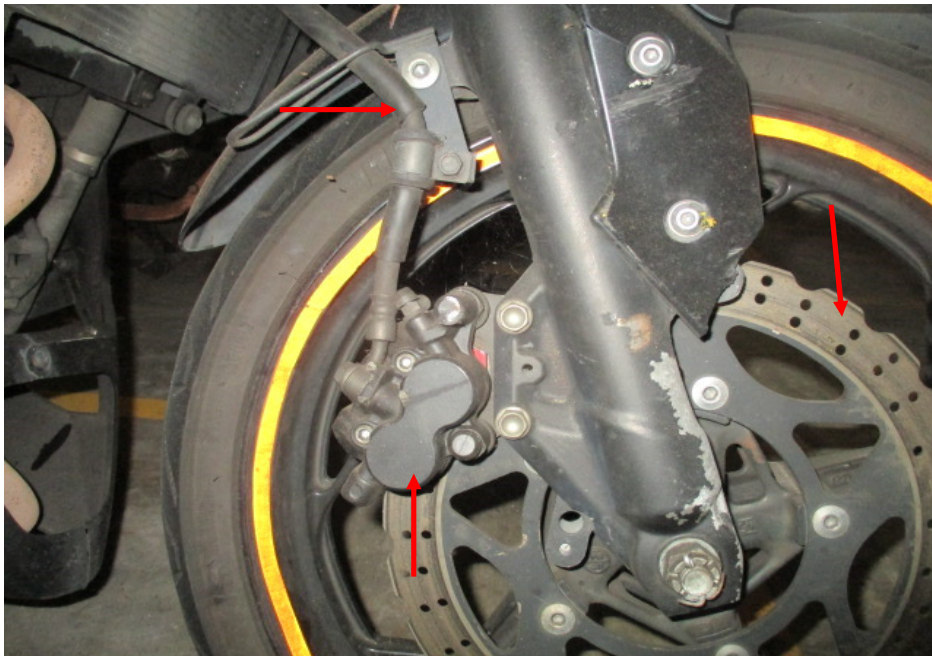
Photo 24 shows a close up view of the front brake caliper, front brake disc and front brake hose (arrowed) of the Motorcycle, which are all part of the components in the hydraulic front brake system of the Motorcycle. Our visual checks of these various components had revealed all to be intact with no visible damage. No leakage of brake fluid was also observed.

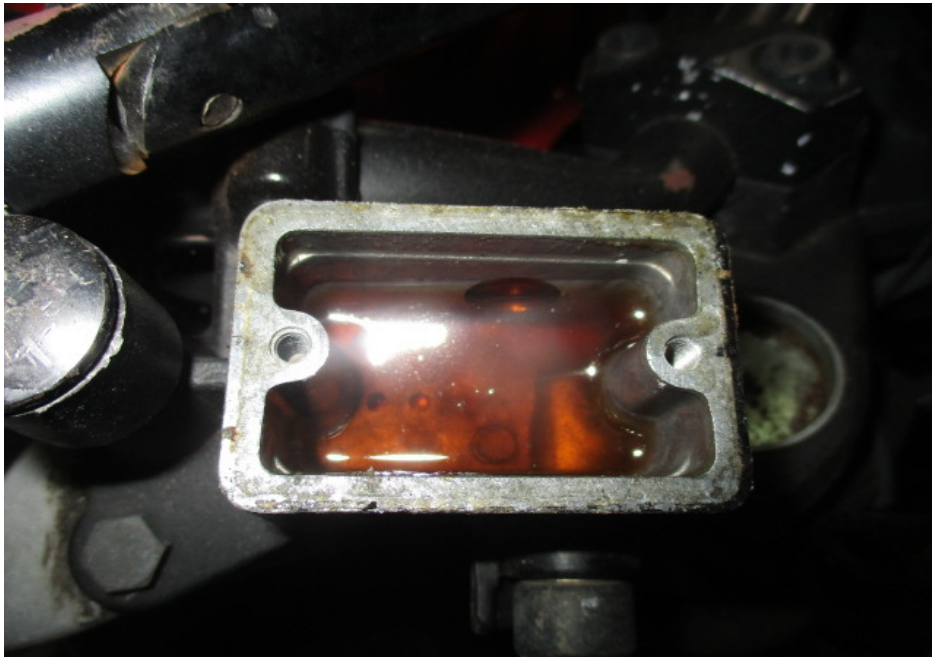
Photo 25 shows the brake fluid reservoir for the front brake of the Motorcycle. The brake fluid was found to be without contamination and of sufficient level for operating purposes.

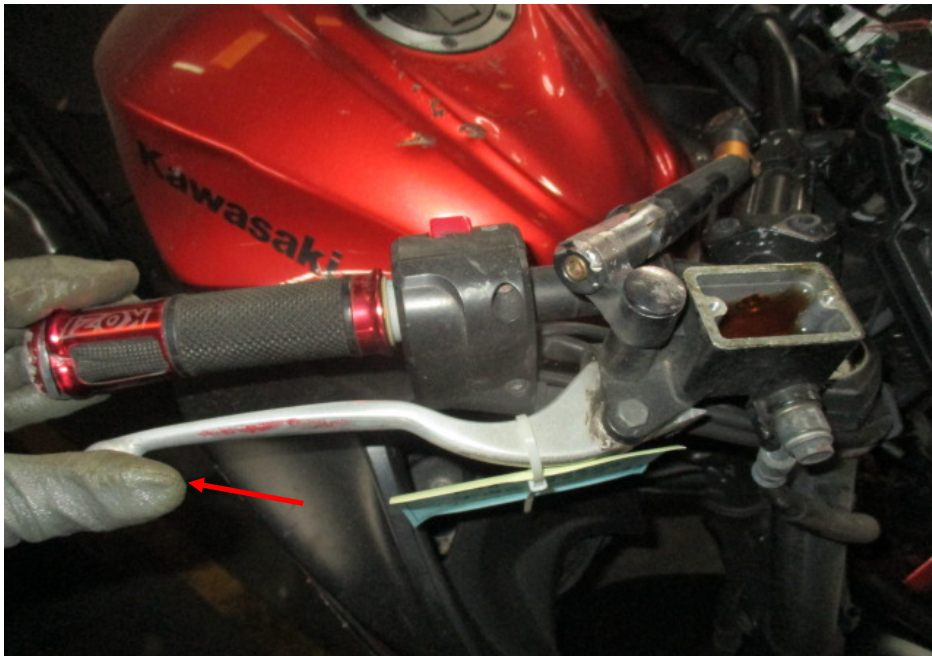
Photo 26 shows the front brake lever being depressed. There was some resistance felt (spongy like feel) upon pressing the front brake lever (arrowed). This would indicate that there is no leakage of pressure/vacuum in the brake system.

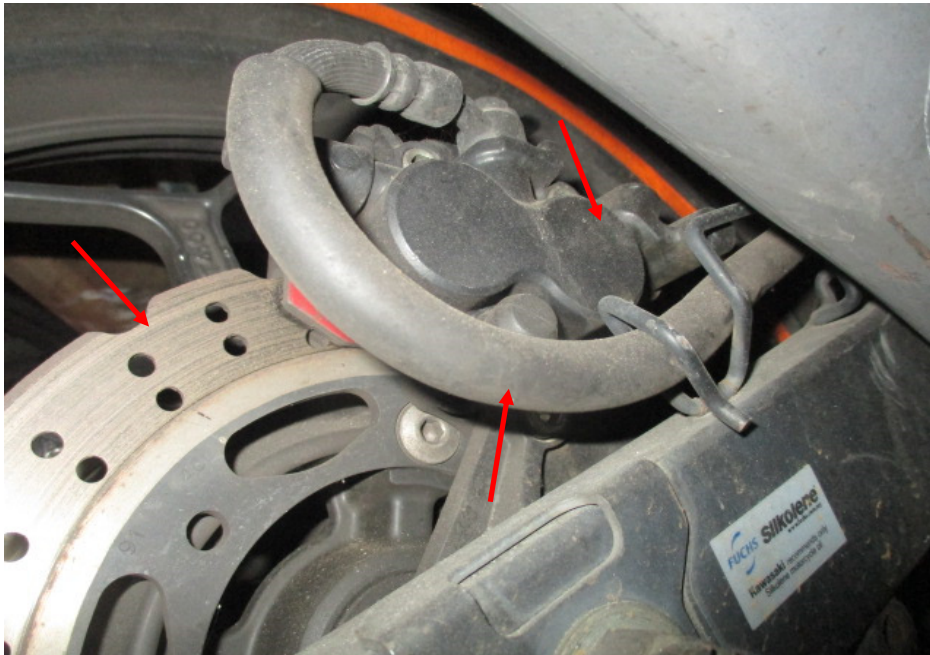
Photo 27 shows a close up view of the rear brake caliper, rear brake disc and rear brake hose (arrowed) of the Motorcycle, which are all part of the components in the hydraulic rear brake system of the Motorcycle. Our visual checks of these various components had revealed all to be intact with no visible damage. No leakage of brake fluid was also observed.

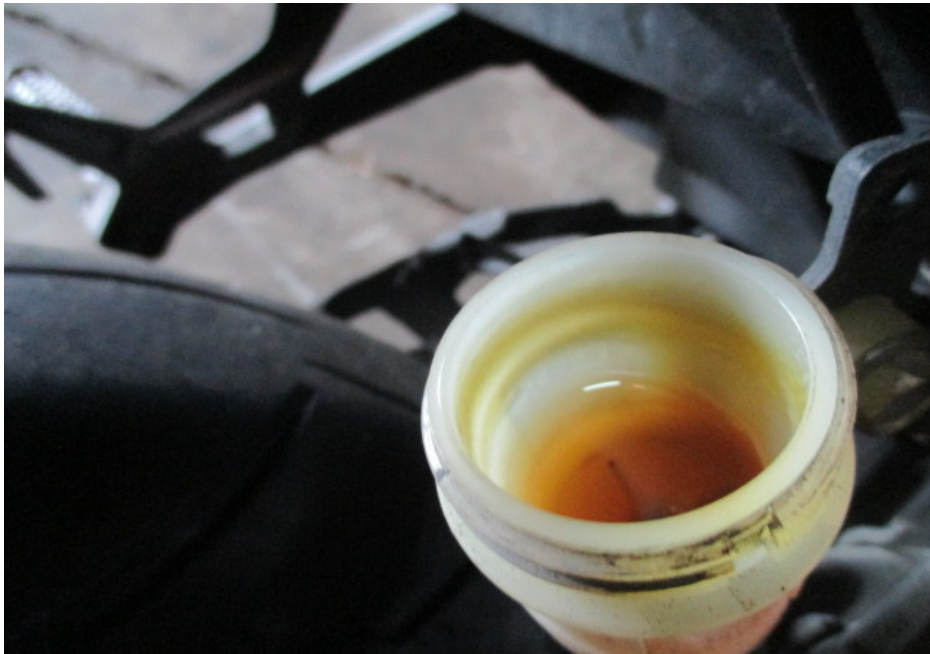
Photo 28 shows the brake fluid reservoir for the rear brake of the Motorcycle. The brake fluid was found to be without contamination and of sufficient level for operating purposes.
