Your Ref: TP/IP/11513/2020
Our Ref : CI/TPD20005428/N

Fatal Accident Investigation Team

MECHANICAL INSPECTION REPORT OF MOTORCYCLE FU 200H

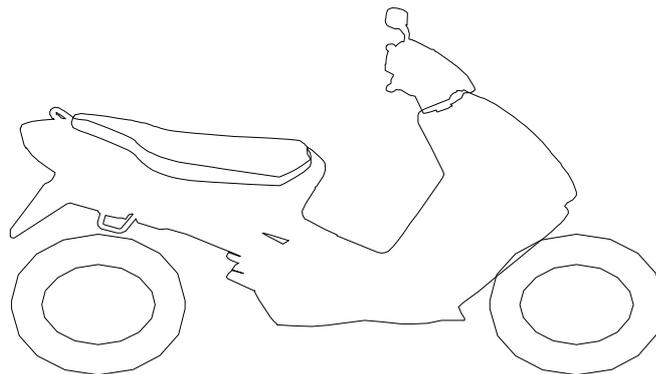
Shinko 150/70 - 18 (4mm)

Shinko 90/90 - 21 (3mm)
(Deflated)

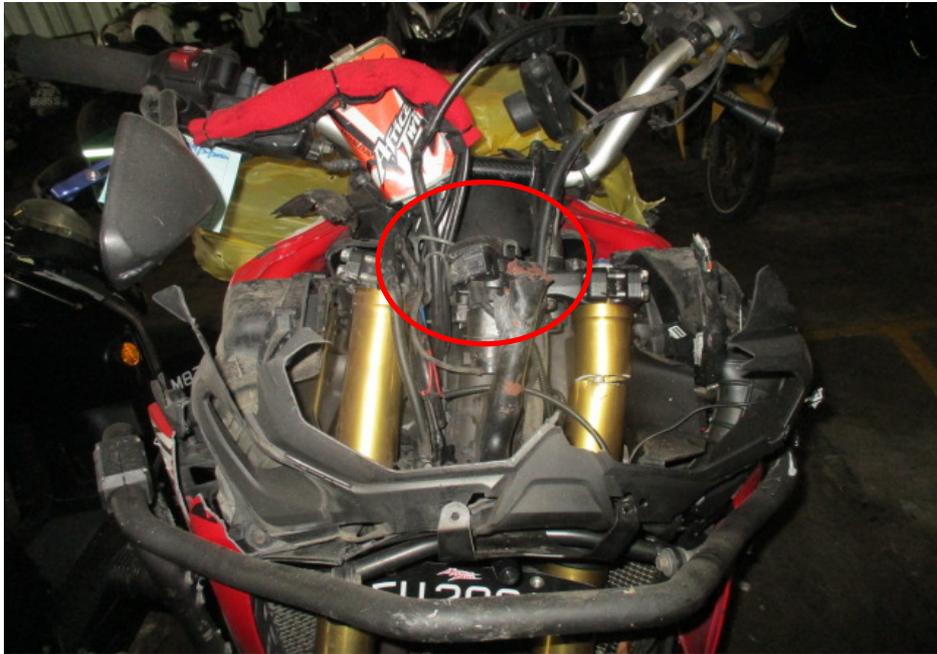
Photo 1 shows the mileage of the Motorcycle at the time of our inspection was not recorded due to a missing speedometer gauge as a result of the accident (circled).

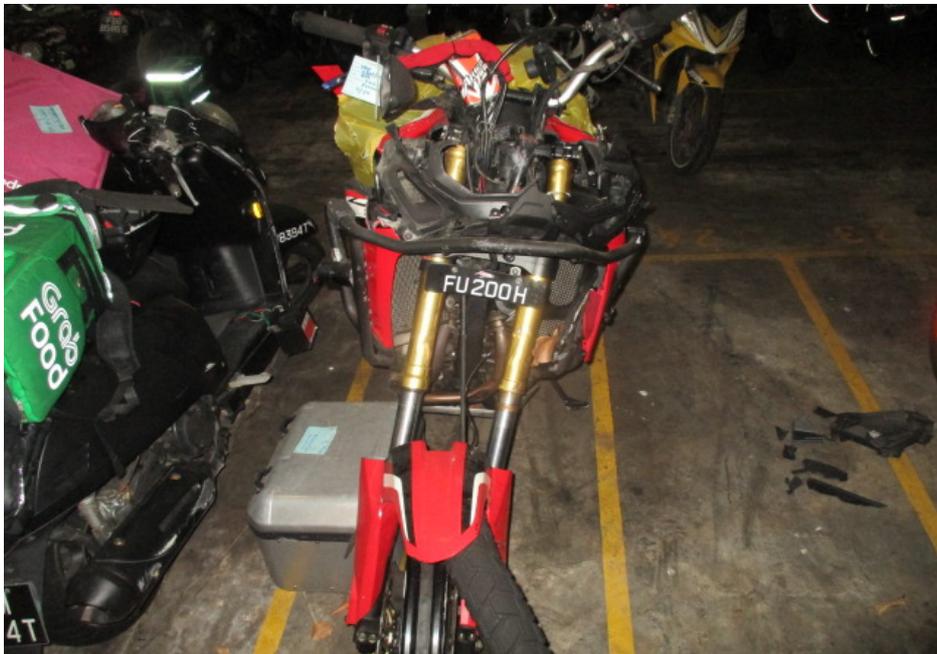
Photo 2 shows a general view of the frontal portion of the Motorcycle at the time of our inspection. The Motorcycle was observed to have sustained damages all around.

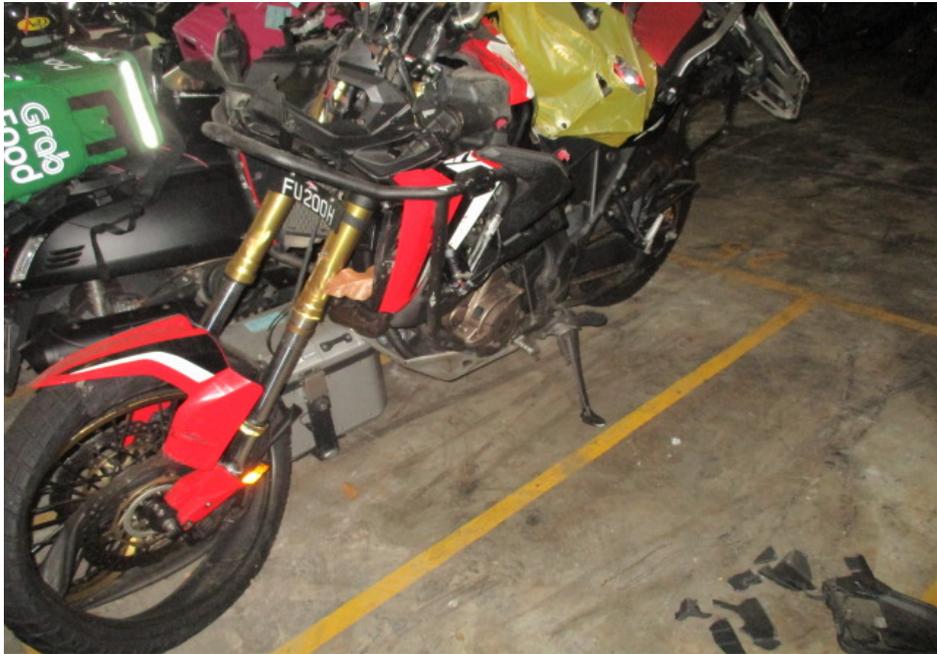
Photo 3 shows a general view of the left body of the Motorcycle at the time of our inspection. The Motorcycle was observed to have sustained damages all around. The body parts that were found to have been damaged include its headlight assembly, front forks, front mudguard, engine crashbars, left engine cover, handlebar, side mirrors, clutch lever, front brake lever, petrol tank, left rear side cover, tail light assembly, top box rack, rear mudguard and exhaust muffler, amongst others.

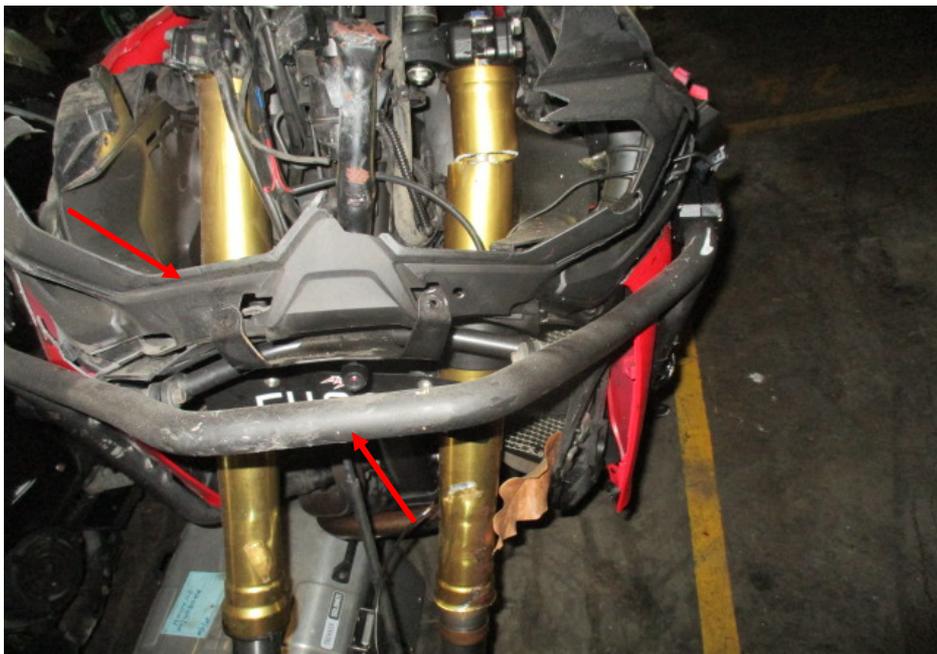
Photo 4 shows a closer view of the missing headlight assembly and deformed front crash bar (arrowed) of the Motorcycle as a result of the accident.

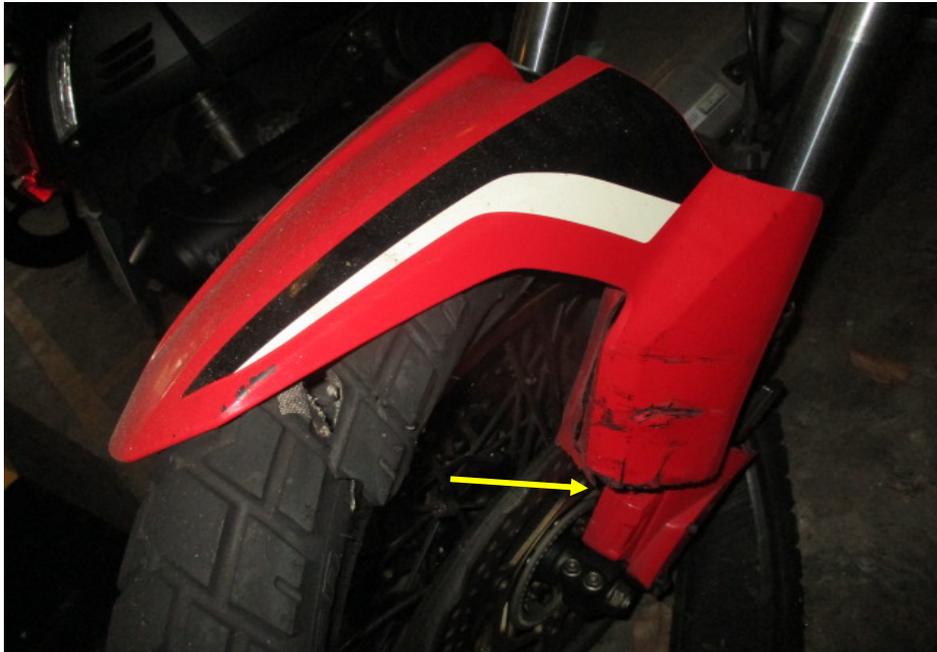
Photo 5 shows a closer view of the front mudguard which was amongst the body parts at the front body of the Motorcycle that had sustained damage as a result of the accident (arrowed).

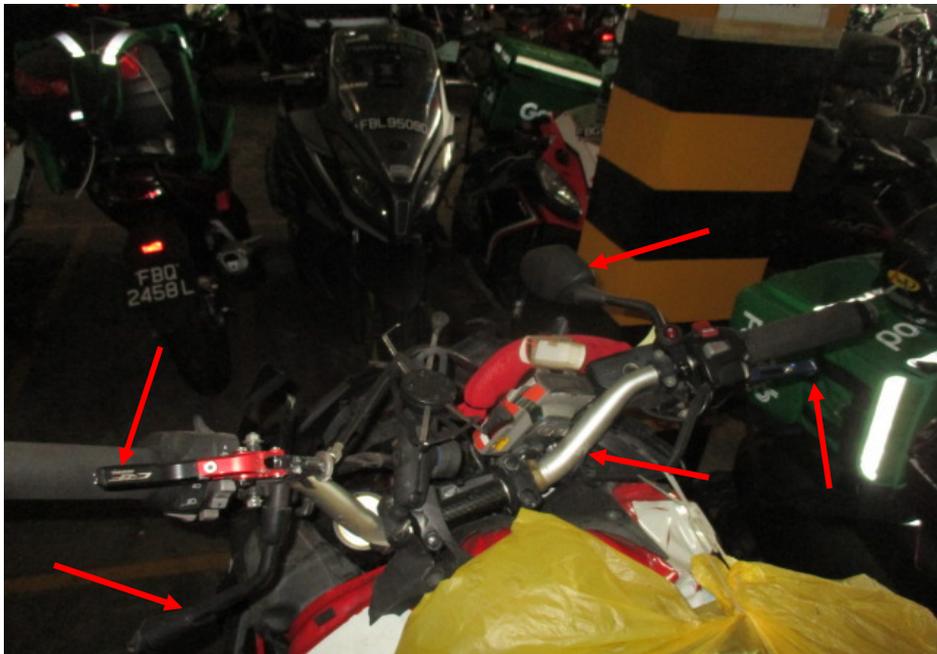
Photo 6 shows a closer view of the handlebar, front brake lever, side mirrors and clutch lever (arrowed) which were amongst the body parts at the front body of the Motorcycle that had sustained damage as a result of the accident.

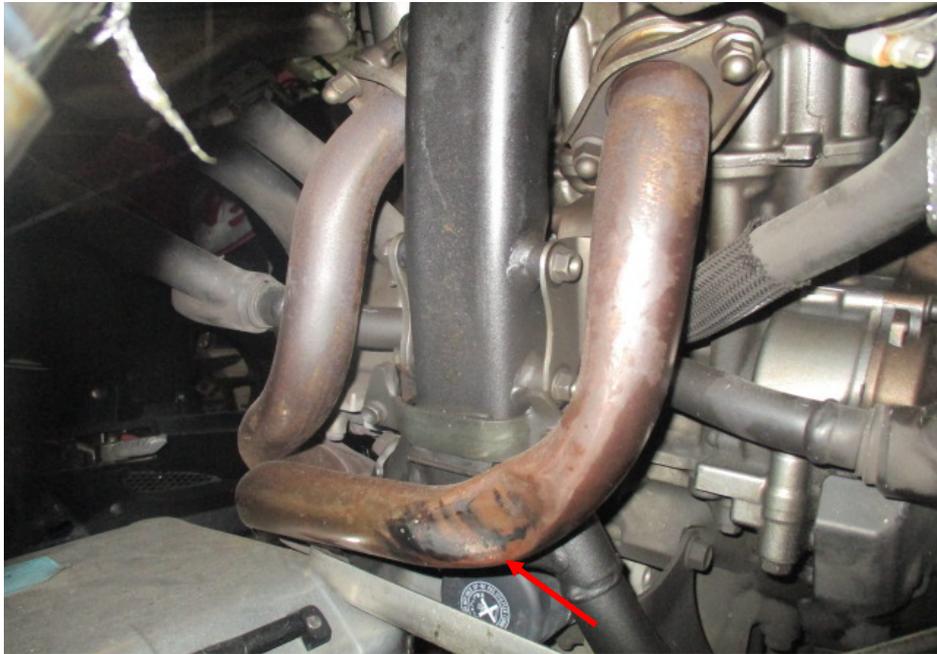
Photo 7 shows the dented exhaust header of the Motorcycle as a result of the accident (arrowed).

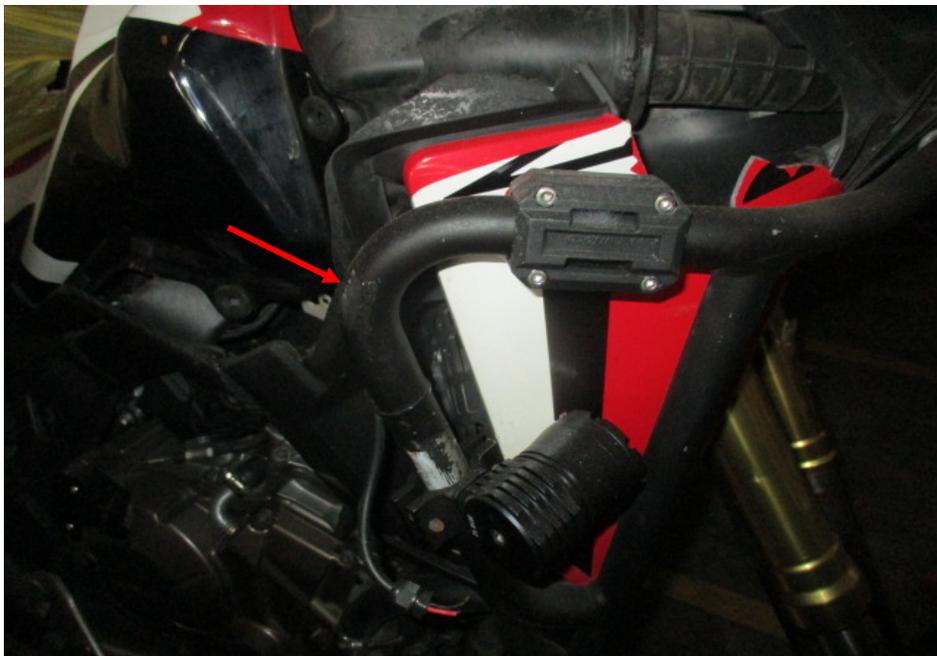
Photo 8 shows the right engine crashbar of the Motorcycle that had sustained damages of grazing nature as a result of the accident (arrowed).

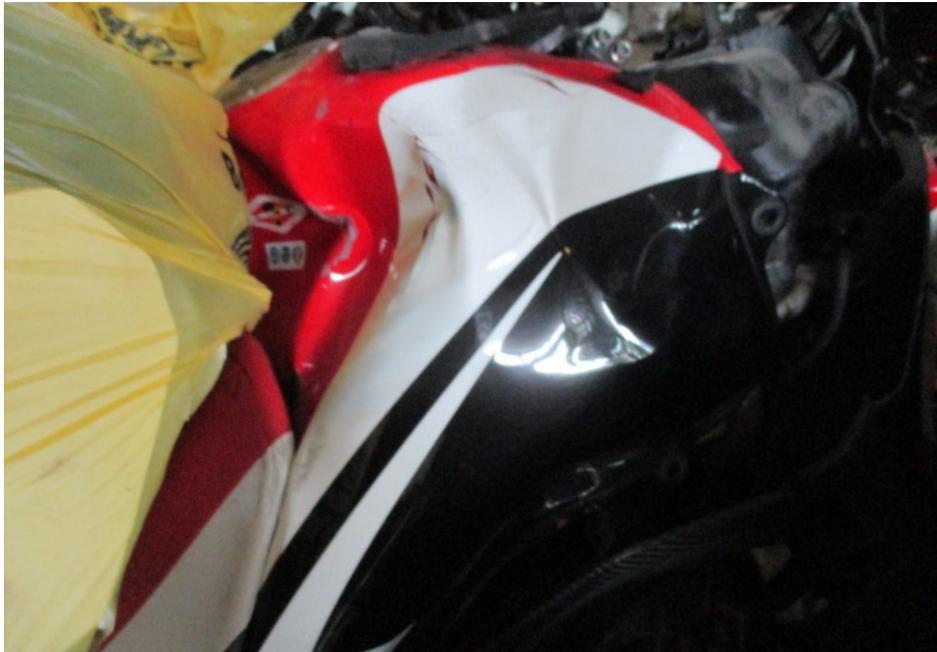
Photo 9 shows a closer view of the petrol tank, which was amongst the body parts of the Motorcycle that had sustained damage as a result of the accident.

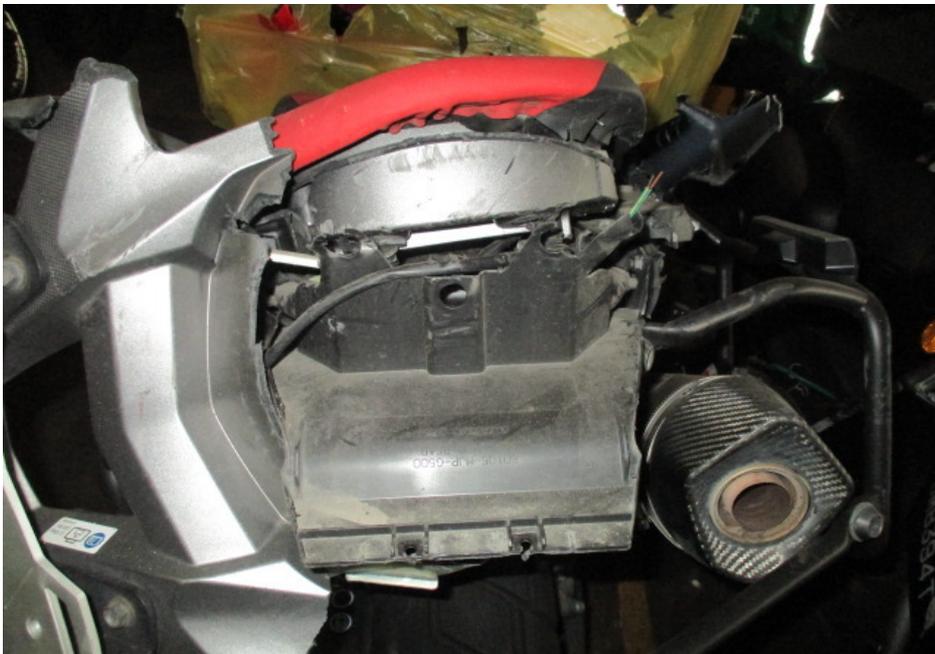
Photo 10 shows a closer view of the tail light assembly, rear mudguard and top box rack which were amongst the body parts of the Motorcycle that had sustained damage as a result of the accident.

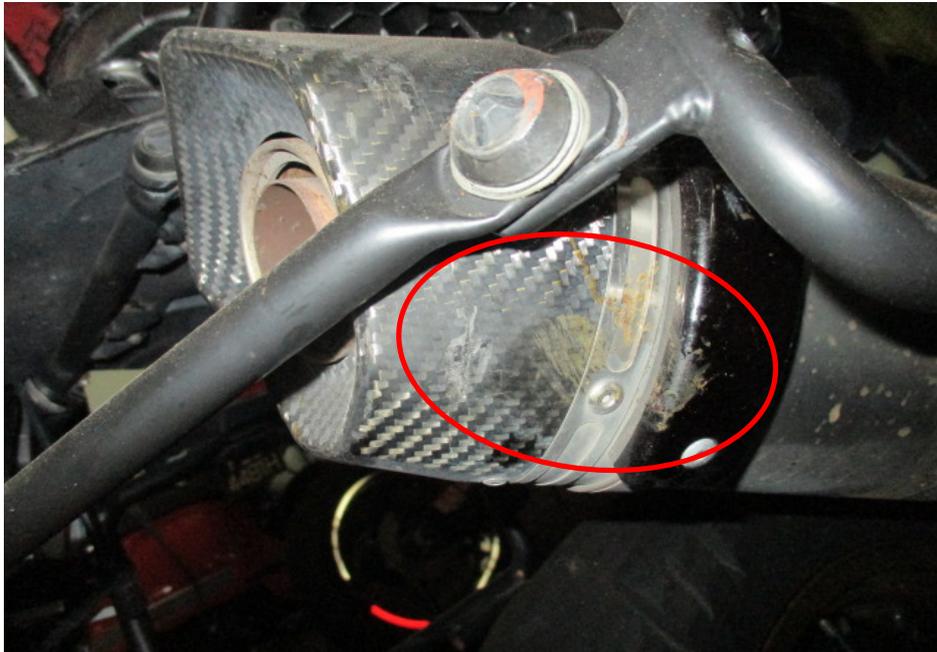
Photo 11 shows the exhaust muffler (circled) which was amongst the body parts of the Motorcycle that had sustained damage as a result of the accident.

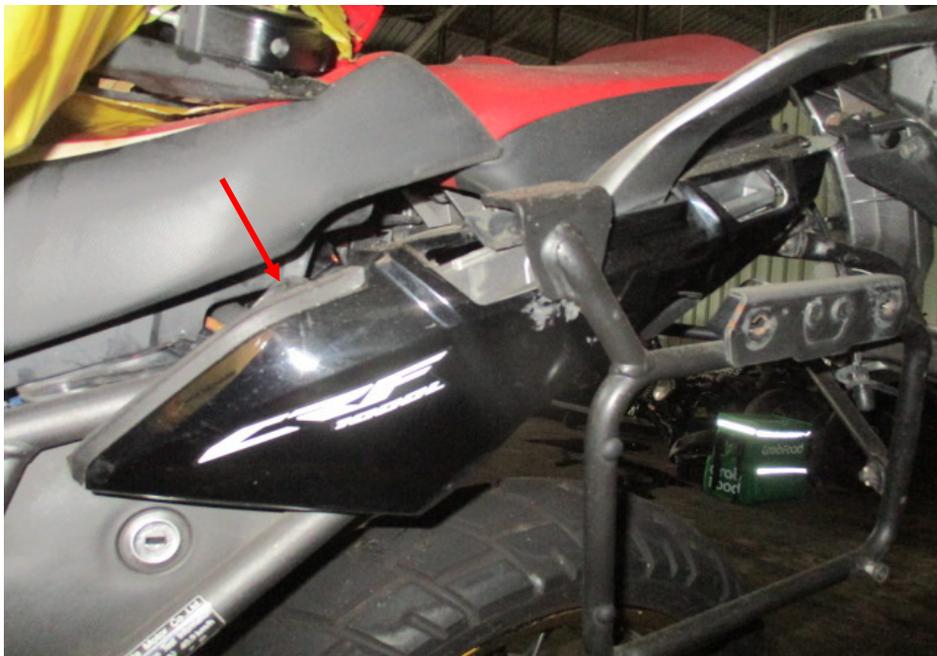
Photo 12 shows a closer view of the cracked left rear side cover (arrowed) which was amongst the body parts at the rear body of the Motorcycle that had sustained damage as a result of the accident.

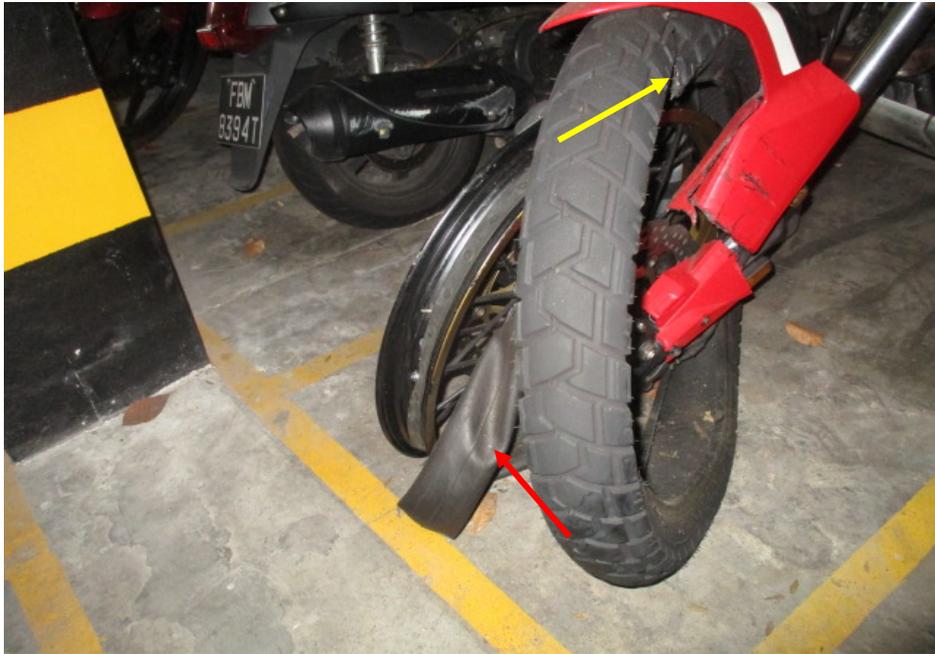
Photo 13 shows the front tyre of the Motorcycle at the time of our inspection. The front tyre was observed to be deflated (red arrow) with remaining tread depth of approximately 3mm. The pattern of the tread was also clearly visible. The front tyre of the Motorcycle was found to be cut (yellow arrow) as a result of the accident.

19. The rear tyre of the Motorcycle was found to be in serviceable condition with remaining tread depth of approximately 4mm. The rear tyre was sufficiently inflated for vehicular operation. The front tyre had remaining tread depth of approximately 3mm. However the front tyre was observed to be deflated and cut as a result of the accident.

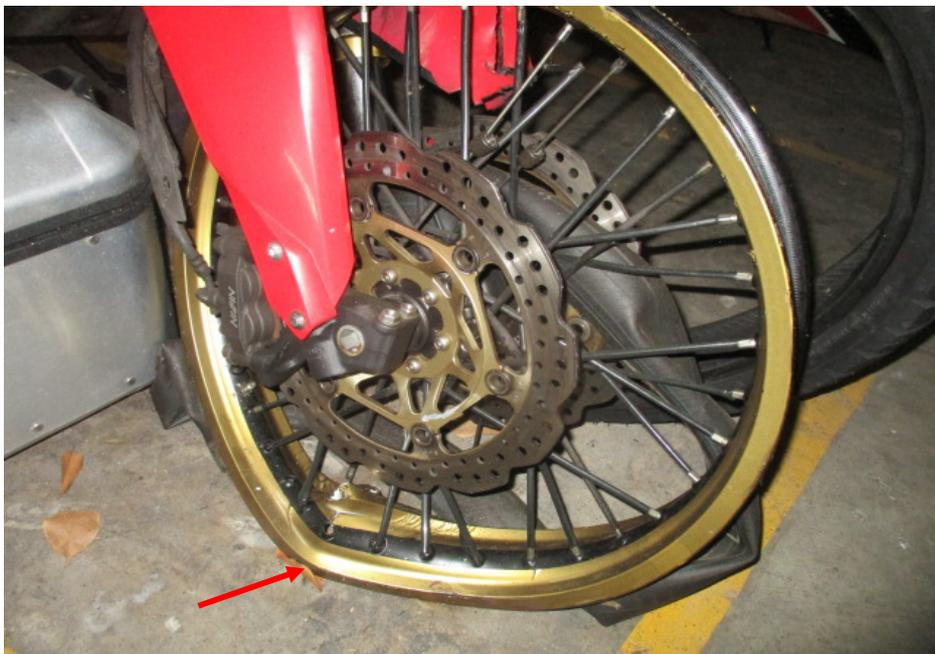
Photo 14 shows the bent front wheel rim of the Motorcycle as a result of the accident (arrowed).

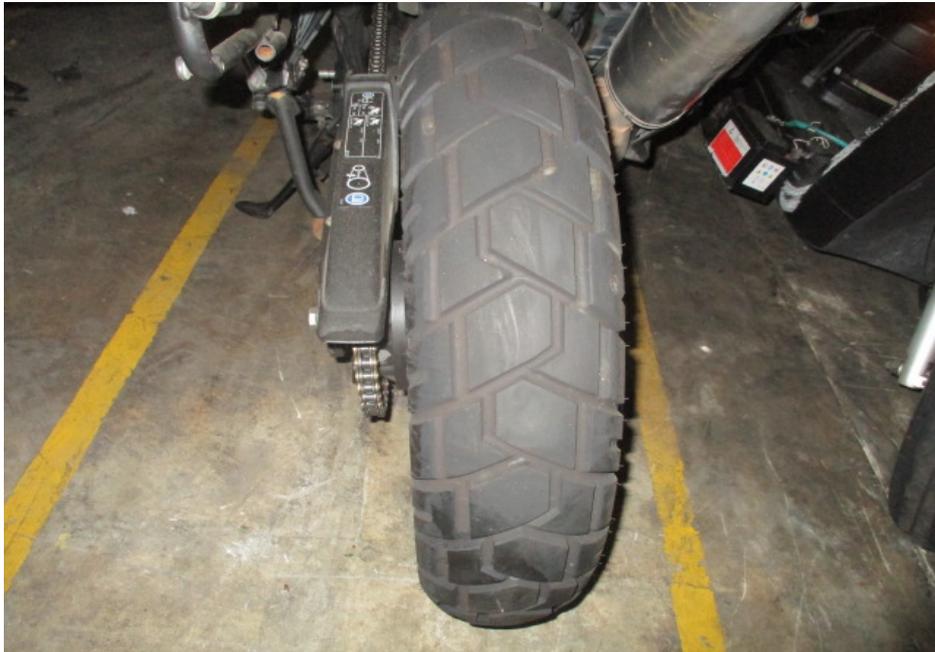
Photo 15 shows the condition of the Motorcycle's rear tyre. The rear tyre was observed to be in serviceable condition with remaining tread depth of approximately 4mm. The tyre was also observed to be sufficiently inflated for vehicular operation. We did not observe any tear, burst mark(s) and/or punctured hole(s) on the sidewalls as well as across the tread of the rear tyre.

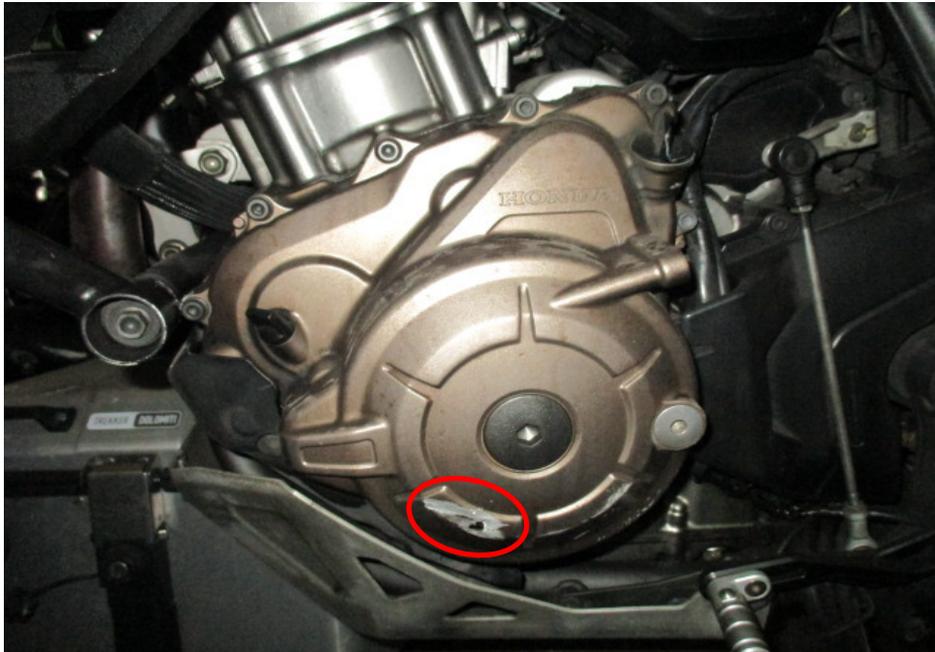
Photo 16 shows the left side of the engine of the Motorcycle at the time of our inspection. The left engine cover was observed to be cracked as a result of the accident (circled). However there was no sign(s) or indication(s) of fluid leak observed around the left engine area of the Motorcycle.

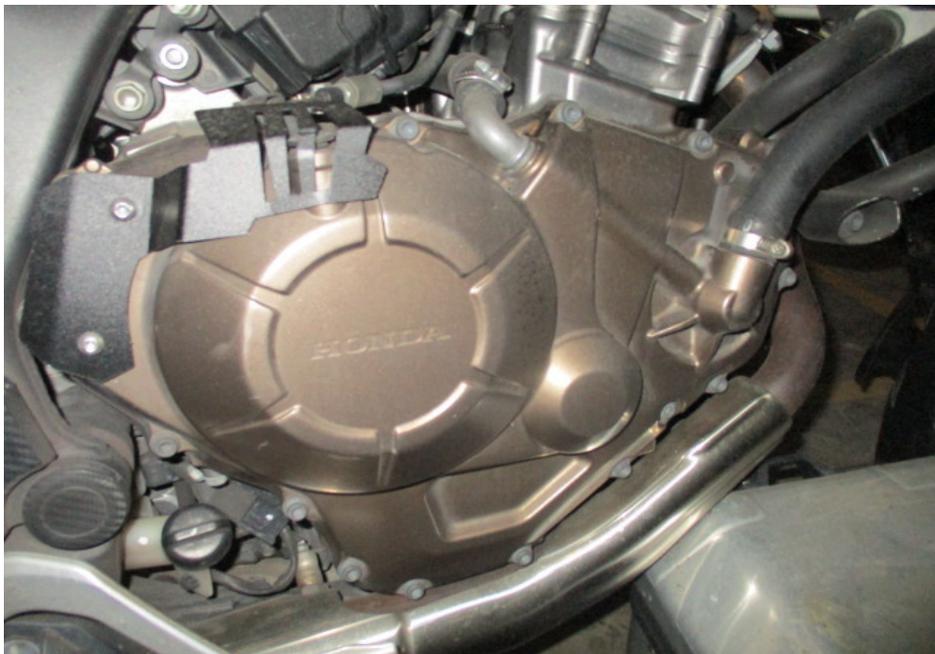
Photo 17 shows the right side of the engine of the Motorcycle at the time of our inspection. The various engine related parts and components were found to be intact with no visible damage. There was also no sign(s) or indication(s) of fluid leak observed around the right engine area of the Motorcycle.

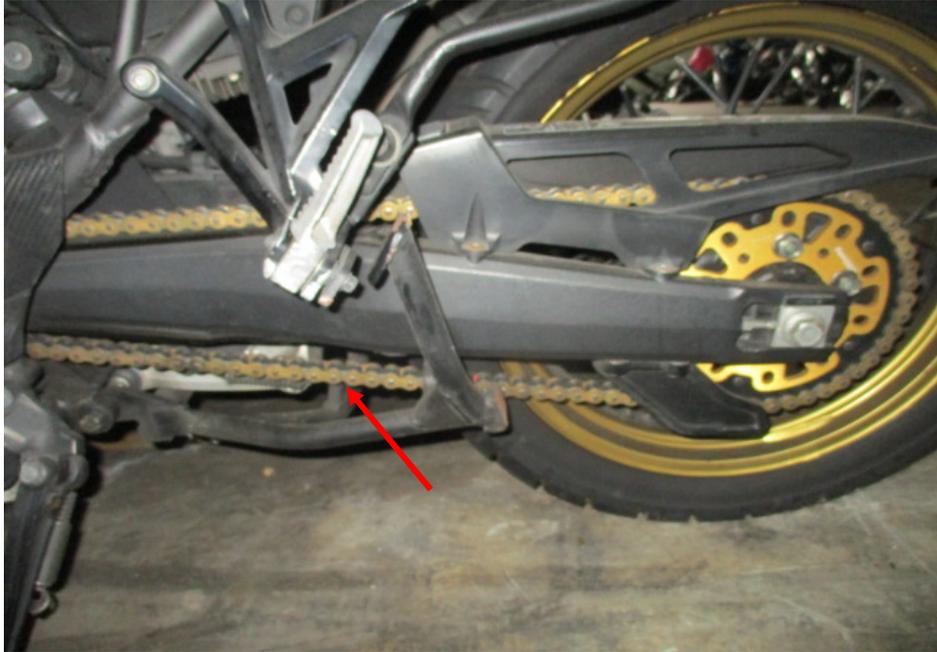
Photo 18 shows the general view of the gear train (arrowed) of the Motorcycle, which was observed to be intact with no misalignment. It was also adequately lubricated for operating purposes.

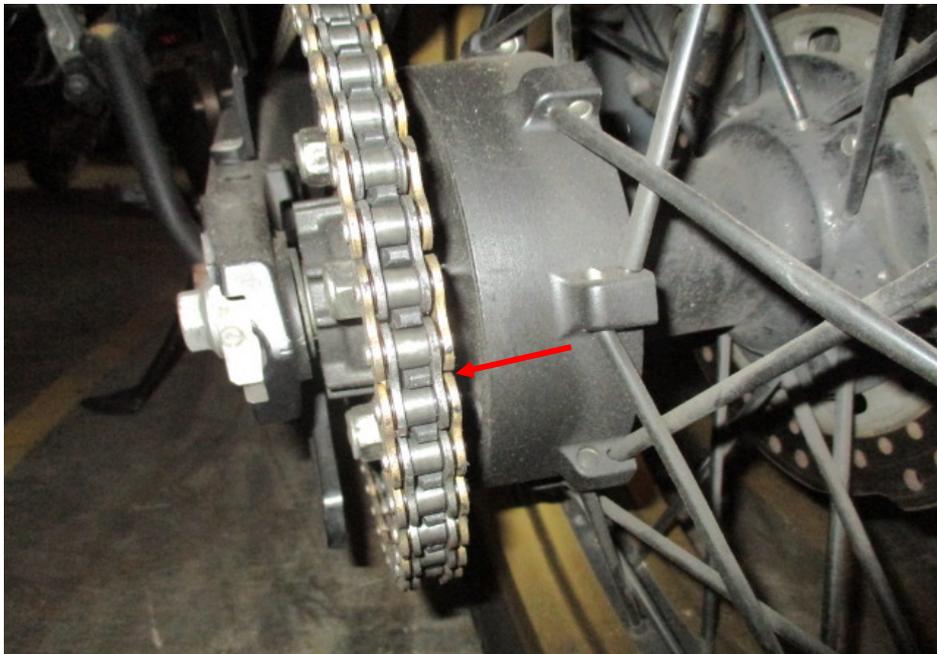
Photo 19 shows a closer view of the gear train (arrowed) of the Motorcycle, which was observed to be intact with no misalignment. It was also adequately lubricated for operating purposes.

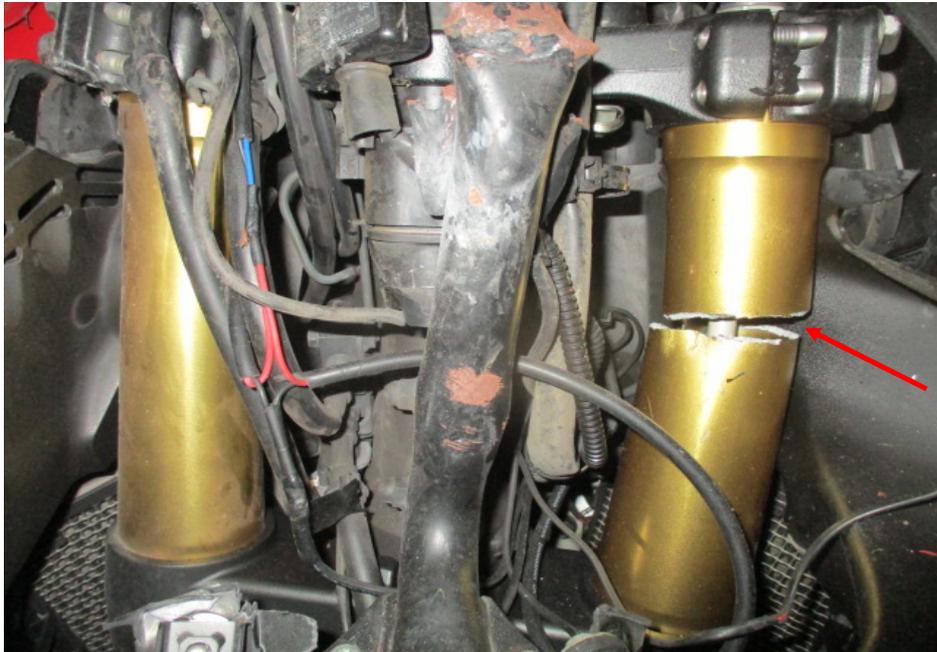
12. For this case, we were not able to conduct any test(s) on the steering system of the Motorcycle due to the damage of its front forks. The left front fork was observed to be broken as a result of the accident which had rendered the Motorcycle immobile.

Photo 20 shows the front forks of the Motorcycle. The left front fork was observed to be broken as a result of the accident (arrowed). We were hence not able to conduct any tests on the steering system of the Motorcycle.

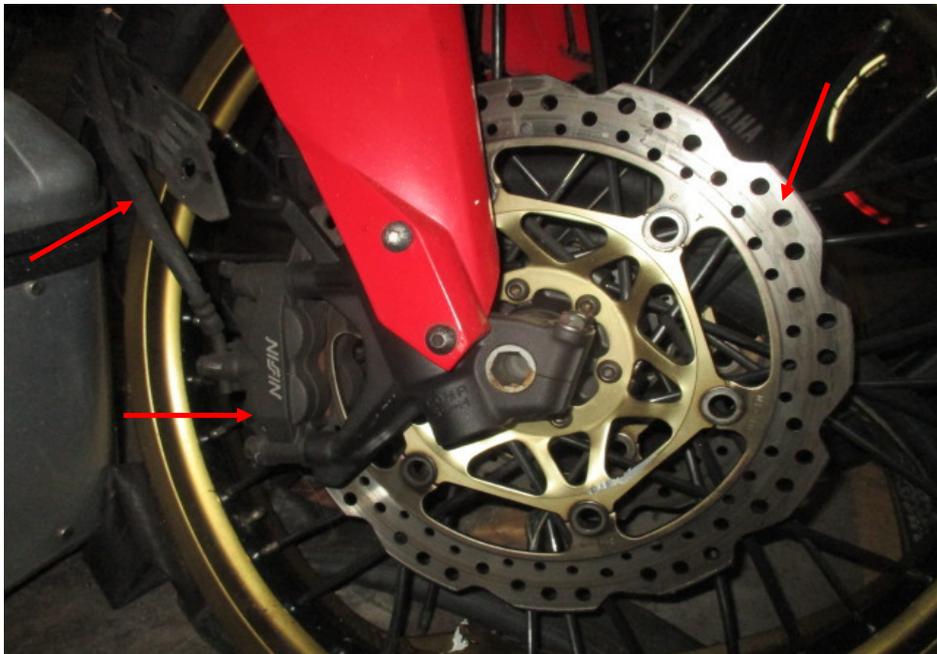
Photo 21 shows a close up view of the front brake caliper, front brake disc and front brake hose (arrowed) at the right side of the Motorcycle's front wheel, which are all part of the components in the hydraulic front brake system of the Motorcycle. Our visual checks of these various components had revealed all to be intact with no visible damage. No leakage of brake fluid was also observed.

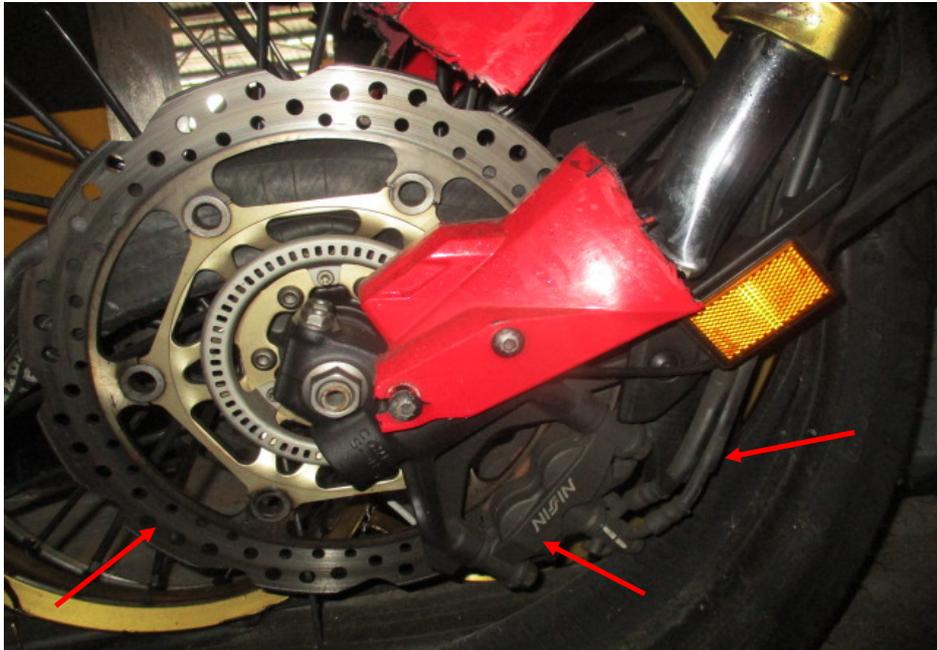
Photo 22 shows a close up view of the front brake caliper, front brake disc and front brake hose (arrowed) at the left side of the Motorcycle's front wheel, which are all part of the components in the hydraulic front brake system of the Motorcycle. Our visual checks of these various components had revealed all to be intact with no visible damage. No leakage of brake fluid was also observed.

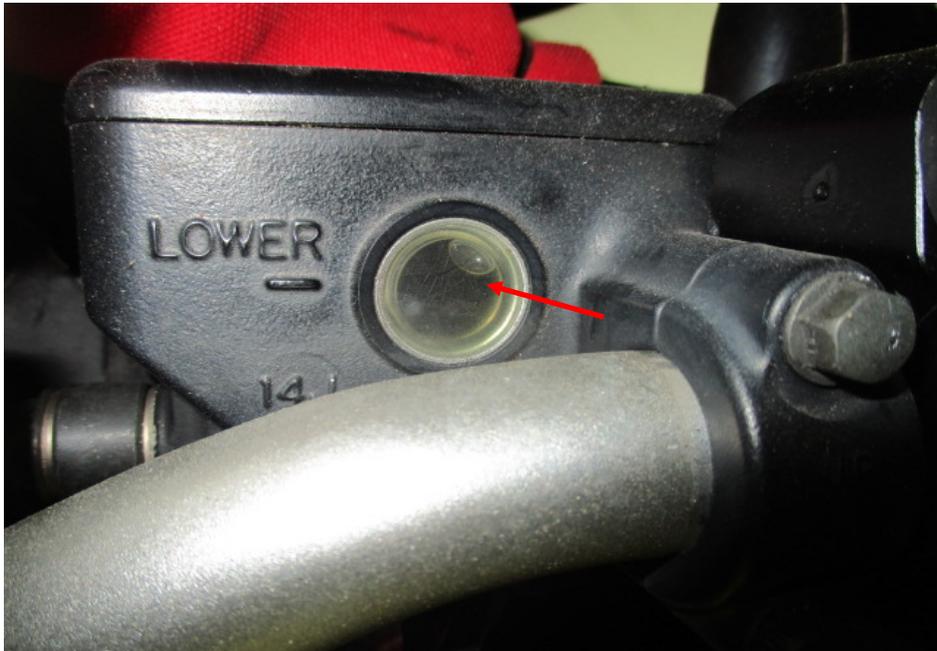
Photo 23 shows the brake fluid reservoir for the front brake of the Motorcycle. The brake fluid was observed to be of sufficient level for operational purposes and without contamination (arrowed).

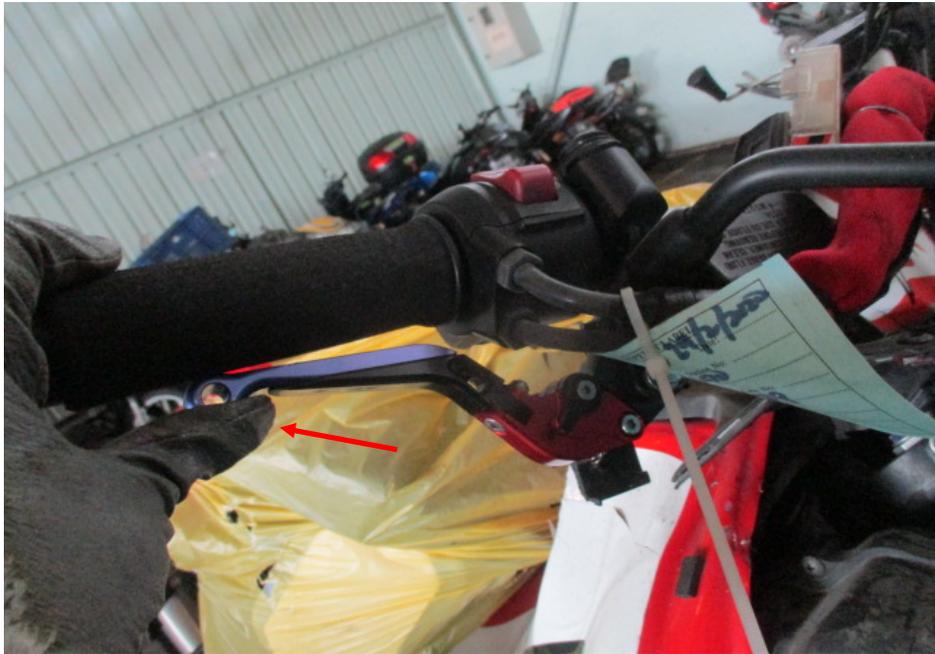
15. Static brake tests conducted on the Motorcycle had appear to indicate that the front braking system of the Motorcycle was not in serviceable condition. There was no resistance felt (spongy like feel) upon pressing the brake lever. This would indicate that there may be a leakage of pressure/vacuum in the front brake system.

Photo 24 shows the front brake lever being depressed. There was no resistance felt (spongy like feel) upon pressing the front brake lever (arrowed). This would indicate that there may be a leakage of pressure/vacuum in the brake system.

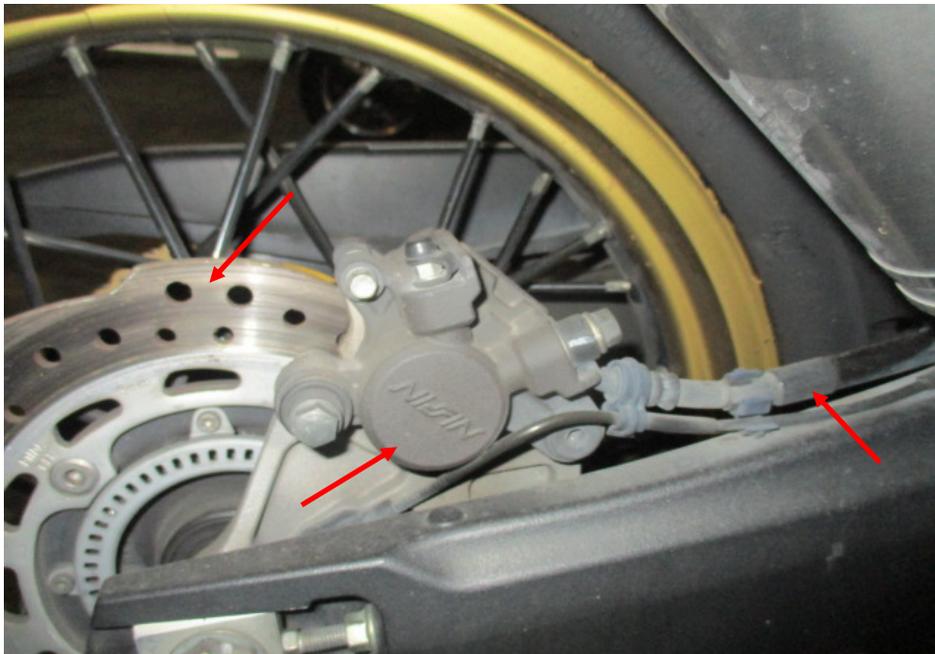
Photo 25 shows a close up view of the rear brake caliper, rear brake disc and rear brake hose (arrowed) of the Motorcycle, which are all part of the components in the hydraulic rear brake system of the Motorcycle. Our visual checks of these various components had revealed all to be intact with no visible damage. No leakage of brake fluid was also observed.
