Your Ref: S0M02MH6  
Our Ref : CS4/ASM20005470/D

**M/s AXA Insurance Pte Ltd**

**TECHNICAL INVESTIGATION REPORT OF FIRE INCIDENT INVOLVING THE INSURED VEHICLE SKE 9898K ON 15 APRIL 2020**

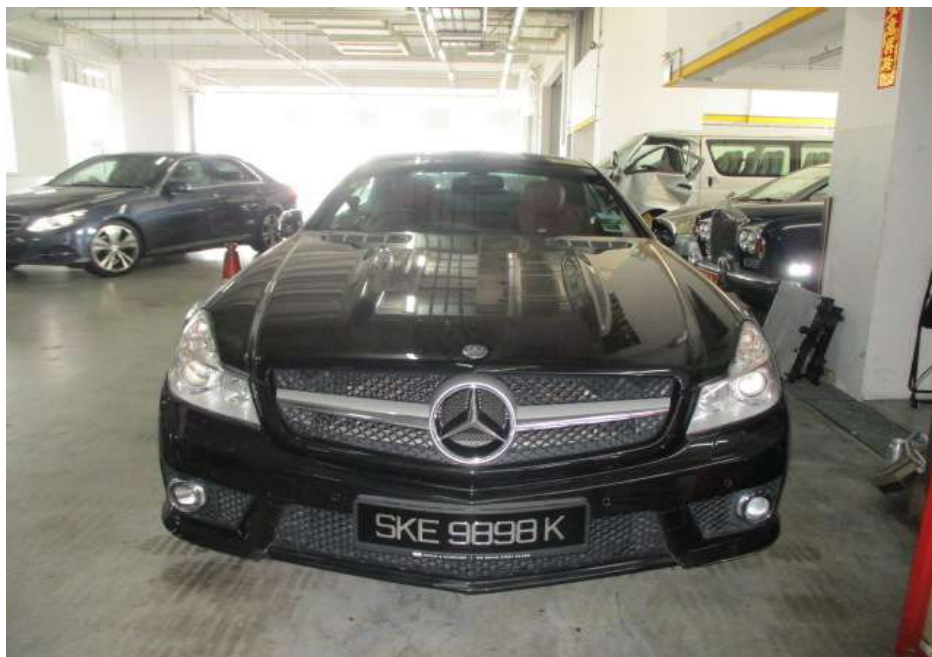
**Photo 1** shows a general view of the frontal body of the Insured Vehicle at the time of my inspection. I did not observe any damage of fire nature to the exterior body of the Insured Vehicle. Its interior compartment and engine compartment were also without any damage of fire nature.

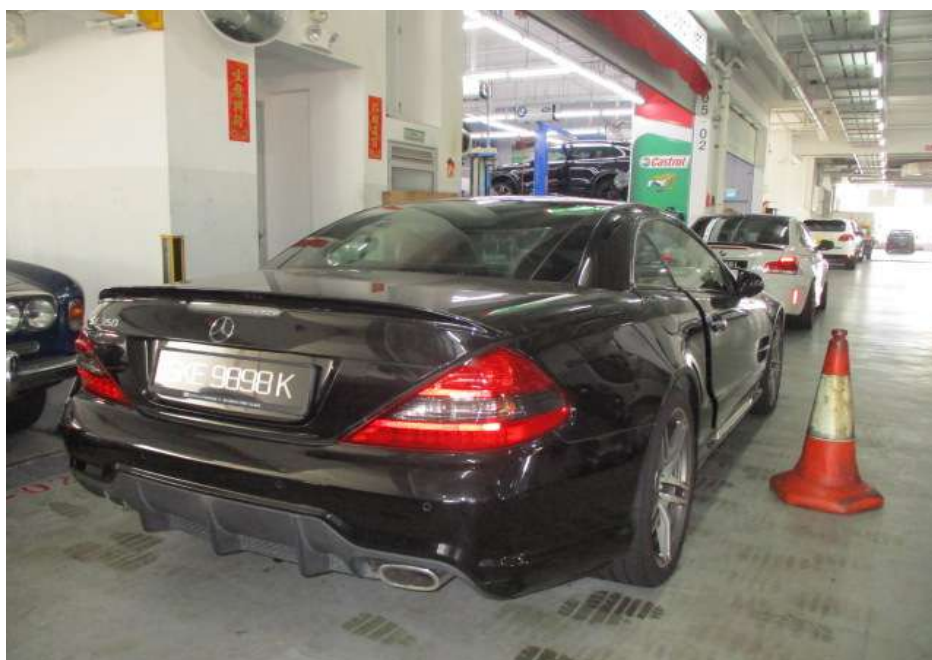
**Photo 2** shows a general view of the rear right body of the Insured Vehicle at the time of my inspection. I did not observe any damage of fire nature to the exterior body of the Insured Vehicle.

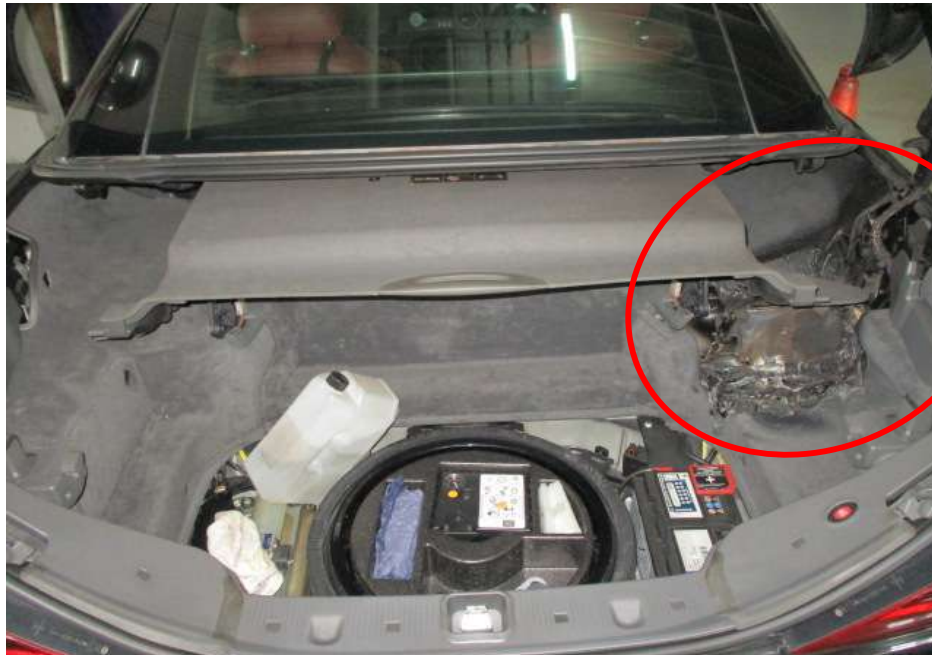
5. No visible damage of fire nature was observed to the exterior body of the Insured Vehicle. Its interior compartment and engine compartment were also without any fire damage.
6. Upon checking the rear boot compartment of the Insured Vehicle, I had found fire damage that was confined to the right side of the rear boot compartment. The carpet upholstery, wirings and a control module unit at the right side of the rear boot compartment were amongst the parts that were observed to be burnt. See photo 1 – 4 below.

**Photo 3** shows the rear boot compartment of the Insured Vehicle. Upon checking the rear boot compartment of the Insured Vehicle, I had found fire damage that was confined to the right side (circled) of the rear boot compartment. The carpet upholstery, wirings and a control module unit at the right side of the rear boot compartment were amongst the parts that were observed to be burnt.

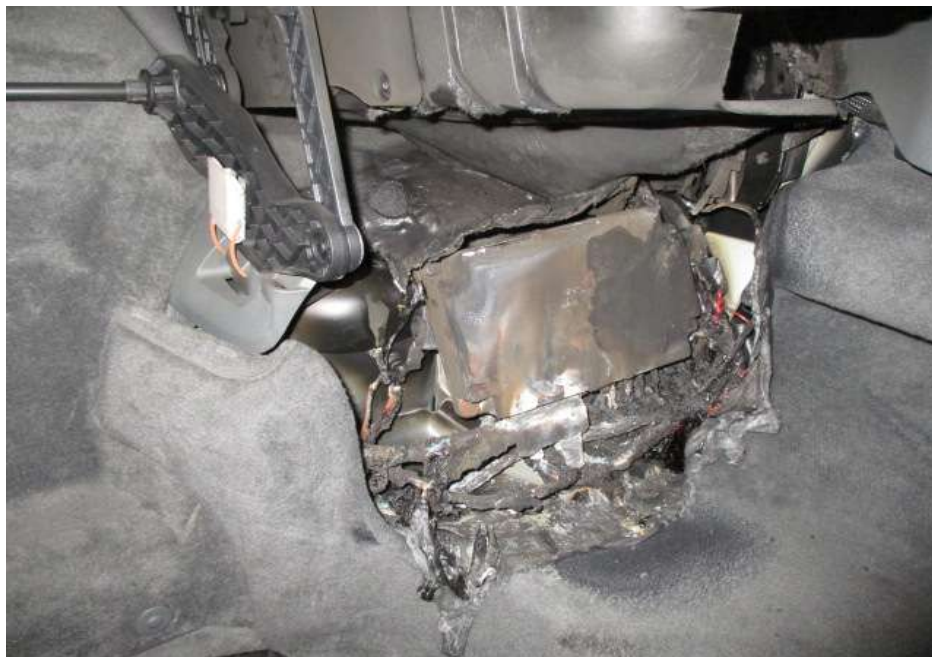
**Photo 4** shows a closer view of the burnt carpet upholstery, wirings and control module unit at the right side of the rear boot compartment.

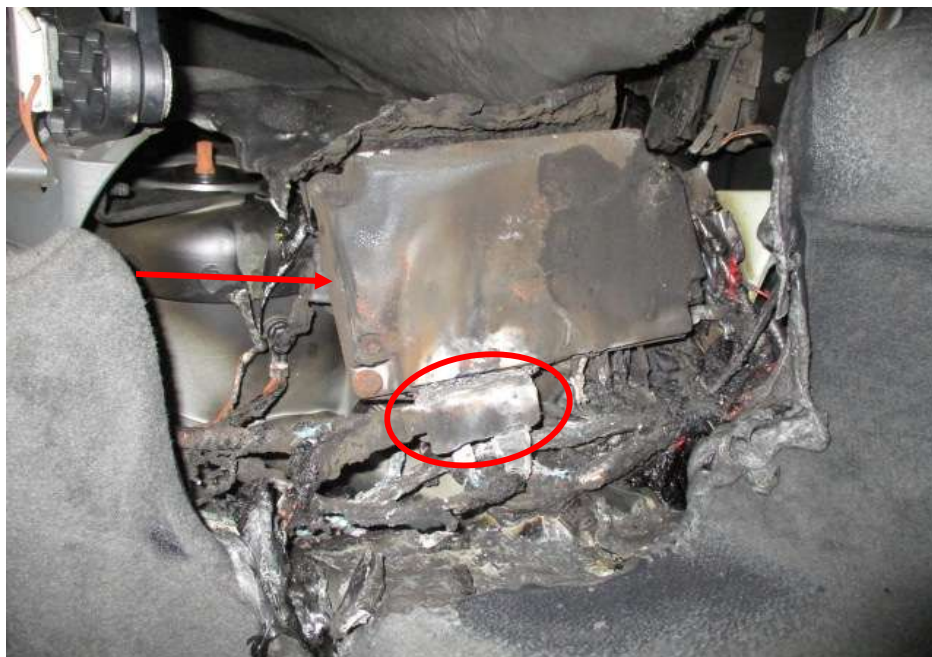
9. For this case, it can be established that the fire had originated within the rear boot compartment of the Insured Vehicle given that there was no fire damage observed on other areas of the Insured Vehicle.
10. Upon my close examination of the burnt area, I had found greenish residue on the stretch of wirings leading to the connector socket of a burnt control module unit. The connector socket itself was found with whitish burnt marks, which are a result of prolong exposure to heat intensity. The presence of greenish residue on the wirings indicate internal heating of copper wires, a sign of an electrical short circuit occurring. The greenish residue is normally left behind from oxidation as a result of chemical reaction involving the copper wires. This physical evidence suggests that the cause of fire to the Insured Vehicle was due to electrical in nature. See photo 5 - 7 below.

**Photo 5** shows the burnt control module unit (arrowed) at the right side of the Insured Vehicle's rear boot compartment. Upon my close examination of the burnt area, I had found greenish residue on the stretch of wirings leading to the connector socket of the burnt control module unit. The connector socket (circled) was found with whitish burnt marks, which are a result of prolong exposure to heat intensity.

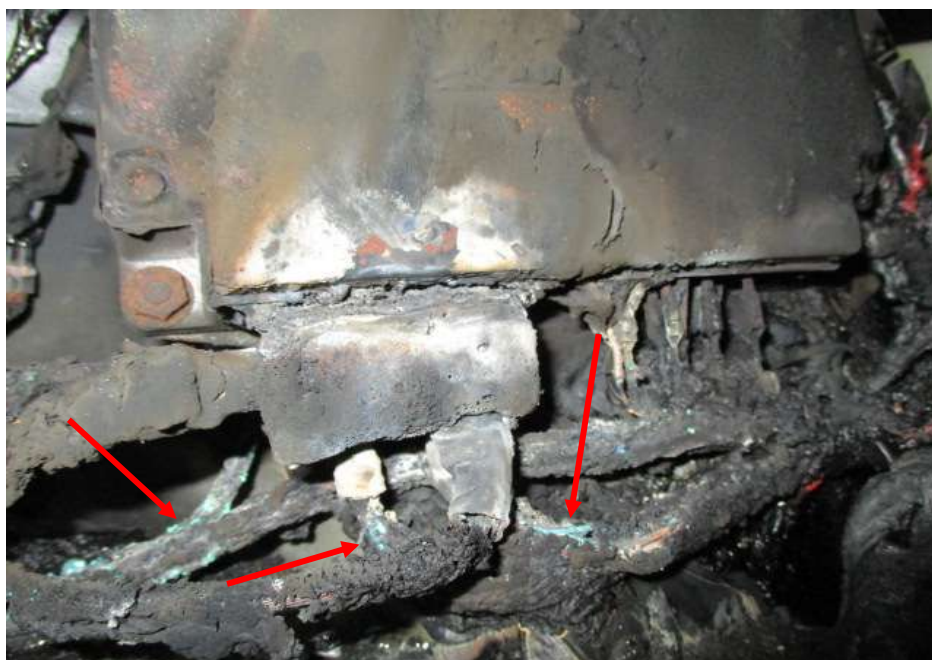
**Photo 6** shows the greenish residue (arrowed) that was found on the wirings leading to the burnt connector socket. The presence of greenish residue suggests occurrence of an electrical short circuit, indicating that the cause of fire to the Insured Vehicle was due to electrical in nature.

14. The possibility of the fire being due to electrical in nature would then be the most probable causation given that engine overheating and external factor would both seem unlikely. Furthermore, my observations of greenish residue on the wirings shown in photograph 6 & 7 supports the finding of fire being due to electrical in nature.

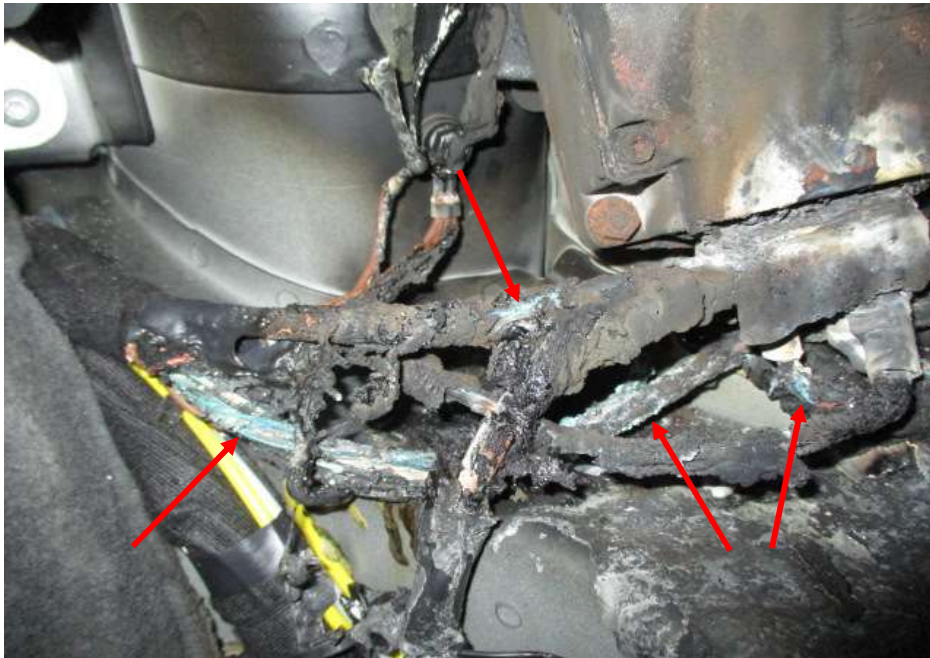
**Photo 7** shows the greenish residue (arrowed) that was found on the wirings leading to the burnt connector socket. The presence of greenish residue on the wirings indicate internal heating of copper wires, a sign of an electrical short circuit occurring. The greenish residue is normally left behind from oxidation as a result of chemical reaction involving the copper wires. This physical evidence suggests that the cause of fire to the Insured Vehicle was due to electrical in nature.

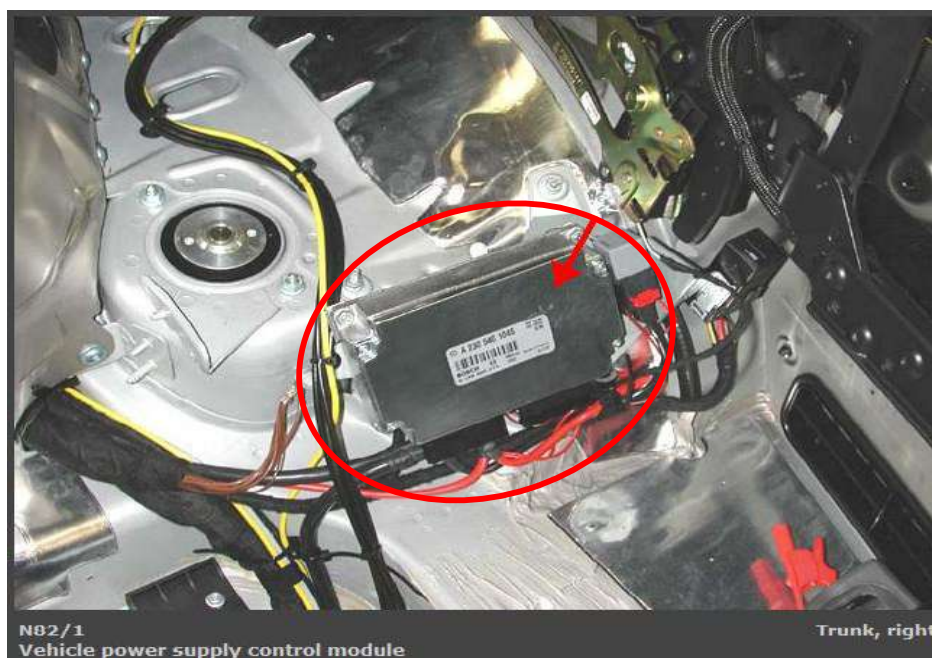
11. My checks and enquiries revealed that the burnt control module was the “vehicle power supply control module”, which monitors and control the supply of electronical power to the various electrical/electronic devices and components fitted on the Insured Vehicle. See photo 8 below showing an example of this “vehicle power supply control module”

**Photo 8** shows the “vehicle power supply control module” (circled), which was found to be burnt on the Insured Vehicle.
