Your Ref: S0M02MH6
Our Ref : CS4/ASM20005470/D

TECHNICAL INVESTIGATION REPORT OF FIRE INCIDENT INVOLVING THE INSURED VEHICLE SKE 9898K ON 15 APRIL 2020

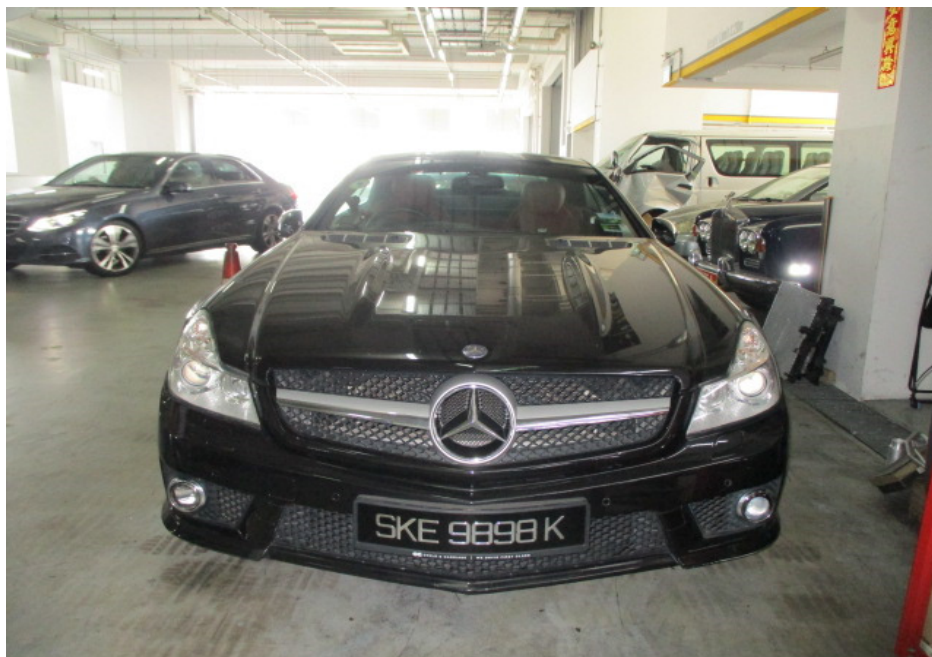
Photo 1 shows a general view of the frontal body of the Insured Vehicle at the time of my inspection. I did not observe any damage of fire nature to the exterior body of the Insured Vehicle. Its interior compartment and engine compartment were also without any damage of fire nature.

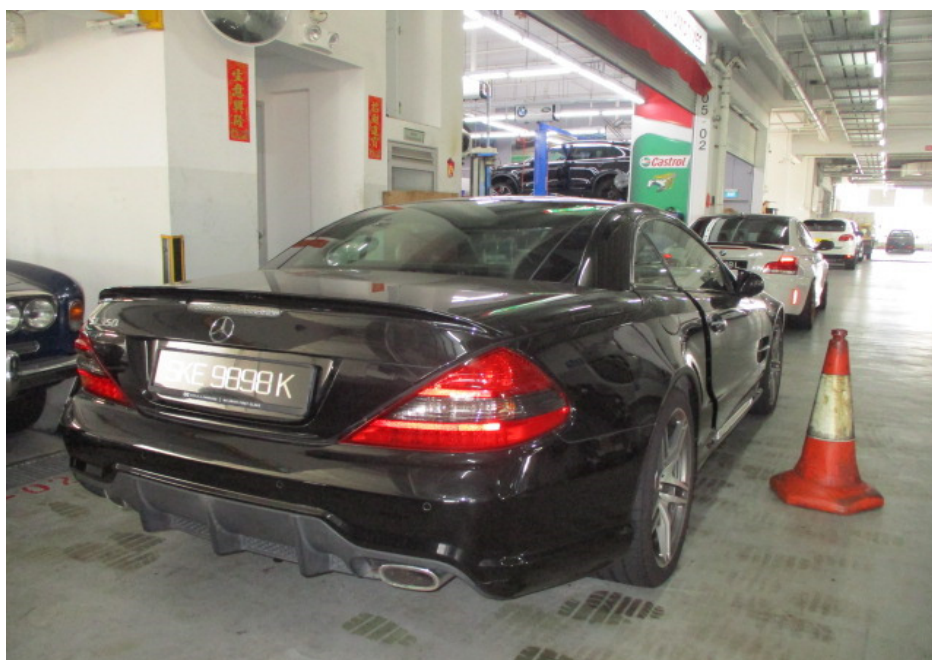
Photo 2 shows a general view of the rear right body of the Insured Vehicle at the time of my inspection. I did not observe any damage of fire nature to the exterior body of the Insured Vehicle.

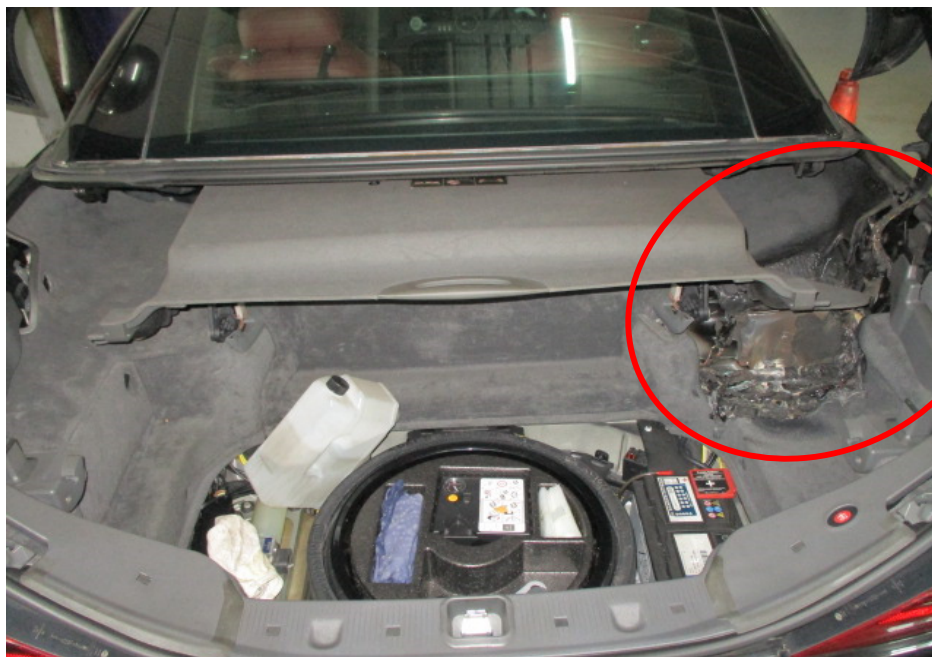
5. No visible damage of fire nature was observed to the exterior body of the Insured Vehicle. Its interior compartment and engine compartment were also without any fire damage.
6. Upon checking the rear boot compartment of the Insured Vehicle, I had found fire damage that was confined to the right side of the rear boot compartment. The carpet upholstery, wirings and a control module unit at the right side of the rear boot compartment were amongst the parts that were observed to be burnt. See photo 1 – 4 below.

Photo 3 shows the rear boot compartment of the Insured Vehicle. Upon checking the rear boot compartment of the Insured Vehicle, I had found fire damage that was confined to the right side (circled) of the rear boot compartment. The carpet upholstery, wirings and a control module unit at the right side of the rear boot compartment were amongst the parts that were observed to be burnt.

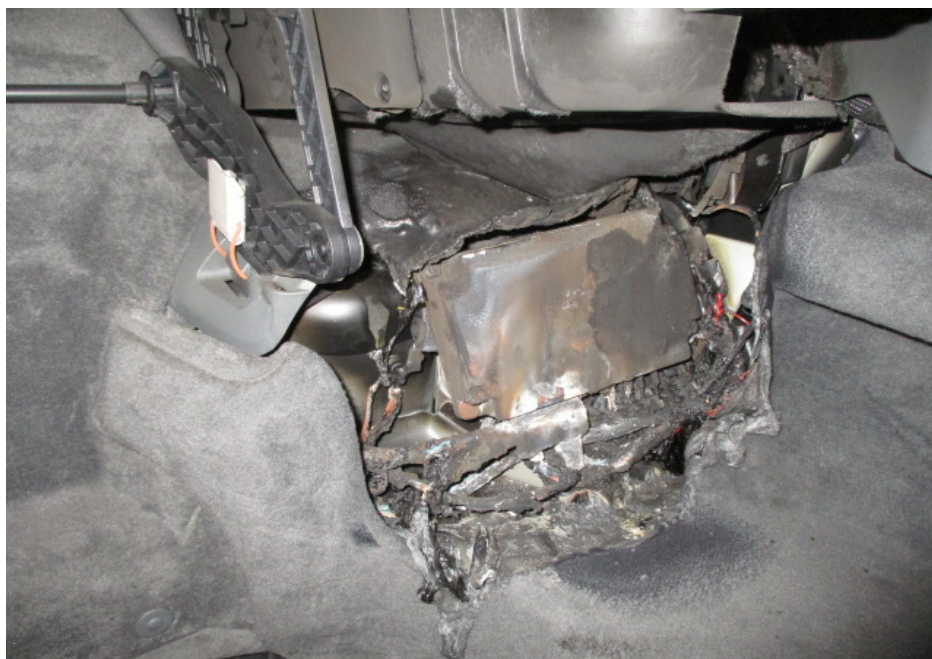
Photo 4 shows a closer view of the burnt carpet upholstery, wirings and control module unit at the right side of the rear boot compartment.

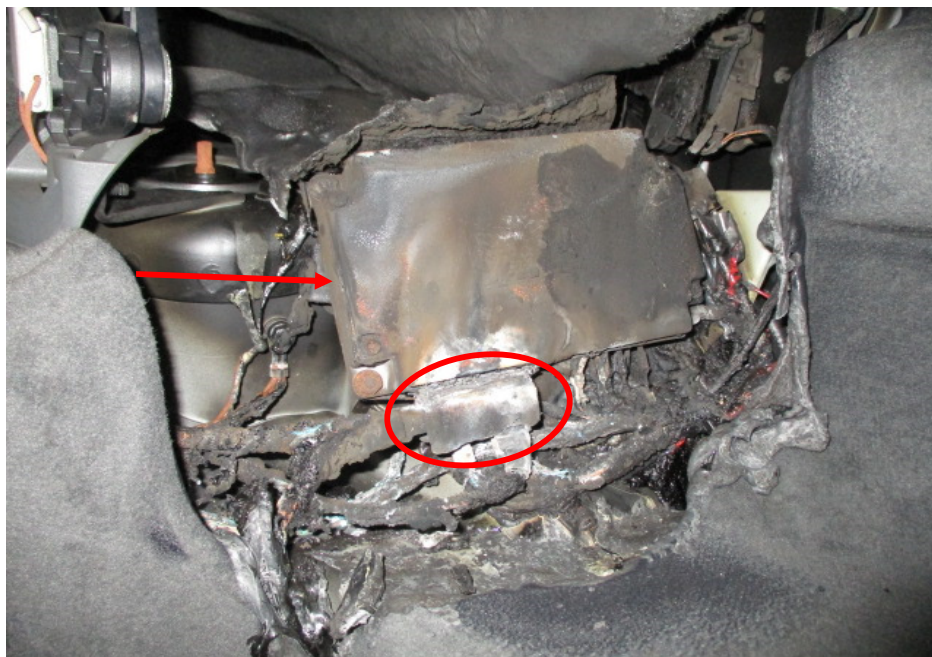
9. For this case, it can be established that the fire had originated within the rear boot compartment of the Insured Vehicle given that there was no fire damage observed on other areas of the Insured Vehicle.
10. Upon my close examination of the burnt area, I had found greenish residue on the stretch of wirings leading to the connector socket of a burnt control module unit. The connector socket itself was found with whitish burnt marks, which are a result of prolong exposure to heat intensity. The presence of greenish residue on the wirings indicate internal heating of copper wires, a sign of an electrical short circuit occurring. The greenish residue is normally left behind from oxidation as a result of chemical reaction involving the copper wires. This physical evidence suggests that the cause of fire to the Insured Vehicle was due to electrical in nature. See photo 5 - 7 below.

Photo 5 shows the burnt control module unit (arrowed) at the right side of the Insured Vehicle's rear boot compartment. Upon my close examination of the burnt area, I had found greenish residue on the stretch of wirings leading to the connector socket of the burnt control module unit. The connector socket (circled) was found with whitish burnt marks, which are a result of prolong exposure to heat intensity.

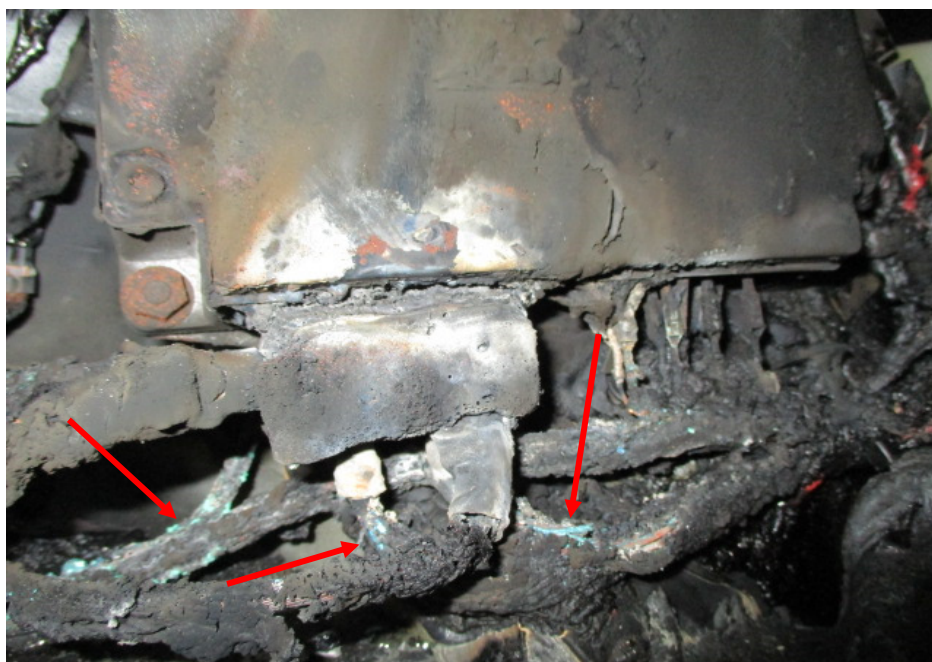
Photo 6 shows the greenish residue (arrowed) that was found on the wirings leading to the burnt connector socket. The presence of greenish residue suggests occurrence of an electrical short circuit, indicating that the cause of fire to the Insured Vehicle was due to electrical in nature.

14. The possibility of the fire being due to electrical in nature would then be the most probable causation given that engine overheating and external factor would both seem unlikely. Furthermore, my observations of greenish residue on the wirings shown in photograph 6 & 7 supports the finding of fire being due to electrical in nature.

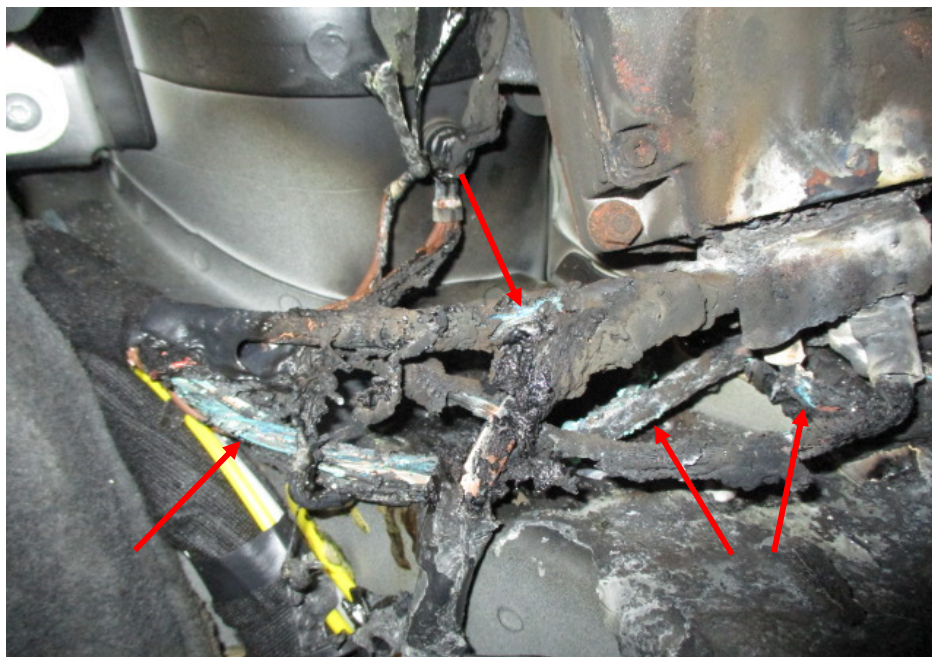
Photo 7 shows the greenish residue (arrowed) that was found on the wirings leading to the burnt connector socket. The presence of greenish residue on the wirings indicate internal heating of copper wires, a sign of an electrical short circuit occurring. The greenish residue is normally left behind from oxidation as a result of chemical reaction involving the copper wires. This physical evidence suggests that the cause of fire to the Insured Vehicle was due to electrical in nature.

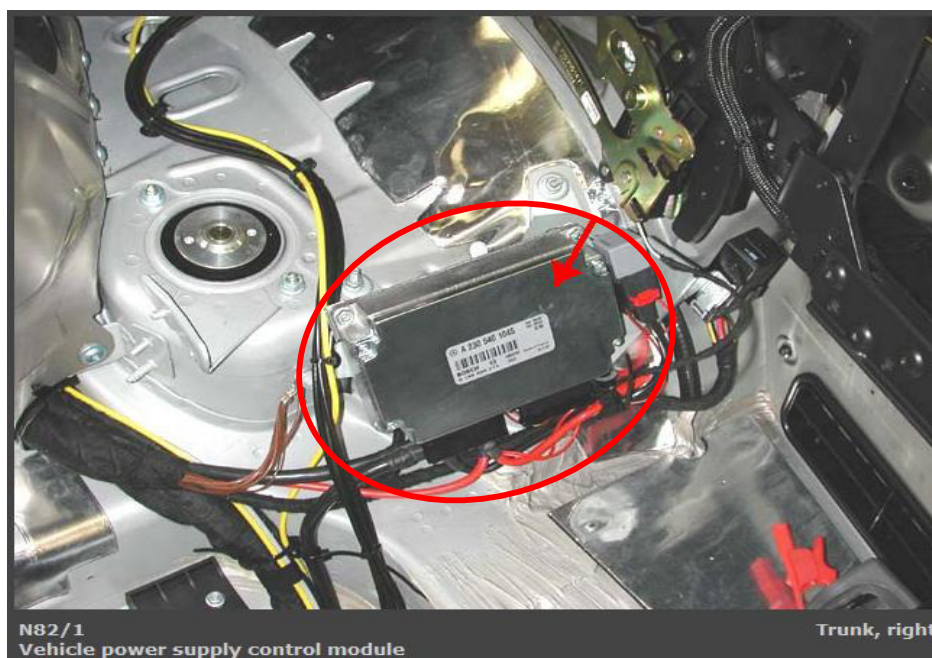
11. My checks and enquiries revealed that the burnt control module was the “vehicle power supply control module”, which monitors and control the supply of electronical power to the various electrical/electronic devices and components fitted on the Insured Vehicle. See photo 8 below showing an example of this “vehicle power supply control module”

Photo 8 shows the “vehicle power supply control module” (circled), which was found to be burnt on the Insured Vehicle.
