Your Ref: AC200046  
Our Ref : CI/III20005512/N

**TECHNICAL REPORT OF DAMAGE CLAIM FOR THE MOTOR BUS CB 7128Z**

1. We refer to your request dated 20 March 2020 to carry out a physical inspection of the motor bus CB 7128Z (herein referred to as "**Motor Bus**") to determine the possible cause(s) of its operational breakdown.

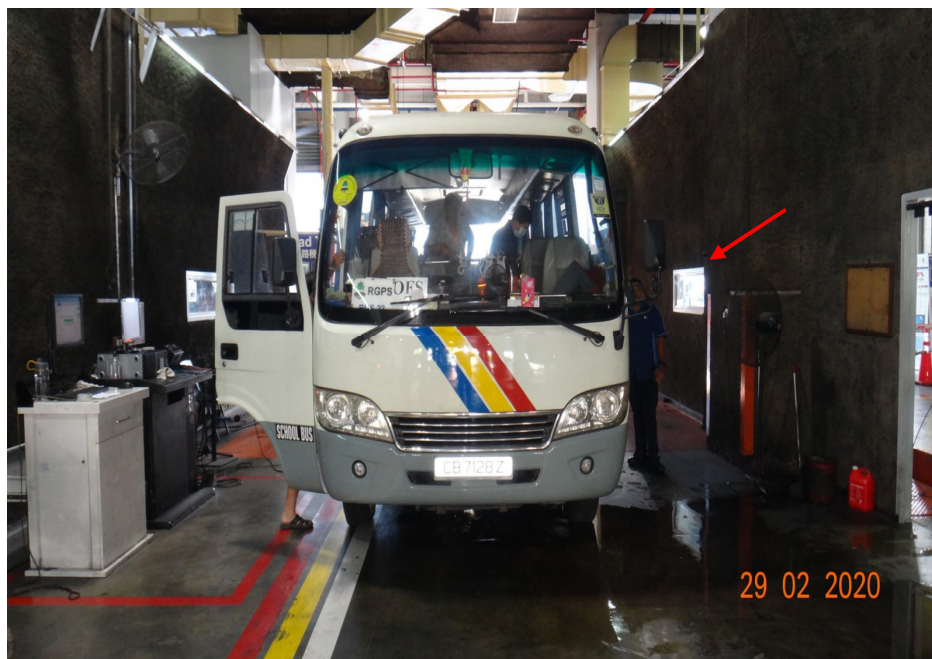
**Photo 1** shows the Motor Bus post- incident. The Motor Bus passed the above-carriage check but failed the Chassis Dynamometer Smoke Test (herein referred to as “CDST”) (arrowed) which are the 2 components for the 1st stage of the inspection.

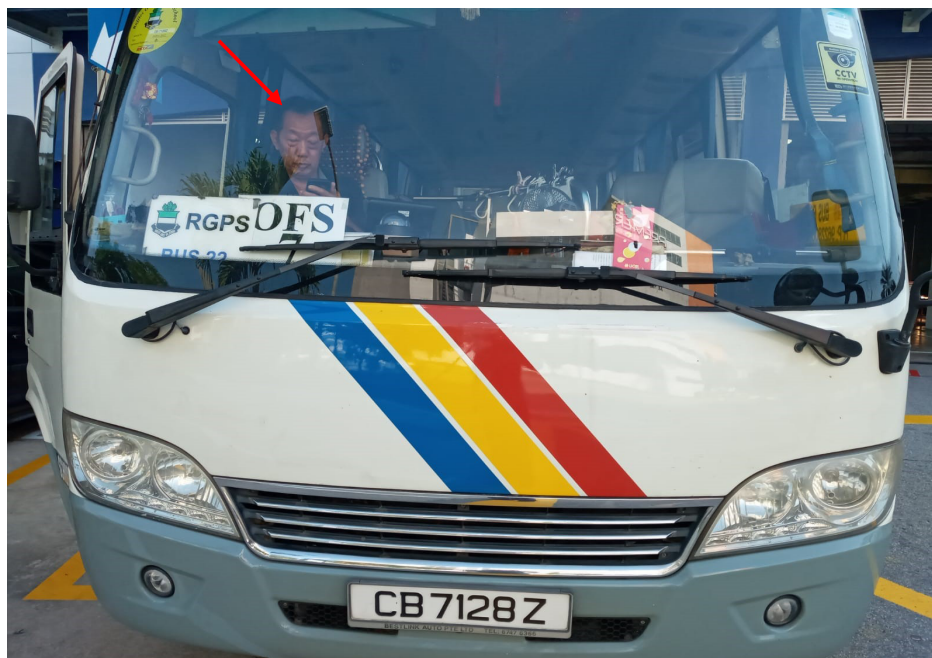
**Photo 2** shows the Motor Bus waiting to be towed post- incident. Mr Loo who is the owner and main driver, was the one who brought the Motor Bus to Vicom for the mandatory yearly vehicle inspection (arrowed).

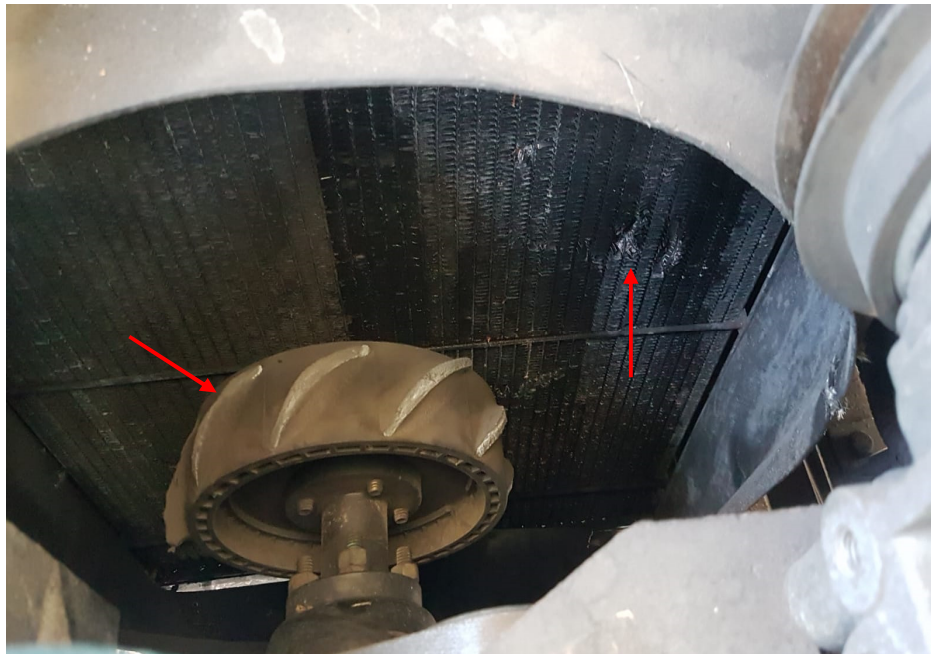
**Photo 4** shows the faulty components of the Motor Bus post- incident. We observed the broken radiator fan as well as the deformed radiator (arrowed).

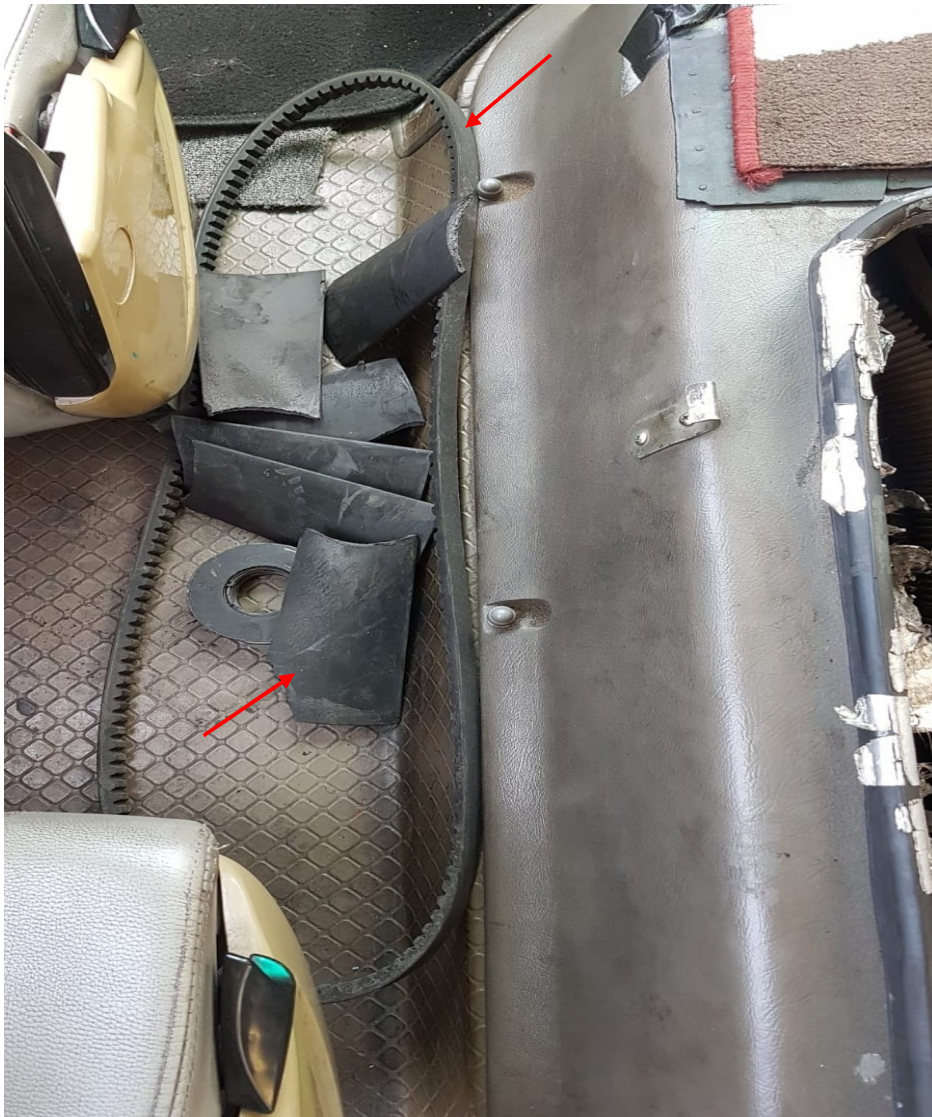
**Photo 5** shows the faulty components of the Motor Bus post- incident. We observed the broken blades of the radiator fan as well as the fan belting (arrowed).

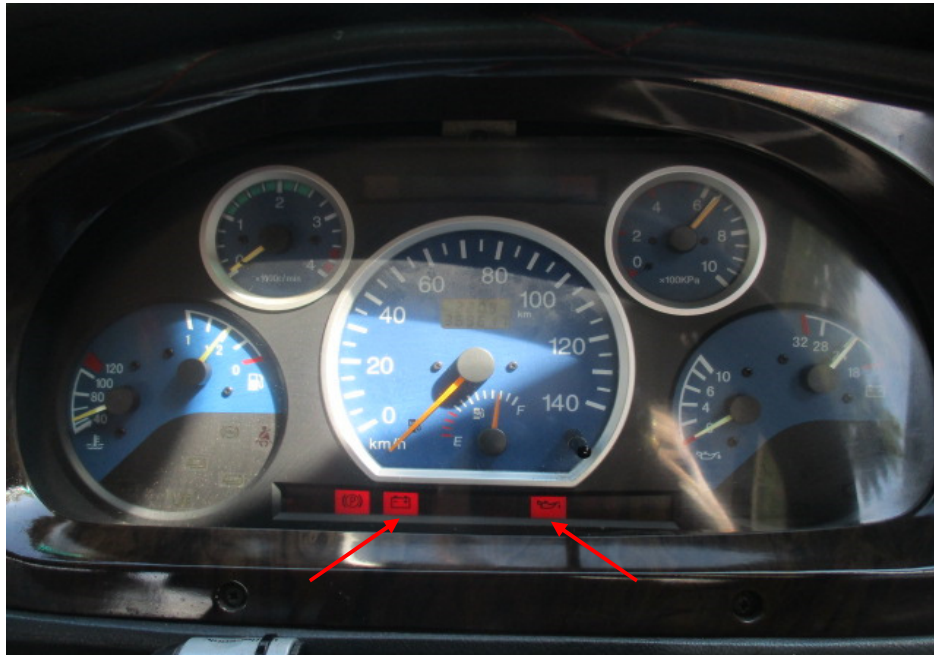
**Photo 6** shows the warning lights for the various electronic/electrical components of the Motor Bus appearing on its instrument panel before the engine is cranked, in particular the 'Battery' warning light and 'Oil Pressure' warning light (arrowed).

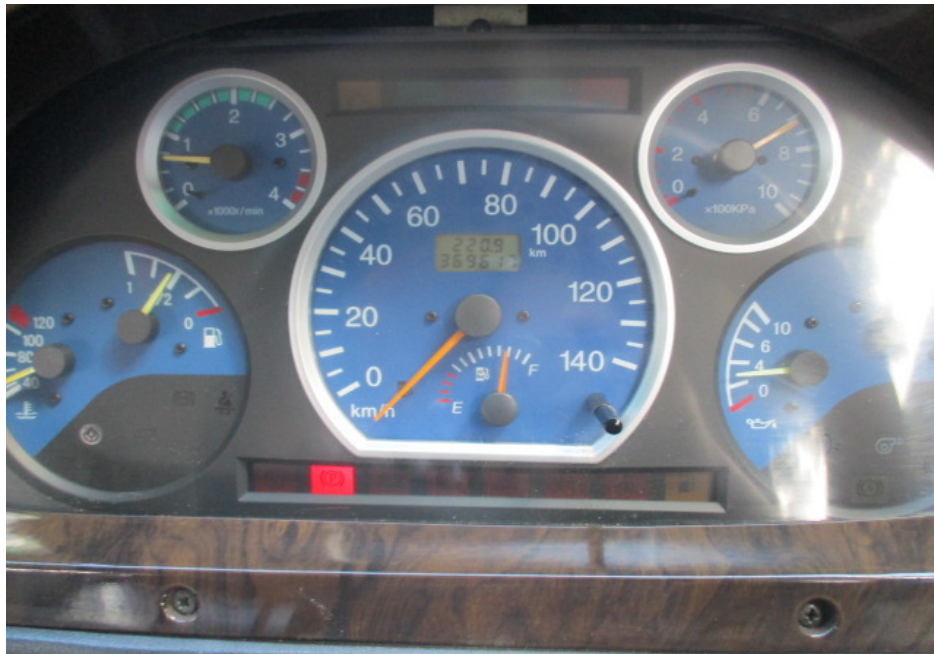
**Photo 7** shows no warning lights illuminated on the instrument panel of the Motor Bus after the engine was cranked. This would suggest that there was no abnormality to the various electronic/electrical components of the Motor Bus.

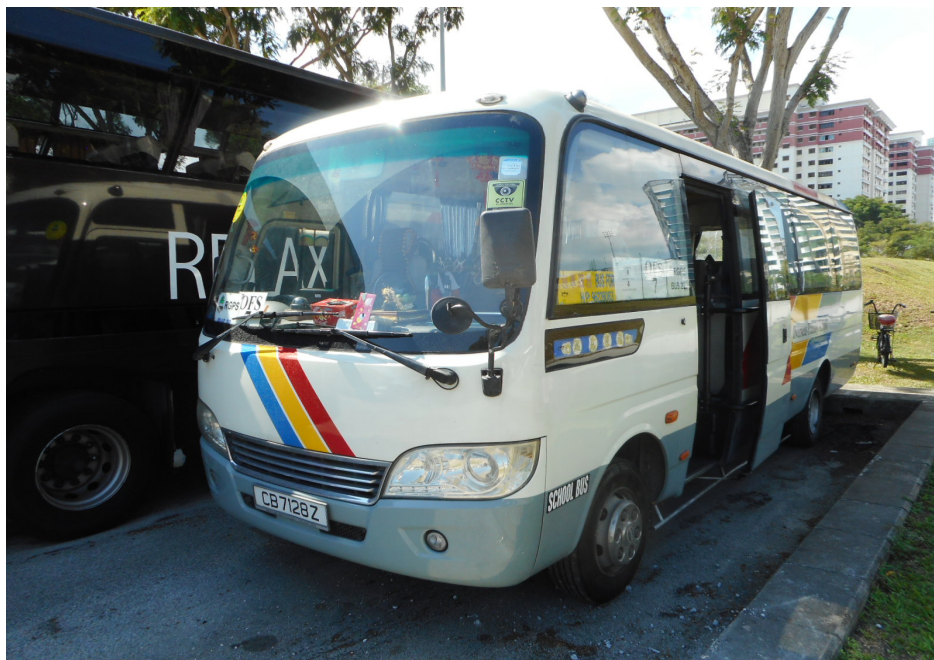
**Photo 8** shows a general view of the Motor Bus at the time of our physical inspection at Heavy Vehicle Carpark located at Tampines Avenue 9. The Motor Bus was observed to be in good general condition with no loose exterior fittings or connections.

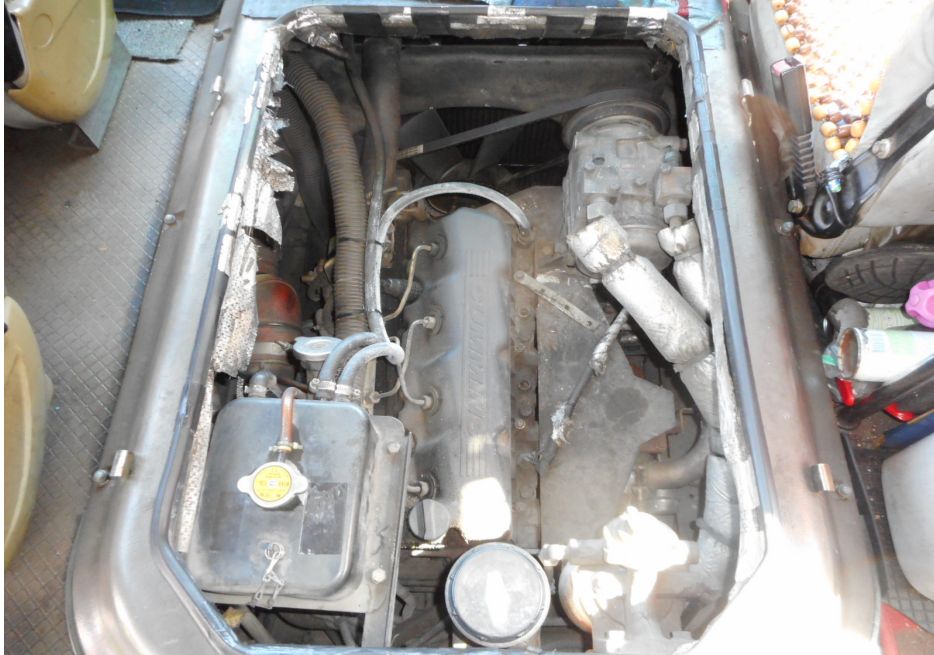
**Photo 9** shows the engine compartment of the Motor Bus upon our inspection. The engine components were all in working condition. We were also informed by Mr Loo that the faulty parts of the Motor Bus which included the fan belting, radiator fan blades as well as the radiator were replaced on 3 March 2020.

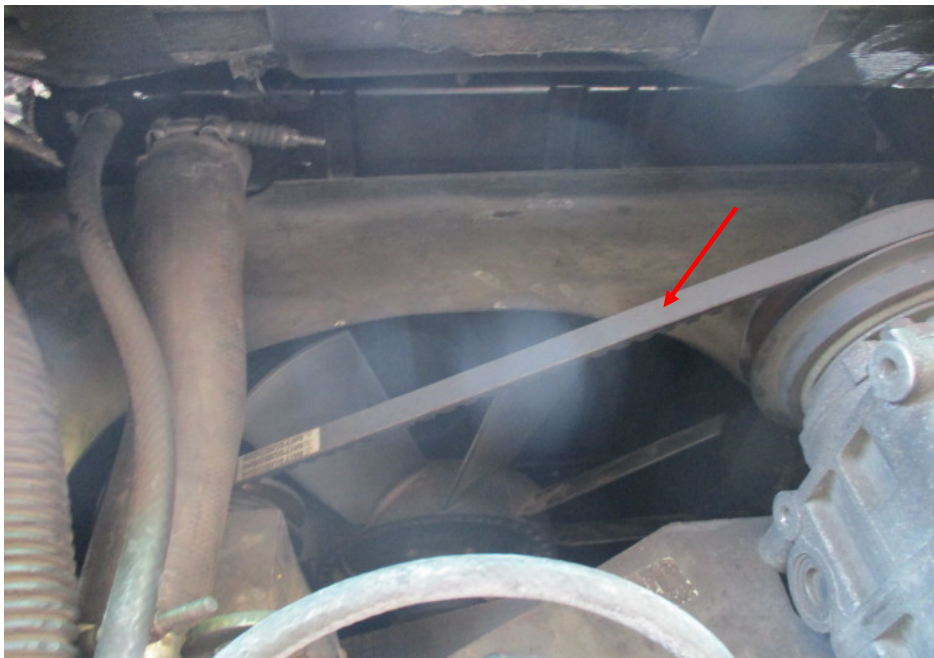
**Photo 10** shows the fan belting of the Motor Bus which was replaced on 3 March 2020 (arrowed).

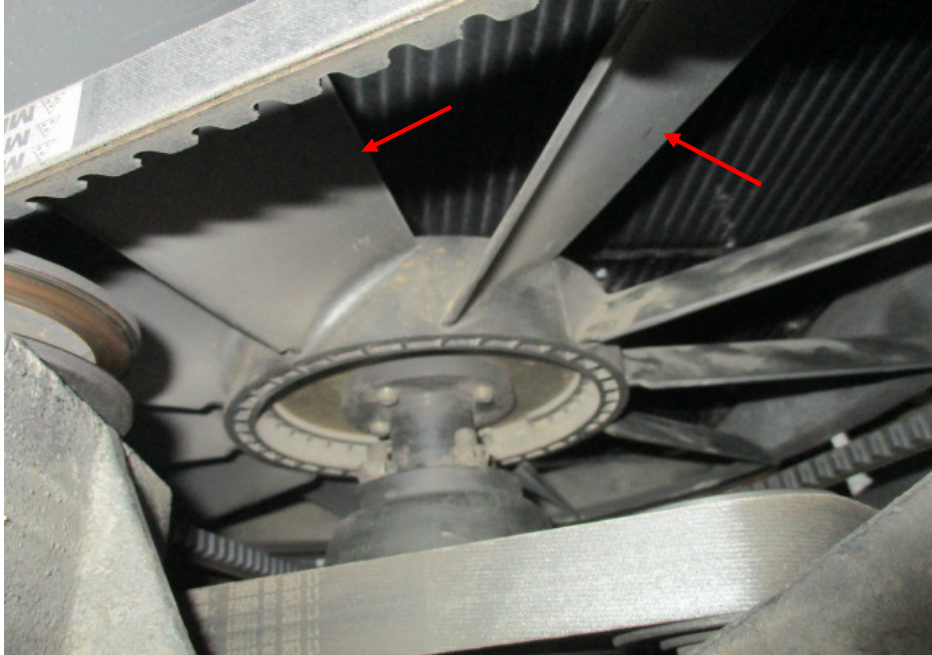
**Photo 11** shows the radiator fan of the Motor Bus which was replaced on 3 March 2020 (arrowed).

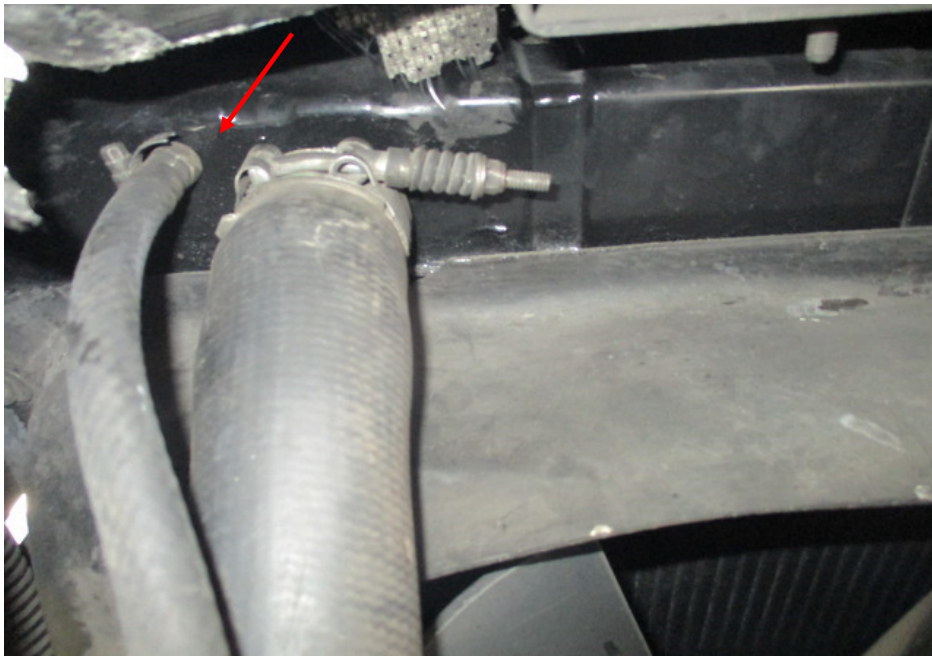
**Photo 12** shows the radiator of the Motor Bus which was replaced on 3 March 2020 (arrowed).
