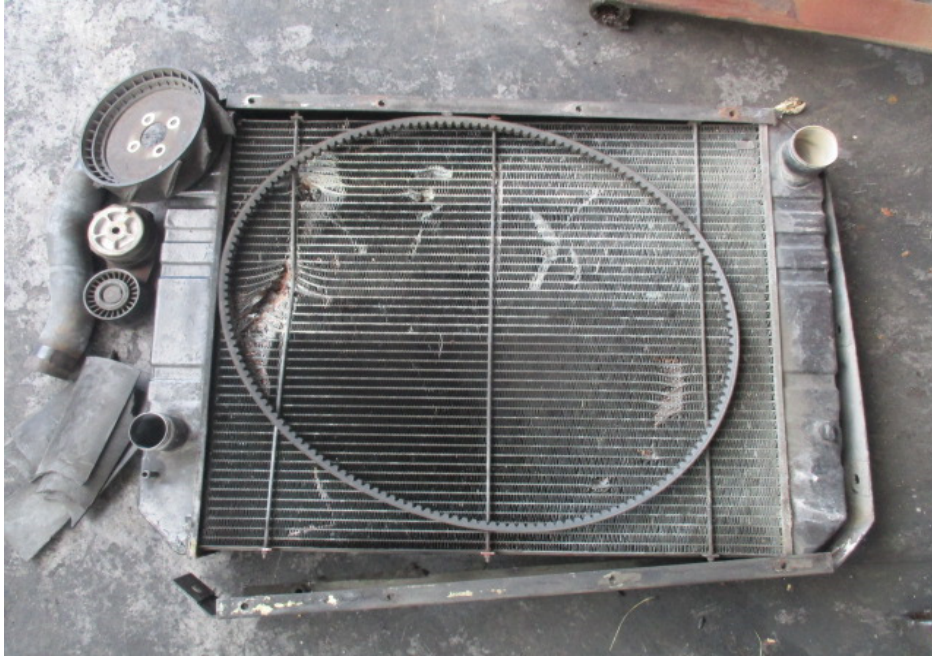
**Photo 13** shows the deformed radiator, broken radiator fan blades as well as torn radiator hose of the Motor Bus which were replaced on 3 March 2020 at GSH.

26. However the malfunction was most likely due to wear and tear of the components of the Motor Bus.

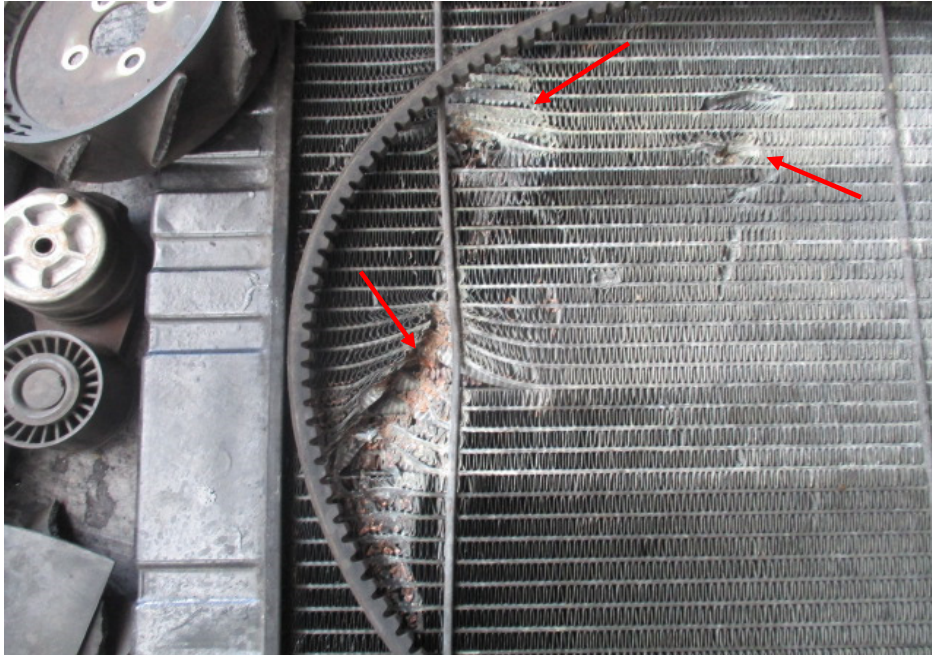
**Photo 14** shows a close up view of the deformed radiator of the Motor Bus which was replaced at GSH on 3 March 2020 (arrowed).

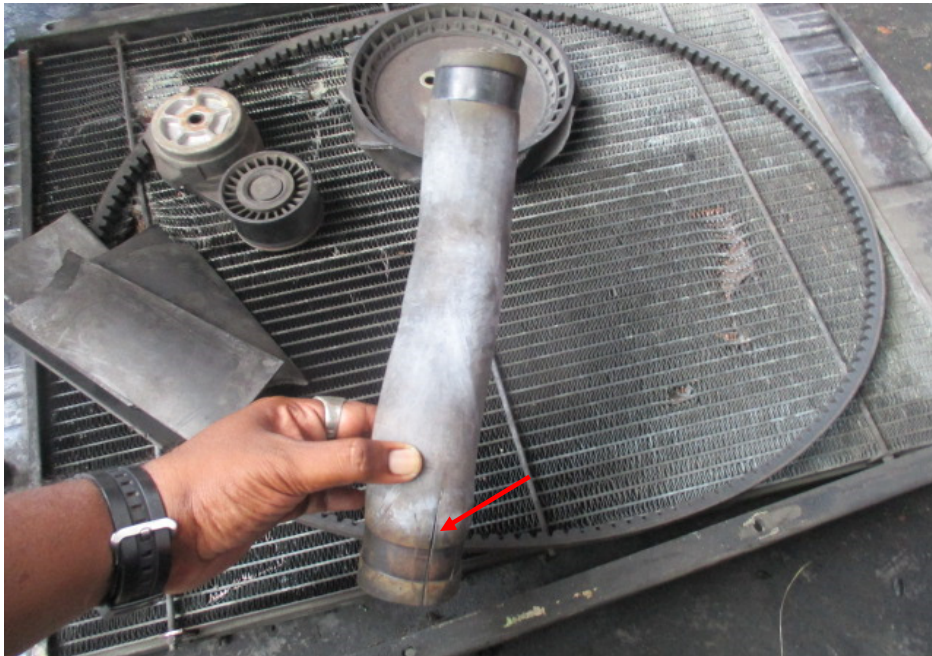
**Photo 15** shows a close up view of the torn radiator hose of the Motor Bus which was replaced at GSH on 3 March 2020 (arrowed).

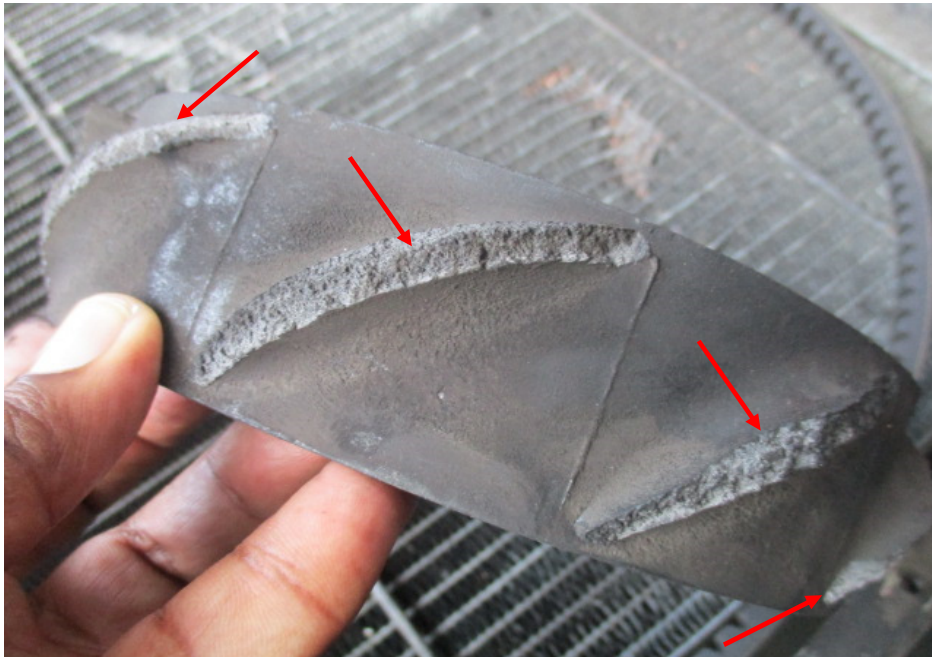
**Photo 16** shows a close up view of the broken radiator fan of the Motor Bus which was replaced at GSH on 3 March 2020 (arrowed).

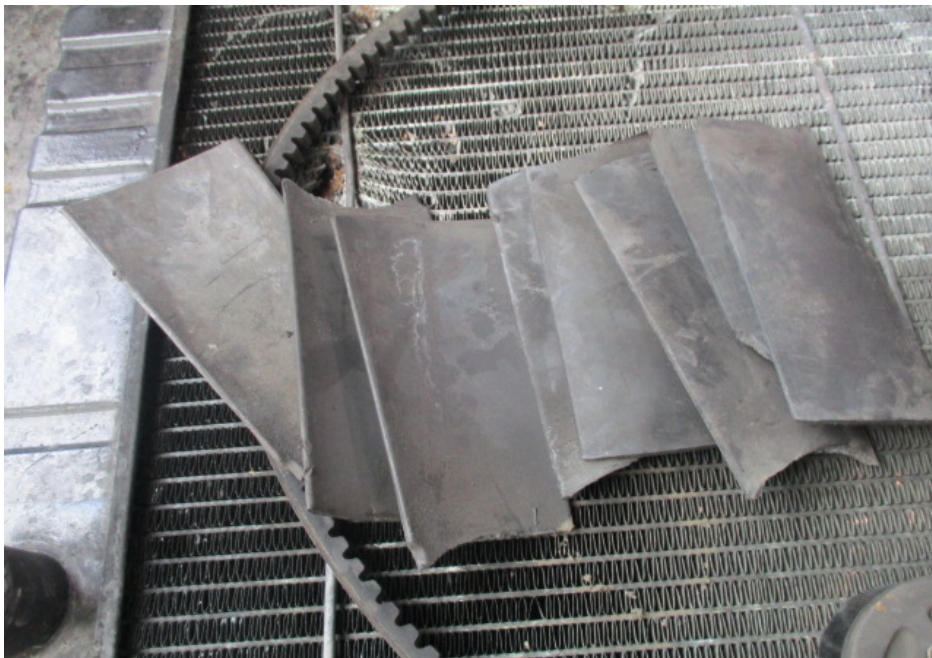
**Photo 17** shows a close up view of the broken blades of the radiator fan of the Motor Bus which was replaced at GSH on 3 March 2020.

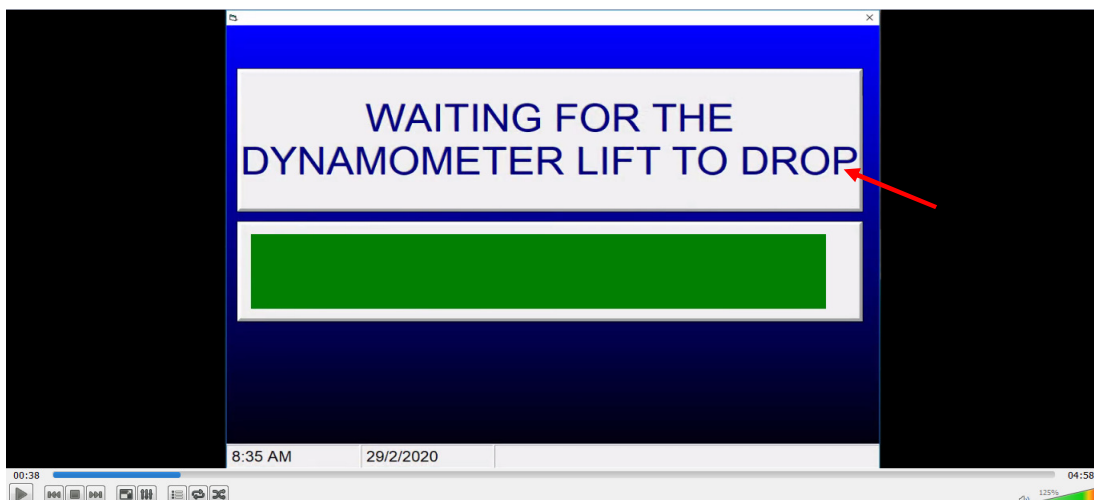
**Screenshot 1** of the video recording shows the dynamometer lift being dropped on the rear wheels of the Motor Bus (as it is a rear-wheel drive) before the commencement of the CDST (arrowed).

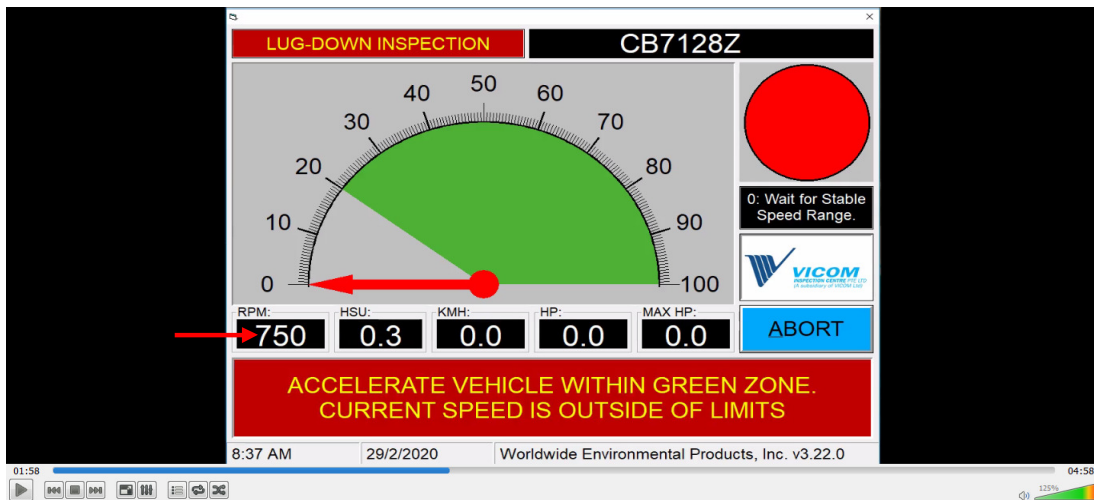
**Screenshot 2** of the video recording shows the transmission of the Motor Bus in 'neutral' mode with the engine running as the speed is at '0' kmph and the rpm is idling at 750 (arrowed).

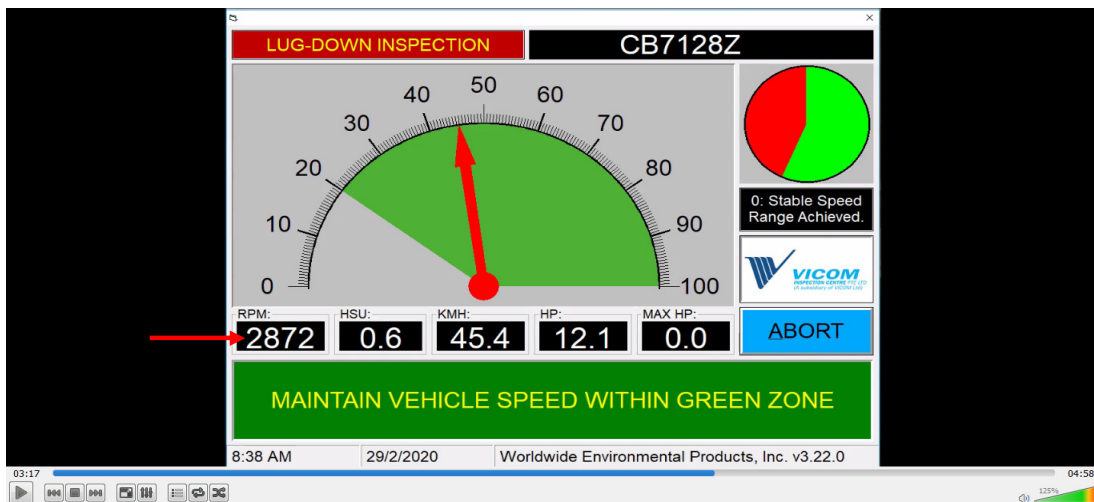
**Screenshot 3** of the video recording shows the maximum rpm of 2872 achieved by the Motor Bus as the vehicle speed is maintained within the green zone (arrowed).

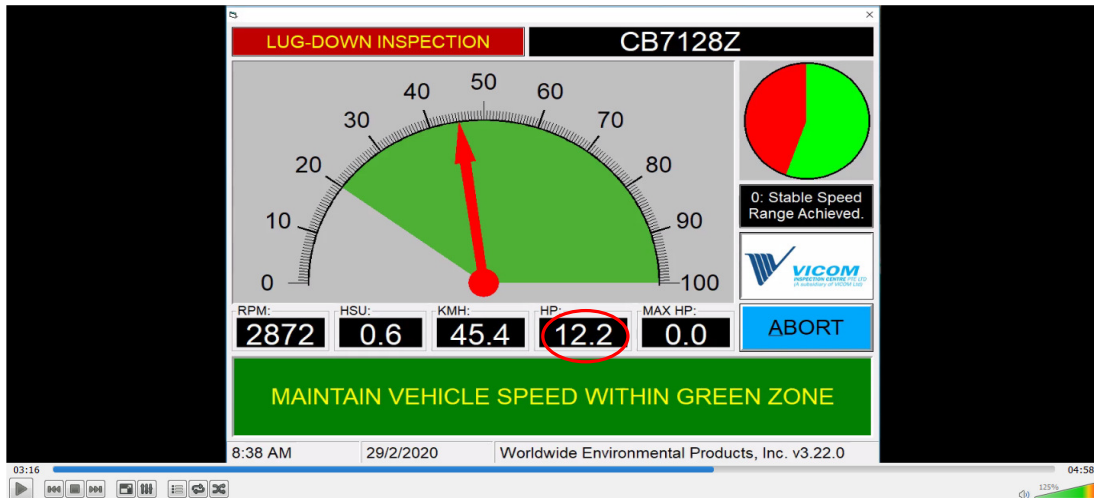
21. The video recording of the CDST in preparation of this report was provided to us by Mr Abdullah. The recording showed the speedometer, rpm and horsepower output of the Motor Bus that was measured as the CDST was conducted. The length (duration) indicated in the video recording was 4 minute 58 seconds. The maximum rpm of the Motor Bus that was measured during the test was 2872 before the Motor Bus broke down as shown in the video recording. It is unlikely possible for excessive revving of the Motor Bus to occur during the CDST as the horsepower output did not reach 80hp which is the estimated maximum horsepower output. The maximum horsepower output reached by the Motor Bus was 12.2hp before it broke down. See screenshots 1 - 6 below.

**Screenshot 4** of the video recording shows the maximum horsepower of 12.2 achieved by the Motor Bus as the vehicle speed is maintained within the green zone (circled).

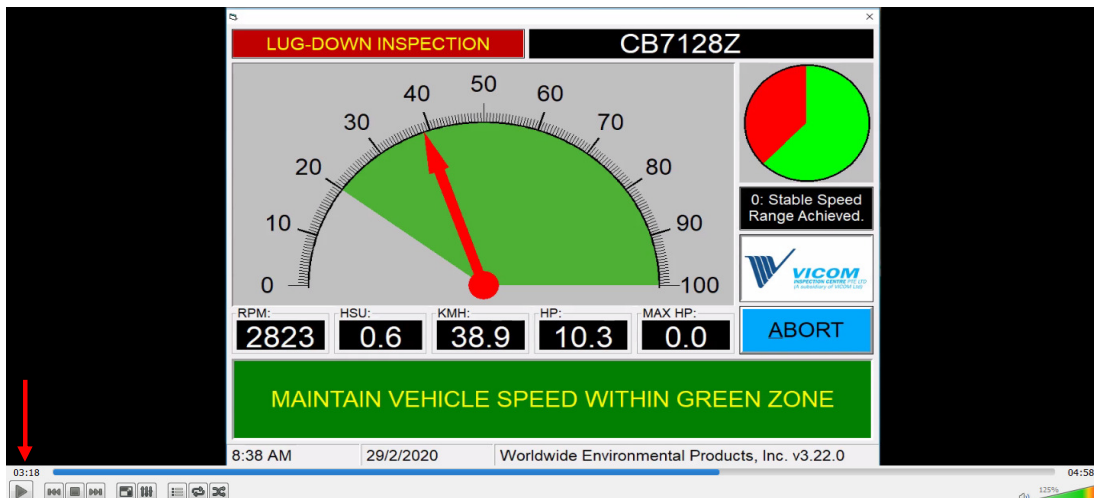
**Screenshot 5** of the video recording shows the rpm decreasing as the Motor Bus broke down at 3 min 18 sec of the CDST (arrowed).

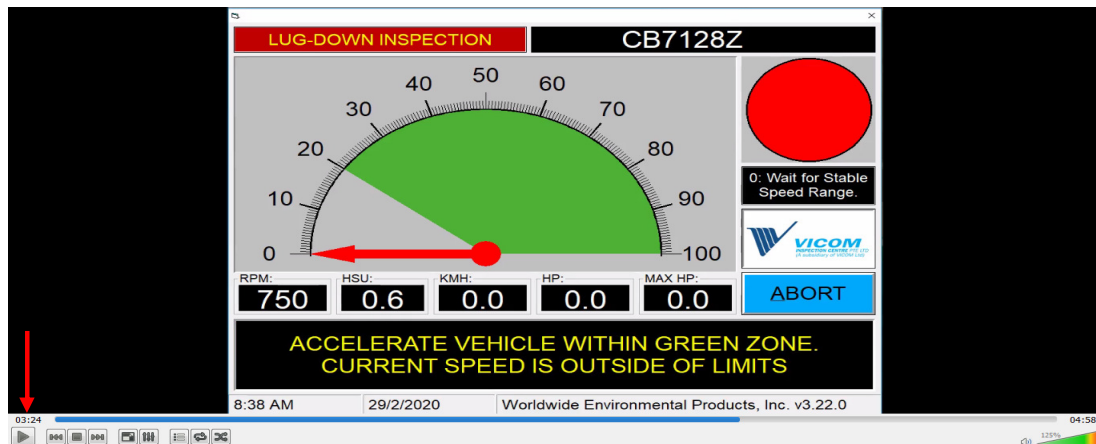
**Screenshot 6** of the video recording shows the rpm decreasing to 750 as the neutral gear is engaged at 3 min 24 sec (arrowed) after the Motor Bus broke down during the CDST.
