Your Ref : D20001724M/CT/EE  
Our Ref : CI/FCI20005562/N

6 April 2020

**TECHNICAL INVESTIGATION REPORT OF FIRE INCIDENT INVOLVING THE  
INSURED VEHICLE SHA 4128P ON 31 MARCH 2020**

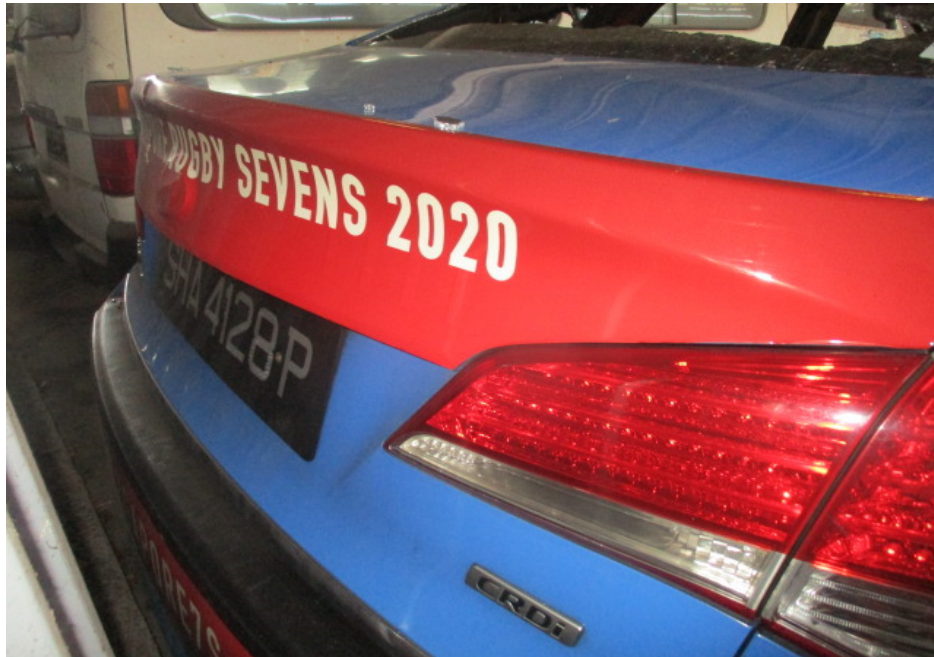
**Photo 1** shows the general view of the rear portion of the Insured Vehicle at the time of our inspection. The rear portion of the Insured Vehicle was relatively unaffected by the fire.

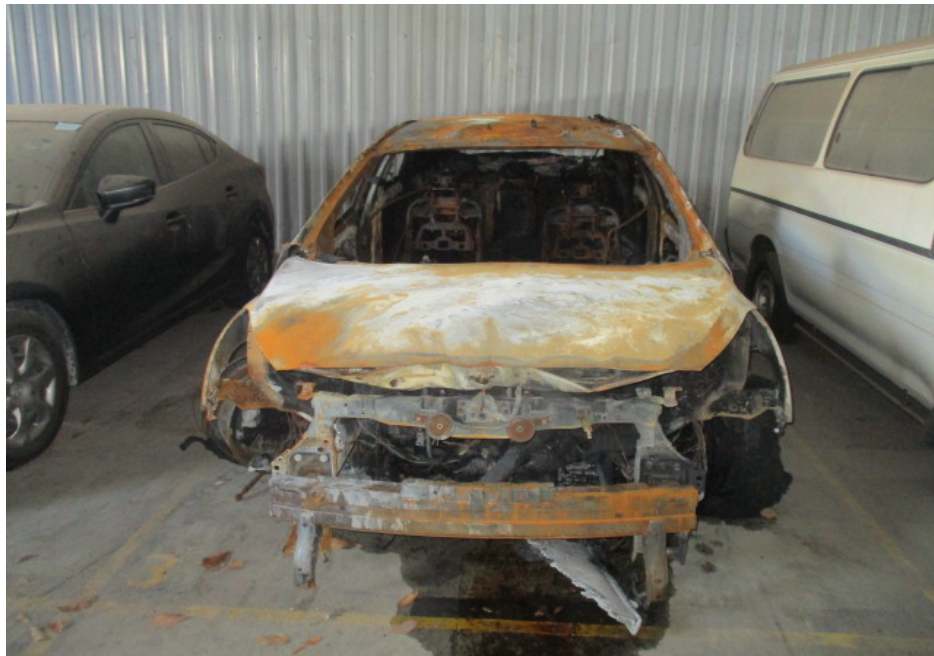
**Photo 2** shows the general view of the front portion of the Insured Vehicle at the time of our inspection. The fire damage to the Insured Vehicle was confined to its front portion. Its front bumper, front bonnet, front support panel, front grille, front headlamps, front windscreen, front rims and front tyres were amongst the body parts that were found to have been affected as a result of the fire.

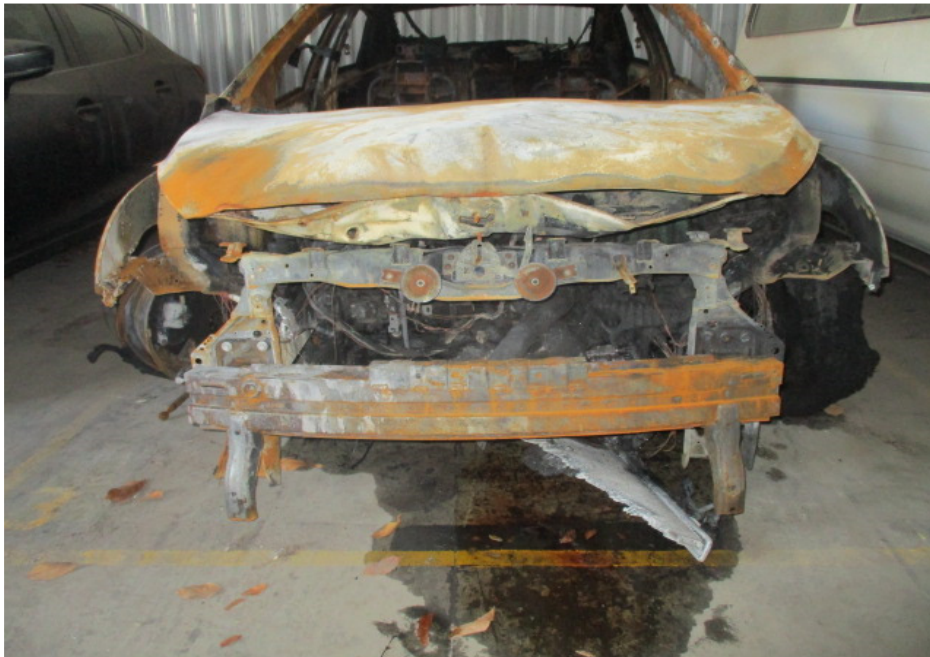
**Photo 3** shows the closer view of the front portion of the Insured Vehicle at the time of our inspection. The fire damage to the Insured Vehicle was confined to its front portion. Its front bumper, front bonnet, front support panel, front tyres and front headlamps were amongst the body parts that were found to have been affected by the fire.

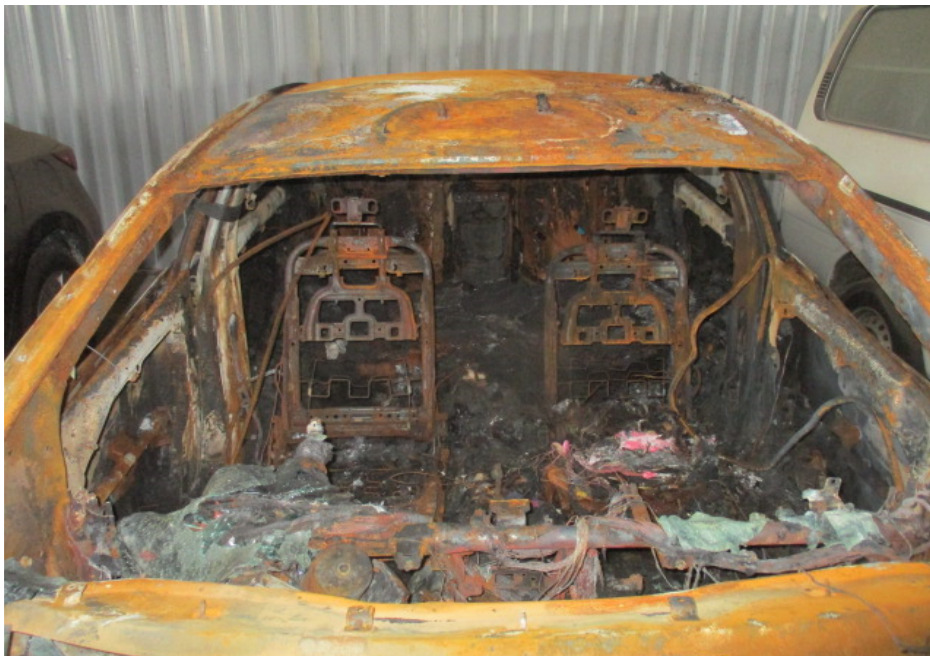
**Photo 4** shows the general view of the front windscreen of the Insured Vehicle at the time of our inspection. The fire damage to the windscreen was extensive.

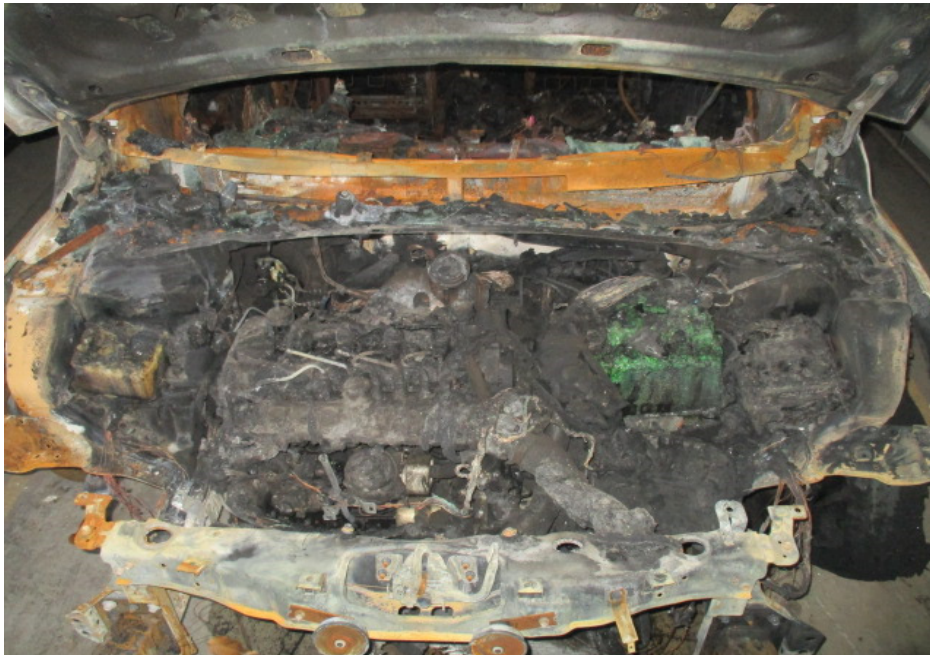
**Photo 5** shows the engine compartment of the Insured Vehicle at the time of our inspection. The entire engine compartment of the Insured Vehicle was observed to be severely burnt. Most of the parts inside the engine compartment were found to be burnt and/or melted as a result of the fire.

14. Based on the incident scene photographs and our physical inspection of the Insured Vehicle, the fire seems to have originated from the frontal portion (engine compartment) of the Insured Vehicle. Fire in the engine compartment is usually caused by either engine overheating, fluid leakage or electrical in nature.

15. Given the extent of fire damage for this case, we are unable to conclusively determine if the cause of fire to the Insured Vehicle was due to engine overheating, fluid leakage or electrical in nature.

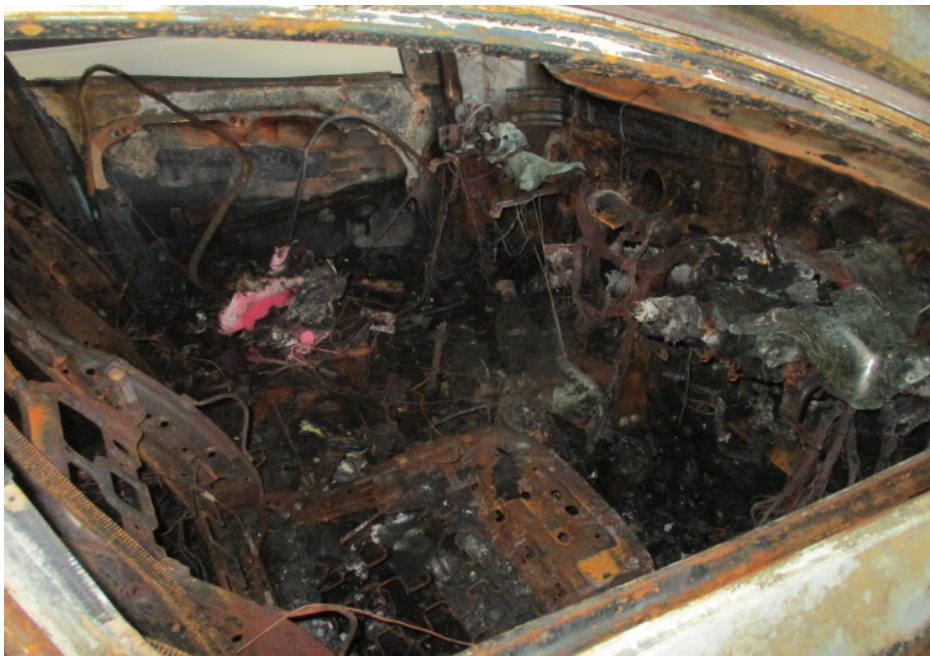
**Photo 6** shows the interior compartment of the Insured Vehicle, which was severely affected by the fire.

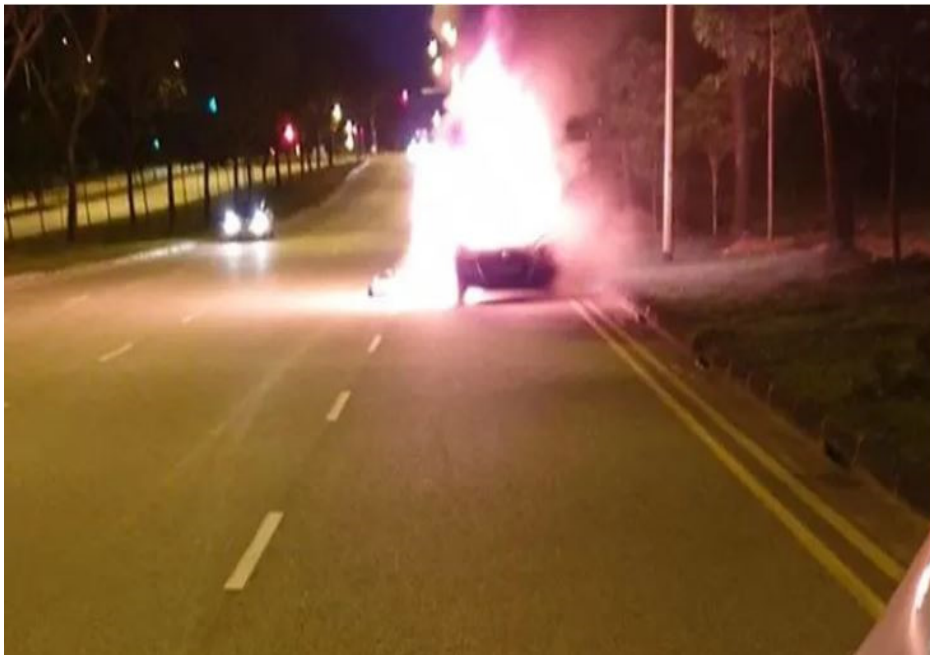
**Photo 7** shows the Insured Vehicle on fire before the arrival of the SCDF.

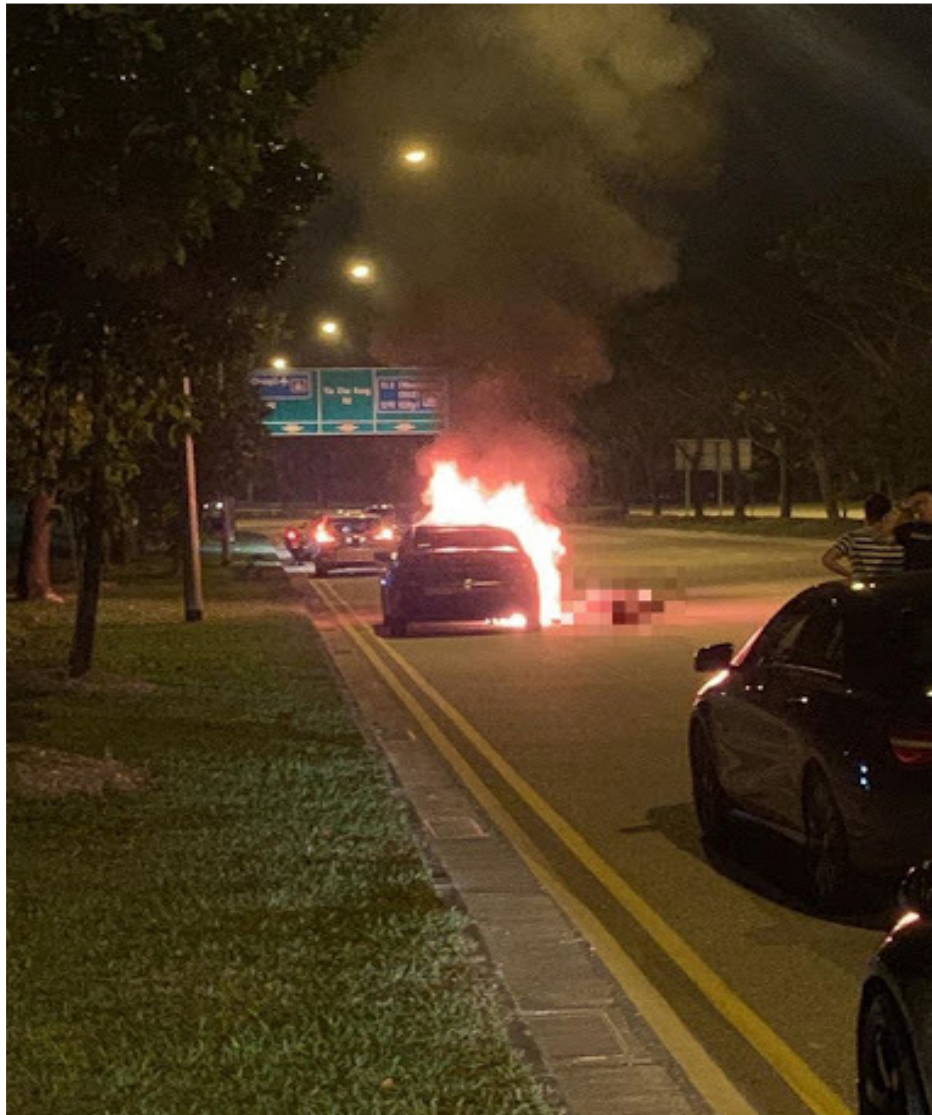
**Photo 8** shows the Insured Vehicle on fire before the arrival of the SCDF (as taken from the rear portion). In general, based on the information that could be gathered from this photograph, the fire seems to have originated from the frontal portion of the Insured Vehicle.

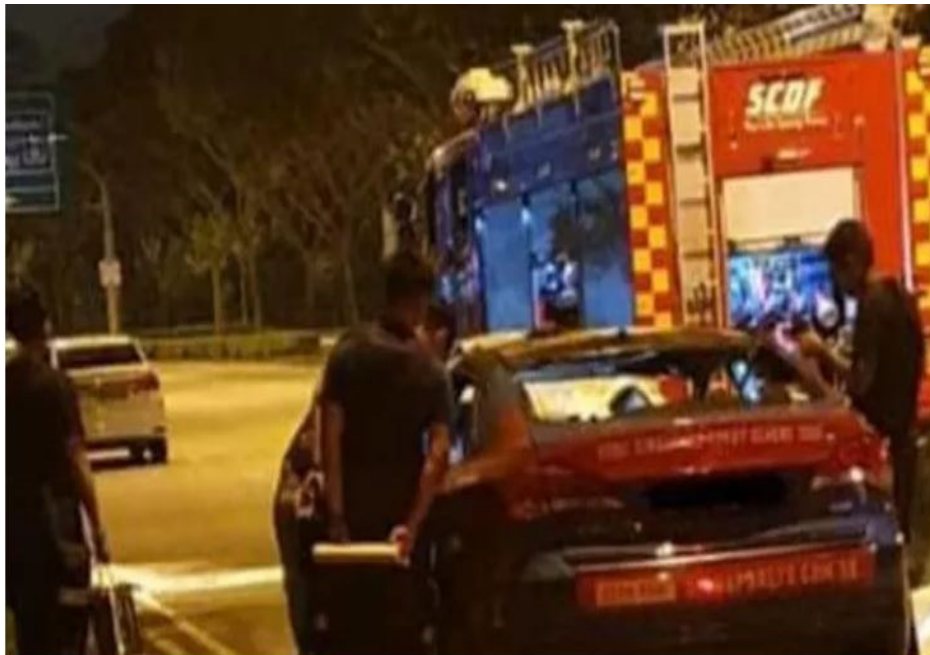
**Photo 9** shows SCDF performing preliminary investigations on the Insured Vehicle after the fire was extinguished.
