Your Ref: TP/IP/12357/2020
Our Ref : CI/TPD20005585/P

19th June 2020

MECHANICAL INSPECTION REPORT OF MOTOR CAR SJN 3125L

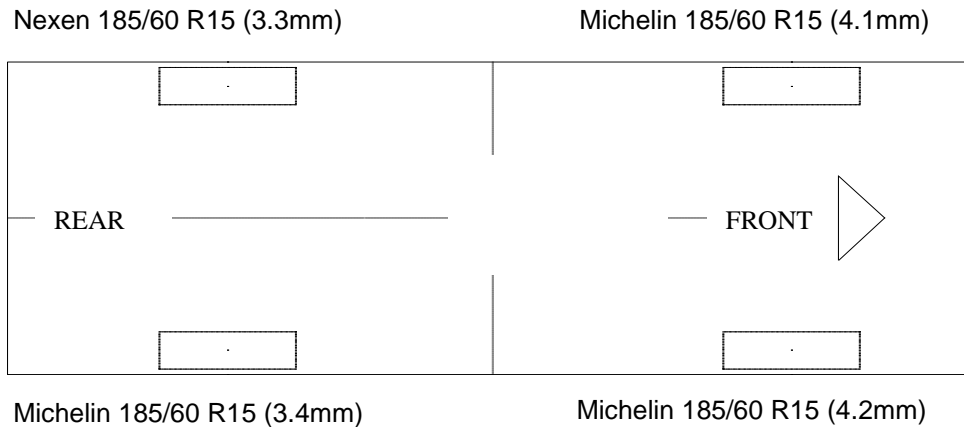
6. The condition of the Motor Car's 4 tyres was observed to be in serviceable condition. I did not find any tear, cut or burst mark(s) on the outer and the inner sidewalls as well as across the tread of the 4 tyres. The 4 tyres were also observed to be sufficiently inflated for vehicular operation. The tyre brand, tyre size and remaining tread depth of the 4 tyres were recorded as follows:-

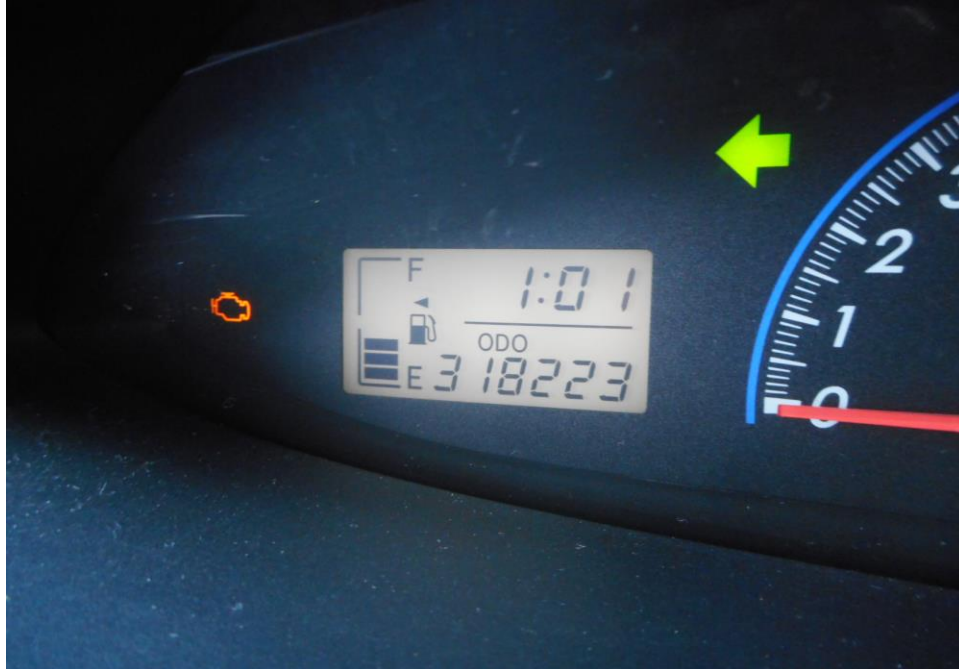
Photo 1 shows a general view of the instrument cluster of the Motor car at the time of my inspection. The mileage of the Motor car was 318,223km

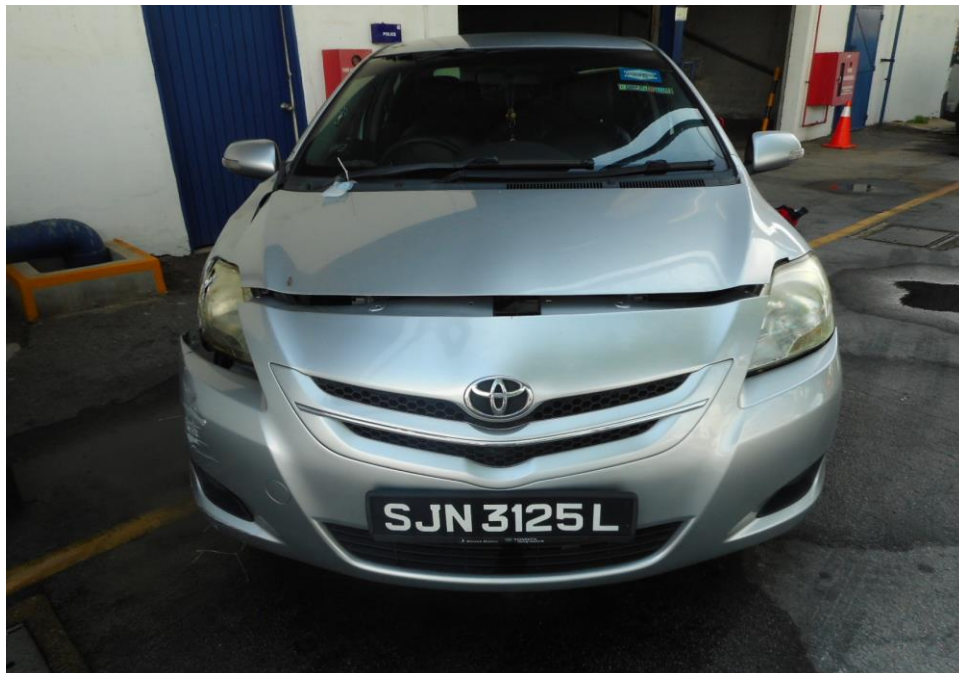
Photo 2 shows a general view of the Motor Car's front body at the time of my inspection. The Motor car was observed to have sustained damage at its front right portion. Its front bumper, front right fender, front right headlamp and right door panel was amongst the body parts and various components in the engine compartments were also damaged as a result of the accident.

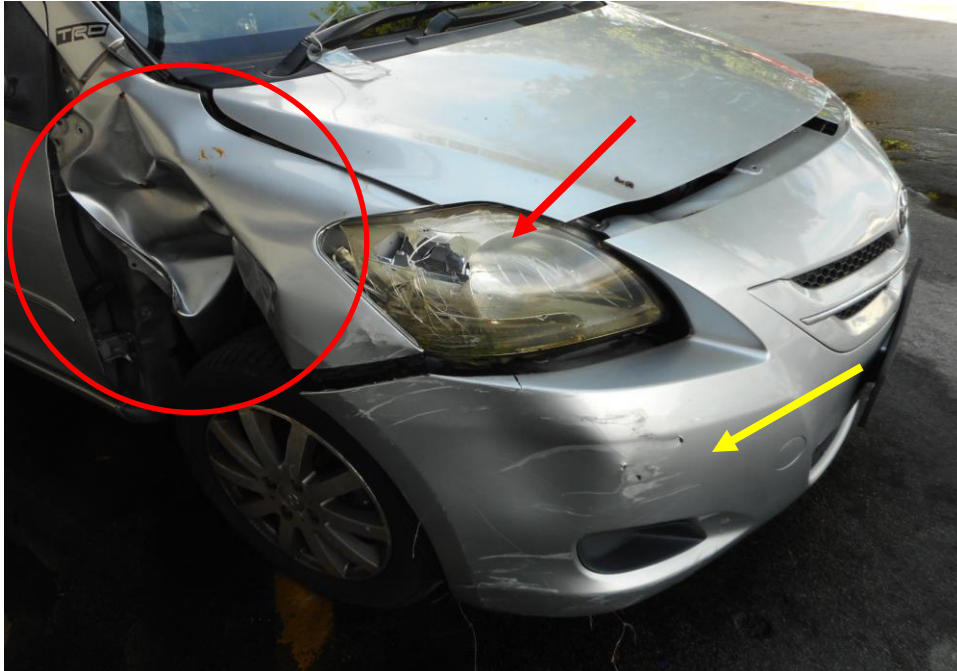
Photo 3 shows a close up view of the Motor Car's engine compartment at the time of my inspection. The Motor car was observed to have sustained damage at its front right portion. Its front bumper (yellow arrow), front right fender (circled) and front right headlamp (red arrow) was amongst the body parts and various components in the engine compartments were also damaged as a result of the accident.

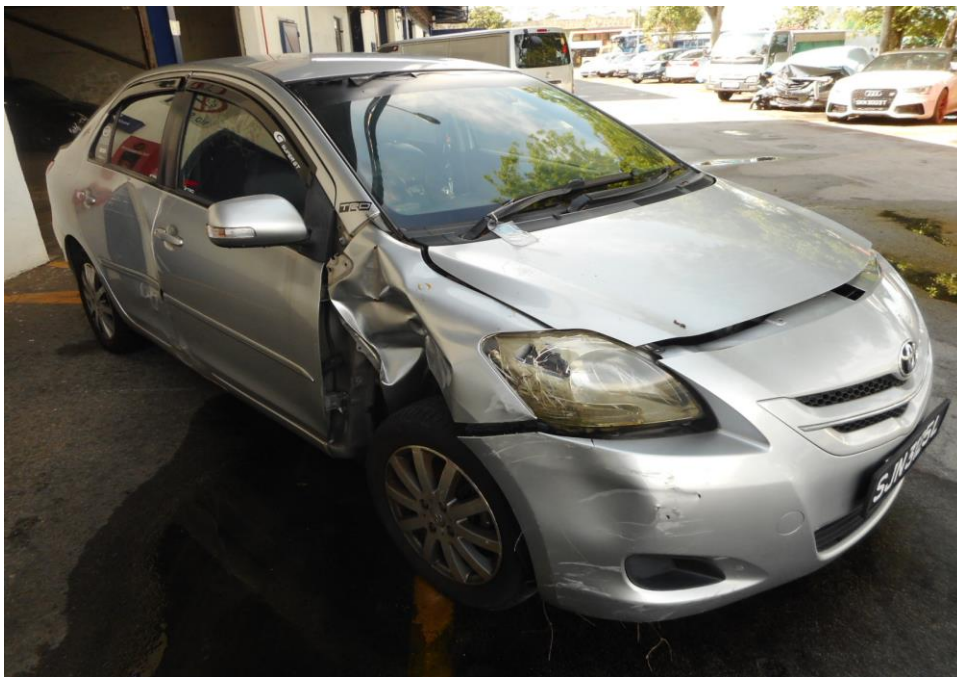
Photo 4 shows a general view of the Motor Car's rear right body at the time of my inspection. The right portion of the Motor Car was observed to have been damaged, its right body panel was damaged as a result of the accident.

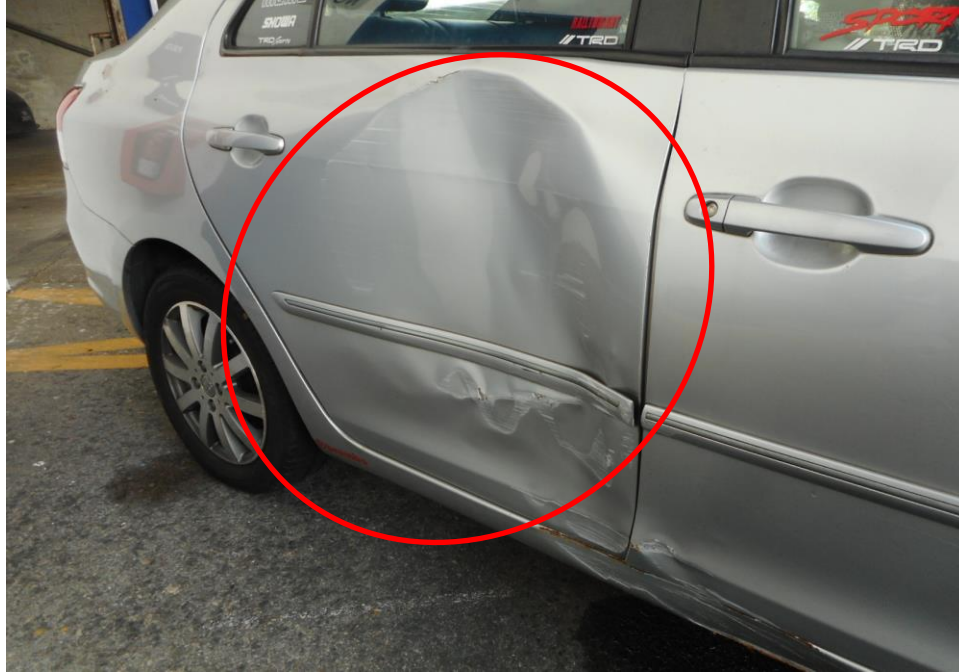
Photo 5 shows a close up view of the Motor Car's right body at the time of my inspection. The right portion of the Motor Car was observed to have been damaged, its right body panel (circled) was damaged as a result of the accident.

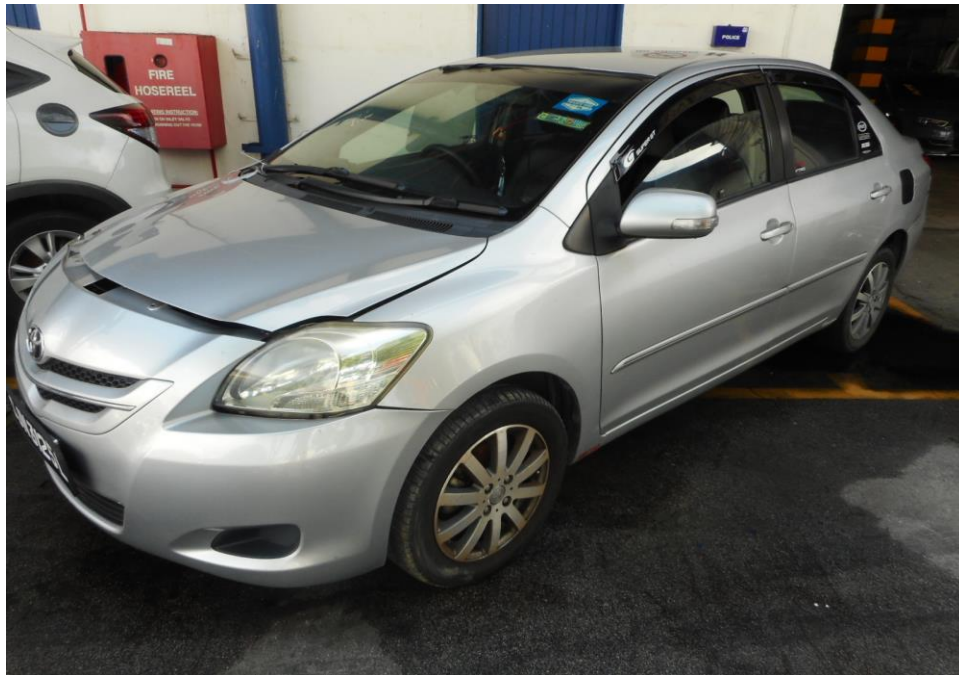
Photo 6 shows a general view of the Motor Car's left body at the time of my inspection. The left portion of the Motor Car was observed to have been undamaged by the accident.

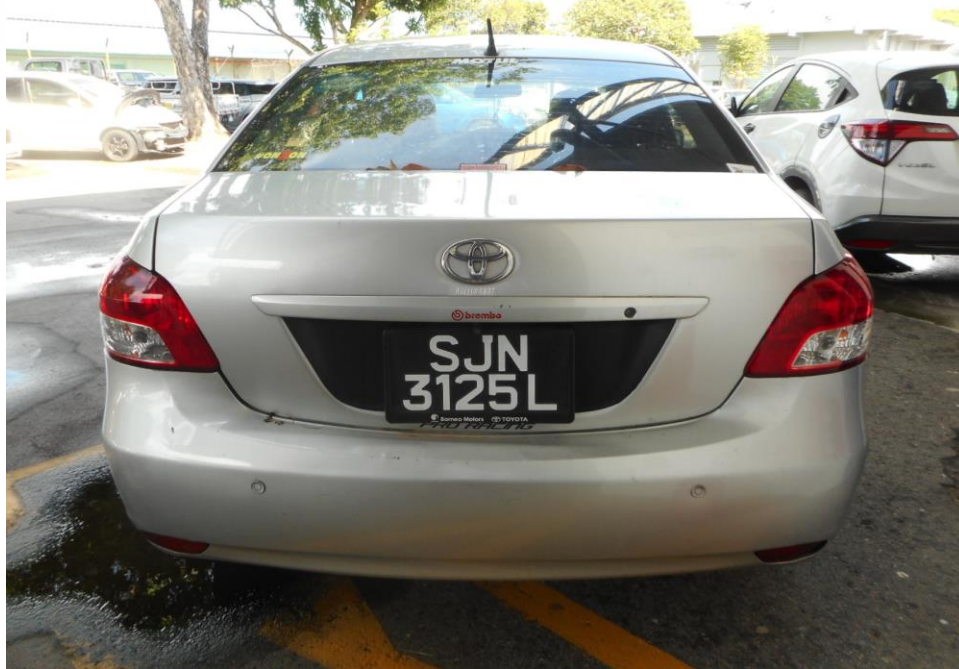
Photo 7 shows a general view of the Motor Car's rear body at the time of my inspection. The rear portion of the Motor Car was observed to have been undamaged by the accident.

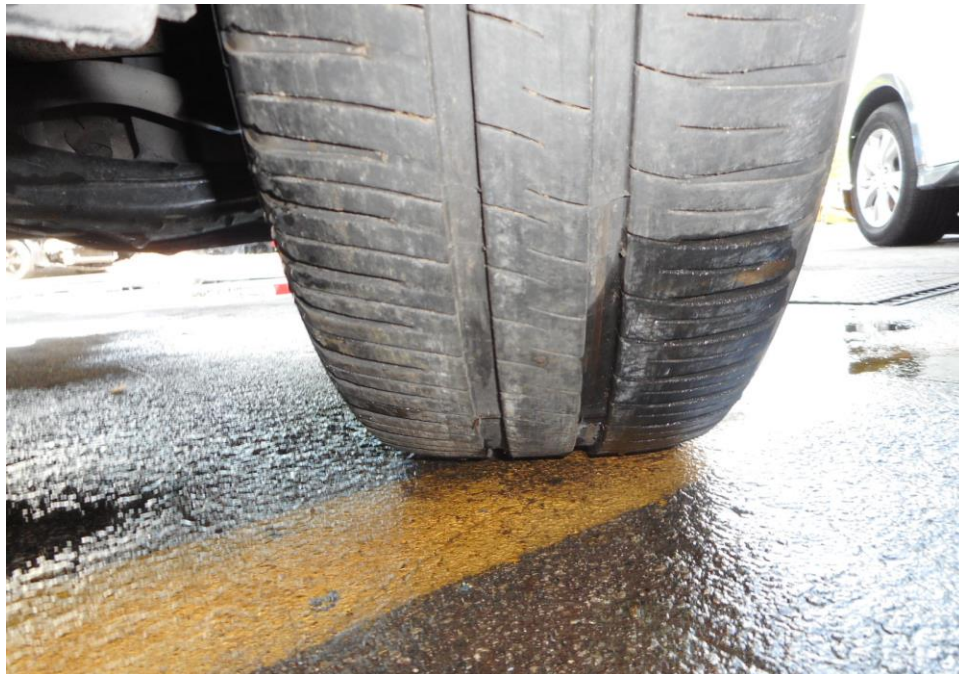
Photo 8 shows the condition of the front right tyre of the Motor Car, which was observed to be in serviceable condition with remaining tread depth of approximately 4.2mm. The tyre, which was wrapped around alloy wheel rim, was also observed to be sufficiently inflated for vehicular operation.

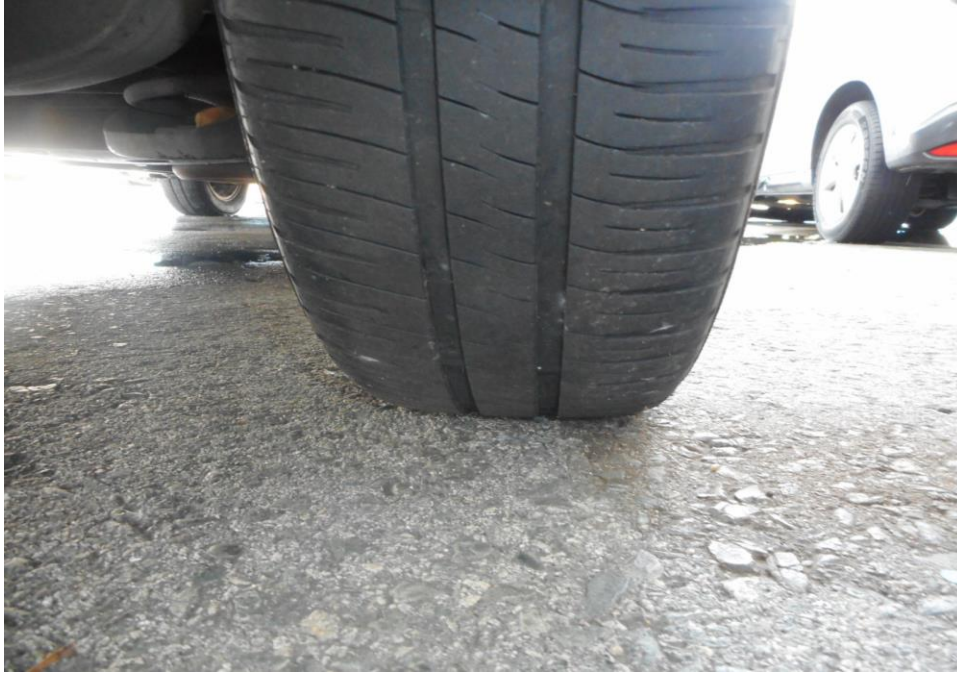
Photo 9 shows the condition of the rear right tyre of the Motor Car, which was observed to be in serviceable condition with remaining tread depth of approximately 3.4mm. The tyre was also observed to be sufficiently inflated for vehicular operation with no tear, cut or burst mark(s).

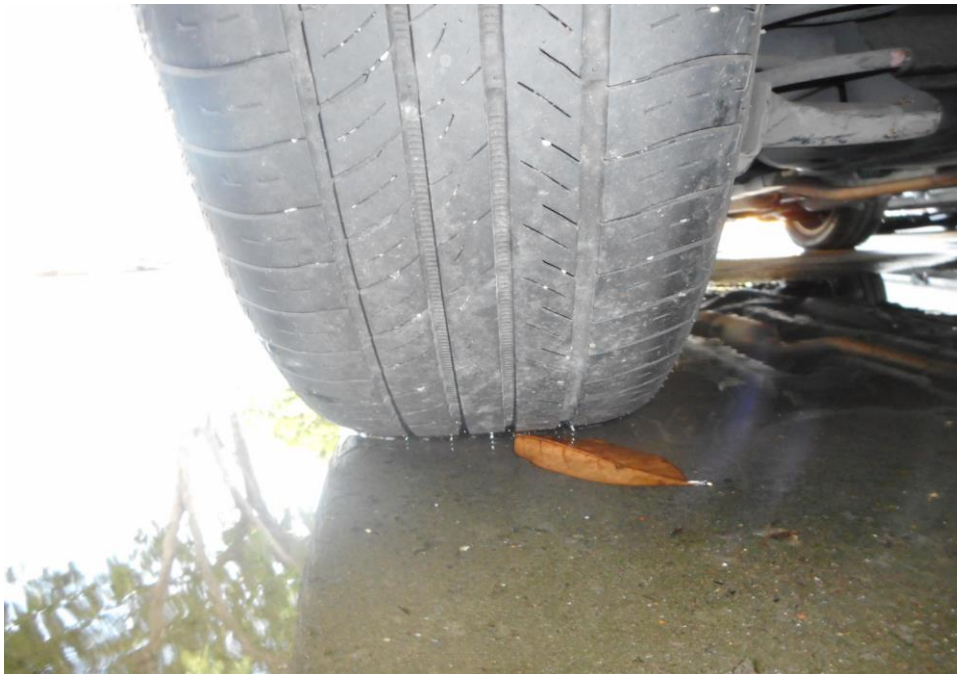
Photo 10 shows the condition of the rear left tyre of the Motor Car, which was observed to be in serviceable condition with remaining tread depth of approximately 3.3mm. The tyre was also observed to be sufficiently inflated for vehicular operation with no tear, cut or burst mark(s).

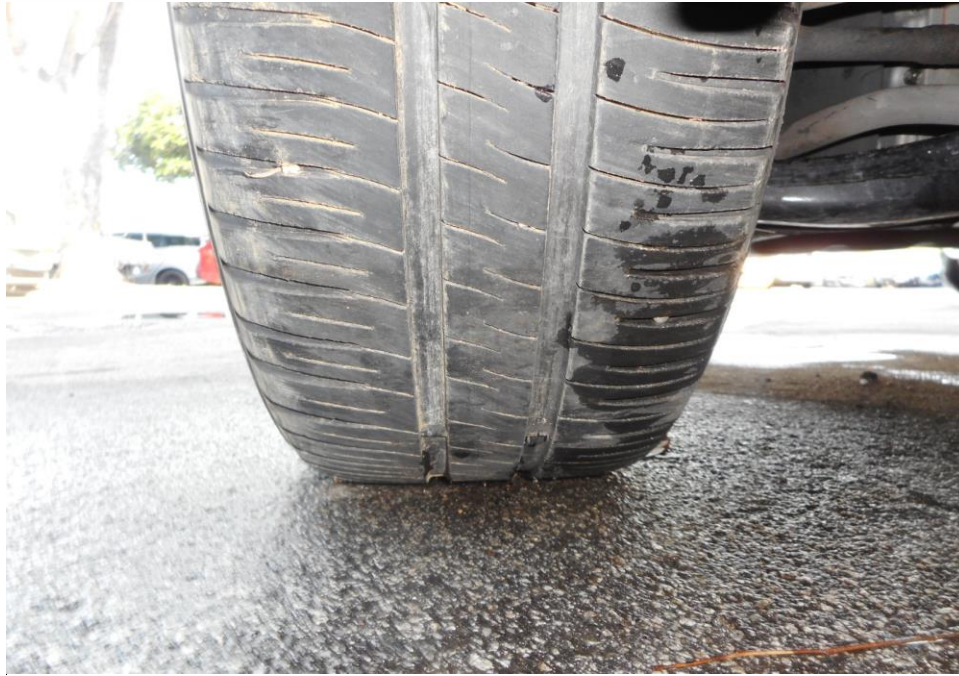
Photo 11 shows the condition of the front left tyre of the Motor Car, which was observed to be in serviceable condition with remaining tread depth of approximately 4.1mm. The tyre was also observed to be sufficiently inflated for vehicular operation with no tear, cut or burst mark(s).

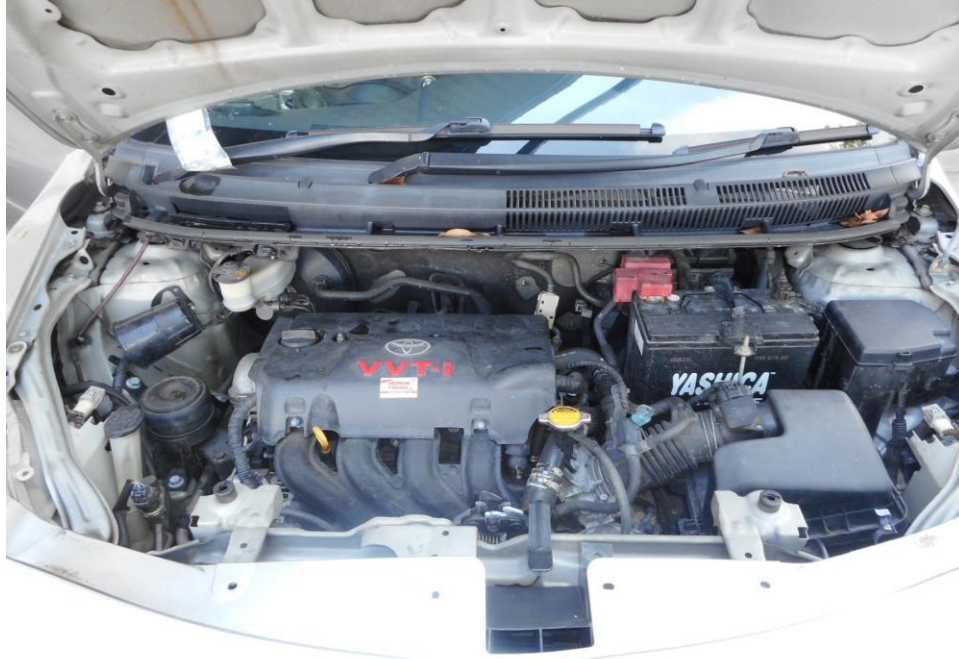
Photo 12 shows a general view of the Motor Car's engine compartment, which was accessed by lifting the front cabin of the Motor Car. The various parts and components inside the engine compartment were unaffected by the accident. There was also no sign(s) or indication(s) of fresh fluid leakage and/or fluid stain within the engine compartment

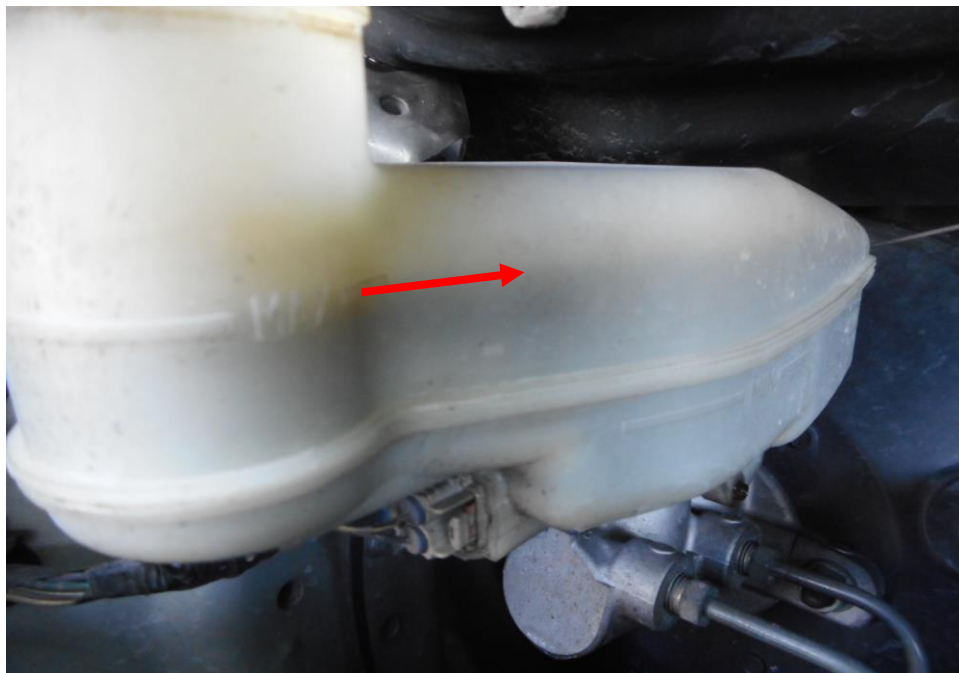
Photo 13 shows the brake fluid reservoir of the Motor Car at the time of my inspection. The brake fluid was observed to be of sufficient level (arrowed) and without any visible contamination.

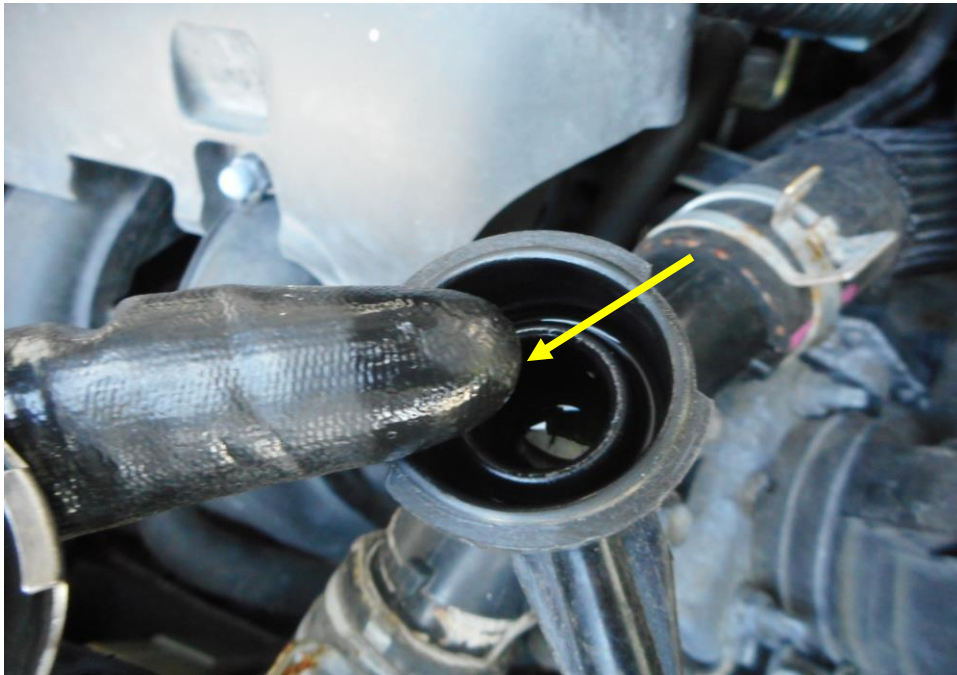
Photo 14 shows the engine coolant reservoir of the Motor Car at the time of my inspection. The engine coolant was observed to be of sufficient level (arrowed) and without any visible contamination.

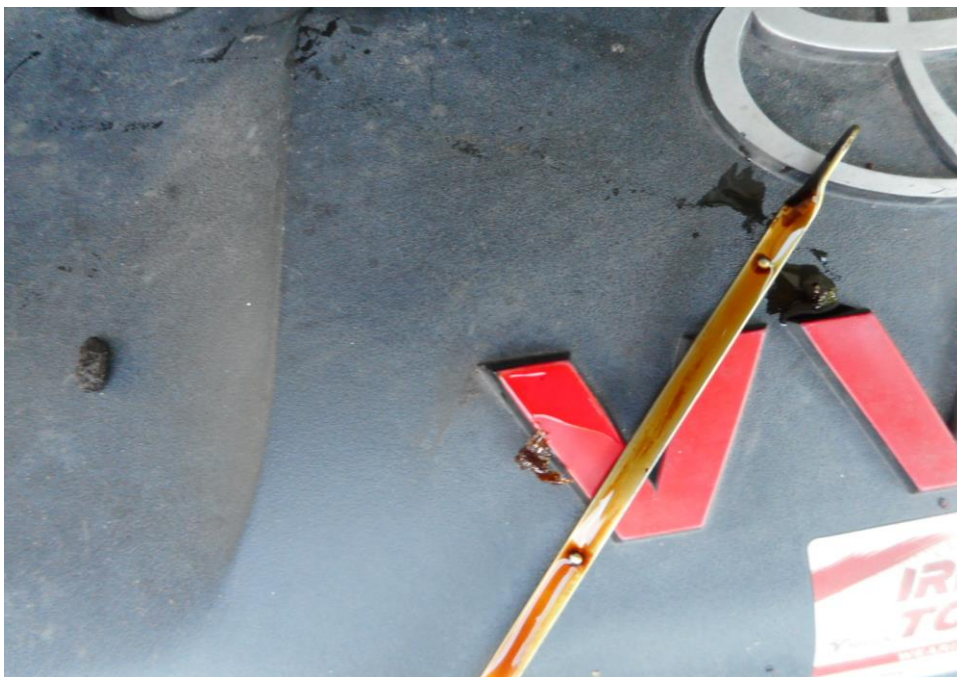
Photo 15 shows the engine oil dip stick of the Motor Car at the time of my inspection. The engine oil was observed to be of sufficient level and without any visible contamination.

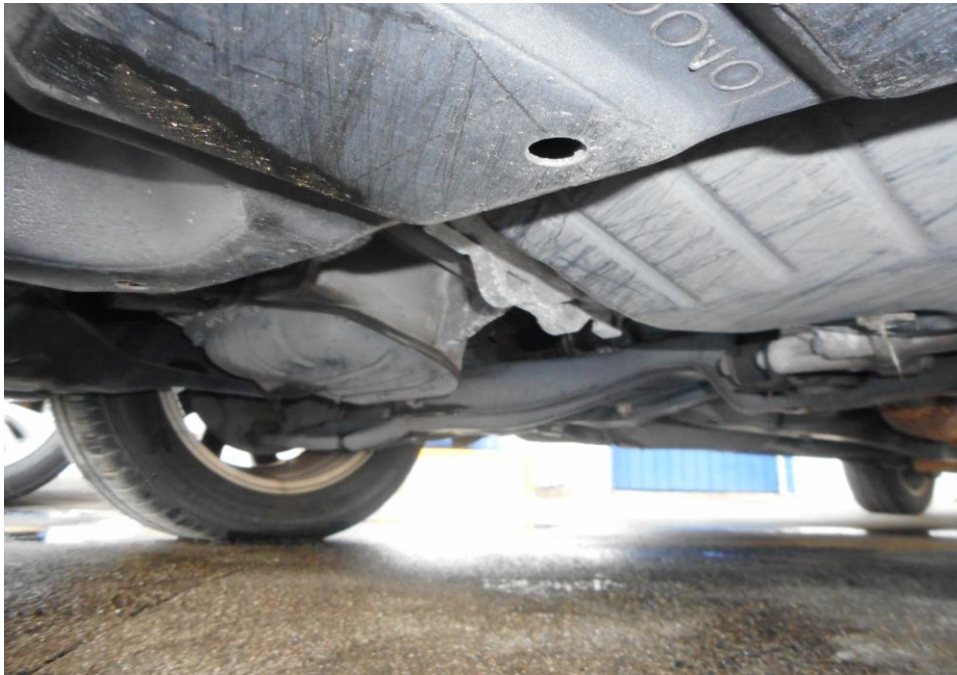
Photo 16 shows the undercarriage of the Motor Car, at the area where the engine housing and transmission housing are located. . I did not find any sign(s) or indication(s) of fluid leak and/or fluid stain(s) on the underside of the Motor Car.

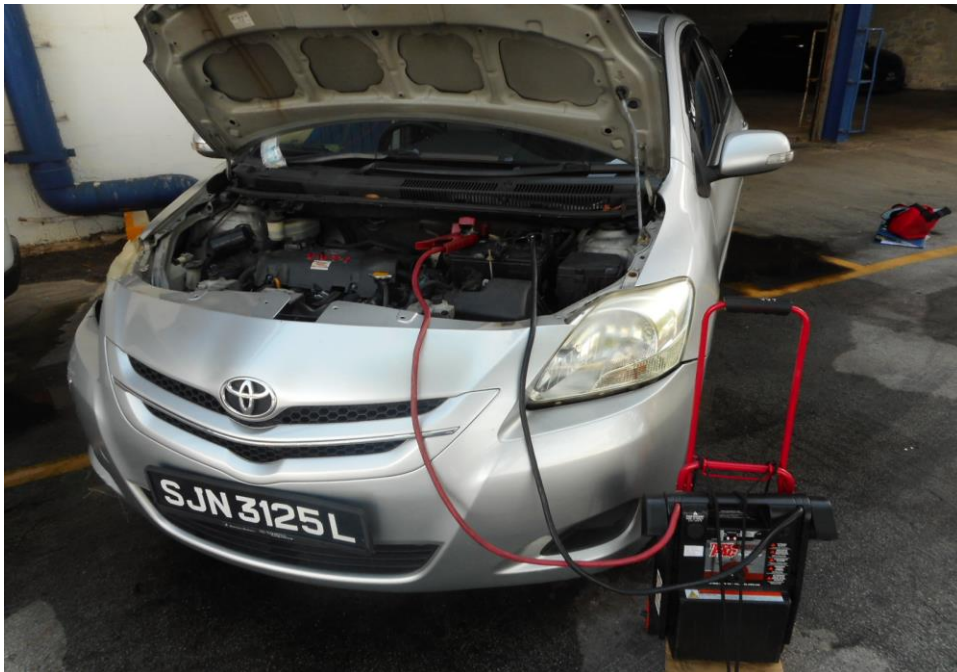
11. However the Motor car's engine was not able to be started up despite multiple attempts of jumpstarting it. See photo 17 below.

Photo 17 shows the jumpstarting of the Motor Car's engine, it was not able to be started up despite multiple attempts in starting the engine.

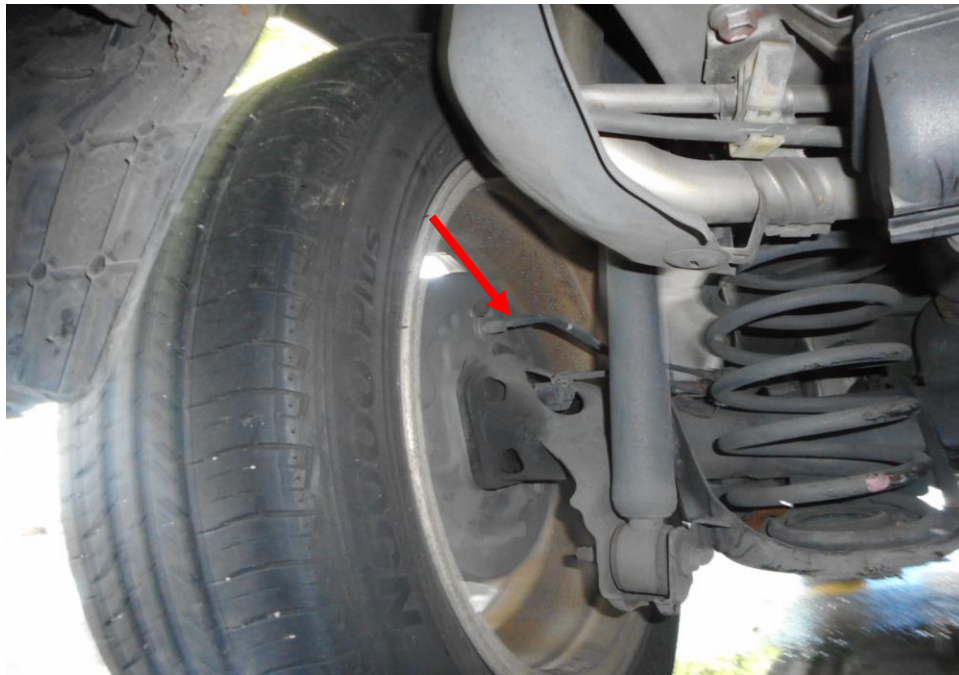
Photo 18 shows the brake hose/pipe (arrowed) at the rear left wheel of the Motor Car. No leakage of brake fluid was observed. Visual examination of the various components of the braking system like the drum brake, brake booster, brake pedal etc. had revealed all to be intact and without visible damage.

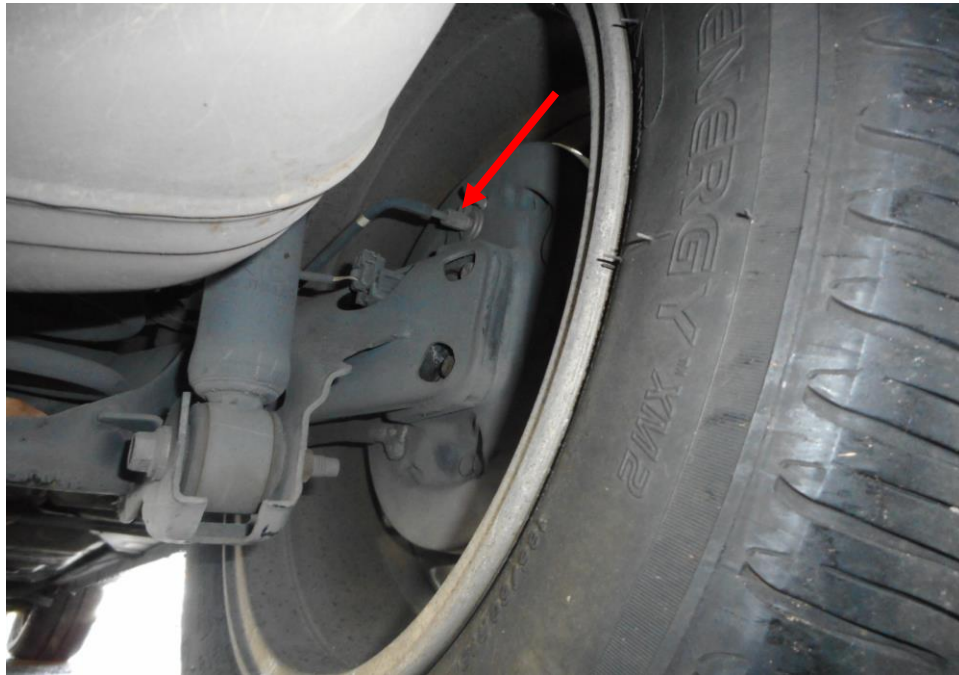
Photo 19 shows the brake hose/pipe (arrowed) at the rear right wheel of the Motor Car. No leakage of brake fluid was observed. Visual examination of the various components of the braking system like the drum brake, brake booster, brake pedal etc. had revealed all to be intact and without visible damage.

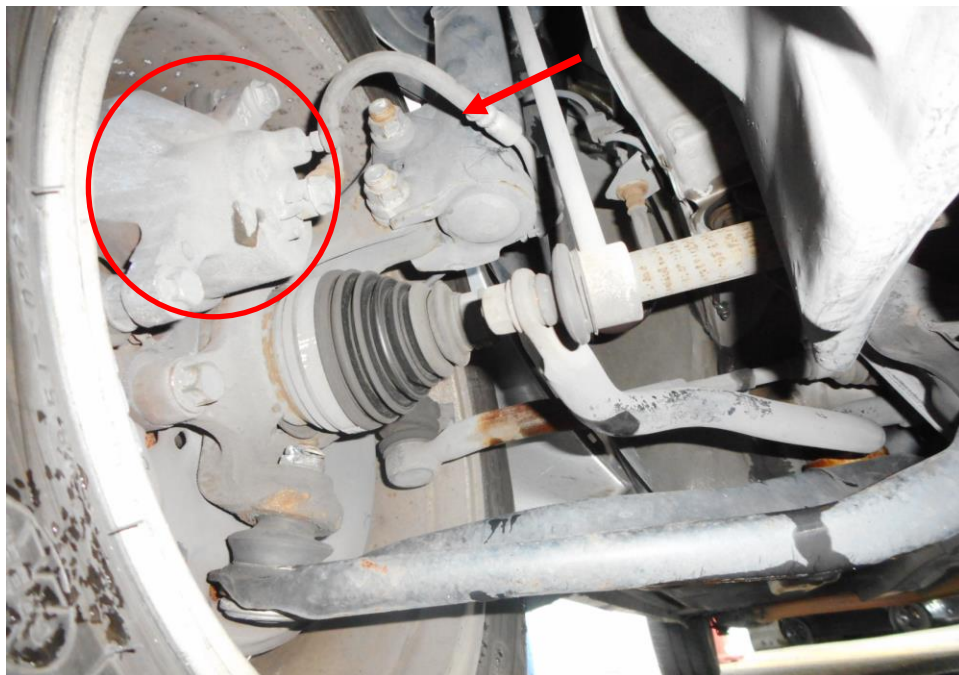
Photo 20 shows the brake hose/pipe (arrowed) at the front right wheel of the Motor Car. No leakage of brake fluid was observed. Visual examination of the various components of the braking system like the brake caliper (circled), brake booster, brake pedal etc had revealed all to be intact and without visible damage at the time of accident. There was also no sign of fluid stain(s) observed on the various undercarriage components.

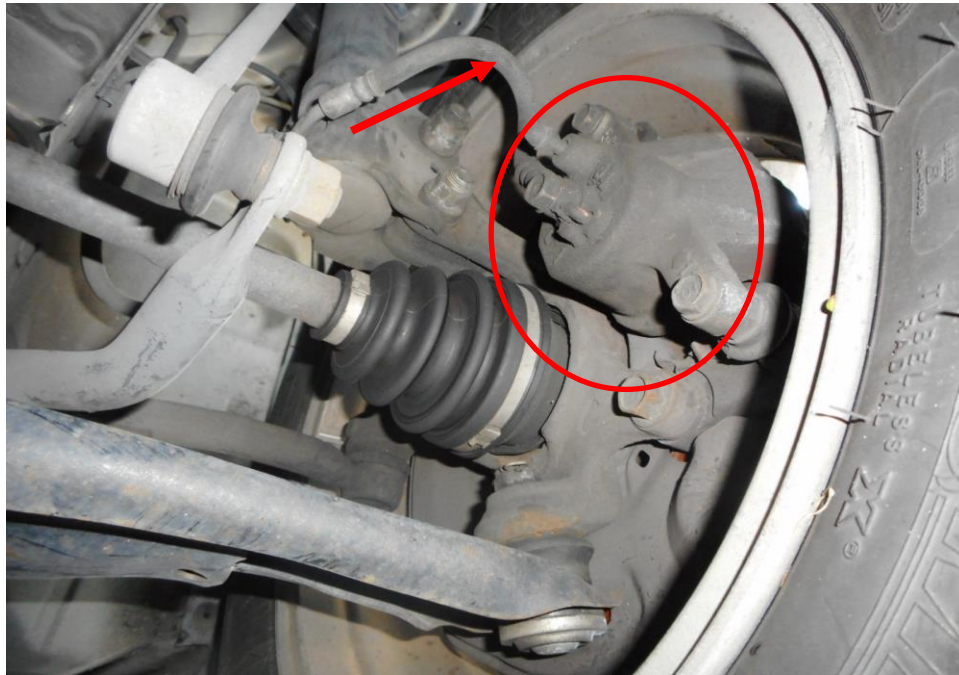
Photo 21 shows the brake hose/pipe (arrowed) at the front left wheel of the Motor Car. No leakage of brake fluid was observed. Visual examination of the various components of the braking system like the brake caliper (circled), brake booster, brake pedal etc had revealed all to be intact and without visible damage at the time of accident. There was also no sign of fluid stain(s) observed on the various undercarriage components.

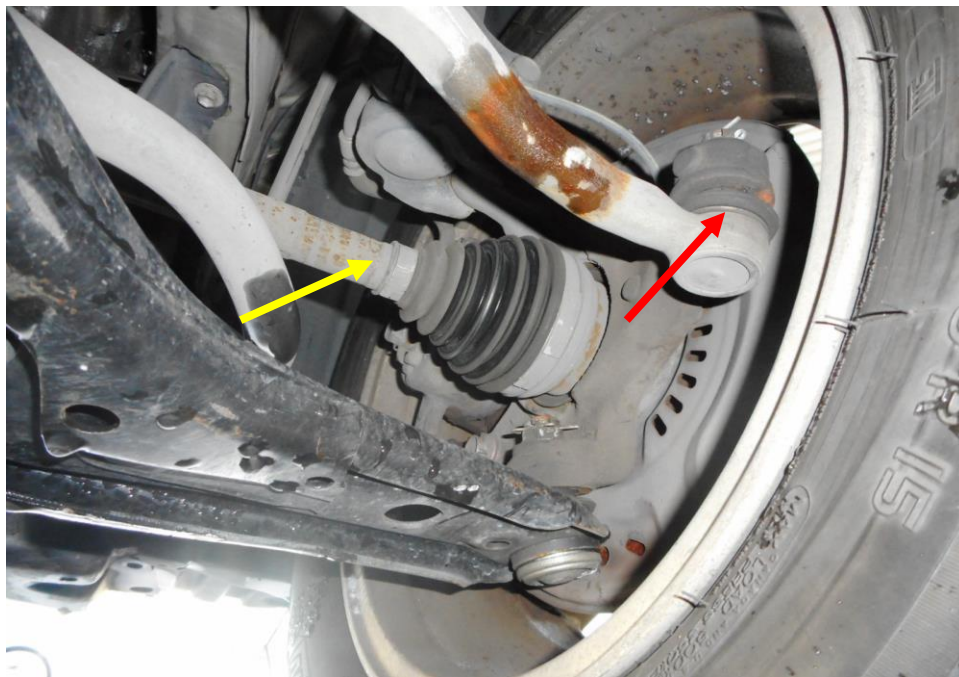
Photo 22 shows the various undercarriage components at the front right wheel of the Motor Car, in particular the steering tie rod end (arrowed) and drive shaft (yellow arrow). The various steering components were all found to be intact, suggesting that the steering system of the Motor Car was likely to be in serviceable condition at the material time of accident. There was also no sign of fluid stain(s) observed on the various undercarriage components.

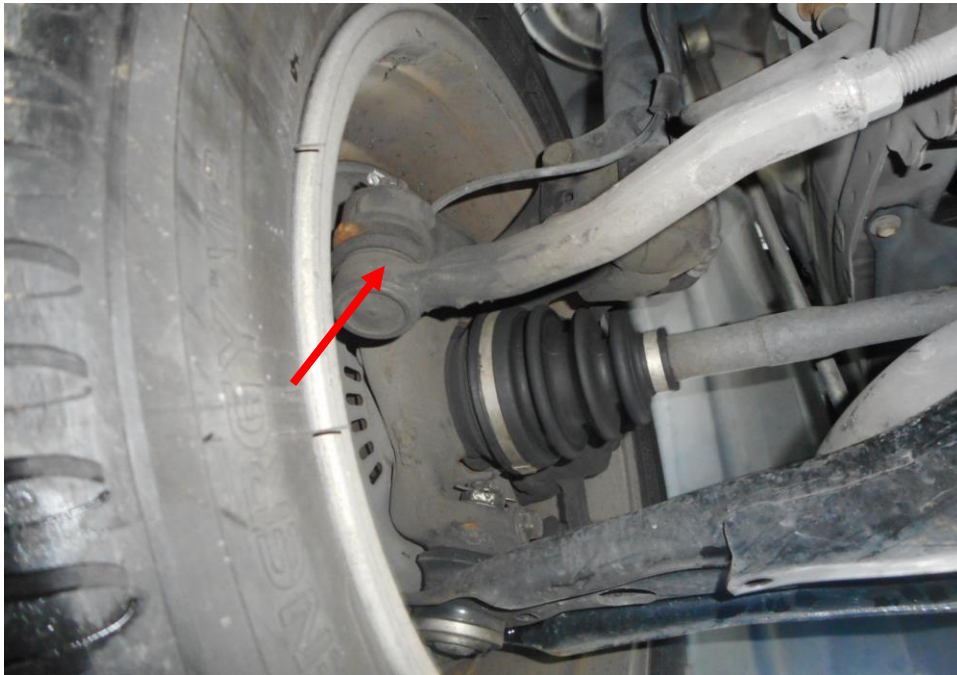
Photo 23 shows the various undercarriage components at the front left wheel of the Motor Car, in particular the steering tie rod end (arrowed). The various Undercarriage components of the Motor Car were all found to be intact without any visible damage. There was also no sign of fluid stain(s) observed on the various undercarriage components.
