Your Ref: TP/IP/05243/2020
Our Ref: CI/TPD20005586/P

11th May 2020

MECHANICAL INSPECTION REPORT OF MOTOR LORRY GBD 8155P

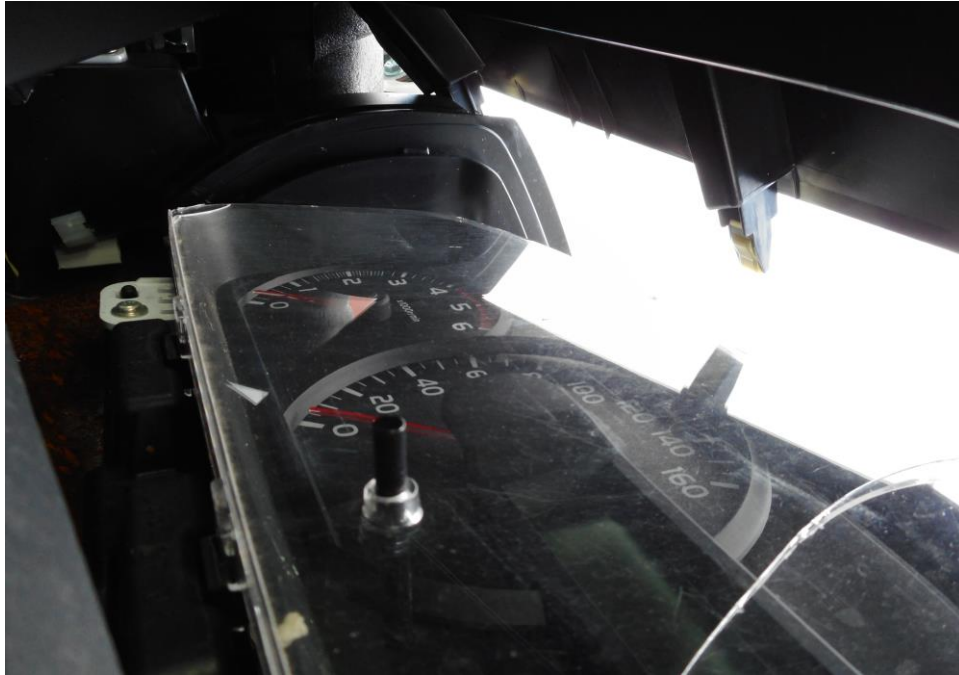
4. The mileage of the Motor Lorry was not able to be recorded as the odometer in the instrument cluster has been damage due to the accident at the time of our inspection.
5. The Motor Lorry was observed to have sustained major damage at its front cabin & windscreen portion as well as its left and right doors, was likely due to a result of the accident. See photo 1 and 9 below.

Photo 1 shows no mileage readings were recorded due to the damaged odometer in the instrument cluster of the Motor Lorry at the time of our inspection.

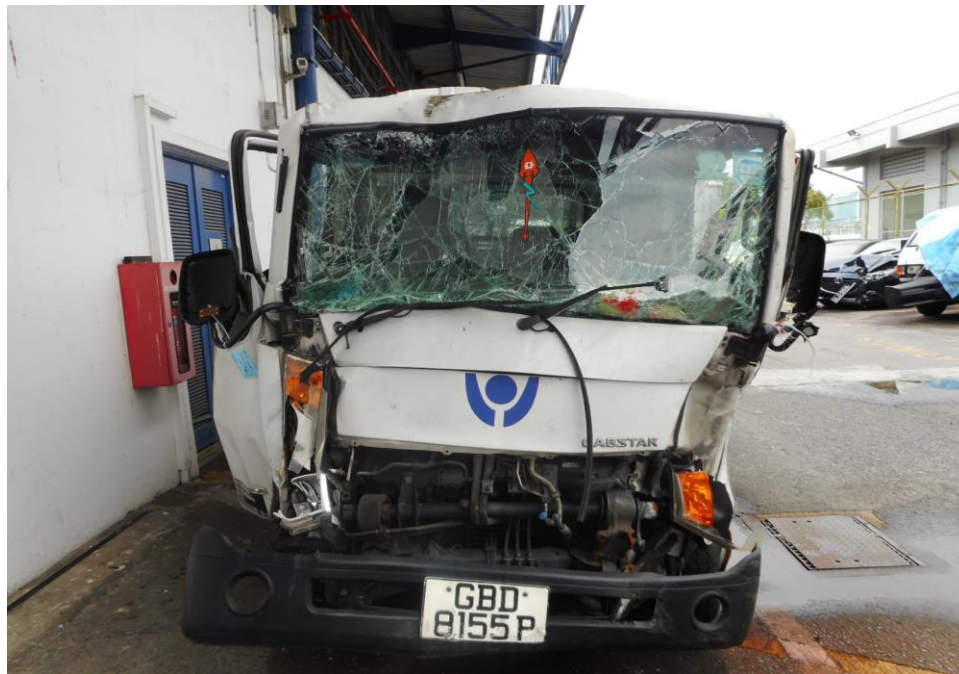
Photo 2 shows a general view of the front windscreen and body panel of the Motor Lorry at the time of our inspection. The Motor Lorry was observed sustained major damages to its frontal likely due to the accident's impact.

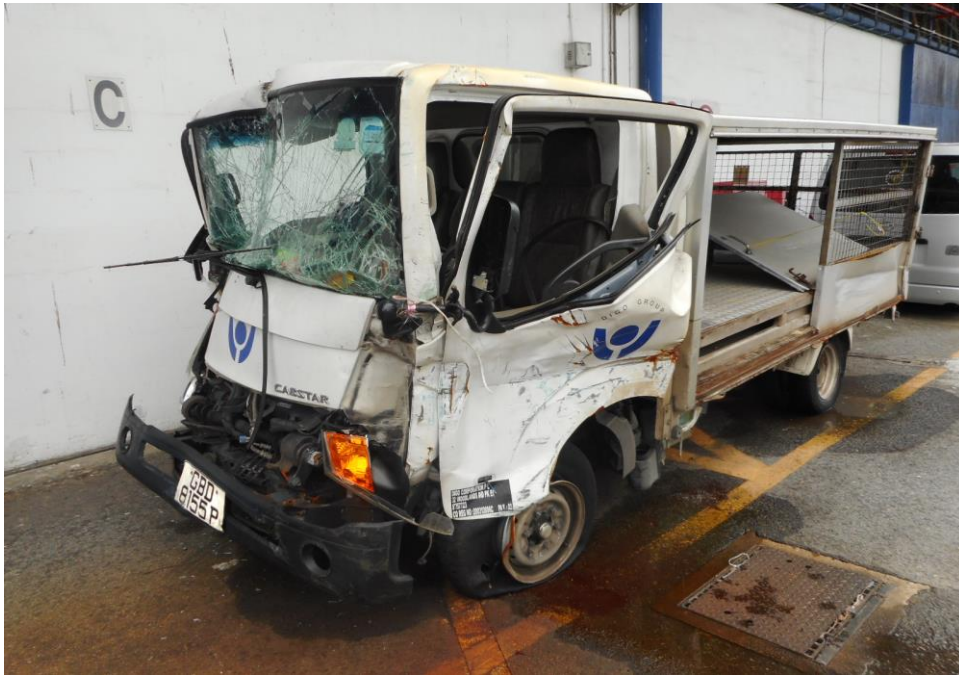
Photo 4 shows a general view of the left body of the Motor Lorry at the time of our inspection. The Motor Lorry was observed to have sustained major damages to its doors that was crushed and dislodged due to the accident's impact.

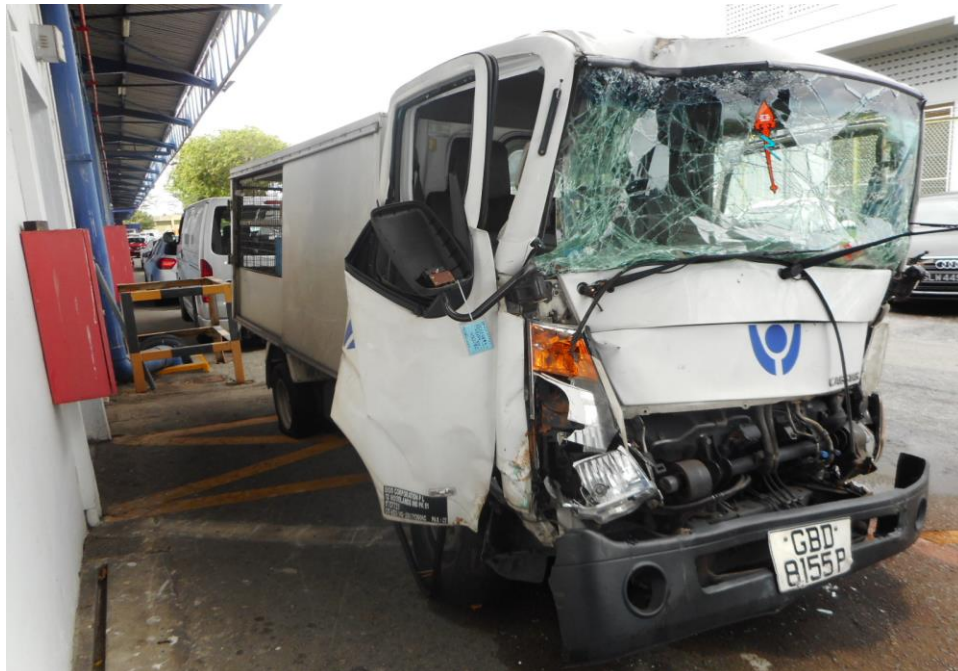
Photo 5 shows a general view of the right body of the Motor Lorry at the time of our inspection. The Motor Lorry was observed to have sustained major damages to its doors that was crushed and dislodged due to the accident's impact.

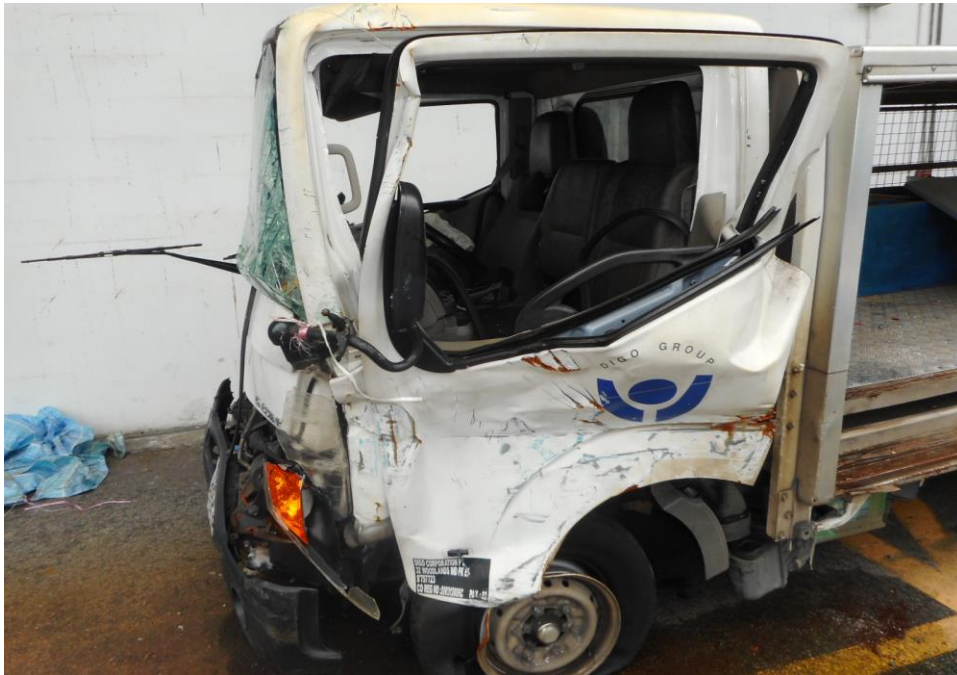
Photo 6 shows the close up view of the left door of the Motor Lorry at the time of our inspection. The Motor Lorry was observed to have sustained major damages to its doors that was crushed and dislodged due to the accident's impact.

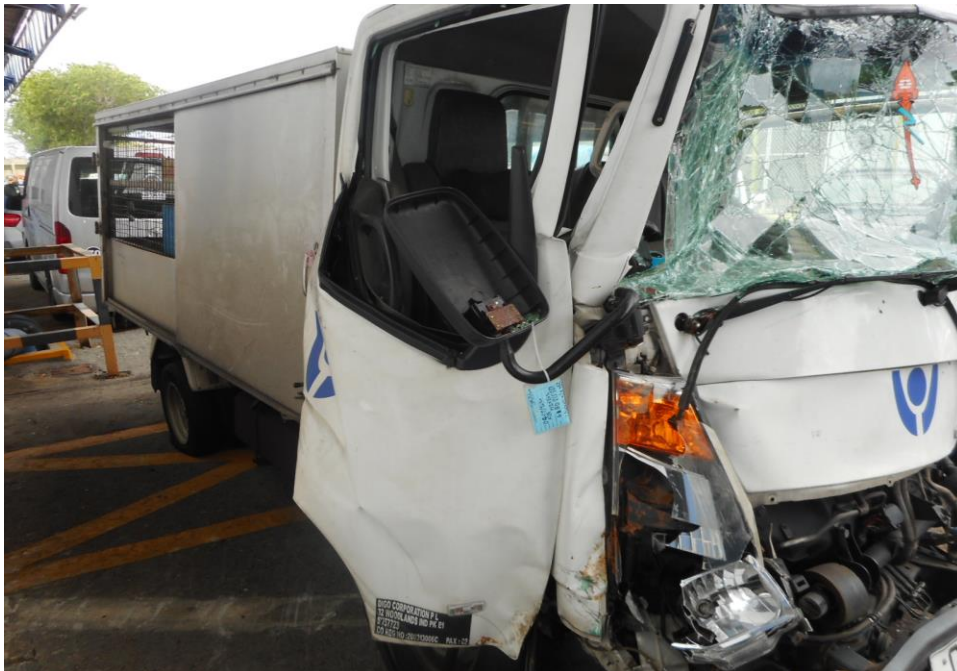
Photo 7 shows the close up view of the right door of the Motor Lorry at the time of our inspection. The Motor Lorry was observed to have sustained major damages to its doors that was crushed and dislodged due to the accident's impact.

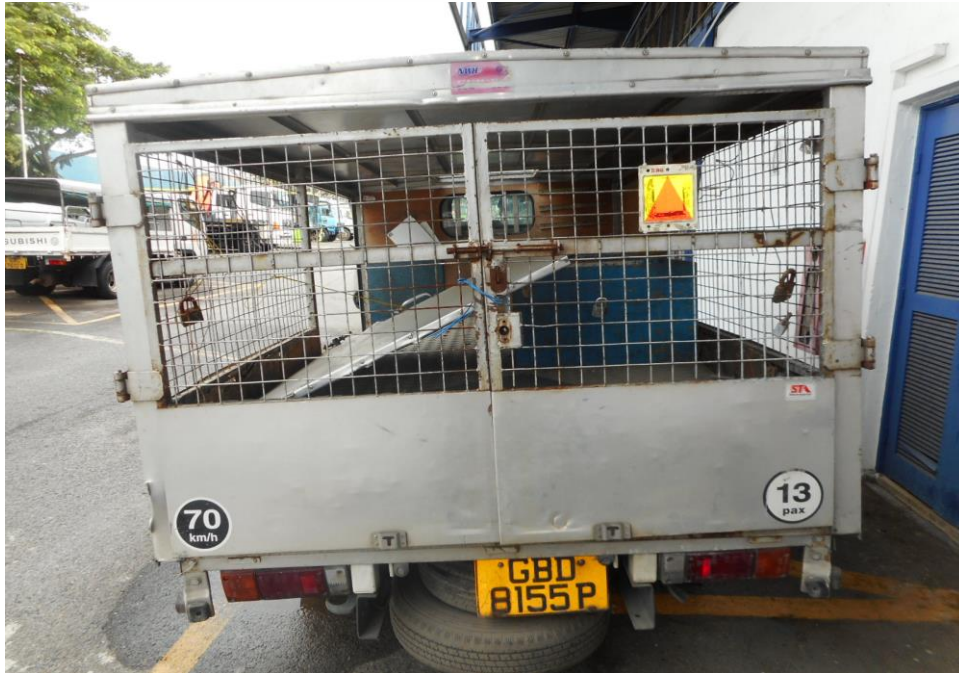
Photo 8 shows the number plate and the general view of the rear portion of the Motor Lorry at the time of our inspection. The Motor Lorry was observed sustained major damages to its rear which the tailgate was shifted out of place, likely due to the accident's impact.

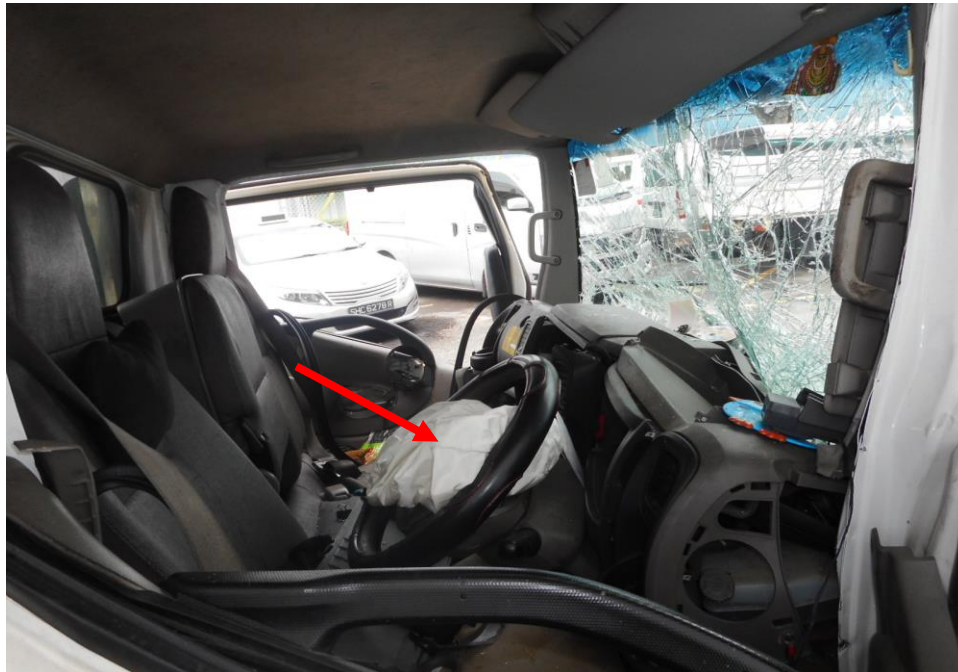
Photo 9 shows the close up view of the interior cabin of the Motor Lorry. It was observed to have sustained extensive induced damages to the dashboard, foot well and triggering the driver's (SRS) airbags (arrowed) to be deployed as a result of the accident.

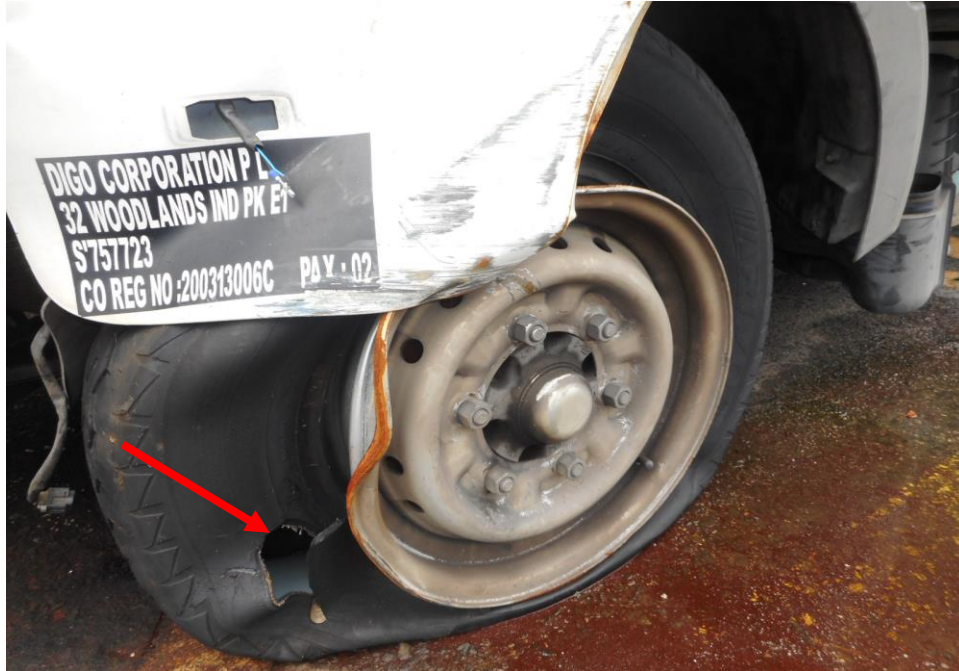
6. The front right tyre of the Motor Lorry were observed cut and deflated. However, the other tyres were observed to be in serviceable condition and sufficiently inflated for vehicular operation and we did not find any tear, cut or burst mark(s) on the outer and the inner sidewalls as well as across the tread of the 5 tyres. The tyre brand, tyre size and remaining tread depth of the 6 tyres of the Motor Lorry were recorded as follows:-

Photo 10 shows the condition of the front left tyre of the Motor Lorry, which was observed to be in unserviceable condition as it was observed with a cut on the sidewall (arrowed) with remaining tread depth of approximately 4.8mm. The tyre, which was wrapped around standard steel wheel rim.

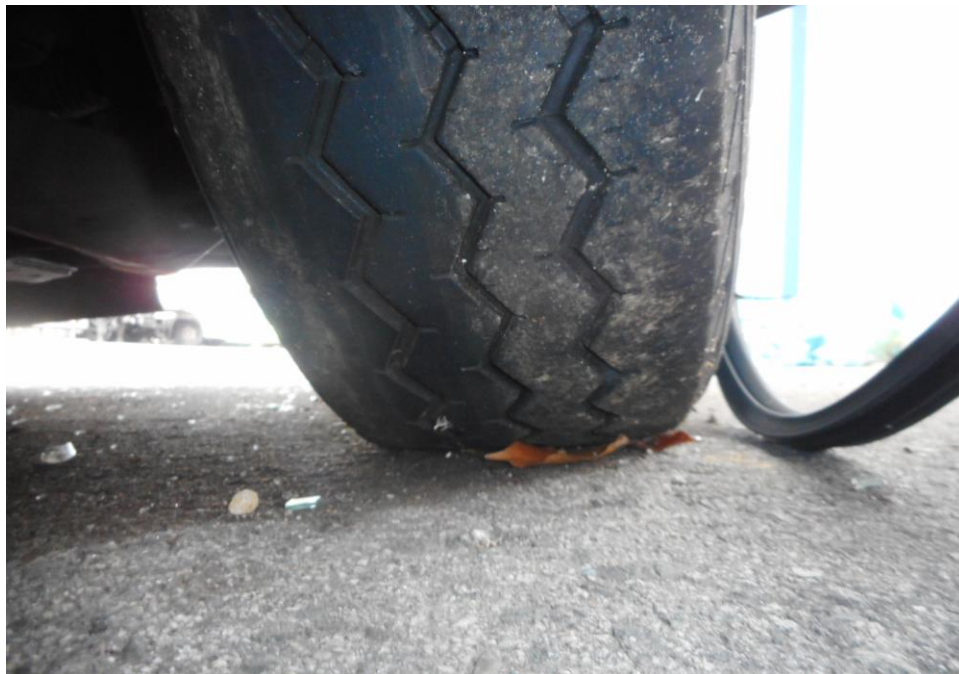
Photo 11 shows the condition of the front right tyre of the Motor Lorry, which was observed to be in serviceable condition with remaining tread depth of approximately 4.7mm. The tyre, which was wrapped around standard steel wheel rim, was also observed to be sufficiently inflated for vehicular operation.

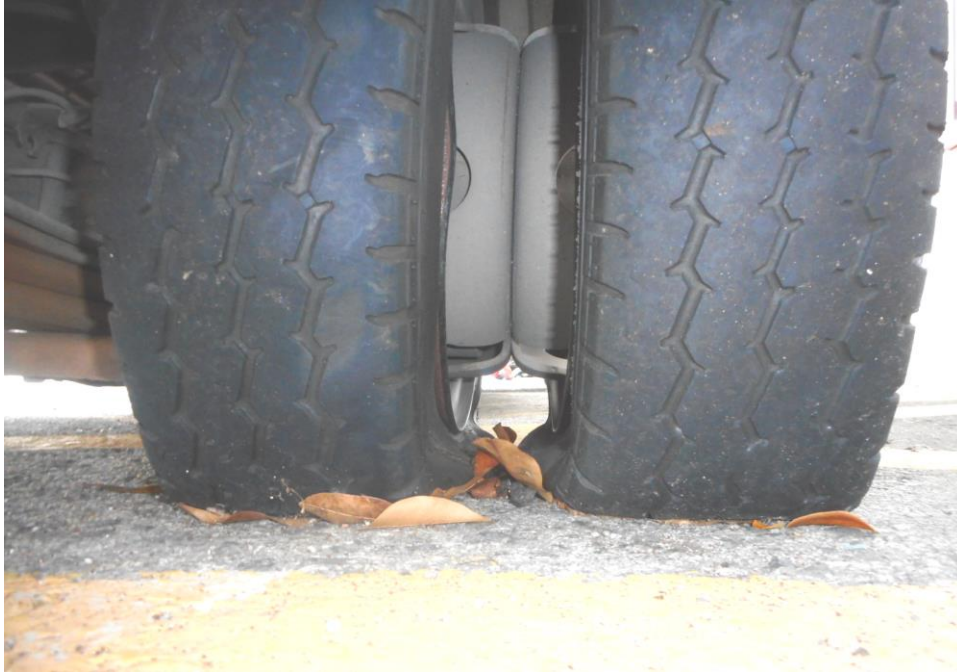
Photo 12 shows the condition of the rear left tyres of the Motor Lorry, which observed to be in serviceable condition with remaining tread depth of approximately 1.7mm. The tyres, which were wrapped around standard steel wheel rim, were also observed to be sufficiently inflated for vehicular operation.

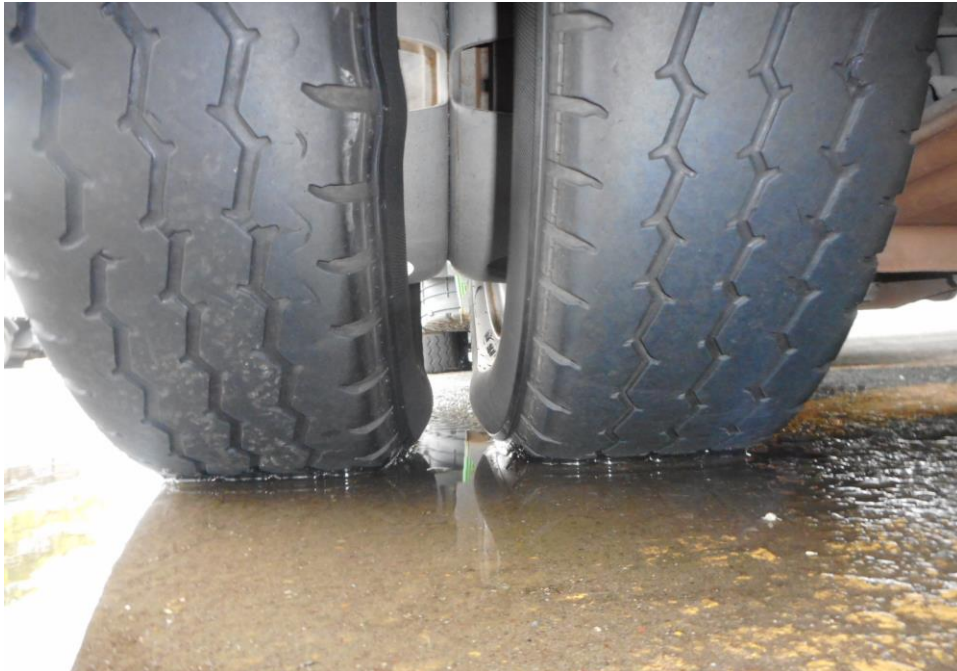
Photo 13 shows the condition of the rear right tyres of the Motor Lorry, which were observed to be in serviceable condition with remaining, tread depth of approximately 1.7mm. See above.

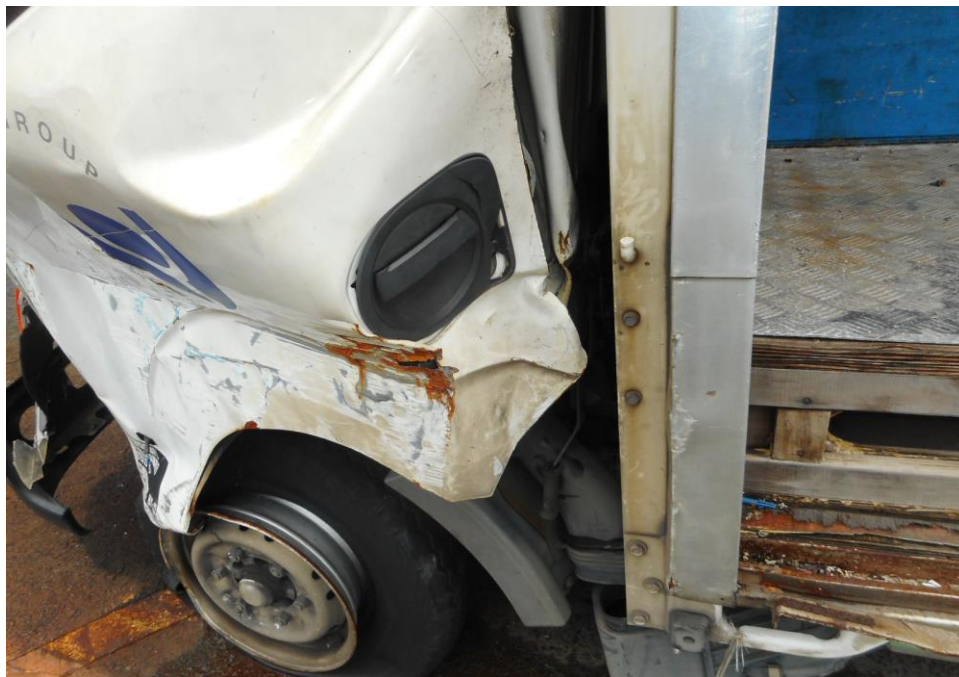
8. Upon examination of the Motor Lorry's engine compartment, we had observed that all the parts, components and fluids could not be inspected as due to the damage induced has crushed and deformed the cabin of the Motor Lorry which immobilized its opening and viewing, however we are able to observe the brake fluid reservoir of the Motor Lorry and it was observed to be sufficient level without any visible contamination.
9. Our subsequent checks on the underside of the Motor Lorry also revealed sign of old fluid stain. Visually, the various undercarriage components of the Motor Lorry were all observed to be intact and without any visible damage. See photo 14 – 16 below.

Photo 14 shows the induced damage to the cabin of the Motor Lorry's which immobilised the opening and viewing of the various parts and components inside the engine compartment, a result of the accident.

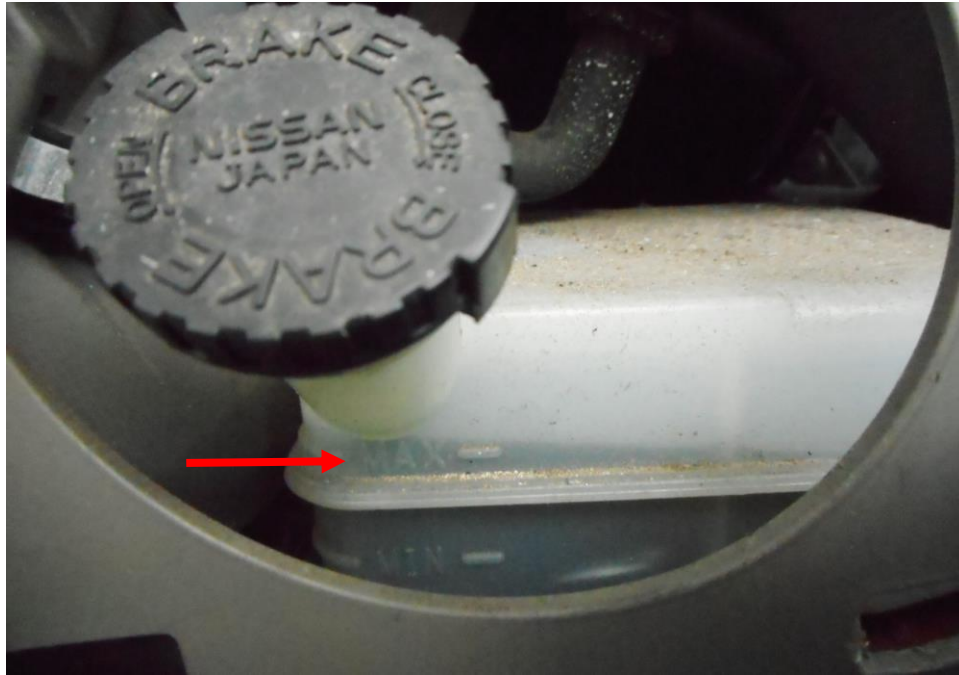
Photo 15 shows the brake fluid reservoir of the Motor Lorry at the time of our inspection. The brake fluid was observed to be of sufficient level and without any visible contamination (arrowed).

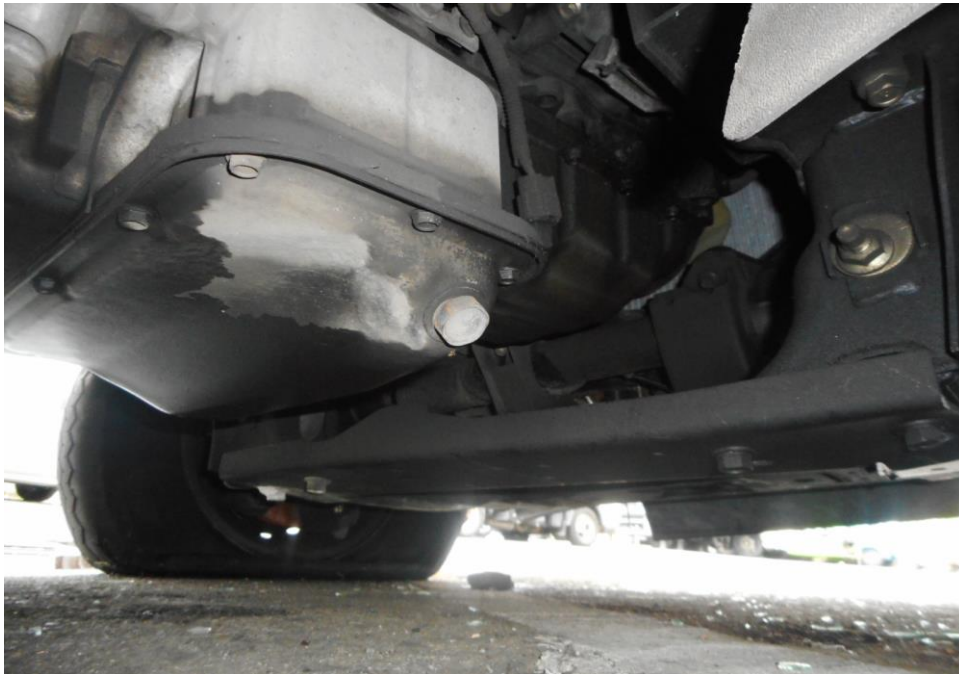
Photo 16 shows the undercarriage of the engine of the Motor Lorry at the time of our inspection. There was also sign(s) and indication(s) of old fluid stain within the engine undercarriage area.

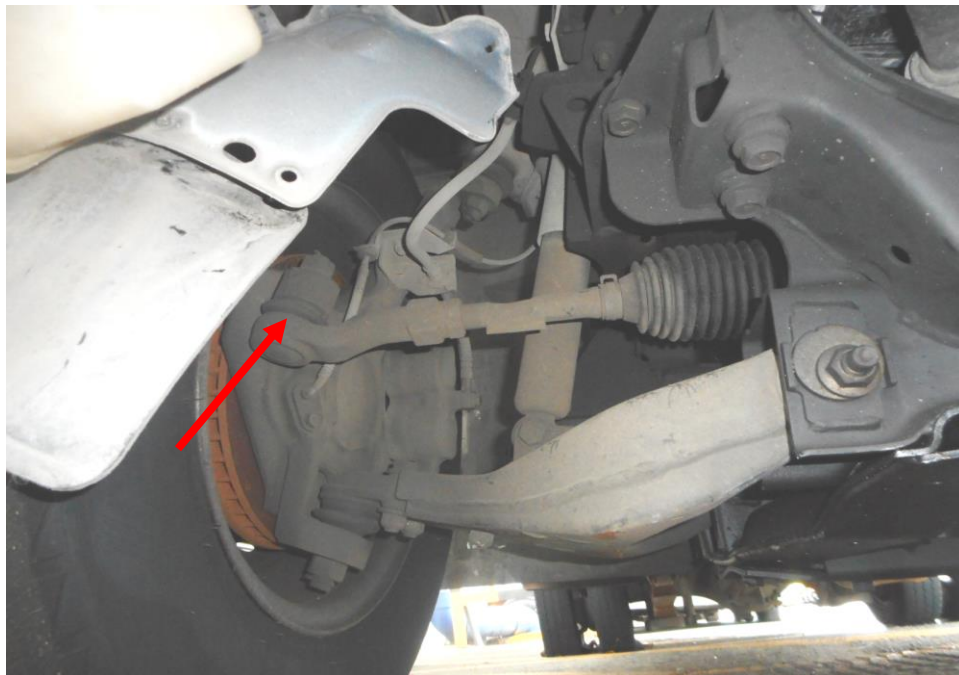
Photo 17 shows the various undercarriage components at the front right wheel of the Motor Lorry, in particular the steering tie rod end and ball joints (arrowed). The various undercarriage components of the Motor Lorry were all found to be intact without any visible damage. There was also no sign of fluid stain(s) observed on the various undercarriage components.

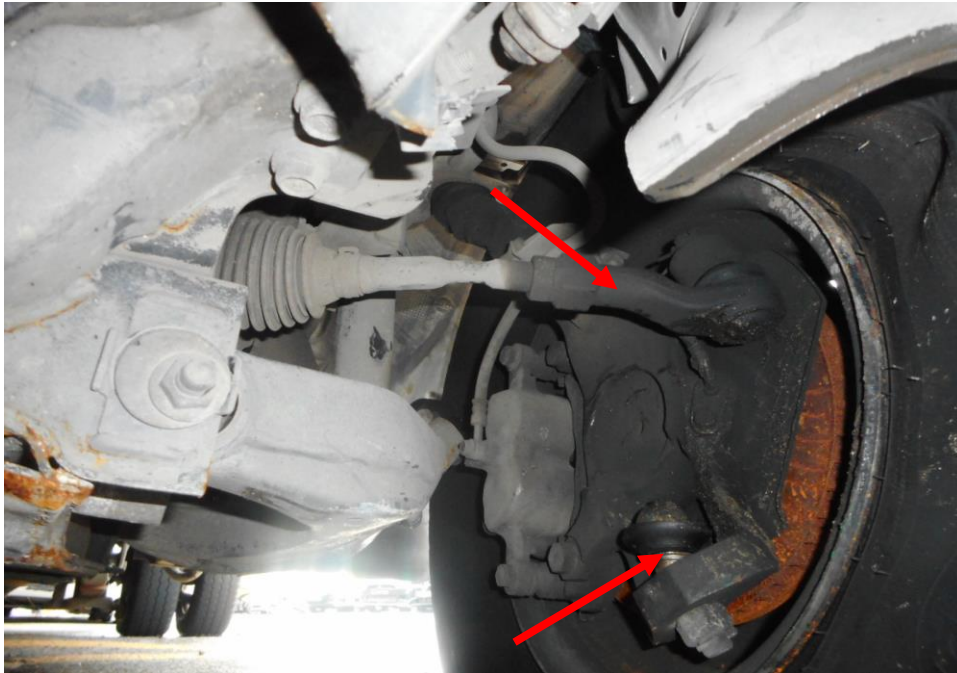
10. The mechanical components of the Motor Lorry steering system for the right side were all found to be visually intact and undamaged, however the components on the left side were observed to be damaged. See photo 17 - 22 below.

Photo 18 shows the various undercarriage components at the front left wheel of the Motor Lorry, in particular the steering tie rod end and ball joints (arrowed) were observed to be damaged.

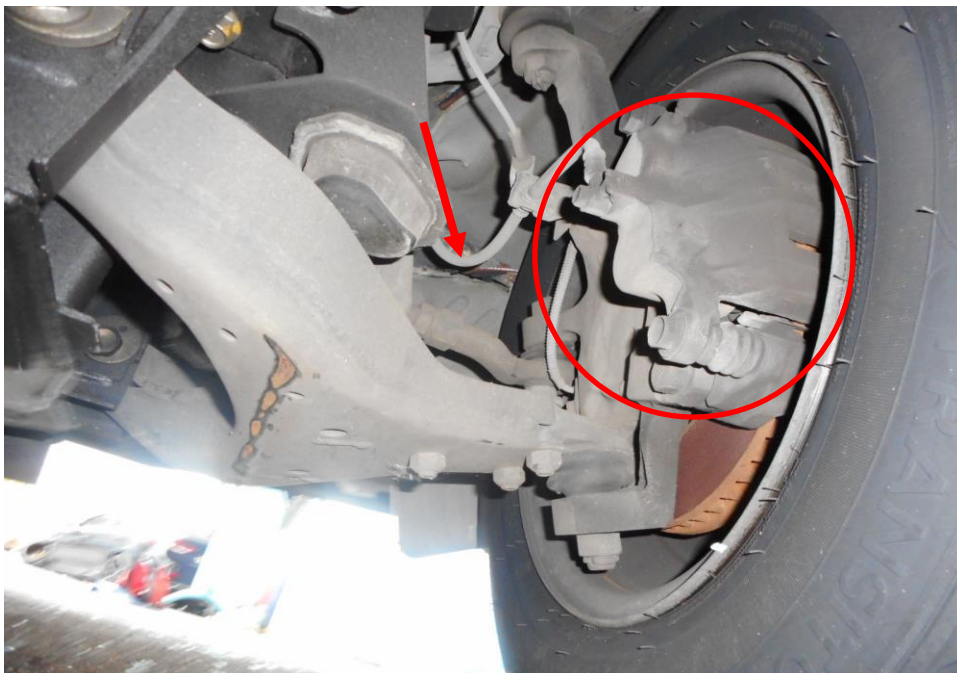
Photo 19 shows the various undercarriage components at the front right wheel of the Motor Lorry, in particular the brake hose (arrowed) and callipers (circled). The various undercarriage components of the Motor Lorry were all found to be intact without any visible damage. There was also no sign of fluid stain(s) observed on the various undercarriage components.

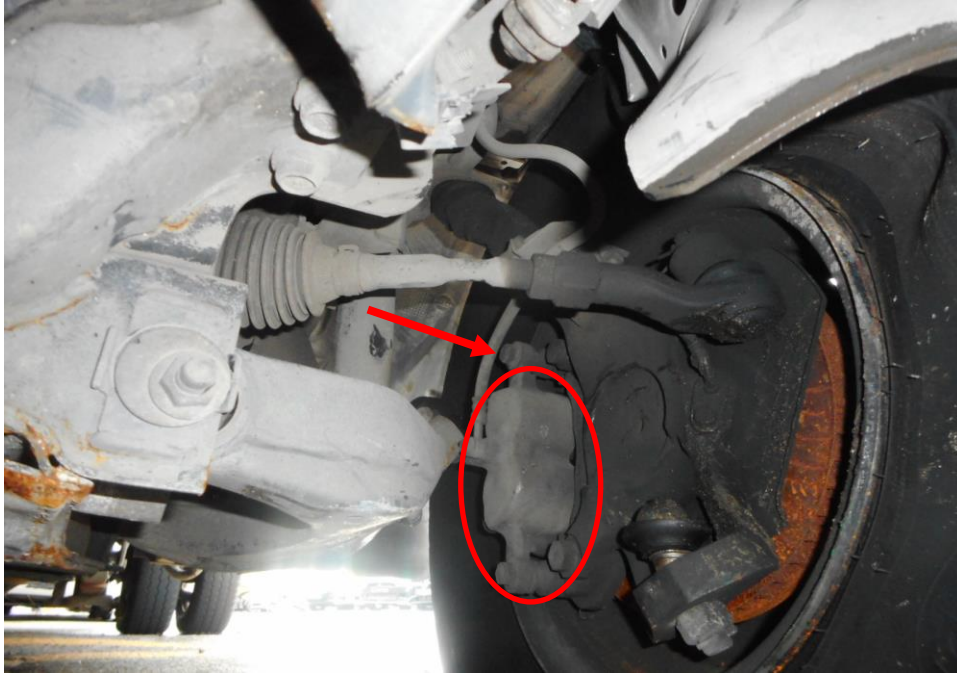
Photo 20 shows the various undercarriage components at the front left wheel of the Motor Lorry, in particular the brake hose (arrowed) and callipers (circled). The various undercarriage components of the Motor Lorry were all found to be intact without any visible damage. There was also no sign of fluid stain(s) observed on the various undercarriage components.

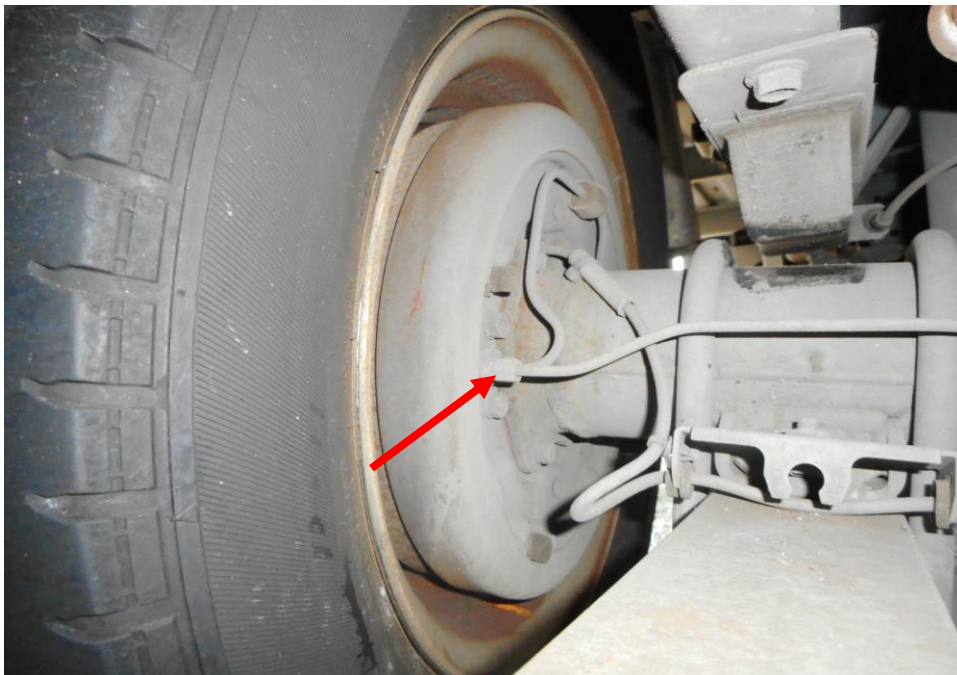
Photo 21 shows the various undercarriage components at the rear left wheel of the Motor Lorry, in particular the brake hose and drum brake (arrowed). The various undercarriage components of the Motor Lorry were all found to be intact without any visible damage. There was also no sign of fluid stain(s) observed on the various undercarriage components.

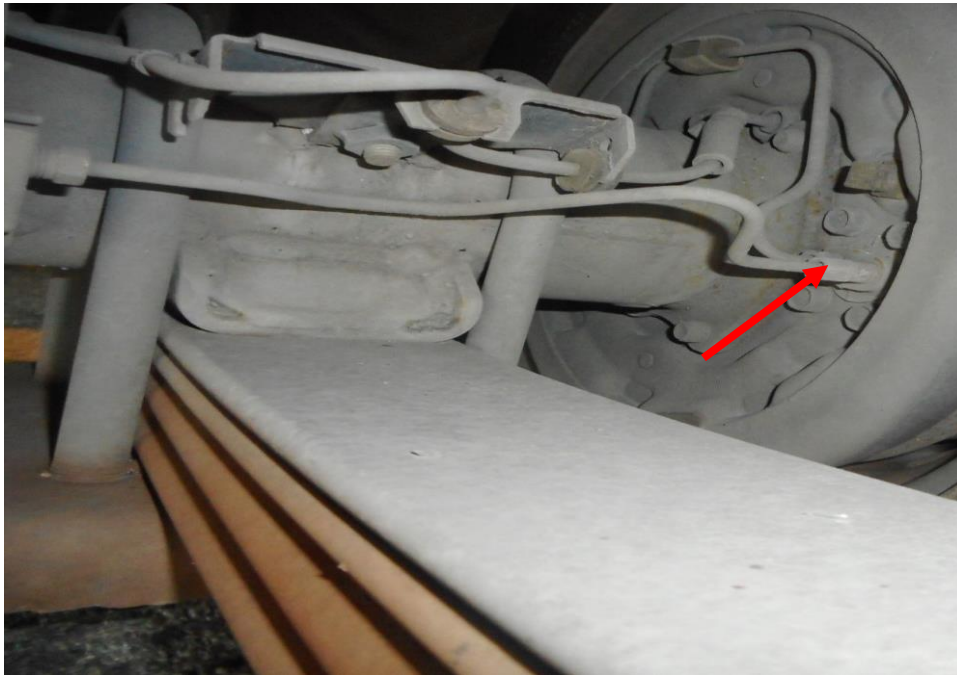
Photo 22 shows the various undercarriage components at the rear right wheel of the Motor Lorry, in particular the brake hose and drum brake (arrowed). The various undercarriage components of the Motor Lorry were all found to be intact without any visible damage. There was also no sign of fluid stain(s) observed on the various undercarriage components.

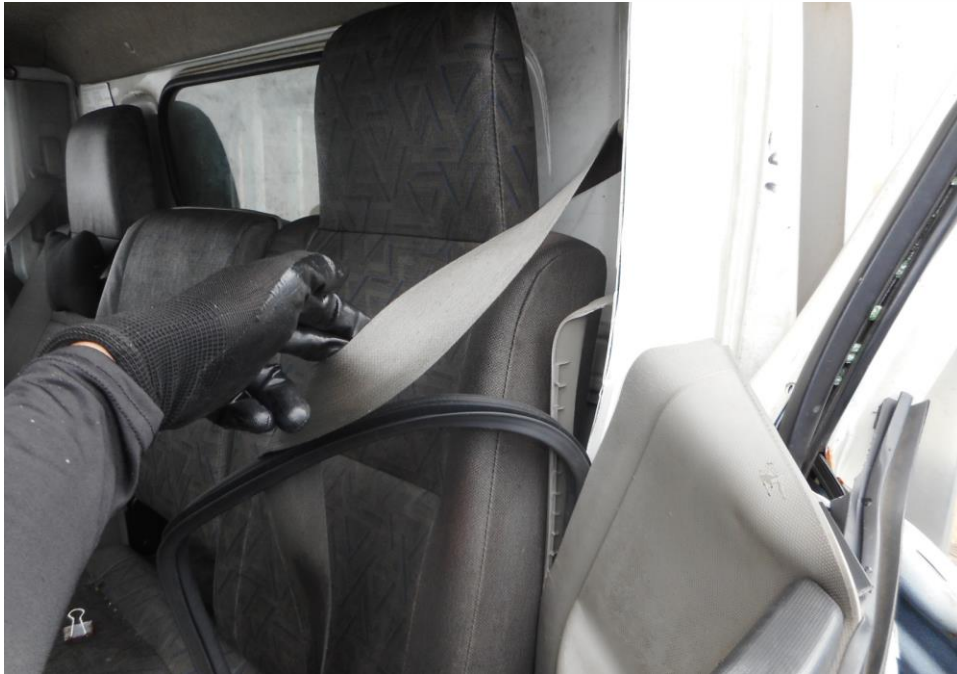
16. Both front right and left, seat belts of the "Motor lorry" were worn at the material time of accident as the respective pre-tensioners that were fitted at the sides of each seat was activated upon the material time. See photo 23 & 24 below.

Photo 23 shows that the seat belt on the left seat was worn at the material time of accident as the safety pre-tensioners was activated at the moment of impact and caused the seat belts to be locked into the last position of the user.

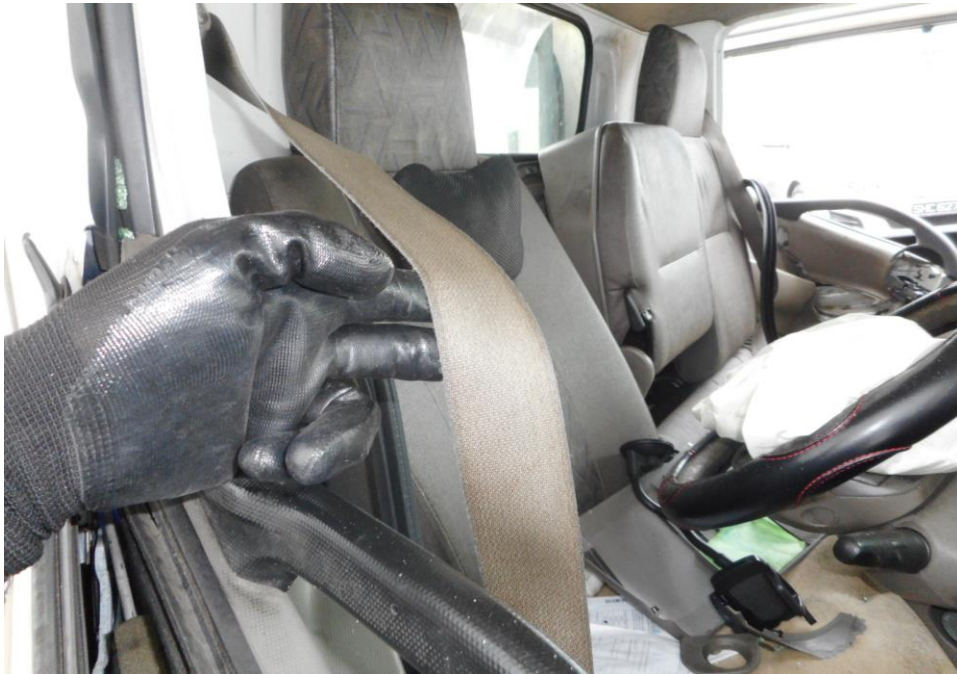
Photo 24 shows that the seat belt on the right seat was worn at the material time of accident as the safety pre-tensioners was activated at the moment of impact and caused the seat belts to be locked into the last position of the user.
