Your Ref: TP/IP/15115/2020  
Our Ref : CI/TPD20005590/P

**General Investigation Team**

**MECHANICAL INSPECTION REPORT OF MOTOR LORRY XD 1936M**

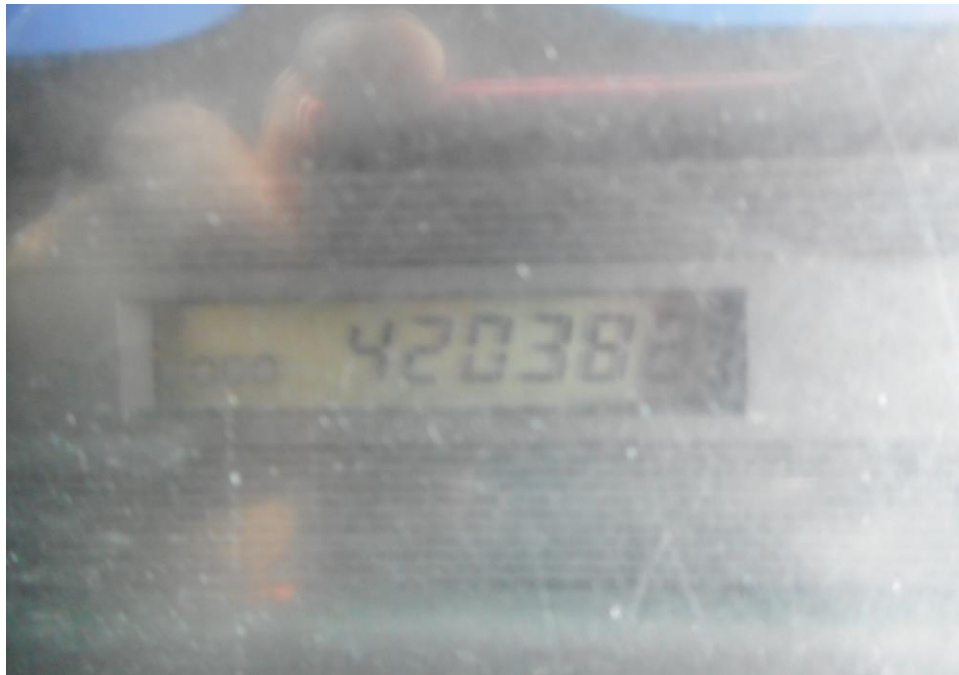
**Photo 1** shows a general view of the instrument cluster of the Motor Lorry at the time of my inspection. The mileage of the Motor Lorry was 420,388km

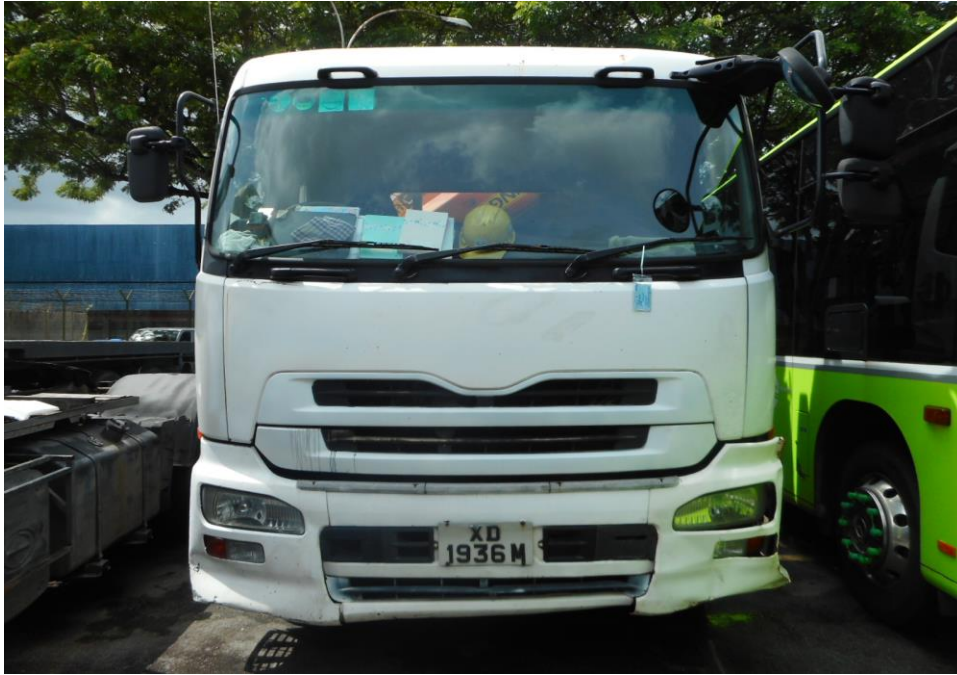
**Photo 2** shows a general view of the Motor Lorry's frontal portion at the time of my inspection. The Motor Lorry was observed to be intact and unaffected by the accident.

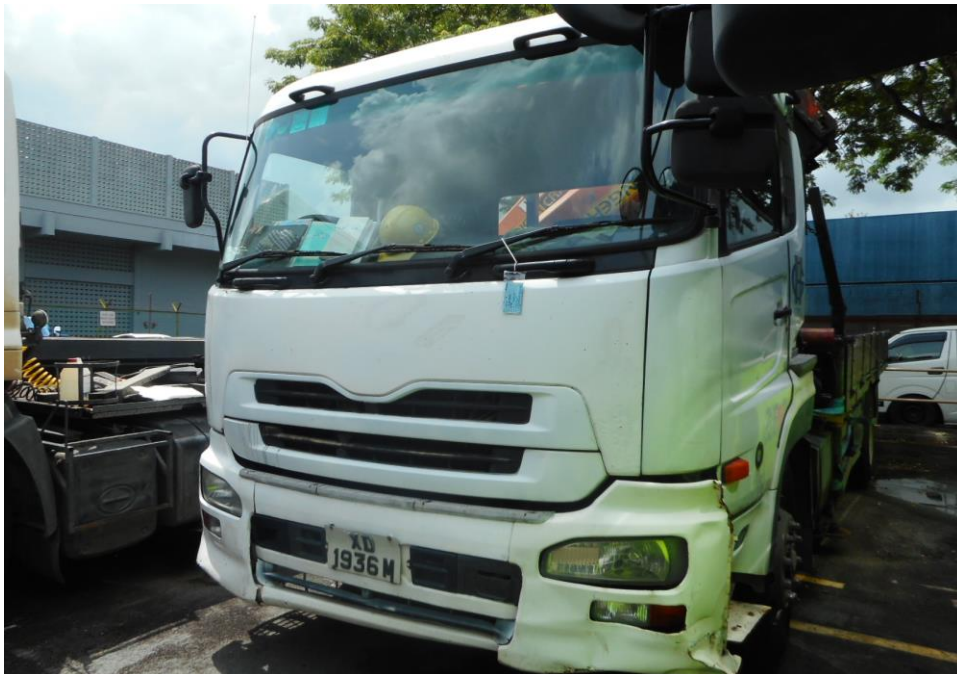
**Photo 3** shows a general view of the left body of the Motor Lorry at the time of my inspection. The Motor Lorry was observed to be intact and unaffected by the accident.

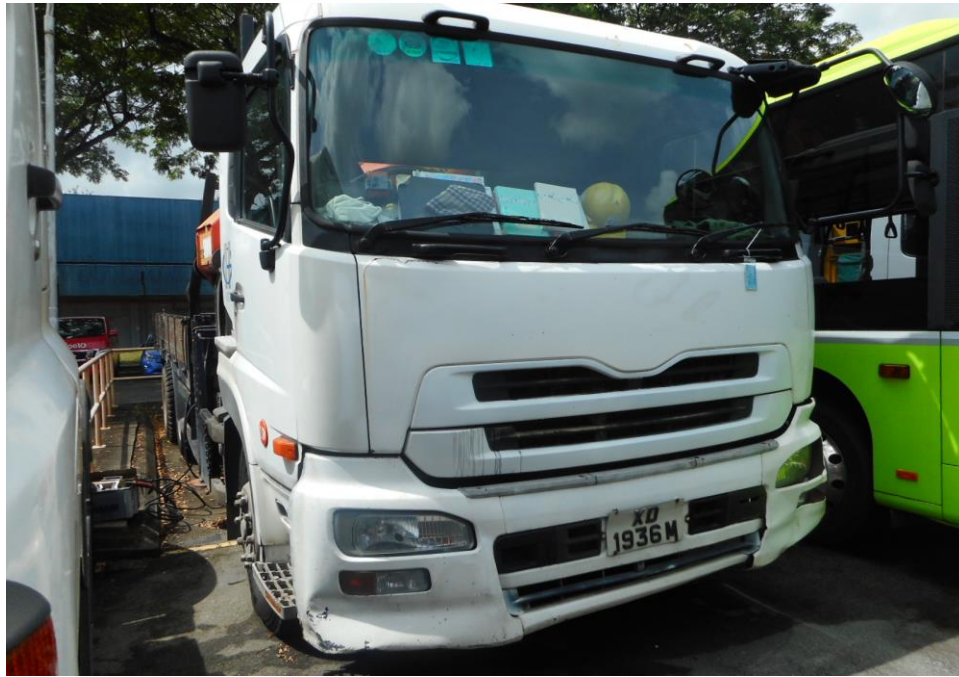
**Photo 4** shows a general view of the right body of the Motor Lorry at the time of my inspection. The Motor Lorry was observed to be intact and unaffected by the accident.

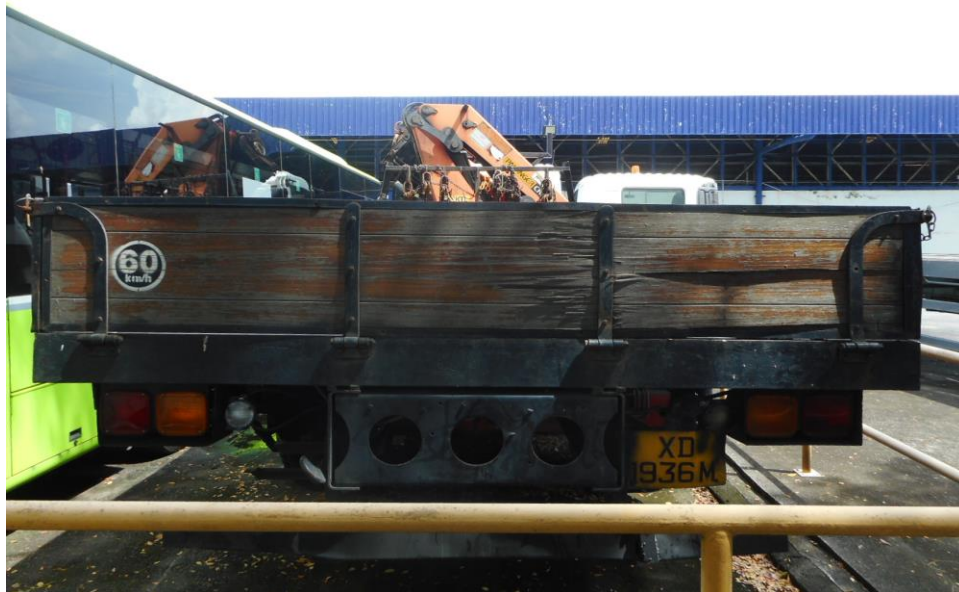
**Photo 5** shows a general view of the rear body of the Motor Lorry at the time of my inspection. The Motor Lorry was observed to be intact and unaffected by the accident.

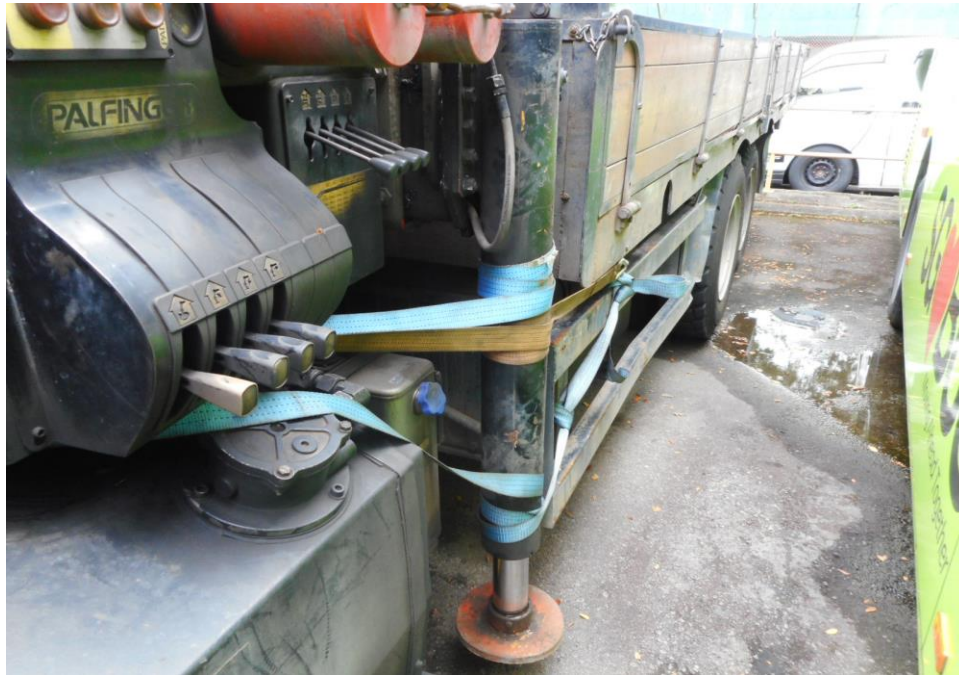
4. The mileage of the Motor Lorry at the time of my inspection was 420,388km.
5. The Motor Lorry was observed to have sustained damage at its left hydraulic arm of the crane system as a result of the accident.

**Photo 6** shows a general view of the left hydraulic arm of the Motor Lorry at the time of my inspection. The left hydraulic arm was observed to be damaged as a result of the accident, it was strapped in by ropes as the hydraulic arm will extend out of place when not strapped in.

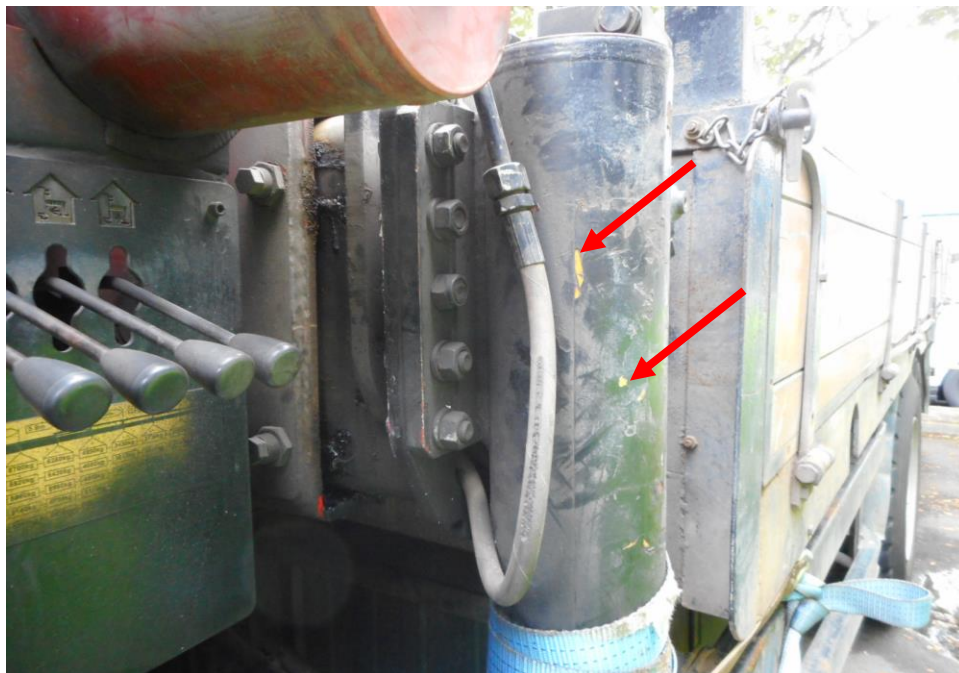
**Photo 7** shows a general view of the left hydraulic arm of the Motor Lorry at the time of my inspection. The left hydraulic arm (arrowed) was observed to be damaged as a result of the accident.

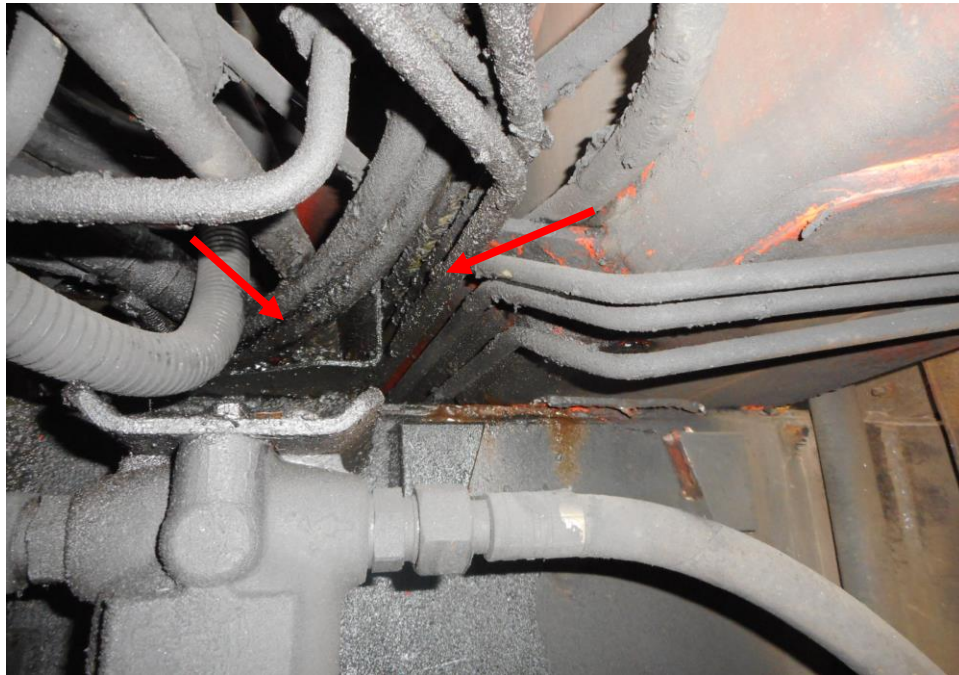
**Photo 8** shows the close up view of the hydraulic pipes (arrowed) of the left hydraulic arm of the Motor Lorry, I observe leakage of hydraulic fluid at the time of my inspection of the Motor Lorry. Upon closer inspection, the fluid stain on the piping's was found to be an old fluid stain as it had accumulated dust & grime over time. This fluid leakage has likely the cause the loss of control pressure to the left hydraulic arm system & causing it to extend outwards at the material time of accident.

16. For this particular case, we visually inspected both hydraulic arms on the Motor Lorry. We observed old hydraulic fluid stain on the left hydraulic arm pipes as compared to its right hydraulic arm. To our understanding the hydraulic fluid in the hydraulic arm system is used to control the extension and retracting of the hydraulic arms, however the leakage of hydraulic fluid to the left hydraulic would have caused a loss of control pressure to the system & resulted in an uncontrolled extension of the left hydraulic arm when the Motor Lorry was making a left turn which had resulted to the accident. Refer to photo 8 & 10.
17. A latest MOM equipment inspection certification of both the hydraulic arms was provided to us. The equipment had been certified and passed its inspection for 1 year from 2<sup>nd</sup> January 2020 to 1<sup>st</sup> January 2021. See below.

19. In our opinion, the likely cause to the extension of the left hydraulic is of wear & tear nature to the hydraulic piping materials that had caused the leakage of hydraulic fluids which had resulted in the uncontrolled extension of the left hydraulic arm when the Motor Lorry was making a right turn resulting to the accident.

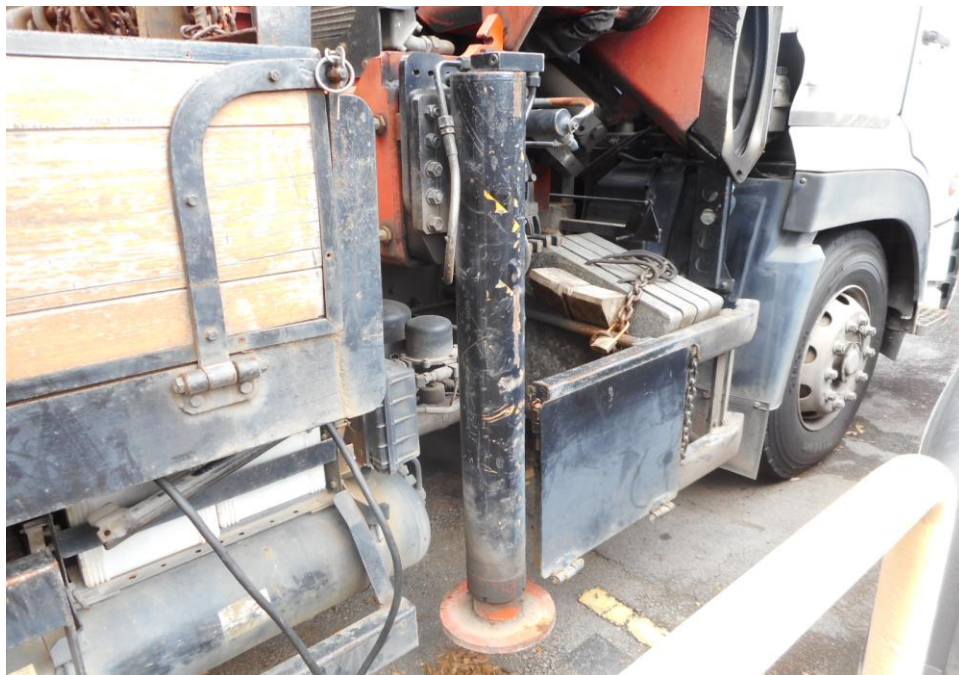
**Photo 9** shows a general view of the right hydraulic arm of the Motor Lorry at the time of my inspection. The right hydraulic arm was observed to be intact and undamaged by the accident.

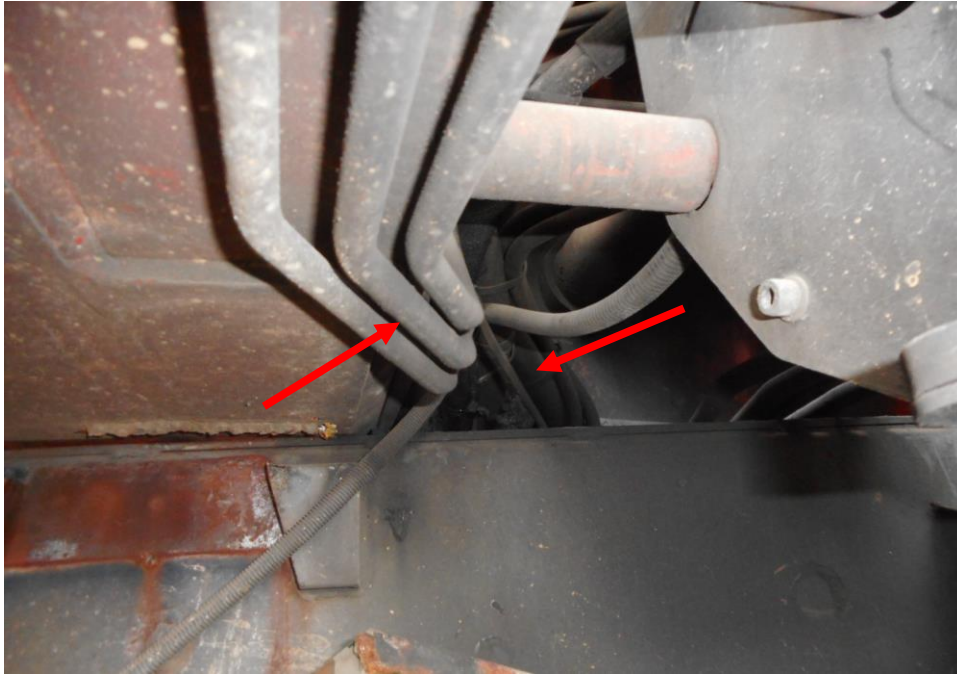
**Photo 10** shows the close up view of the hydraulic pipes (arrowed) of the right hydraulic arm of the Motor Lorry. I did not observe any leakage of hydraulic fluid at the time of my inspection. Hence the right hydraulic arm system of the Motor Lorry was likely to be in serviceable condition at the material time of accident.

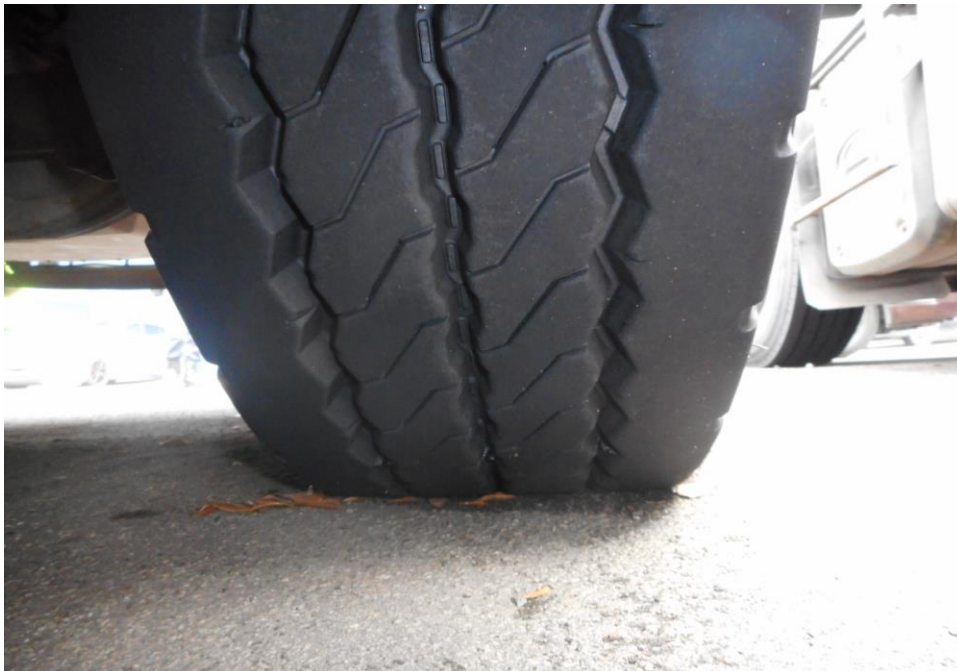
**Photo 11** shows the condition of the front right tyre of the Motor Lorry, which was observed to be in serviceable condition with remaining tread depth of approximately 13.7mm. The tyre, which was wrapped around standard steel wheel rim, was also observed to be sufficiently inflated for vehicular operation. There was no tear, cut or burst mark(s) on the outer and the inner sidewalls as well as across the tread of the 6 tyres that were fitted on the Motor Lorry.

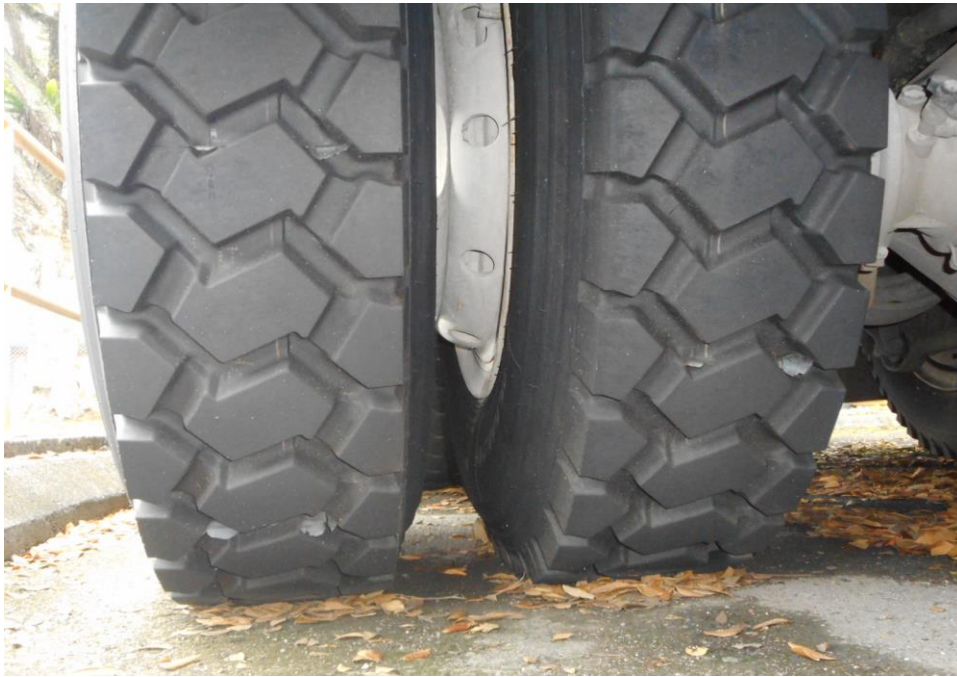
**Photo 12** shows the condition of the rear right tyres of the Motor Lorry, which was observed to be in serviceable condition with remaining, tread depth of approximately 14.7mm. The tyres, which were wrapped around standard steel wheel rim, were also observed to be sufficiently inflated for vehicular operation. There was also no damage found on all 6 steel wheel rims of the Motor Lorry.

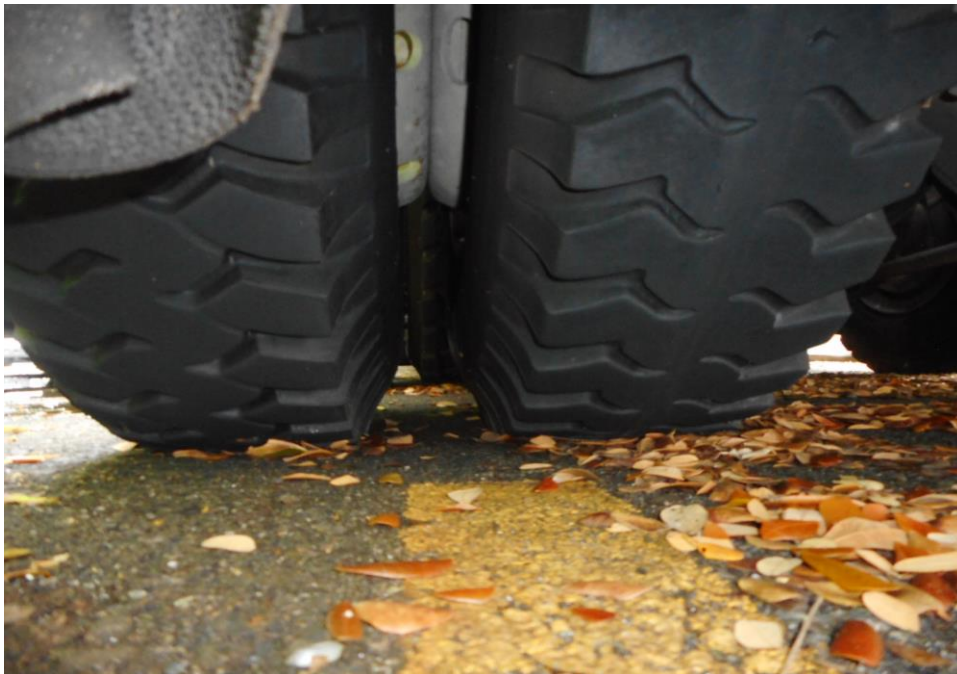
**Photo 13** the condition of the rear left tyres of the Motor Lorry, which was observed to be in serviceable condition with remaining, tread depth of approximately 12.6mm. The tyres, which were wrapped around standard steel wheel rim, were also observed to be sufficiently inflated for vehicular operation. There was also no damage found on all 6 steel wheel rims of the Motor Lorry.

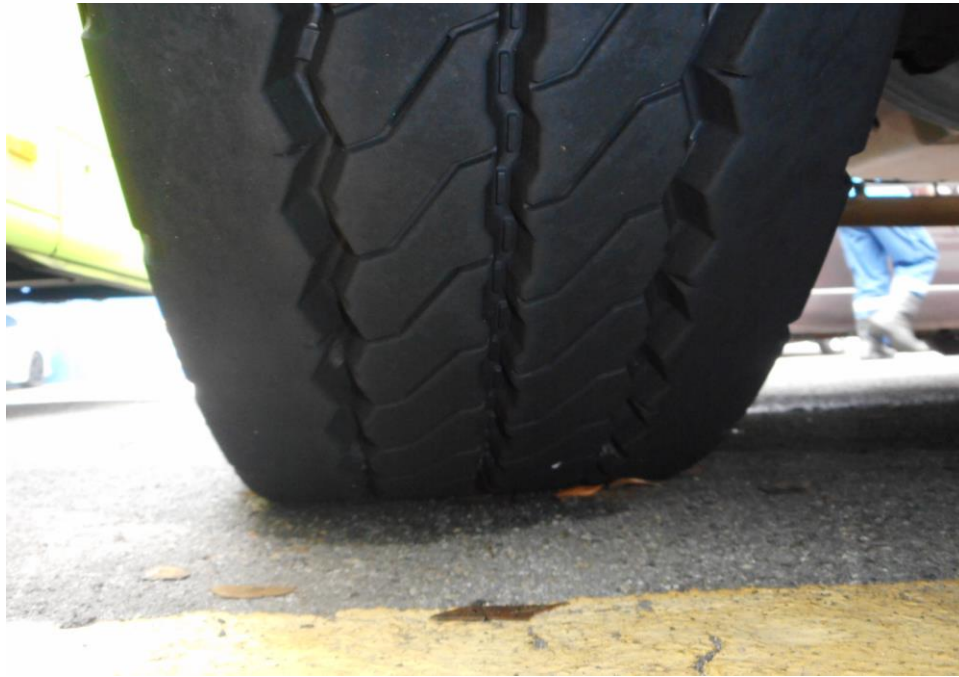
**Photo 14** shows the condition of the front left tyre of the Motor Lorry, which were observed to be in serviceable condition with remaining, tread depth of approximately 14.4mm. There was also no tear, cut or burst mark(s) on the outer and the inner sidewalls as well as across the tread of the 6 tyres that were fitted on the Motor Lorry.

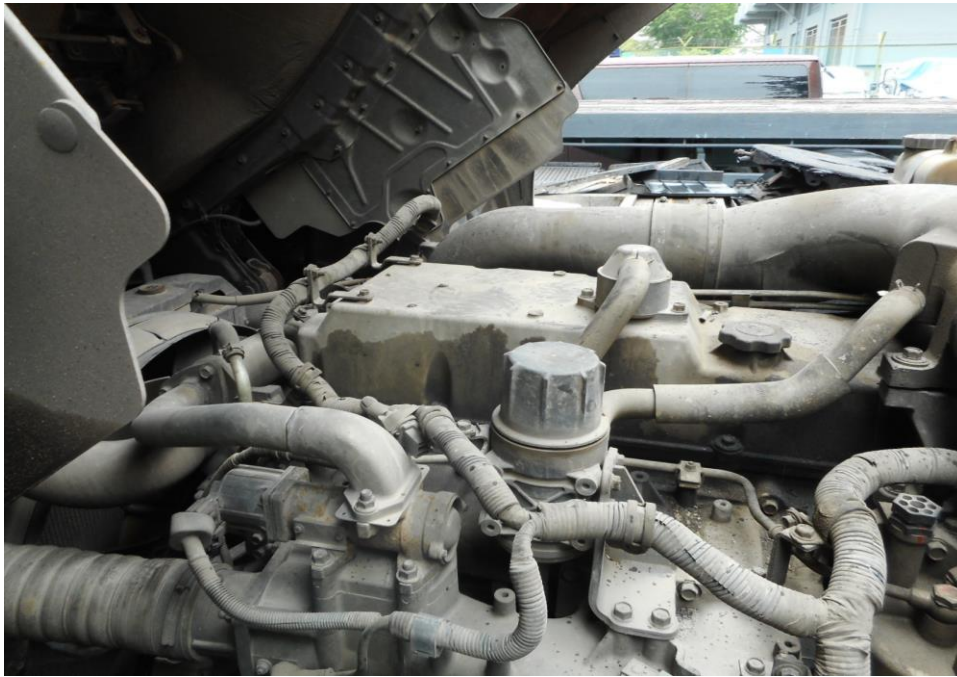
**Photo 15** shows a general view of the Motor Lorry's engine compartment, which was accessed by lifting the front cabin of the Motor Lorry. The various parts and components inside the engine compartment were unaffected by the accident. There was also no sign(s) or indication(s) of fresh fluid leakage and/or fluid stain within the engine compartment

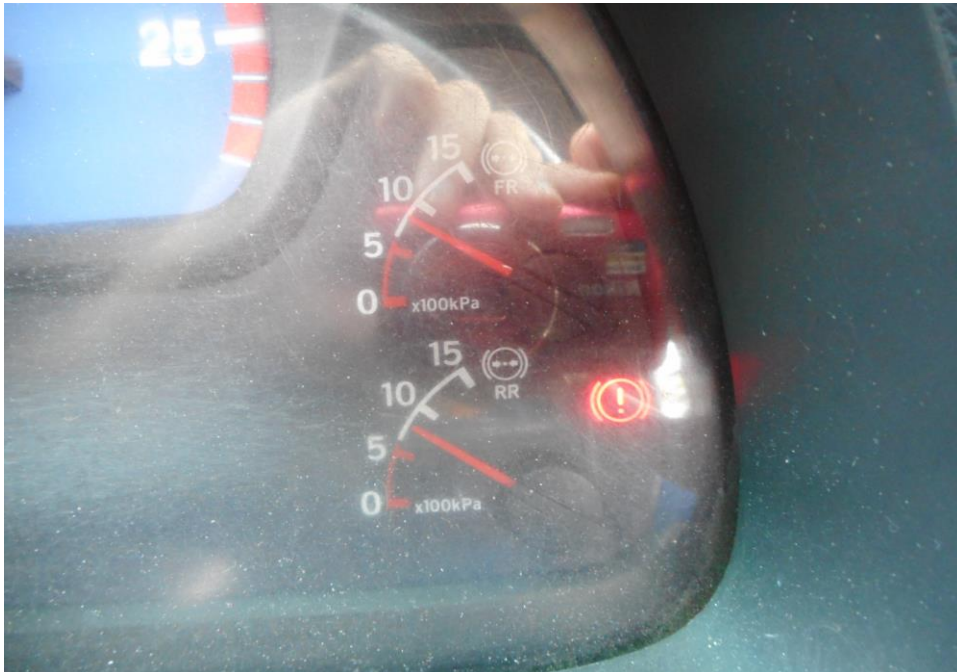
**Photo 16** shows the air in the air brake cylinders of the Motor Lorry at the time of my inspection. The air in the cylinder was observed to be of sufficient level & serviceable at the time of the accident.

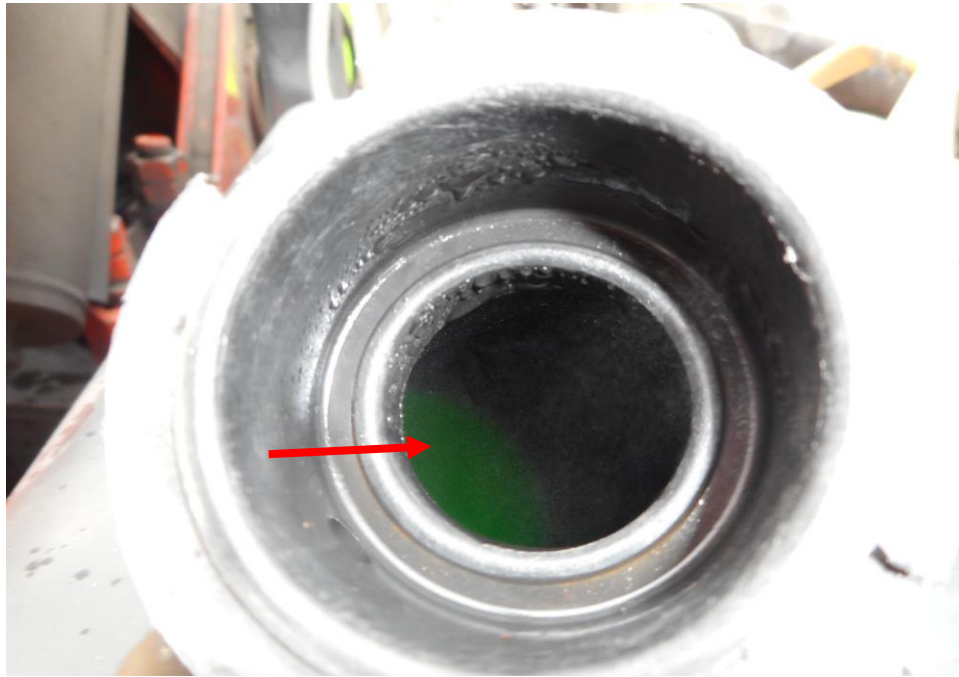
**Photo 17** shows the engine coolant reservoir of the Motor Lorry at the time of my inspection. The engine coolant was observed to be of sufficient level (arrowed) and without any visible contamination.

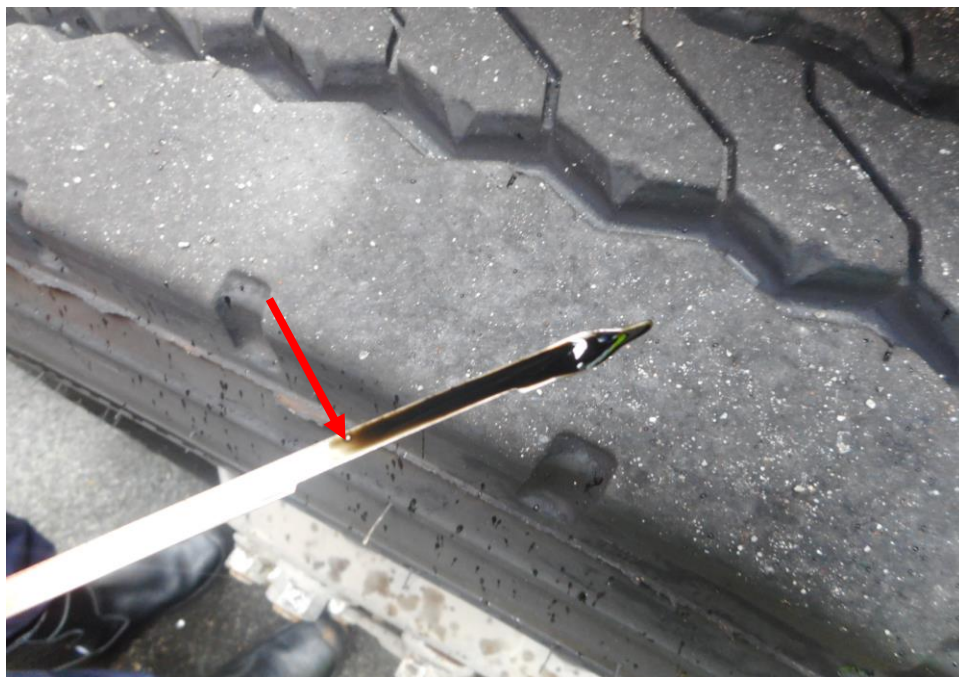
**Photo 18** shows the engine oil dip stick of the Motor Lorry at the time of my inspection. The engine oil was observed to be of sufficient level (arrowed) and without any visible contamination.

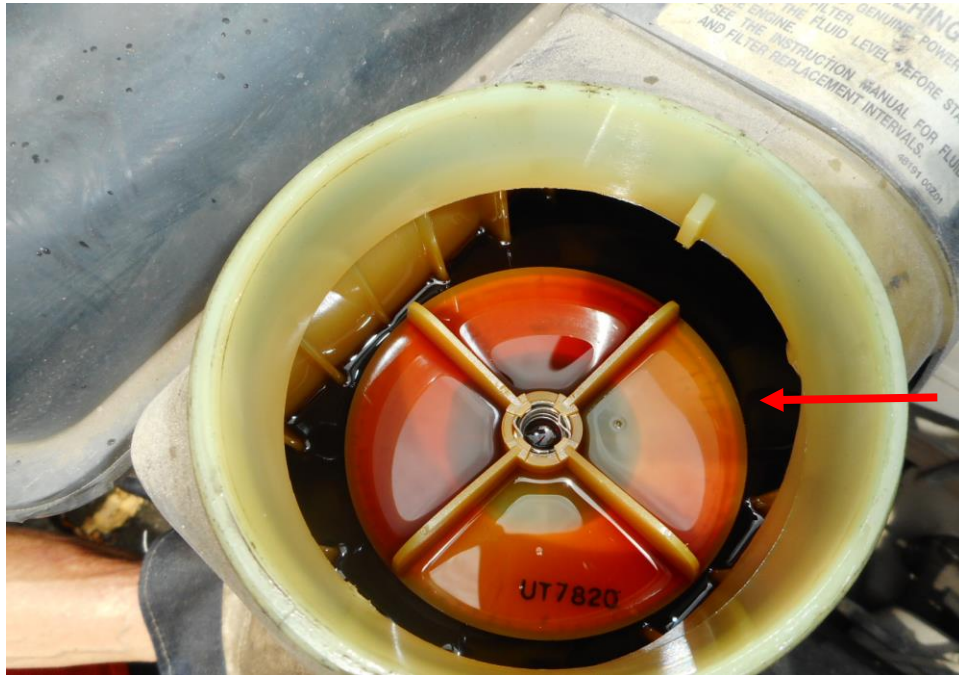
**Photo 19** shows the power steering fluid reservoir of the Motor Lorry at the time of my inspection. The power steering fluid (arrowed) was observed to be of sufficient level and without any visible contamination.

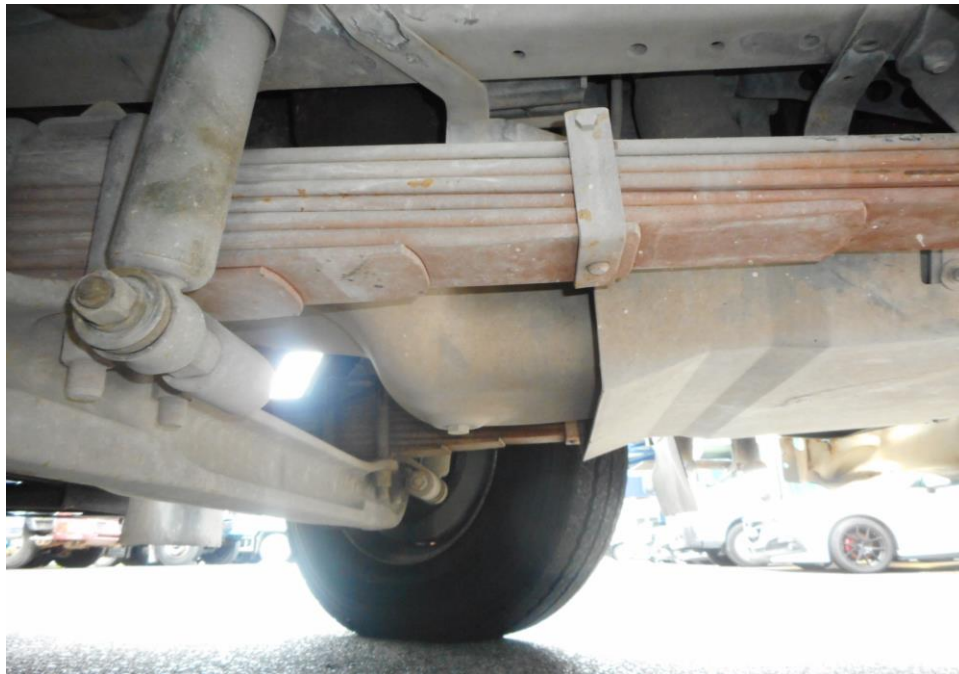
**Photo 20** shows the undercarriage of the Motor Lorry, at the area where the engine housing and transmission housing are located. I did not observe any leakage or fluid stain on the underside of the Motor Lorry.

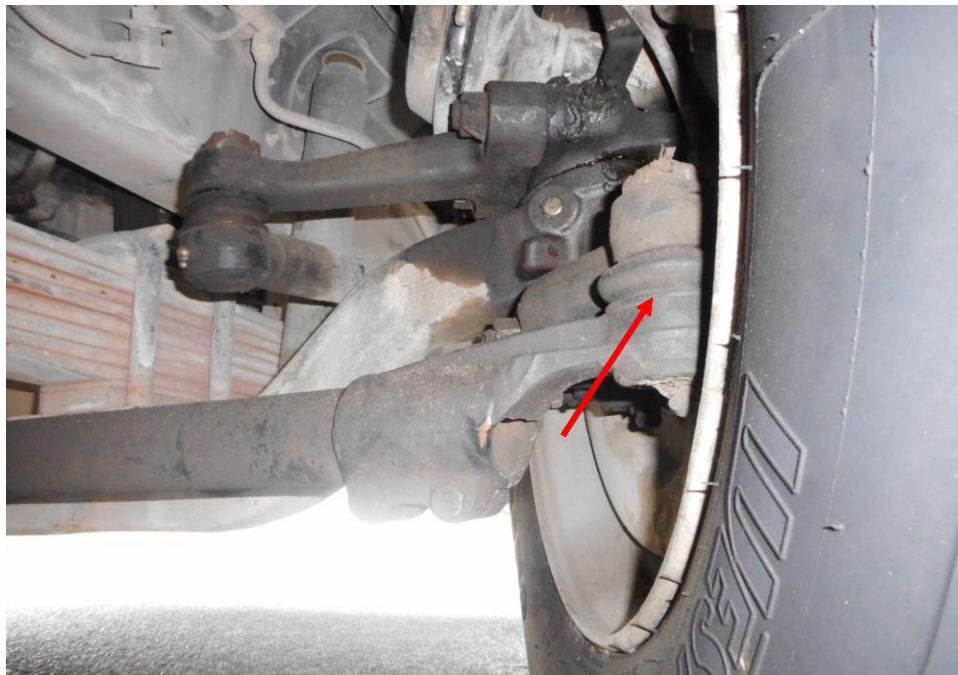
**Photo 21** shows the various undercarriage components at the front right wheel of the Motor Lorry, in particular the steering tie rod end (arrowed). The various steering components were all found to be intact, suggesting that the steering system of the Motor Lorry was likely to be in serviceable condition at the material time of accident. There was also no sign of fluid stain(s) observed on the various undercarriage components.

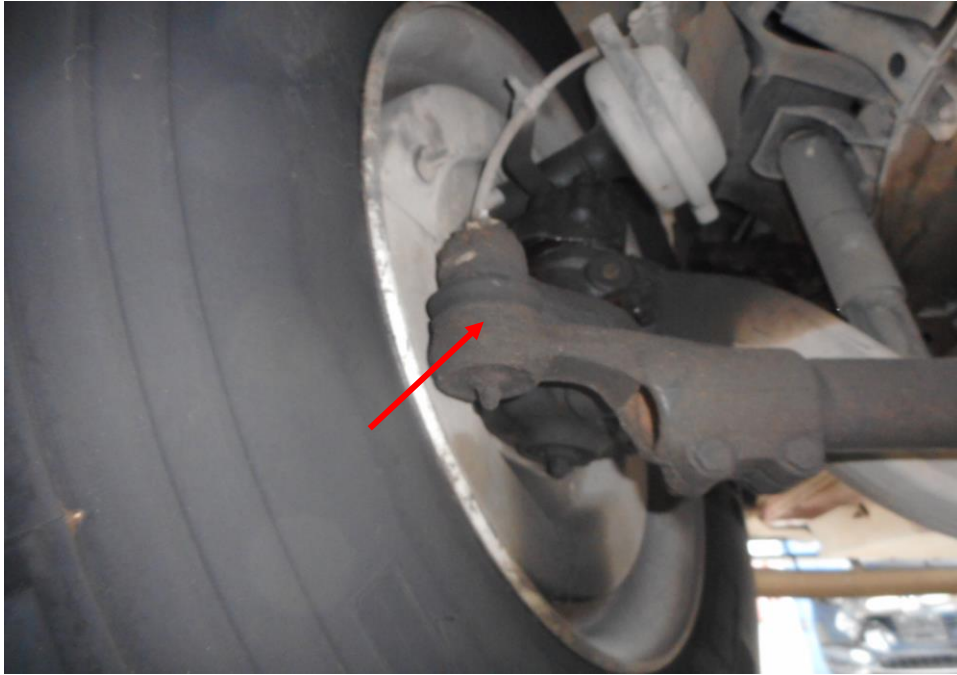
**Photo 22** shows the various undercarriage components at the front left wheel of the Motor Lorry, in particular the steering tie rod end (arrowed). The various Undercarriage components of the Motor Lorry were all found to be intact without any visible damage. There was also no sign of fluid stain(s) observed on the various undercarriage components.

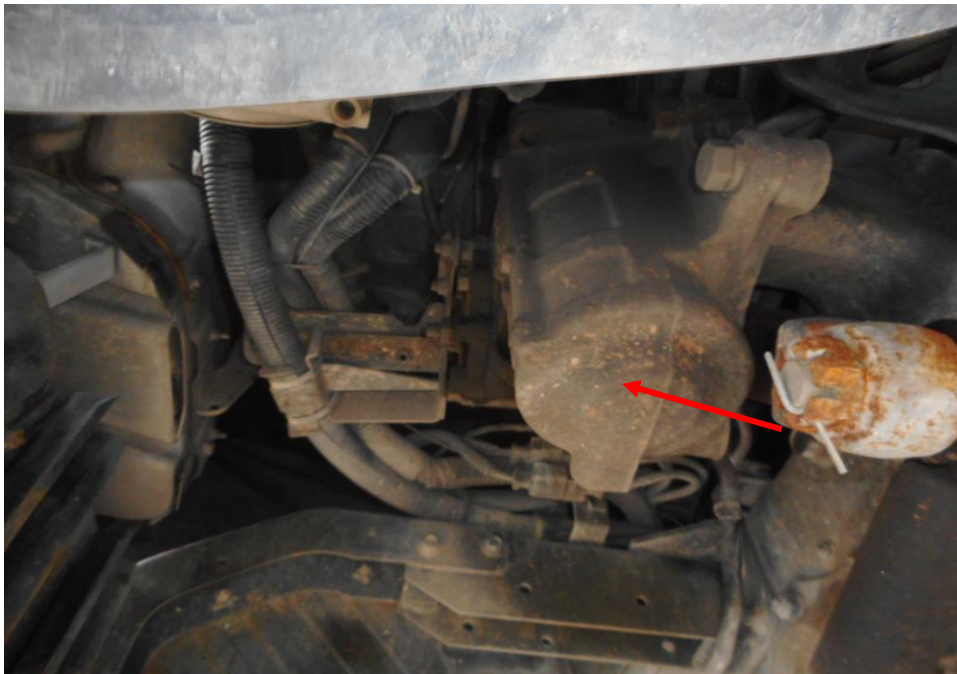
**Photo 23** shows the steering box component (arrowed) at the undercarriage of the Motor Lorry was found to be intact without any visible damage. There was also no sign of fluid stain(s) observed on the various undercarriage components.

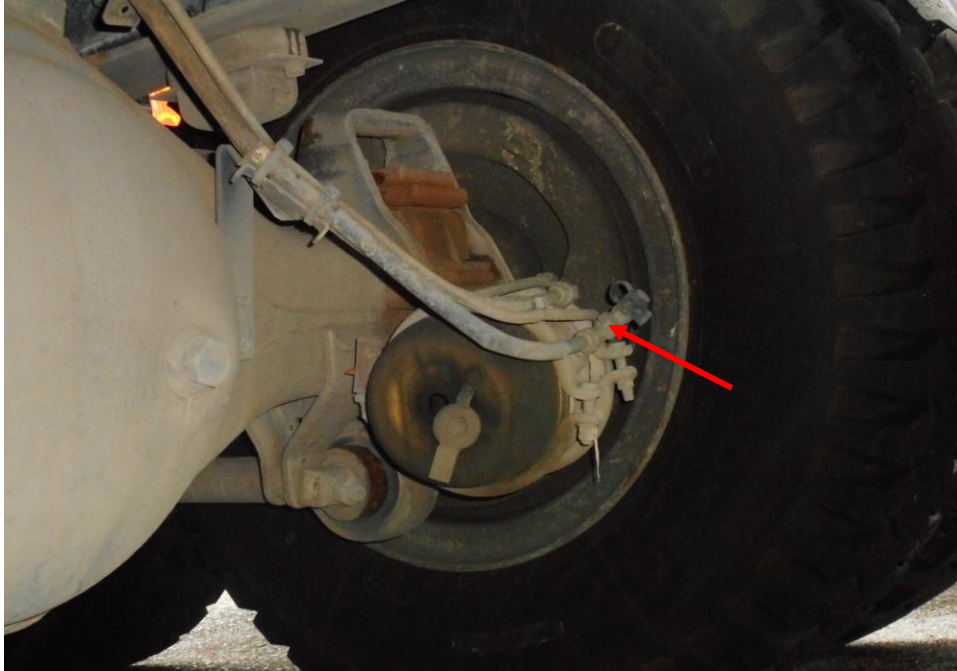
**Photo 24** shows the brake pipe (arrowed) at the rear right wheel of the Motor Lorry. I did not observe any leakage of brake fluid at the time of my inspection of the Motor Lorry. My static tests of the Motor Lorry's braking system, along with my visual examination of the various mechanical components in the braking system, had indicated that there was no internal leakage of pressure/vacuum. Hence the braking system of the Motor Lorry was likely to be in serviceable condition at the material time of accident.

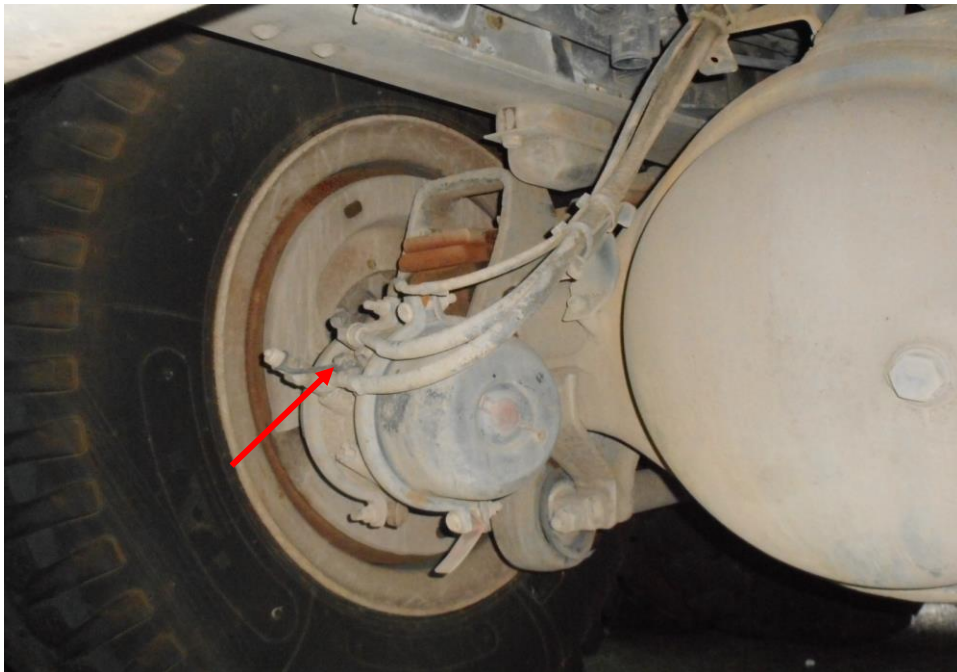
**Photo 25** shows the brake pipe (arrowed) at the rear left wheel of the Motor Lorry. I did not observe any leakage of brake fluid at the time of my inspection of the Motor Lorry. My static tests of the Motor Lorry's braking system, along with my visual examination of the various mechanical components in the braking system had indicated that there was no internal leakage of pressure/vacuum. Hence the braking system of the Motor Lorry was likely to be in serviceable condition at the material time of accident.

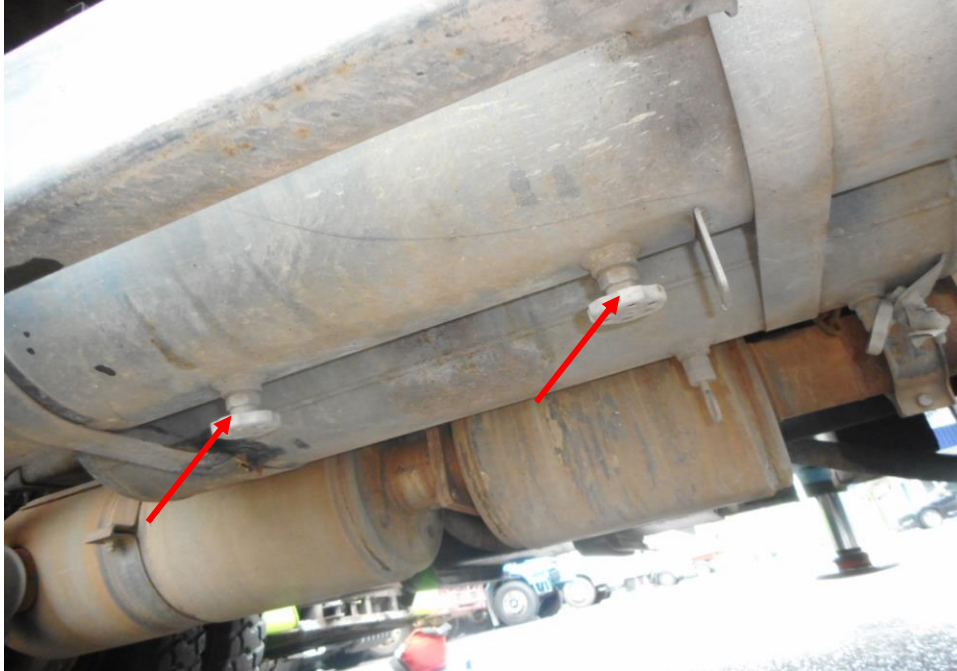
**Photo 26** shows the air brake cylinders (arrowed) at the undercarriage of the Motor Lorry. I did not observe any leakage of air brake fluid at the time of my inspection of the Motor Lorry. My static tests of the Motor Lorry's braking system, along with my visual examination of the various mechanical components in the braking system had indicated that there was no internal leakage of pressure/vacuum. Hence the braking system of the Motor Lorry was likely to be in serviceable condition at the material time of accident.

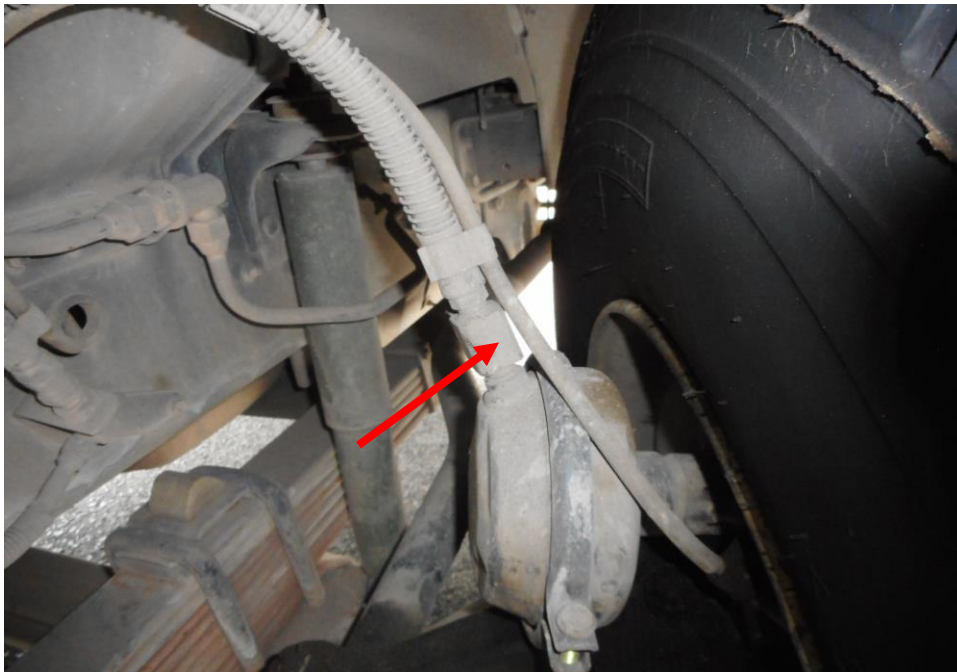
**Photo 27** shows the brake hose/pipe (arrowed) at the front right wheel of the Motor Lorry. I did not observe any leakage of brake fluid at the time of my inspection of the Motor Lorry. My static tests of the Motor Lorry's braking system, along with my visual examination of the various mechanical components in the braking system had indicated that there was no internal leakage of pressure/vacuum. Hence the braking system of the Motor Lorry was likely to be in serviceable condition at the material time of accident.

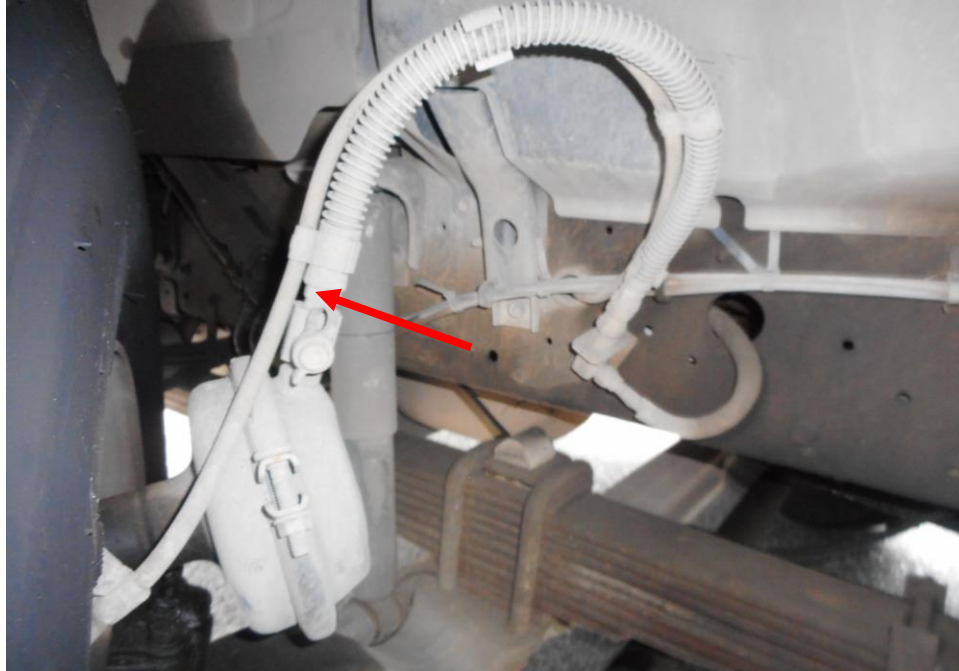
**Photo 28** shows the brake hose/pipe (arrowed) at the front left wheel of the Motor Lorry. I did not observe any leakage of brake fluid at the time of my inspection of the Motor Lorry. My static tests of the Motor Lorry's braking system, along with my visual examination of the various mechanical components in the braking system had indicated that there was no internal leakage of pressure/vacuum. Hence the braking system of the Motor Lorry was likely to be in serviceable condition at the material time of accident.

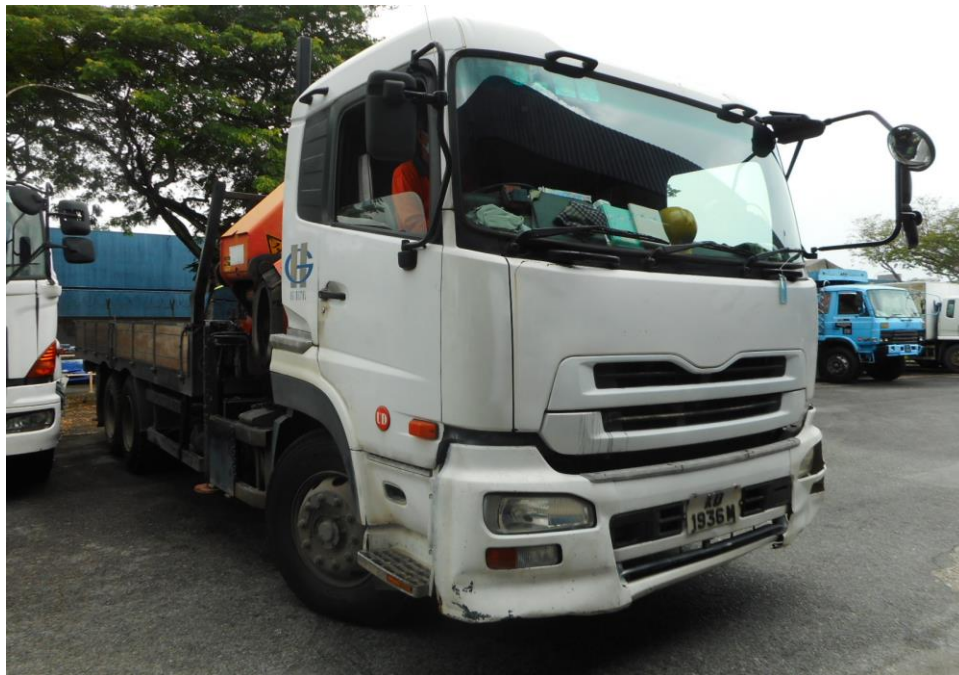
**Photo 29** shows the front right wheel of the Motor Lorry turned to its full left. During my steering system test, I did not experience any abnormal free play and/or resistance when I had turned the steering wheel towards full left and full right. This would suggest that the steering system of the Motor Lorry was likely to be in serviceable condition at the material time of accident.
