Your Ref: TP/IP/73827/2019  
Our Ref : CI/TPD20005592/P

**Fatal Accident Investigation Team**

**MECHANICAL INSPECTION REPORT OF MOTOR TAXI SHC 1824Y**

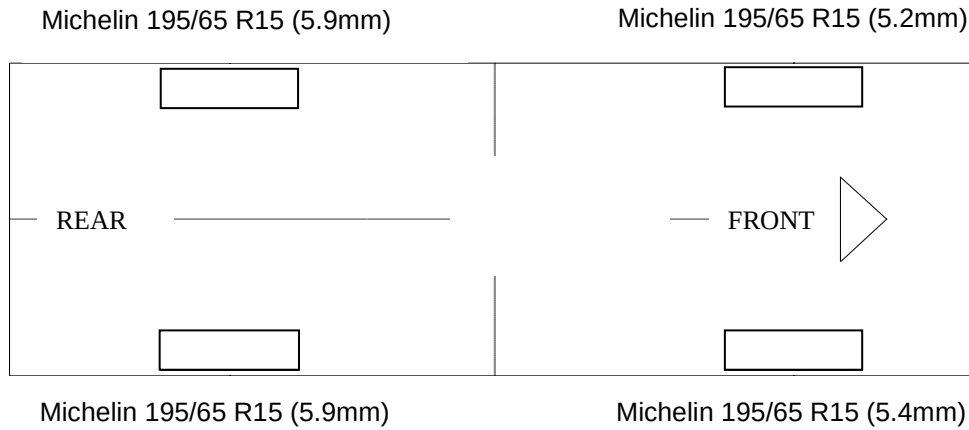
6. The 4 tyres of the Motor Taxi were observed to be in serviceable condition and sufficiently inflated for vehicular operation. I did not find any tear, cut or burst mark(s) on the outer and the inner sidewalls as well as across the tread of the 4 tyres. The tyre brand, tyre size and remaining tread depth of the 4 tyres of the Motor Taxi were recorded as follows:-

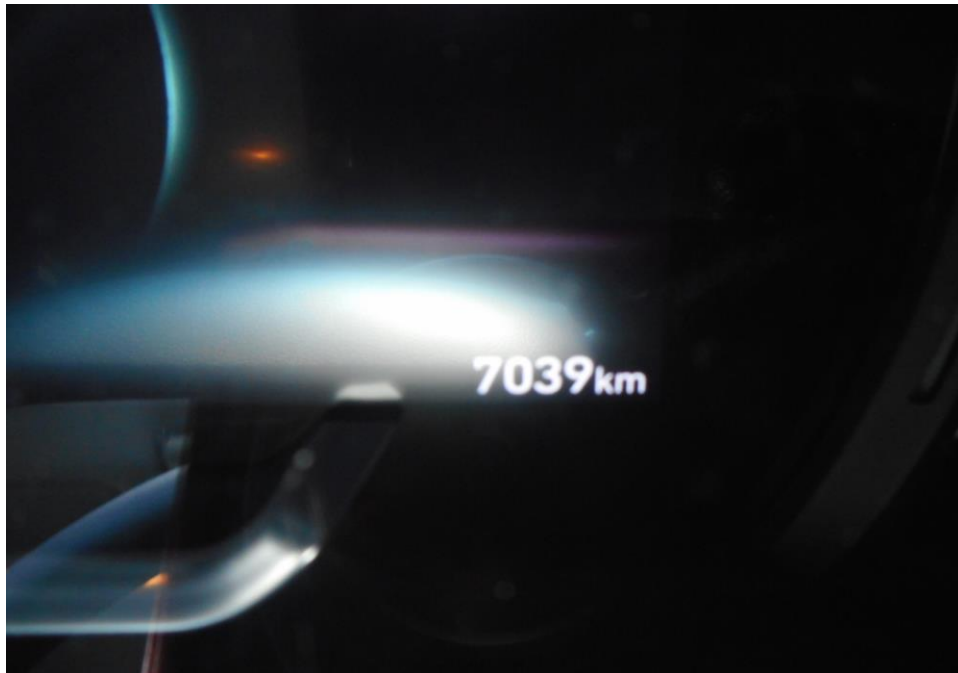
4. The mileage of the Motor Taxi at the time of my inspection was 7,039km.
5. There was visible damage observed on Motor Taxi's front right door and fender portion at the time of my inspection.

**Photo 1** shows a general view of the instrument cluster of the Motor Taxi at the time of my inspection. The mileage of the Motor Taxi was 7,039km

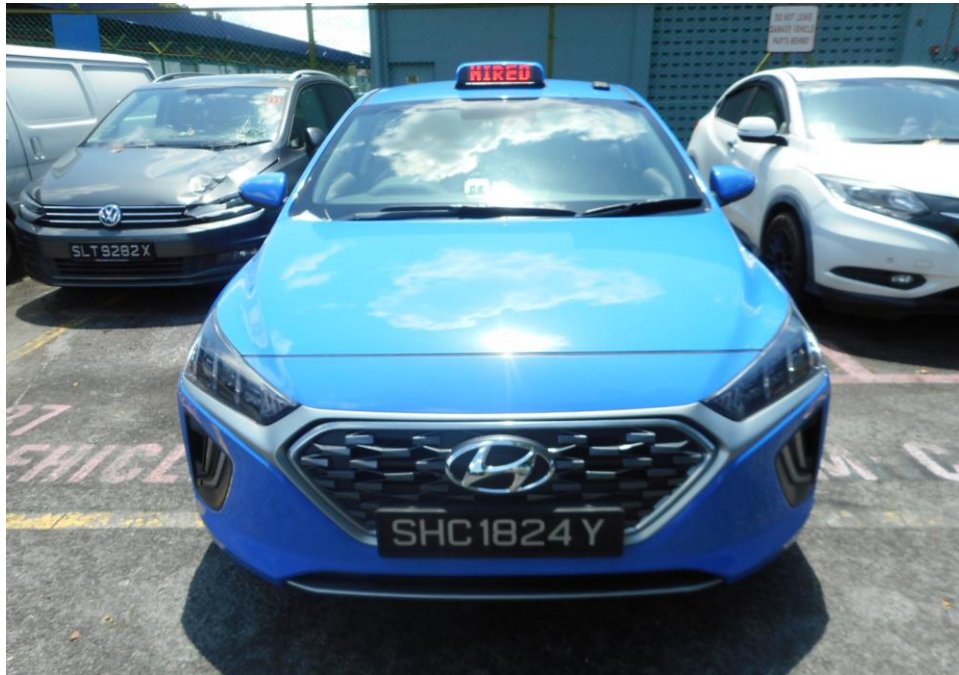
**Photo 2** shows a general view of the Motor Taxi front portion at the time of my inspection. The Motor Taxi was observed to be intact and unaffected by the accident

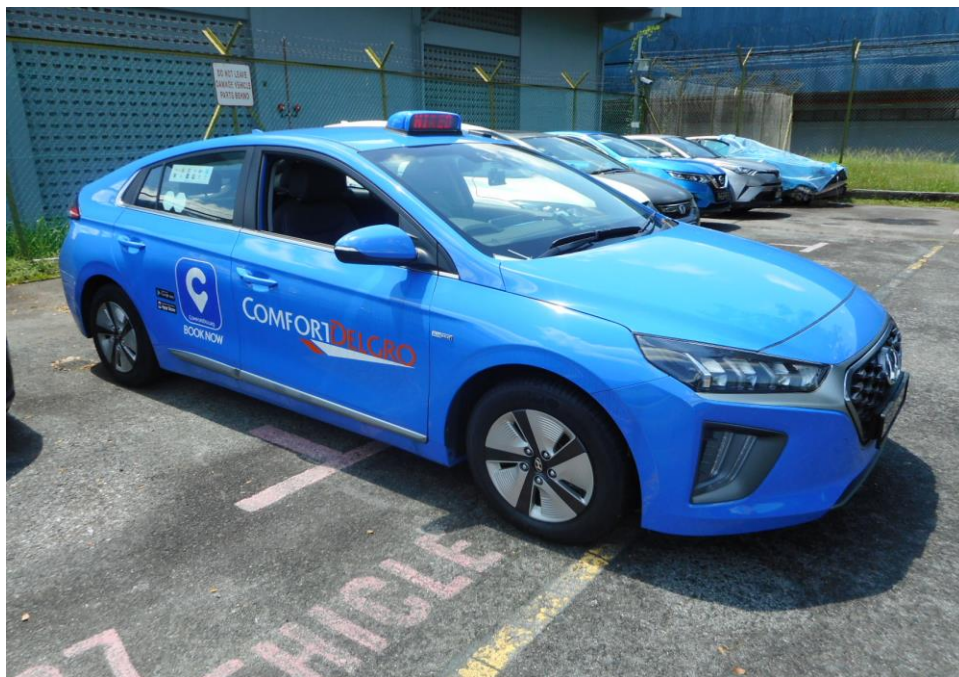
**Photo 3** shows a general view of the right body of the Motor Taxi at the time of my inspection. The Motor Taxi was observed to visually sustain damage at its front right door and fender portion which had caused difficult in opening the door.

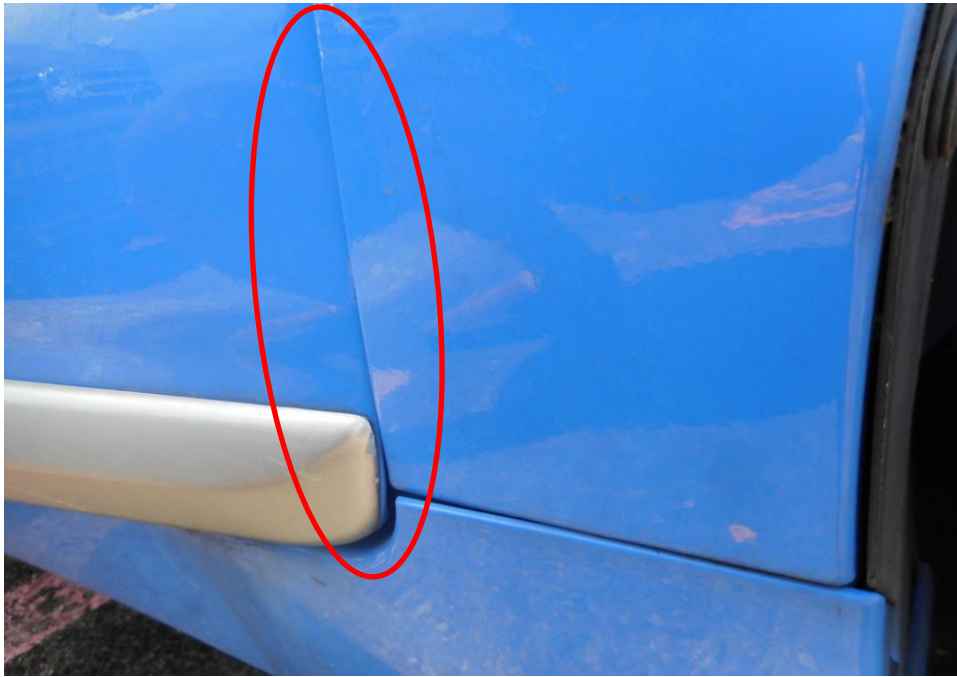
**Photo 4** shows a close up view of the right body of the Motor Taxi at the time of my inspection. The Motor Taxi was observed to visually sustain damage at its front right bumper and fender portion (circled) which had cause difficult in opening the door.

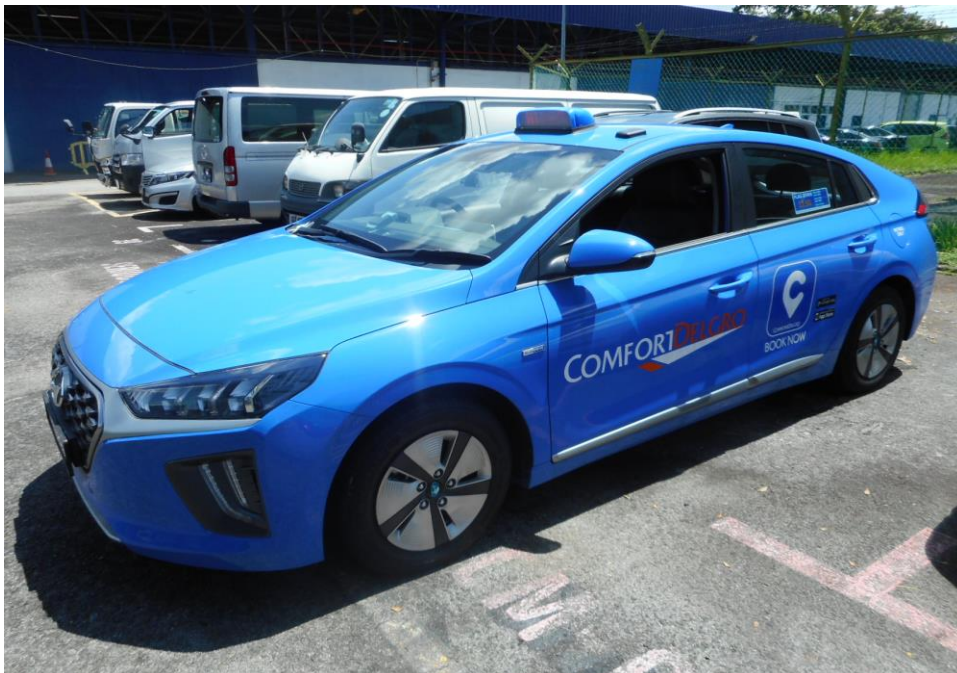
**Photo 5** shows a general view of the left body of the Motor Taxi at the time of my inspection. The Motor Taxi was observed to be intact and unaffected by the accident.

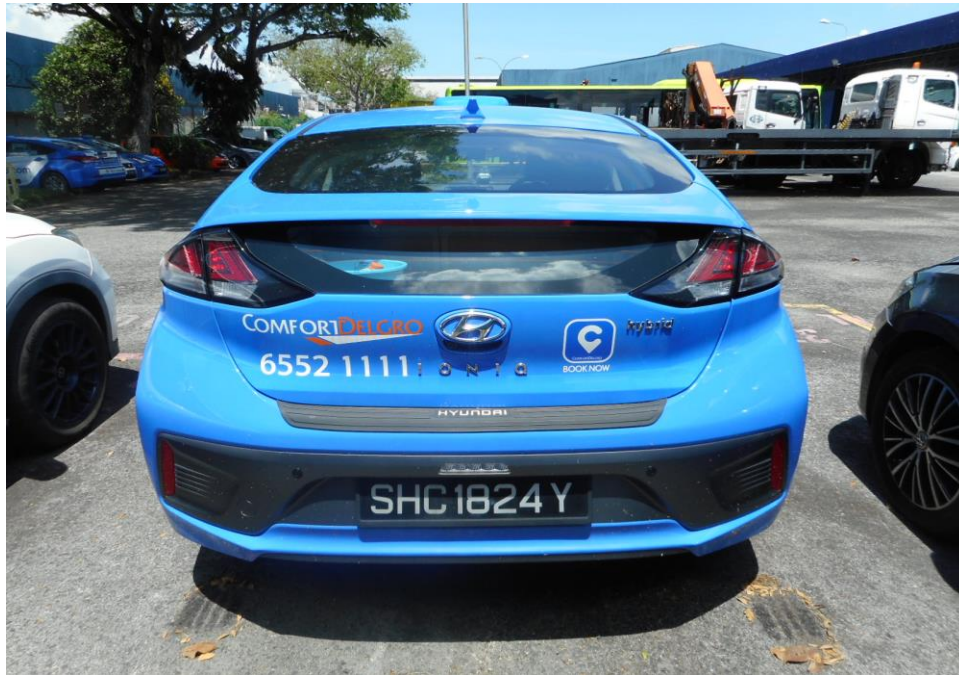
**Photo 6** shows a general view of the rear body of the Motor Taxi at the time of my inspection. The Motor Taxi was observed to be intact and unaffected by the accident.

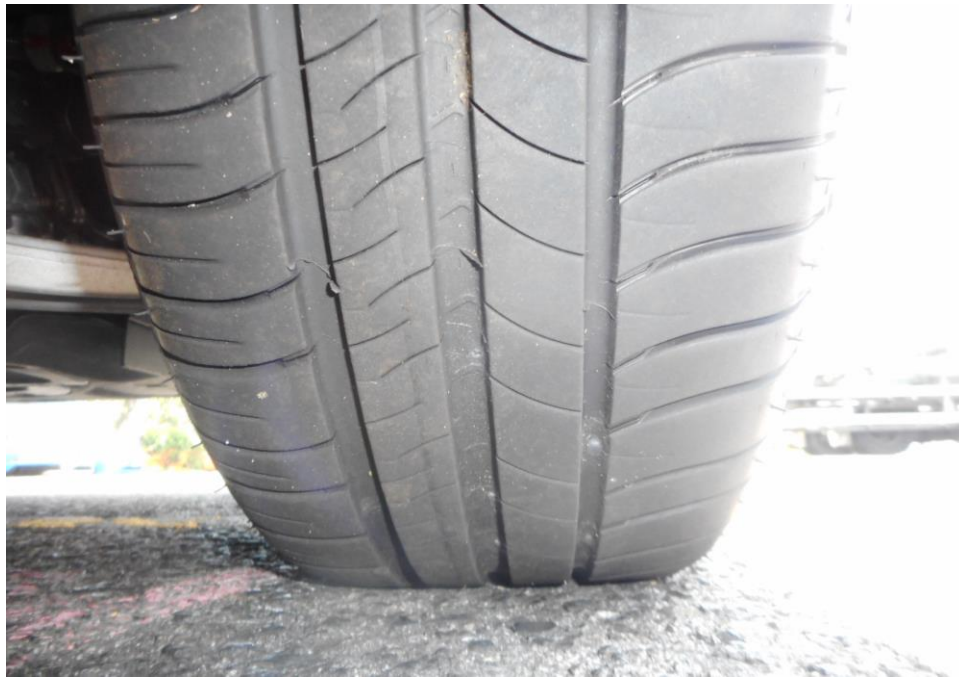
**Photo 7** shows the condition of the front right tyre of the Motor Taxi, which was observed to be in serviceable condition with remaining tread depth of approximately 5.4mm. The tyre, which was wrapped around standard alloy wheel rim, was also observed to be sufficiently inflated for vehicular operation. There was no tear, cut or burst mark(s) on the outer and the inner sidewalls as well as across the tread of the 4 tyres that were fitted on the Motor Taxi.

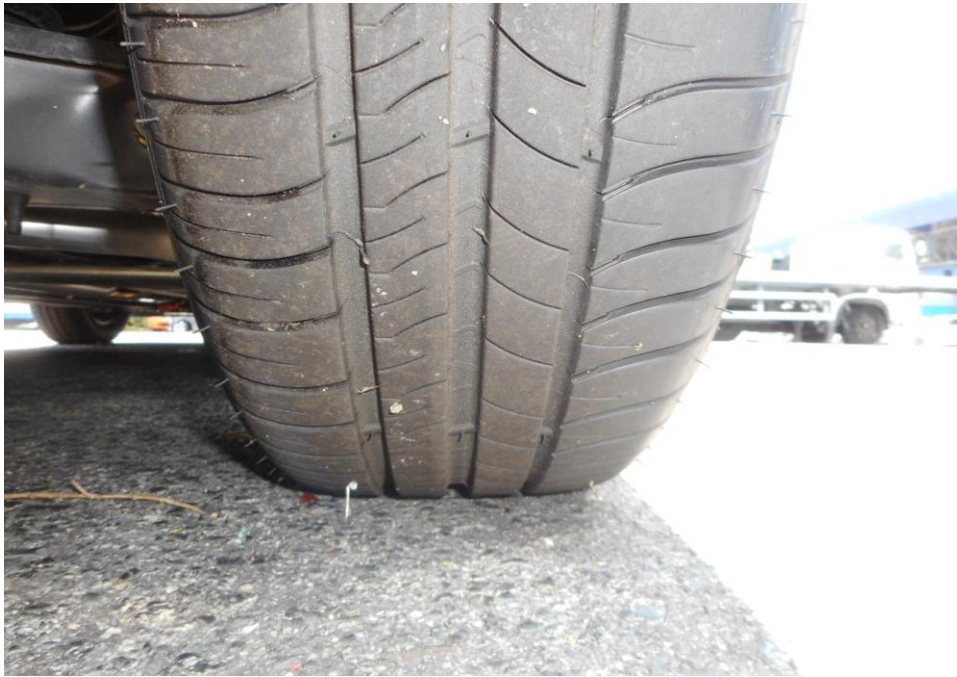
**Photo 8** shows the condition of the rear right tyre of the Motor Taxi, which was observed to be in serviceable condition with remaining tread depth of approximately 5.9mm. The tyre, which was wrapped around standard alloy wheel rim, was also observed to be sufficiently inflated for vehicular operation.

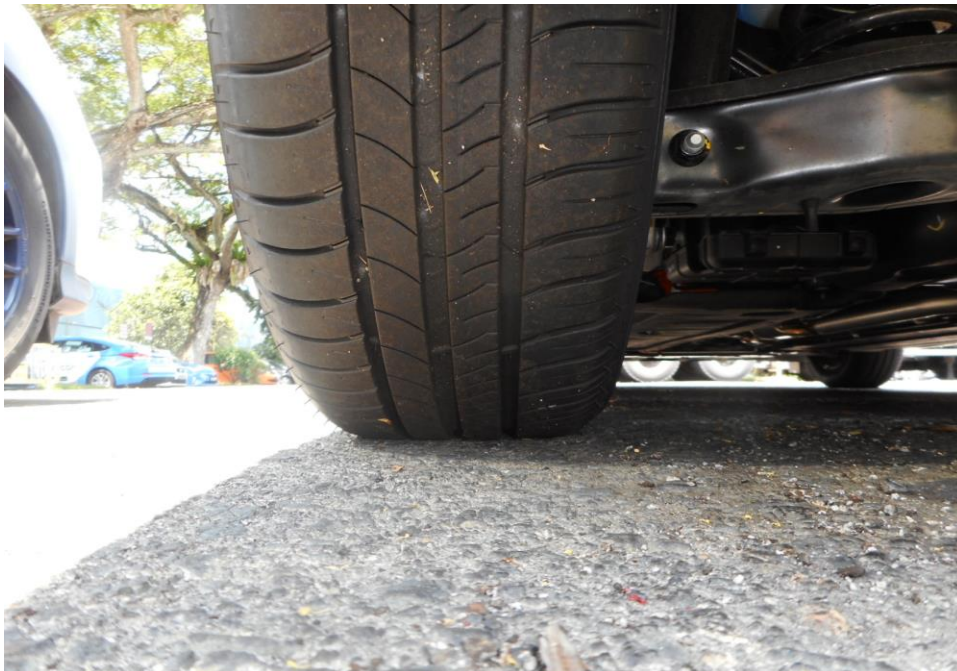
**Photo 9** shows the condition of the rear left tyres of the Motor Taxi, which was observed to be in serviceable condition with remaining tread depth of approximately 6.8mm. The tyres, which were wrapped around standard alloy wheel rim, were also observed to be sufficiently inflated for vehicular operation. There was also no damage found on all 4 alloy wheel rims of the Motor Taxi.

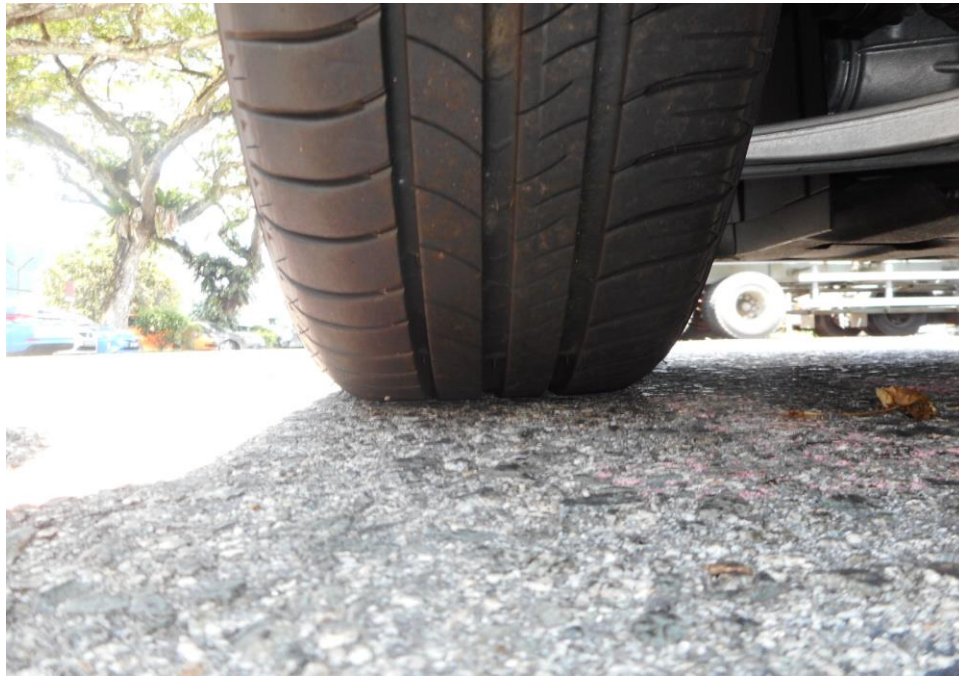
**Photo 10** shows the condition of the rear right tyres of the Motor Taxi, which were observed to be in serviceable condition with remaining, tread depth of approximately 5.2mm. There was also no tear, cut or burst mark(s) on the outer and the inner sidewalls as well as across the tread of the 4 tyres that were fitted on the Motor Taxi.

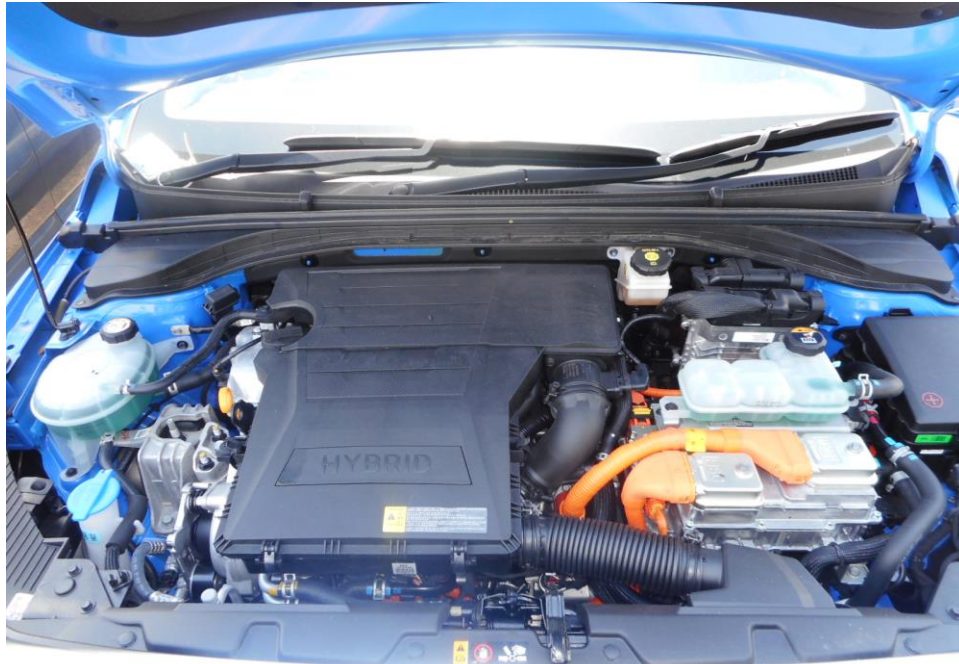
**Photo 11** shows a general view of the Motor Taxi's engine compartment, which was accessed by lifting the front cabin of the Motor Taxi. The various parts and components inside the engine compartment were unaffected by the accident. There was also no sign(s) or indication(s) of fresh fluid leakage and/or fluid stain within the engine compartment

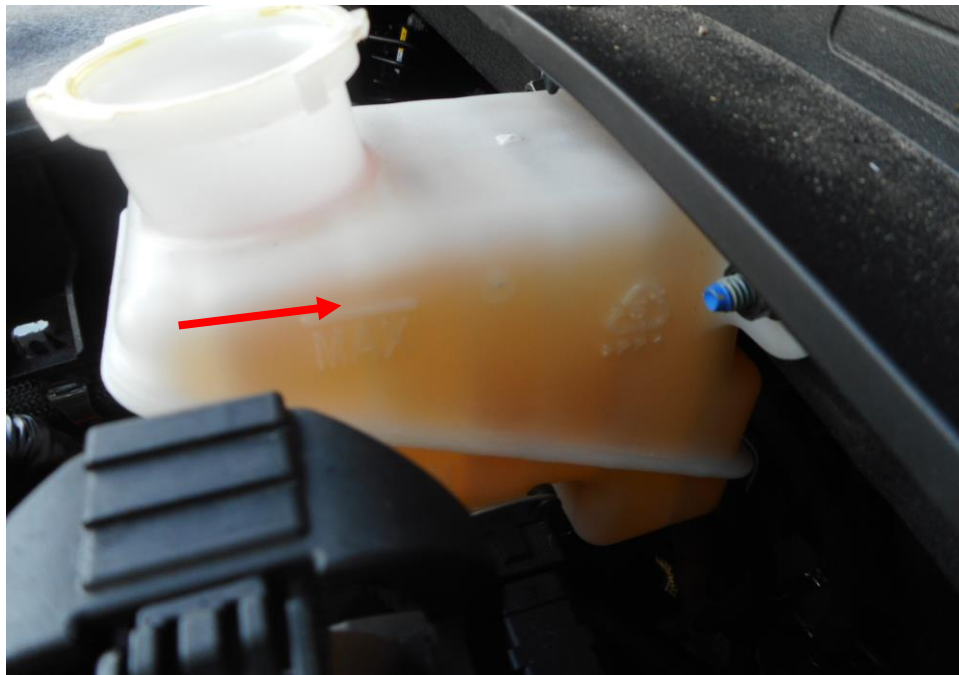
**Photo 12** shows the brake fluid reservoir of the Motor Taxi at the time of my inspection. The brake fluid was observed to be of sufficient level (arrowed) and without any visible contamination.

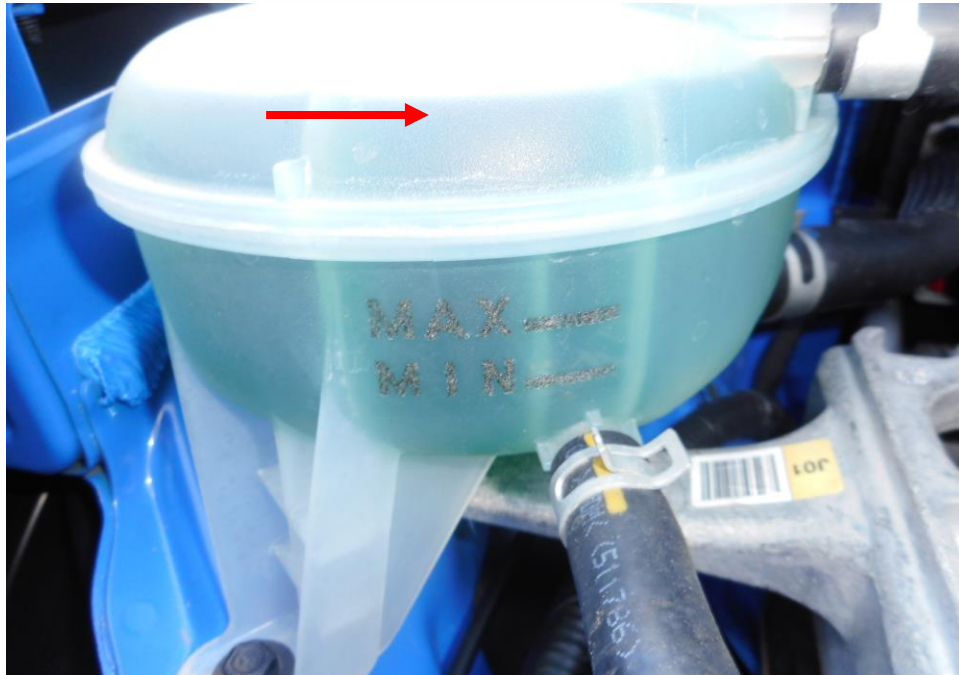
**Photo 13** shows the engine coolant reservoir of the Motor Taxi at the time of my inspection. The engine coolant was observed to be of sufficient level (arrowed) and without any visible contamination.

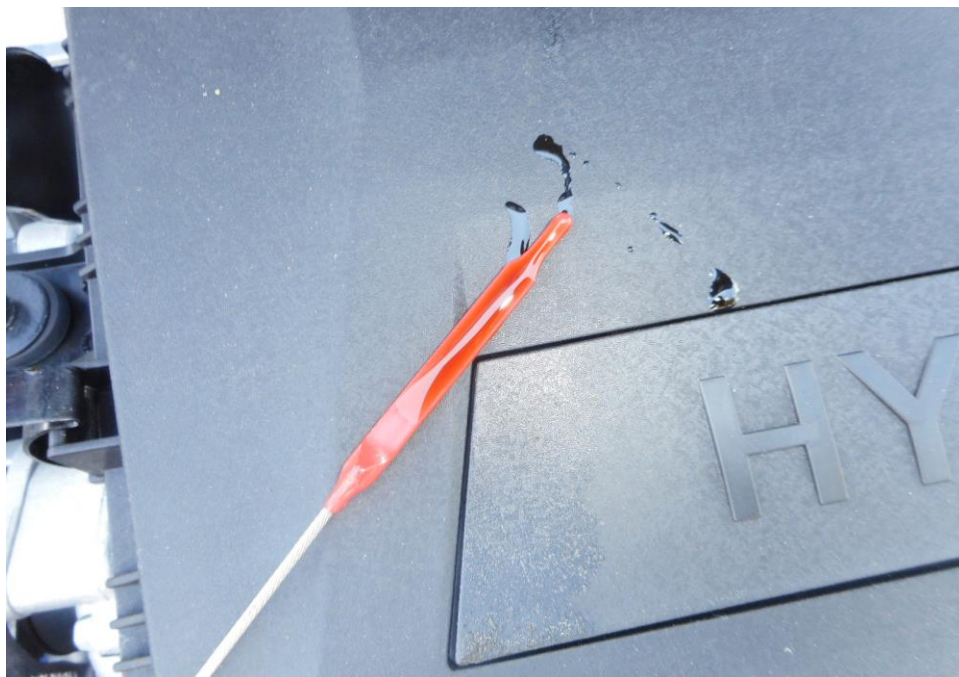
**Photo 14** shows the engine oil dip stick of the Motor Taxi at the time of my inspection. The engine oil was observed to be of sufficient level and without any visible contamination.

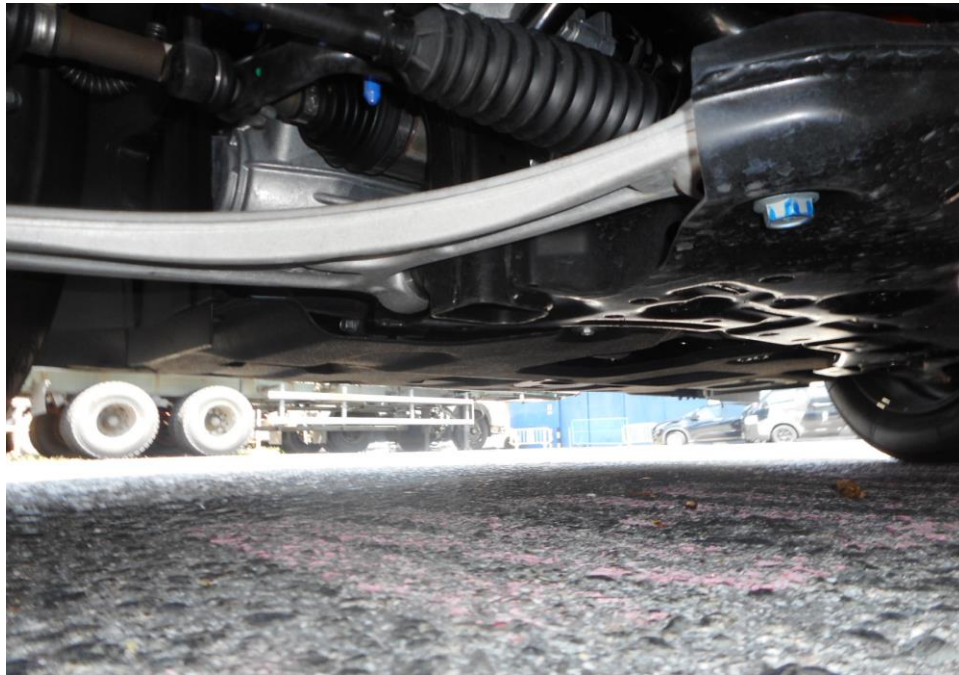
**Photo 15** shows the undercarriage of the Motor Taxi, at the area where the engine housing and transmission housing are located. . I did not find any sign(s) or indication(s) of fluid leak and/or fluid stain(s) on the underside of the Motor Taxi.

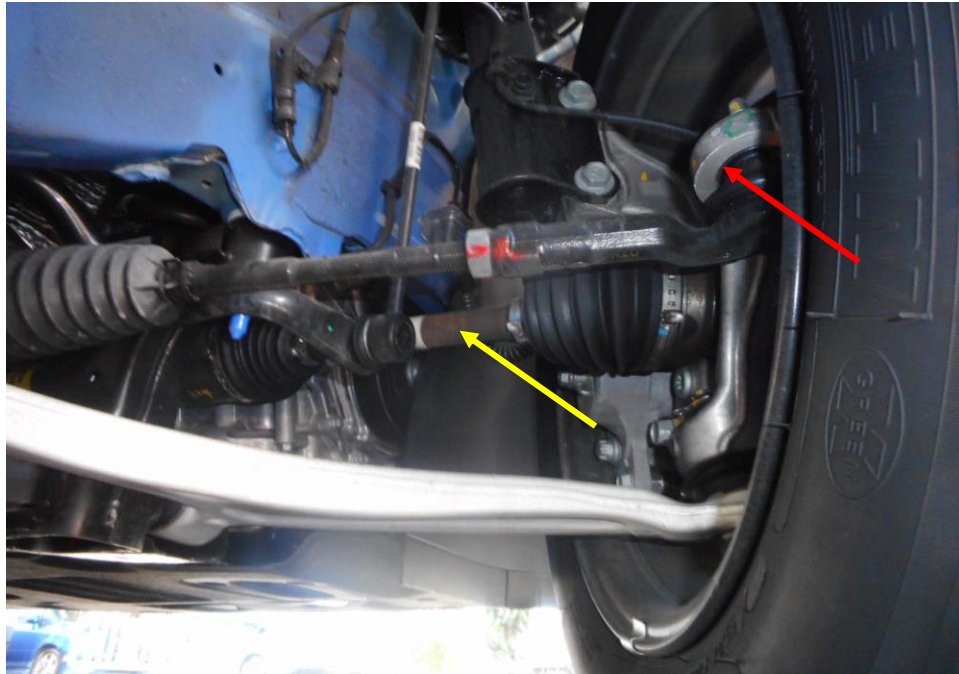
**Photo 16** shows the various undercarriage components at the front right wheel of the Motor Taxi, in particular the steering tie rod end (arrowed) and drive shaft (yellow arrow). The various steering components were all found to be intact, suggesting that the steering system of the Motor Taxi was likely to be in serviceable condition at the material time of accident. There was also no sign of fluid stain(s) observed on the various undercarriage components.

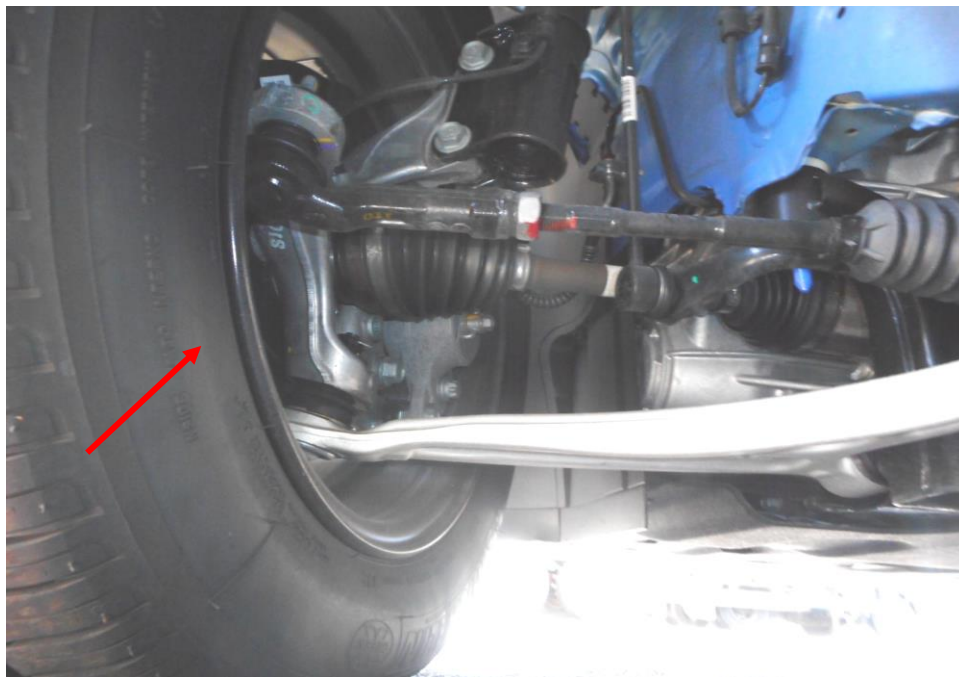
**Photo 17** shows the various undercarriage components at the front left wheel of the Motor Taxi, in particular the steering tie rod end (arrowed). The various Undercarriage components of the Motor Taxi were all found to be intact without any visible damage. There was also no sign of fluid stain(s) observed on the various undercarriage components.

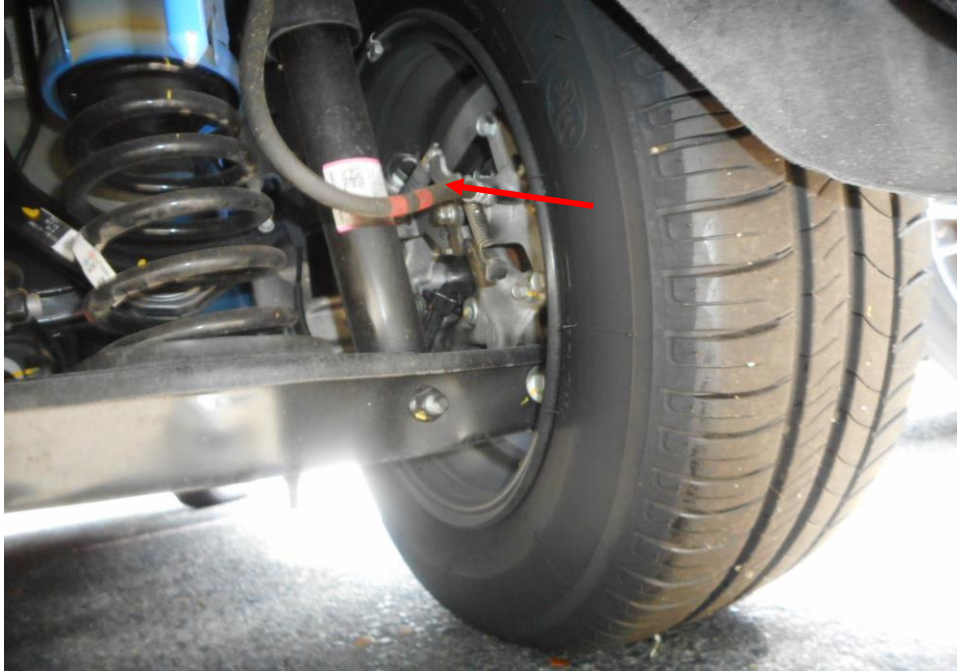
**Photo 18** shows the brake pipe (arrowed) at the rear right wheel of the Motor Taxi. I did not observe any leakage of brake fluid at the time of my inspection of the Motor Taxi. My static tests of the Motor Taxi's braking system, along with my visual examination of the various mechanical components in the braking system, had indicated that there was no internal leakage of pressure/vacuum. Hence the braking system of the Motor Taxi was likely to be in serviceable condition at the material time of accident.

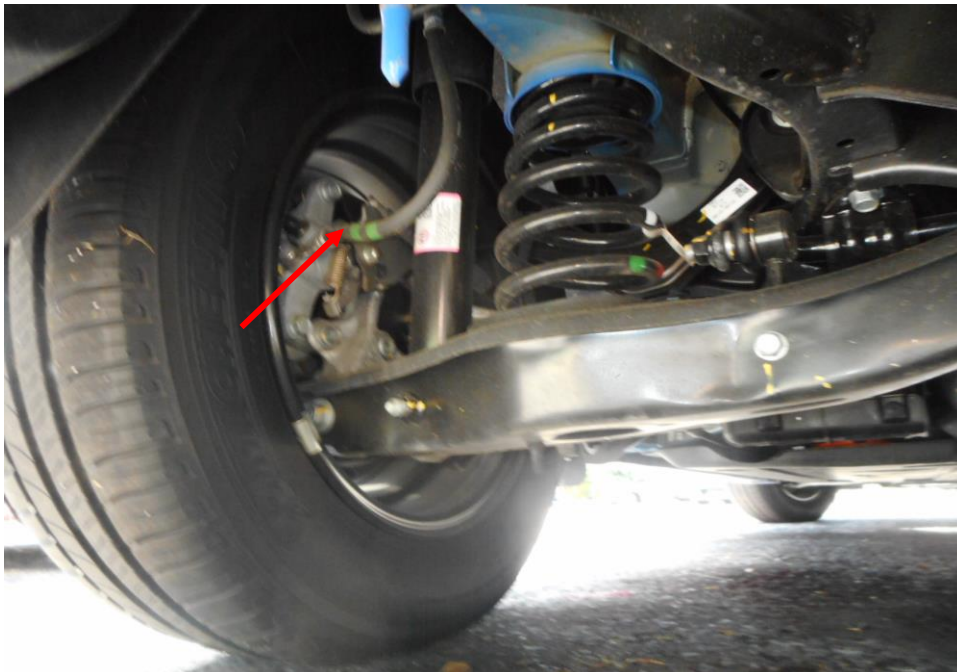
**Photo 19** shows the brake pipe (arrowed) at the rear left wheel of the Motor Taxi. I did not observe any leakage of brake fluid at the time of my inspection of the Motor Taxi. My static tests of the Motor Taxi's braking system, along with my visual examination of the various mechanical components in the braking system had indicated that there was no internal leakage of pressure/vacuum. Hence the braking system of the Motor Taxi was likely to be in serviceable condition at the material time of accident.

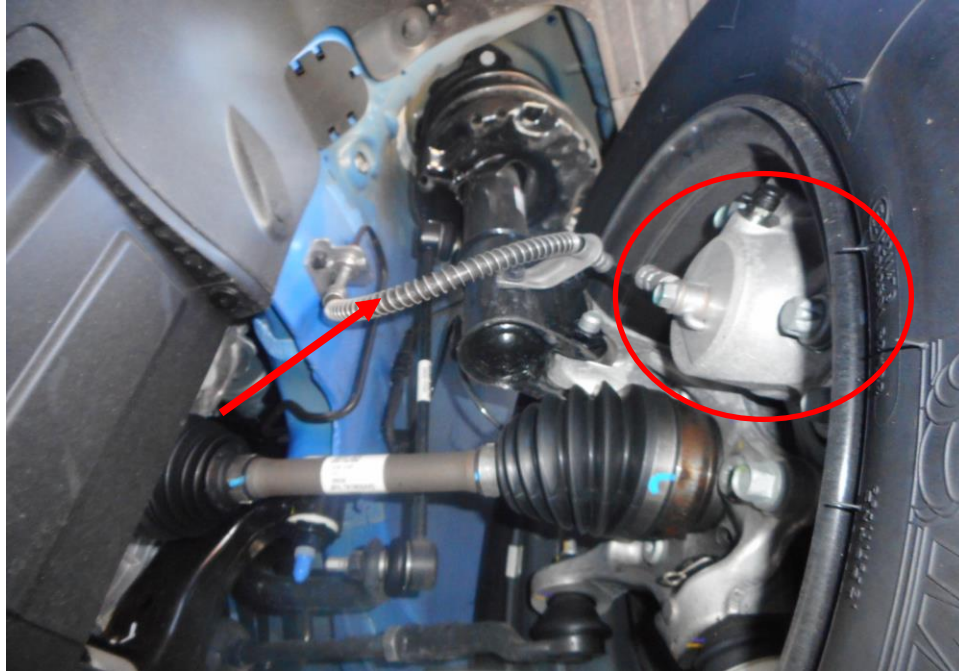
**Photo 20** shows the brake hose/pipe (arrowed) at the front right wheel of the Motor Taxi. No leakage of brake fluid was observed. Visual examination of the various components of the braking system like the brake caliper (circled), brake booster, brake pedal etc had revealed all to be intact and without visible damage at the time of accident. There was also no sign of fluid stain(s) observed on the various undercarriage components.

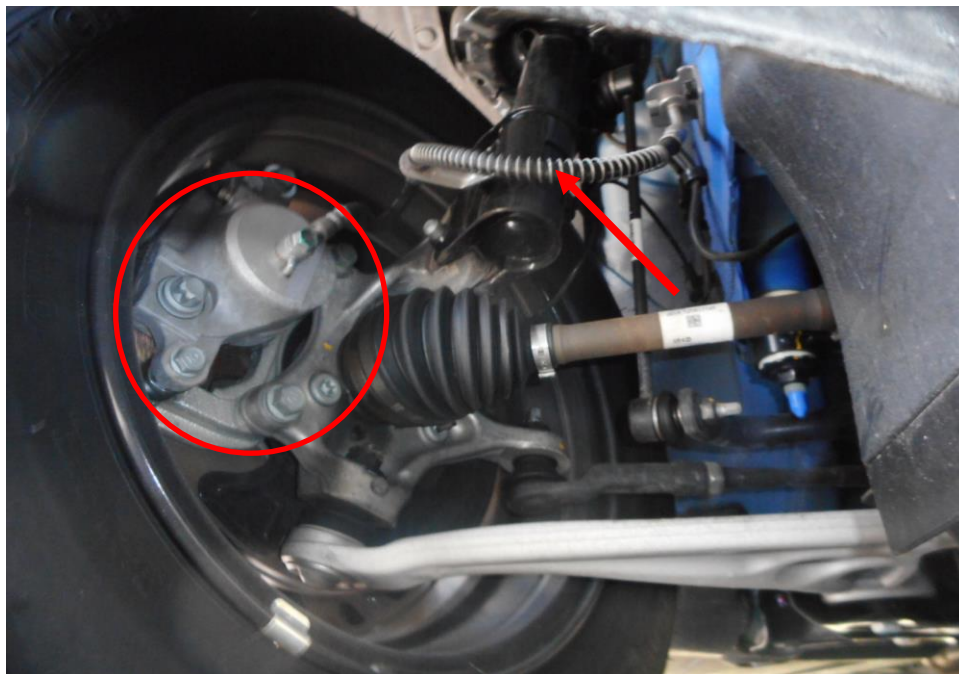
**Photo 21** shows the brake hose/pipe (arrowed) at the front left wheel of the Motor Taxi. No leakage of brake fluid was observed. Visual examination of the various components of the braking system like the brake caliper (circled), brake booster, brake pedal etc had revealed all to be intact and without visible damage at the time of accident. There was also no sign of fluid stain(s) observed on the various undercarriage components.

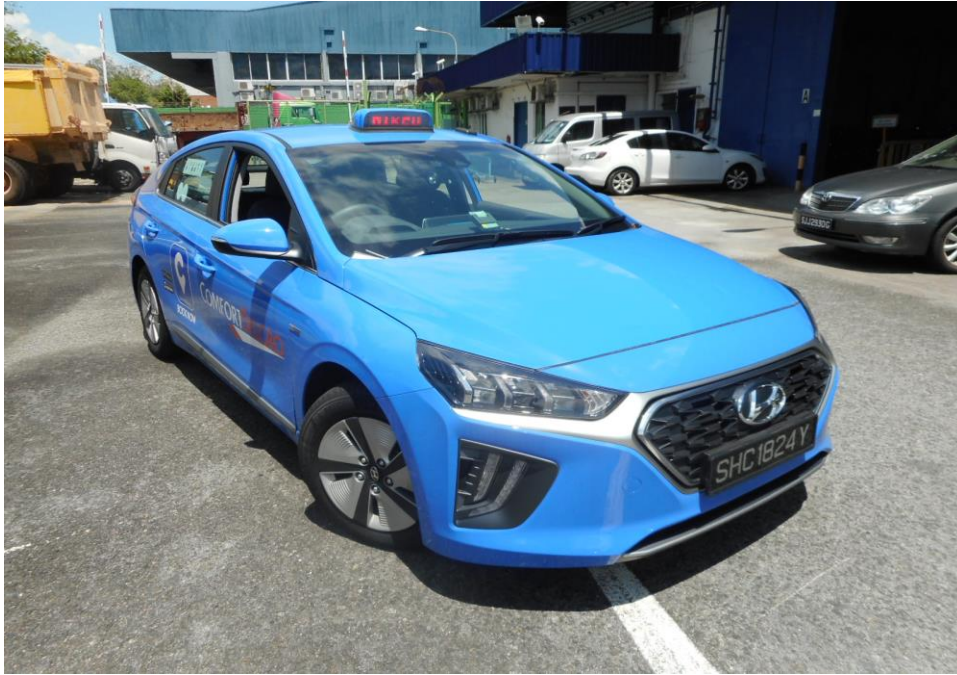
**Photo 22** shows the front right wheel of the Motor Taxi turned to its full left. During my steering system test, I did not experience any abnormal free play and/or resistance when I had turned the steering wheel towards full left and full right. This would suggest that the steering system of the Motor Taxi was likely to be in serviceable condition at the material time of accident.

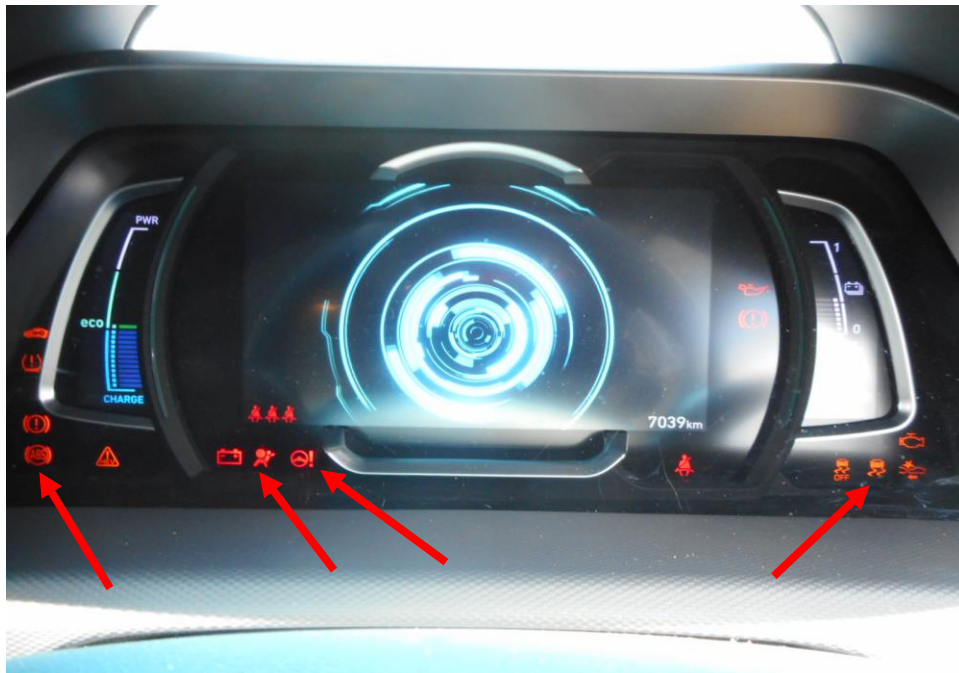
**Photo 23** shows the warning light for Anti-Lock Brake System (ABS), Supplemental Restraint System (SRS), Traction Control System (TC) and Electric Power Steering System (EPS) appearing on the instrument panel of the Motor Taxi during the self-test of its various electronic operating systems when its engine was cranked.

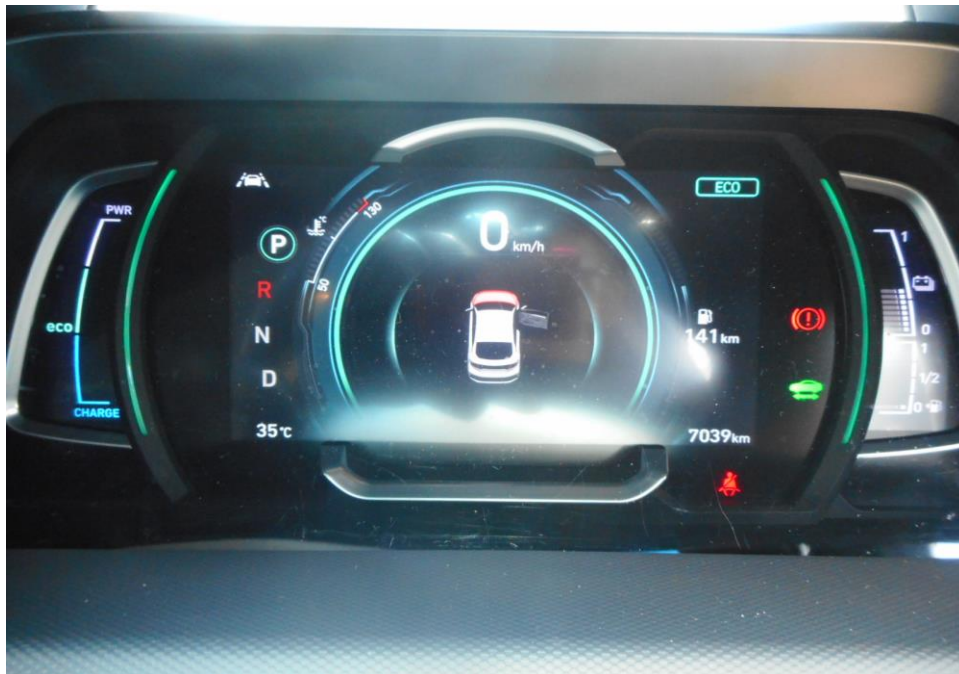
**Photo 24** shows no warning lights illuminated on the instrument panel of the Motor Taxi after the engine was cranked. This would suggest that there was no abnormality to the various electronic operating systems of the Motor Taxi, like the ABS, SRS, TC and EPS.
