Your Ref: TP/IP/18045/2020
Our Ref : CI/TPD20005594/P

9th September 2020

MECHANICAL INSPECTION REPORT OF MOTOR VAN GBC 6370C

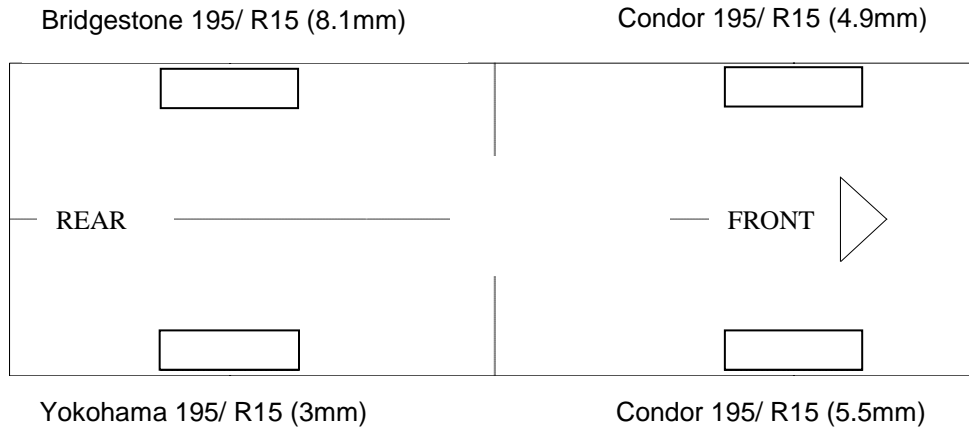
6. The 4 tyres of the Motor Van were observed to be in serviceable condition and sufficiently inflated for vehicular operation. I did not find any tear, cut or burst mark(s) on the outer and the inner sidewalls as well as across the tread of the 4 tyres. The tyre brand, tyre size and remaining tread depth of the 4 tyres of the Motor Van were recorded as follows:-

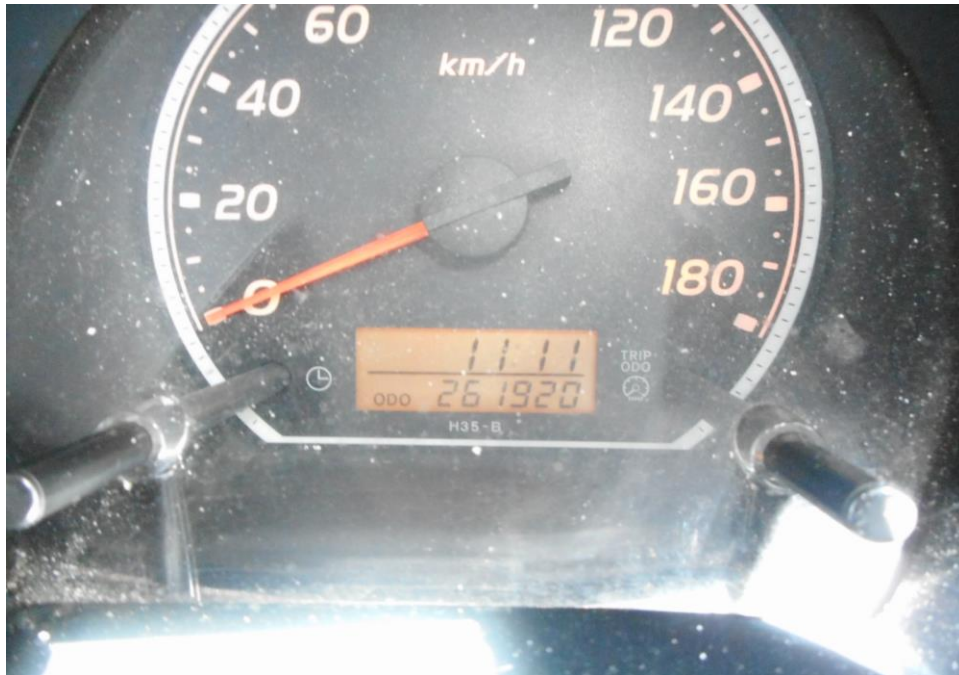
Photo 1 shows a general view of the instrument cluster of the Motor Van at the time of my inspection. The mileage of the Motor Van was 261,920km

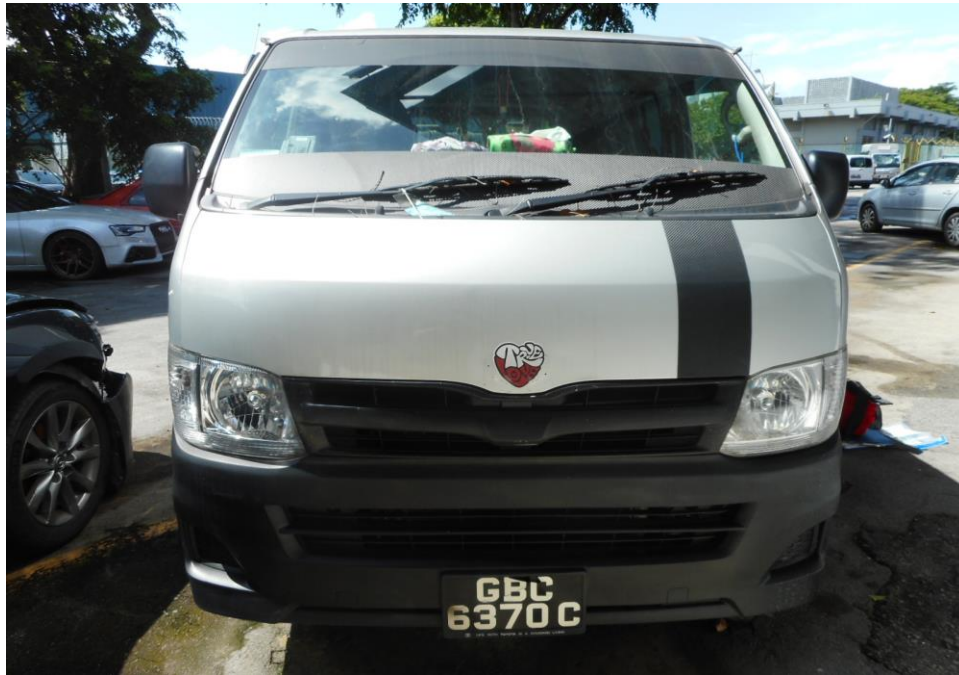
Photo 2 shows a general view of the Motor Van at the time of my inspection. The Motor Van was observed to be intact and unaffected by the accident.

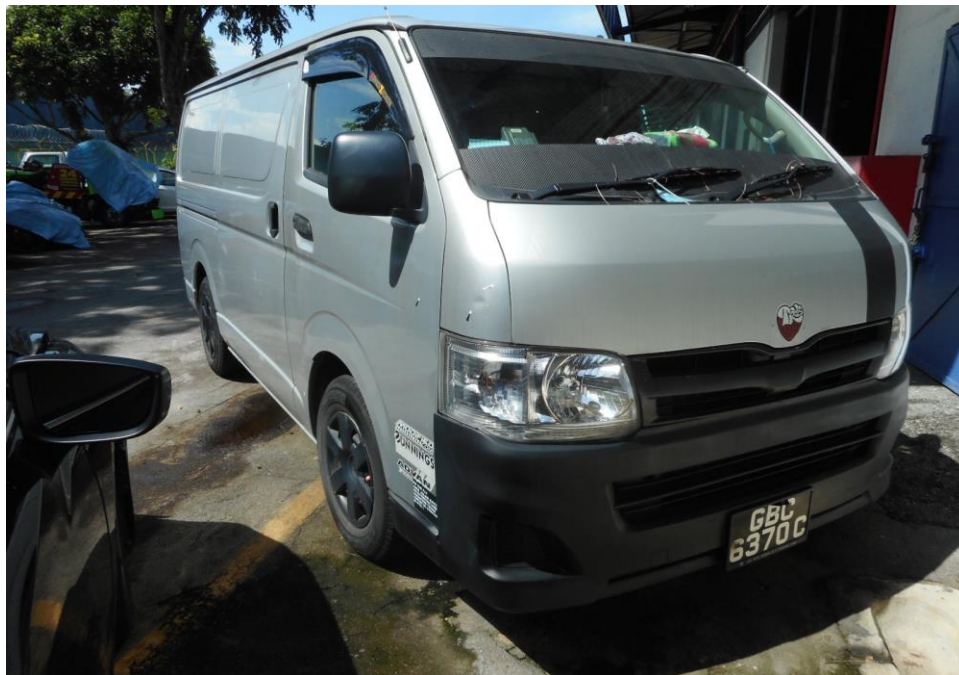
Photo 3 shows a general view of the right body of the Motor Van at the time of my inspection. The Motor Van was observed to be intact and unaffected by the accident.

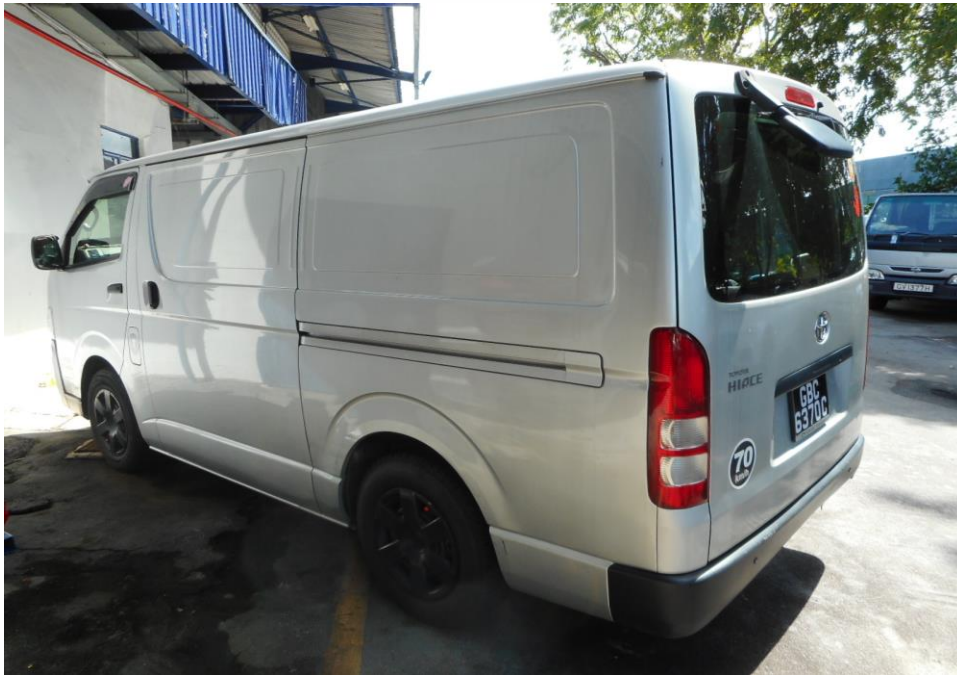
Photo 4 shows a general view of the left body of the Motor Van at the time of my inspection. The Motor Van was observed to be intact and unaffected by the accident.

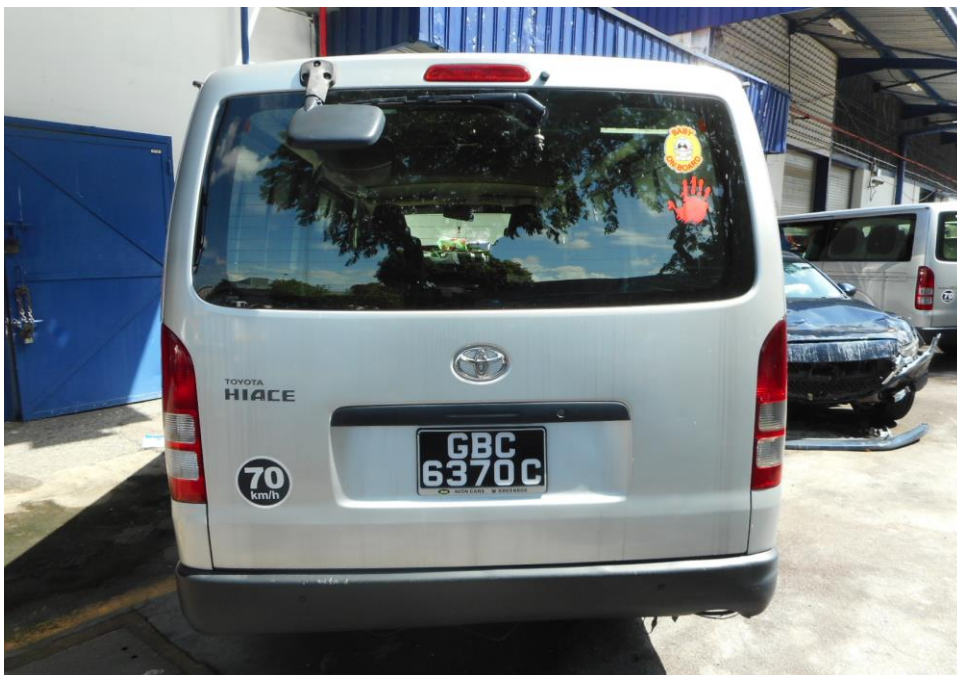
Photo 5 shows a general view of the rear body of the Motor Van at the time of my inspection. The Motor Van was observed to be intact and unaffected by the accident.

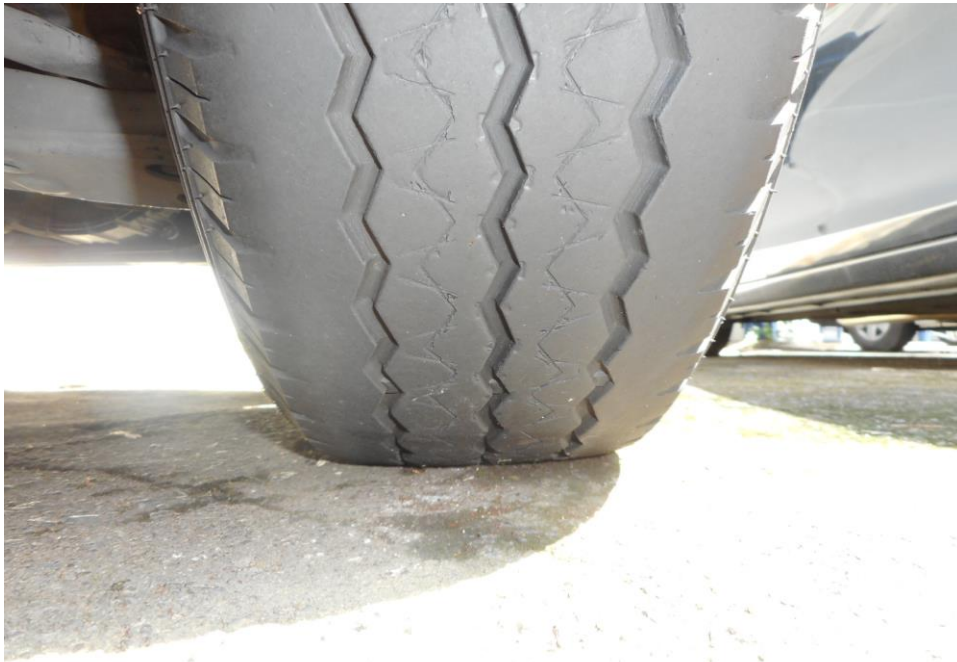
Photo 6 shows the condition of the front right tyre of the Motor Van, which was observed to be in serviceable condition with remaining tread depth of approximately 5.5mm. The tyre, which was wrapped around standard alloy wheel rim, was also observed to be sufficiently inflated for vehicular operation. There was no tear, cut or burst mark(s) on the outer and the inner sidewalls as well as across the tread of the 4 tyres that were fitted on the Motor Van.

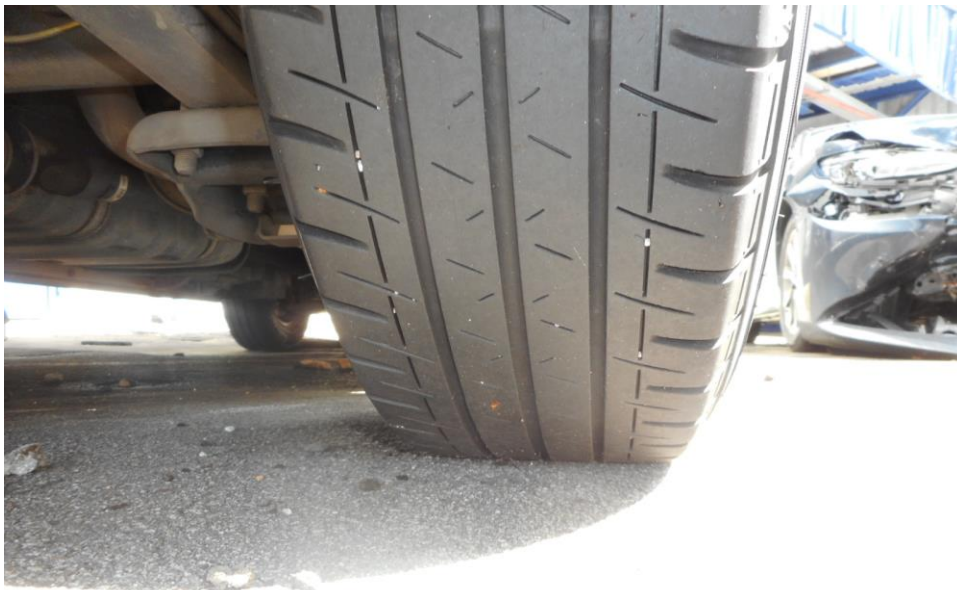
Photo 7 shows the condition of the rear right tyre of the Motor Van, which was observed to be in serviceable condition with remaining tread depth of approximately 3mm. The tyre, which was wrapped around standard alloy wheel rim, was also observed to be sufficiently inflated for vehicular operation.

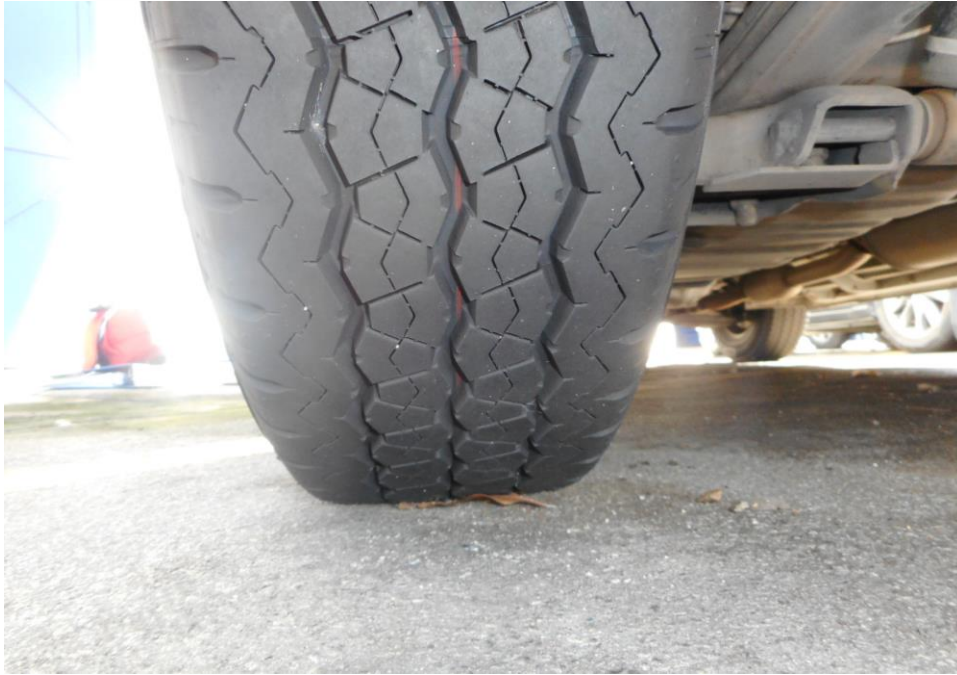
Photo 8 shows the condition of the rear left tyres of the Motor Van, which was observed to be in serviceable condition with remaining tread depth of approximately 8.1mm. The tyres, which were wrapped around standard alloy wheel rim, were also observed to be sufficiently inflated for vehicular operation. There was also no damage found on all 4 alloy wheel rims of the Motor Van.

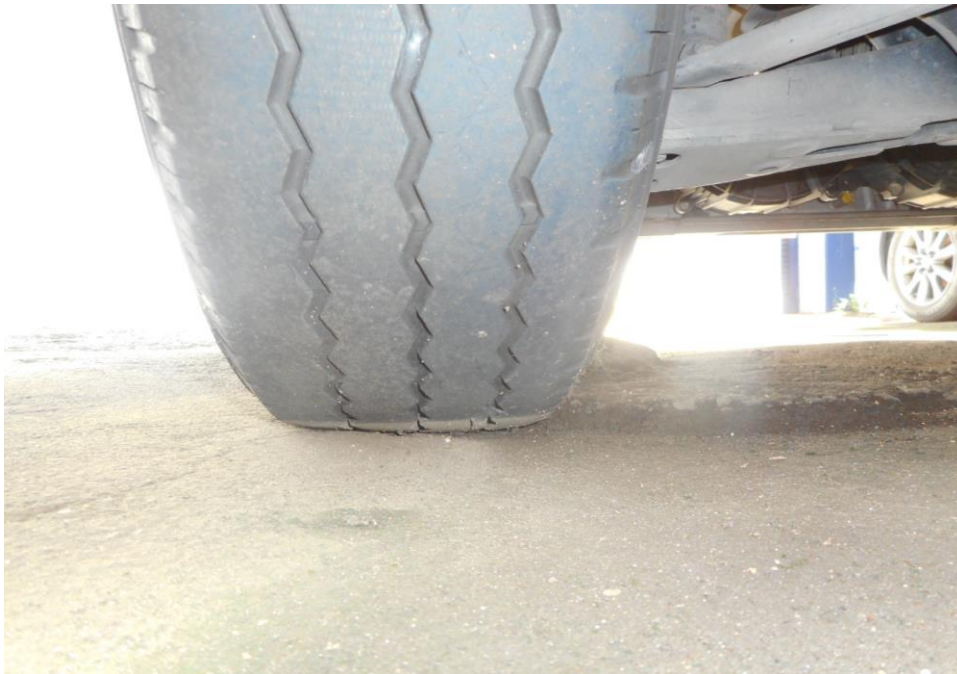
Photo 9 shows the condition of the rear right tyres of the Motor Van, which were observed to be in serviceable condition with remaining, tread depth of approximately 4.9mm. There was also no tear, cut or burst mark(s) on the outer and the inner sidewalls as well as across the tread of the 4 tyres that were fitted on the Motor Van.

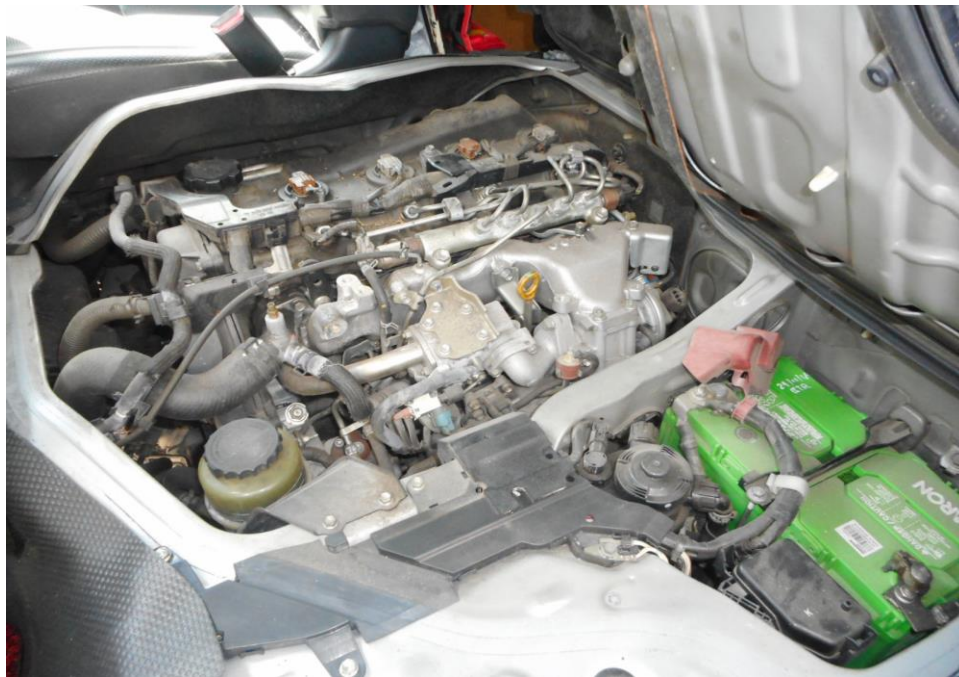
Photo 10 shows a general view of the Motor Van's engine compartment, which was accessed by lifting the front cabin of the Motor Van. The various parts and components inside the engine compartment were unaffected by the accident. There was also no sign(s) or indication(s) of fresh fluid leakage and/or fluid stain within the engine compartment

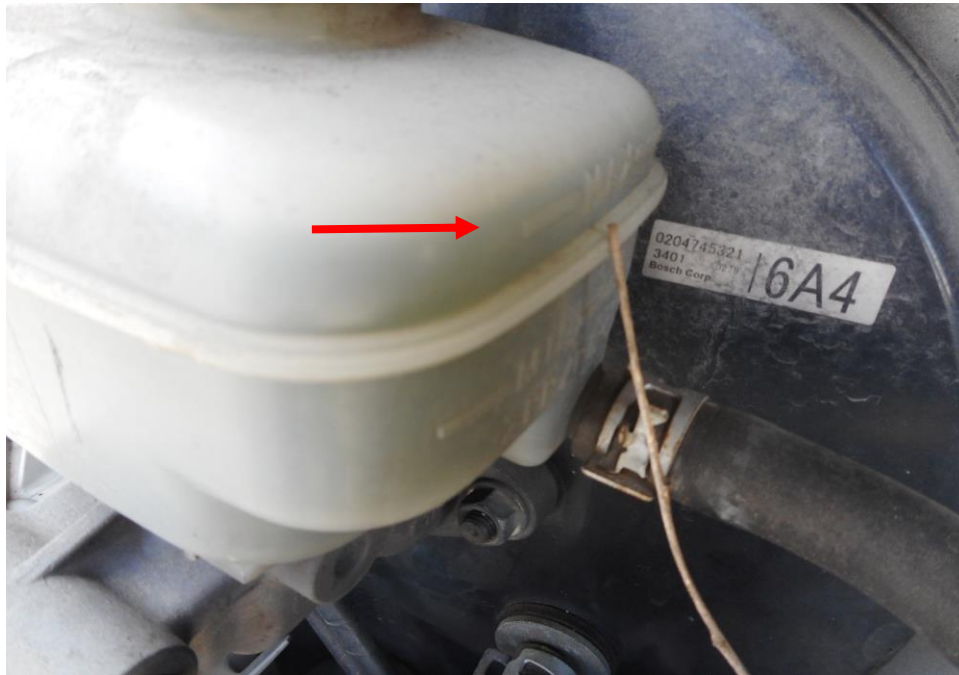
Photo 11 shows the brake fluid reservoir of the Motor Van at the time of my inspection. The brake fluid was observed to be of sufficient level (arrowed) and without any visible contamination.

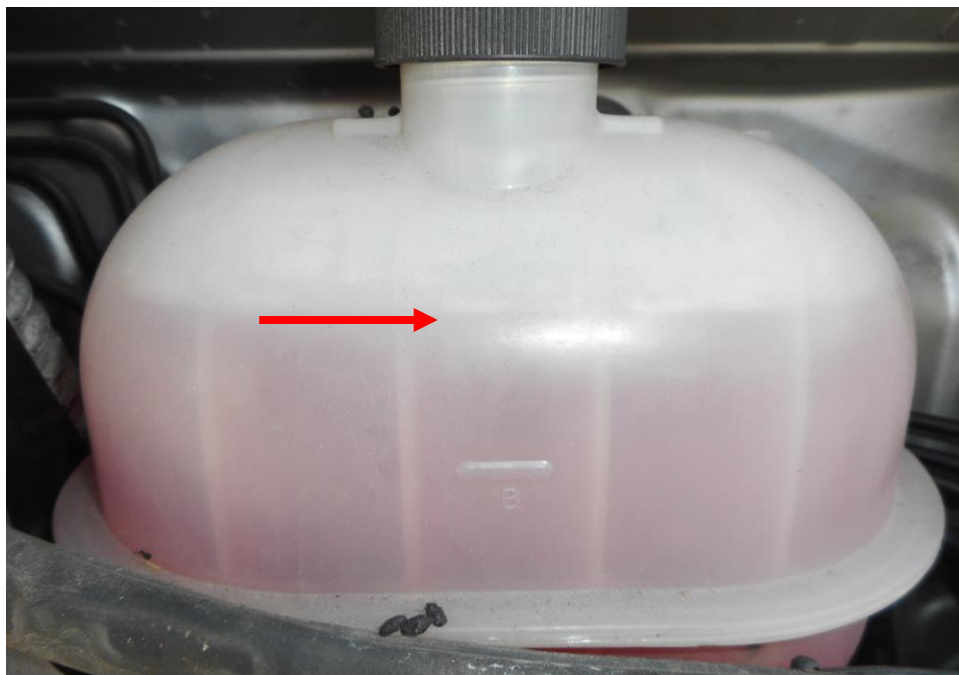
Photo 12 shows the engine coolant reservoir of the Motor Van at the time of my inspection. The engine coolant was observed to be of sufficient level (arrowed) and without any visible contamination.

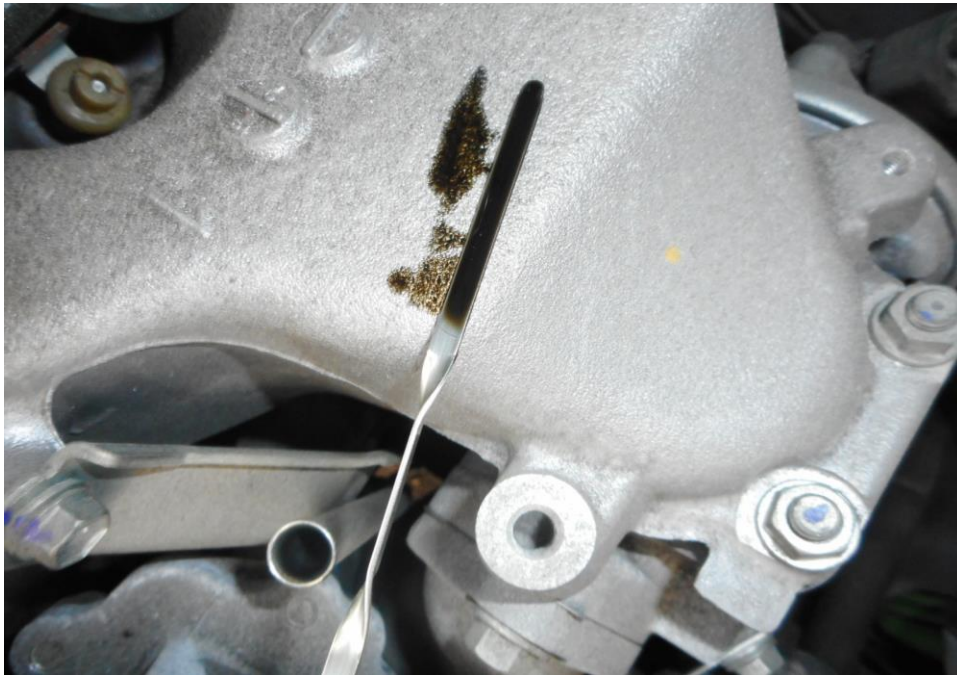
Photo 13 shows the engine oil dip stick of the Motor Van at the time of my inspection. The engine oil was observed to be of sufficient level and without any visible contamination.

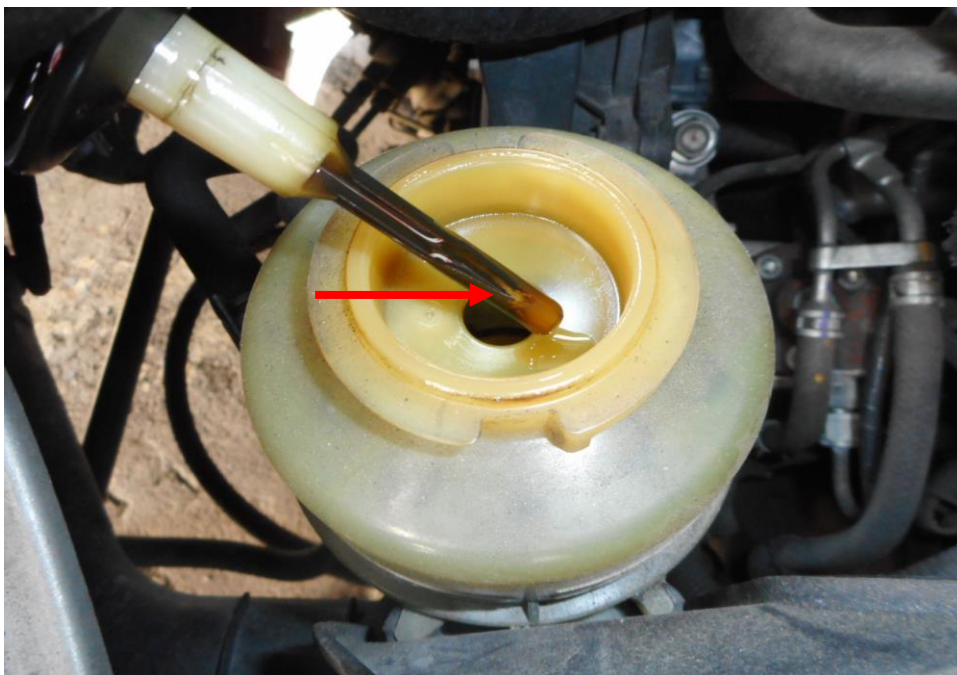
Photo 14 shows the power steer fluid reservoir of the Motor Van at the time of my inspection. The power steering fluid was observed to be of sufficient level (arrowed) and without any visible contamination.

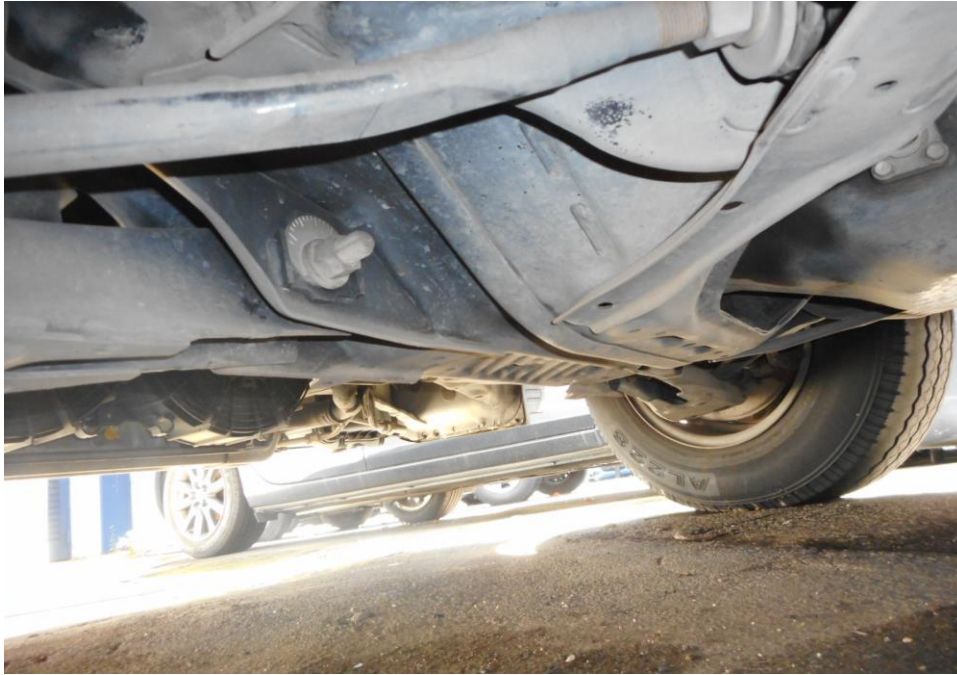
Photo 15 shows the undercarriage of the Motor Van, at the area where the engine housing and transmission housing are located. . I did not find any sign(s) or indication(s) of fluid leak and/or fluid stain(s) on the underside of the Motor Van.

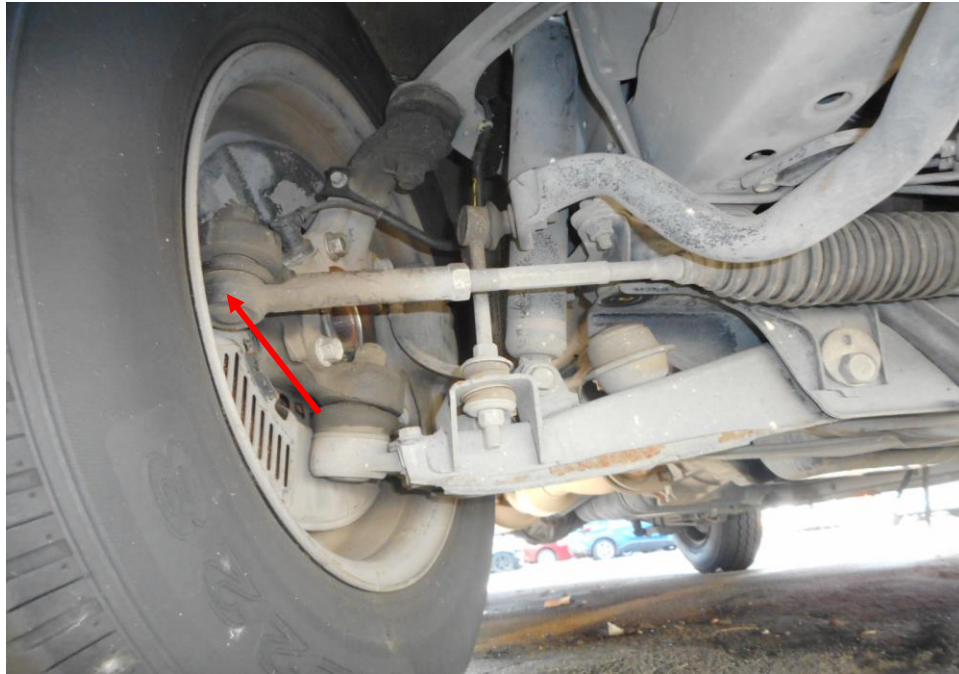
Photo 16 shows the various undercarriage components at the front right wheel of the Motor Van, in particular the steering tie rod end (arrowed). The various steering components were all found to be intact, suggesting that the steering system of the Motor Van was likely to be in serviceable condition at the material time of accident. There was also no sign of fluid stain(s) observed on the various undercarriage components.

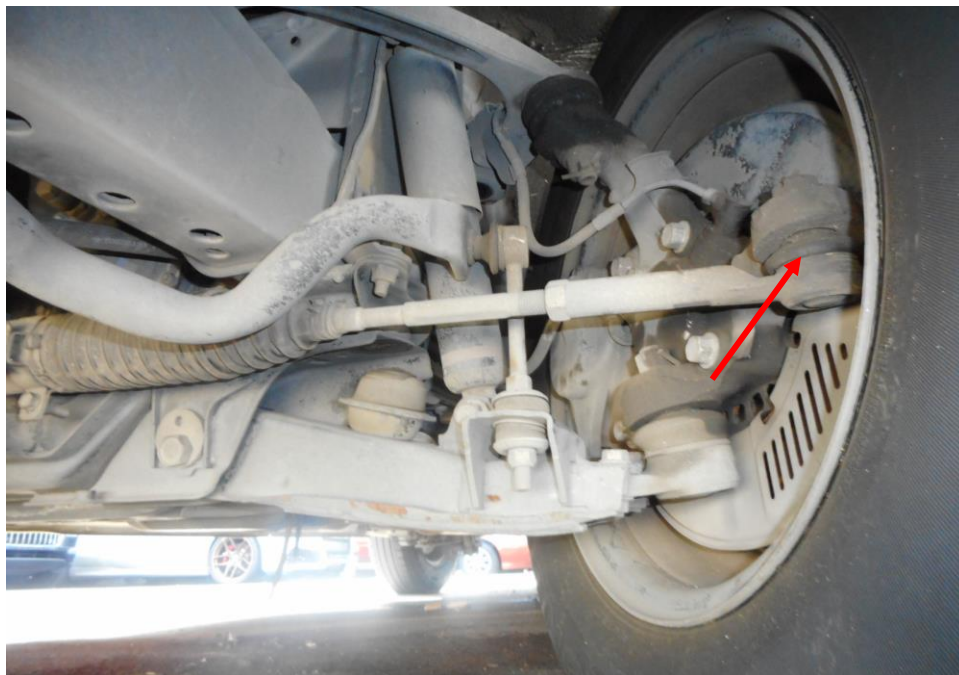
Photo 17 shows the various undercarriage components at the front left wheel of the Motor Van, in particular the steering tie rod end (arrowed). The various Undercarriage components of the Motor Van were all found to be intact without any visible damage. There was also no sign of fluid stain(s) observed on the various undercarriage components.

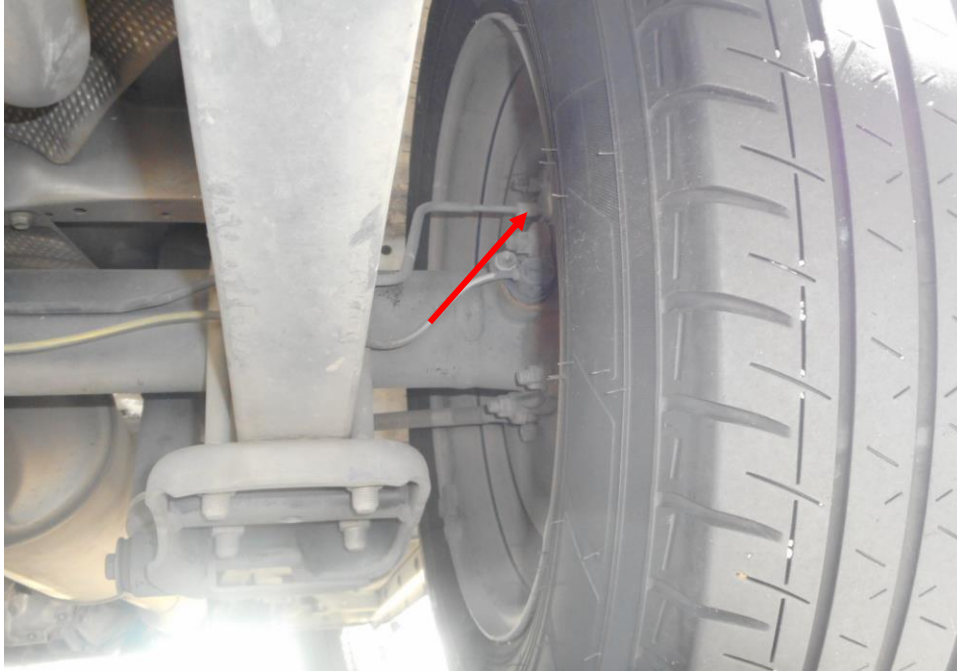
Photo 18 shows the brake pipe (arrowed) at the rear right wheel of the Motor Van. I did not observe any leakage of brake fluid at the time of my inspection of the Motor Van. My static tests of the Motor Van's braking system, along with my visual examination of the various mechanical components in the braking system, had indicated that there was no internal leakage of pressure/vacuum. Hence the braking system of the Motor Van was likely to be in serviceable condition at the material time of accident.

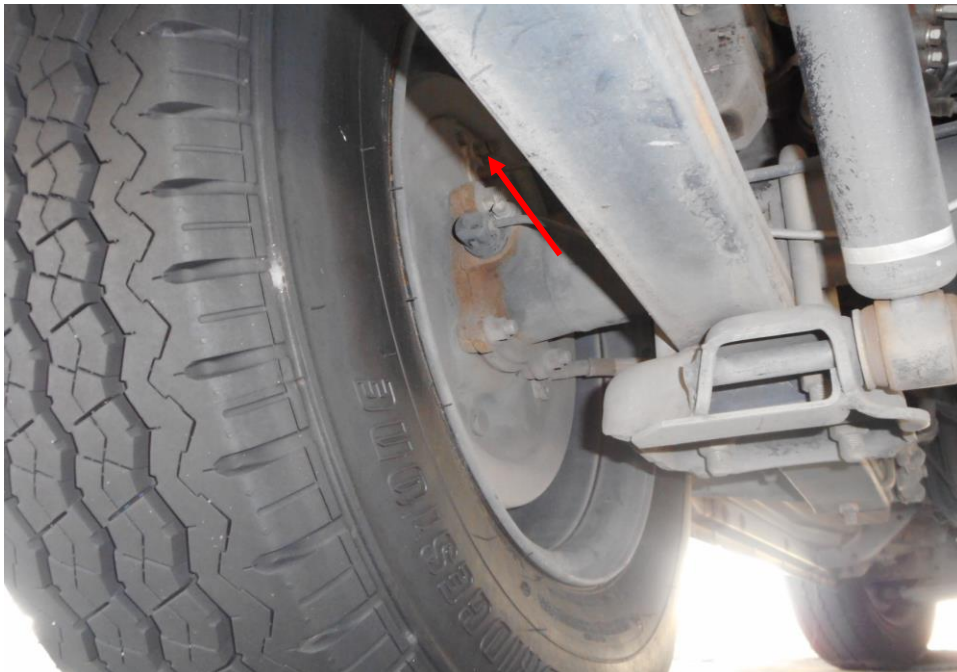
Photo 19 shows the brake pipe (arrowed) at the rear left wheel of the Motor Van. I did not observe any leakage of brake fluid at the time of my inspection of the Motor Van. My static tests of the Motor Van's braking system, along with my visual examination of the various mechanical components in the braking system had indicated that there was no internal leakage of pressure/vacuum. Hence the braking system of the Motor Van was likely to be in serviceable condition at the material time of accident.

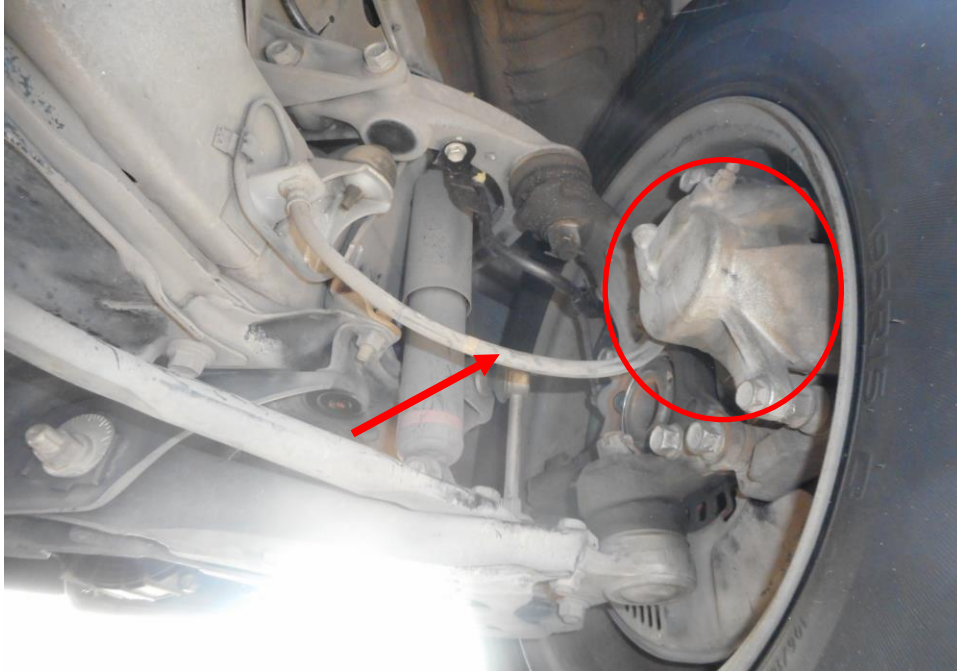
Photo 20 shows the brake hose/pipe (arrowed) at the front right wheel of the Motor Van. No leakage of brake fluid was observed. Visual examination of the various components of the braking system like the brake caliper (circled), brake booster, brake pedal etc had revealed all to be intact and without visible damage at the time of accident. There was also no sign of fluid stain(s) observed on the various undercarriage components.

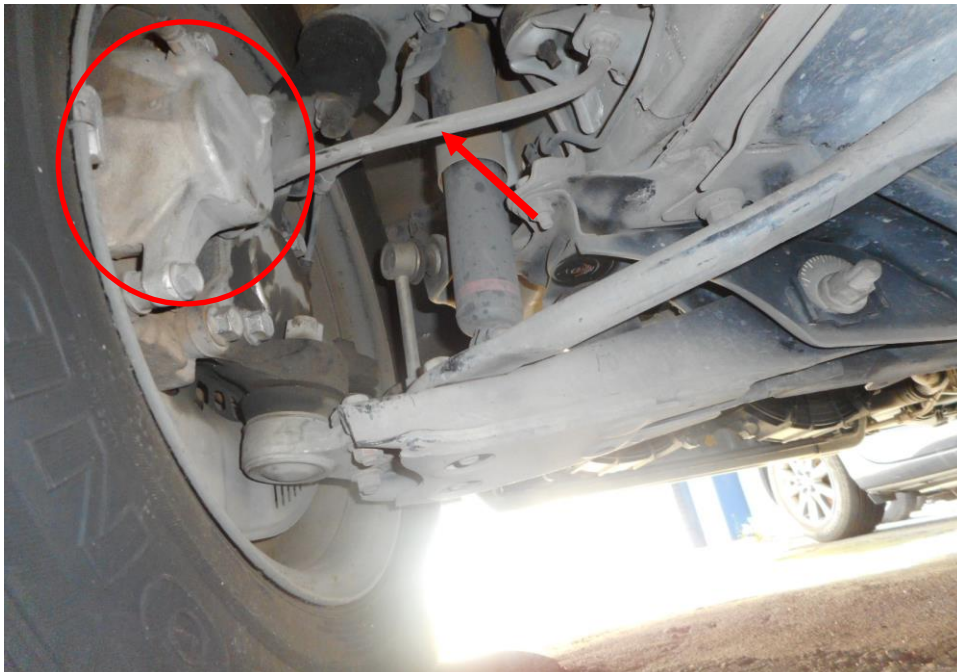
Photo 21 shows the brake hose/pipe (arrowed) at the front left wheel of the Motor Van. No leakage of brake fluid was observed. Visual examination of the various components of the braking system like the brake caliper (circled), brake booster, brake pedal etc had revealed all to be intact and without visible damage at the time of accident. There was also no sign of fluid stain(s) observed on the various undercarriage components.

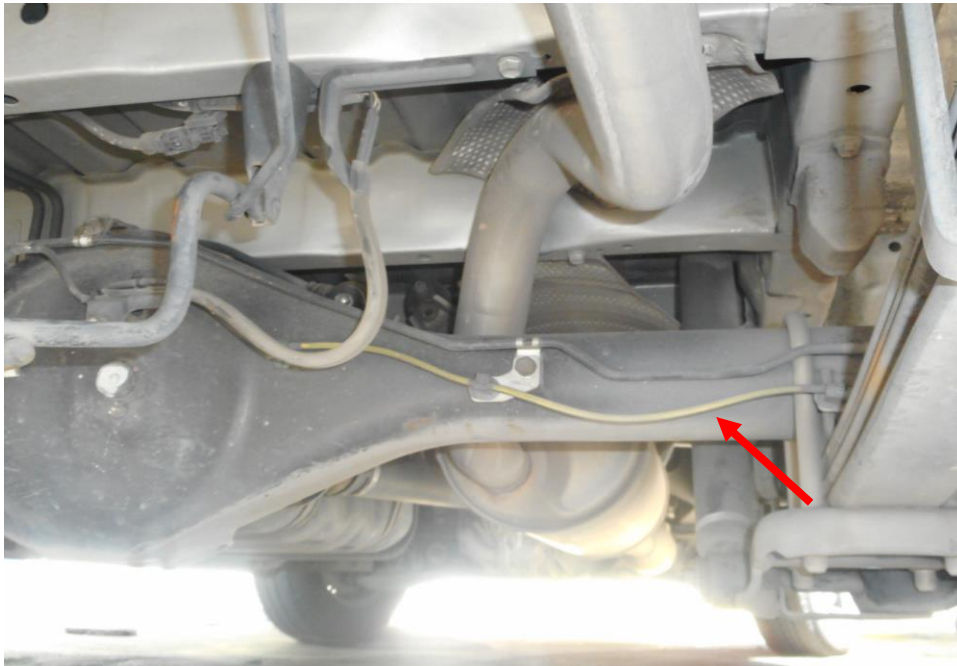
Photo 22 shows the various undercarriage components at the rear right wheel of the Motor Van, in particular the drive shaft (arrowed). The various steering components were all found to be intact, suggesting that the steering system of the Motor Van was likely to be in serviceable condition at the material time of accident. There was also no sign of fluid stain(s) observed on the various undercarriage components.

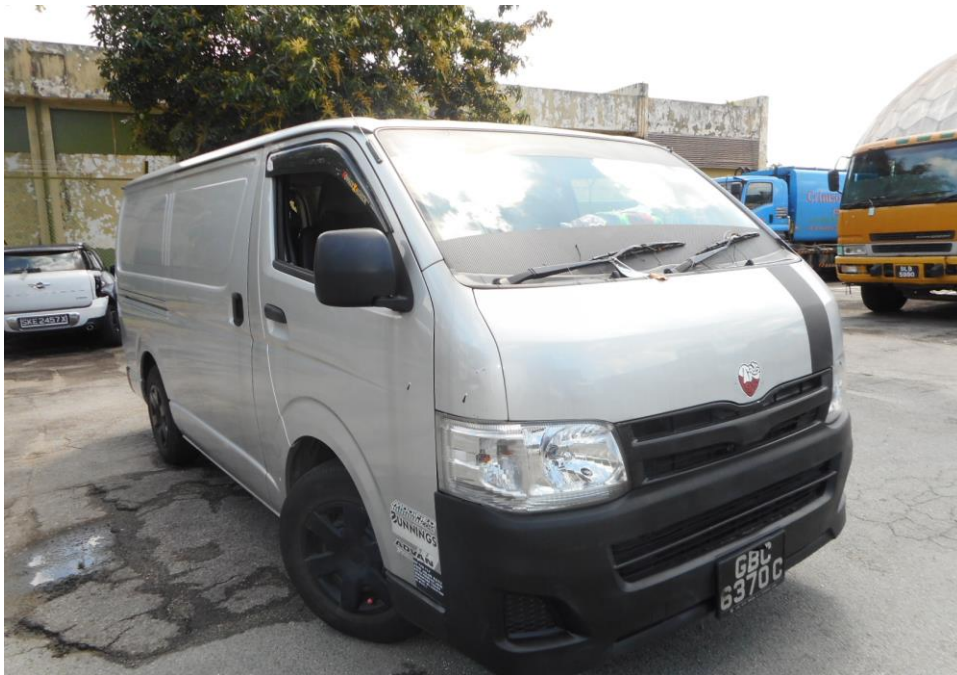
Photo 23 shows the front right wheel of the Motor Van turned to its full left. During my steering system test, I did not experience any abnormal free play and/or resistance when I had turned the steering wheel towards full left and full right. This would suggest that the steering system of the Motor Van was likely to be in serviceable condition at the material time of accident.

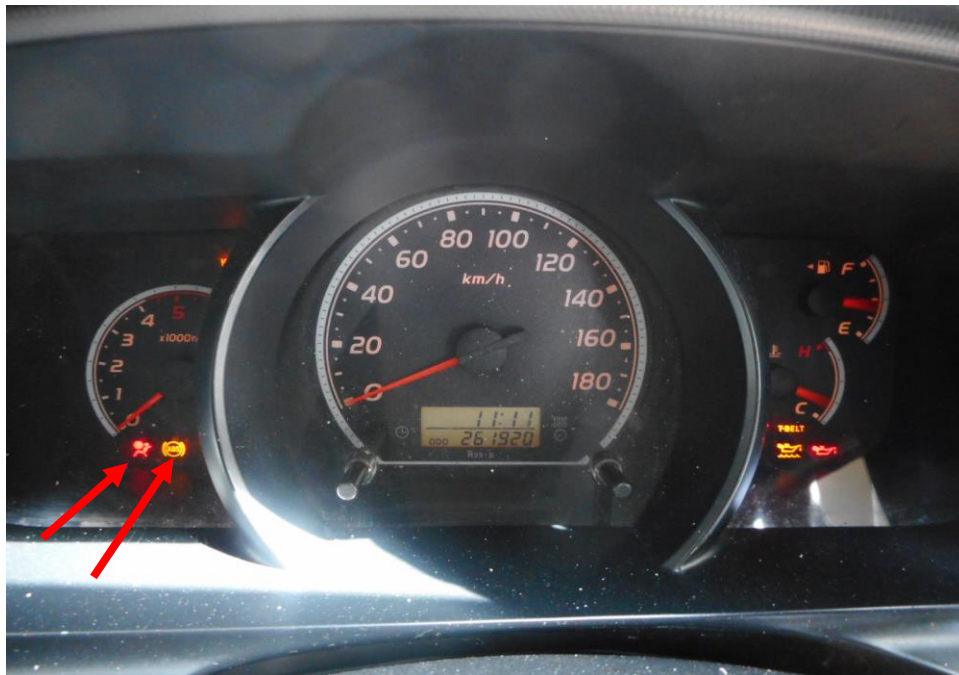
Photo 24 shows the warning light for Anti-Lock Brake System (ABS) and Supplemental Restraint System (SRS) appearing on the instrument panel of the Motor Van during the self-test of its various electronic operating systems when its engine was cranked.

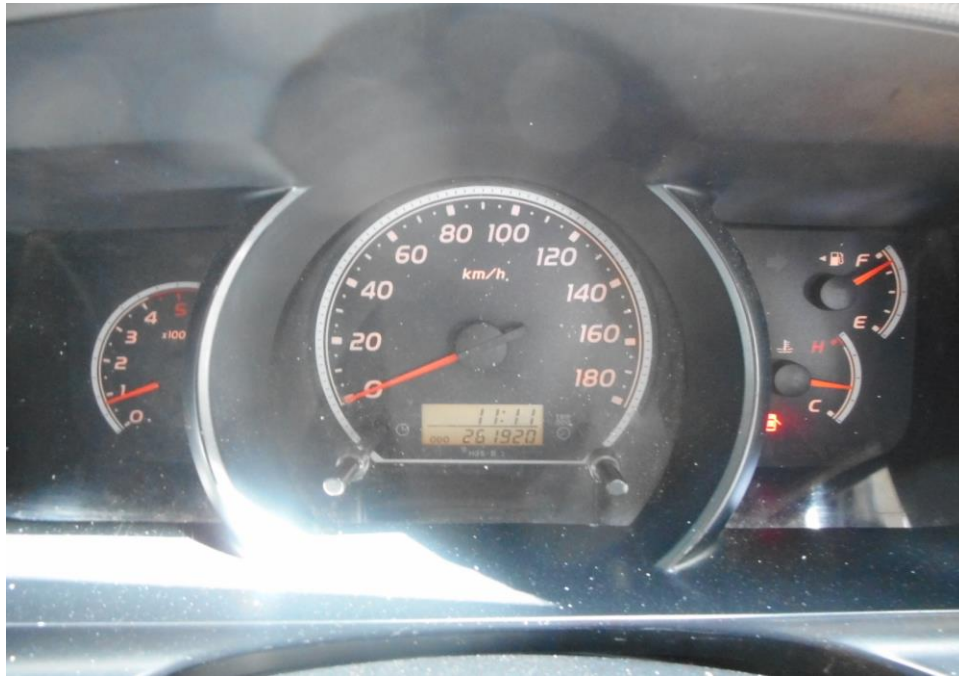
Photo 25 shows no warning lights illuminated on the instrument panel of the Motor Van after the engine was cranked. This would suggest that there was no abnormality to the various electronic operating systems of the Motor Van, like the ABS and SRS.
